July 15, 2024

CON0022166 Peace Region (Grande Prairie District – South) GRMP Instrumentation Monitoring Site GP034; H40:38, km 21.016 Slide South of Kakwa River Section C – 2024 Spring Readings

TITLE
 Site Plan
 GP034 - Slide South of Kakwa River
 Hwy 40:38, km 21.016

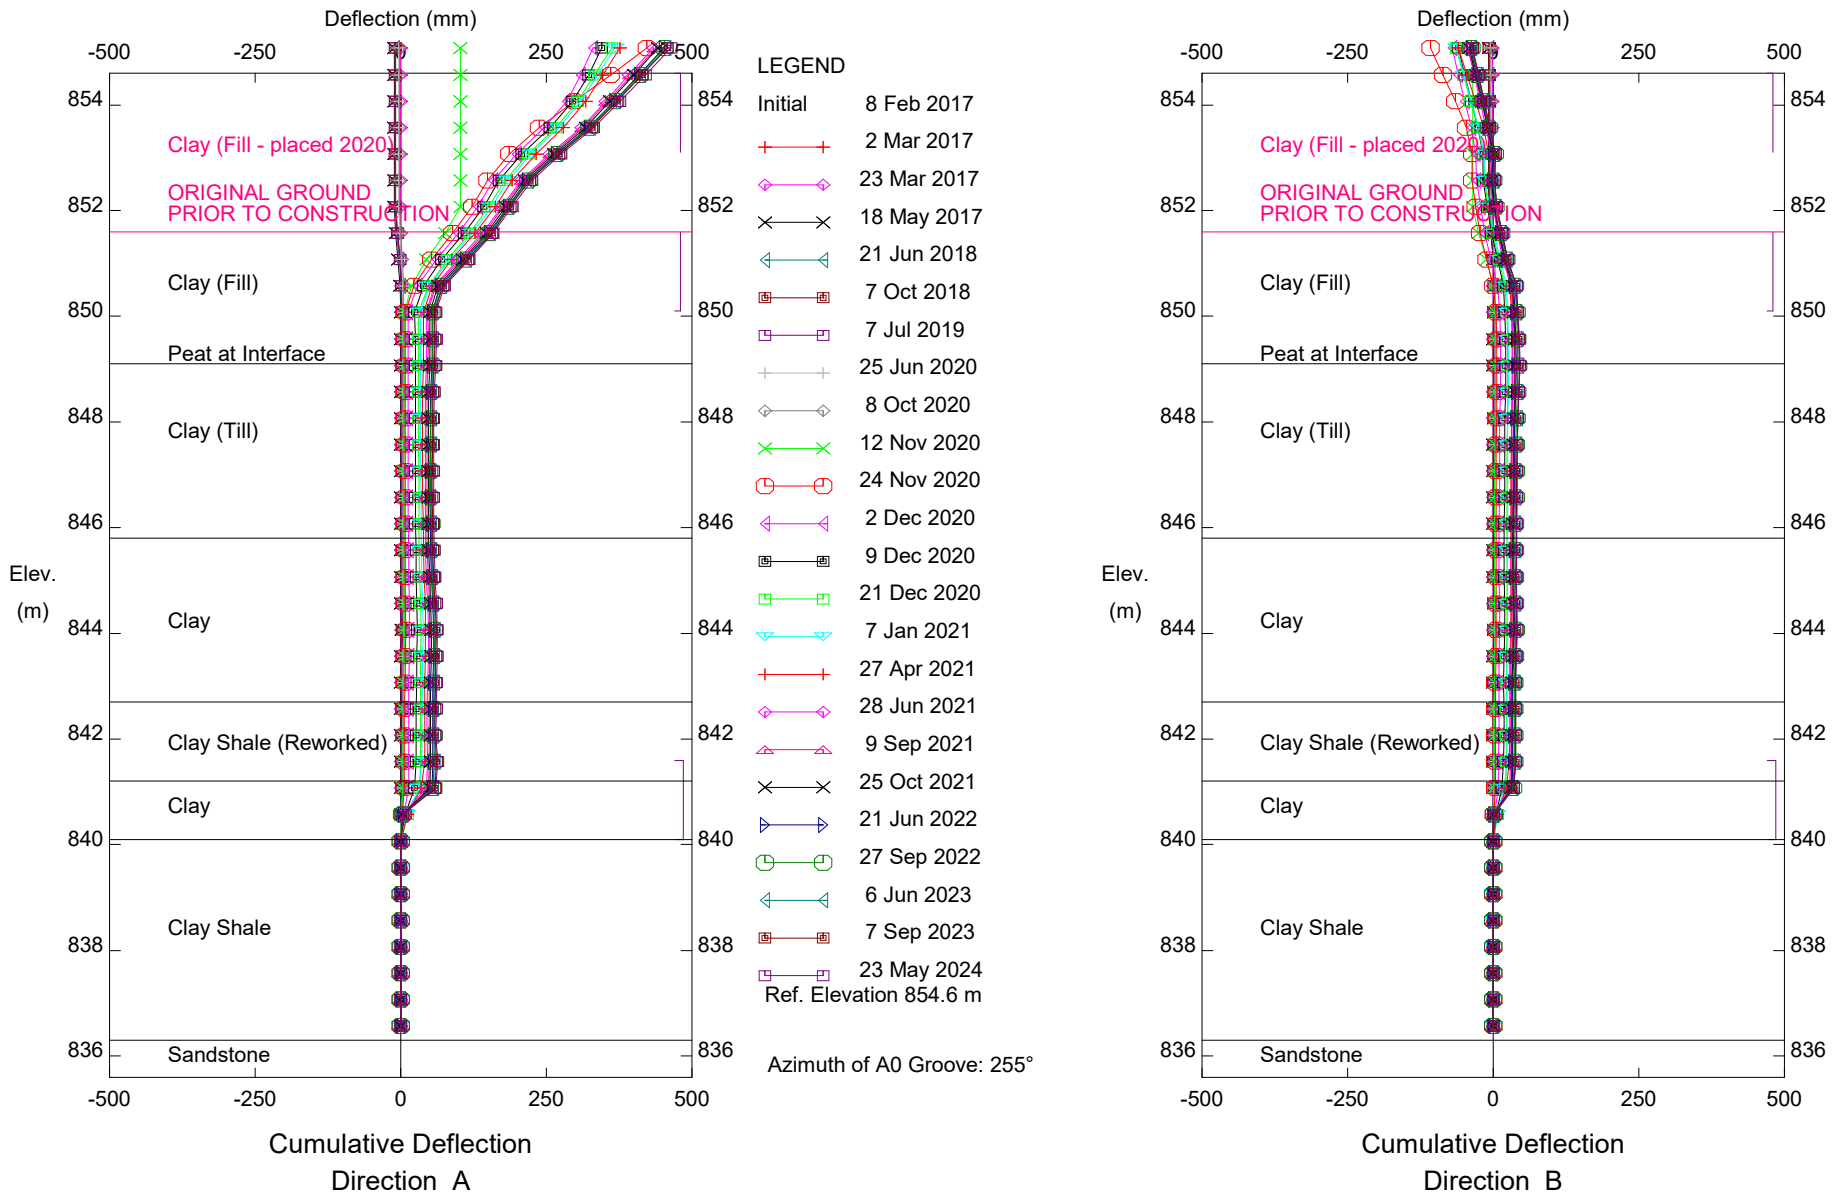
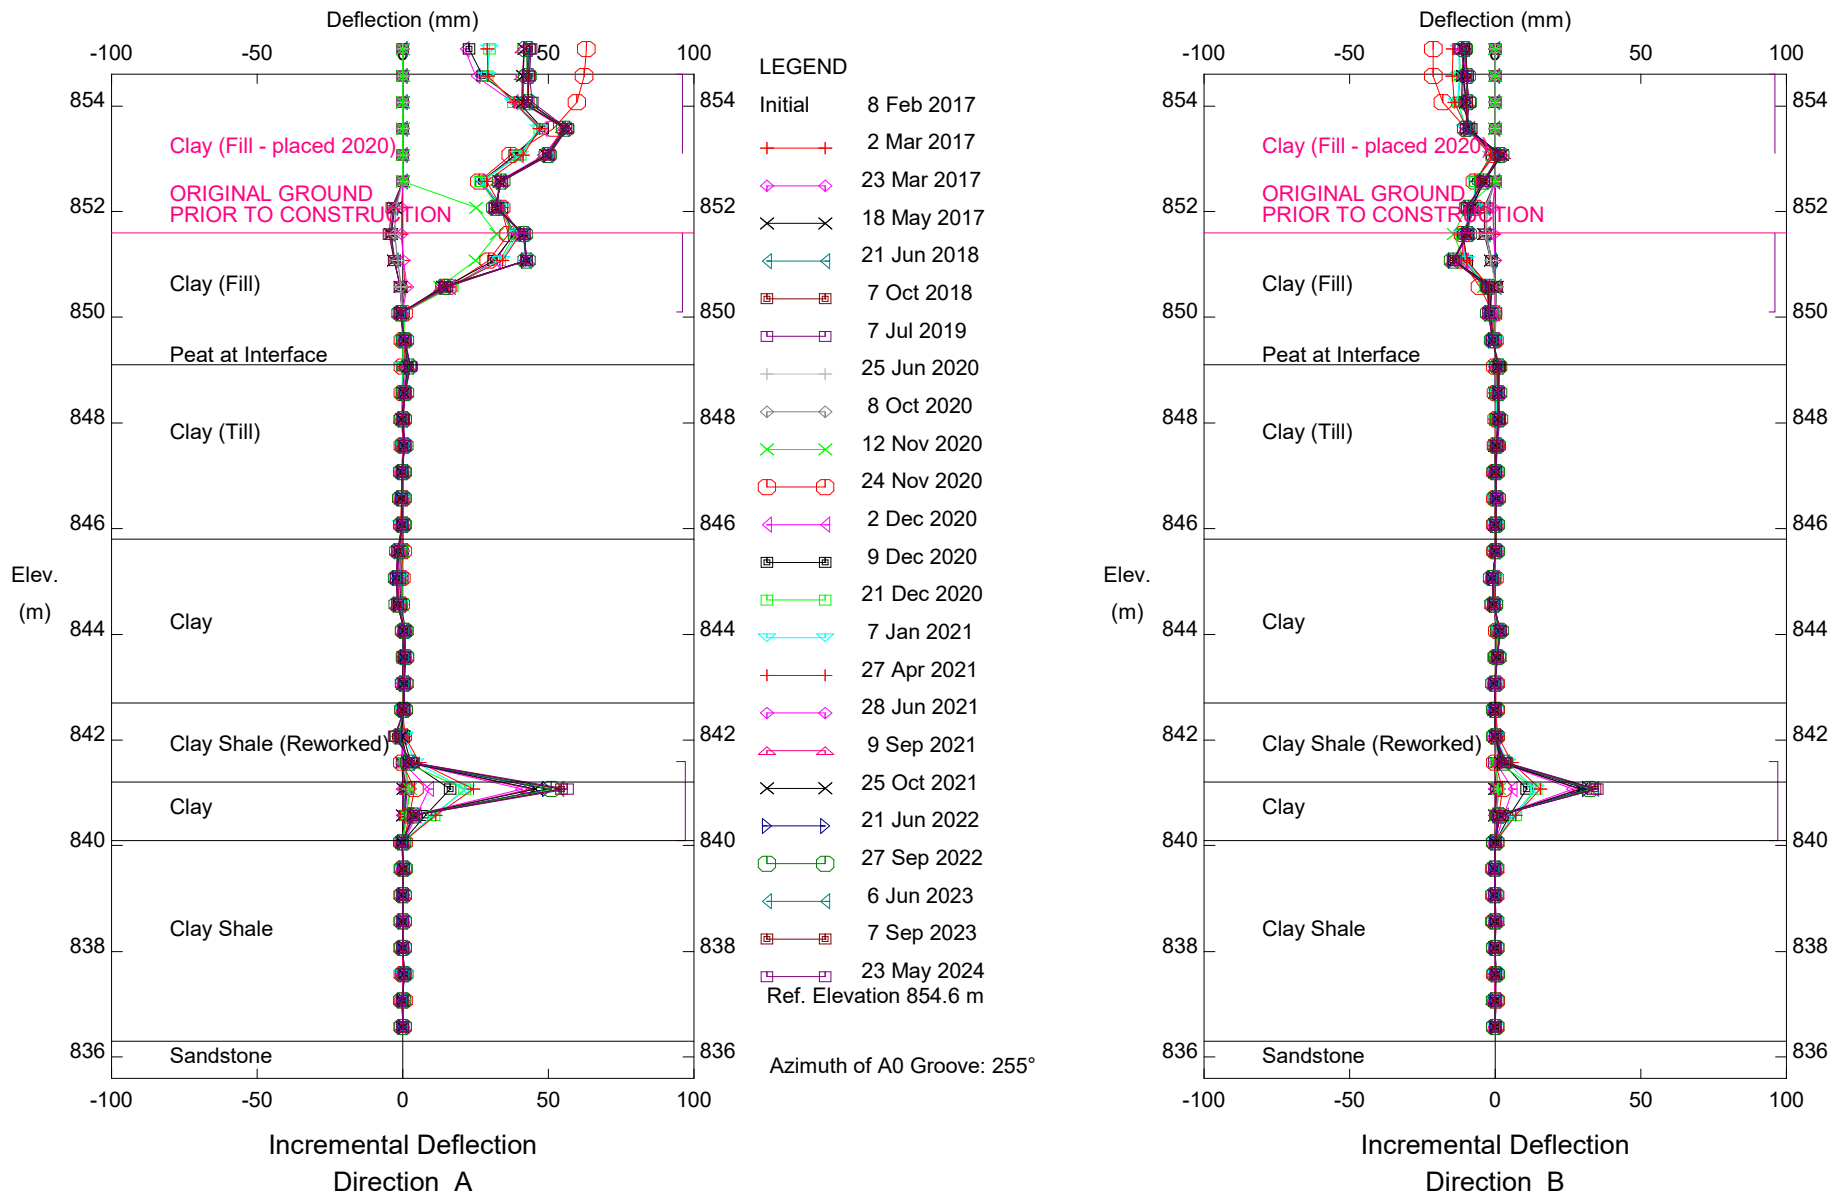
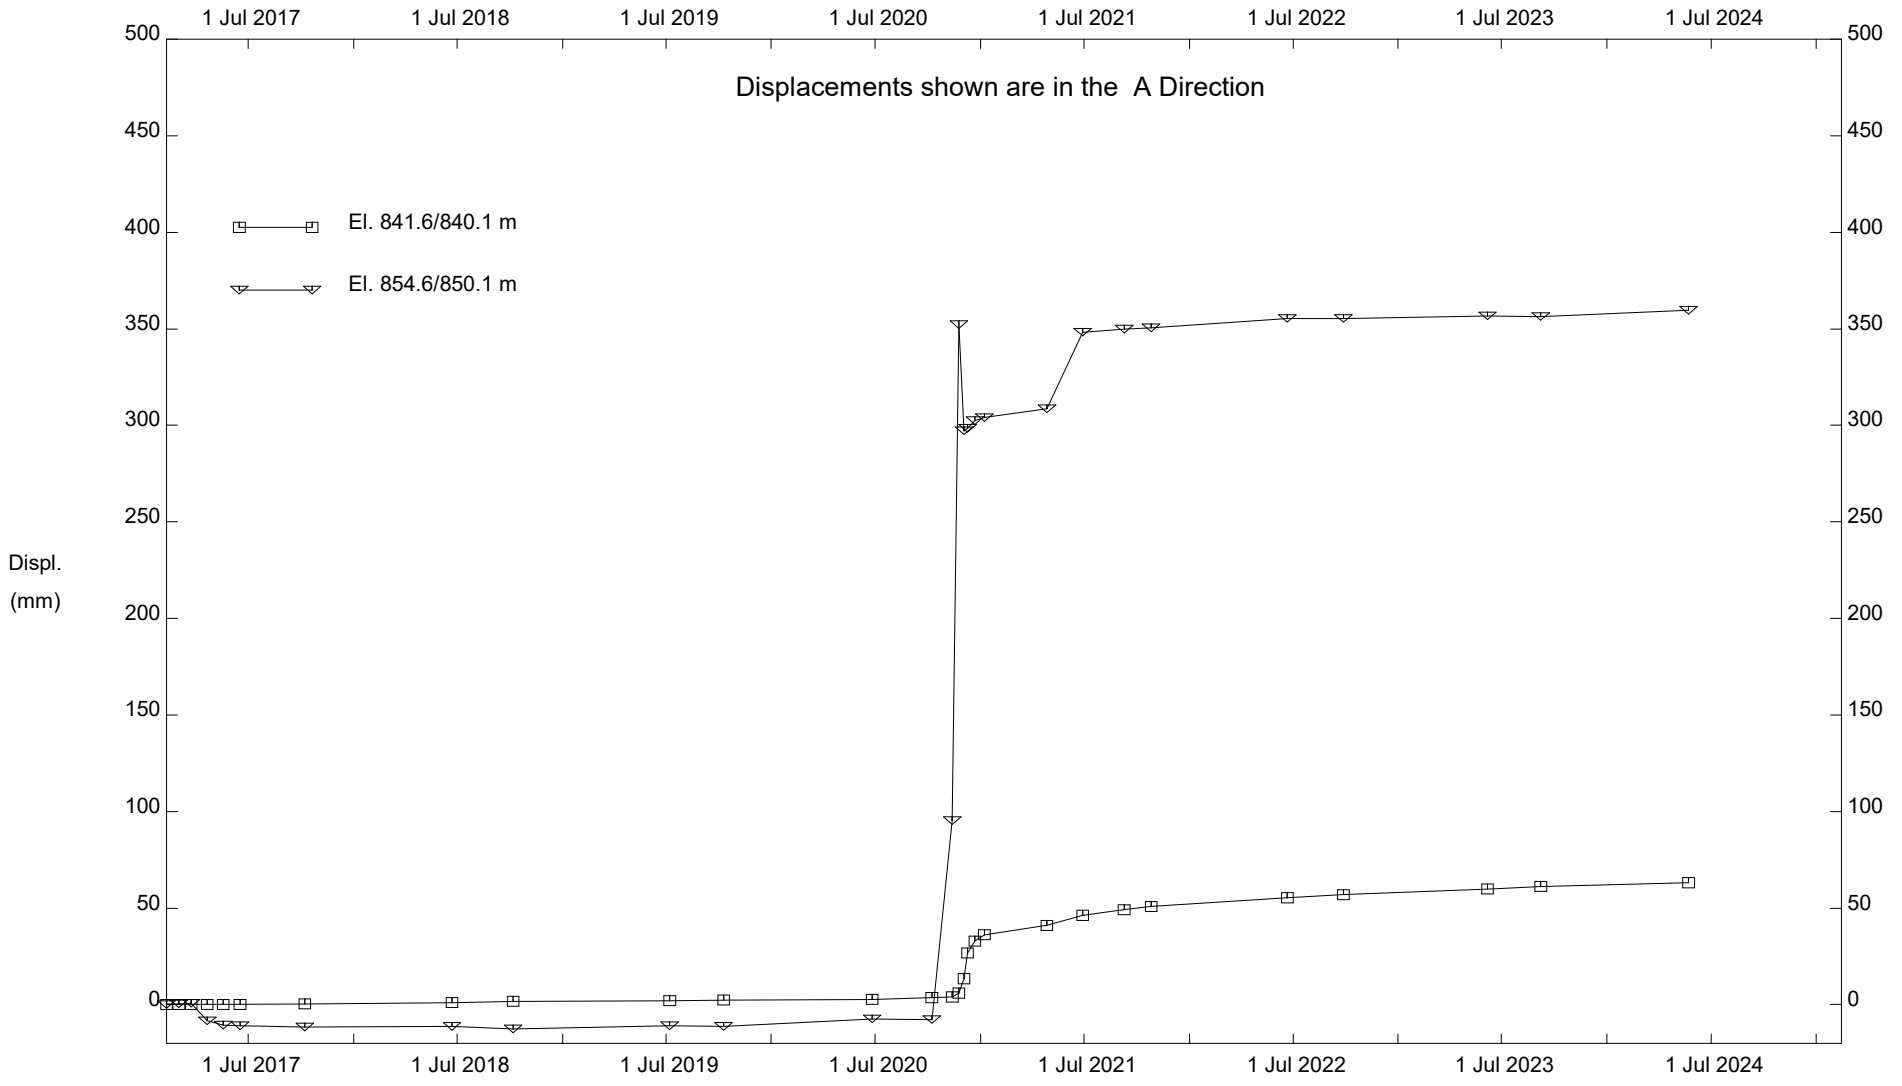
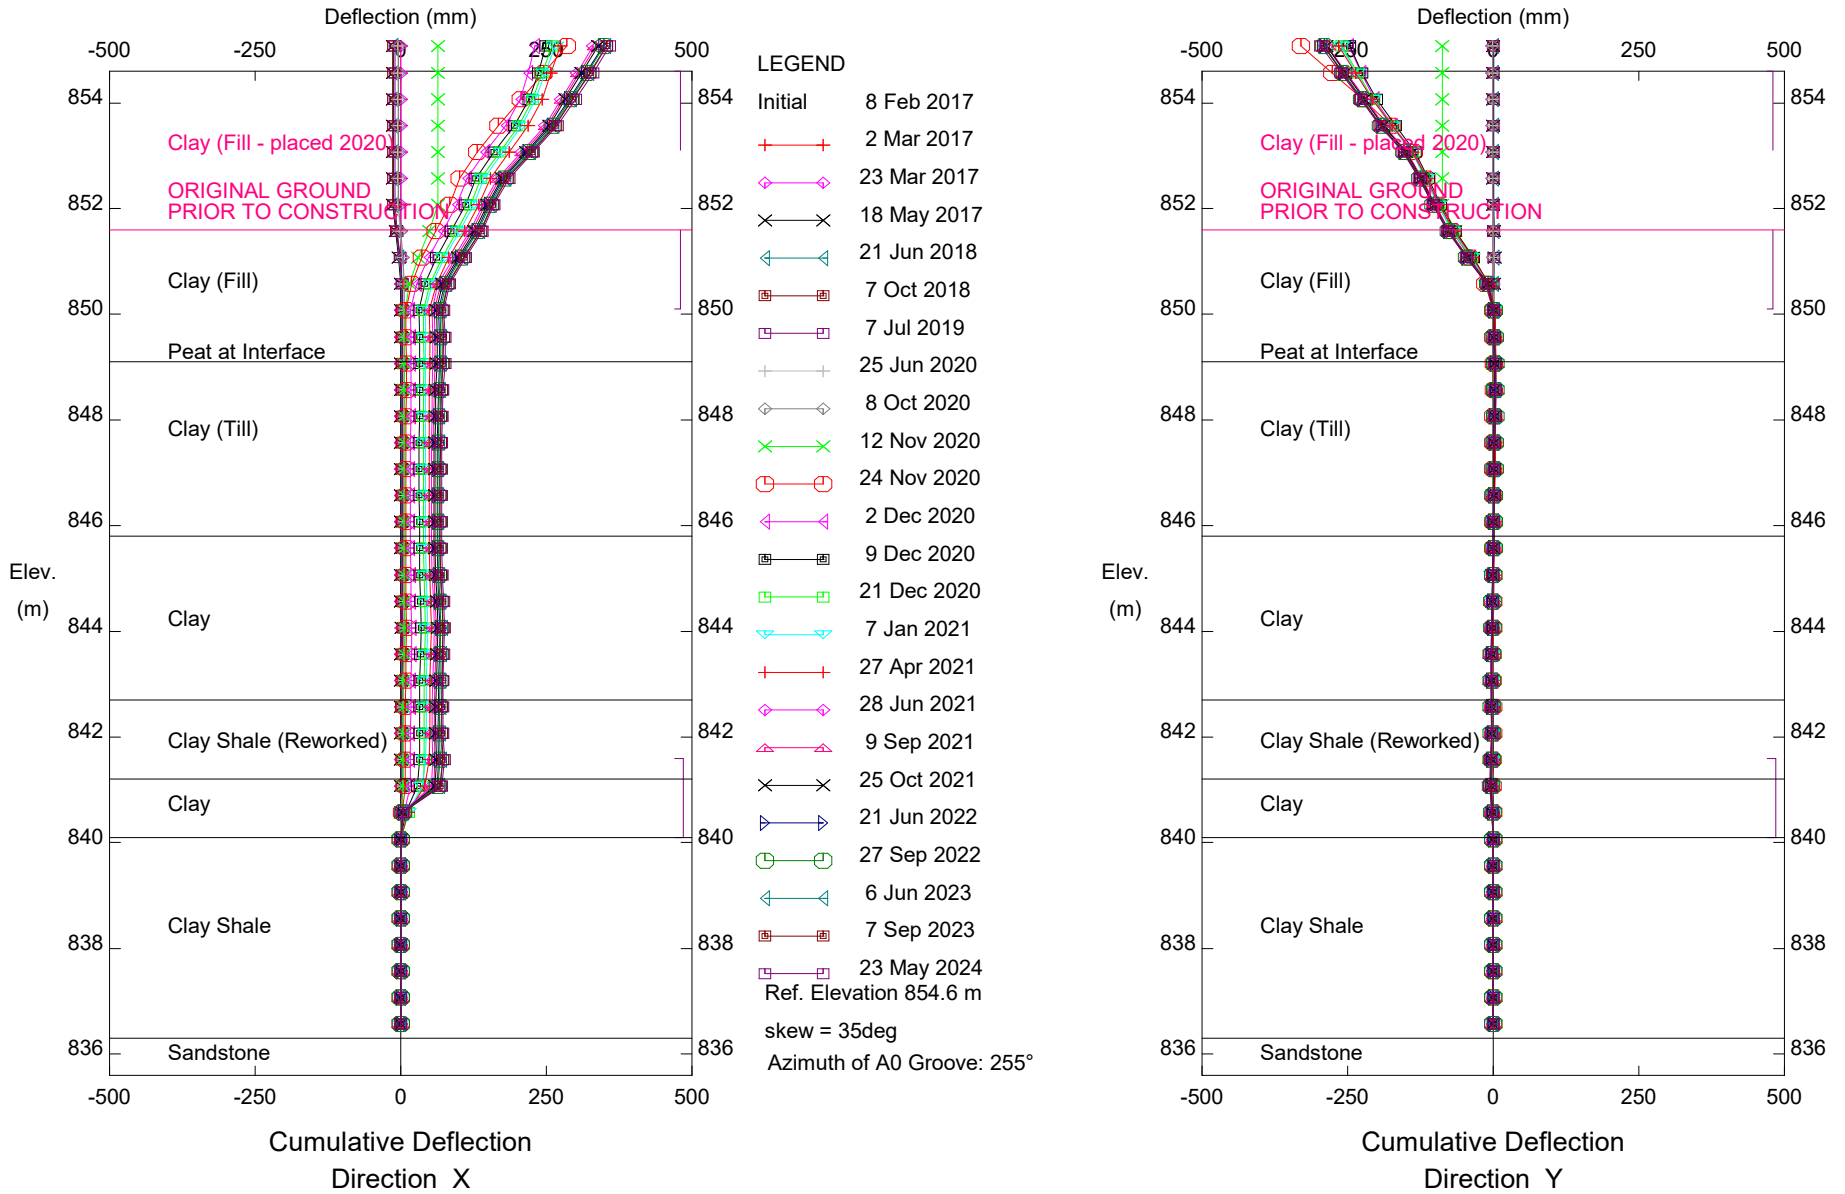
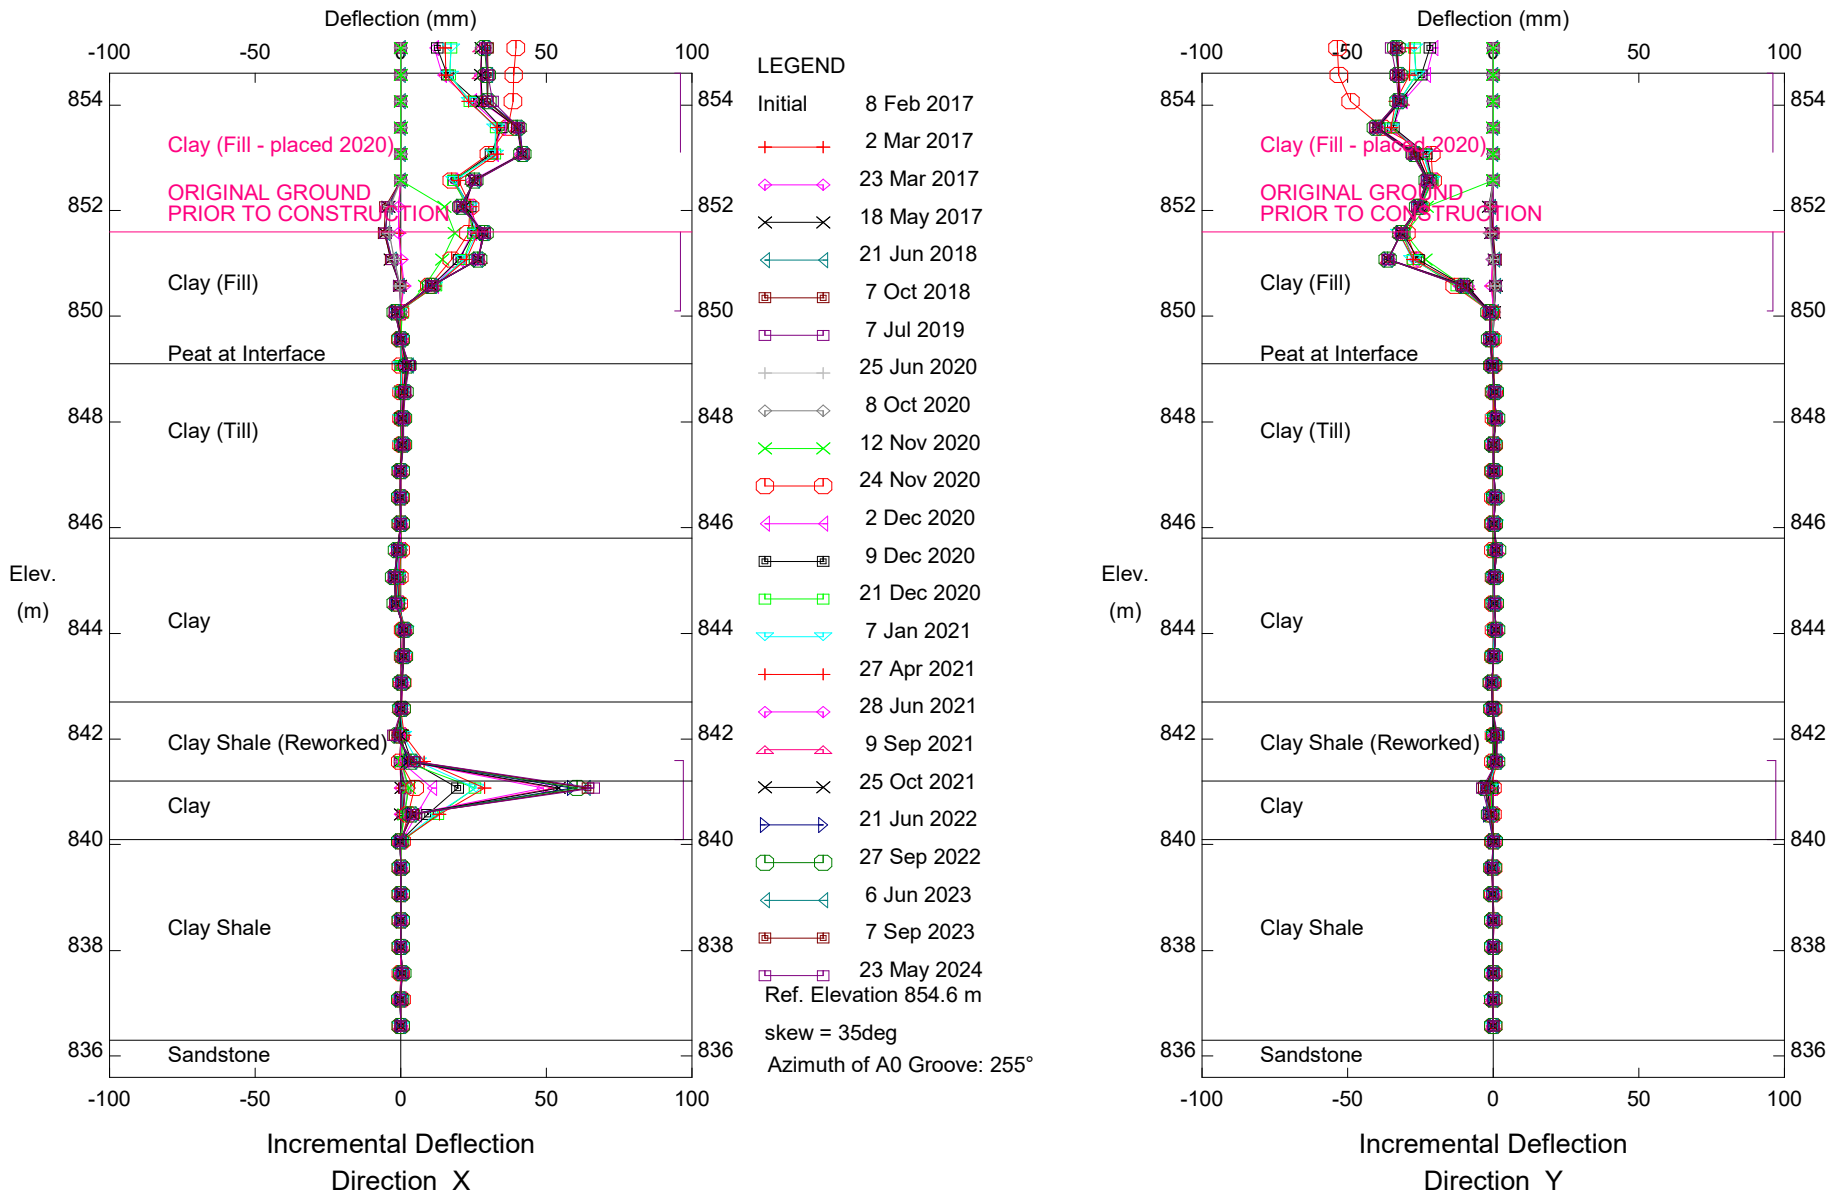
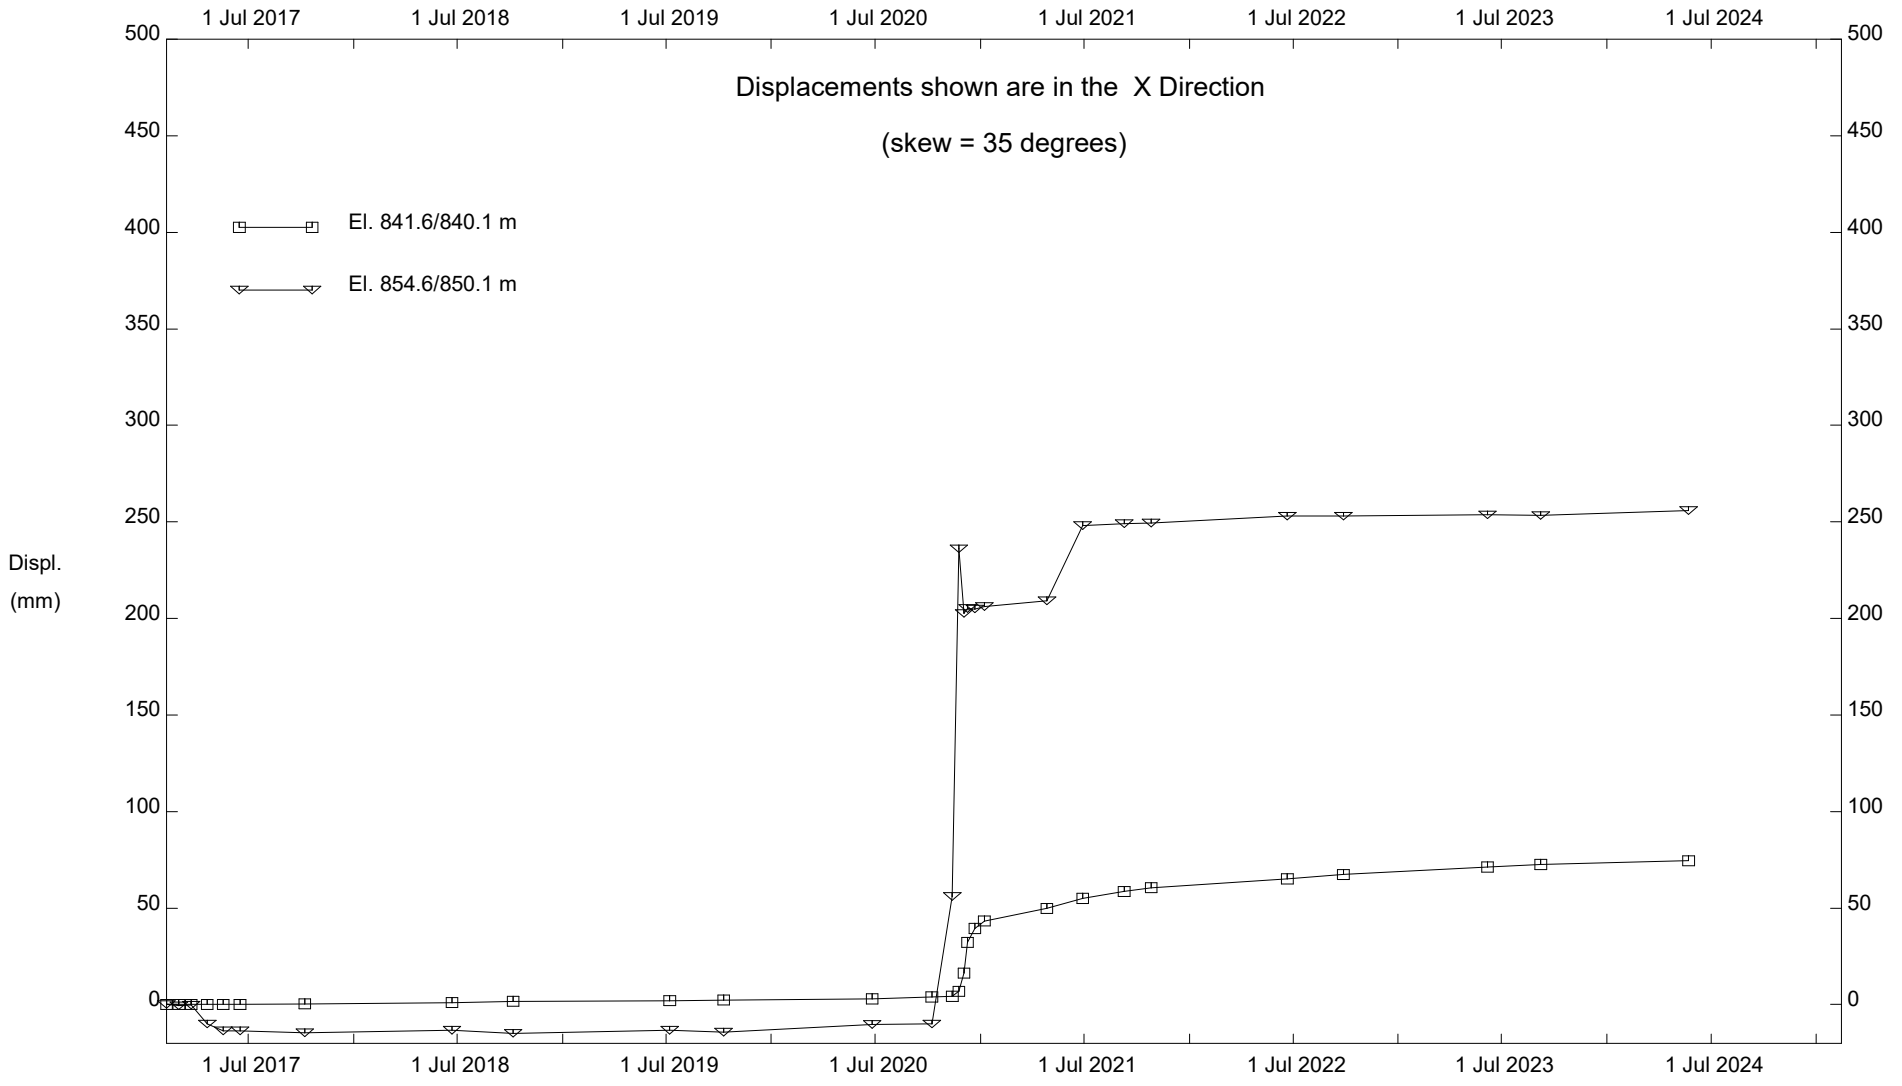
GP034; H40:38, Inclinator SI17-3

- SI17-2 between an approximate depth of 9.3 m and 10.8 m below ground surface (elevation 856.6 m to 855.1 m) at the bottom of a clay till foundation unit overlying bedrock (siltstone); and
- SI17-3 between an approximate depth of 13.0 m and 14.5 m below ground surface (elevation 841.6 m to 840.1 m) in a clay foundation unit overlying bedrock (clay shale).

Distributed movement is also being recorded in SI17-3 from the top of the casing to an approximate depth of 4.5 m below ground surface in the fill placed during late-2020 construction.

Since November 2020, shallow movements have been recorded in the upper 4.5 m of SI17-3 in the clay fill placed during late-2020 construction. This shallow movement is believed to be causing the pavement cracking observed on site and may be an extension upwards along the backscarp, associated with deeper movement. The rate of shallow movement recorded in SI17-3 in late-2020 is difficult to assess due to the SI casing being extended in November 2020. Between December 2020 and April 2021, the rate of movement decreased to approximately 15 mm/year, before increasing to approximately 230 mm/year in June 2021. Since September 2021, the rate of recorded movement has been decreasing and is now less than approximately 5 mm/year.

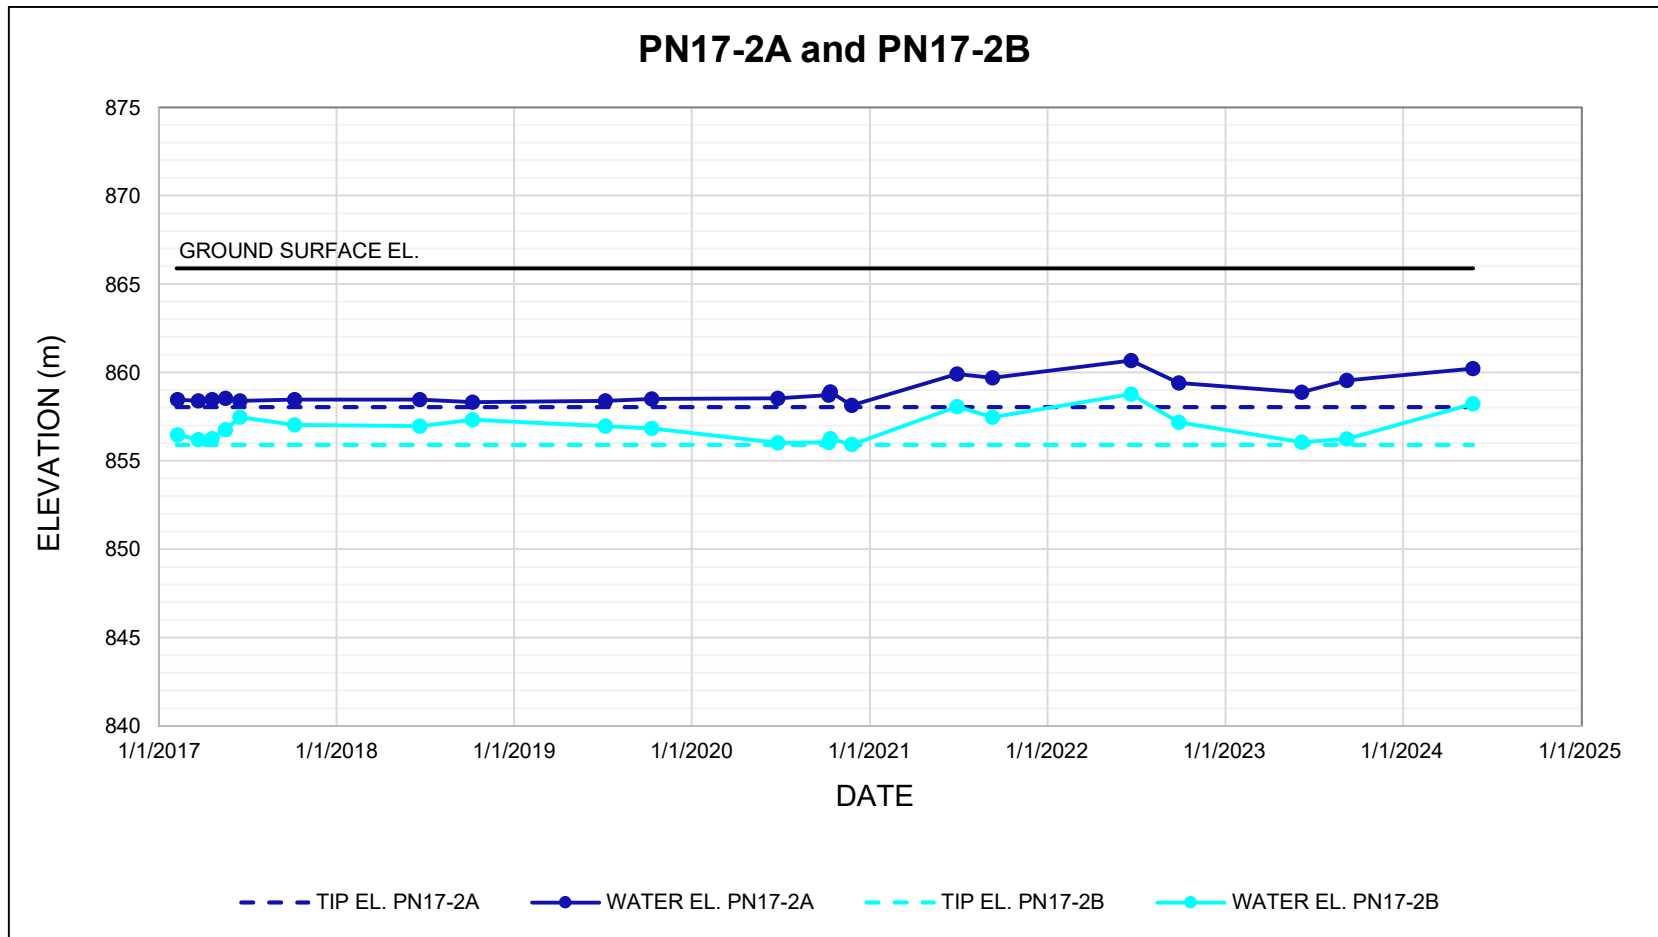
Between November 2020 and June 2022, a relatively steady increase in porewater pressure (between approximately 2.5 m and 2.9 m, respectively) was recorded in PN17-2A and PN17-2B, which are located at the crest of the highway embankment. Between June 2022 and June 2023, a decrease between approximately 1.1 m and 2.5 m was recorded in these instruments.

The increase and decrease in porewater pressure recorded in PN17-2A, PN17-2B, and PN17-6A can most likely be attributed to construction-induced porewater pressure response and post-construction porewater pressure dissipation, respectively. Since June 2023, porewater pressures recorded in these instruments have fluctuated up to approximately 2.9 m, likely in response to seasonal variations in precipitation and freshet infiltration.

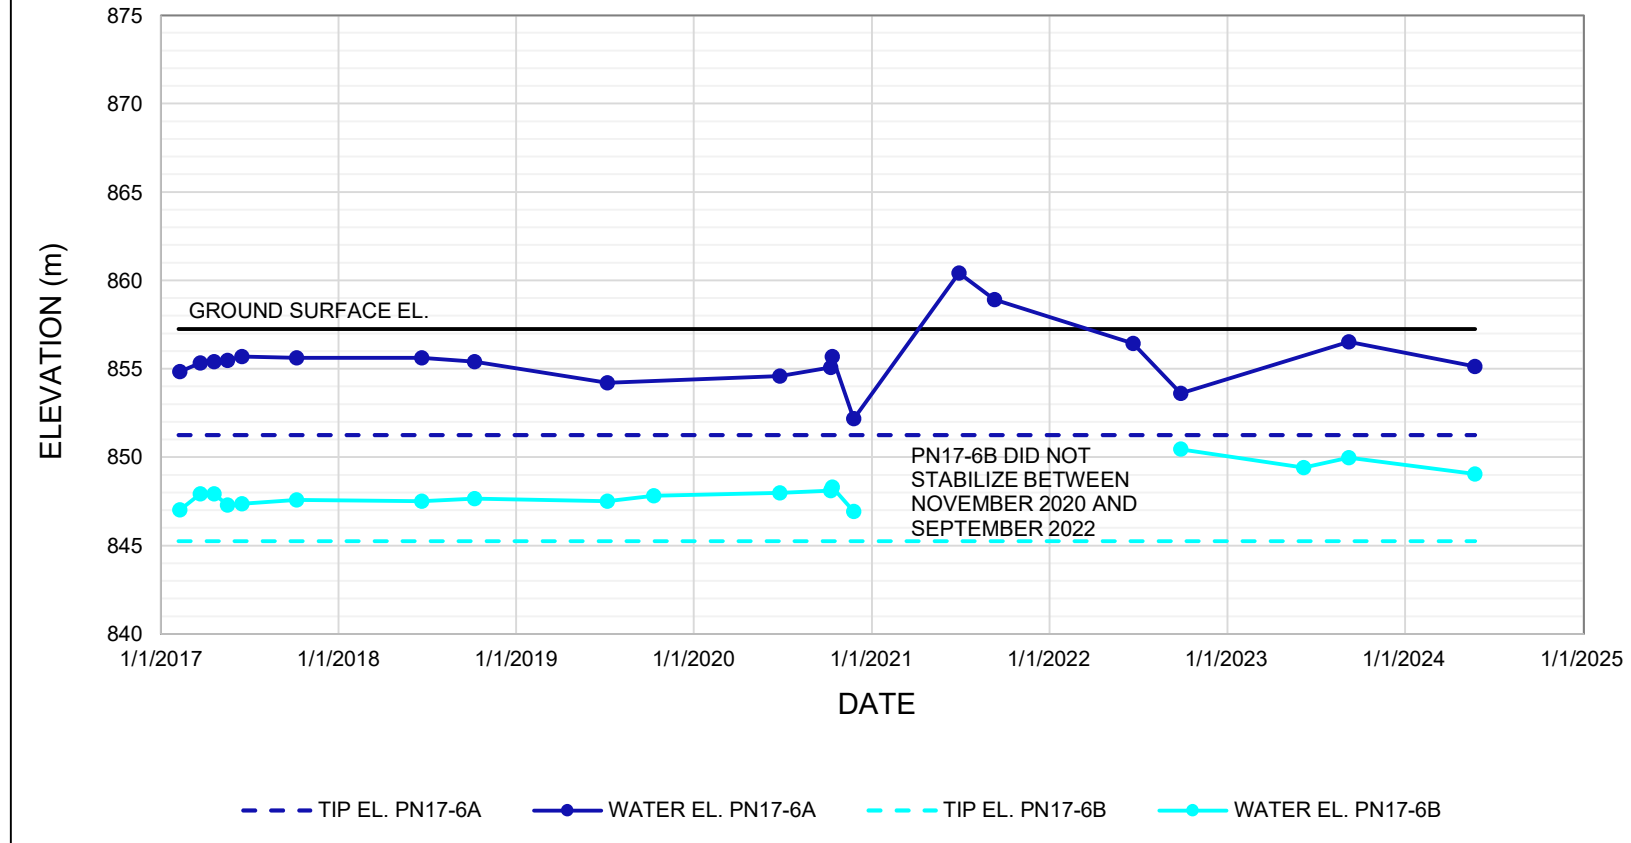
PN17-6A and PN17-6B

Between late-2020 and June 2021, a large porewater pressure increase (up to approximately 10 m) was recorded in PN17-6A, which is installed beneath the toe berm crest. Between June 2021 and June 2022, a steady decrease of approximately 7.3 m was recorded in this instrument.

PN17-6B did not stabilize between November 2020 and September 2022. Since September 2022, porewater pressures recorded in this instrument have been relatively steady.
