December 2, 2024

Alberta Transportation and Economic Corridors Main Floor, Provincial Building 9621 – 96th Avenue Peace River, Alberta T8S 1T4

CON0022166 Peace Region (Grande Prairie District – South) GRMP Instrumentation Monitoring Site GP034; H40:38, km 21.016 Slide South of Kakwa River Section C – 2024 Fall Readings

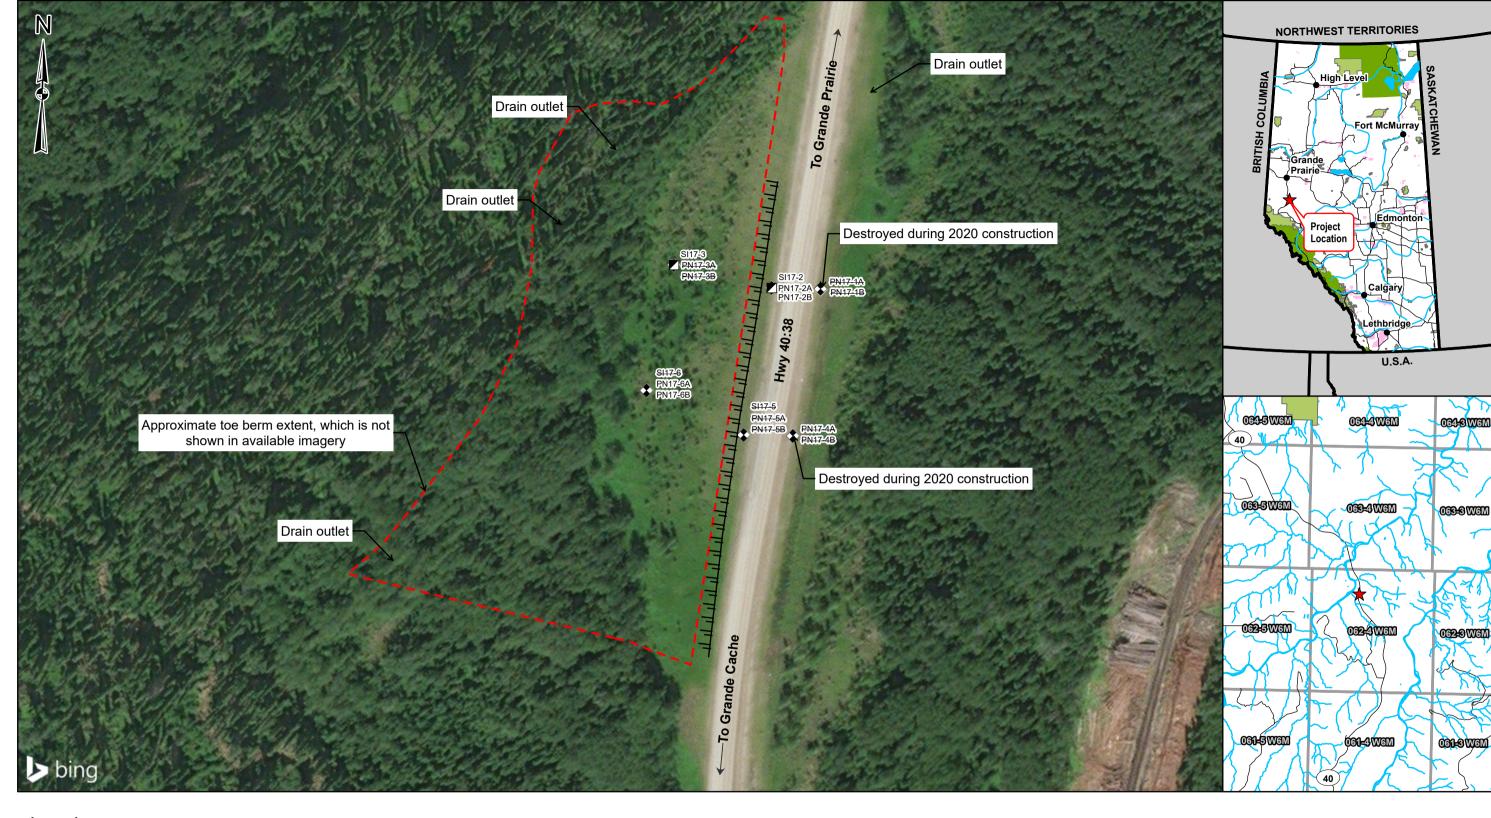
Site Plan GP034 - Slide South of Kakwa River Hwy 40:38, km 21.016

The geohazard at the GP034 site consists of a landslide in a 25-m-high sidehill highway embankment fill, approximately 500 m upslope (east) from the Kakwa River.

Previous remedial actions completed at the GP034 site include the enlargement of an existing toe berm in late 2020, which is not shown on the available imagery shown on Figure 1. Foundation movements and cracking of the asphalt in response to toe berm construction resulted in work being halted. Significant asphalt cracking continued into the spring and fall of 2021.

PN17-1A/B and PN-4A/B were destroyed in 2020 during construction, and PN-3A/B and PN-5A/B have also become inoperable (i.e., readings do not stabilize). Replacement of these instruments should be considered if repair work were to be resumed.

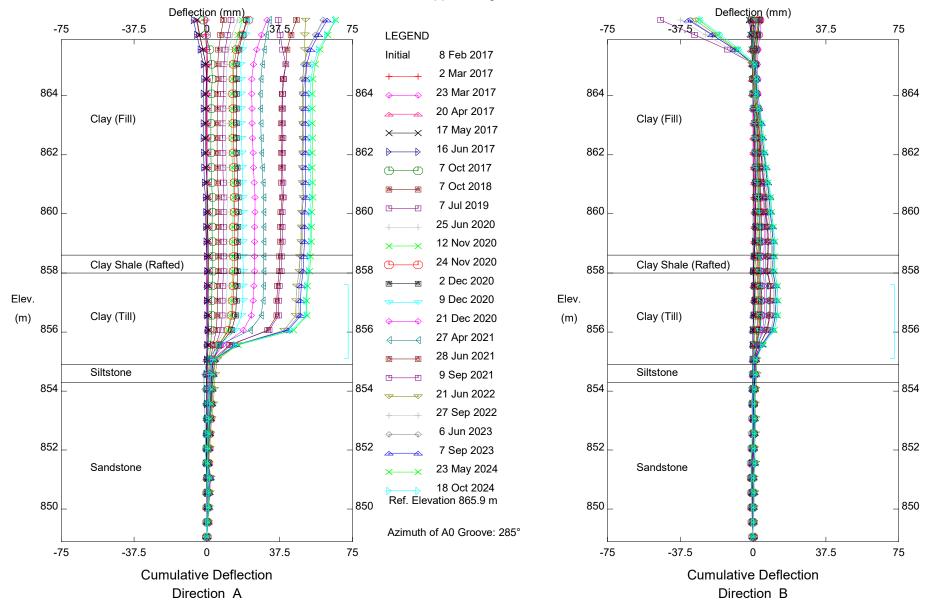
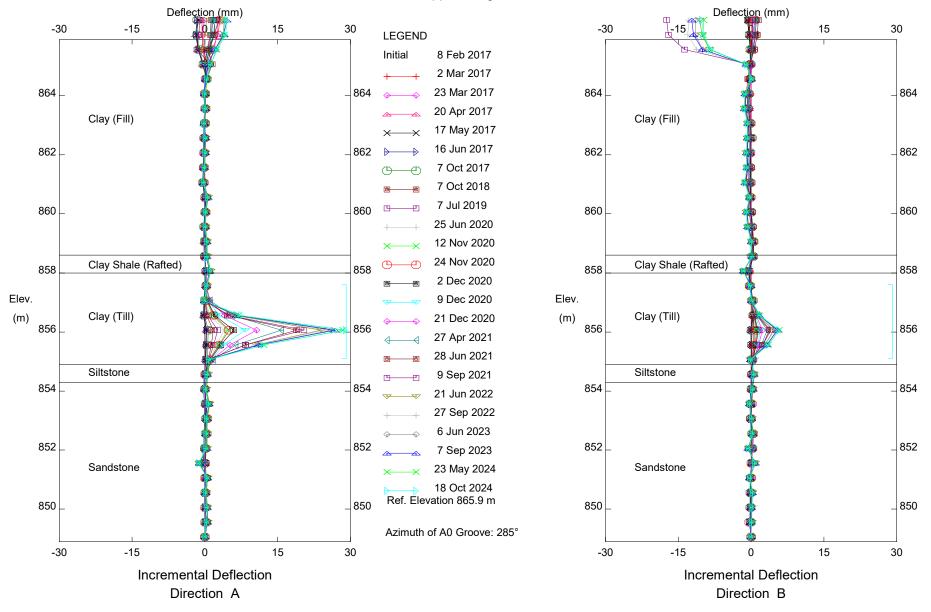
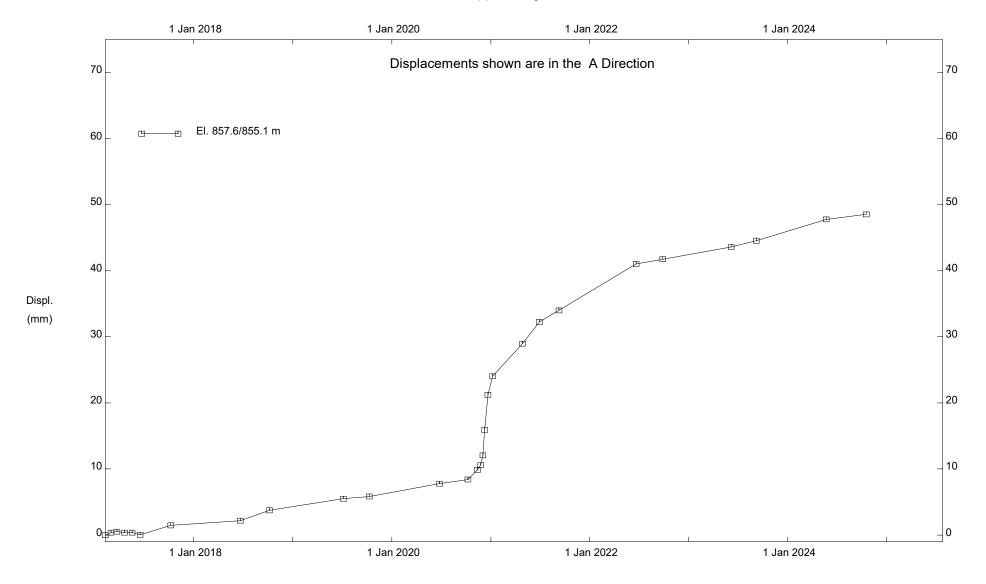
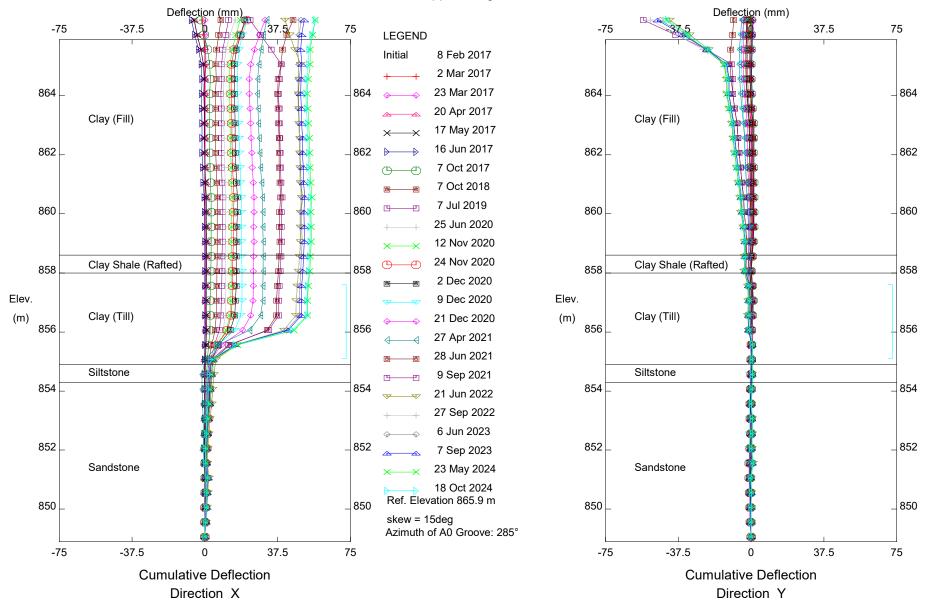
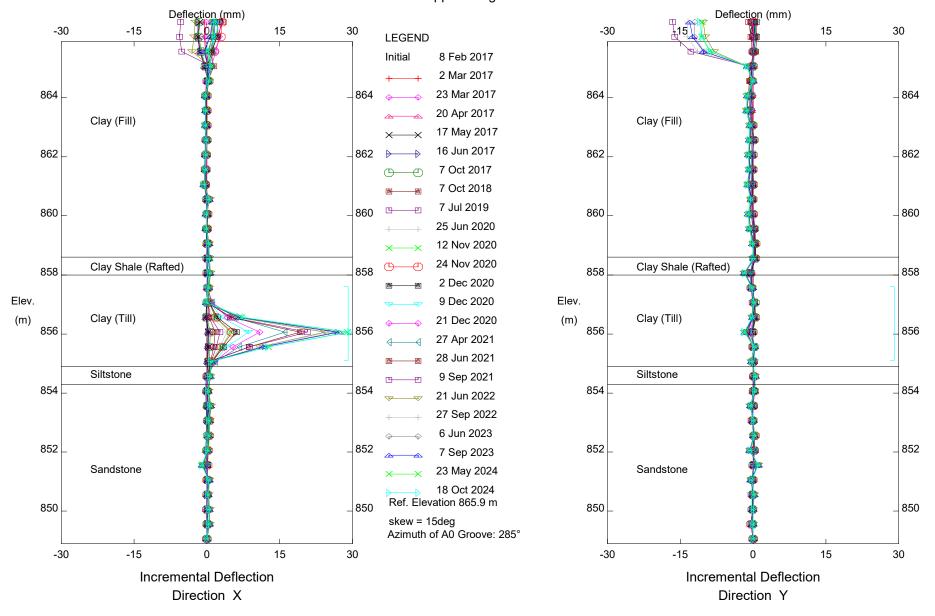
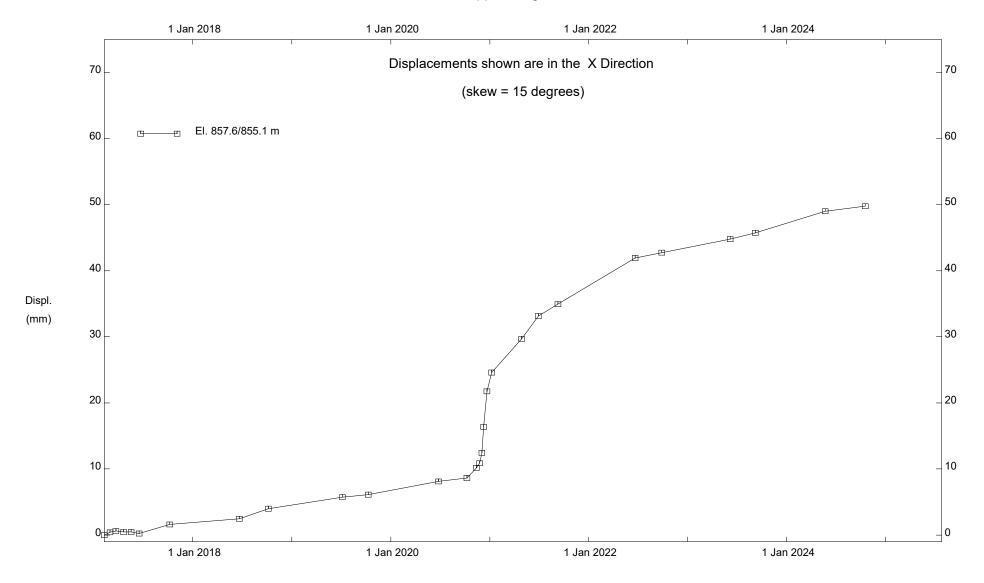
GP034; H40:38, Inclinometer SI17-2

- SI17-2 between an approximate depth of 9.3 m and 10.8 m below ground surface (approximately elevation 856.6 m to 855.1 m) at the bottom of a clay till foundation unit overlying bedrock (siltstone); and
- SI17-3 between an approximate depth of 13.0 m and 14.5 m below ground surface (approximately elevation 841.6 m to 840.1 m) in a clay foundation unit overlying bedrock (clay shale).

The rate of foundation movement being recorded in SI17-2 and SI17-3 was relatively slow and steady (less than 5 mm/year) between February 2017 (installation/initialization) and October 2020 but increased up to approximately 212 mm/year and 867 mm/year, respectively, when toe berm construction began in late 2020. Since January 2021, the rate of foundation movement recorded in SI17-2 and SI17-3 has been decreasing and is currently less than 5 mm/year.

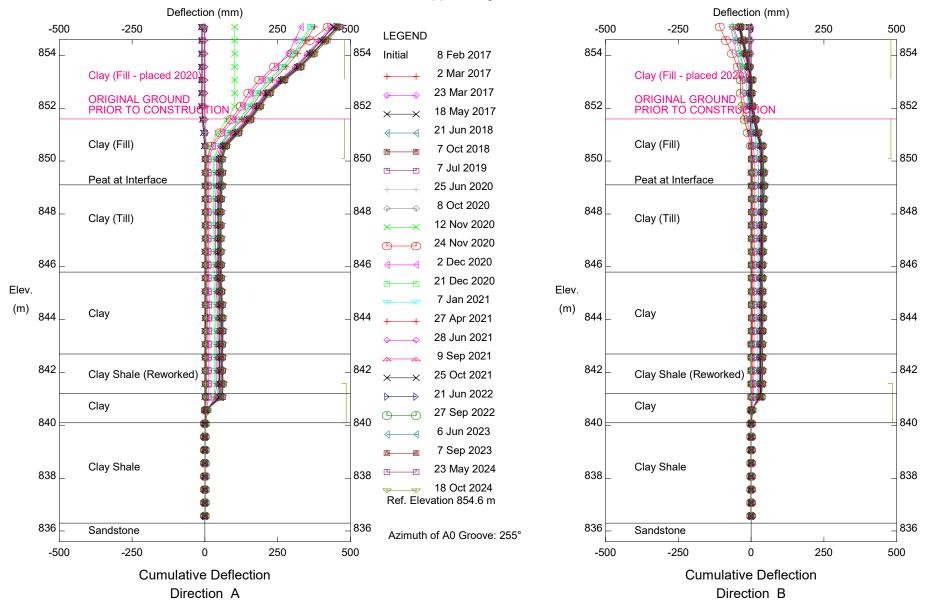
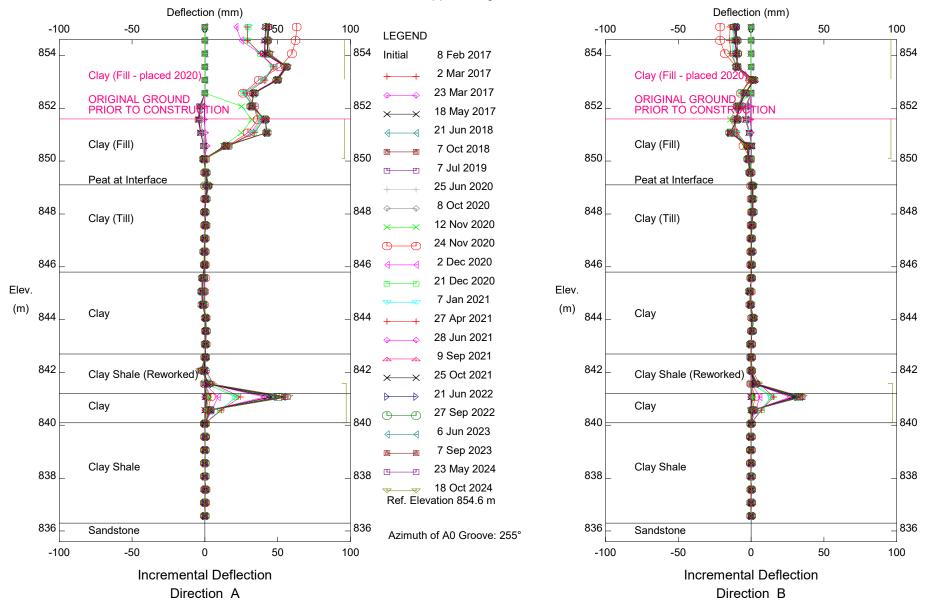
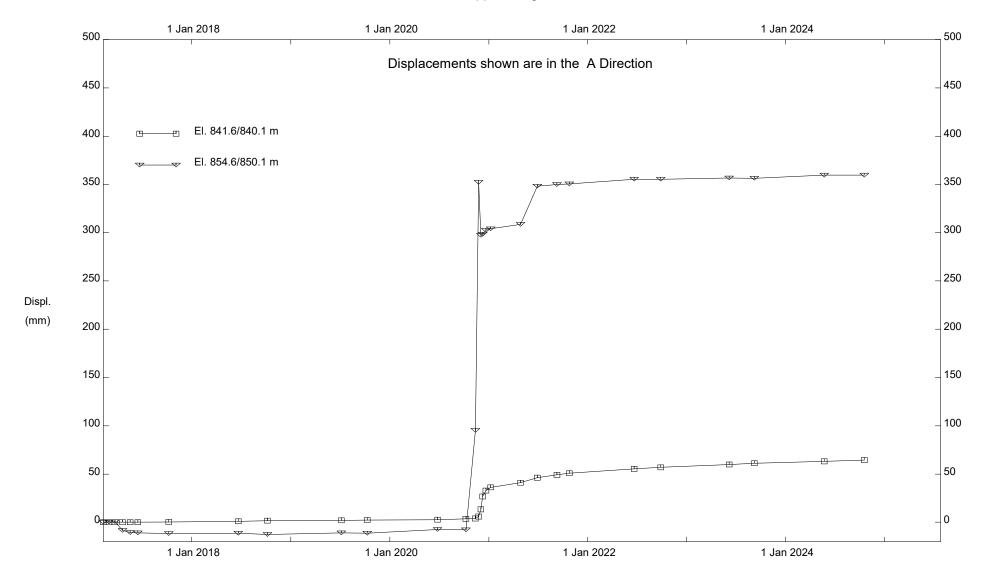
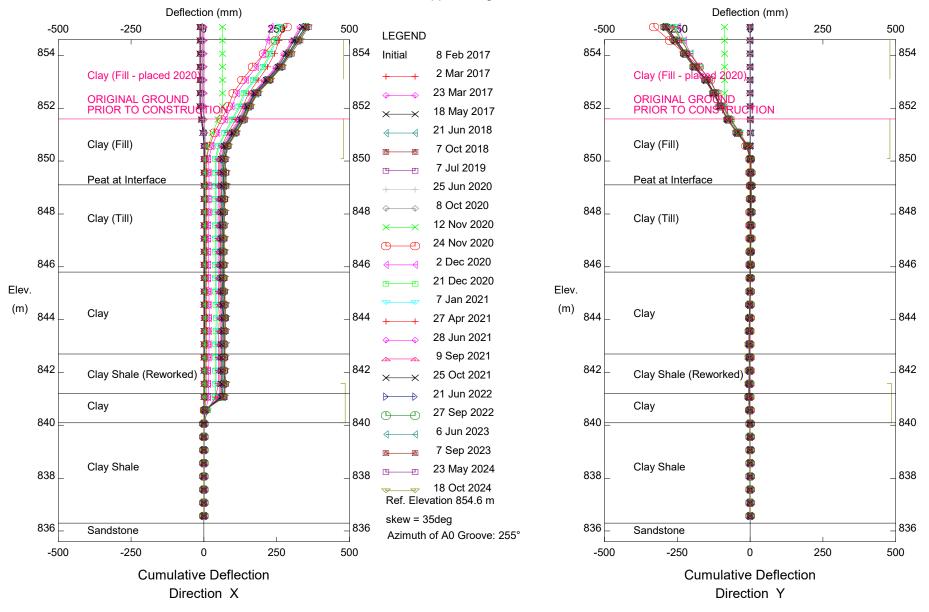
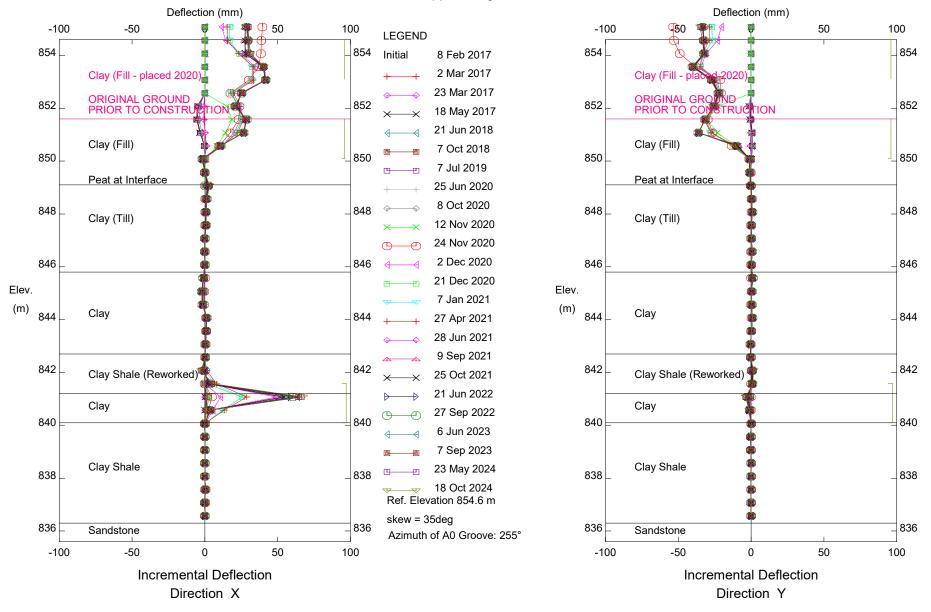
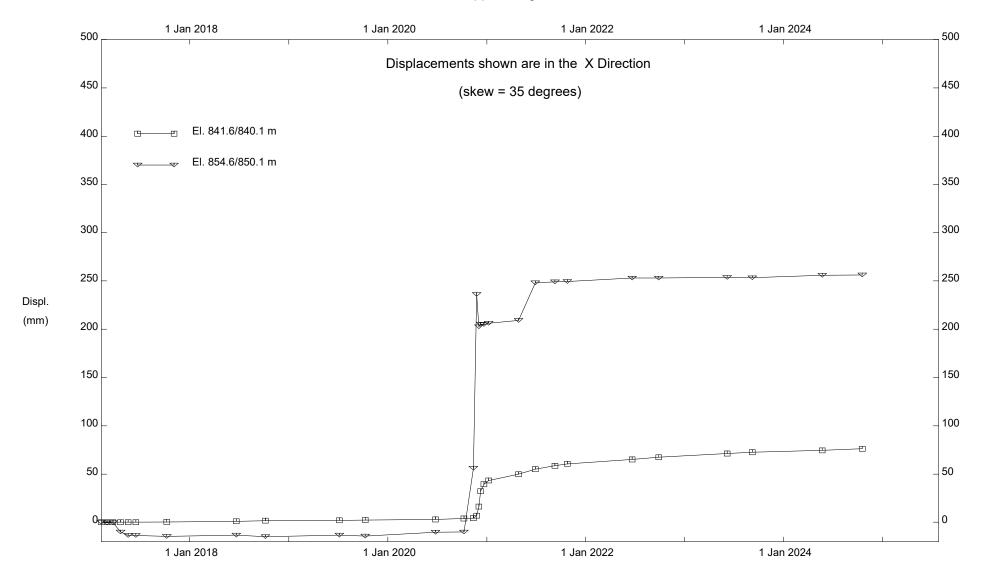
GP034; H40:38, Inclinometer SI17-3

Shallow distributed movement is also being recorded in the upper 4.5 m of SI17-3 in the toe berm fill placed in late 2020.

The shallow fill movement being recorded in SI17-3, since toe berm construction in late 2020, is believed to be causing the cracks observed in the pavement surface and along the highway embankment and may be an extension upwards along the backscarp, associated with deeper movement. The rate of shallow movement recorded between late 2020 and September 2021 is difficult to assess due to the SI casing being extended in November 2020 and the SI reading equipment being changed in four times between November 2020 and June 2021. The maximum rate of movement recorded during toe berm construction was approximately 5,519 mm/year. Since September 2021, the rate of shallow fill movement recorded in SI17-3 has been decreasing and is currently less than 5 mm/year.

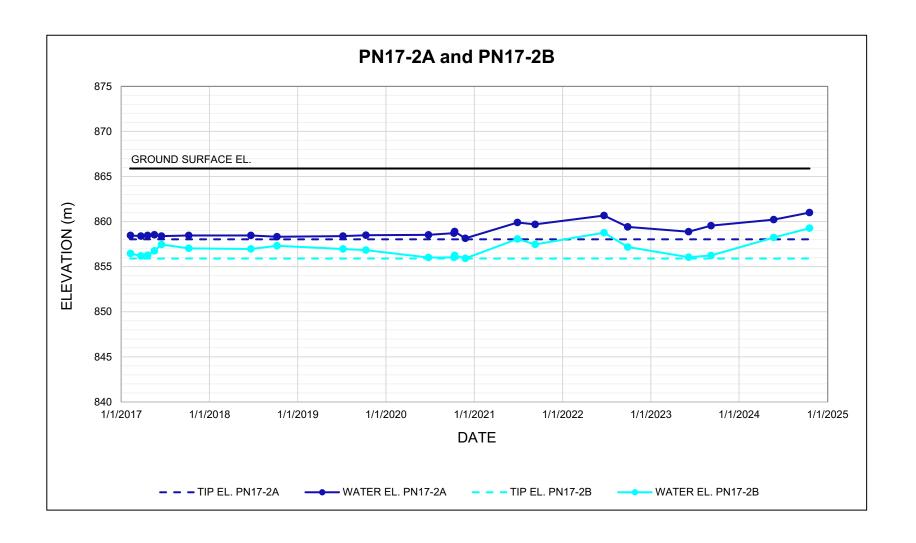
- **PN17-2A/B:** Porewater pressures recorded in these instruments have been fluctuating from tip elevation (i.e., dry) to approximately 3.0 m and 3.4 m above tip elevation, respectively, likely due to seasonal variations in precipitation and freshet infiltration.

- It is unclear if the increase recorded between October 2020 and June 2022 (approximately 1.8 m and 2.5 m, respectively) and the subsequent decrease recorded between June 2022 and June 2023 (approximately 1.8 m and 2.7 m, respectively) was influenced by toe berm construction (similar to PN17-6A, see above) since the instruments are installed outside the toe berm footprint, or just seasonal variations.

• It is unclear if the increase recorded since June 2023 (approximately 2.1 m and 3.2 m approximately, respectively) is being influenced by increased water infiltration into cracks that have formed in the pavement surface and along the highway embankment associated with the shallow movements recorded in SI17-3 (see above), which is located downslope of PN17-2A/B, or just seasonal variations.

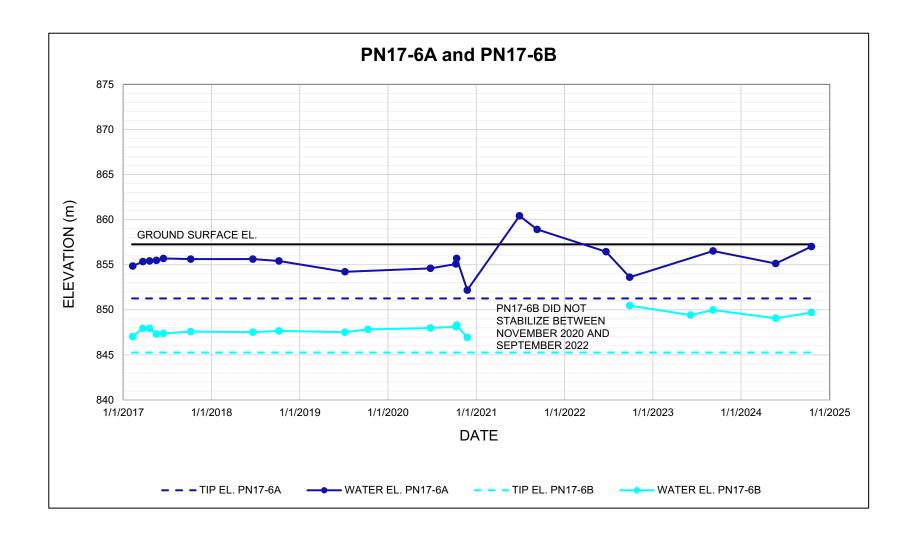
- PN17-6A: Porewater pressures recorded in this instrument increased approximately 4.7 m between October 2020 and June 2021 before decreasing approximately 4.0 m between June 2021 and June 2022. This increase and decrease are most likely due to construction-induced porewater pressure response followed by post-construction porewater pressure dissipation, respectively. Since June 2022, porewater pressures recorded in PN17-6A have been fluctuating (approximately 1.4 m to 2.9 m reading to reading, with the spring reading higher than the fall reading) likely in response to seasonal variations in freshet and precipitation infiltration.

- PN17-6B: This instrument did not stabilize between November 2020 and September 2022. Since September 2022, porewater pressures recorded in this instrument have been relatively steady and approximately 2 m higher than readings obtained before toe berm construction in late 2020.
