**ALBERTA TRANSPORTATION  
GEOHAZARD ASSESSMENT PROGRAM  
PEACE REGION – GRANDE PRAIRIE DISTRICT  
2016 INSPECTION**

<b>Site Number</b>	<b>Location</b>	<b>Name</b>	<b>Hwy</b>	<b>km</b>
Callout by GP38	NW of Grande Cache	1.6 km N of Kakwa River Bridge	40:38	25.5
<b>Legal Description</b>		<b>UTM Co-ordinates (NAD 83)</b>		
SE8-63-4-W6		11U N 6,032,885	E 398,710

**PEACE REGION (GRANDE PRAIRIE) 2016  
CALLOUT: HWY 40:38, 1.6km NORTH OF  
KAKWA RIVER BRIDGE**

**MAY 31, 2016 INSPECTION PLAN**

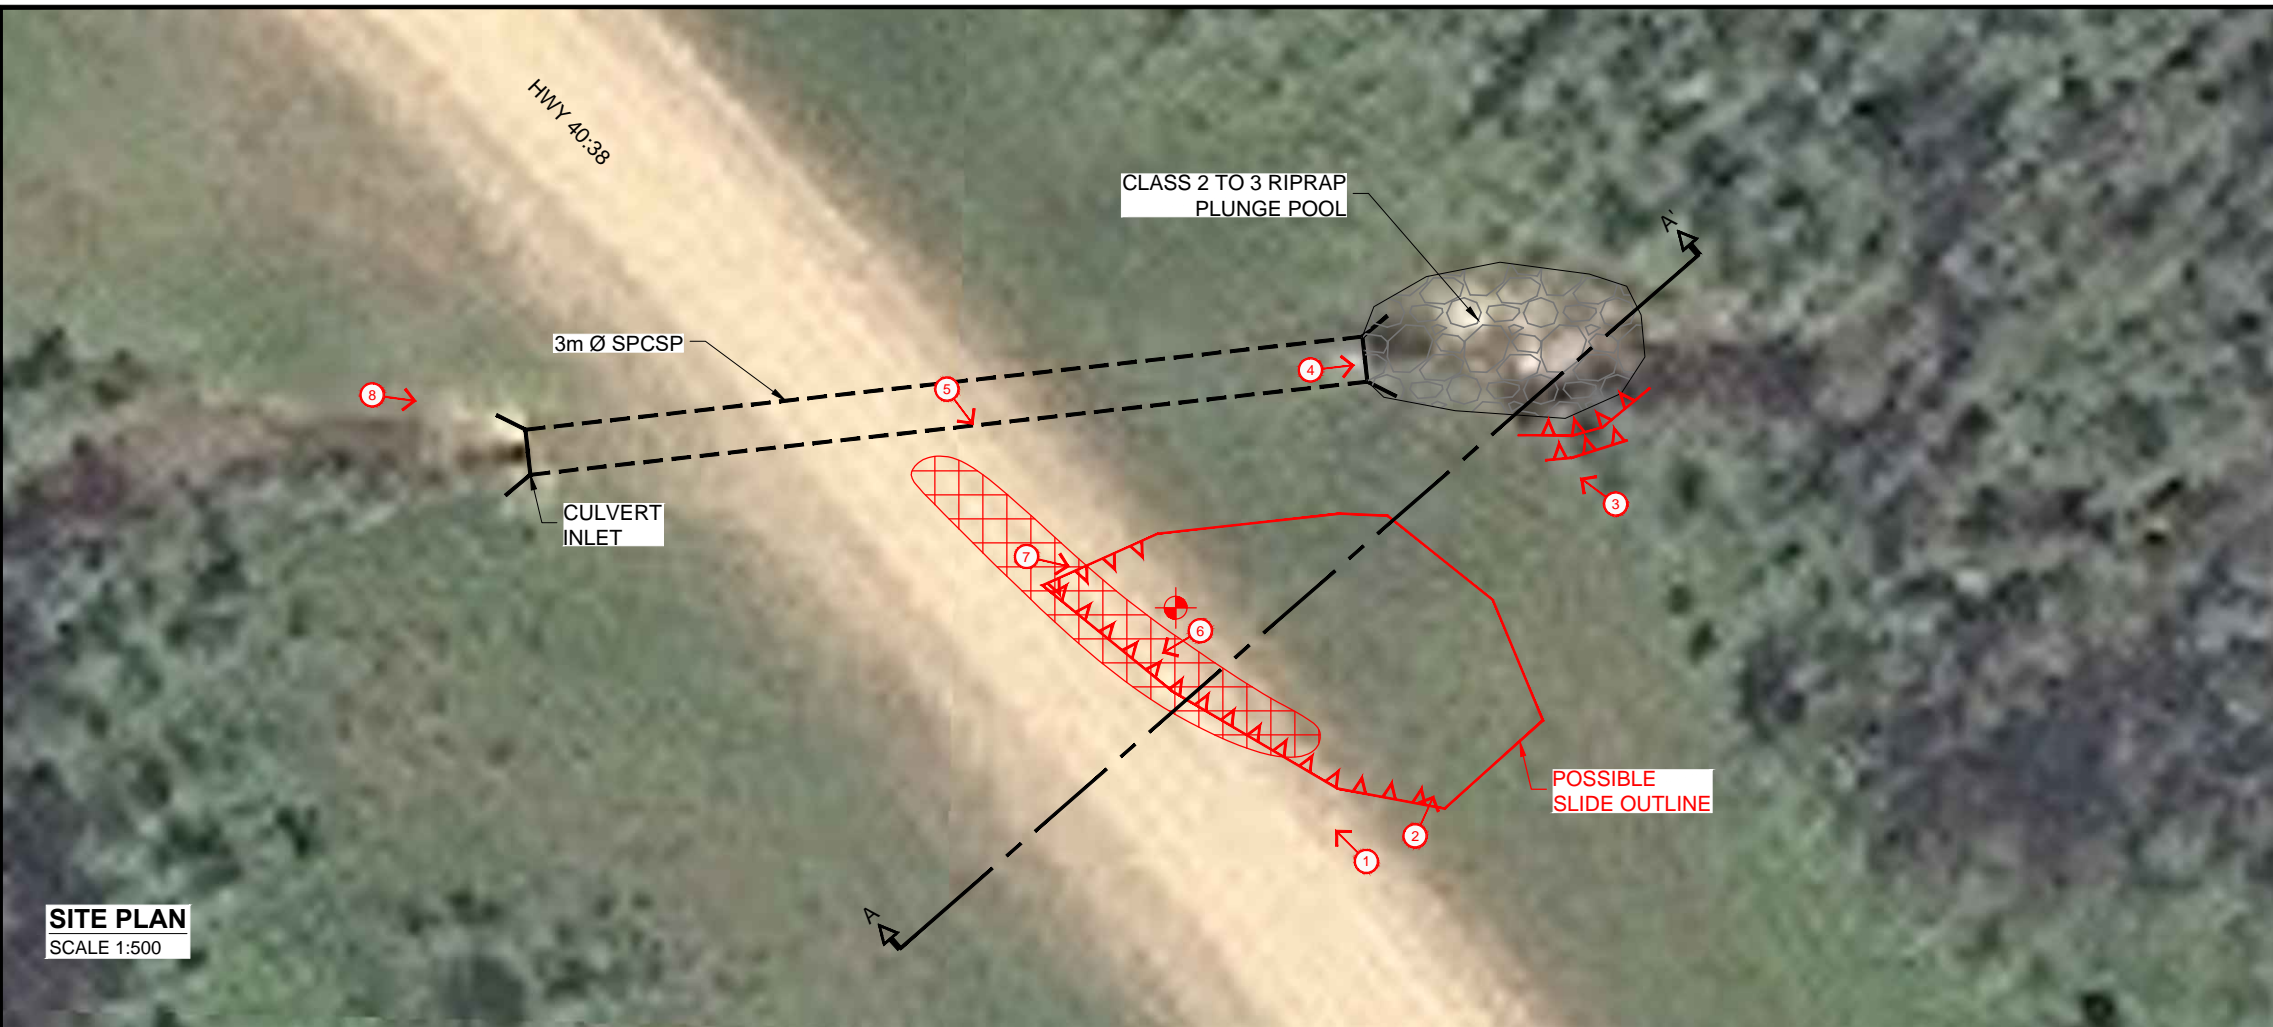
**SITE PLAN**  
SCALE 1:500

<b>Primary Site Issue:</b>	Landslide in an 8 m high sidehill highway embankment fill	
<b>Dimensions:</b>	About 20 m long by ~10 m wide	
<b>Date of any remediation:</b>		
<b>Maintenance:</b>		
<b>Observations:</b>	<b>Description</b>	<b>Worse?</b>
<input checked="" type="checkbox"/> Pavement Distress	A dip in the eastbound driving lane and shoulder, and a developing headscarp crack is appearing and affecting an approximate 20 m length of pavement. This area is also exhibiting a heavy alligator crack pattern.	<input type="checkbox"/>
<input checked="" type="checkbox"/> Slope Movement	The east embankment fill is bulged below the dip in the pavement.	<input type="checkbox"/>
<input type="checkbox"/> Erosion		<input type="checkbox"/>
<input checked="" type="checkbox"/> Seepage	Slight seepage noted near the toe of the downstream embankment fill.	<input type="checkbox"/>
<input type="checkbox"/> Bridge/Culvert Distress		<input type="checkbox"/>

<input type="checkbox"/> Other		<input type="checkbox"/>
<b>Instrumentation:</b> None		
<b>Assessment:</b>		
<p>A dip exists in the northbound driving lane/shoulder, and along the perimeter of the dip some slight cracking can be observed. The east highway fill embankment, which is inclined at ~21°, is also bulged partway down the slope. This appears to signify the early stages of development of a landslide in the highway embankment fill at this location, which may not enable accurate delineation of the slide extent at this time.</p> <p>Distortion of the pavement was first noticed in April, 2016. Recent heavy truck traffic is causing alligator cracking in the pavement surface through this area. The alligator cracking appears to extend beyond the area of the discernible slump outline area. Some slight seepage was observed near the lower portion of the east embankment, therefore the subgrade could also be wet.</p> <p>A 3 m diameter SPCSP culvert exists adjacent to the north side of the alligator cracked area. This culvert did not have any identifiable distress at the time, however a small slump was observed in the south channel bank downstream of the culvert riprap plunge pool.</p>

It is anticipated that this slide was caused by potential wet subgrade materials (possibly from groundwater seepage or a naturally high water table), and which was aggravated by the recent high frequency of heavy truck traffic traversing the area. The embankment fill slope of about  $21^{\circ}$  (~2.6H:1V), may be too steep for the subgrade materials it is composed of (especially if it is clay).

Drill 1 test hole complete with a piezometer on the downslope edge of the highway (as shown on Figure Callout-1) to a depth of about 12 m to provide information on the soil and groundwater conditions at this location, and to confirm slope stabilization design measures.

The recommended repair (especially considering a rush time frame) is to subexcavate the failed slide mass down to intact foundation soil, and rebuild the slope with imported 6-80 gravel to a slightly flatter 3H:1V inclination. The new fill material should be placed and compacted in thin horizontal lifts, benched into the intact slope surface, utilizing a gravel shear key (if required) to stabilize the slide area. Some of the more suitable excavated material could be used to provide a covering layer overtop the gravel as the finished slope surface to shed runoff, with any excess removed from site. A subdrain should be installed along the base of the slide excavation to drain any subsurface water that may enter the new fill zone. A temporary detour will likely have to be constructed on the west side of existing highway to allow two-way traffic. If a portion of the repair area intersects near the riprap bowl and culvert outlet, any existing Class 2/3 riprap should be salvaged and re-instated over non-woven geotextile along a new contoured channel beyond the new slope. Some additional riprap should be added to the south side of the plunge pool.

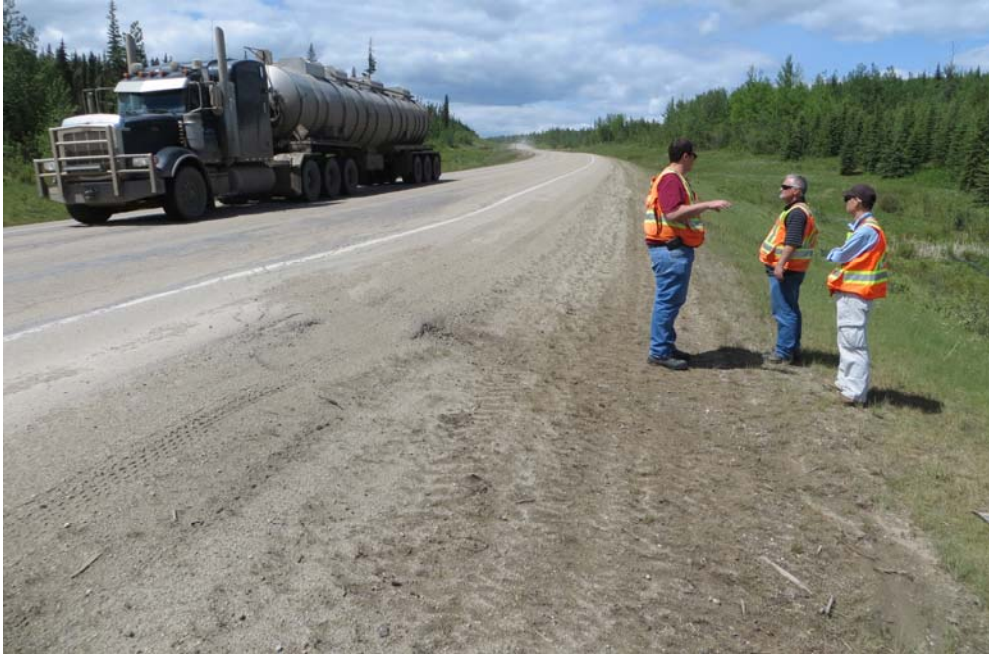
Photo 1 – Looking north along the east edge of the highway, at the dipped area. A slide scarp appears to be developing at this location.

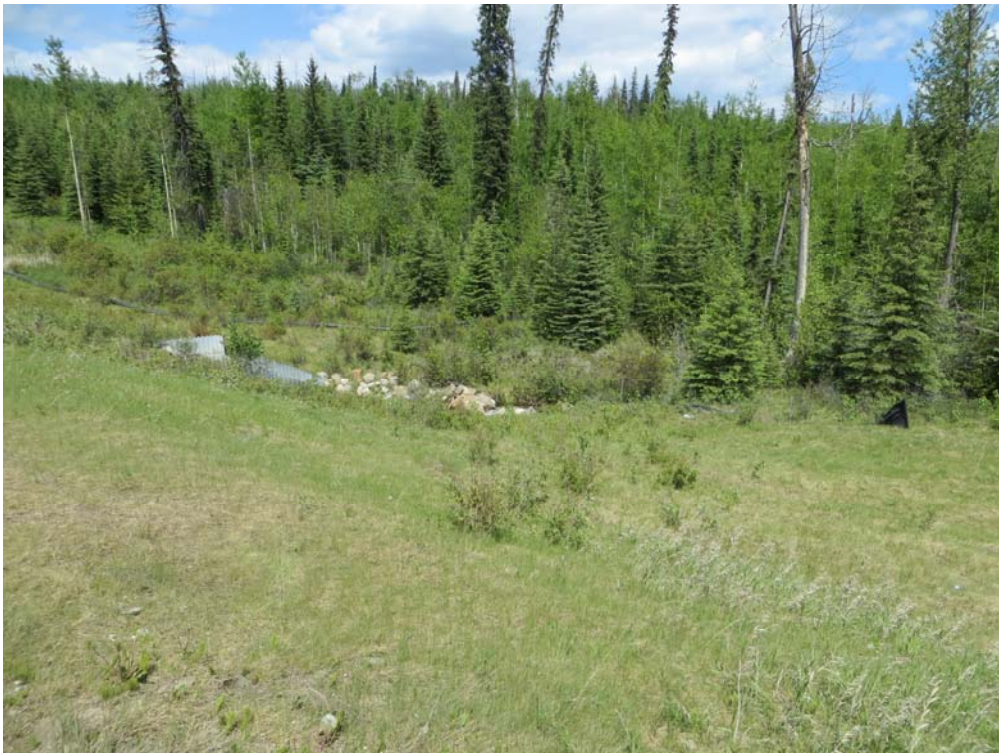
Photo 2 – Looking northeast across the east highway embankment, with the culvert outlet in the background.

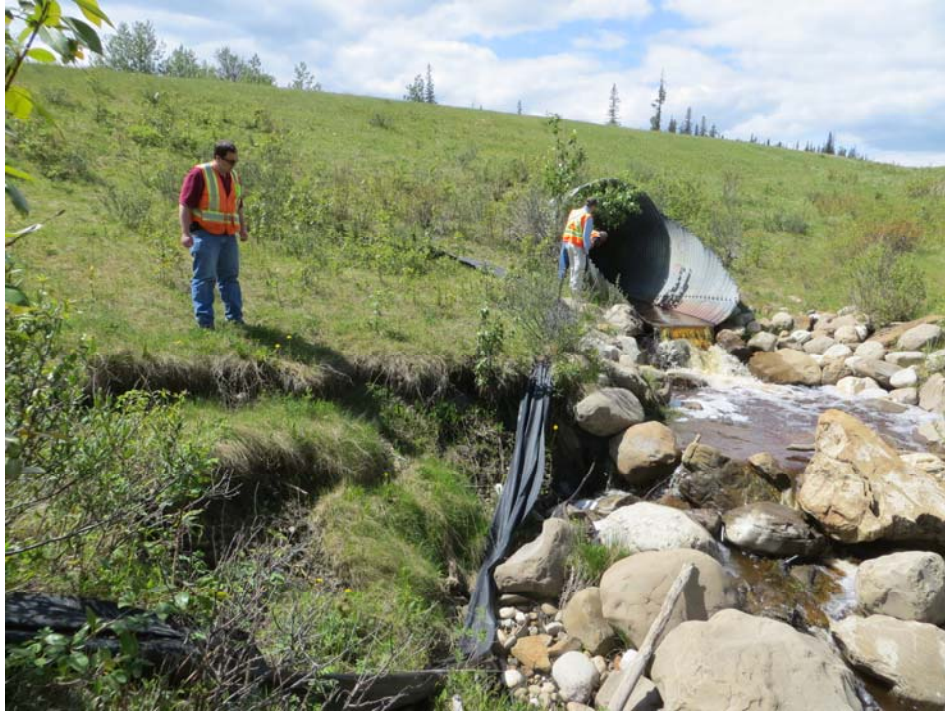
Photo 3 – Looking west at the 3 m diameter SPCSP outlet, plunge pool, and east highway embankment. Note the exposed woven geotextile adjacent to the slumped channel.

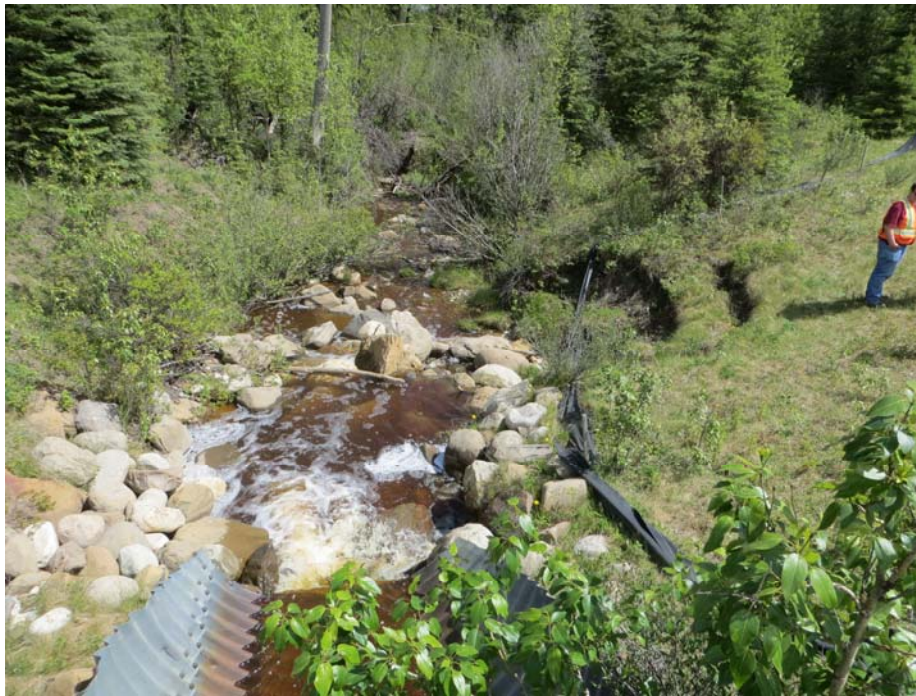
Photo 4 – Looking east at the culvert outlet and the riprap plunge pool. Note the slump scarp alongside the south channel edge.

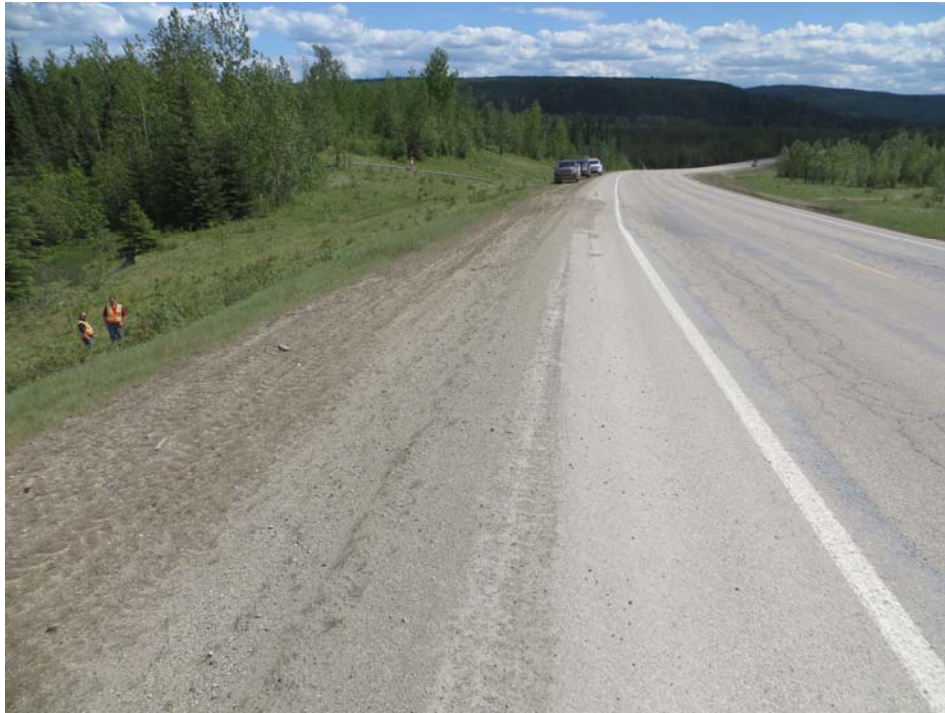
Photo 5 – Looking south along the east highway shoulder at the dip and scarp crack.

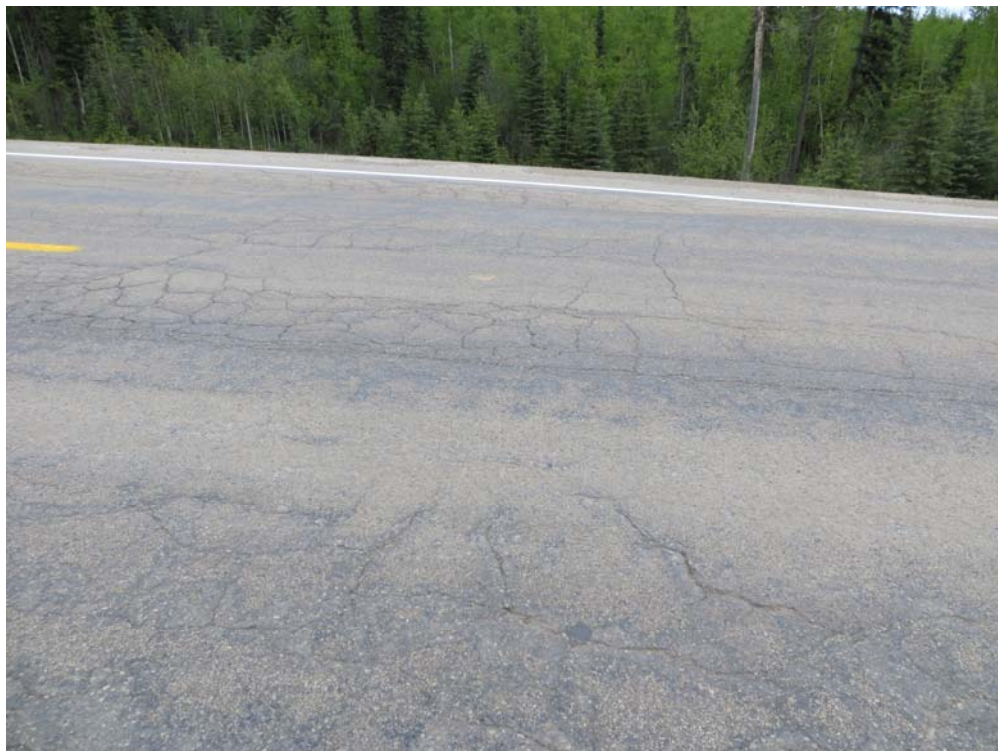
Photo 6 – Looking west across the alligator cracked pavement.

Crack filling and/or patching may be required until remedial repair measures are undertaken.

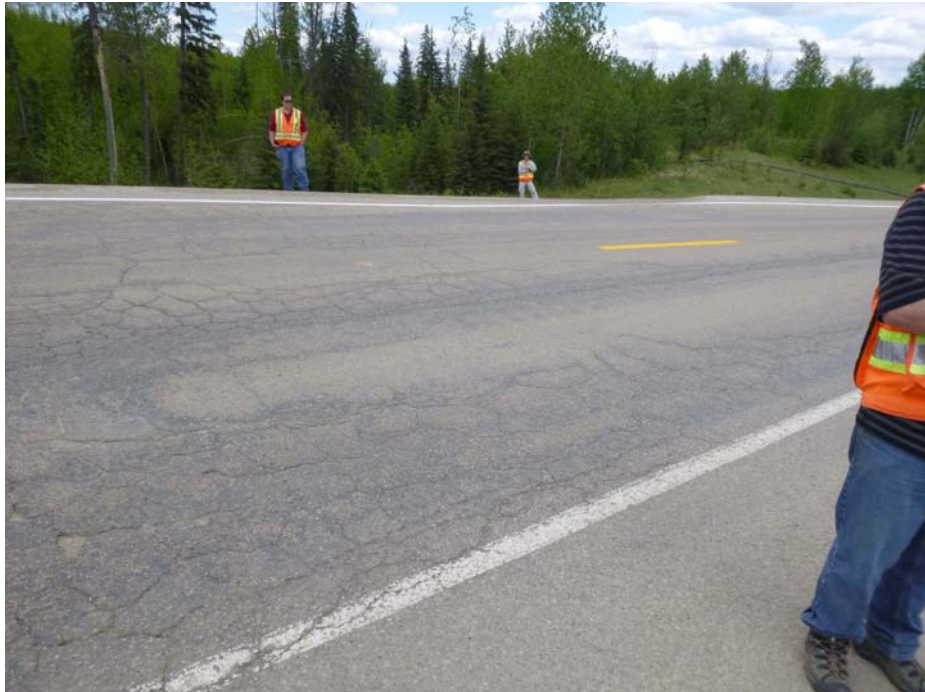
Photo 7 – Looking southeast at the alligator cracked pavement, and the dip in the east highway shoulder.

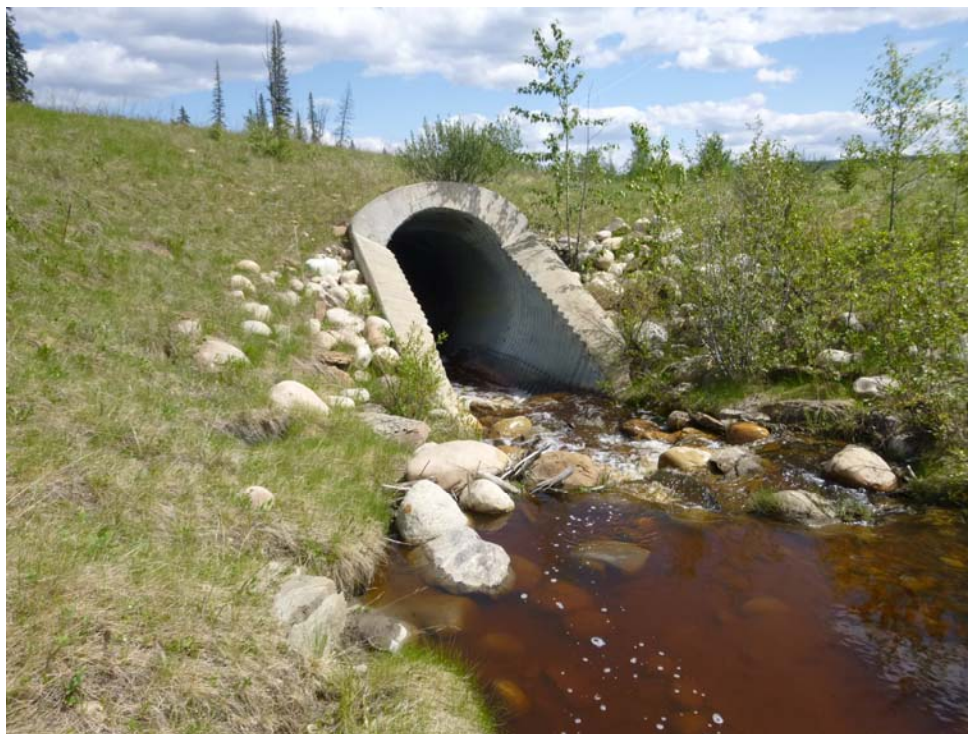
Photo 8 – Looking east at the 3 m SPCSP inlet.
