**PEACE REGION – GRANDE PRAIRIE
GEOHAZARD RISK ASSESSMENT
SITE INSPECTION FORM**

SITE NUMBER GP-38	SITE NAME Kakwa R. North Slide at a bridge culvert loc. (2 km north of bridge)	HIGHWAY & KM Hwy 40:42 (2 km north of Kakwa River)	PREVIOUS INSPECTION DATE <i>New Site</i> <i>no inspection previous</i>	INSPECTION DATE May 29, 2014
LEGAL DESCRIPTION -W6M	NAD 83 COORDINATES N 5,442,991 E 118,557	RISK ASSESSMENT PF: 11 CF: 6 TOTAL: 66		
		CURRENT 2014 RISK ASSESSMENT PF: 11 CF: 6 TOTAL: 66

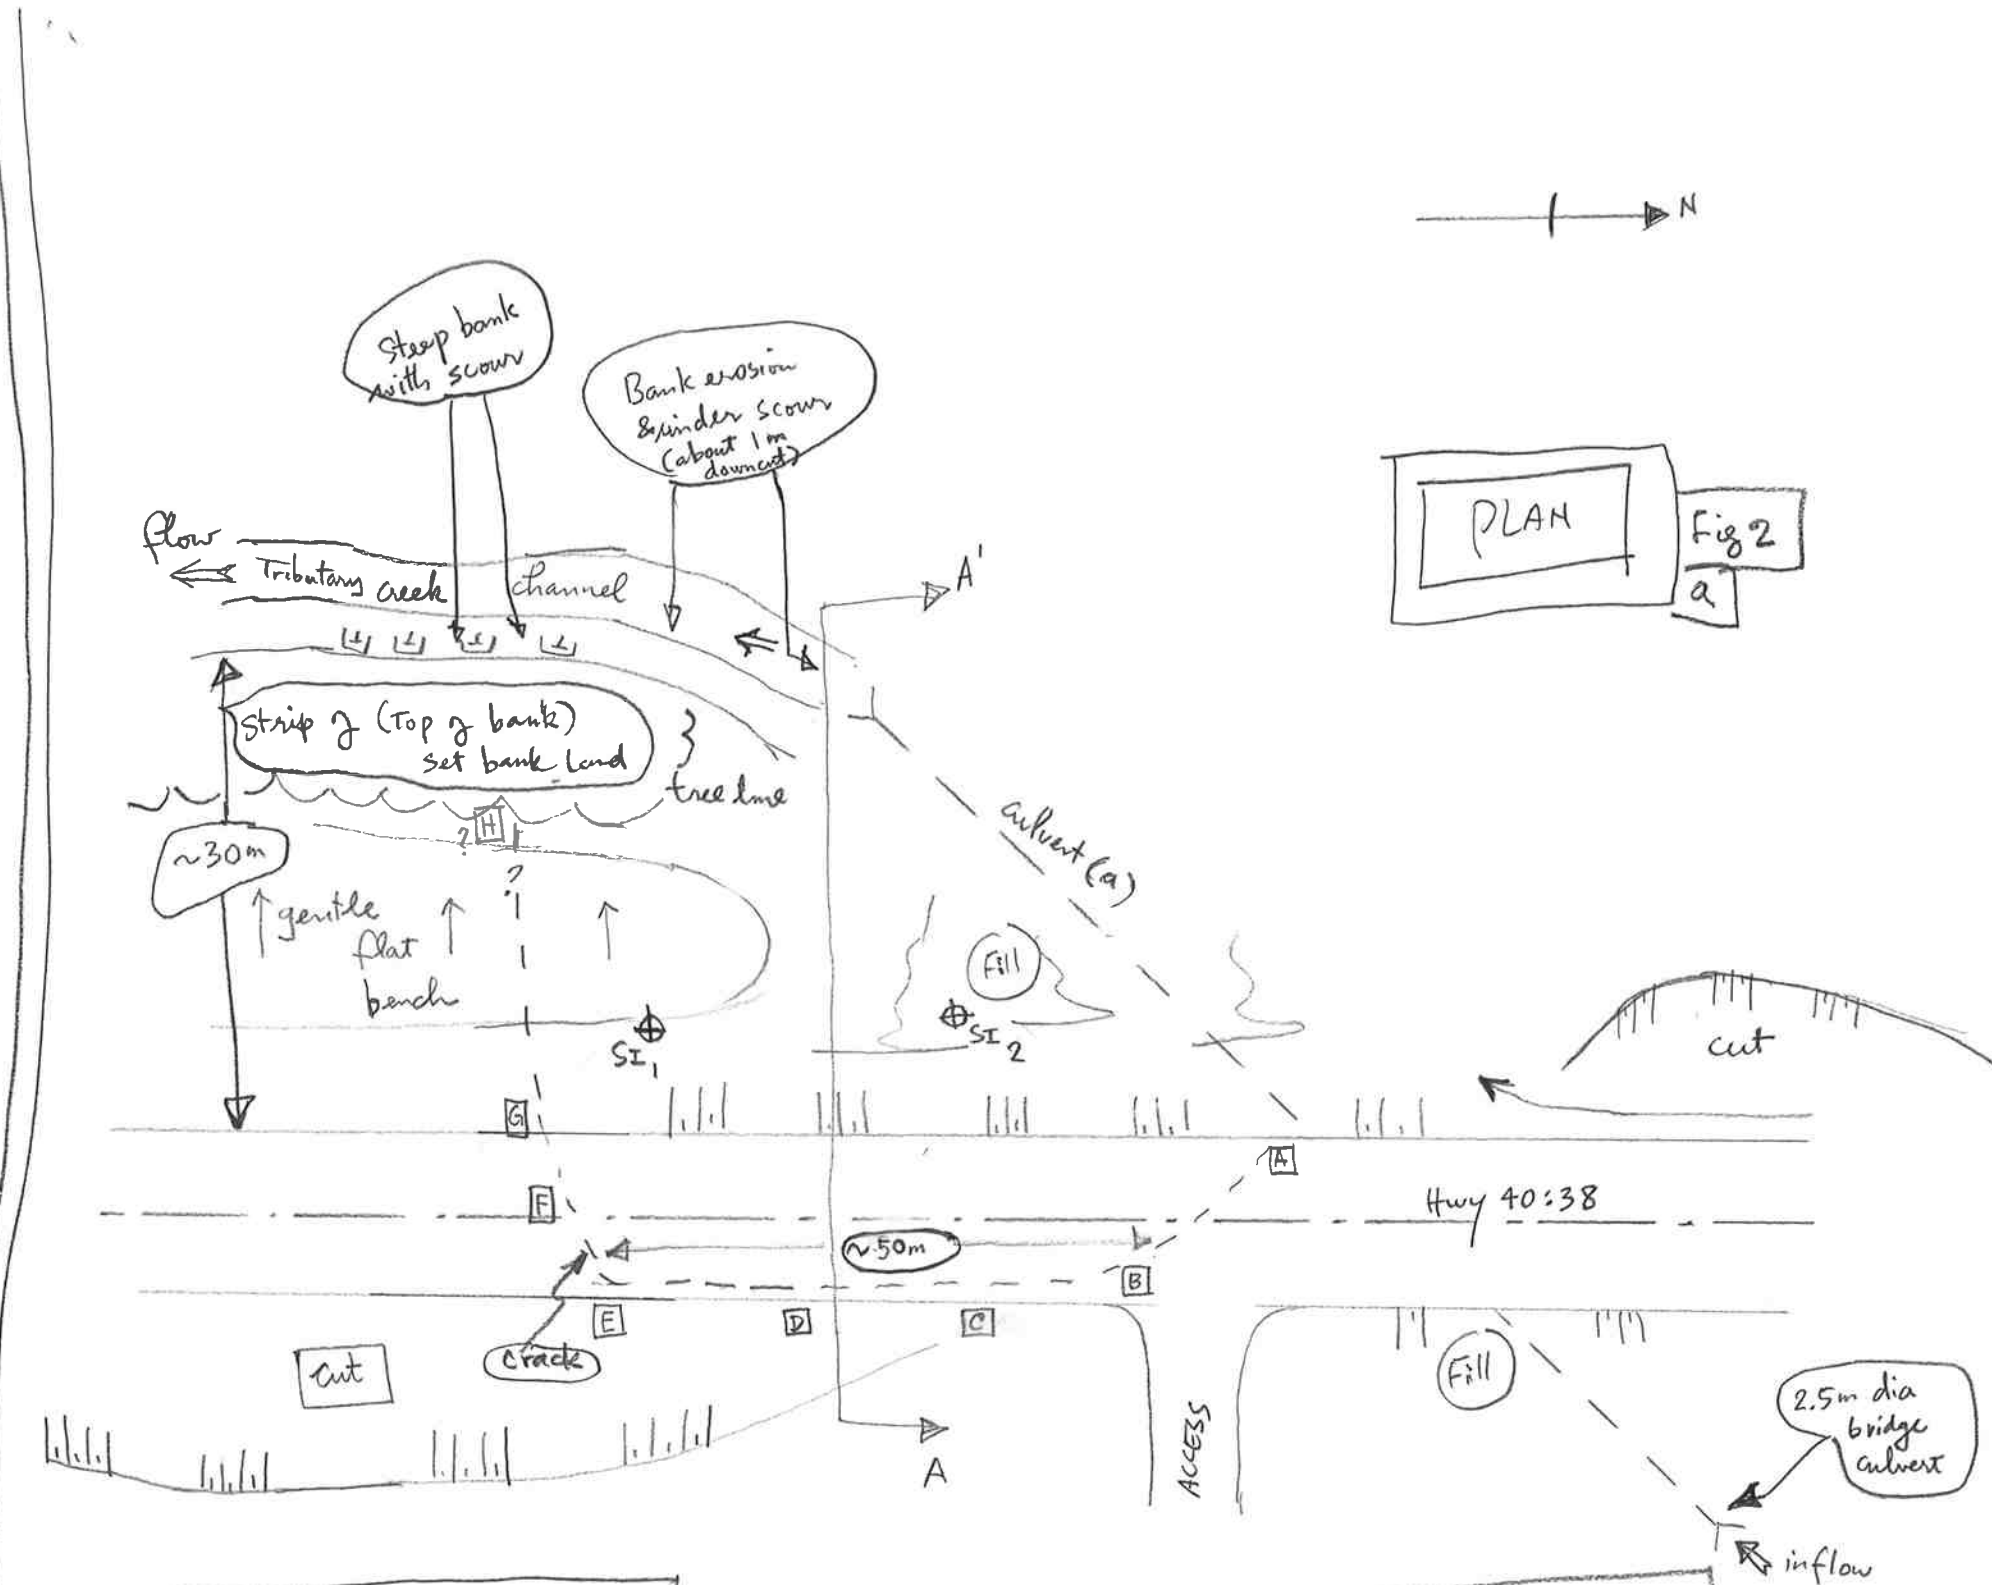
Figure 2 slide detail sketch
Hwy 40:38 Slide at 2.5km North of Kakua Kuer Bridge

note:-
(i) crack pattern	A B C D E F G H is the crack pattern as heads up shown in site photos
(ii)	SI ₁ SI ₂ suggested SI locations

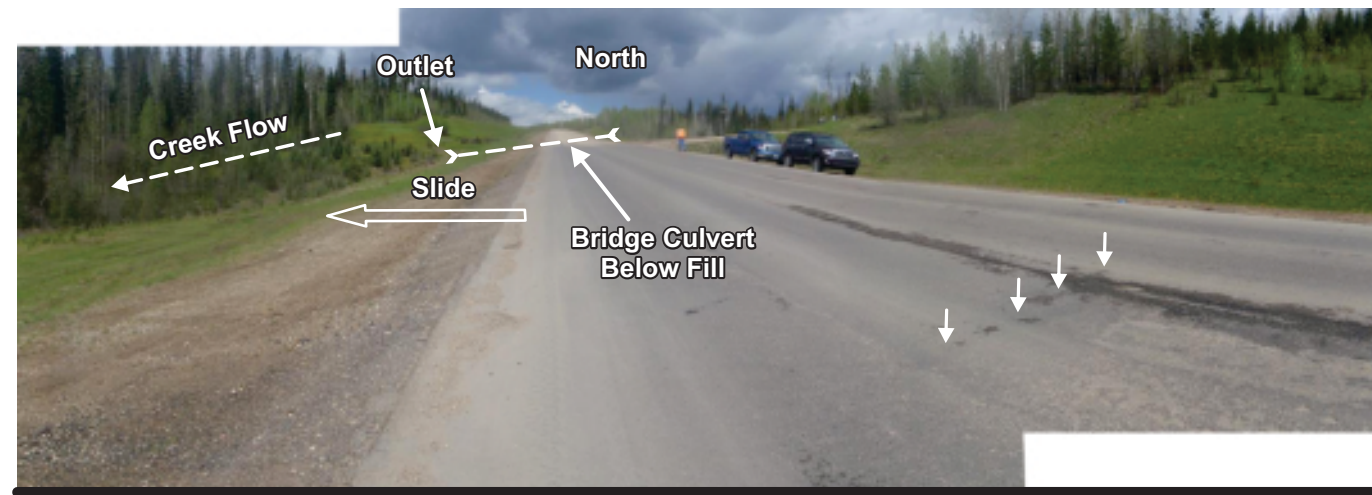
Photo 1

Looking north upgrade (away from Kakwa River bridge)

- Slide movement (likely partly movement of fill and partly movement of creek bank slope adjacent downstream) at outlet of a bridge culvert
- A bridge culvert I-II was constructed below this fill across a creek bed. This is a tributary creek to Kakwa River.
- Movement from right to left of photo
- Patching overlay has covered off most of cracks
- But some minor cracking started to reflect back and still visible

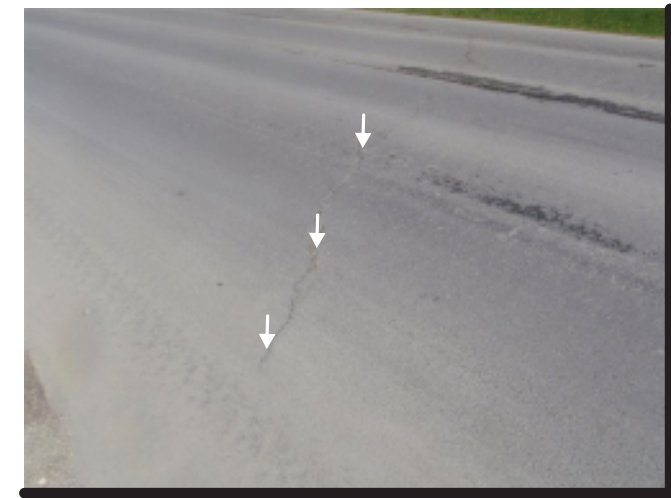
Photo 1a
 Cracks – Closeup

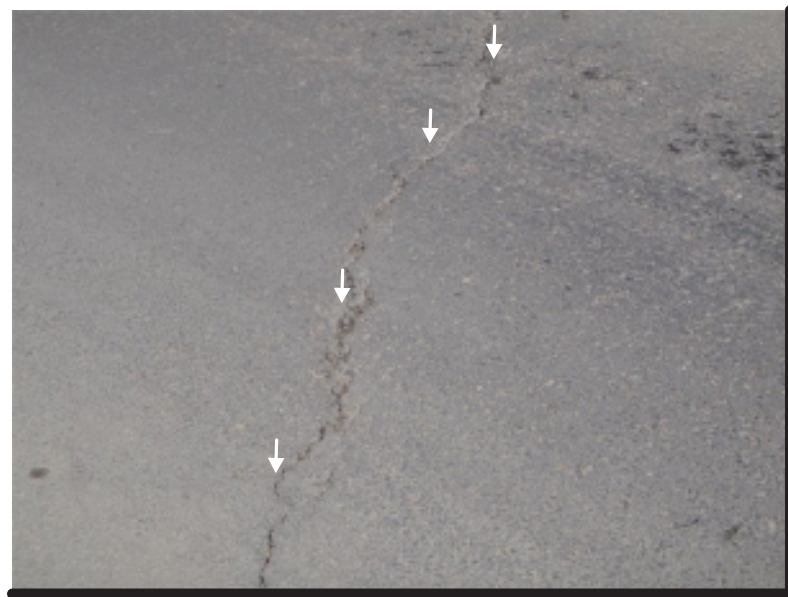
Photo 1b
 Cracks – Closeup

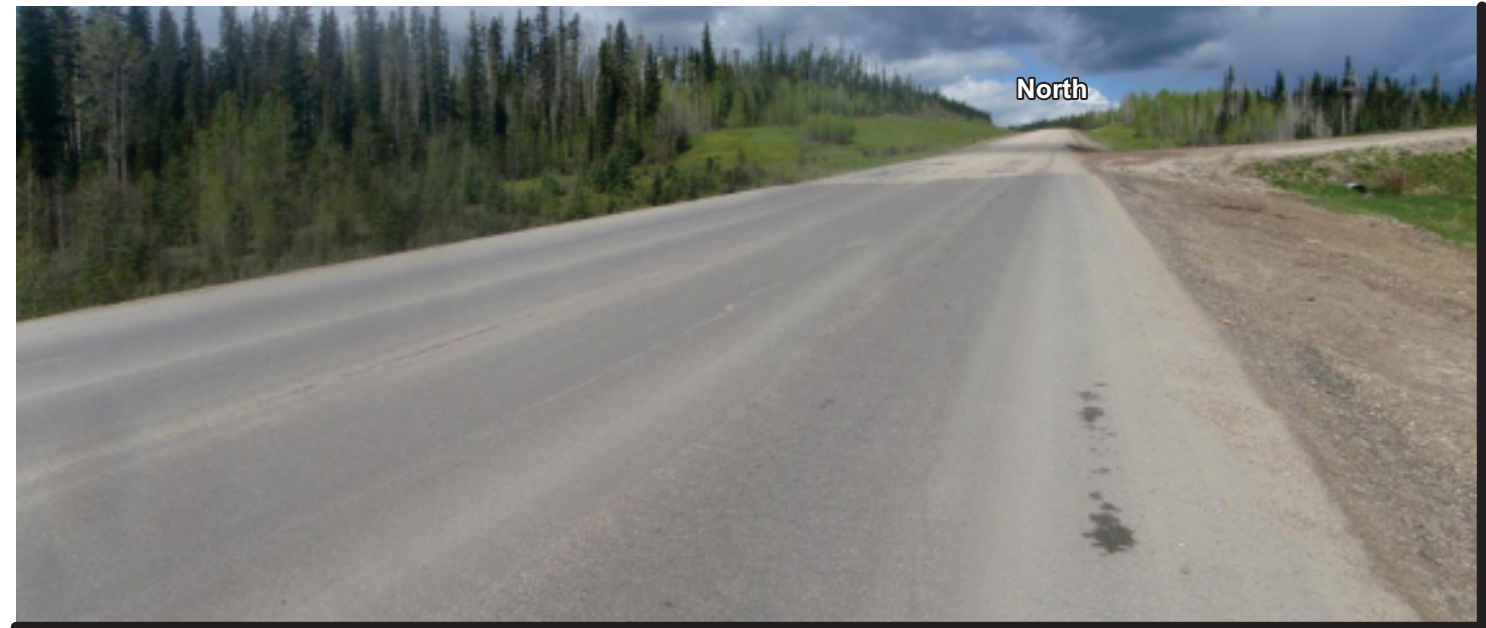
Photo 1c

Another view of pavement

- Patching overlay has covered off most of cracks
- Will monitor to observe reflection recurrence of the cracks

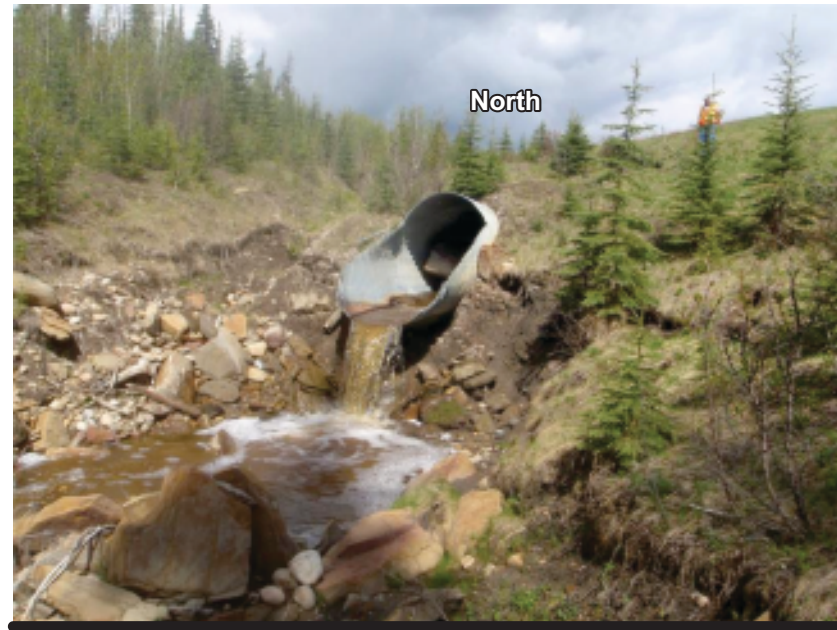
Photo 2

Outlet and outflow of bridge culvert

- Vast outflow of culvert and erosion with downcut of channel at outlet zone evident
- About 1.5m erosion downcut of bank (and toe of fill slope) was evident and riprap stone along bank was eroded
- Minor toe rolling and some lateral spreading (at upper portion) of fill embankment can be observed

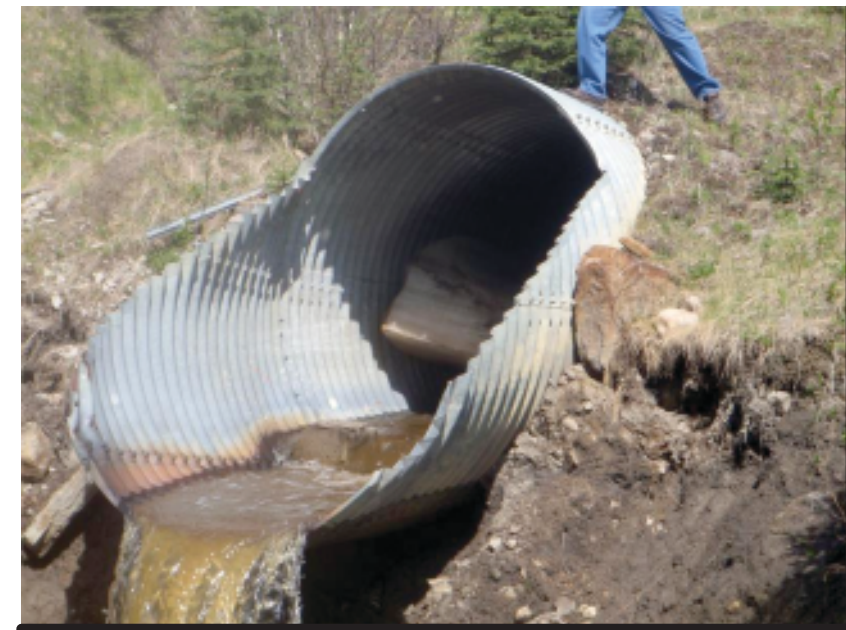
Photo 2a

Outlet and outflow of bridge culvert

- Vast outflow of culvert and erosion with downcut of channel at outlet zone evident
- About 1.5m erosion downcut of bank (and toe of fill slope) was evident and riprap stone along bank was eroded
- Minor toe rolling and some lateral spreading (at upper portion) of fill embankment can be observed

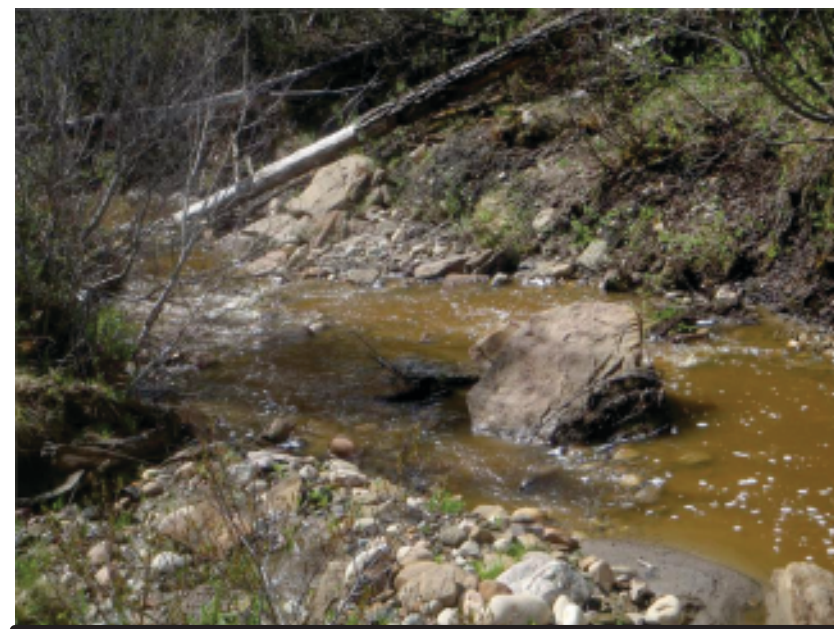
Photo 2b

Channel condition just downstream of culvert outlet
