CON0022166 Peace Region (Grande Prairie District – South) GRMP Instrumentation Monitoring Site GP038-I; H40:38; km 25.831 North of Kakwa River Bridge (North Little Prairie Creek) Section C – 2021 Spring Readings

Site GP038; H40:38, km 25.831 Kakwa River Bridge Section C – 2021 Spring Readings

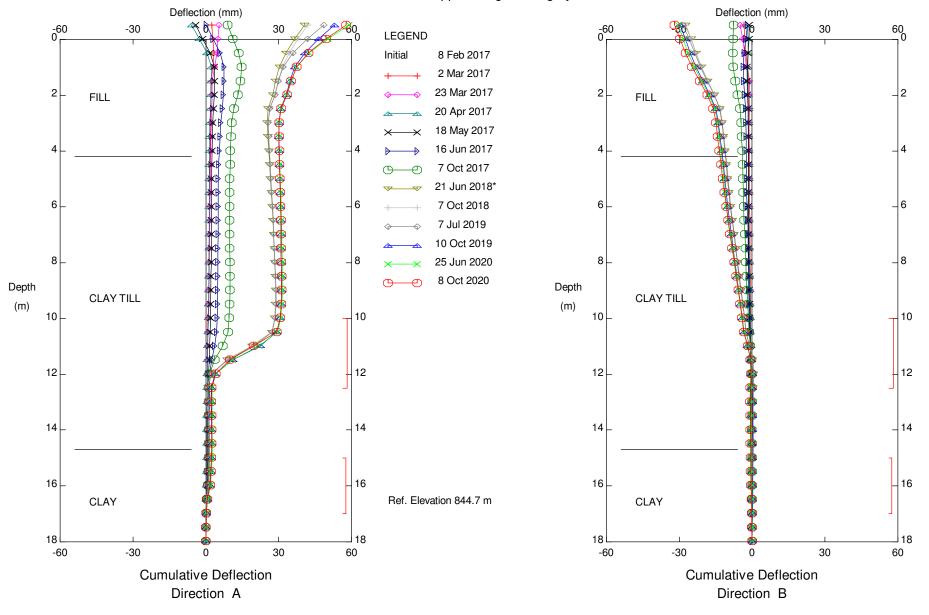
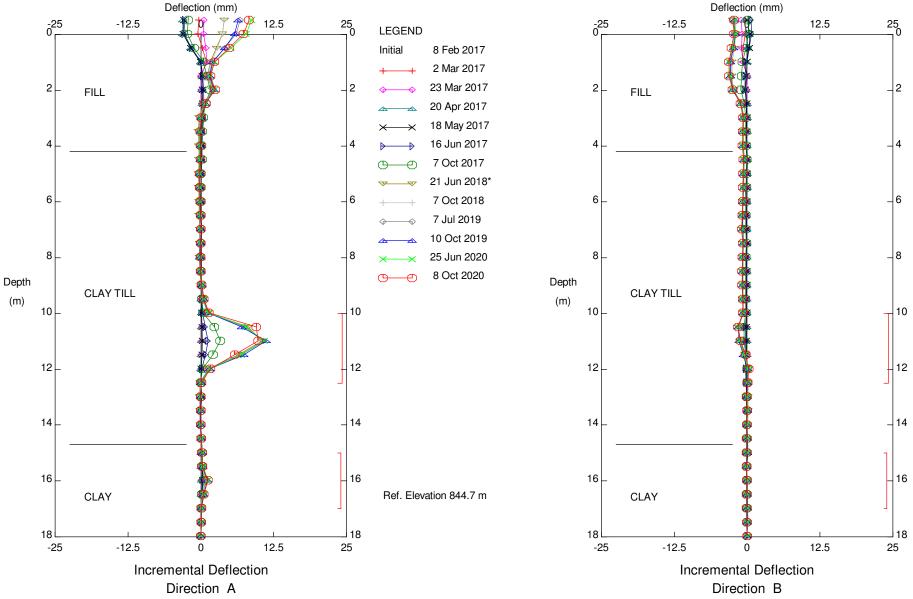
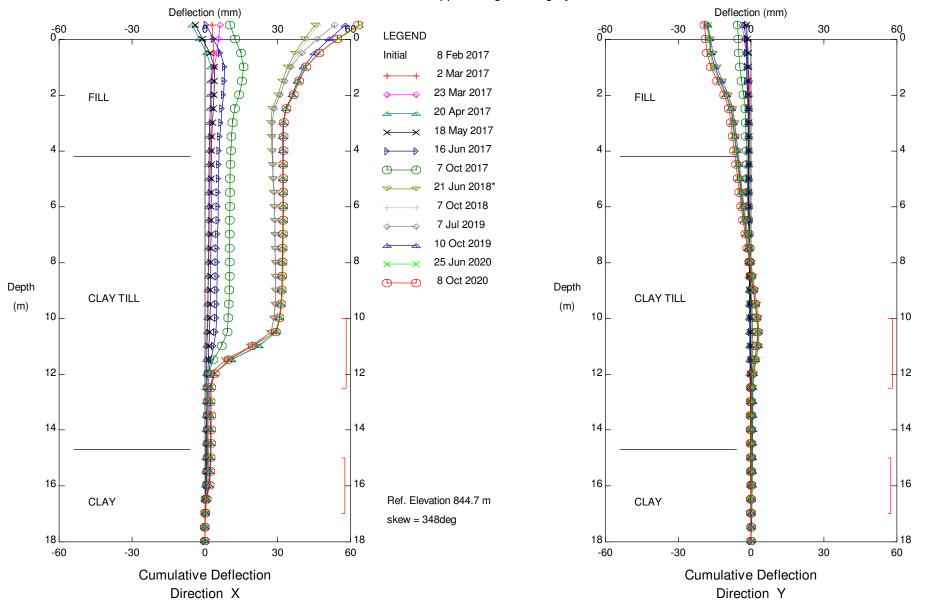
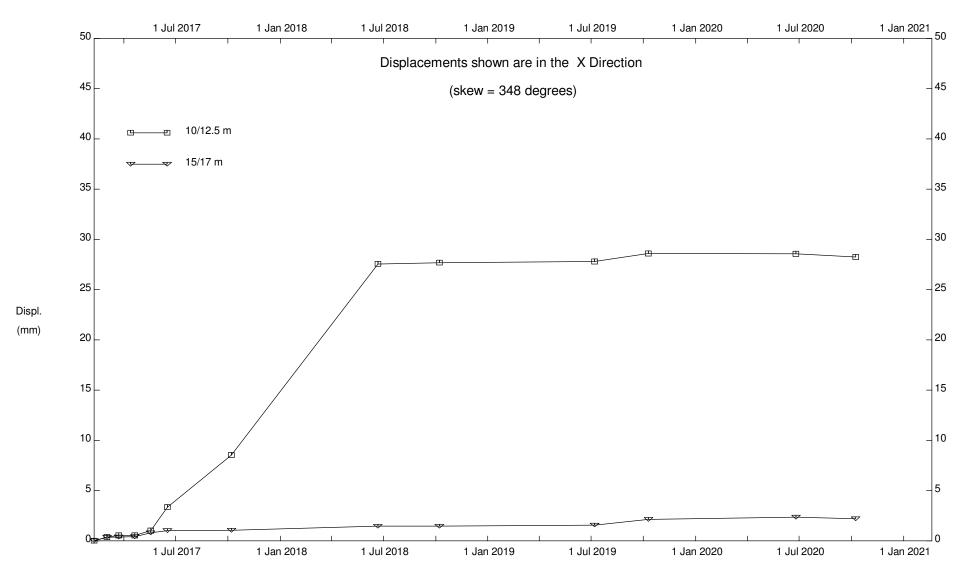
GP038-I; H40:38, Kakwa River Bridge, Inclinometer SI17-1 Alberta Transportation

SI17-1 is recording two zones of movement. There is a deeper zone of movement from approximately El. 828.5 m to El. 829.5.0 m (in the upper portion of the clay underlying clay till) and a more-shallow zone of distributed movement from approximately El. 832.0 m to El. 843.5 m (lower portion of the clay till foundation unit).

There was an increased rate of movement recorded in SI17-1 between June 2017 and June 2018 (27 mm/year). However, in 2017 and 2018, the CSP culvert was extended, and a toe berm was built to stabilize the highway embankment. Since construction, the rate of movement has attenuated (less than 1 mm/year). The movements recorded in SI17-1 do not appear to be influenced yet by the slowly rising pore pressures recorded by PN17-1A.

All operational instruments should continue to be read once per year (spring).

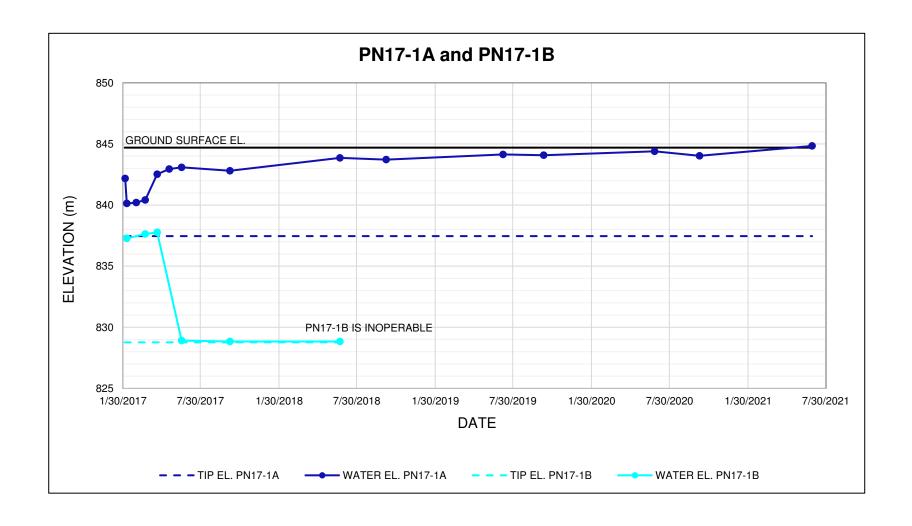
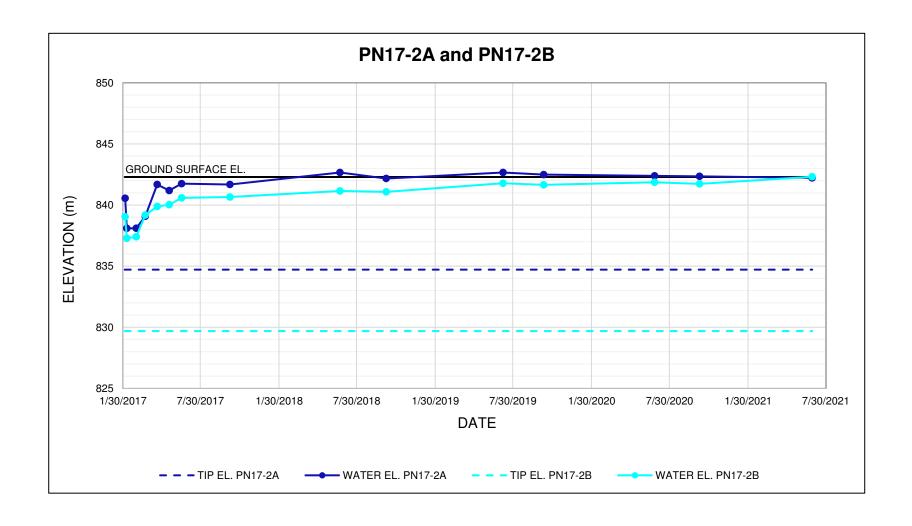
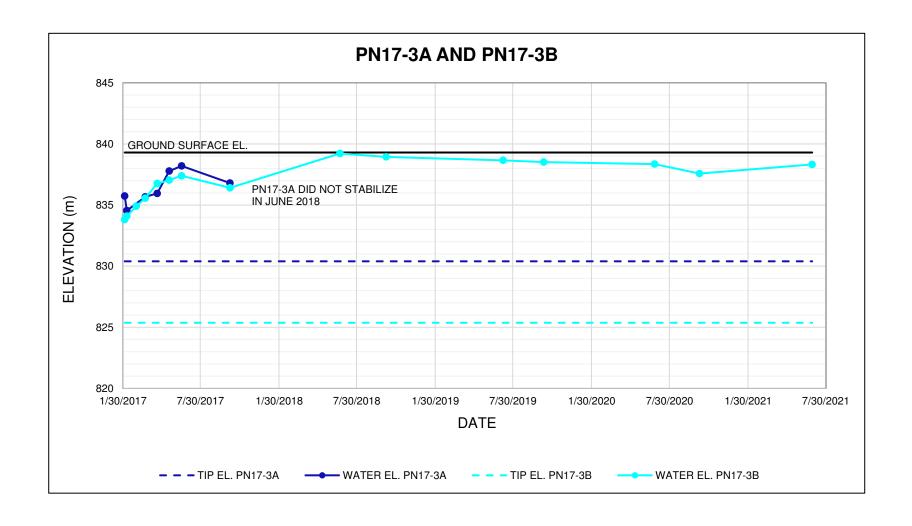
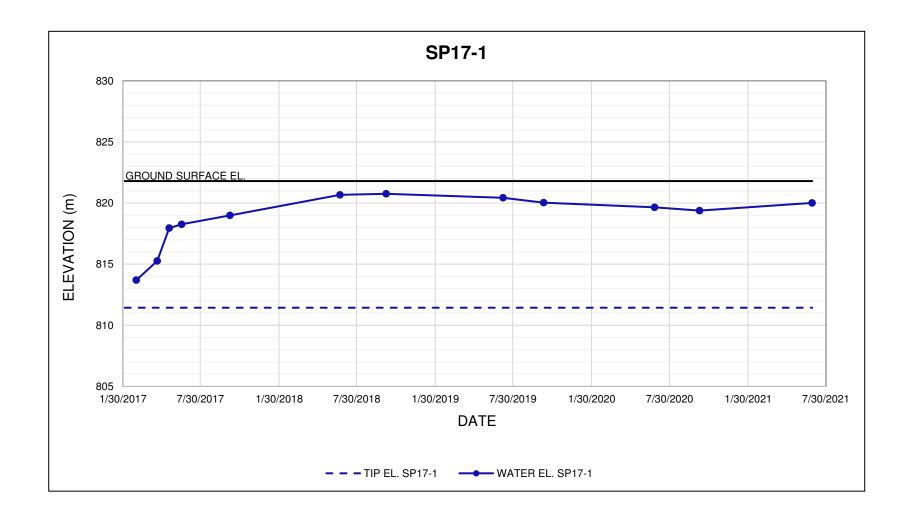
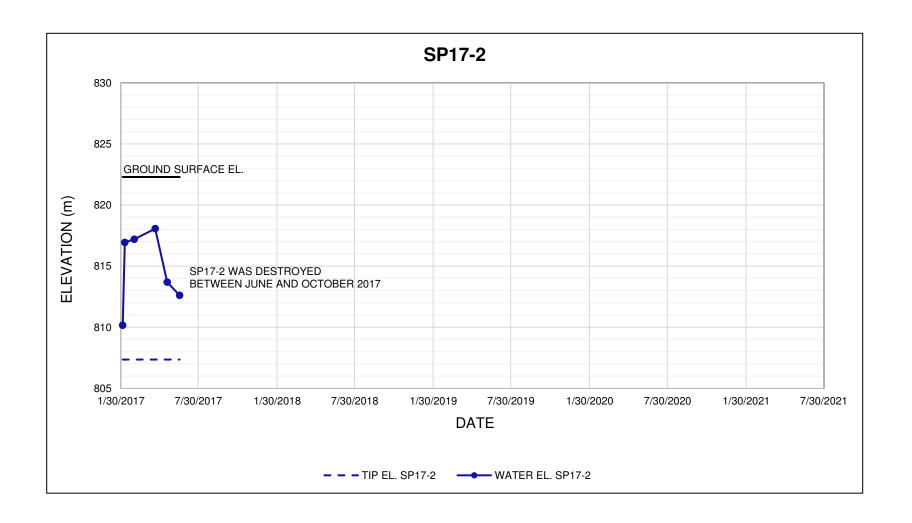
Piezometer Data GP038 - Kakwa River Bridge Hwy 40:38, km 25.831

All of the active piezometers (PN17-1A, PN17-2A and -2B, PN17-3B) are recorded water level near ground (fill) surface elevation. Four of the five piezometers recorded water level increases (0.6 m to 0.8 m), excluding PN17-2A, which recorded a 0.1 m decrease. The relatively high-water level could result in the embankment having reduced stability and explain the hairline cracks showing up on the pavement surface in previous years. Continued erosion or increases in water levels could result in reactivation of slope instability.

The water level recorded in SP17-1 in the upslope ditch is relatively high. The settlement of the pavement may be unrelated to the water level recorded in SP17-1, being more likely to be minor settlement of recently placed fill.
