July 15, 2024

**CON0022166 Peace Region (Grande Prairie District – South) GRMP Instrumentation Monitoring Site GP038-I and II; H40:38, km 25.831 and km 25.426 Slides 1.6 km and 2.0 km North of Kakwa River Bridge (North Little Prairie Creek) Section C – 2024 Spring Readings**

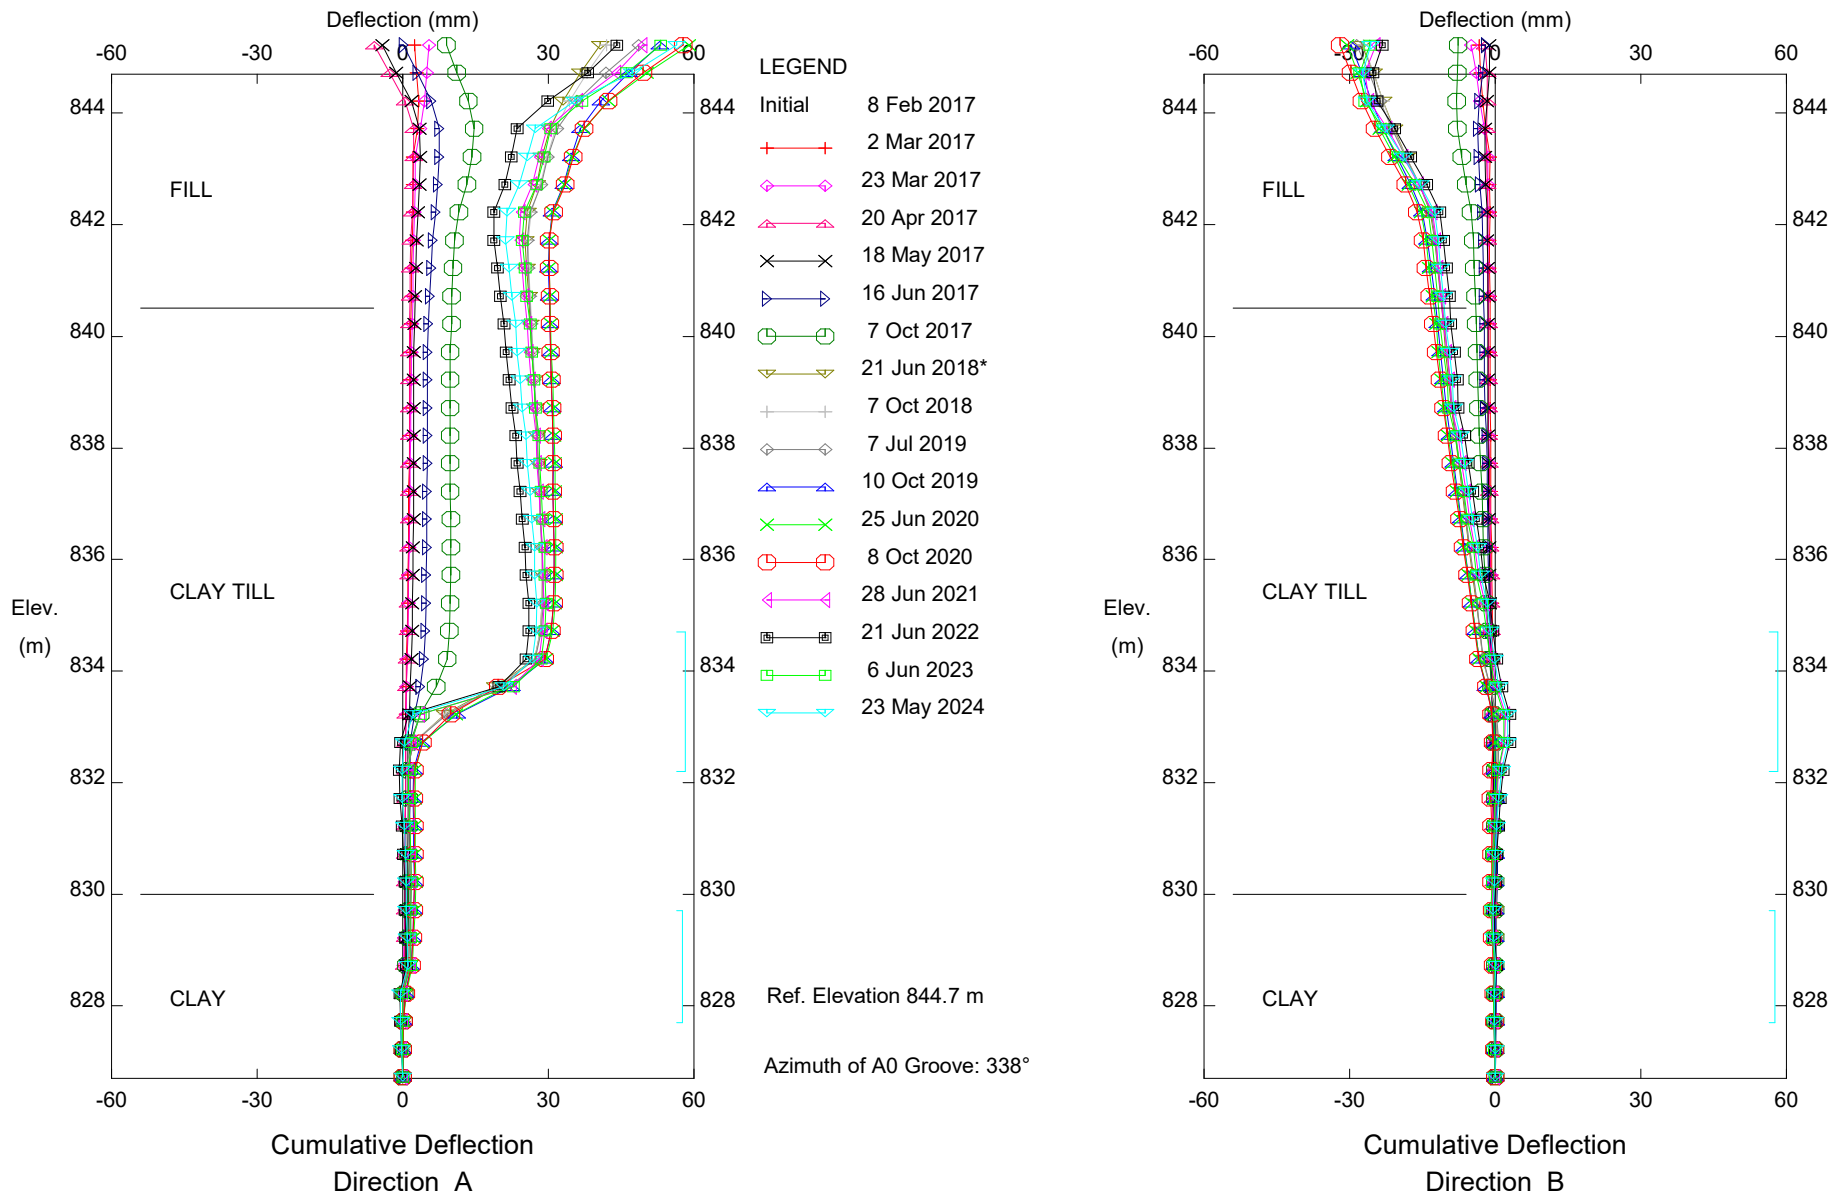
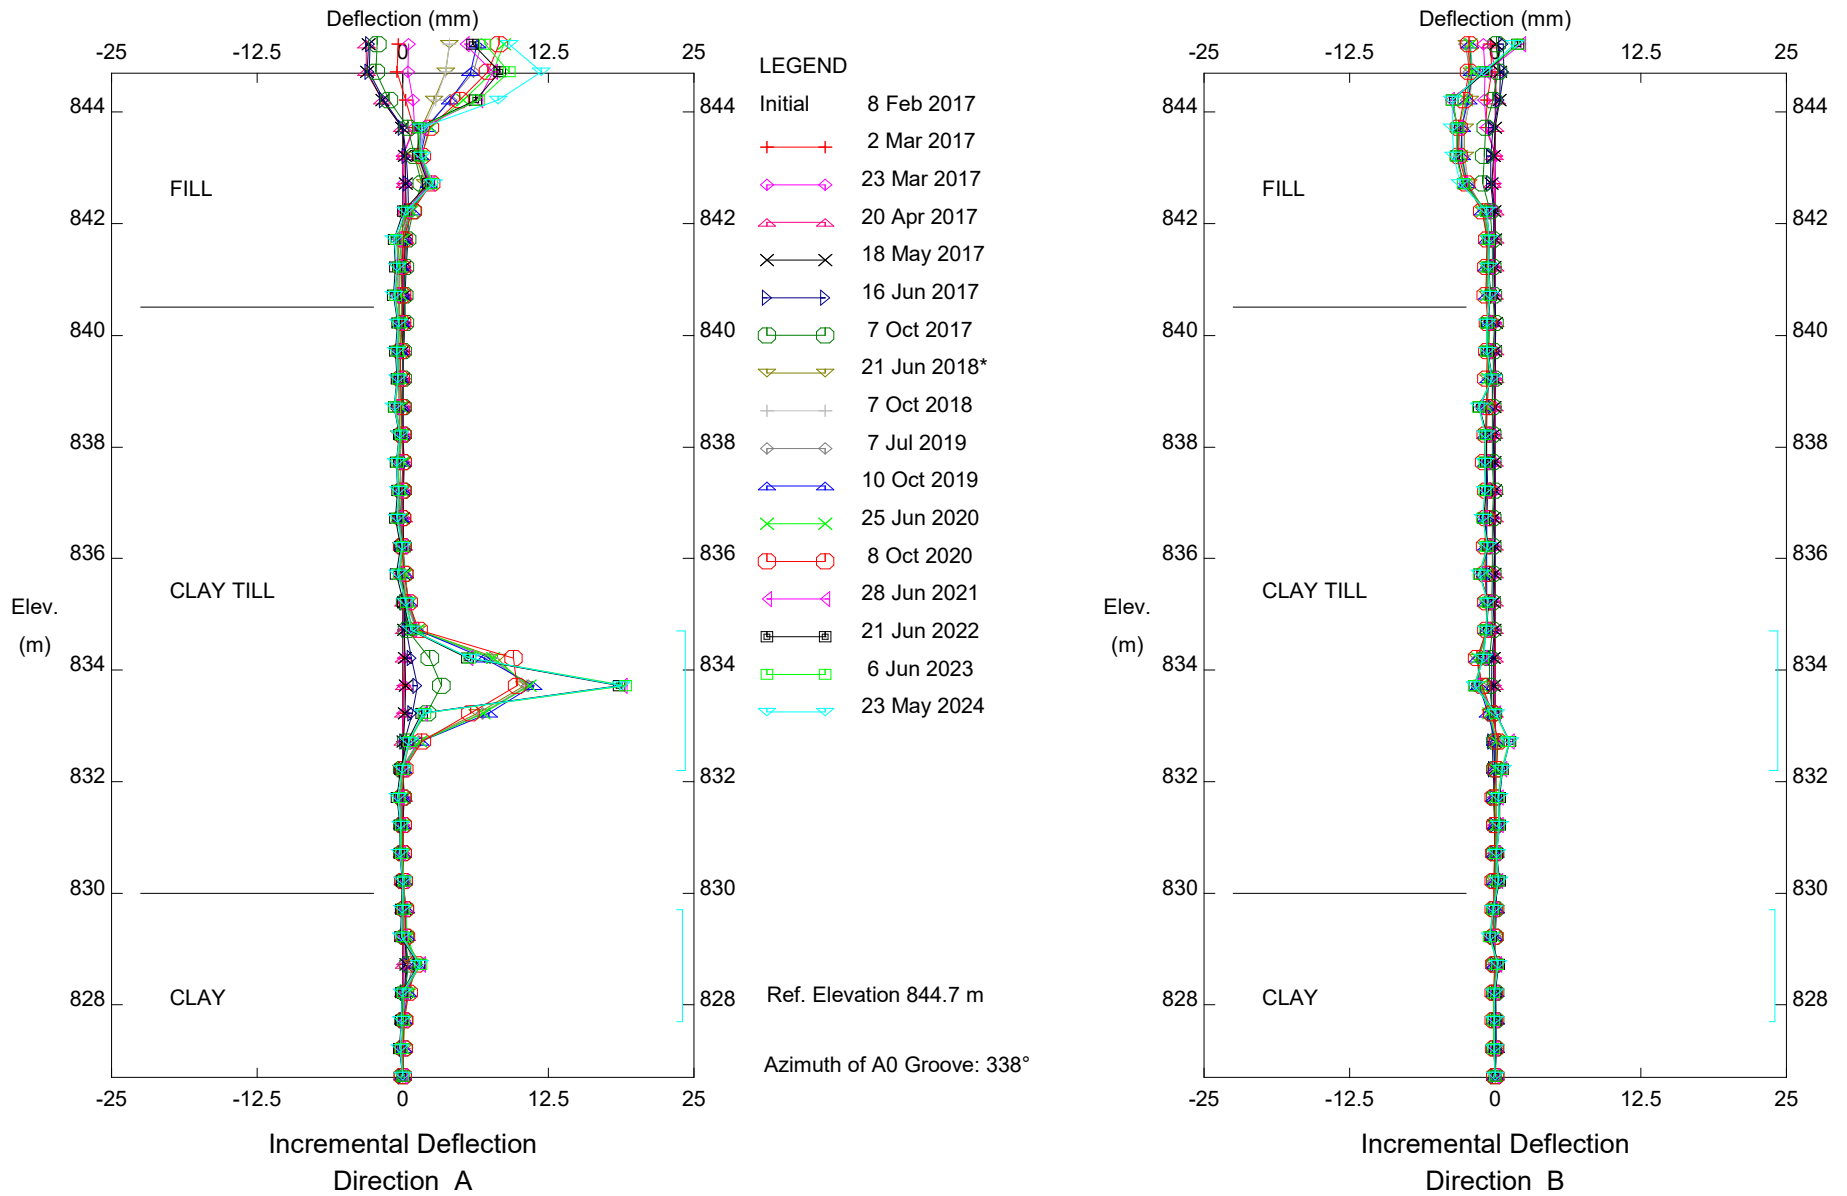
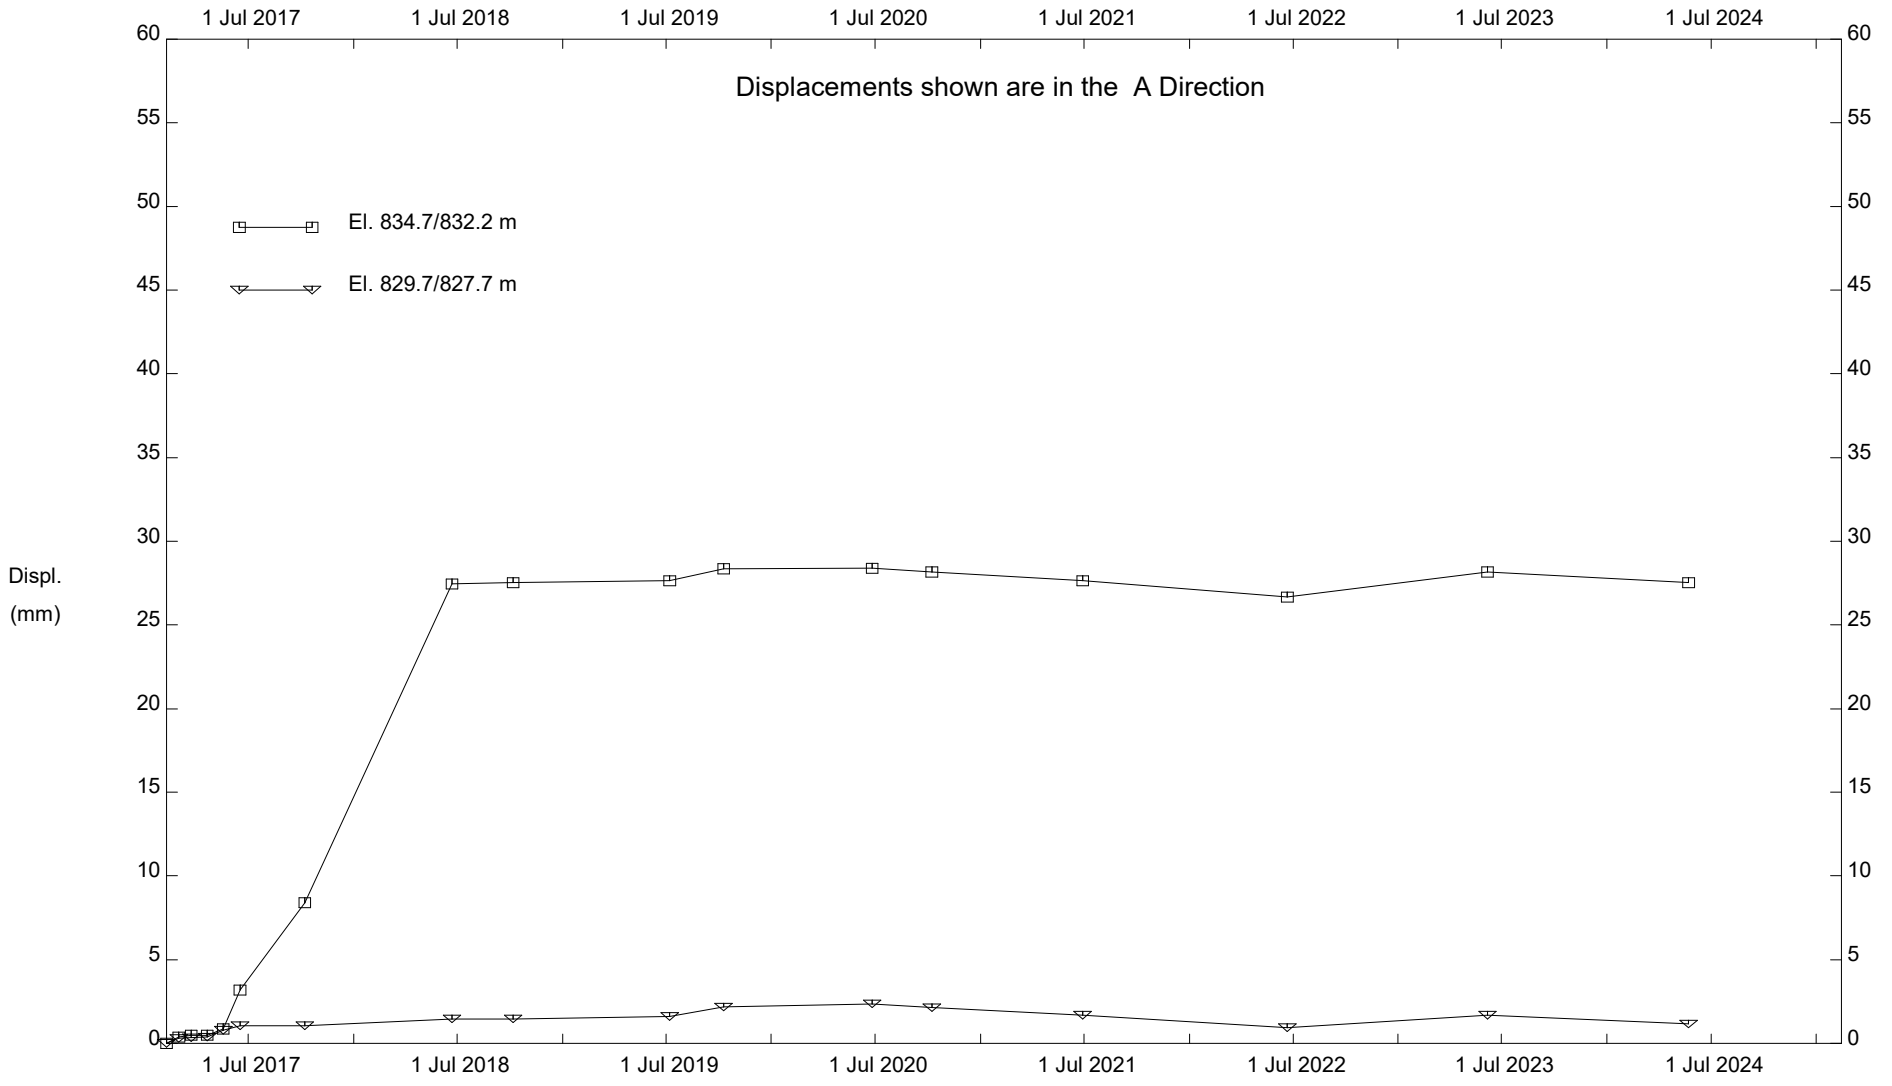
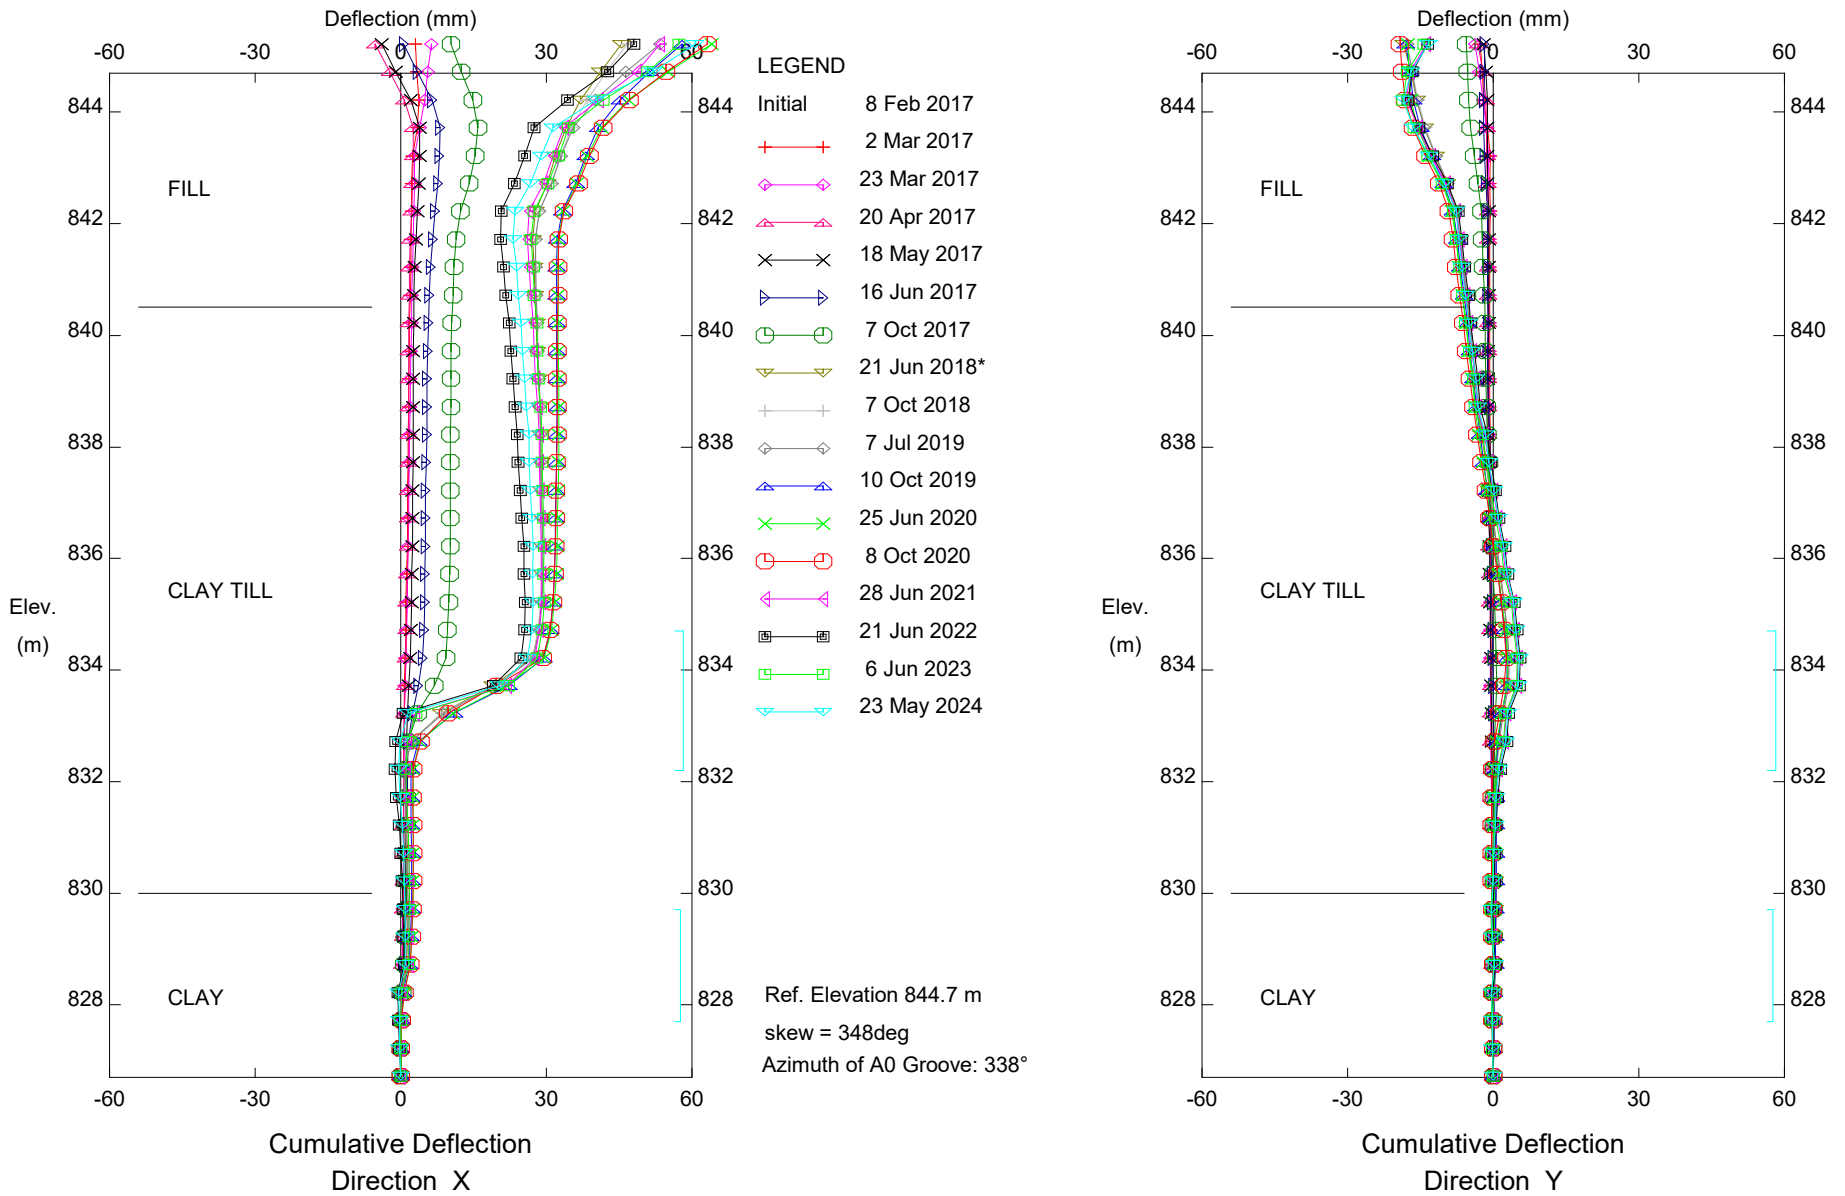
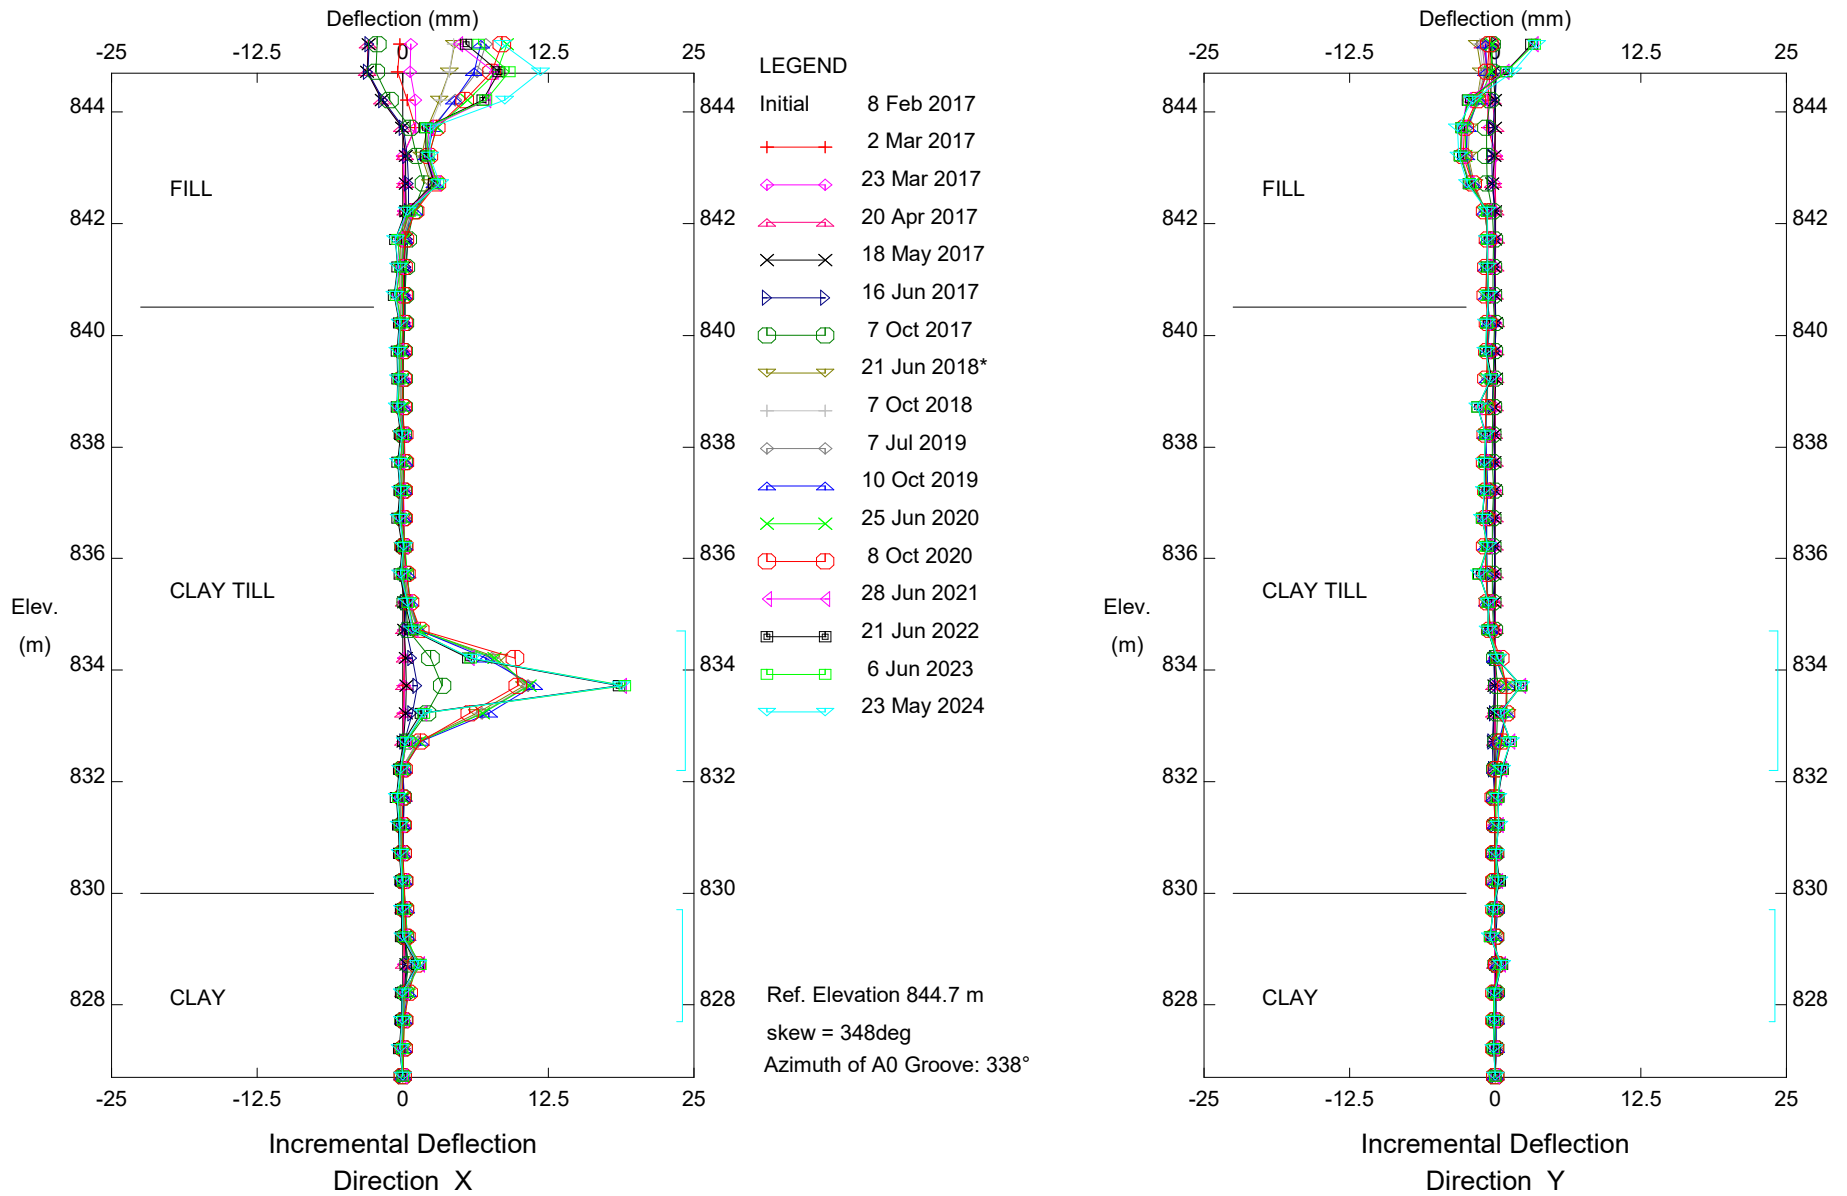
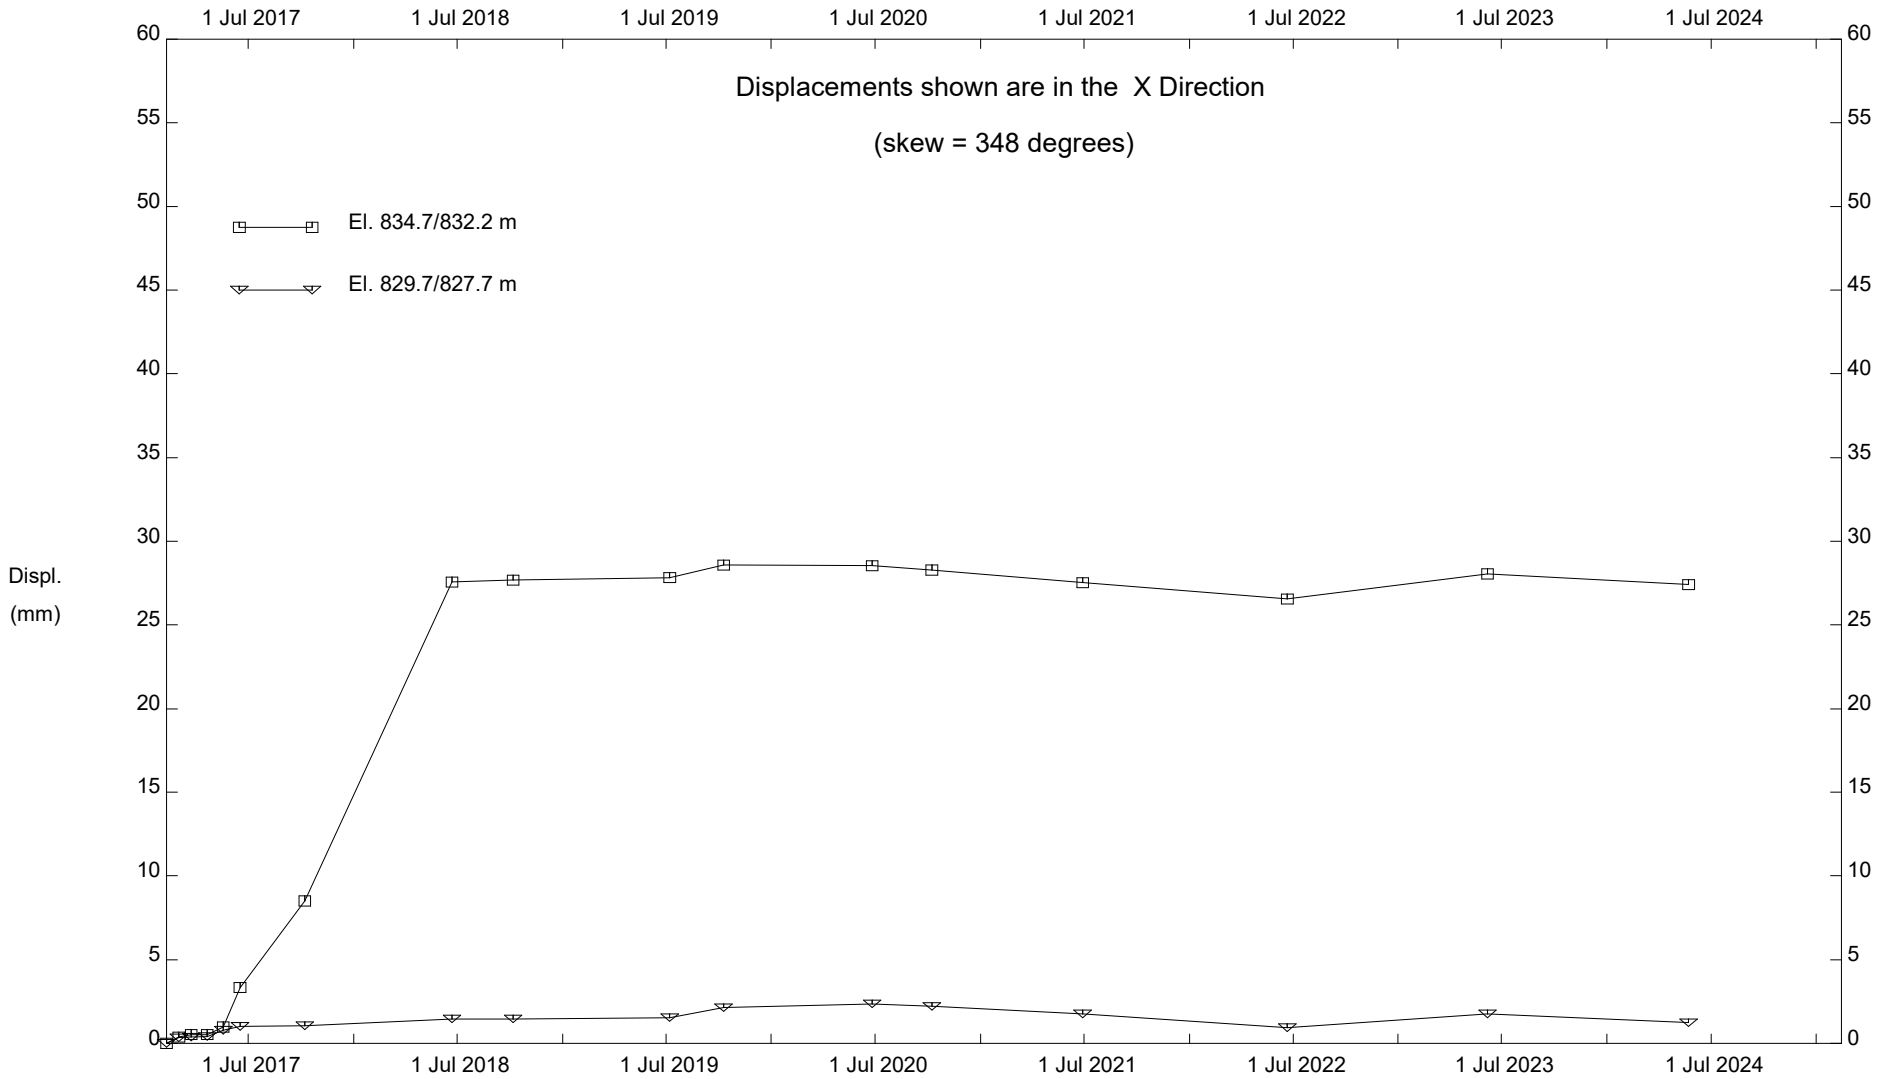
GP038-I; H40:38, Kakwa River Bridge, Inclinometer SI17-1

Discrete movement (i.e., occurring on a defined failure plane) is being recorded in SI17-1 from an approximate depth of 10.0 m to 12.5 m below ground surface (approximately elevation 832.2 m to 834.7 m) and possibly from 15.0 m to 17.0 m (approximately elevation 827.7 m to 829.7 m). The upper and lower zones of movement are occurring in the clay till and the underlying clay foundation units, respectively. Shallow distributed movement is also being recorded in the fill from an approximate depth of 2.5 m below ground surface to ground surface (approximately elevation 842.2 m to 844.7 m).

Between June 2017 and June 2018, an increased rate of movement (approximately 29 mm/year) was recorded in the upper monitoring zone of SI17-1, likely in response to toe berm construction in 2017 and 2018. Since June 2018, the rate of movement has decreased and is currently less than 1 mm/year indicating the toe berm is stabilizing the highway embankment. The rate of movement recorded in the lower monitoring zone of SI17-1 has been slow (less than 1 mm/year) since installation and is within the reading accuracy of the SI equipment.

All operable instruments should continue to be read once per year (spring). Spring readings should be completed after late-May or early-June, due to the risk of water inside the instrument casings being frozen earlier in the year.

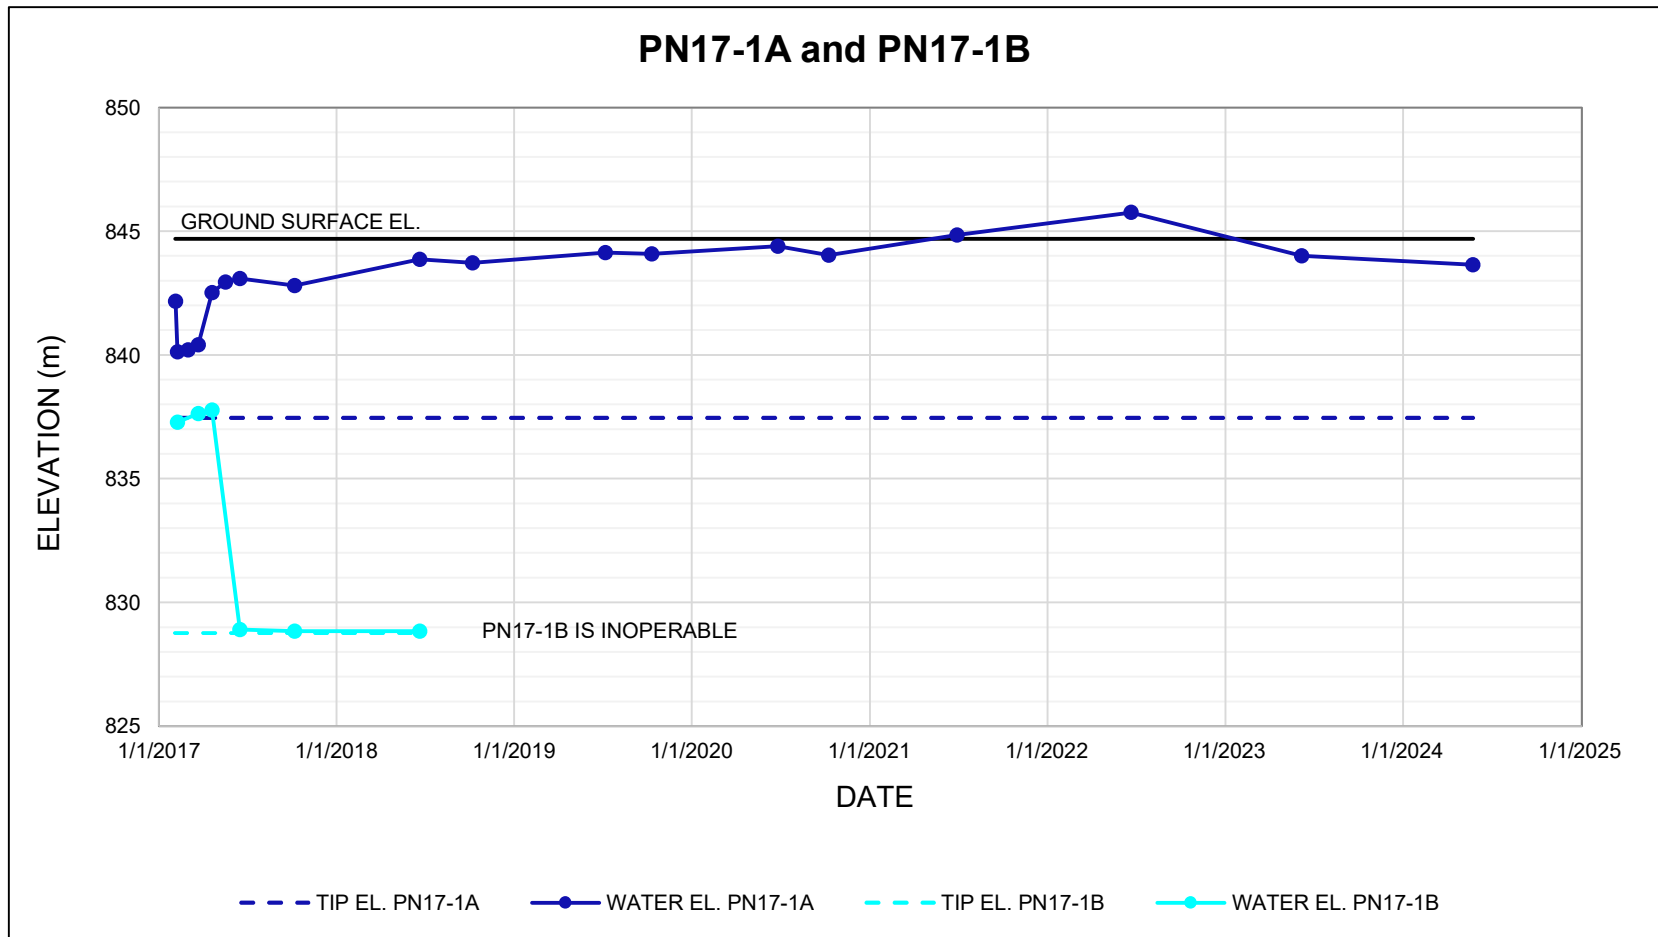
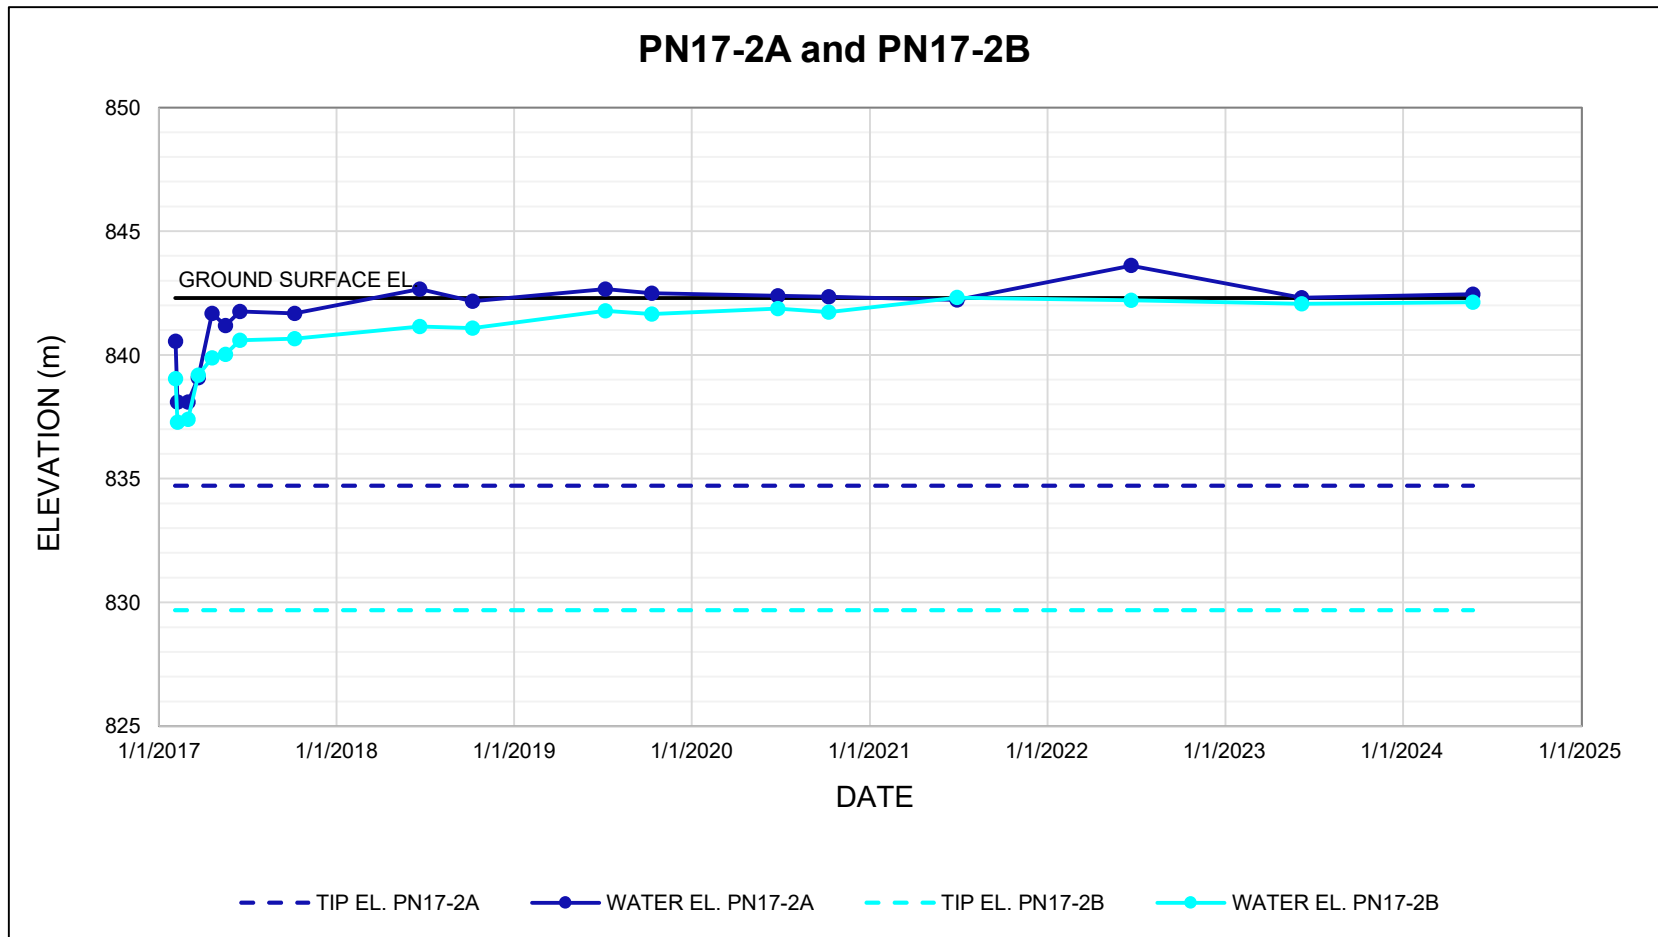
Overall, the water levels/porewater pressures recorded in the piezometers are relatively high and have been near to above ground surface since mid-2017, indicating the presence of a high groundwater table. The relatively high-water level recorded in the piezometers could result in embankment instability and explain the pavement cracking observed at this site. However, the cracking, in combination with the observed pavement dip and settlement, could also be due to settlement of the recently placed fill. Reactivation of the slide could occur due to continued erosion (less likely) or increases in water level. However, the large toe berm should reduce the potential for reactivation of the slide.

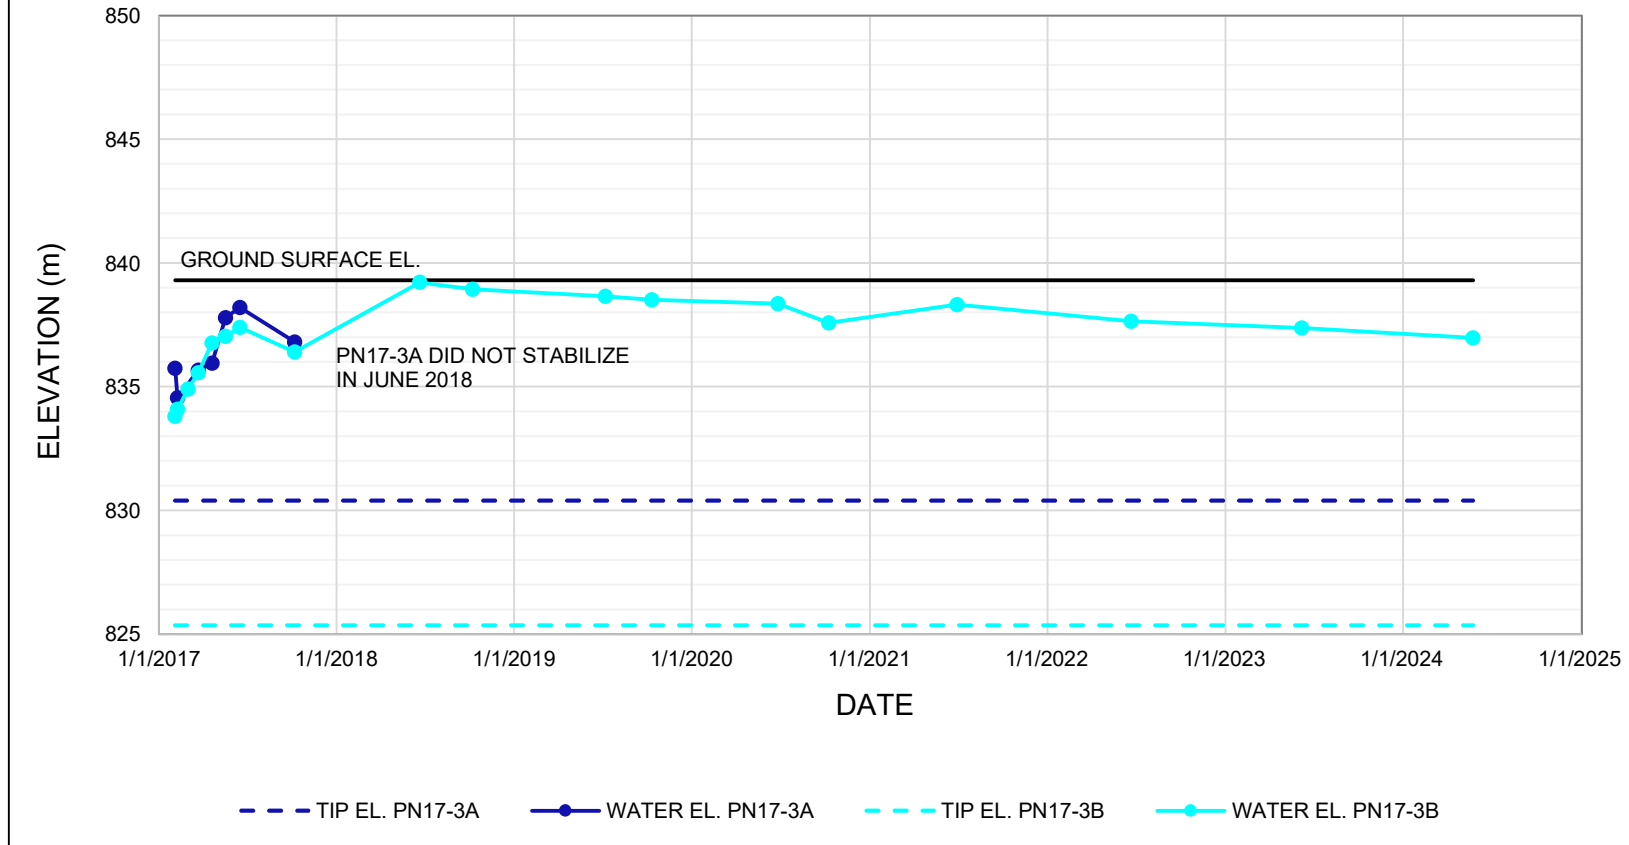
### PN17-3A AND PN17-3B

Since mid-2018, an approximate 2.3 m decrease has been recorded in PN-3B, which is installed below the toe berm in a clay foundation unit. The recorded decrease is most likely due to porewater pressures dissipating following toe berm construction between 2017/2018.
