**PEACE REGION  
(GRANDE PRAIRIE DISTRICT – SOUTH) GRMP**

**SITE INSPECTION FORM**

Should be SITE NUMBER AND NAME: <b>GP044 Cutbank River Slide (North)</b>	HIGHWAY & KM: 40:40, 1.002	PREVIOUS INSPECTION DATE: June 15, 2022	INSPECTION DATE: <b>June 11, 2024</b>
LEGAL DESCRIPTION: NE-21-65-05-W6M	NAD 83 COORDINATES: UTM Northing Easting 11 6056410 391477	RISK ASSESSMENT: PF: 9 CF: 2 TOTAL: 18	
AVERAGE ANNUAL DAILY TRAFFIC (AADT): 2,300 (north) & 2,280 (south) (Reference No. 70000761, 2023) 2,520 (north) & 2,300 (south) (Reference No. 70000671, 2023)		CONTRACT MAINTENANCE AREA (CMA): 504

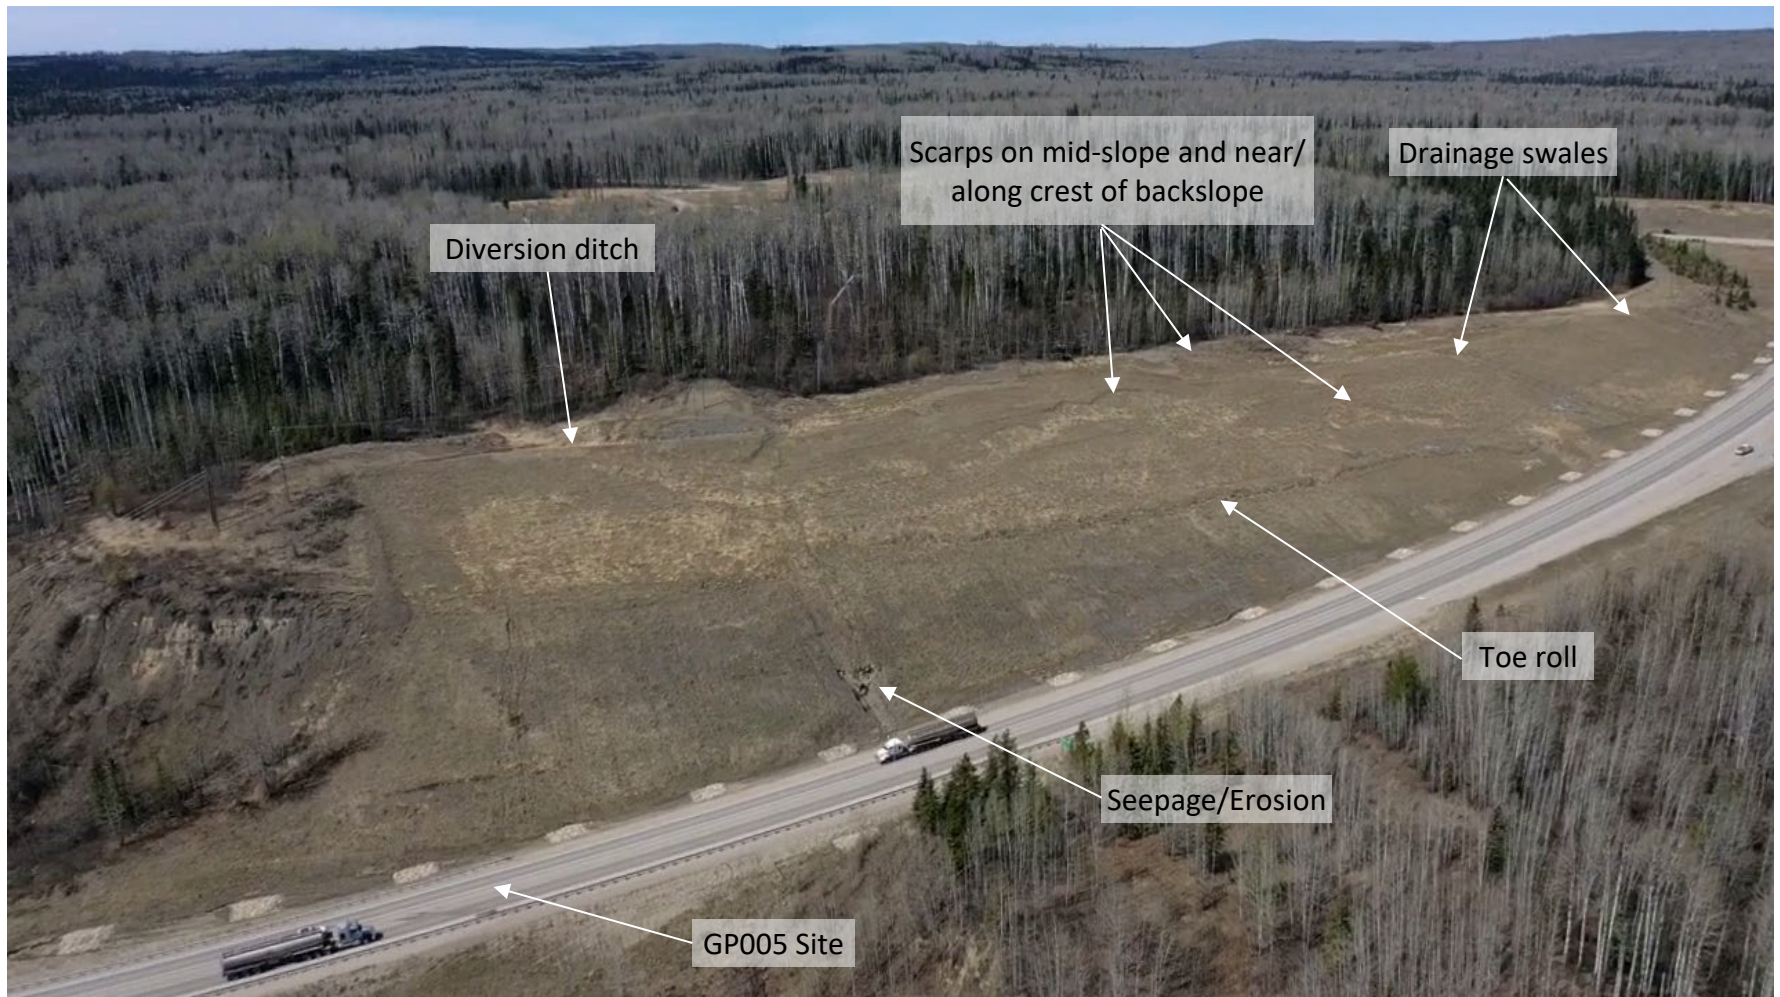
ITEM	CONDITION EXISTS		DESCRIPTION AND LOCATION	NOTICABLE CHANGE FROM LAST INSPECTION	
	YES	NO		YES	NO
Pavement Distress		X	None observed at time of 2024 inspection, except at GP005 site just south of GP044 site (Photo 1).		X
Slope Movement	X		Scarps on mid-slope and near/ along crest of backslope, and toe rolls on backslope (Photos 1 through 4), which are more apparent than previous inspection. Overall, slide movements appear minimal compared to movements observed prior to repair completed in 2020.	X	
Erosion	X		Rill and small gully erosion on backslope (Photo 5). South drainage swale failing, gully eroded down center which appears deeper than previous inspection (Photos 3 and 4).	X	
Seepage	X		Seepage/erosion feature on backslope (approximately 1 m wide at base, 10 m wide at top, and 10 m high up backslope) near south end of site. Feature appears to be caused by groundwater seepage and possible flow over crest of backslope, and is larger than previous inspection (Photos 1, 2, and 5). Seepage and ponded water have also previously observed by others on backslope.	X

**Photo 1** Overview of GP044 site along backslope on west side of Hwy 40:40. Photo taken with Unmanned Aerial Vehicle (UAV) on May 9, 2024, facing northwest.

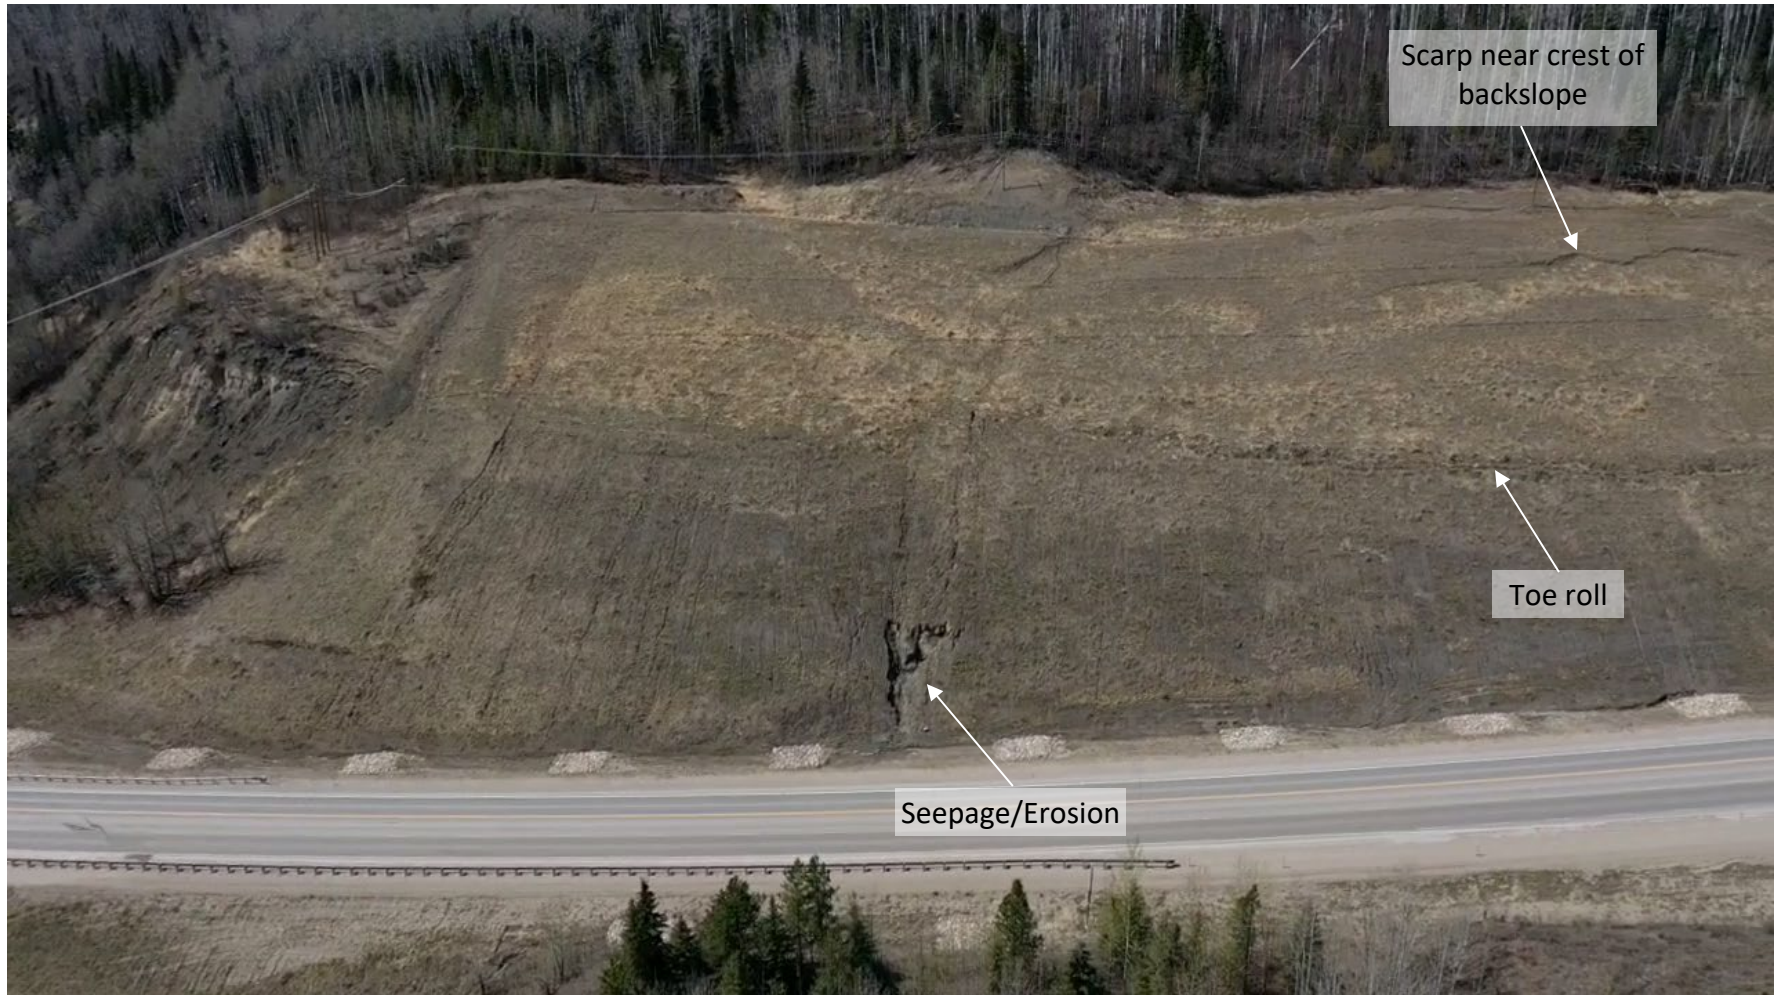
**Photo 2** South end of GP044 site along backslope on west side of Hwy 40:40. Note rill and small gully erosion on backslope. Photo taken with UAV on May 9, 2024, facing west.

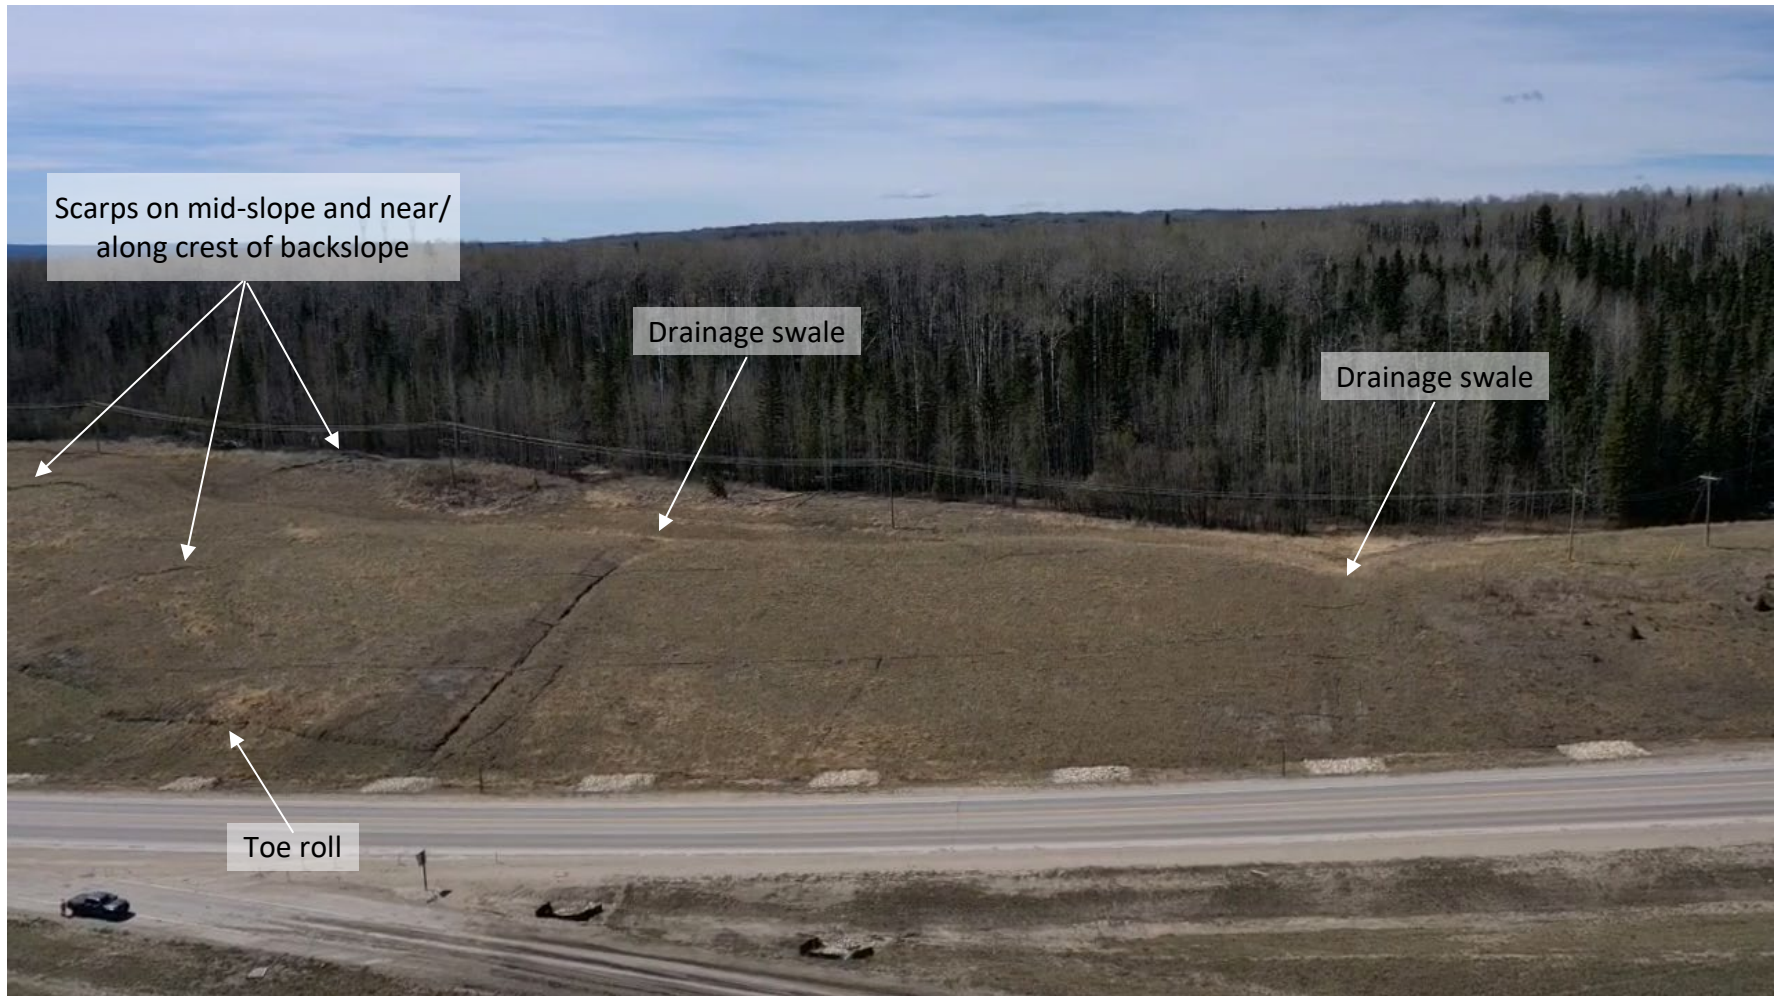
**Photo 3** North end of GP044 site along backslope on west side of Hwy 40:40. Note rill and small gully erosion on backslope and in drainage swale. Photo taken with UAV on May 9, 2024, facing west.

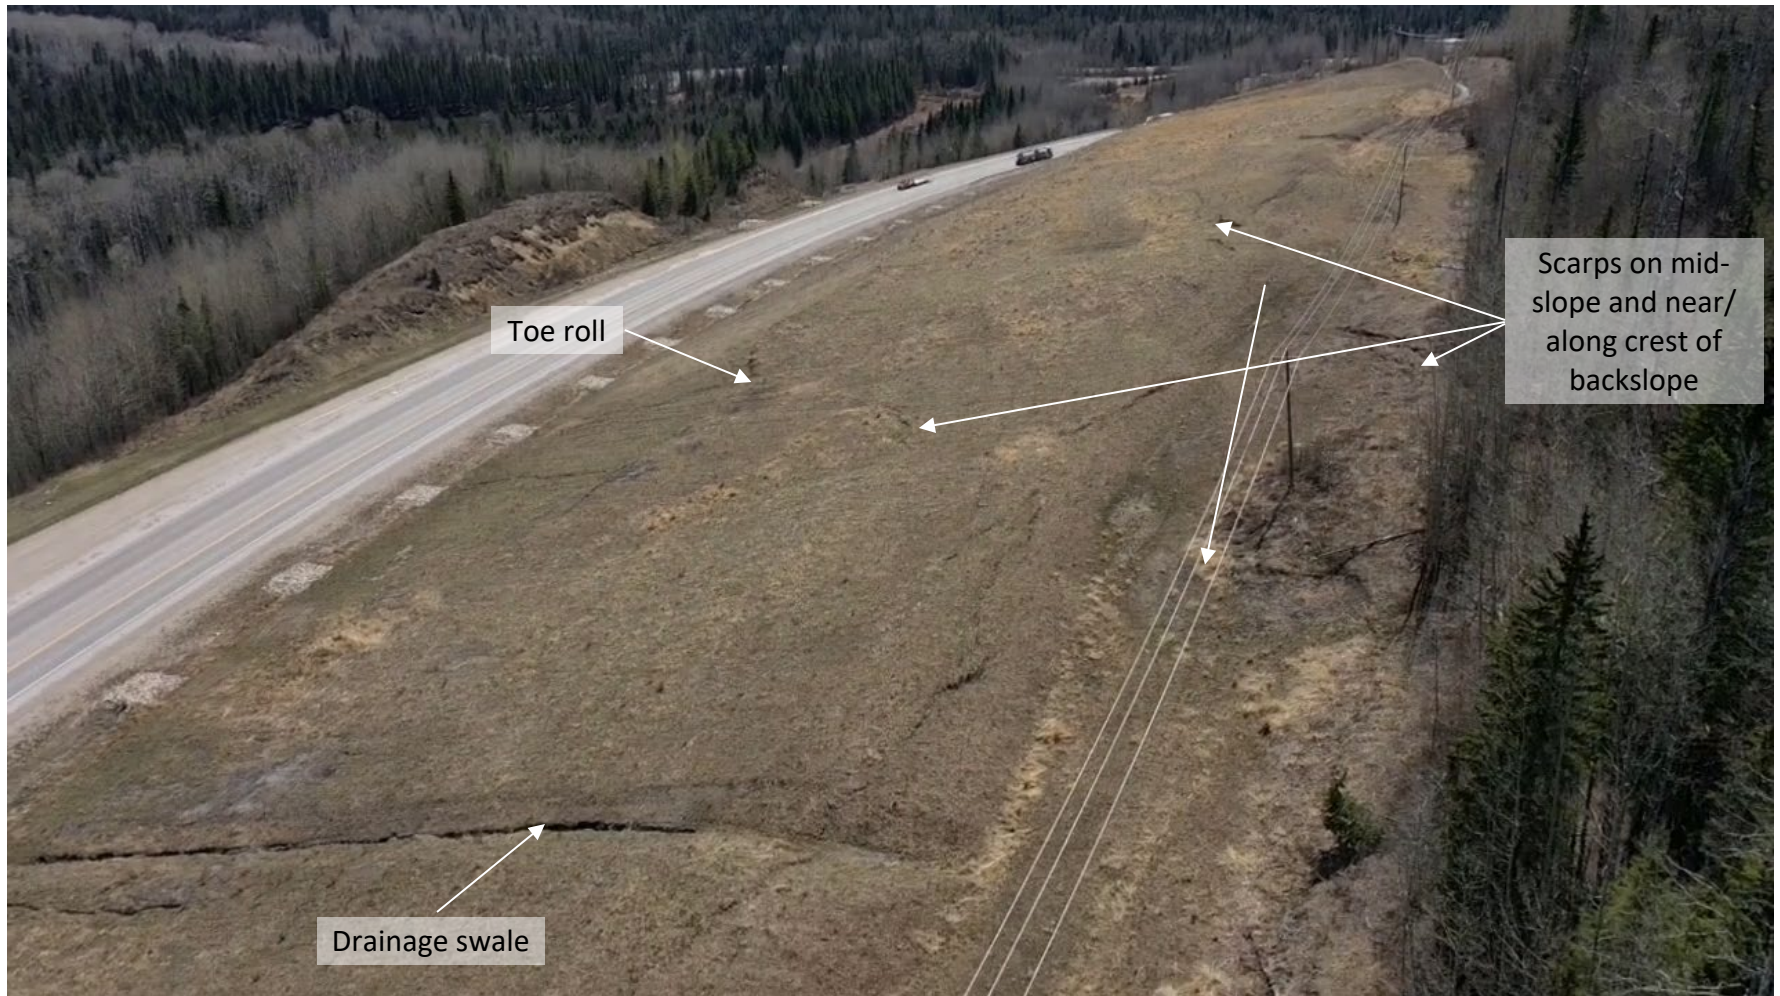
**Photo 4**      **Scarps on mid-slope and near/along crest of backslope. Note rill and small gully erosion on backslope and in drainage swale. Photo taken with UAV on May 9, 2024, facing south.**

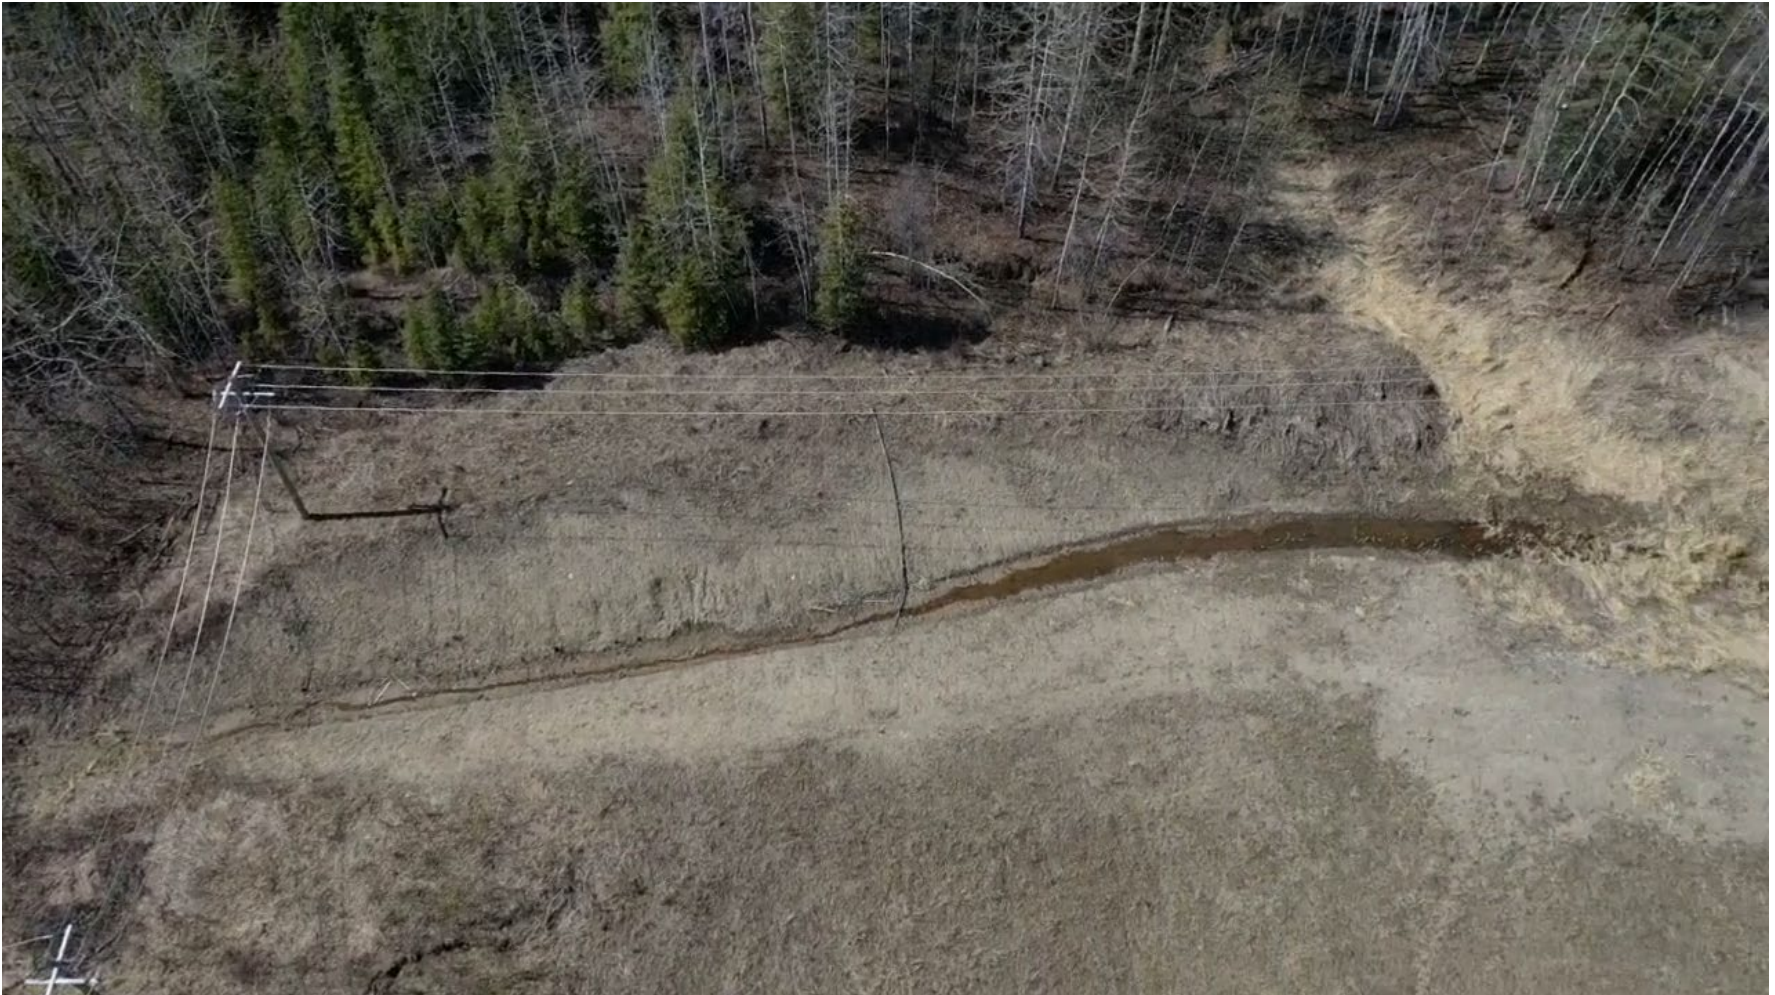
**Photo 5**      **Diversion ditch on crest of backslope. Photo taken with UAV on May 9, 2024, facing west near south end of the GP044 site.**

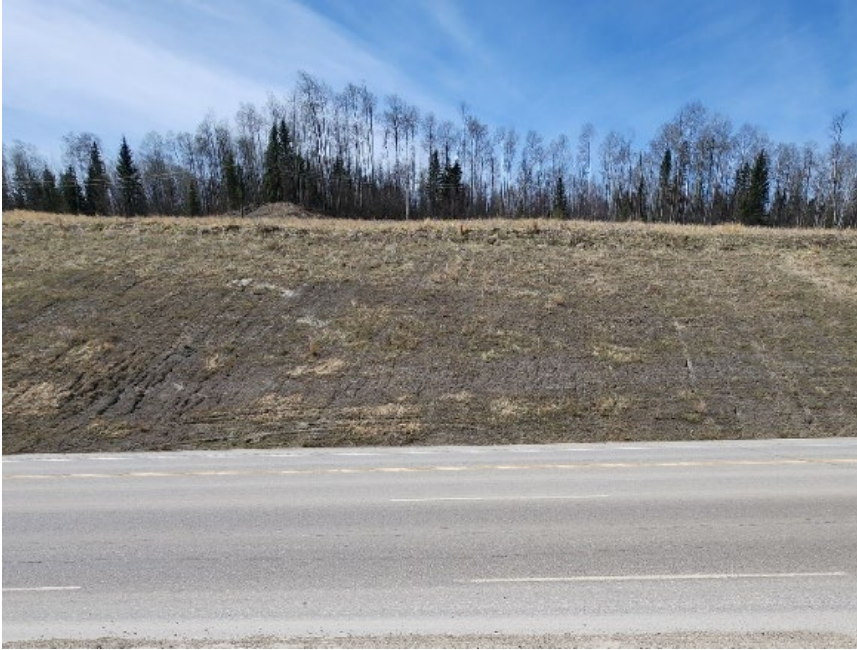
**Photo 6** Rill and gully erosion on backslope. Photo taken May 9, 2024, facing west.

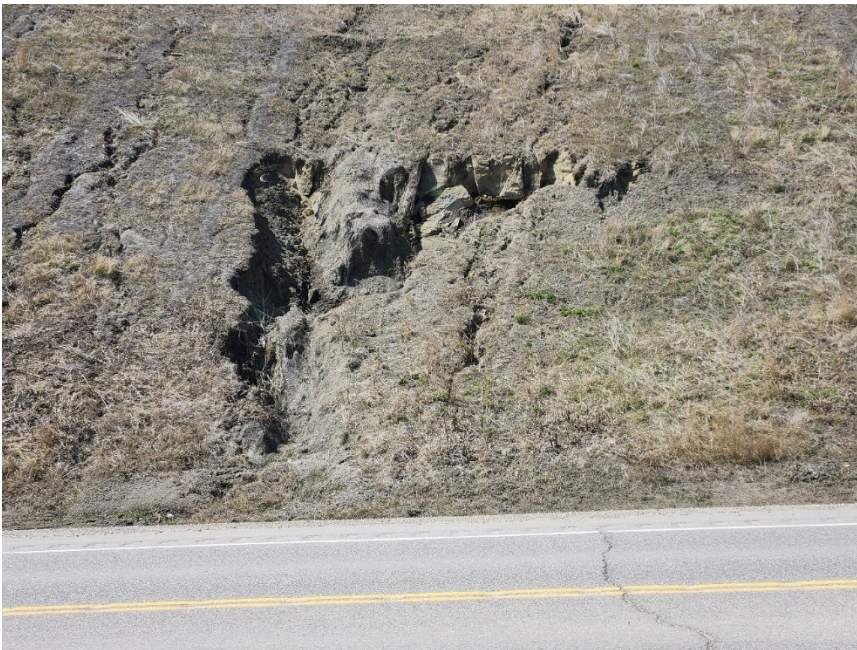
**Photo 7** Erosion and seepage on backslope. Photo taken May 9, 2024, facing west.
