**ALBERTA TRANSPORTATION
GEOHAZARD ASSESSMENT PROGRAM
PEACE REGION – GRANDE PRAIRIE DISTRICT
2018 CALL OUT**

Site Number	Location	Name	Hwy	km
Call Out	Hwy 43/Smoky River East	Hwy 43 Runaway Ramp	43:04	34.7
Legal Description		UTM Co-ordinates		
SW¼ 16-072-02 W6M		11U E 420351	N 6121546

**CALLOUT: HWY 43:04, km 34.7
RUNAWAY RAMP
MAY 24, 2018 CALLOUT FIGURE
SITE PLAN**

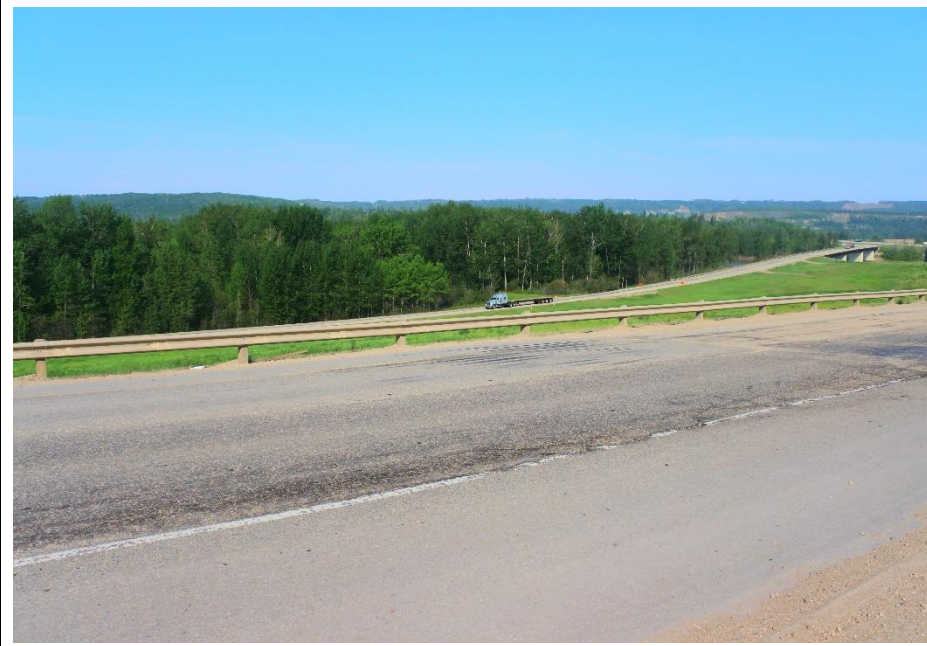
Primary Site Issue:	<p>Hwy 43 was twinned through the site by AT in 1999/2000 under Contract No. 6335/01 with the construction of a new SBL/EBL, while the original highway became the new NBL/WBL.</p> <p>A 1.2 m diameter CSP culvert is located about 1 km east of the Smoky River Bridge. A dip in the pavement exists on the southern west bound lane.</p> <p>The surface of the WBL has several vehicle marks from the dip and several cracks and ruts present (Photos 1 to 3).</p>	
Dimensions:	About ~10m stretch of pavement on both WBLs has been affected.	
Maintenance:	No maintenance has been performed recently at the site however, patching took place in 2014/2015	
Observations:	Description	Worsened?
<input checked="" type="checkbox"/> Pavement Distress	There is a deep dip and cracking in the ACP of the WBL of Hwy 43:04 above the a 1,200 mm diameter CSP at km 34.7 (Photos 1 to 3).	<input type="checkbox"/>

Photo 1.
Looking northwest
at dip in the
pavement.

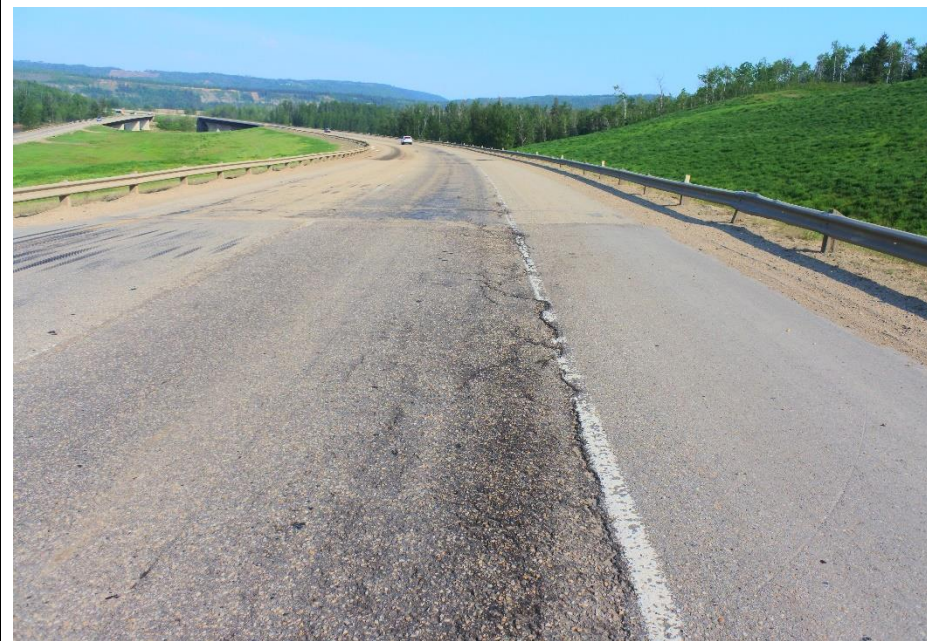
Photo 2.
Looking northwest
standing in right
NBL looking at
cracks and the dip.

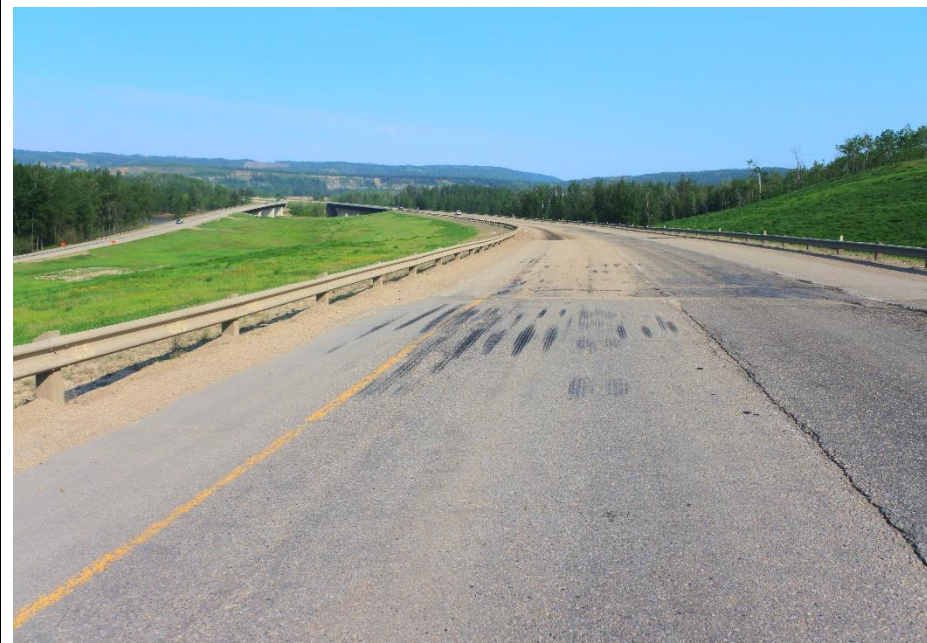
Photo 3.
Looking northwest
from left NBL at
vehicle marks on
the road before the
dip.

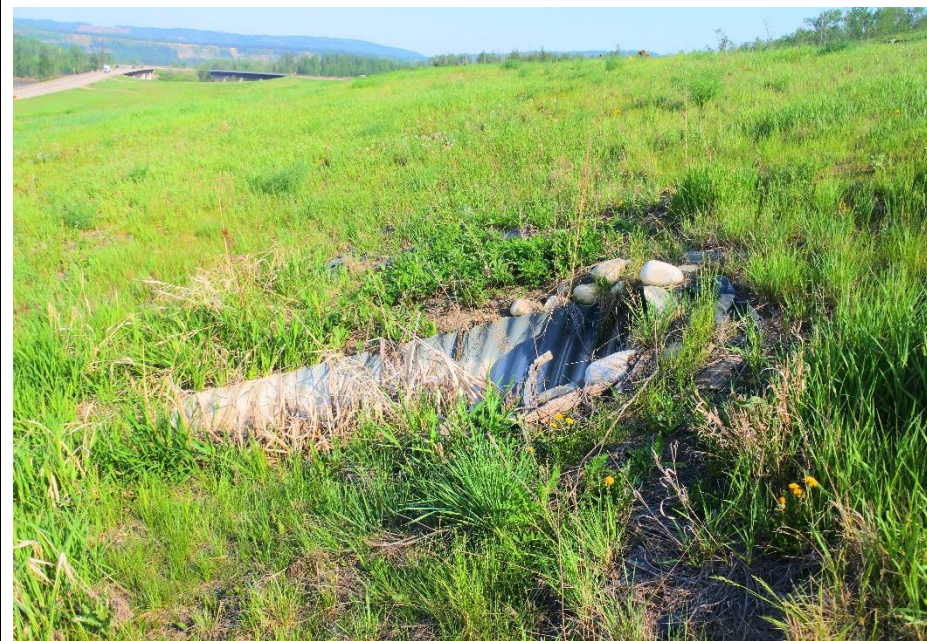
Photo 4.
Looking northwest
at 1200 mm
diameter CSP
culvert outlet.

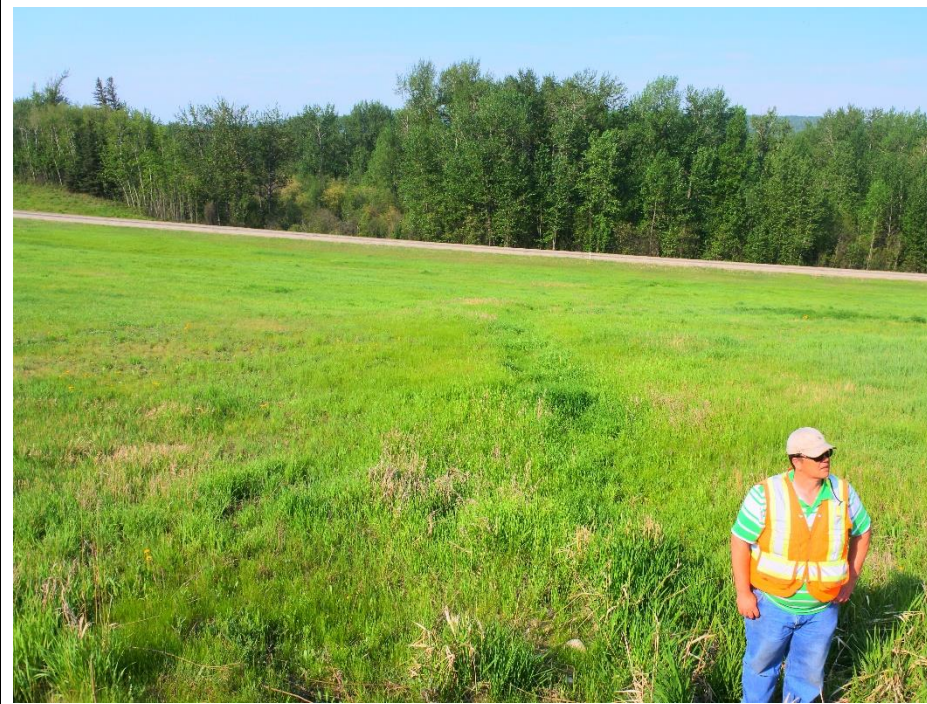
Photo 5.
Looking southwest
and grown over
outlet seepage
water trail.

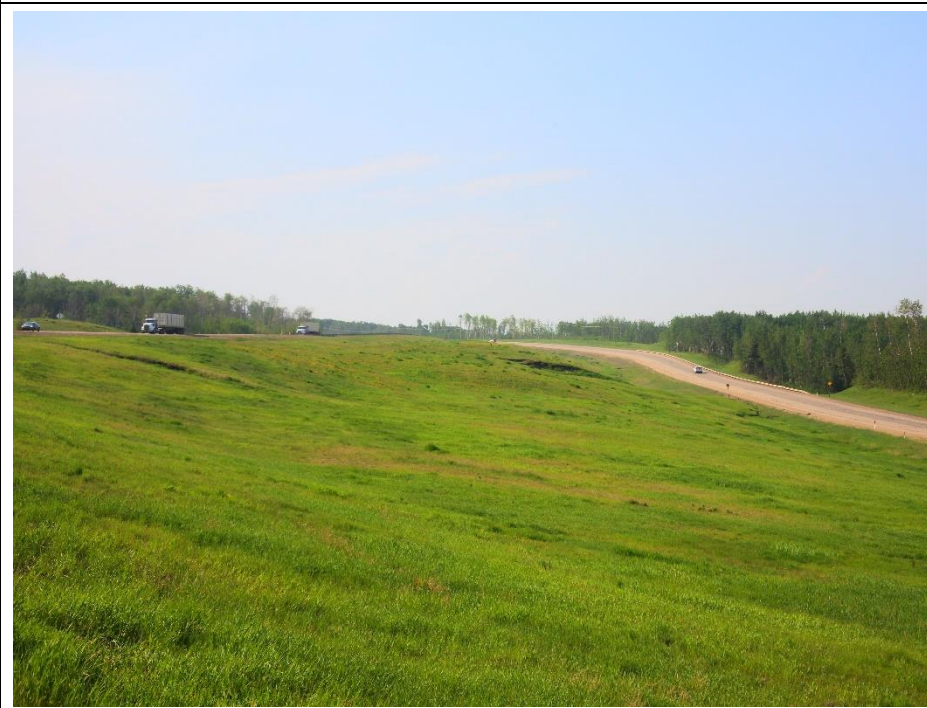
<input type="checkbox"/> Slope Movement		<input type="checkbox"/>
<input checked="" type="checkbox"/> Erosion	No erosion was evident near the pipe inlet or outlet other than a hint of a depression further downslope from the outlet which was overgrown at the time of the inspection. An erosion gully exists about 140 m southeast of the site within the median.	<input type="checkbox"/>
<input checked="" type="checkbox"/> Seepage	No Seepage was observed; however, there was standing water noted near the culvert outlet along with some build up of debris.	<input type="checkbox"/>
<input checked="" type="checkbox"/> Bridge/Culvert Distress	No significant distress was noted at the outlet or inlet; however, the culvert may be damaged or the backfill surrounding the culvert may not have been compacted adequately.	<input type="checkbox"/>

Photo 6.
Looking southeast
at GP 45 and
eroded area 140 m
east.

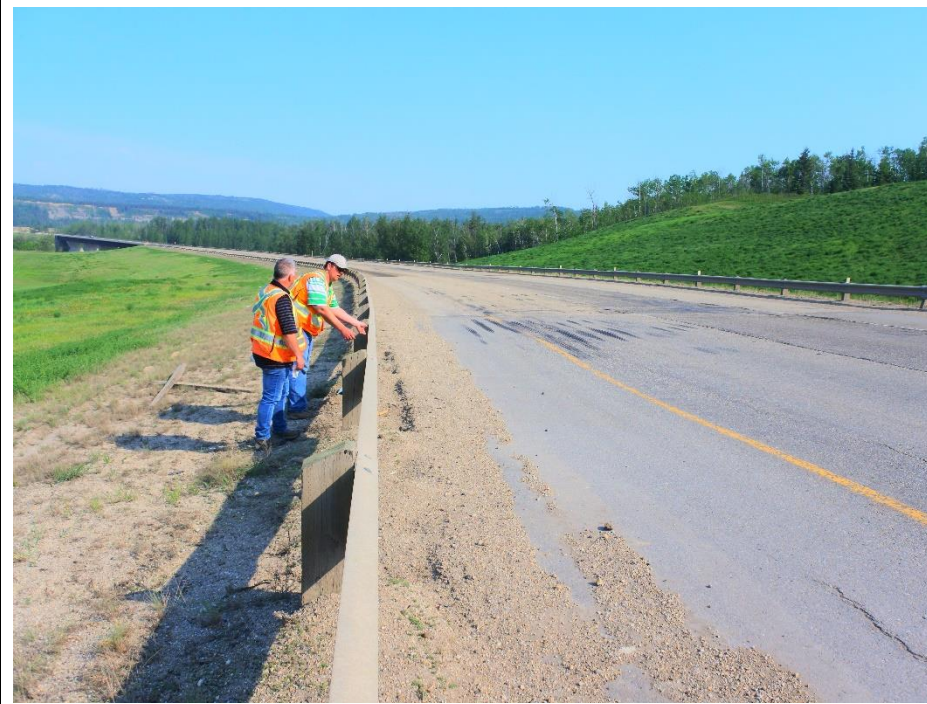
Photo 7.
Looking northwest
towards dip.

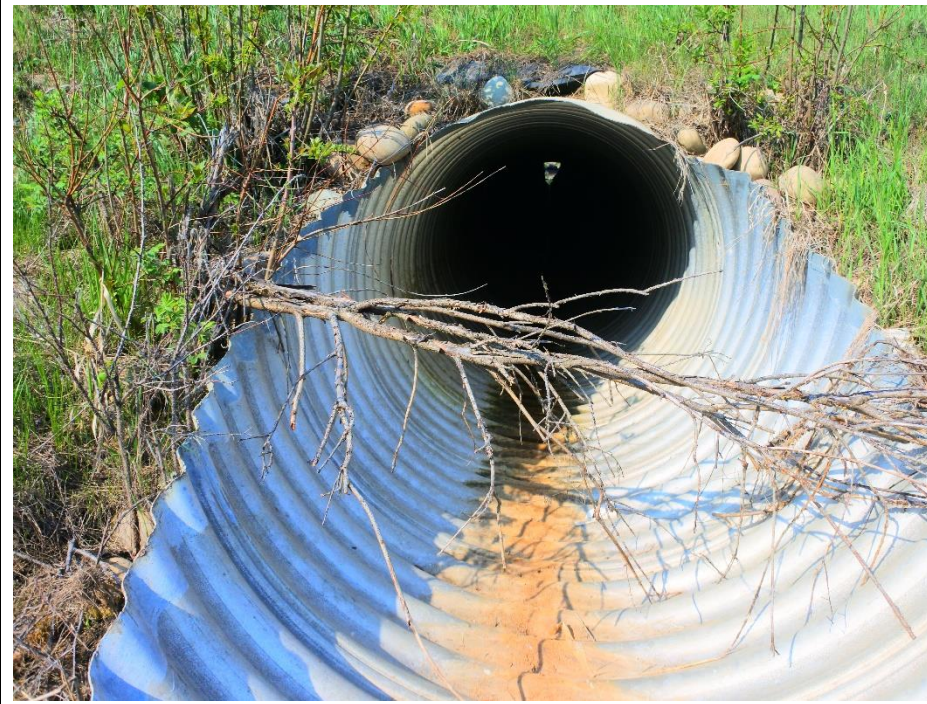
Photo 8.
Looking southwest
at culvert inlet.

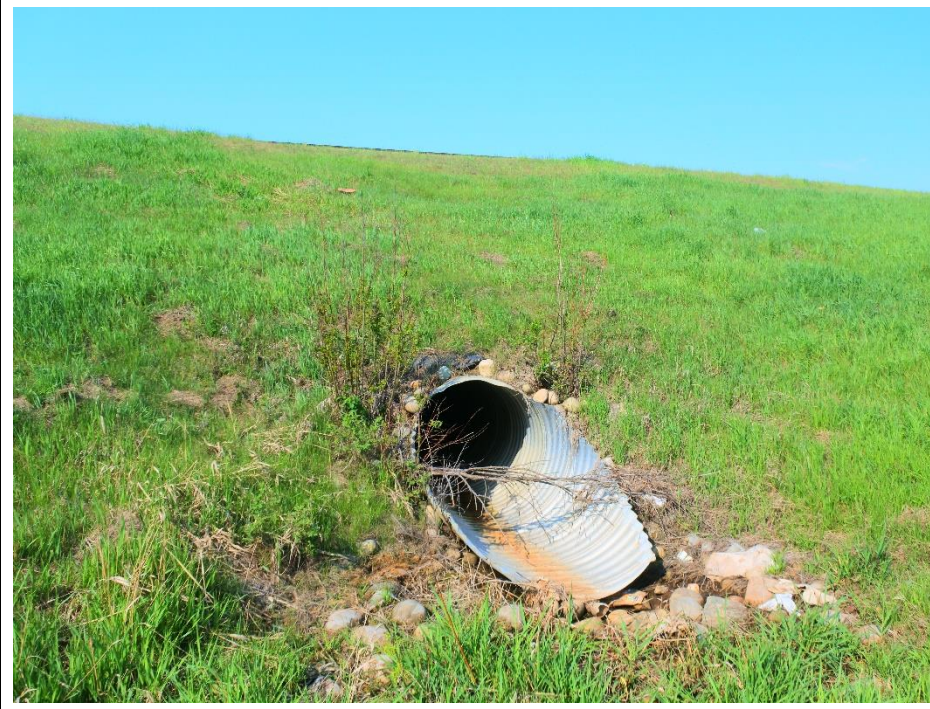
Photo 9.
Looking west at
culvert inlet.
