**PEACE REGION
(GRANDE PRAIRIE DISTRICT – SOUTH) GRMP**

SITE INSPECTION FORM

SITE NUMBER AND NAME: GP046 Smoky River West Valley EBL Backslope Slumps		HIGHWAY & KM: 43:04, 32.004	PREVIOUS INSPECTION DATE: July 19, 2021	INSPECTION DATE: June 13, 2023
LEGAL DESCRIPTION: SW 18-72-02 W6M	NAD 83 COORDINATES: UTM Northing Easting 11 6121397 417585		RISK ASSESSMENT: PF: 12 CF: 4 TOTAL: 48	
AVERAGE ANNUAL DAILY TRAFFIC (AADT): 5,940 (west) & 6,480 (east) (Reference No. 30720 & 70000114, 2022)			CONTRACT MAINTENANCE AREA (CMA): 504

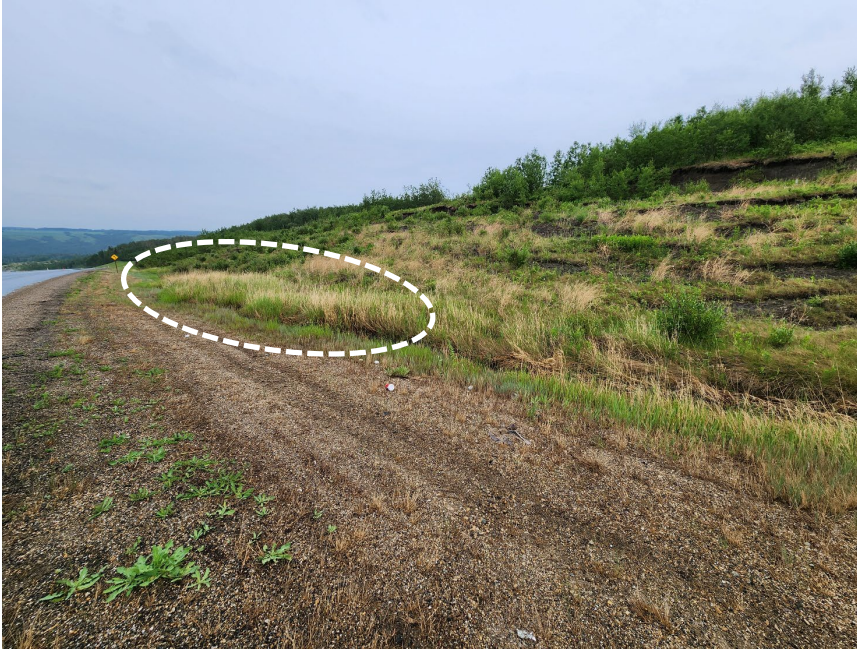
- Photo 1** Slide area along eastbound lanes (south side) of Hwy 43:04 near western site limit. Note toe roll blocking highway ditch (circled in white). Photo taken June 13, 2023, facing southeast.

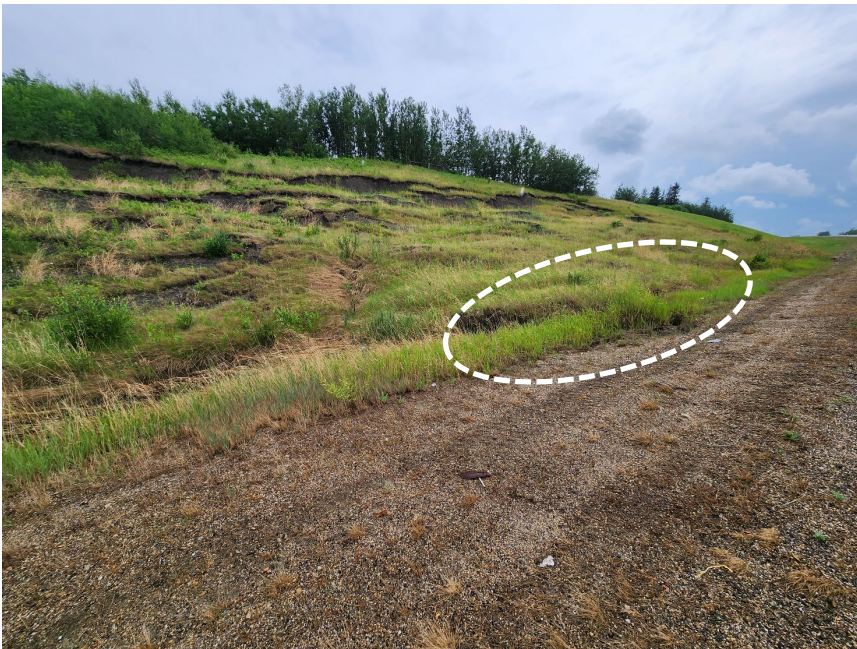
- Photo 2** Slide area along eastbound lane (south side) of Hwy 43:04 near western site limit. Note toe roll blocking highway ditch (circled in white). Photo taken June 13, 2023, facing southwest.

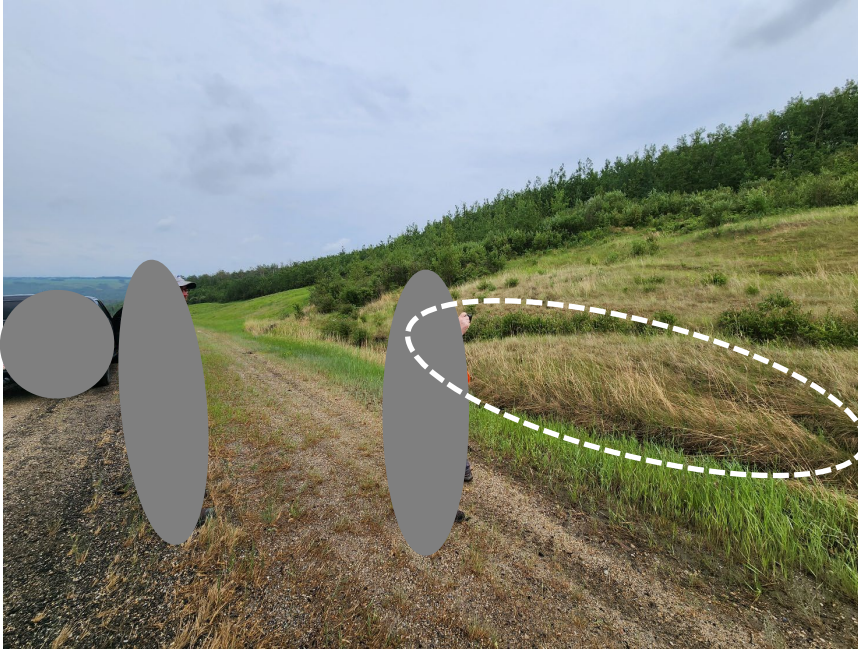
Photo 3 Slide area along eastbound lane (south side) of Hwy 43:04 near eastern site limit. Note toe roll blocking highway ditch (circled in white). Photo taken June 13, 2023, facing south.

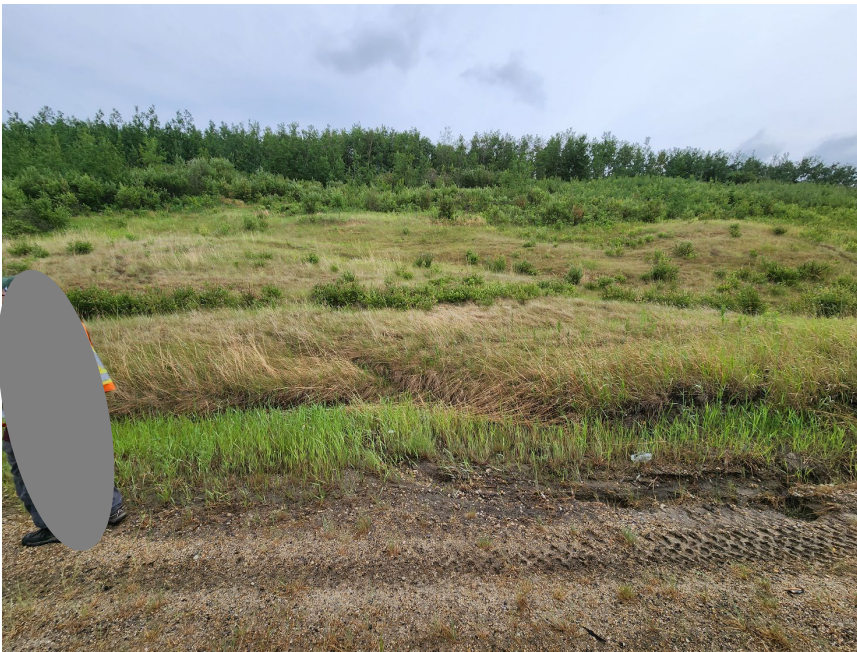
Photo 4 Slide area along eastbound lane (south side) of Hwy 43:04 near eastern site limit. Photo taken June 13, 2023, facing south.

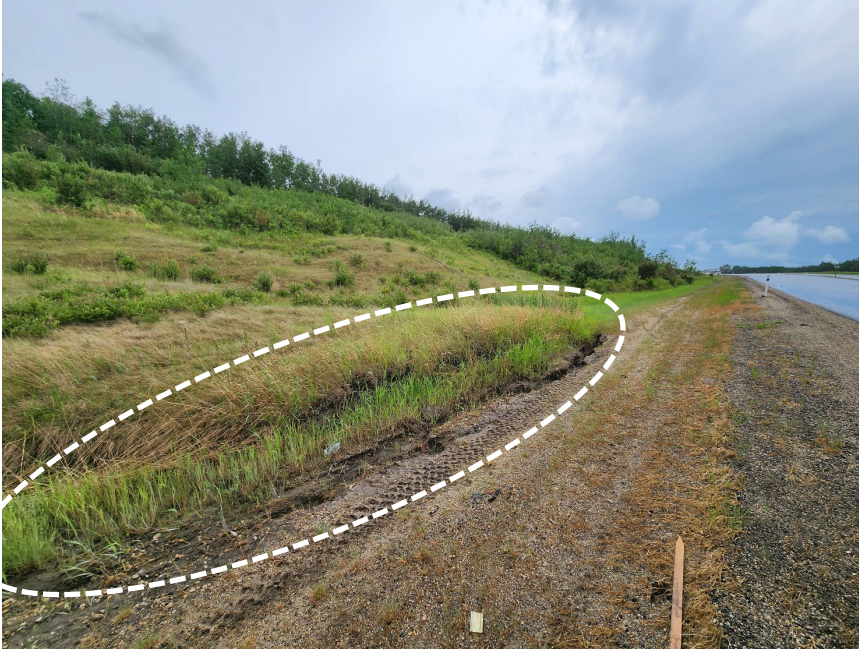
Photo 5 Slide area along eastbound lanes (south side) of Hwy 43:04 near eastern site limit. Note toe roll blocking highway ditch and channel eroded around toe roll (circled in white, see photo below). Photo taken June 13, 2023, facing southwest.

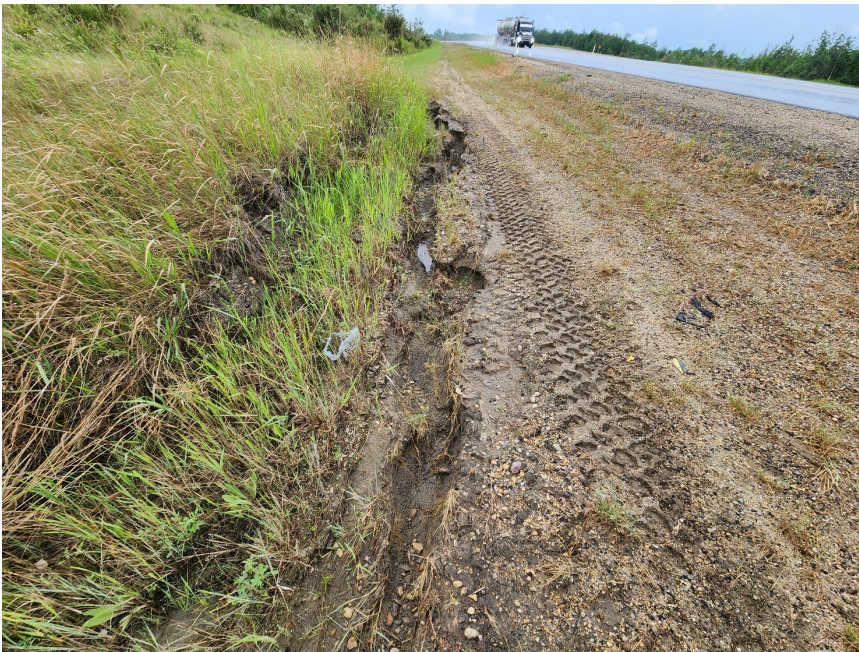
Photo 6 Erosion along toe of backslope and toe roll shown in previous photo near WP317. Photo taken June 13, 2023, facing southwest.

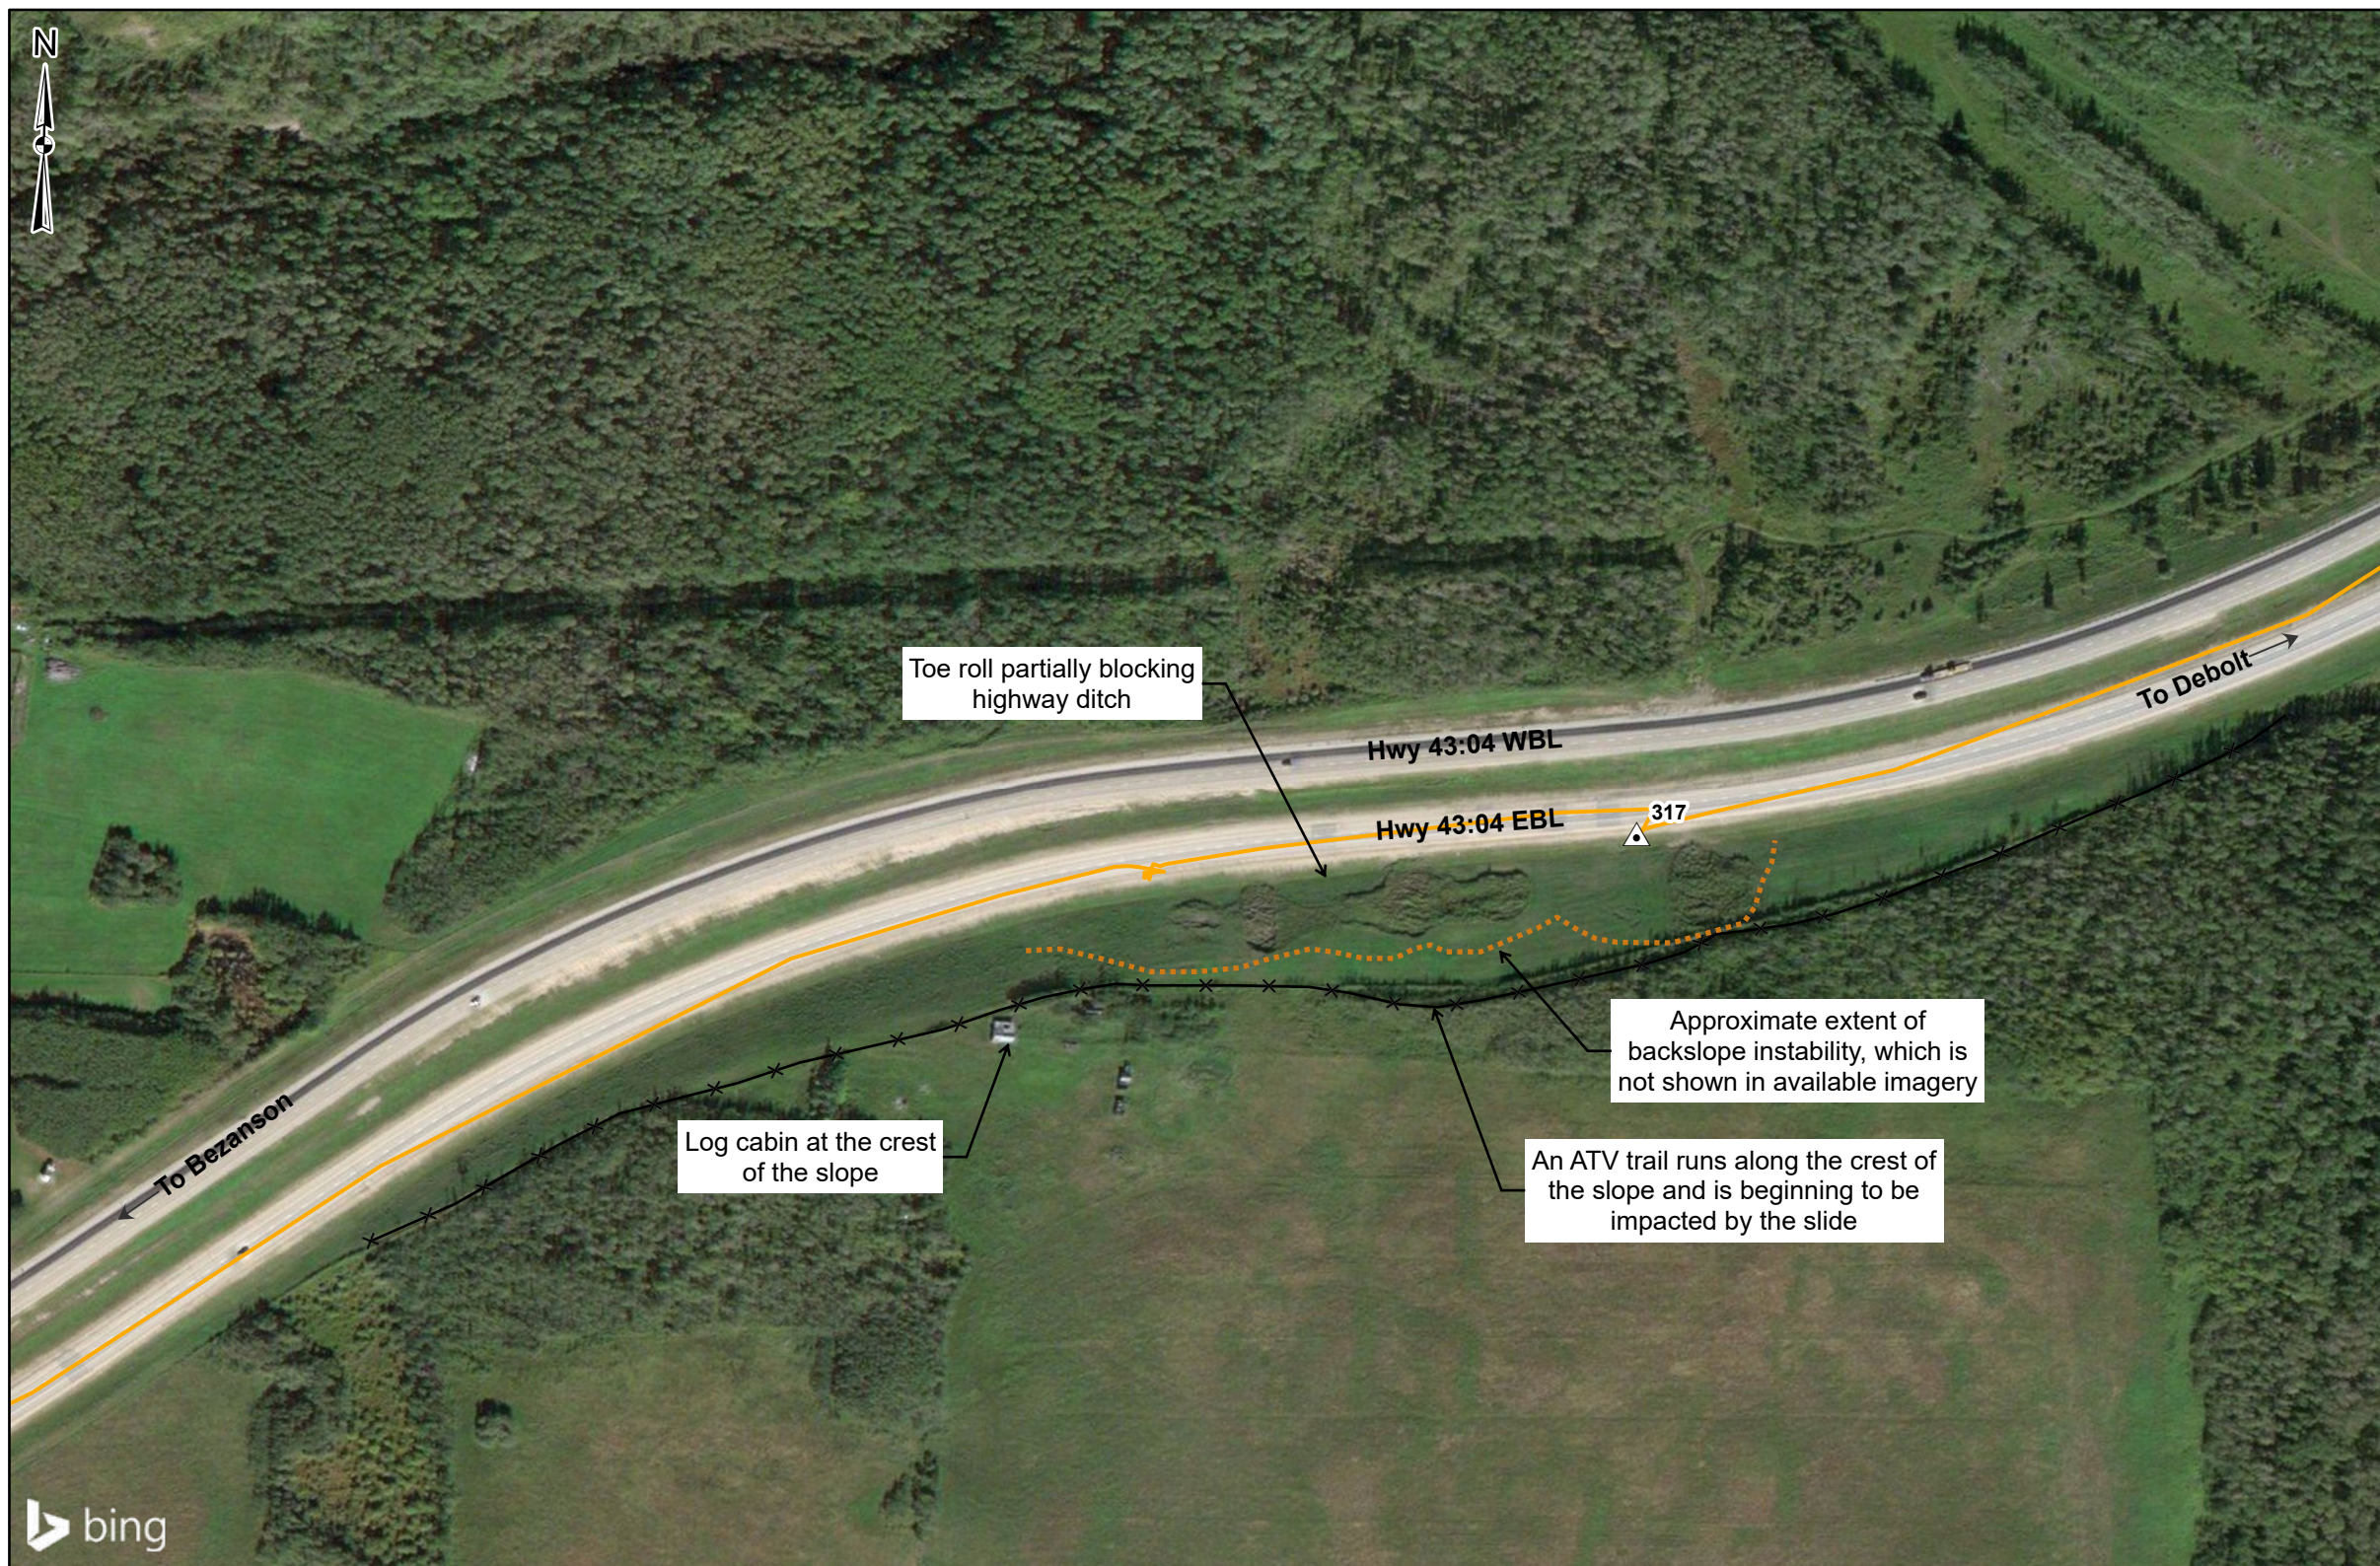
Site Plan
 GP046 - Smoky River W. Valley EBL Backslope Slumps
 Hwy 43:04, km 32.004

NOTES:
 1. HORIZONTAL DATUM: NAD83
 2. GRID ZONE: UTM ZONE 11N
 3. IMAGE SOURCE: MICROSOFT CORPORATION 2023 MAXAR CNES, DISTRIBUTION AIRBUS DS
 4. SIZE OF BACKSLOPE SLIDE HAS GROWN SINCE AIRPHOTO IMAGERY WAS TAKEN.
