File: 2008-1002 (call out)

Date: Nov 1, 2010

Re: **Call-out Inspection Report (GP-30a) –Slide Repair**
Hwy 43:12 –Iosegun River West Backslope (Catchwater ditch) slide
Overview Summary of Slide Repair Work (1) Designed by Karl Eng (2) Construction Managed by AMEC

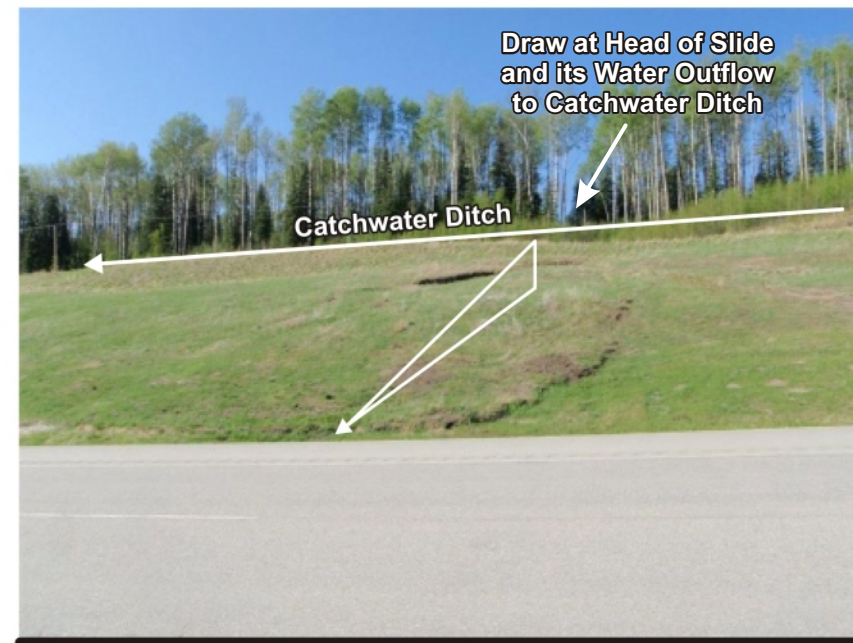
Photo 1
Looking east downgrade at backslope along eastbound lane

- Shallow seated failure of the cut slope occurred and was primarily caused by soil wetting+saturation of slope from overspill of a shallow catchwater (of about 300m in length) located along top of the backslope. The gentle (flat) gradeline and nominal channel size (draft and width) of ditch was considered inadequate to provide hydraulic capacity of the catchwater ditch flow. Thus, the hydraulic inadequacy of ditch caused water overspill onto the slope below. In addition, another flow source added to hydraulic burden of the ditch.

- An additional flow source is from a natural draw located at the top head of the slide area. This draw joins (at right angle to juncture with) to flow into this shallow catchwater ditch. It was very likely that the water flow from this draw can overshoot the catchwater ditch to overspill down the slope and cause wetting of slope face soils especially likely at times of wet weather events.

- Slide located at below a catchwater ditch
- Headscarp just below catchwater ditch
- Toe bulge not affecting ditch yet

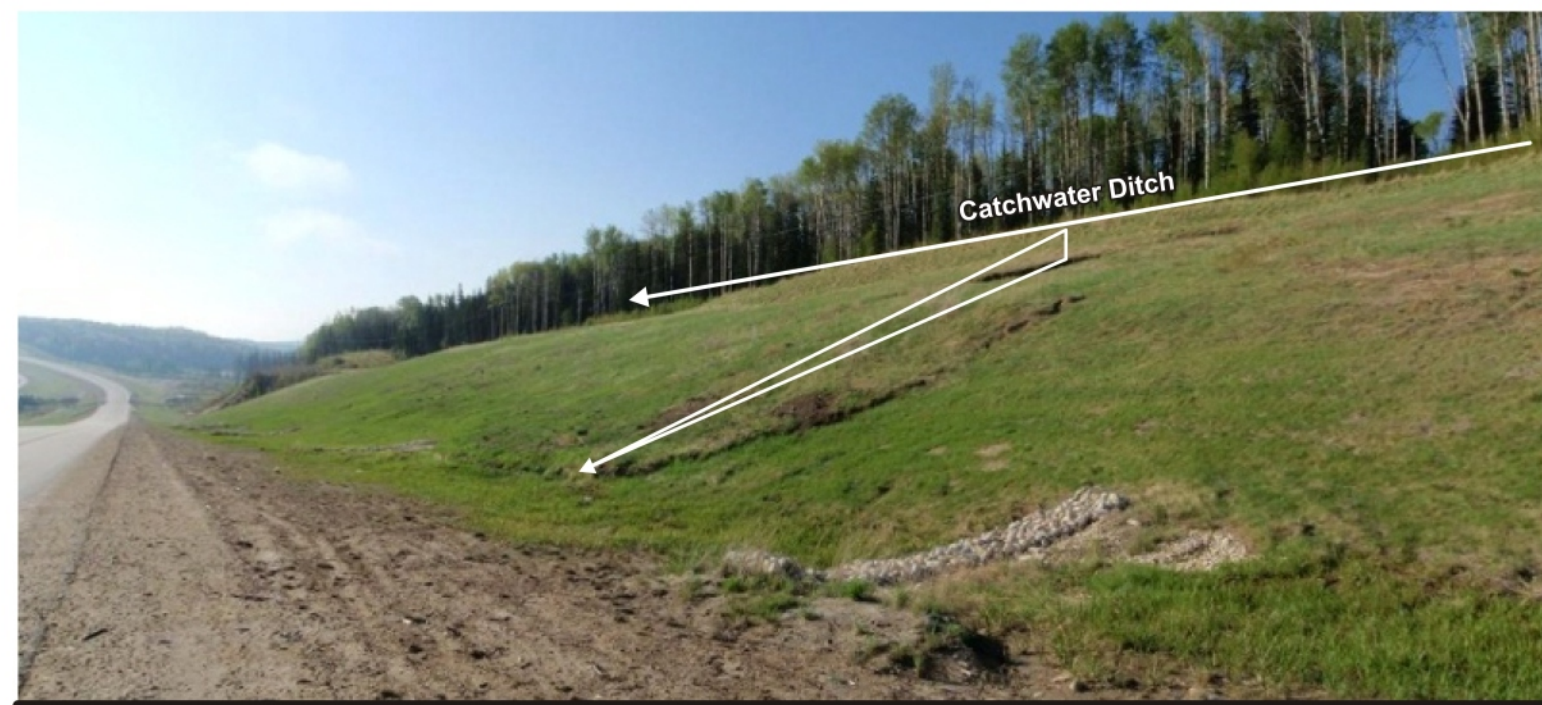
Photo 1a
Looking east and south downgrade

- Another view of slide

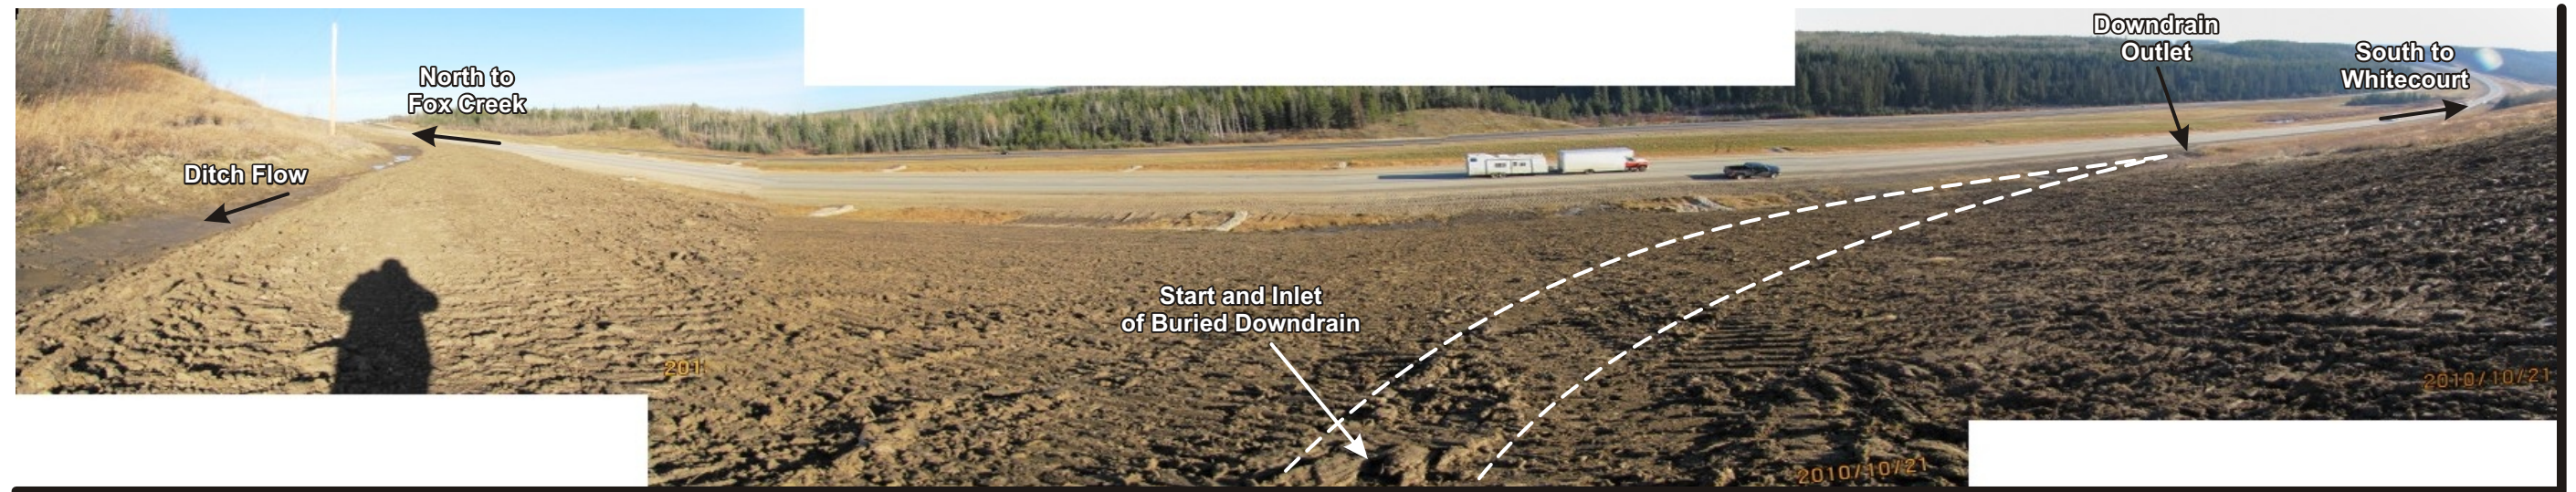
Photo 2

- Downdrain pipe is slanted to run down slope face and aligned to outfall with its outlet in-line with ditch onto a new gabion splash pad
- Inlet of downdrain is located at centre of photo (just outside photo)
- Catchwater ditch is dyked up and regraded to provide adequate hydraulic flow conditions to allow inflow into buried downdrain
- Slide is regraded and shallow scarps simonized to a landscape surface

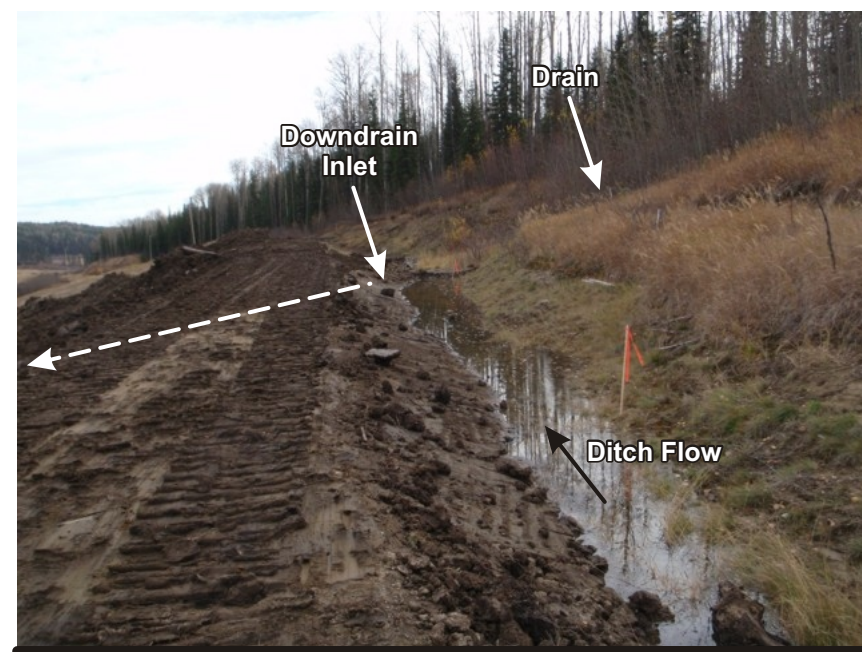
Photo 2a

- Inlet area of downdrain, both west and east approach of ditch is graded to flow towards the downdrain.

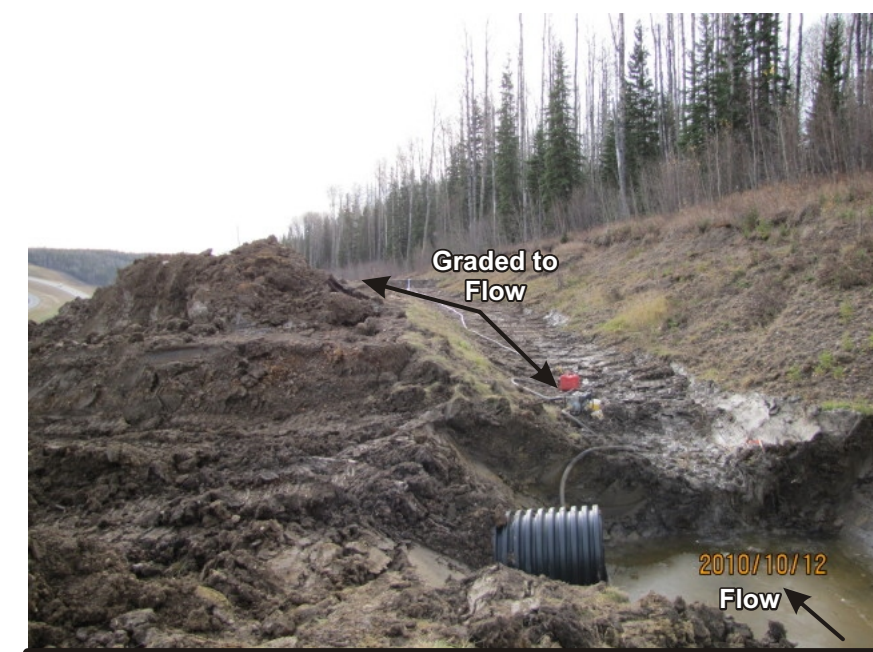
Photo 2b

- Inlet area of downdrain, both west and east approach of ditch is graded to flow towards the downdrain.

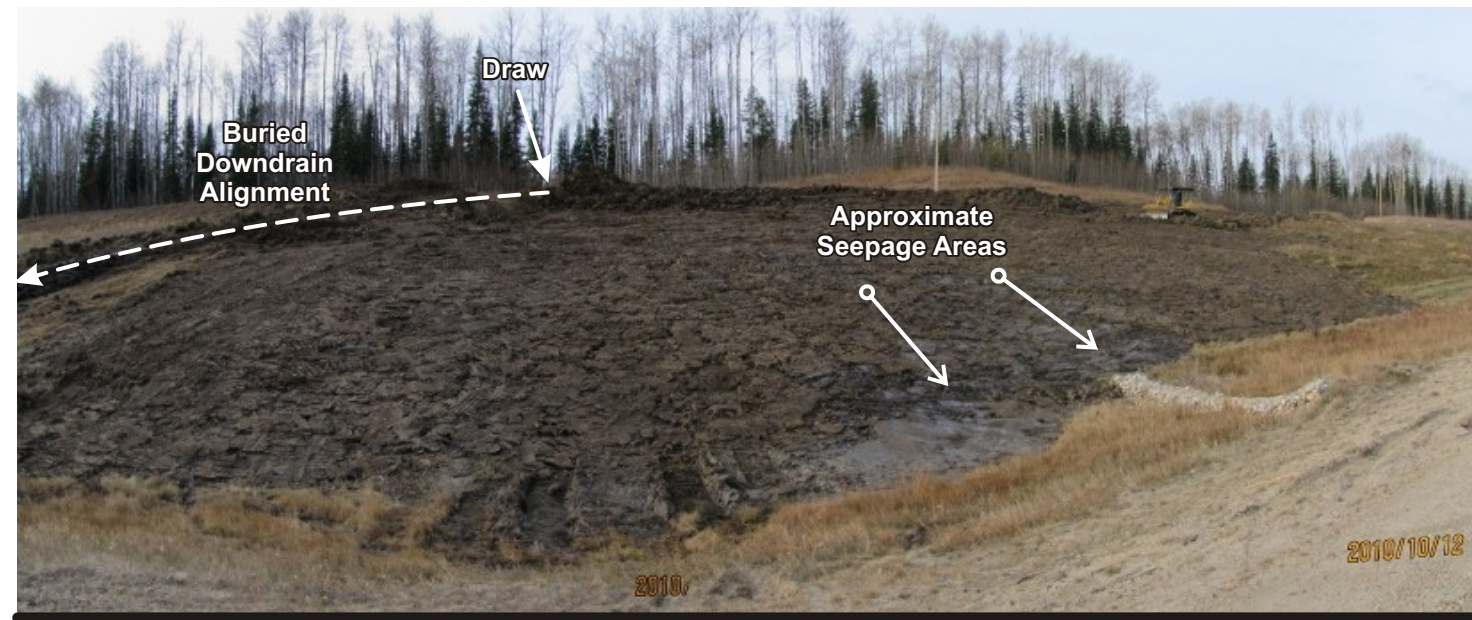
Photo 3

-
- Finger drains (2 pcs) were installed to tap to seepage zones located during construction. Perforated pipe and free draining gravel were utilized for finger drains.
 - The scarps of this shallow seated slide was simonized and landscaped to a smooth surface. The slope face was top soiled and seeded.

- Slide scarp simonized and re-landscaped. Slope reconstructed.
- Finger drains (gravel+perforated pipe) installed to tap to seepage zones

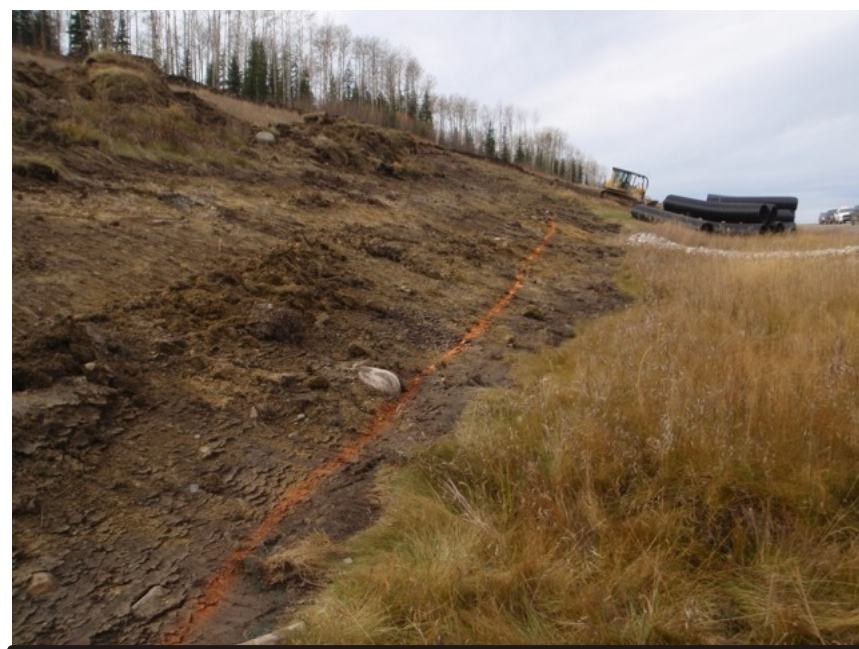
Photo 3a

- Marked up alignment of downdrain prior to its construction

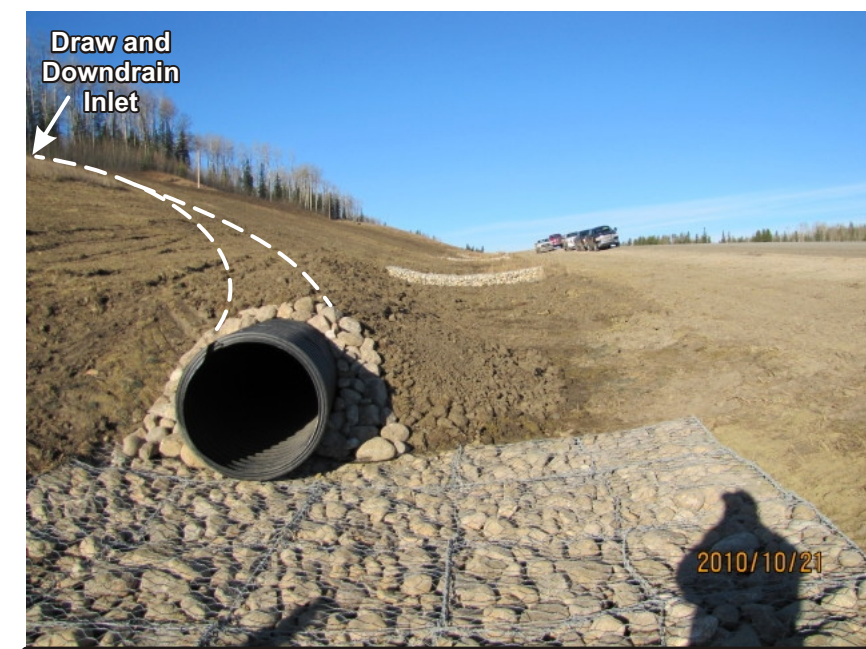
Photo 3b

- Downdrain outlet and splash pad

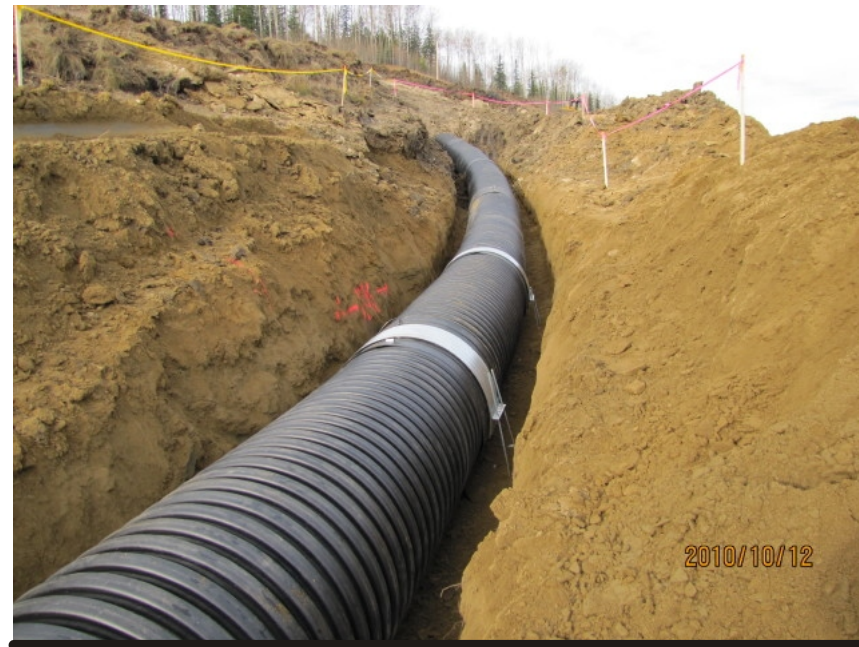
Photo 3c

- Metal bracelet to tie down the joint locations (of 10 feet sections of pipes) and to anchor (screw) down at 1m below pipe bottom. This anchorage was constructed along bottom 4 outlet sections which are of shallow burial depths.

- to add anchorage (hangers) to tie down the bottom sections (4-5) due to shallow burial depths along the lower portion of the slope.
- to use metal steel bandits to “more strongly” strap down the overlap connections at the joints of each pipe sections which were presently manufactured as flush ends. (Flush end pipe are very susceptible to leakage when its wrapping connector loosens.) Such “strong steel bandits” strappings will allow a stronger connections to be constructed thus, minimizing the chances of joint loosening and thus leakage at the pipe (flush end) connections

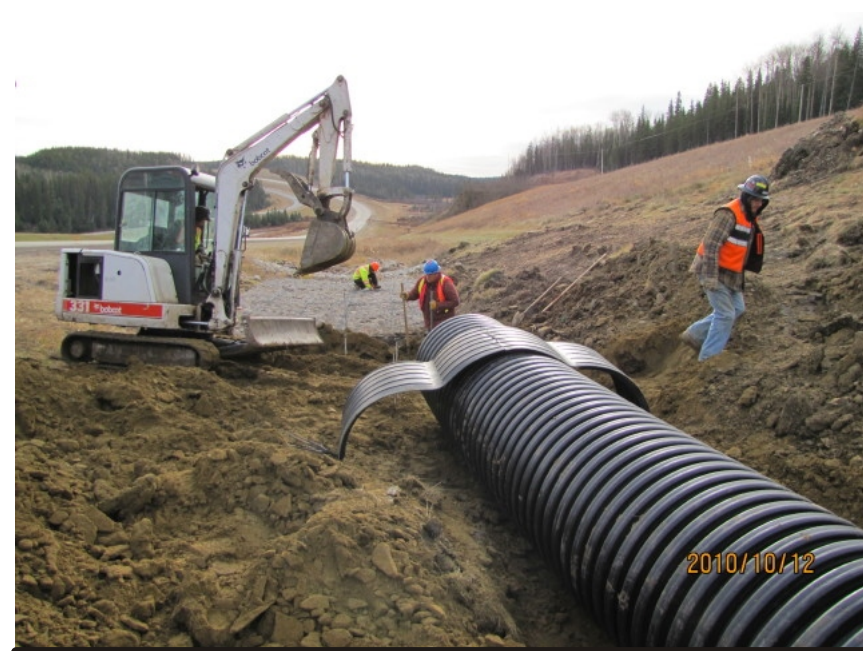
Photo 3d

Corrugated pipe section ends connected by a wide plastic wrap to overlap the joints

- The plastic overlap wrap also tied down by steel bandits.

- For better leakage proof, it is more preferable that “male to female couple connections’ can be designed and manufactured and supplied in the future. The coupling connection design can allow funneling of pipe flow down into the subsequent pipe sections (downgrade) without serious concern (worry) of pipe loosening as in case of flush end pipe sections. The loosening of flush end pipes can arise due to conditions of drastic weather temperature cyclic changes (causing shrinkage loosening of wrap connector materials) especially when pipes are exposed and/or under shallow burial depths.

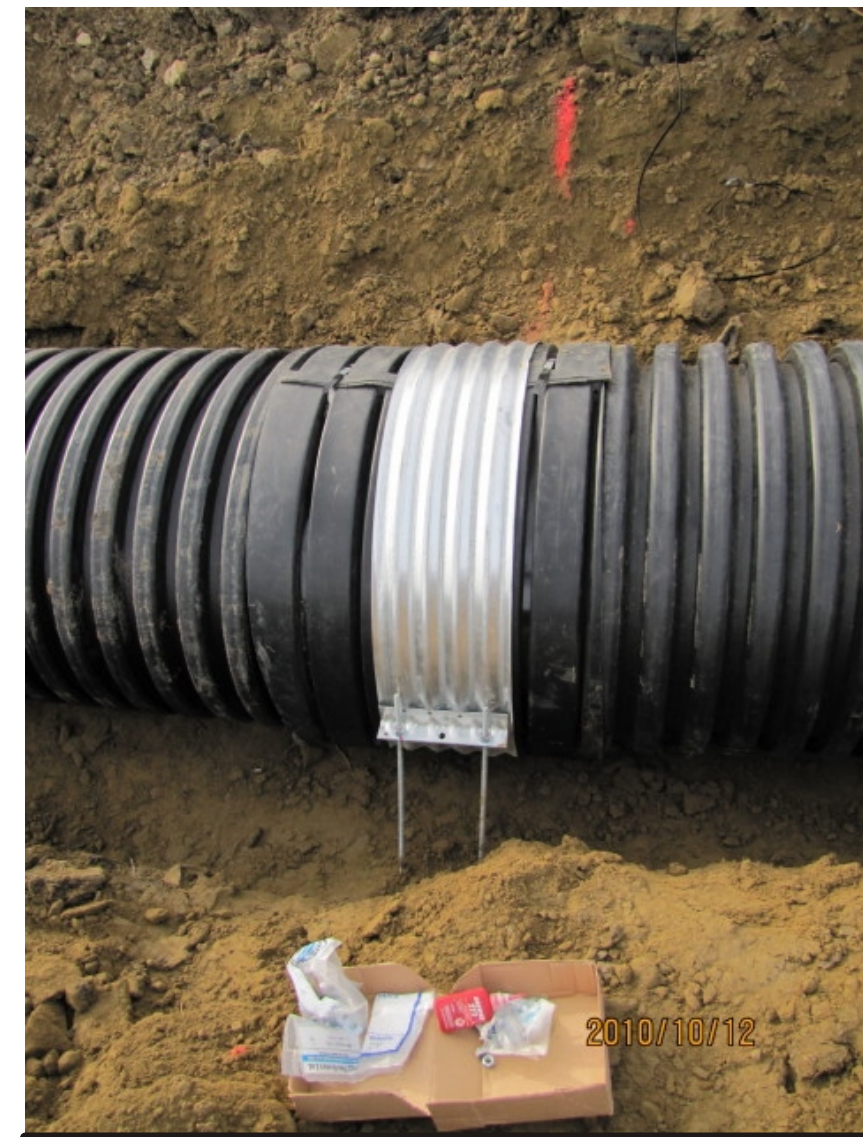
Photo 3e

- Metal bracelet tied to hanger anchor (with screw anchor to 1m below bottom of pipe)
