**ALBERTA TRANSPORTATION
GEOHAZARD ASSESSMENT PROGRAM
PEACE REGION–GRANDE PRAIRIE
2019 CALL OUT**

THURBER ENGINEERING LTD.

Site Number	Location	Name	Hwy	km
Call Out GP16	Hwy 666:02 S. of Grande Prairie (Wapiti River Valley Slides)	Mid-Valley/Old Major (Site 1)	666:02	34+773
		Lower Valley (Site 2)		34+837
		Valley Top (Site 3)		34+250
Legal Description (Site 1)		UTM Co-ordinates (Site 1)		
NE¼ 15-070-06 W6M		11U E 383370		N 6103058

**GP016: HWY 666:02, KM 34 SOUTH OF GRANDE PRAIRIE
2019 CALL OUT**

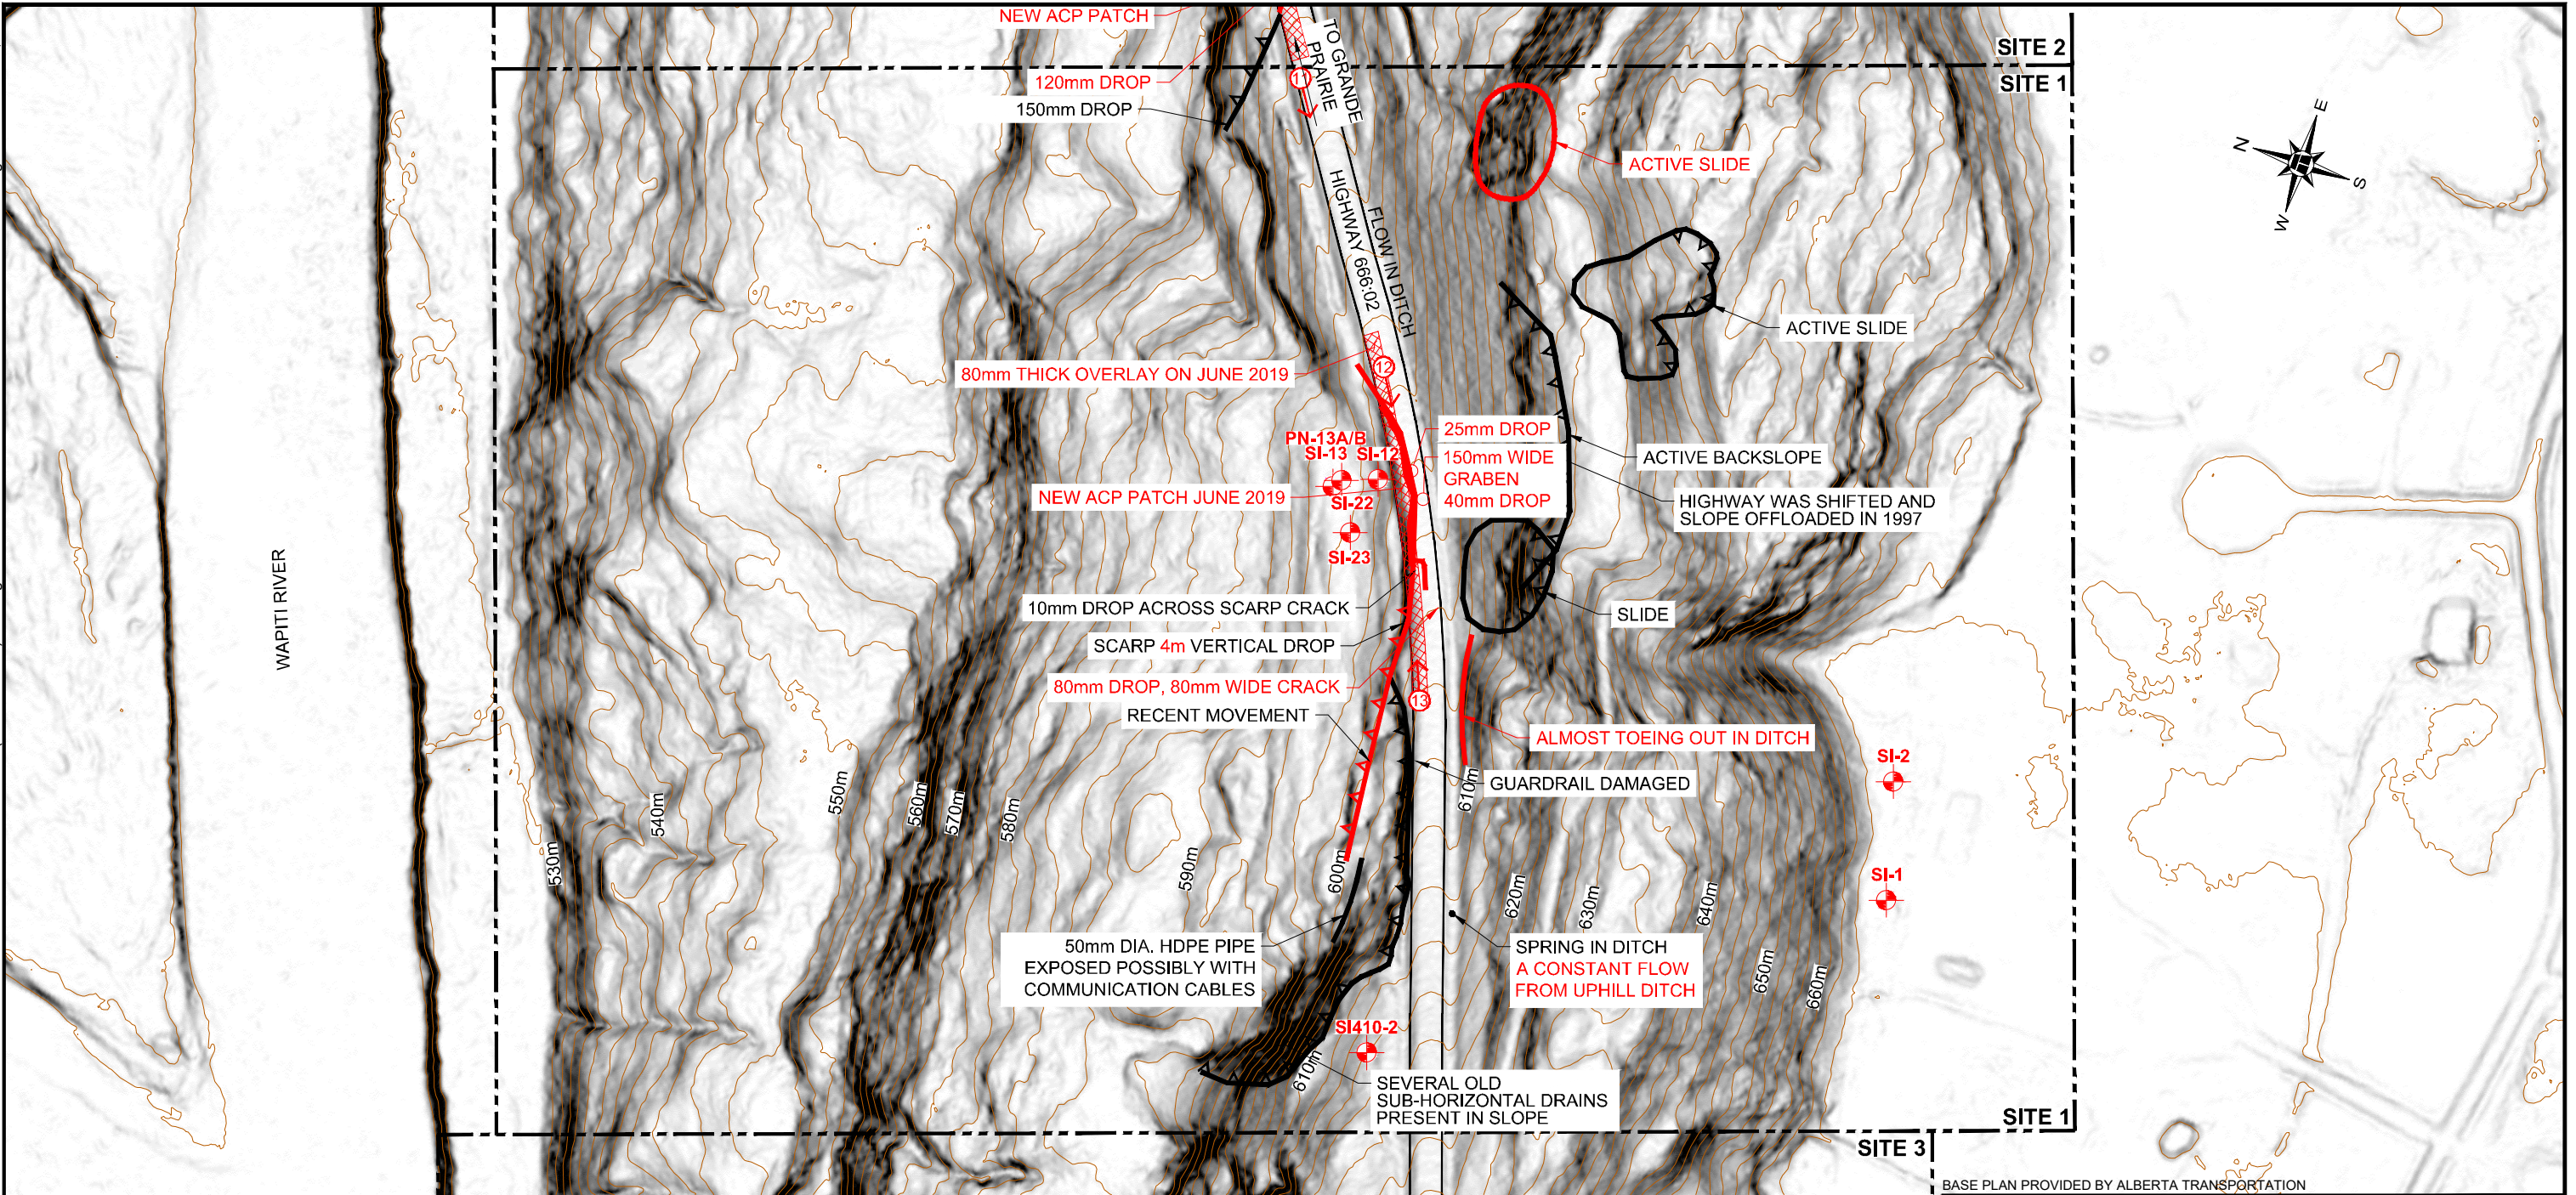
FIGURE 2

Mid-Valley/" Old Major" Landslide (Site 1):

Deep seated landslide, believed to be rotational in nature at a depth of about 20 m to 25 m along the embankment sideslope, which corresponds to the top of the underlying bedrock and is affecting about 300 m of roadway. The toe of the landslide is believed to be at the bottom of the valley possibly within the limits of the Wapiti River bank itself. In addition, the backslope above the highway, which was offloaded and regraded in 1997-1998, has surficial slumps features above and below the intermediate level bench, which periodically cause slide debris to accumulate at the EBL ditch thus blocking the surface water flow.

<p>In the mid term, a partial realignment at Site 1 could be performed with the support of a pile wall. The realignment alone would provide about 5 years of additional service life to the current alignment through the site. There is a possibility to extend the life span to about 10 years with the additional support of a pile wall on the upslope side.</p>	\$5,000,000 (Realignment Only) \$10,000,000 (Realignment with Pile Wall)
<p>For Site 3, a pile wall could be constructed to help preserve the current alignment for about 5 to 10 years.</p> <p>For Site 2, further geotechnical investigation would be required to propose an effective mid-term solution such as pile walls or realignment through this site. Consideration should be given to replacing the current 600 mm diameter SWSP culvert with a larger diameter pipe connected to a solid drain pipe that would extend down the slope to the valley floor.</p>	\$3,000,000 to \$5,000,000

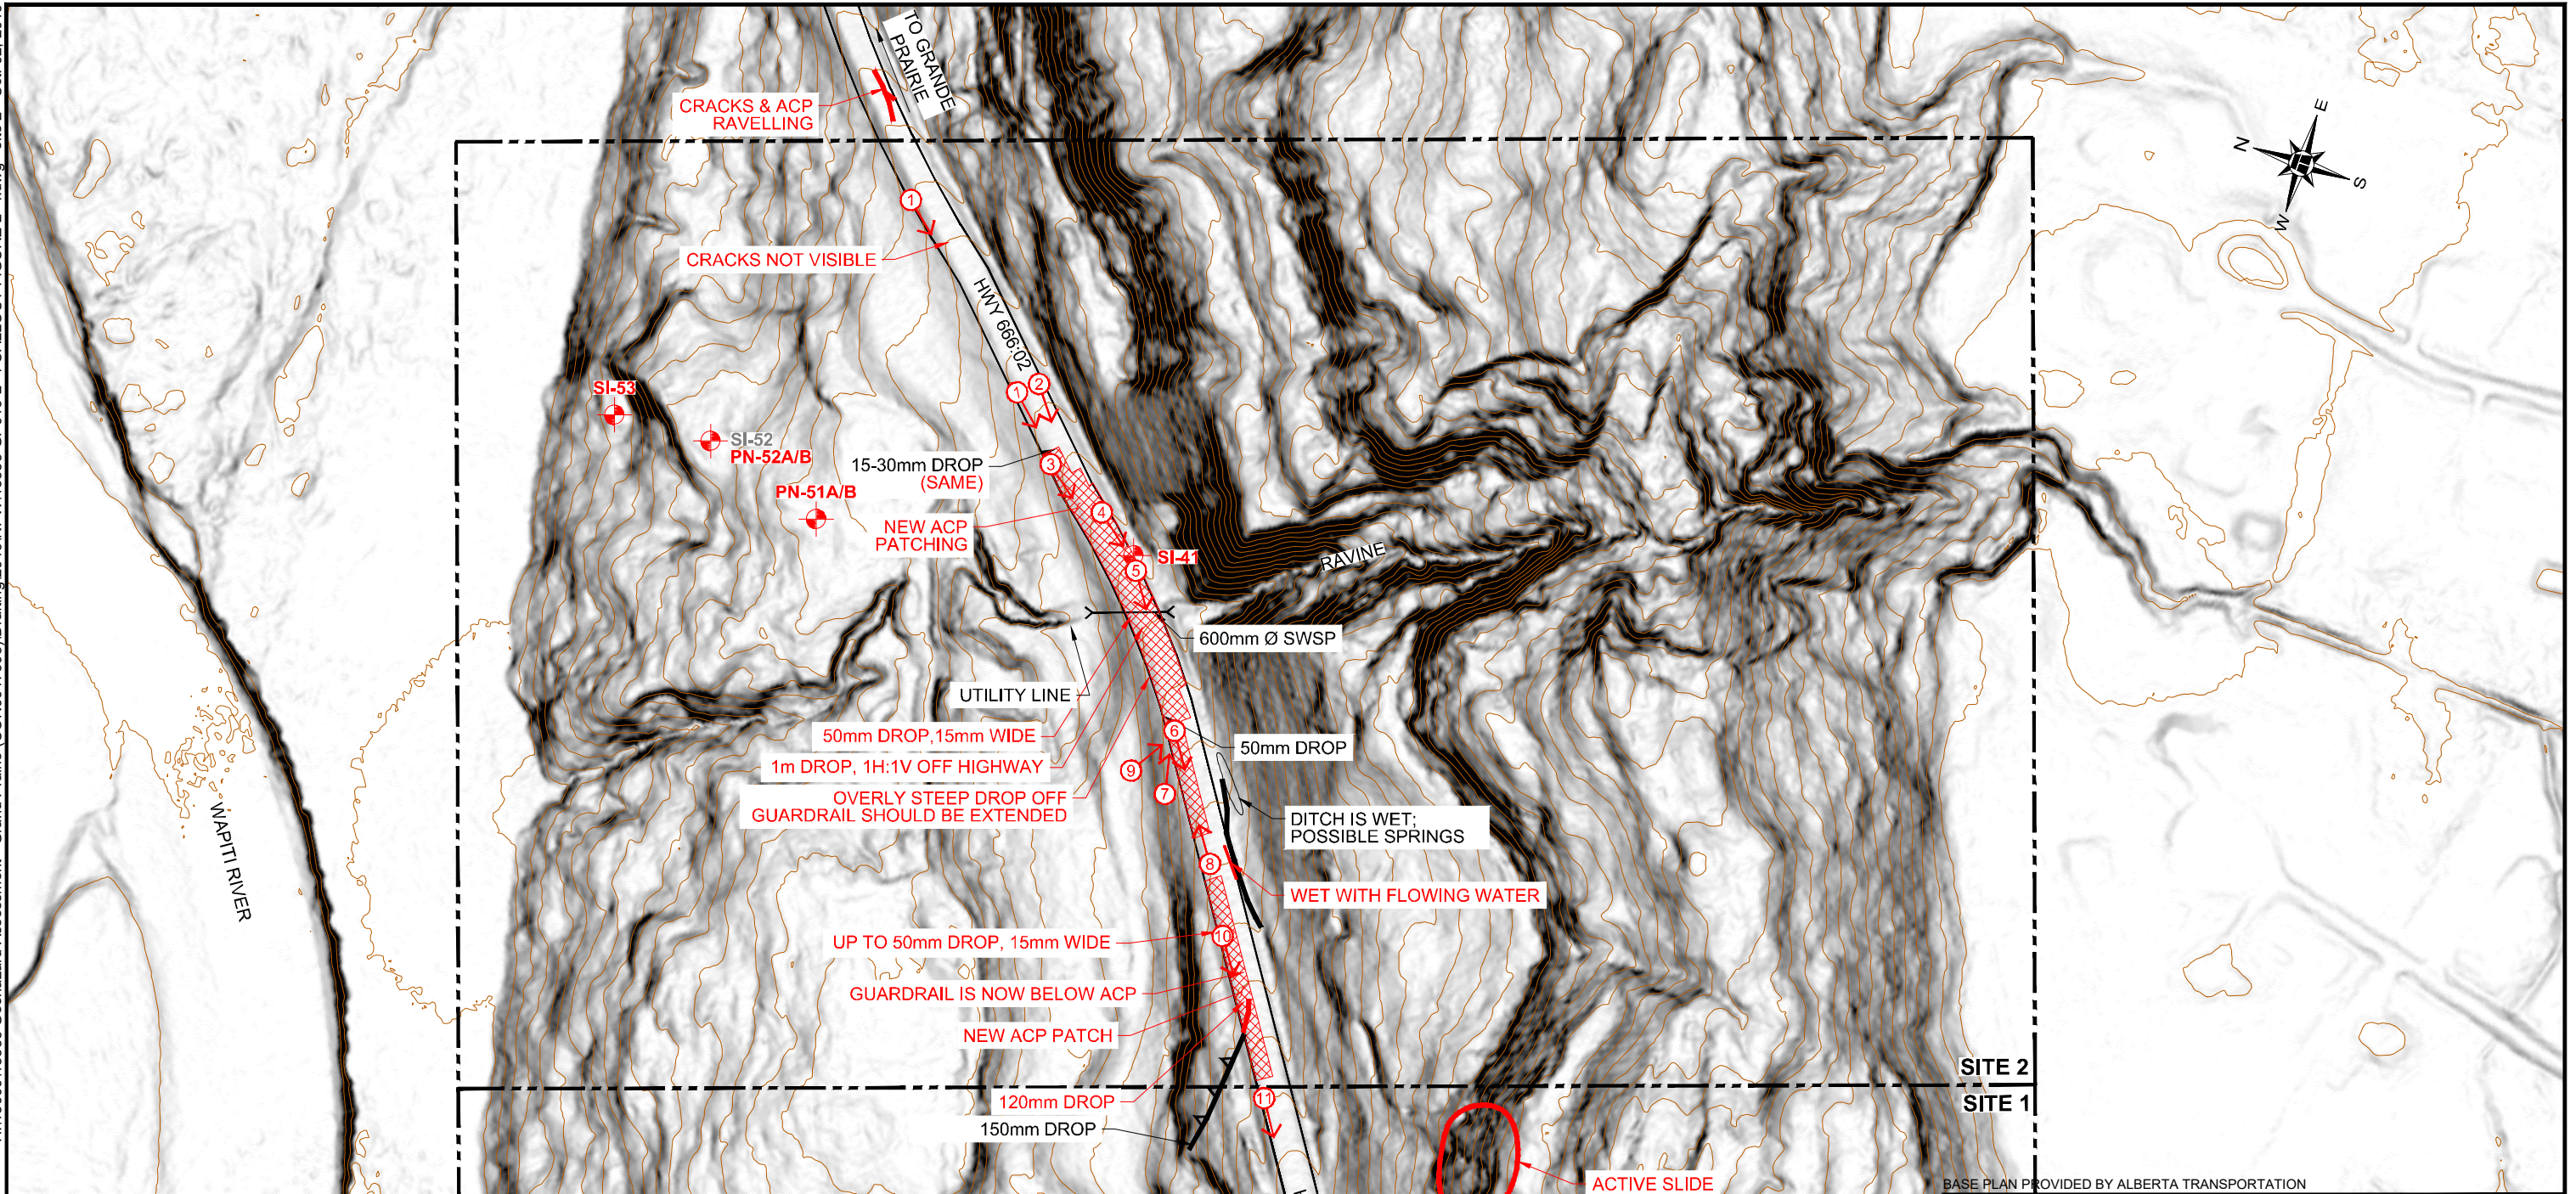
FIGURE 3

Lower Valley Landslide (Site 2):

Deep seated rotational landslide assessed to be at 12m in depth along the embankment sideslope and 18 m in depth at mid slope and at 6 m in depth at the toe which is believed to be about 300 m downslope of the highway embankment, resulting in about 300 m of affected roadway.

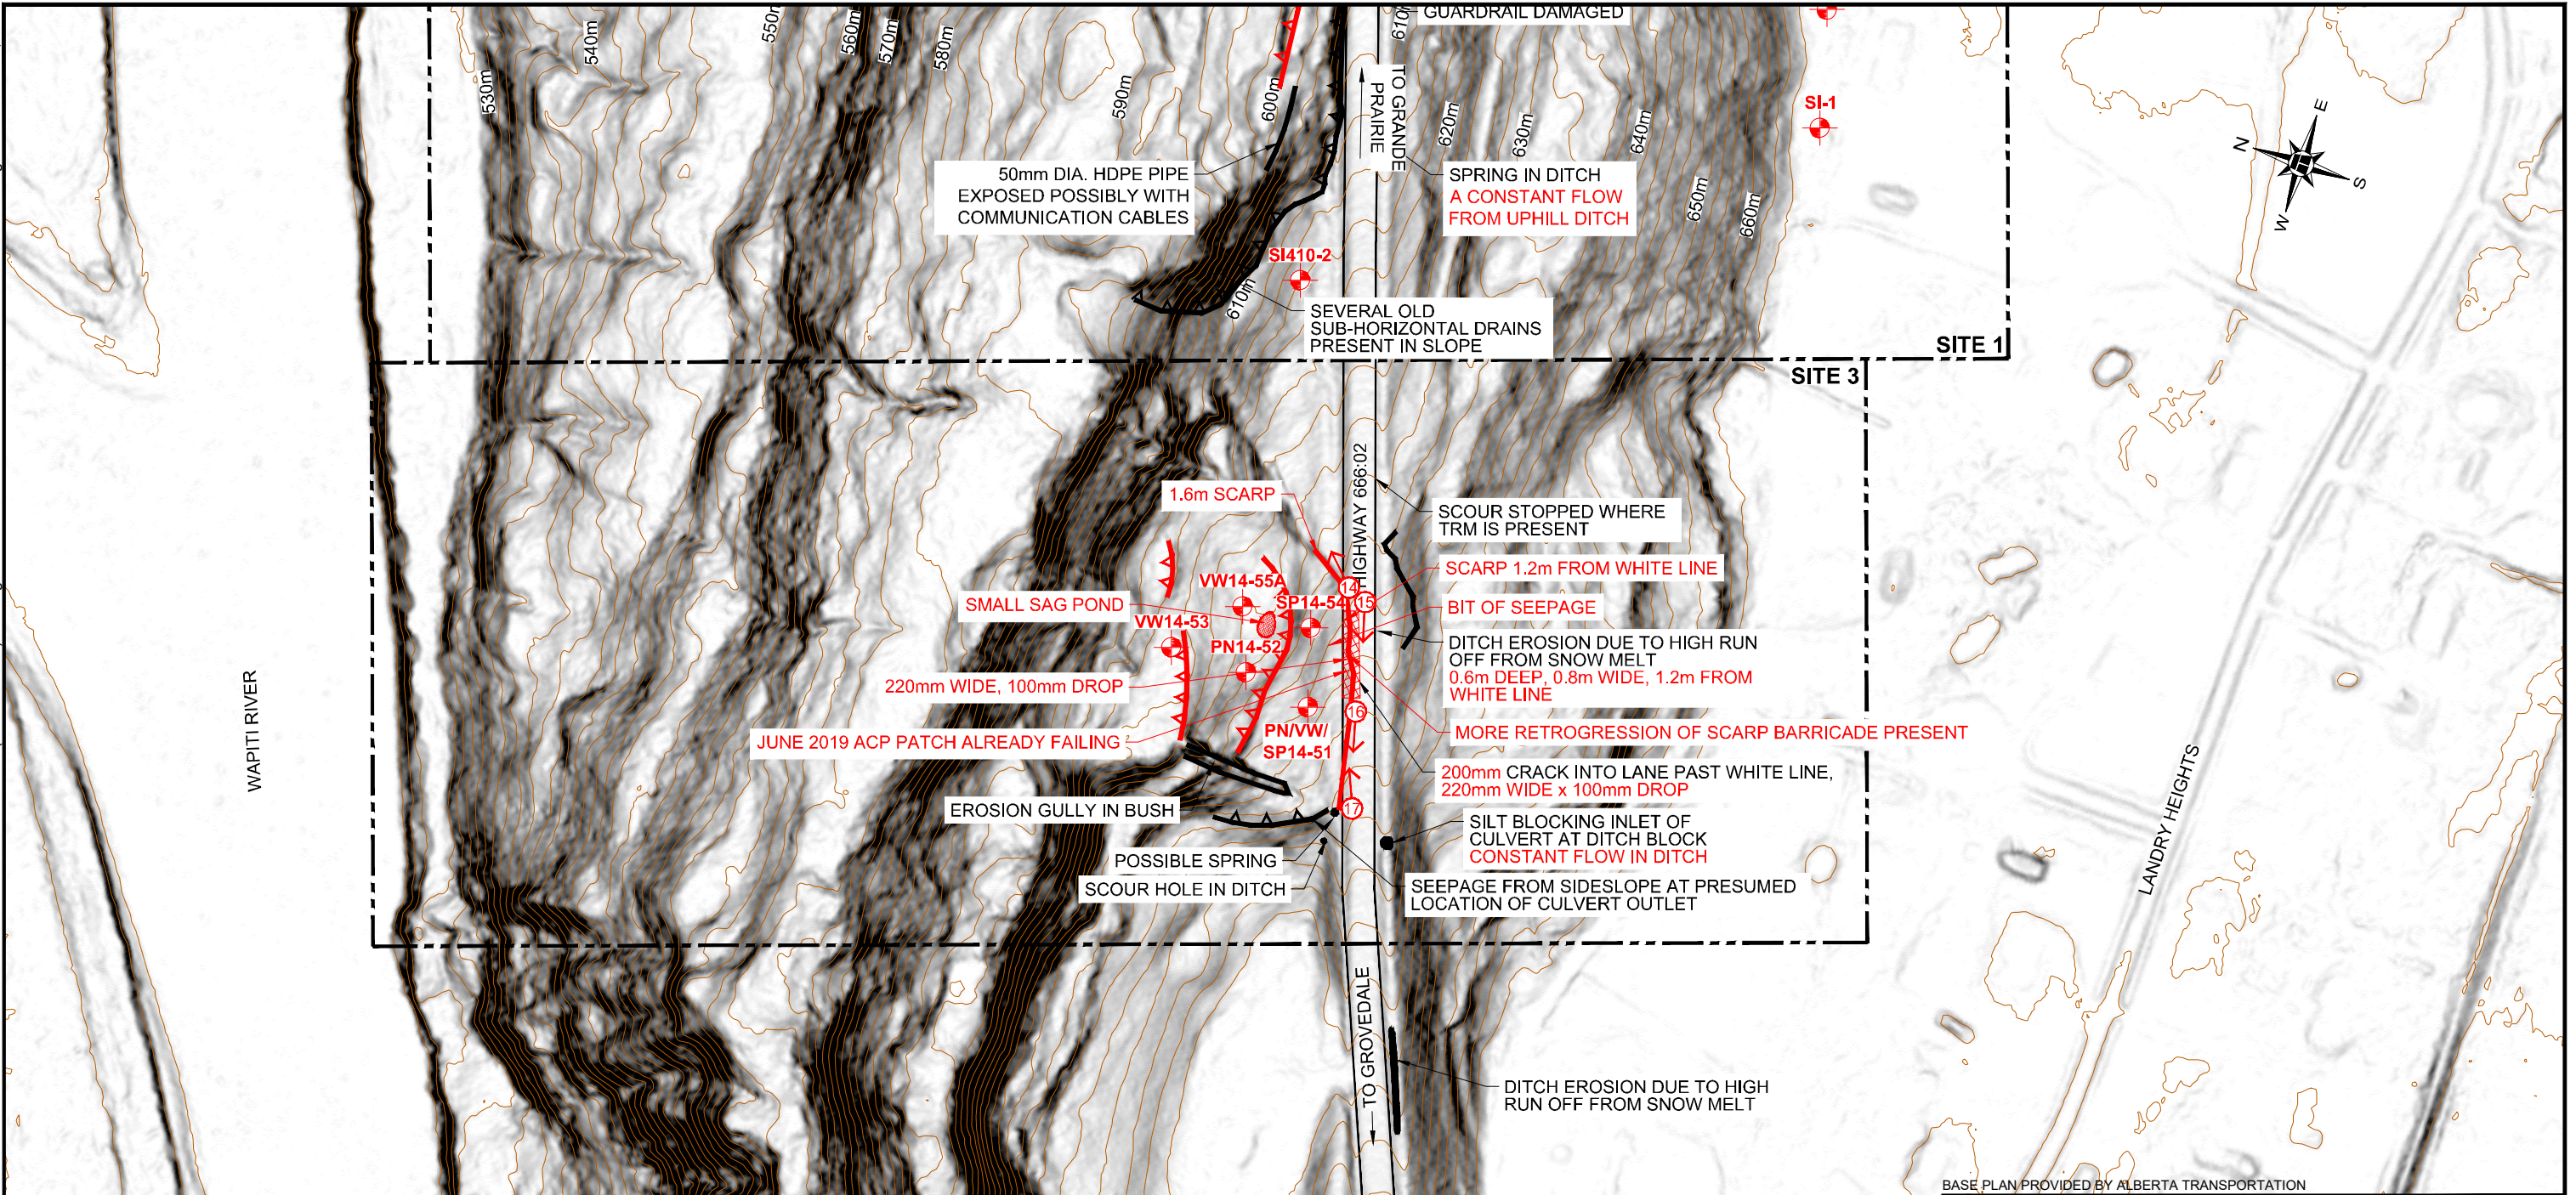
FIGURE 4

Valley Top Landslide (Site 3):

Located near the top of the valley slope, assessed to be at about 7 m to 11 m depth along the highway embankment sideslope and is affecting about 250 m of roadway along the WBL shoulder.

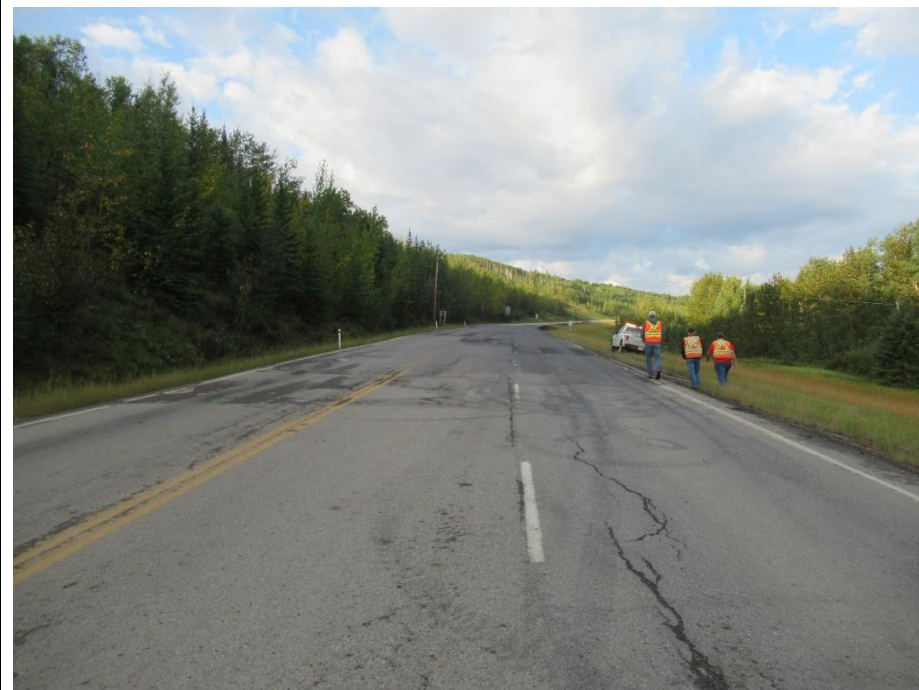
Photo 1.
Looking southwest
towards the Lower
Valley Landslide
(Site 2).

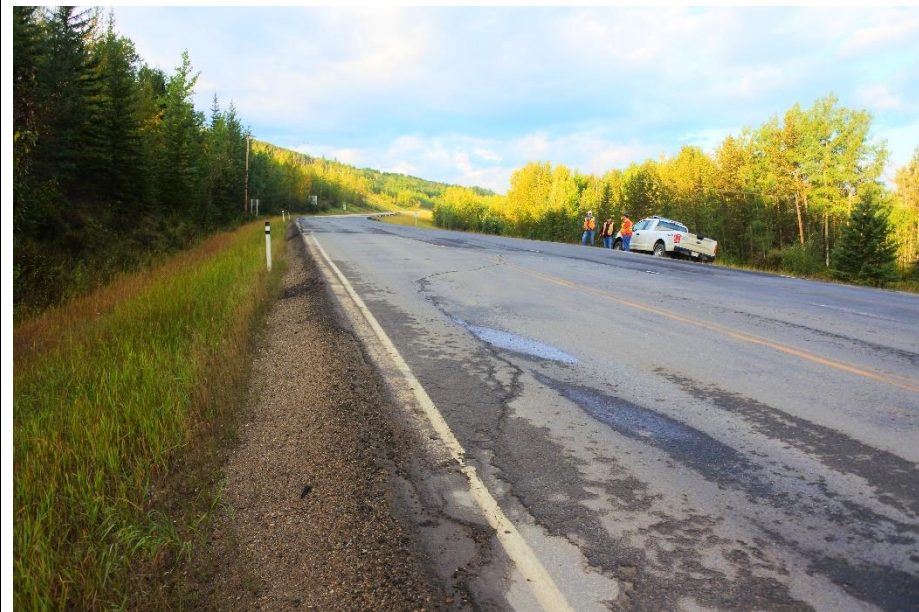
Photo 2.
Looking southwest
towards the Lower
Valley Landslide
(Site 2).

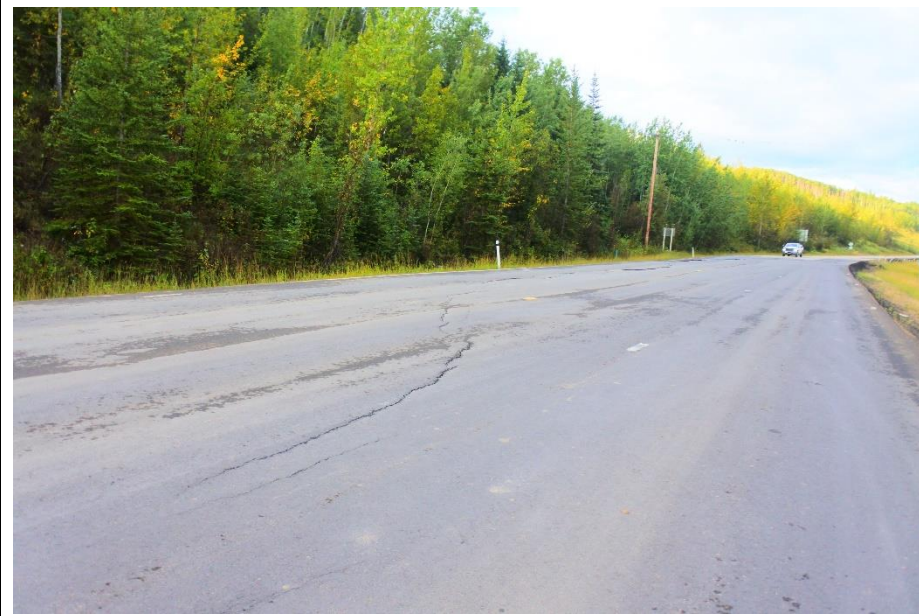
Photo 3.
Looking southwest along Hwy 666 at west portion Lower Valley Landslide (Site 2). The drops along the scarp in the ACP in this section in the roadway surface were about 15 mm to 30 mm.

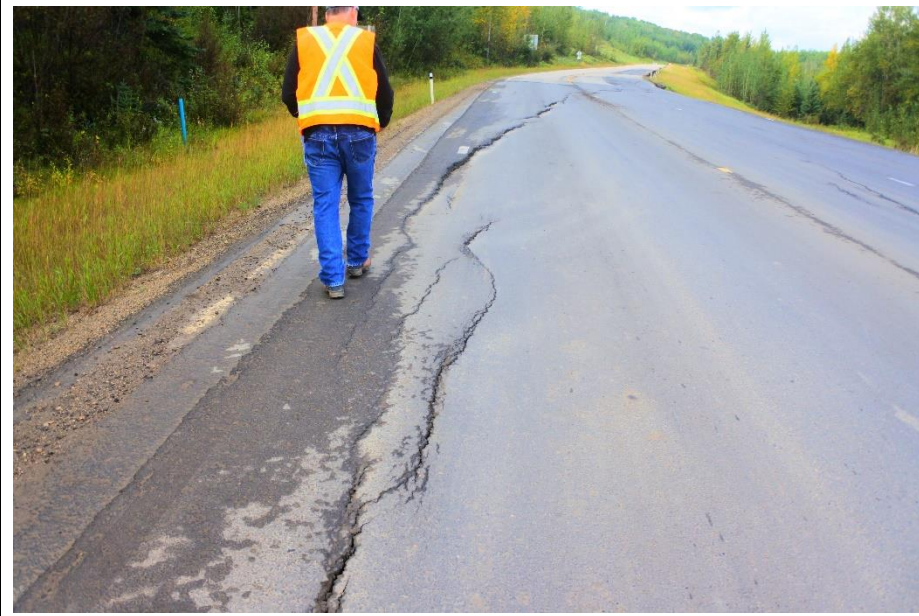
Photo 4.
Looking southwest along Hwy 666 at middle portion Lower Valley Landslide (Site 2). The drop along the scarp in the ACP in this section in the roadway surface was up to about 70 mm

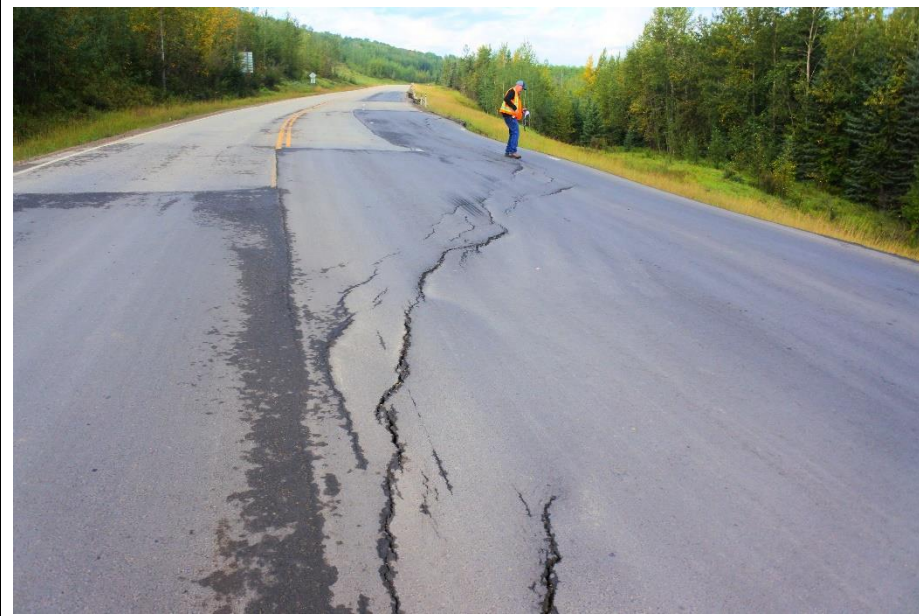
Photo 5.
Looking southwest along Hwy 666 at west portion Lower Valley Landslide (Site 2). The scarp has a 0.3 m drop in the WBL shoulder.

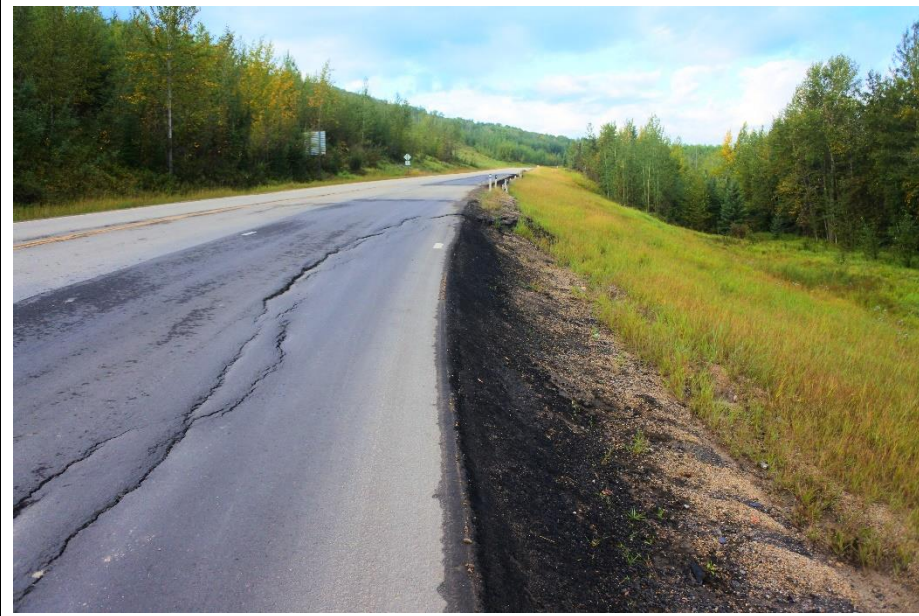
Photo 6.
Looking southwest along Hwy 666 at west portion Lower Valley Landslide (Site 2). The scarp has a 0.3 m drop in the WBL shoulder.

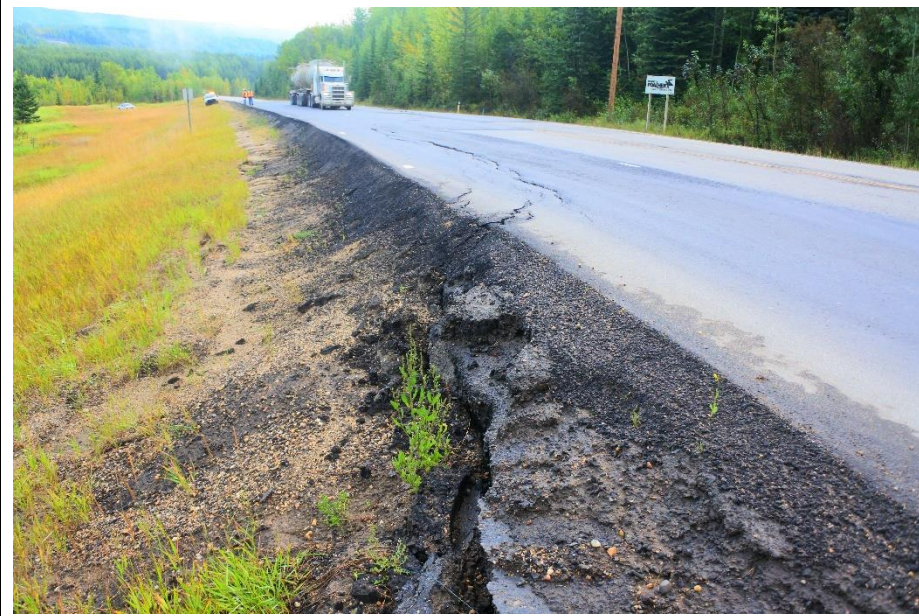
Photo 7.
Looking northeast
along cracks in
pavement at Lower
Valley Landslide
(Site 2) that extend
off the roadway.

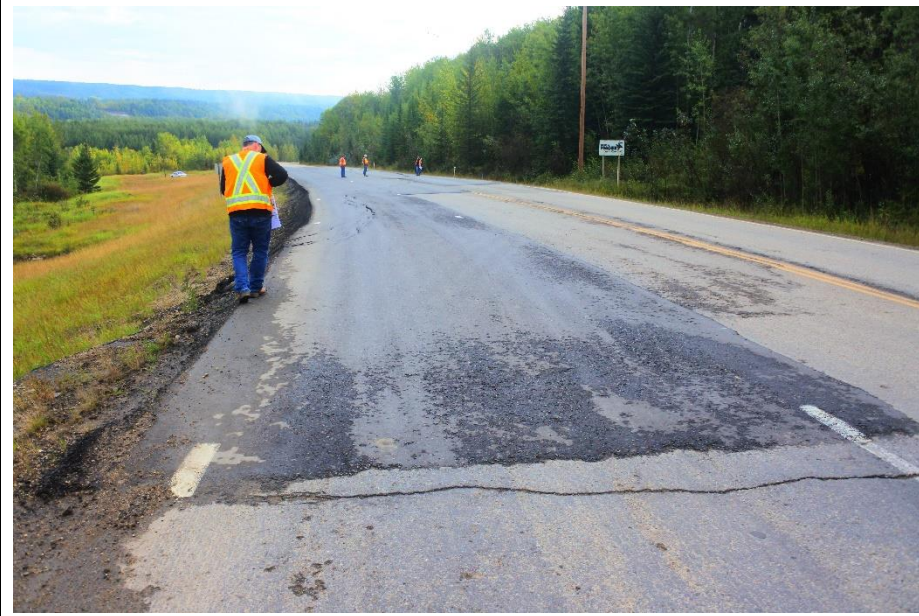
Photo 8.
Looking northeast
along cracks in
pavement Lower
Valley Landslide
(Site 2).

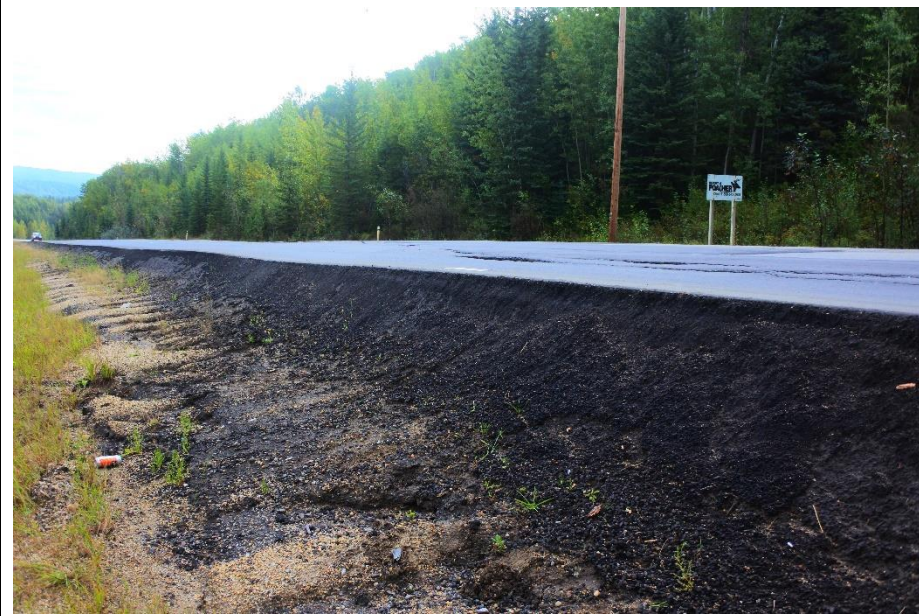
Photo 9.
Looking east at overly steep drop off from several layers of ACP patching at Lower Valley Landslide (Site 2).

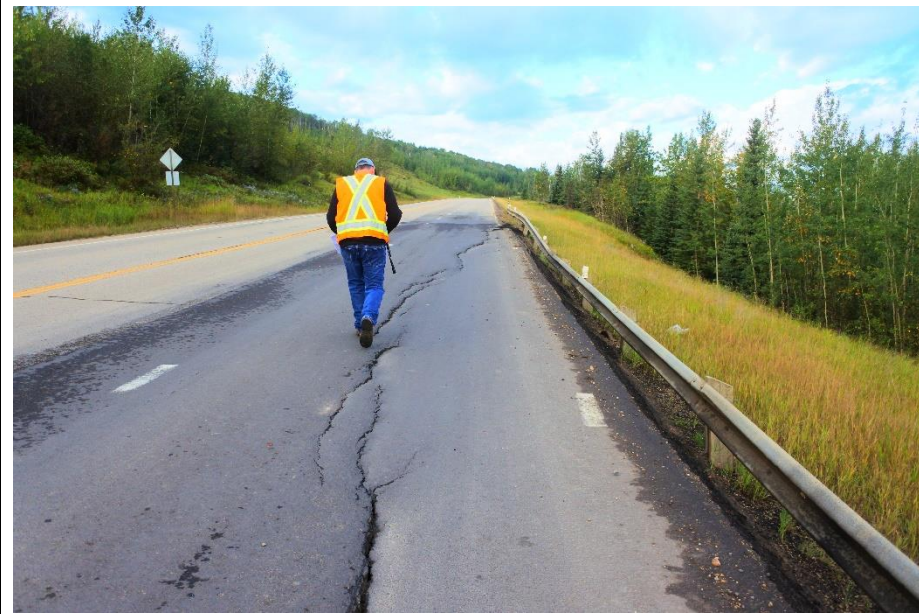
Photo 10.
Looking southwest along WBL between the Lower Valley Landslide (Site 2) and the Mid-Valley/"Old Major" Landslide (Site1). Cracks drop from 50 mm to 120 mm along the scarp at the west end.

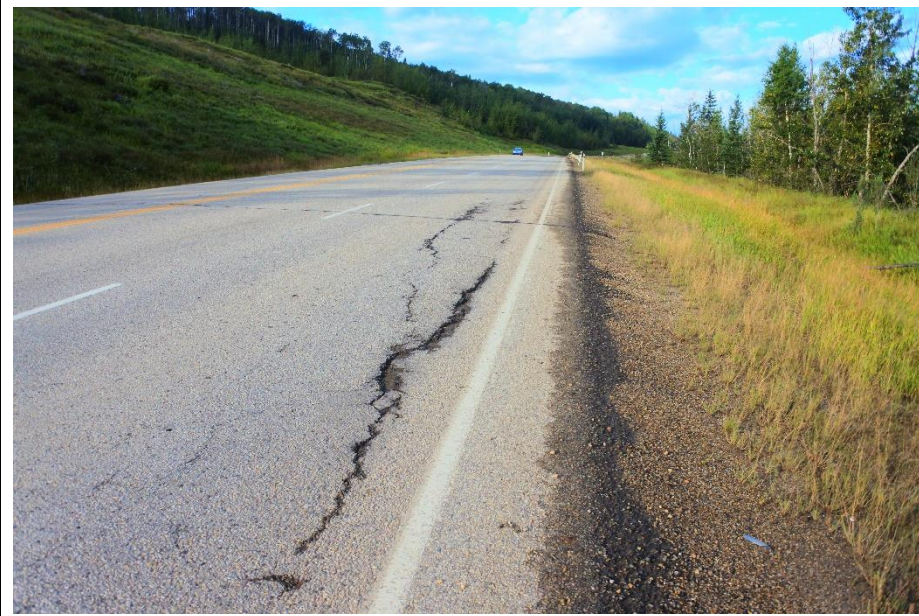
Photo 11.
Looking southwest from the WBL shoulder at the slide in the backslope in the eastern portion of the Mid-Valley/"Old Major" Landslide (Site 1).

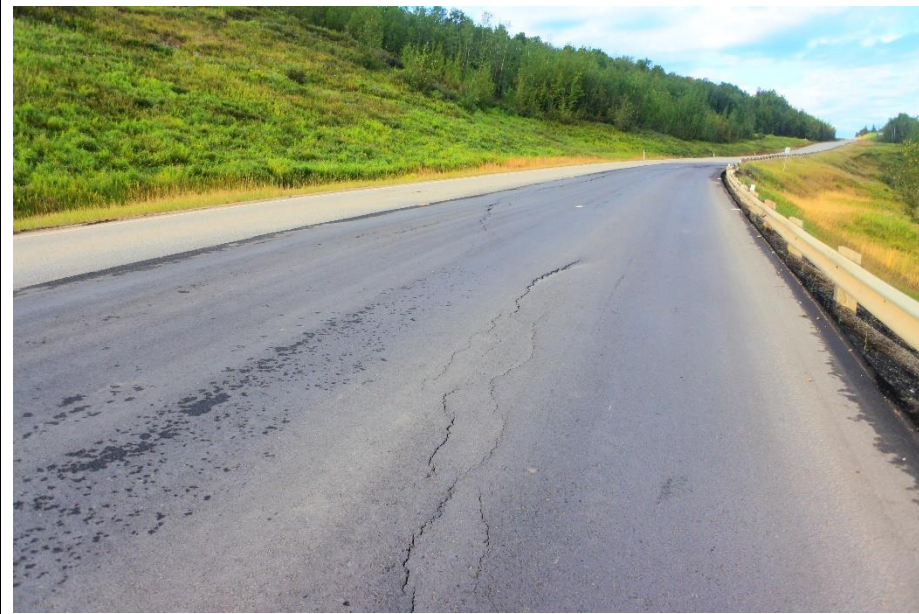
Photo 12.
Looking west at the ACP patch in outer WBL at Mid-Valley/"Old Major" Landslide (Site 1). There is a 40 mm drop along the scarp in the ACP.

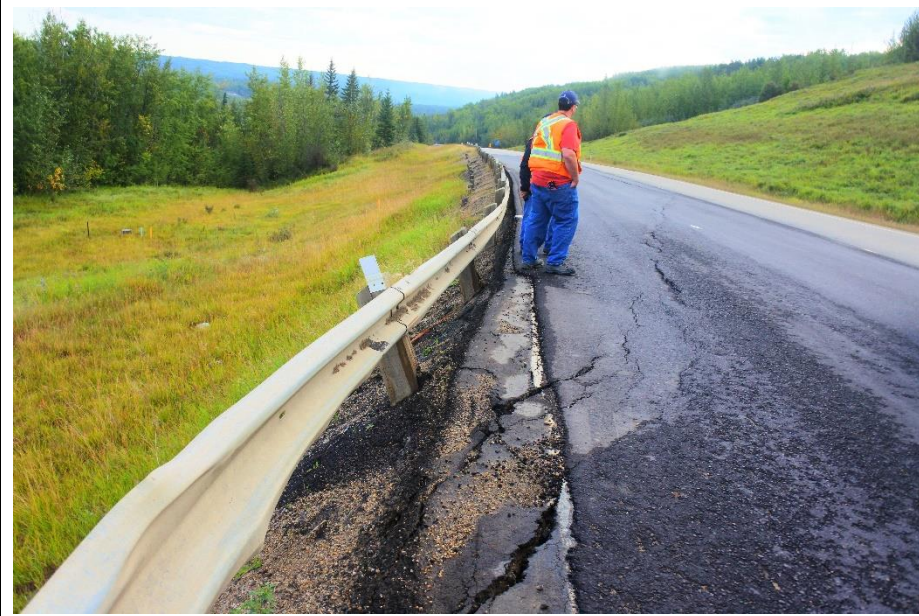
Photo 13.
Looking northeast at graben below the highway at the Mid-Valley Landslide / “Old Major”(Site 1) and the cracking in the ACP in the WBL. The drop in the ACP along the backscarp near the guardrail at the west end is now at about 80 mm and the cracks are open to 80 mm.

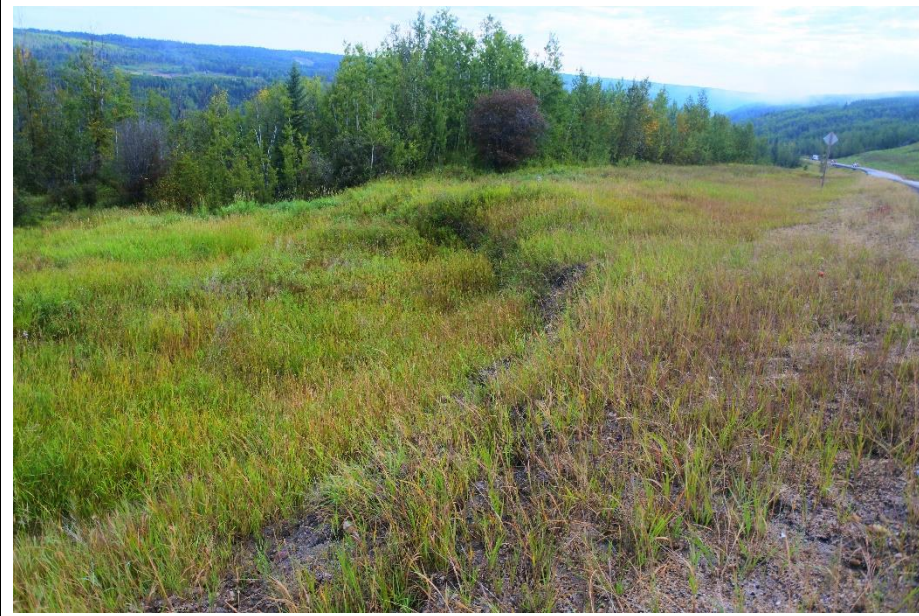
Photo 14.
Looking northeast from the shoulder of the WBL at the scarp extending into the brush at the Valley Top Landslide (Site 3).

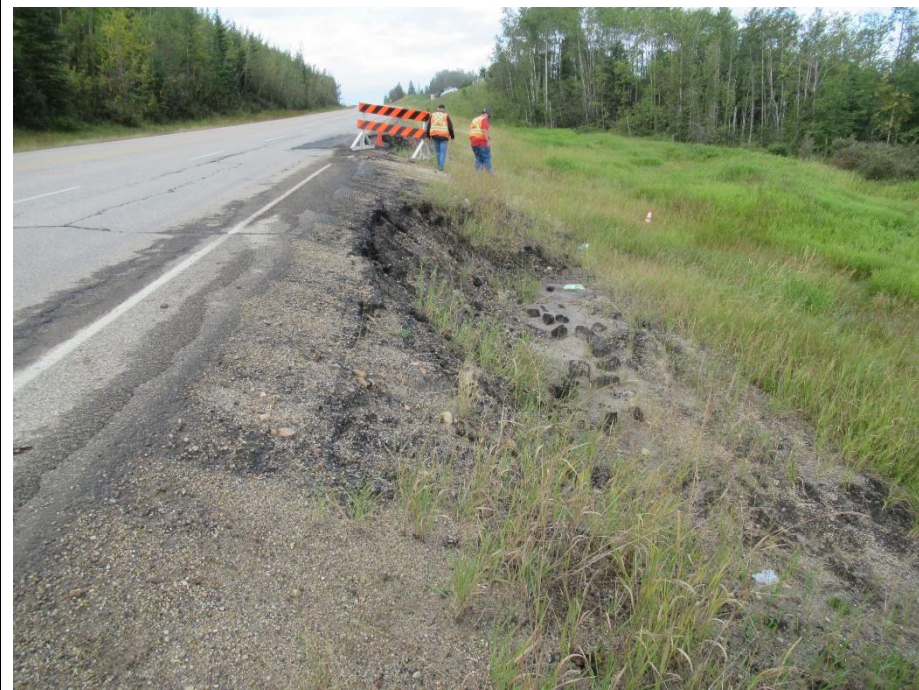
Photo 15.
Looking southwest
along backscarp of
Valley Top
Landslide (Site 3).
Backscarp drop in
embankment side
slope now about
1.5 m

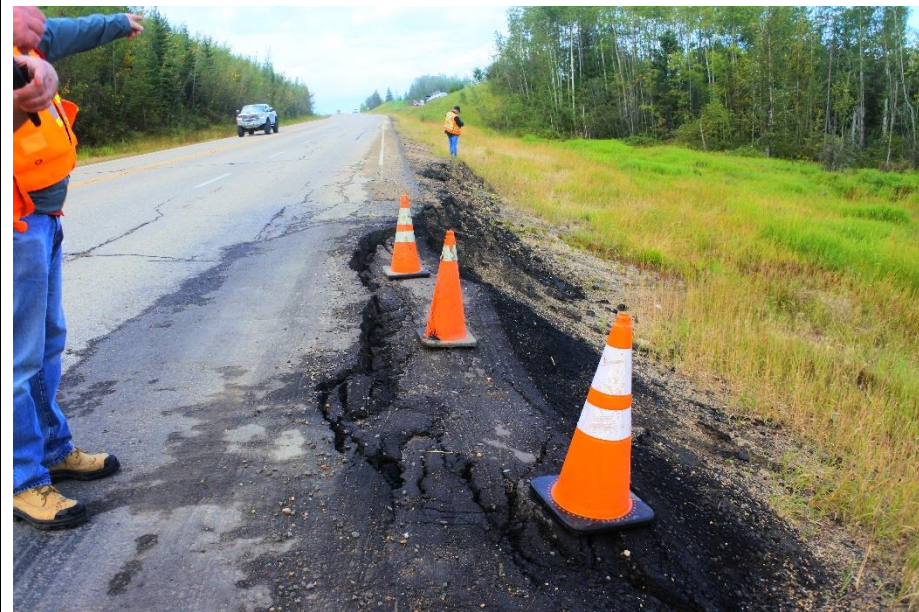
Photo 16.
Looking southwest
along backscarp in
the west section of
the Valley Top
Landslide (Site 3).
Site was patched in
June 2019. Cracks
extend 200 mm
past the white line
into the WBL, are
open 220 mm and
are 1 m deep.

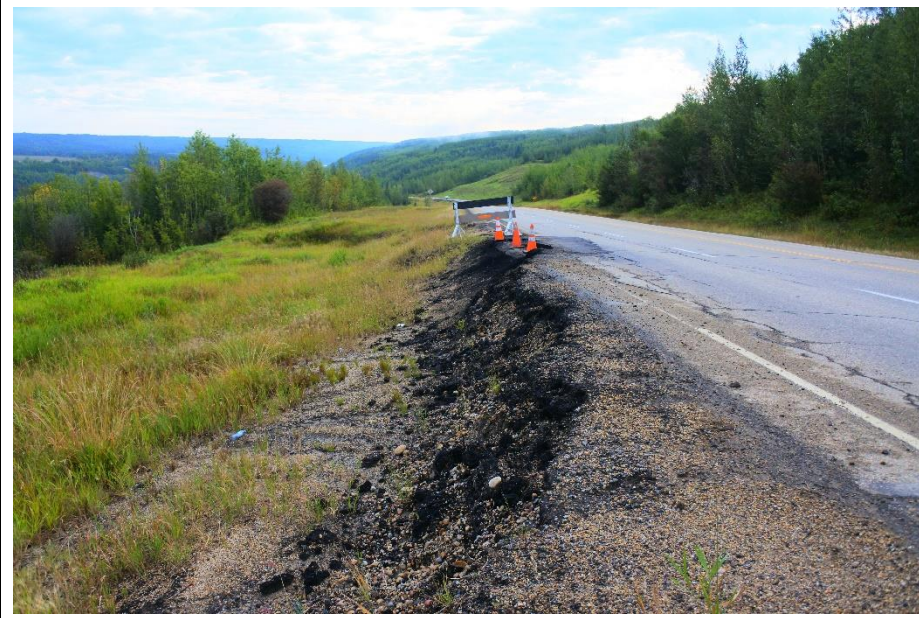
Photo 17.
Looking northeast
along backscarp in
the west section of
the Valley Top
Landslide (Site 3).
