**PEACE REGION  
(GRANDE PRAIRIE DISTRICT – SOUTH) GRMP**

**SITE INSPECTION FORM**

<b>SITE NUMBER AND NAME:</b> GP016 Slide 2 km West of Hwy 40 and Hwy 666 Junction		<b>HIGHWAY &amp; KM:</b> 666:02, 34.095 to 34.837	<b>PREVIOUS INSPECTION DATE:</b> July 20, 2021	<b>INSPECTION DATE:</b> <b>June 13, 2023</b>
<b>LEGAL DESCRIPTION:</b> NE 15-70-06-W6M SW/SE-15-70-06-W6M	<b>NAD 83 COORDINATES:</b> UTM    Northing    Easting 11      6103361    383748		<b>RISK ASSESSMENT:</b> Lower (2): PF: 13    CF: 7    TOTAL: 91 Middle (1): PF: 11    CF: 5    TOTAL: 55 Upper (3): PF: 11    CF: 4    TOTAL: 44	
<b>AVERAGE ANNUAL DAILY TRAFFIC (AADT):</b> 2,400 (west) & 1,960 (east) (Reference No. 28690 & 70000759, 2022)			<b>CONTRACT MAINTENANCE AREA (CMA):</b> 504

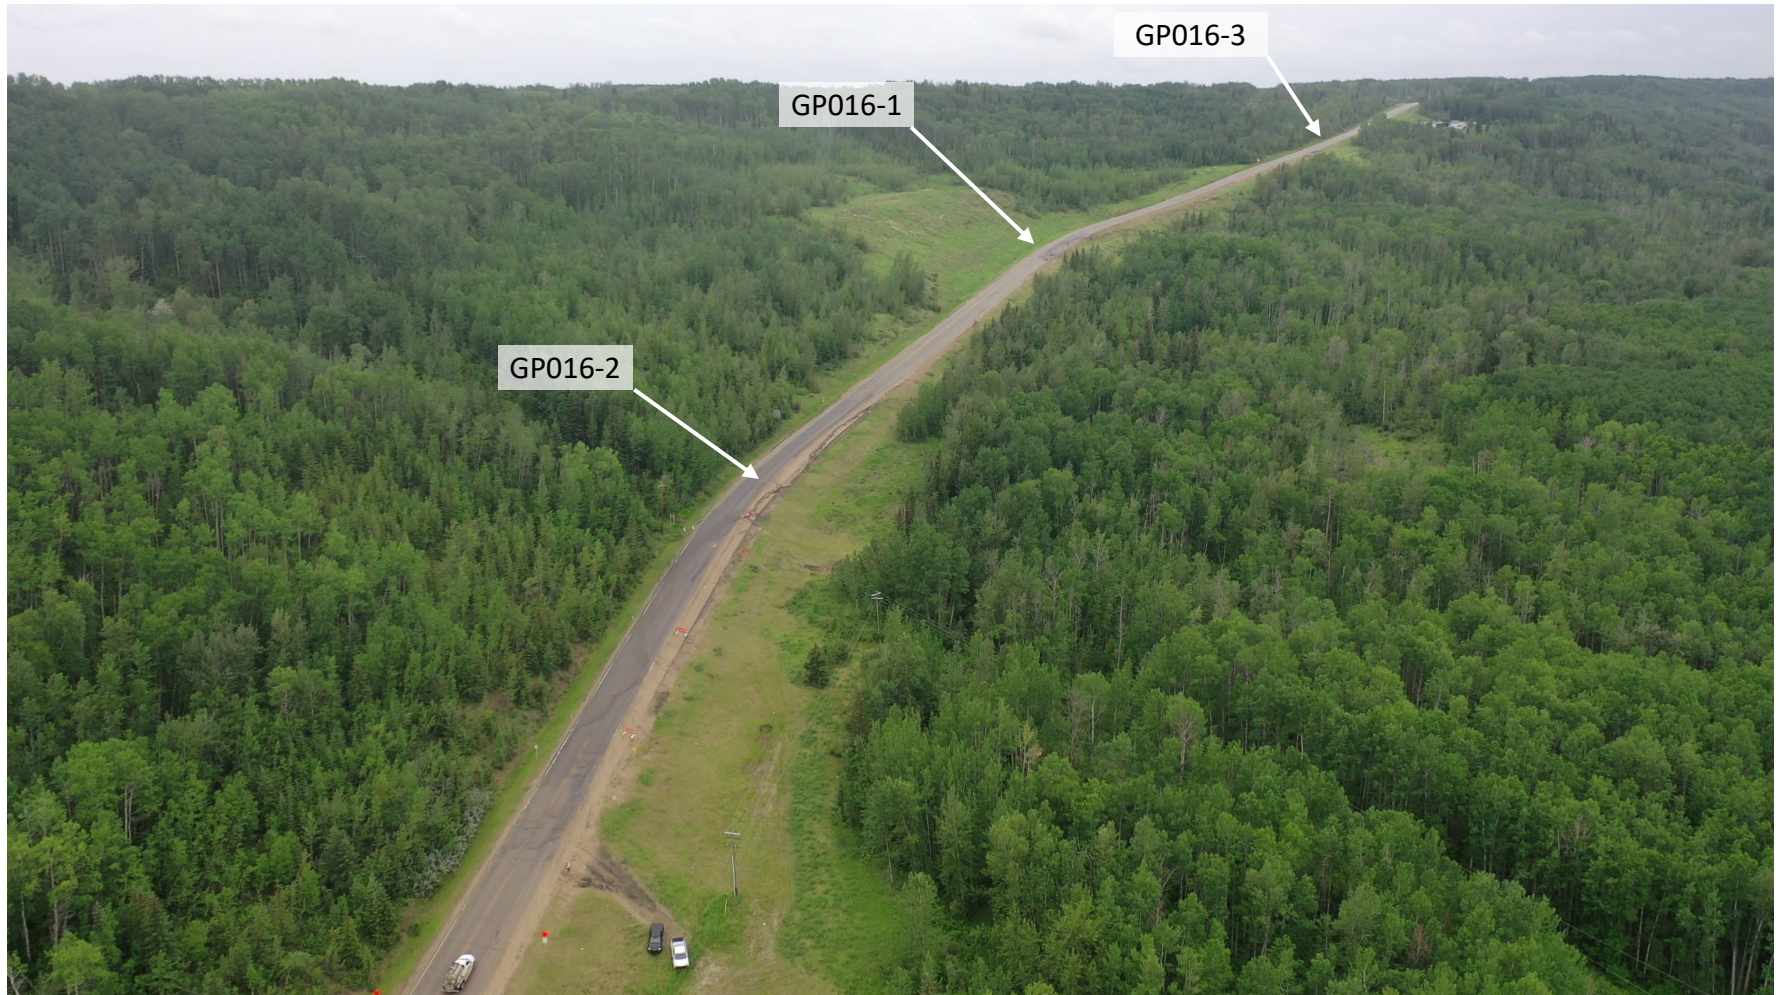
**Photo 1** Overview of GP016-1 (middle), 2 (lower), and 3 (upper) sites. Photo taken June 13, 2023, facing southwest.

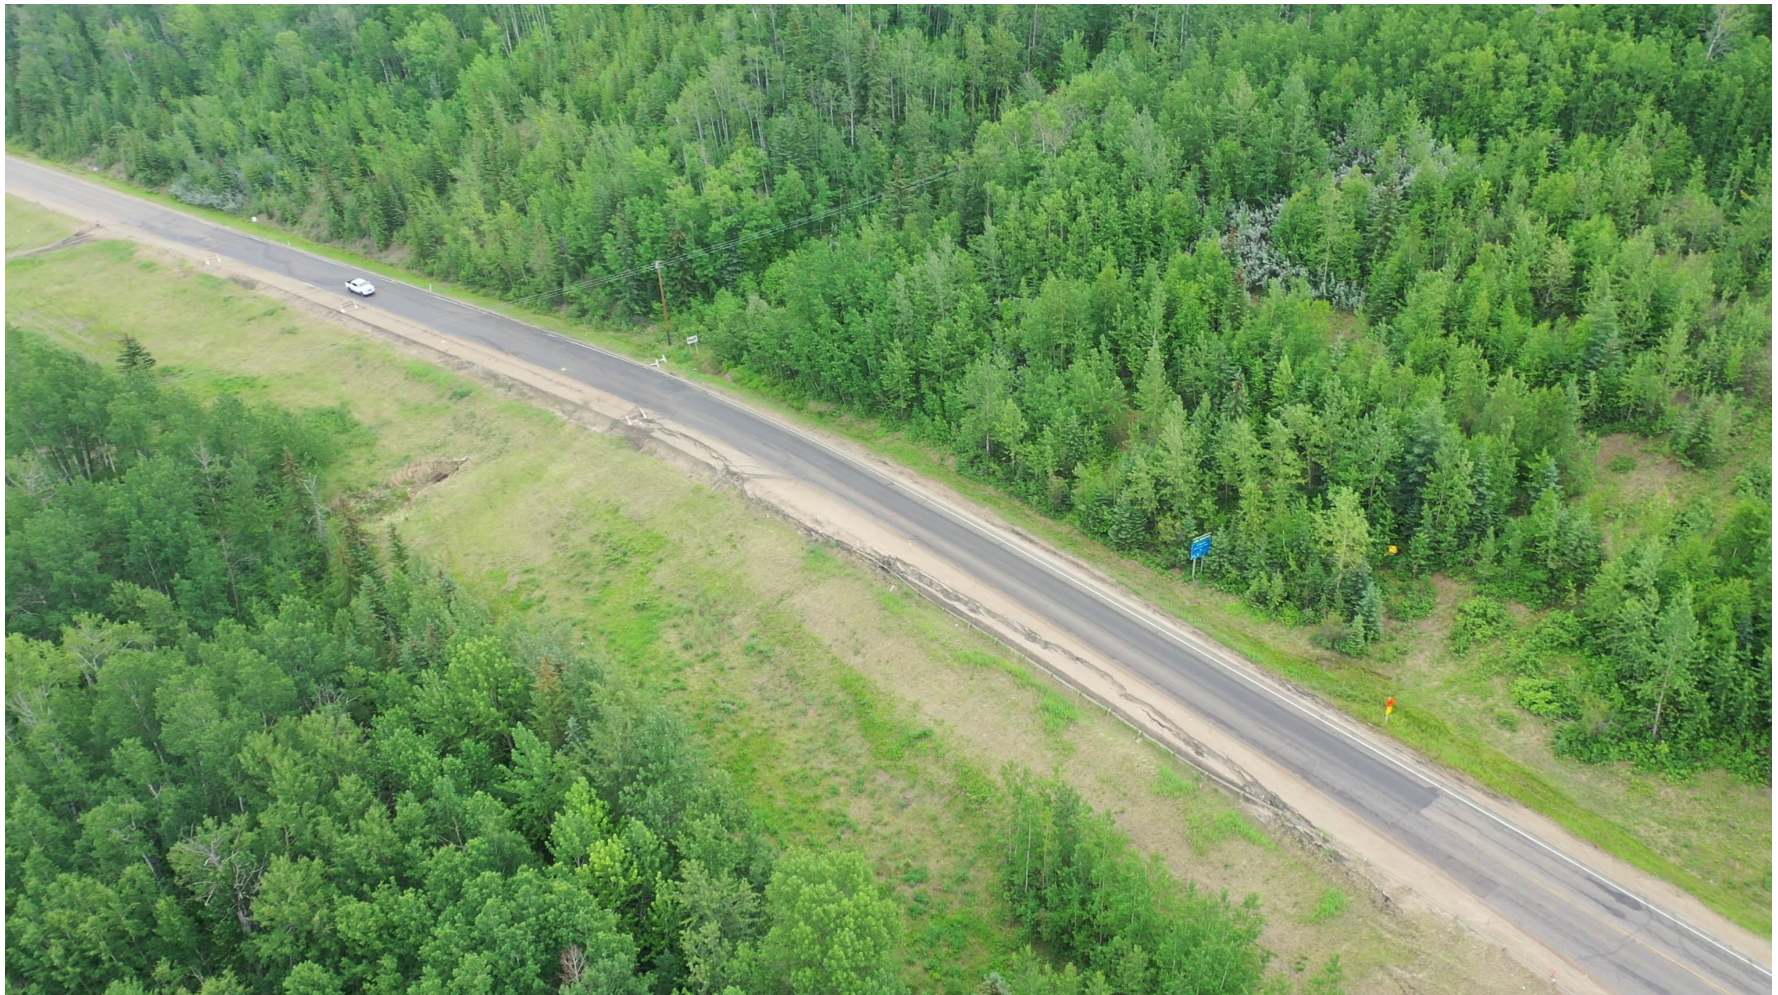
**Photo 2** Overview of GP016-2 (lower) site. Note pavement patches, and cracking and settlement along both lanes of Hwy 666:02. Photo taken June 13, 2023, facing southeast.

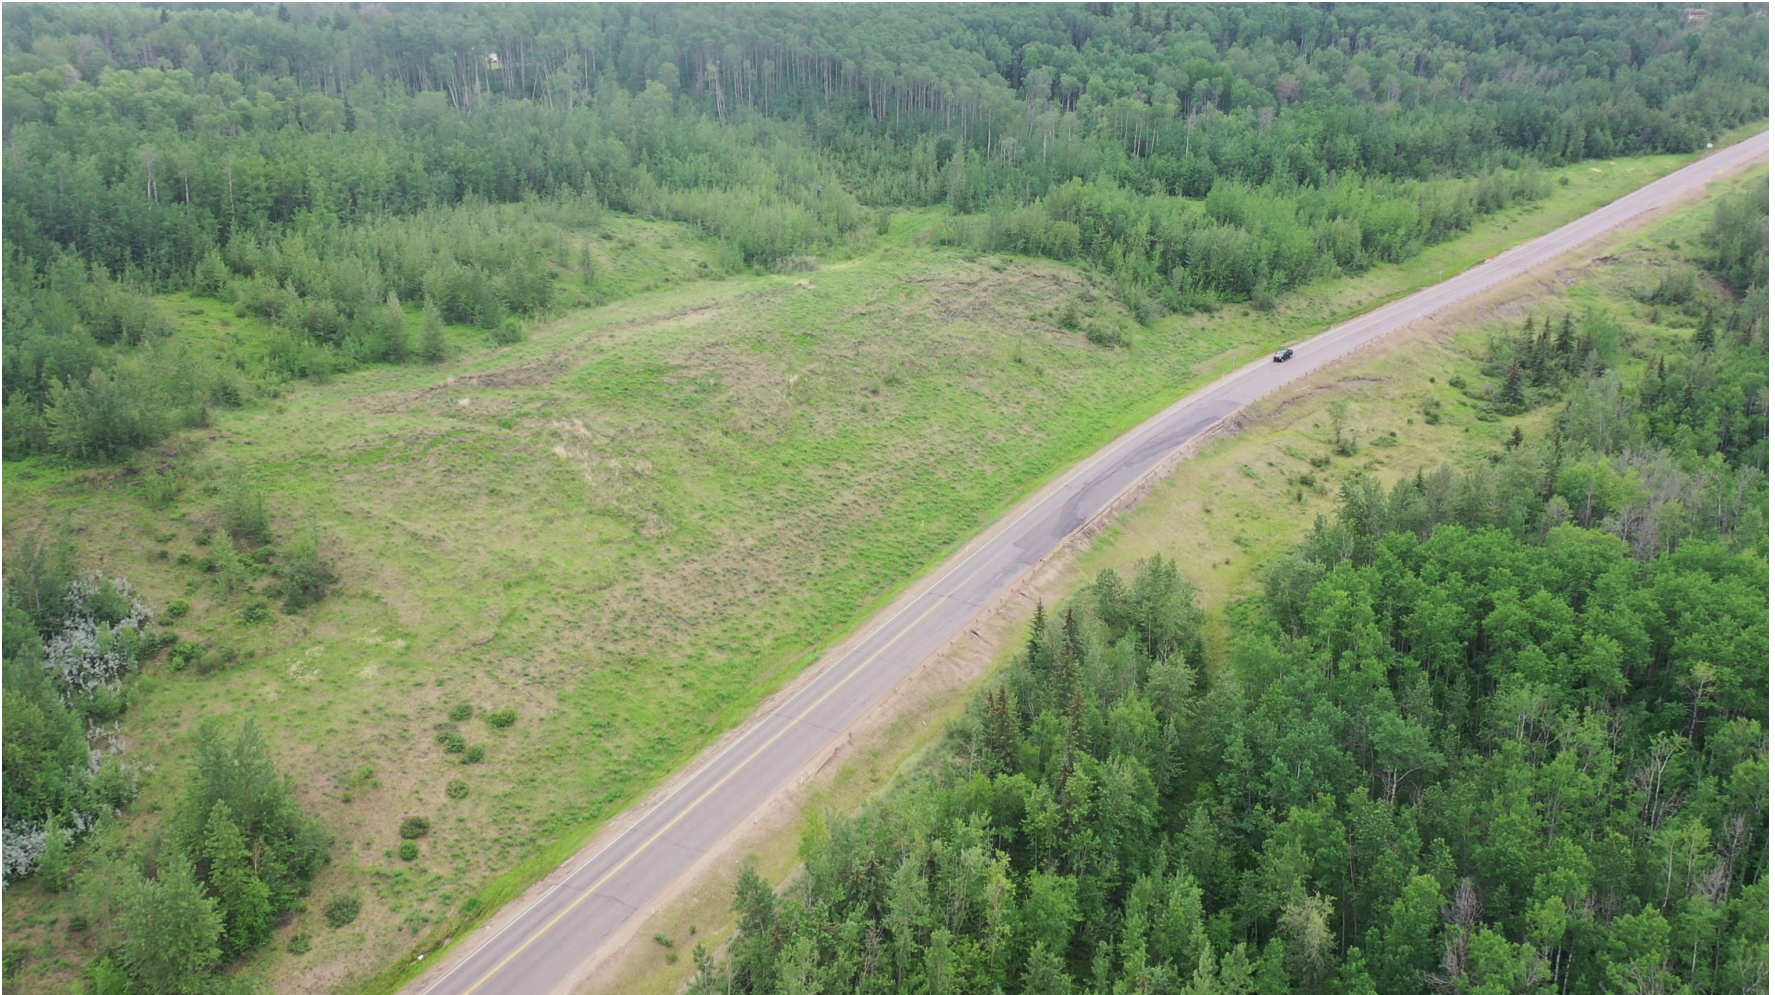
**Photo 3** Overview of GP016-1 (upper) site. Note pavement patches, and cracking and settlement in westbound (north) lane of Hwy 666:02. As well as sliding along backslope and highway embankment (see next photo). Photo taken June 13, 2023, facing southwest.

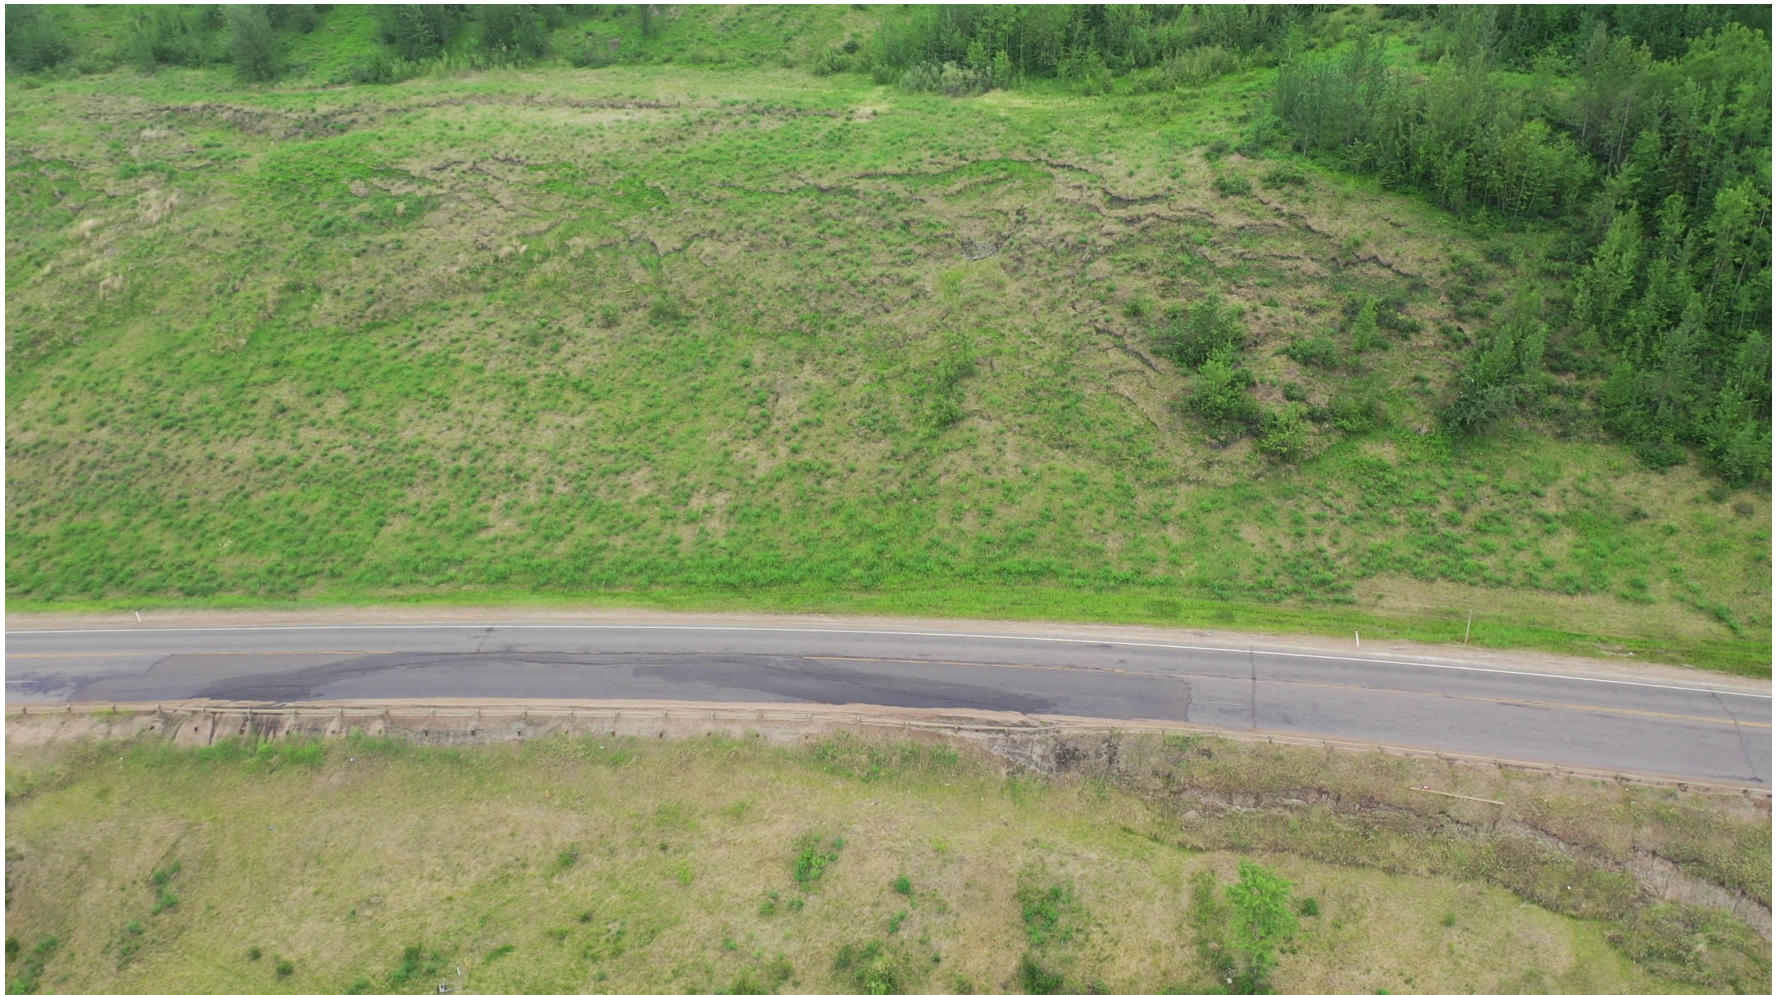
**Photo 4** Cracking and settlement westbound (north) lane of Hwy 666:02 at GP016-1 (middle) site. Note cracking and toe rolls along backslope and highway embankment. Photo taken June 13, 2023, facing southeast.

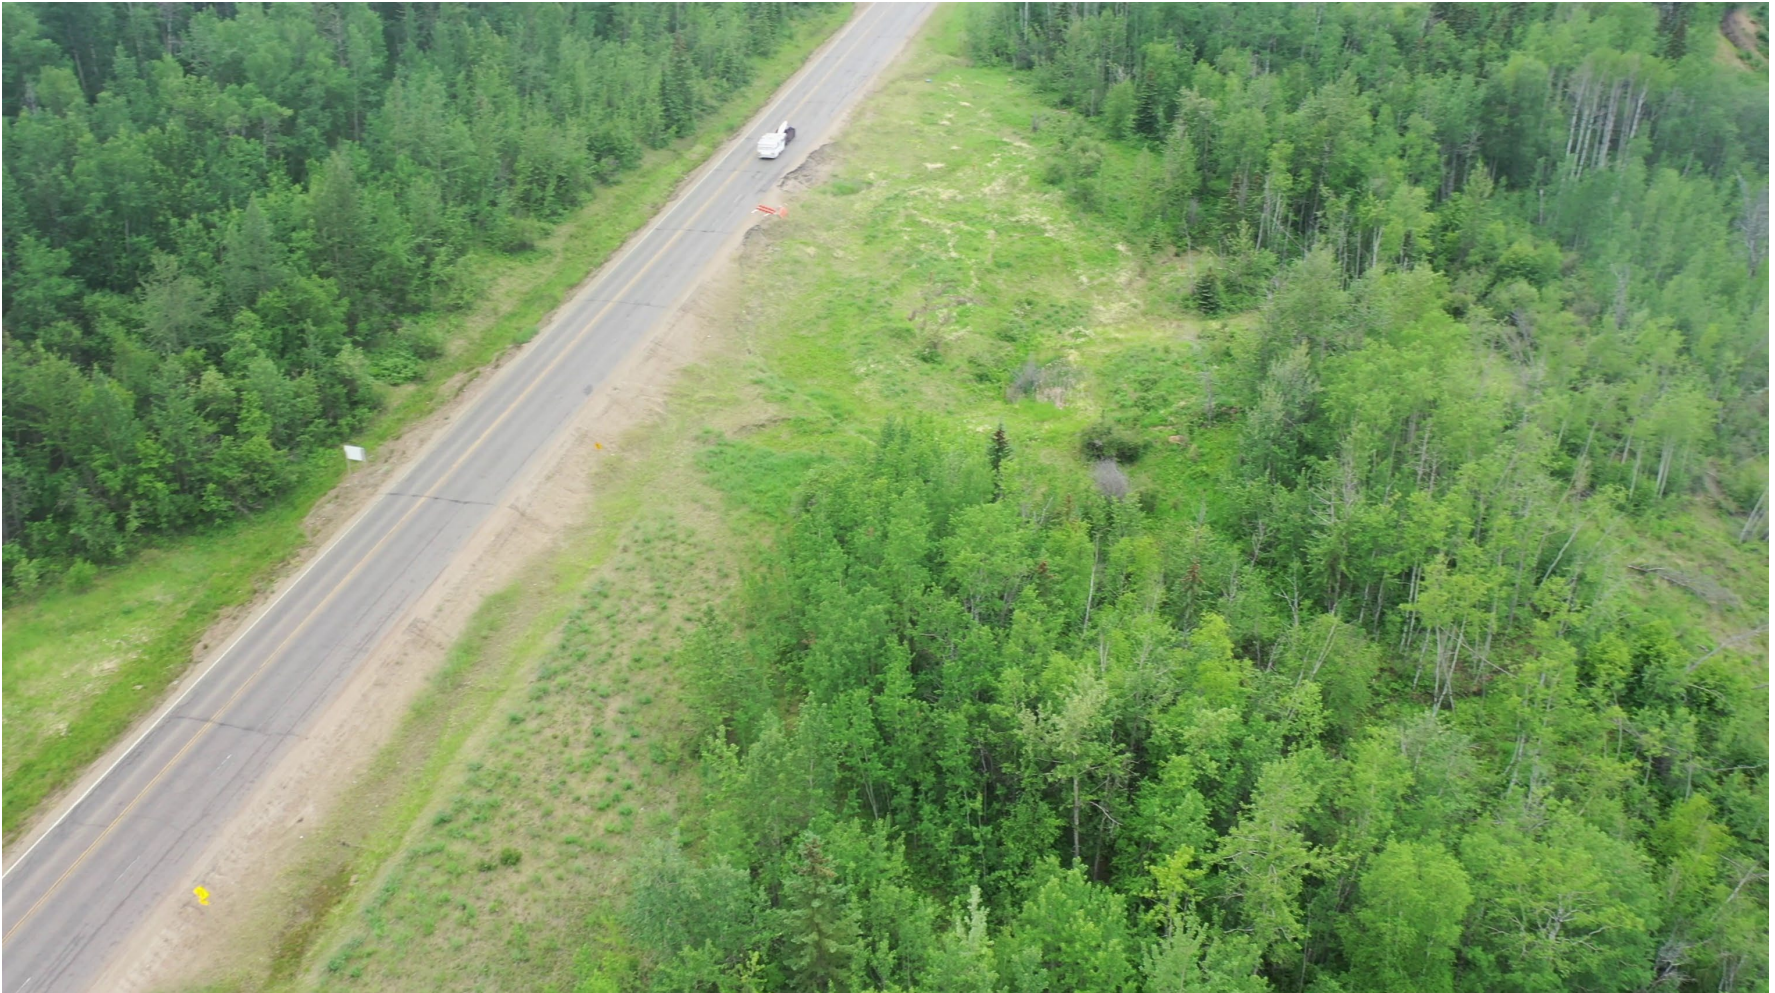
**Photo 5** Overview of GP016-3 (upper) site. Note slide along shoulder of westbound (north) lane of Hwy 666:02. Photo taken June 13, 2023, facing southwest.

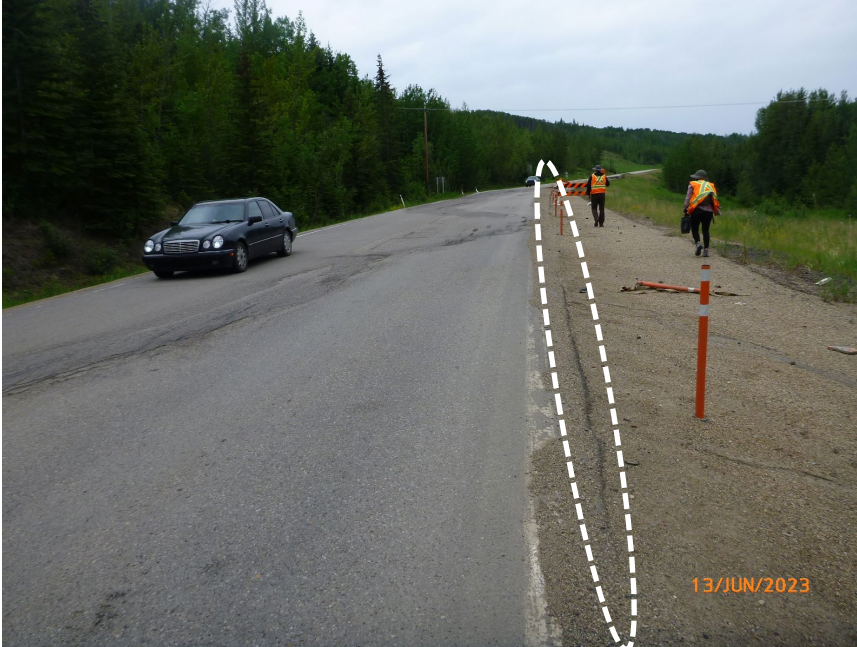
**Photo 6** Cracking and settlement in both lanes of Hwy 666:02 at GP016-2 (lower) site. Note edge along passing lane which has been decommissioned and blocked with wooden barricades and orange delineators. Photo taken June 13, 2023, facing southwest.

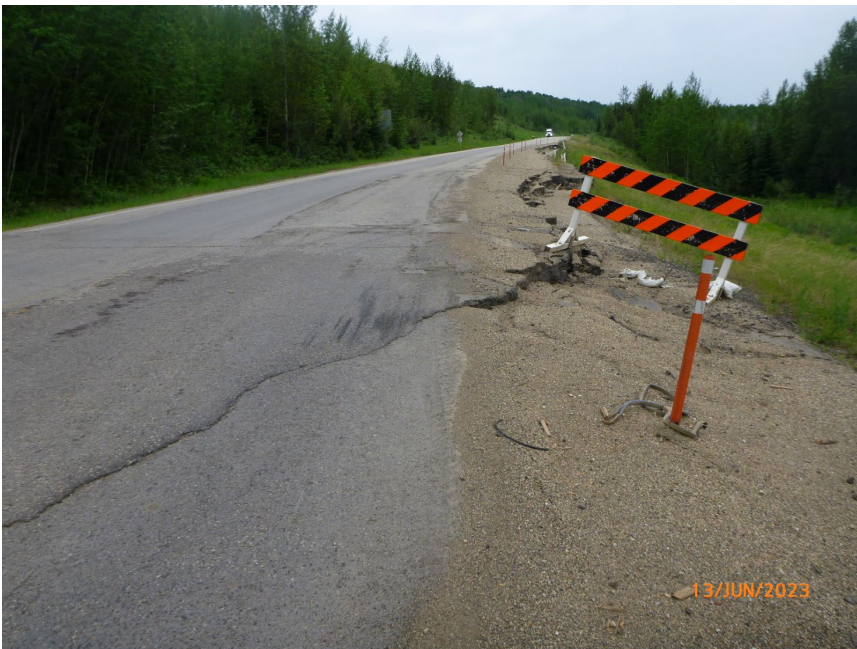
**Photo 7** Cracking and settlement in westbound (north) lane of Hwy 666:02 at GP016-2 (lower) site. Note drop in pavement along slide scarp. Photo taken June 13, 2023, facing southwest.

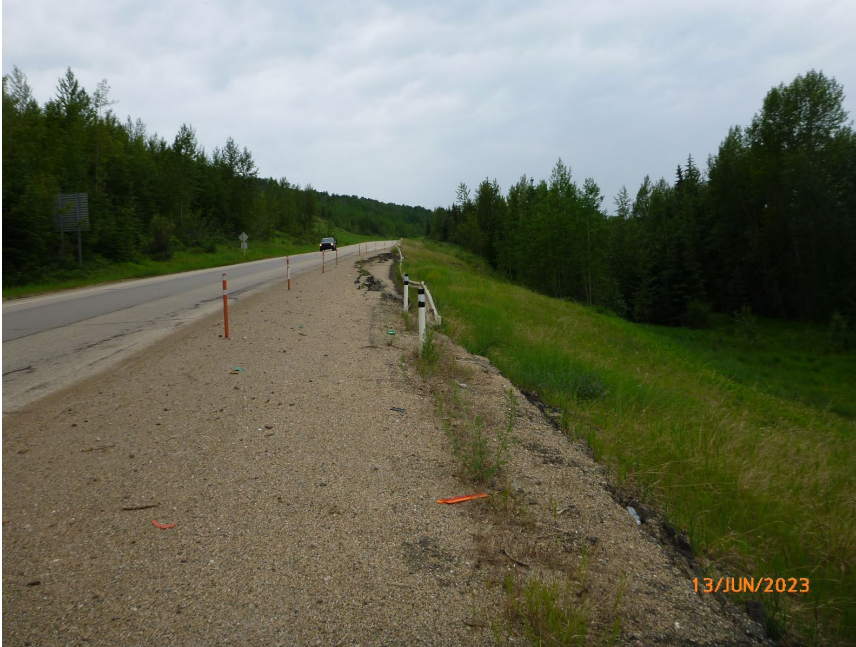
**Photo 8** Pavement breaking away highway along westbound (north) shoulder of Hwy 666:02 at GP016-2 (lower) site. Note guardrail deflected and below top of pavement. Photo taken June 13, 2023, facing northeast.

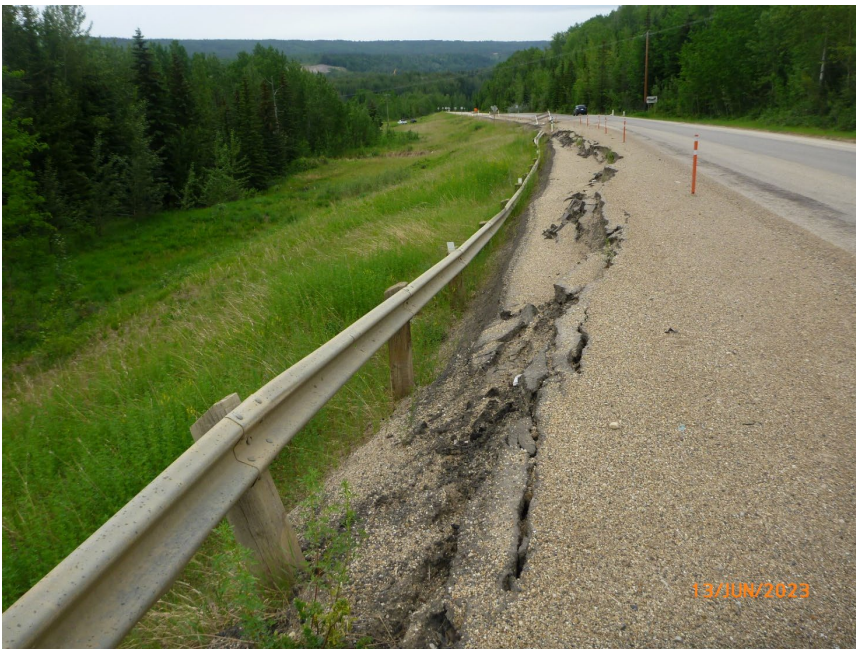
**Photo 9** Pavement breaking away highway along westbound (north) shoulder of Hwy 666:02 at GP016-2 (lower) site. Note guardrail deflected and below top of pavement. Photo taken June 13, 2023, facing northeast.

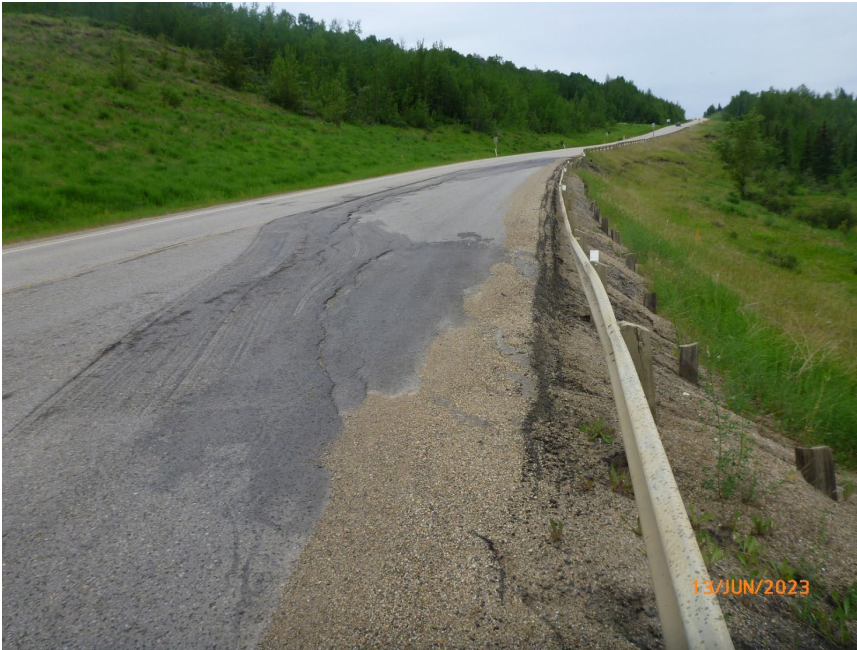
**Photo 10** Cracking and settlement in westbound (north) lane of Hwy 666:02 at GP016-1 (middle) site. Photo taken June 13, 2023, facing southwest.

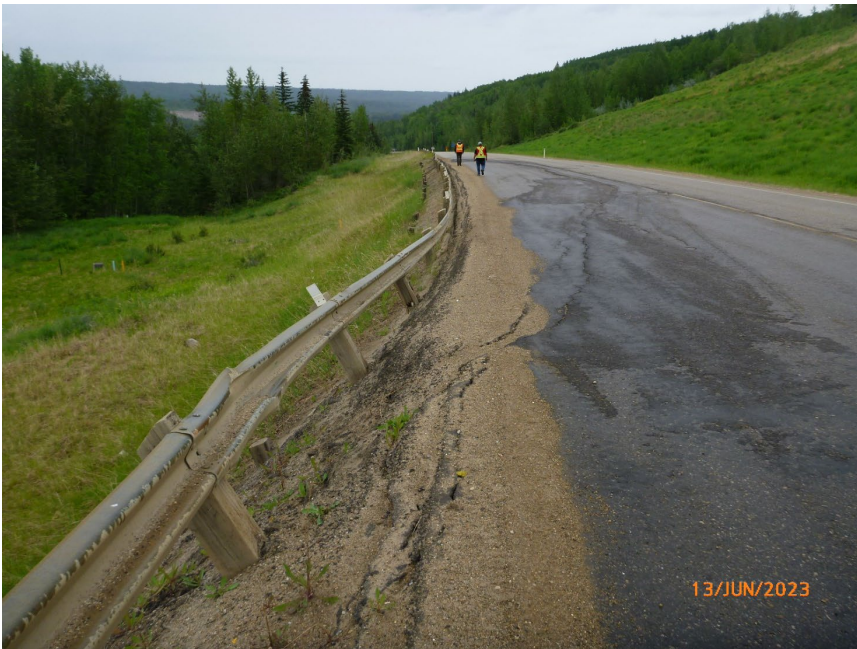
**Photo 11** Cracking and settlement in westbound (north) lane of Hwy 666:02 at GP016-1 (middle) site. Note guardrail deflected at a similar level as top of pavement. Photo taken June 13, 2023, facing northeast.

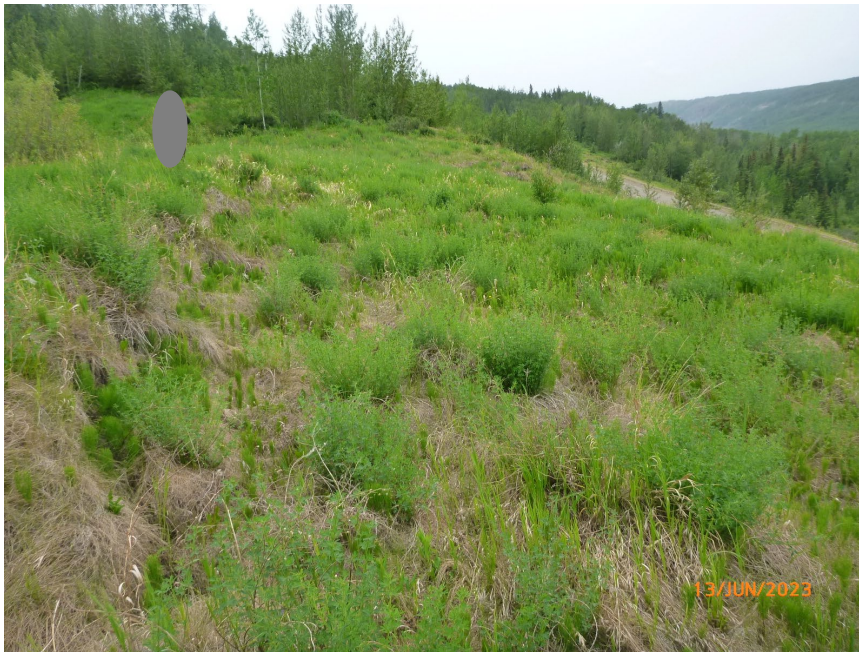
**Photo 12** Crest of backslope at GP016-1 (middle) site near WP314. Area appeared wetter than during 2021 inspection. Photo taken June 13, 2023, facing southwest.

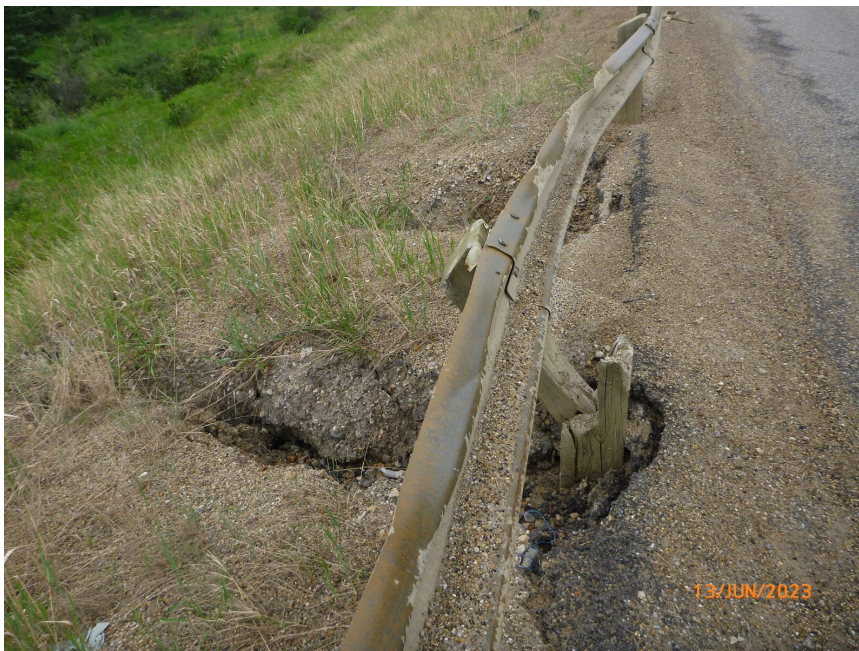
**Photo 13** Erosion at WP316 due to surface water flow over edge of pavement. Note guardrail also deflected and post is damaged. Photo taken June 13, 2023, facing southwest.

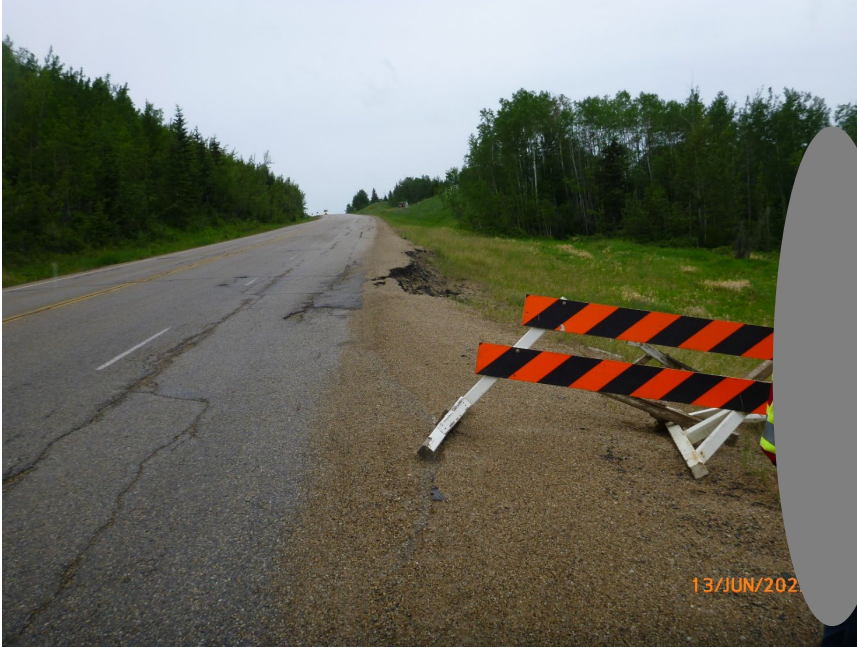
**Photo 14** Pavement breaking away highway along westbound (north) shoulder of Hwy 666:02 at GP016-3 (upper) site. Note longitudinal cracking in pavement. Photo taken June 13, 2023, facing southwest.

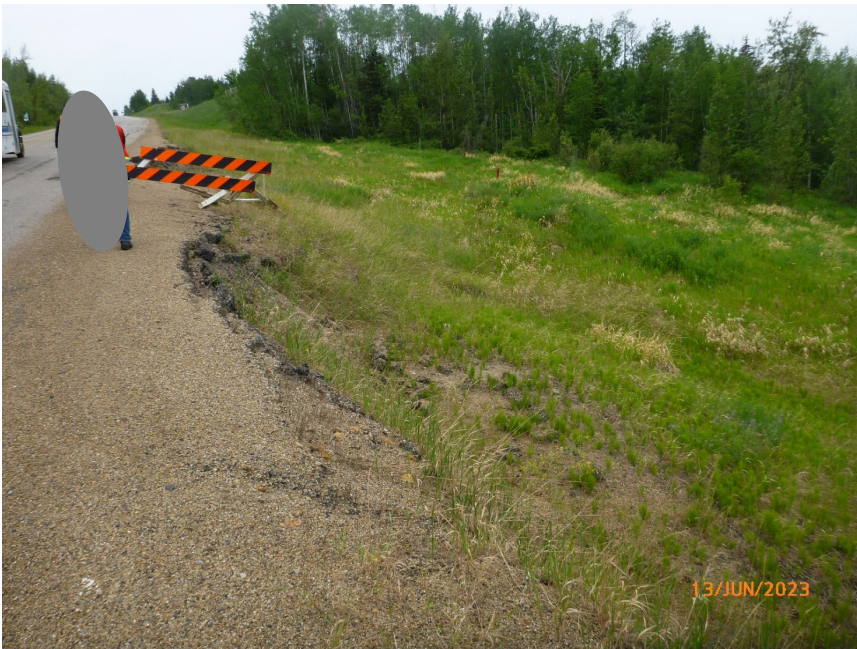
**Photo 15** Pavement breaking away highway along westbound (north) shoulder of Hwy 666:02 at GP016-3 (upper) site. Photo taken June 13, 2023, facing southwest.
