July 15, 2024

CON0022166 Peace Region (Grande Prairie District – South) GRMP Instrumentation Monitoring Site GP016; H666:02, km 34.837 Slide 2 km West of Hwy 40 and Hwy 666 Junction Section C – 2024 Spring Readings

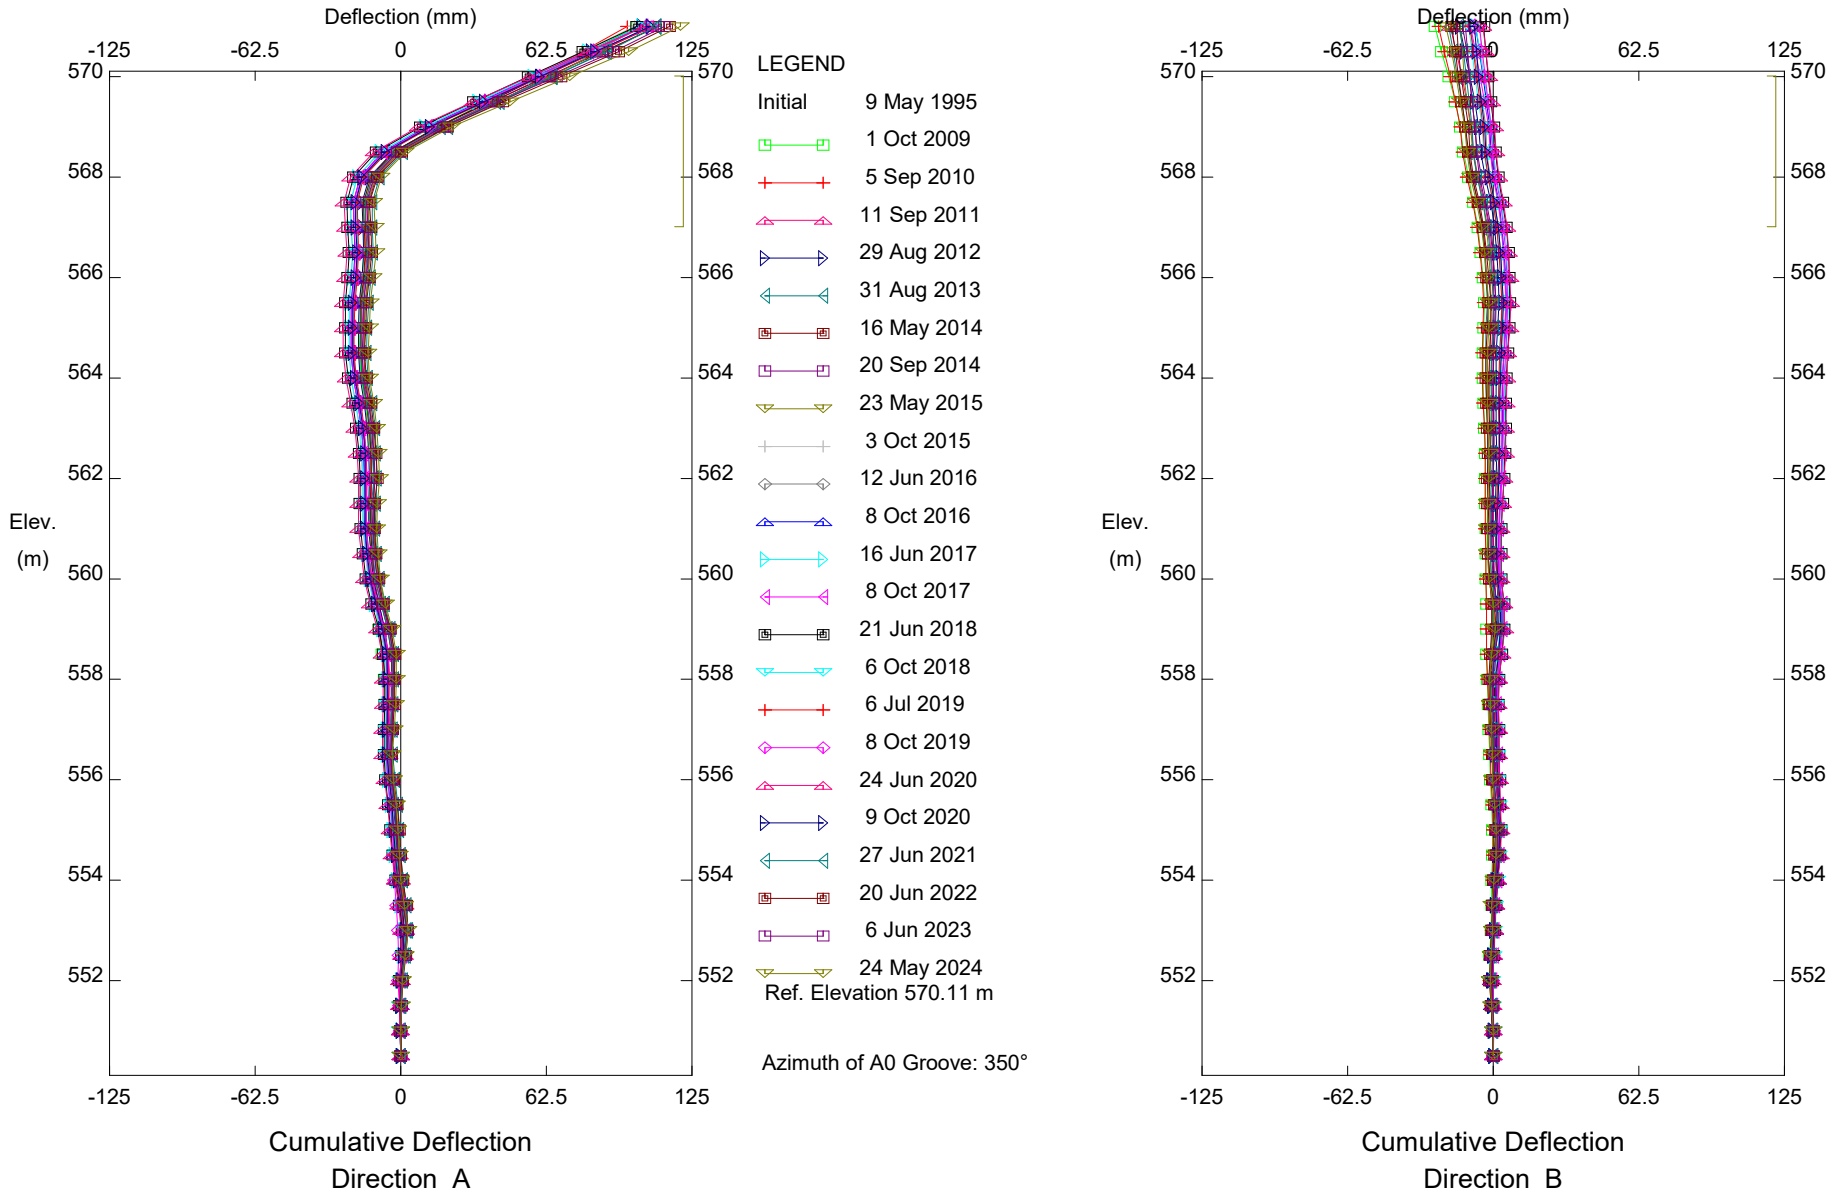
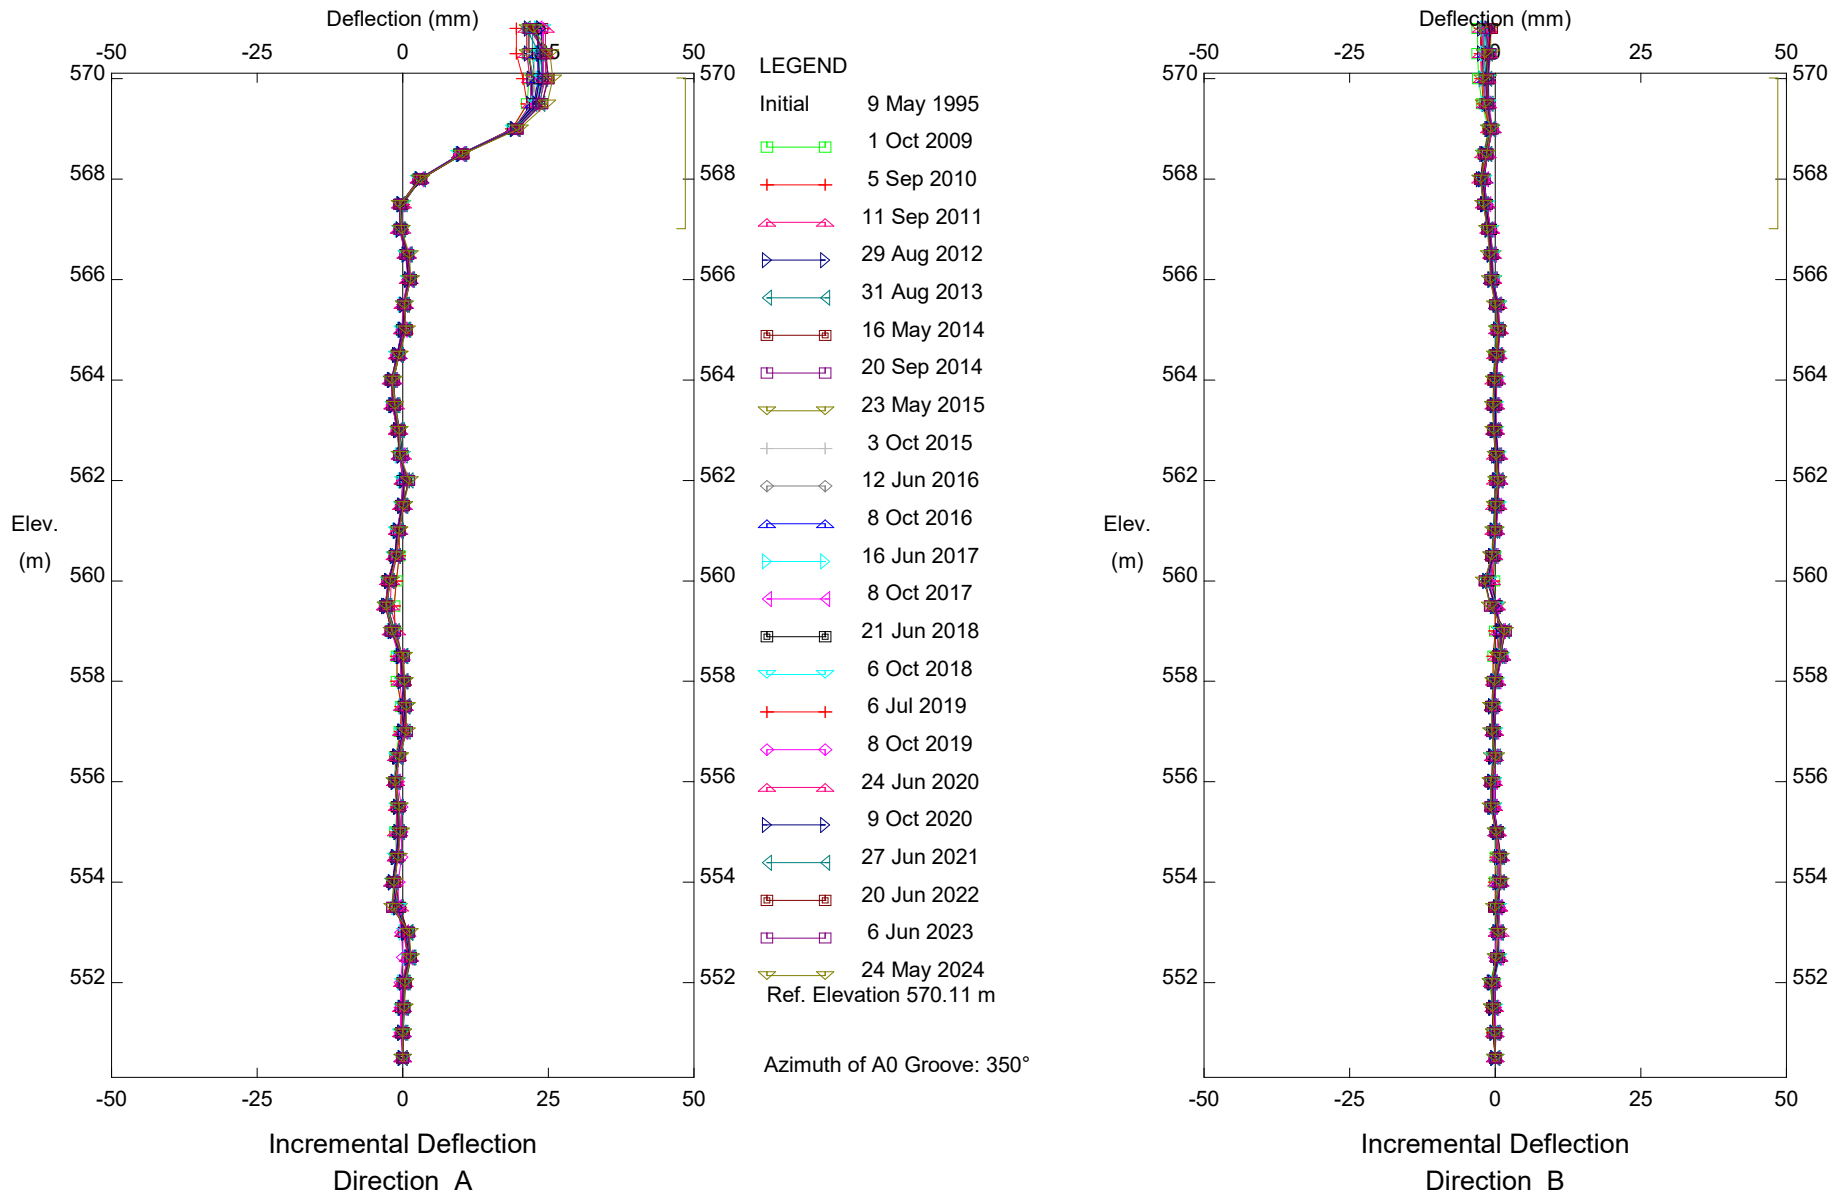
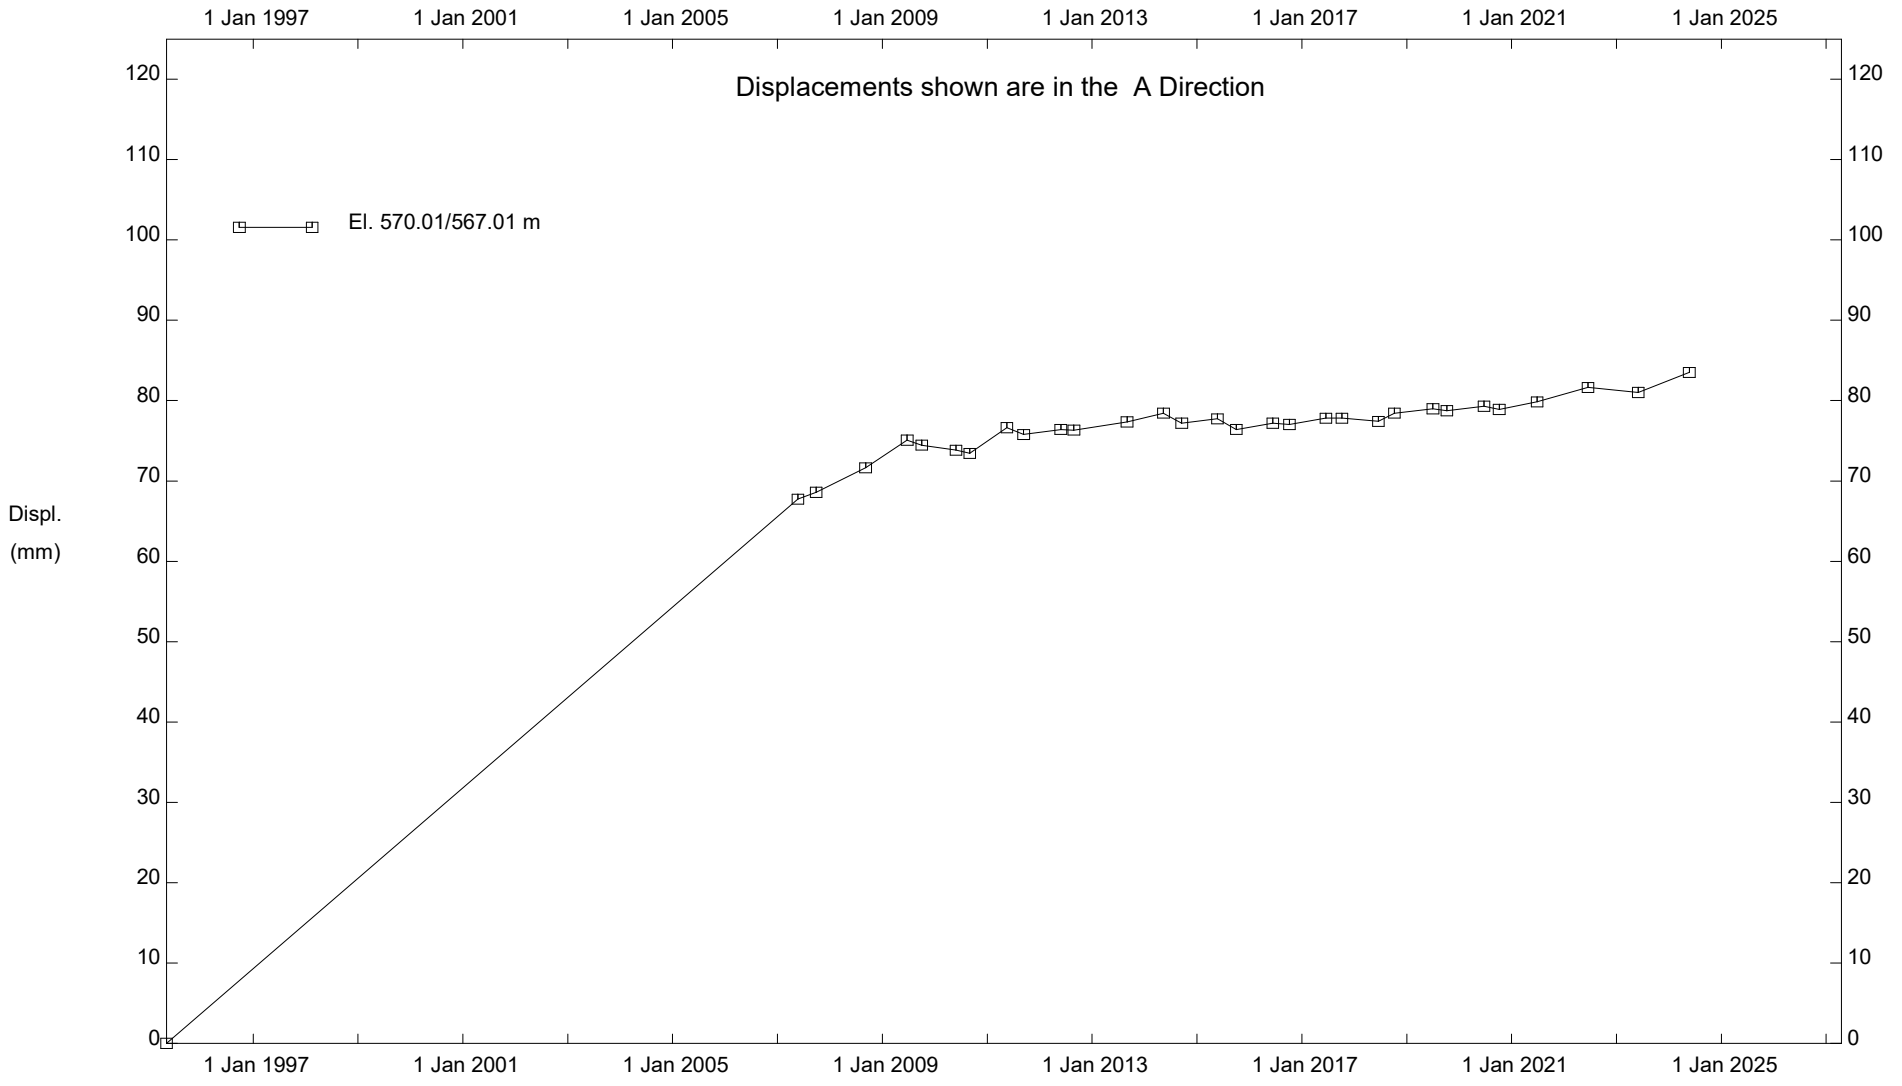
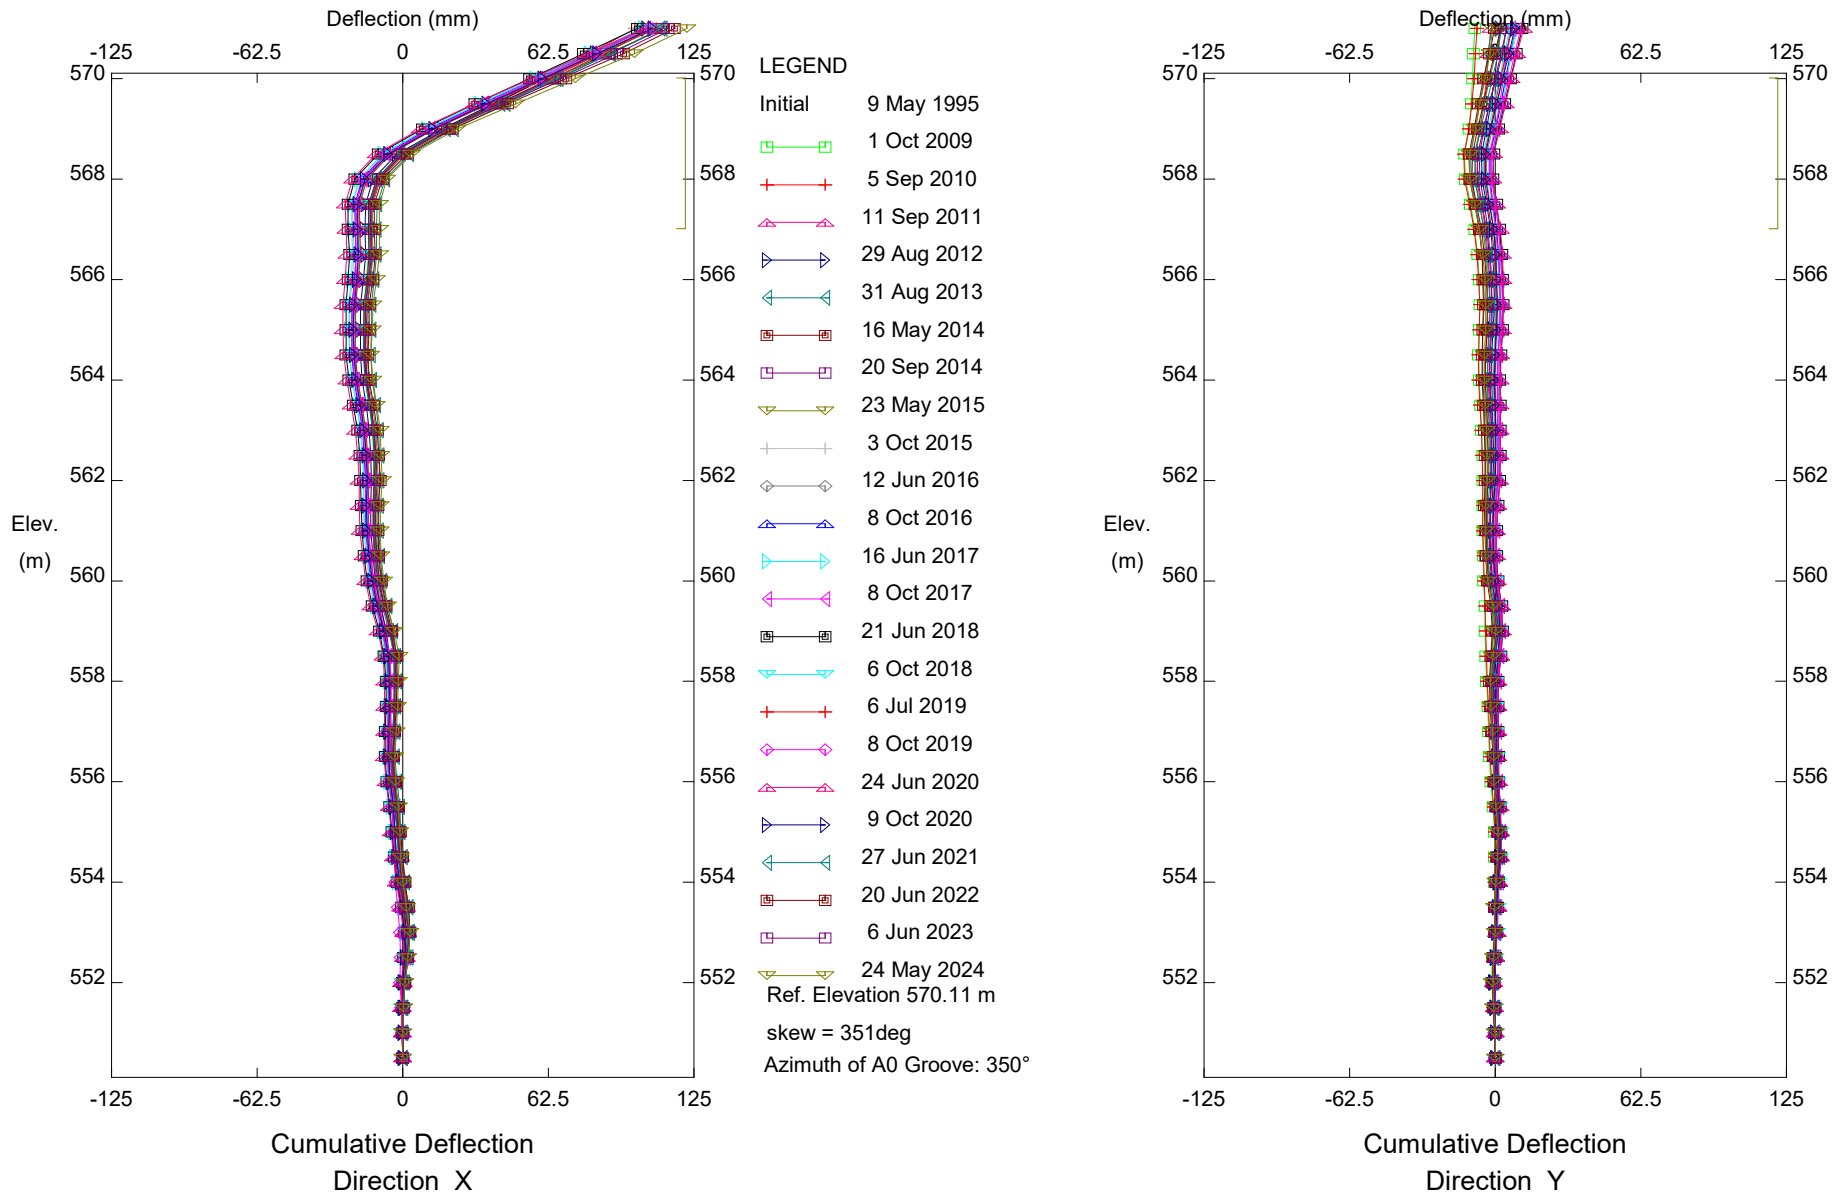
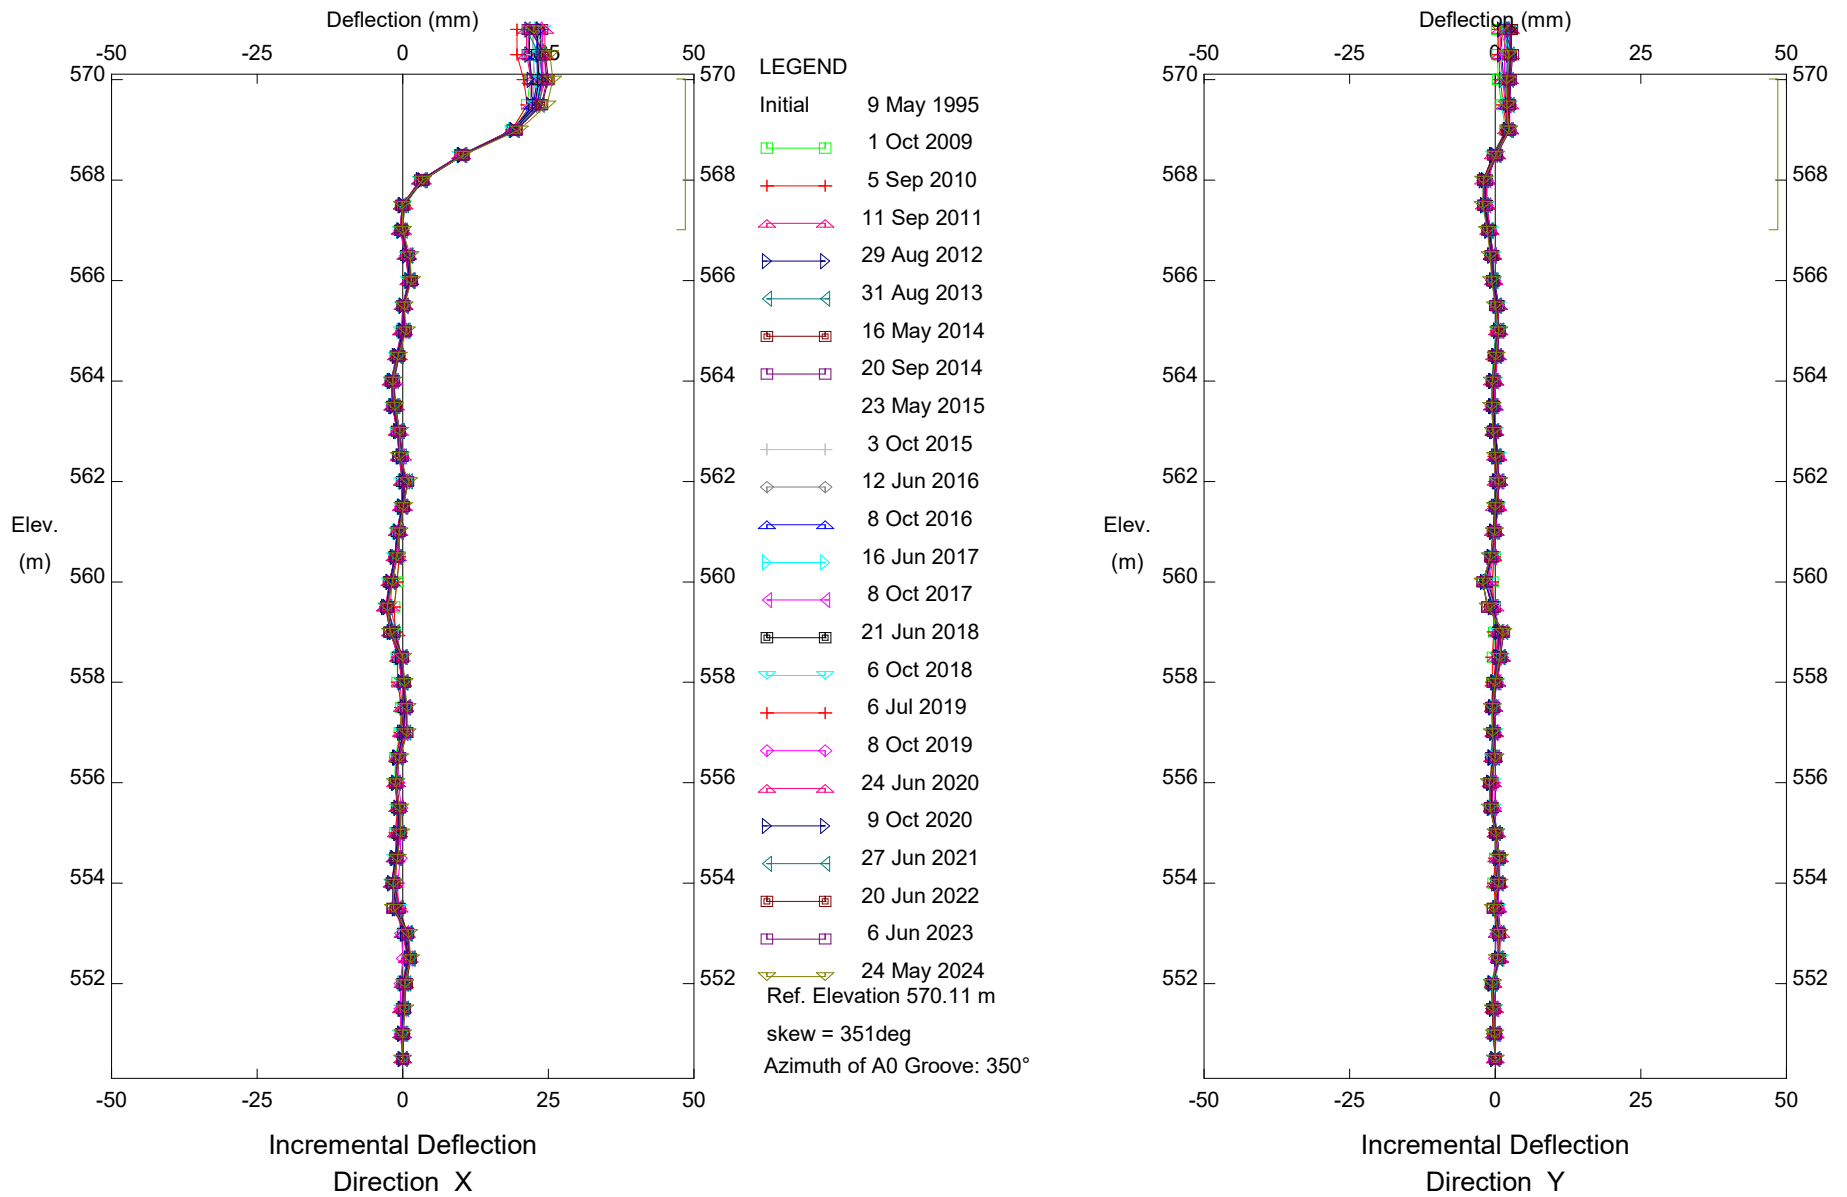
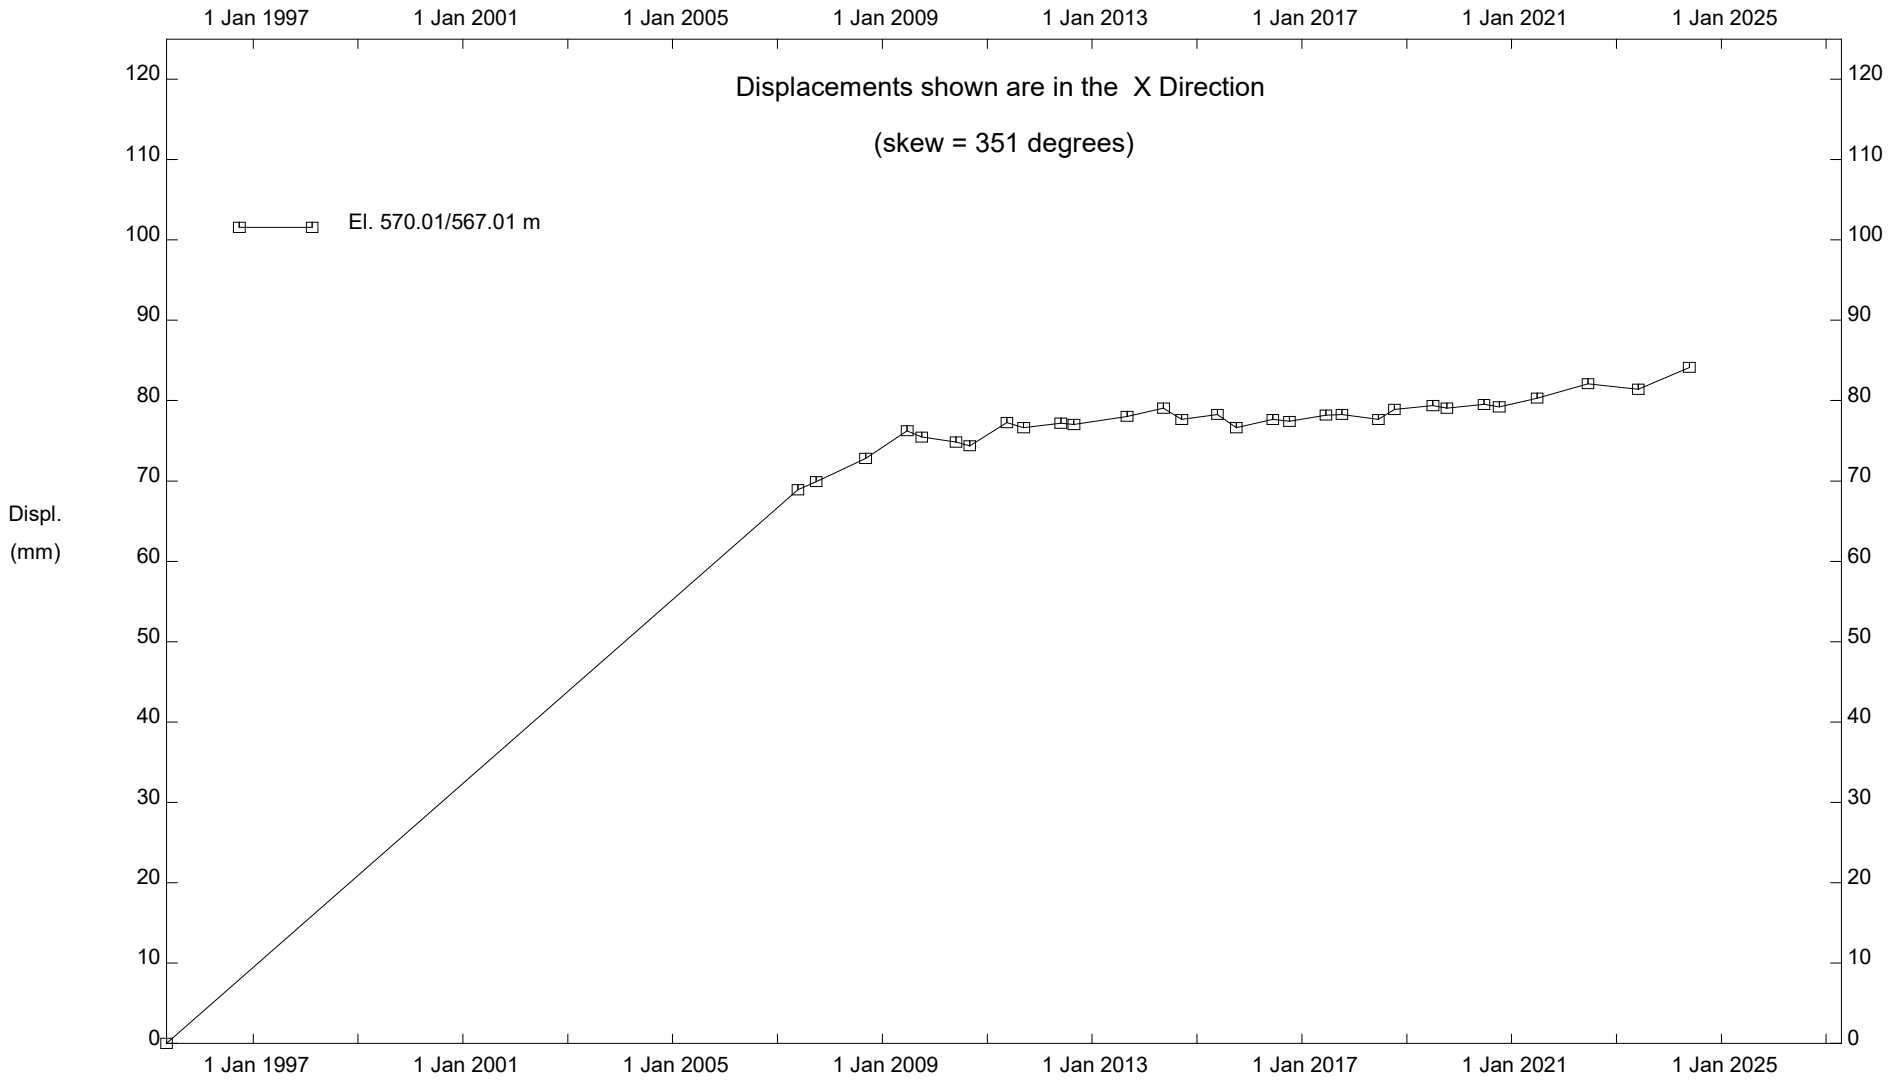
GP016; H666:02 Slide 2 km West of Hwy 40, Inclinometer SI-41

In SI-41, which is installed upslope (south) of the highway at Site 2, distributed movement is being recorded from ground surface to an approximate depth of 2.1 m below ground surface (elevation 570 m to 568 m).

Since June 2009, the rate of movement recorded in SI-41 has been slow (less than 4 mm/year). The pavement distress observed at Site 2 does not appear to be reflected in the data obtained from SI-41, which is installed upslope (south) of the highway.

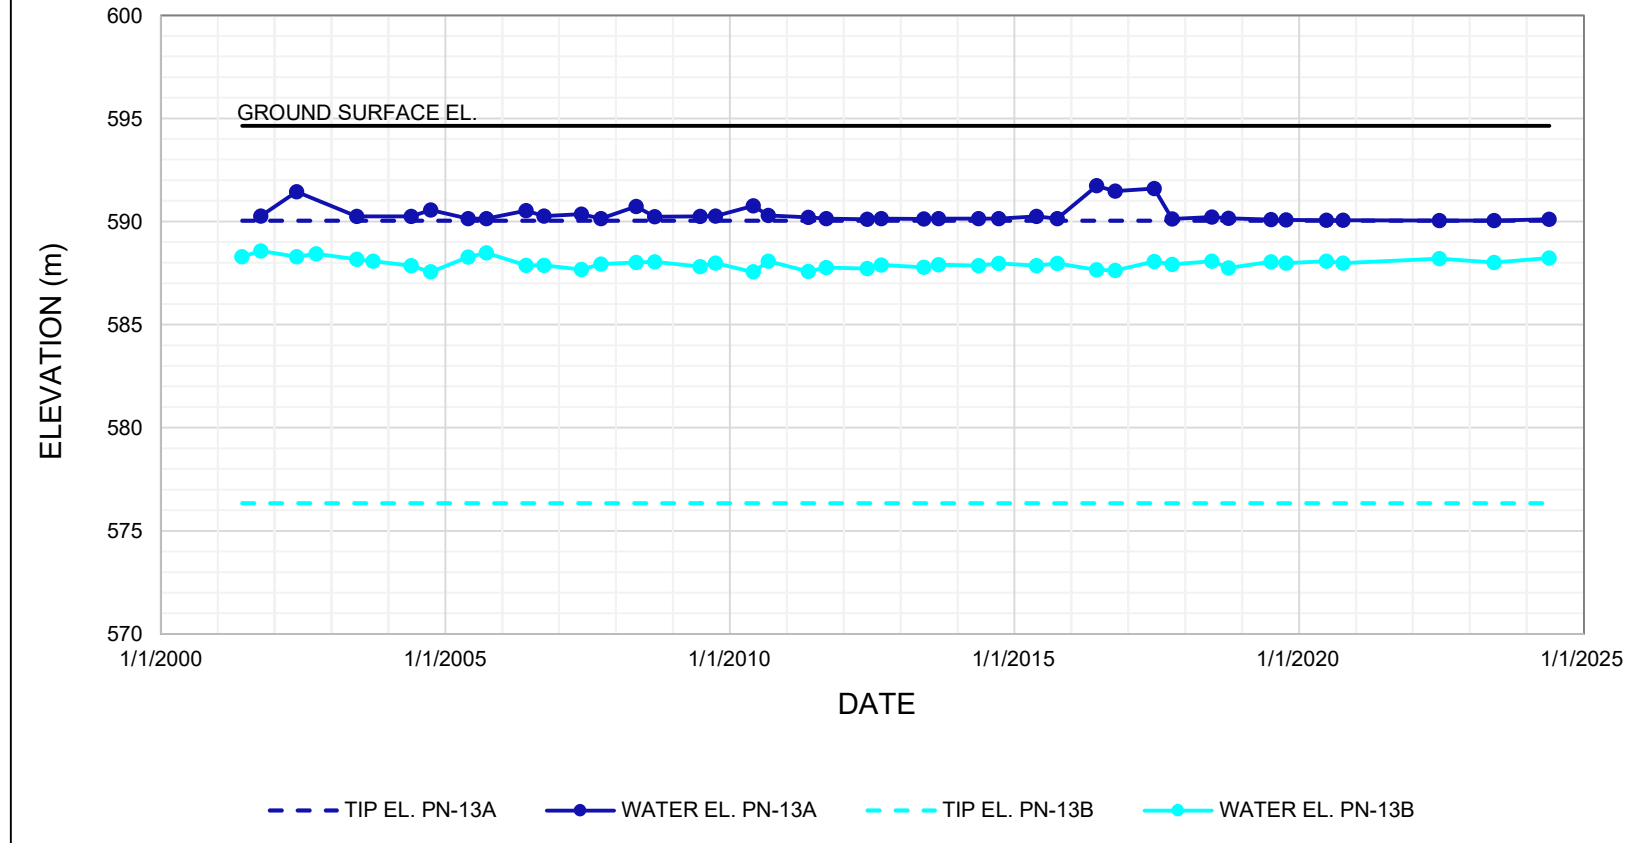
PN-13A and PN-13B

The spring 2024 readings for most of the piezometers (SP14-51, SP14-54, PN-13A, PN-13B, PN-51B, PN52-B, and VW14-55A) are relatively consistent with previous readings for these instruments. Water levels/porewater pressures recorded in these instruments have historically fluctuated, likely in response to seasonal variations in precipitation and freshet infiltration.
