**SITE INSPECTION FORM**

<b>SITE NUMBER AND NAME:</b> GP055 Hwy 674 Embankment Slide North of Sexsmith		<b>HIGHWAY &amp; KM:</b> 674:02, 15.150	<b>PREVIOUS INSPECTION DATE:</b> August 31, 2022	<b>INSPECTION DATE:</b> <b>June 13, 2023</b>
<b>LEGAL DESCRIPTION:</b> SW 03-74-04-W6M	<b>NAD 83 COORDINATES:</b> UTM Northing Easting 11 6137493 403024		<b>RISK ASSESSMENT:</b> PF: 10 CF: 4 TOTAL: 40	
<b>AVERAGE ANNUAL DAILY TRAFFIC (AADT):</b> 1,080 (east) & 540 (west) (Reference No. 29750 and 30730, 2022)			<b>CONTRACT MAINTENANCE AREA (CMA):</b> 504

**PEACE REGION  
(GRANDE PRAIRIE DISTRICT – SOUTH) GRMP**

PROJECT	PEACE REGION (GRANDE PRAIRIE DISTRICT-SOUTH) GEOHAZARD RISK MANAGEMENT PROGRAM	
TITLE	Site Plan GP055 - Slide North of Sexsmith Hwy 674:02, km 15.150	
SCALE	PROJECT No. A05116F01	FIG No. 1

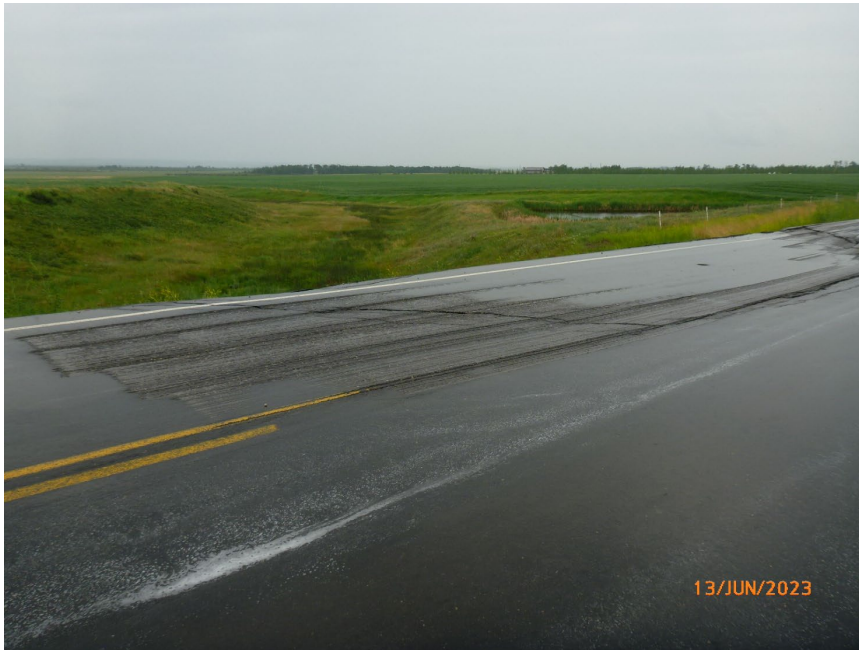
**Photo 1** Cracking and settlement (up to approximately 10 cm) along slide headscarp in south (eastbound) lane of Hwy 674:02. Note pavement was recently milled. Photo taken June 13, 2023, facing southwest.

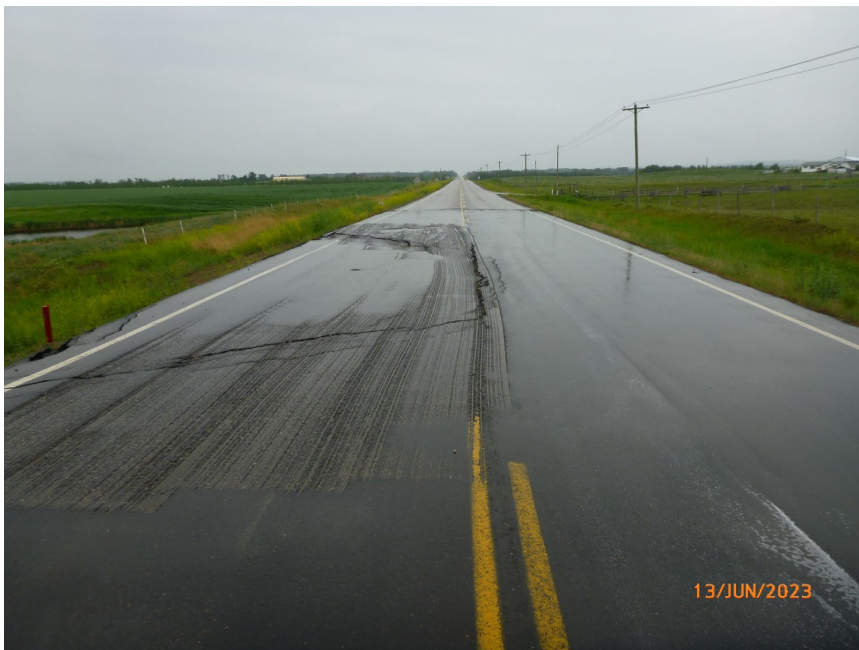
**Photo 2** Cracking and settlement along slide headscarp in south (eastbound) lane of Hwy 674:02. Photo taken June 13, 2023, facing west.

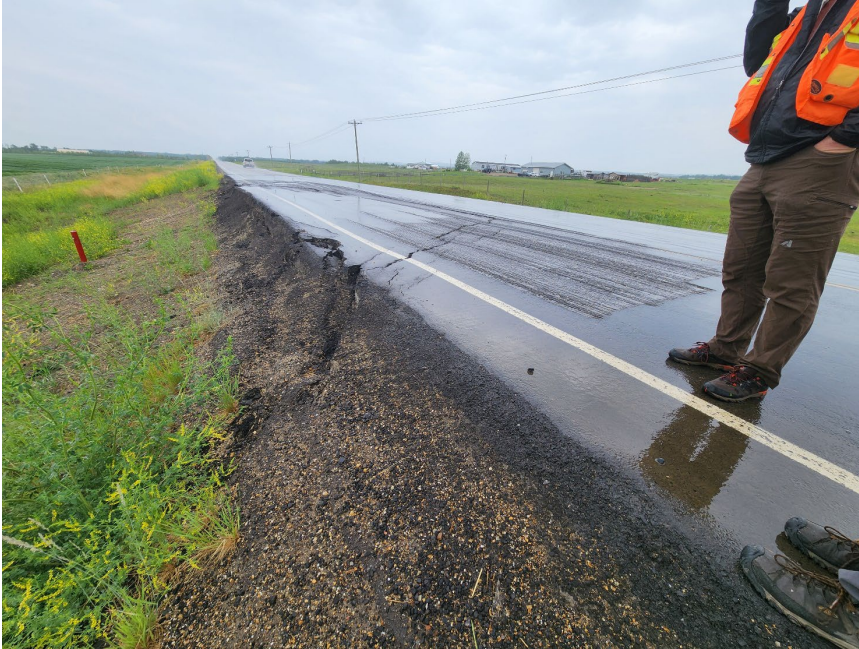
**Photo 3** Cracking and settlement along slide scarp in south (eastbound) lane of Hwy 674:02. Note thickness (up to approximately 0.5 m) and near-vertical edge of exposed pavement. Photo taken June 13, 2023, facing northwest.

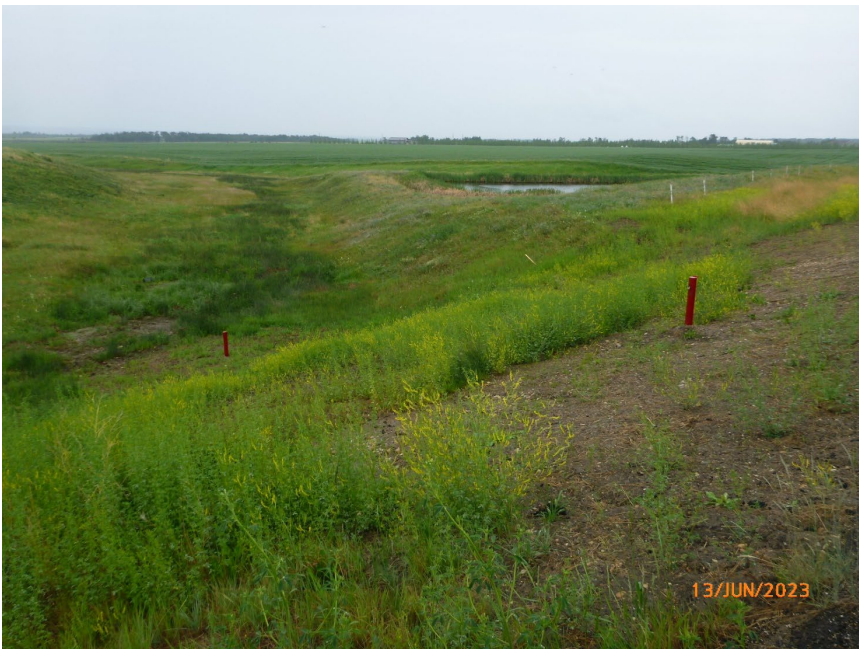
**Photo 4** Slope and toe area of slide on south side of Hwy 674:02 embankment. Note pond water in dug out southwest of highway embankment and slide. Photo taken June 13, 2023, facing southwest.
