**SITE INSPECTION FORM**

<b>SITE NUMBER AND NAME:</b> GP055 Hwy 674 Embankment Slide North of Sexsmith		<b>HIGHWAY &amp; KM:</b> 674:02, 15.150	<b>PREVIOUS INSPECTION DATE:</b> June 13, 2023	<b>INSPECTION DATE:</b> <b>June 11, 2024</b>
<b>LEGAL DESCRIPTION:</b> SW 03-74-04-W6M	<b>NAD 83 COORDINATES:</b> UTM Northing Easting 11 6137500 403034		<b>RISK ASSESSMENT:</b> PF: 10 CF: 5 TOTAL: 50	
<b>AVERAGE ANNUAL DAILY TRAFFIC (AADT):</b> 1,100 (east) & 540 (west) (Reference No. 29750 and 30730, 2023)			<b>CONTRACT MAINTENANCE AREA (CMA):</b> 504

**PRIMARY SITE ISSUE:** Slide in highway embankment fill on south side of Hwy 674:02 due to a high groundwater table that primarily affects eastbound lane of highway. At the site, the highway crosses a low narrow valley (approximately 4 m deep and 10 m wide at base).

PROJECT  
 PEACE REGION (GRANDE PRAIRIE DISTRICT-SOUTH)  
 GEOHAZARD RISK MANAGEMENT PROGRAM

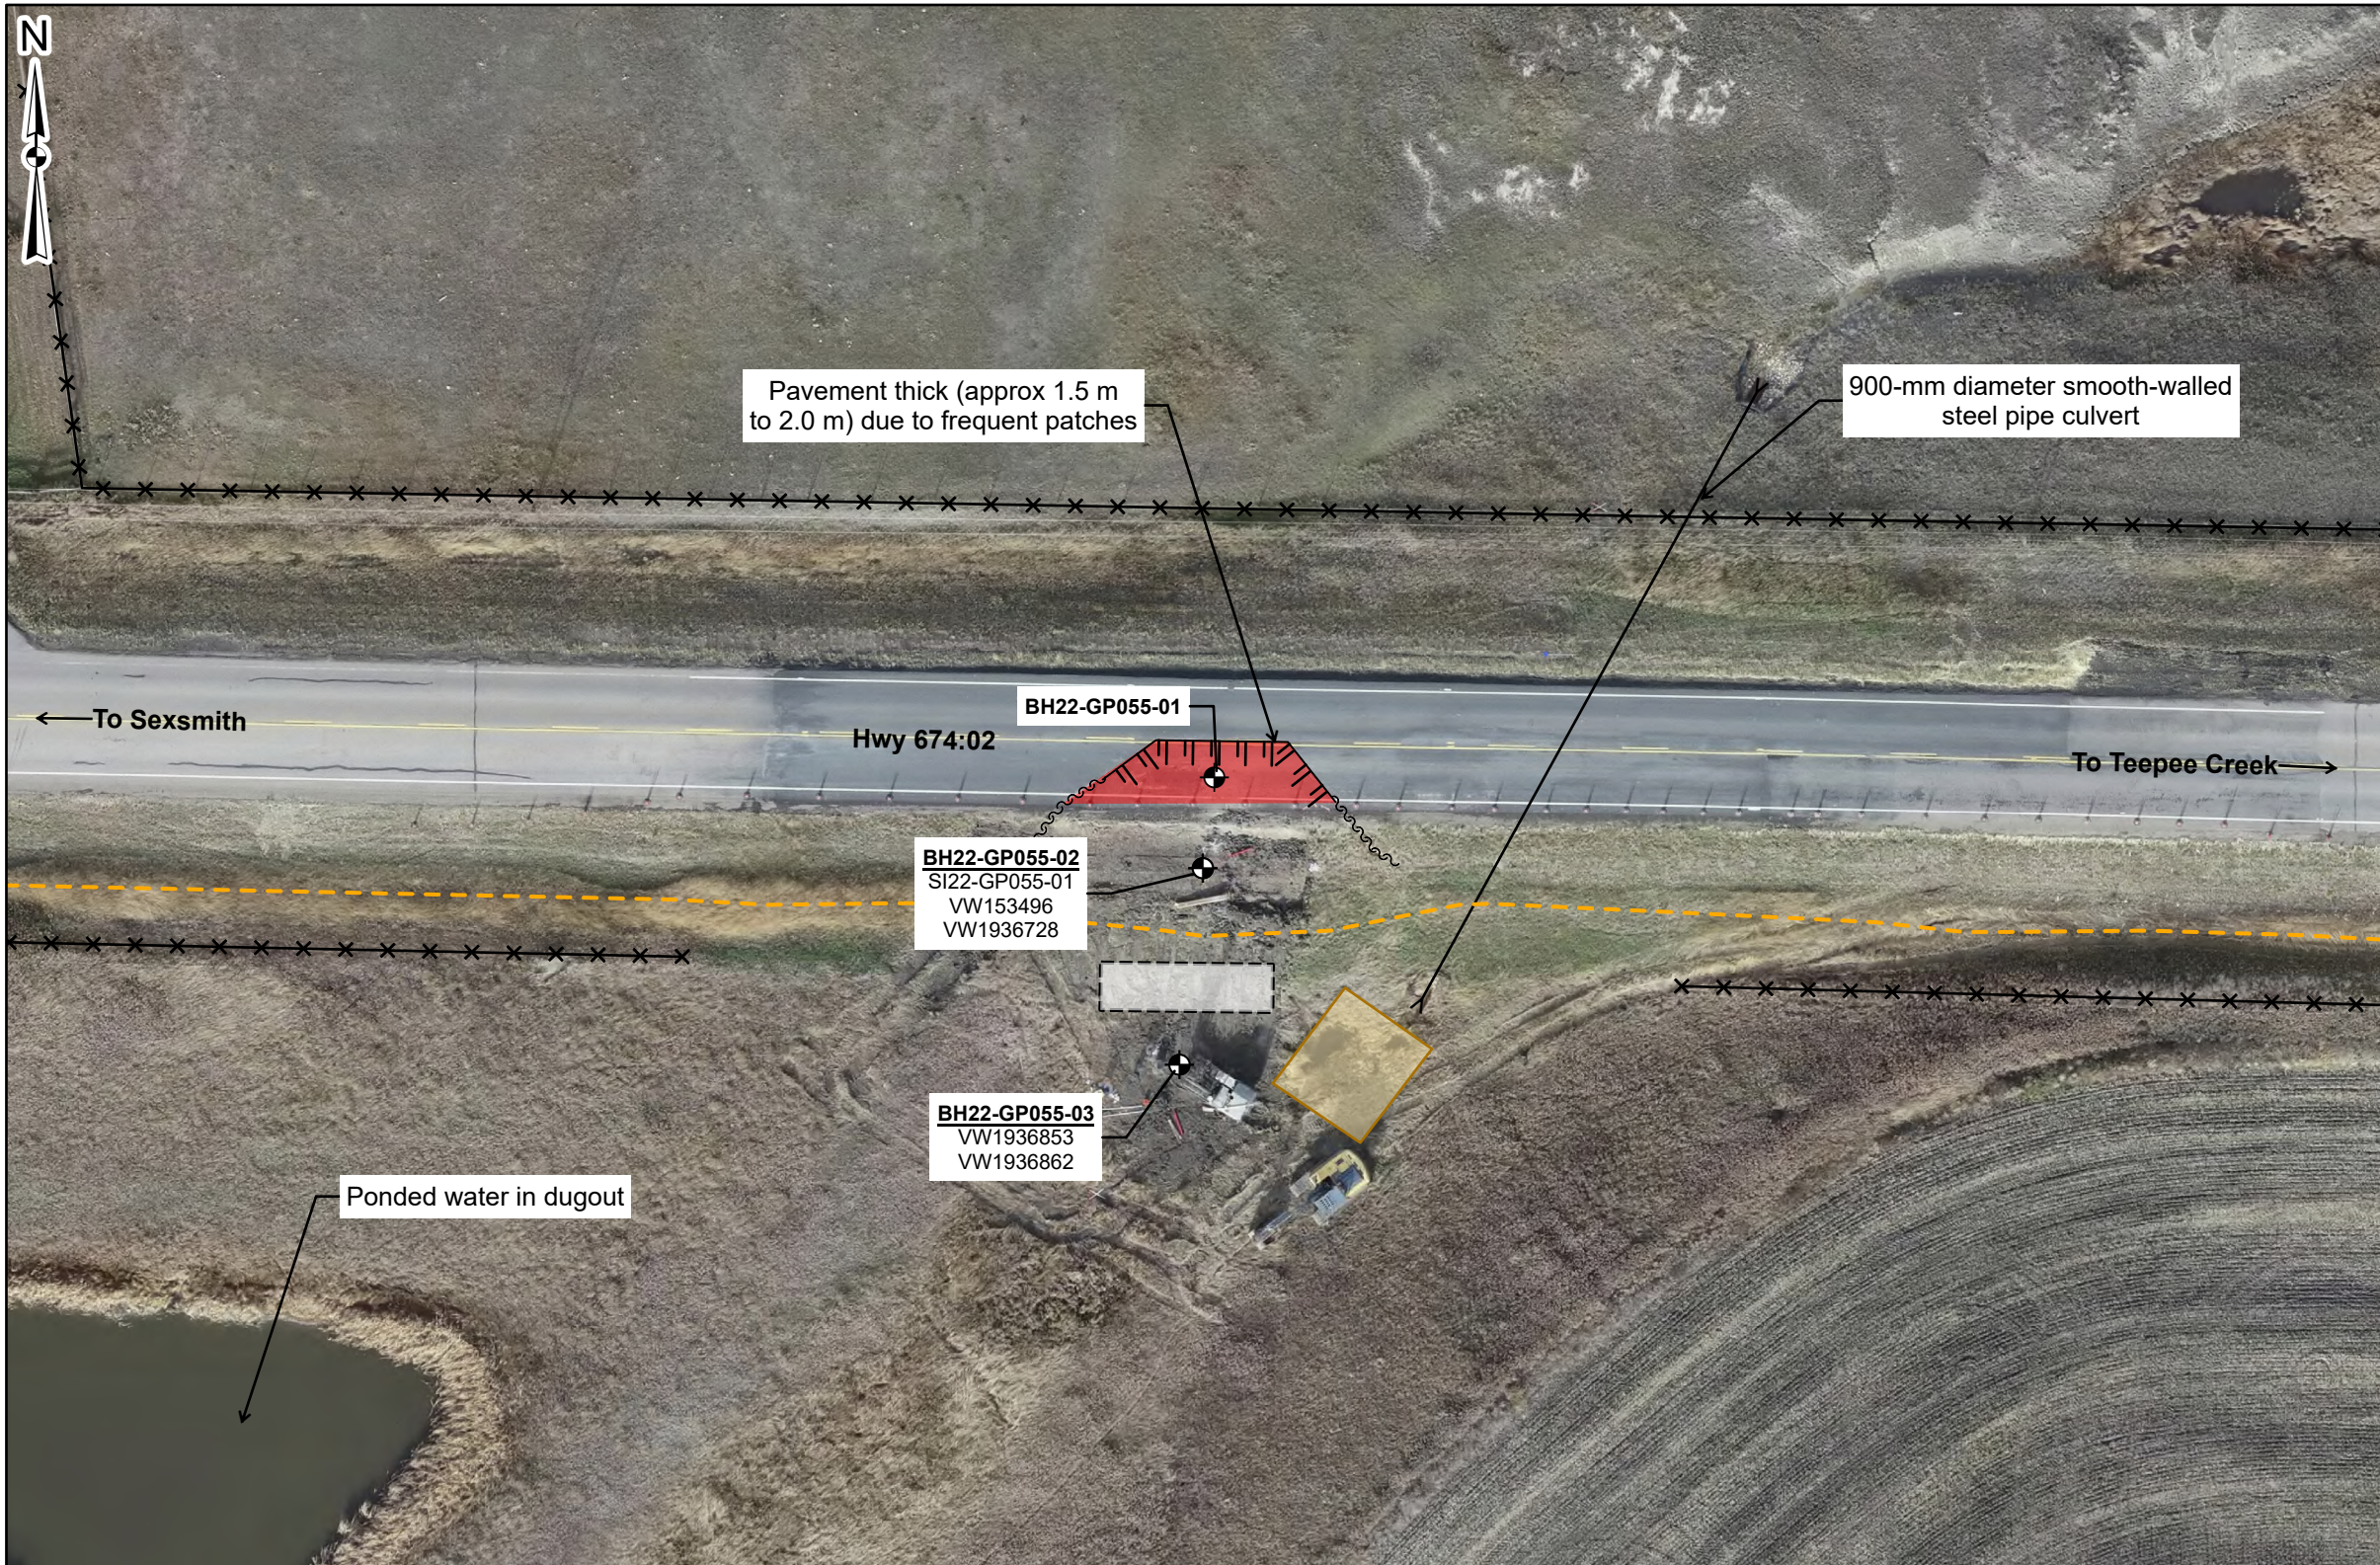
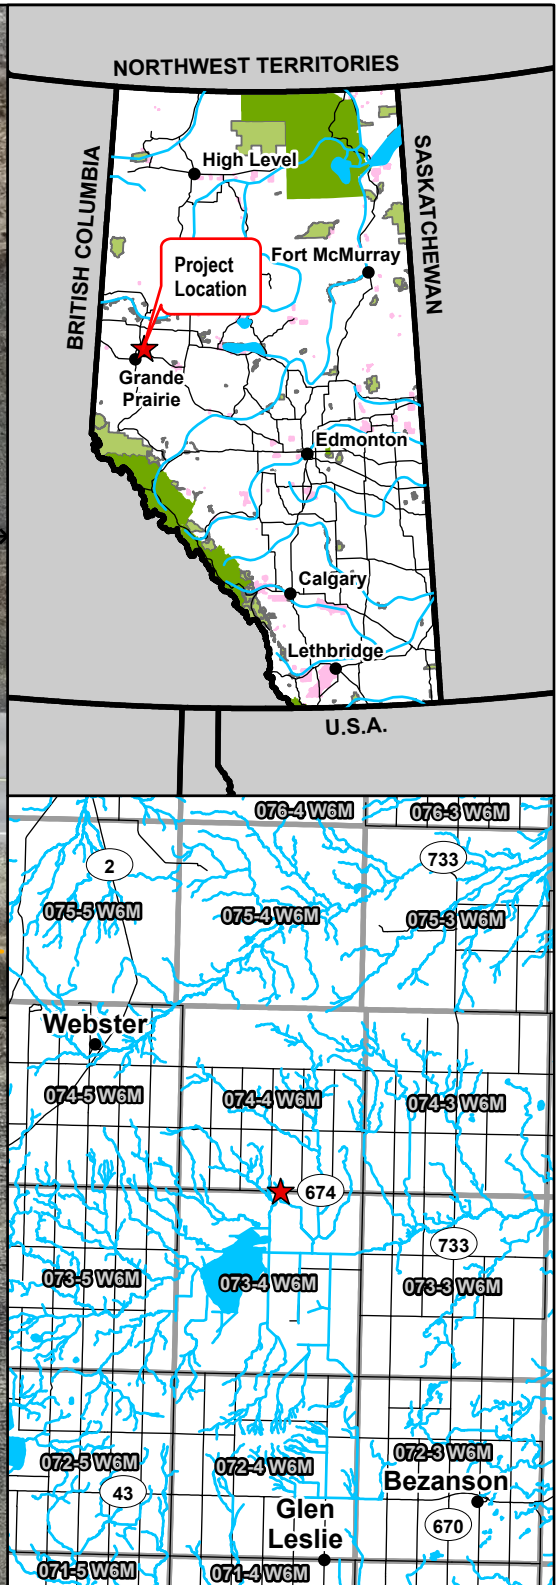
SCALE 1:500 PROJECT No. A05116F01 FIG No. 1

TITLE  
 Site Plan  
 GP055 - Slide North of Sexsmith  
 Hwy 674:02, km 15.150

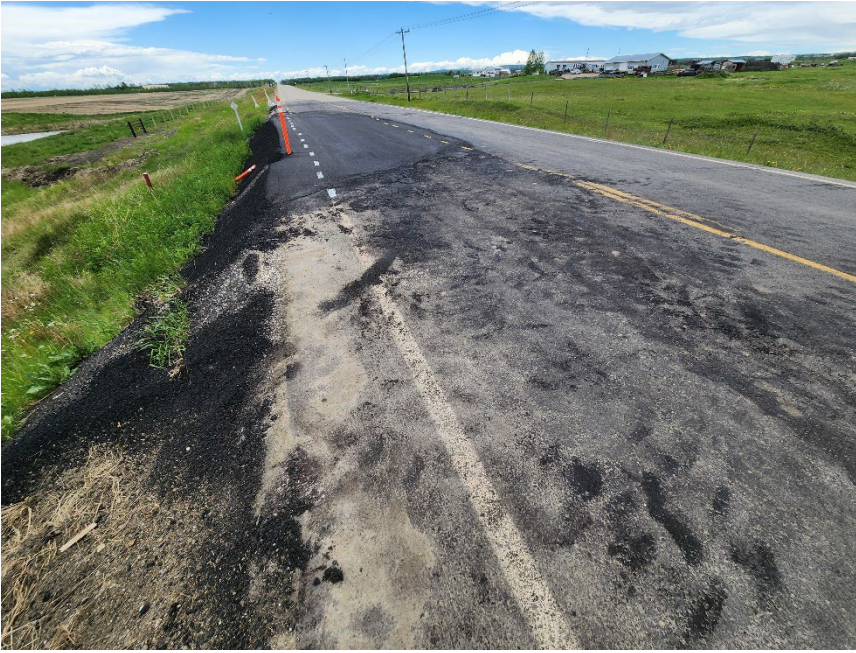
**Photo 1** Cracking and settlement in eastbound lane of Hwy 674:02. Note scarp area was patched last week. Photo taken June 11, 2024, facing northwest

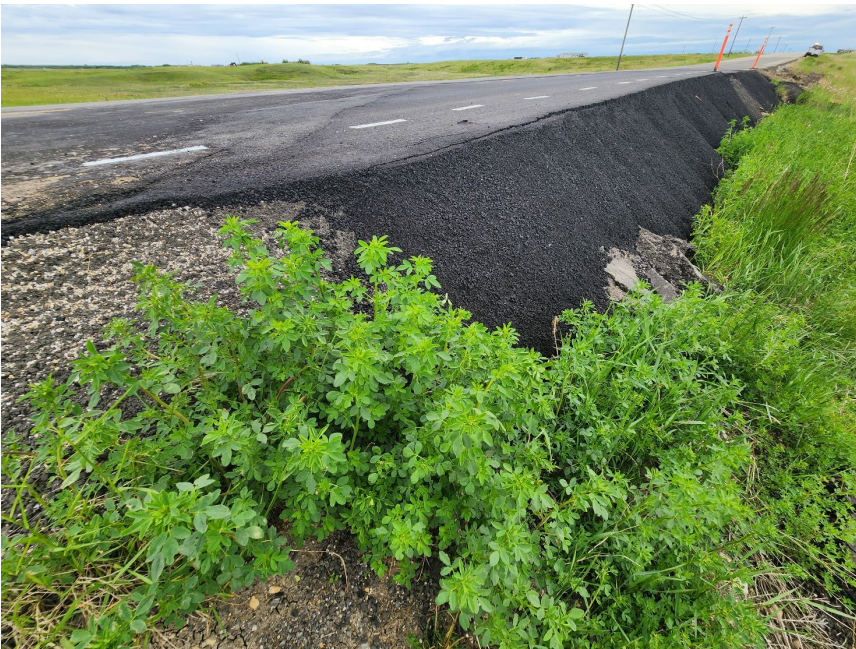
<b>COMMENTS</b>
Pavement is approximately 1.5 m to 2.0 m thick with near-vertical shoulders (Photo 2).
Slide scarp and flanks are well-defined and extend from highway centerline to the eastbound shoulder and down the south slope of the highway embankment to the downstream toe where there is a well-defined toe roll (Photos 1 through 5). Pavement cracks up to approximately 20 mm to 40 mm wide and differential settlement were observed along the slide scarp. The slide scarp has previously been observed in the westbound lane of Hwy 674:02 by the maintenance contract inspector (MCI) between pavement patches. The well-defined slide scarp, flanks, and toe roll indicate the slide has formed a near-complete or complete three-dimensional failure surface which supports observations that the slide has retrogressed past the highway centerline and movements are getting worse with time.
A 900-mm-diameter smooth-walled steel-pipe culvert appears to have been drilled into place on the east abutment of the highway embankment.

**Photo 2** Cracking and settlement in eastbound lane of Hwy 674:02. Note near-vertical edge and height of exposed pavement. Photo taken June 11, 2024, facing northeast.

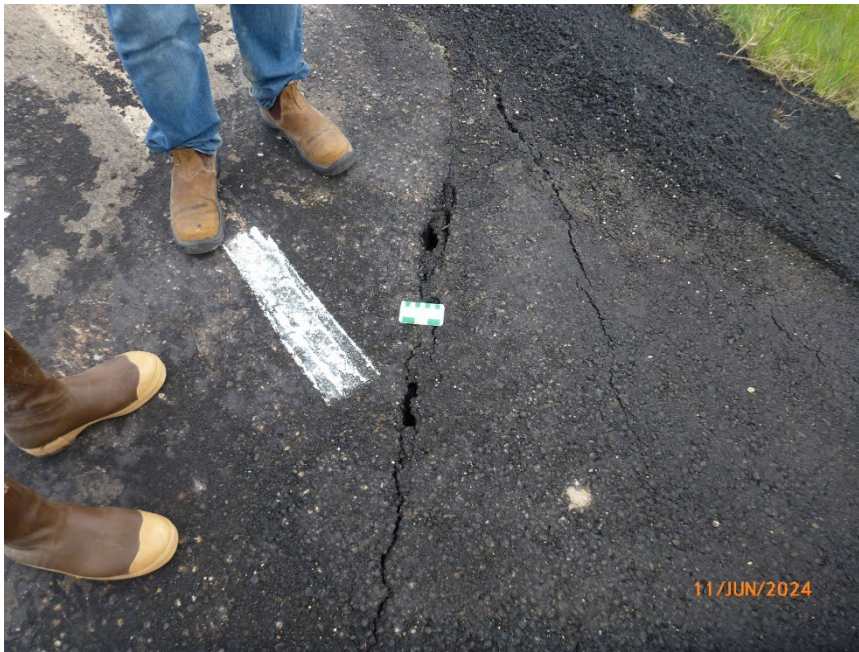
**Photo 3** Cracking in eastbound lane of Hwy 674:02 through recent patch. Photo taken June 11, 2024, facing southeast.

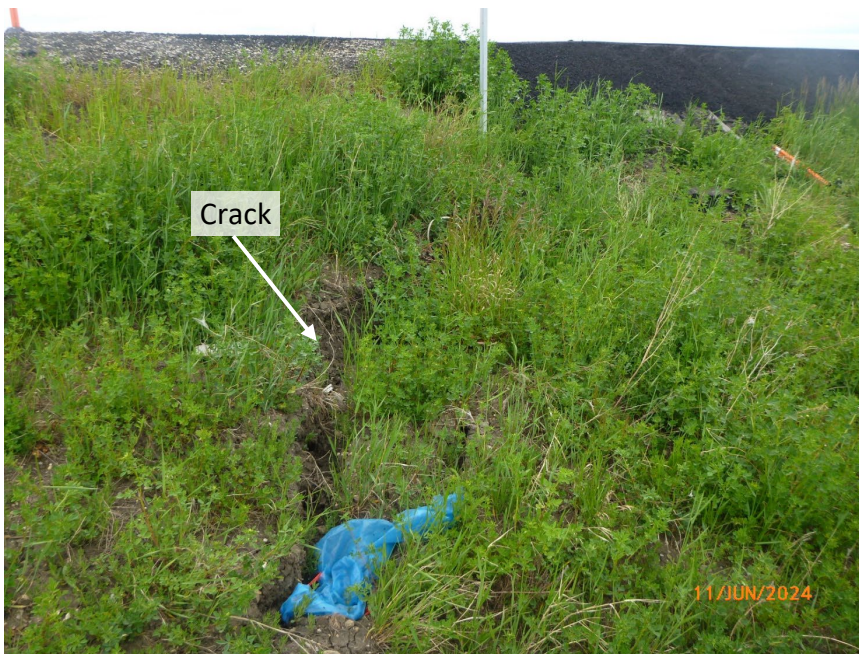
**Photo 4** Cracking along south slope of Hwy 674:02 embankment. Photo taken June 11, 2024, facing north.

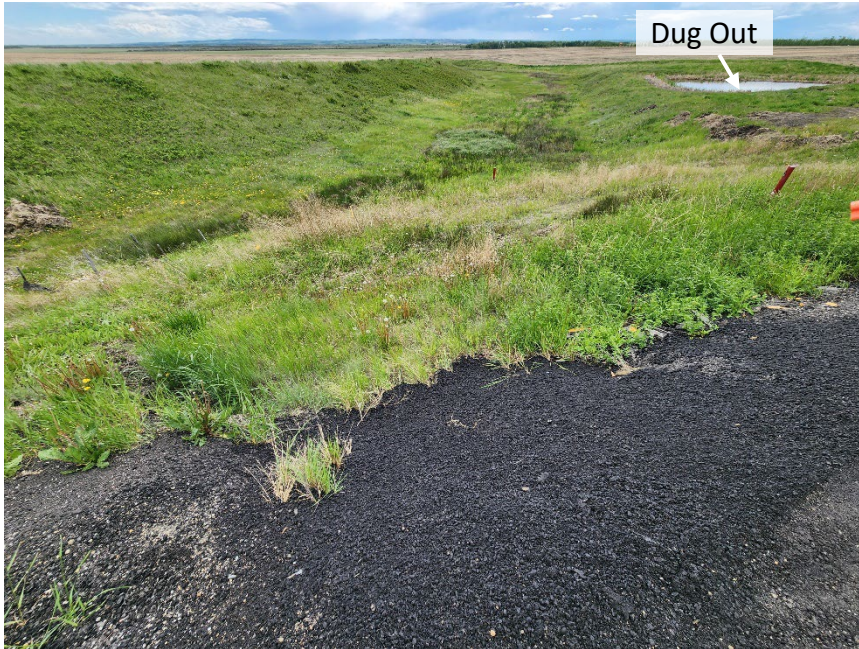
**Photo 5** Slope and toe area of slide on south side of Hwy 674:02. Note pond water in dug out southwest of highway embankment and slide. Photo taken June 11, 2024, facing southwest.

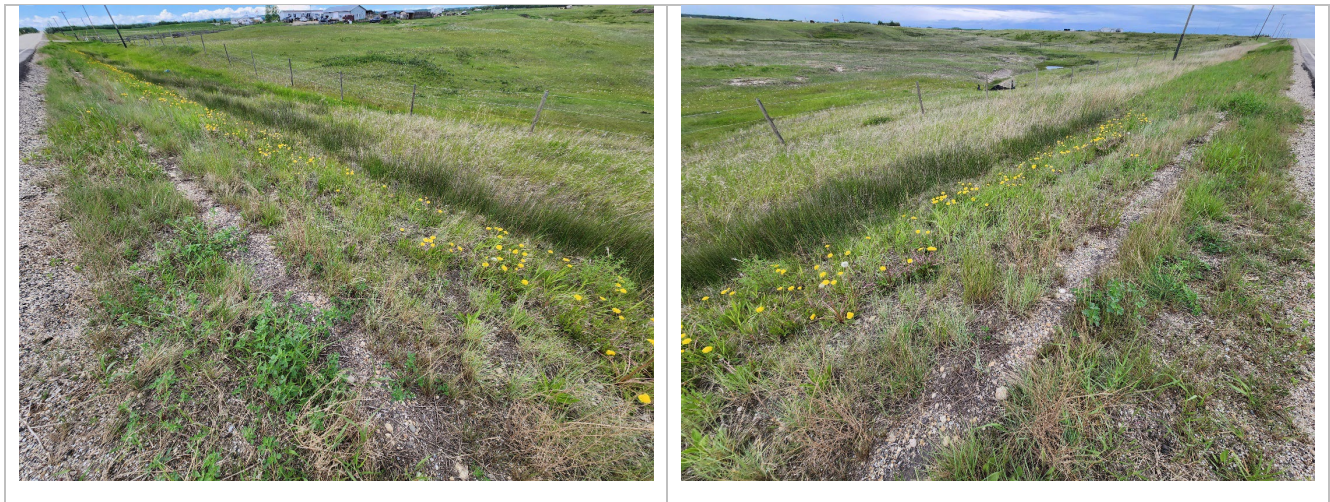
**Photo 6** North side of Hwy 674:02. Photos taken June 11, 2024, facing northwest and northeast, respectively.
