**ALBERTA TRANSPORTATION  
GEOHAZARD ASSESSMENT PROGRAM  
PEACE REGION – GRANDE PRAIRIE DISTRICT  
2020 CALLOUT**

| Call Out 733:02 | NW of Grande Prairie | Kleskun Creek | 733:02 | 14.5 |

| <b>Current Inspection:</b> | May 28, 2020 | 11 | 4 | 44 (Erosion Risk Scale) |

**MAY 28, 2020 CALLOUT PLAN**

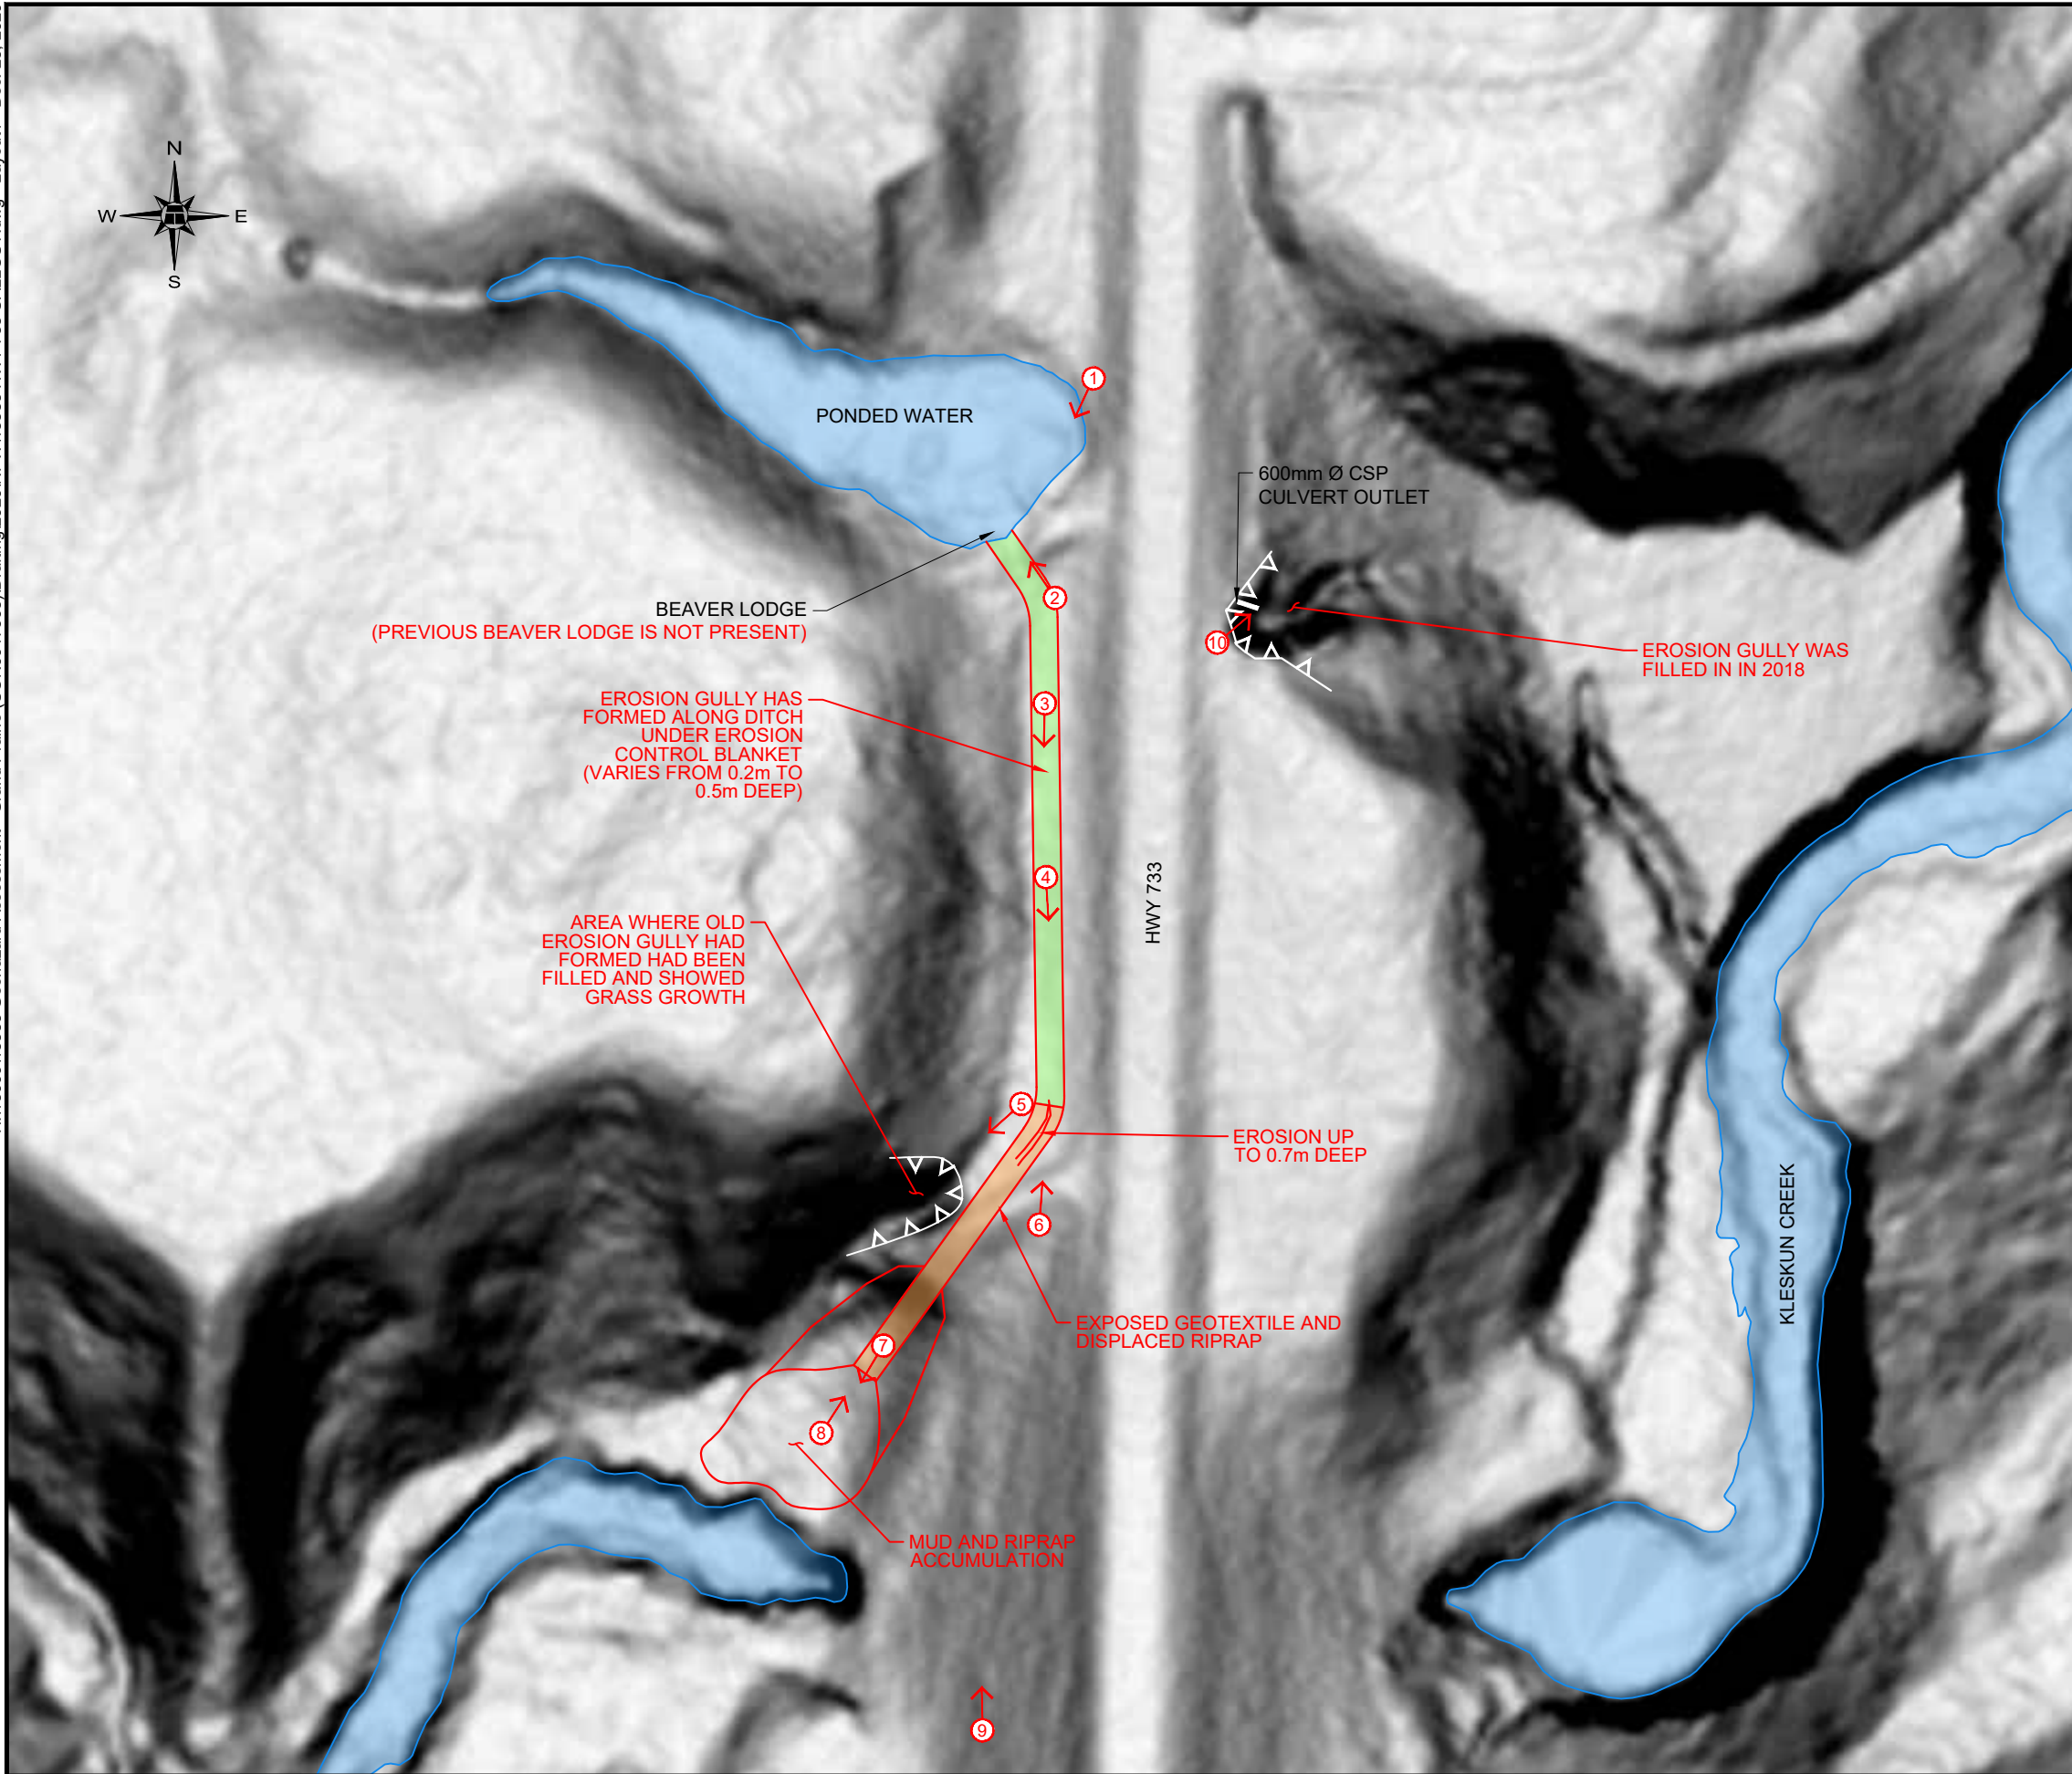
| <b>Primary Site Issue:</b> | The original issue was two erosion areas, one on either side of the highway which had retrogressed towards the highway and created major erosion gullies. The area on the east side of the highway remains in similar condition as after it was repaired. The erosion gullies were repaired by the maintenance contractor in 2018; however, the erosion has reoccurred on the west side of the highway with an erosion channel paralleling the highway and becomes worst near the area where it was previously repaired. | | |
| <b>Dimensions:</b> | The erosion on the east side of the highway was about 15 m wide and ~35 m long to the toe on the east side of the highway; but was filled in in 2018. The erosion that has reoccurred on the west side of the highway is approximately 1 m wide and about 80 m long then widens to about 12 m wide further south where debris has accumulated near Kleskun Creek about 70 m in length diagonally from the highway. | | |

| <p>A hydrology study is recommended, to assess flows, and to determine the size of erosion resistant surfacing that is required in the west highway ditch. The base of the channel will need to be re-established with well compacted clay and it is likely that the ditch size will need to be enlarged and the ditch lined with hard armouring over its entire length. The upper flatter section could likely be lined with 0.23 m thick gabion mattress while the lower section would likely need to be lined with a series of stepped gabions or thicker anchored gabion mattress draining into a rock lined dissipation bowl.</p> | | |

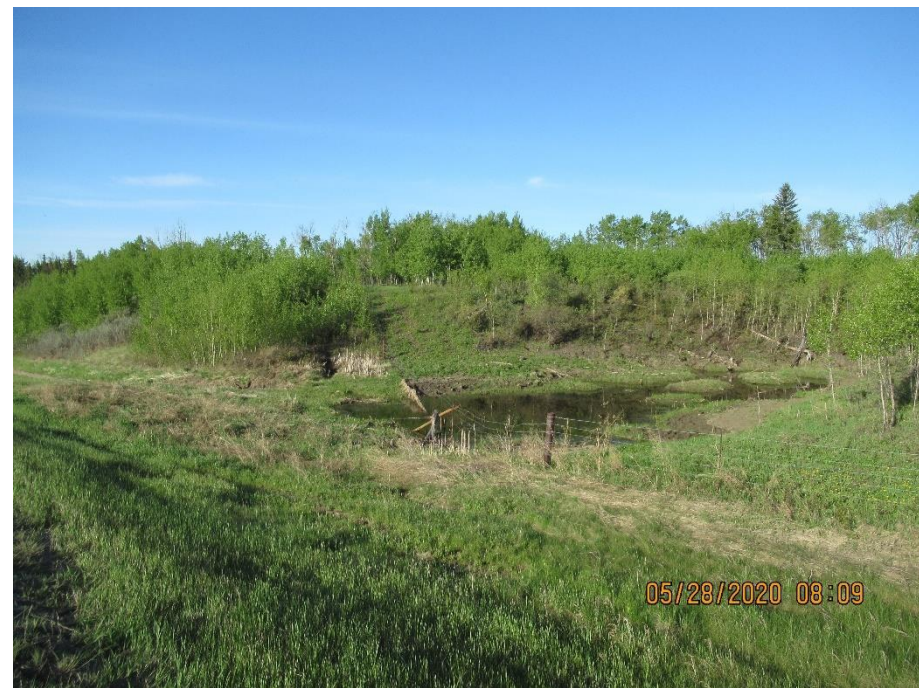
**Photo 1.**  
Looking southwest  
at ponded water  
west of the  
roadway where  
there was  
previously a beaver  
lodge.

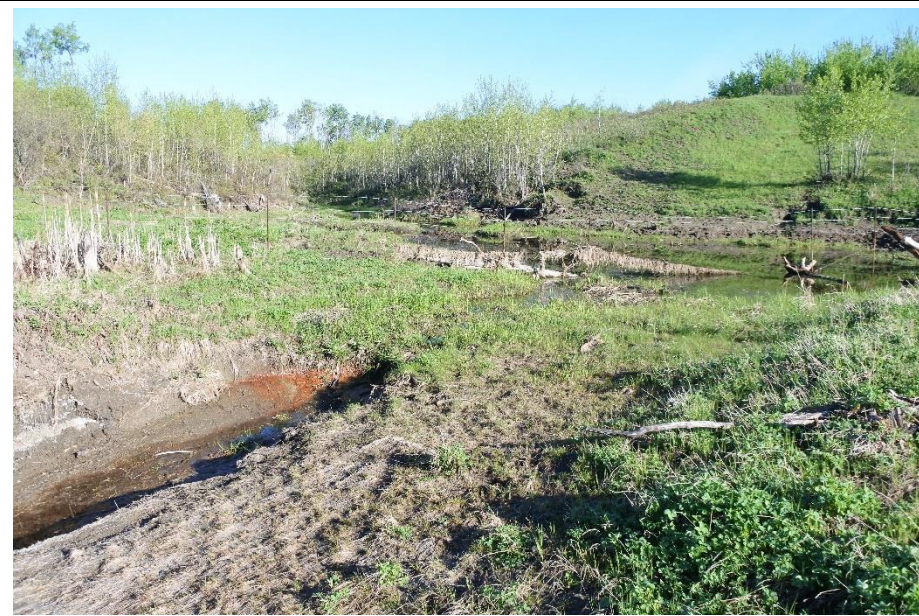
**Photo 2.**  
Looking northwest  
at upstream end of  
eroded channel.

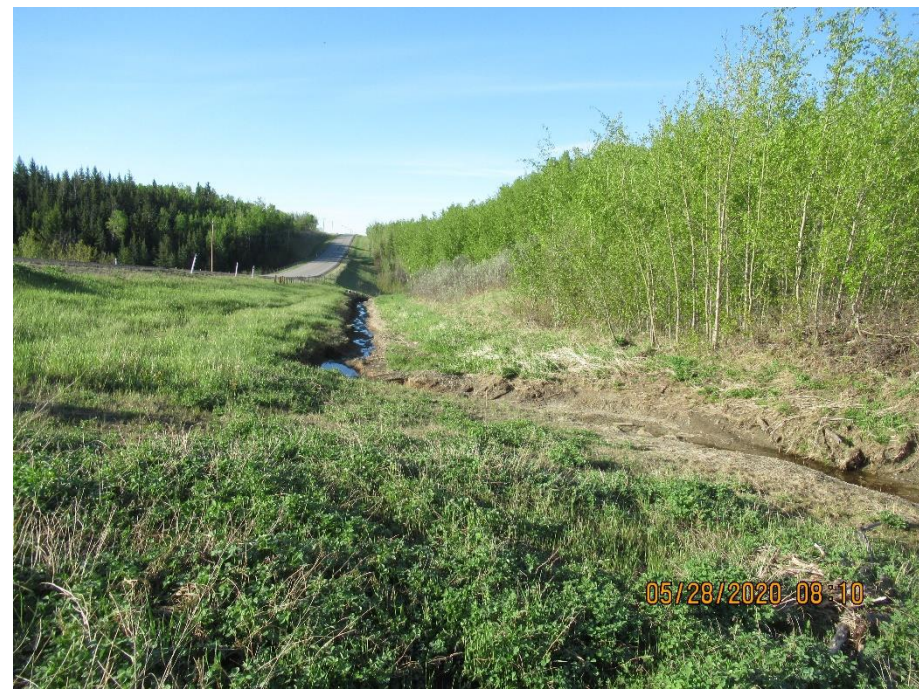
**Photo 3.**  
Looking south at eroded ditch along straw and coconut matting in west ditch.

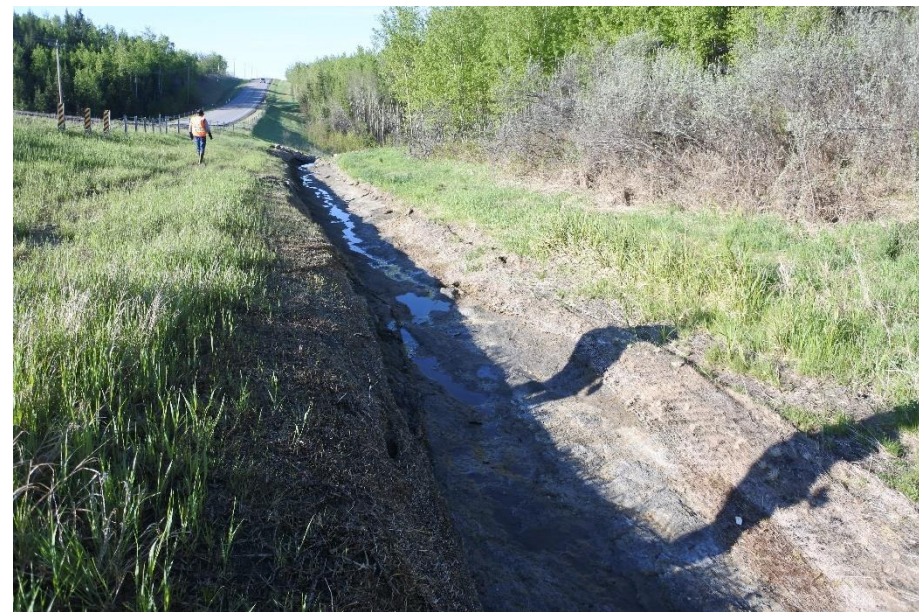
| <input checked="" type="checkbox"/> Erosion | Erosion has reoccurred within the remediated area on the west side of the highway following a high spring snow melt runoff event. The southwest ditch has been undermined below the straw and coconut matting and runoff has eroded the rip rap swale and exposed the non-woven geotextile in some areas with mud and riprap debris accumulating near the toe of the highway embankment adject to the creek. The previous erosion gully on the northeast appeared in good condition since the repair. | <input checked="" type="checkbox"/> | |

**Photo 4.**  
Looking south at erosion gully has undermined the straw and coconut matting in west ditch.

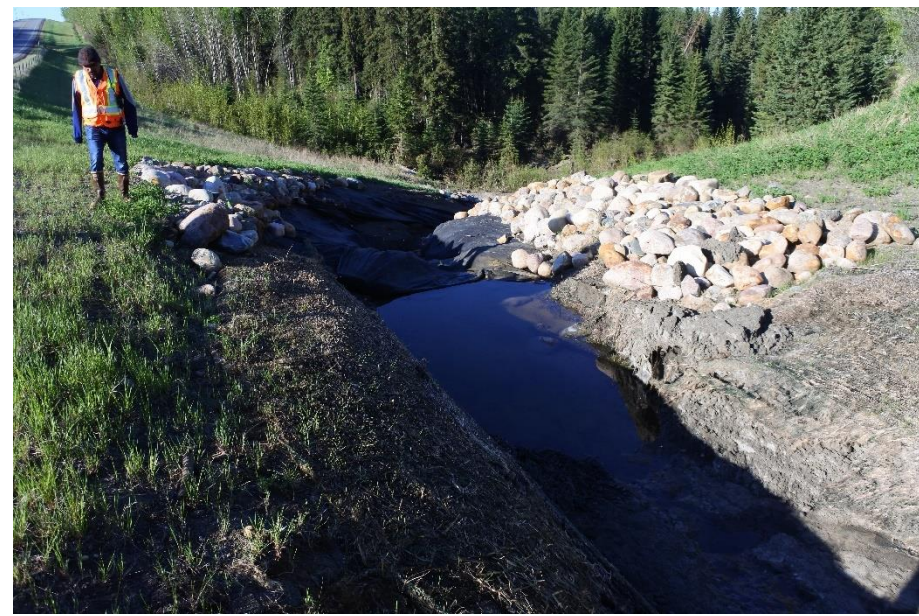
**Photo 5.**  
Looking southwest at point where flatter ditch lined with ECB meets the steeper ditch lined with rip rap. Not the extensive erosion at the curve transition.

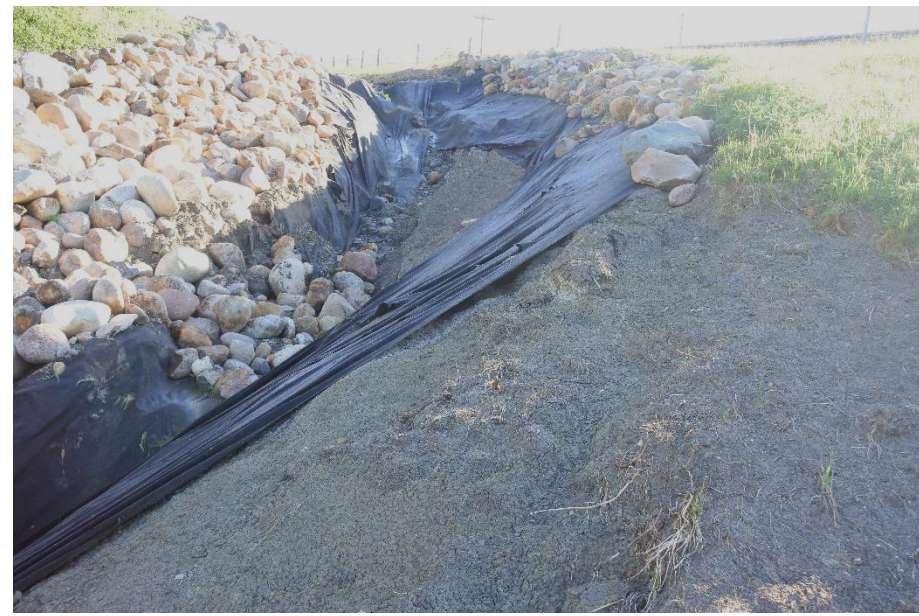
**Photo 6.**  
Looking north at reinforced swale that was constructed during the 2018 repair which has been eroded and the non-woven geotextile has been exposed.

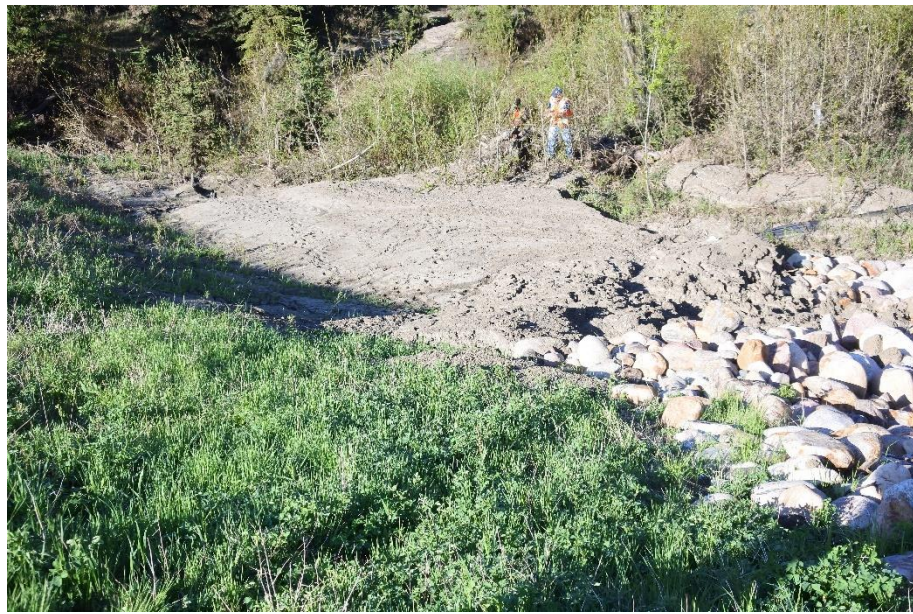
**Photo 7.**  
Looking southwest at the accumulation of mud and silt near the toe of the embankment slope above the creek.

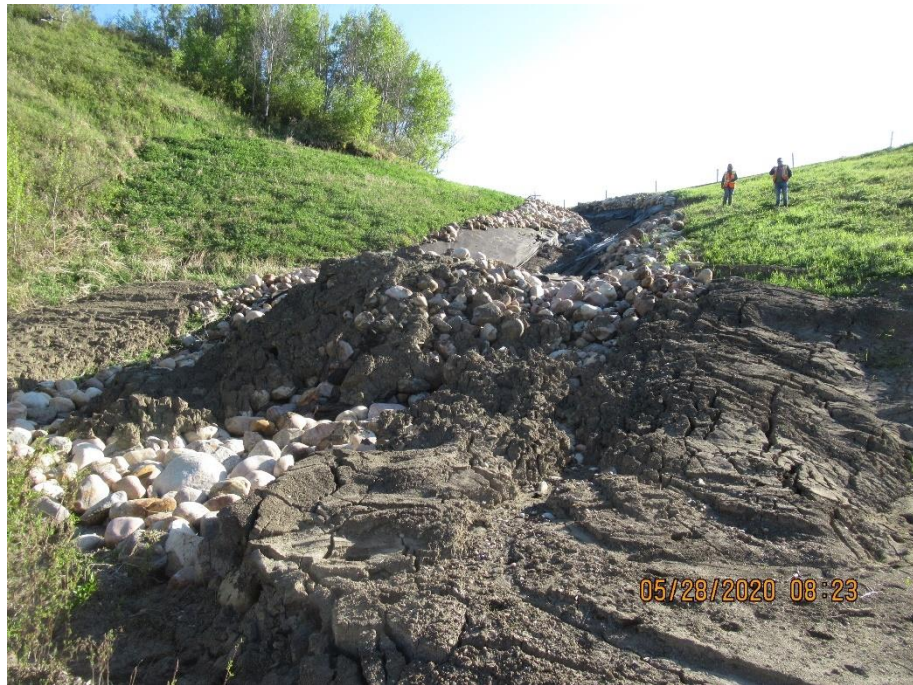
**Photo 8.**  
Looking northeast at the swale and debris accumulation near the toe of the embankment slope. The grassed area to the left was where the previous erosion gully had been filled in.

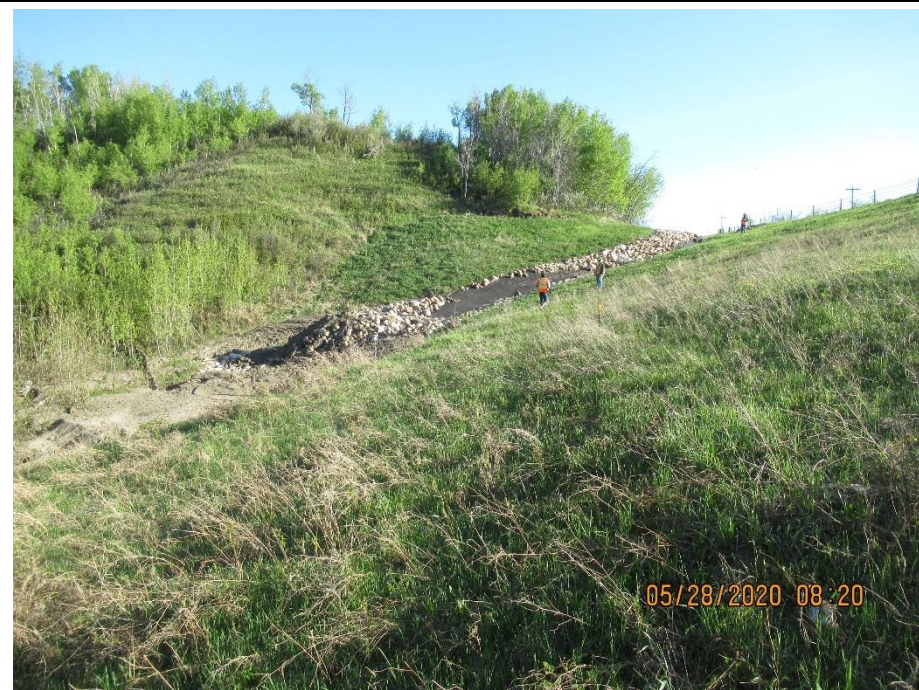
**Photo 9.**  
Looking north at the swale and debris accumulation pile below the area that had the previous erosion gully filled in.

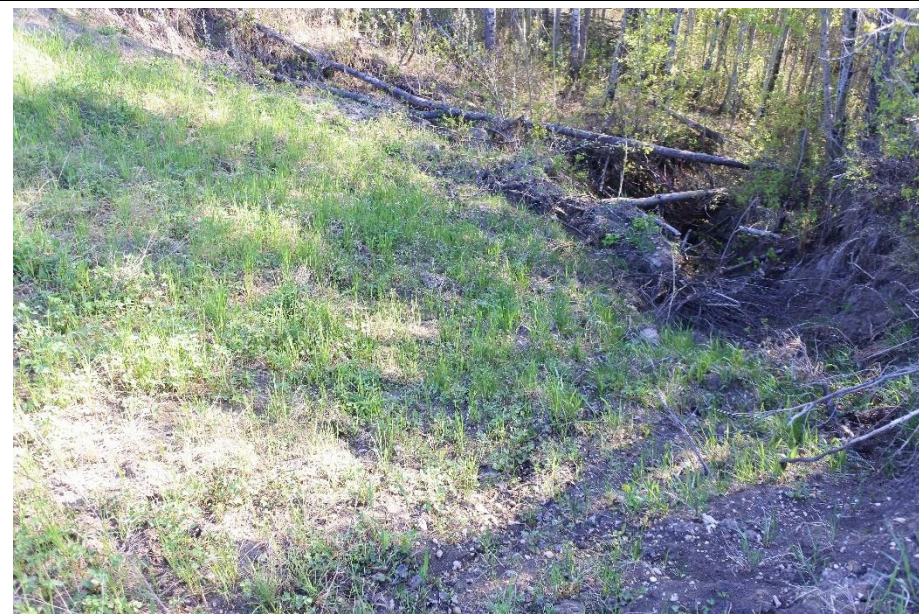
**Photo 10.**  
Looking northeast where the previous scarp had formed on the east side and was filled in in 2018.
