**PEACE REGION  
(GRANDE PRAIRIE DISTRICT – SOUTH) GRMP**

**SITE INSPECTION FORM**

<b>SITE NUMBER AND NAME:</b> GP048 Kleskun Creek Erosion		<b>HIGHWAY &amp; KM:</b> 733:02, 14.506	<b>PREVIOUS INSPECTION DATE:</b> June 16, 2022	<b>INSPECTION DATE:</b> <b>June 11, 2024</b>
<b>LEGAL DESCRIPTION:</b> SE 33-73-03-W6M	<b>NAD 83 COORDINATES:</b> UTM Northing Easting 11 6135882 412217		<b>RISK ASSESSMENT:</b> PF: 9 CF: 6 TOTAL: 54	
<b>AVERAGE ANNUAL DAILY TRAFFIC (AADT):</b> 940 (north) & 940 (south) (Reference No. 30730, 2023)			<b>CONTRACT MAINTENANCE AREA (CMA):</b> 504

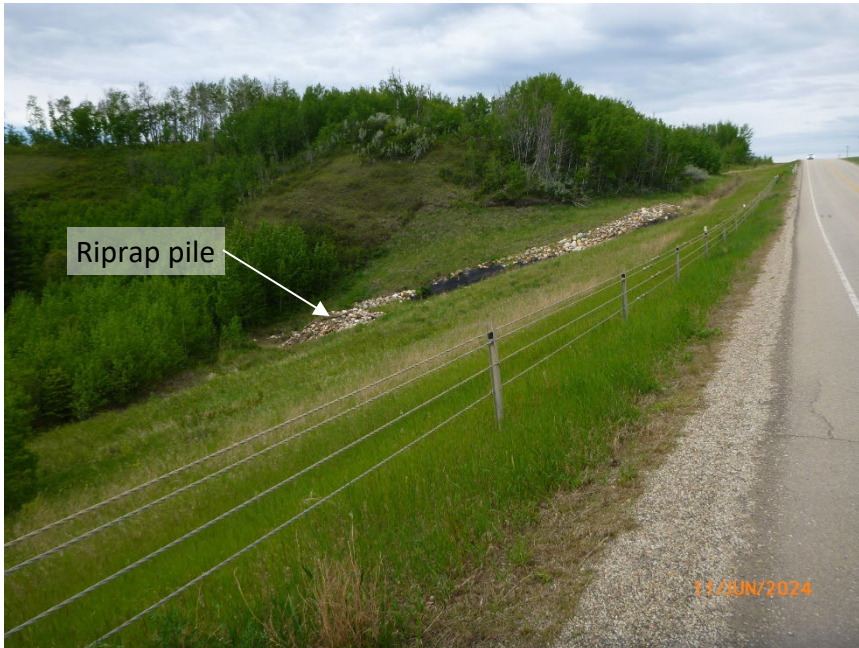
Almost all riprap from the previously riprap-lined portion of the ditch channel has been displaced and deposited in a pile near the bottom of the ditch channel exposing the underlying geotextile, which is damaged (Photos 1 to 3). Riprap appears to have failed because the riprap is undersized. The non-woven geotextile also appears to have been undermined, which could have been initiated by lower flows passing below the non-woven geotextile causing erosion of the subgrade.

**Photo 1** Overview of GP048 site on west side of Hwy 733:02. Note displaced riprap deposited in pile near bottom of ditch channel. Photo taken June 11, 2024, facing northwest.

- KCB has prepared a repair design for the site, which includes replacing the riprap-lined channel with a gabion basket drop structure, and re-shaping and backfilling areas of erosion in the west highway ditch with check trenches. The repair is tentatively scheduled for 2025 and is expected to take two to four weeks to complete. Estimate cost: approximately \$300,000 to \$400,000.
  - High-tension-cable barrier (HTCB) is located too far downslope from the highway and may not redirect motorist back onto highway (Photo 4). TEC should consider moving HTCB during repair work.

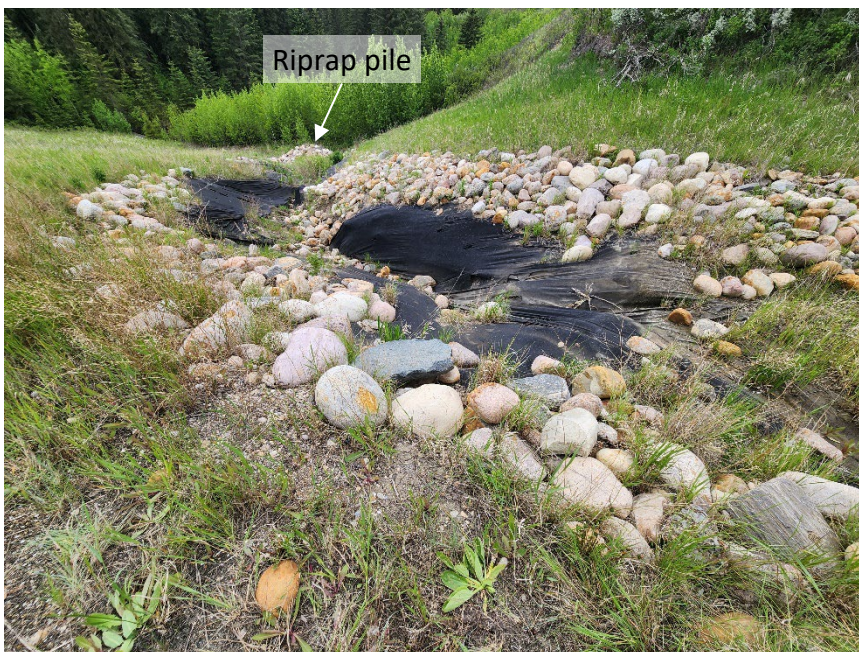
**Photo 2** Displaced riprap deposited in pile near bottom of ditch channel. Note exposed geotextile is damaged and undermined. Photo taken June 11, 2024, facing southwest.

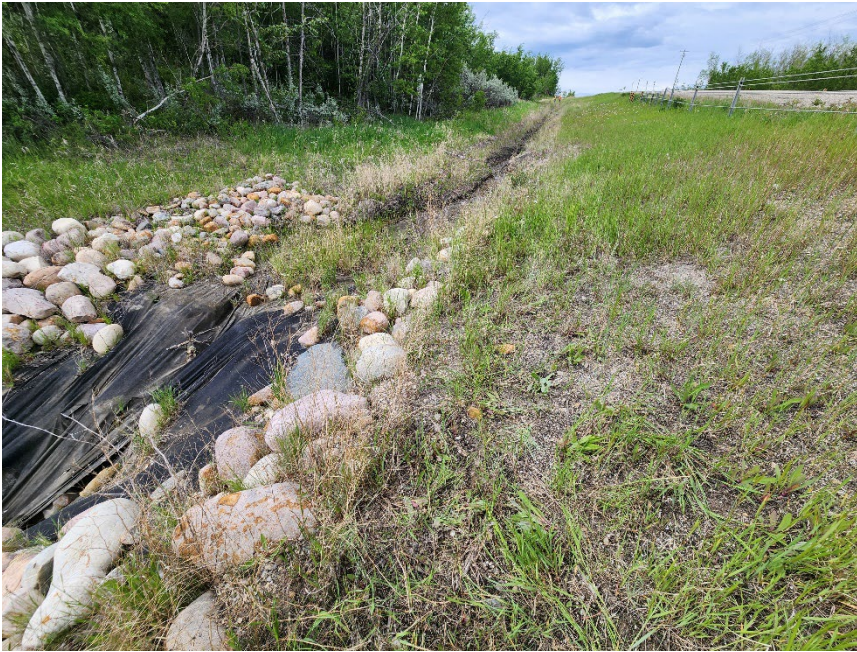
**Photo 3** Channel eroded into bottom of ditch channel on west side of Hwy 733:02. Photo taken June 11, 2024, facing north.

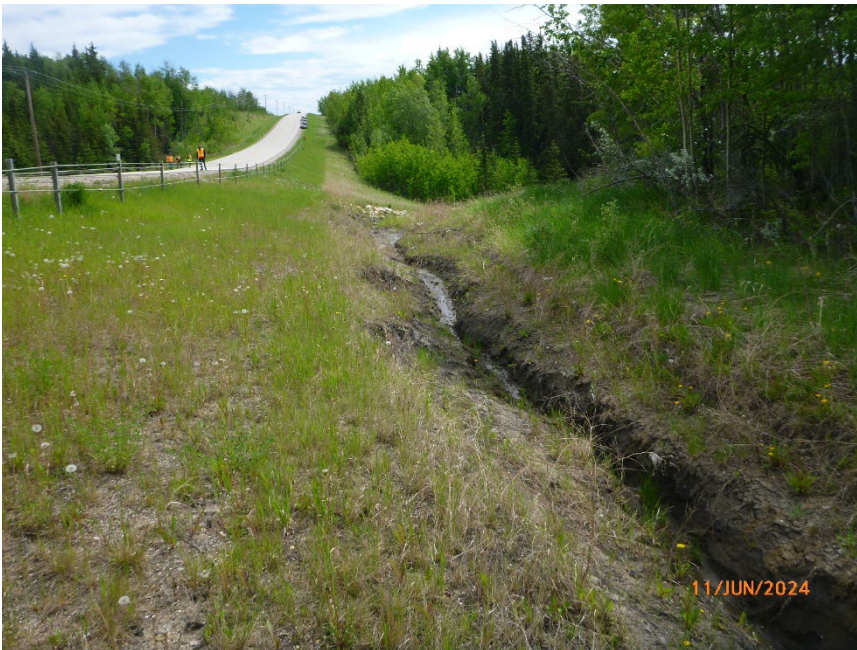
**Photo 4** Channel eroded into bottom of ditch channel on west side of Hwy 733:02. Note guardrail located downslope of pavement edge. Photo taken June 11, 2024, facing south.
