**ALBERTA TRANSPORTATION
GEOHAZARD ASSESSMENT PROGRAM
PEACE REGION – SWAN HILLS DISTRICT
2020 CALL OUT INSPECTION**

Site Number	Location	Name	Hwy	km
Call Out – GP052	North of Debolt	Puskwaskau River Slide	736:02	27.1
Legal Description		UTM Co-ordinates (NAD 83)		
NW26-74-1-W6		11U N 6,144,288	E 434,543

Date	PF	CF	Total
Previous Inspection:				
Current Inspection:	May 30, 2020	13	5	65
Road AADT:	130	Year:		2019
Inspected By:	Don Proudfoot, Nicole Wilder (Thurber) Ed Szmata, Rishi Adhikari (AT)			
Report Attachments:	<input checked="" type="checkbox"/> Photographs <input checked="" type="checkbox"/> Plans <input type="checkbox"/> Maintenance Items

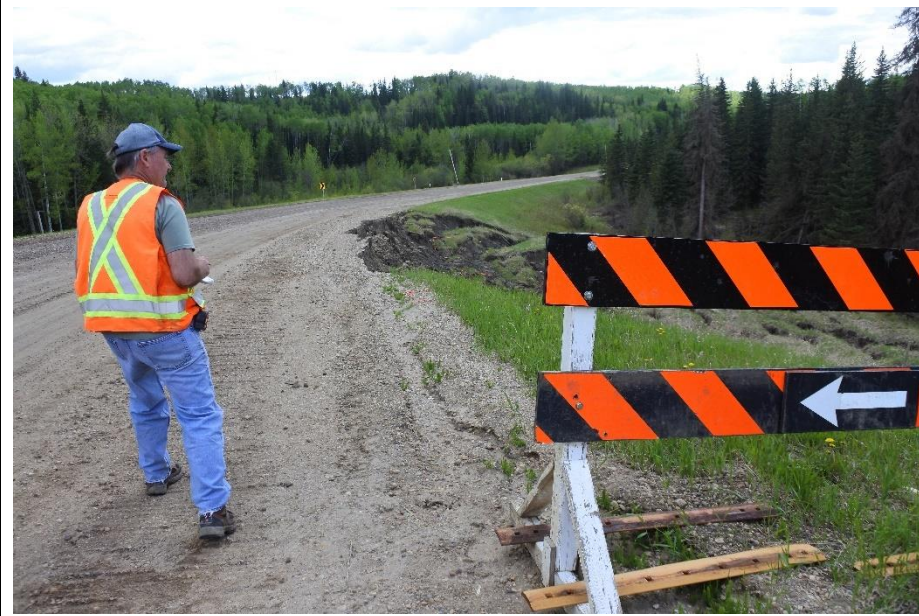
Primary Site Issue:	Landslide with a 5 m high backscarp in embankment fill on northwest side of highway which is now cutting into road edge.		
Dimensions:	The slide is about ~20 m long by 40 m wide and there is an overly steepened bank along the Puskwaskau River which has been eroded.		
Date of any remediation:			
Maintenance:			
Observations:	Description	Worse?	
<input checked="" type="checkbox"/> Pavement Distress	The main scarp has retrogressed into the highway and a portion of the southbound lane has slid away.	<input type="checkbox"/>	
<input checked="" type="checkbox"/> Slope Movement	The landslide occurred within the west sideslope of a 13 m high embankment fill, adjacent to an oxbow. The toe roll is present at the base of the slope encroaching into the oxbow, while the backscarp has retrogressed into the highway. On the south side of the highway an overly steep riverbank has been eroded and has sloughed into the river causing it to retrogress towards the highway.	<input type="checkbox"/>

There was damage to the highway as the backscarp had retrogressed into the highway and there was relatively fresh sloughing and moist/wet soil within the slide mass, which was marked with many small tension cracks and tears further downslope within the slide mass, along with free ponding of water in a couple low lying tears.

It is anticipated that the slide was triggered by water seepage and weathering leading to loss of cohesion in the embankment fill. Weak high plastic clay embankment materials along with excessive precipitation leading to a rise in groundwater level may also have contributed to causing the slide. The main scarp of the active landslide has retrogressed into the highway which may soon require partial closure of the highway.

Photo 1.
Looking southwest
at main scarp from
the road.

In the short term, the slide should be regularly monitored for regression of the slide scarp. The southbound lane may need to be closed if retrogression continues and more signage/barricades placed.

Sub-excavate the failed slide mass down to intact foundation soil and rebuild the slope with imported pit run gravel with layers of geogrid. The excavation for the gravel wedge would likely need to extend to about the east shoulder of the highway, requiring a depressed detour on the east slope, however this should be confirmed by the slope stability assessment. The new fill material should be placed and compacted in thin horizontal lifts, benched into the intact slope surface, utilizing a gravel shear key (if required) to stabilize the slide area. Some of the more suitable excavated clay material could be used to provide a clay cap overtop the gravel as the finished slope surface to shed runoff, with any excess removed from site. A subdrain should be installed along the base of the slide excavation to drain any subsurface water that may enter the new fill zone.

An alternate option would be to construct a toe berm within the oxbow/marsh area and rebuild the slope above the berm with granular fill to an inclination of 3H:1V or flatter. A subdrain should be installed along the base of the slide excavation to drain any subsurface water that may enter the new fill zone. To complete work in the wetland area, a Water Act application and a WAIR will be required.

A third option consists of installing two h-pile walls parallel to one another and the highway downslope of the backscarp and armouring the toe area with rip rap.

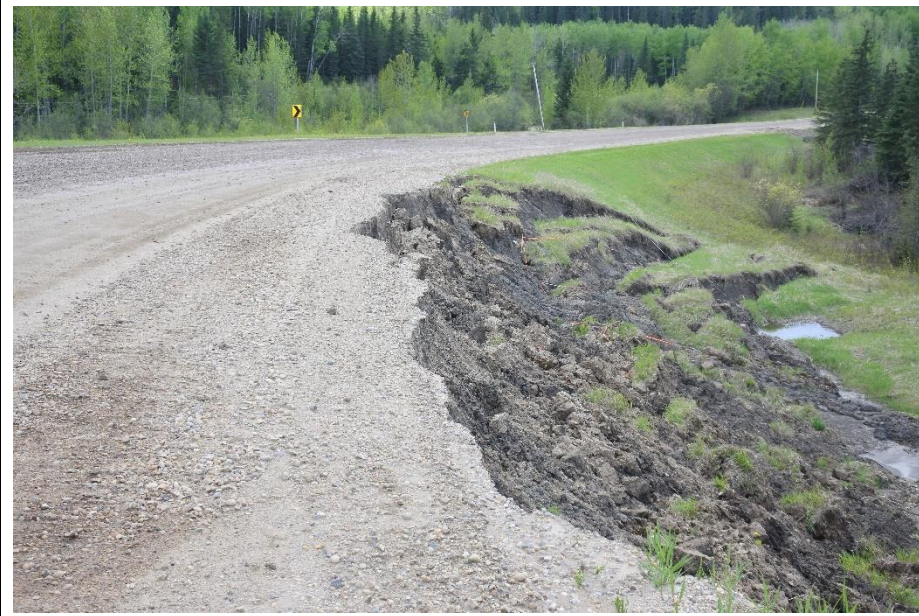
Photo 2.
Looking southwest
at the back scarp
which has
retrogressed into
the highway.

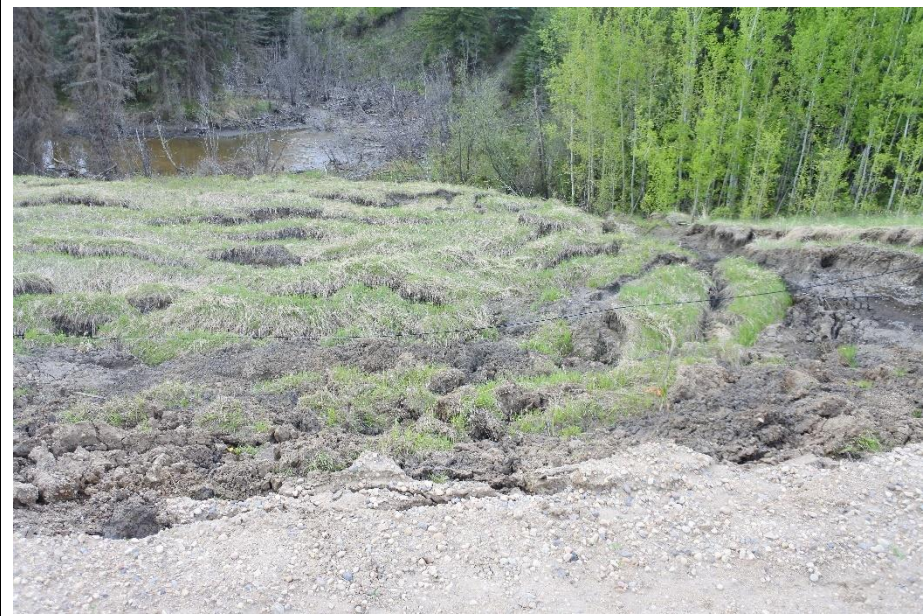
Photo 3.
Looking west down
at failed slide mass.

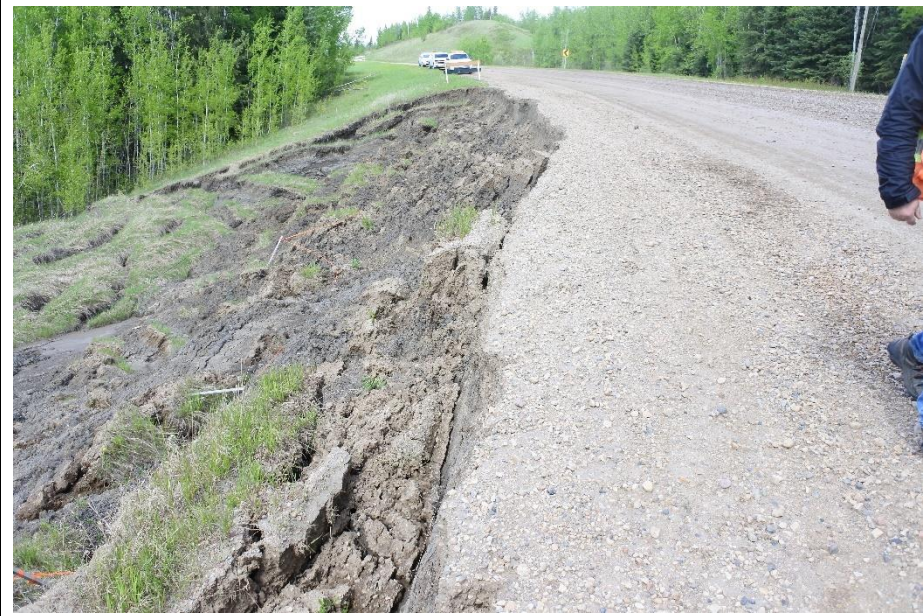
Photo 4.
Looking northeast
at back scarp.

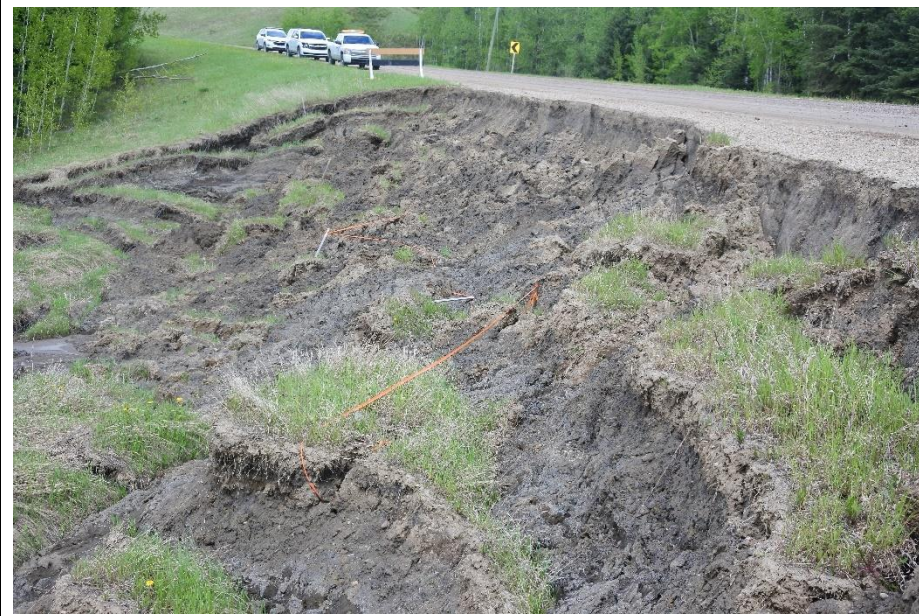
Photo 5.
Looking east at
back scarp and
destroyed Telus
line.

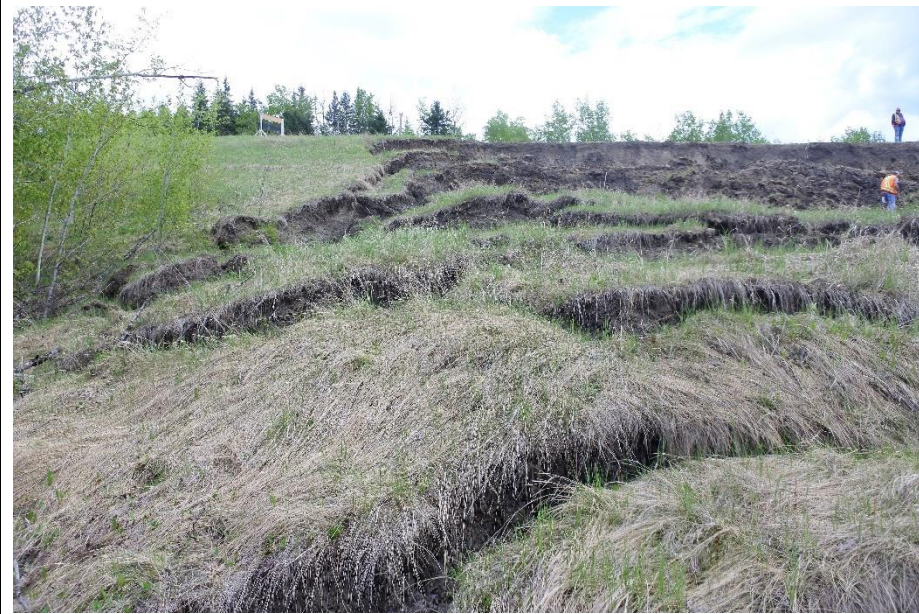
Photo 6.
Looking southeast
up slide mass.

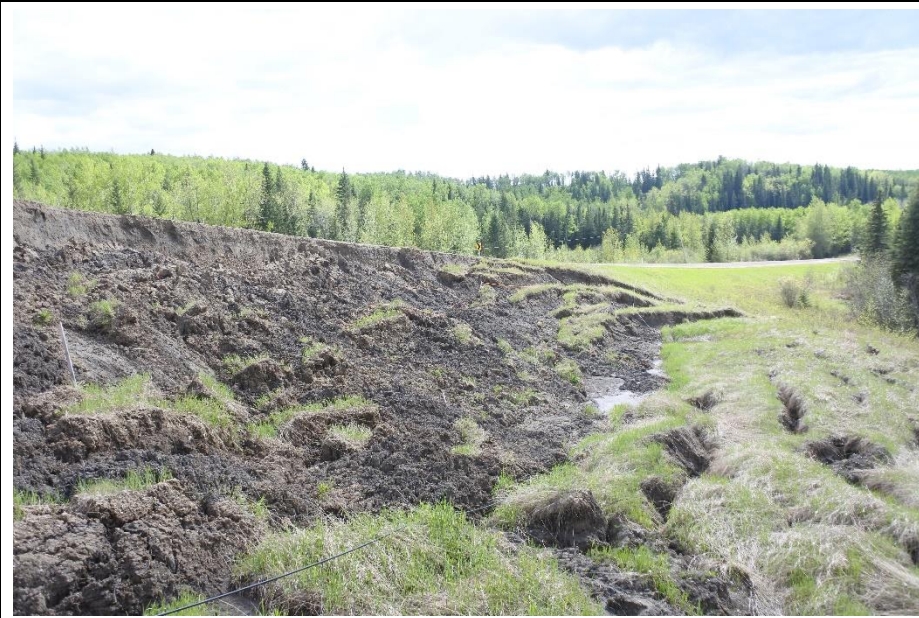
<input checked="" type="checkbox"/> Erosion	There is some erosion on the south side of the highway along the Puskwaskau Riverbank.	<input type="checkbox"/>	
<input checked="" type="checkbox"/> Seepage	The landslide mass and backscarp was wet and there was ponded water within several tension cracks. The backscarp was wet	<input type="checkbox"/>	
<input type="checkbox"/> Bridge/Culvert Distress		<input type="checkbox"/>	
<input checked="" type="checkbox"/> Other	The overly steepened riverbank on the south side of the highway will likely continue to retrogress towards the highway due to erosion and continued sloughing. There is a leaning power pole that may be compromised soon. There is a broken Telus communications cable (due to the slide movements) and a temporary Telus line installed that runs through the west landslide area.	<input type="checkbox"/>	
Instrumentation: None			
Assessment:			
The slide is approximately 20 m long by 40 m wide and located in a 13 m high embankment fill side slope. The soils exposed in the slide scarp appeared to consist of brown high plastic clay. The slide mass has slid down and is toeing out at the edge of an oxbow lake.

Photo 7.
Looking south at
the back scarp and
wet slide mass.

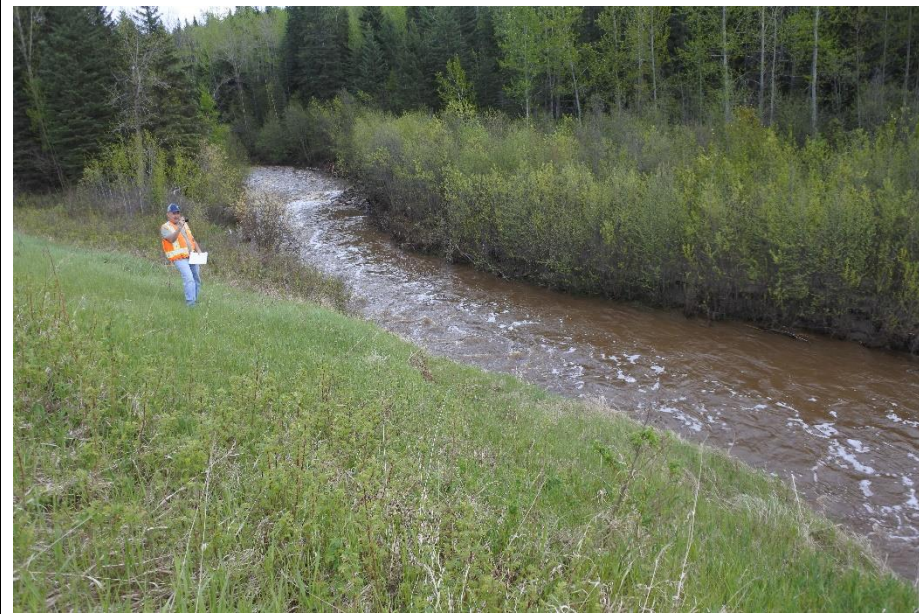
Photo 8.
Looking east at the
Puskwaskau River.

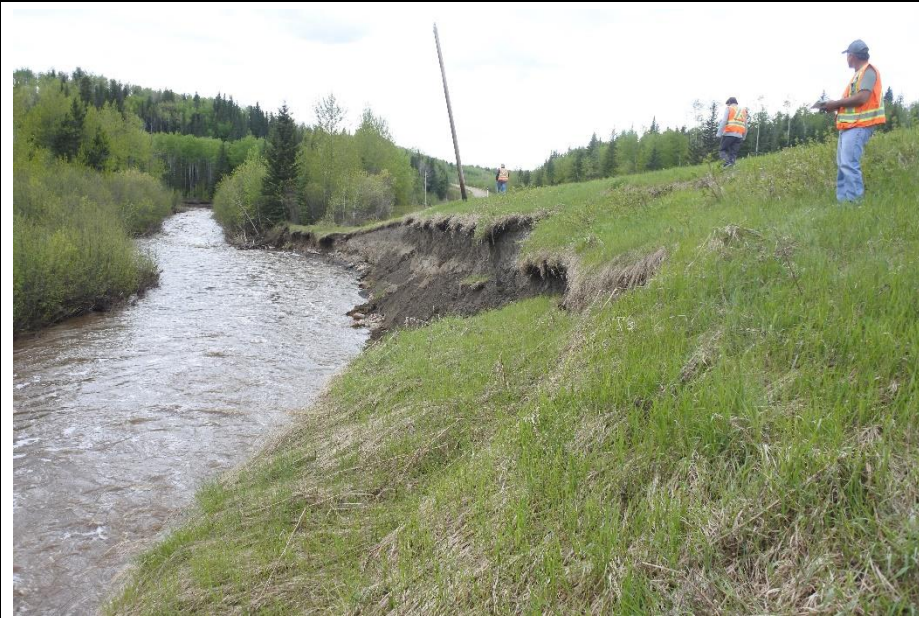
The riverbank next to the Puskwaskau river on the other (south) side of the highway is very steep. The river appears to eroding/undercutting the bank which causes the overhang to slough into the river and this process continues to retrogress towards the highway. At the time of the inspection the erosion was approximately 6 m away from the highway; however, there was a leaning power pole that will likely be compromised soon.

Photo 9.
Looking southwest
at the riverbank
erosion.

Armour the base of the bank with a heavy riprap toe berm and rebuild the portion of slope above the berm with geogrid reinforced gravel

Construct rock vanes or spurs to deflect the flow of the river away from the eroded bank and cut the bank back to a more consistent inclination and reinforce it with soil nails (or anchors) and a mesh facing (such as armourmax or equivalent).

Both of the options for the riverbank erosion will require permits from DFO to work within the river. Also, for each of the options, the power pole should be straightened and reinforced or moved to a more stable location.

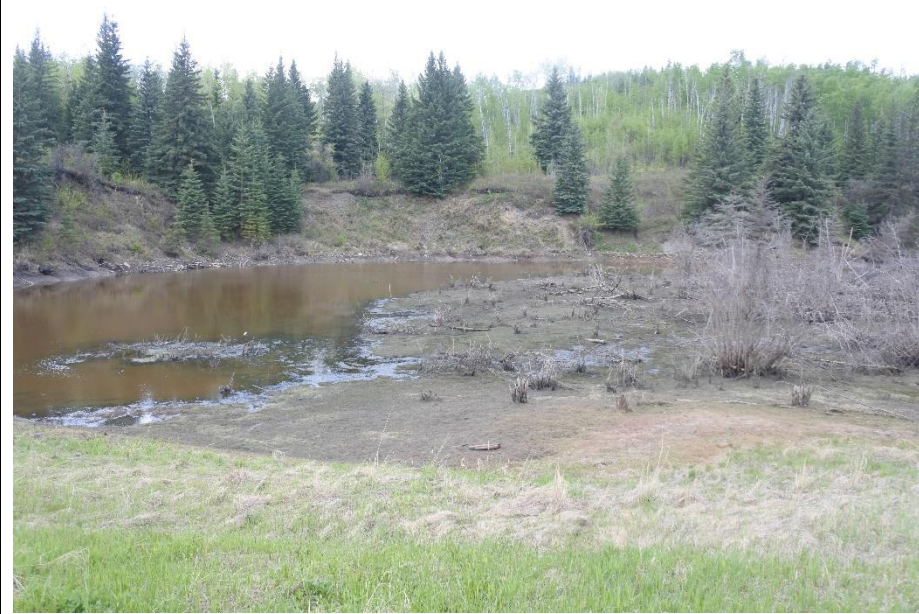
Photo 10.
Looking north at
the oxbow lake.
