June 30, 2016

File: 13355

**GEOHAZARD ASSESSMENT PROGRAM  
CALL-OUT INSPECTION  
HWY 2A:54 EAST OF GUNNS CREEK**

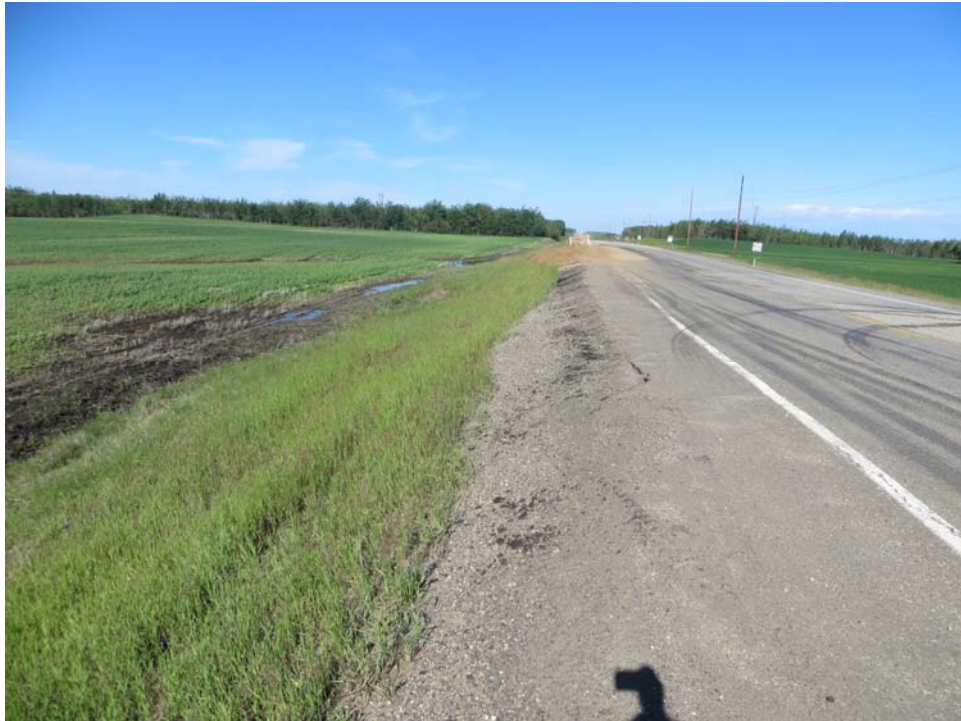
The west slide area had been covered with uncompacted crushed gravel by the Maintenance Contractor to restore the pavement surface. The length of the gravel patch was approximately 48 m. A scarp was visible through gravel approximately over the existing edge of asphalt. A toe roll was visible at the bottom of the slope.

The east slide area affected approximately 15 m of the paved highway surface with cracks extending up to 1.2 m into the east-bound lane. Differential heights across the cracks were between 25 mm to 50 mm. A secondary, 300 mm high scarp was observed partway down the slope and a toe roll was visible at the bottom of the embankment.

Photo 1: Looking west along south shoulder of Hwy 2A:54. Note crack of east slide at edge of asphalt and gravel placed over west side.

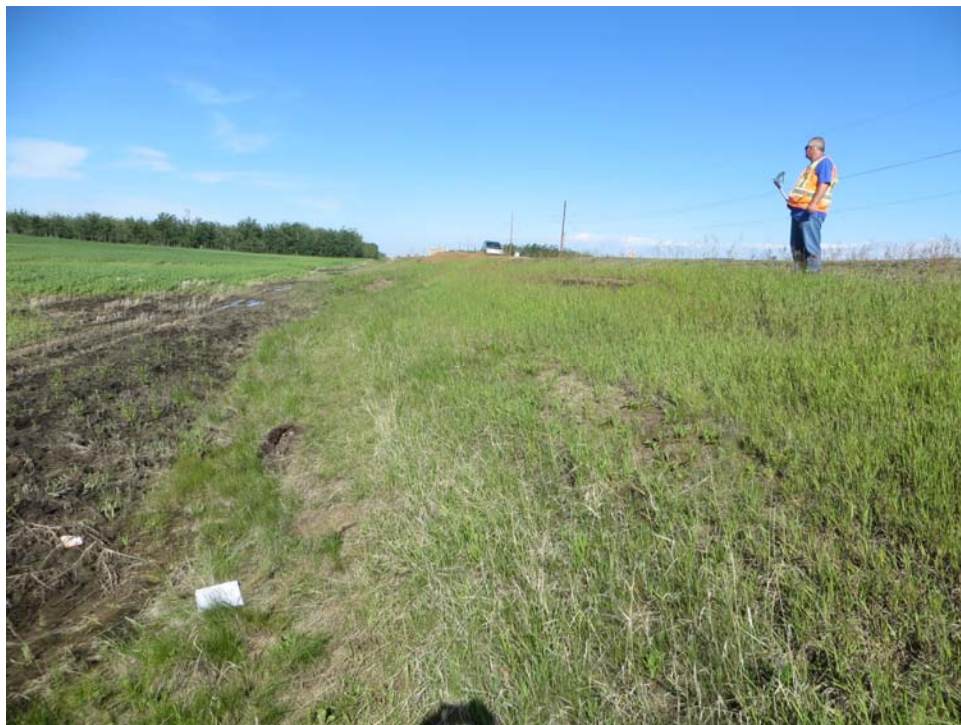
Photo 2: Looking west at east slide. Note scarp near top of embankment and toe roll at the bottom.

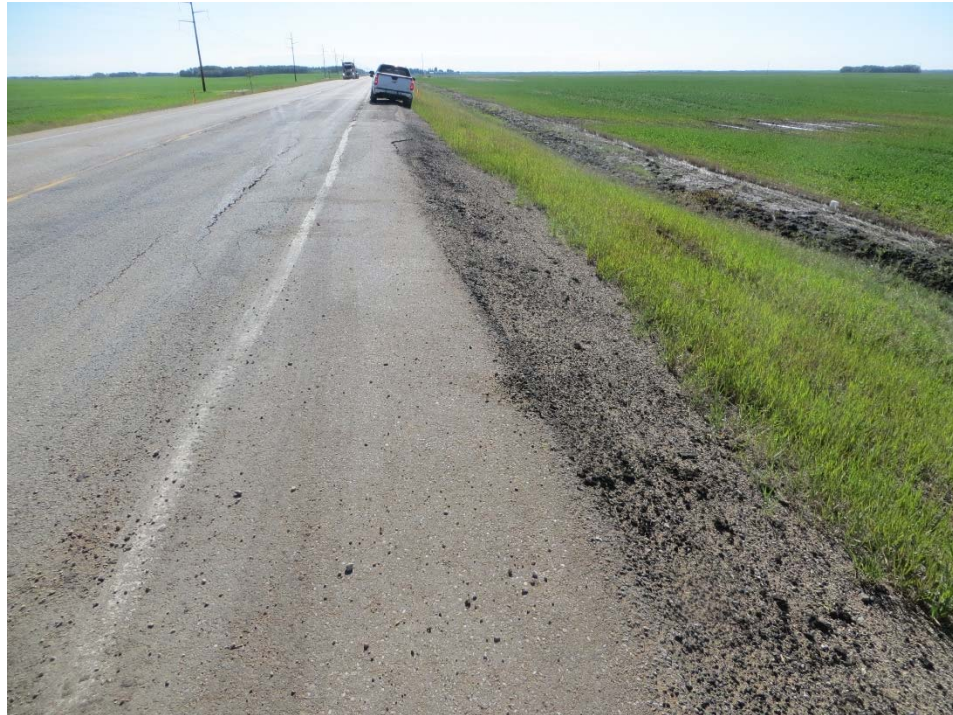
Photo 3: Looking east at east slide. Note cracks in the asphalt of the eastbound lane.

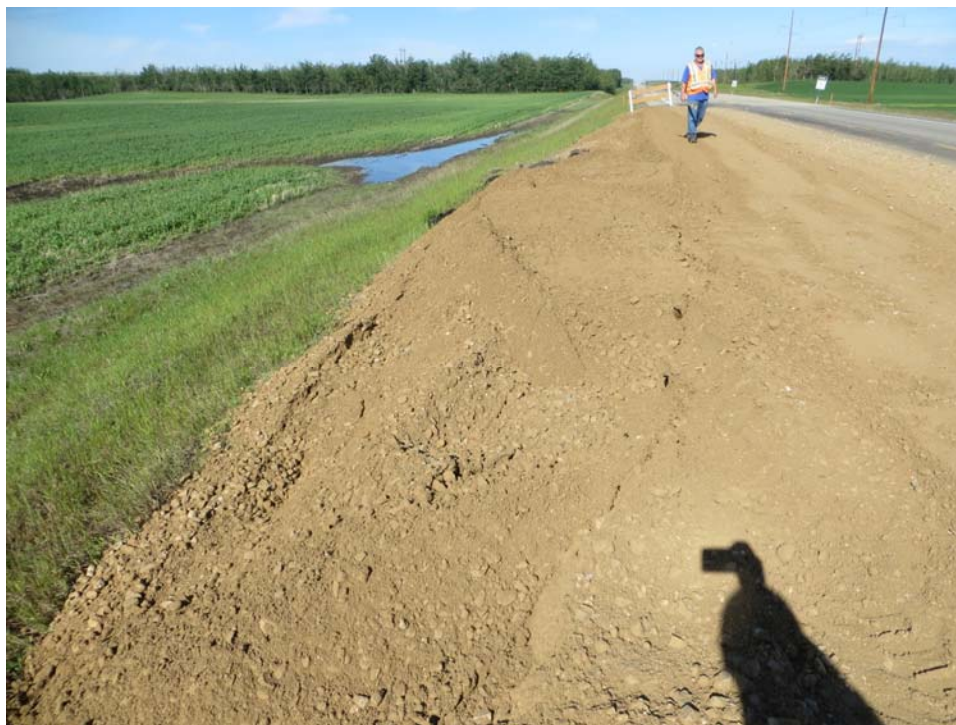
Photo 4: Looking south at west slide. Note crack through temporary gravel in line with the buried edge of asphalt.

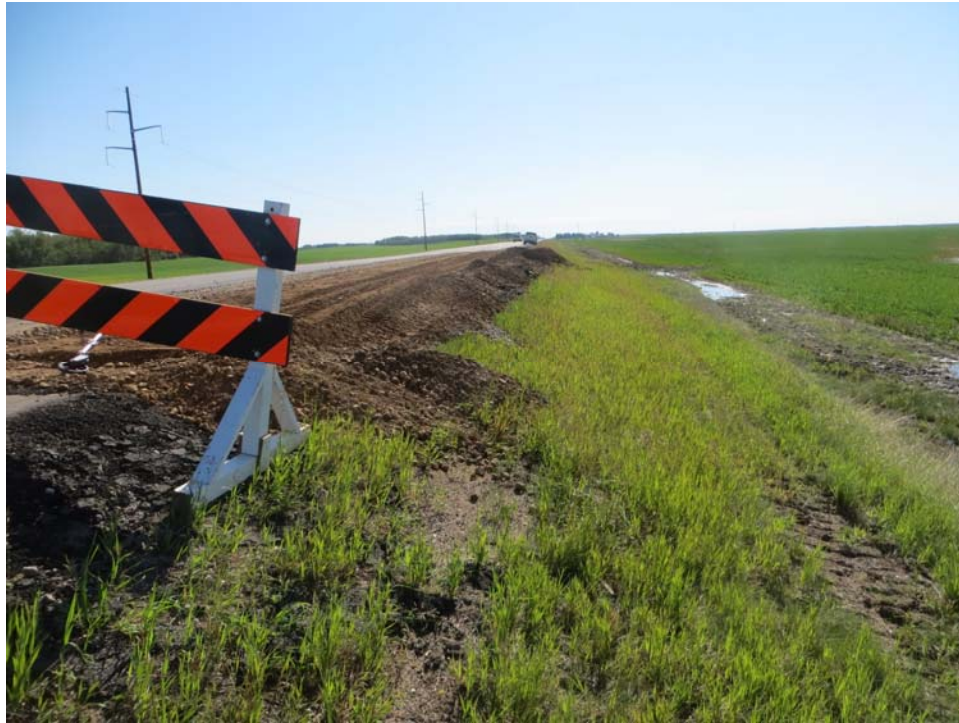
There was no record of previous instability at this location. Based on recent precipitation patterns, it is likely that the embankment and/or foundation soil material became saturated reducing the strength of the material allowing failure of the embankment.

Photo 5: Looking east from west side of west slide. Note ponded water adjacent to embankment and lack of drainage.

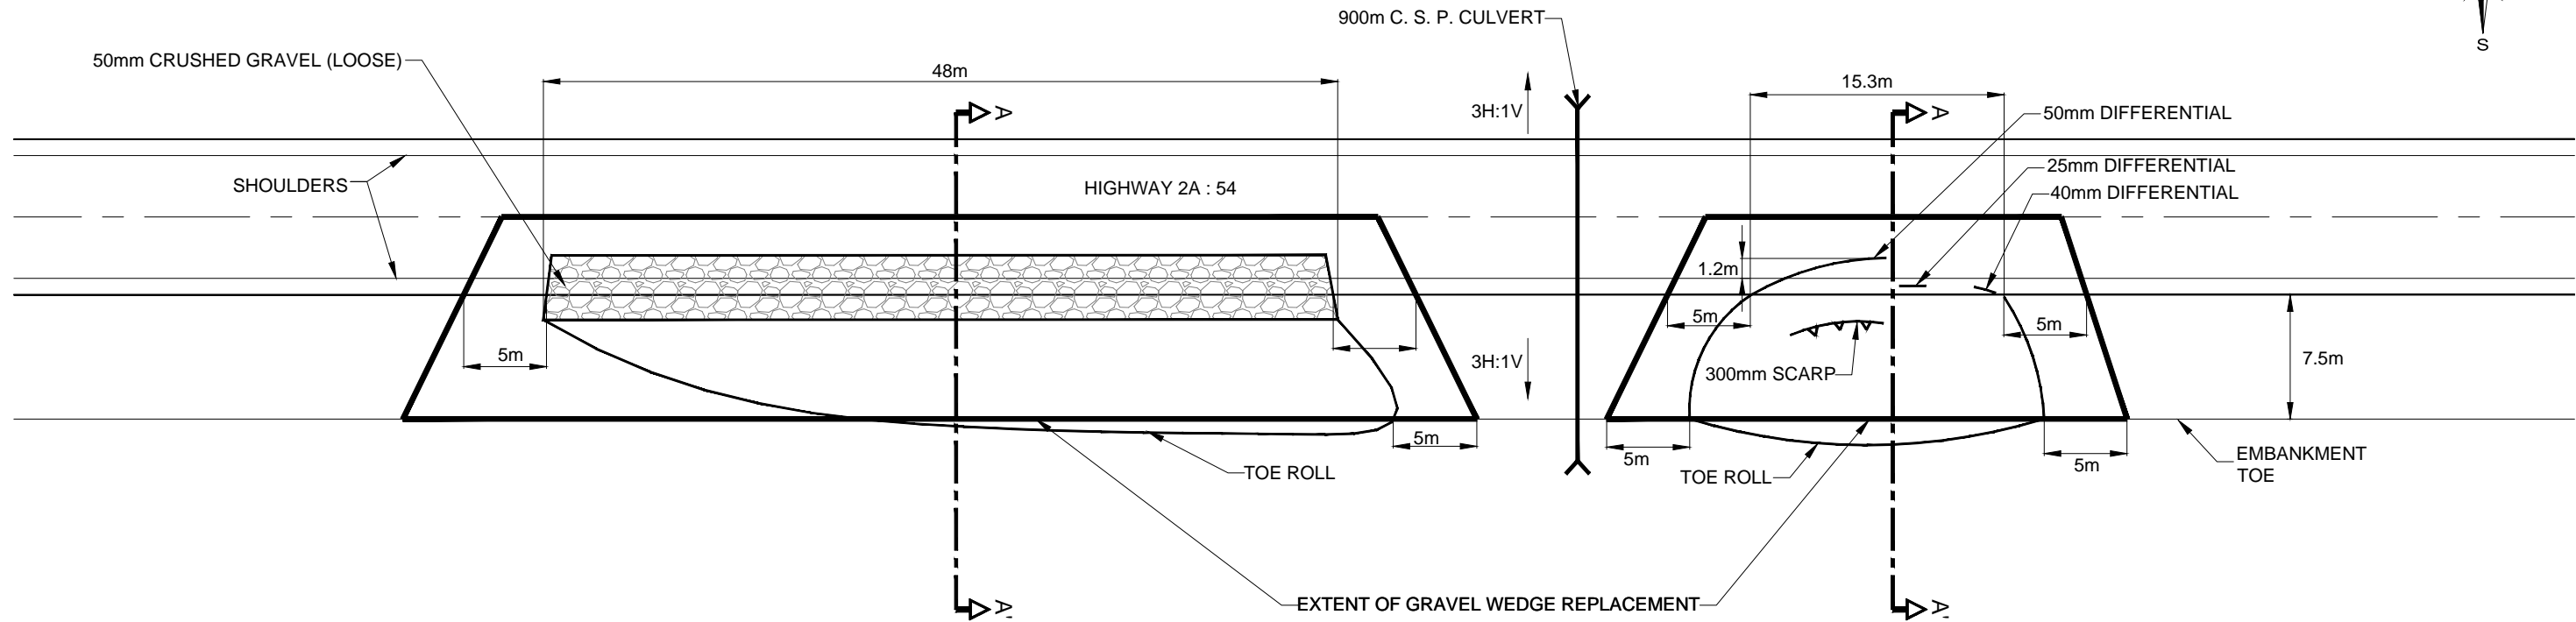
**SITE PLAN**  
SCALE: 1:400

The site is located on the south side of Hwy 2A:54 (the highway is oriented east-west) about 700 m east of the Gunns Creek culvert (GeoHazard site SH26). There were two areas of distress observed on either side of a 900 mm-diameter centerline culvert as shown on the attached Drawing 13355-1. The embankment is approximately 2.5 m in height at this location with sideslopes inclined at 3H:1V. The surrounding terrain is flat agriculture fields with no obvious drainage patterns and ponded water located on the south side of the embankment at the west edge of the areas of distress. There had been significant rainfall in the area in the preceding few weeks. Selected photographs taken during the site inspection are attached to this letter.

- The gravel wedge should extend to the centreline with the east-west extents to be 5 m beyond the edge of visible cracks and toe bulges.
- The excavation slopes should be inclined no steeper than 1H:1V. The excavation should extend to 0.5 m below the surrounding ground surface. A shear key should be excavated an additional 1 m deep with slopes at 1H:1V and a base width of 1.5 m.

- To reduce the risk of a further slope failure into the westbound lane, the width of the excavation should be limited to 20 m open at one time with each section backfilled prior to commencing excavation of the adjacent section. Drainage measures such as sumps and pumps may be necessary to keep the excavation dry.

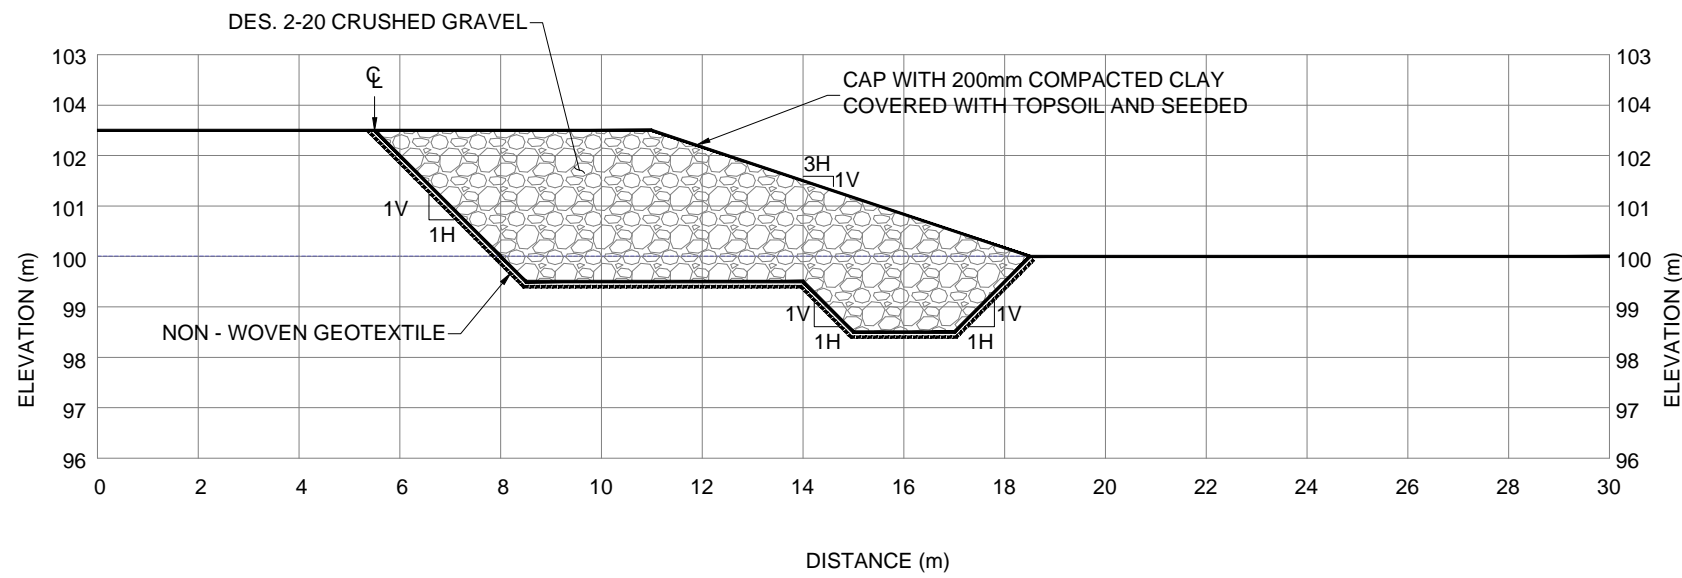
**CROSS - SECTION A - A'**  
SCALE: 1:150

Using the observed pattern of cracking, a preliminary stability analysis conducted assuming the groundwater at the ground surface determined a back-analysed friction angle for a uniform embankment and foundation clay soil of 15°. This friction angle is relatively conservative for soils in the area.

A preliminary assessment completed as part of this callout determined that replacement of the slumped material with a gravel wedge and shear key was sufficient to improve the estimated factor of safety to 1.3.

- The excavation should be backfilled with Designation 2, Classification 20 gravel with a non-woven geotextile placed below the gravel. The gravel should be packed in 150 mm thick lifts to at least 95% of SPMDD, except for the top 300 mm of the subgrade, which should be packed to 100% of SPMDD.

- The roadway should be rebuilt using the same pavement structure as will be used at the nearby SH26 slide repair. A 200 mm thick clay cap should be placed on the side slope surface (but not over the pavement GBC) and covered with a layer of topsoil and seeded.
