**ALBERTA TRANSPORTATION
GEOHAZARD ASSESSMENT PROGRAM
PEACE REGION (PEACE RIVER DISTRICT)
2023 INSPECTION**

Site Number	Location	Name	Hwy	km
SH030-1	West of High Prairie	East of Gunns Creek	2A:54	17.56 – 17.82
Legal Description		UTM Co-ordinates		
NE&SE32-73-19-W5M		11U E 508,043		N 6,135,622

**SH030-1: HWY 2A:54 km 17.6 TO km 17.9
2023 SITE INSPECTION PLAN**

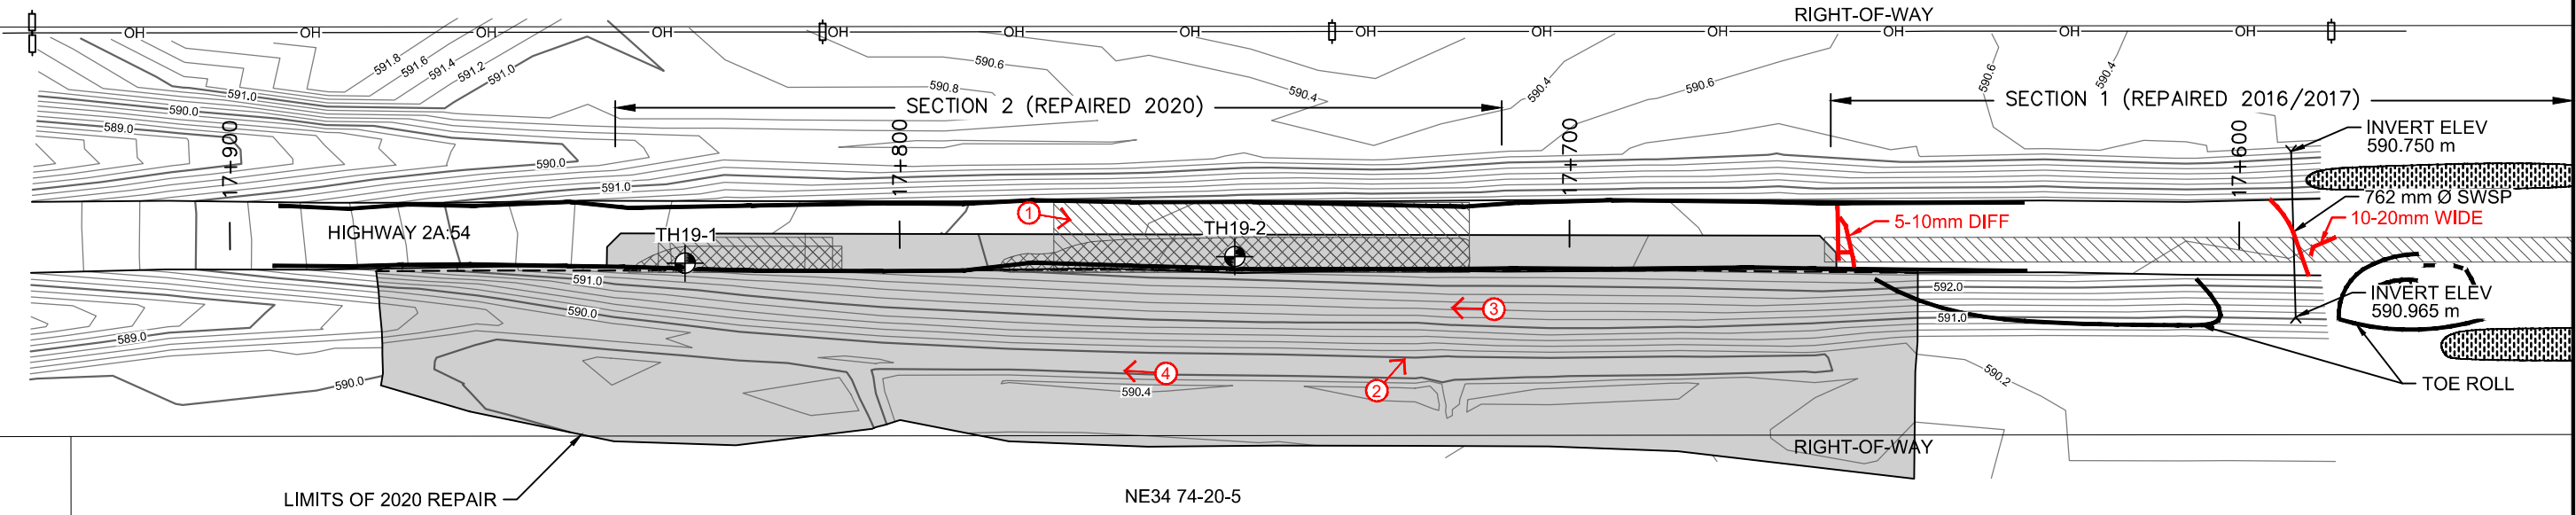
DWG No. 32121-SH030-1

<input checked="" type="checkbox"/> Pavement Distress	New transverse cracks have appeared; one of the cracks is over the SWSP culvert.	<input checked="" type="checkbox"/>
<input type="checkbox"/> Slope Movement	No new movements observed during 2023 inspection.	<input type="checkbox"/>
<input type="checkbox"/> Erosion		<input type="checkbox"/>
<input type="checkbox"/> Seepage	South ditch was dry during 2021 inspection.	<input type="checkbox"/>
<input checked="" type="checkbox"/> Bridge/Culvert Distress	762 mm culvert (km 17.612) at east end of area in a good condition.	<input type="checkbox"/>
<input type="checkbox"/> Other		<input type="checkbox"/>
Instrumentation:		
None

There were no significant changes observed during the 2023 inspection, suggesting that the remedial measures have suitably stabilized the treated area.

This site has been scheduled for inspection twice on the current contract. The site can be dropped from the GRMP since there were no significant changes observed during the 2021 and 2023 inspections.

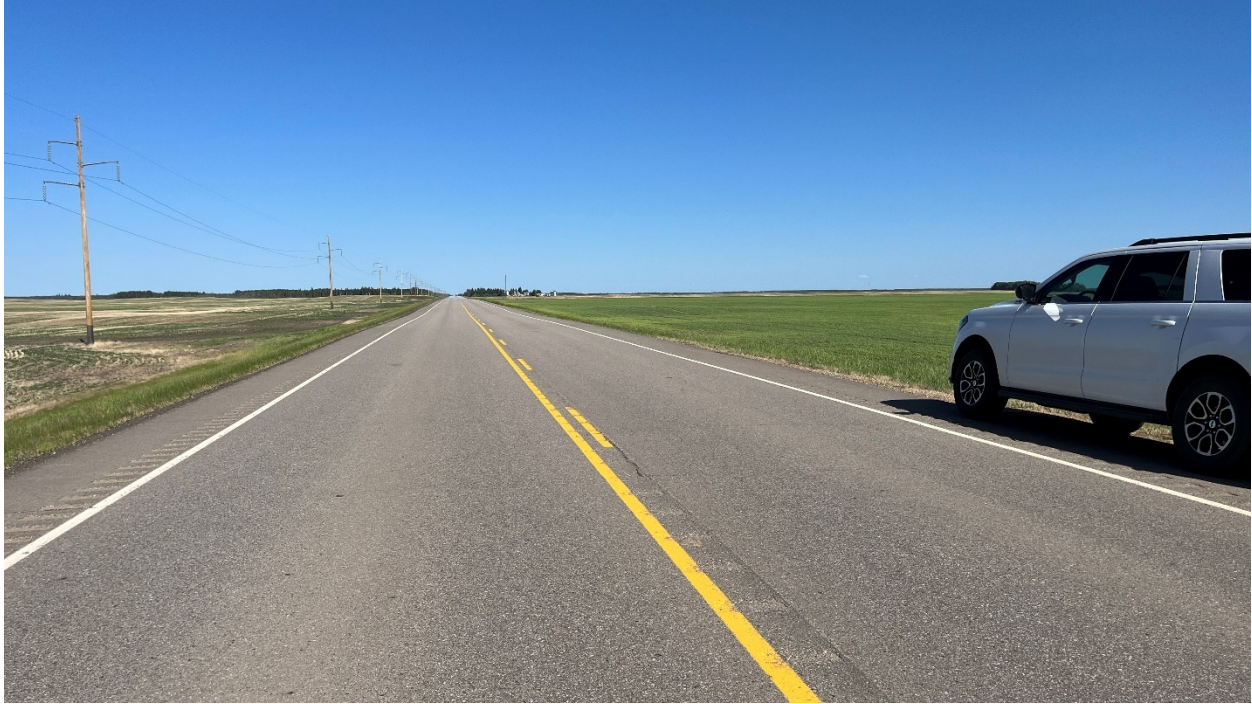
Photo 1 – Looking east from WBL at middle of the reconstructed portion of EBL.

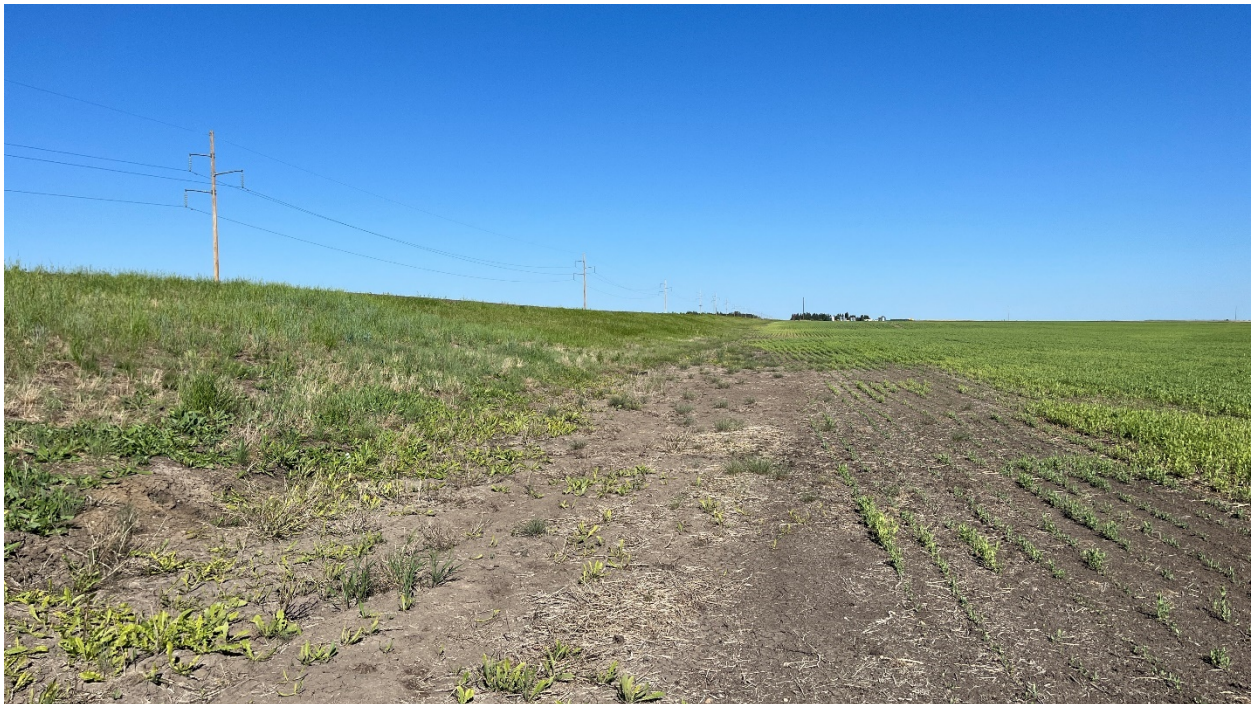
Photo 2 – Looking northeast at south slope of highway embankment from the south ditch.

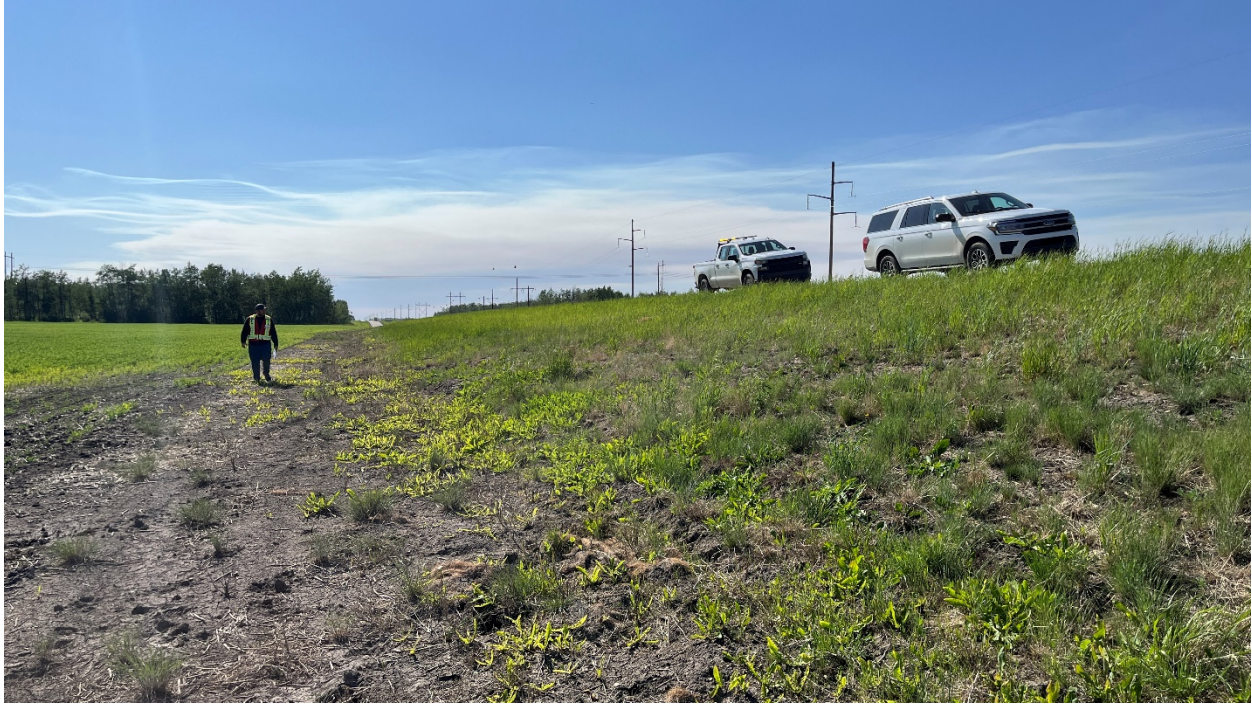
Photo 3 – Looking west along south side slope of highway embankment.

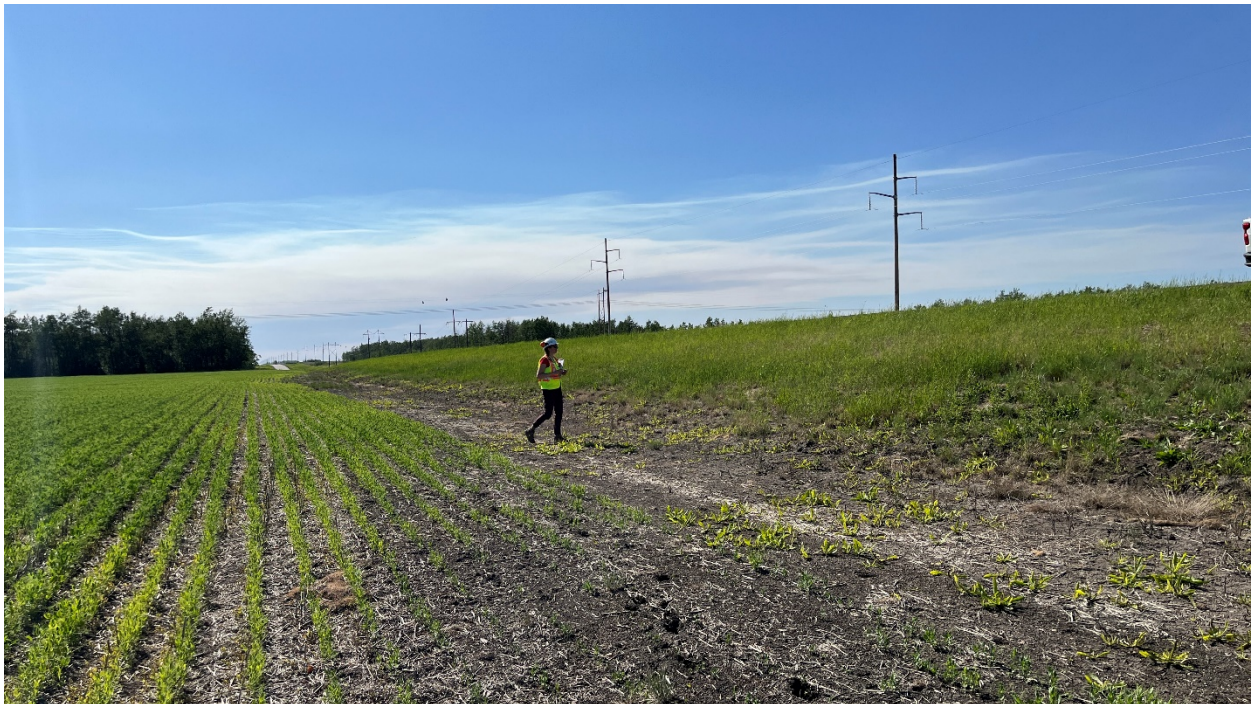
Photo 4: Looking west along south ditch where TRM was installed.
