**ALBERTA TRANSPORTATION
GEOHAZARD ASSESSMENT PROGRAM
PEACE REGION (PEACE RIVER DISTRICT)
2023 INSPECTION**

Site Number	Location	Name	Hwy	km
SH034	East of Arcadia	Near Arcadia Embankment Slide	2:50	44.42
Legal Description		UTM Co-ordinates		
NE9-74-14-W5		11U N 6,139,489	E 557,842

**SH034-1 HWY 2:50 KM 44.4, EAST OF ARCADIA
2023 SITE INSPECTION PLAN**

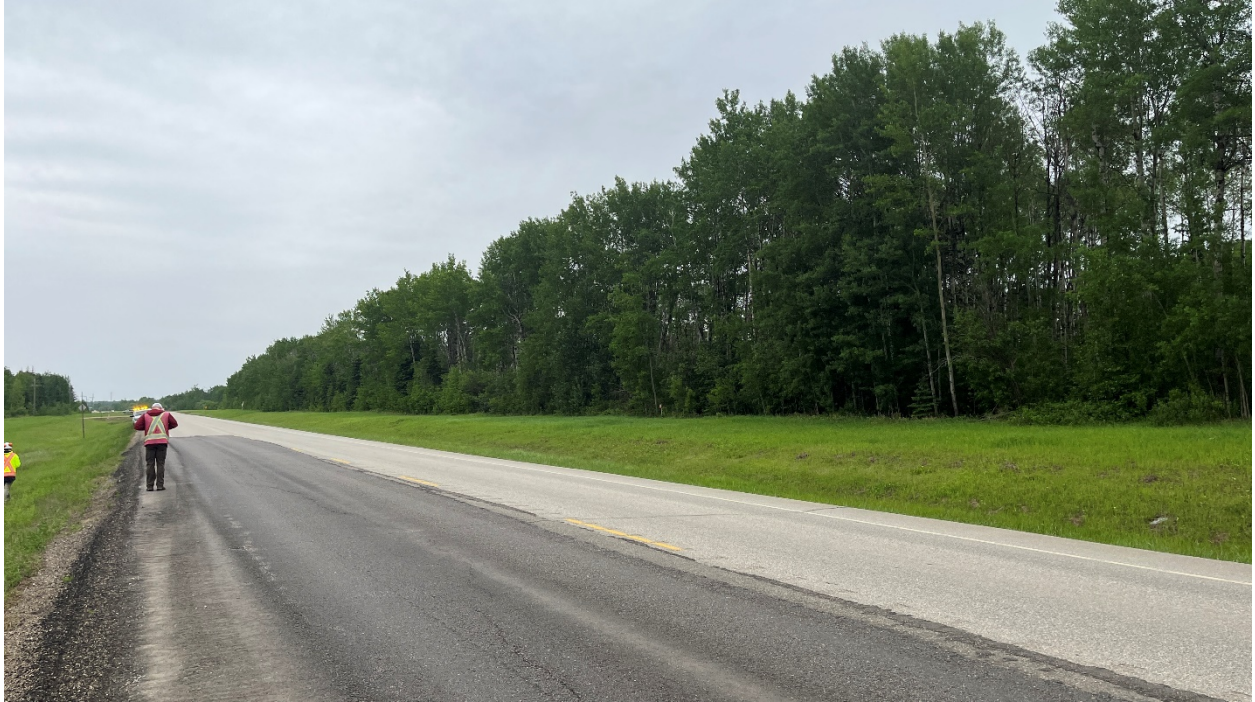
During the call-out inspection in 2020, approximately 21 m length of the west-bound lane (WBL) had an arch-shaped crack in the middle of the lane with a dip between the crack at the south shoulder. This main crack was up to 50 mm in width and 40 mm of height differential. There was a secondary crack near the shoulder on the north side of the dip which was up to 30 mm wide with 30 mm of differential. There appeared to be a toe roll in the lower part of the sideslope. The crack in the centre of the lane continued an additional 30 m east indicating that a greater extent of movement was likely.

The site appears similar to other failures seen in the general area such as at SH030 and SH031 thus a similar mechanism is expected: higher-than average precipitation over a few years prior to and including 2020 resulting in elevation of the groundwater table or saturation of the high plastic foundation soils leading to shallow rotation failure. Given the terrain, it will be difficult to improve the drainage. Thus, mitigation will need to either reduce the loading on the foundation soils or improving the embankment strength. The types of repairs used at SH030 and SH031 are also appropriate for this site:

Photo 1 – Looking east along the WBL at the main landslide’s head scarp crack and highway dip.

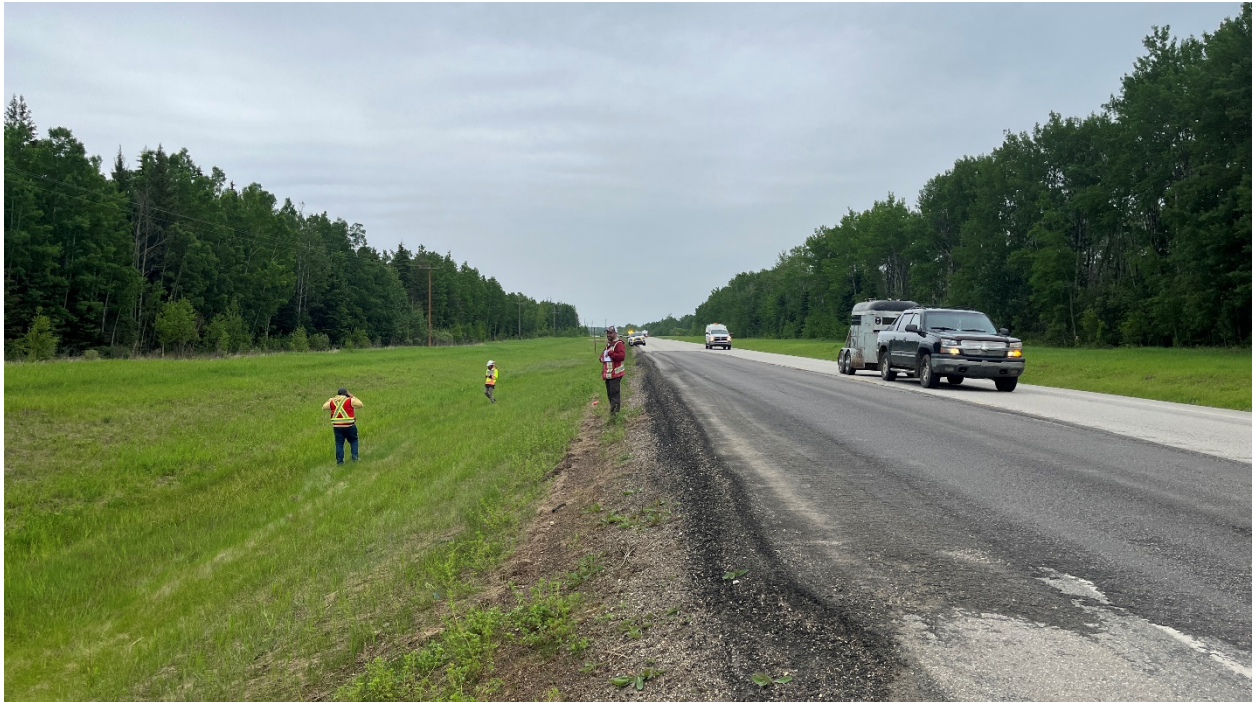
Photo 2 – Looking east at the sideslope below the main crack where a toe roll is present in the ditch.

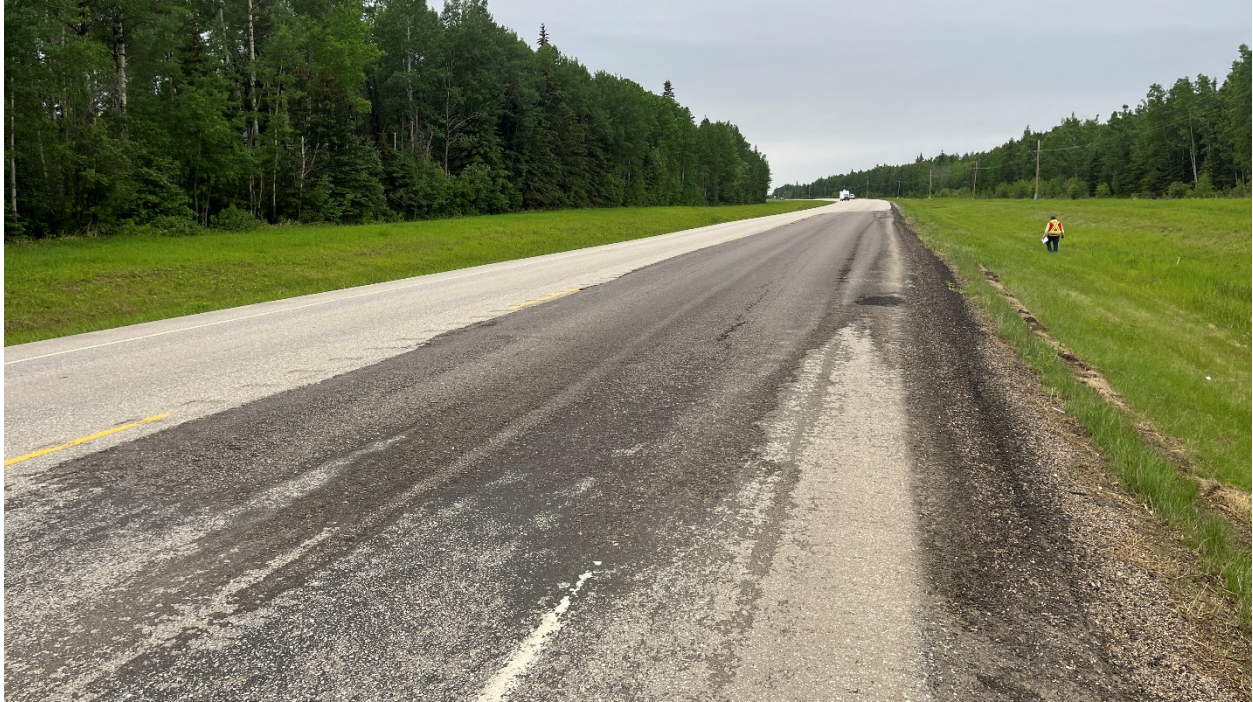
Prior to the 2021 inspection, a 70 m long section of the WBL was patched. A similar length was patched between the 2021 and 2023 inspections (date unknown). During the 2021 and 2023 inspections, it appeared that the features observed during the call-out inspection were starting to reflect through the corresponding patch. According to the MCI, the site has a long history of being patched (since 1995). The cracking continues to the east beyond the area that was patched.

Photo 3 – Looking west at the main area of distress.

- Road maintenance should continue as necessary to maintain an even, safe roadway surface and may consist of milling, patching, and crack sealing of the pavement. The site was patched after the call-out inspection in 2020 and annual inspection in 2023, but the cracks have reflected through and vertical displacement is anticipated as the slide continues to move. The cracks should be sealed to avoid surface water infiltration into the tracks and additional patching as needed to maintain a safe highway surface.

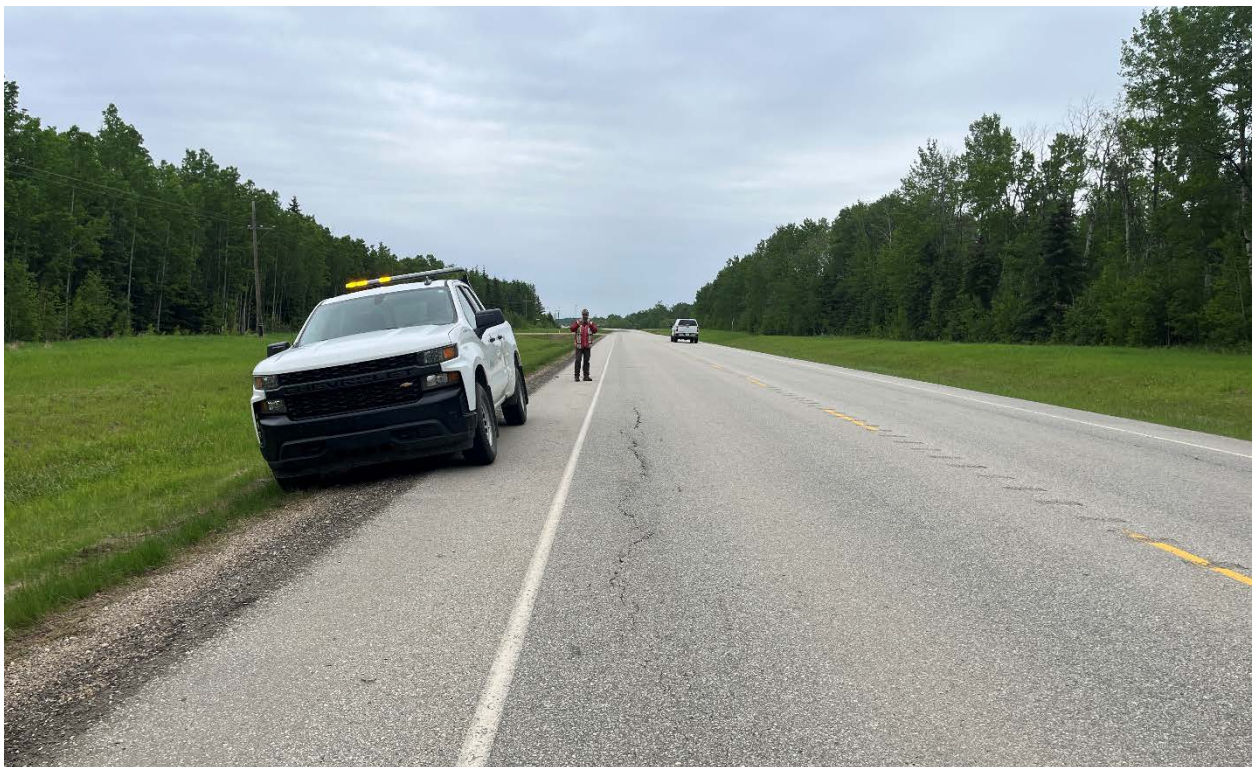
Photo 4 – Looking east along the WBL where cracks are starting to form east of the patched area.
