THURBER ENGINEERING LTD.

File No.: 32121

**GEOHAZARD RISK MANAGEMENT PROGRAM (CON0022164)
PEACE REGION (PEACE RIVER DISTRICT)**

**SECTION D CALLOUT REPORT
CAUDRON: HWY 2:50 km 43.61 – 43.67**

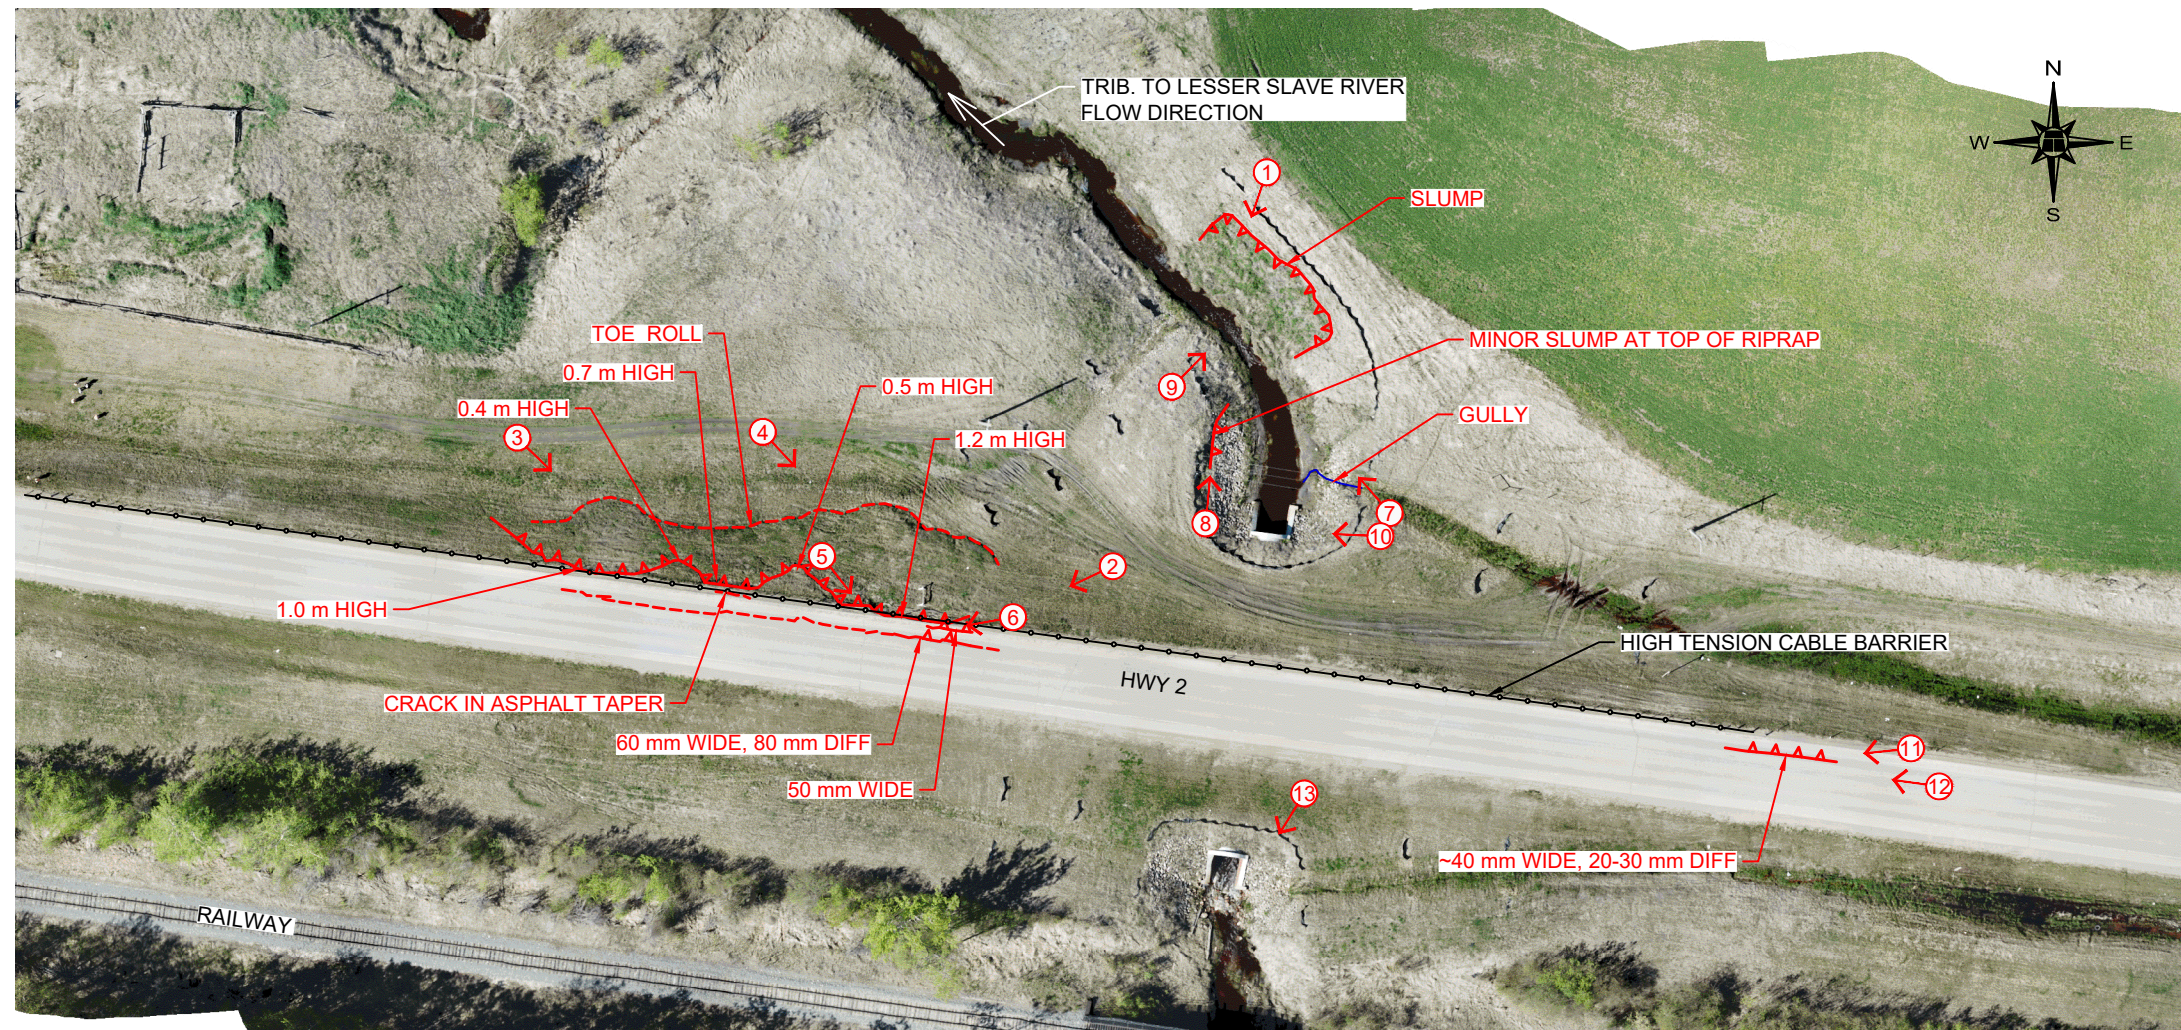
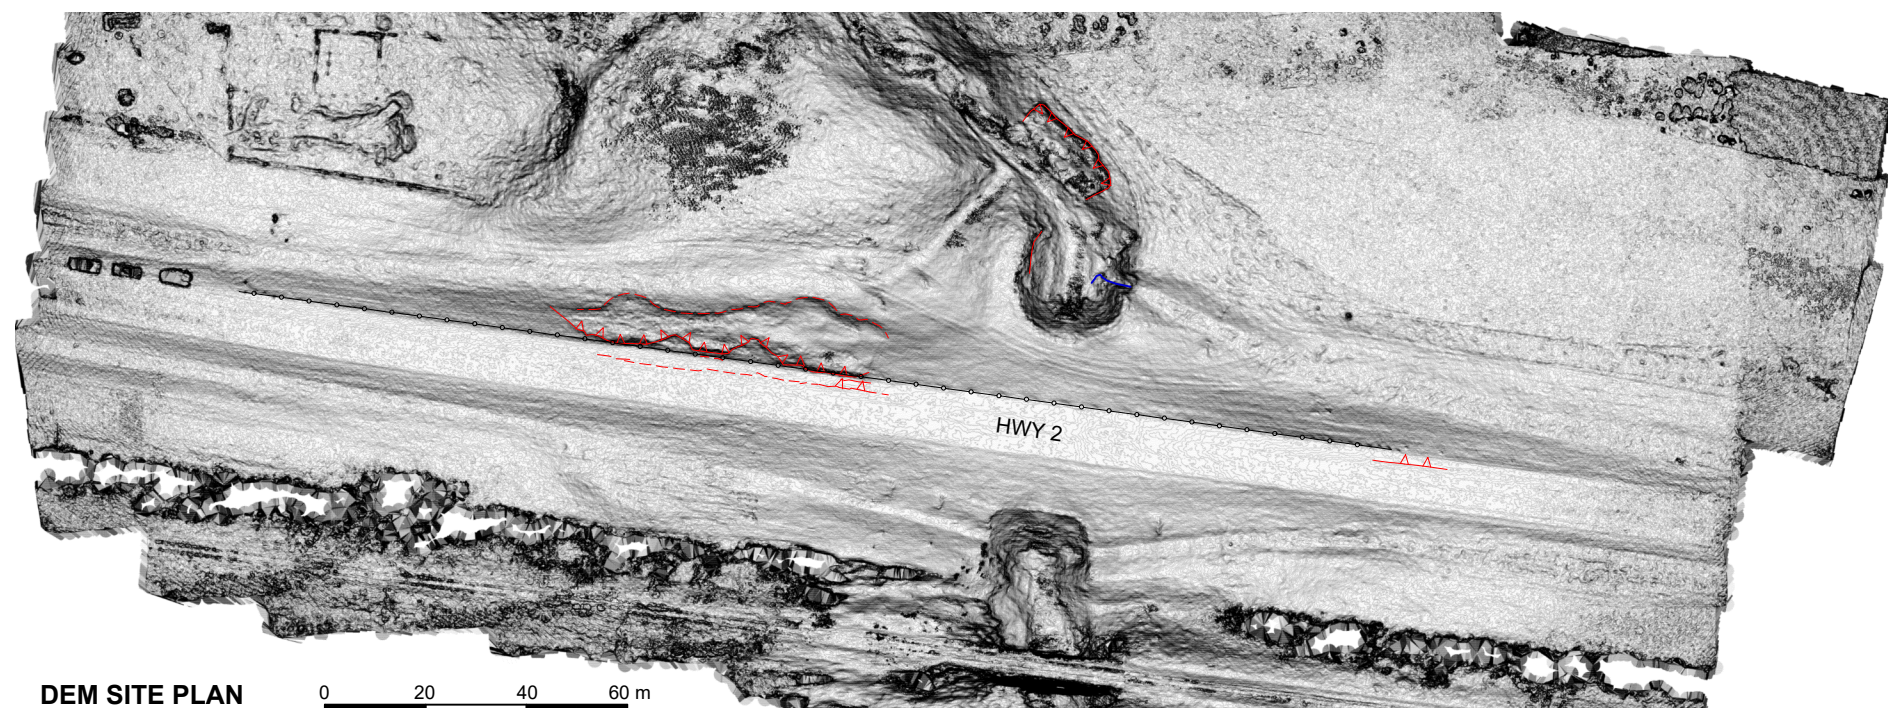
FIGURE 1

Observations made during the site visit are illustrated on Figure 1, attached. Selected photographs of the site visit are also included at the end of this letter.

At the time of the call-out inspection, the main slump on the west side of the culvert was approximately 65 m in length and had three “arcs” encroaching near the pavement edge. There was a visible toe roll over most of the length which was between 0.5 m and 0.7 m in height. The embankment increased in height from about 3.5 m at the west end to 4.5 m at the east. The west-most “arc” had not yet affected the highway and had approximately 1.0 m of vertical displacement. The second arc, with approximately 0.7 m of vertical displacement, was roughly parallel to the highway and there was a crack forming in the asphalt taper just south of the high-tension steel cable (HTSC) guardrail. The third arc, closest to the culvert, was the largest and had undermined one post of the HTSC. This scarp was about 9 m in width (measured at the edge of asphalt), about 1.2 m of vertical displacement, and was about 350 mm into the asphalt although still within the shoulder of the road. There appeared to be at least two layers of asphalt exposed in the scarp. In addition, there were parallel cracks in the outer wheel path of the north lane. The crack furthest into the highway was 60 mm wide with 80 mm of height differential.

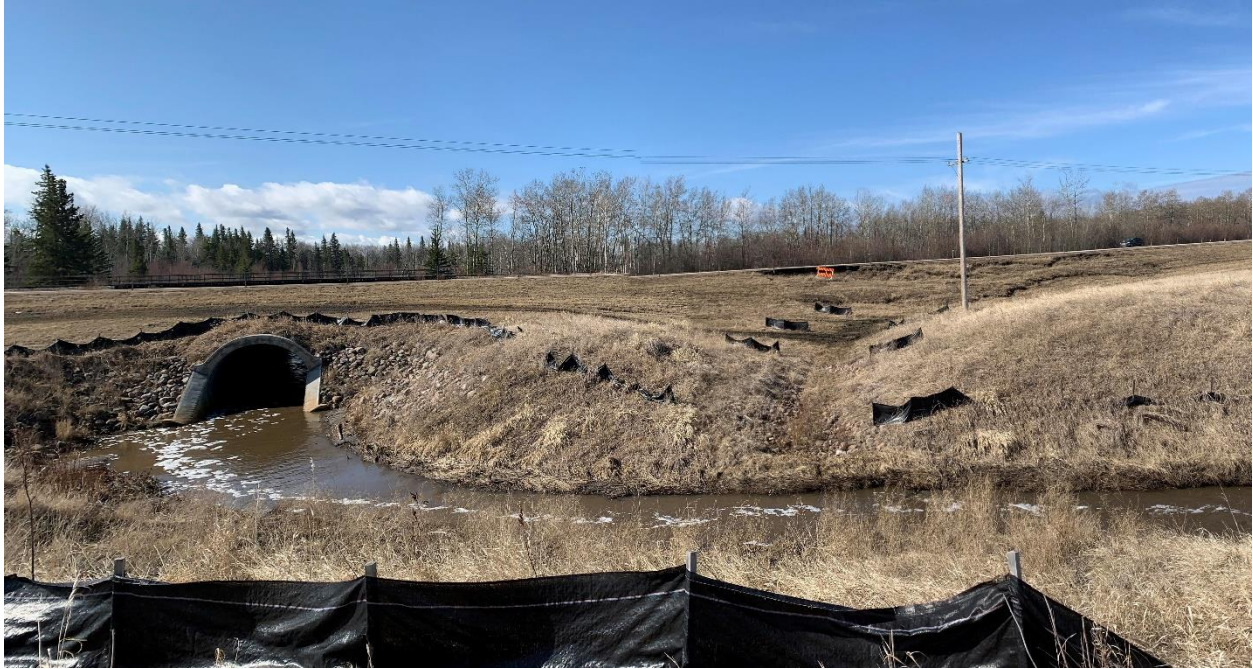
Photo 1 (AT, May 3, 2022) - Looking south across creek at slump in north shoulder.

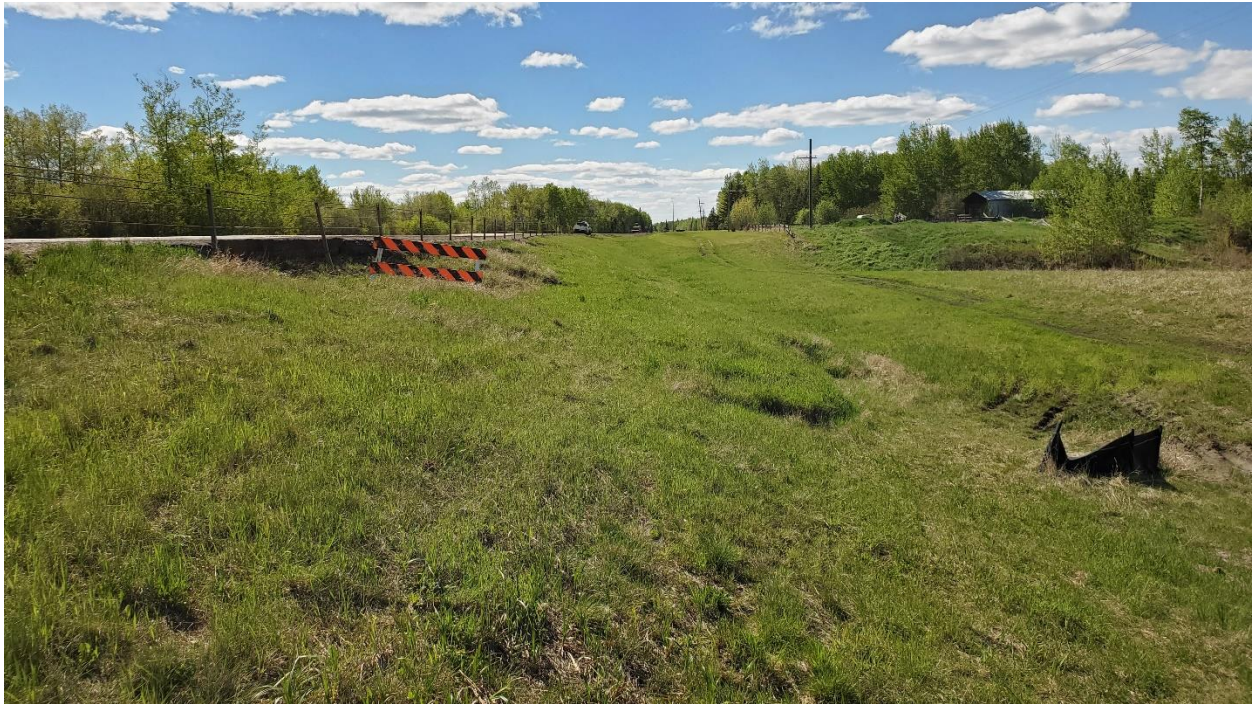
Photo 2 – Looking west from east end of slump.

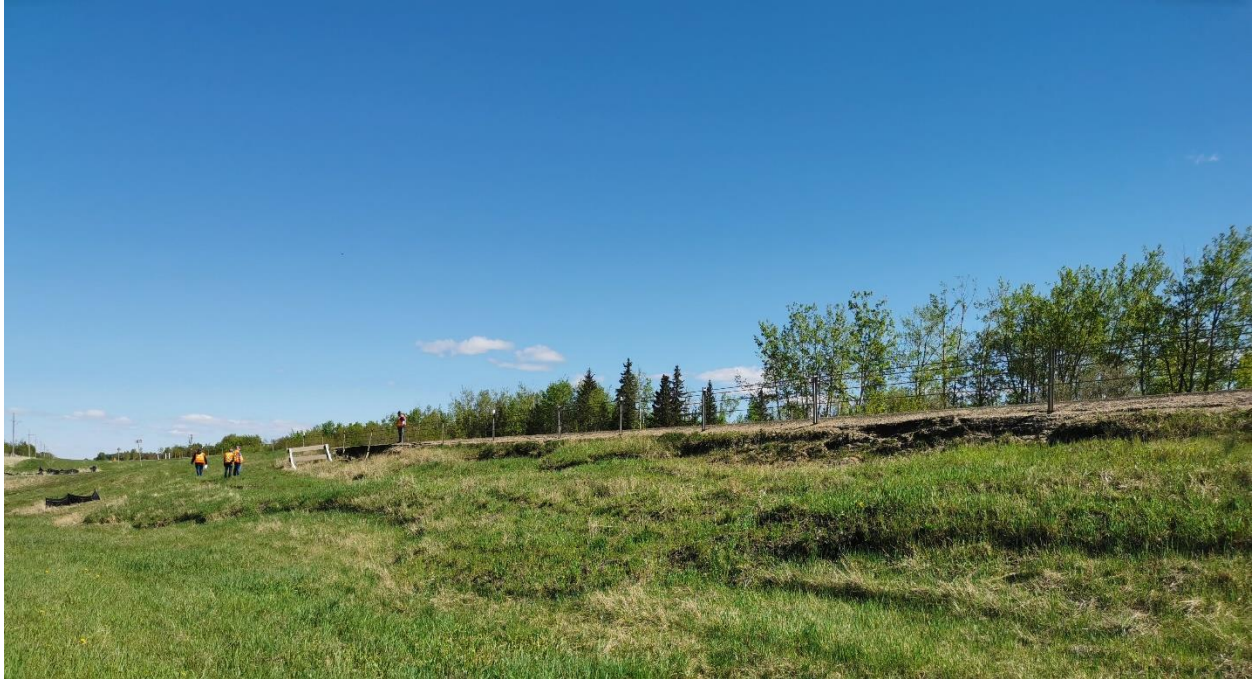
Photo 3 – Looking southeast at east end of slump.

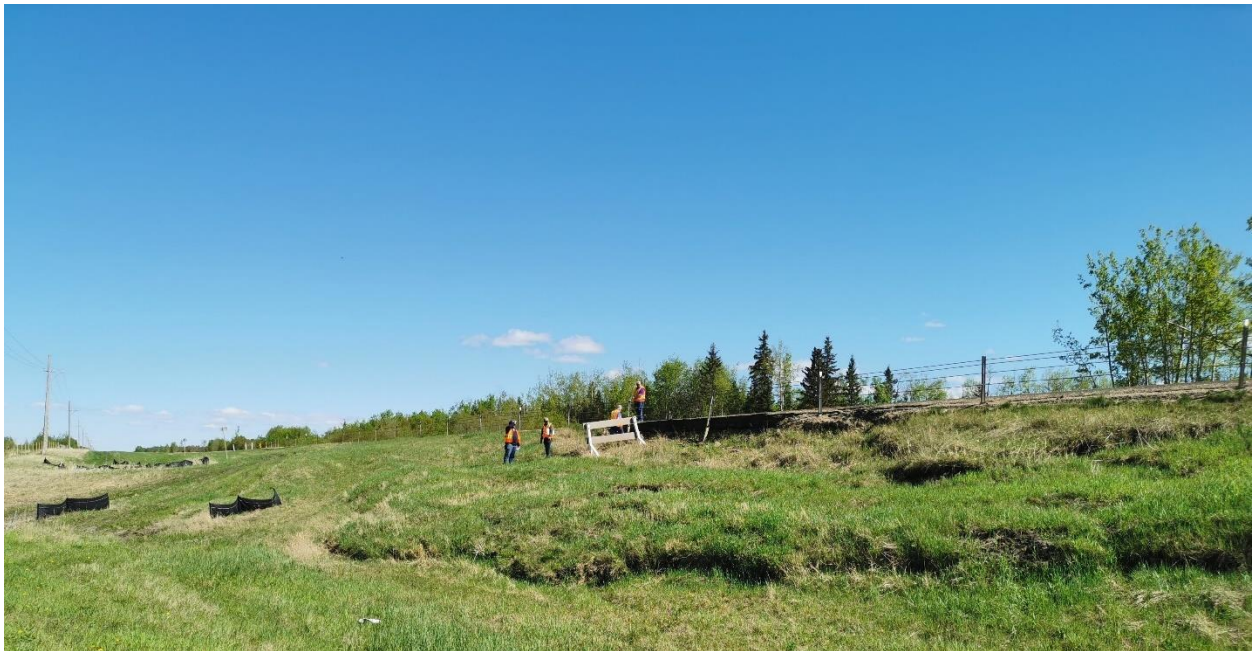
Photo 4 – Looking southeast at east end of slump.

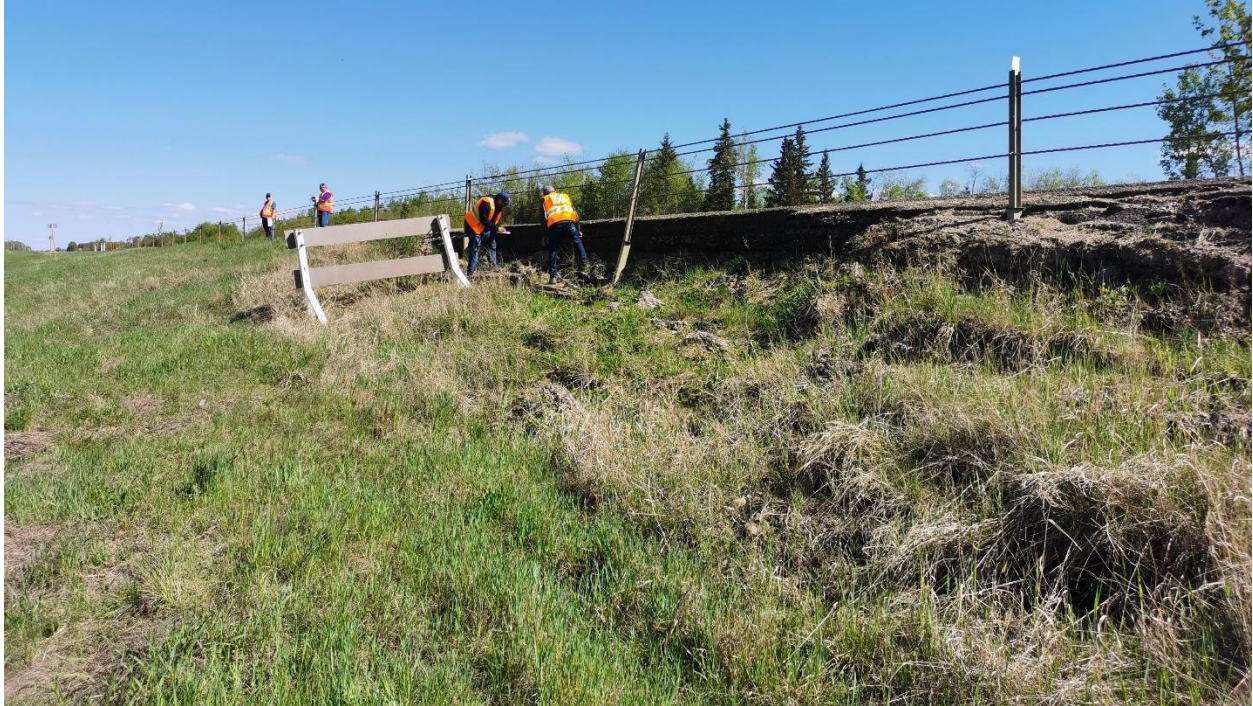
Photo 5 – Looking southeast at undermined guardrail and exposed pavement structure.

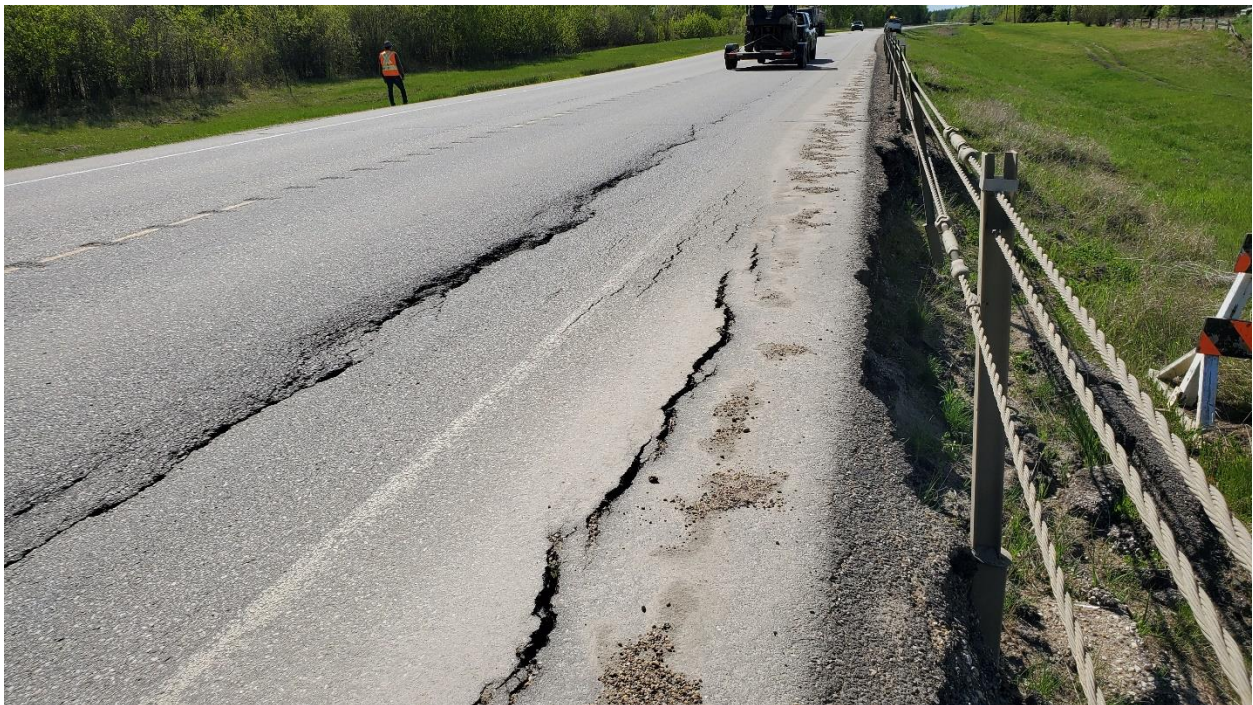
Photo 6 – Looking west at cracks and subsidence in highway above scarp shown in Photo 5.

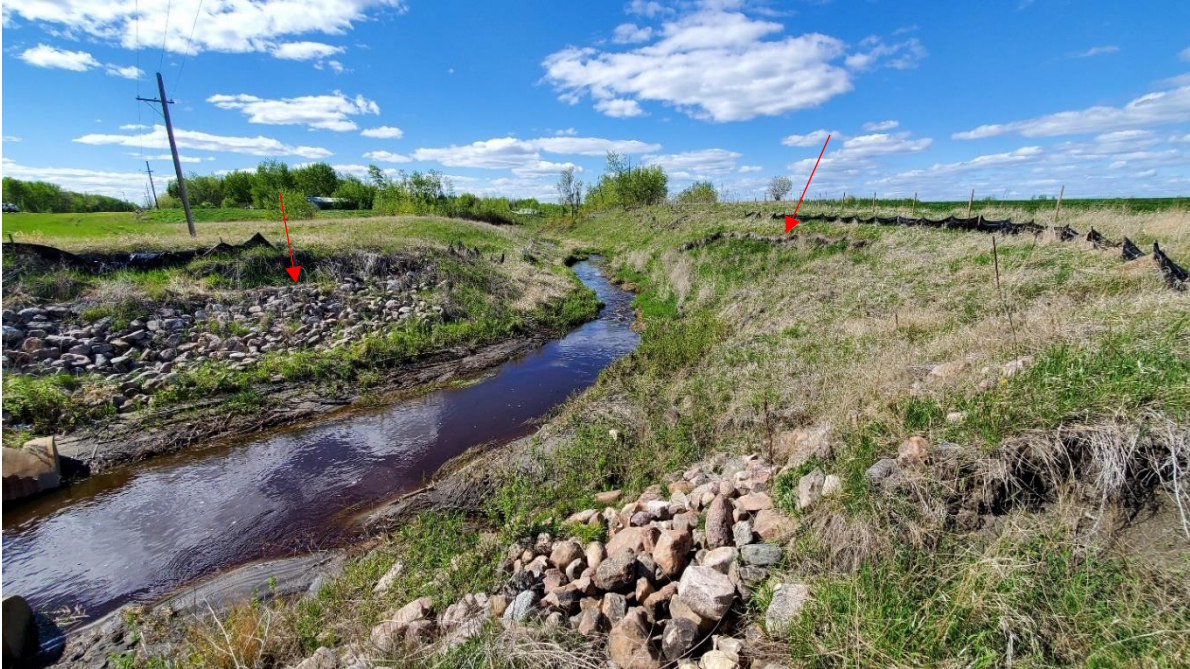
A brief review of the ground conditions around the culvert outlet determined that the culvert itself appears to be in good condition and no instability was observed. However, there appeared to be some slumping of the riprap on the west (left) bank just beyond the outlet and a larger slump (about 17 m wide) on the east (right) bank about 23 m downstream of the culvert. The drainage channel from the east ditch is starting to erode creating a shallow gully.

Photo 7 – Looking north (downstream) along the creek. There is minor slumping at the top of the riprap on the west (left) side and a larger slump further downstream on the right (east) side.

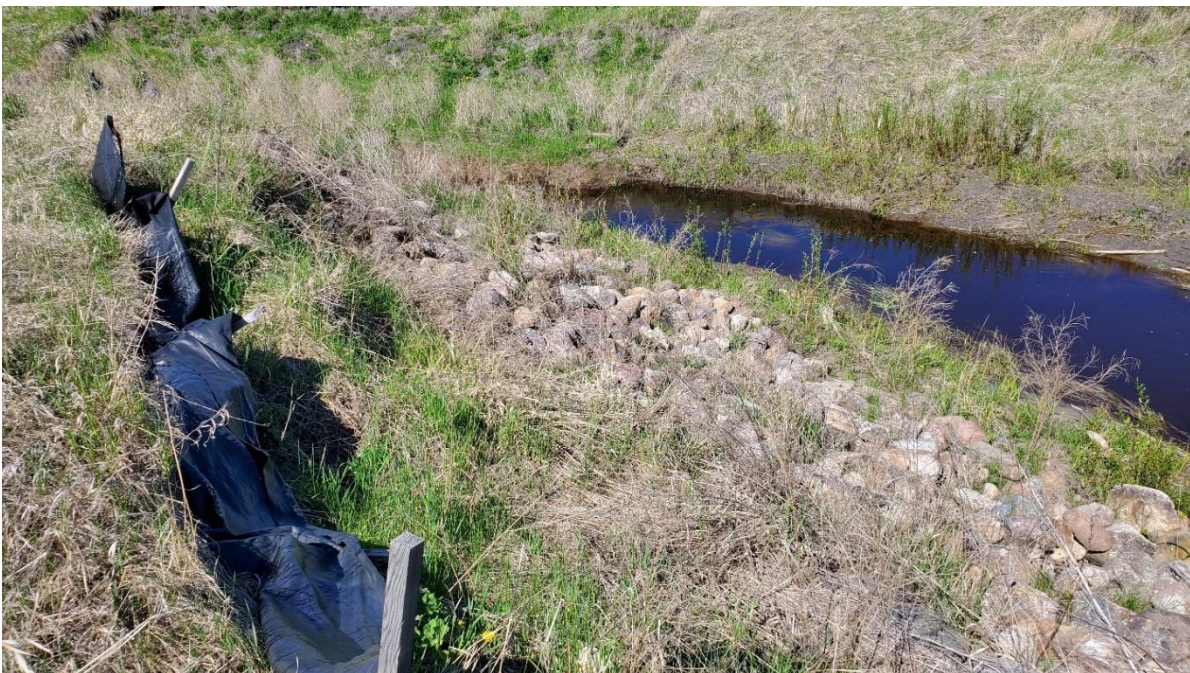
Photo 8 – Looking at slumping above west riprap (somewhat obscured by grass).

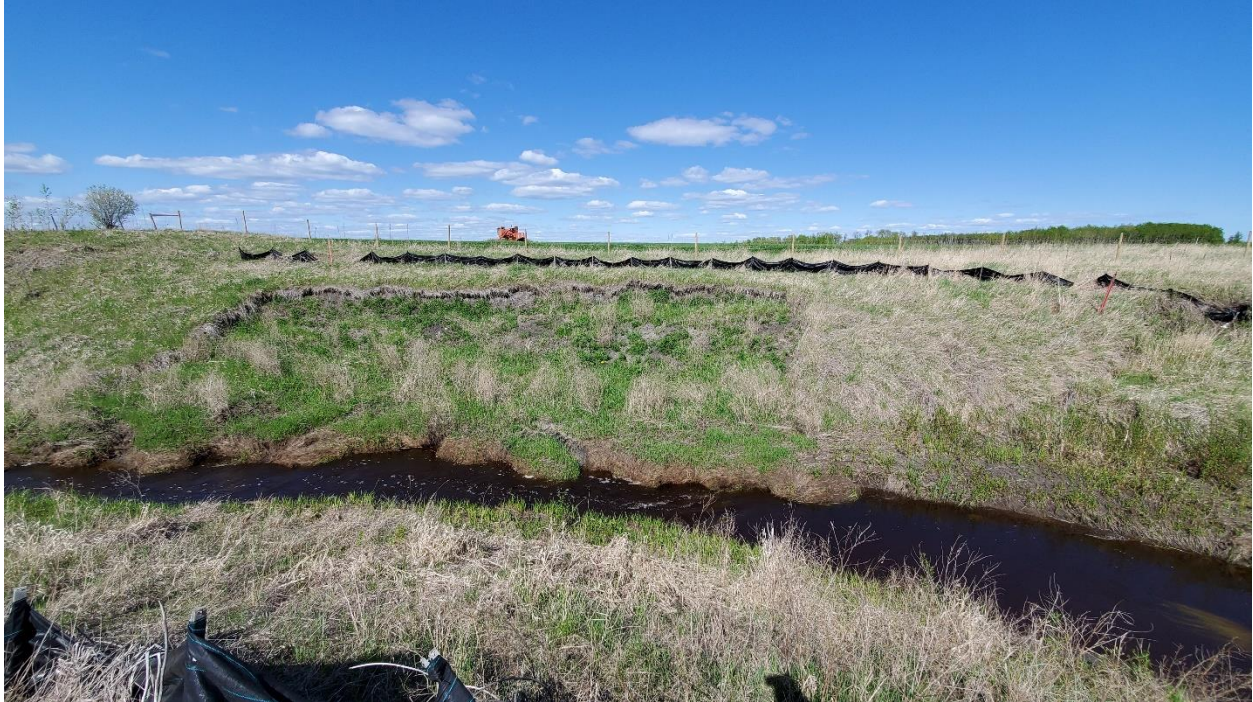
Photo 9 – Looking northeast at slump on east side of channel.

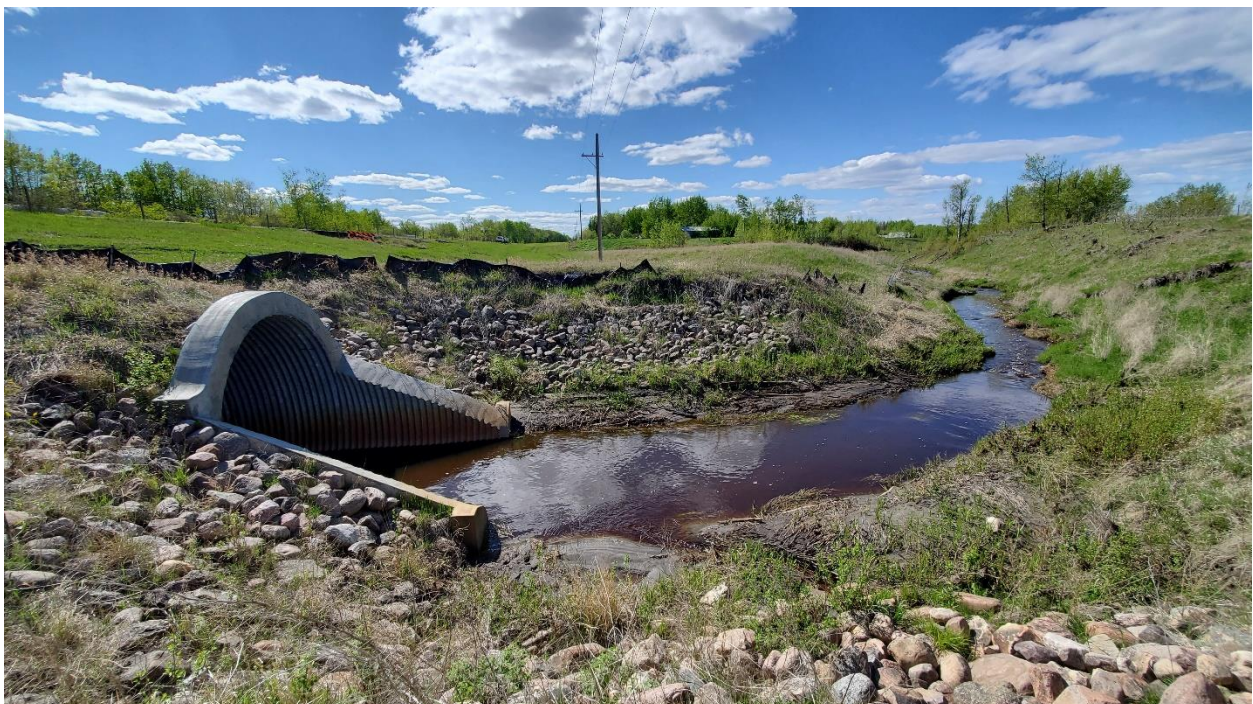
Photo 10 – Looking west at culvert outlet, with slump beyond, and riprap with minor movement.

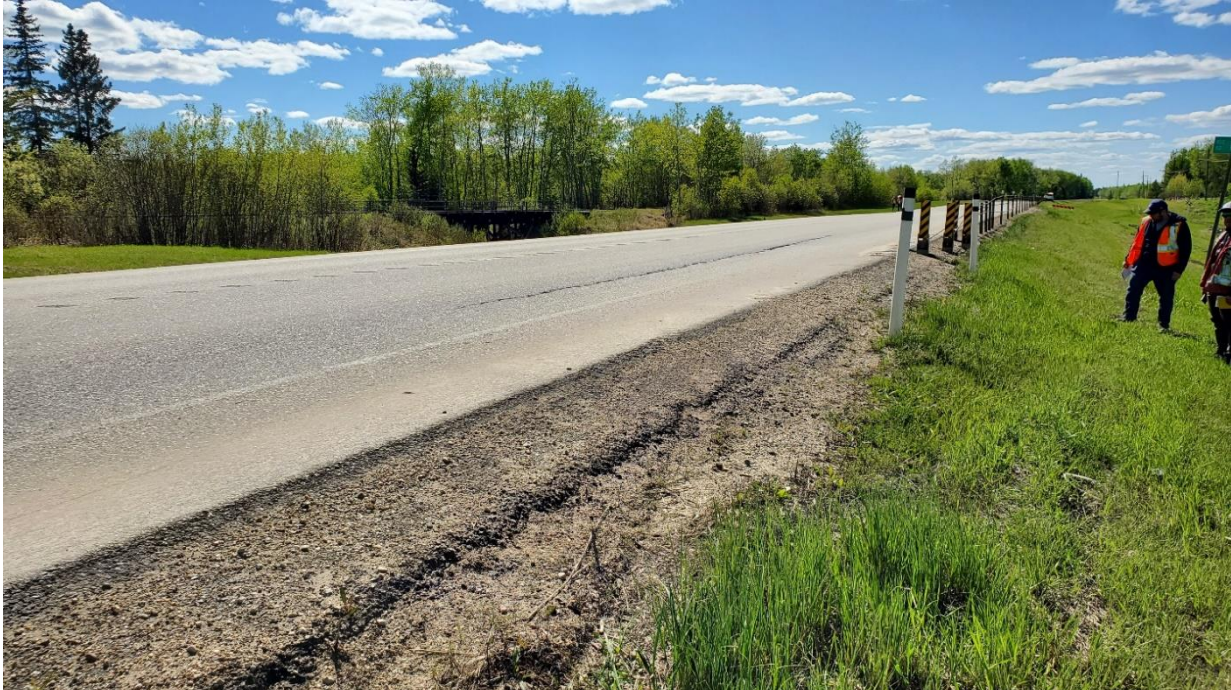
To the east of the culvert, at and further east of the end of the HTSC, there was another crack noted in the outside wheel path of the north lane. This crack was similar in appearance to the crack noted at the east end of the main slide and likely indicates impending movement at this second location. The embankment at this location was about 2 m high with a 4H:1V sideslope.

Photo 11 – Looking southwest at crack near east end of guardrail which is on the other side of the culvert from the main area of movement.

The second site on the east side of the culvert could be repaired pre-emptively using a similar methodology. This would add an estimated \$100,000 to the cost but would be less expensive as part of the other repair than as a stand-alone project if required at a later date.

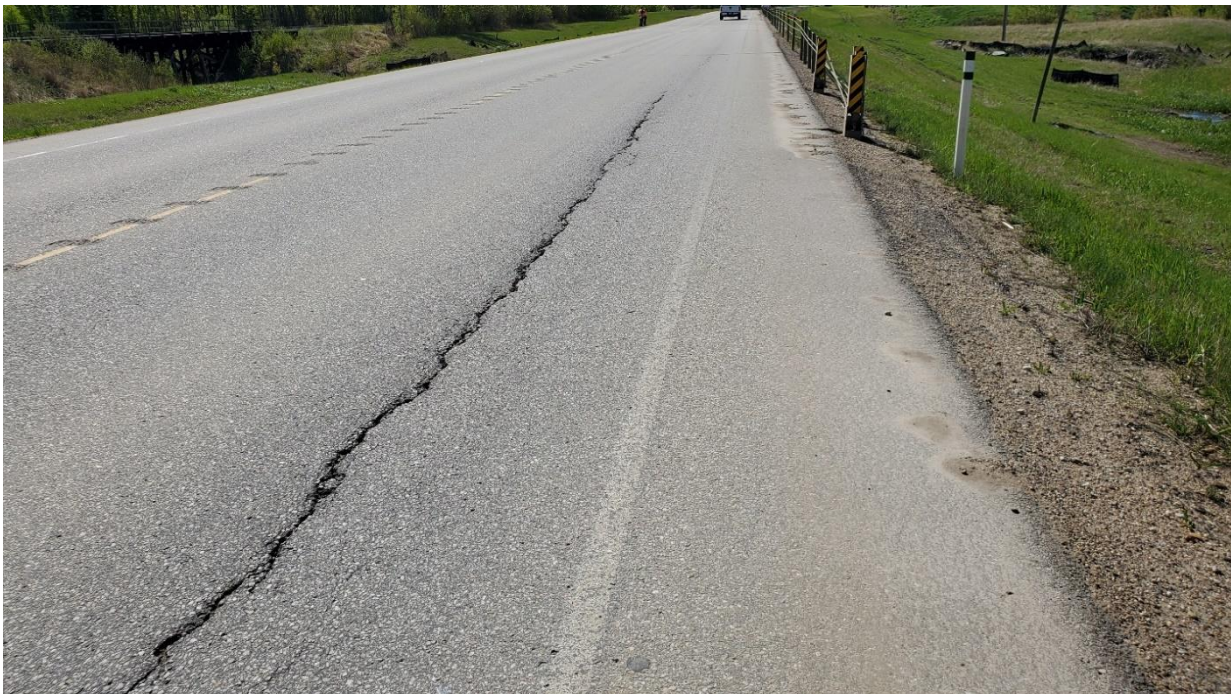
Photo 12 – Looking west at the same crack shown in Photo 11 which may be related to separate movement zone.

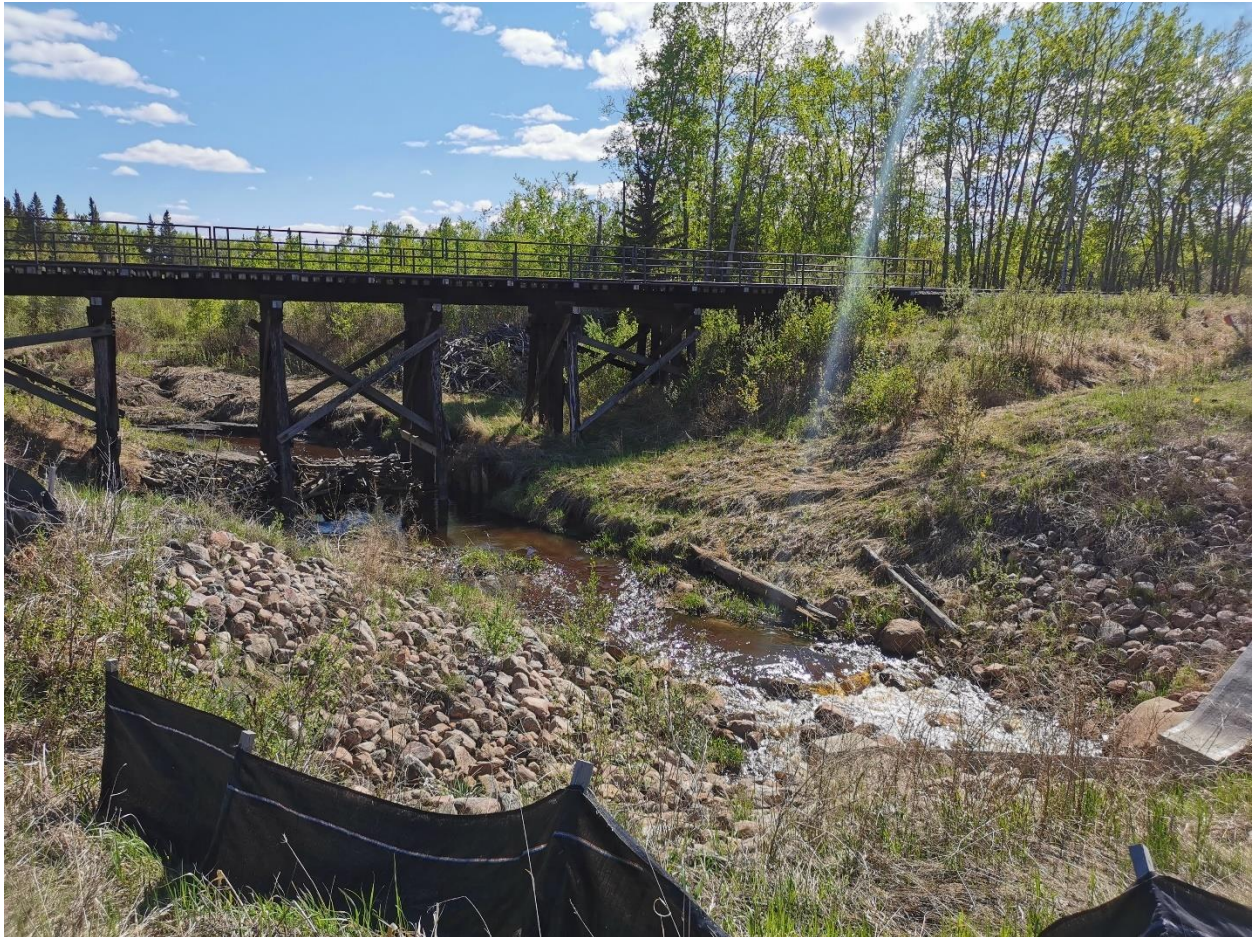
Photo 13 – Looking south at culvert inlet and adjacent rail bridge.
