**ALBERTA TRANSPORTATION
GEOHAZARD ASSESSMENT PROGRAM
PEACE REGION (PEACE RIVER DISTRICT)
2023 INSPECTION**

Site Number	Location	Name	Hwy	km
SH035-1	Southeast of High Prairie	Caudron Bridge	2:50	43.61 – 43.67
Legal Description		UTM Co-ordinates		
W10-74-14-W5M		11U E 558,678		N 6,139,283

**SH035: HWY 2:50 km 43.4 TO km 43.7
2023 INSPECTION PLAN**

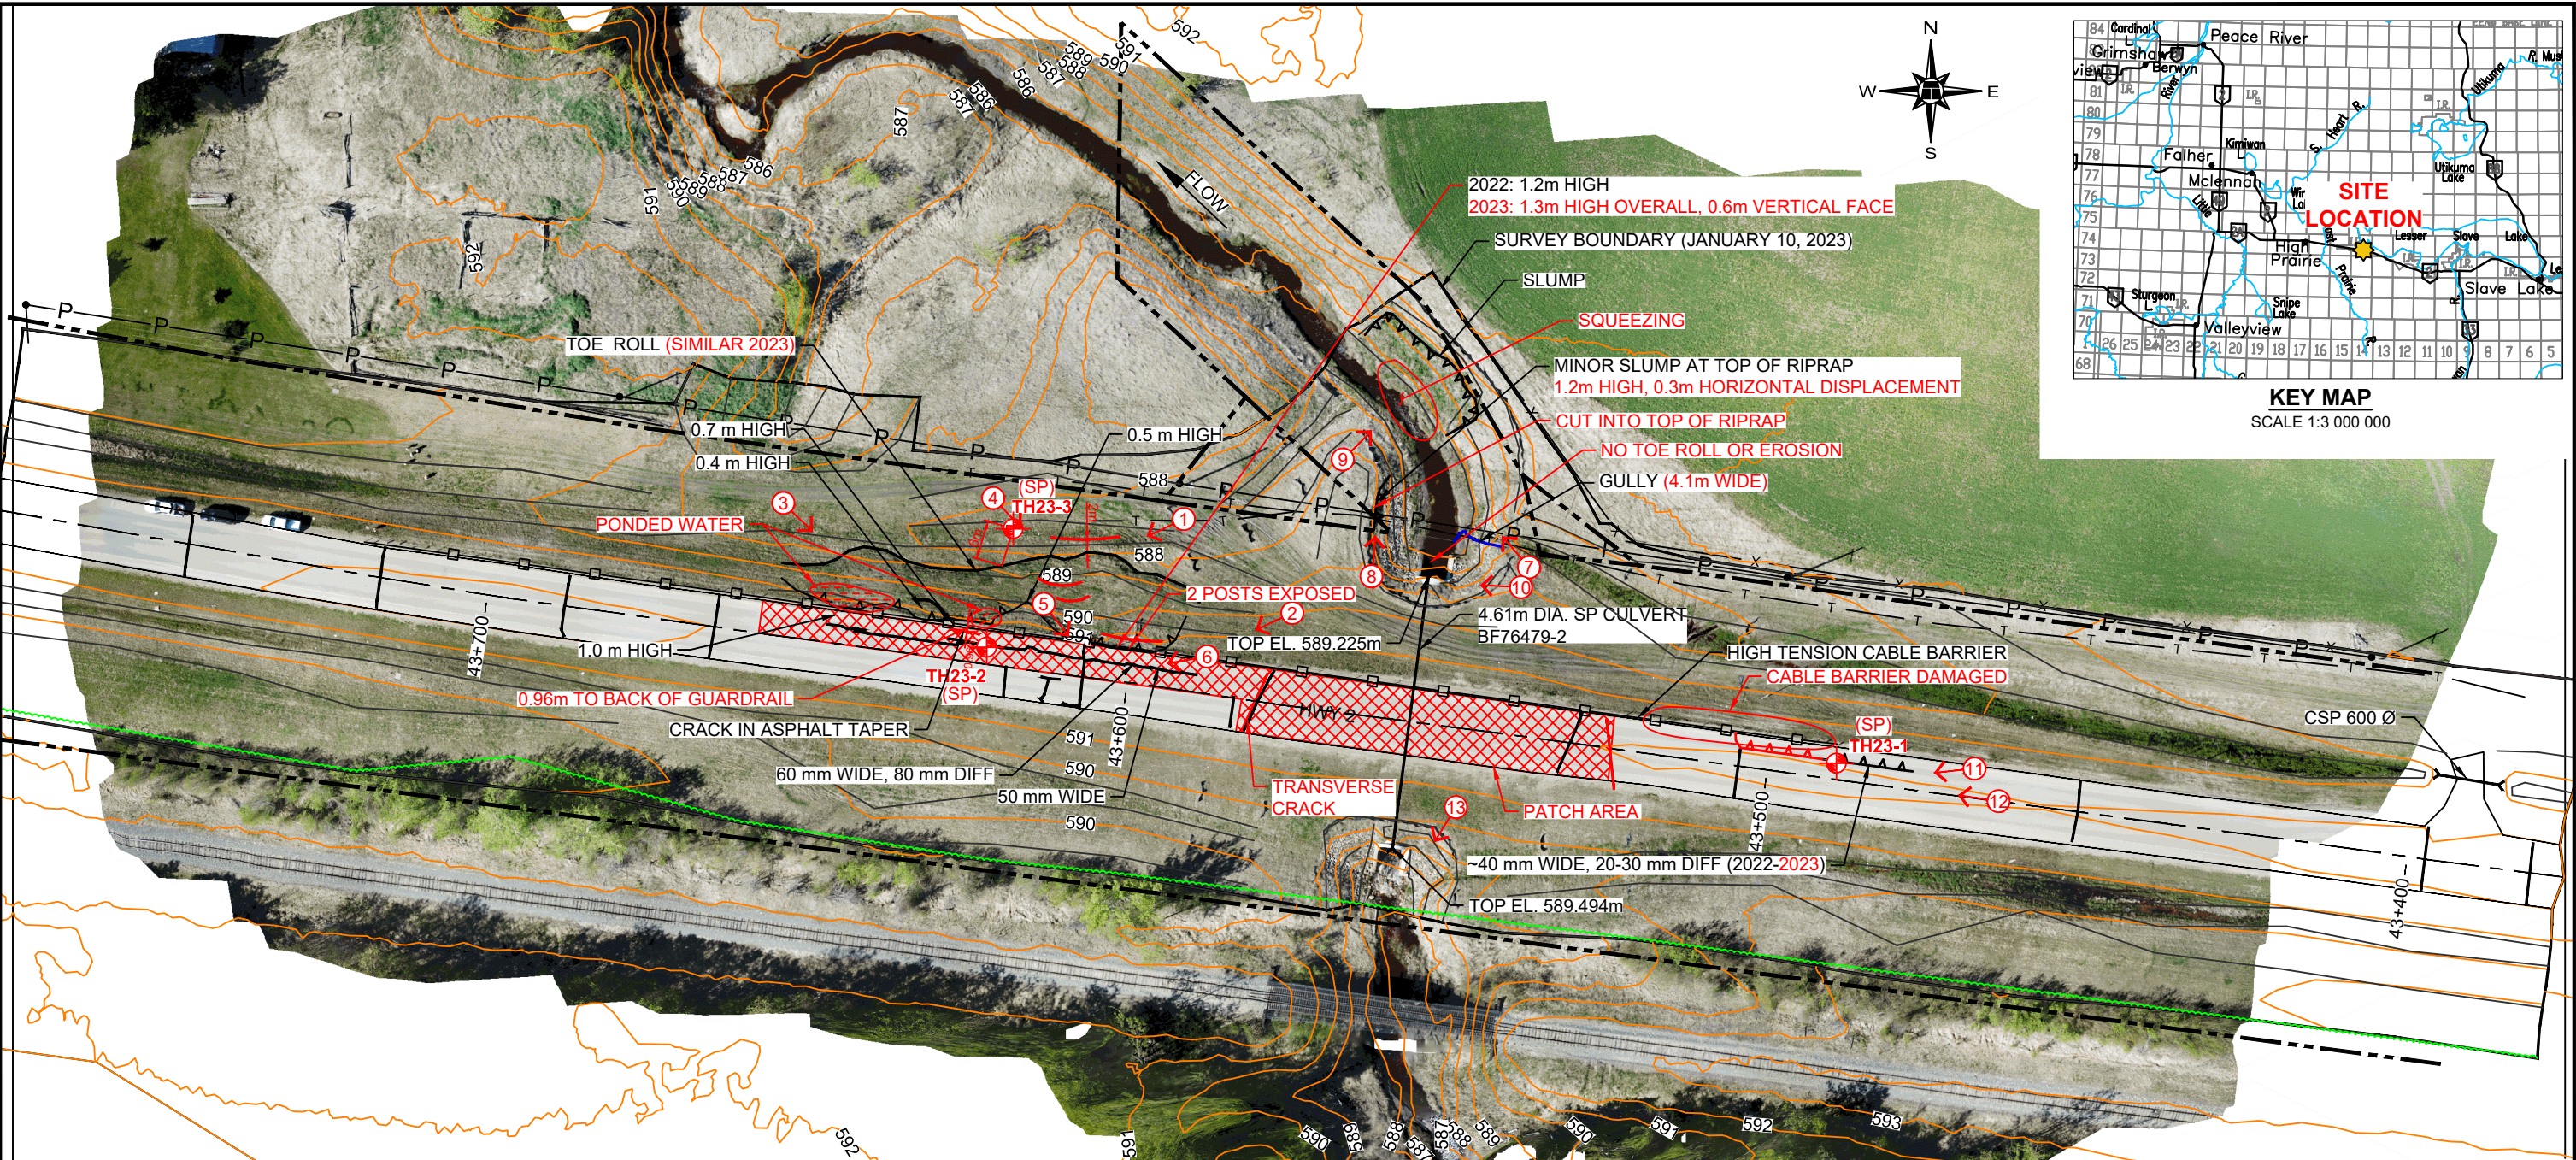
DWG NO. 32121-SH035-1

Primary Site Issue:	Landslide on the north embankment with three scarp lobes encroaching into the pavement.		
Dimensions:	65 m long and embankment height of 4 m.		
Date of Remediation:			
Maintenance:	Spring 2023: Highway patched		
Observations:	Description	Worsened?	
<input checked="" type="checkbox"/> Pavement Distress	Landslide-related cracks in the outer wheel path of the WBL adjacent to scarp requiring patching. Secondary cracks forming in outer wheel path of WBL at east end of site.	<input checked="" type="checkbox"/>	
<input checked="" type="checkbox"/> Slope Movement	Landslide scarp at highway edge with toe roll at ditch level approximately 65 m in length. Displacement causing distress at pavement edge and retrogressive scarps in pavement surface. Two of the high-tension steel cable (HTSC) guardrail posts are exposed at the scarp closest to and west of the culvert.	<input checked="" type="checkbox"/>

In early 2023, the site was drilled for a preliminary engineering assessment (see Thurber Project 35964). The test holes drilled through the highway WBL, and the north ditch (locations shown on the drawing) encountered about 1.2 m to 3.5 m of clay fill overlying firm to stiff, high plastic native clay that extended to depths 2.7 m to 6.9 m below ground surface. The clay was underlain by clay till that extended to the bottom of the test holes.

Based on the review meeting with TEC, the selected remedial option was Option 2 which includes excavating the upper portion of the failed landslide, replacing it with gravel and using suitable clay from the excavation for to construct a toe berm. Construction is scheduled for 2024.

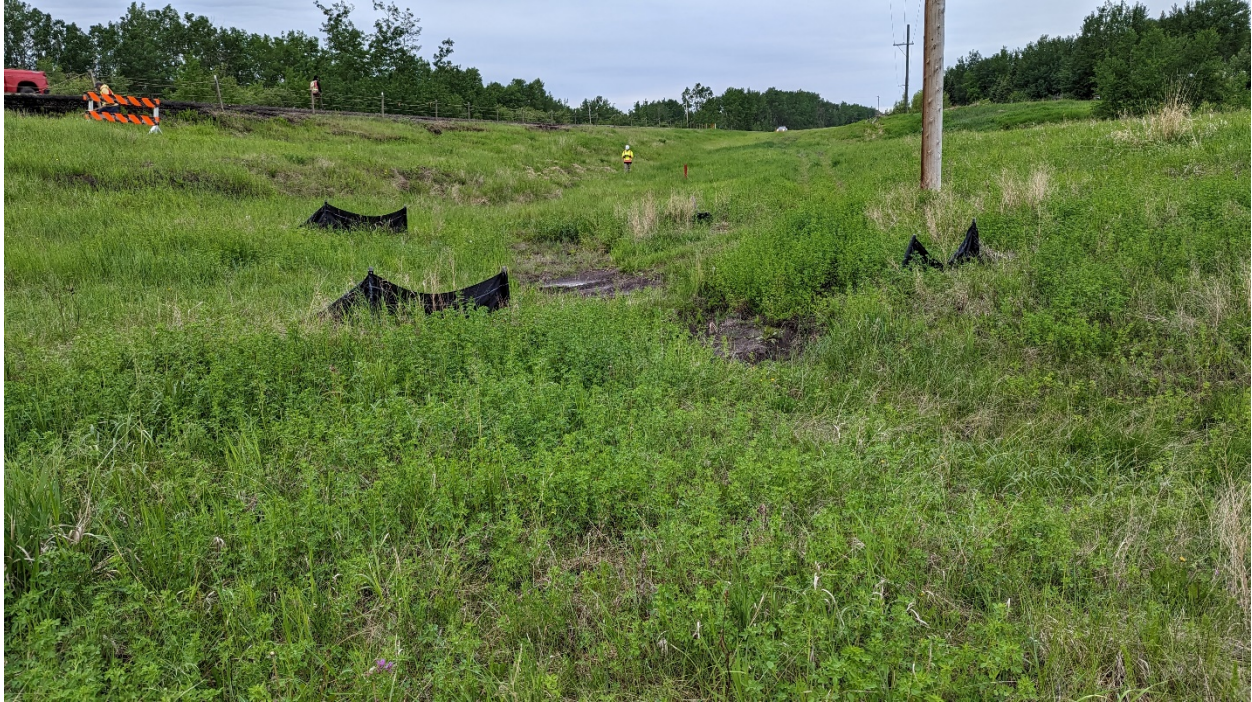
At the time of the call-out inspection, the main slump on the west side of the culvert was approximately 65 m in length and had three "arcs" encroaching near the pavement edge. There was a visible toe roll over most of the length which was between 0.5 m and 0.7 m in height. The embankment increased in height from about 3.5 m at the west end to 4.5 m at the east. The west-most "arc" did not affect the highway and had approximately 1.0 m of vertical displacement. The second arc, with approximately 0.7 m of vertical displacement, was roughly parallel to the highway and there was a crack forming in the asphalt taper just south of the high-tension steel cable (HTSC) guardrail. The third arc, closest to the culvert, was the largest and had undermined one post of the HTSC which had increased to two posts in 2023. This scarp was about 9 m in width (measured at the edge of asphalt), about 1.2 m of vertical displacement, and was about 350 mm into the asphalt although still within the shoulder of the road. There appeared to be at least two layers of asphalt exposed in the scarp. In addition, there were parallel cracks in the outer wheel path of the north lane. The crack furthest into the highway was 60 mm wide with 80 mm of height differential. The north sideslopes of the embankment outside of the slumped zone are about 3H:1V becoming about 5H:1V over the culvert outlet.

Photo 1 – Looking southwest at slump in north shoulder.

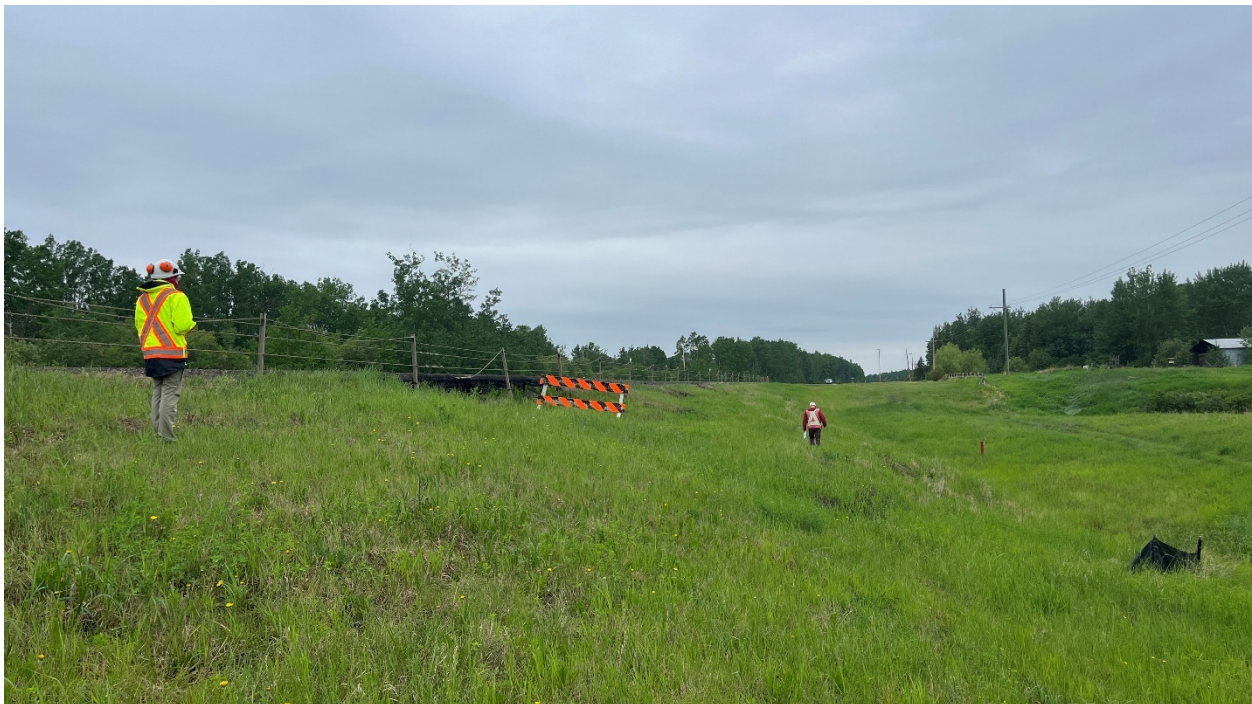
Photo 2 – Looking west from the east end of slump.

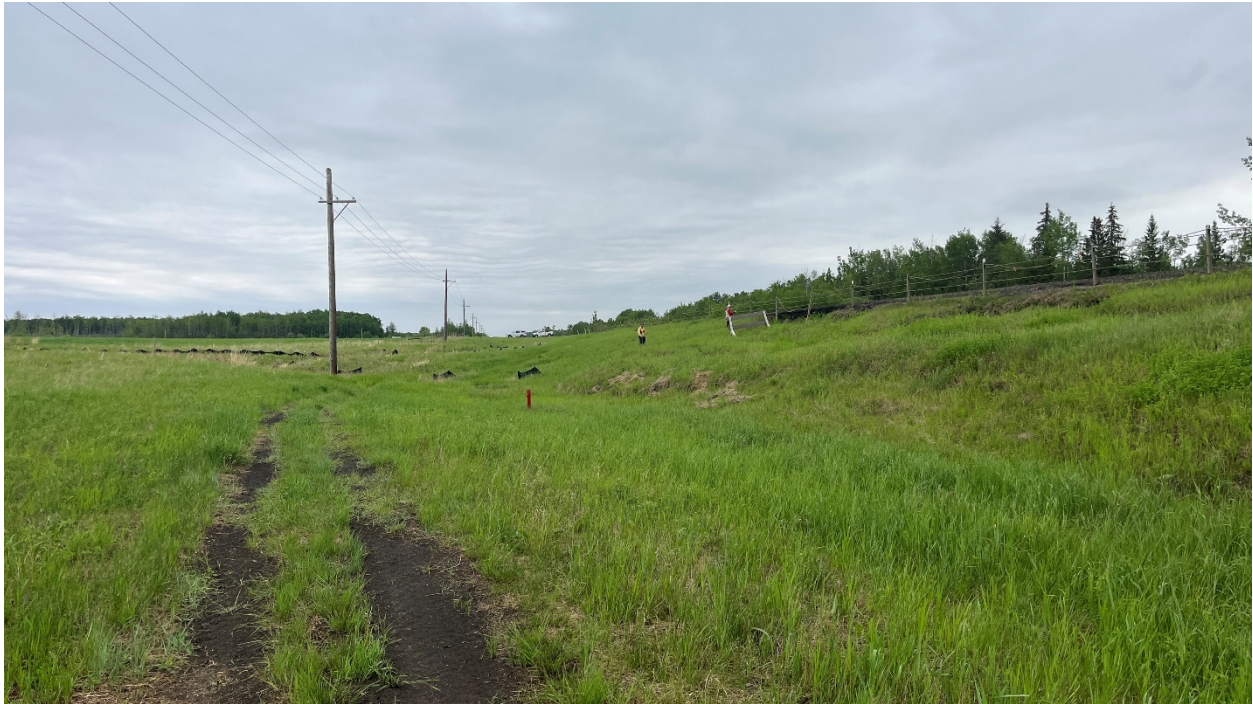
Photo 3 - Looking southeast at the slump.

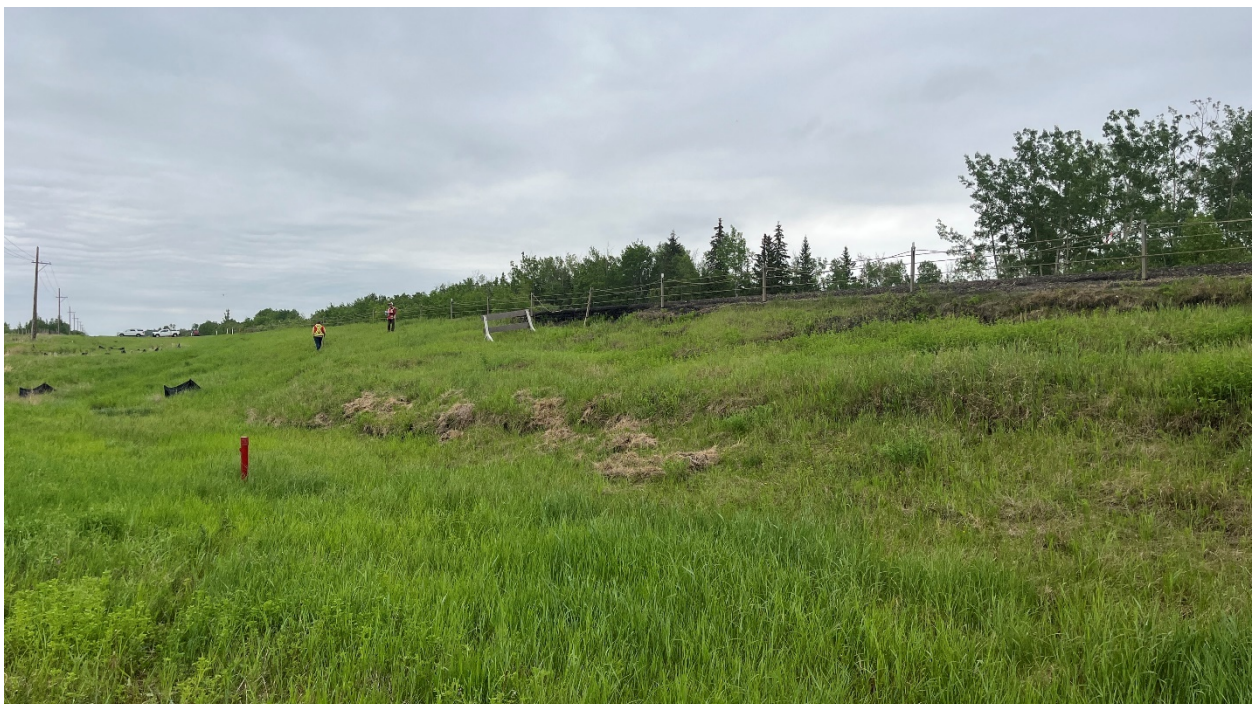
Photo 4: Looking southeast at the east end of the slump; note the presence of a well-defined toe roll.

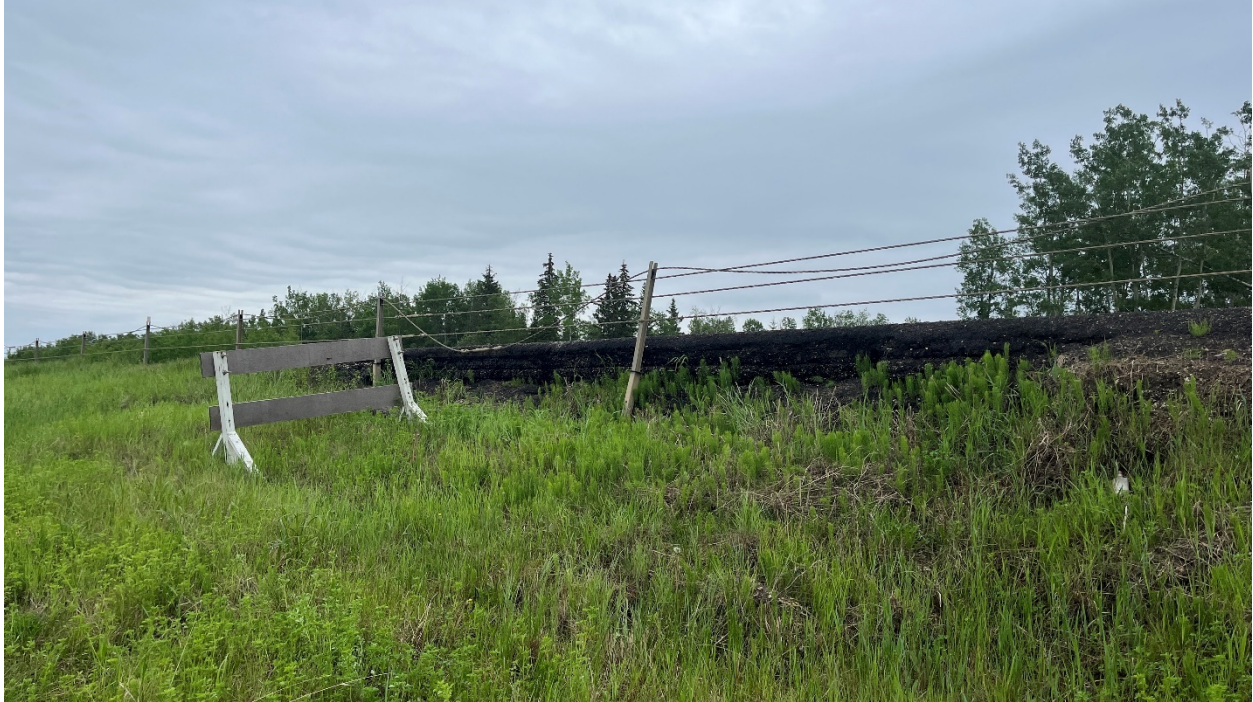
During the 2023 geohazard inspections, the cracks on the highway upslope of the three "arcs" had been covered with the recent patch and had not yet reflected through. The west-most and middle arc did not appear to have indications of further displacement. For the third (east-most) arc, west of the culvert, the vertical displacement had increased by 0.1 m to a total height of 1.3 m. Three layers of asphalt were exposed and the granular base course (GBC) was also visible. Additional tension cracks were observed downslope of the third arc. Ponded water was also observed in the "bowl" areas of the west-most and middle arcs.

Photo 5 - Looking southeast at undermined guardrail and exposed pavement structure.

- Road maintenance should continue as necessary to maintain a safe roadway surface and may consist of patching and crack sealing of the ACP. It may be beneficial to place a small wedge of gravel or sand bags against the exposed face of edge of pavement to provide lateral support and potentially reduce the ravelling rate of GBC (if the scarp drops significantly to expose the GBC below the road).

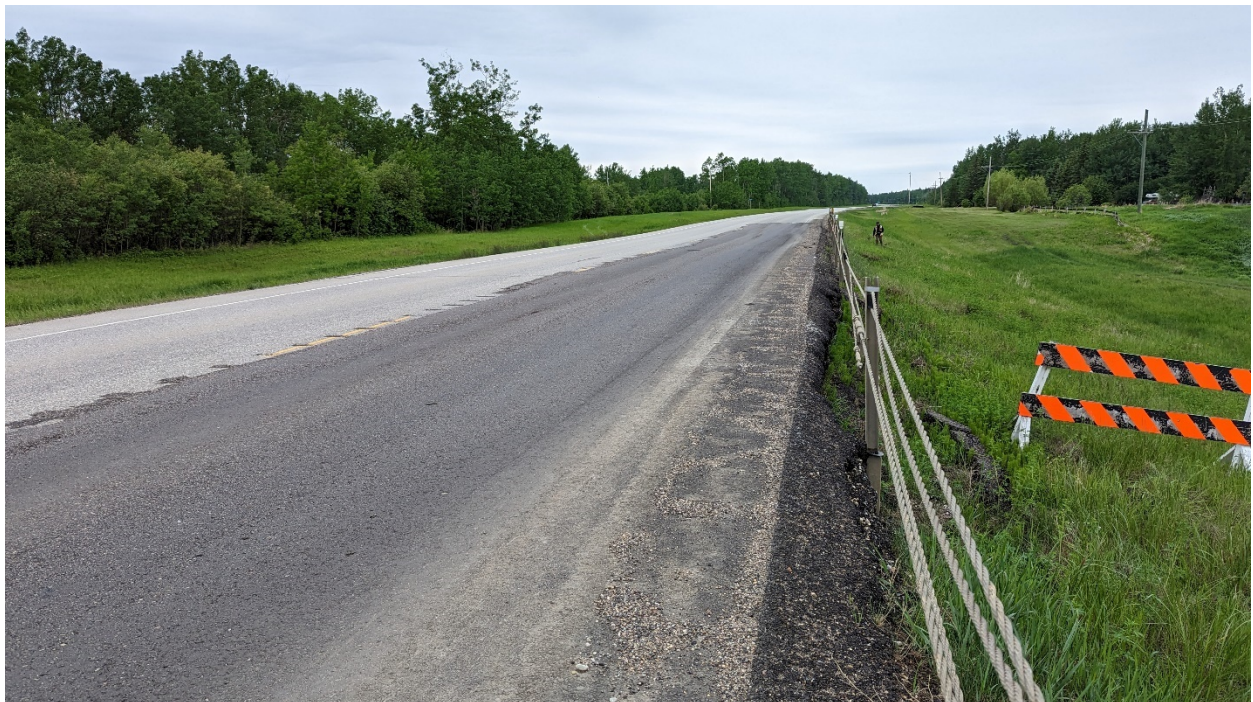
Photo 6 - Looking west at location of previous cracks and subsidence in highway above scarp shown in Photo 5.

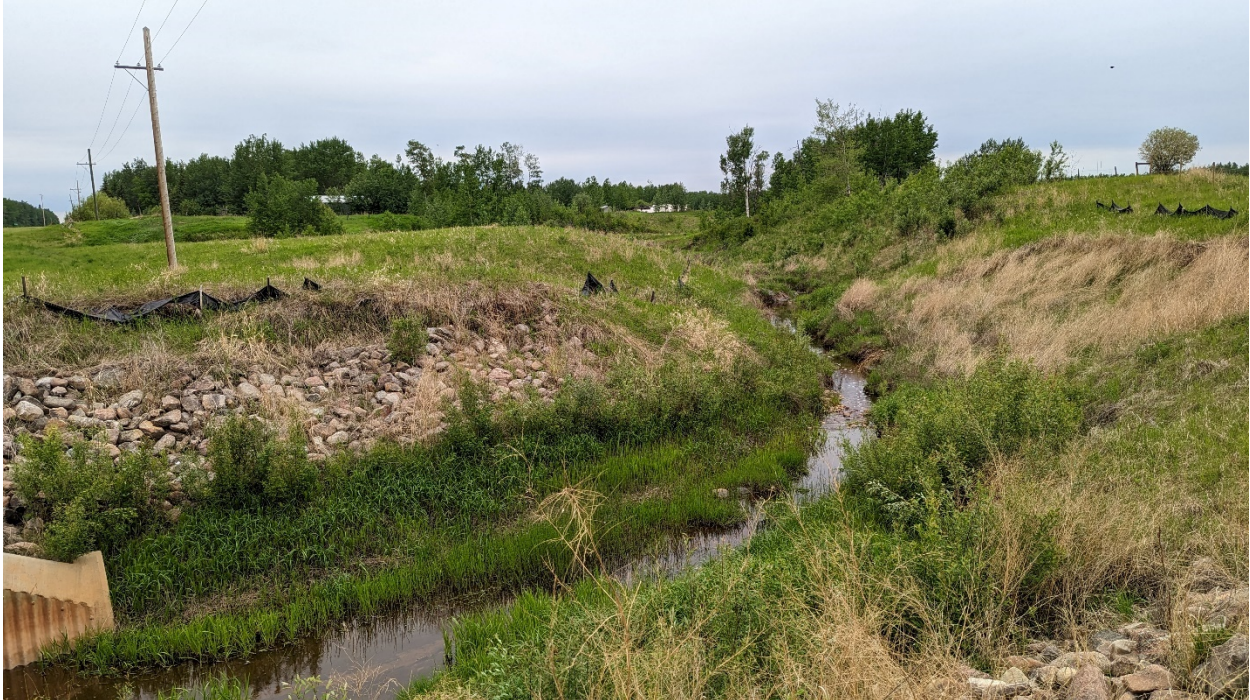
Photo 7 – Looking north (downstream) along the creek. There is minor slumping at the top of the riprap on the west (left) side and a larger slump further downstream on the right (east) side.

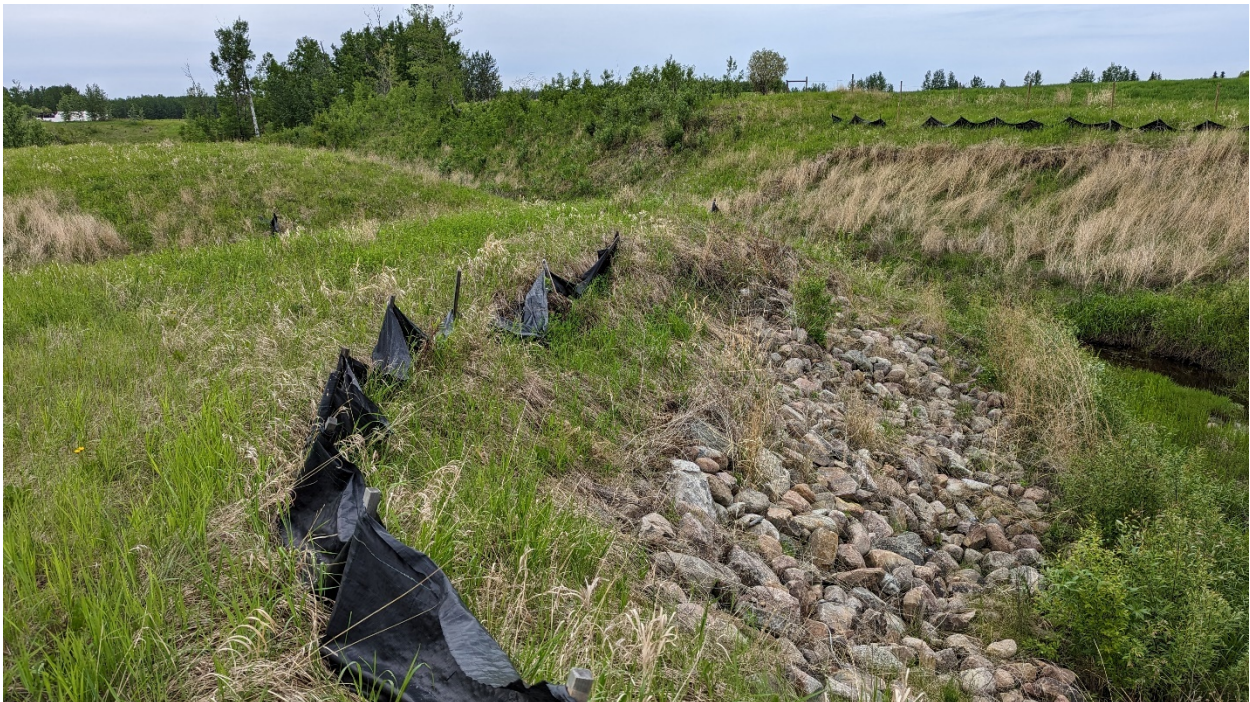
Photo 8 – Looking at slumping above west riprap (somewhat obscured by grass).

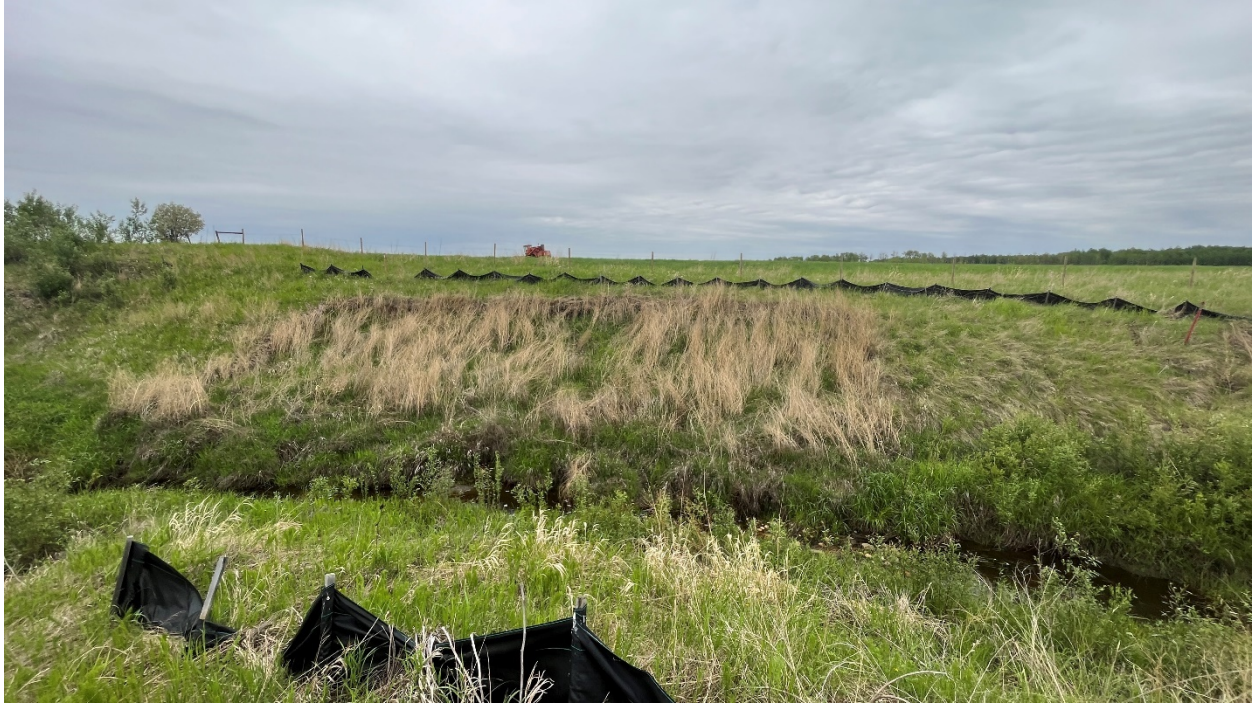
The culvert outlet itself continues to have no signs of instability. However, the slumping of the riprap on the west bank showed minor increases in displacement compared to the conditions observed during the call-out. The toe of the slump on the east bank north of the culvert outlet (about 17 m wide) appears to be constricting the channel. The gully created from the drainage channel from the east ditch widened since the call-out inspection.

Photo 9 – Looking northeast at slump on east side of channel.

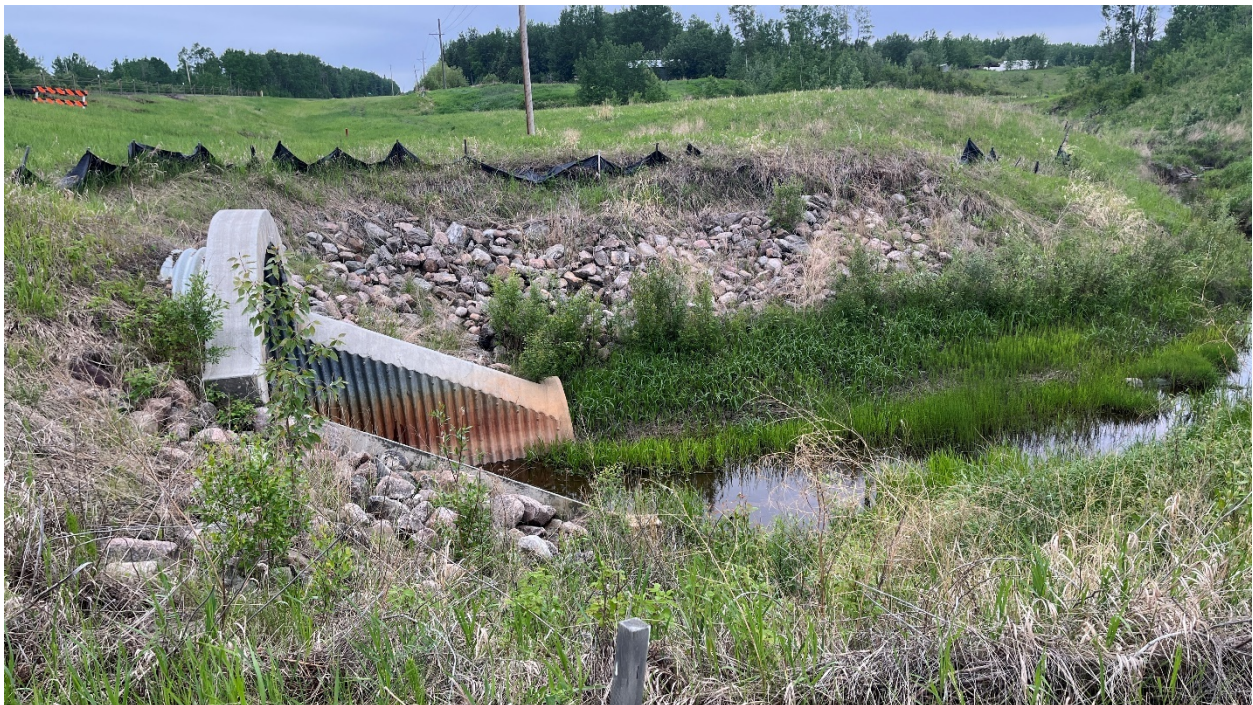
Photo 10 – Looking west at culvert outlet, with slump beyond, and riprap with minor movement.

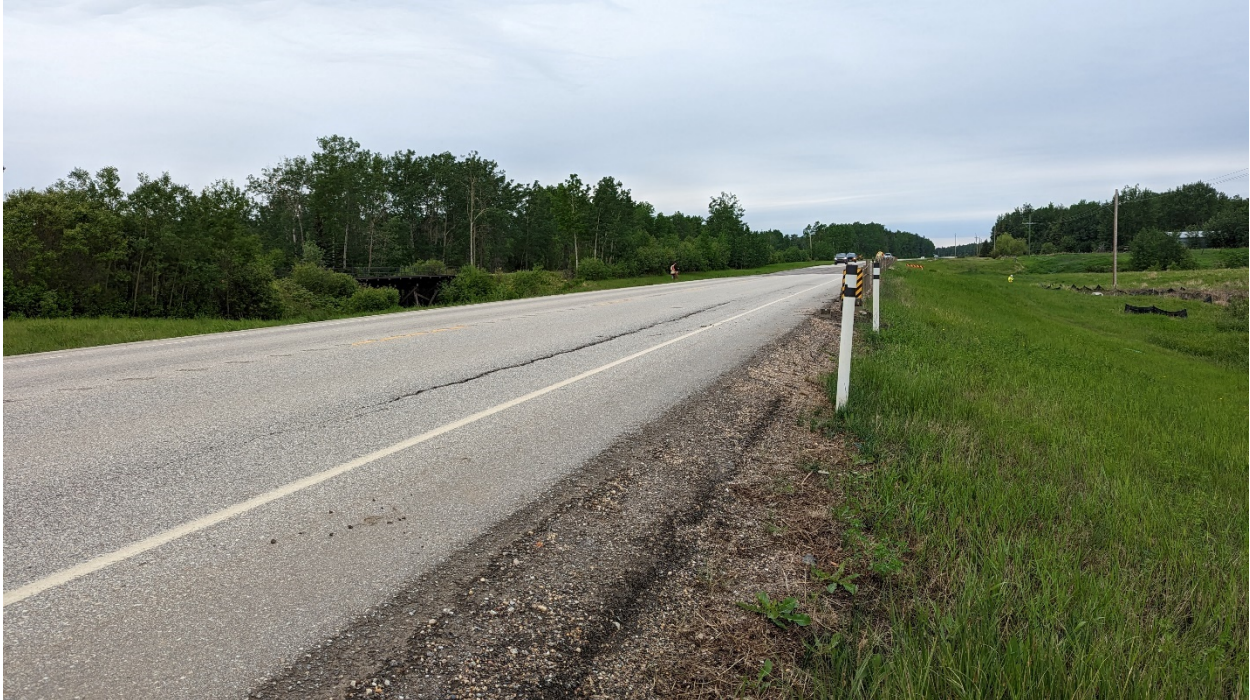
The crack observed at and further east of the end of the HTSC, extended further west. The HTSC barrier was also damaged at this location. The embankment below is about 2 m high with a 4H:1V sideslope.

Photo 11 – Looking west at crack near east end of guardrail which is on the other side of the culvert from the main area of movement.

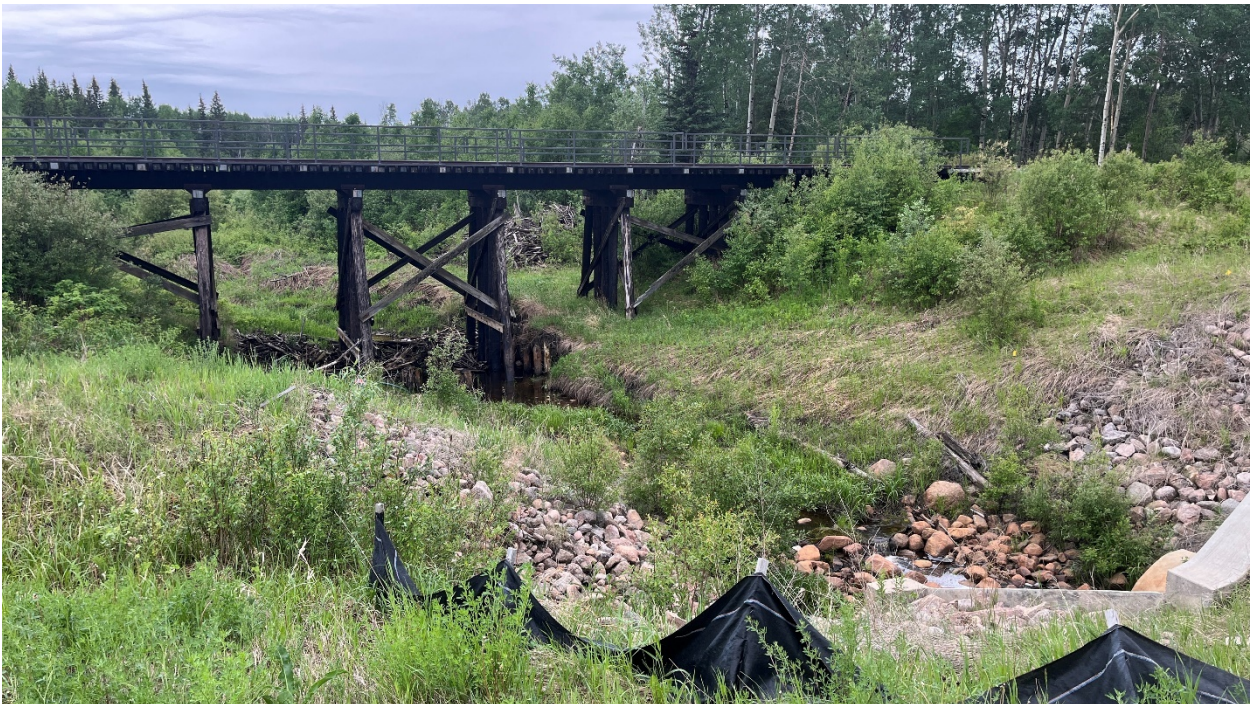
Photo 12 – Looking south at culvert inlet and adjacent rail bridge.
