**ALBERTA TRANSPORTATION AND
ECONOMIC CORRIDORS
GEOHAZARD ASSESSMENT PROGRAM
PEACE REGION (PEACE RIVER DISTRICT)
2024 INSPECTION**

Site Number	Location	Name	Hwy	km
PH002	East Hill :32+800 to 34+780 (excludes PH070 wall site - 33+800 to 34+100)	Peace River East Hill	2:60	33.5 – 34.5
Legal Description		UTM Co-ordinates (NAD 83)		
SW27 & SE 28-083-21 W5M		11V E 485640	N 6230750

Date	PF	CF	Total
Previous Inspection:	May 25, 2022 Top of East Hill (32+800-33+800)	8	3	24 (Slide Risk Rating)
	Site 1 (34+100-34+780)	11	5	55 (Slide Risk Rating)
Current Inspection:	May 27, 2024 Top of East Hill (32+800-33+800)	6	3	18 (Slide Risk Rating)
	Site 1 (34+100-34+780)	11	5	55 (Slide Risk Rating)
Road WAADT:	3760	Year:	2023	
Inspected By:	Don Proudfoot, Tyler Clay, Cole Szakacs (Thurber). Rocky Wang, Robert Senior (TEC)			
Report Attachments:	<input checked="" type="checkbox"/> Photographs <input checked="" type="checkbox"/> Plans <input type="checkbox"/> Maintenance

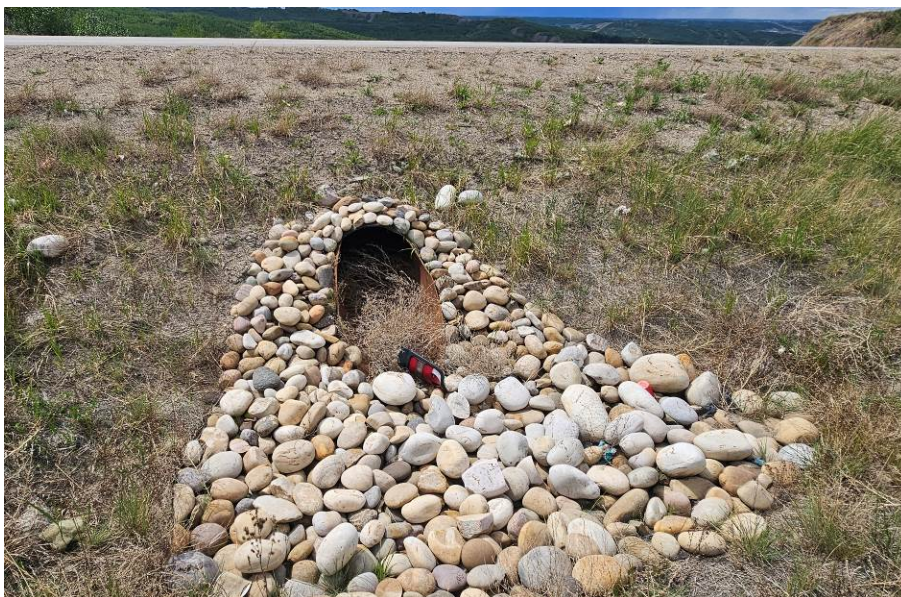
Photo 2-01.
Previously damaged and partially buried culvert inlet was repaired and rock armoured at 33+000 as part of the Fall 2022 overlay and repair work.

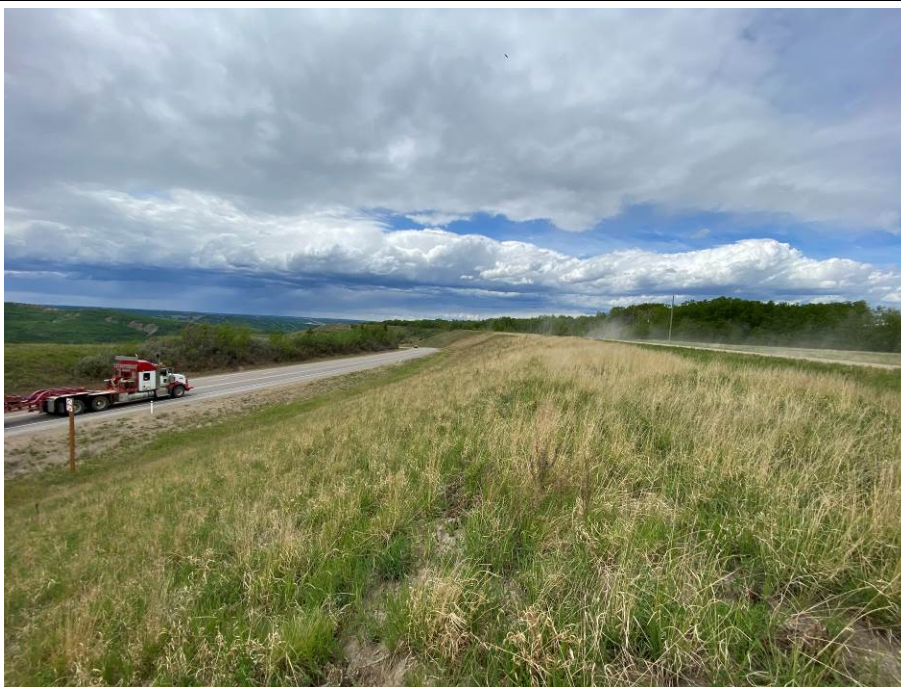
Photo 2-02.
Looking northwest at cut slope area with previous shallow slumps on the northeast side of the road (33+100). Backslope regrading and granular replacement was completed as part of the Fall 2022 repair work. Repaired slopes were good condition, well vegetated and no new slide damage was observed.

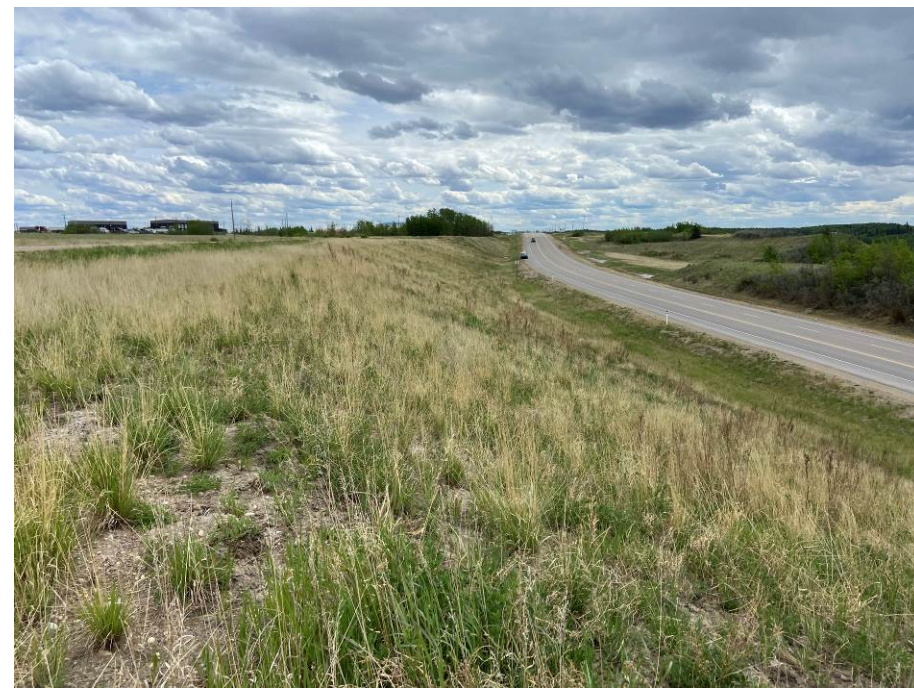
Photo 2-03.
Looking southeast at the cut slope repair section (33+150). No new slide damage was noted.

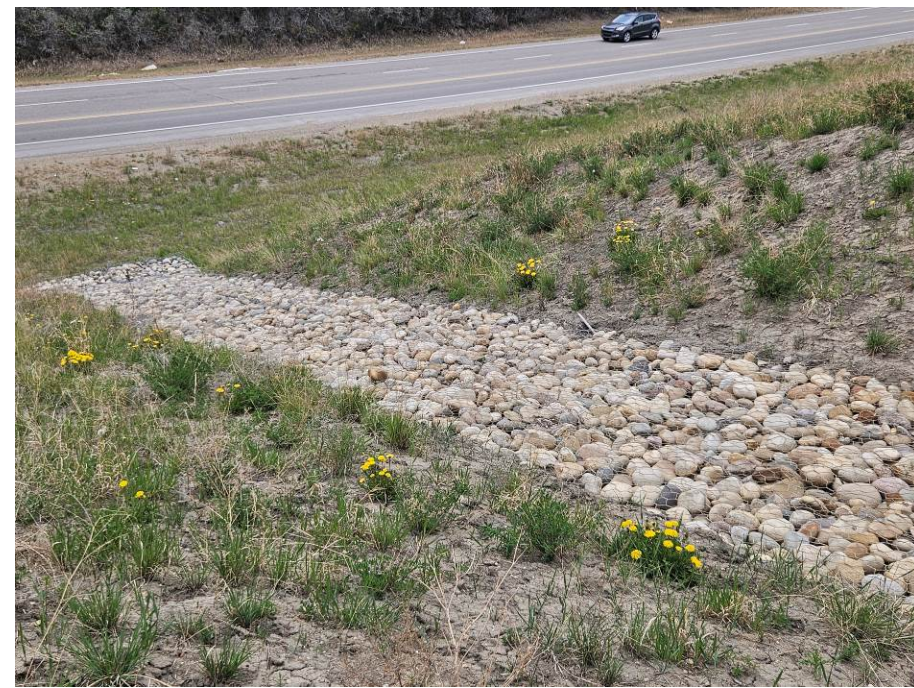
<input checked="" type="checkbox"/> Other	<p>A gabion mattress armoured drainage swale was installed near km 33+175 as part of the Fall 2022 cut slope repair work. The swale conveys ditch flow from the gravel road above the cut slope. Some minor erosion was noted at the edges of the mattress at the base to swale side slope transition. (Photo 2-04)</p>	<input type="checkbox"/>	<input checked="" type="checkbox"/>

Photo 2-04.
Looking south from the top of a gabion mattress armoured drainage swale installed near km 33+175 as part of the Fall 2022 repair work. The swale conveys ditch flow from the gravel road above the cut slope. Some minor erosion was noted at the edges of the mattress at the base to swale side slope transition.

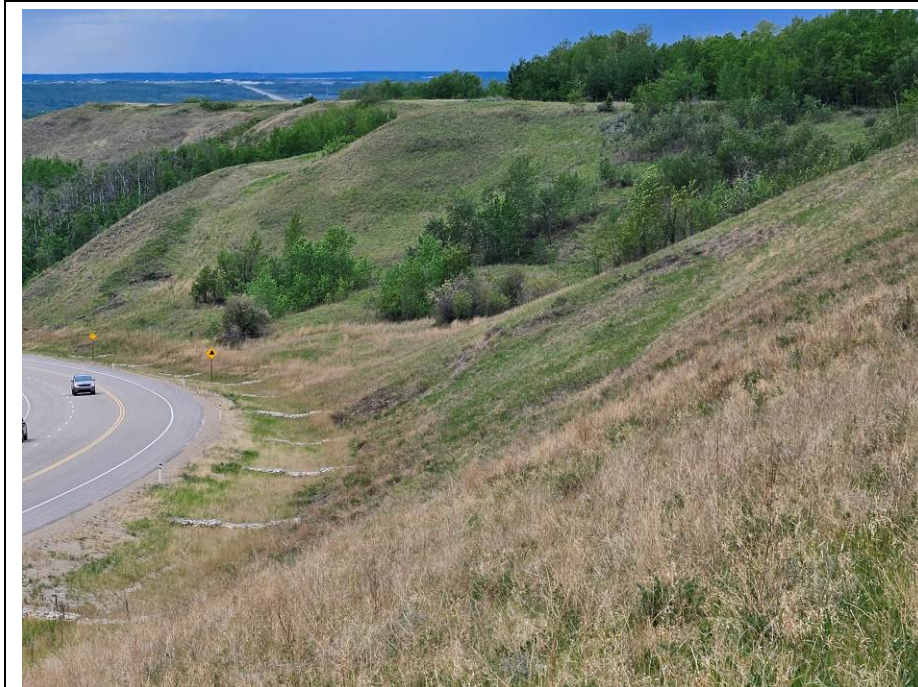
Photo 2-05.
Looking west towards the toe roll of a larger surficial slump (130 m wide) within the cut slope near 33+450. There was minor ravelling of disturbed slide materials but no major changes relative to the 2022 condition. Previous slide toe material that entered the ditch was cleaned out as part of the Fall 2022 repairs. New gabion check dams in the north ditch are visible.

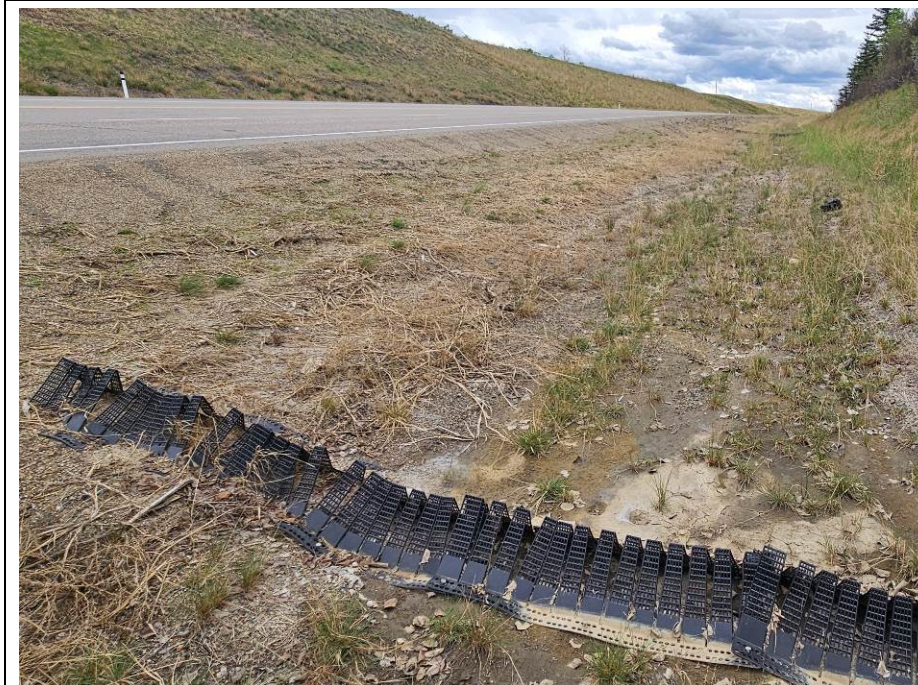
<input checked="" type="checkbox"/> Erosion	<p>Previous ditch erosion damage on the south side of the highway was repaired in 2022 between 33+300 and 33+715 with ECB and synthetic check dams installed. Overall, the ditch repairs were in good condition and grass growth was starting to develop. (Photo 2-06)</p> <p>Ditch repairs were completed on the north side of the highway between 32+700 and 33+715. ECB and synthetic check dams or gabion basket check dams (within steeper ditch grade sections) were installed. Minor erosion area (0.3 m x 0.2 m) was noted within the ditch bottom upstream of the culvert inlet near 33+715. (Photos 2-05 and 2-08)</p>	<input checked="" type="checkbox"/>	<input type="checkbox"/>

Photo 2-06.
Looking east towards the south road ditch where there was previous erosion damage between 33+300 to 33+715 that was repaired in Fall 2022. Ditch was regraded and ECB and synthetic check dams were installed.

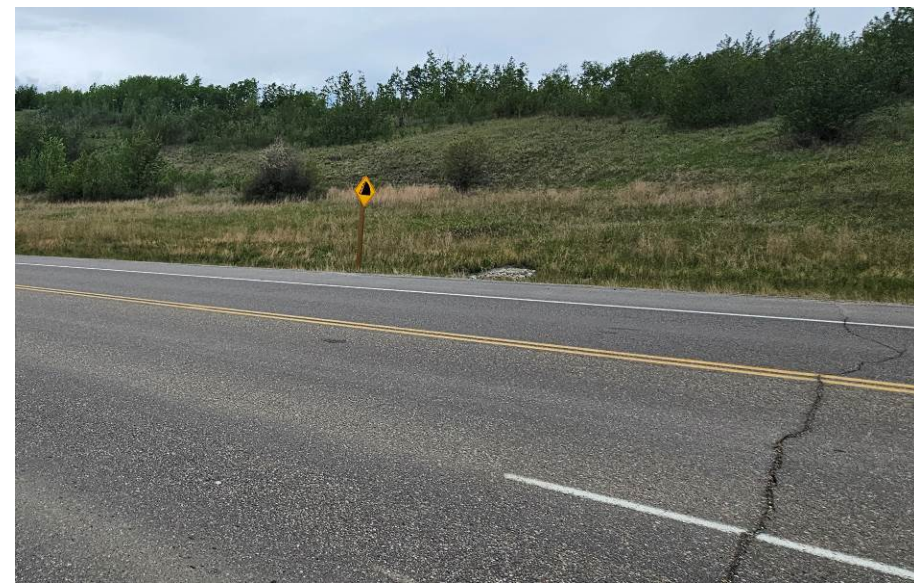
Potential exists that the landslide at 33+550 could flow onto roadway. Movements of this landslide over the last decade have been intermittent and very slow but could accelerate after a heavy precipitation event. The shallow slide upslope of the highway near 33+450 has potential to block the ditch if a large increment of movement occurs but only minor movements have been observed since 2016.

Photo 2-07.
Looking northwest towards the shallow slump north of the highway near 33+550. Previous slide toe material that was encroaching into ditch cleaned out as part of the ditch regrading work in 2022.

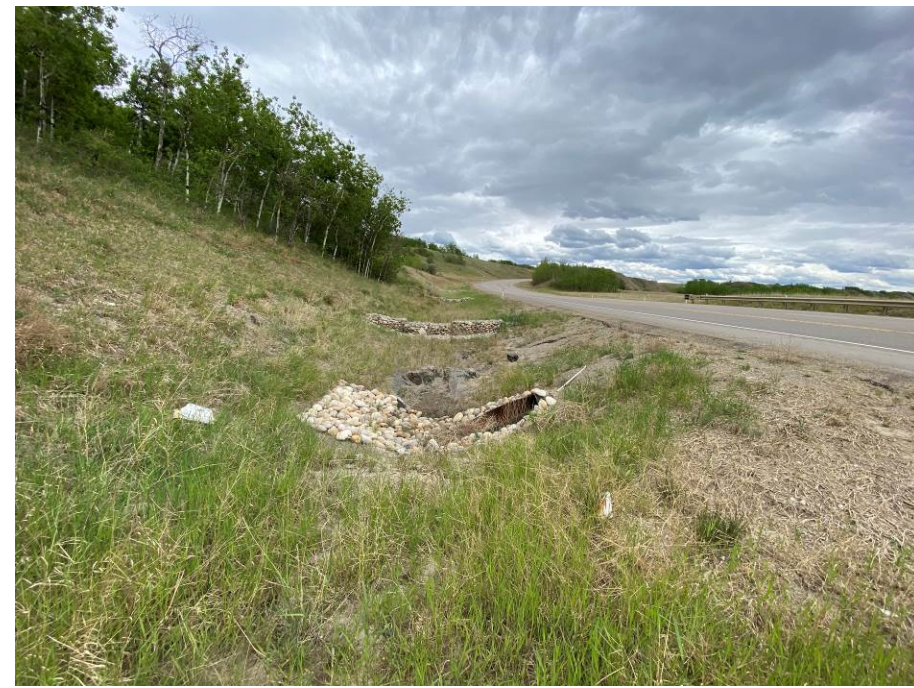
Photo 2-08.
Looking east within the north ditch at the culvert inlet near 33+715 that was relined with SWSP and inlet/outlet rock armoured during the 2022 repairs. Minor erosion area (0.3 m x 0.2 m) was noted within the ditch bottom upstream of the inlet.

- Add additional ditch armouring rock upstream of culvert inlet and downstream of outlet to the trunk drain inlet near 33+715.
- Fill erosion gully near armoured swale (34+450) with granular fill. Consider building a small berm (armoured with rock or non-permeable woven geotextile) to direct ditch flow upstream from the head of the gully into the armoured swale.

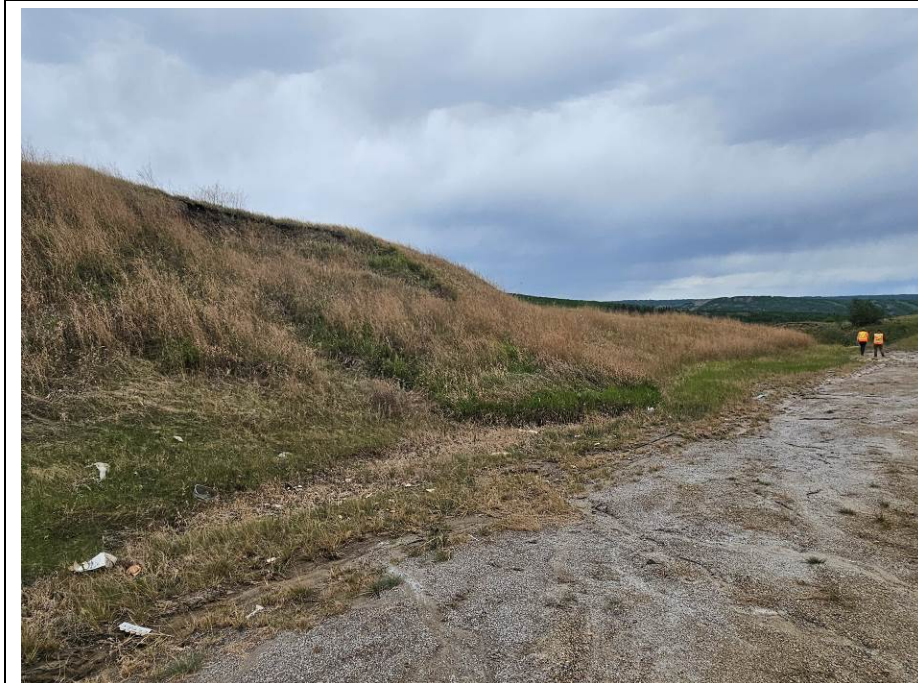
Photo 2-10.
Backslope slump near 34+000 south of highway had no visible changes from the 2022 condition.

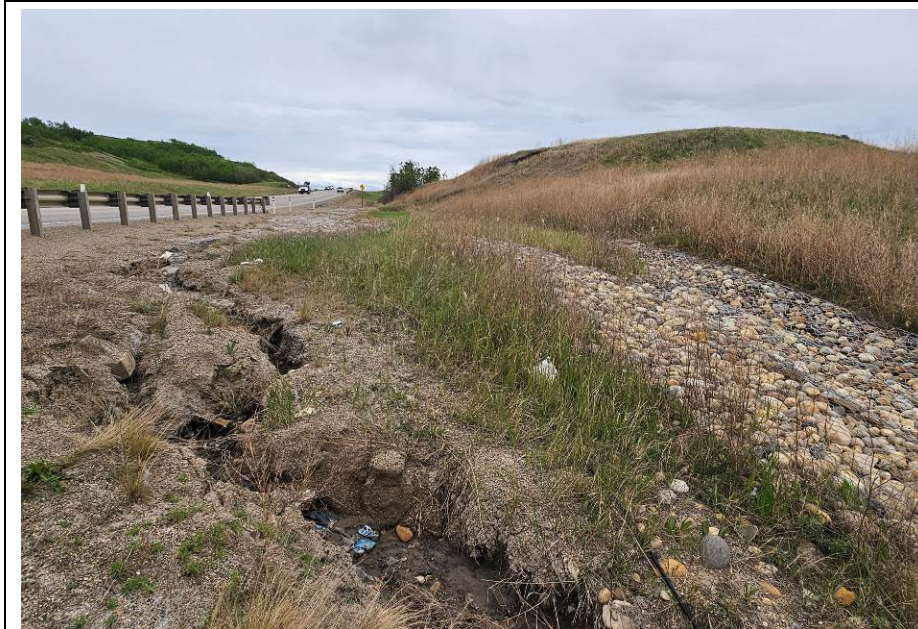
Photo 2-11.
Looking east at slightly worse erosion gully from ditch flow outside the armored swale near 34+450.

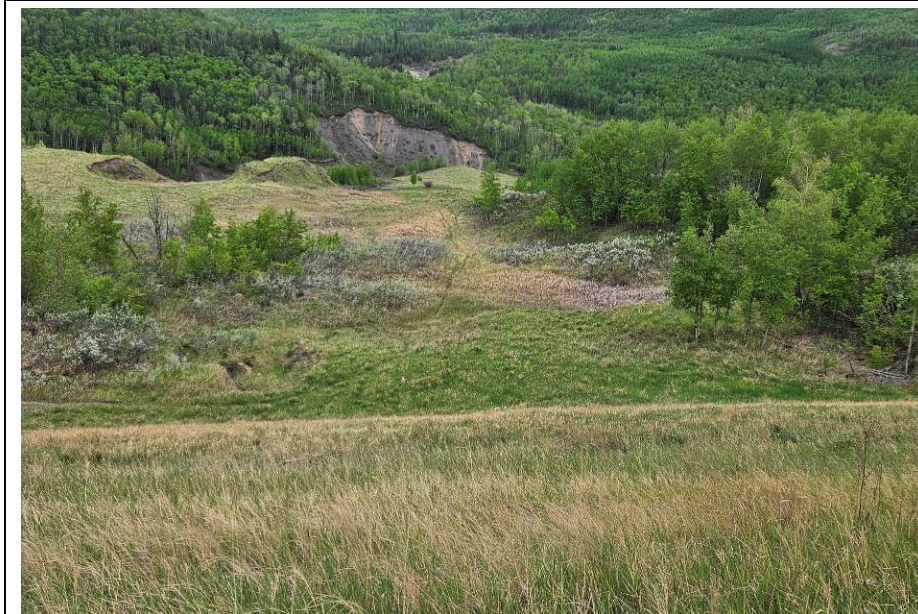
Deep-seated movements within the old berms on downslope side of roadway continue to be of concern to the stability of the road embankment at 34+550. Mitigation would be required if SI 10-3 began to register ground movements. The upslope portion of the Site 1 landslide is affected by numerous local shallow instabilities in the form of slumps. These slumps typically do not affect the roadway and toe out above the ditch. The possibility of deep-seated creep movement of the old rupture surface cannot be ruled out, although there is no surviving instrumentation to confirm or disprove.

Photo 2-12.
Downslope (south) view of the mid-slope below the road embankment near 34+550 (Old Site 1). No visible changes from the 2022 condition.

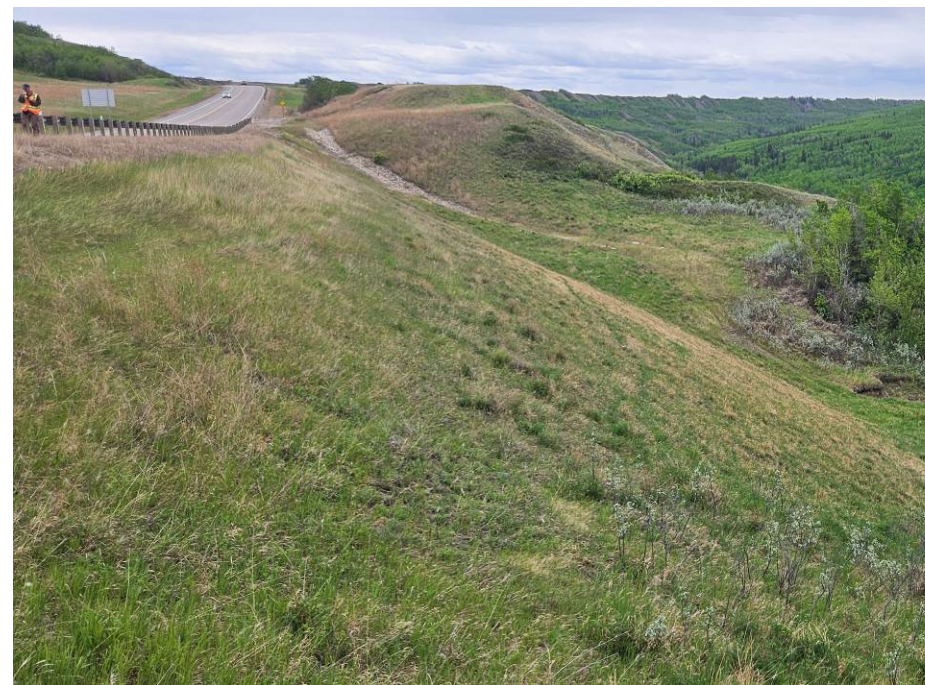
Photo 2-13.
Looking east towards the road fill embankment between 34+450 to 34+600 (old Site 1). No visible changes from the 2022 condition.

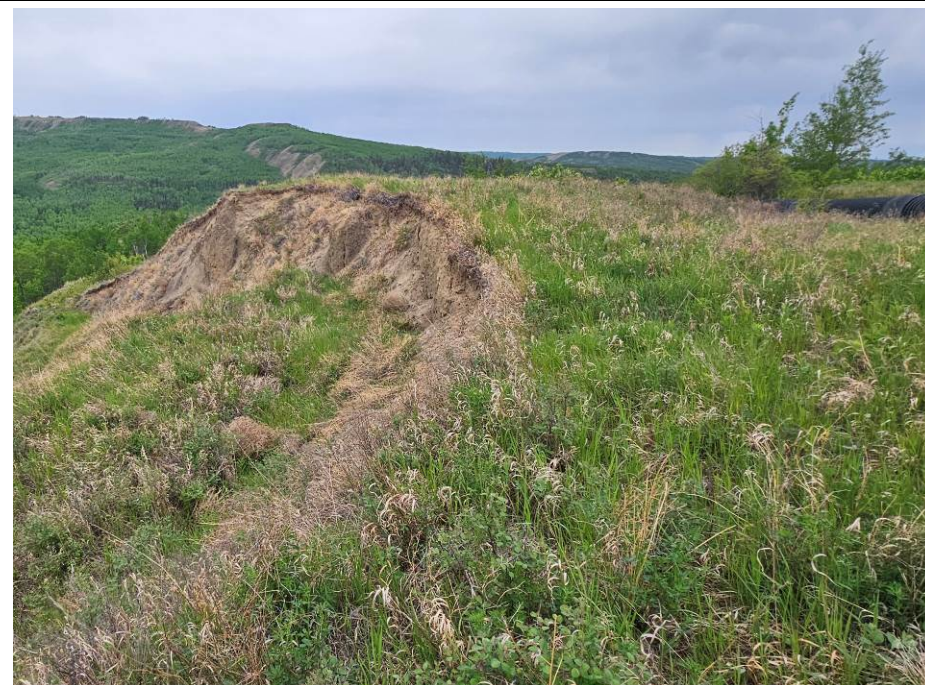
Photo 2-14.
View southwest of the 6 m backscarp near the top of trunk drain, near 34+625. No major changes visible since 2022.

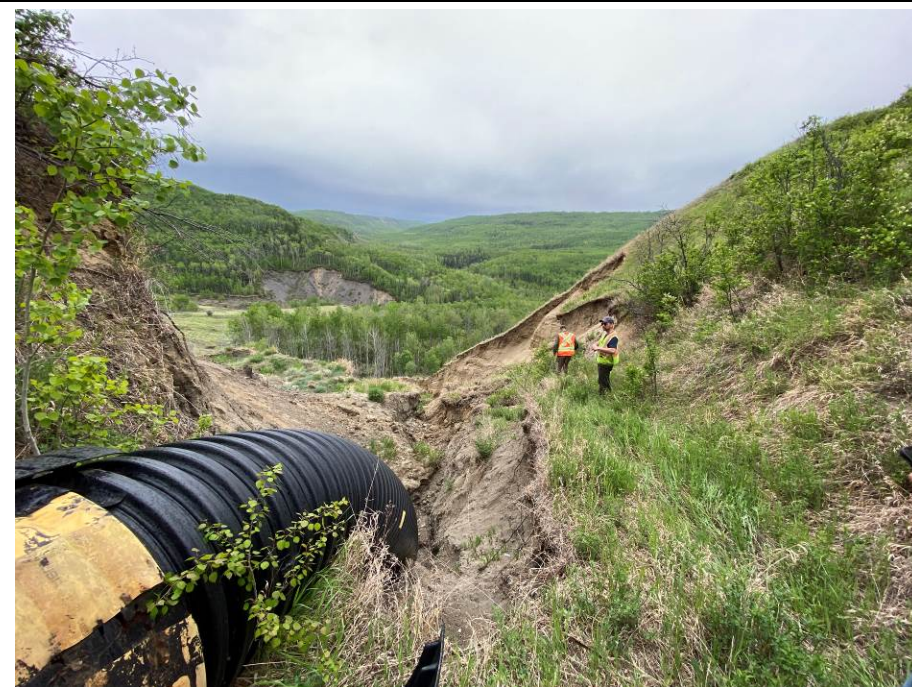
Erosion at the breach in the elephant trunk drain (34+650) has become significantly worse and will continue to retrogress further upslope and destabilize upper portions of the slope closer to the road. The drain itself has become completely disconnected further upslope and has created a new outlet area. As gullying continues it is expected the trunk drain will undergo further stress and these new leak points will continue to move upslope along the joints if left unmitigated. Diversion of the current trunk drain to a new alignment to the east is required to slow the erosion.

Photo 2-15.
Looking east at the trunk drain breach (34+650). Significant gully erosion and landsliding has developed upslope from the initial breach. Terrain is actively eroding and sliding that is expected to continue to retrogress upslope. Diversion of the current trunk drain to a new alignment is required to slow the erosion.

- A new trunk drain alignment should be constructed at 34+650. (\$350k - \$700k)

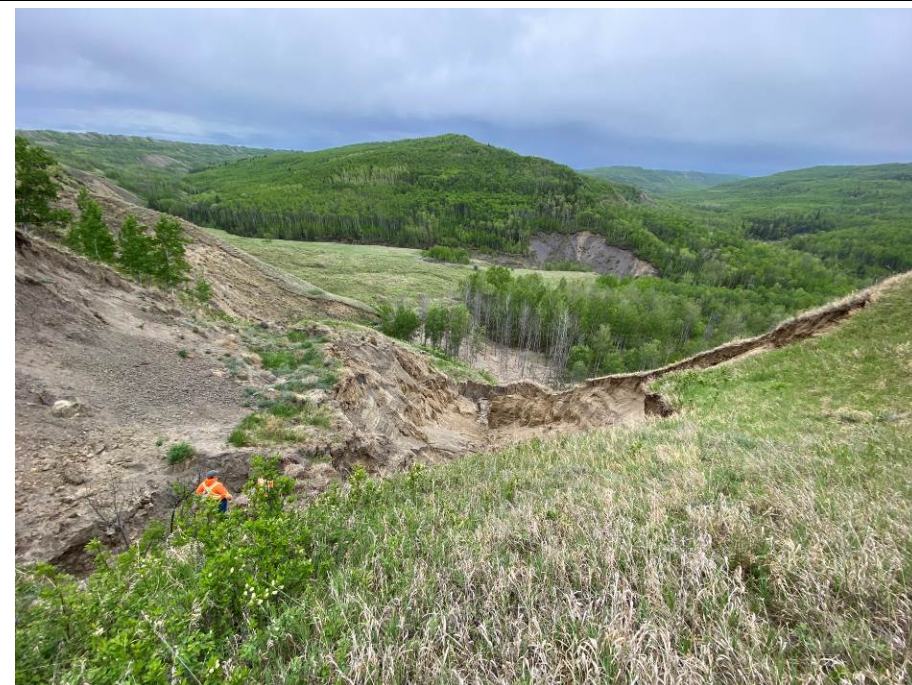
Photo 2-16.
View east of the expanded erosion gully below the hanging trunk pipe breach.
