ALBERTA TRANSPORTATION AND
ECONOMIC CORRIDORS GRMP
PEACE REGION – (PEACE RIVER DISTRICT)
INSTRUMENTATION MONITORING - FALL 2024

Site Number	Location	Name	Hwy	km
PH059	Station 34+770 to 35+680	Peace River East Hill	2:60	Km 34.8 to 35.7
Legal Description:		UTM Co-ordinates		
6-28-83-21 W5		11U E 484136.86	N	6231088.27

Current Monitoring:	21-Sep-2024	Previous Monitoring	19-May-2024
Instruments Read By:	Mr. Niraj Regmi, G.I.T and Mr. Nixon Mationg, of Thurber

**SITE PH059: HWY 2:60, PEACE RIVER EAST HILL
(SITE # 2, STATION 34+770 TO 35+680)**

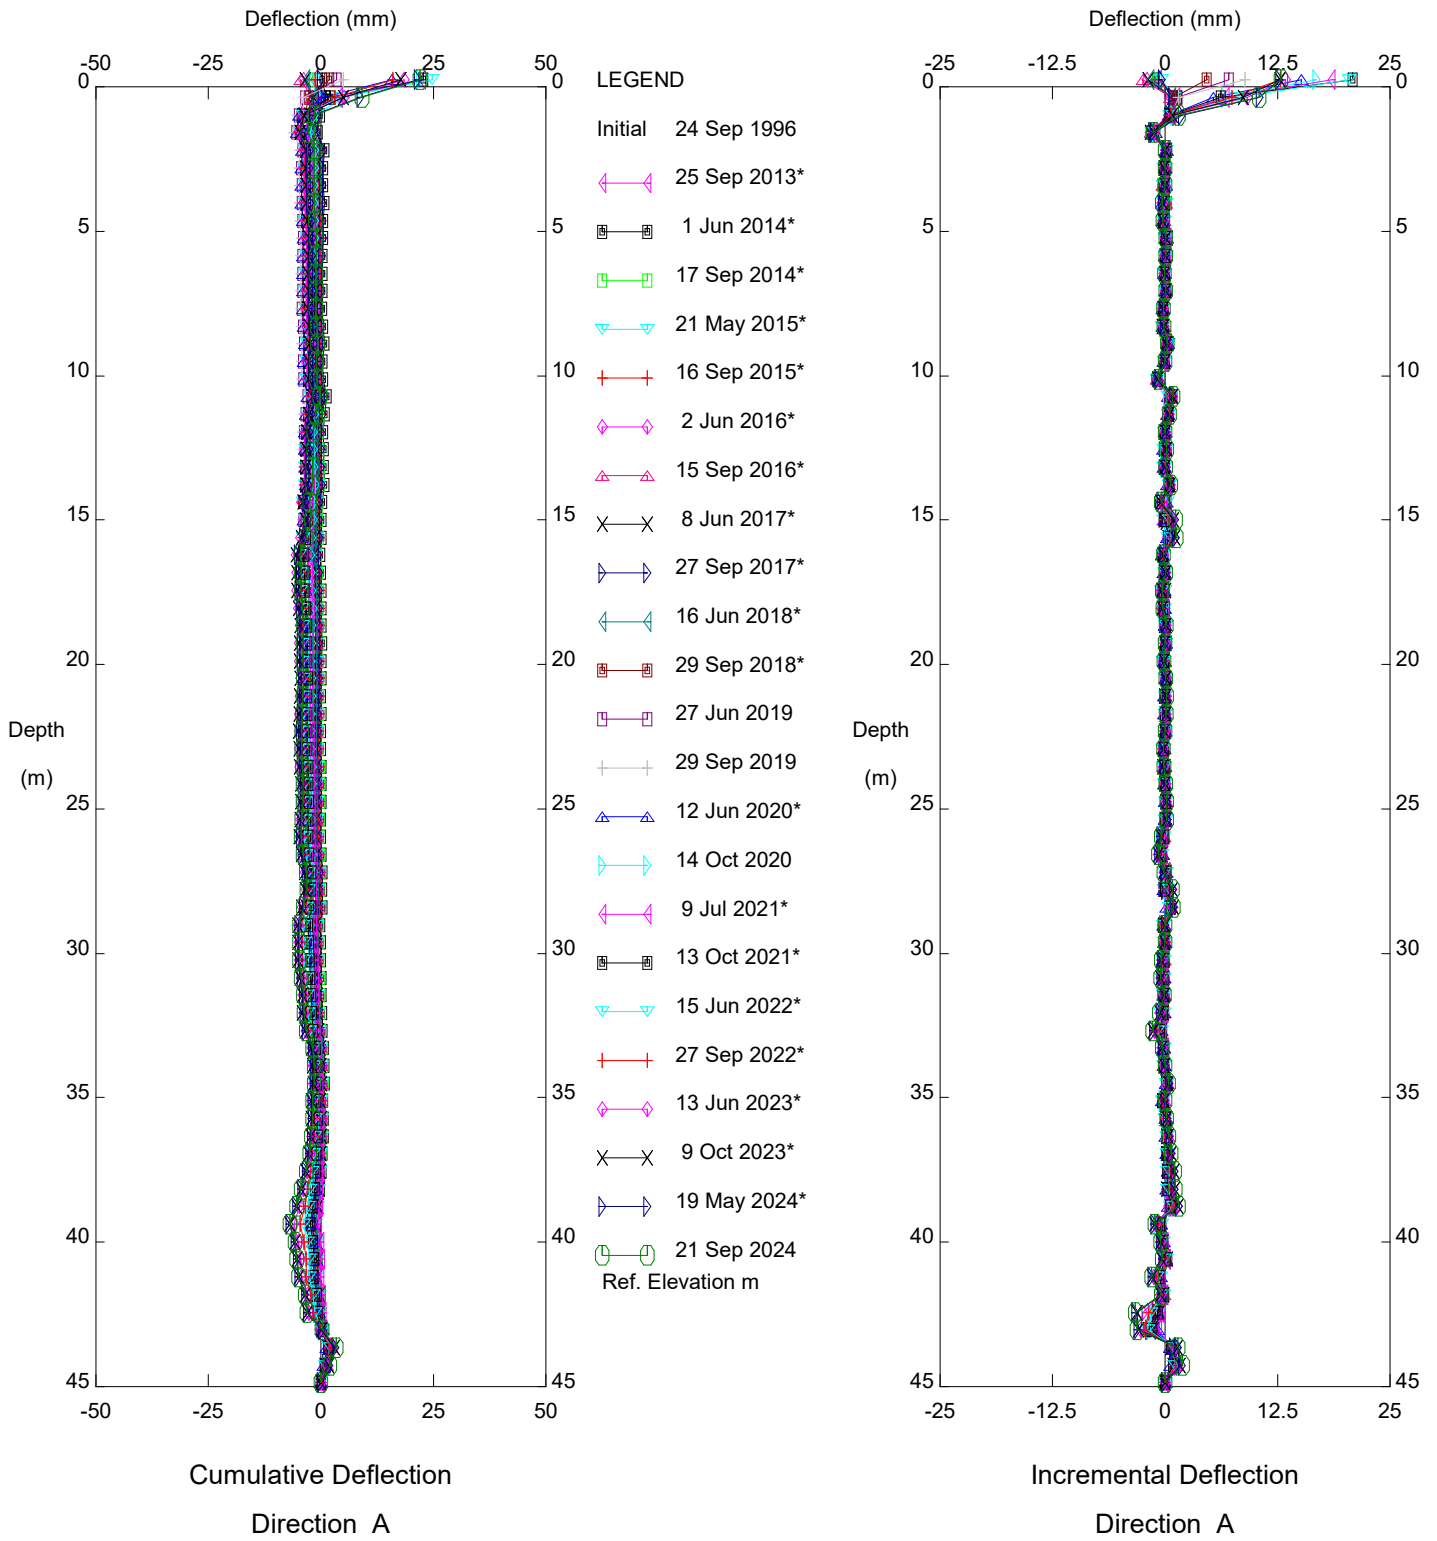
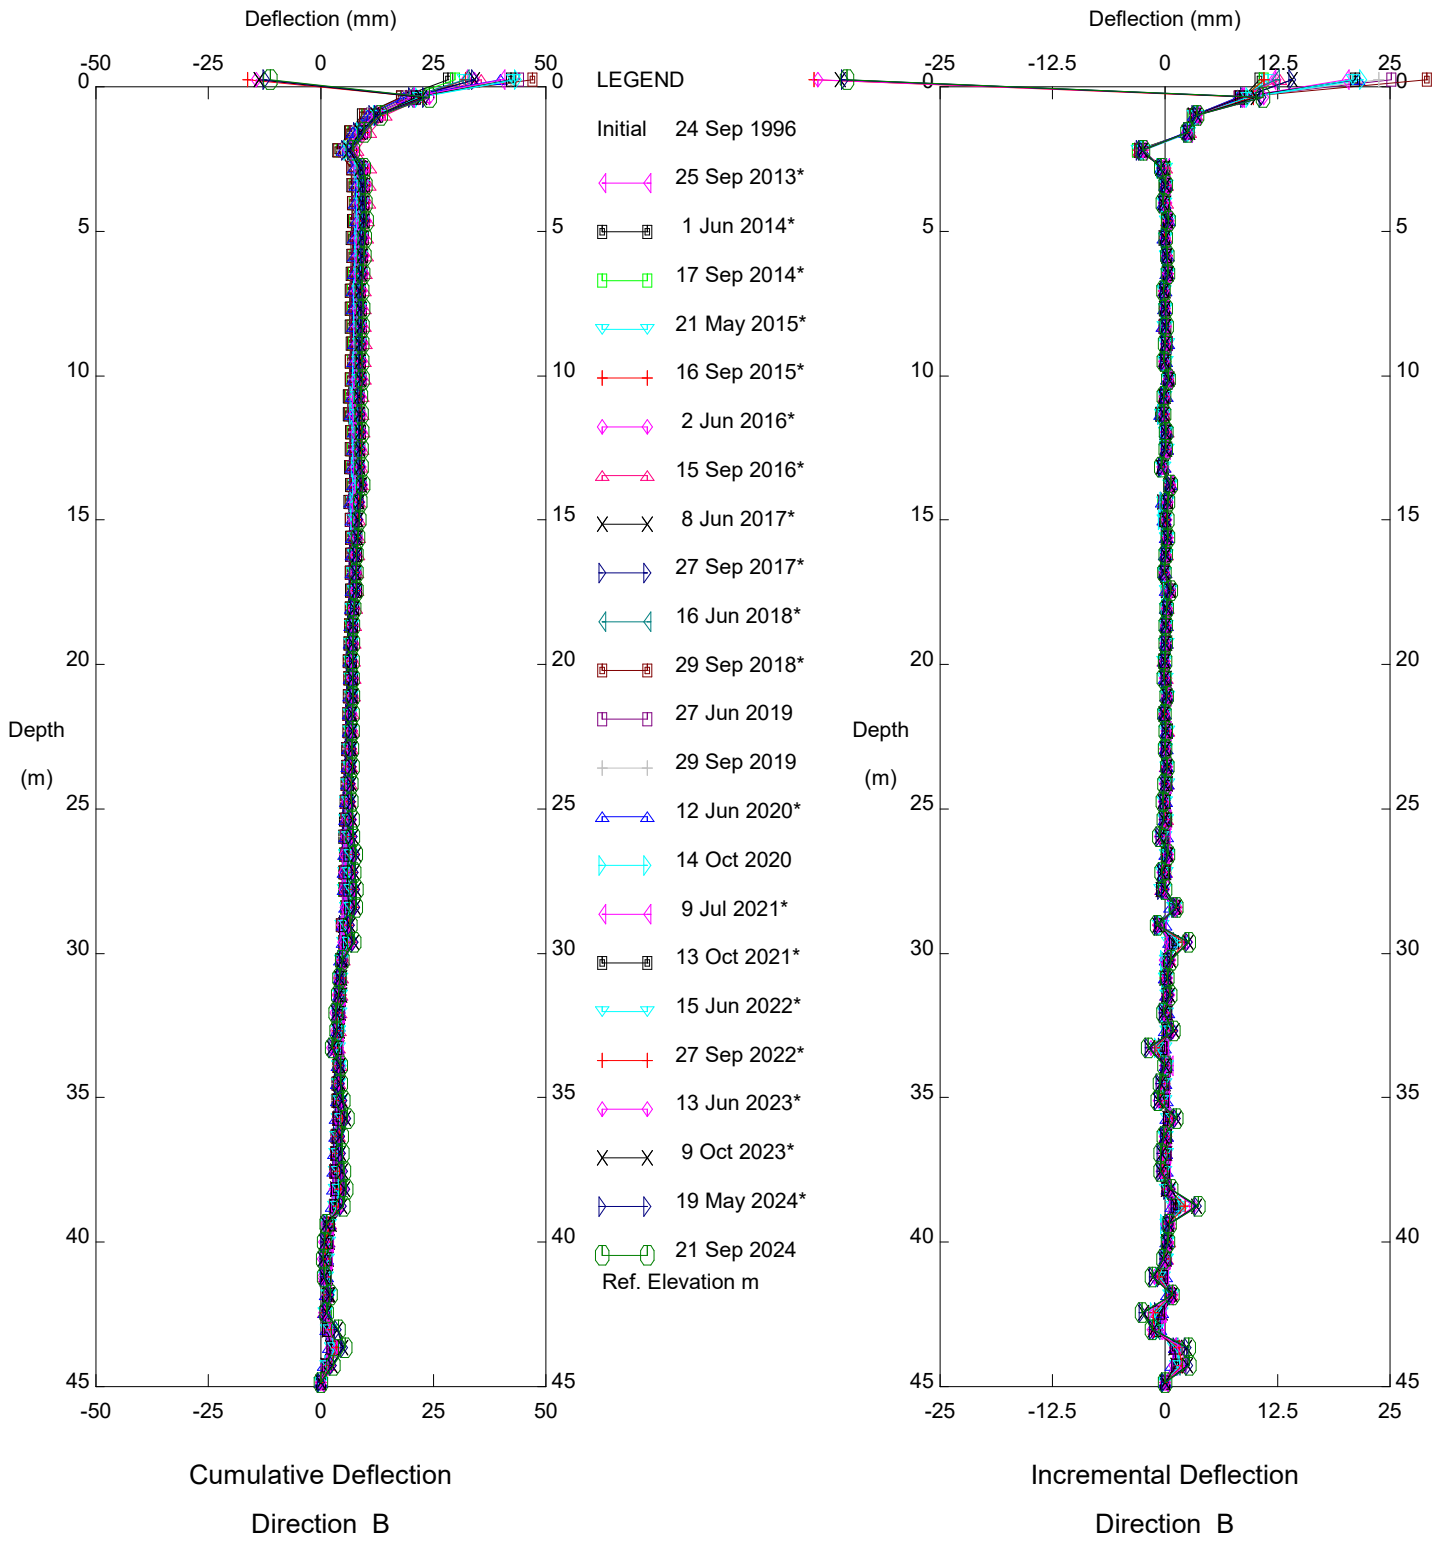
(PH059) PEACE RIVER EAST HILL -SITE 2, Inclinometer SI-67

Discussion	
Zones of New Movement:	None
Interpretation of Monitoring Results:	<p>Slope indicator SI-67 is located upslope of the highway and SI-69, 75 and 81 are all located downslope of the highway.</p> <p>SI-67 showed no discernible movement although there are many zones of very subtle movement at significant depth.</p> <p>SI-69 showed no discernible movement although there are many zones of very subtle movement at significant depth.</p> <p>SI-75 showed a rate of movement of 10.5 mm/yr over 0.0 m to 5.4 m depth since the spring of 2024 readings. This represents an increase in rate of movement of 6.7 mm/yr since the spring of 2024 readings. An overall accelerated movement rate has been present since the spring of 2023 readings (6 mm/yr after spring 2023 versus 2 mm/yr between about spring 2007 to spring 2023).</p> <p>SI-81 showed rates of movement of 5.0 mm/yr and 3.0 mm/yr over 1.9 m to 6.1 m depth and 8.8 mm/yr over 6.1 m to 9.2 m depth, respectively, since the spring of 2024 readings. The movement rates over 6.1 m to 9.2 m and 6.1 m to 9.2 m depth decreased by 4.6 mm/yr and 5.8 mm/yr, respectively, since the spring of 2024 readings.</p>

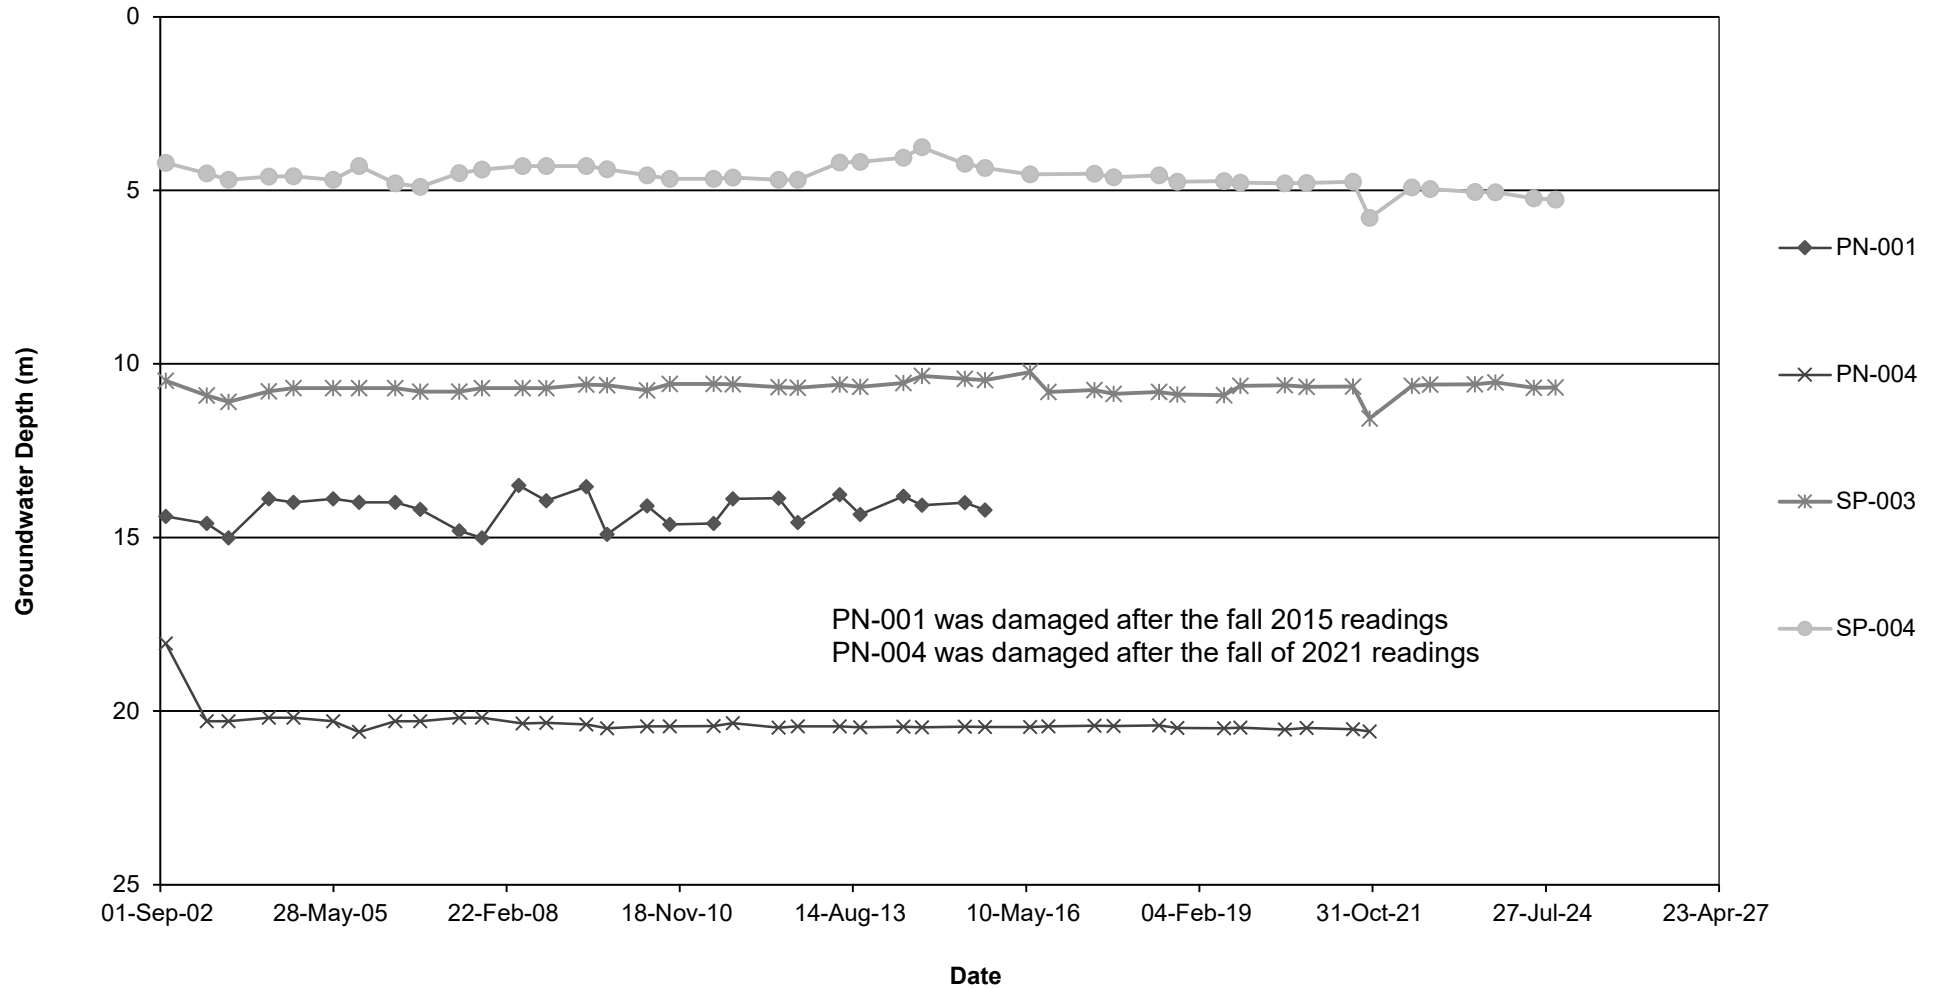
**FIGURE PH059-1
PIEZOMETER DATA: PEACE RIVER EAST HILL SITE #2**

Standpipe piezometer SP-003 showed an increase in groundwater level of 0.01 m since the spring of 2024 reading. SP-004 showed a decrease in groundwater level of 0.04 m since the spring of 2024 readings.
Future Work:	The instruments should be read again in the spring of 2025.
Instrumentation Repairs:	No instrument repairs are required at this time.
Additional Comments:
