**ALBERTA TRANSPORTATION AND
ECONOMIC CORRIDORS
GEOHAZARD ASSESSMENT PROGRAM
PEACE REGION (PEACE RIVER DISTRICT)
2024 INSPECTION**

Site Number	Location	Name	Hwy	km
PH059	East Hill	34+770 to 35+680 Site 2	2:60	35.2
Legal Description		UTM Co-ordinates (NAD 83)		
S28-083-21 W5M		11V E 484105	N 6231090

**PEACE RIVER EAST HILL
HWY 2:60 (PH059) STA. 34+770 TO 35+680
LOCATION PLAN**

FIGURE PH059-2

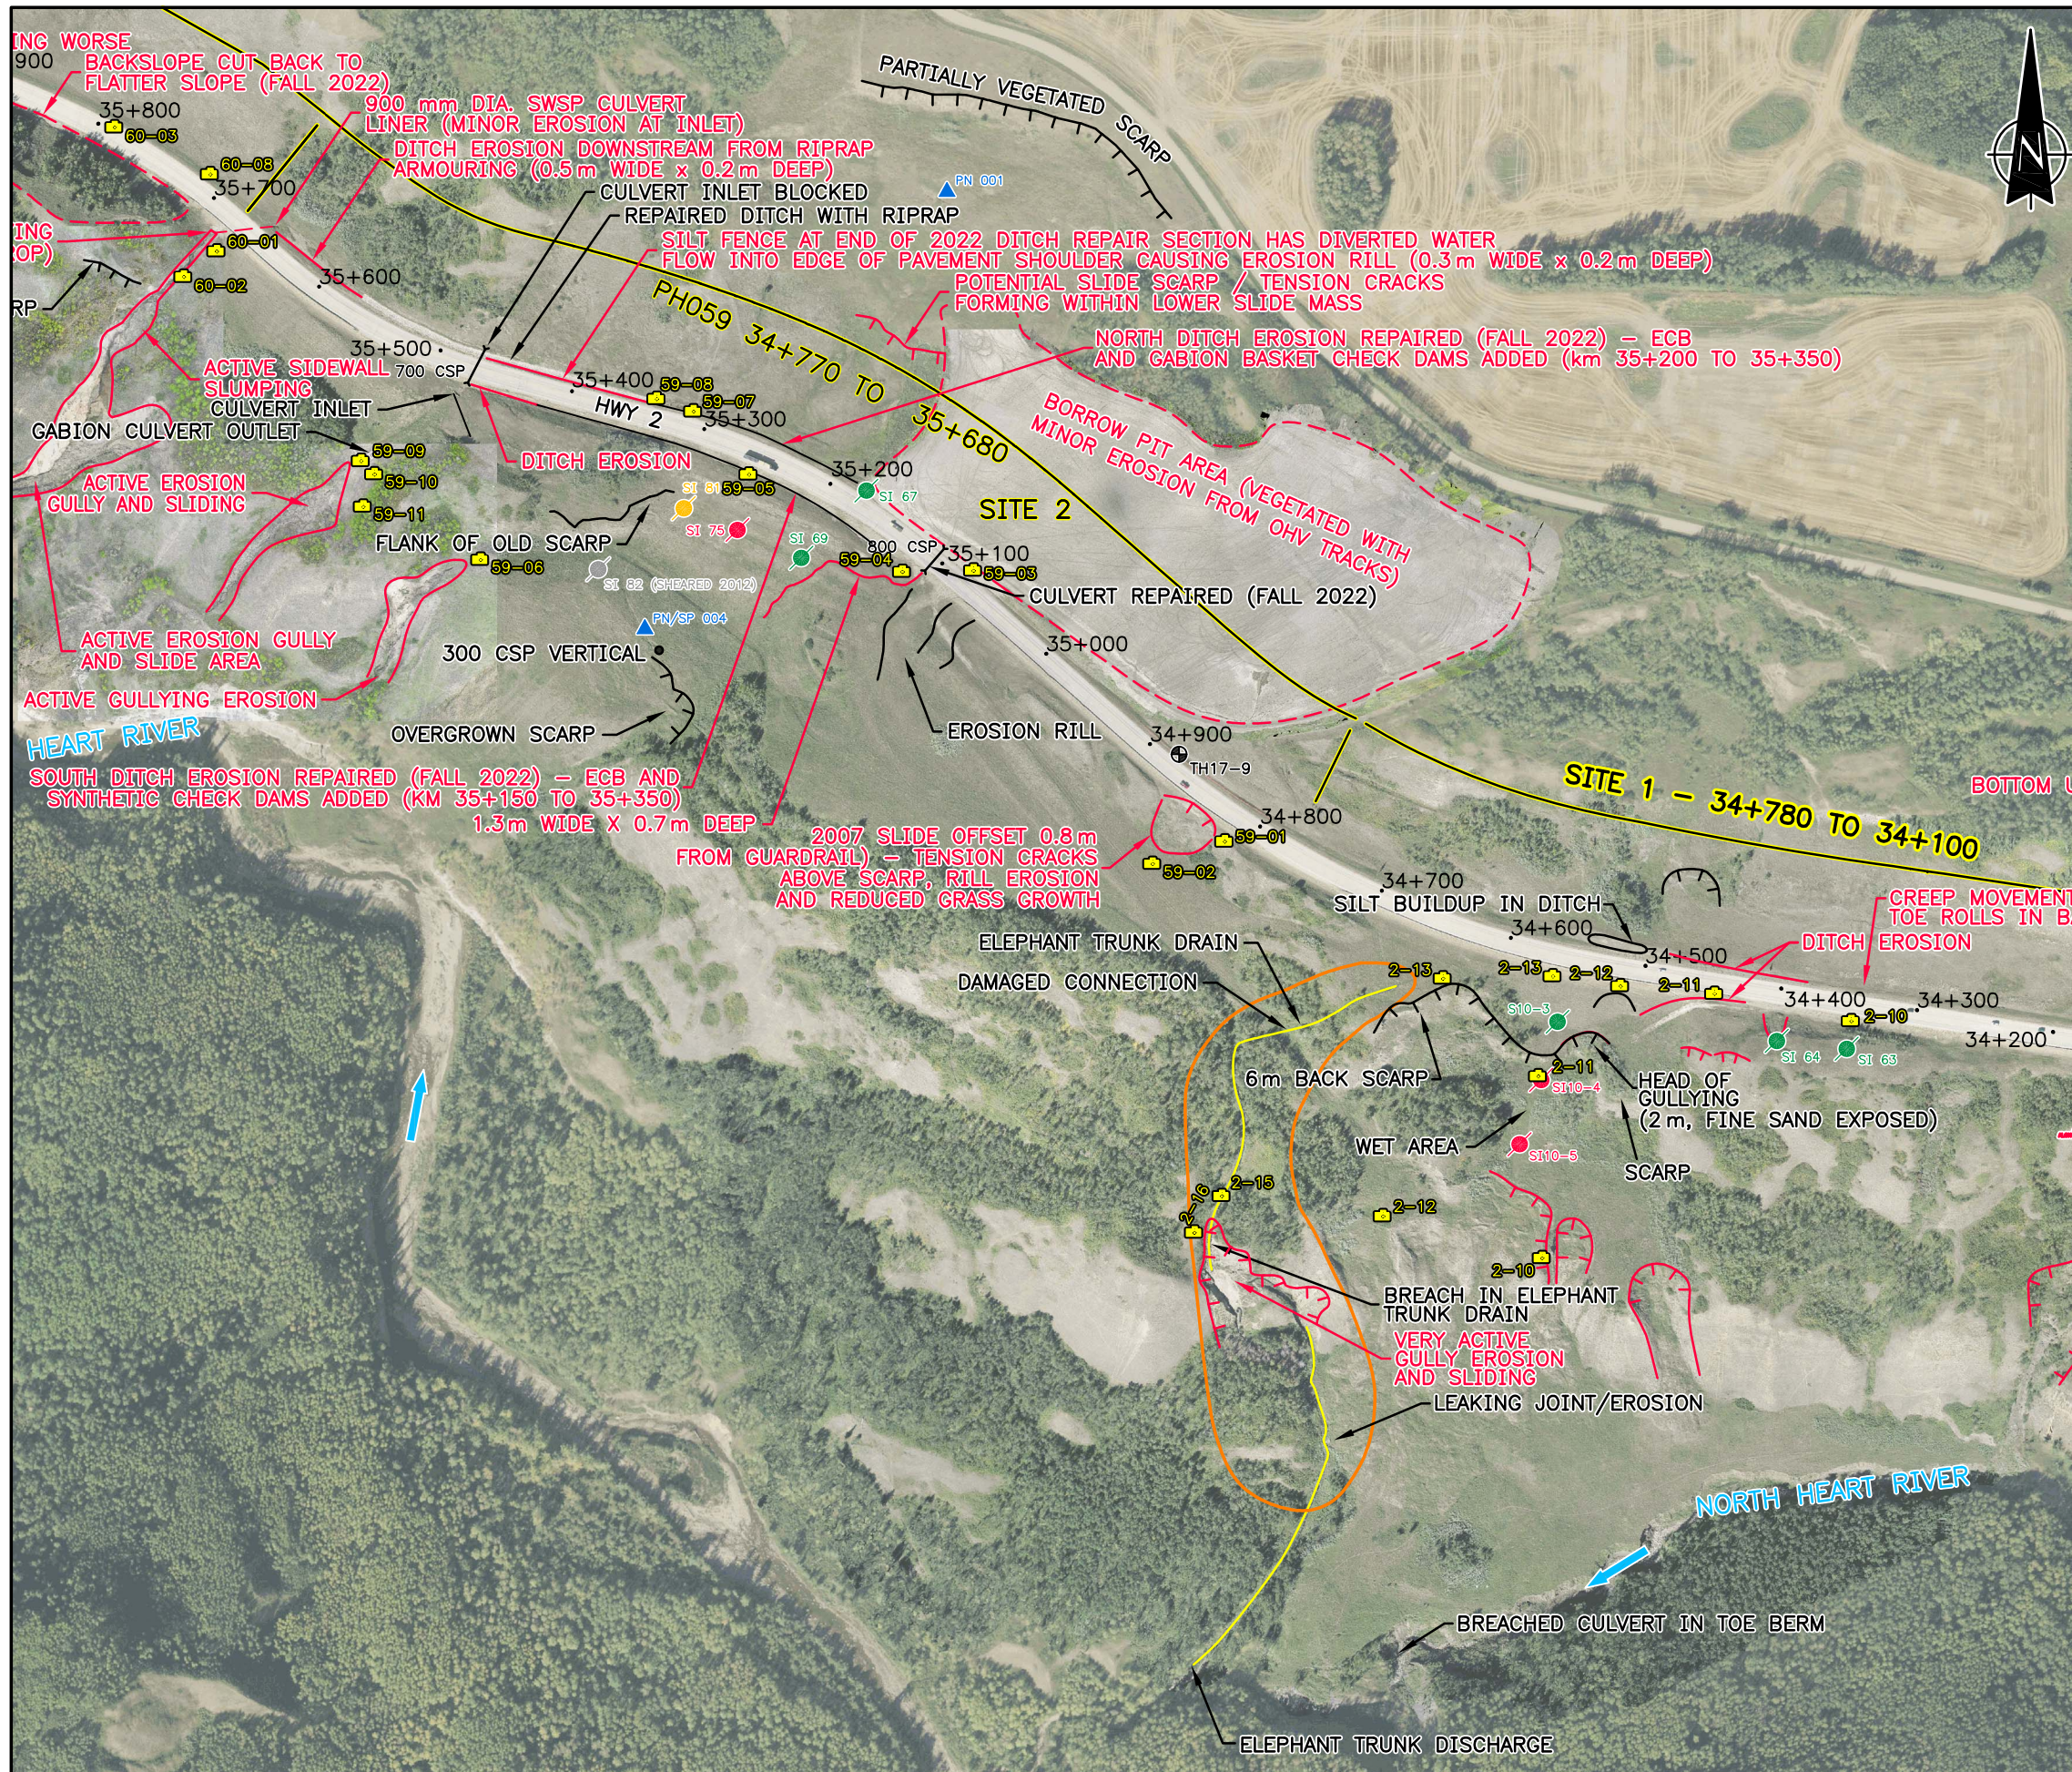
Assessment (Refer to Drawings PH060-2):

Small deep-seated movements are occurring within fill embankment downslope of roadway (35+250) indicating low Factors of Safety. Measured rates of movement within two of the instruments below the road (SI 81 and S I75) have averaged around approximately 2 mm/yr to 6 mm/yr since 2007; however, an acceleration trend has been observed since Spring 2023 (average of 7 mm/yr at SI 75). These rates of movement are still well below measured historic rates (prior to 2000) of up to 30 mm/yr. No visible indications of slope movement have been observed along the slope near these SI's.

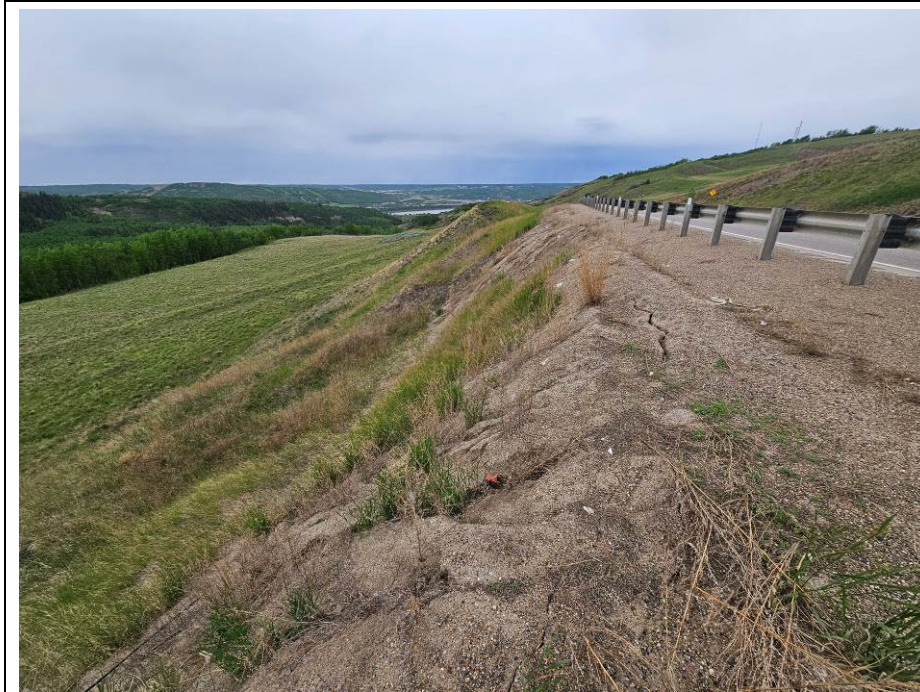
<p>above the main scarp, there was some rill erosion in the upper scarp and reduced vegetation growth (likely a result of winter salt and sanding). (Photos 59-01 and 59-02)</p> <p>No surficial signs of instability in embankment below highway between 35+100 to 35+350. Flank of scarp near 35+300 has no change from 2022 condition. (Photo 59-04)</p> <p>Potential new slide scarps or tension cracks appeared to be forming within the disturbed slide toe deposits approximately 75 m to 100 m upslope from the highway ditch near 35+250. (Photo 59-05)</p> <p>Active landslide area occurring at the base of the valley below the erosion gully at KM 35+500 as well as ongoing slide movements in the gully flanks further up the valley slope and downstream from the gabion culvert outlet (Photo 59-11).</p>		
<input checked="" type="checkbox"/> Erosion	<p>Erosion gully is active near 35+450, approximately 125 m downslope from highway. There was increased erosion/sliding within the vertical sidewalls and some minor expansion relative to the 2022 condition but no major headwall retrogression. (Photo 59-06)</p> <p>Erosion gully downstream of gabion culvert outlet near 35+500 had increased erosion/expansion along the sidewalls but no major headwall retrogression since previous inspection (Photos 59-10 and 59-11).</p> <p>As part of the Fall 2022 repair work, ditches were repaired, lined with ECM and gabion check dams were installed on both sides of the highway between approximately 35+200 to 35+350. At the downstream end of the 2022 north ditch repair section (near 35+350) water flow has been directed outside the gabion ditch armouring and eroded along the edge of the pavement shoulder due to a silt fence. The erosion channel was up to 0.3 m wide and 0.2 m deep. (Photos 59-07 and 59-08)</p> <p>Silt buildup and minor erosion was noted within ditch on the north side of the highway near 35+650 (Photo 59-02).</p>	<input checked="" type="checkbox"/>	<input type="checkbox"/>

The shallow slump at 34+850 appears to have recent activity and may retrogress closer to the road in the next several years based on tension crack development and increase vegetation disturbance within the upper scarp.

Photo 59-01.
 Looking northwest at headscarp area of shallow landslide on downslope side of roadway first observed in 2007 (34+850). There was additional downslope movement of the slide mass, a new tension crack was observed above the main scarp, there was some rill erosion in the upper scarp and reduced vegetation growth (likely a result of winter salt and sanding).

- Anchored (Duckbill anchors or equivalent) TRM could be installed between the road and upper slide area for the shallow slump at 34+850 to reduce rates of erosion/retrogression of the oversteepened scarp face and limit undermining of the pavement edge and guardrail (\$50k - \$100k), or the shallow slide could be stabilized by placing a toe berm against the lower part of the slope or digging out the slide material and rebuilding the slope with a gravel over a gravel shear key (\$300k to \$800k).

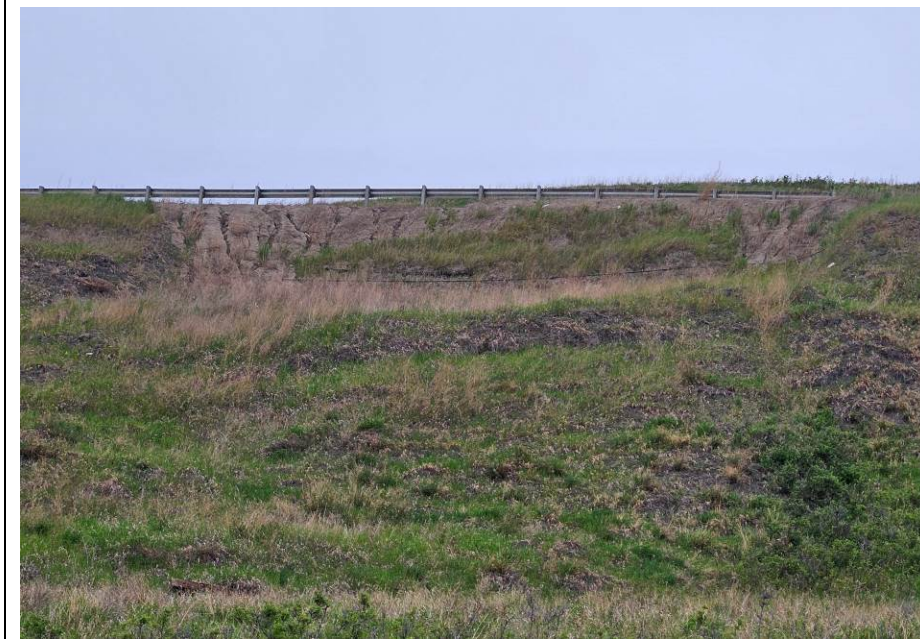
Photo 59-02.
 Looking north (upslope) from the base of the slide area near 34+850. Increased downslope movement of the slide mass relative to the 2022 condition. Rill erosion visible in the backscarp. Scarp is still offset 0.8 m from the guardrail (unchanged since 2022).

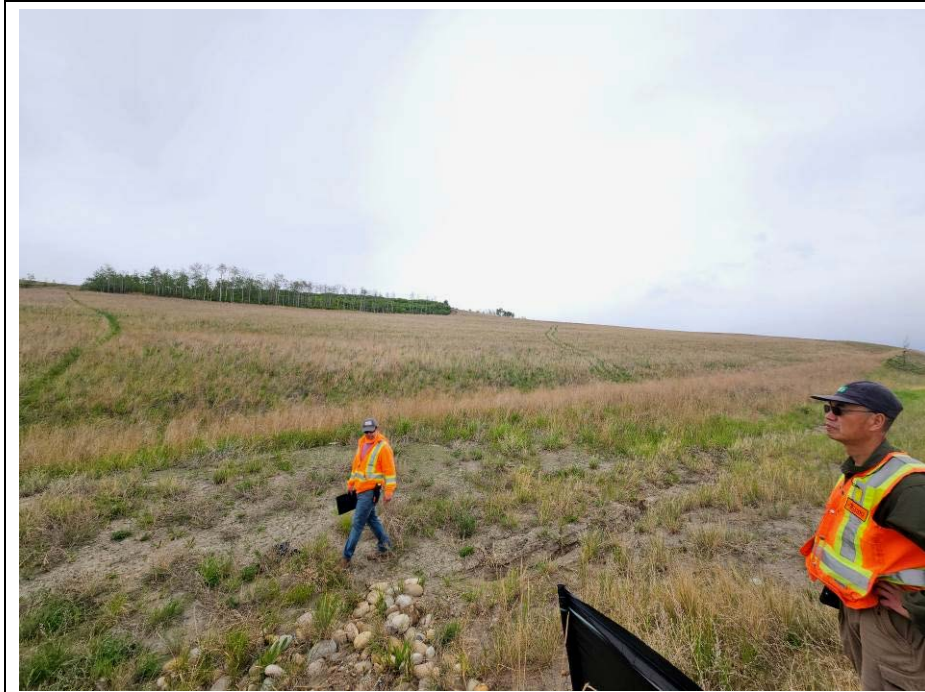
<input type="checkbox"/> Seepage		<input type="checkbox"/>	<input type="checkbox"/>
<input checked="" type="checkbox"/> Bridge/Culvert	Culvert at 35+100 was repaired in Fall 2022.	<input type="checkbox"/>	<input checked="" type="checkbox"/>
<input checked="" type="checkbox"/> Other	The slope above the road between 35+200 and 34+700 that was used as a borrow source area has been graded back and reclaimed. Slope was well vegetated with minor track erosion from off-highway vehicles. No stability issues were apparent. (Photo 59-03).	<input type="checkbox"/>	<input checked="" type="checkbox"/>

The unloading of the upslope area above the highway between 35+200 to 34+700 is expected to help reduce the potential reactivation of the old landslide plane from the 1980s.

Photo 59-03.
Looking northeast at the borrow area upslope of the highway between approximately 34+700 and 35+200. Slope was well vegetated with minor track erosion from off-highway vehicles. No stability issues were apparent.

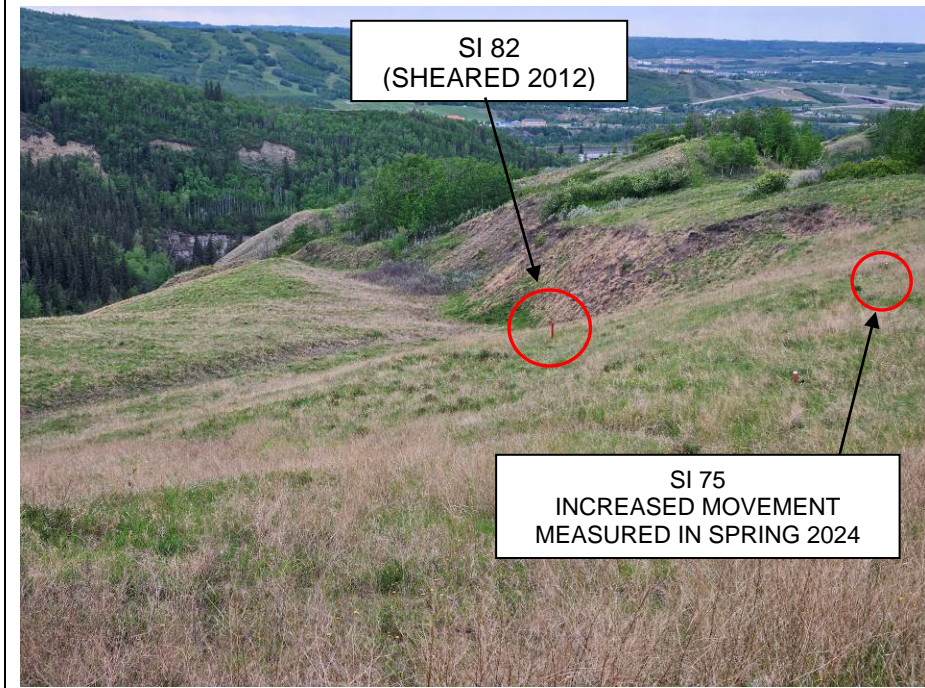
Photo 59-04.
Looking west at old slide flank near KM 35+300. Area is vegetated with no visible signs of major change or slope movement. SI indicated with trend of increased movement since Spring 2023. No change to the overgrown slide flank near 35+300.

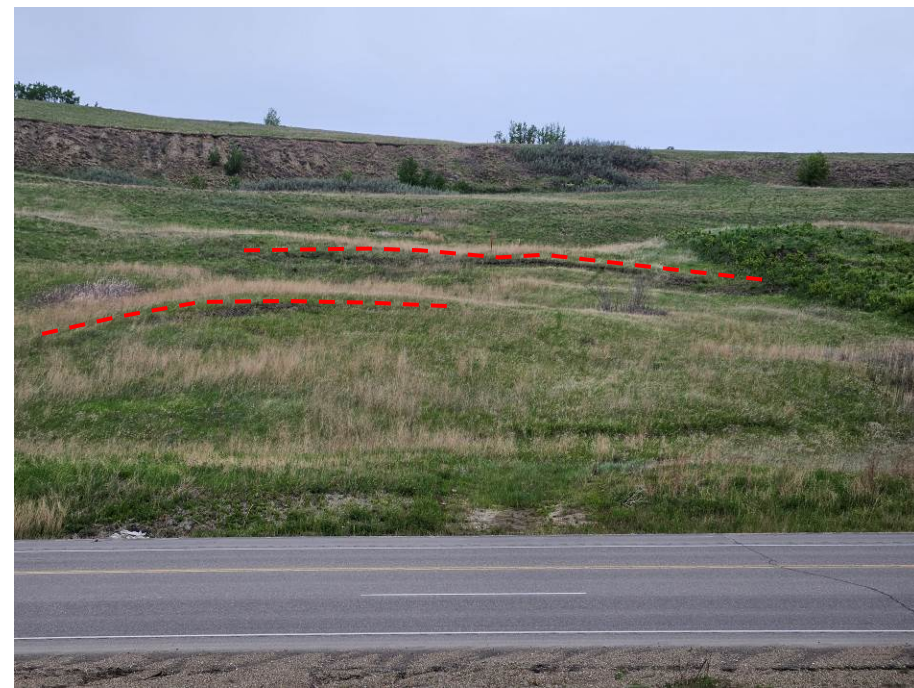
No movement has been measured within the SI upslope of the road at 35+200. Shallow slumping upslope of roadway may potentially have increased activity but has limited potential to affect roadway at this time.

Photo 59-05.
Looking at backslope north of the highway near KM 35+250 within historic slide terrain. Potential new slide scarps and tension cracks appeared to be forming within the disturbed slide toe deposits approximately 75 m to 100 m upslope from the highway ditch near 35+250.

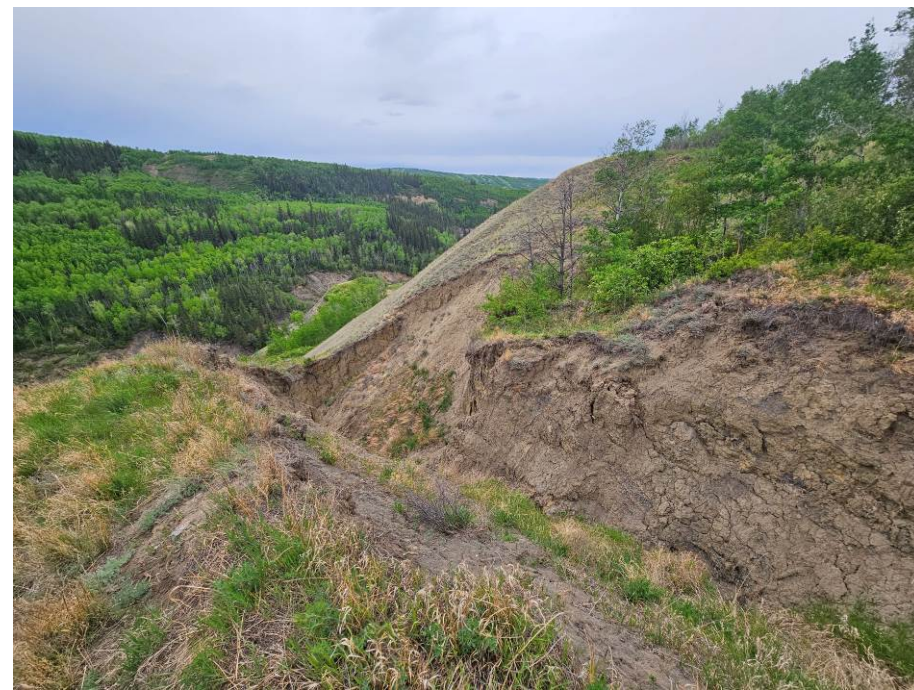
Erosion is very active within the two major gullies south of the highway, forming localized slides within the vertical sidewalls. Current gullies do not present an immediate risk to the highway but adding a trunk drain to this section should be considered to reduce rate of retrogression and loss of embankment toe berm support.

Photo 59-06.
Looking west at headwall area of an erosion gully approximately 125 m downslope (south) from the highway (35+450). Ongoing erosion and sliding of the vertical sidewalls and some minor expansion relative to the 2022 condition but no major headwall retrogression.

- Installation of one or two trunk drains to convey water drainage past the gullies. (\$1M - 2M)

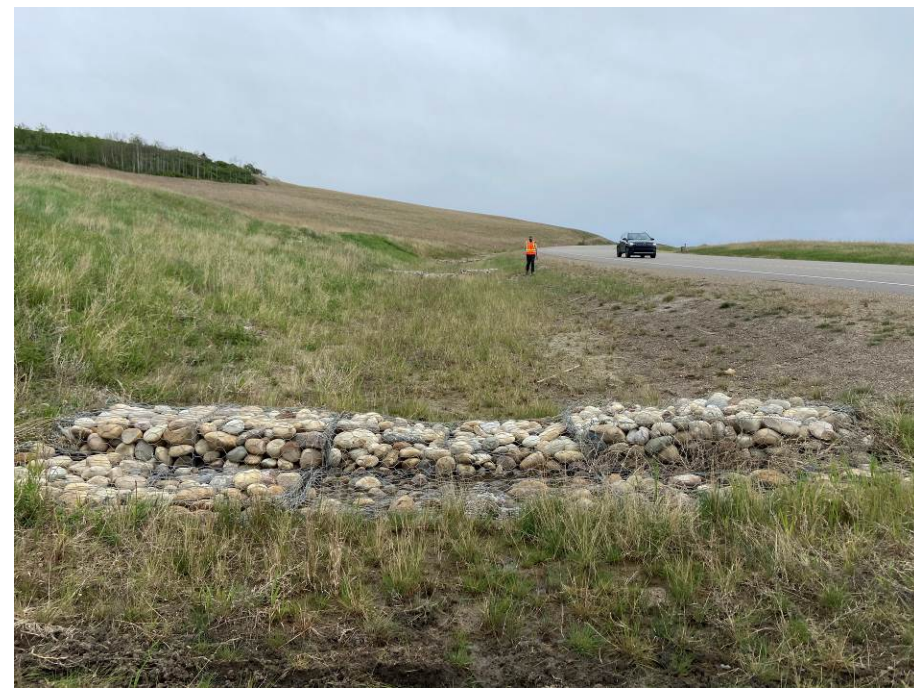
Photo 59-07.
Looking east towards the Fall 2022 north ditch repair section (35+200 to 35+350) with gabion basket check dams. Similar repairs were also completed within this section in the south ditch.

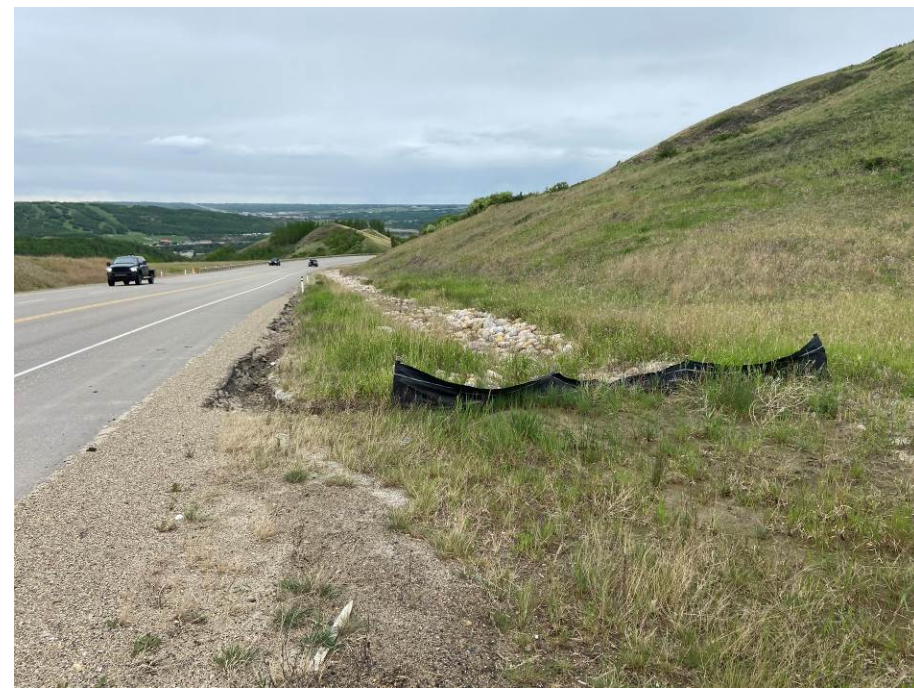
Photo 59-08.
Looking west at north ditch erosion damage starting at the downstream end of the 2022 repair section near 35+350. Water flow has been directed outside the gabion ditch armouring and eroded along the edge of the pavement shoulder due to the silt fence. Erosion channel was up to 0.3 m wide and 0.2 m deep.

- The drain pipe outlet needs to be cleared in gabion discharge structure at 35+480. Slope regrading or fill placement at 34+850 may be required in the future if the guardrail becomes undermined due to erosion or movement at the slide scarp.
- The silt fence in the north ditch near 35+350 should be removed and the ditch graded to ensure there is a smooth transition into the rock armored ditch section. ECM and synthetic check dams should be installed upstream of the rock armoured section. The erosion channel along the pavement edge should be backfilled with nominally compacted clay, ECM and seeded.

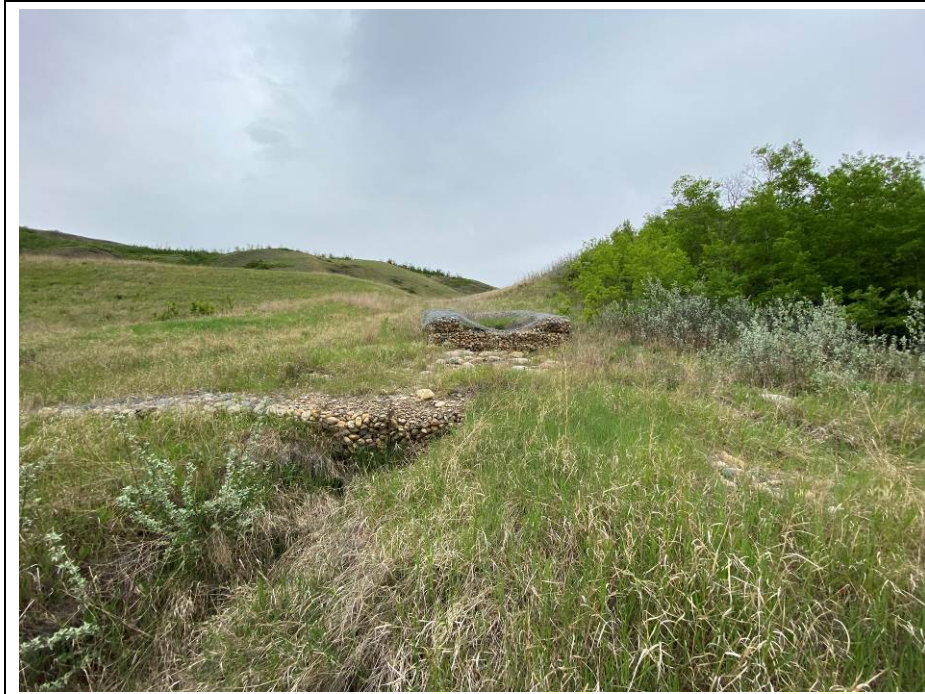
<p>Outlet drain pipe blocked in gabion discharge structure at 35+480. Slumping and erosion downslope of discharge structure is ongoing. Structure is in similar condition to previous inspection. (Photo 59-09).</p>		
--	--	--	--

Photo 59-09.
View northeast downslope from the gabion culvert outlet structure (35+500). There was a 0.5 m scour drop below the downslope row of gabion baskets that drains towards a much large erosion gully.

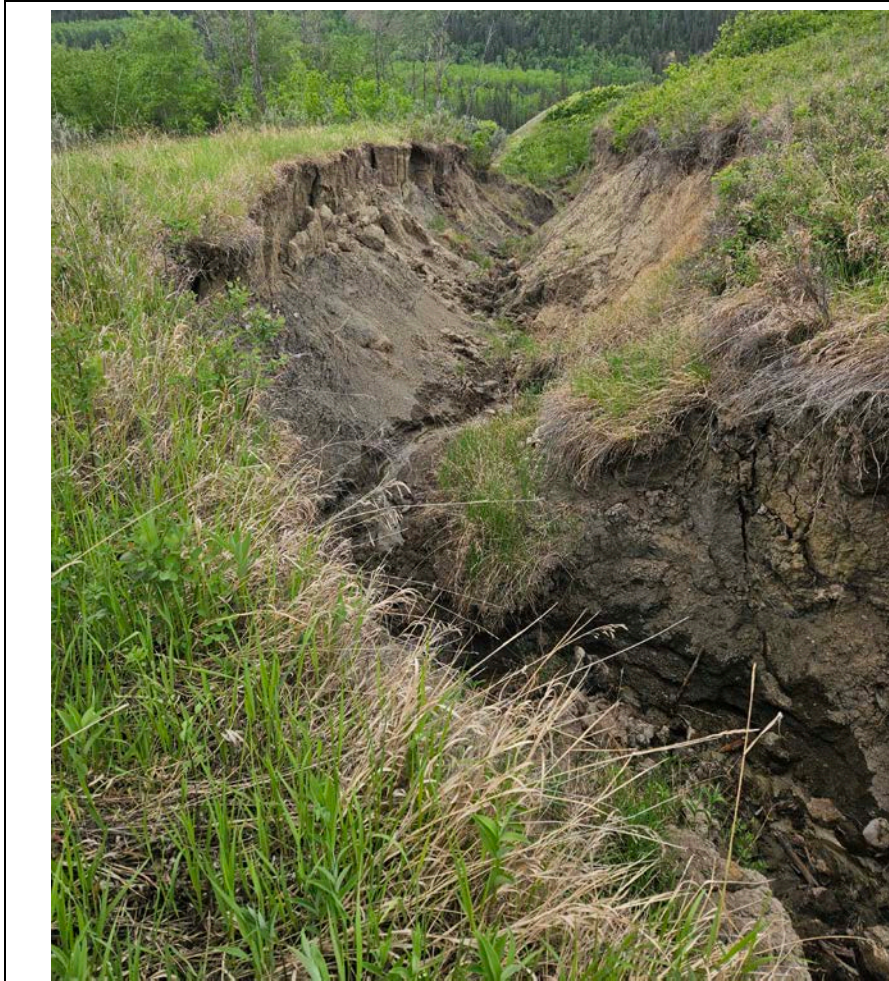
Photo 59-10.
Looking southwest at the erosion gully downstream of the gabion culvert outlet (35+500). Ongoing erosion and flank expansion relative to the 2022 condition.

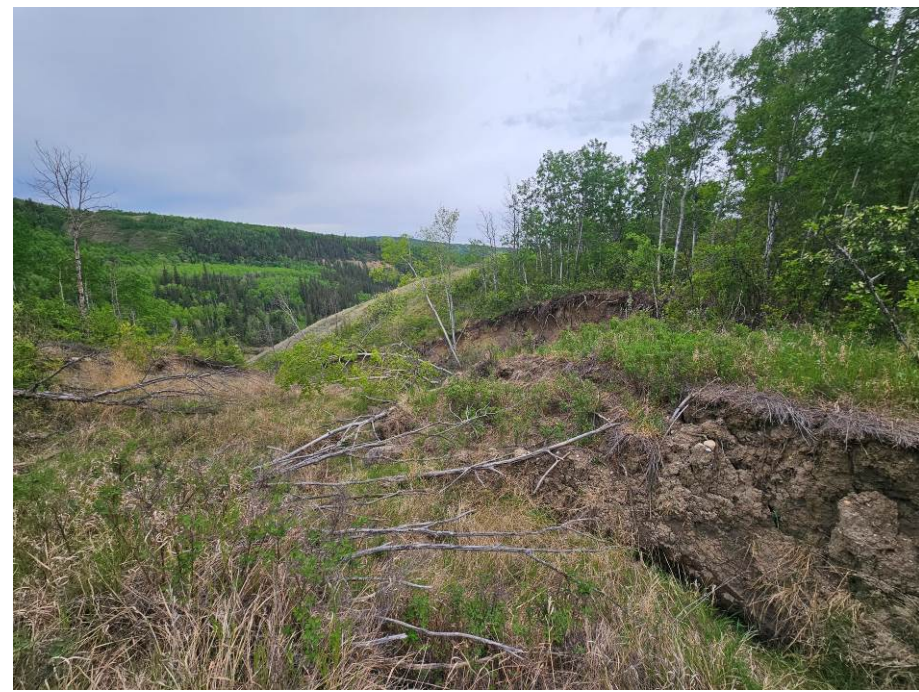
Photo 59-11.
Looking southwest at the erosion gully / slide area downstream of the erosion gully near KM 35+500. Ongoing erosion and slide movement but no significant retrogression towards the highway (main headwall offset approximately 115 m from the highway). More trees have fallen into gully due to the collapse of the gully sidewalls.
