| Site Number | Location | Name | Hwy | km |
|---|---|---|---|---|
| PH059 | Station 34+770 to 35+680 | Peace River East Hill | 2:60 | Km 34.8 to 35.7 |

**ALBERTA TRANSPORTATION AND ECONOMIC CORRIDORS GRMP (CON0022164)  
PEACE REGION (PEACE RIVER DISTRICT)  
INSTRUMENTATION MONITORING RESULTS**

**SPRING 2024**

**SITE PH059: HWY 2:60, PEACE RIVER EAST HILL  
(SITE # 2, STATION 34+770 TO 35+680)**

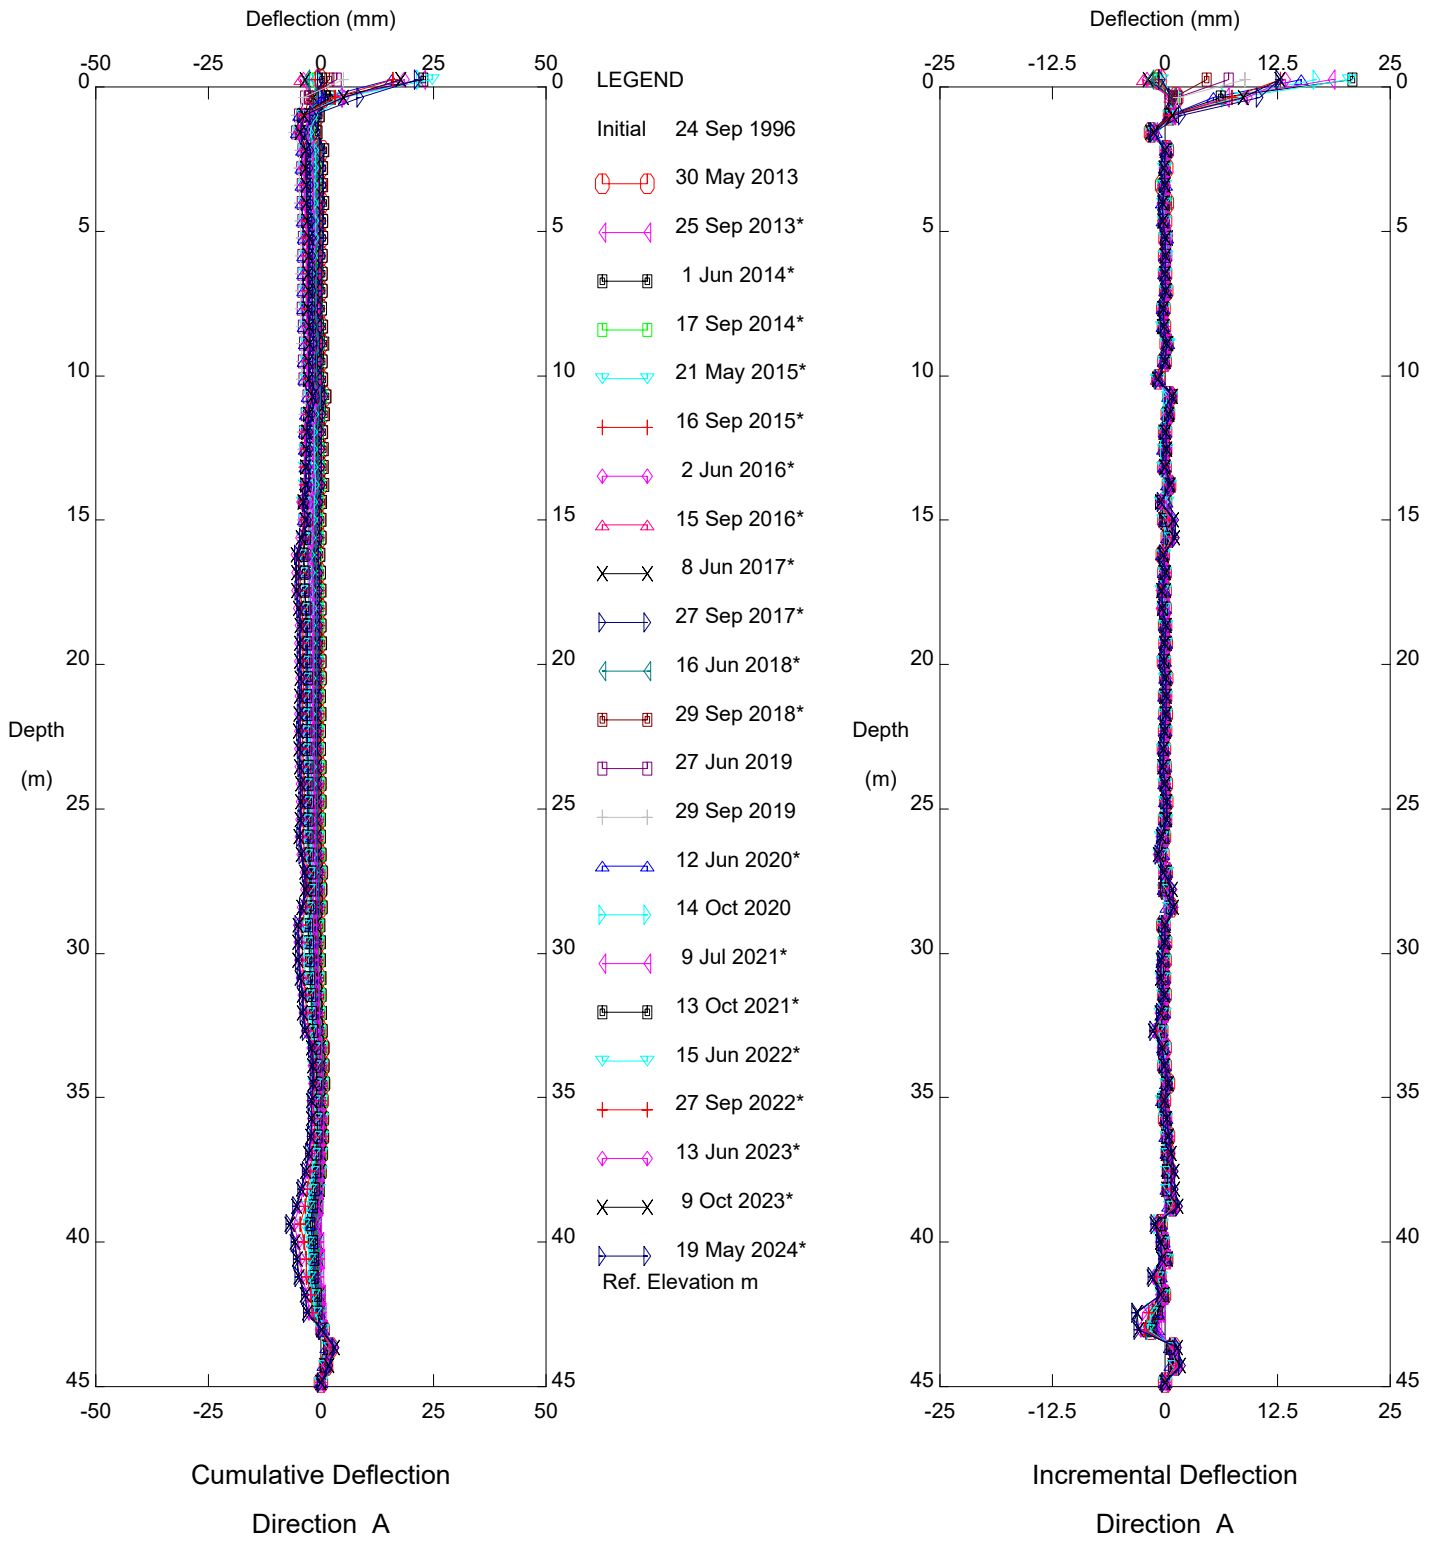
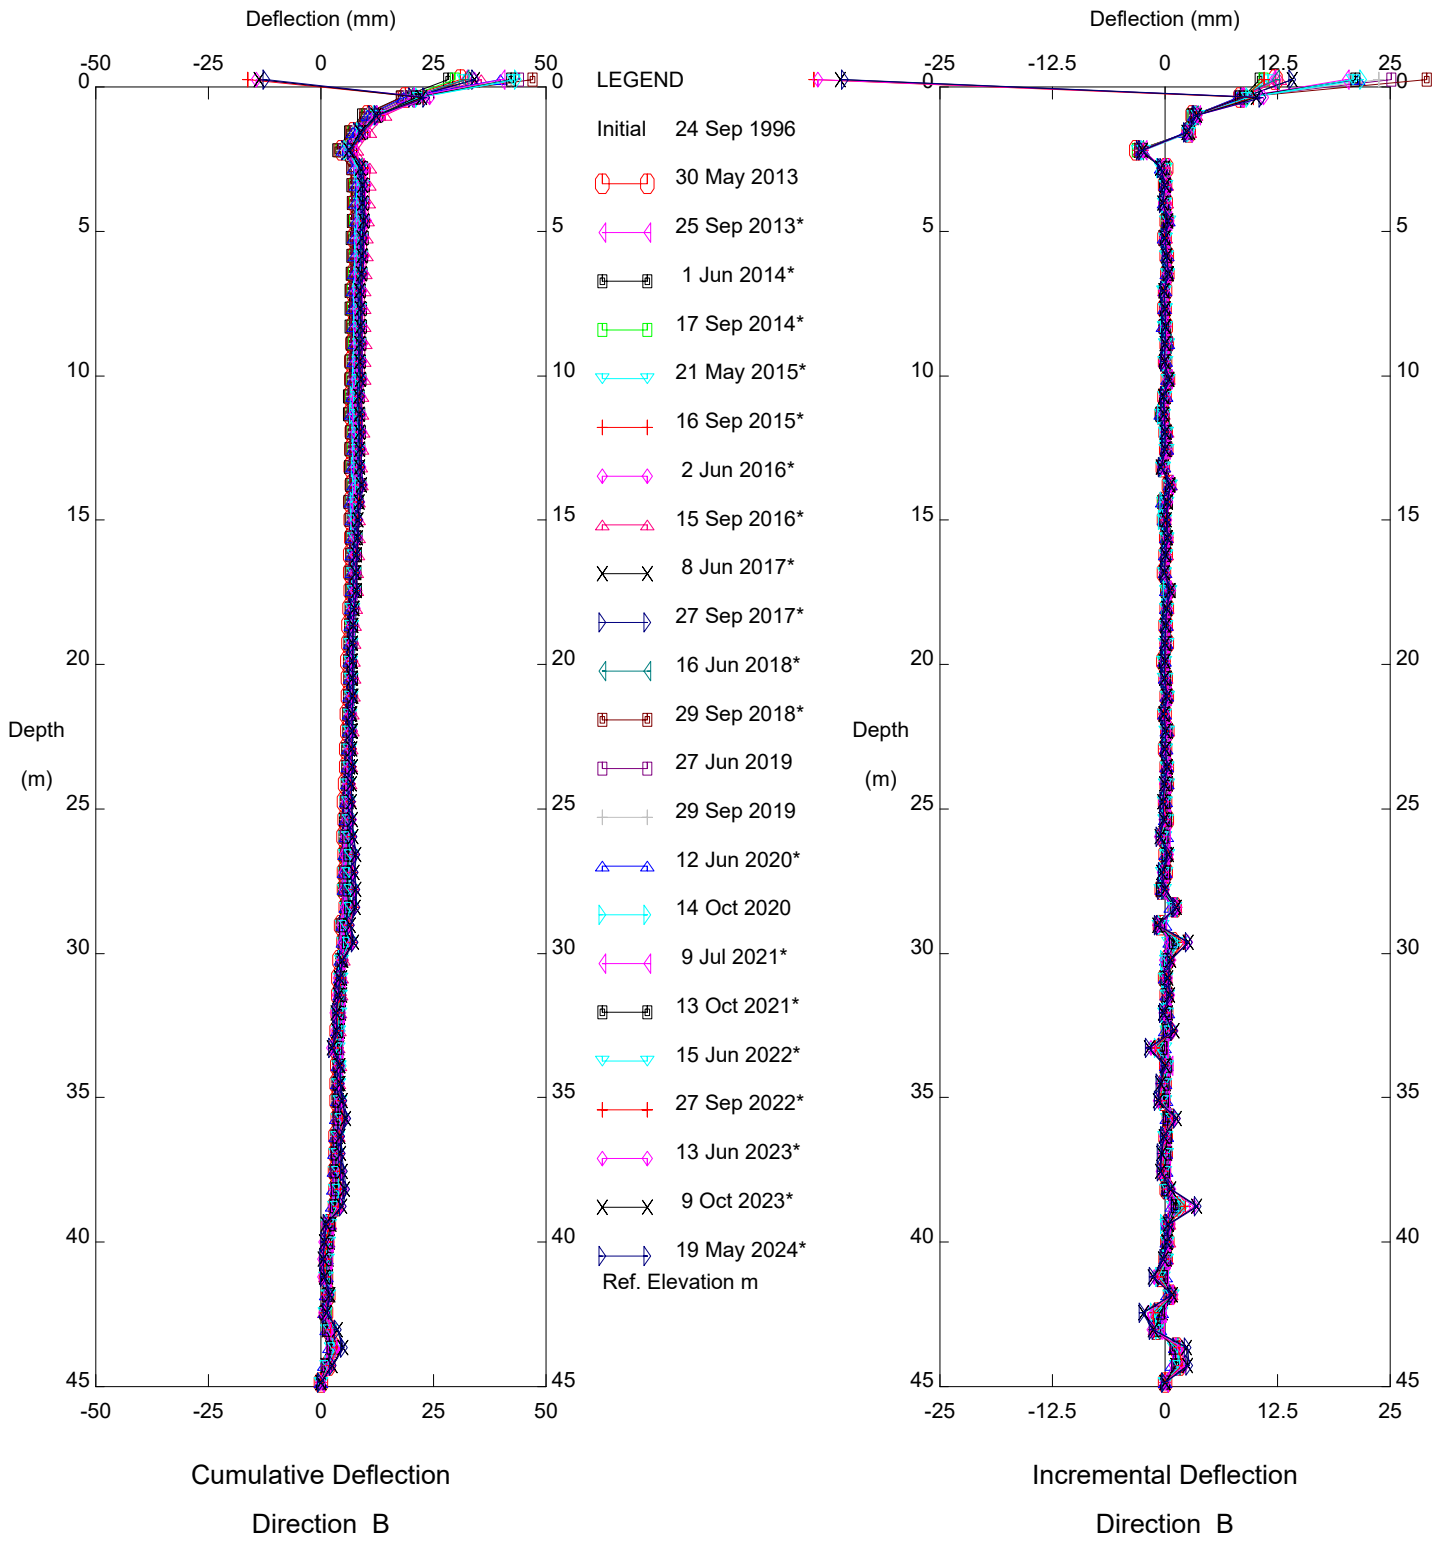
(PH059) PEACE RIVER EAST HILL -SITE 2, Inclinometer SI-67

| INSTRUMENT # | DATE INITIALIZED | TOTAL CUMULATIVE RESULTANT MOVEMENT AT NOTED DEPTH SINCE INITIAL READING (mm) | MAXIMUM RATE OF MOVEMENT (mm/yr) | CURRENT STATUS | DATE OF PREVIOUS READING | INCREMENTAL MOVEMENT SINCE PREVIOUS READING (mm) | CURRENT RATE OF MOVEMENT (mm/yr) | CHANGE IN RATE OF MOVEMENT SINCE PREVIOUS READING (mm/yr) |
|---|---|---|--|---|---|--|---|---|
| SI-67 | Sept. 24, 1996 | No discernible movement | N/A | Operational | October 9, 2023 | N/A | N/A | N/A |

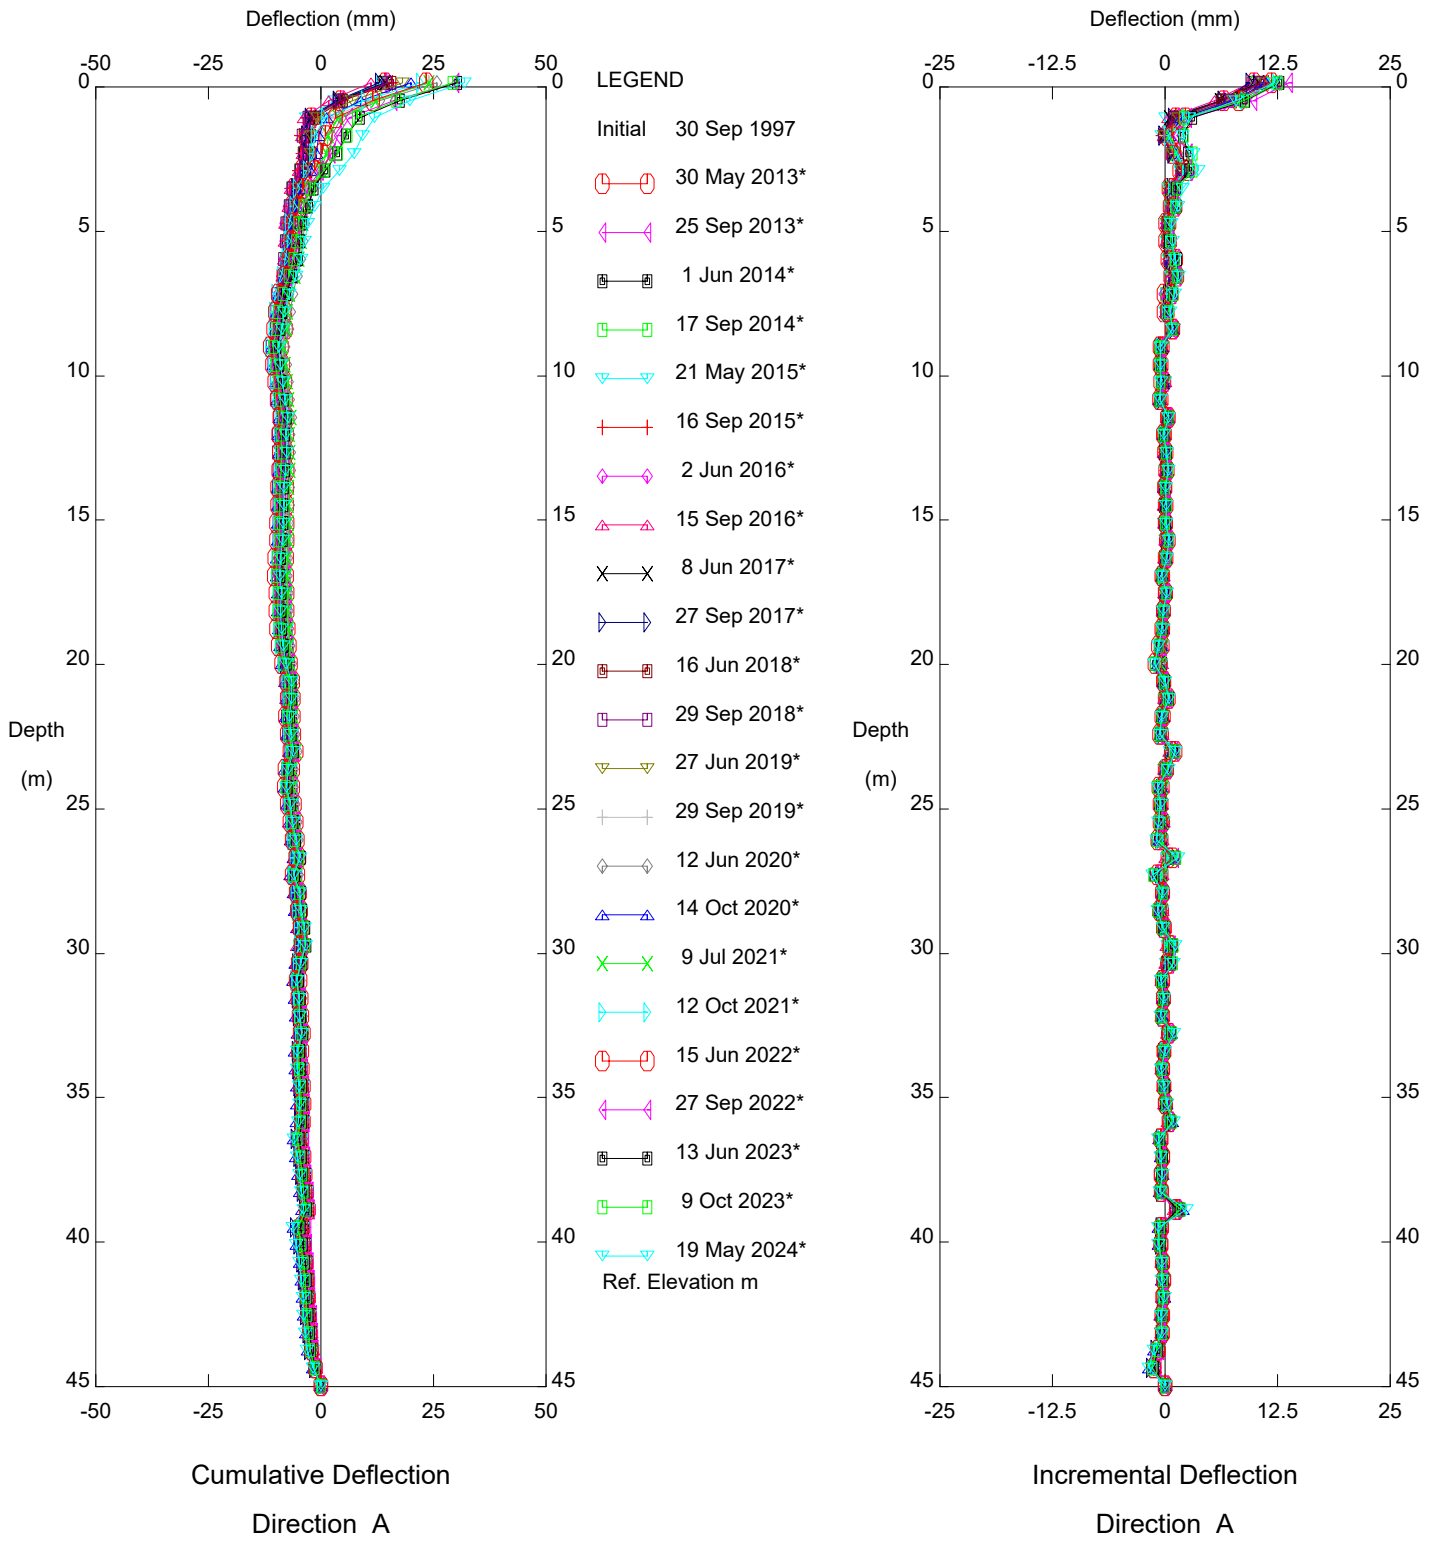
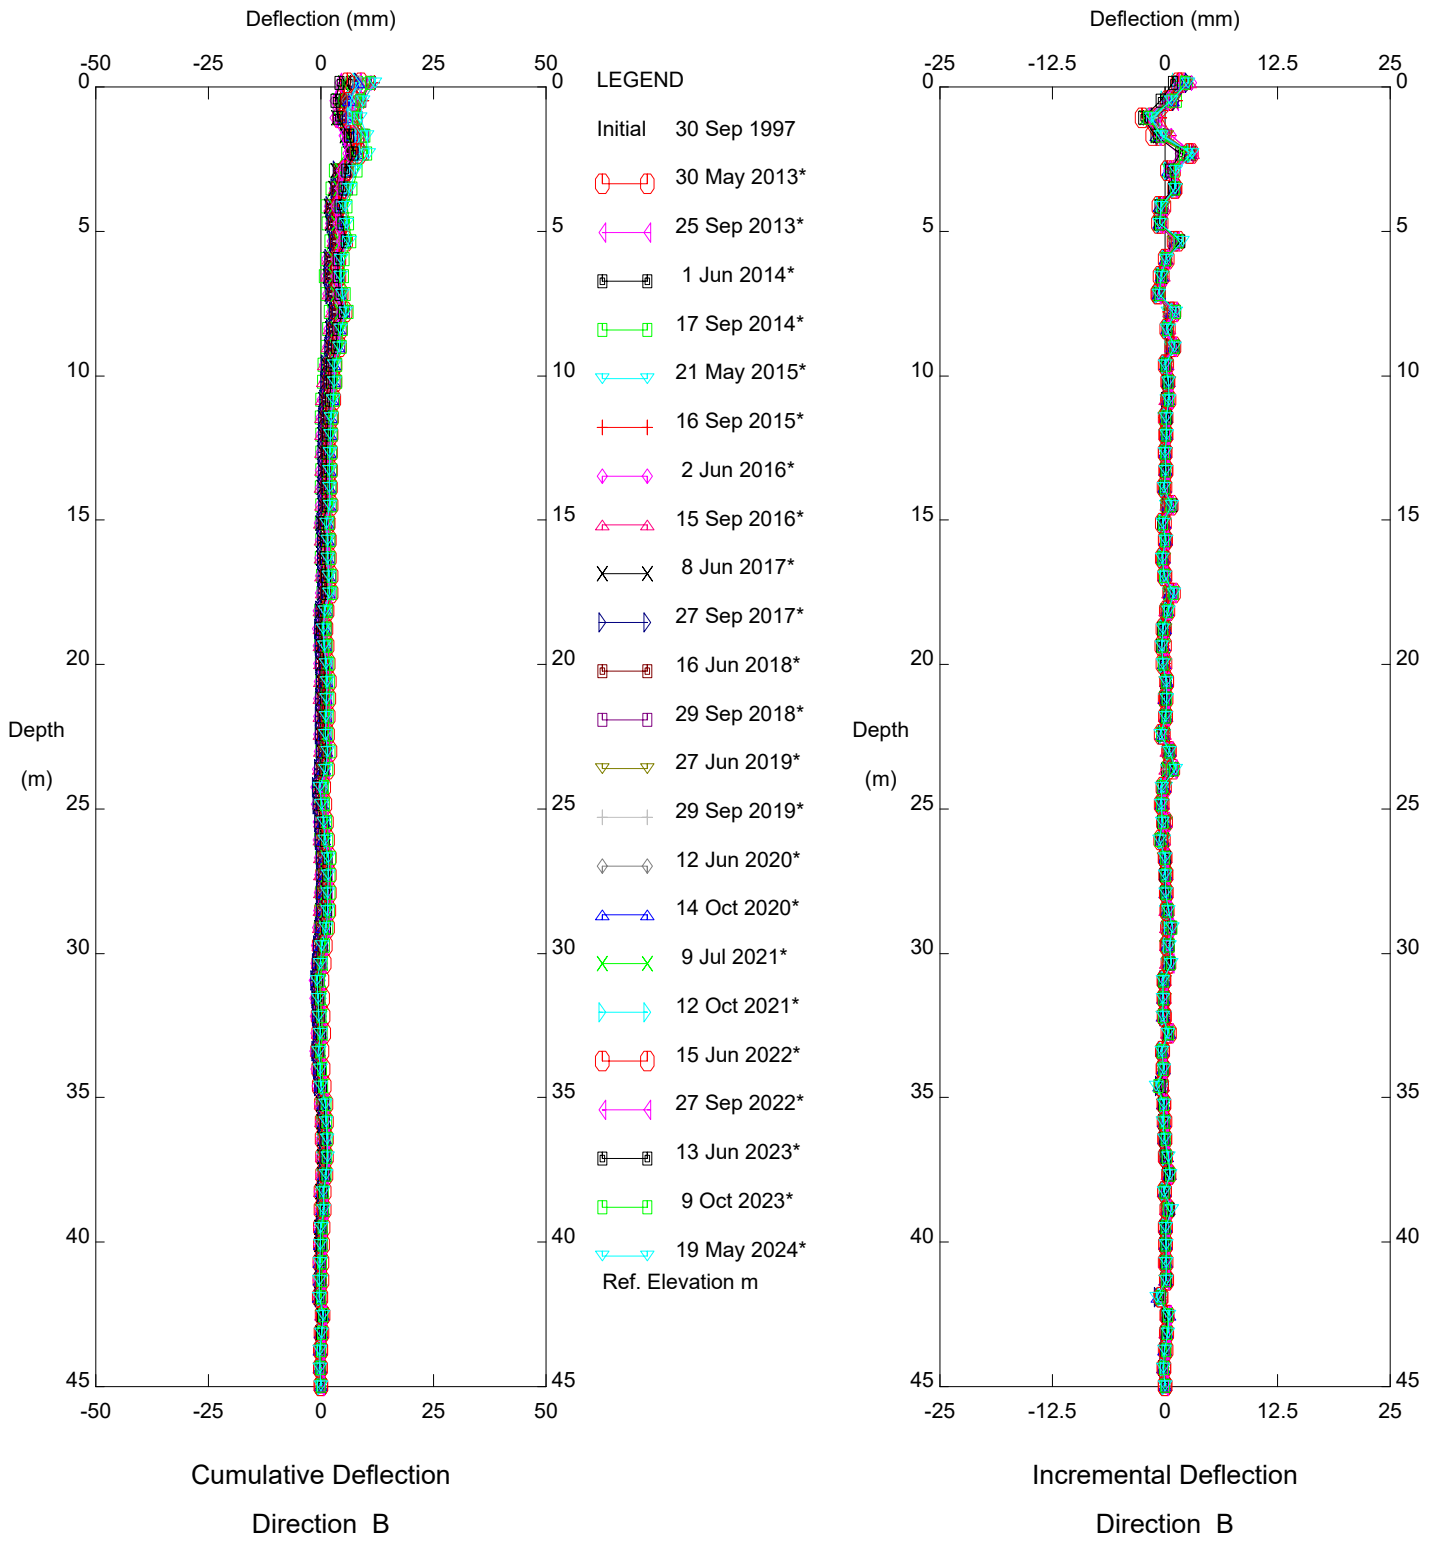
(PH059) PEACE RIVER EAST HILL -SITE 2, Inclinometer SI-69

| INSTRUMENT # | DATE INITIALIZED | TOTAL CUMULATIVE RESULTANT MOVEMENT AT NOTED DEPTH SINCE INITIAL READING (mm) | MAXIMUM RATE OF MOVEMENT (mm/yr) | CURRENT STATUS | DATE OF PREVIOUS READING | INCREMENTAL MOVEMENT SINCE PREVIOUS READING (mm) | CURRENT RATE OF MOVEMENT (mm/yr) | CHANGE IN RATE OF MOVEMENT SINCE PREVIOUS READING (mm/yr) |
|---|---|---|--|---|---|--|---|---|
| SI-69 | Oct. 2, 1996 | No discernible movement | N/A | Operational | October 9, 2023 | N/A | N/A | N/A |

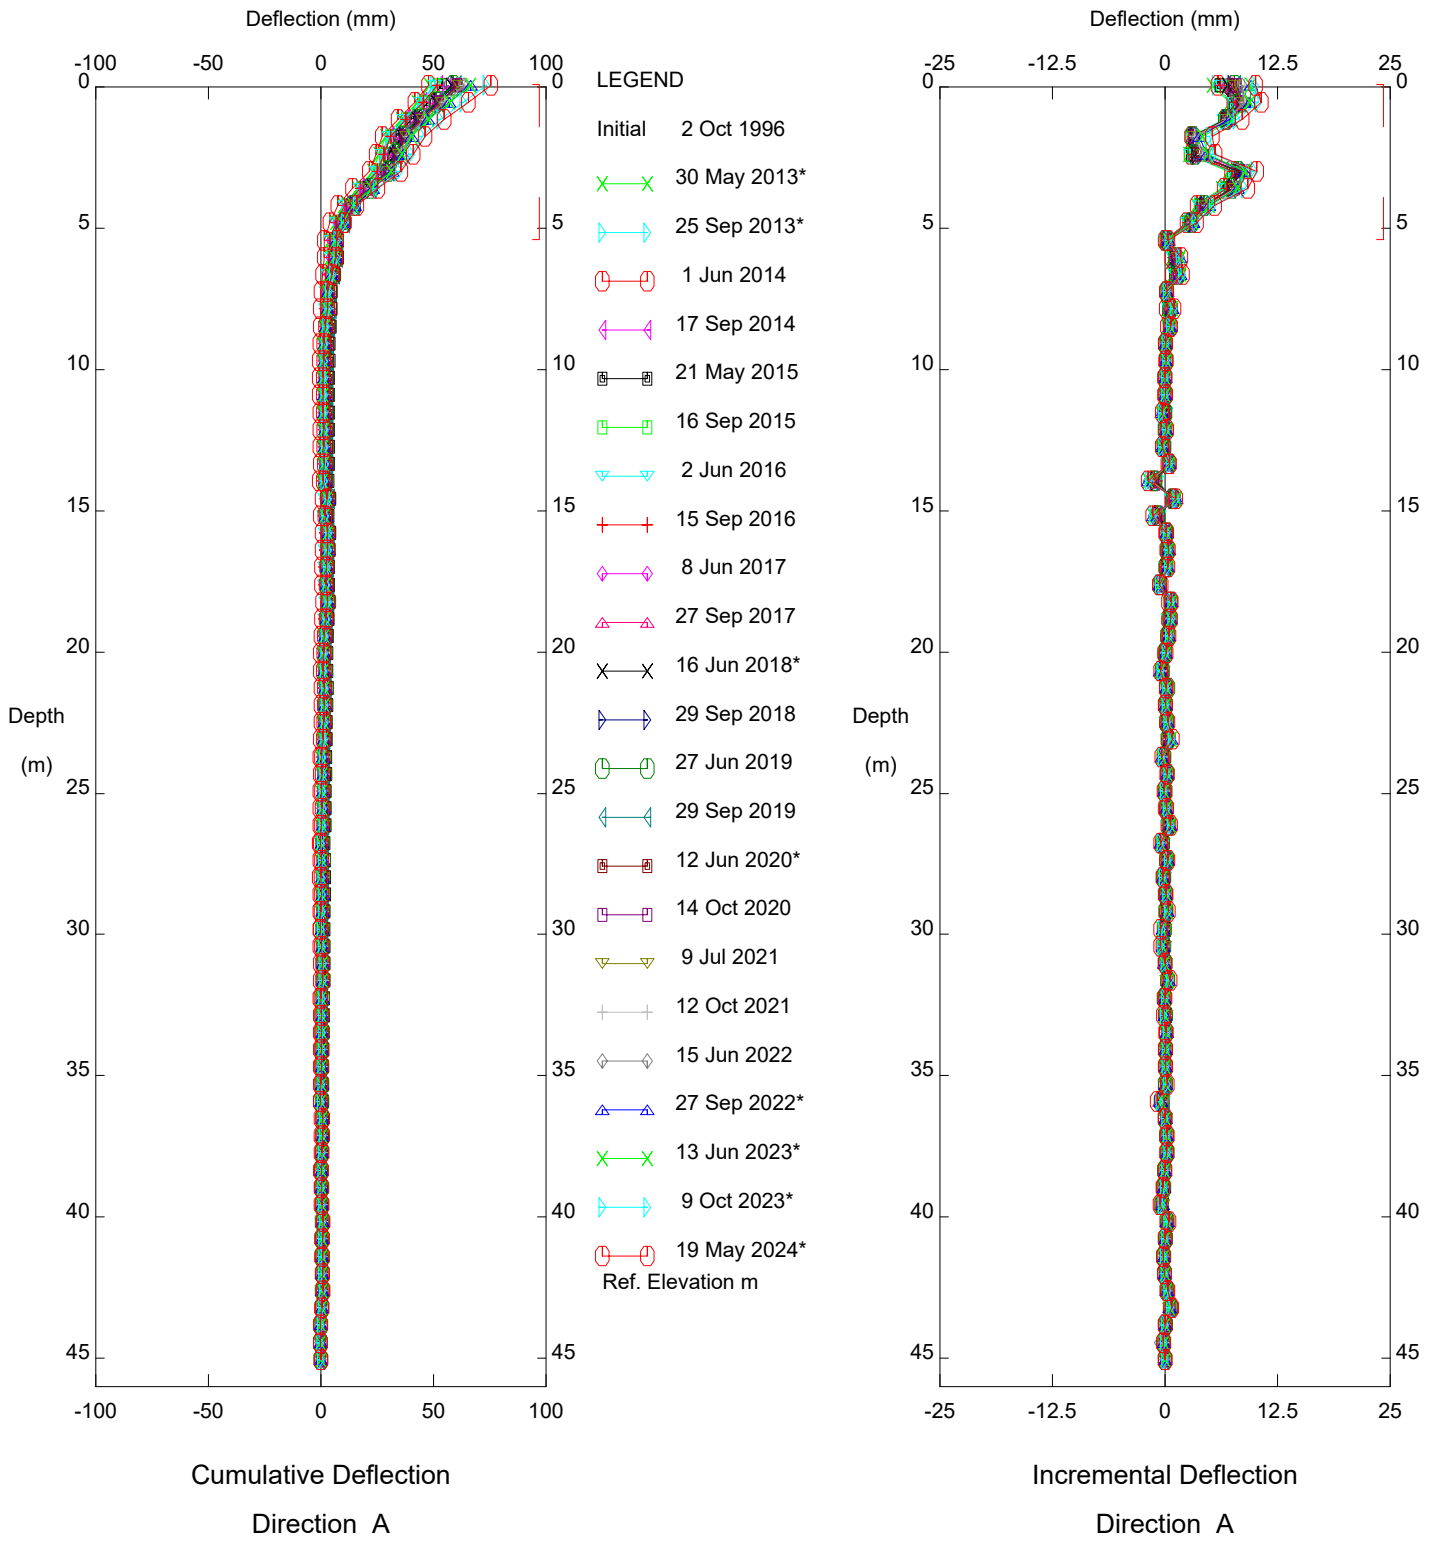
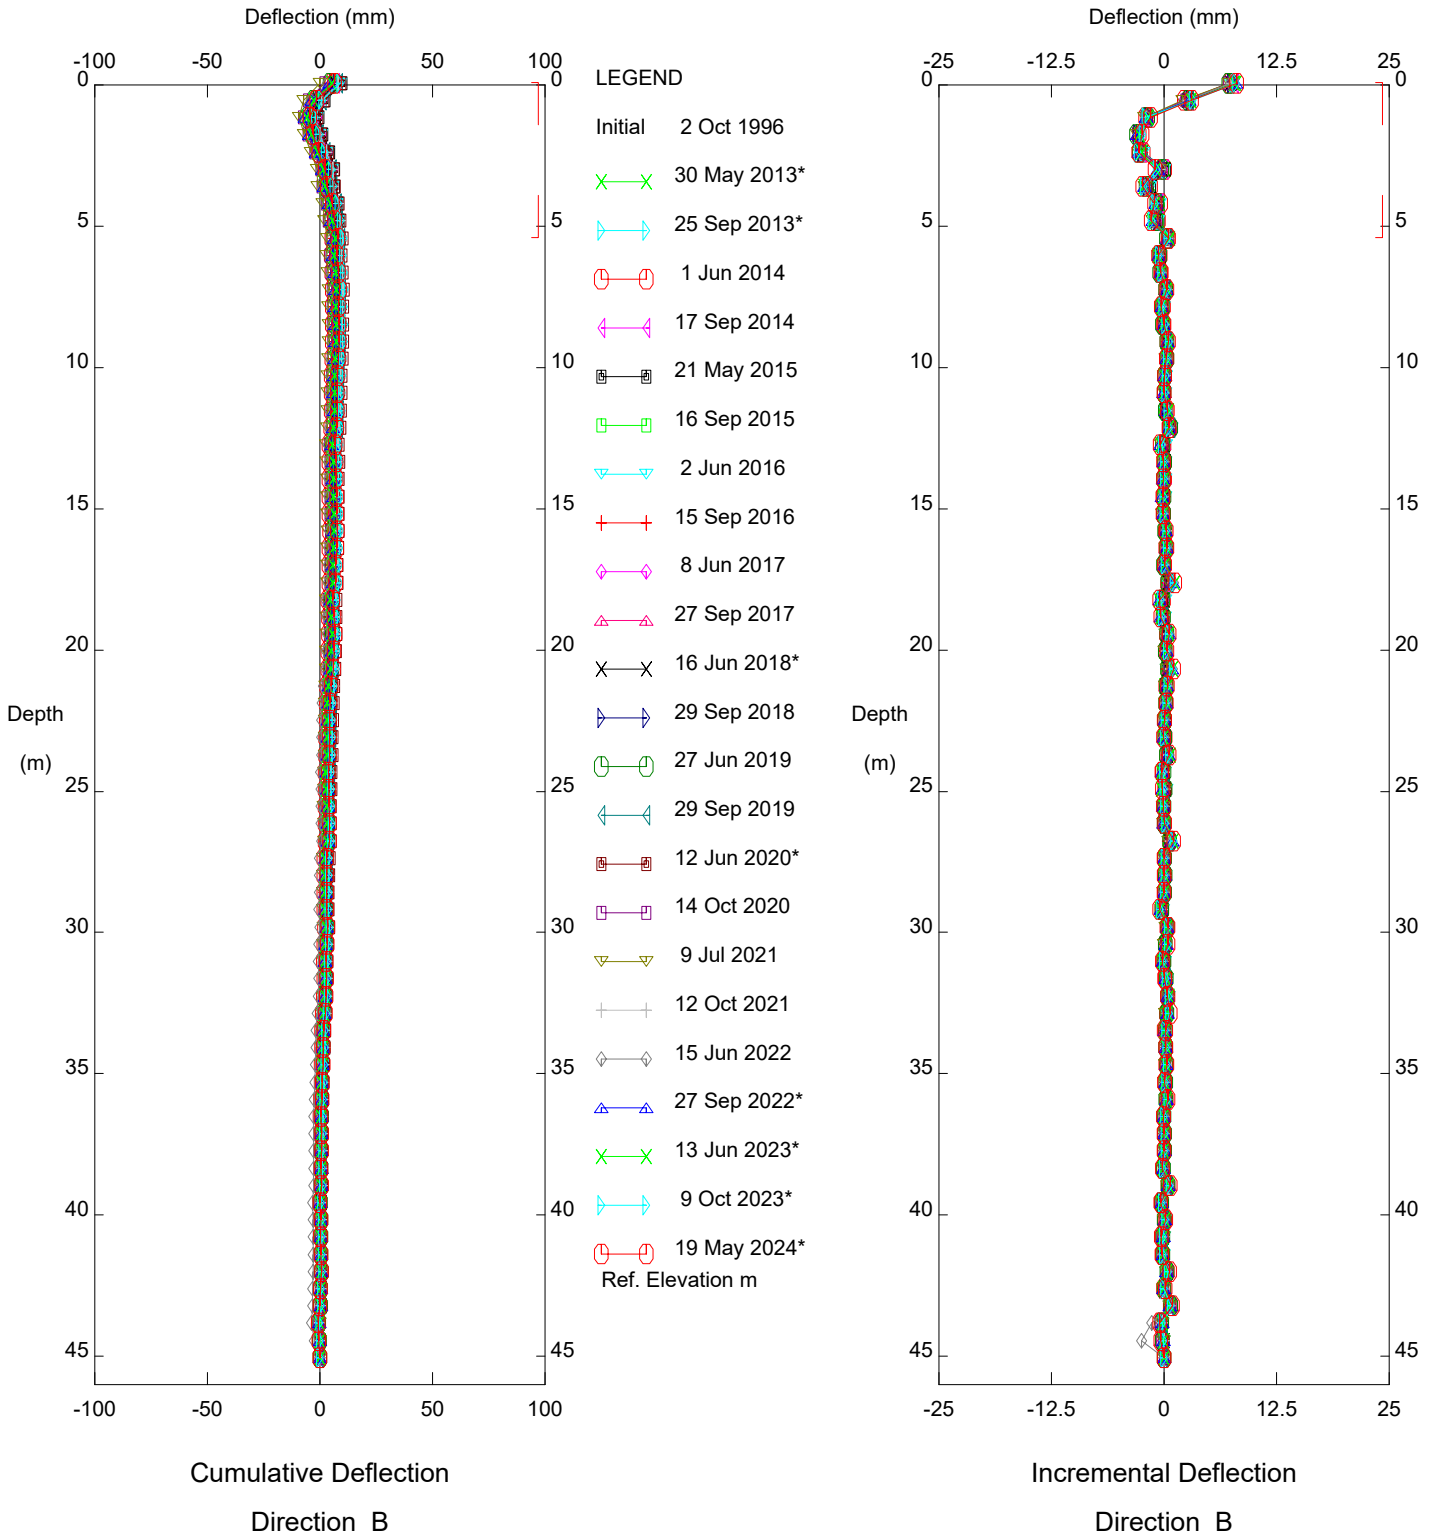
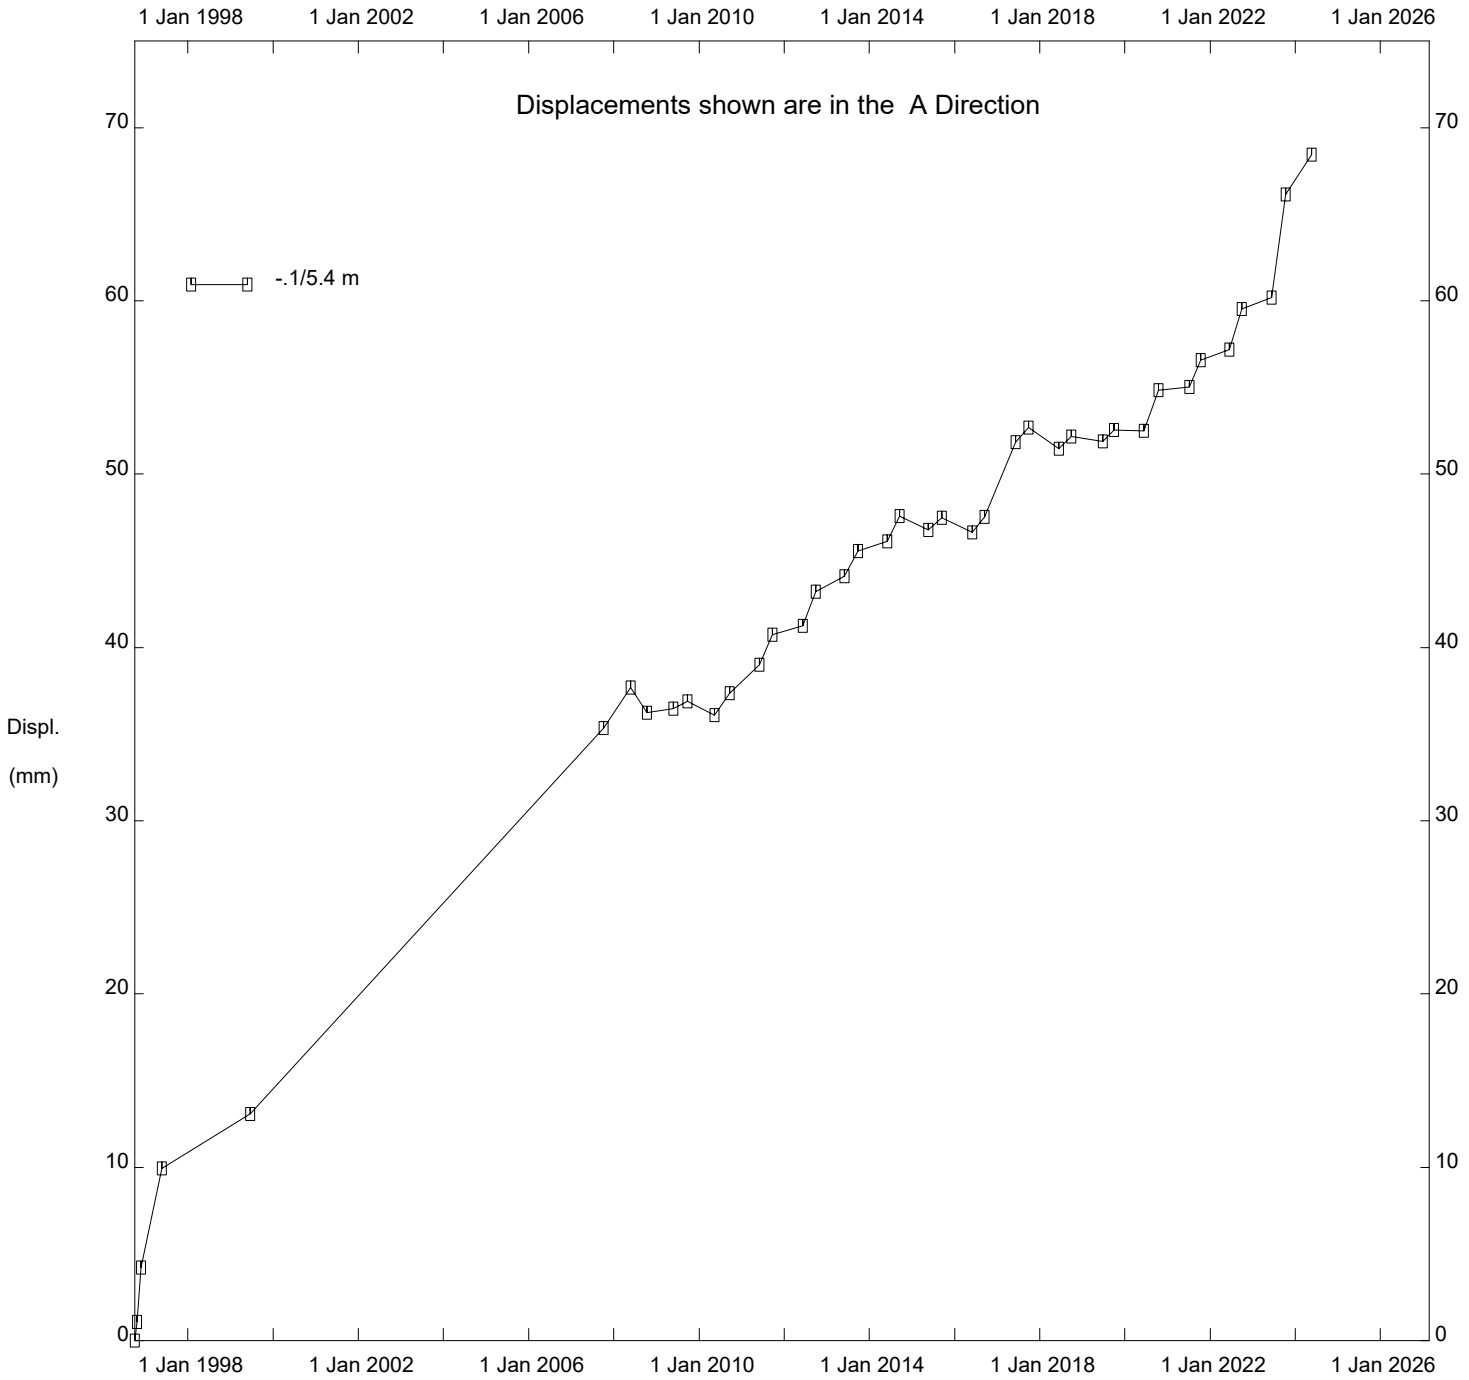
(PH059) PEACE RIVER EAST HILL -SITE 2, Inclinator SI-75

| INSTRUMENT # | DATE INITIALIZED | TOTAL CUMULATIVE RESULTANT MOVEMENT AT NOTED DEPTH SINCE INITIAL READING (mm) | MAXIMUM RATE OF MOVEMENT (mm/yr) | CURRENT STATUS | DATE OF PREVIOUS READING | INCREMENTAL MOVEMENT SINCE PREVIOUS READING (mm) | CURRENT RATE OF MOVEMENT (mm/yr) | CHANGE IN RATE OF MOVEMENT SINCE PREVIOUS READING (mm/yr) |
|---|---|---|--|---|---|--|---|---|
| SI-75 | Oct. 2, 1996 | 68.5 mm over 0 m to 5.4 m depth in 208° direction | 33.7 mm/yr<br>In Nov. 1996 | Operational | October 9, 2023 | 2.3 | 3.8 | -14.6 |
