| Site Number | Location | Name | Hwy | km |
|---|---|---|---|---|
| PH059 | Station 34+770 to 35+680 | Peace River East Hill | 2:60 | Km 34.8 to 35.7 |

**ALBERTA TRANSPORTATION AND ECONOMIC CORRIDORS GRMP (CON0022164)  
PEACE REGION (PEACE RIVER DISTRICT)  
INSTRUMENTATION MONITORING RESULTS**

**SPRING 2024**

**SITE PH059: HWY 2:60, PEACE RIVER EAST HILL  
(SITE # 2, STATION 34+770 TO 35+680)**

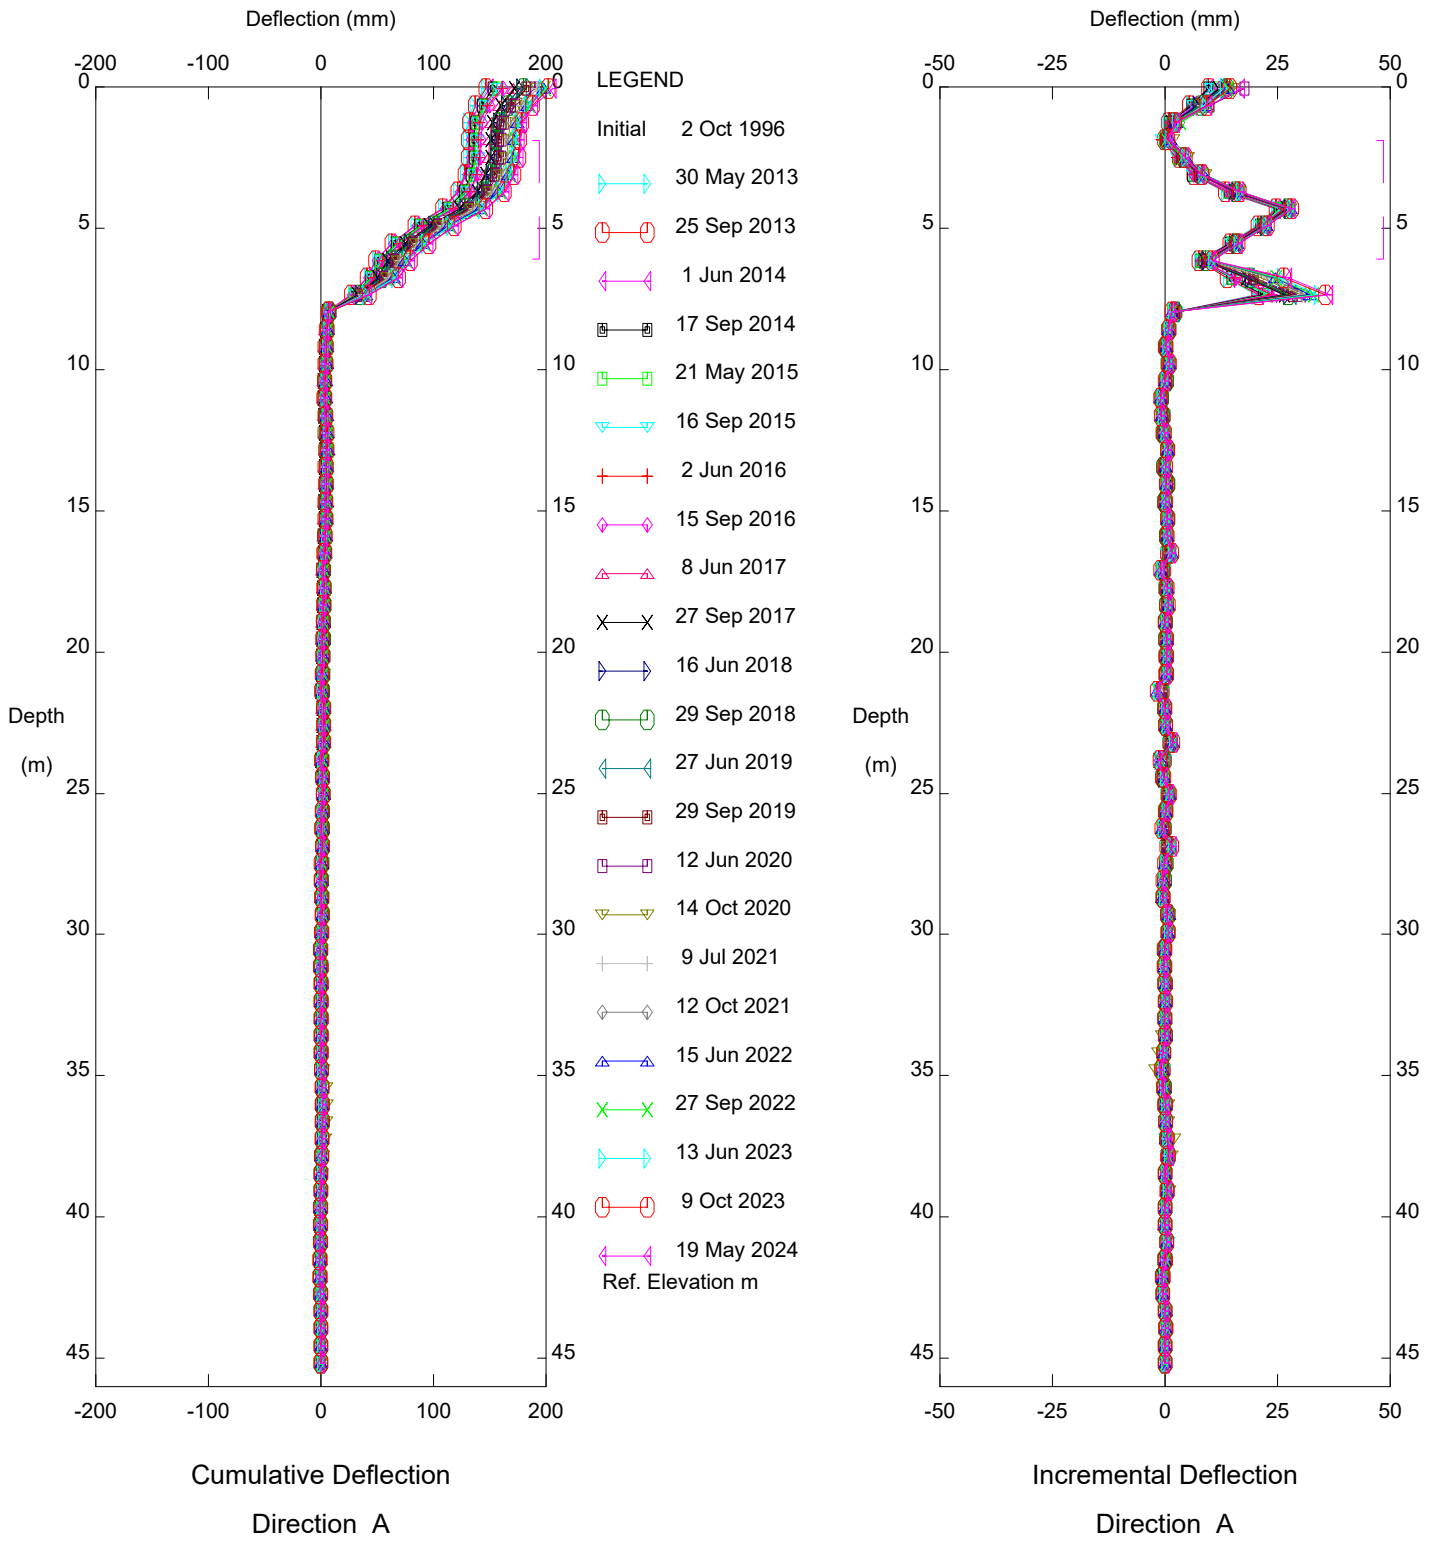
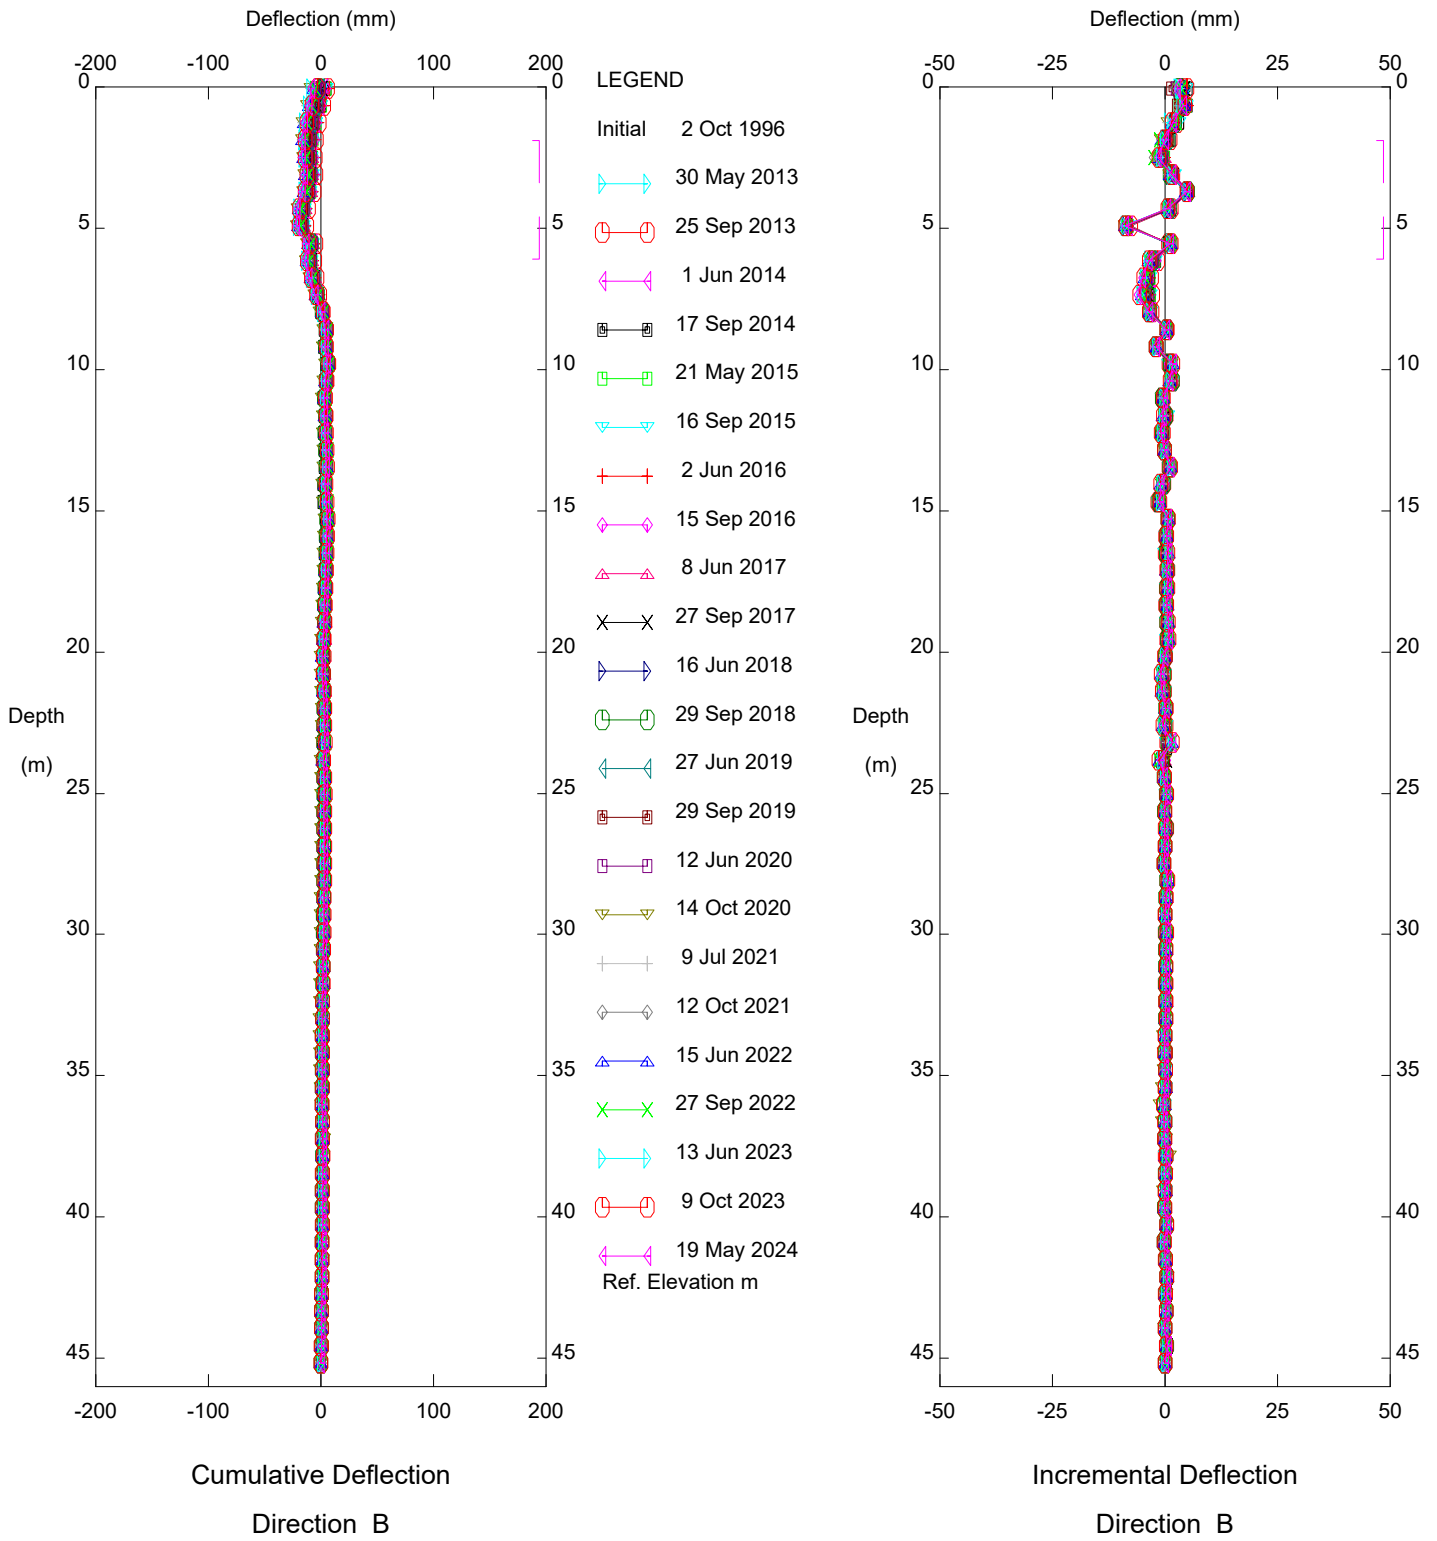
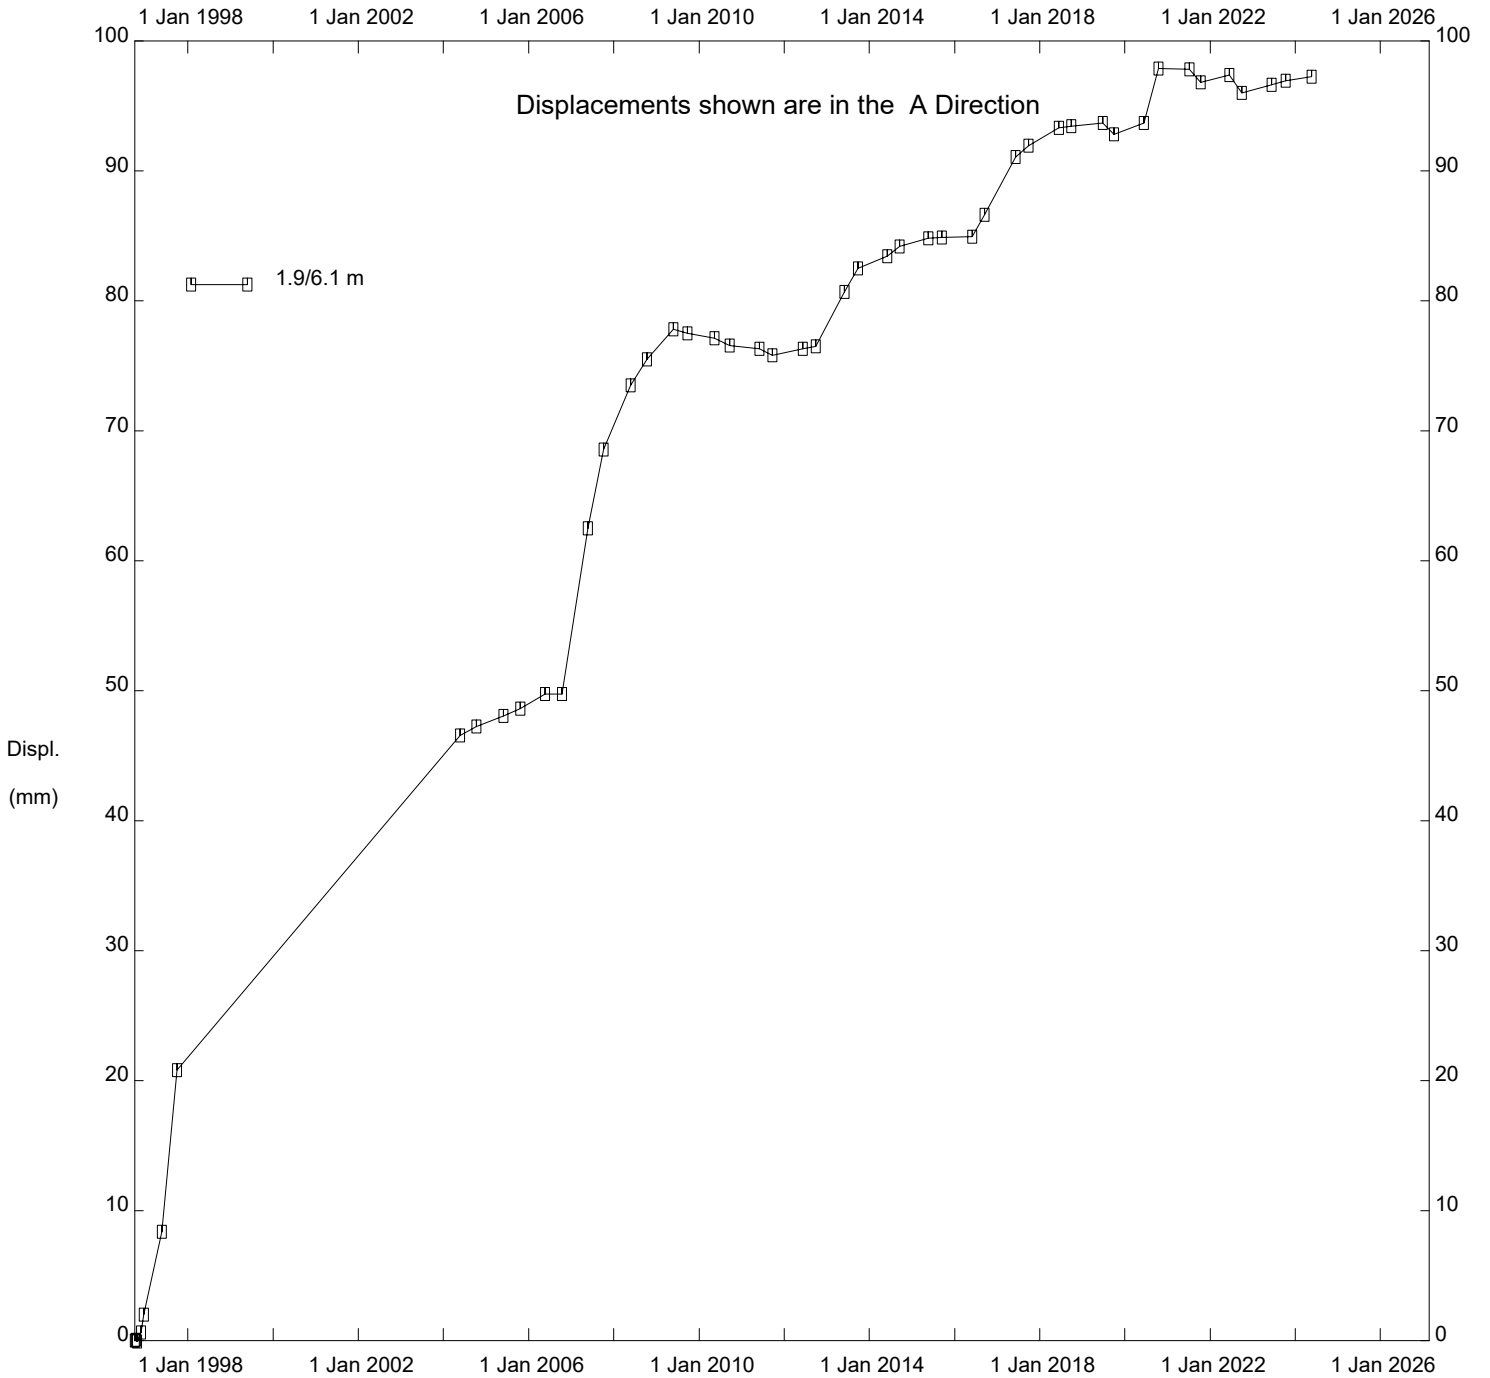
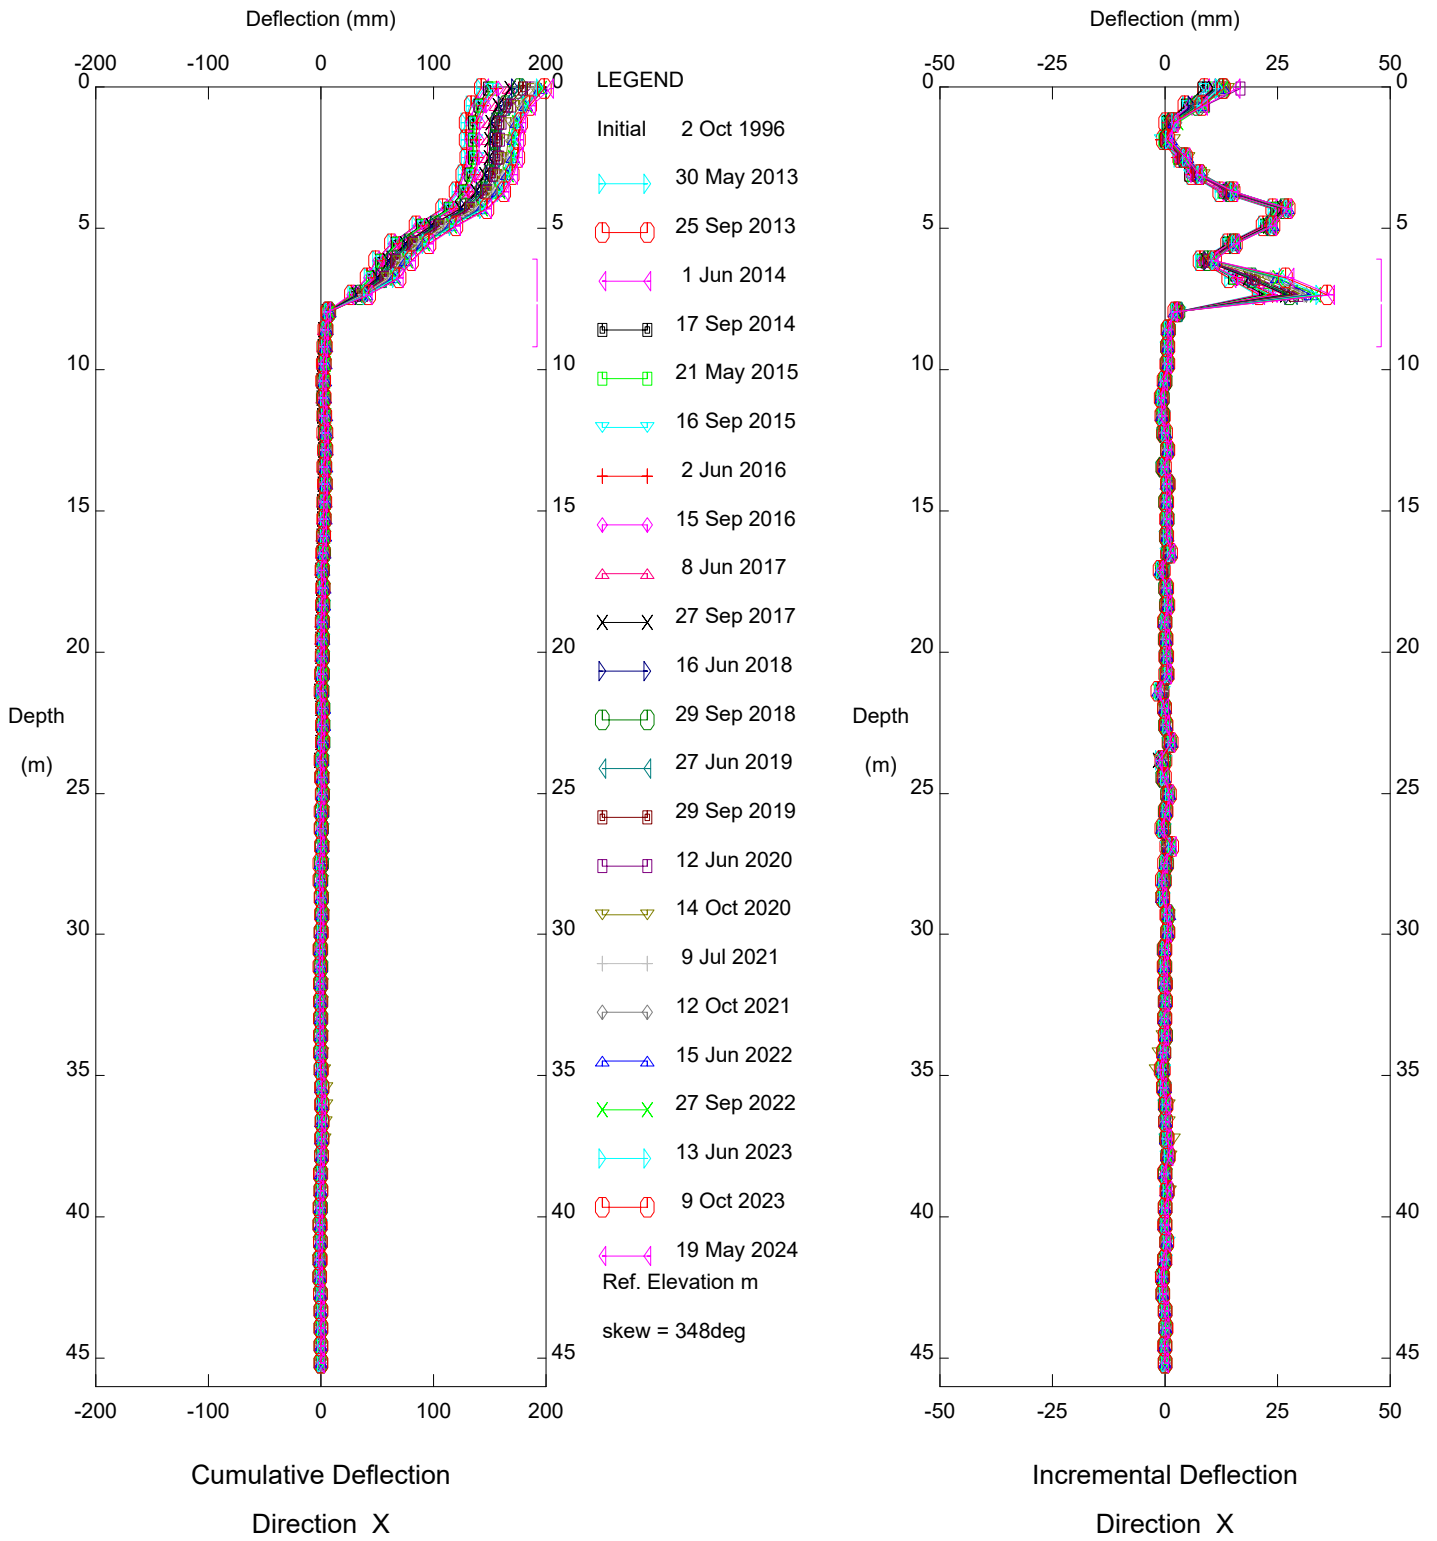
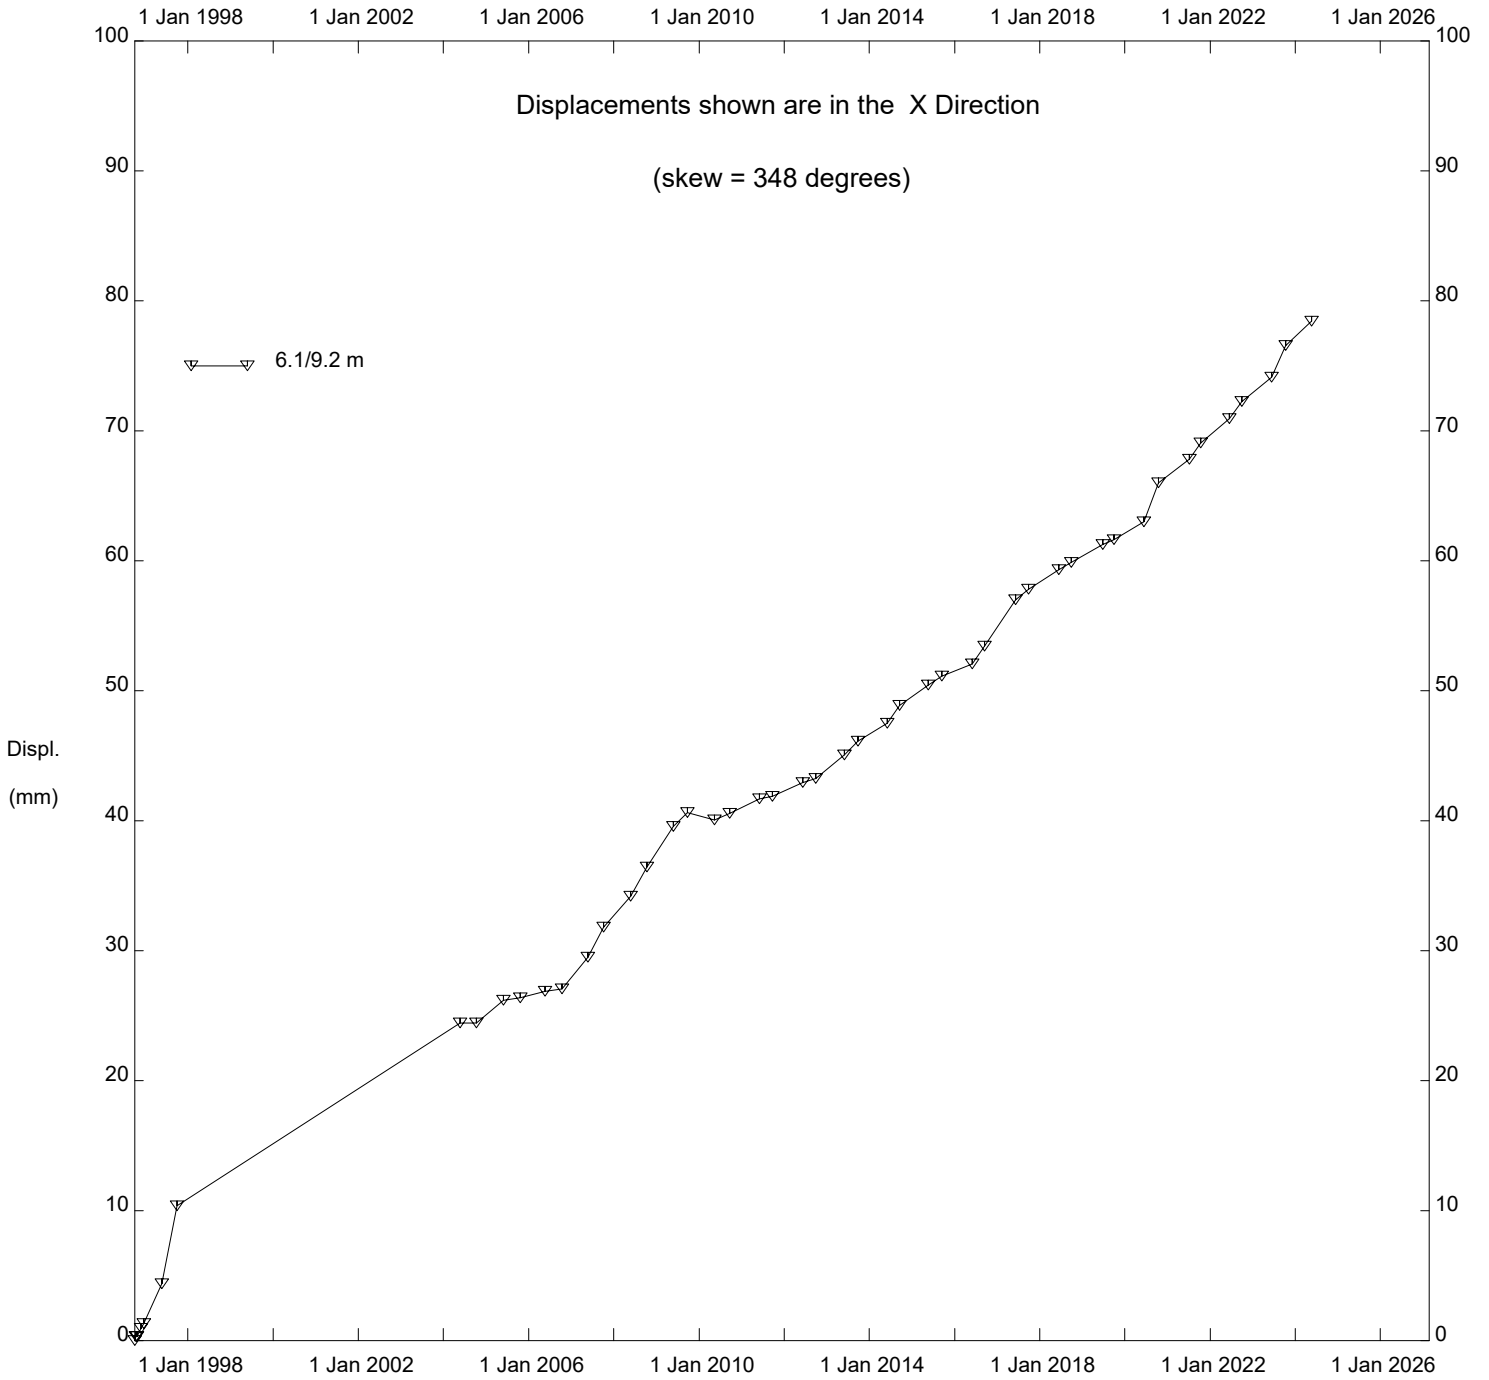
(PH059) PEACE RIVER EAST HILL -SITE 2, Inclinometer SI-81

| INSTRUMENT # | DATE INITIALIZED | TOTAL CUMULATIVE RESULTANT MOVEMENT AT NOTED DEPTH SINCE INITIAL READING (mm) | MAXIMUM RATE OF MOVEMENT (mm/yr) | CURRENT STATUS | DATE OF PREVIOUS READING | INCREMENTAL MOVEMENT SINCE PREVIOUS READING (mm) | CURRENT RATE OF MOVEMENT (mm/yr) | CHANGE IN RATE OF MOVEMENT SINCE PREVIOUS READING (mm/yr) |
|---|---|---|--|---|---|--|---|---|
| SI-81 | Oct. 2, 1996 | 97.3 mm over 1.9 m to 6.1 m depth in 191° direction | 34.9 mm/yr in September 1997 | Operational | October 9, 2023 | 0.4 | 0.6 | -0.3 |
| | | 78.4 mm over 6.1 m to 9.2 m depth in 179° direction | 16.9 mm/yr in September 1997 | | | 1.9 | 3.0 | -4.6 |

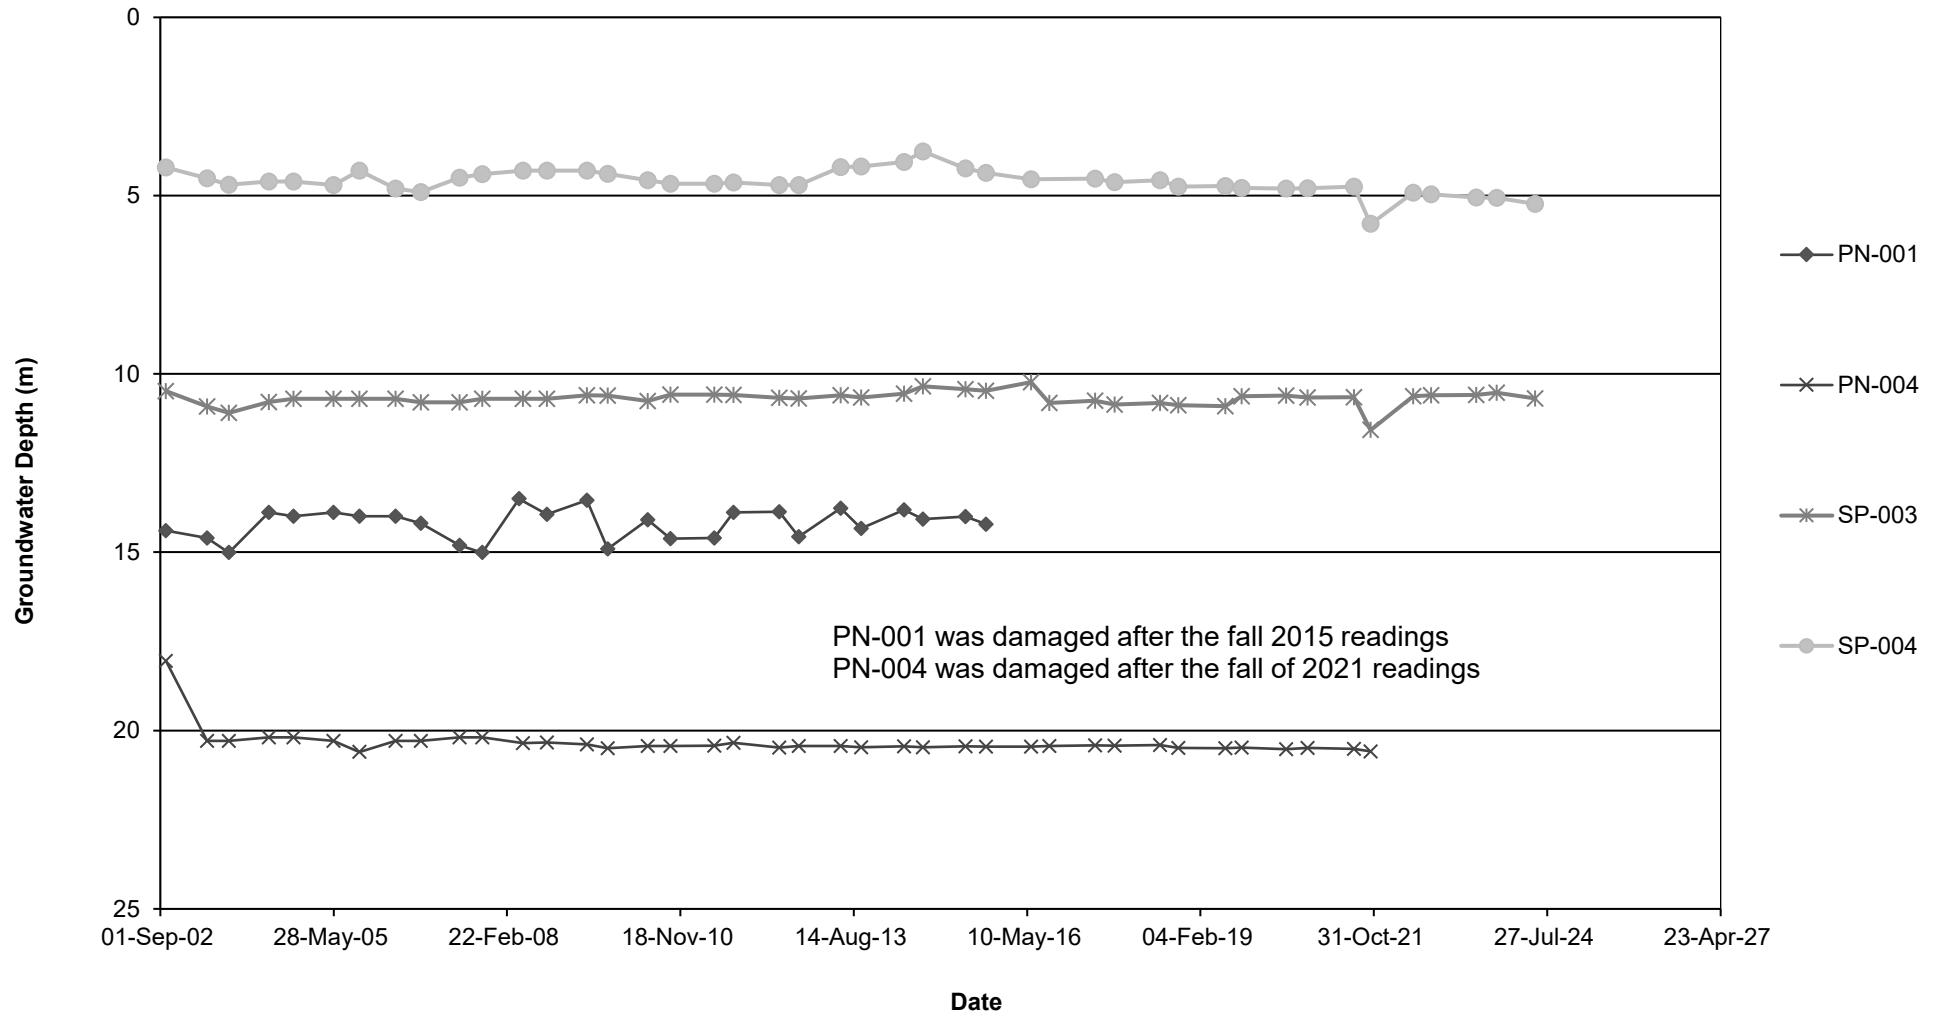
**FIGURE PH059-1  
PIEZOMETER DATA: PEACE RIVER EAST HILL SITE #2**

| | Standpipe piezometers SP-003 and SP-004 showed decreases in groundwater level of 0.16 m and 0.17 m, respectively, since the fall of 2023 readings. |
