**ALBERTA TRANSPORTATION AND
ECONOMIC CORRIDORS
GEOHAZARD ASSESSMENT PROGRAM
PEACE REGION (PEACE RIVER DISTRICT)
2024 INSPECTION**

Site Number	Location	Name	Hwy	km
PH060	East Hill	35+680 to 36+180 Site 3	2:60	35.95
Legal Description		UTM Co-ordinates (NAD 83)		
W28 & E29-083-21 W5M		11V E 483450	N 6231395

Date	PF	CF	Total
Previous Inspection:	May 25, 2022	13	4	52 (Slide Risk Rating)
Current Inspection:	May 27, 2024	13	4	52 (Slide Risk Rating)
Road WAADT:	3760	Year:		2023
Inspected By:	Don Proudfoot, Tyler Clay, Cole Szakacs (Thurber). Rocky Wang, Robert Senior (TEC)			
Report Attachments:	<input checked="" type="checkbox"/> Photographs <input checked="" type="checkbox"/> Plans <input type="checkbox"/> Maintenance

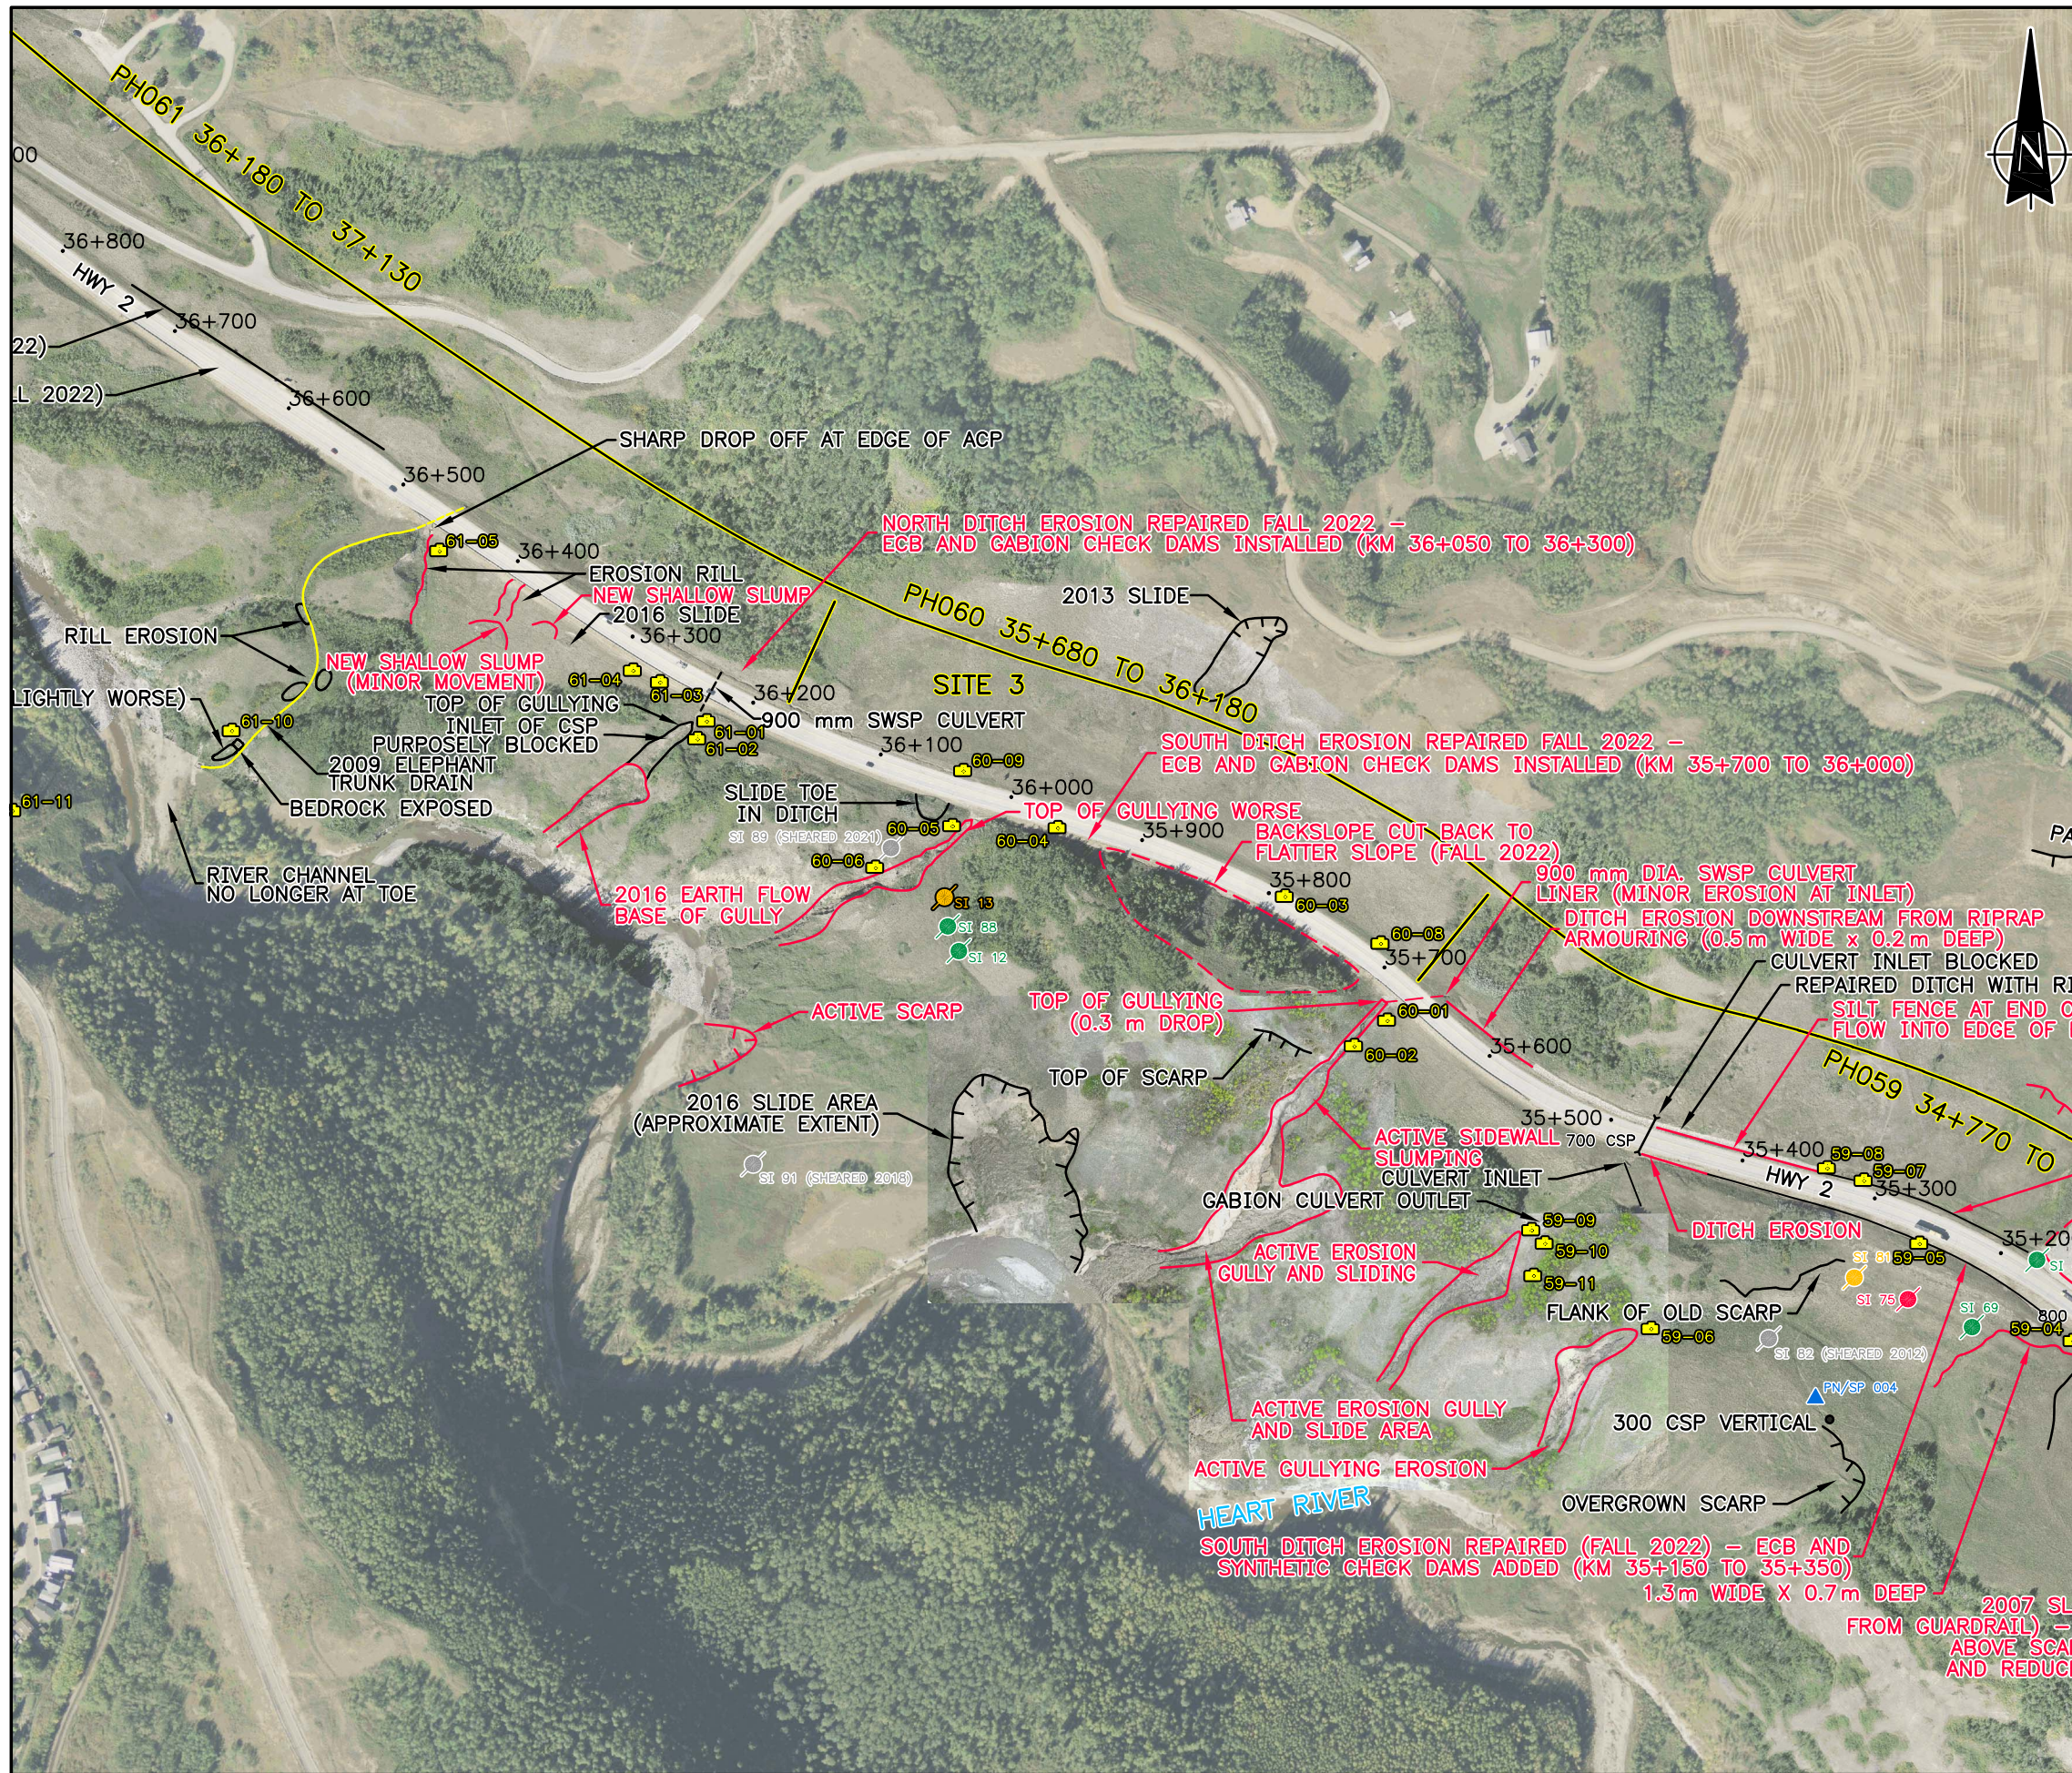
FIGURE PH060-2

Small deep-seated movements are occurring within the fill embankment downslope of roadway indicating low Factors of Safety. The Spring 2019 instrument readings indicated an accelerating trend of annual movement rate since 2016 from an average of approximately 7 mm/yr between the years 2013 to 2016 to approximately 10 mm/yr since 2017 at SI 89. Prior to 2016, the average annual movement rate was approximately 3 to 4 mm/yr (not including initial movement picked up within the same year following the SI installation in 1996). SI 91, located in the base of the valley slope was sheared off at 13.1 m depth in the recent Spring 2019 readings. SI89 was found sheared in the Spring 2021 readings located in the upper valley slope above the erosion gully at KM 36+050. The three remaining operational instruments located in the upper to mid-slope below the highway near km 36+000 have only shown creep or negligible movement to date.

Surficial observations of active movement near the highway have not been observed, likely due to the relatively small magnitude, but the risk level for this site has been adjusted accordingly due to the concerning trend of increased movement rates over the last five years and active movement near the valley bottom. A significant volume of material has been displaced from the valley toe in localized areas due to gullying and mass soil flow events that could be contributing to this trend. The movement leading to shearing at SI 89 may have been driven by a loss of toe material at the erosion gully to the south.

The mass movement near the valley base below 35+900 is expected to retrogress upslope and could cause instabilities that could potentially impact the highway in the future as toe support is lost. No slope instrumentation exists above this area to monitor potential impacts to the highway if movement were to occur.

The erosion gullies at 36+075 and 35+700 do not threaten the highway in their current state but a drainage structure (e.g. trunk drain) should be considered in the next 5 to 10 years to reduce the rate of retrogression.

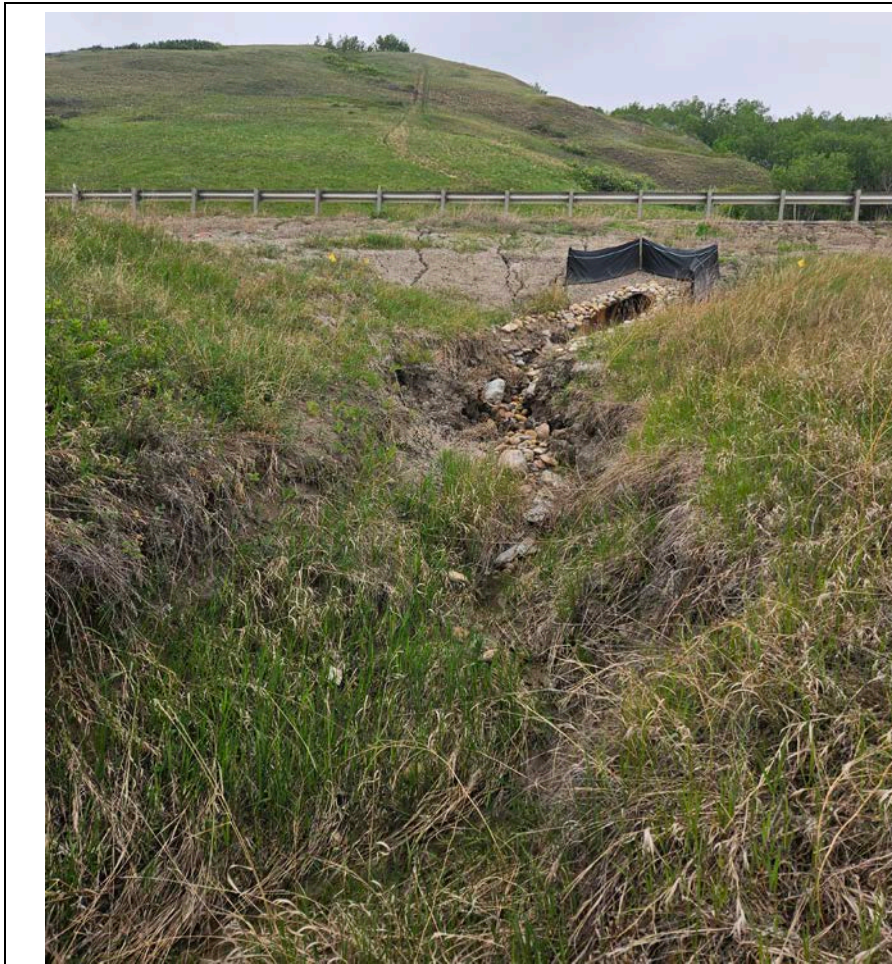
<input type="checkbox"/> Seepage		<input type="checkbox"/>	<input type="checkbox"/>
<input checked="" type="checkbox"/> Bridge/Culvert	Culvert was relined with SWSP and rock armoured at the inlet/outlet as part of Fall 2022 repair work. (Photos 60-01 and 60-08)	<input type="checkbox"/>	<input checked="" type="checkbox"/>
<input type="checkbox"/> Other		<input type="checkbox"/>	<input type="checkbox"/>

Photo 60-01.
View north towards the culvert outlet near km 35+675. As part of Fall 2022 repair work, a 900 mm diameter SWSP liner was installed and rock armoring was added at the inlet and outlet. Ongoing erosion downstream of culvert and rilling above. Scour depth below culvert inlet was 0.3 m.

- Add additional armoring rock, ECM and upstream synthetic check dams at the km 35+675 culvert inlet.

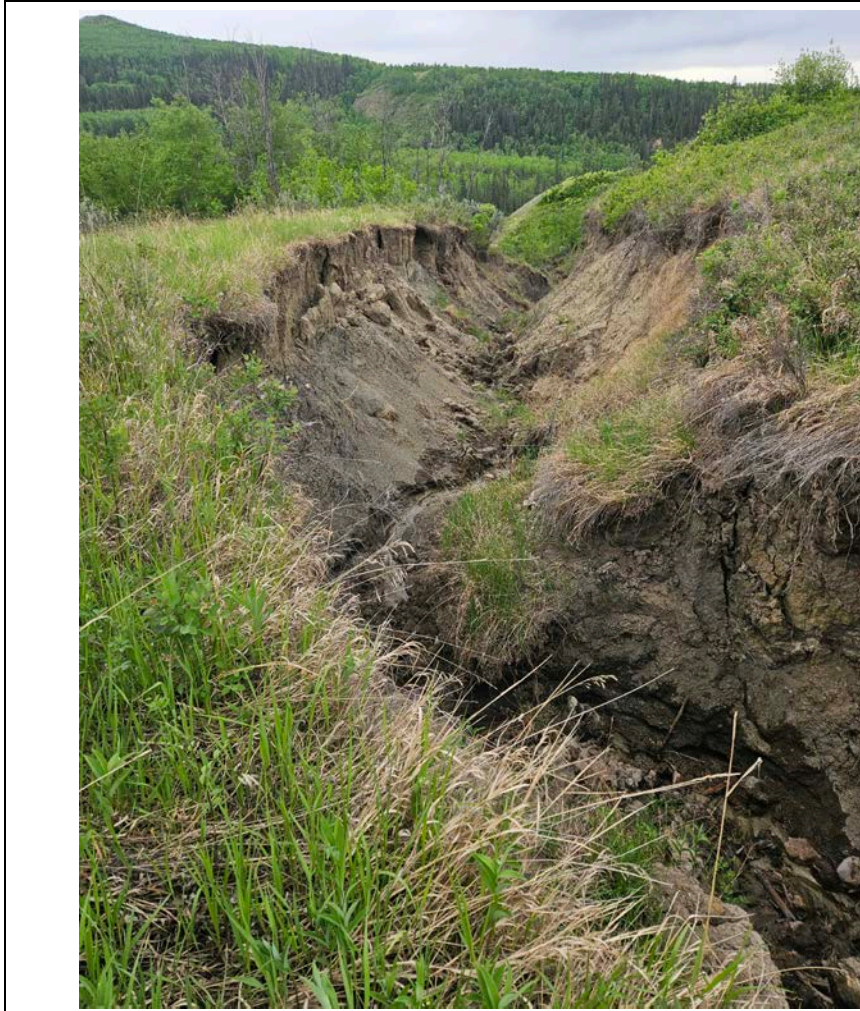
Photo 60-02.
Looking downslope at erosional gullying below culvert shown in Photo 60-01 (35+675). Active slumping on gully sidewalls has expanded gully width since 2022.

- Consider redirecting surface runoff further downslope of headcutting/gullying that is occurring at 36+000 and 35+700. The upper erosion gully at 35+675 should be graded and armored with rock riprap or gabion mattress. Armoring the upper gully headwall should also be carried out at km 36+000. (\$250k to \$400k)

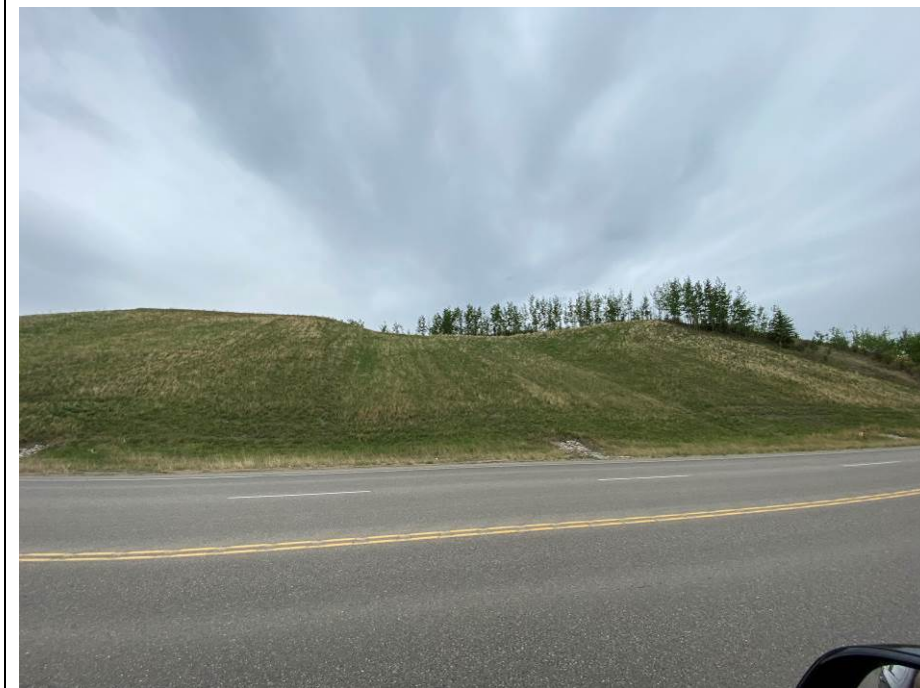
Photo 60-03.
View south towards the backslope near km 35+830 where a landslide had previously developed. As part of the Fall 2022 repair work the backslope was cut back flatter and regraded. New slope configuration was well vegetated and in good condition.

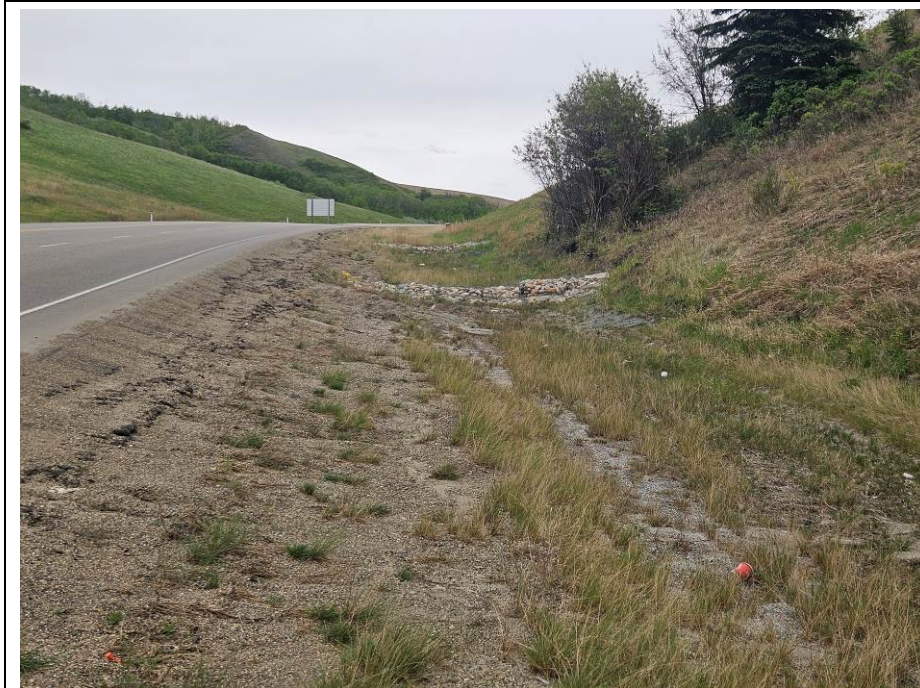
Photo 60-04.
Looking east near km 35+950 at the regraded south ditch. ECM and gabion check dams installed as part of Fall 2022 repairs.

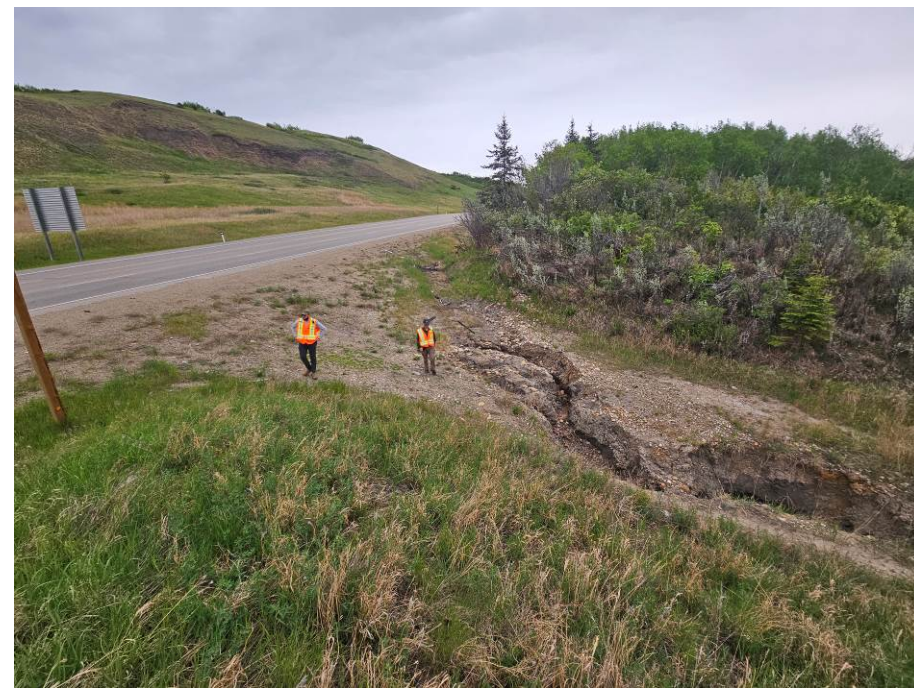
<input checked="" type="checkbox"/> Erosion	<p>Ongoing erosion at the culvert outlet and inlet near km 35+675. Outlet and inlet were regraded and rock armour added as part of the Fall 2022 repairs. Scour below the culvert outlet was 0.3 m in depth. Erosion at the inlet measured 0.5 m wide and 0.2 m deep creating a drop from ditch elevation into the inlet. (Photos 60-01 and 60-08)</p> <p>Gullying immediately downstream from culvert outlet at km 35+675 had active slumping on gully sidewalls that has expanded the gully width since 2022 (Photos 60-02). The erosion and gullying significantly expands approximately 125 m downslope of the highway where trees and thicker vegetation becomes sparse.</p> <p>Previous ditch erosion on both sides of the roadway between 35+850 and 36+300 was repaired in Fall 2022 with ECM and check dams. (Photos 60-04 and 60-09)</p> <p>At 36+050, active gully erosion is ongoing on the upper portion of the toe berm below the roadway. Top of the gullying was slightly deeper and closer to the highway relative to the 2022 condition. Further downstream the gully continues to expand with ongoing erosion and collapse of the vertical sidewalls. (Photos 60-05 and 60-06)</p>	<input checked="" type="checkbox"/>	<input type="checkbox"/>

Photo 60-05.
View south towards erosional gullying occurring below the roadway where ditch runoff enters near km 36+050. Top of the gullying was slightly deeper and closer to the highway relative to the 2022 condition.

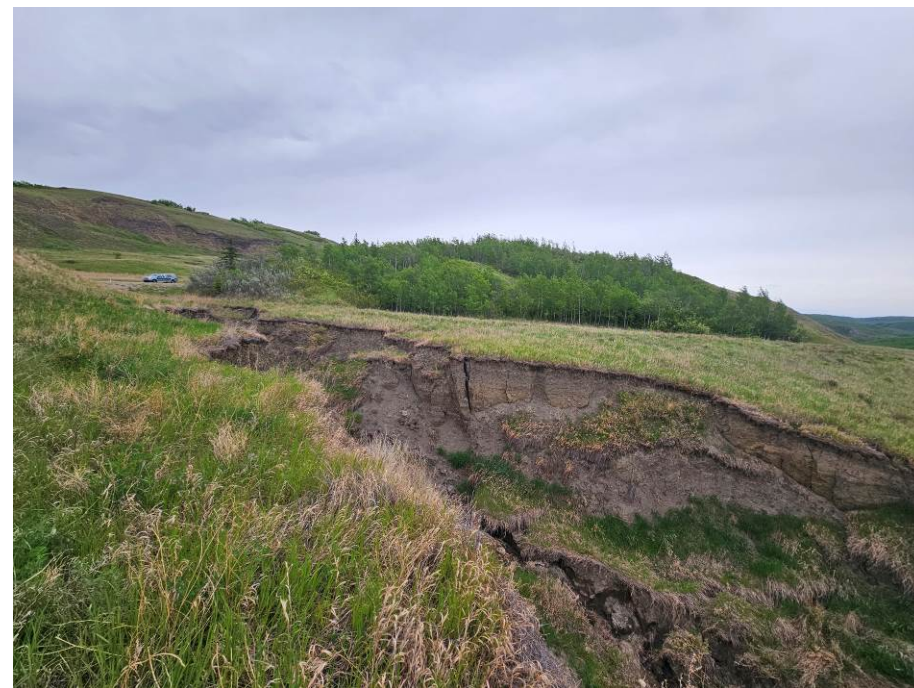
Photo 60-06.
Looking north towards expanded gully erosion downstream from km 36+050. Ongoing erosion and collapse of the near vertical gully sidewalls.

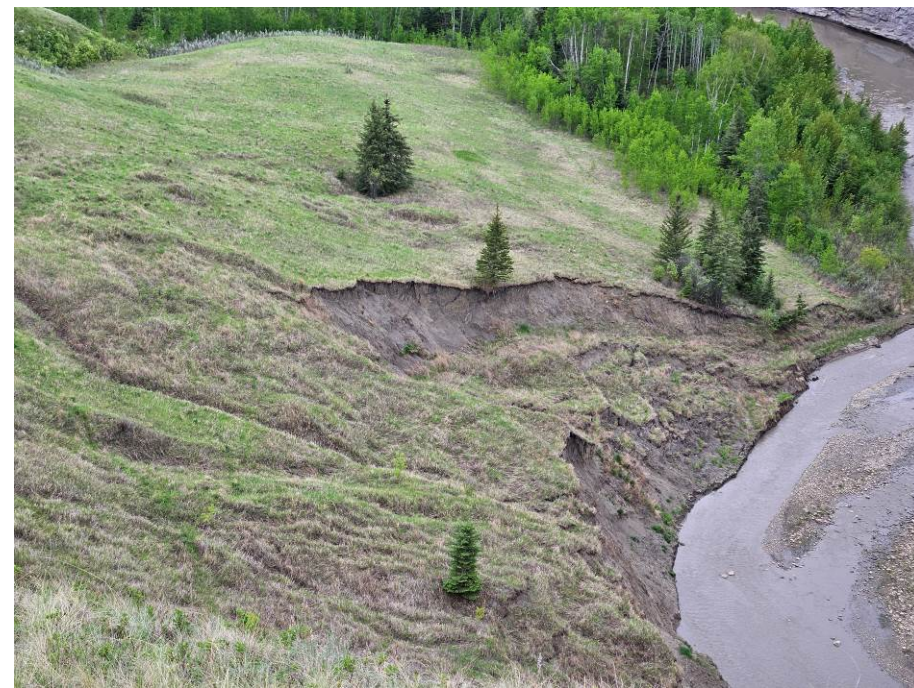
Observations:	Description:	Worsened?	
		Yes	No
<input type="checkbox"/> Pavement		<input type="checkbox"/>	<input type="checkbox"/>
<input checked="" type="checkbox"/> Slope Movement	<p>Retrogressive slumping along Heart River is actively continuing, which encompasses the lower portions of the large toe berm constructed downslope of the roadway to stabilize the initial landslide in this area. Areas have ongoing movement and river erosion at the toe with some minor retrogression/lateral expansion of the main 2016 slide area which is offset approximately 180 m from highway.</p> <p>Overgrown scarp on north side of highway near 35+750 shows no sign of recent movement.</p> <p>Shallow slide/flow on the backslope at 35+830 was regraded and slope was flattened as part of Fall 2022 repair work. New backslope was vegetated and in good condition. (Photo 60-03).</p> <p>Active sliding is occurring at the valley bottom between km 35+650 and km 35+750 (partially into the PH059 site extents) (Photo 60-07).</p>	<input checked="" type="checkbox"/>	<input type="checkbox"/>

Photo 60-07.
Looking southeast at active sliding at the bottom of the Heart River valley near KM 35+600 (downslope from PH059 site). Increased downdrop and expansion of the sliding area as the slide material and valley toe soils are eroded by the river.

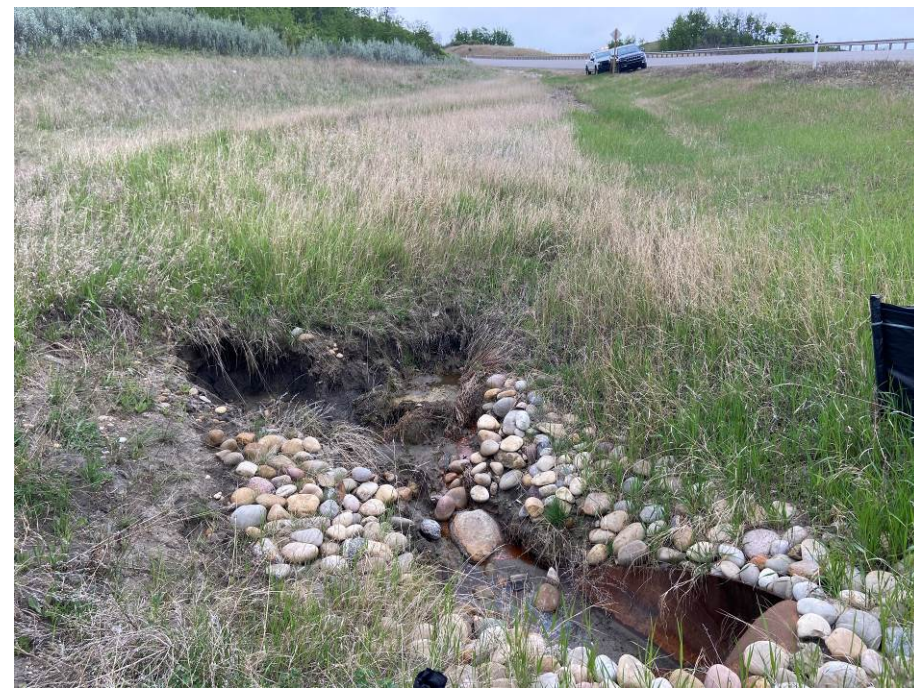
Photo 60-08.
Minor erosion at the culvert inlet near km 35+675. Culvert was lined and had rock armoring added as part of the Fall 2022 repairs. Erosion damage was approximately 0.5 m wide and there was a 0.2 m drop.

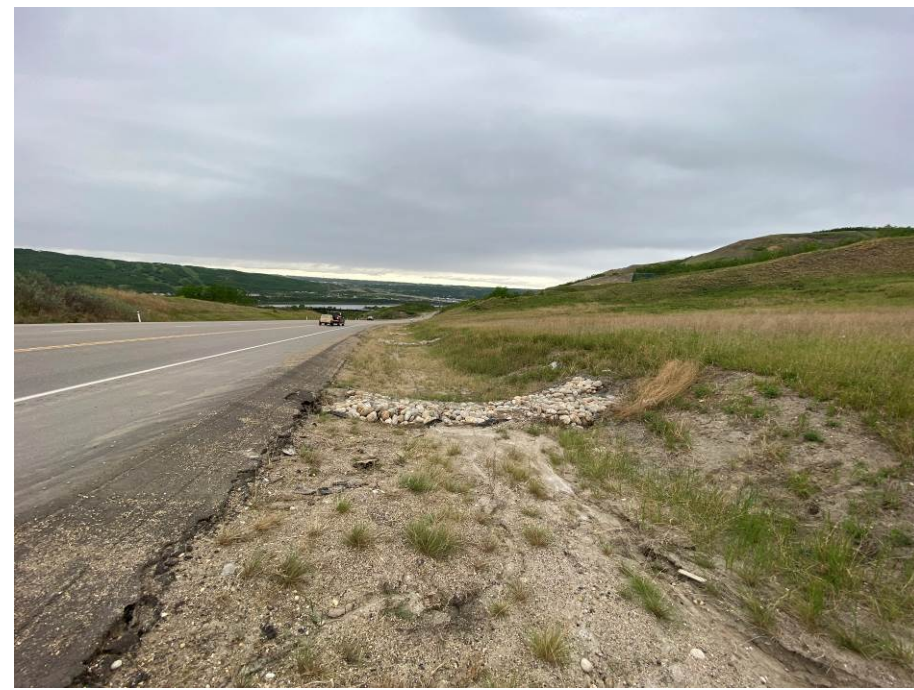
Photo 60-09.
Looking west towards the north ditch where Fall 2022 erosion repairs were completed with gabion check dams installed between approximately km 36+050 and km 36+300.
