## **ALBERTA TRANSPORTATION AND ECONOMIC CORRIDORS GRMP** PEACE REGION – (PEACE RIVER DISTRICT) INSTRUMENTATION MONITORING - SPRING 2024

Site Number	Location	Name	Hwy	km
PH060	Station 35+680 to 36+180	Peace River East Hill Site #3	2:60	36.0
Legal Description:		UTM Co-ordinates		·
9-29-83-21 W5		11U E 483348	N 6	231305

<b>Current Monitoring:</b>	19-May-2024	Previous Monitoring	9-Oct-2023
Instruments Read By:	Mr. Niraj Regmi, G.	I.T and Mr. Nixson Mationg, of Thurber	r

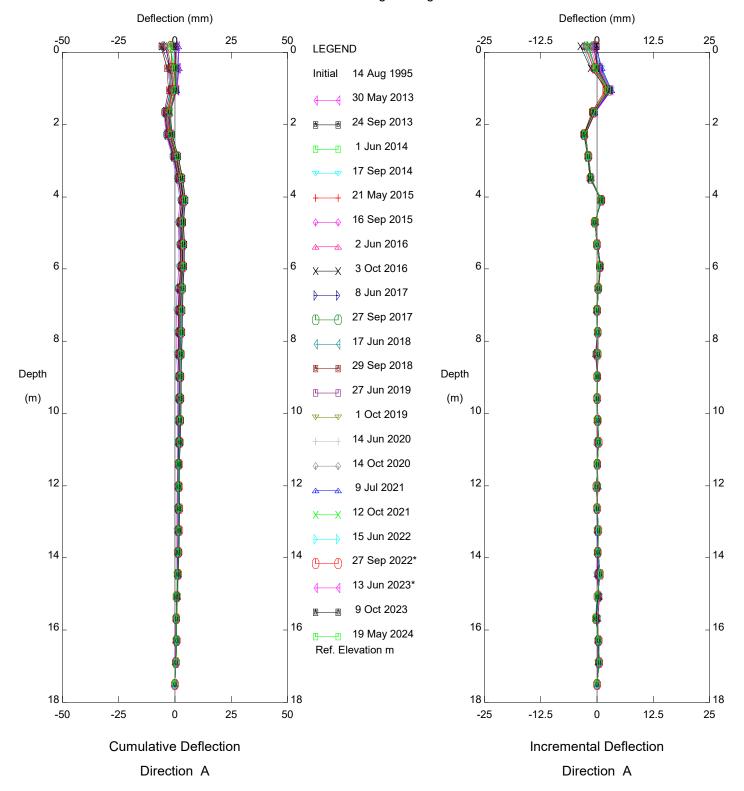
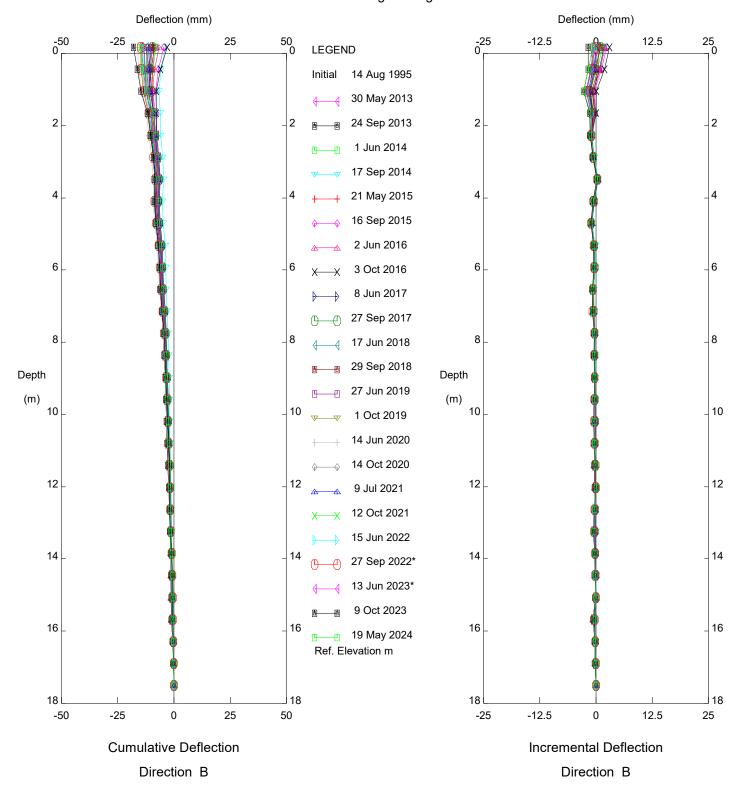
(PH060) PEACE RIVER EAST HILL -SITE 3, Inclinometer SI-12

Discussion								
Zones of New Movement:	None							
	Slope indicators SI-12 and SI-88 are located about 20 m apart and continued to show no discernible movement.							
Interpretation of Monitoring Results:	SI-13 showed a rate of movement of 0.1 mm/yr over 2.2 m to 4.7 m depth, corresponding to an increase in rate of movement of 0.8 mm/yr since the fall of 2023 readings. Over the long-term a movement rate of about 0.3 mm/yr has been observed since about 2007.							
Future Work:	The instruments should be read again during the fall of 2024 reading program.							
Instrumentation Repairs:	No instrument repairs are required at this time.							
Additional Comments:	Consideration could be given to reducing the reading frequency for SI-12 as it is in close vicinity to SI-88 and is a much shallower installation. Reduction to biennial spring readings could be sufficient.
