**ALBERTA TRANSPORTATION AND
ECONOMIC CORRIDORS
GEOHAZARD ASSESSMENT PROGRAM
PEACE REGION (PEACE RIVER DISTRICT)
2024 INSPECTION**

Site Number	Location	Name	Hwy	km
PH061	East Hill	36+180 to 37+130 Site 4	2:60	36.7
Legal Description		UTM Co-ordinates (NAD 83)		
NW & E29-083-21 W5M		11V E 482790	N 6231755

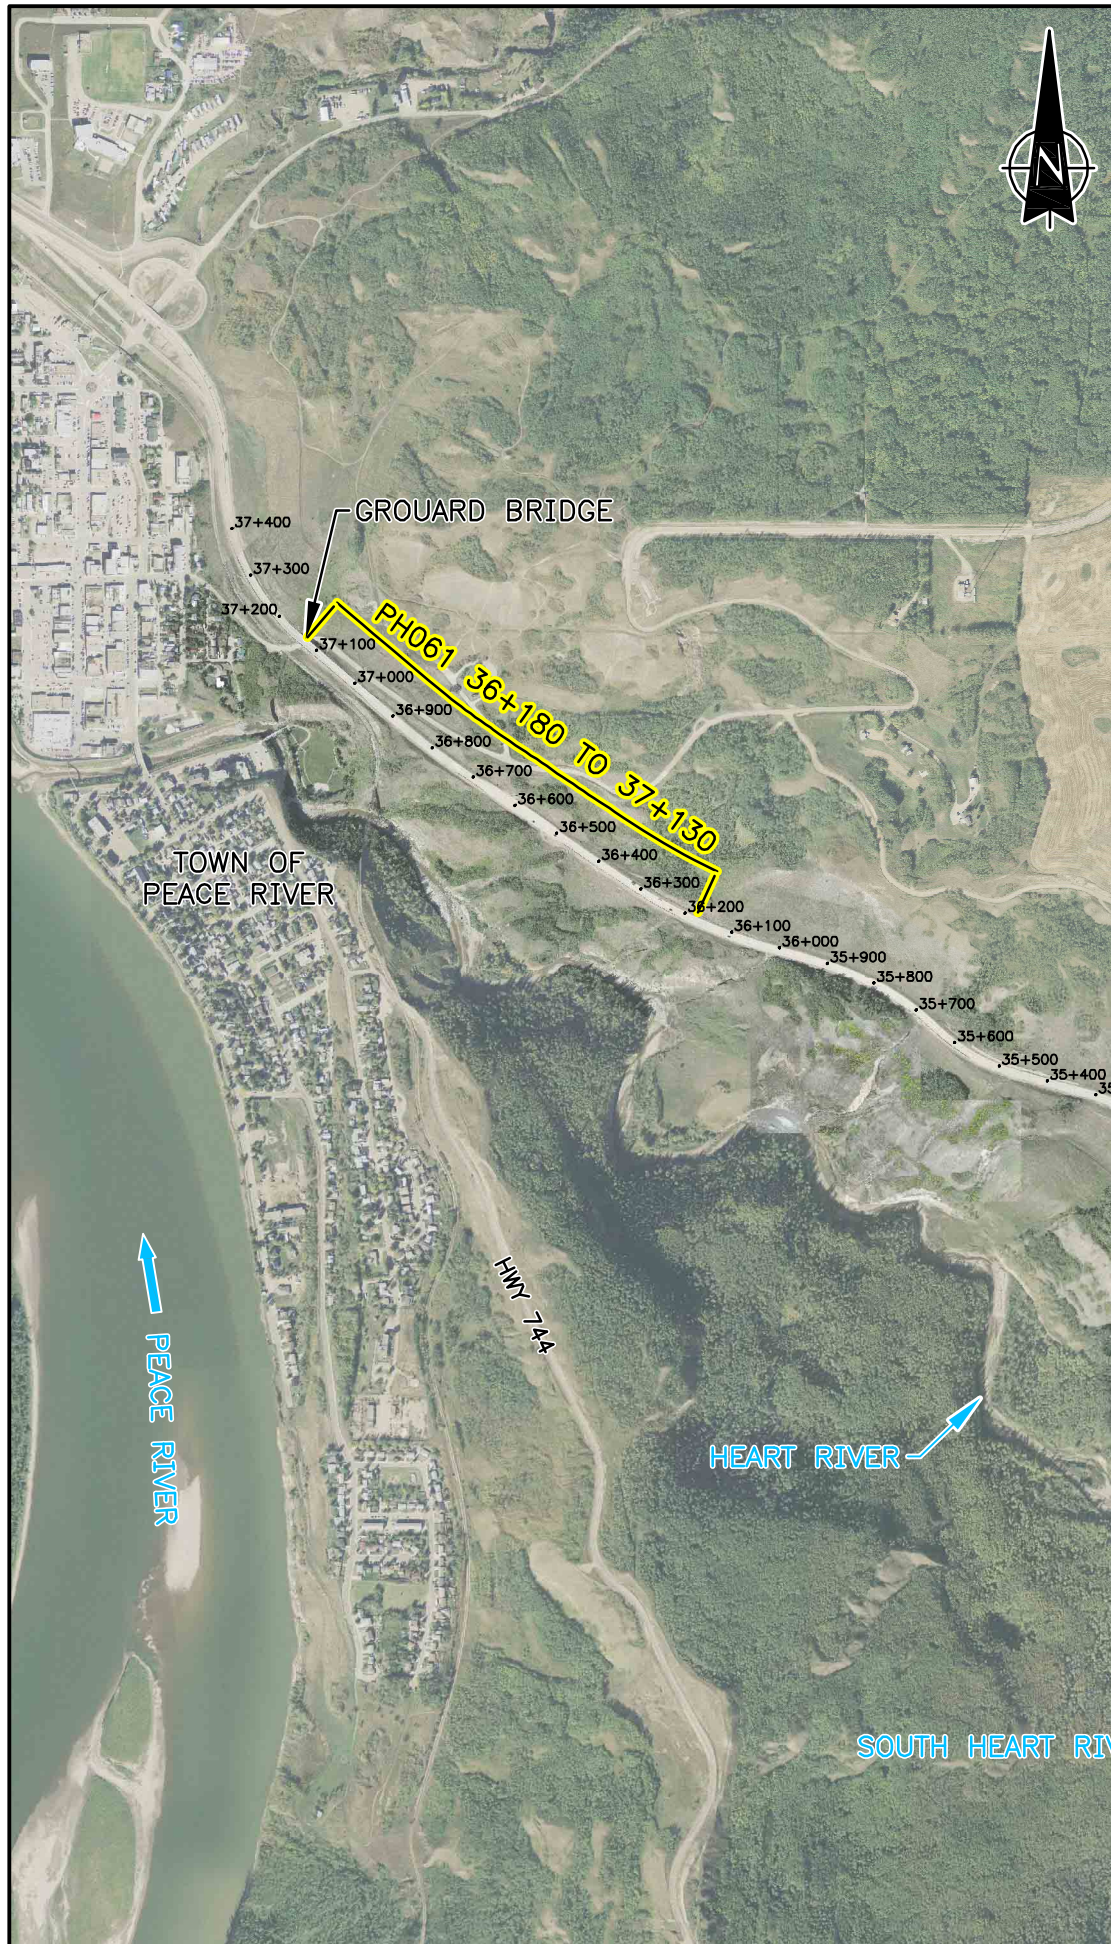
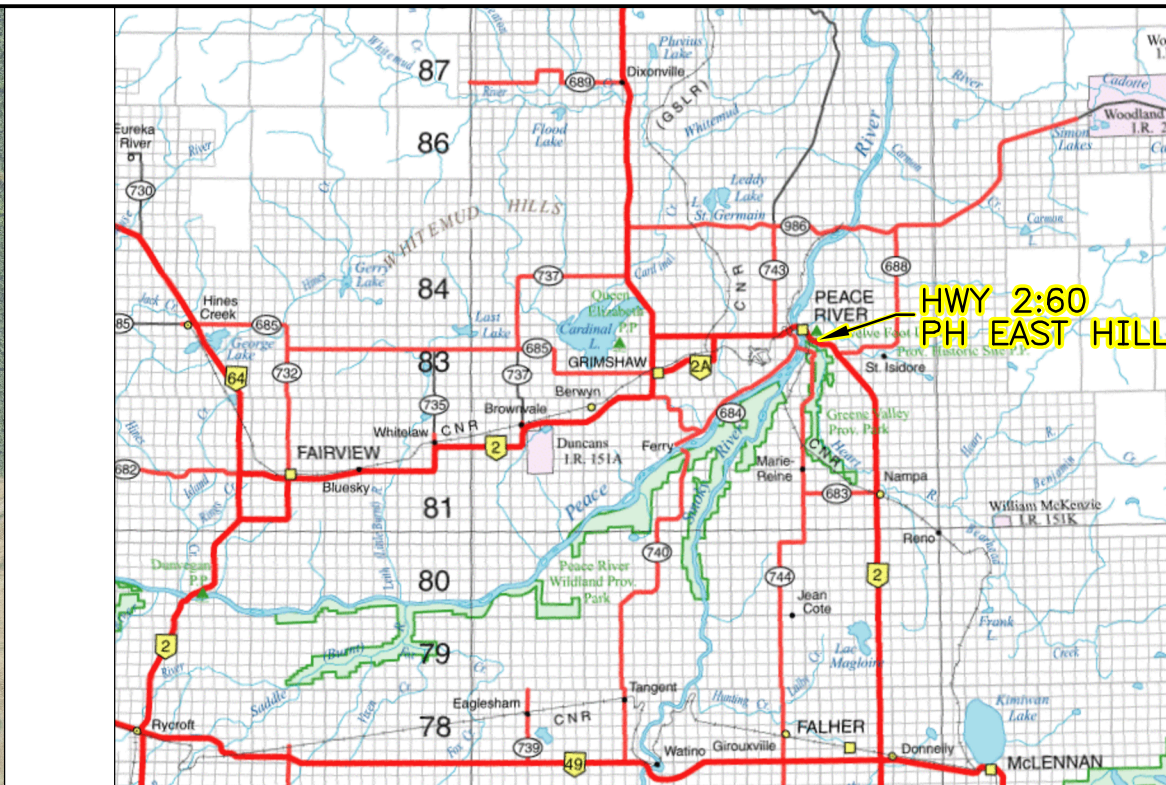
KEY MAP
SCALE 1:1 000 000

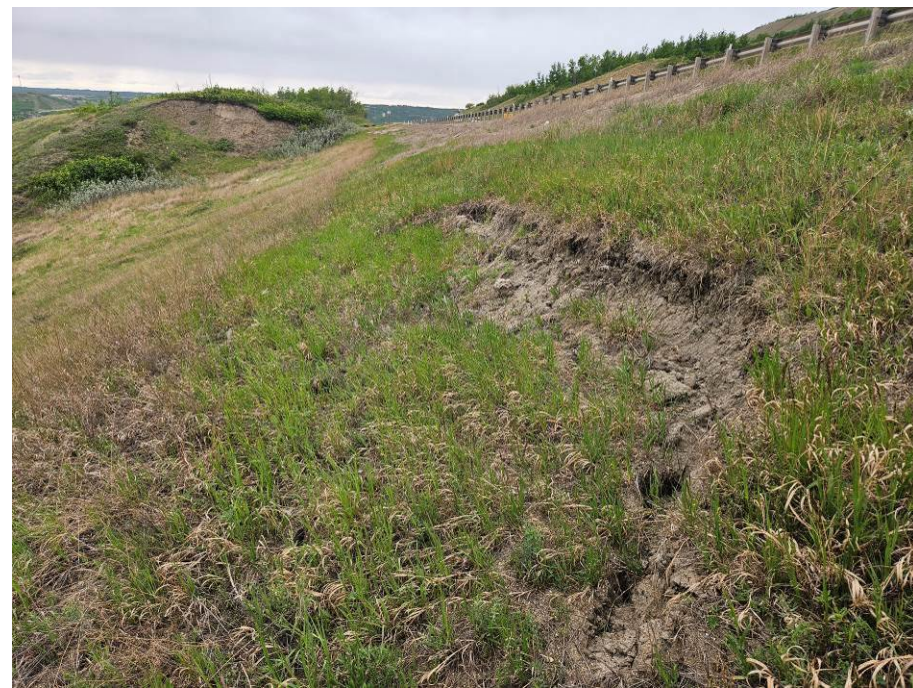
Photo 61-04.
Looking west towards a new surficial skin failure that developed approximately 10 m below the highway and immediately northeast of the previous shallow slide (36+365). Slide area was approximately 15 m wide with 0.15 m of vertical drop and is similar to the two other shallow failures observed within this embankment section downslope of the highway.

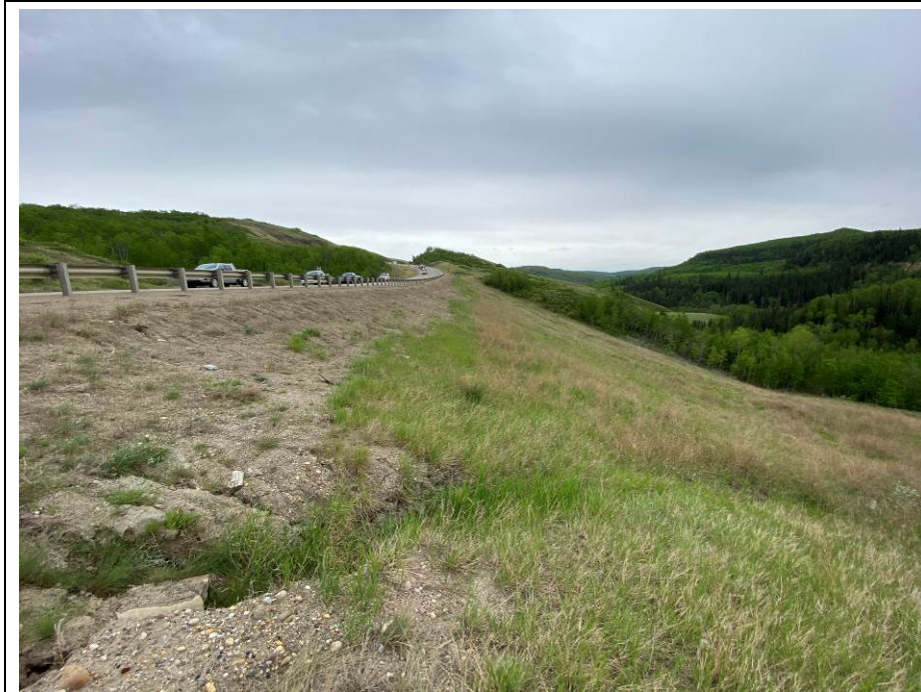
Photo 61-05.
View towards the southeast from km 36+450 where three shallow slumps are located on the embankment downslope from the highway. Erosion rill is visible within the bottom of the photo which appeared similar to the 2022 condition.

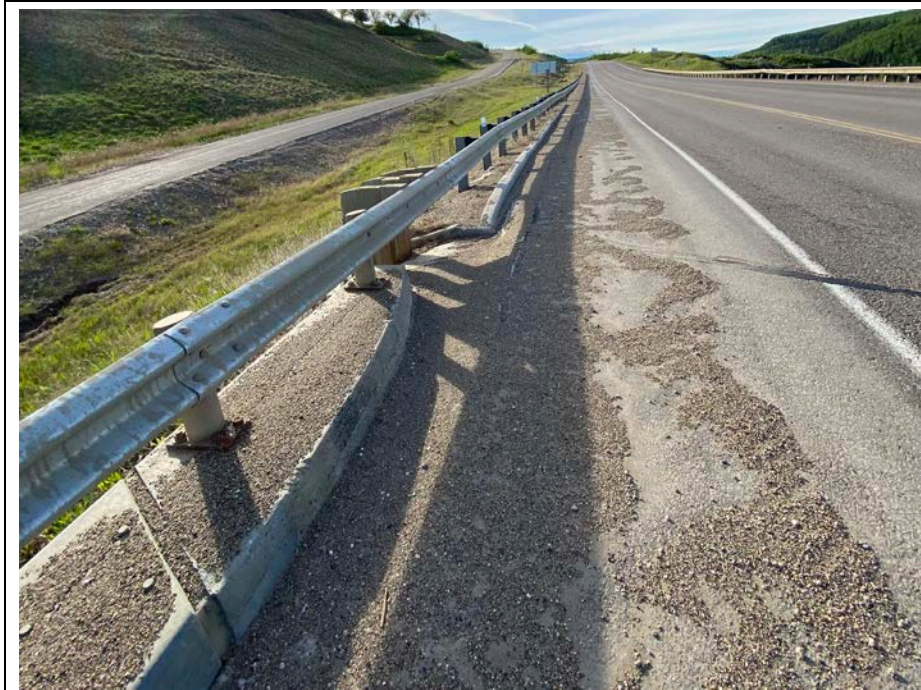
Photo 61-06.
View southeast near km 37+100 at the concrete curb constructed in Fall 2022 and swale at Grouard Bridge constructed in 2017/2018. There was some minor sand buildup but overall, the drain structure was performing as intended.

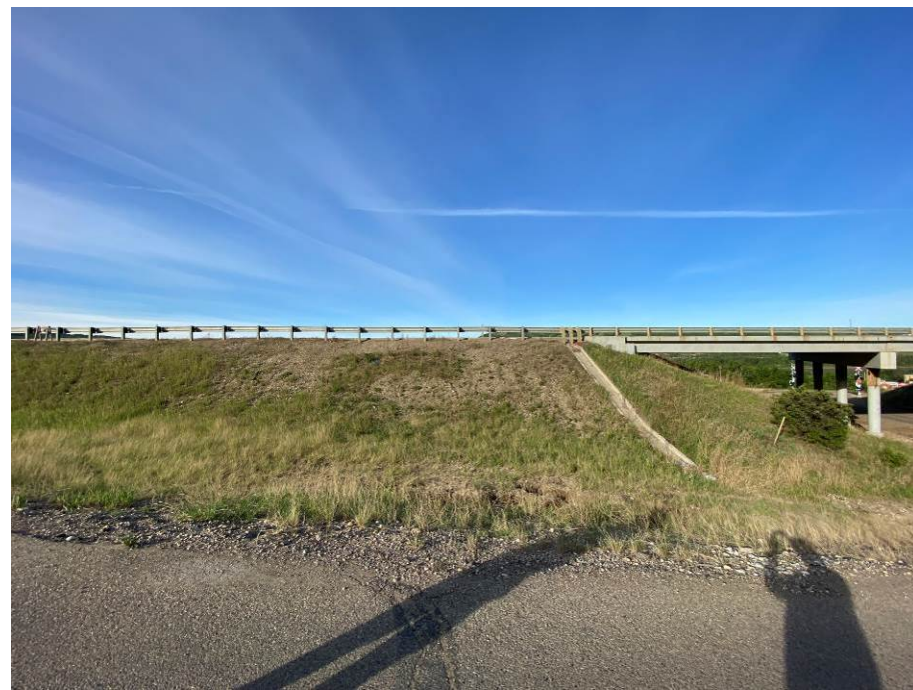
Photo 61-07.
View southwest of the east Grouard bridge embankment (km 37+100) where there was previous gully erosion damage that was repaired in Fall 2022. There were minor rills and vegetation disturbance (likely from winter salt) but overall repairs were in good condition and the curb/swale drainage system was functioning as intended.

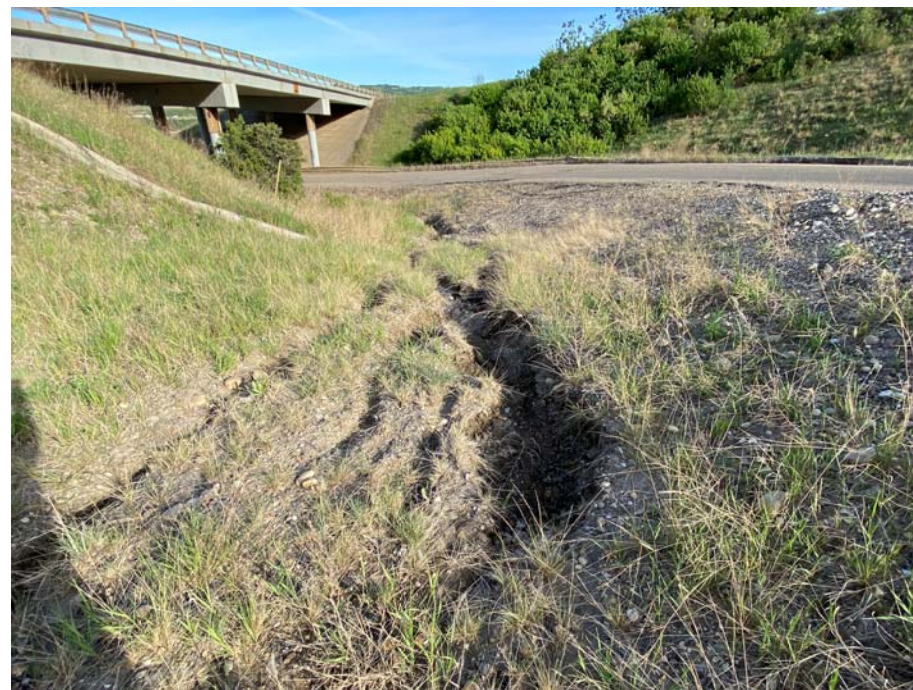
Photo 61-08.
Looking northwest at increased ditch erosion at the base of the eastern Grouard bridge embankment (km 37+100). Erosion gully has formed up to 0.8 m wide and 0.6 m deep.

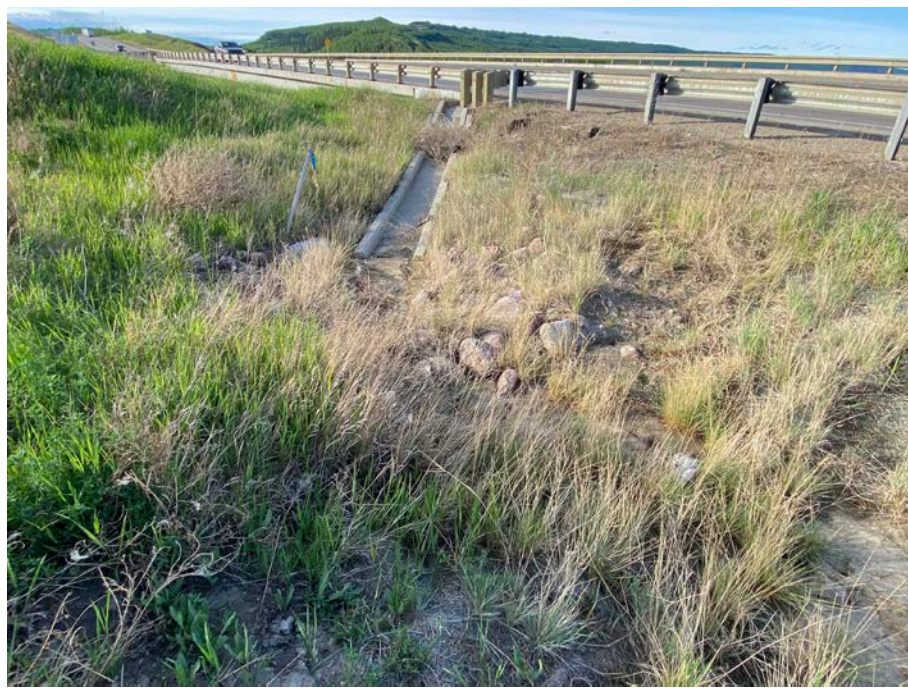
Photo 61-09.
Concrete swale and cobble armor outlet at the northeast side of the Grouard Bridge (37+125). Previous ditch erosion further downstream from the outlet area was repaired in Fall 2022.

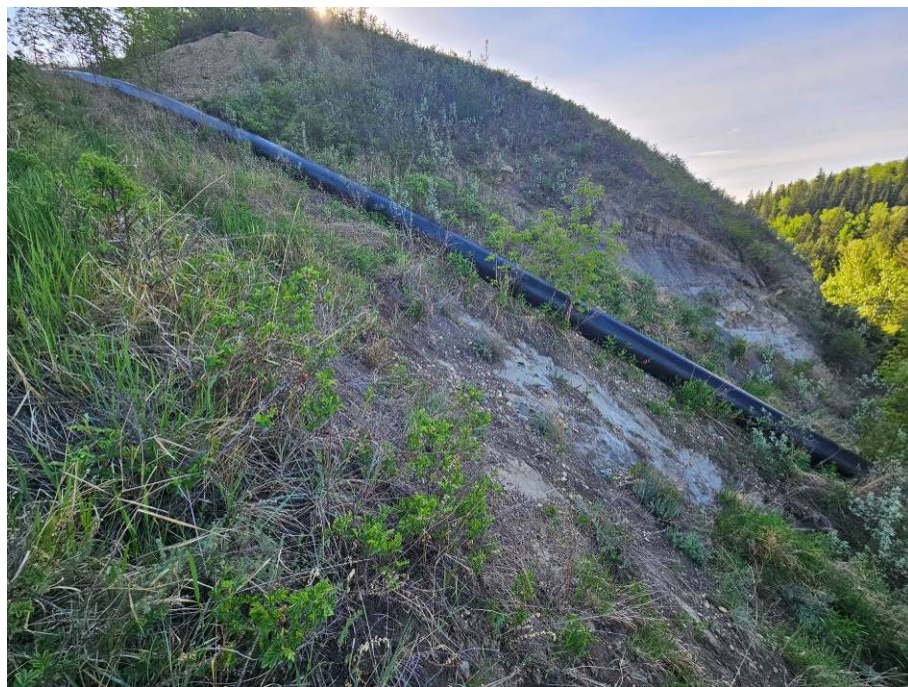
Photo 61-10.
View looking southeast at ongoing erosion of fill area around the lower segment of the elephant trunk drain (km 36+475). Erosion and vegetation disturbance was slightly worse relative to the 2022 condition.

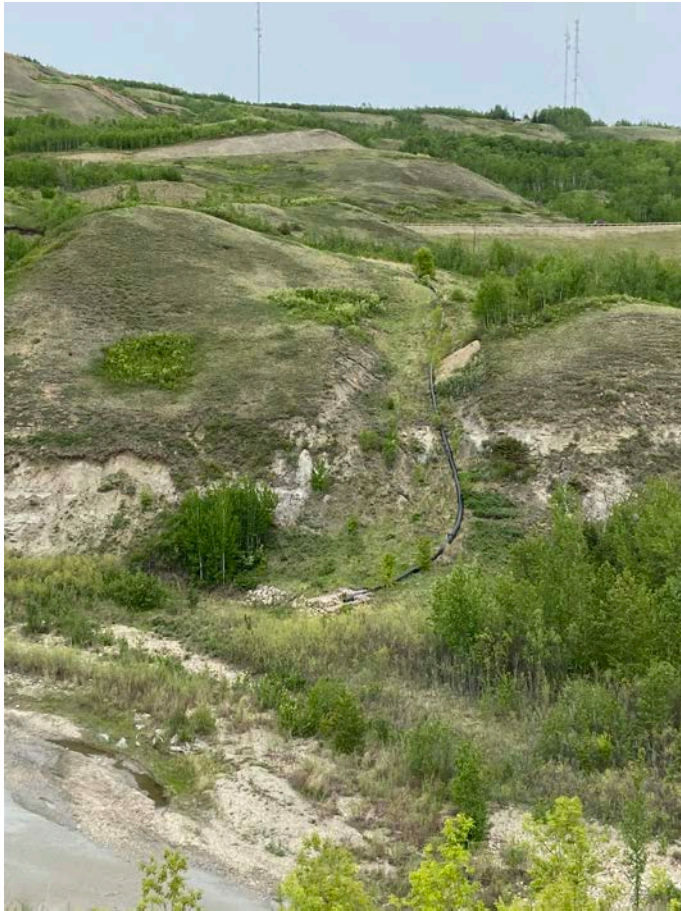
Photo 61-11.
Overall site view from the south side of the valley looking north. Lower section of the elephant trunk drain is visible with no major visible changes since 2022.
