Site Number	Location	Name	Hwy	km
PH070	HWY 2:60 C1 33.840	East Hill Retaining Wall Site	2:60	Km 33.84
Legal Description: 4-27-83-21 W5		UTM Co-ordinates		
		11U E 485285	N	6230649

Current Monitoring:	20-Sep-2024	Previous Monitoring	19-May-2024
Instruments Read By:	Mr. Niraj Regmi, G.I.T and Mr. Nixson Mationg, of Thurber

**ALBERTA TRANSPORTATION AND ECONOMIC CORRIDORS GRMP (CON0022164)
PEACE REGION (PEACE RIVER DISTRICT)
INSTRUMENTATION MONITORING RESULTS**

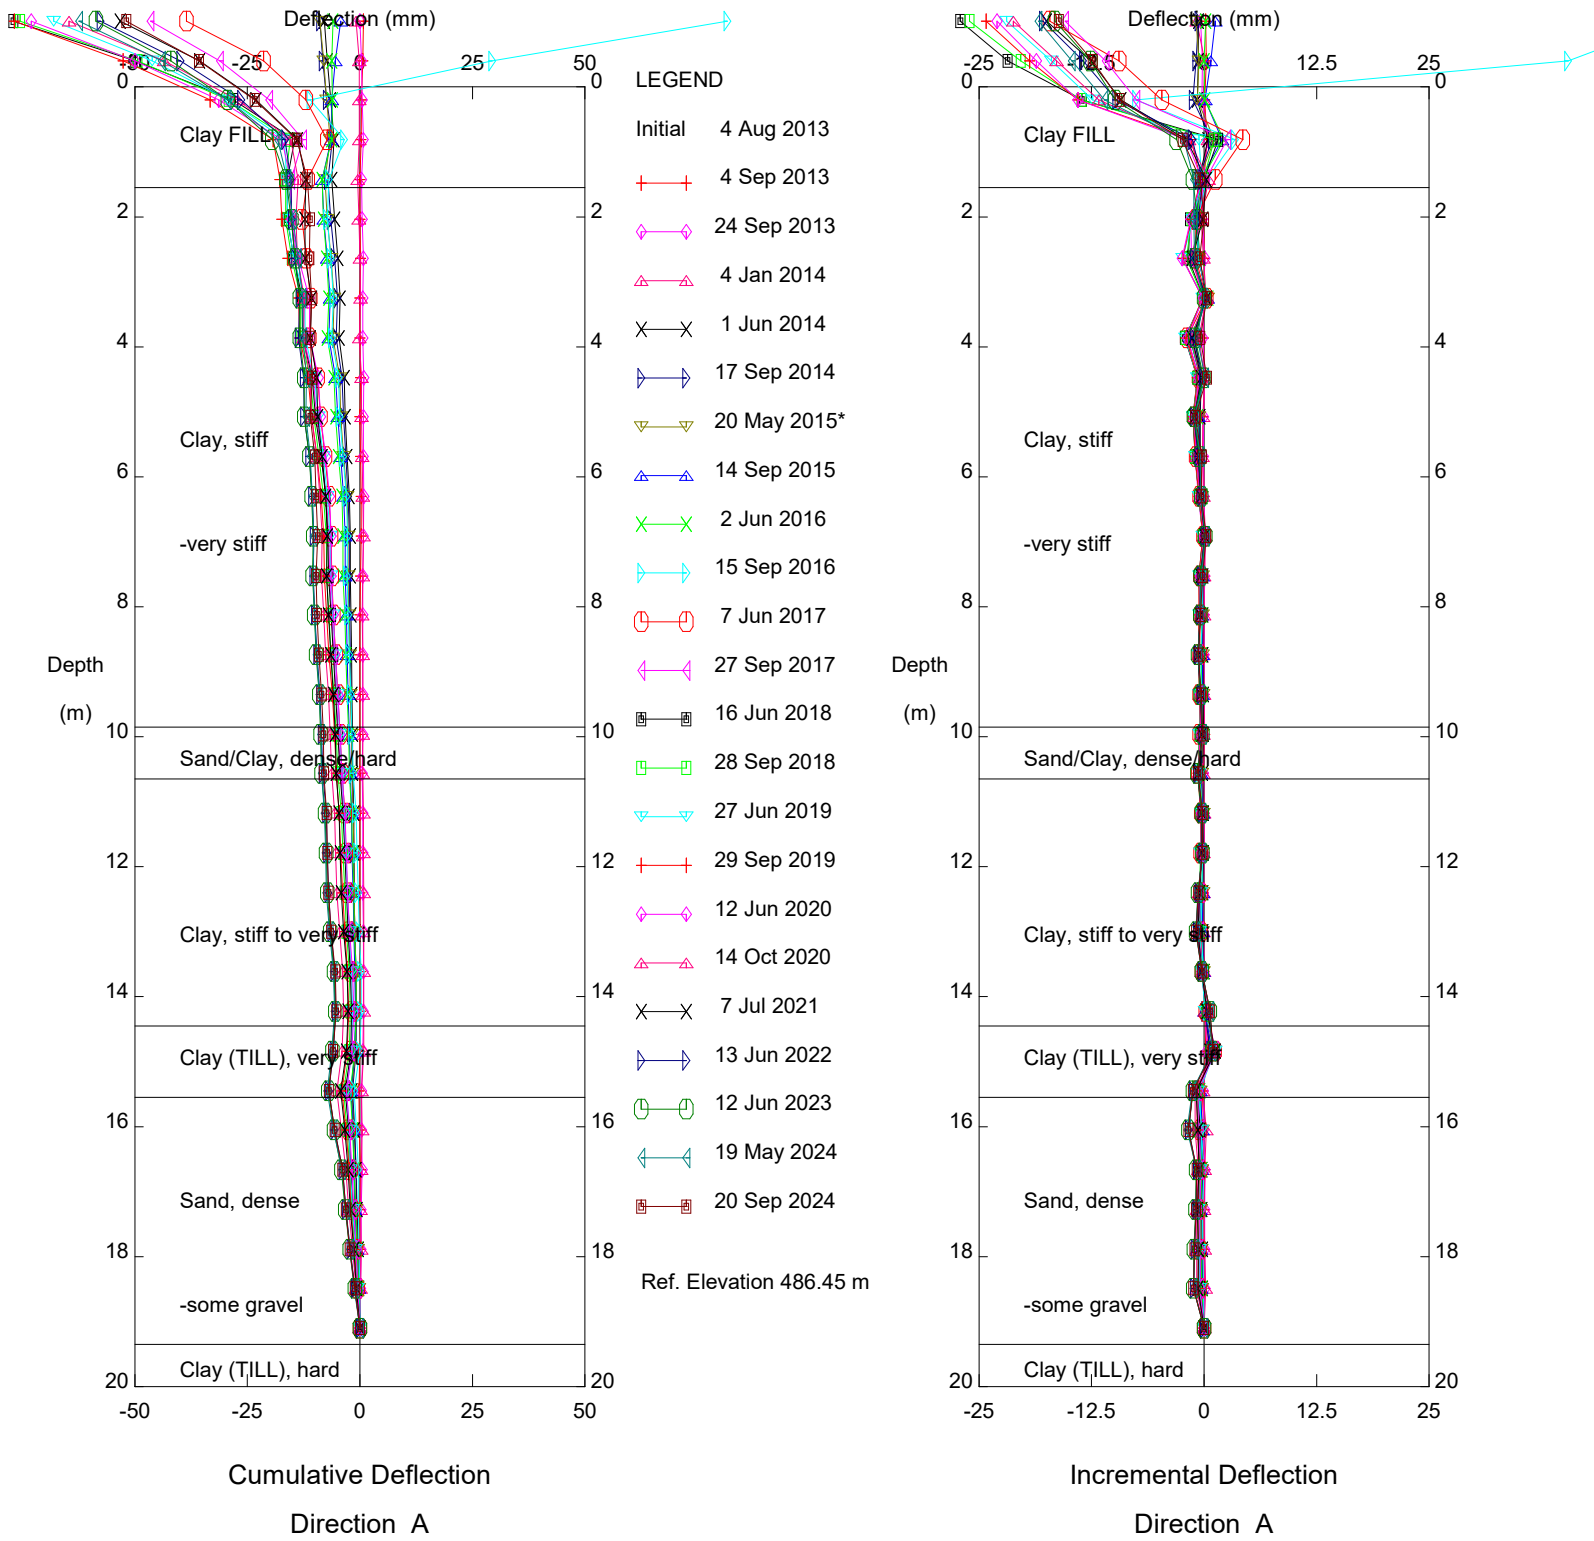
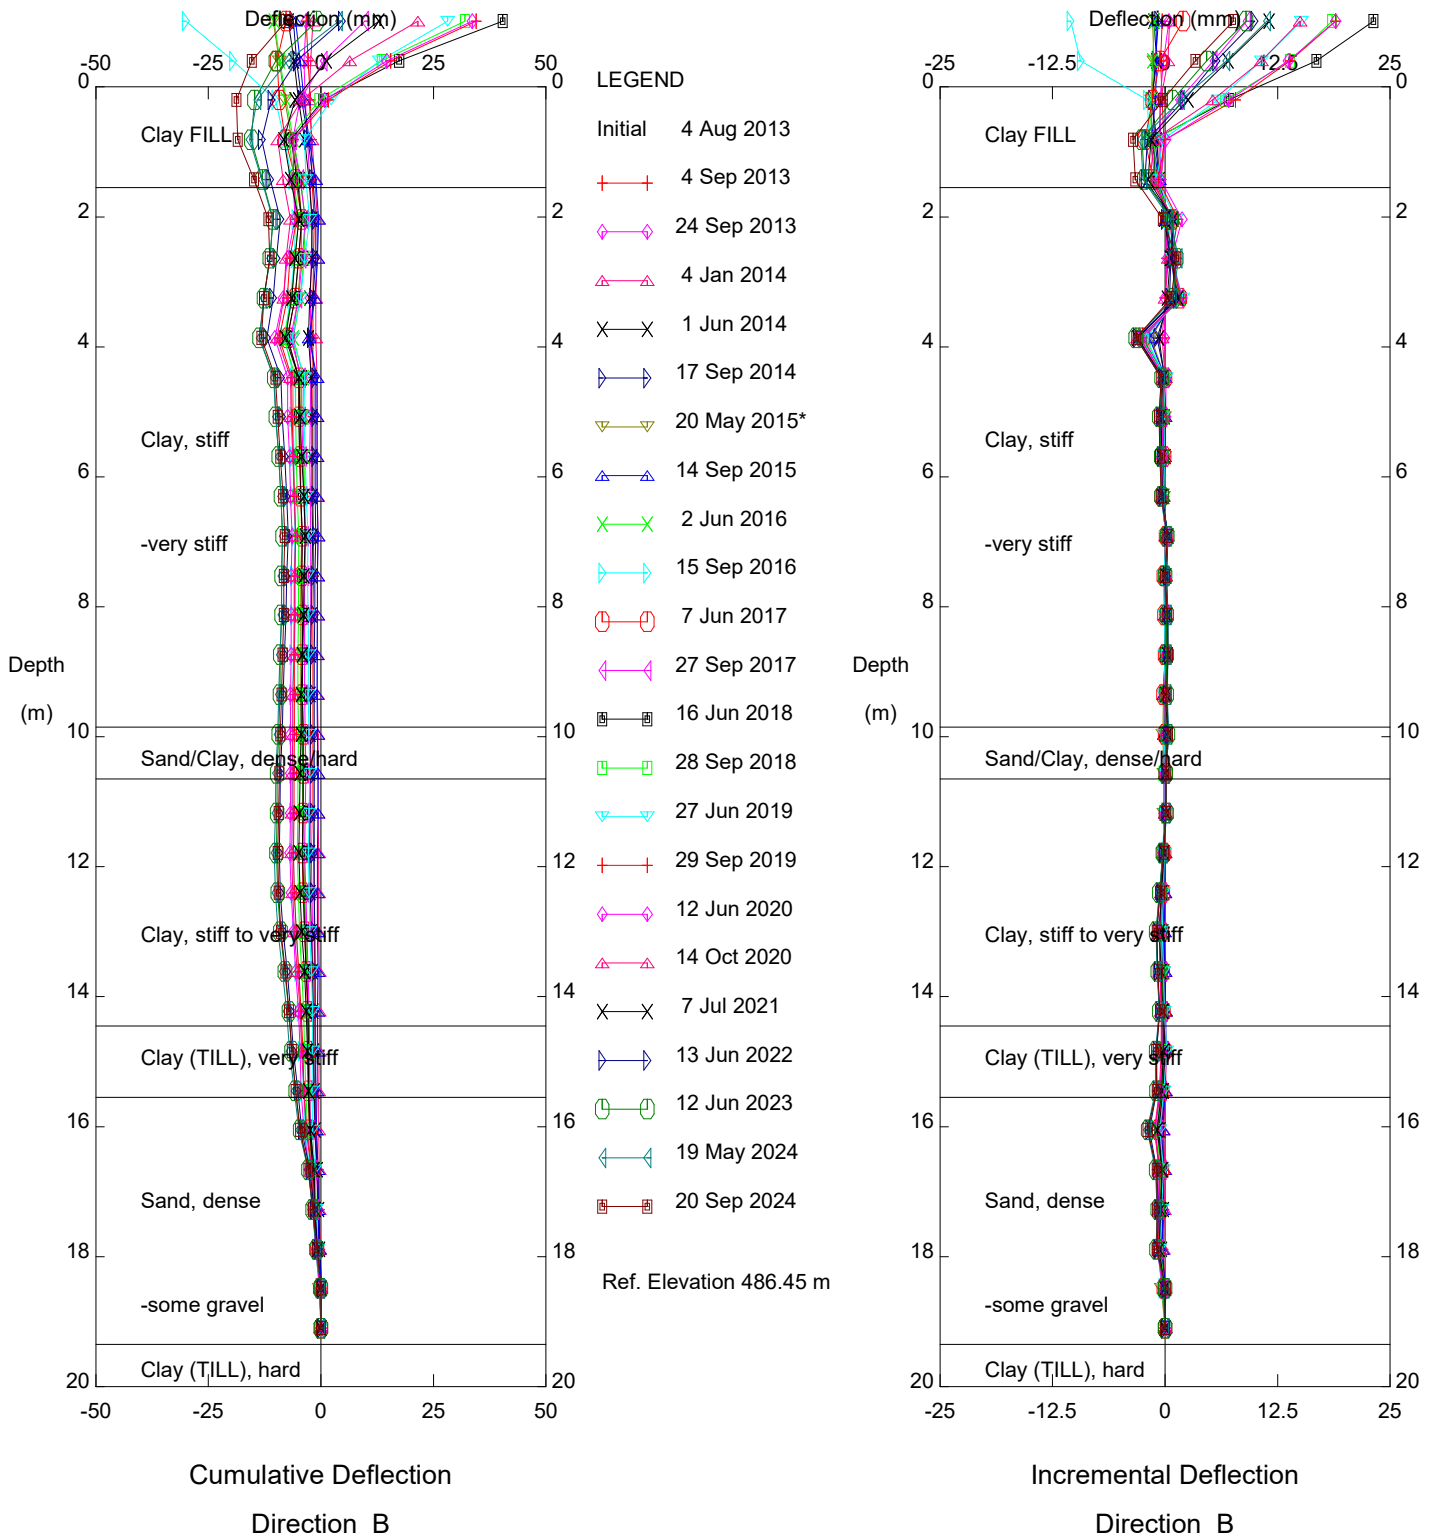
Peace River East Hill PH070, Inclinometer SI13-3

Discussion	
Zones of New Movement:	None
Interpretation of Monitoring Results:	<p>SLOPE INDICATORS AND SAA</p> <p>SI13-3, located downslope of the new pile wall, continued to show no discernible movement. Based on the instrument readings and observations on site, SI13-3 is not installed deep enough to intercept the shear surface of the landslide. Slope inclinometer SI14-2, located upslope of the new pile wall, showed a rate of movement of 0.13 mm/yr over 2.8 m to 5.8 m depth, a rate of movement of 0.9 mm/yr over 17.4 m to 21.0 m depth and a rate of movement of 0.9 mm/yr over 24.7 m to 27.1 m depth since the spring of 2024 readings. These movement rates have been steady for several years. Slope inclinometer SI14-3, also located upslope of the new pile wall, showed a rate of movement of 1.4 mm/yr</p>

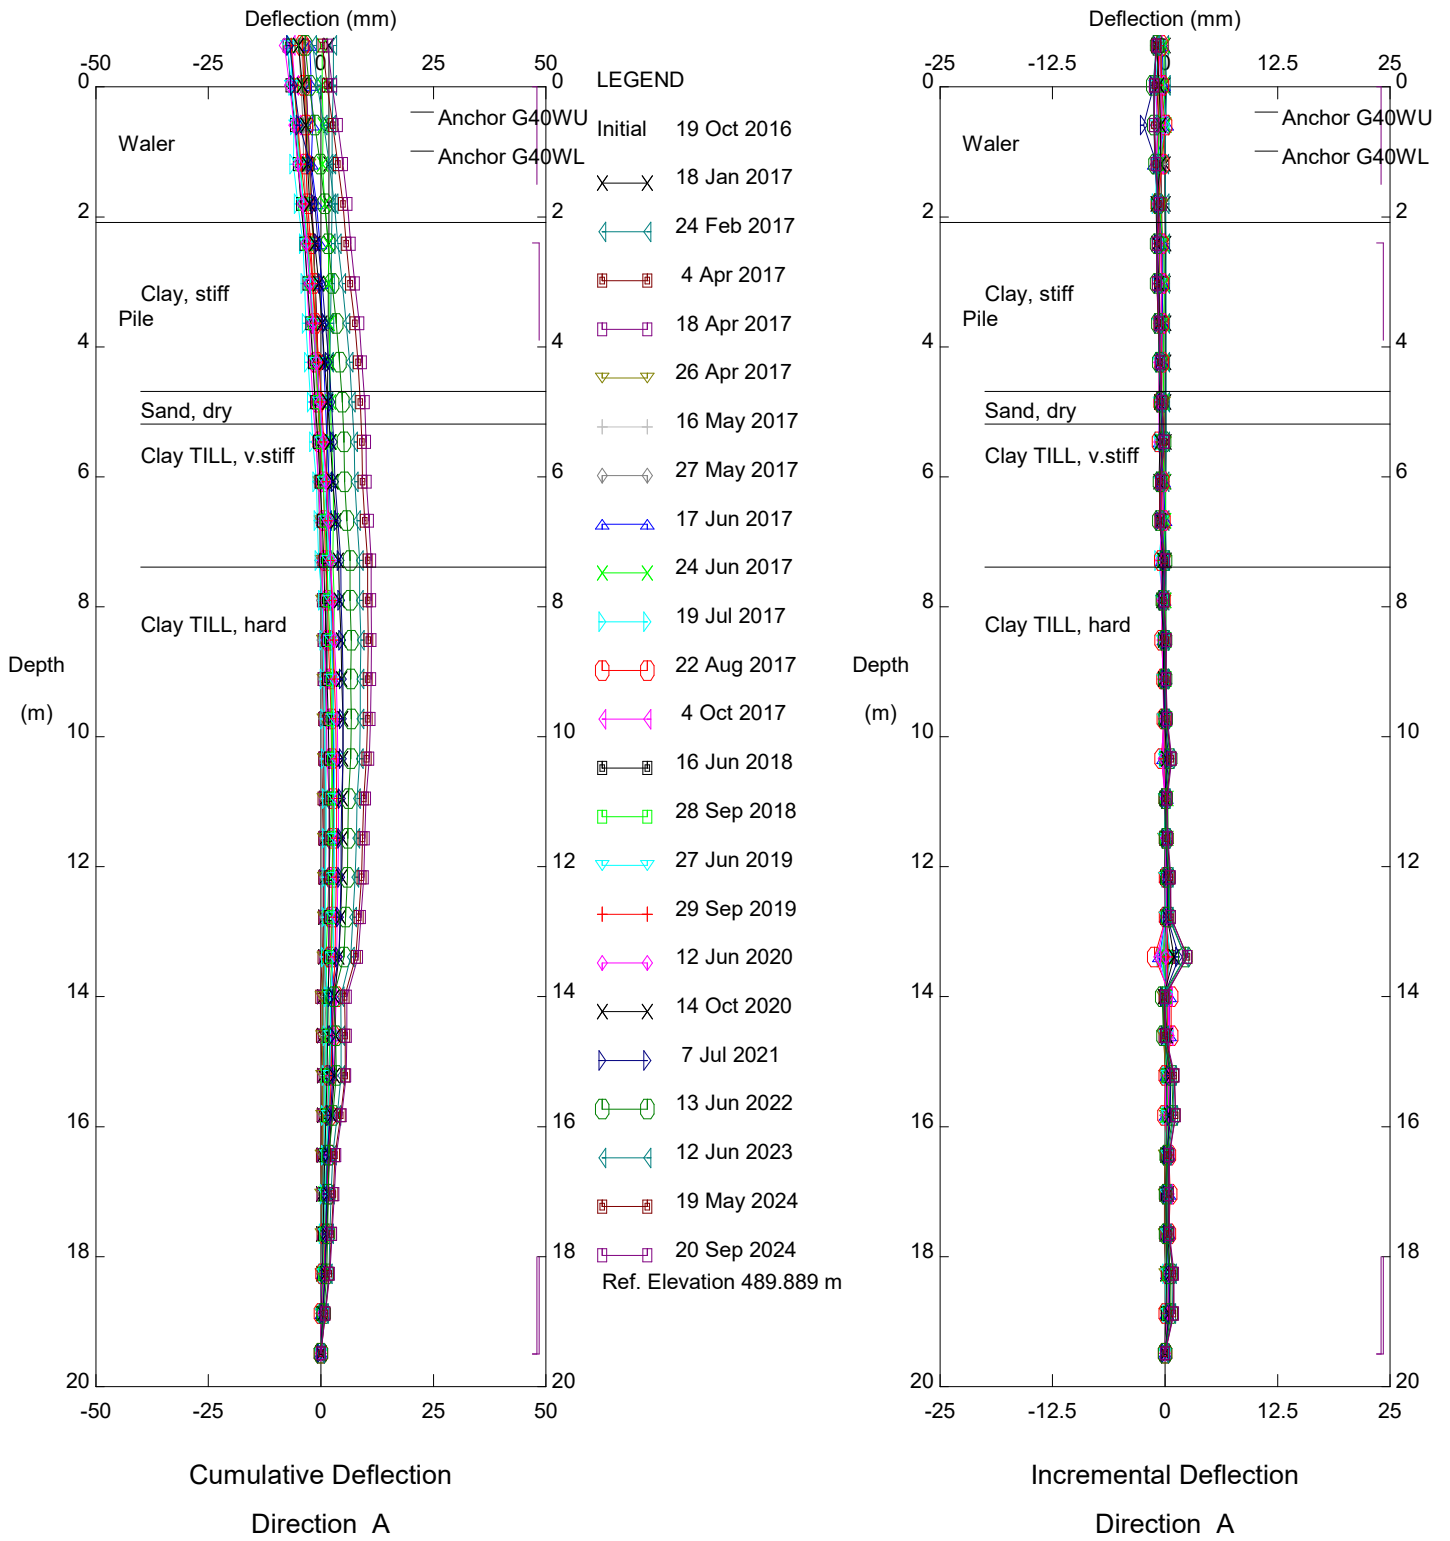
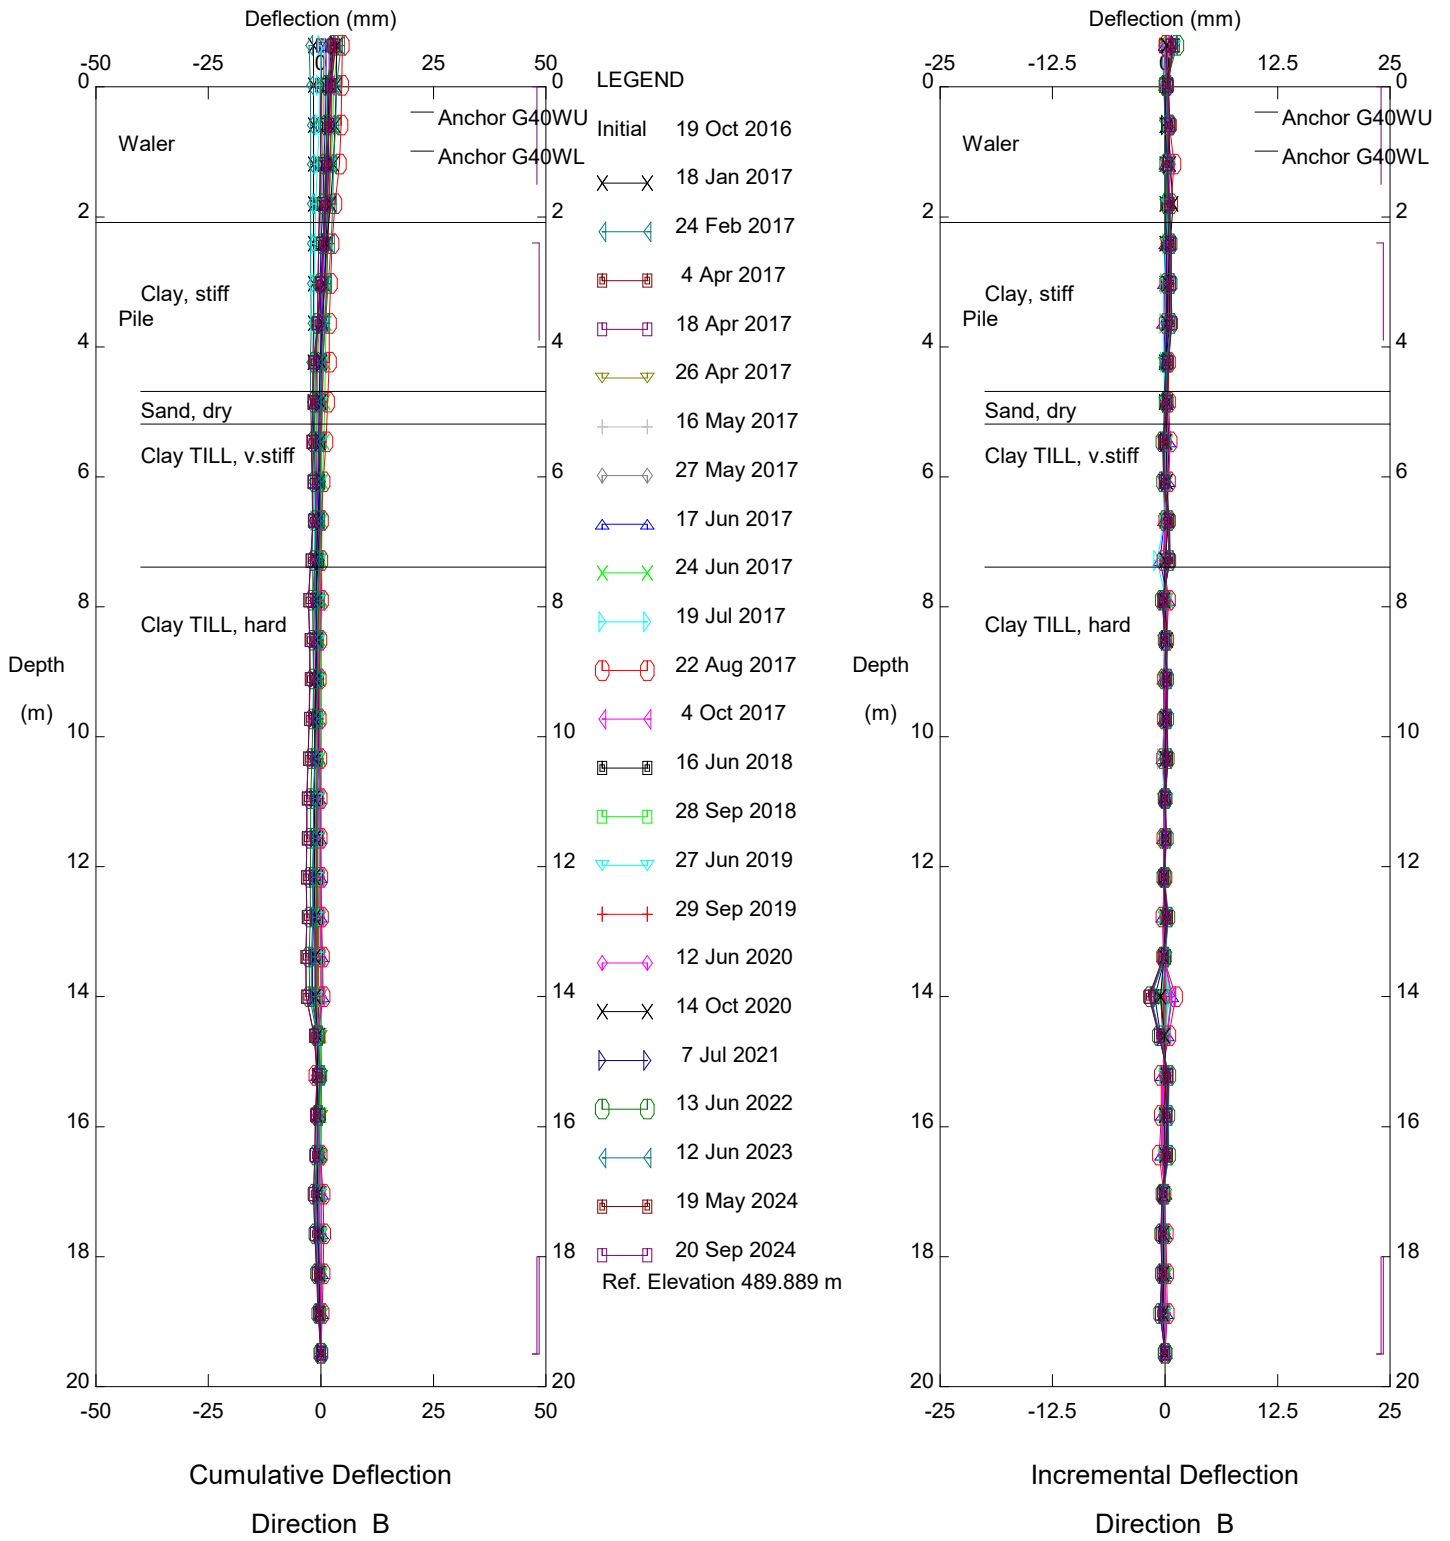
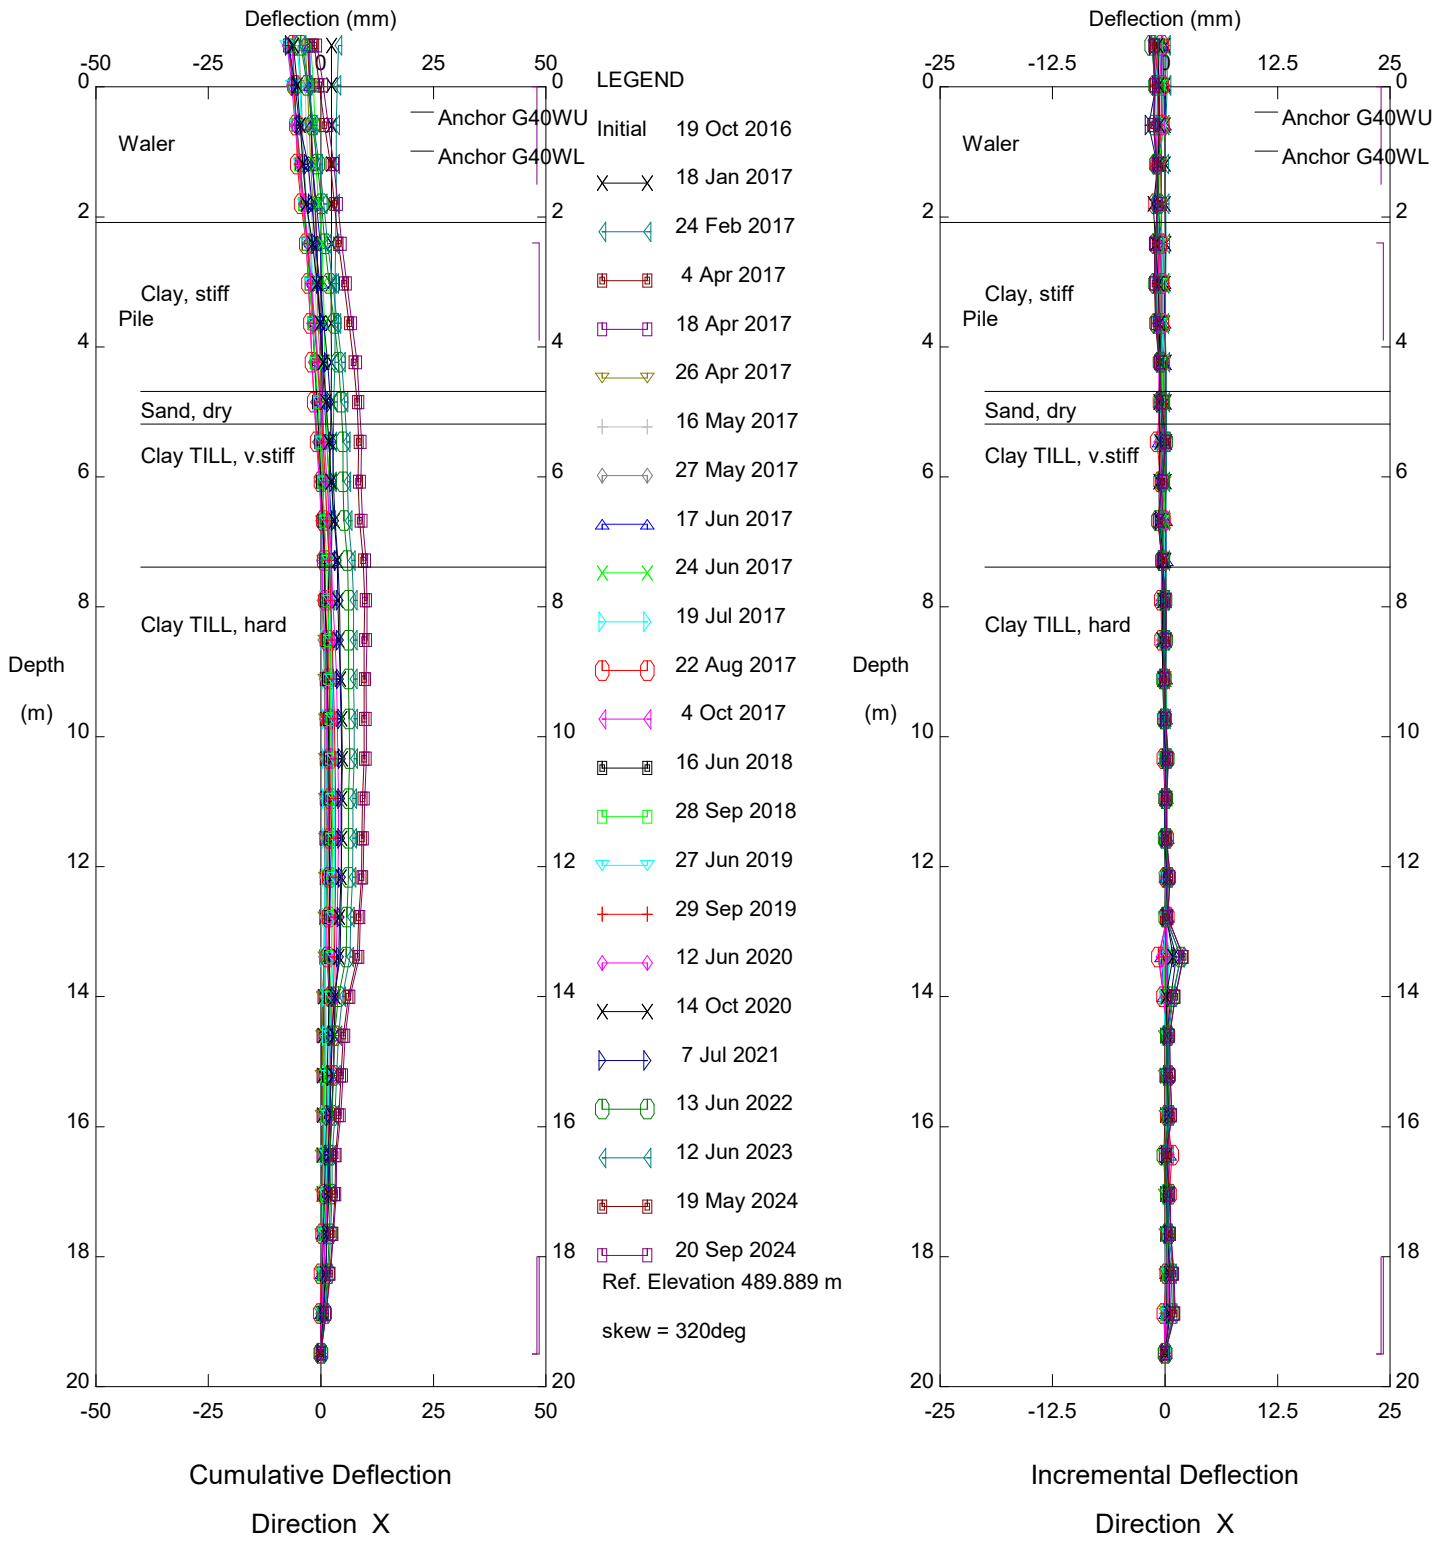
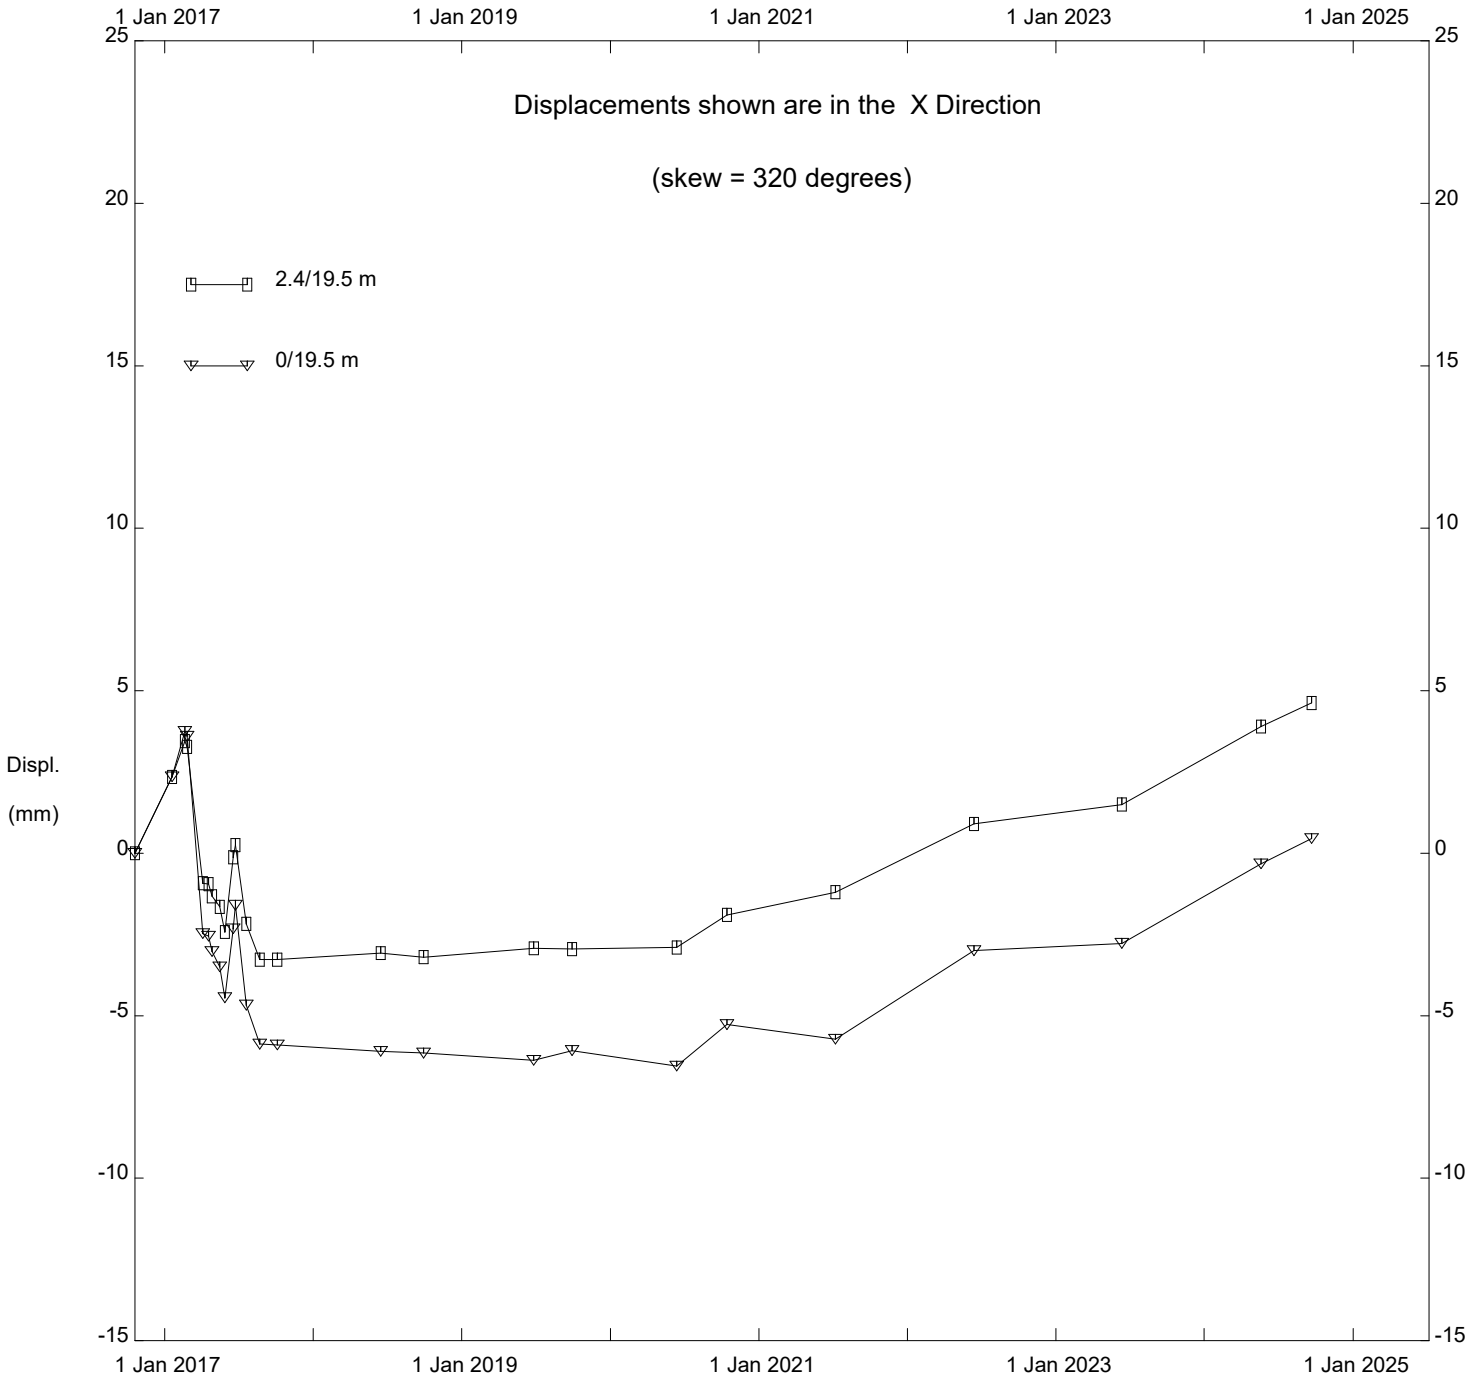
Peace River East Hill PH070, Inclinometer P40

SI-P40, installed in Pile 40, showed a rate of movement of 2.1 mm/yr in the downslope direction over the length of the pile and a rate of movement of 2.3 mm/yr over the combined length of the pile and waler since the spring of 2024 readings. Pile 40 has shown a total cumulative pile head movement of 4.6 mm in the downslope direction and a total cumulative movement of 0.5 mm in the downslope direction over the combined length of the pile and waler.

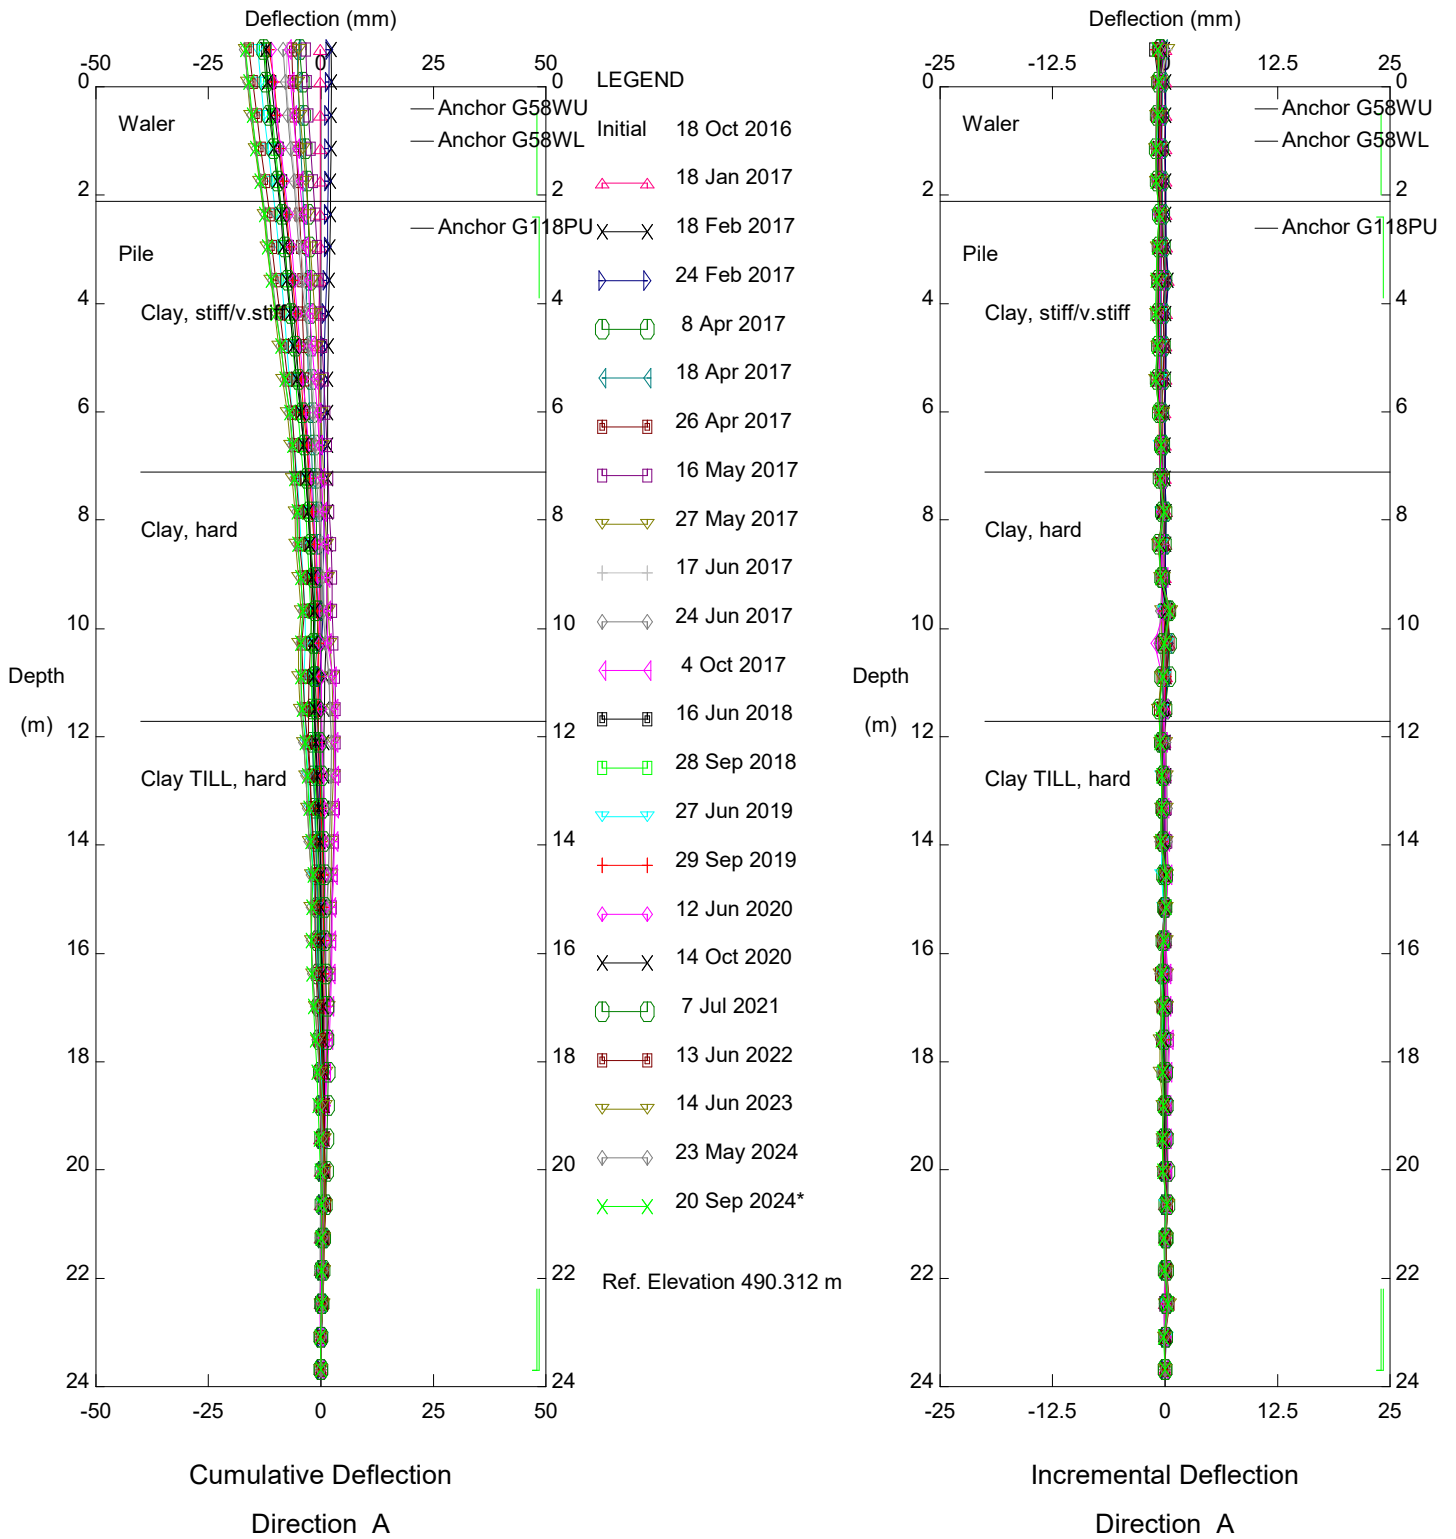
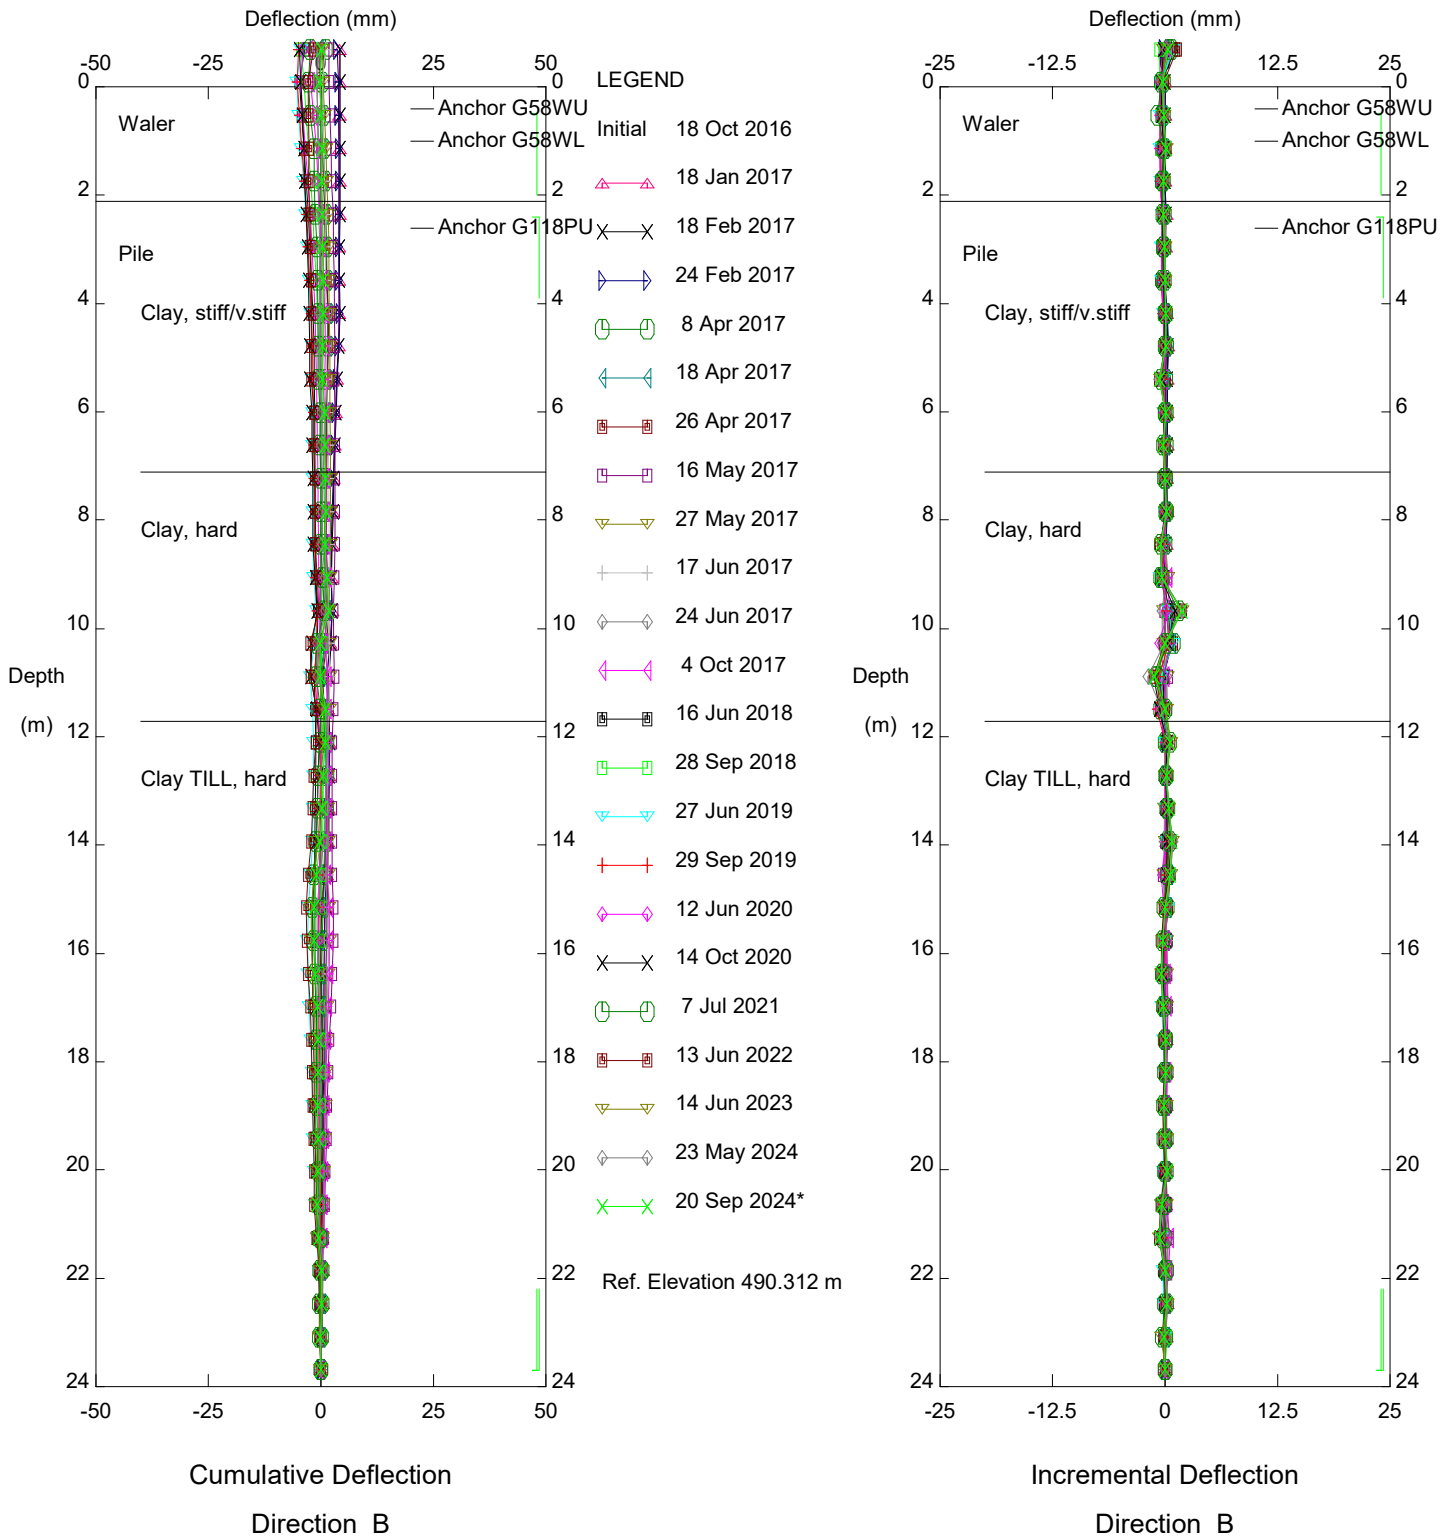
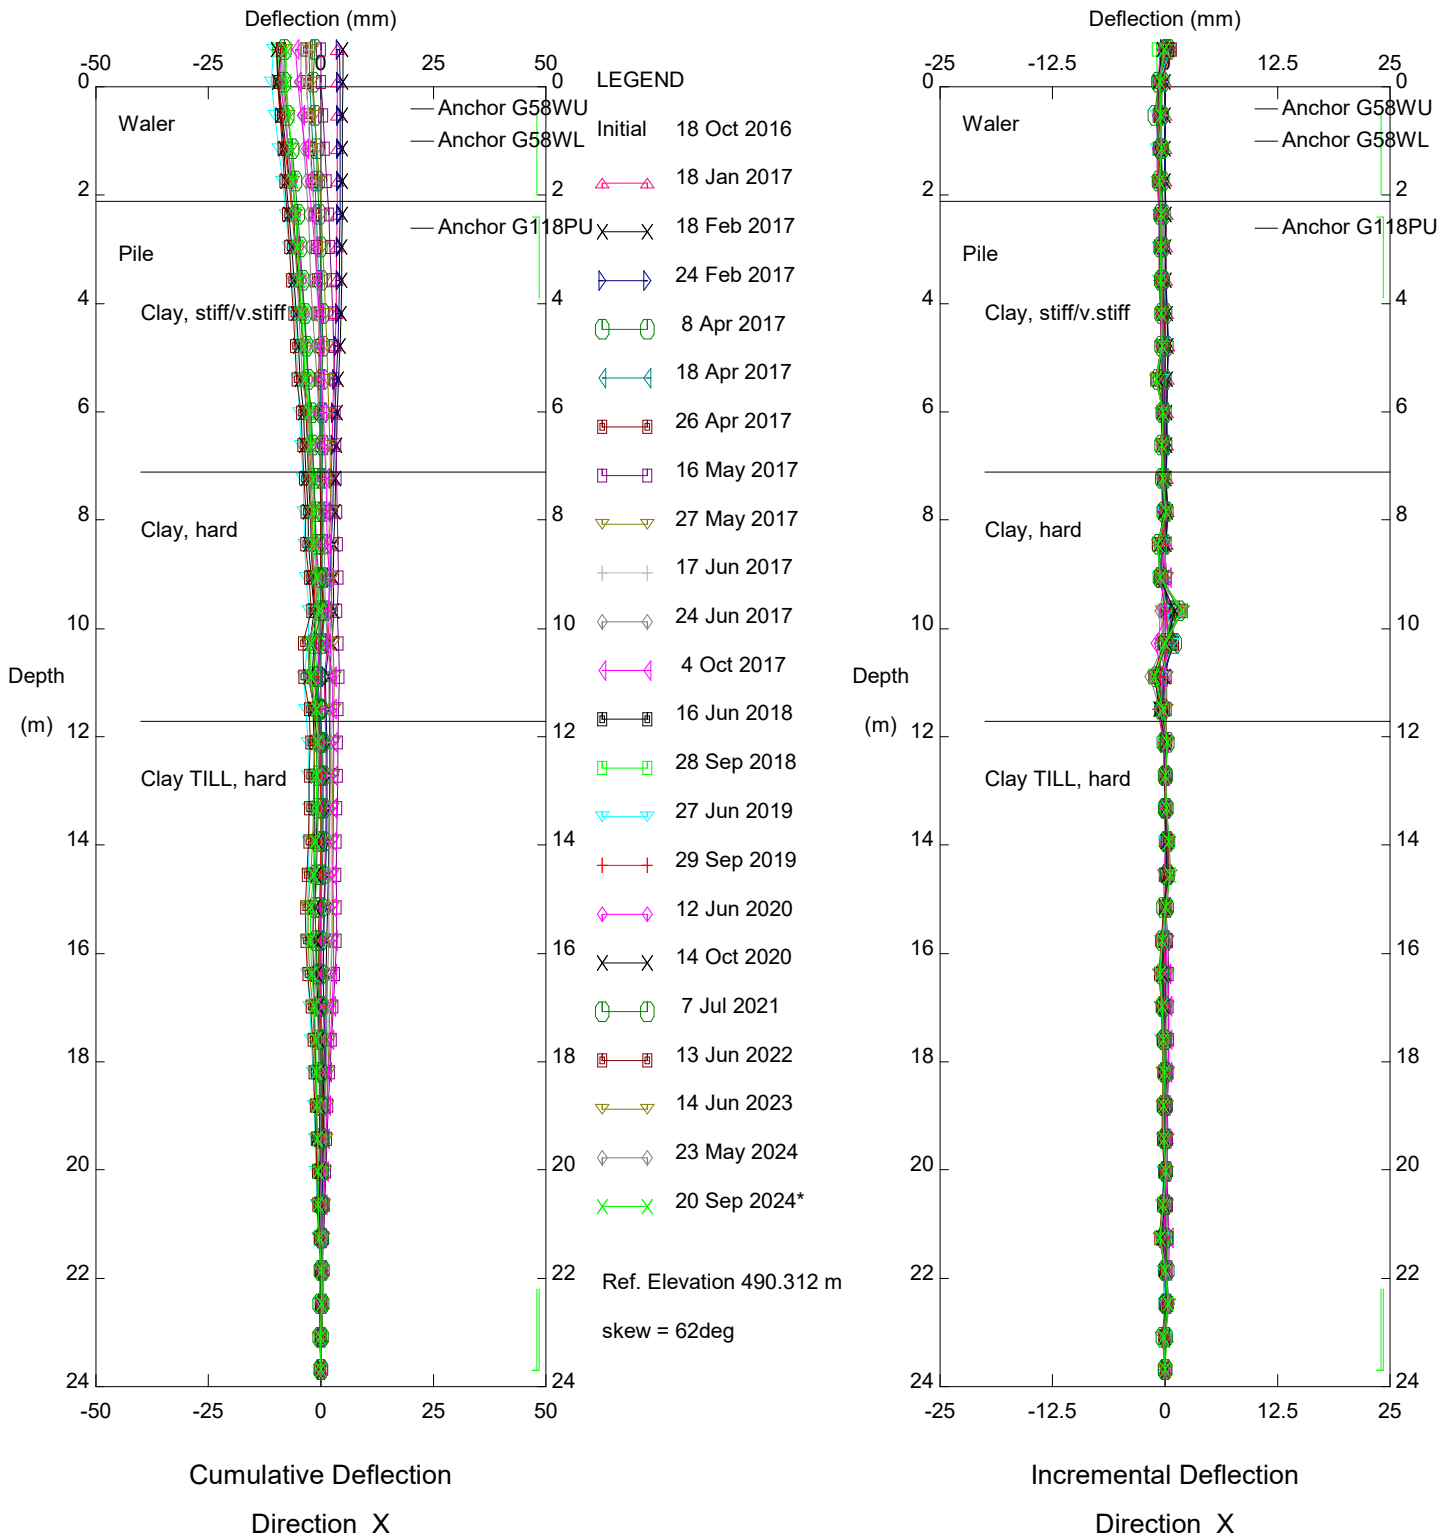
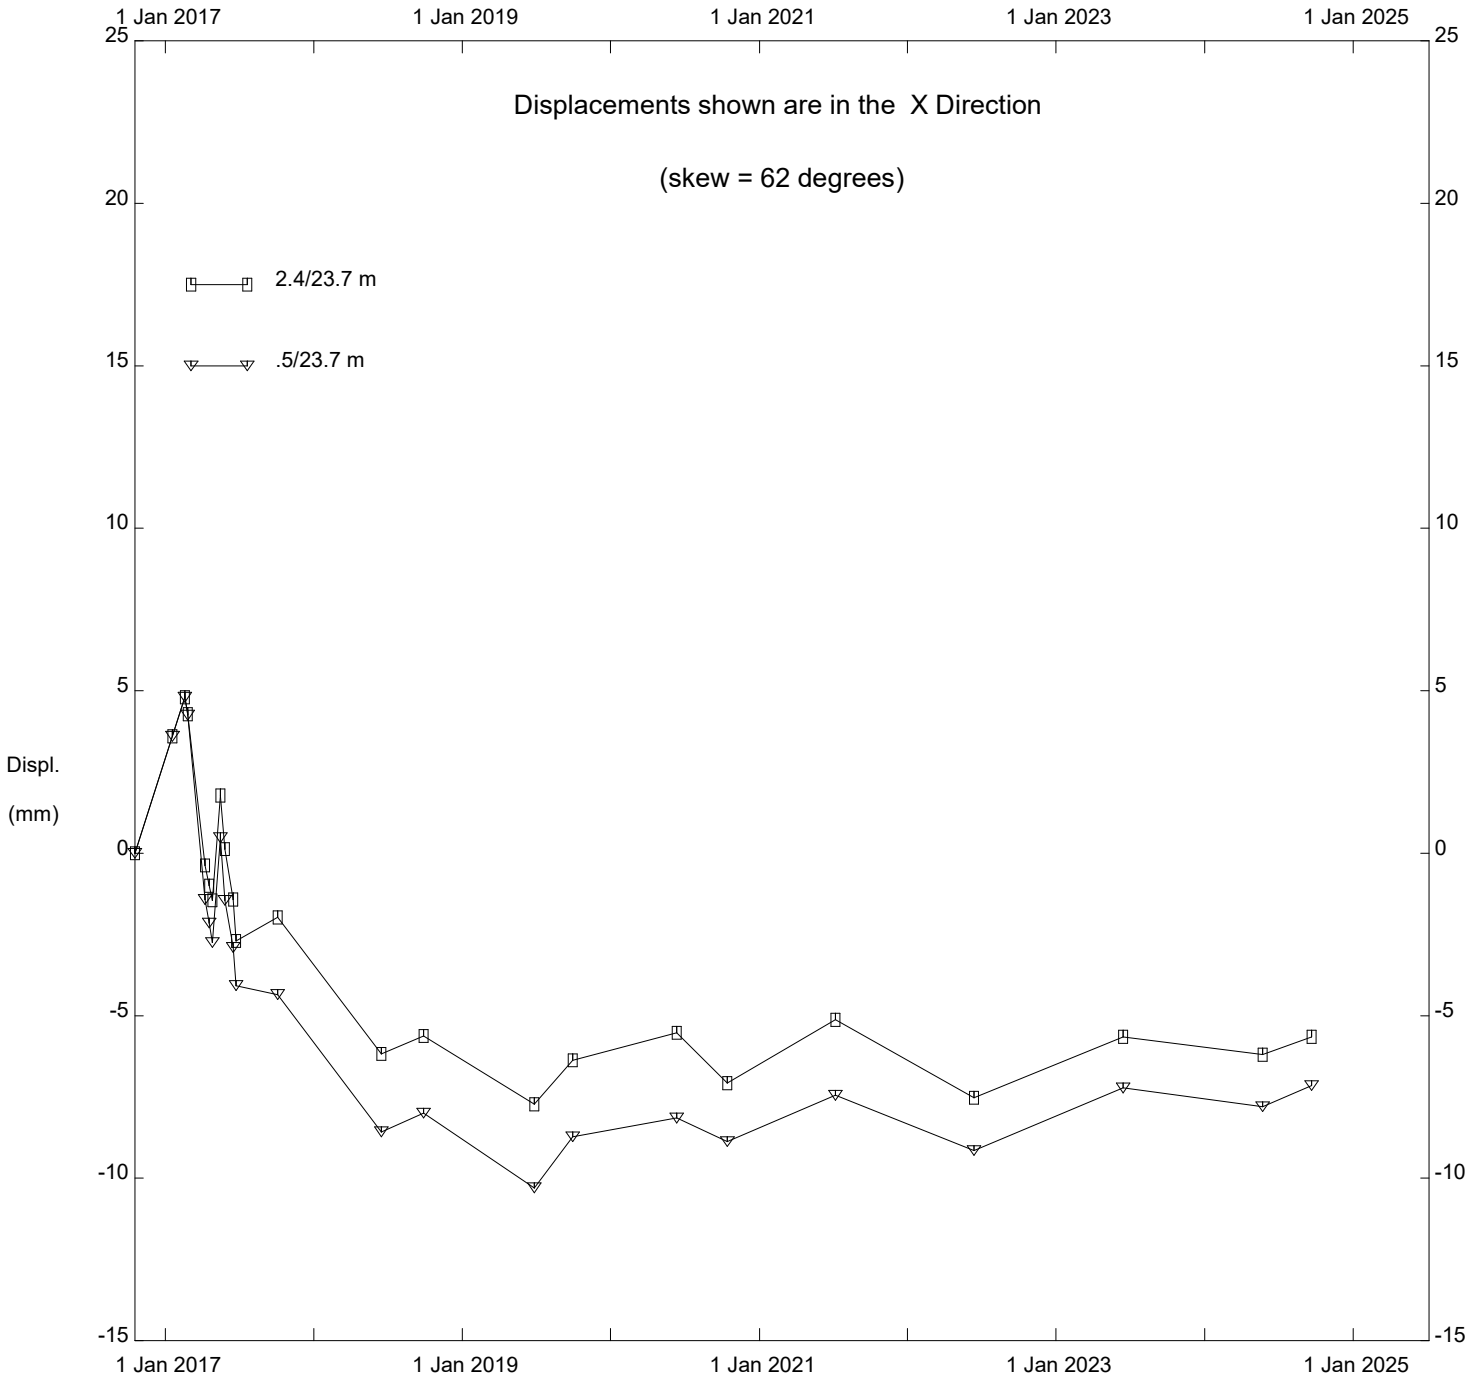
Peace River East Hill PH070, Inclinometer P58

SI-P58, installed in Pile 58, a rate of movement of 1.7 mm/yr over the length of the pile and a rate of movement of 2.0 mm/yr over the combined length of the pile and waler since the spring of 2024 readings. The cumulative pile head movement was 5.7 mm in the upslope direction and the cumulative movement at the top of the water was 7.1 mm in the upslope direction.
