Site Number	Location	Name	Hwy	km
PH070	HWY 2:60 C1 33.840	East Hill Retaining Wall Site	2:60	Km 33.84
Legal Description: 4-27-83-21 W5		UTM Co-ordinates		
		11U E 485285	N	6230649

Current Monitoring:	20-Sep-2024	Previous Monitoring	19-May-2024
Instruments Read By:	Mr. Niraj Regmi, G.I.T and Mr. Nixson Mationg, of Thurber

**ALBERTA TRANSPORTATION AND ECONOMIC CORRIDORS GRMP (CON0022164)
PEACE REGION (PEACE RIVER DISTRICT)
INSTRUMENTATION MONITORING RESULTS**

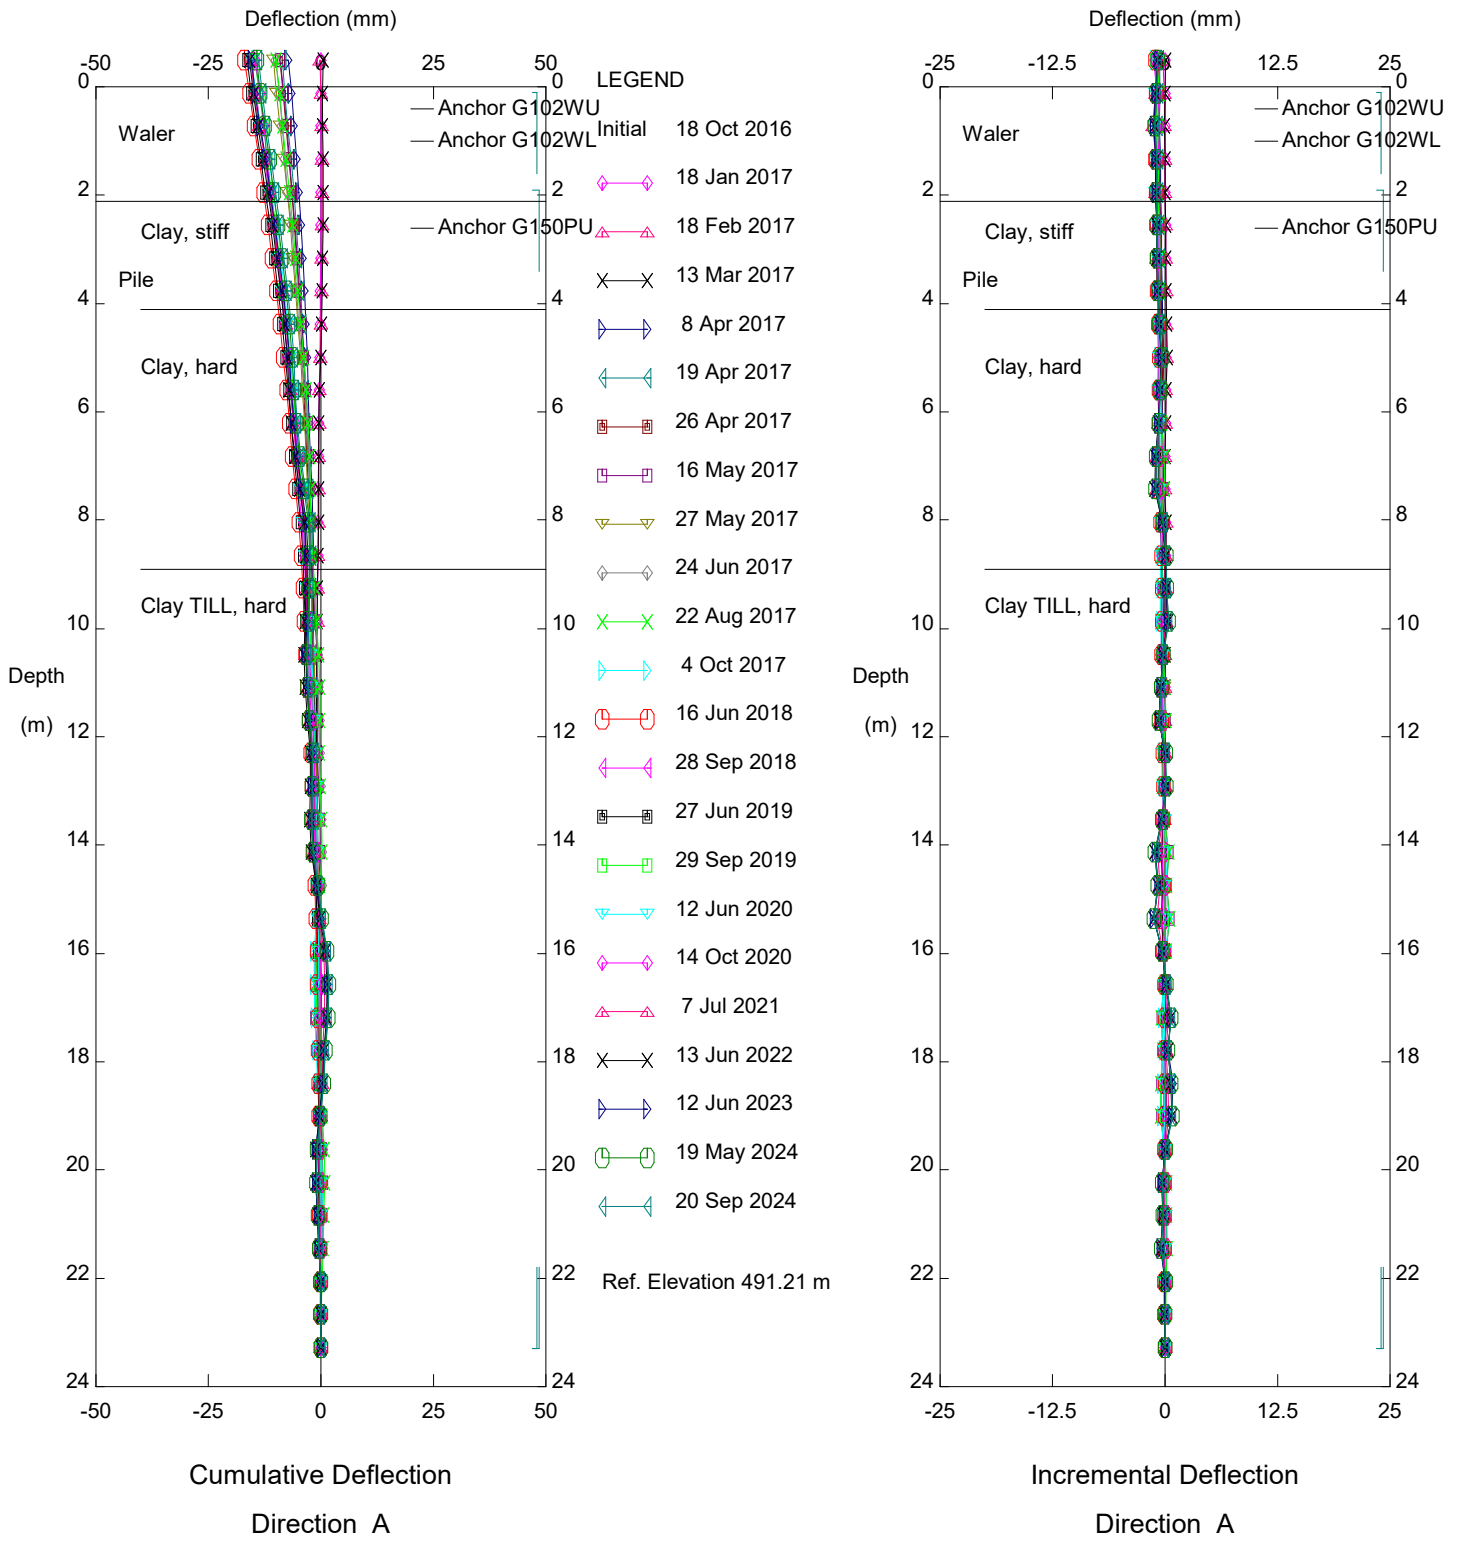
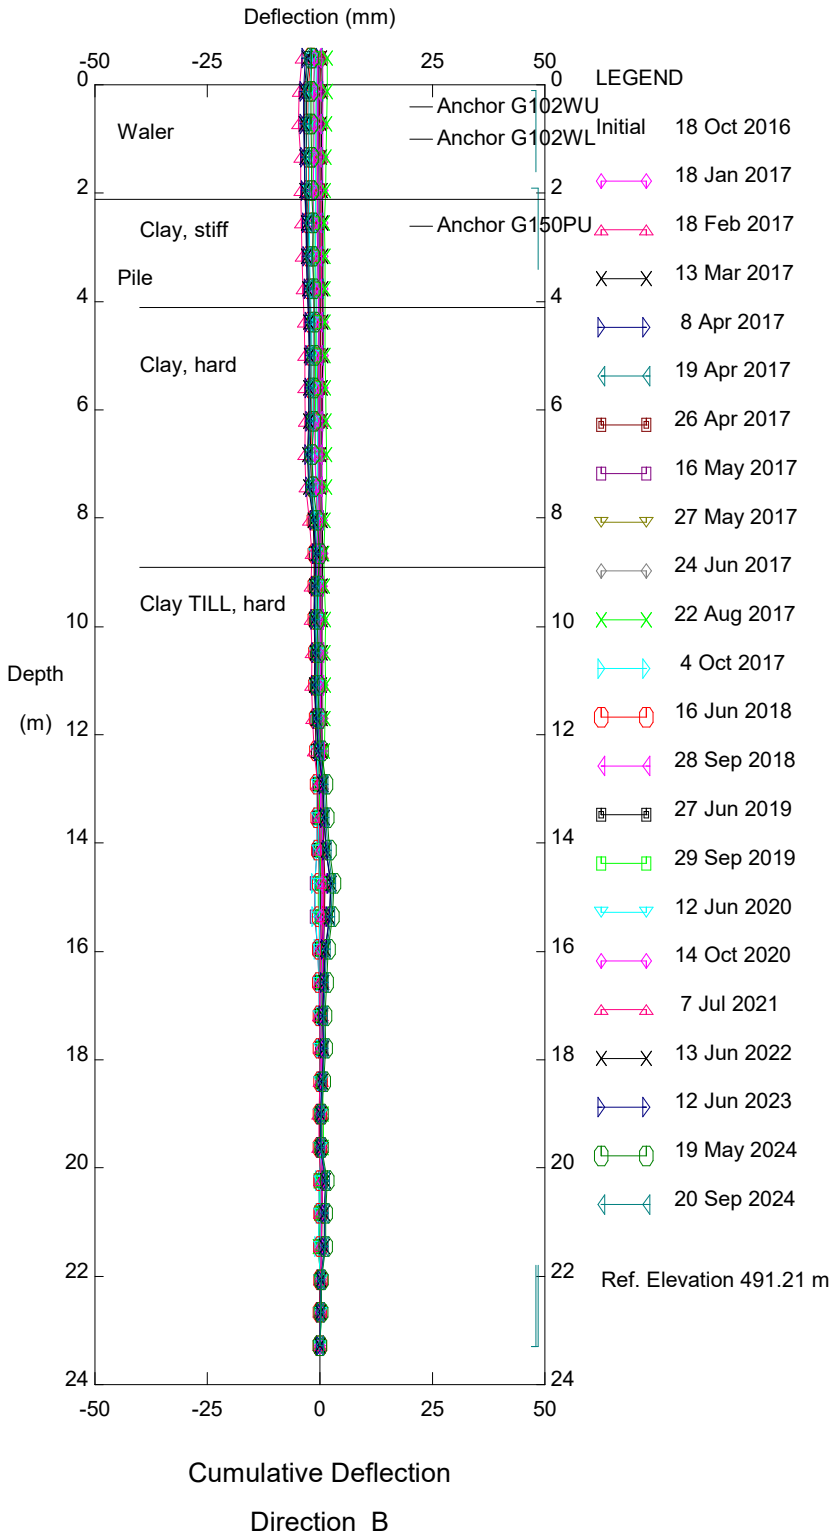
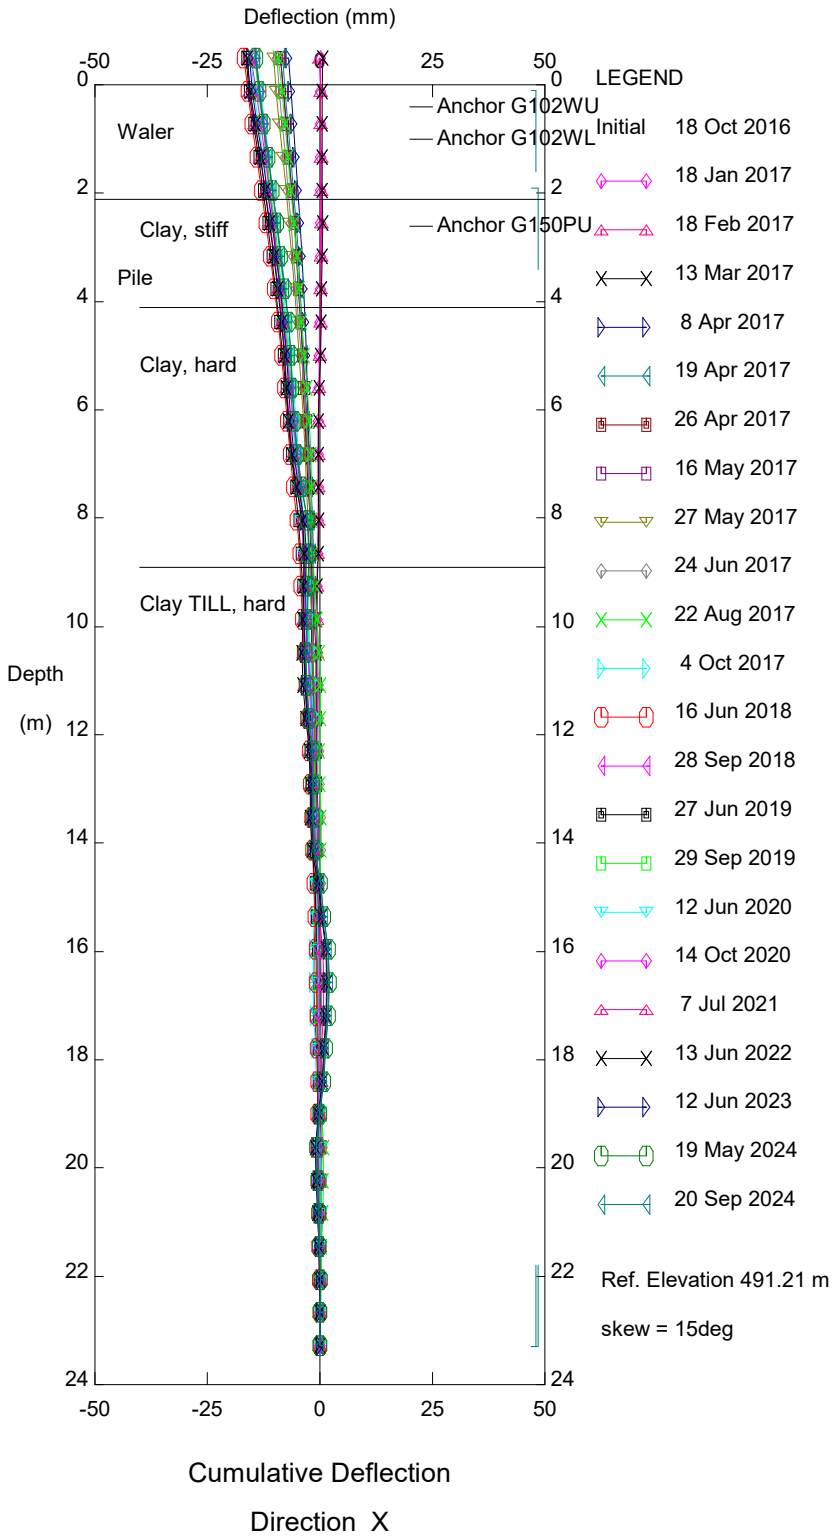
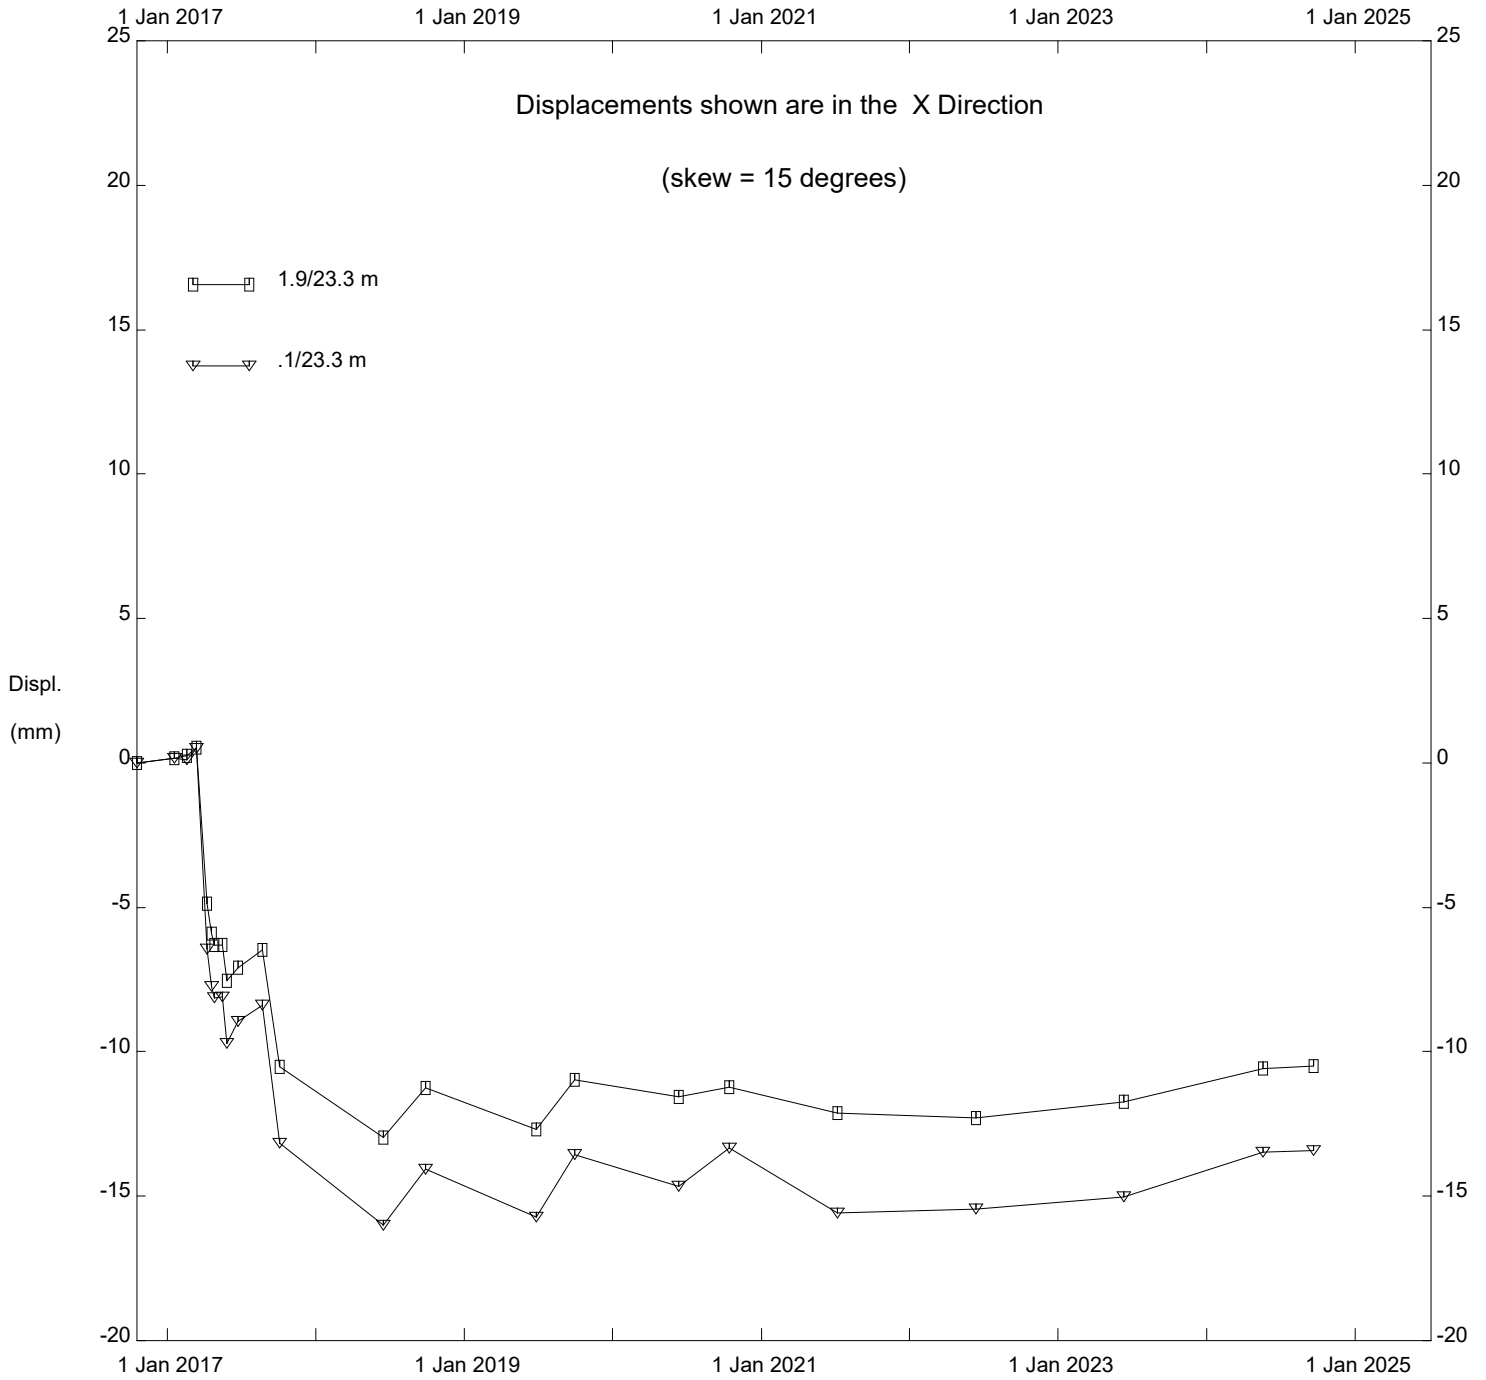
Peace River East Hill PH070, Inclinometer P90

SI-P90, installed in Pile 90, showed a rate of movement of 0.2 mm/yr over both the length of the pile and over the combined length of the pile and waler since the spring of 2024 readings. Pile 90 has shown a total cumulative pile head movement of 10.5 mm in the upslope direction and a total cumulative movement of 13.4 mm in the upslope direction over the combined length of the pile and waler.

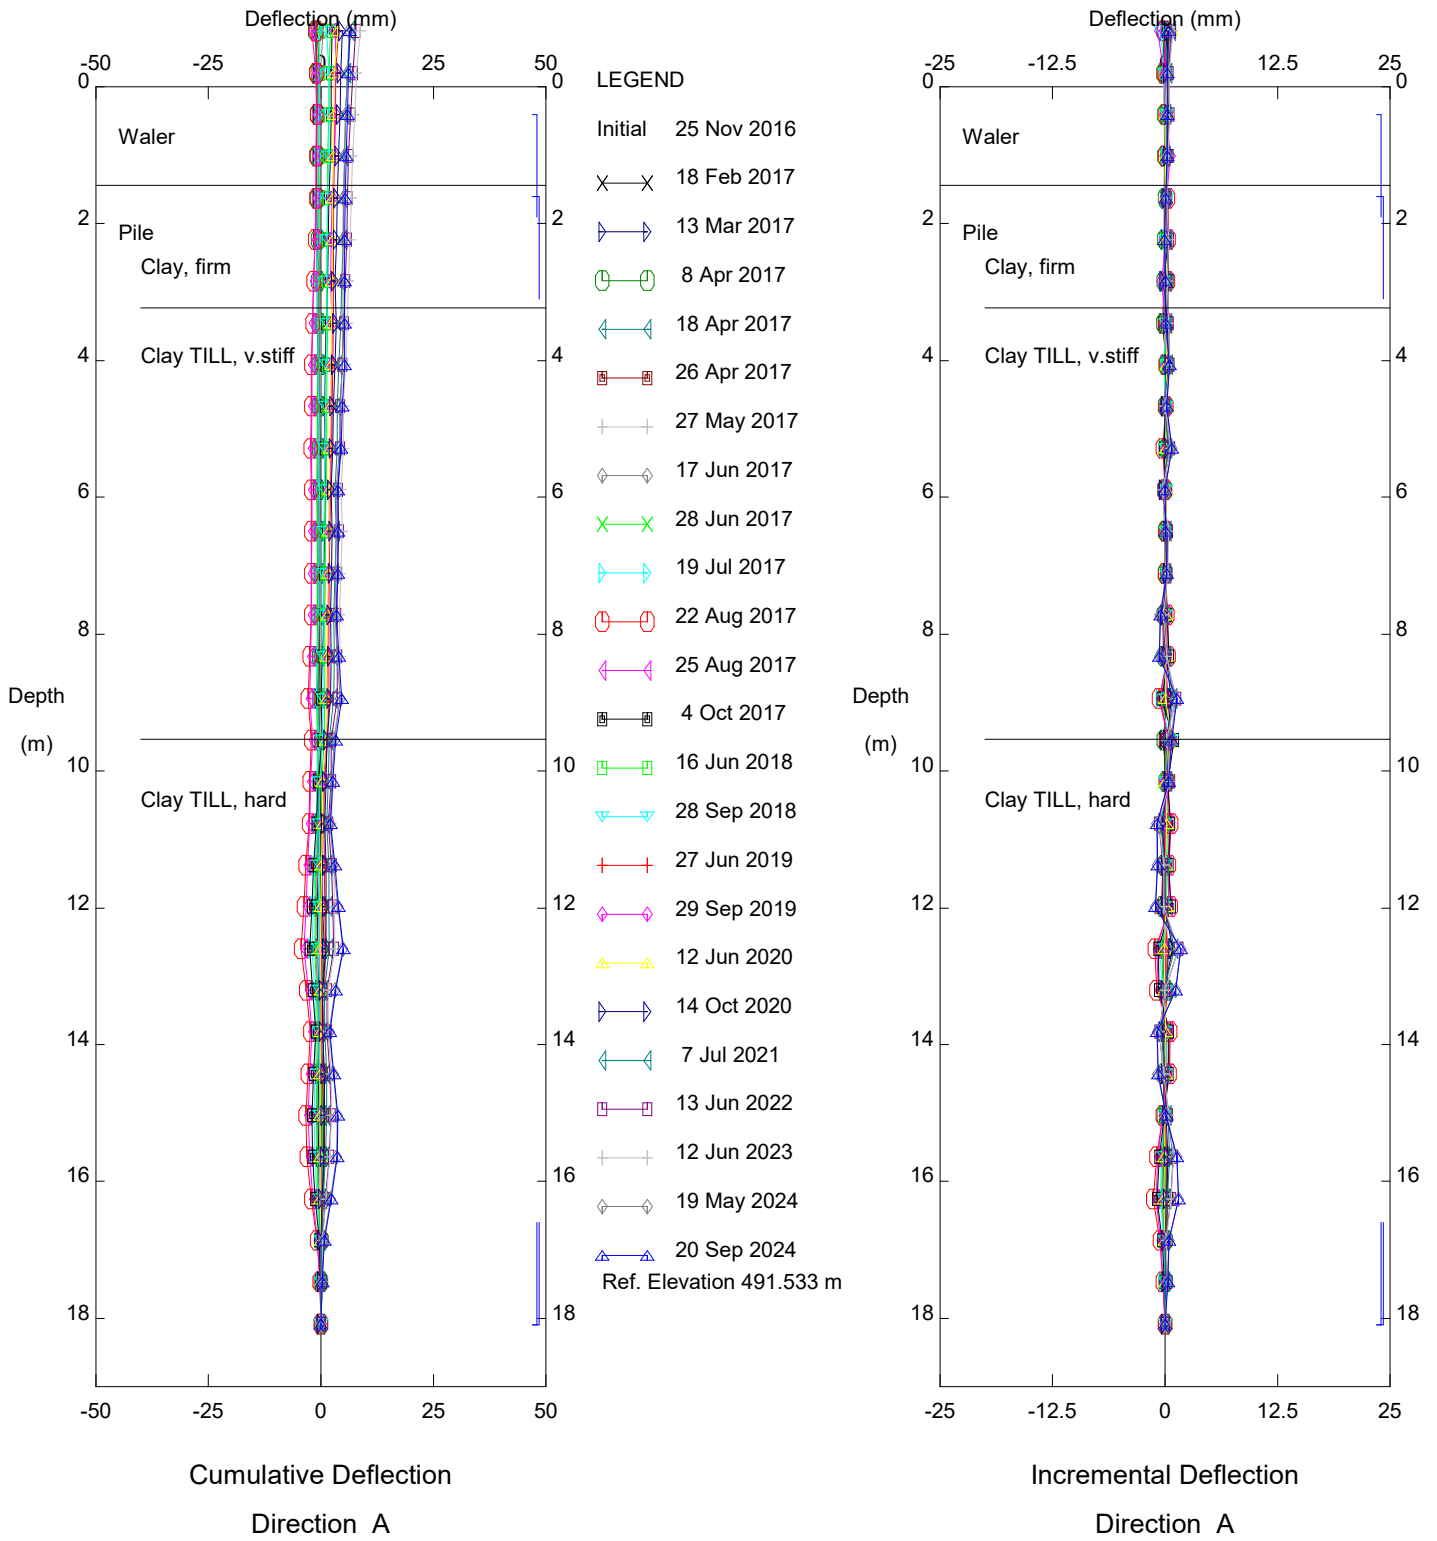
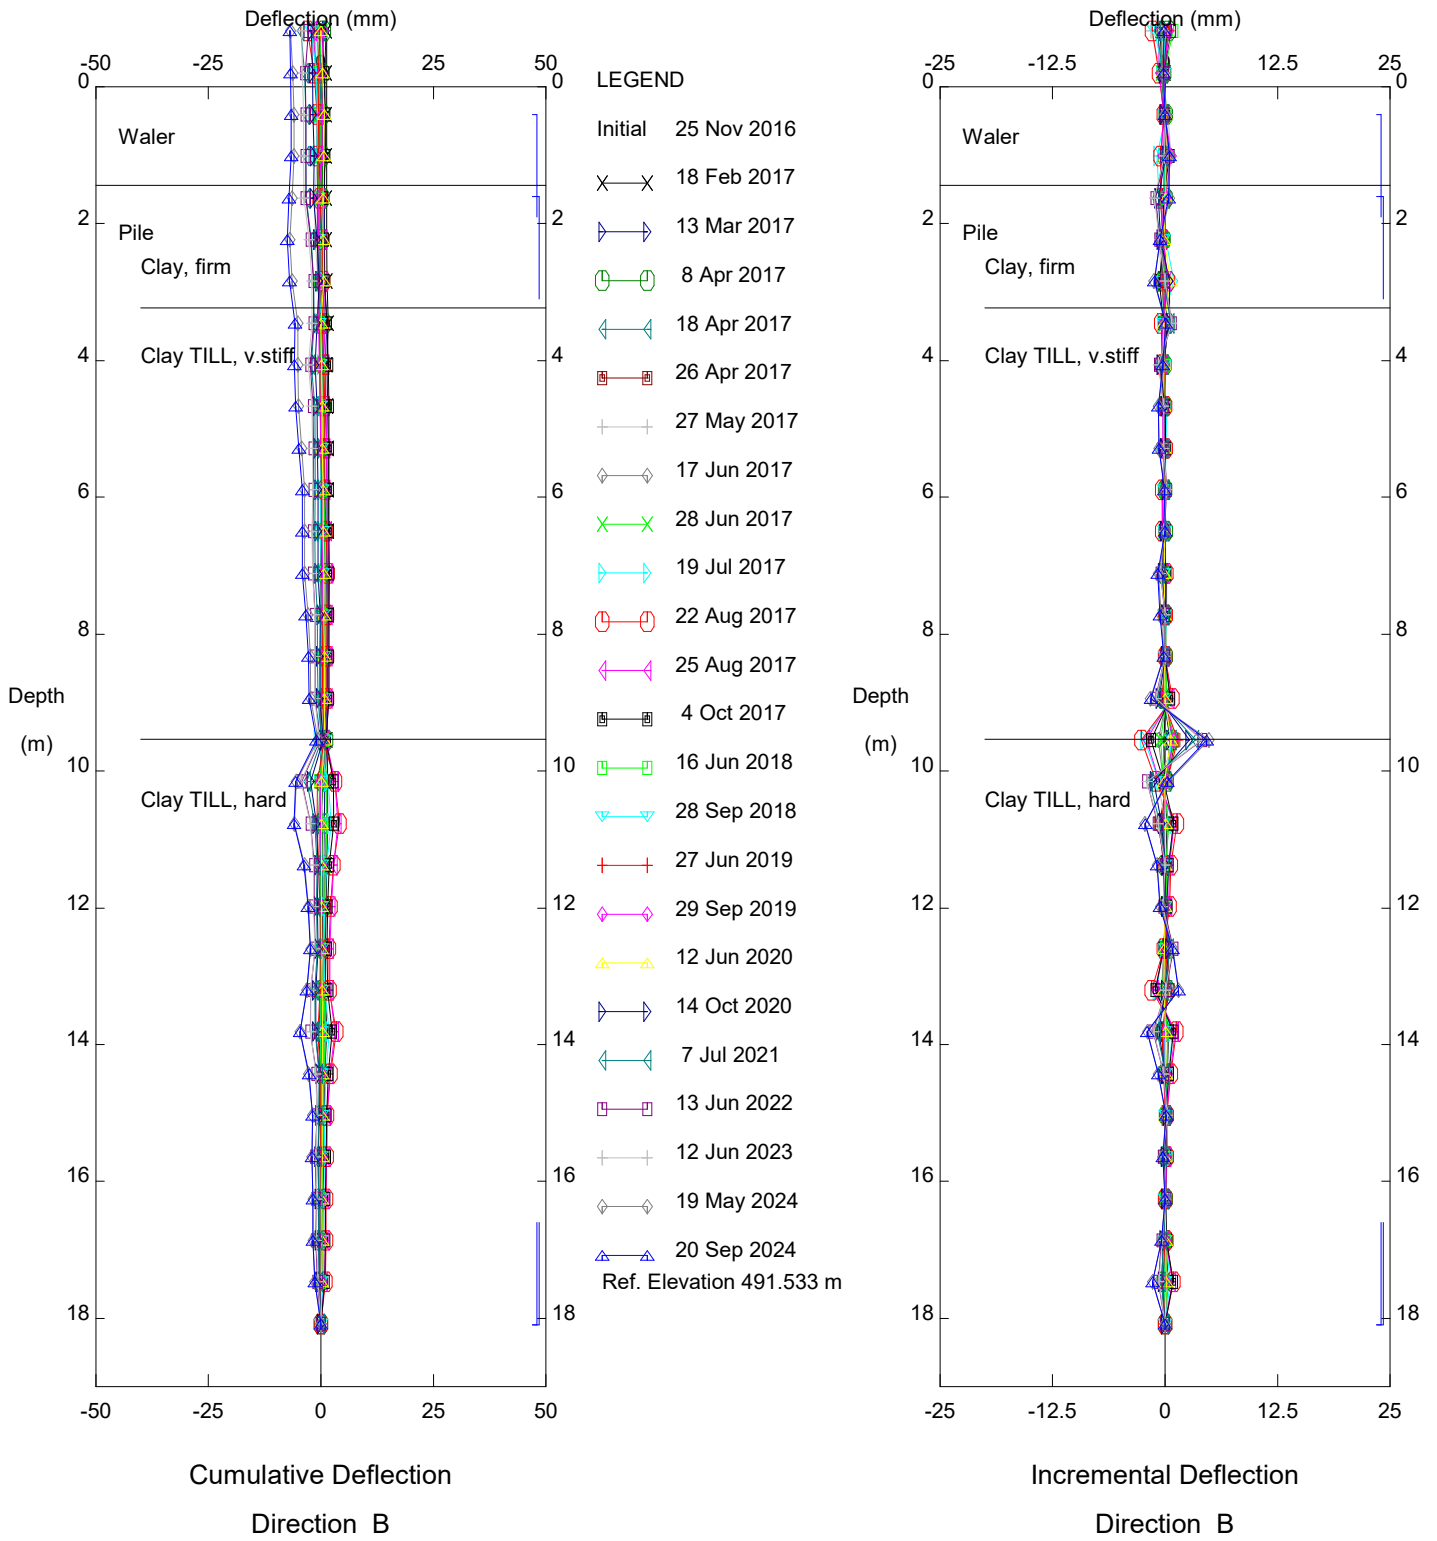
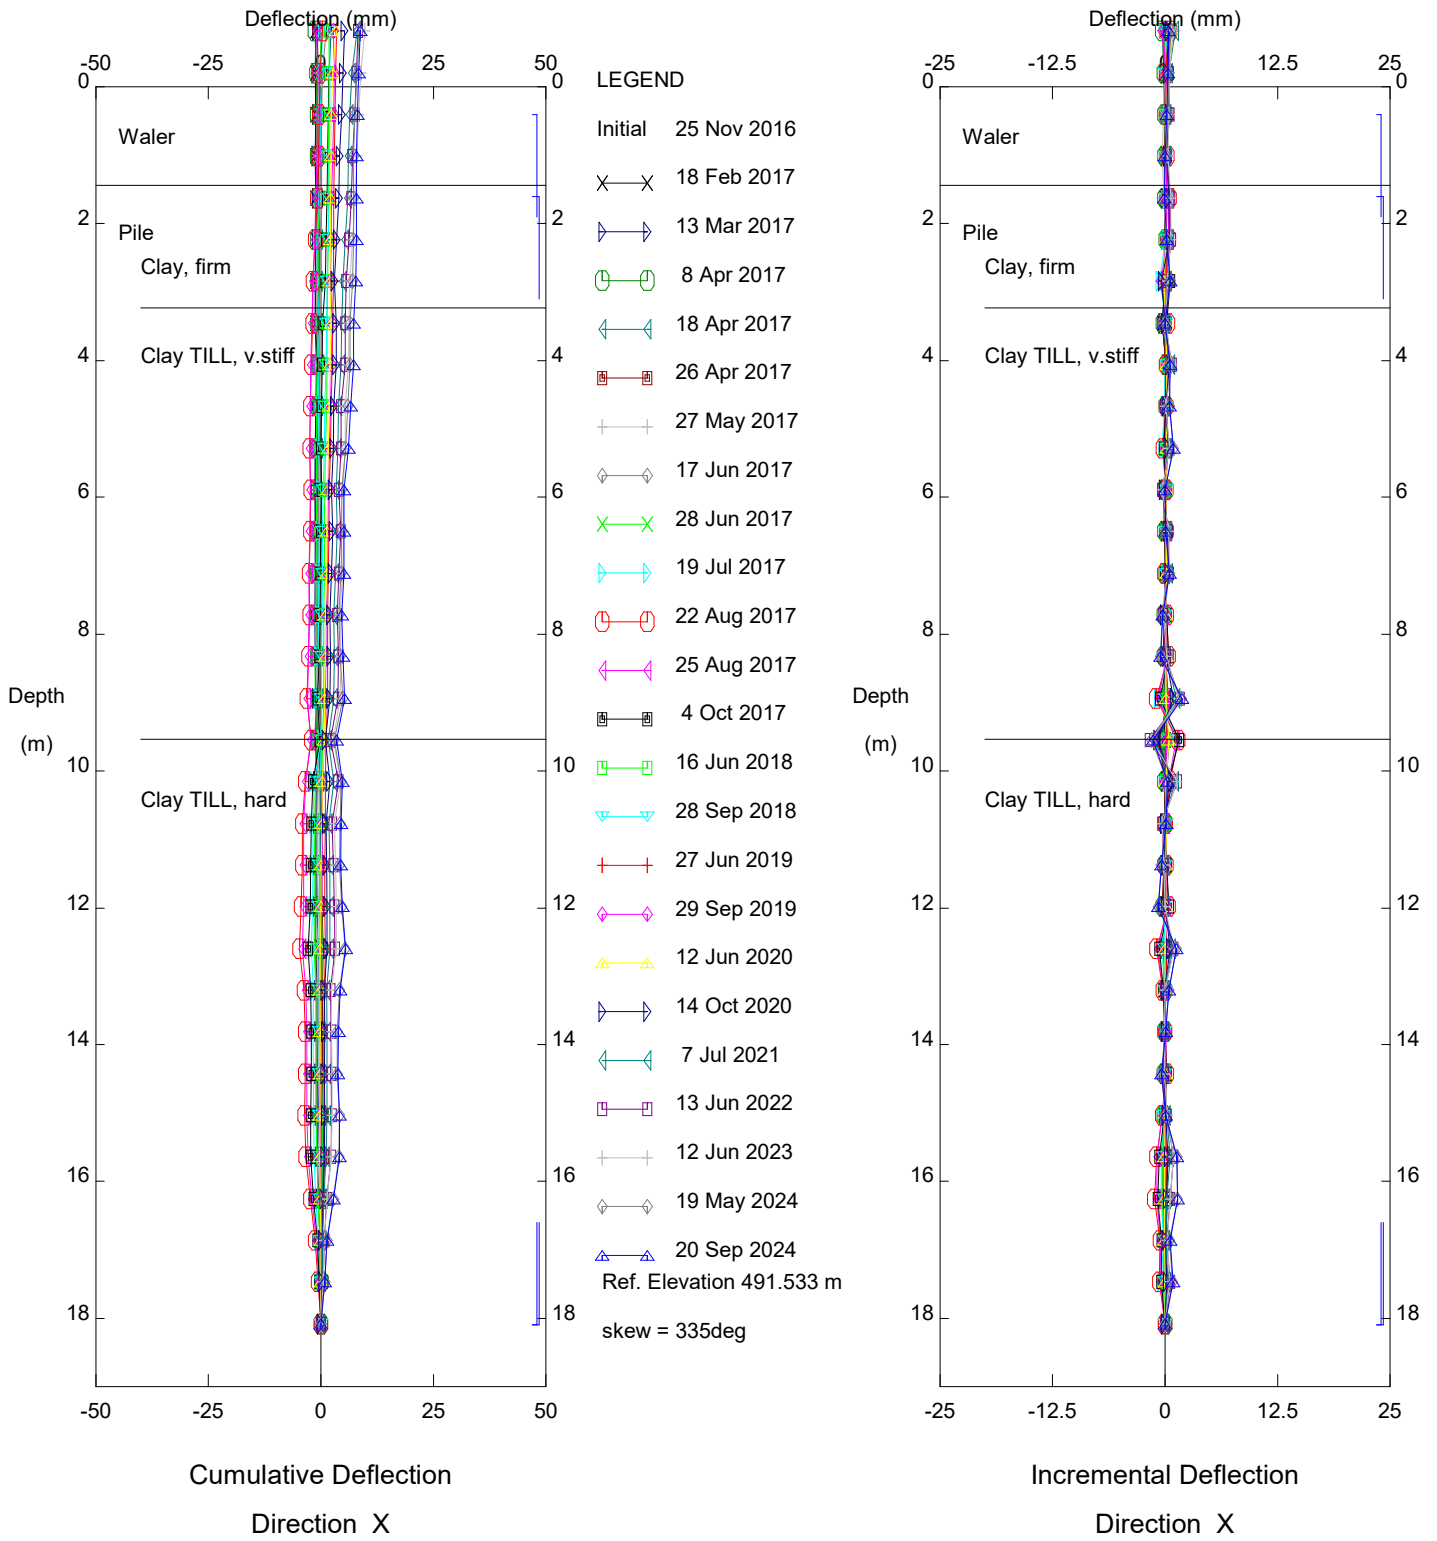
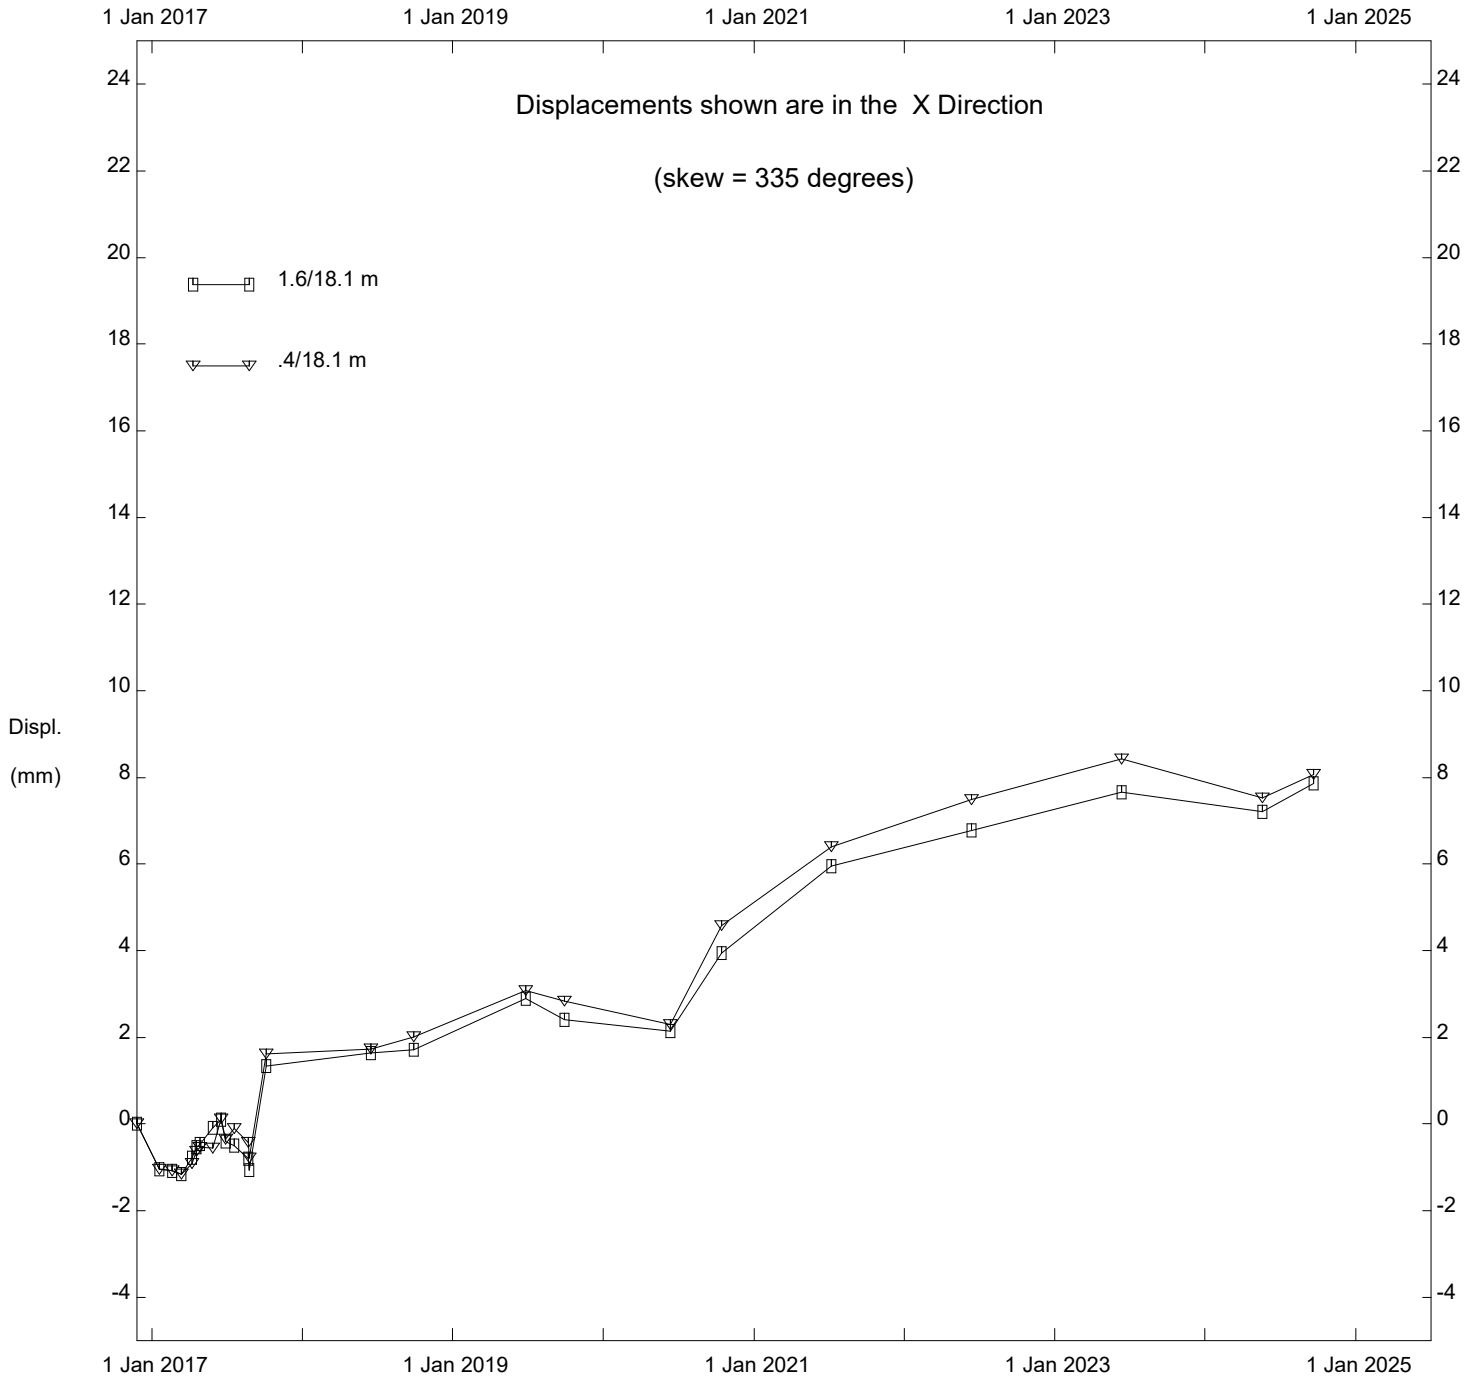
Peace River East Hill PH070, Inclinometer P116

SI-P116, installed in Pile 116, showed a rate of movement of 1.9 mm/yr over both the length of the pile and a rate of movement of 1.6 mm/yr over the combined length of the pile and waler since the spring of 2024 readings. Pile 116 has shown a total cumulative pile head movement of 7.9 mm in the downslope direction and a total cumulative movement of 8.1 mm in the downslope direction over the combined length of the pile and waler.
