Site Number	Location	Name	Hwy	km
PH070	HWY 2:60 C1 33.840	East Hill Retaining Wall Site	2:60	Km 33.84
Legal Description: 4-27-83-21 W5		UTM Co-ordinates		
		11U E 485285	N	6230649

Current Monitoring:	20-Sep-2024	Previous Monitoring	19-May-2024
Instruments Read By:	Mr. Niraj Regmi, G.I.T and Mr. Nixson Mationg, of Thurber

**ALBERTA TRANSPORTATION AND ECONOMIC CORRIDORS GRMP (CON0022164)
PEACE REGION (PEACE RIVER DISTRICT)
INSTRUMENTATION MONITORING RESULTS**

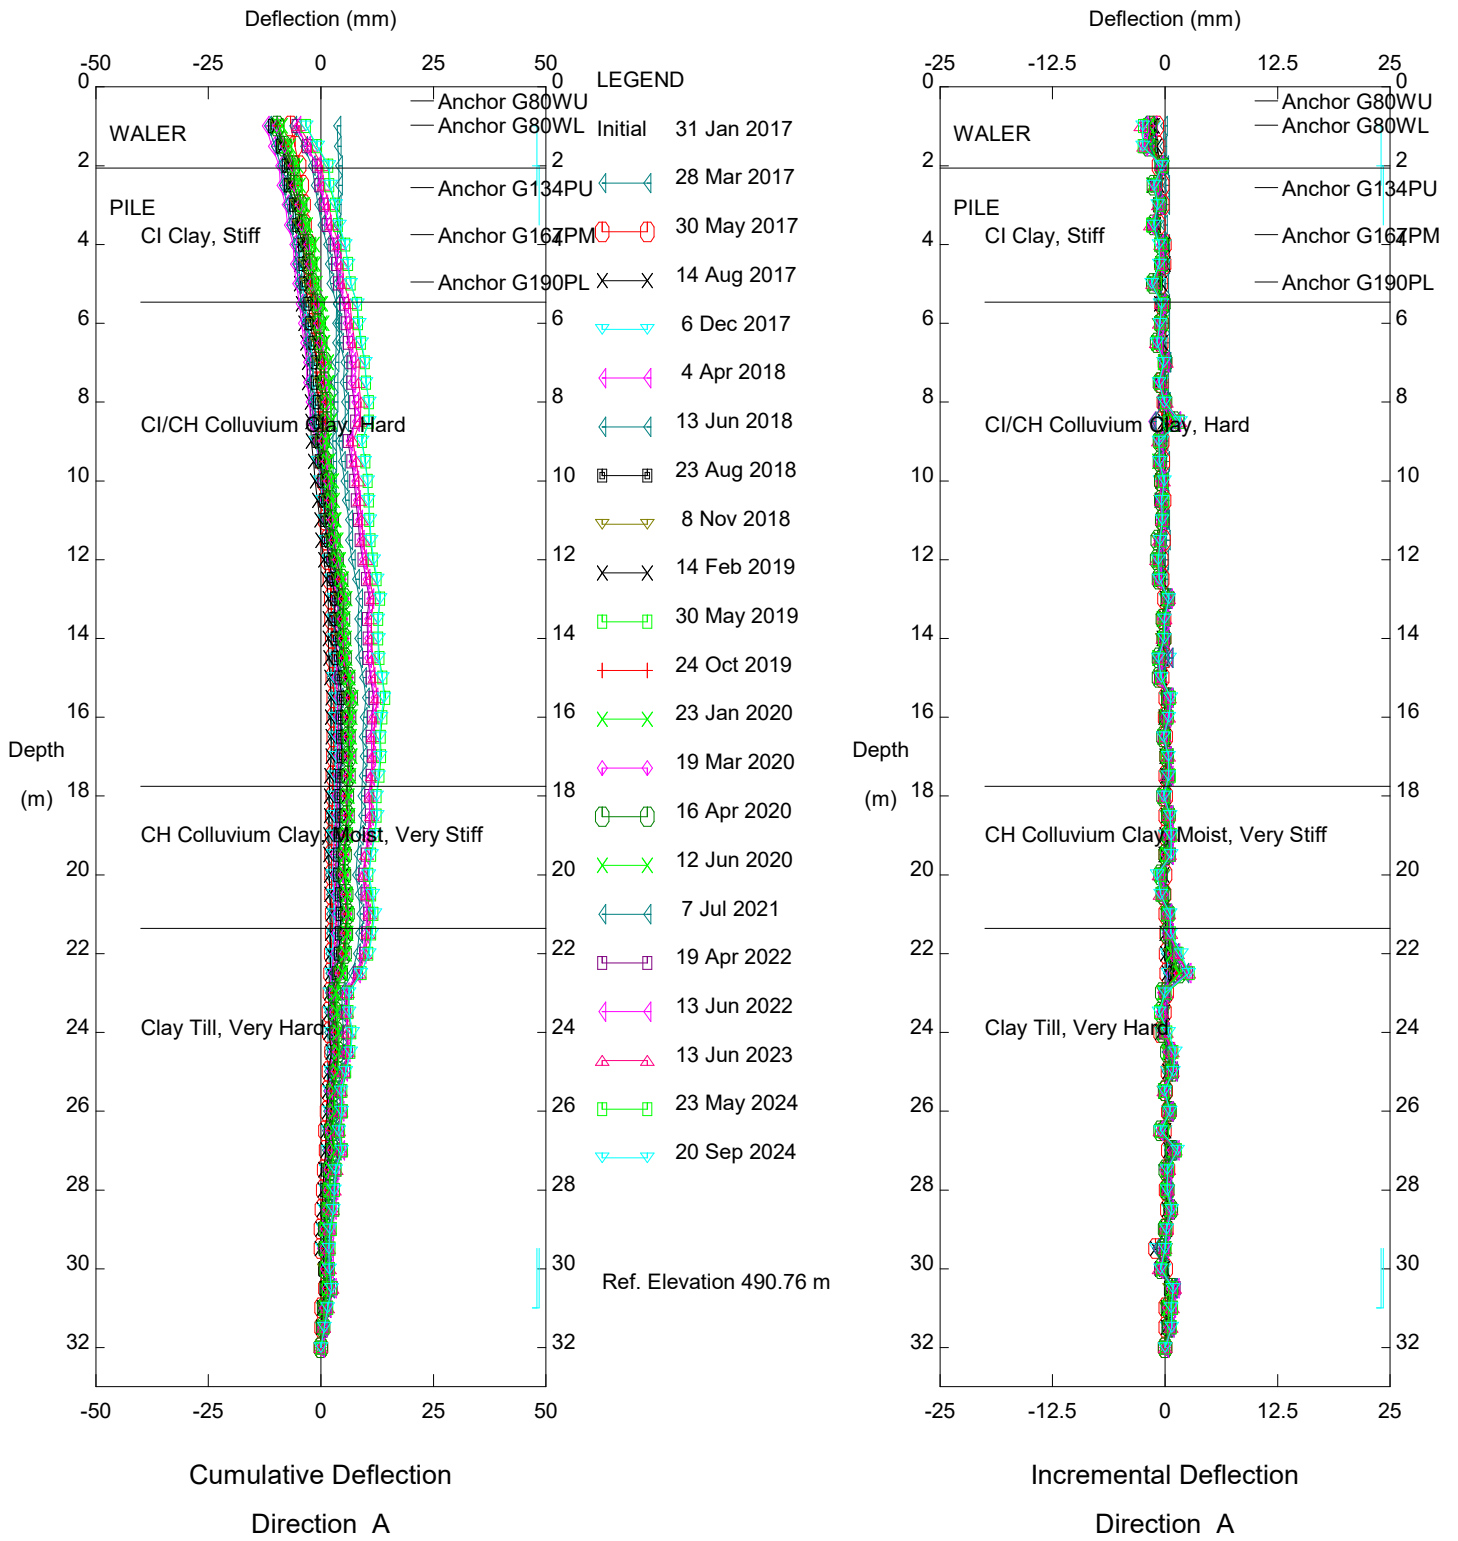
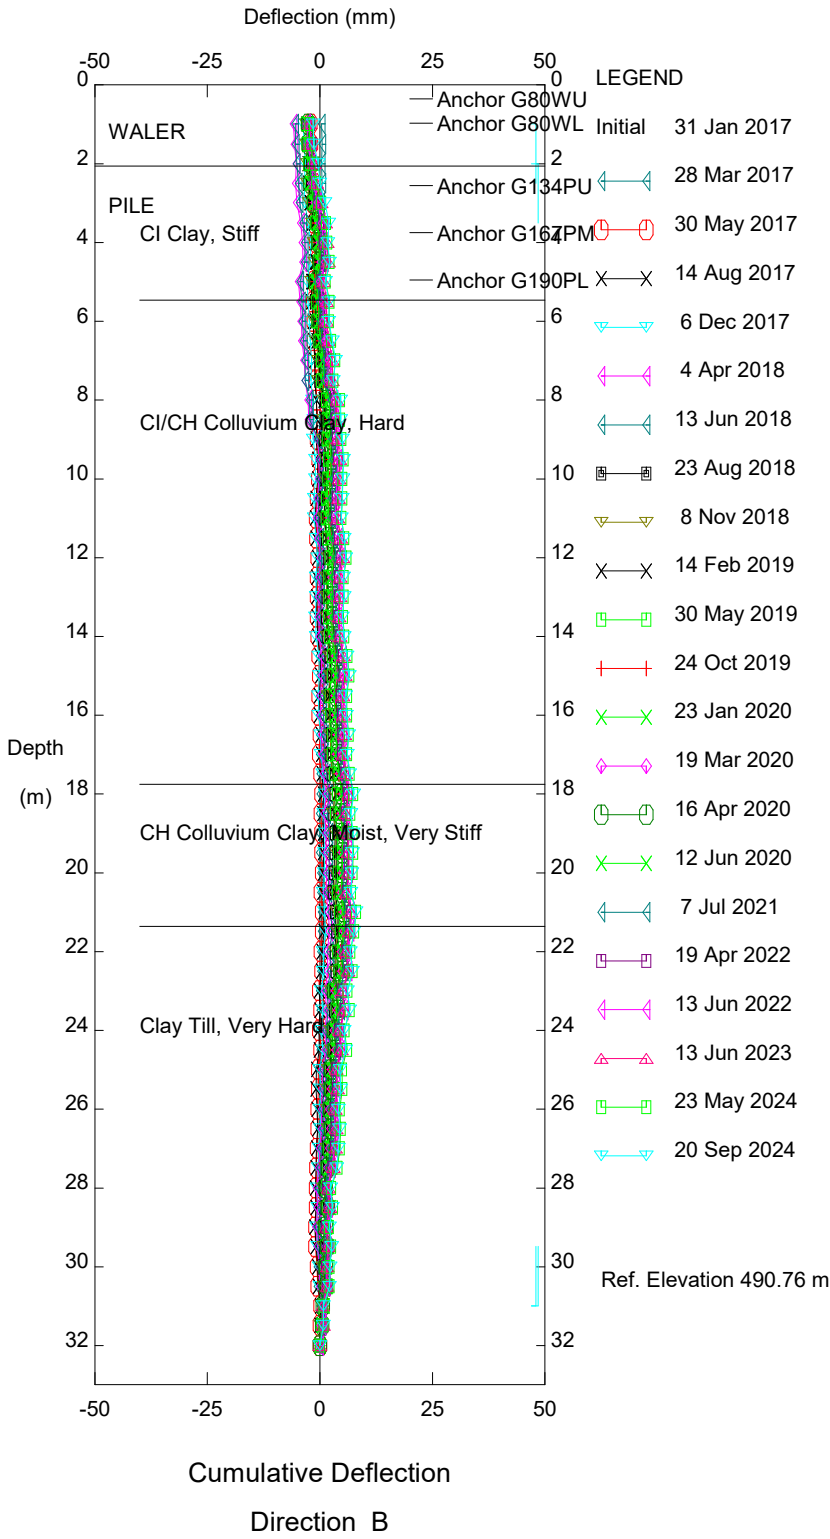
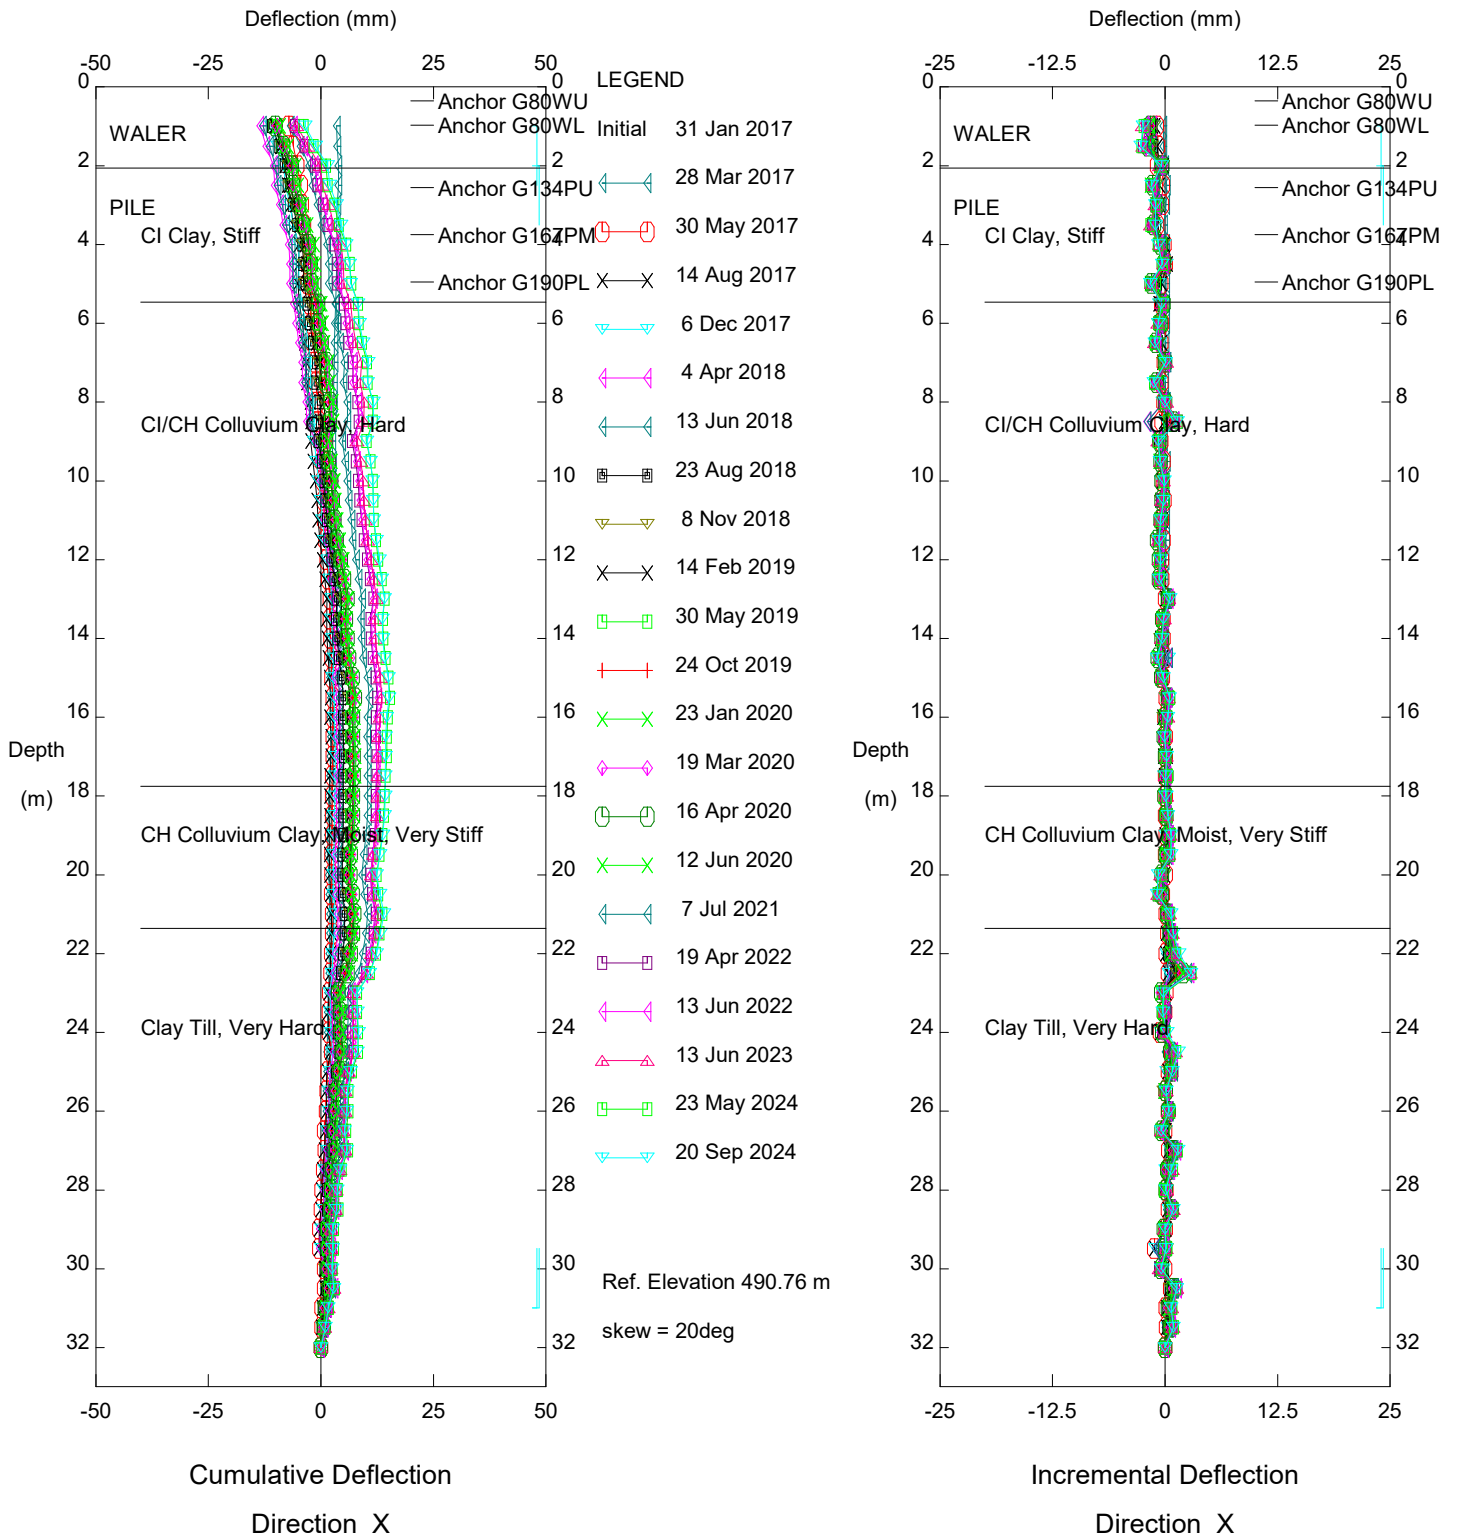
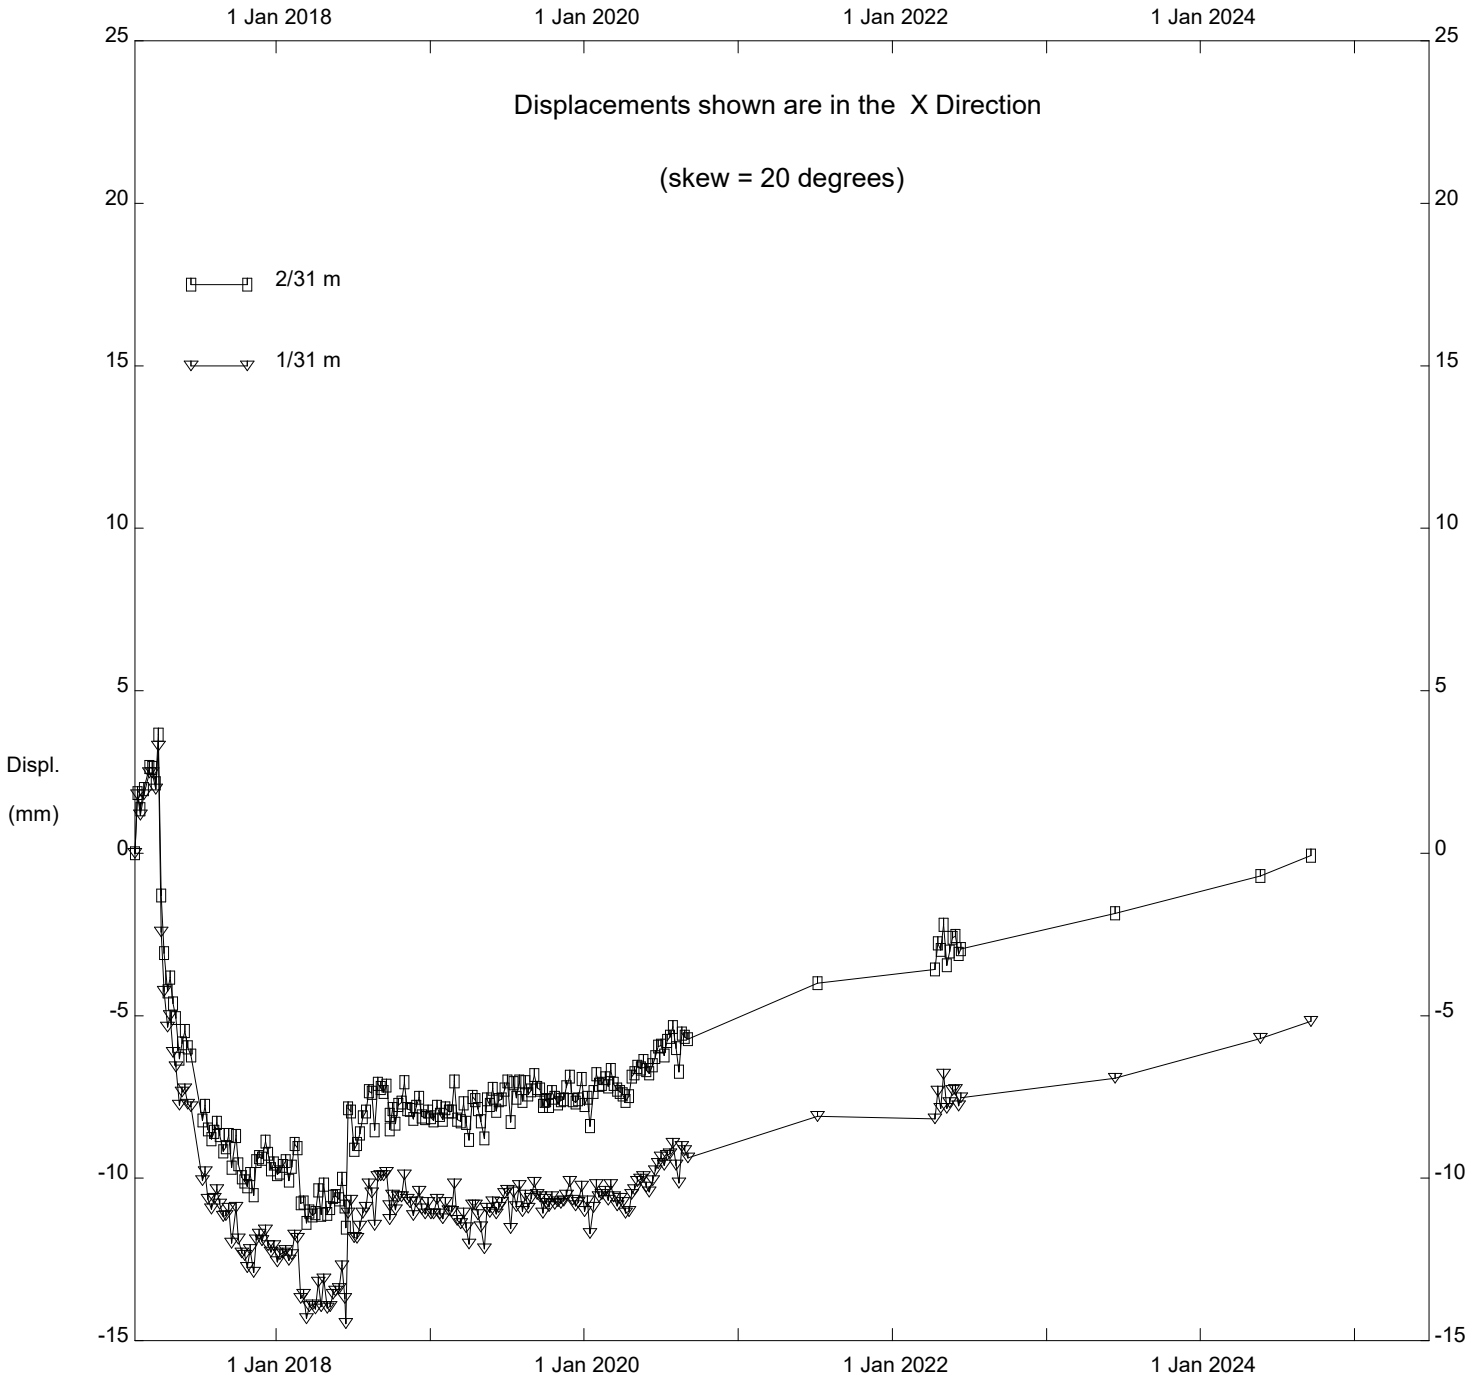
PH070 Hwy 2:60 East Hill, Inclinometer SAA-P74

SAA-P74, installed in pile P74, showed an average rate of movement of 1.9 mm/yr in the downslope direction over the length of the pile and an average rate of movement of 1.6 mm/yr over the combined length of the pile and waler in the downslope direction since the spring of 2024 readings. SAAP74 has shown a total cumulative pile head movement of 0.1 mm in the upslope direction and a total cumulative movement of 5.2 mm in the upslope direction over the combined length of the pile and waler.

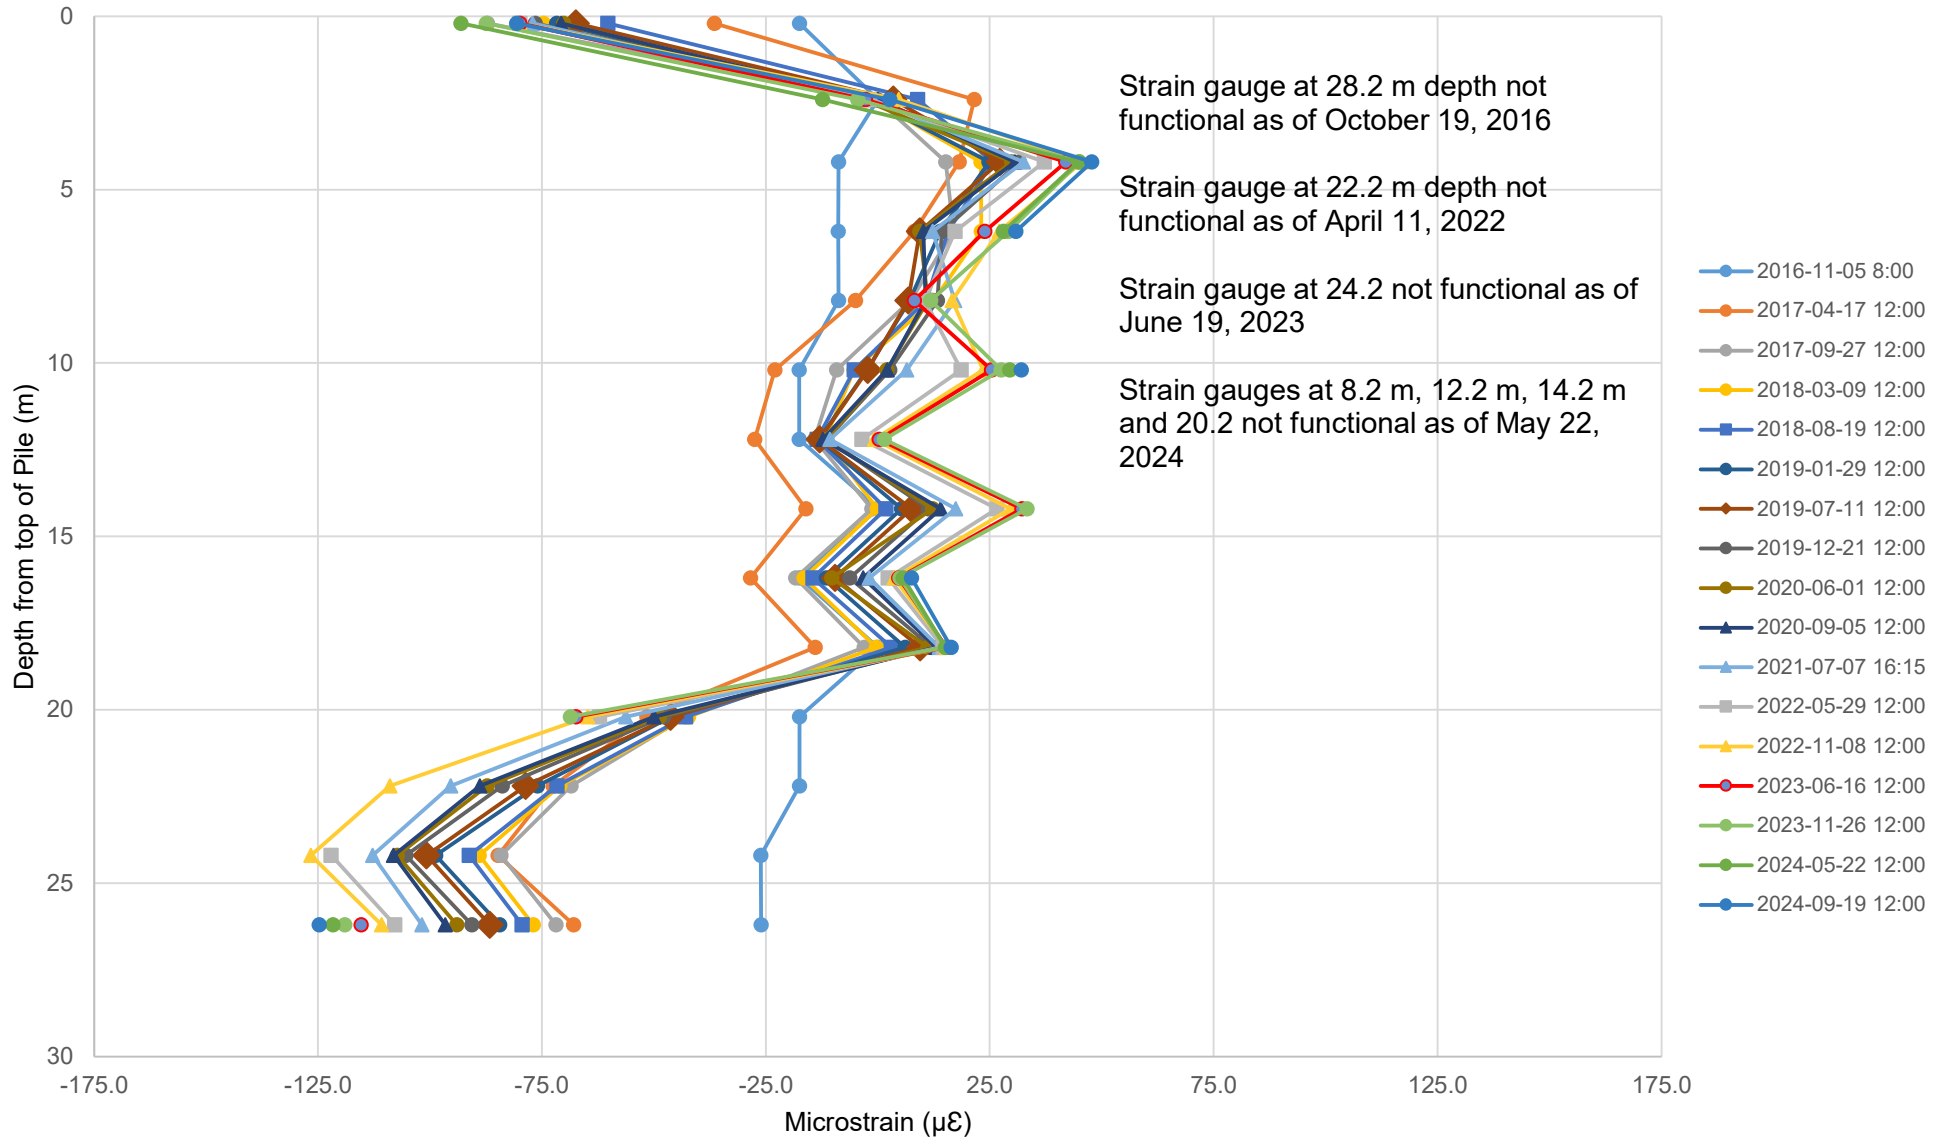
FIGURE PH070-1
HWY 2:60 PEACE RIVER EAST HILL RETAINING WALL SITE (km 33.84)
PILE P74 DOWNSLOPE SIDE STRAIN GAUGE VALUES VS DEPTH

The strain gauges generally showed small increases in negative (compressive) strain on the upslope pile face. On the downslope pile face, there was not a clear trend of overall increasing or decreasing strain; seven of the strain gauges on the downslope pile face were not functioning during the current readings which also made it difficult to observe a trend in the strain. The maximum change in microstrain ($\mu\epsilon$) since the previous readings was $-14.5 \mu\epsilon$, measured at 2.4 m depth on the upslope pile face.

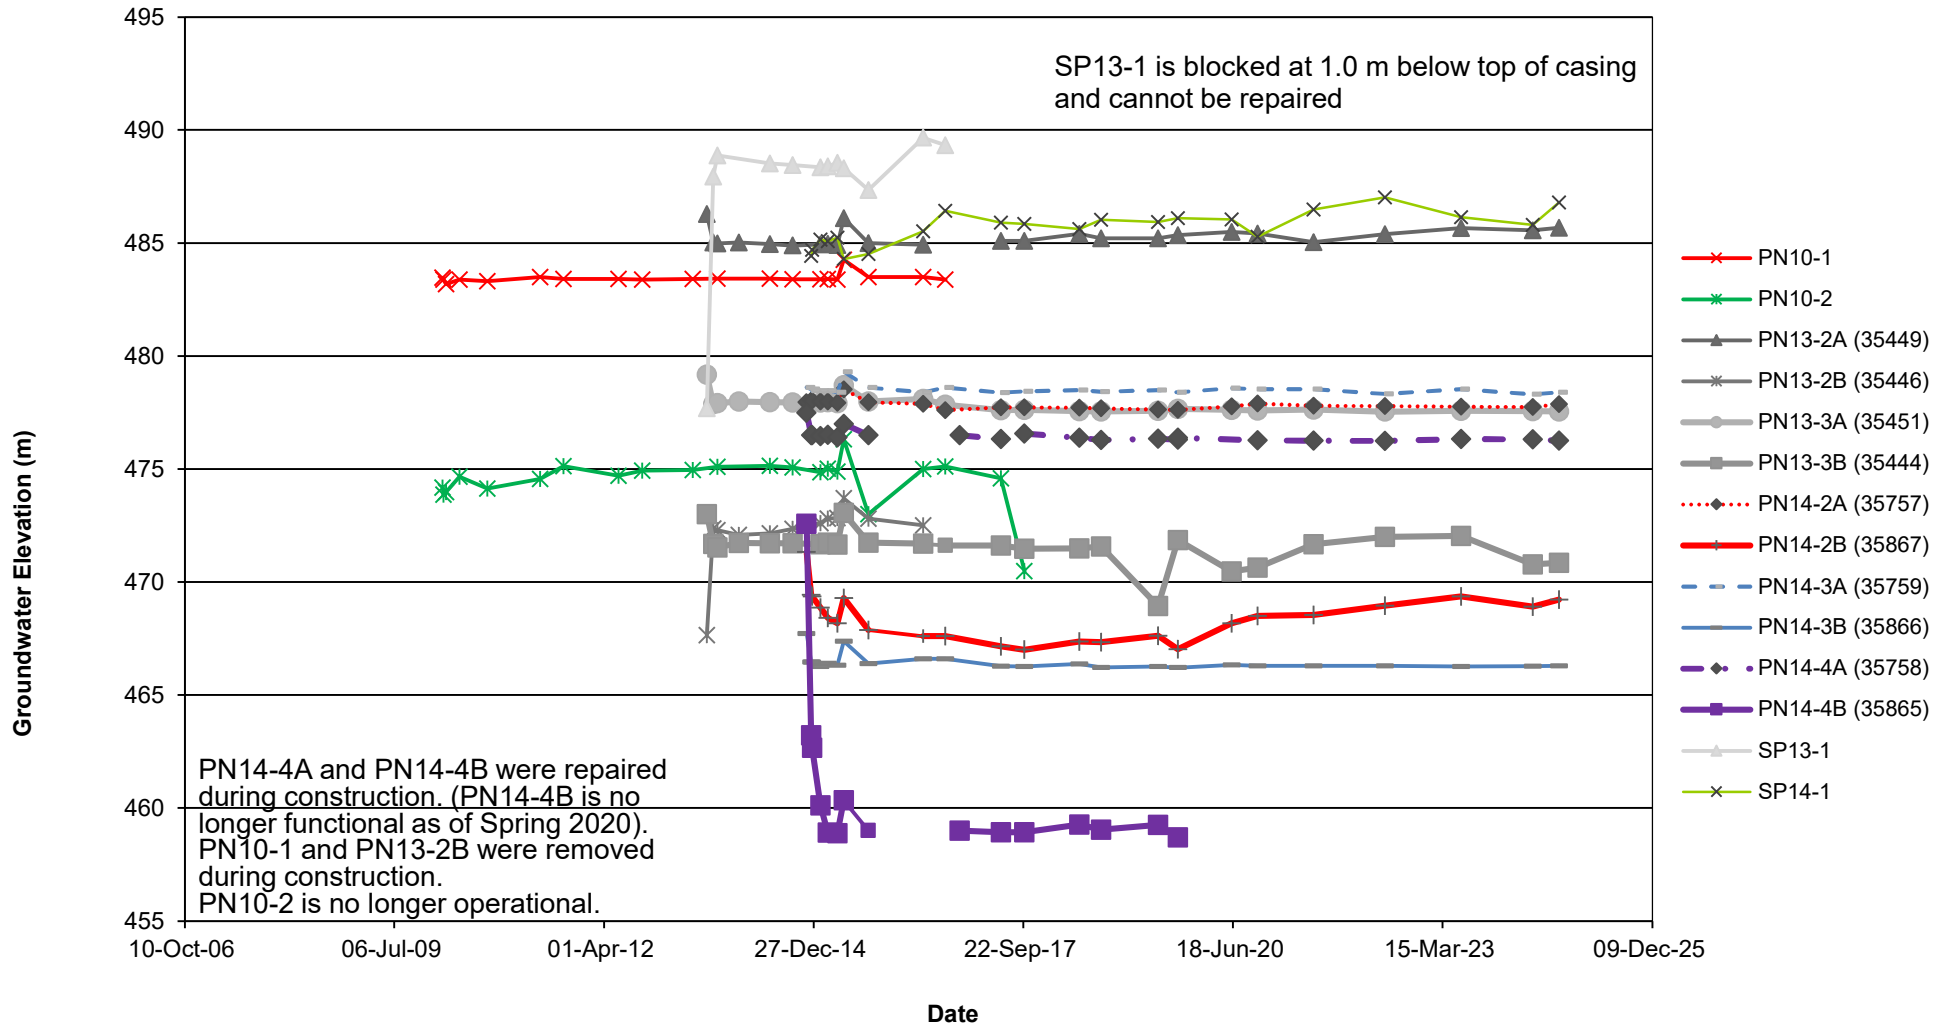
FIGURE PH070-3
HWY 2:60 PEACE RIVER EAST HILL RETAINING WALL SITE (km 33.84)
PIEZOMETRIC ELEVATIONS

Pneumatic piezometers PN13-2A, PN13-3B, PN14-2A, PN14-2B, PN14-3A and PN14-3B showed increases in groundwater level of 0.10 m, 0.07 m, 0.13 m, 0.31 m, 0.09 m, and 0.01 m, respectively, since the spring of 2024 readings. PN14-3A and PN14-4A showed decreases in groundwater level of 0.01 m and 0.06 m, respectively, since the spring of 2024 readings.

Standpipe piezometer SP14-1 showed an increase in groundwater level of 0.99 m since the spring of 2024 readings.

<p>Overall, the piezometers have shown relatively stable groundwater levels for the past several years, with the exception of PH14-2B and SP14-1, which showed larger increases in groundwater level. These groundwater levels are still within historical maximums.</p> <p>LOAD CELLS</p> <p>The load cells showed relatively small changes in measured load compared to the spring of 2024 readings, ranging from a decrease of 3.08 kN in anchor G102WU to an increase of 9.10 kN in G190PL. The current loads for G39WL, G190PL, G188PL and G202PL) are the highest ever recorded by the respective load cells. It should also be noted that the datalogger did not record any readings between November 29, 2023 and May 22, 2024, and between May 22, 2024 and September 20, 2024, when the datalogger was manually read on site. Historically, the load cells have registered higher loads during the winter months, which may have been missed during the last winter.</p> <p>Wall Section 2: Anchors G39WL and G40WU currently show a trend of gradually increasing load. G39WL and G40WU are currently 4.35 kN and 4.65 kN, respectively, above their SLS design loads.</p> <p>Wall Section 3A and 3B: Anchor G58WU shows a trend of slowly increasing loads; the current load is currently 15.73 kN above the SLS design load. Anchor G59WL, G118PU, G102WU, G102WL and G150PU have not shown changes in load since about 2017 and are all below SLS design loads.</p> <p>Wall Section 4: Anchor G190PL, in the bottom (fifth) row of anchors, shows a trend of increasing load. This is not a concern currently as the design of the wall assumed that the anchors installed through the piles in this wall section will pick up load over time. Anchors G134PU and G168PM both show a trend of small load increases. Currently the loads on these two anchors are well below the design SLS loads.</p> <p>Anchors G182PL, G188PL and G202PL were installed as 'stiff anchors' that were left with some slack to allow the piles to deform before the anchors pick up load. These load cells indicate current loads ranging from 12.86 kN to 16.63 kN. These anchors have not shown significant changes in the loads since the end of construction, suggesting that there may still be some slack at the nut in these anchors.</p> <p>The load cells on G80WU and G80WL are showing loads that are 55.39 kN and 22.32 kN above SLS design load, respectively. However, these anchors were intentionally locked off at a higher load than the SLS load during construction, with the expectation that they would slacken over time.</p>
