**ALBERTA TRANSPORTATION AND  
ECONOMIC CORRIDORS  
GEOHAZARD ASSESSMENT PROGRAM  
PEACE REGION (PEACE RIVER DISTRICT)  
2024 INSPECTION**

Site Number	Location	Name	Hwy	km
PH070	East Hill 33+850 to 34+050	East Hill – Retaining Wall Site	2:60	33.84
Legal Description		UTM Co-ordinates (NAD 83)		
SW27-083-21 W5M		11V E 485363	N 6230677

**PEACE RIVER EAST HILL**  
**HWY 2:60 (PH070) STA. 34+200 TO 33+700**  
**LOCATION PLAN**

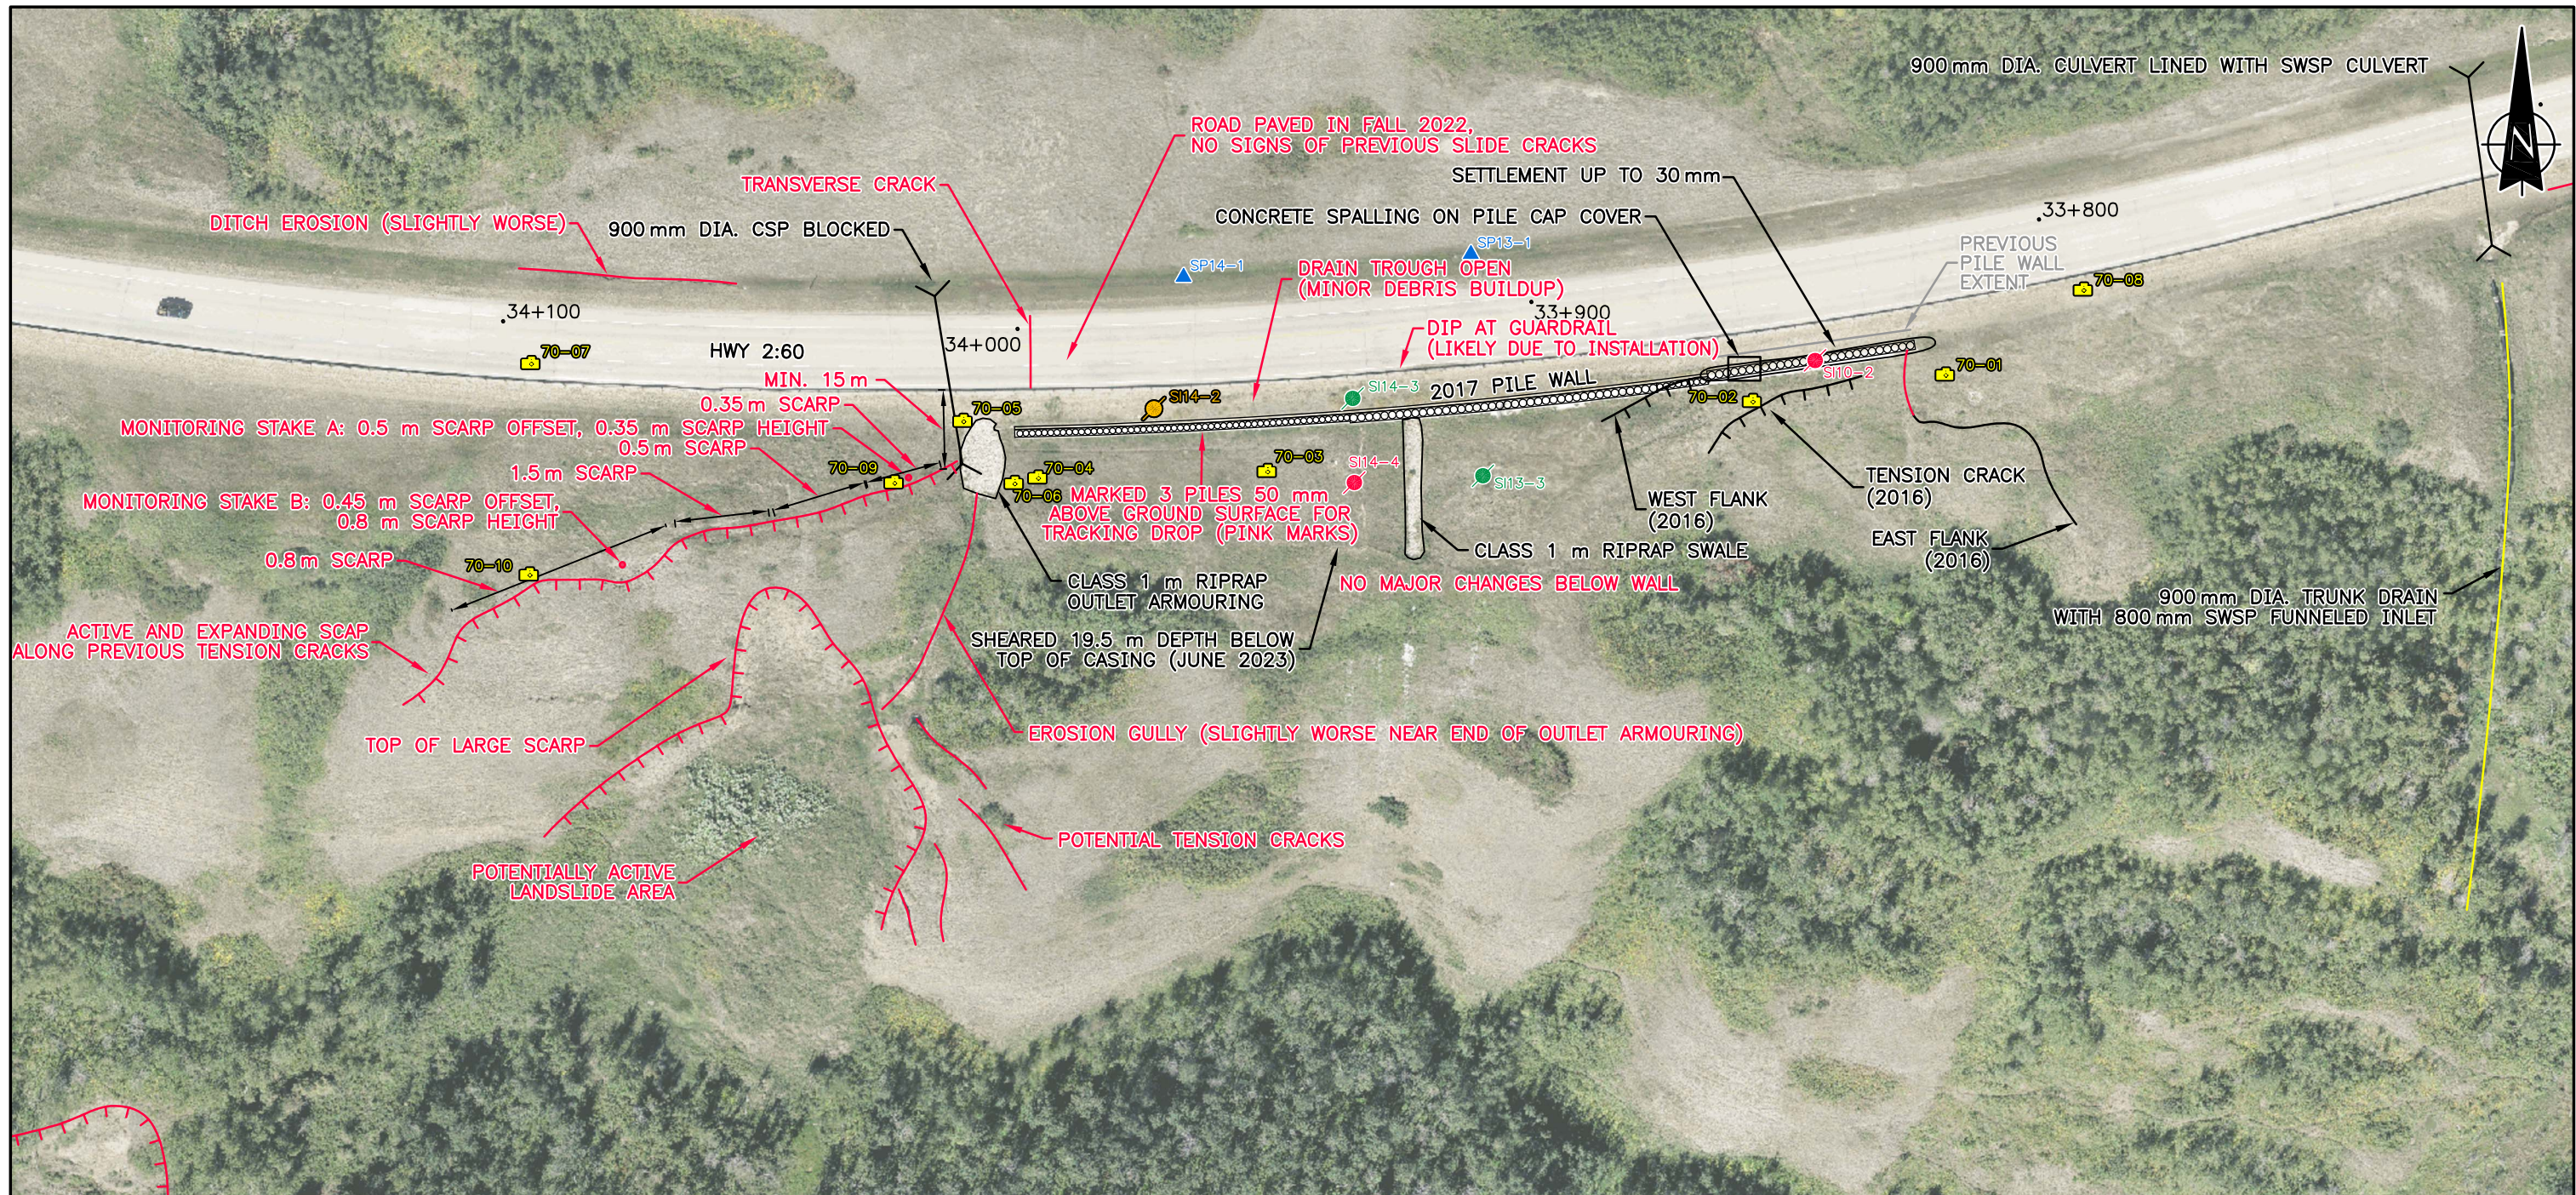
**FIGURE PH070-1**

Large deep-seated landslides are widespread below roadway in this area and have potential to affect the highway if they retrogress. The pile wall system (tied back pile wall and new cantilever wall) appears to be mitigating the previously observed settlement and pavement damage issues related to the landslide movement between 33+850 and 34+000. The tied-back pile wall is designed to accommodate ongoing downslope movement of the slide mass downslope of the wall. Based on instrument data and site observations there is ongoing creep movement downslope of the wall and movement rates upslope of the wall have diminished significantly. However, SI14-4 located downslope of the tied-back pile wall was found sheared at 19.5 m depth below top of casing. A review of the surface conditions around SI14-2 and future readings is recommended as current trends show potential movement of a failure surface occurring below the pile tips.

The slide developing west of the tied-back wall has developed a very apparent scarp and is expected to considerably worsen over the next 5 years. Due to its current offset from the highway (approximately

15 m at the east end) it is not expected to have an immediate impact to the NBL; however, future retrogression could cause instability that reaches the road shoulder or further if left unmitigated. The progression of this slide area relative to any changes in the rate of creep movements below the west portion of the wall should be made following each annual inspection to determine if the two are related to a single larger slide movement (note two monitoring stakes were installed above the scarp in 2023 with locations marked on Figure PH070-1). Drainage into the disturbed slide terrain below this area is expected to be a factor as the slope loses toe support. Expansion and retrogression of the erosion gully forming downslope from the armored outlet for the pile wall drain trough could cause further destabilization at the east flank of the new slide due to soil loss.

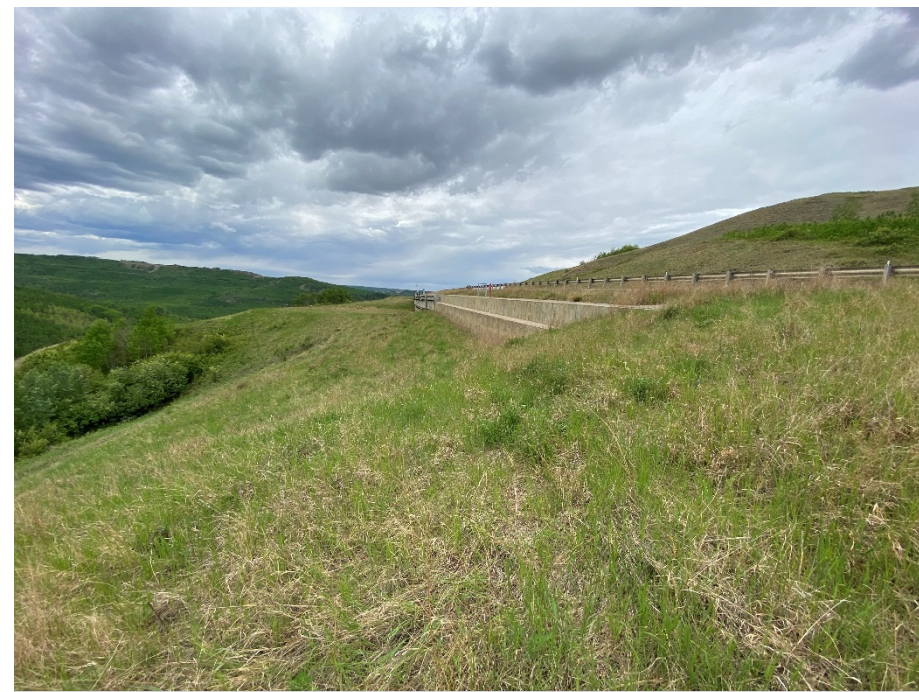
**Photo 70-01.**  
Looking west at  
concrete pile  
retaining wall at  
33+850. No major  
visible changes  
downslope from the  
wall since 2023.

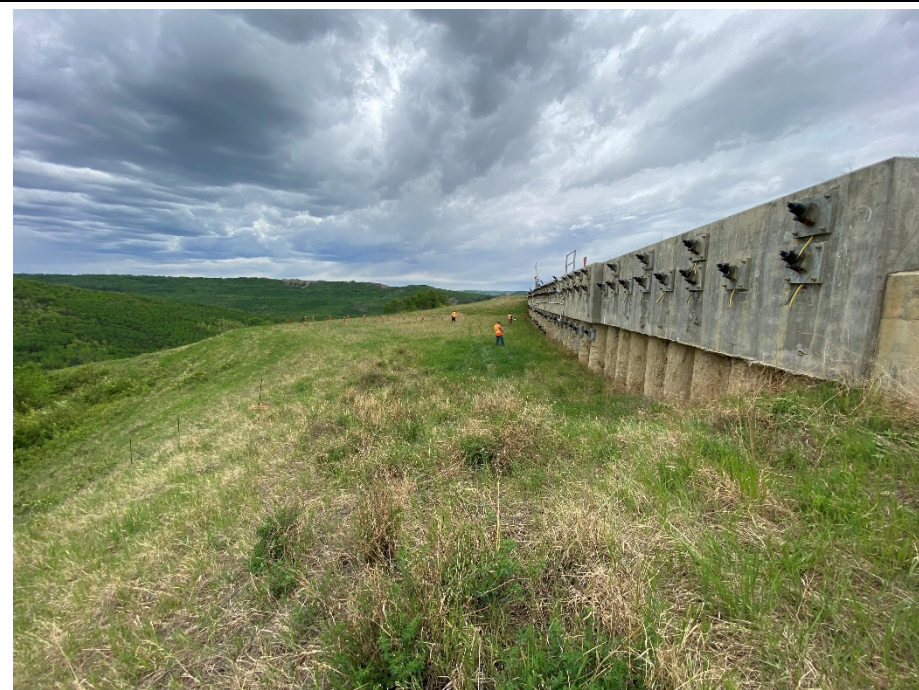
**Photo 70-02.**  
Looking west from  
the east end of the  
2017 concrete pile  
retaining wall near  
33+875.

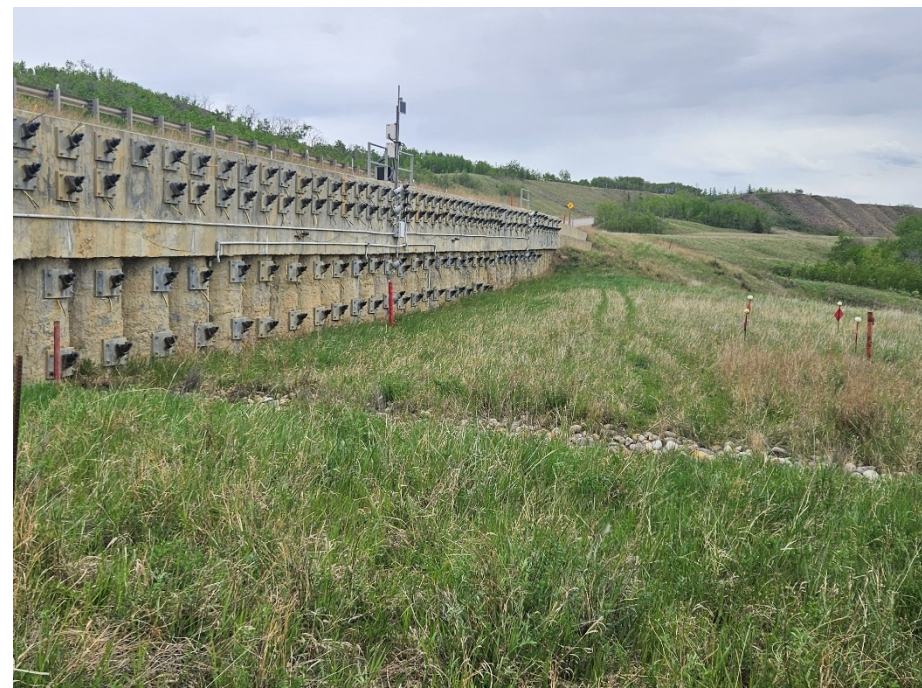
**Photo 70-03.**  
Looking east near the centre of the retaining wall with Class 1 riprap swale located near 33+950. East flank of the 2016 slide is visible in the background. SI13-3 is visible on the right side of the photo. No major changes were visible on the bench below the wall since 2023.

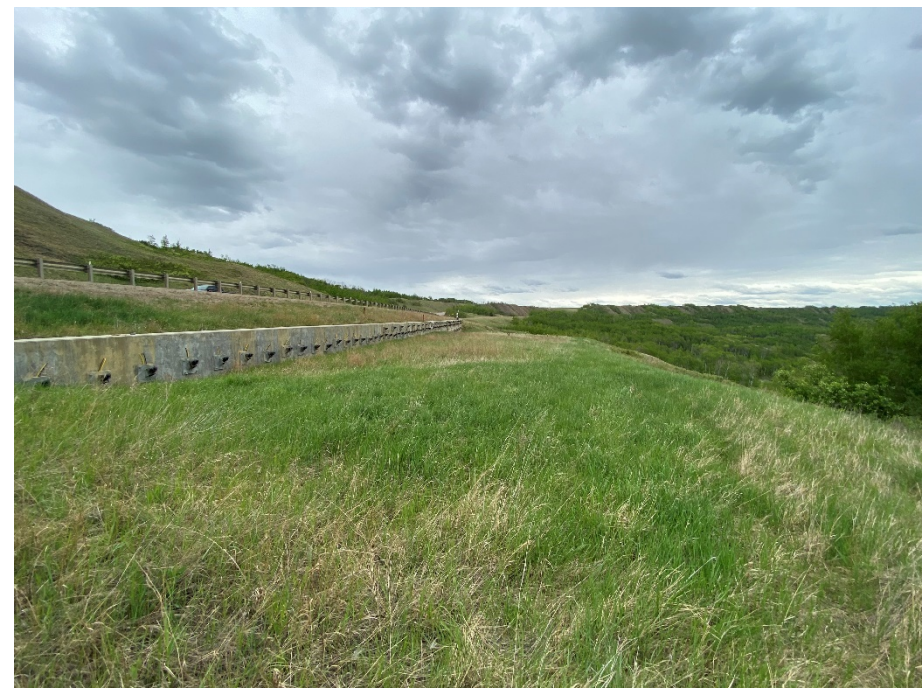
**Photo 70-04.**  
View east from the west end of the 2017 pile wall (34+000) on the downslope side. Similar appearance to the 2023 conditions.

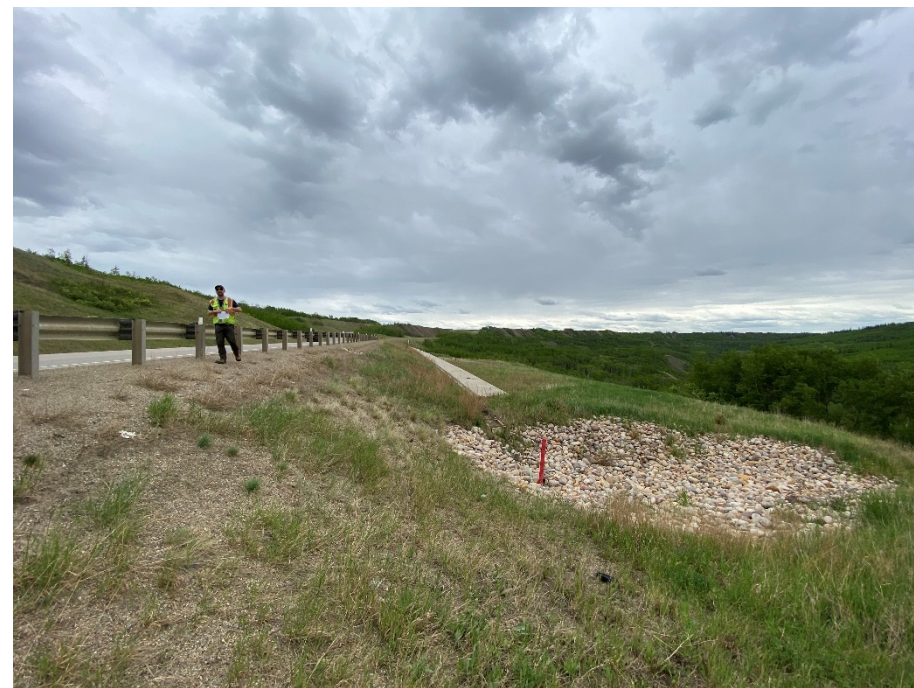
armouring (34+000) was functioning as intended with no visible changes from the 2023 condition. (Photo 70-05)		
--	---	--	--

**Photo 70-05.**  
View east from west end of pile wall (km 34+015) at armoured drainage outlet for the drain trough along top of wall. Trough drain was open and working as intended with some minor debris and sediment buildup. Overall no major changes from the 2023 condition.

- The erosion downstream of the drainage outlets should be monitored by regular visual inspection and if the condition significantly worsens, consideration should be given to extending the rock armoring or installing a drainpipe to prevent gully retrogression towards the road and potentially exacerbating landslide movement west of the tied-back pile wall.
- Drain trough along top of pile wall should be cleaned of sediment and debris every Spring.

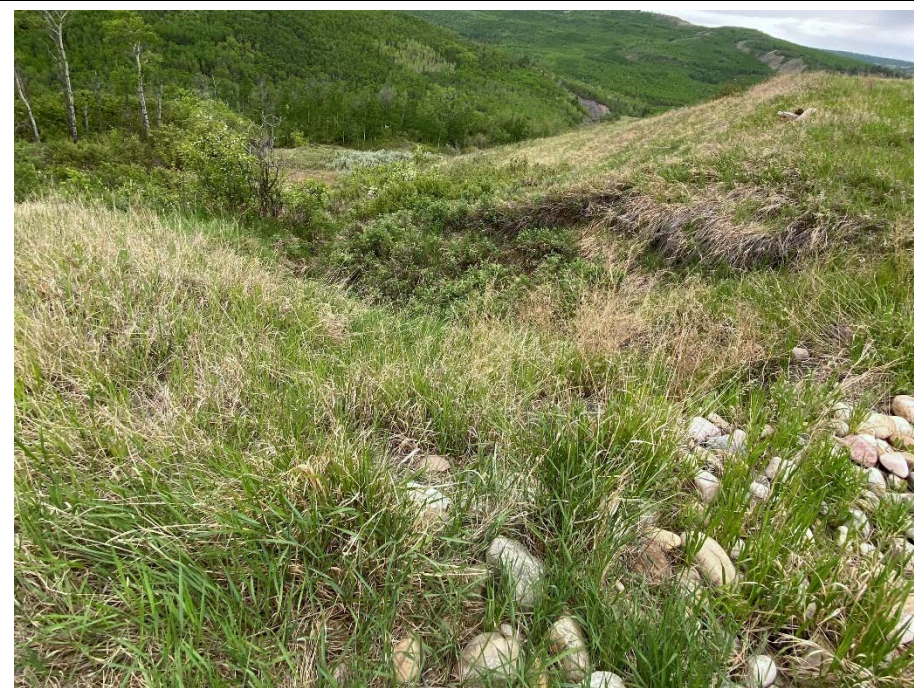
<input checked="" type="checkbox"/> Erosion	<p>Erosion gully at the end of the armored drainage outlet area at the west end of the pile wall was slightly worse but gully sidewalls were well vegetated. (Photo 70-06)</p> <p>Minor erosion in the north ditch between 34+000 and 34+100 was not significantly worse relative to the 2023 condition.</p>	<input checked="" type="checkbox"/>	<input type="checkbox"/>
<input type="checkbox"/> Seepage		<input type="checkbox"/>	<input type="checkbox"/>
<input type="checkbox"/> Bridge/Culvert		<input type="checkbox"/>	<input type="checkbox"/>
<input checked="" type="checkbox"/> Other	Drain trough along top of wall was open with minor sediment and debris buildup. Drainage outlet	<input type="checkbox"/>	<input checked="" type="checkbox"/>

**Photo 70-06.**  
Looking south at the top of the erosion gully at the downstream end of the armoured drainage outlet (34+015). Slightly worse but gully sidewalls have grass growth.

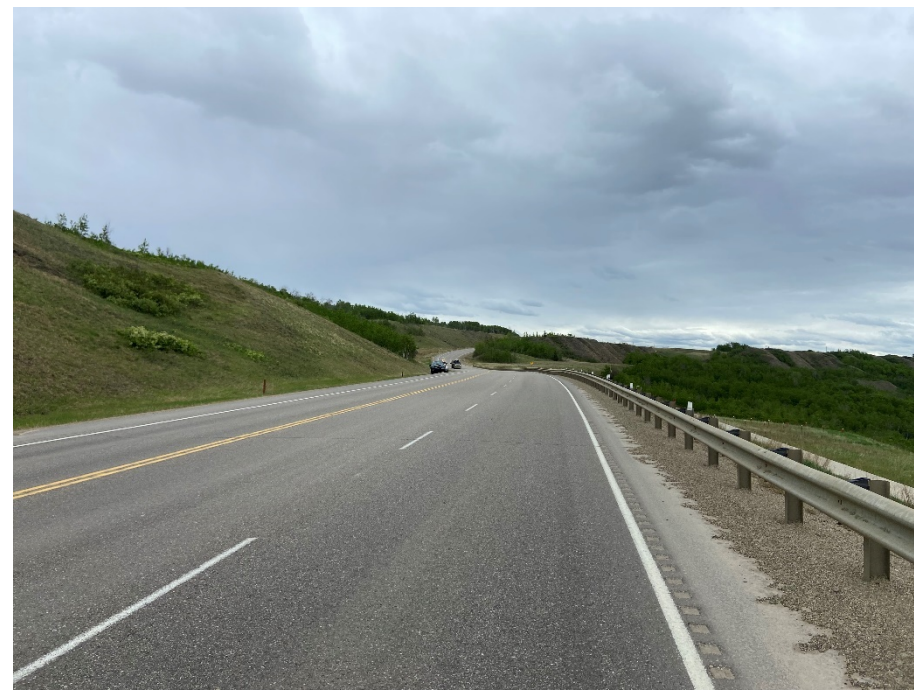
Unstable ravine width at 33+875: 65 m Previous cantilevered wall length: 40 m New anchored tangent pile retaining wall length: 175 m		
<b>Date of any remediation:</b>	2016 - 2017 – retaining walls installed between 33+850 and 34+000		
<b>Maintenance:</b>	2022 – Highway was repaved and there were numerous ditch and culvert repairs along entire East Hill section (no ditch or culvert repairs within PH070 site extents).		
<b>Observations:</b>	<b>Description:</b>	<b>Worsened?</b>	
		<b>Yes</b>	<b>No</b>
<input checked="" type="checkbox"/> Pavement	Minor dip in guardrail and NBL along previously observed extents behind wall in eastbound lane near 33+900 was unchanged from the 2023 condition. Dip at guardrail is suspected to be the installed condition and not due to slide related settlement. Overall pavement section upslope from the wall was in good condition with no distress noted along previous damage extents since being repaved in Fall 2022. (Photos 70-07 and 70-08)	<input type="checkbox"/>	<input checked="" type="checkbox"/>

**Photo 70-07.**  
View along highway looking east above pile wall. No pavement disturbance was visible since the Fall 2022 repaving.

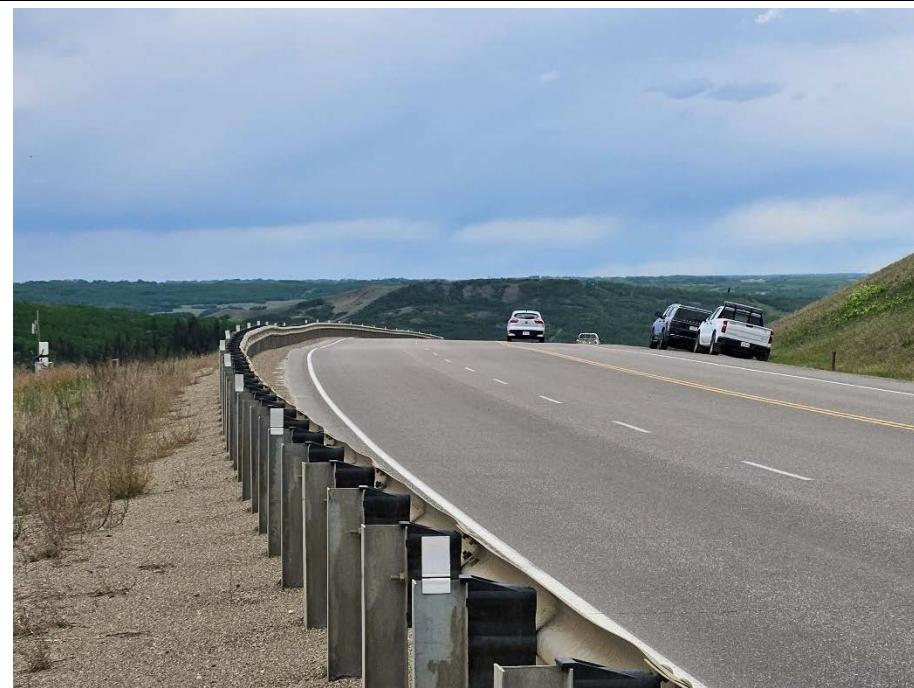
**Photo 70-08.**  
Looking west along highway above pile wall. Visible dip in guardrail (near 33+900) suspected from install and likely not related to slide related settlement that occurred prior to the pile wall. No cracking or other slide related distress was visible in pavement along previous damage extents since the highway was repaved in 2022.

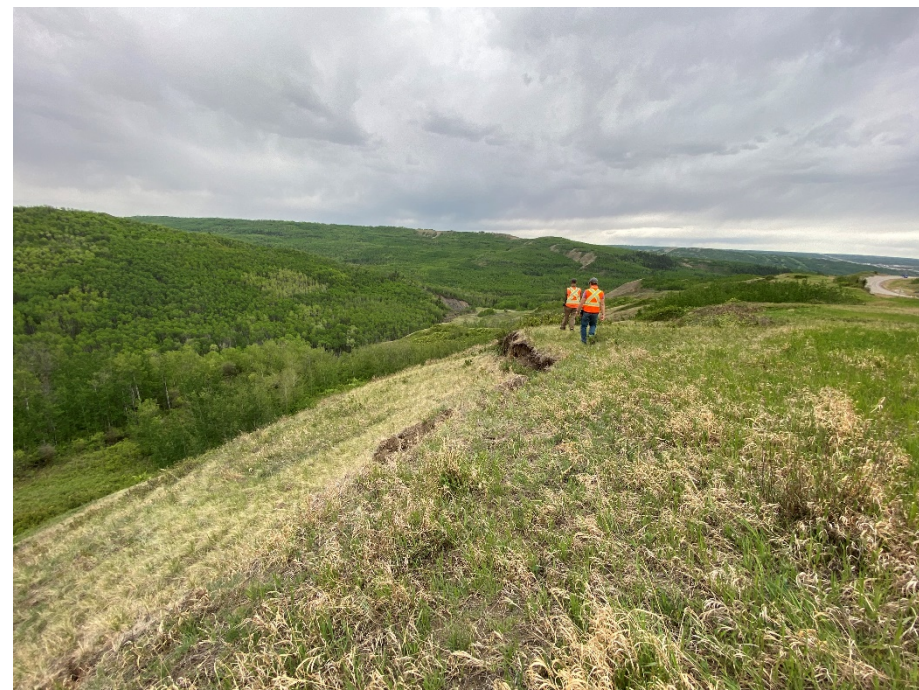
<input checked="" type="checkbox"/> Slope Movement	<p>The fill slope below the wall and area of previously observed movement has been regraded as part of the pile wall installation work. At the east end of the wall a previously identified scarp/tension crack developing along the extents o the east flank of the previous slide was unchanged from the 2023 condition. (Photos 70-01 and 70-03)</p> <p>No other visual indicators of slide disturbance were observed downslope of the pile wall. Piles at the west side of the wall were marked with pink paint along the base to monitor future soil drop. (Photos 70-01 to 70-04)</p> <p>Active slide area developing west and downslope of the pile wall at 34+050 has expanded with significant more downdrop at the scarp (up to 1.5 m) and extended tension cracks. New tension cracks were forming 0.3 to 1.0 m upslope from the main scarp. Width of the main slide scarp is now approximately 115 m and has a minimum offset approximately 15 m from the highway at the east end (unchanged from 2023). (Photos 70-09 and 70-10)</p>	<input checked="" type="checkbox"/>	<input type="checkbox"/>

**Photo 70-09.**  
Looking west from the east end of the active landslide scarp developing west of the pile wall (34+050). There was a more visible scarp with increased dropdown (up to 1.5 m deep) and the tension cracks have extended and opened up further relative to the 2023 condition.

- An investigation program should be considered for the slide at 34+050 if movement rates continue at the observed rates over the last several years. This would likely involve accessing the relatively flat bench between the current scarp and guardrail with tracked drill equipment from the highway approximately 250 m west (end of guardrail section) and drilling two to three test holes with slope inclinometers. This would allow monitoring for a potential slide surface undermining the highway and provide design input for future remediation if required. (\$100k - \$150k)

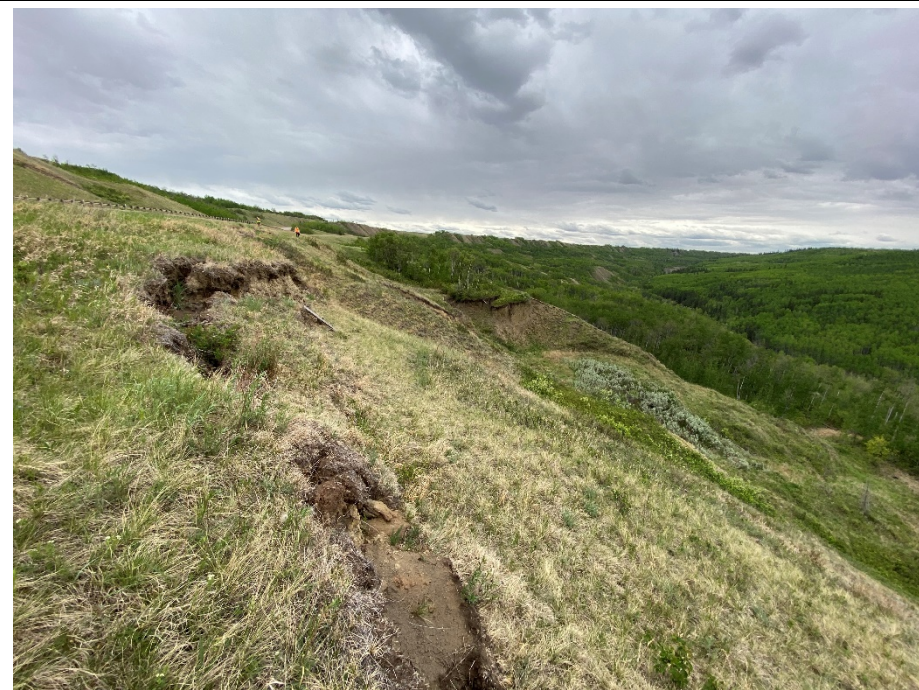
**Photo 70-10.**  
Looking east at main scarp expansion west of the pile wall near 34+100 with increased movement since 2023. Dropdown of the scarp in this area was up to 0.8 m in height. Increase dropdown and lateral expansion along previously observed tension cracks. No major retrogression towards the highway was observed. Lower slide terrain has ongoing movement but no major visible changes.
