Site Number	Location	Name	Hwy	km
PH070	HWY 2:60 C1 33.840	East Hill Retaining Wall Site	2:60	Km 33.84
<b>Legal Description:</b> 4-27-83-21 W5		<b>UTM Co-ordinates</b>		
		11U E 485285	N	6230649

<b>Current Monitoring:</b>	19-May-2024	<b>Previous Monitoring</b>	12-Jun-2023
<b>Instruments Read By:</b>	Mr. Niraj Regmi, G.I.T and Mr. Nixon Mationg, of Thurber

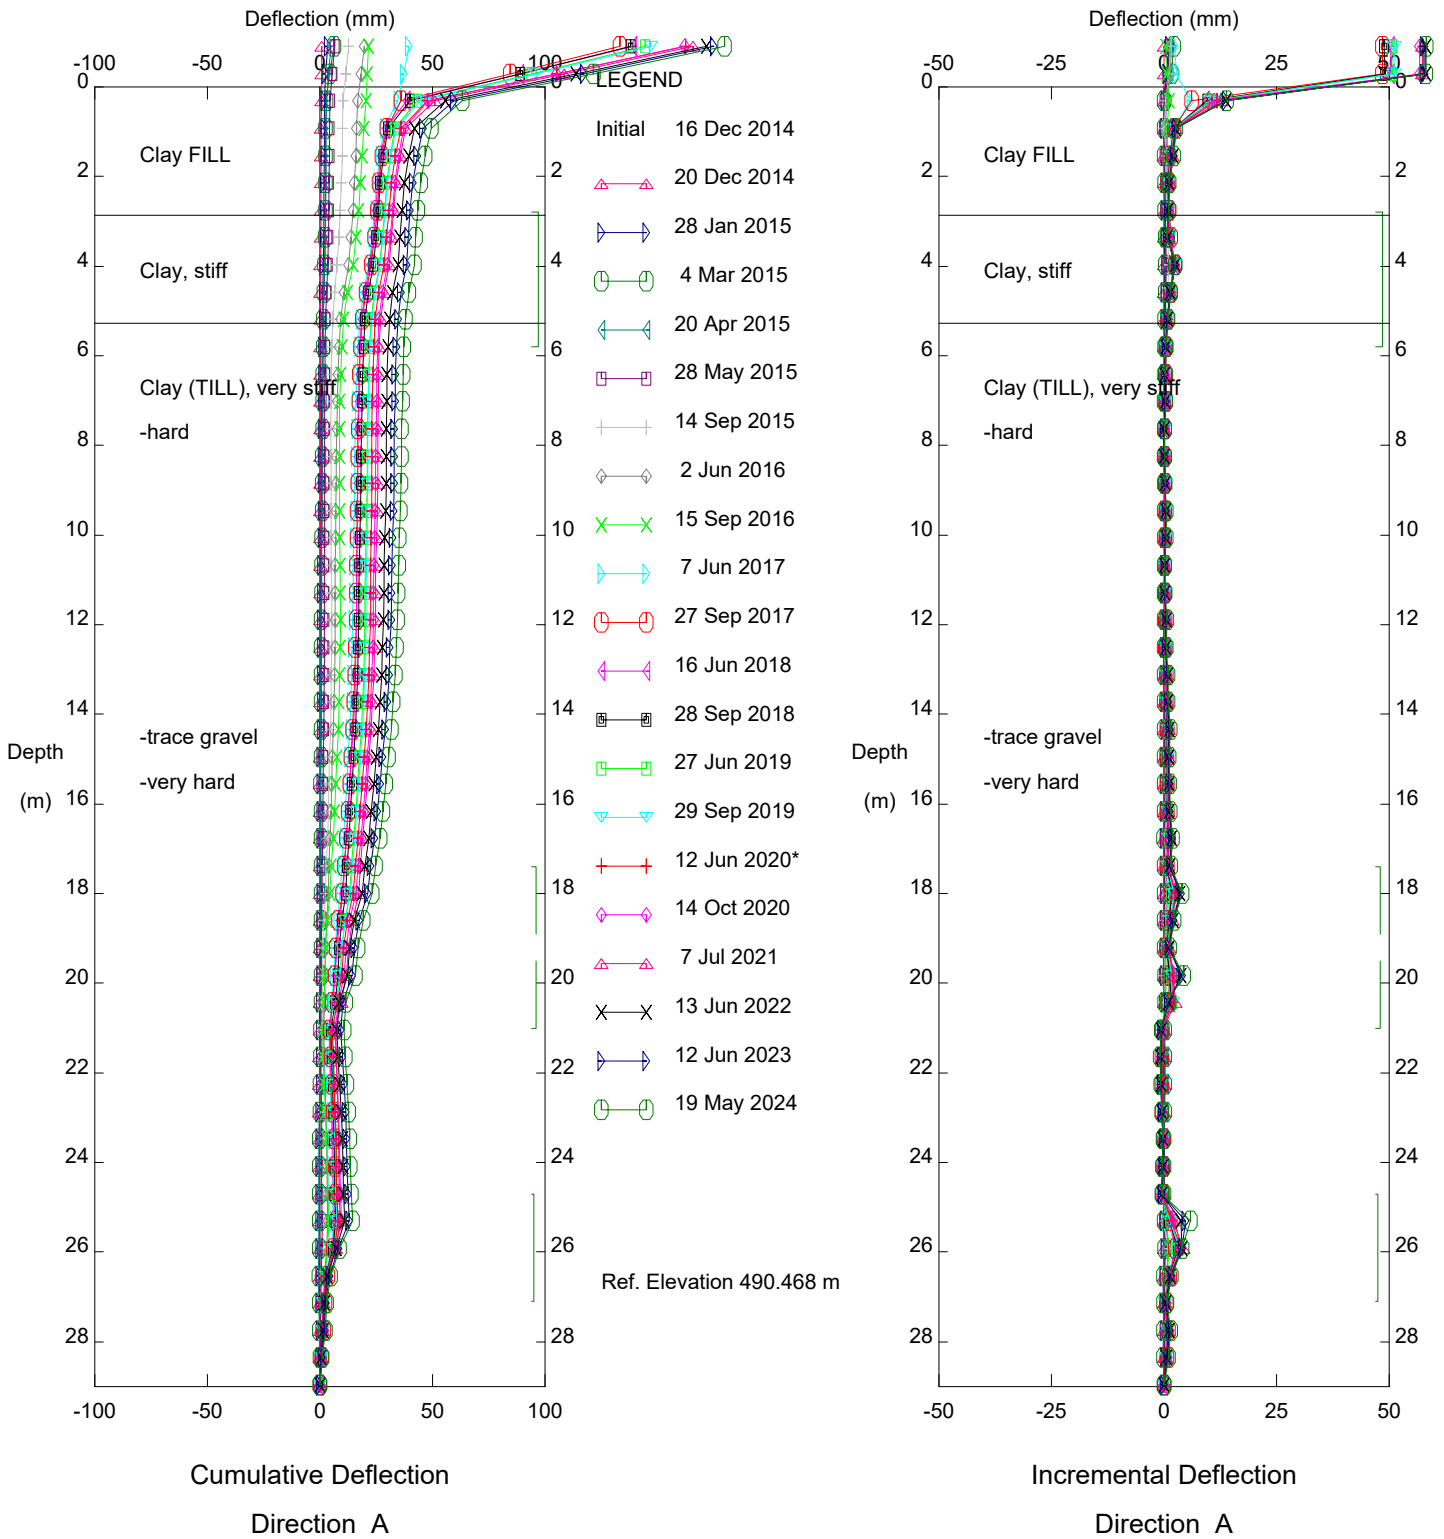
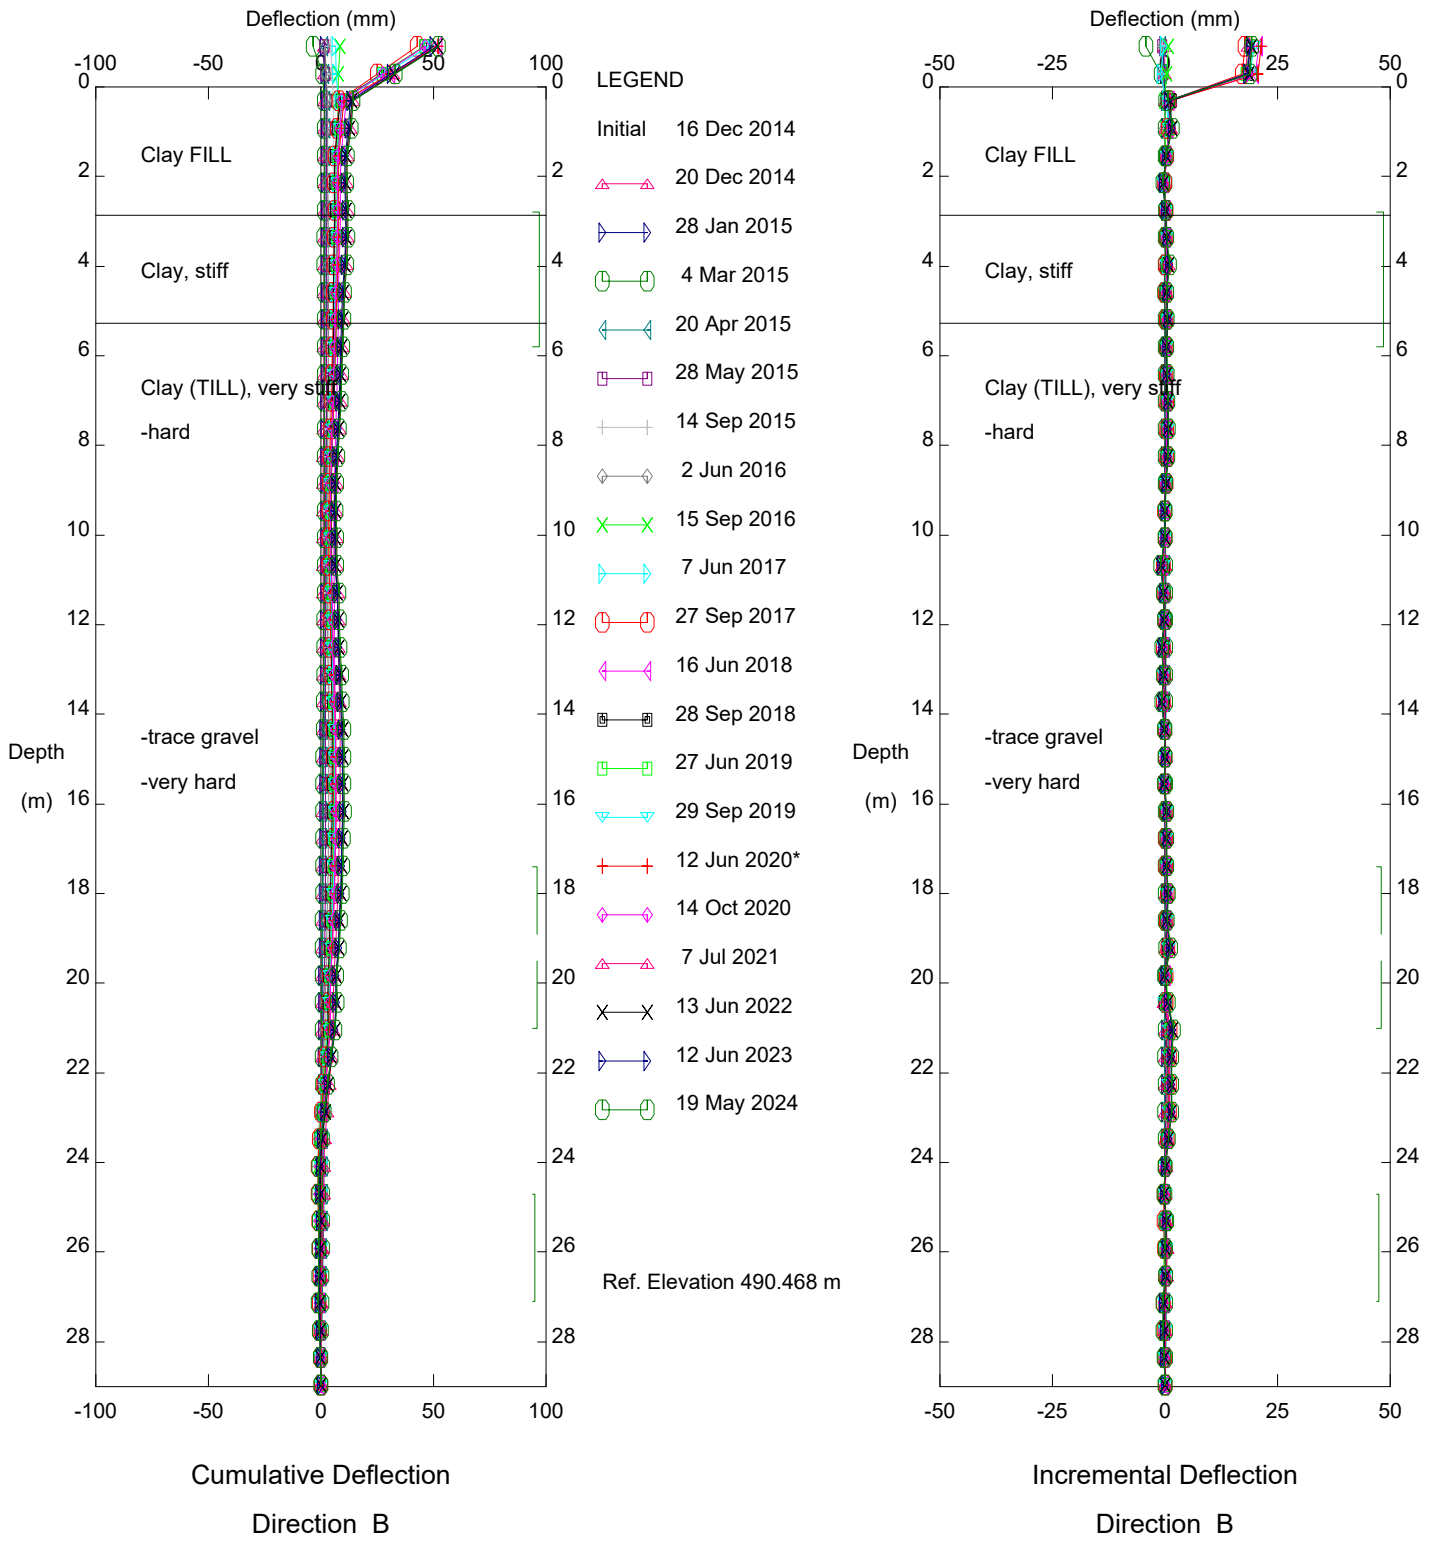
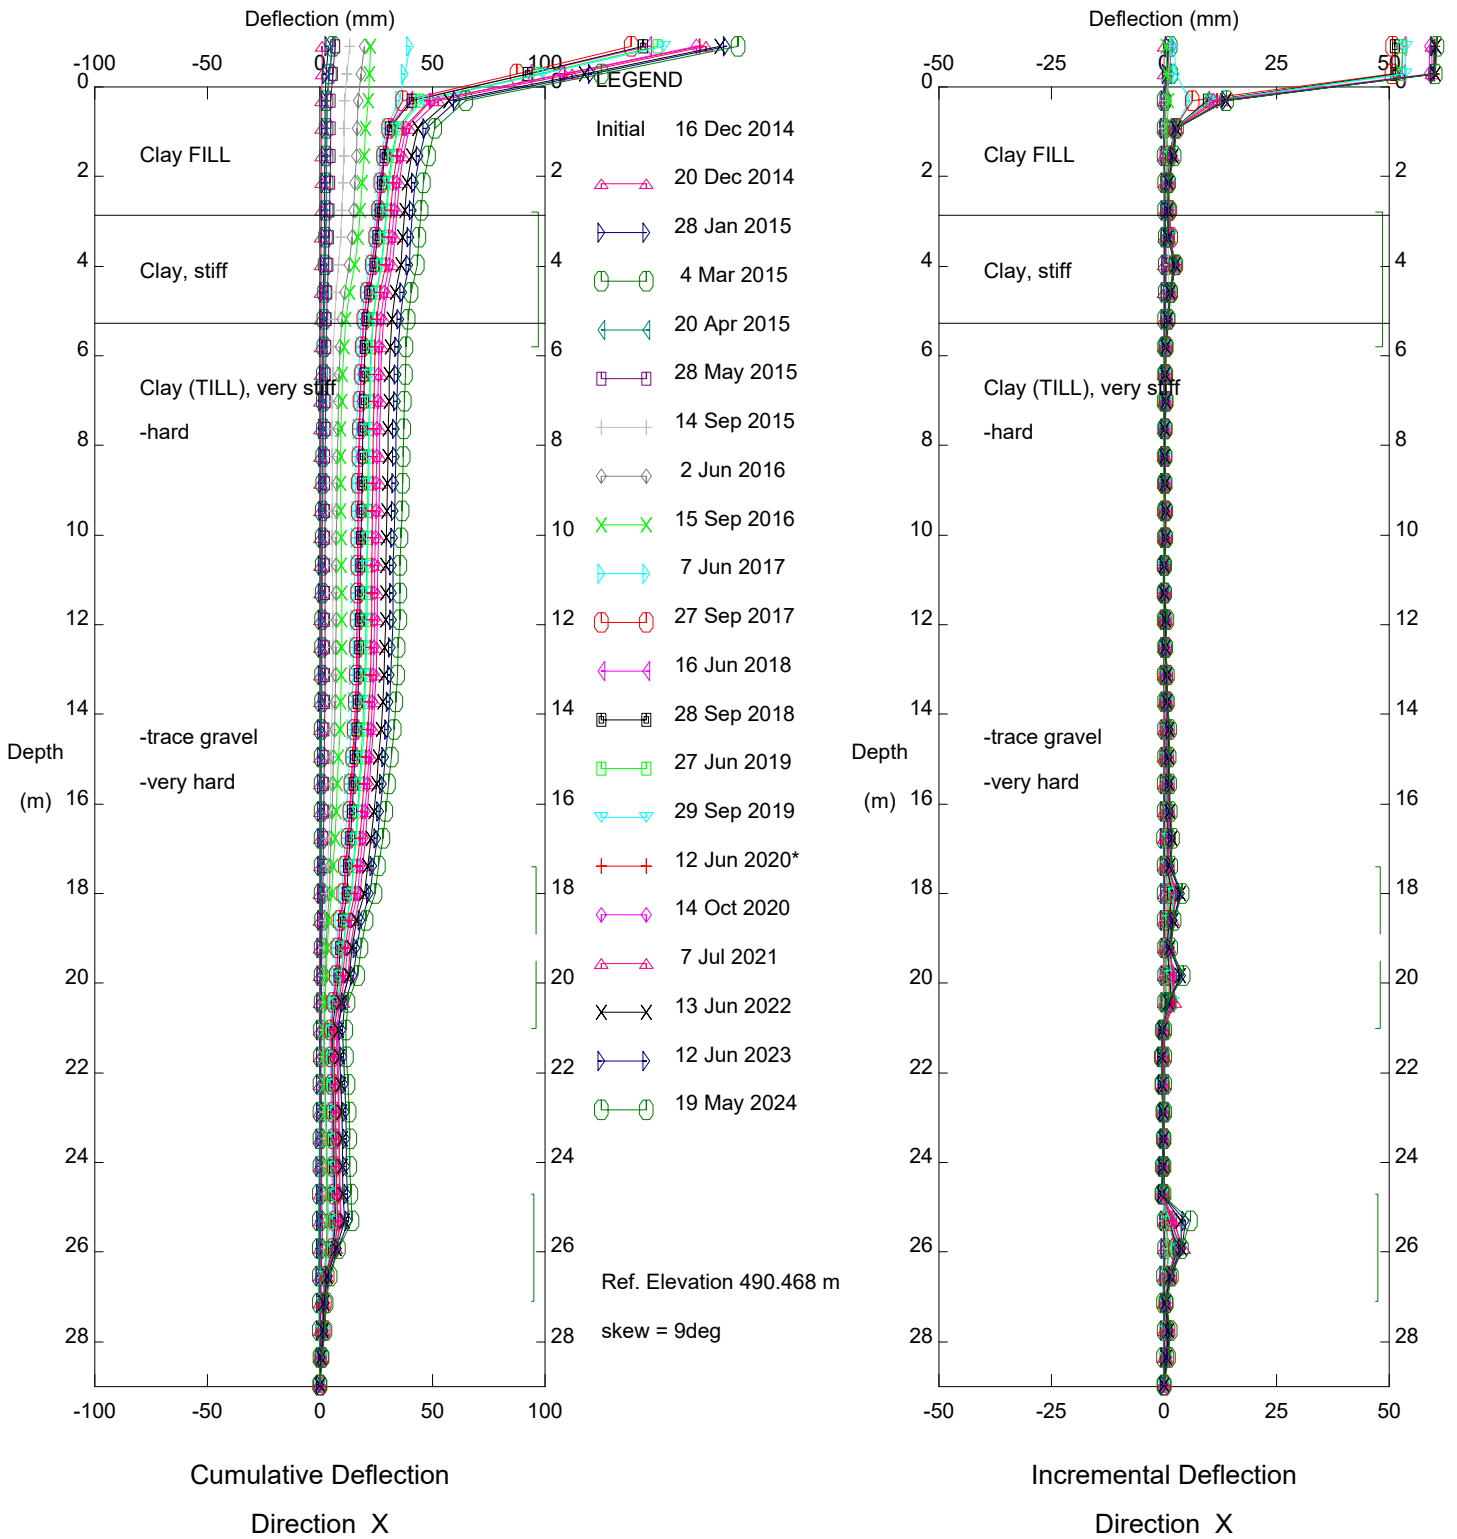
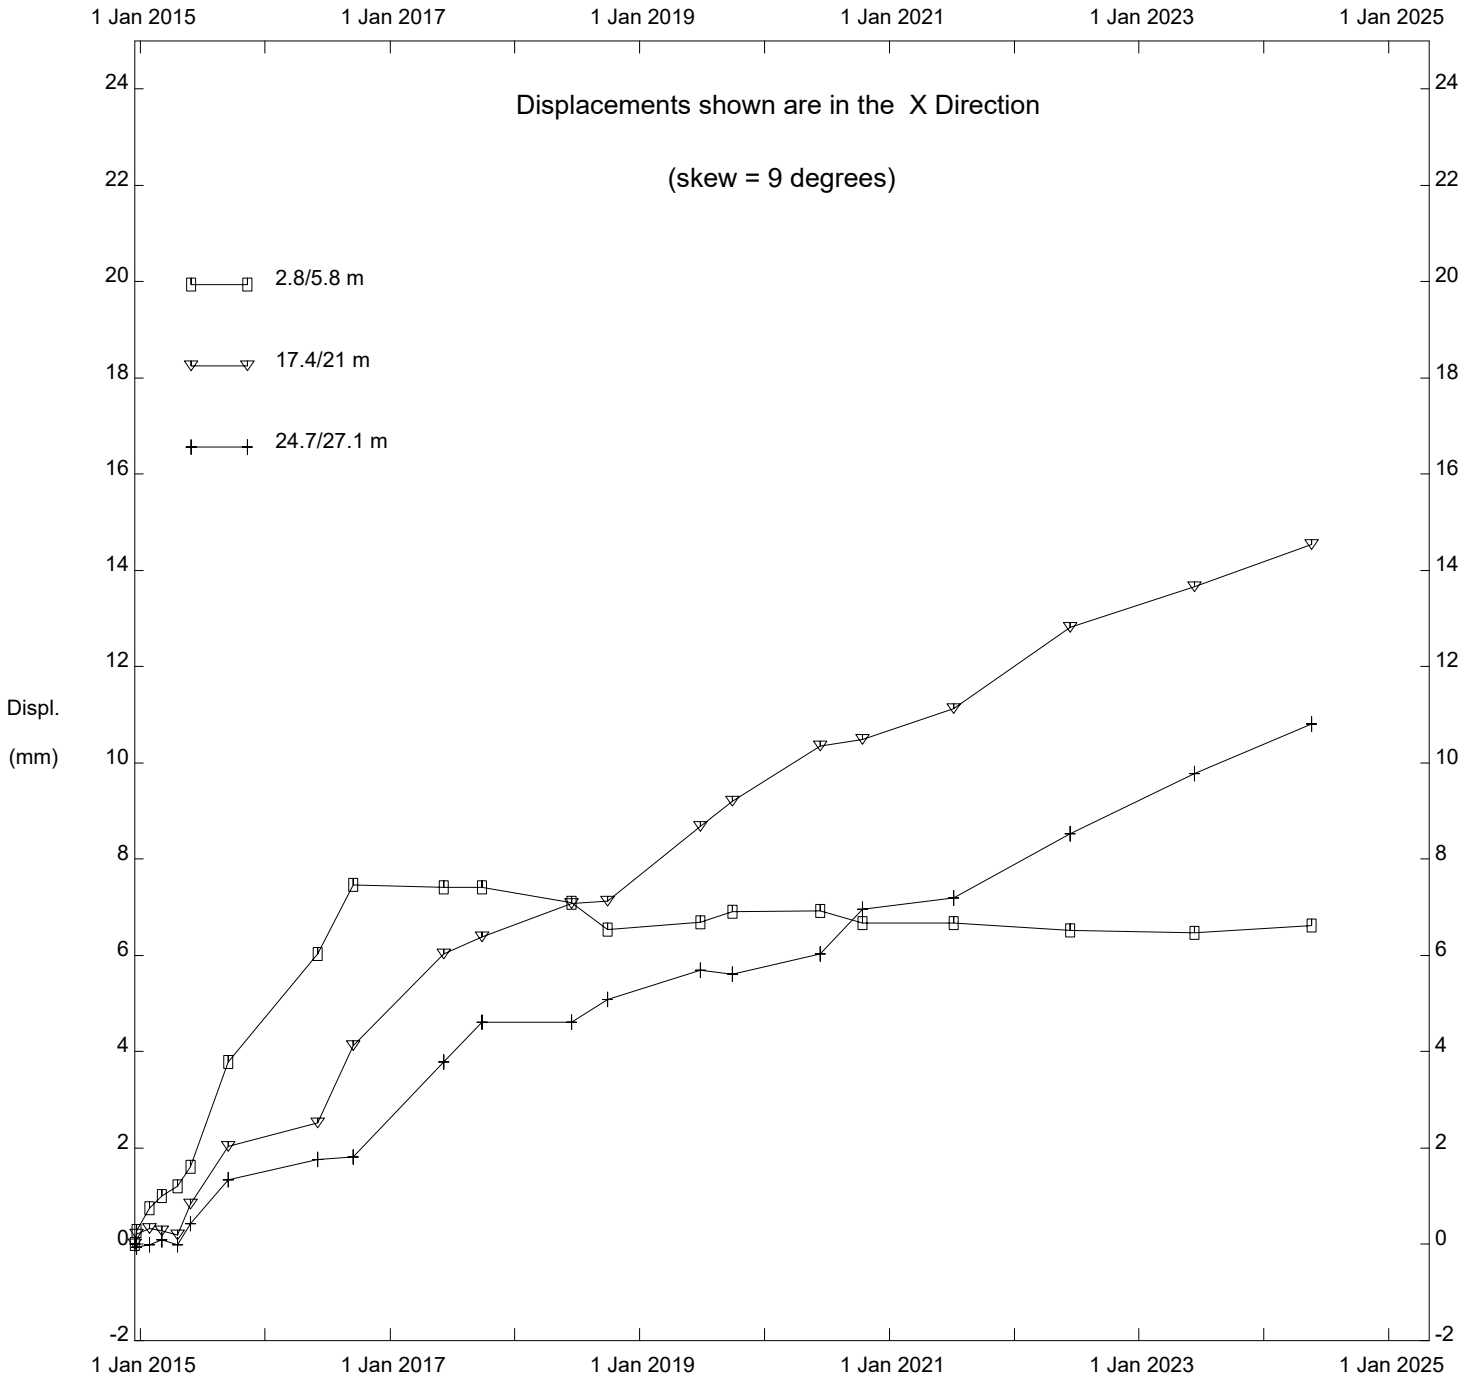
Peace River East Hill PH070, Inclinometer SI14-2

Discussion	
<b>Zones of New Movement:</b>	None
<b>Interpretation of Monitoring Results:</b>	<p>Slope inclinometer SI14-2, located upslope of the new pile wall, showed a rate of movement of 0.1 mm/yr over 2.8 m to 5.8 m depth, a rate of movement of 0.9 mm/yr over 17.4 m to 21.0 m depth and a rate of movement of 1.1 mm/yr over 24.7 m to 27.1 m depth since the spring of 2023 readings. Slope inclinometer SI14-3, also located upslope of the new pile wall, showed no discernible movement since the spring of 2023 readings. SI14-3 has not shown any downslope movement overall since the construction of the pile wall.</p> <p>SI13-3, located downslope of the new pile wall, continued to show no discernible movement. Based on the instrument readings and observations on site, it is believed that SI13-3 is not installed deep enough to intercept the shear surface of the landslide.</p>

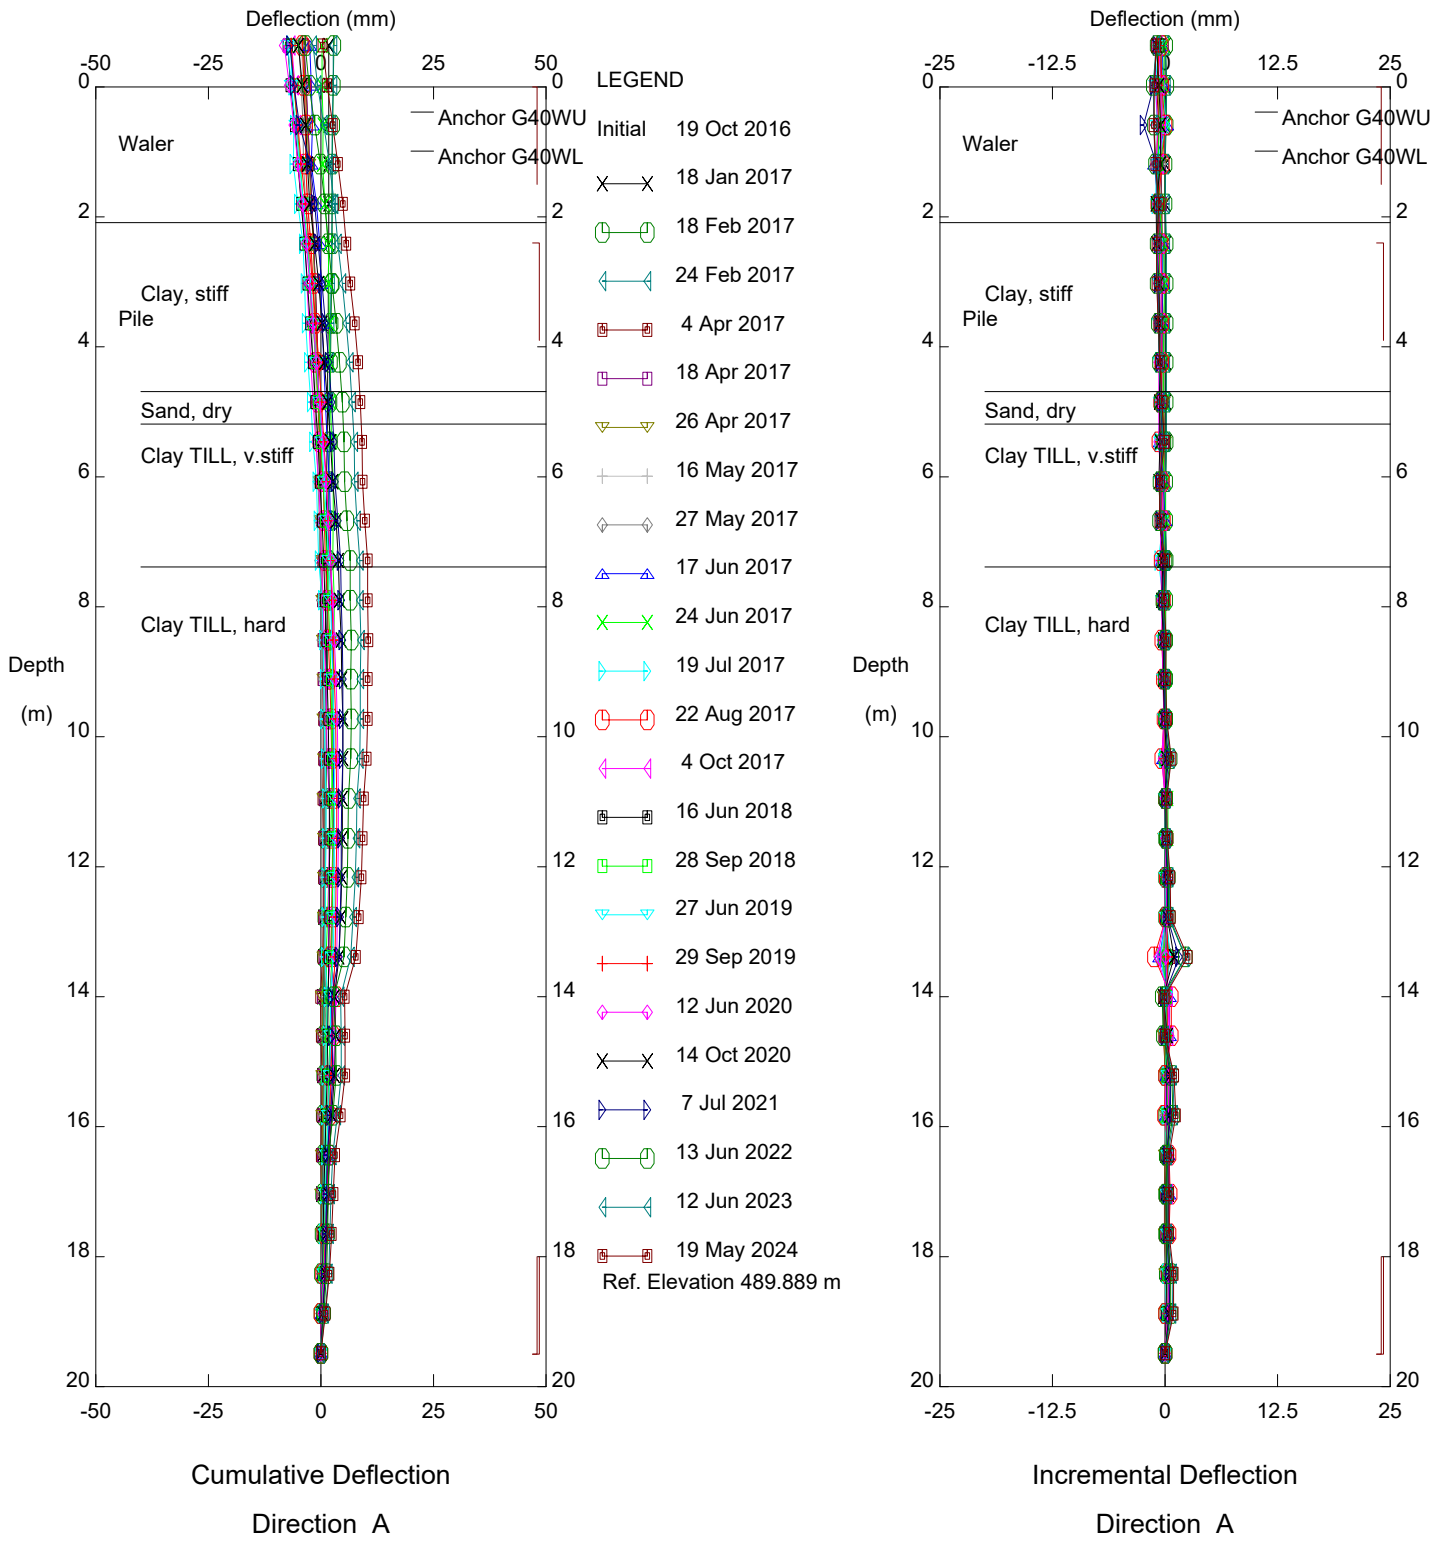
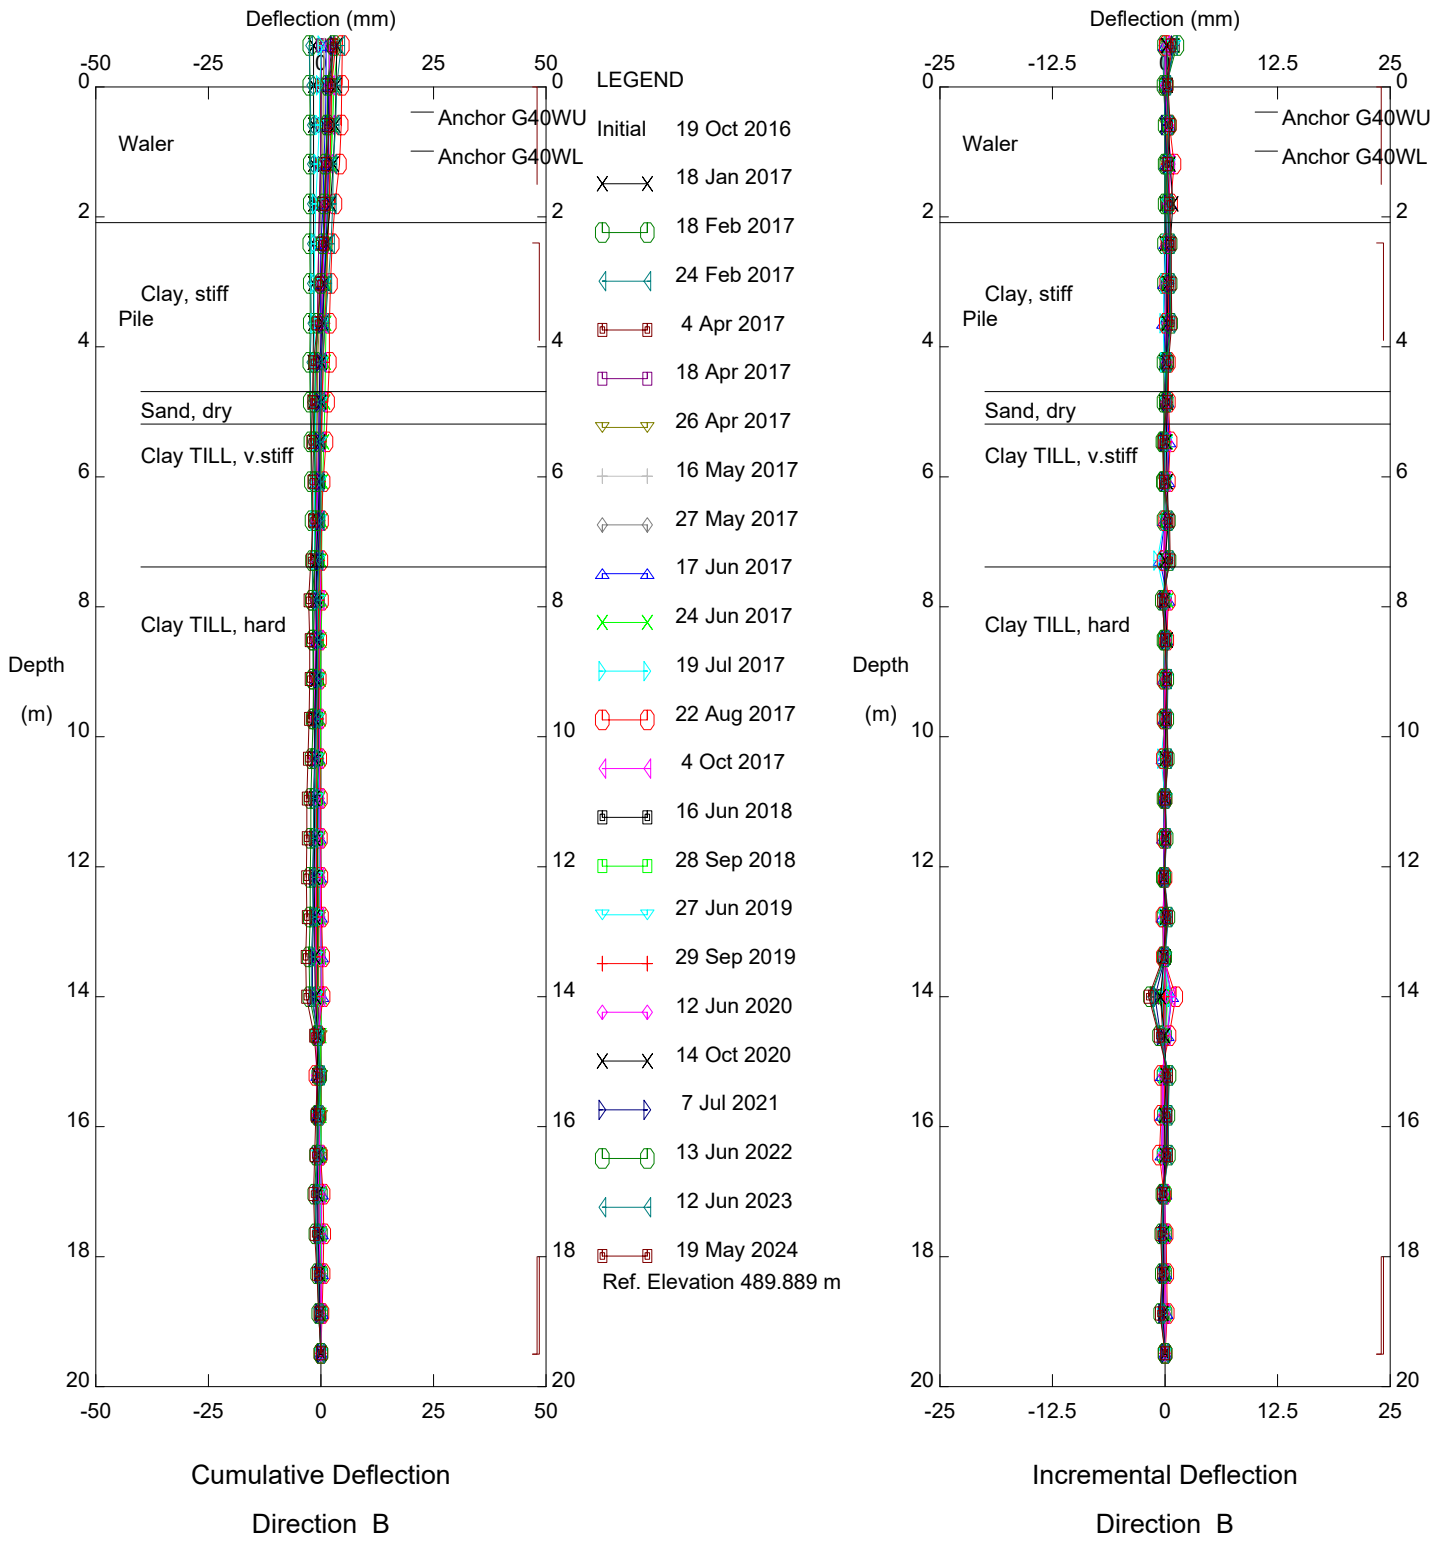
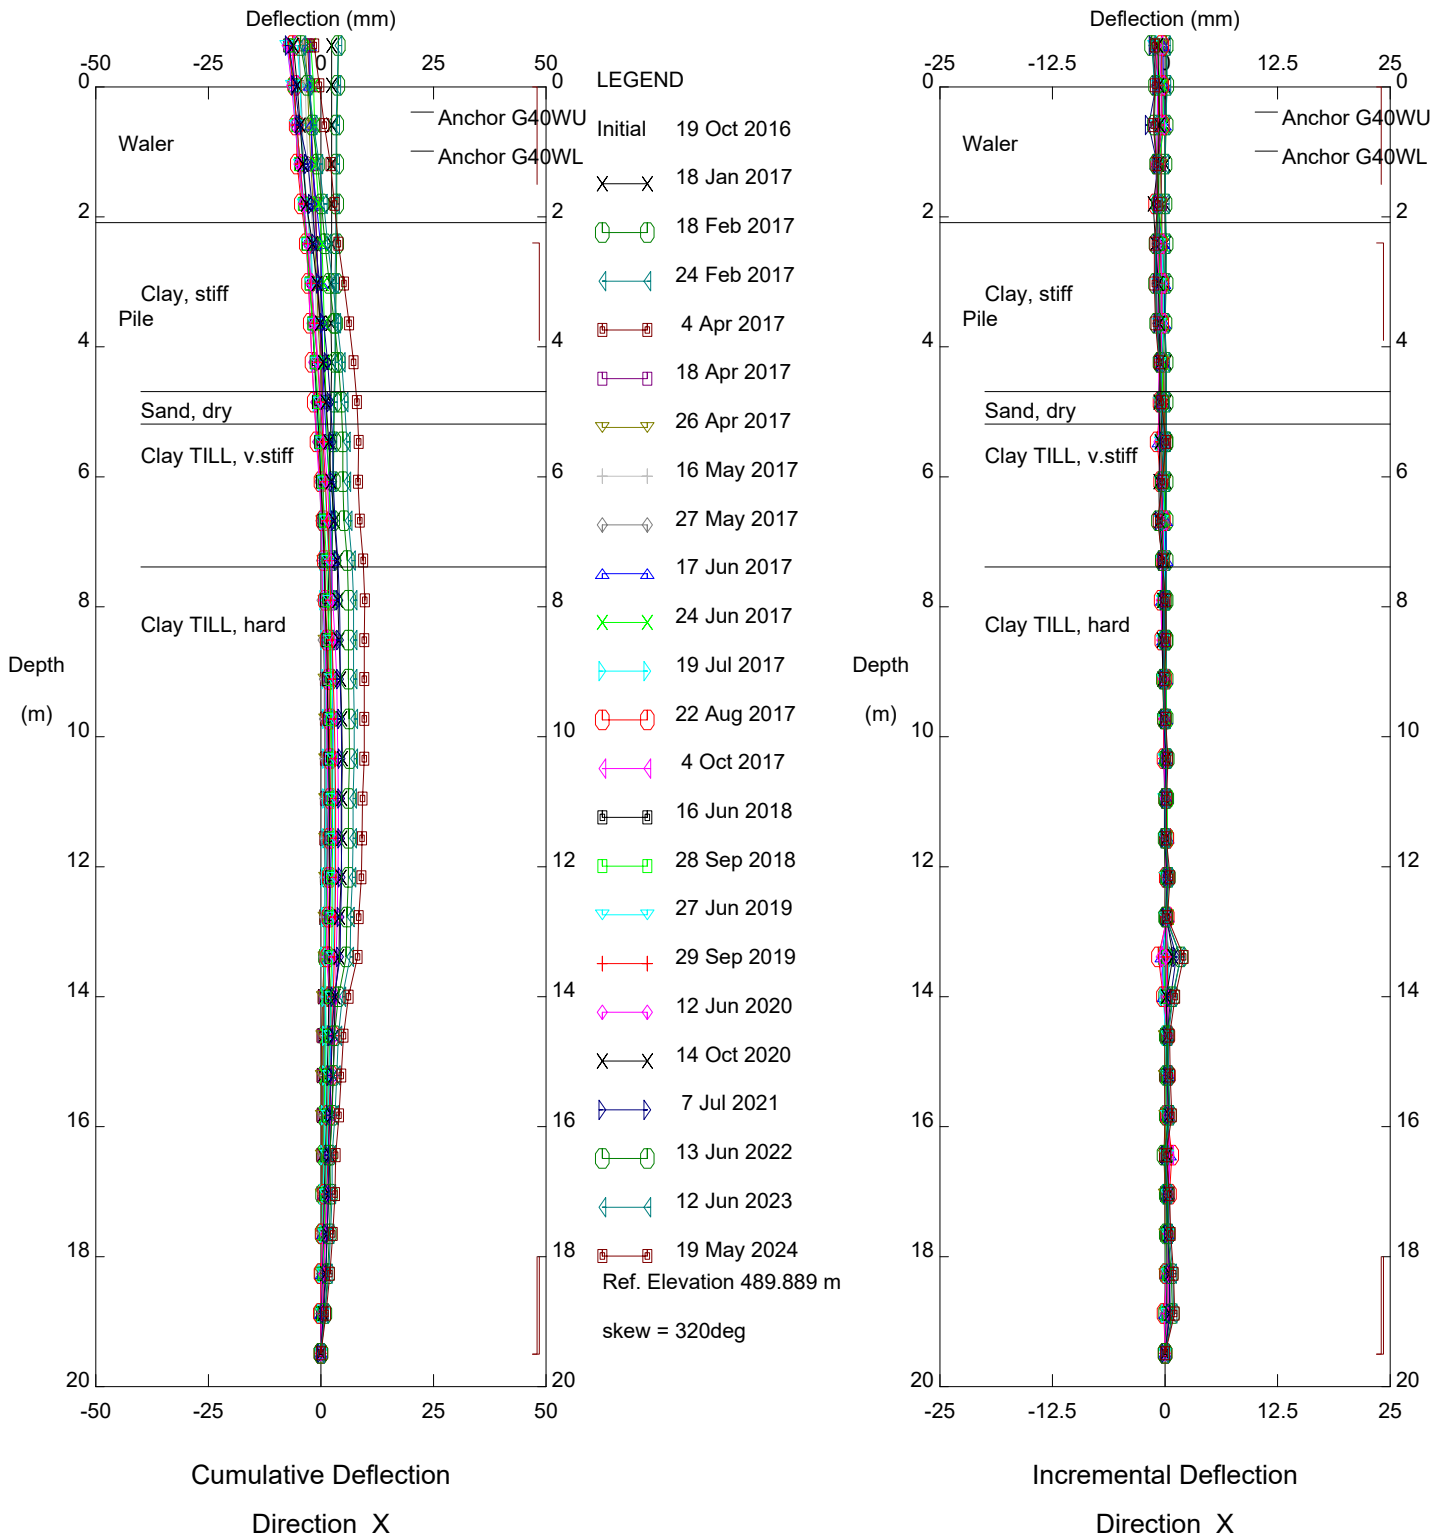
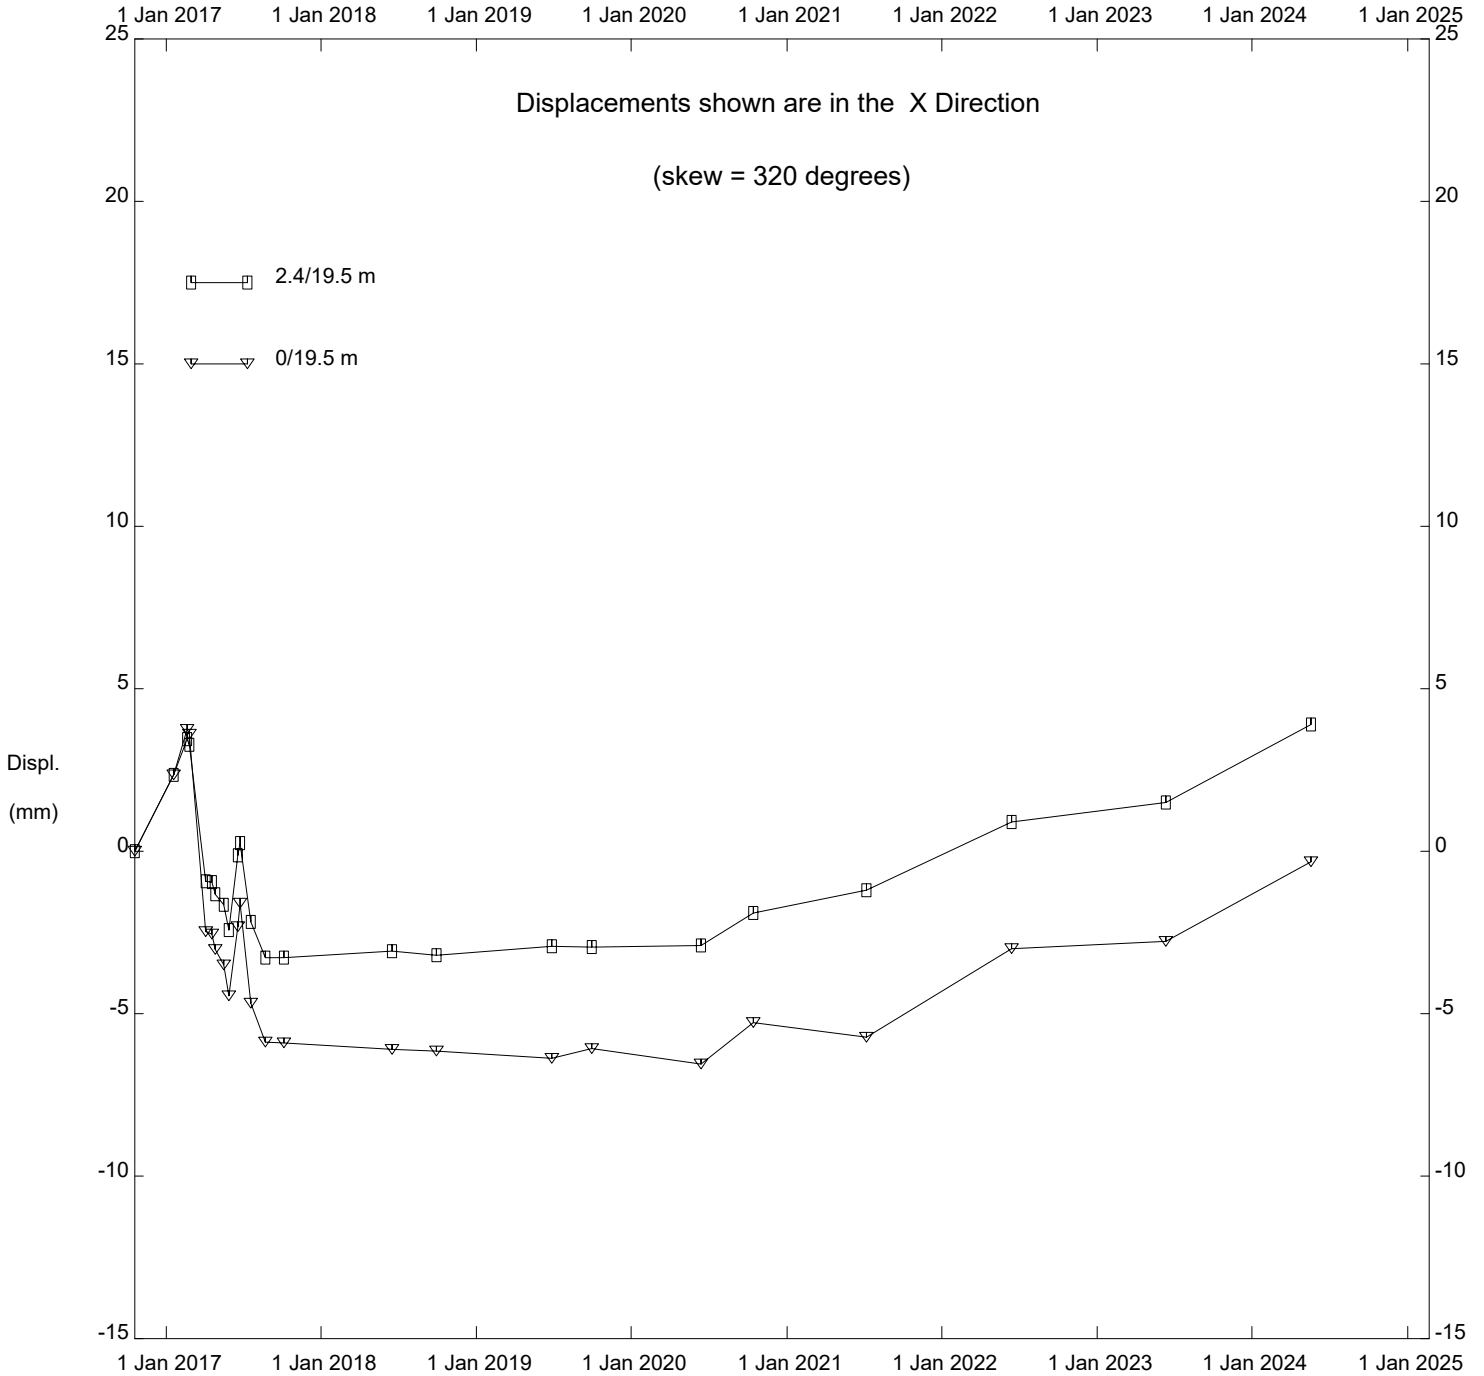
Peace River East Hill PH070, Inclinometer P40

SI-P40, installed in Pile 40, showed a rate of movement of 2.6 mm/yr in the downslope direction over both the length of the pile and over the combined length of the pile and water since the spring of 2023 readings. Pile 40 has shown a total cumulative pile head movement of 3.9 mm in the downslope direction and a total cumulative movement of 0.3 mm in the upslope direction over the combined length of the pile and water.
