Site Number	Location	Name	Hwy	km
PH070	HWY 2:60 C1 33.840	East Hill Retaining Wall Site	2:60	Km 33.84
<b>Legal Description:</b> 4-27-83-21 W5		<b>UTM Co-ordinates</b>		
		11U E 485285	N	6230649

<b>Current Monitoring:</b>	19-May-2024	<b>Previous Monitoring</b>	12-Jun-2023
<b>Instruments Read By:</b>	Mr. Niraj Regmi, G.I.T and Mr. Nixon Mationg, of Thurber

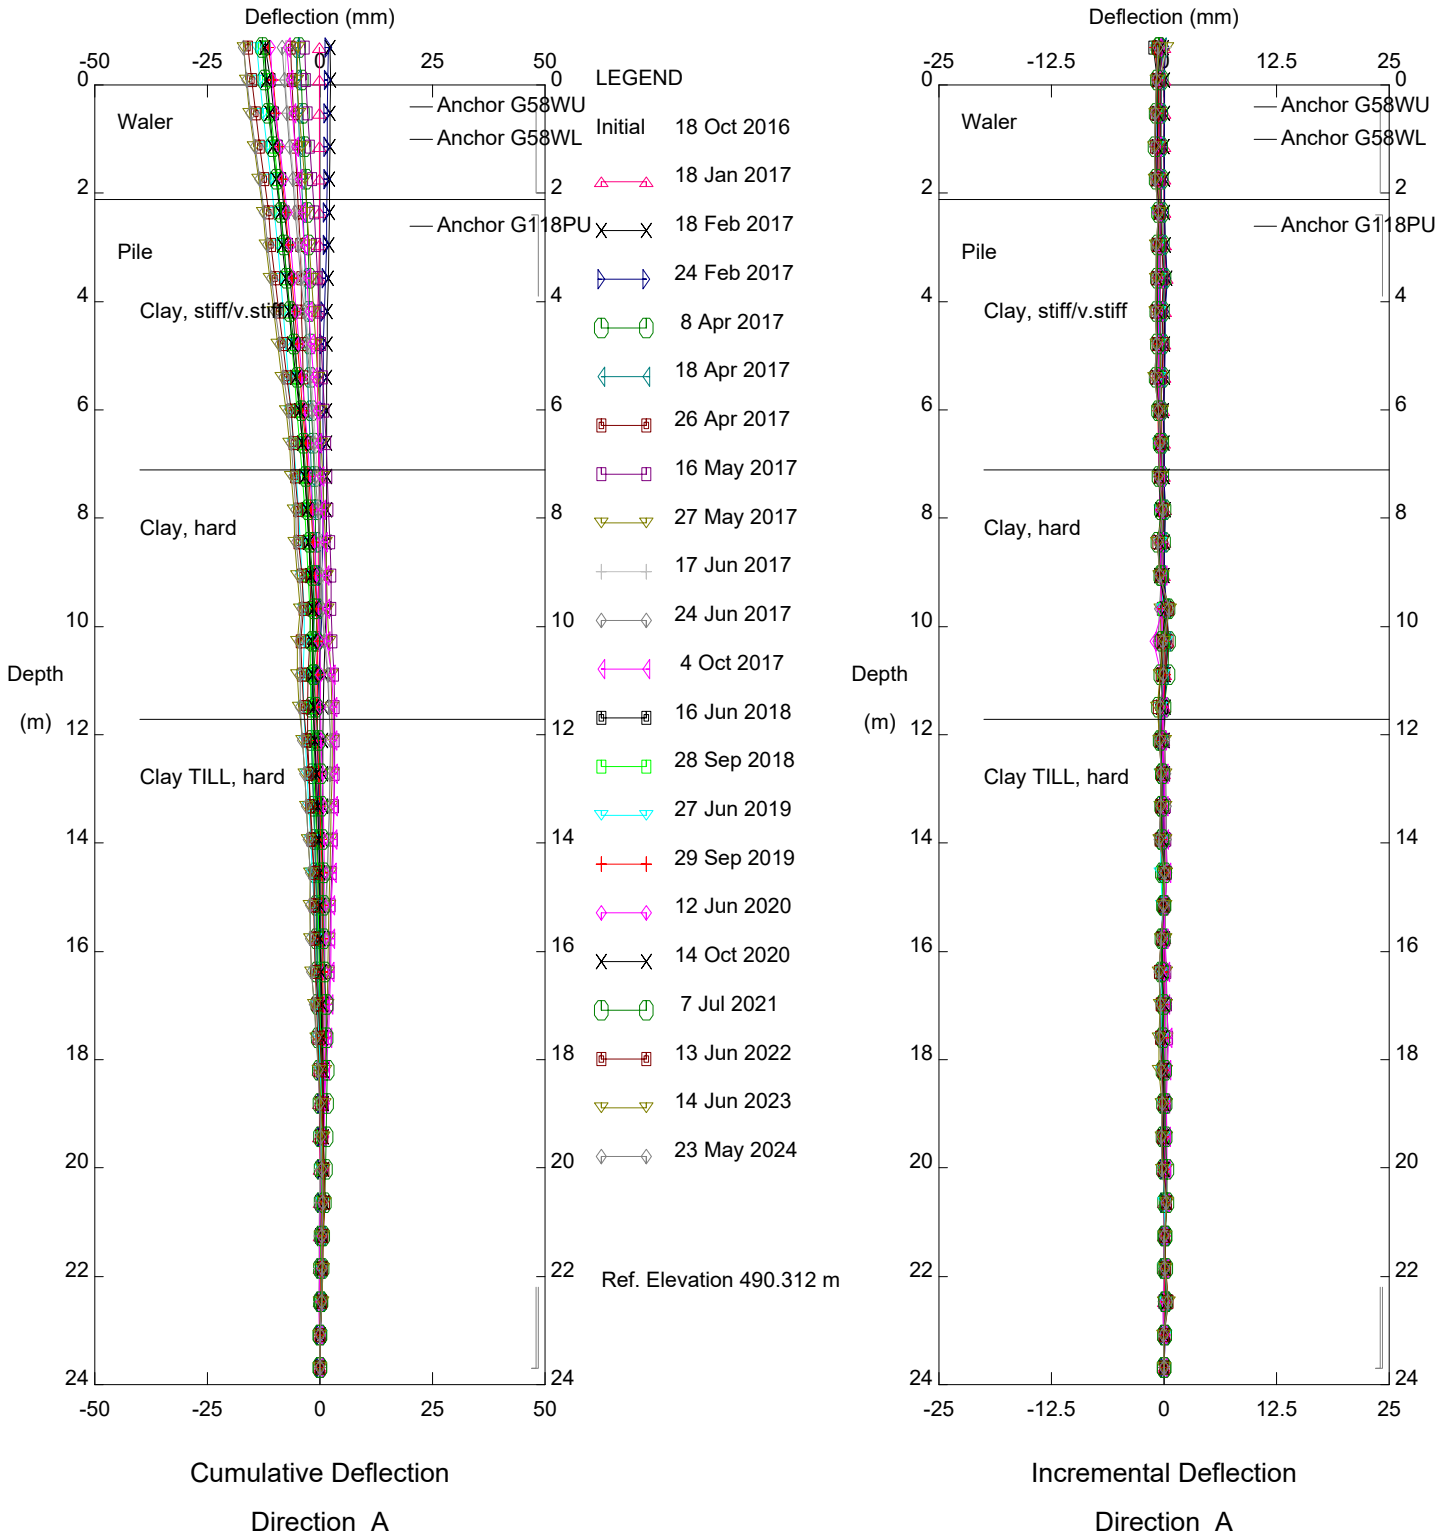
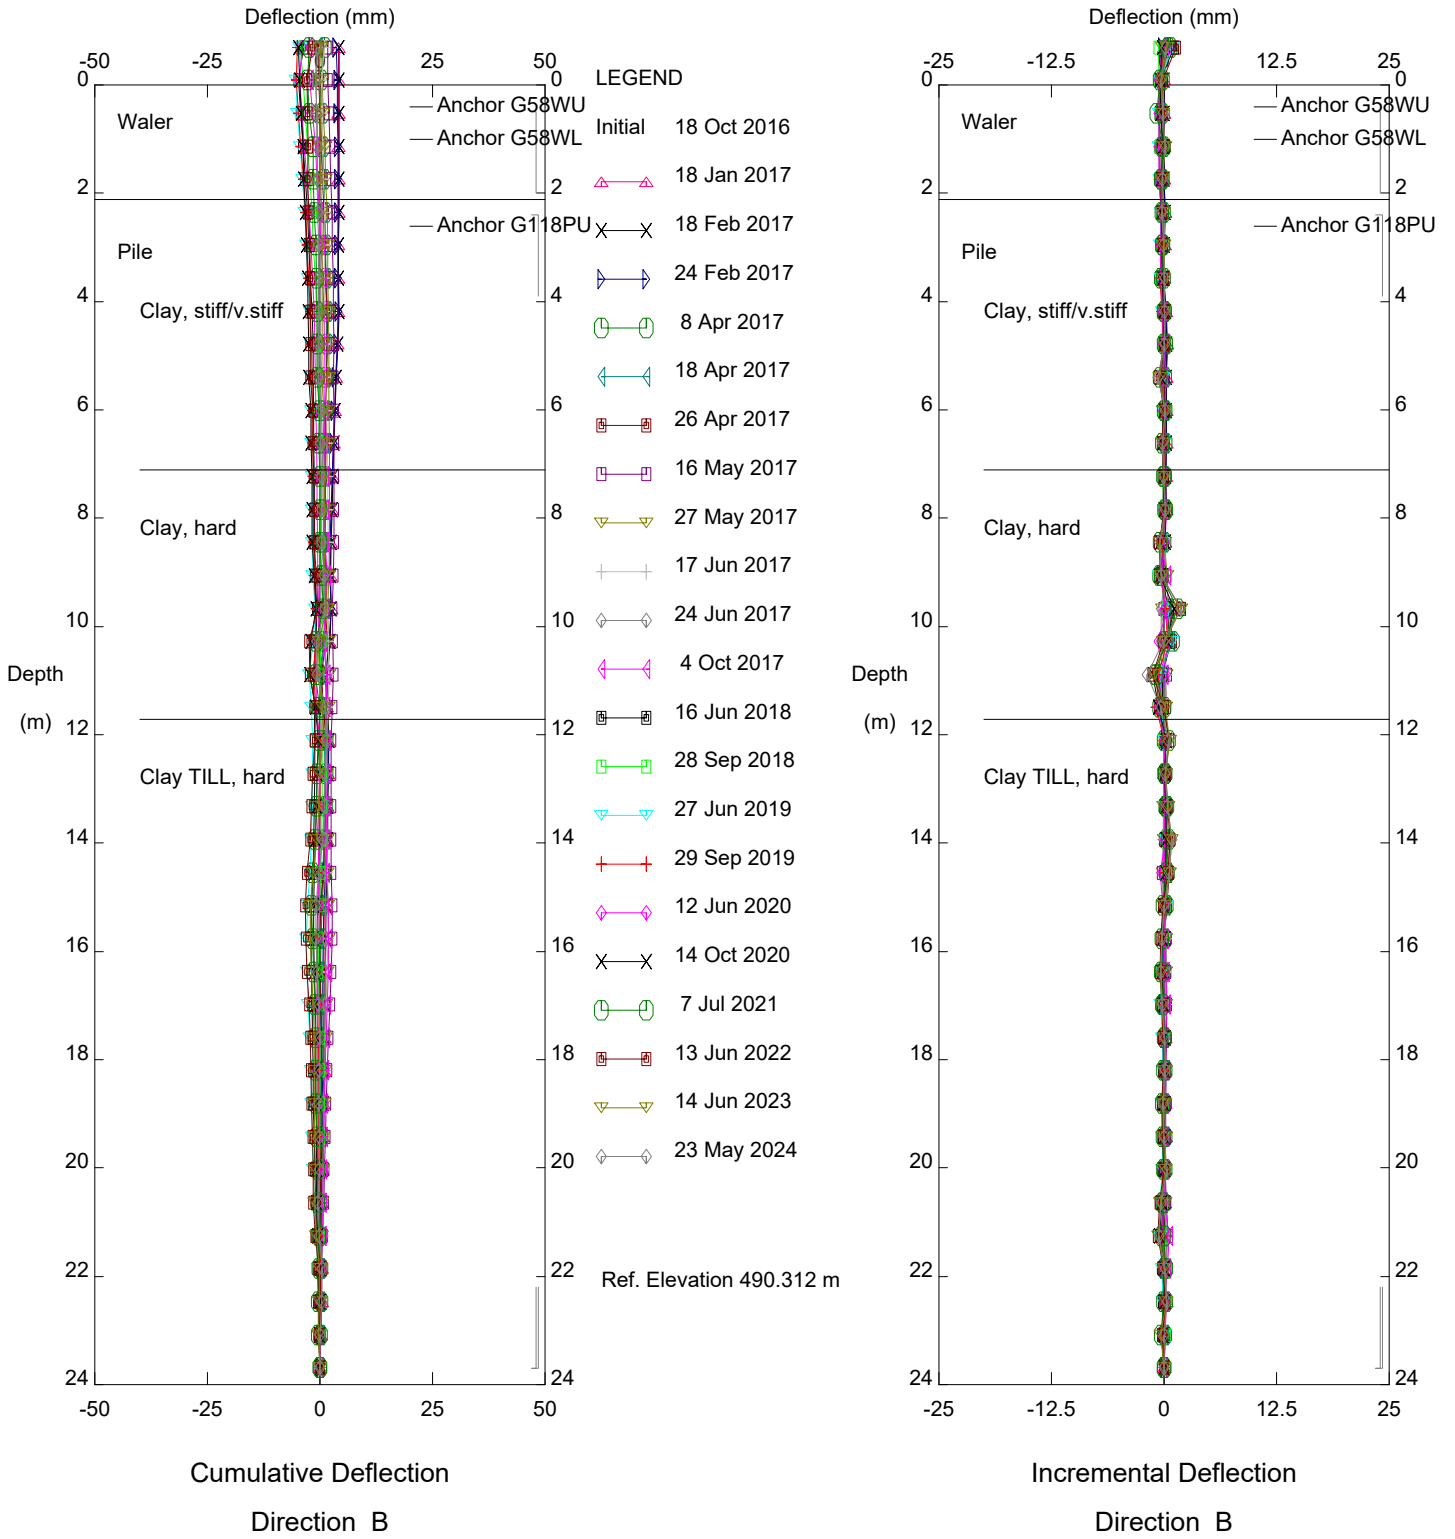
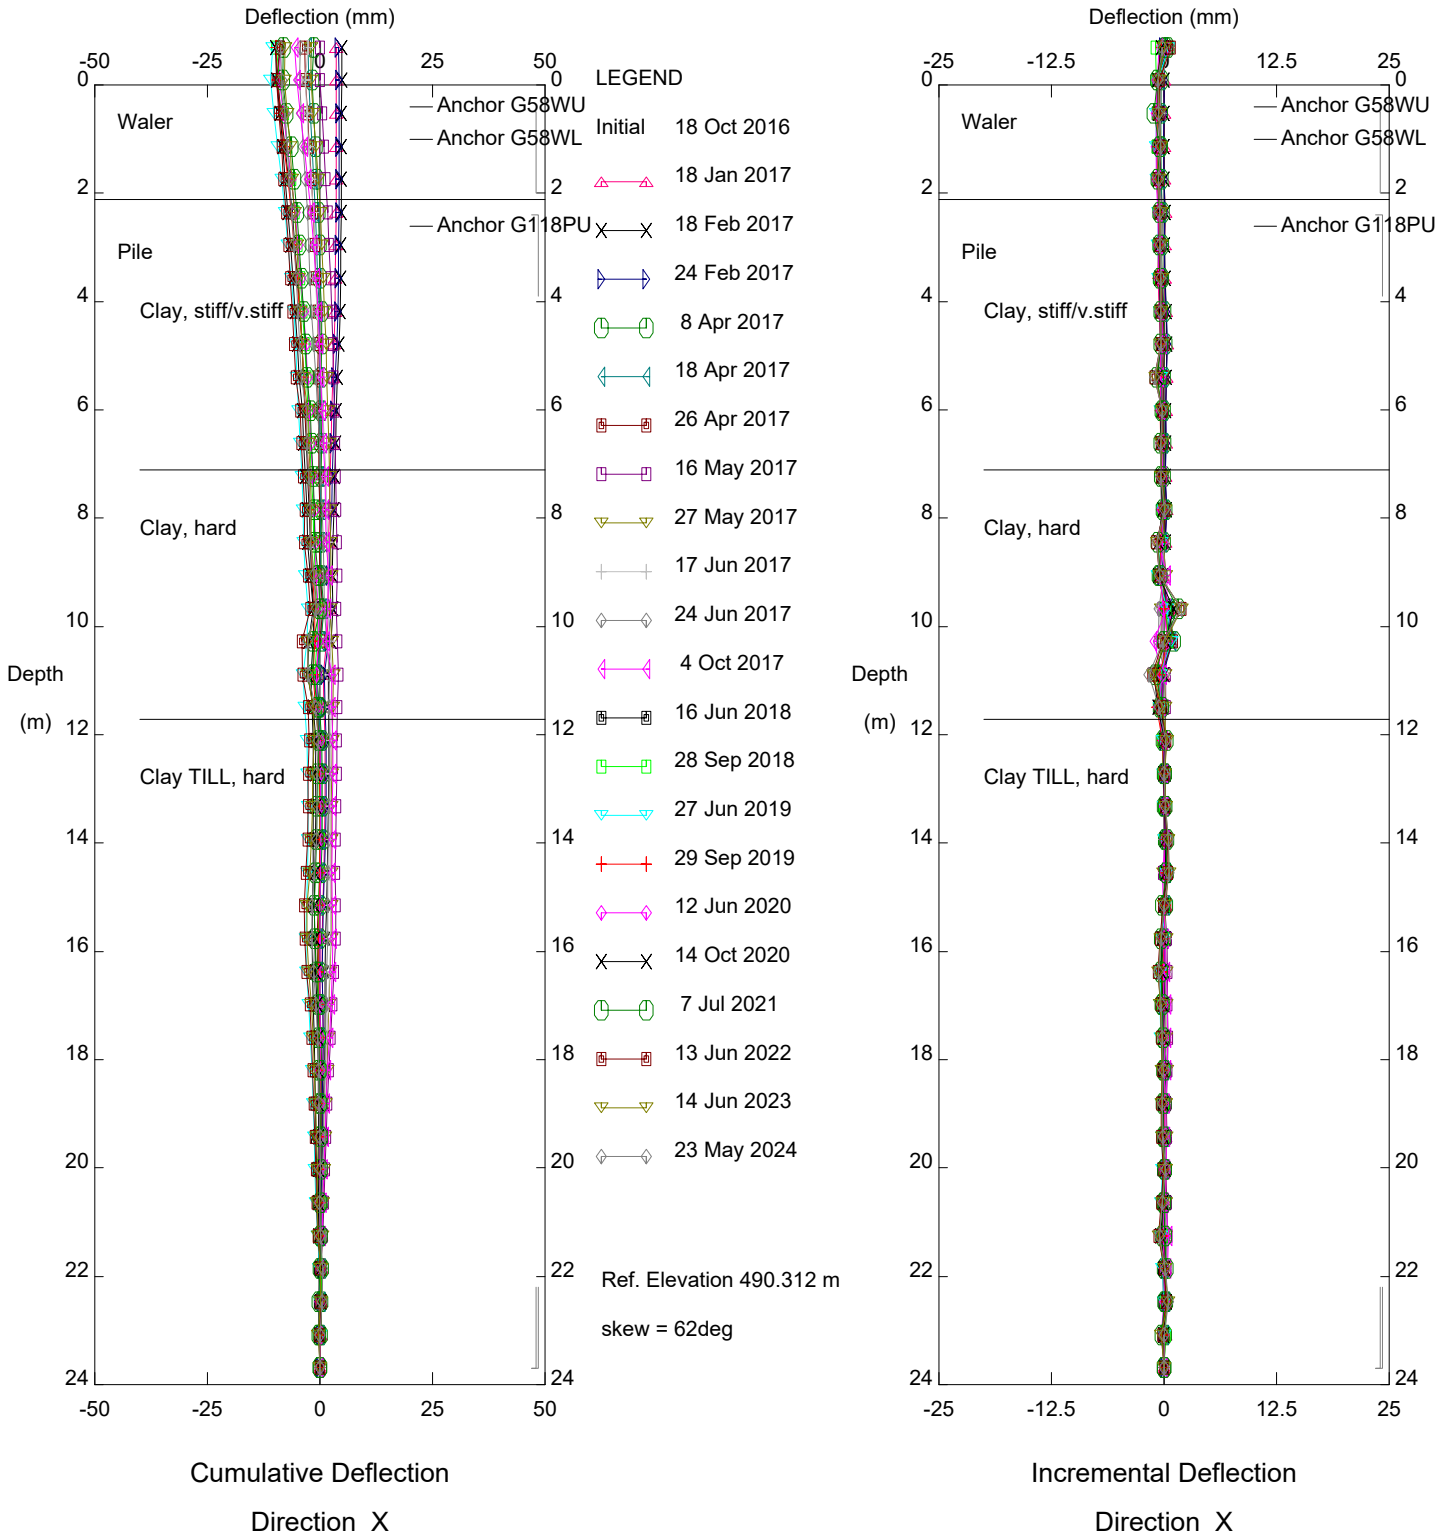
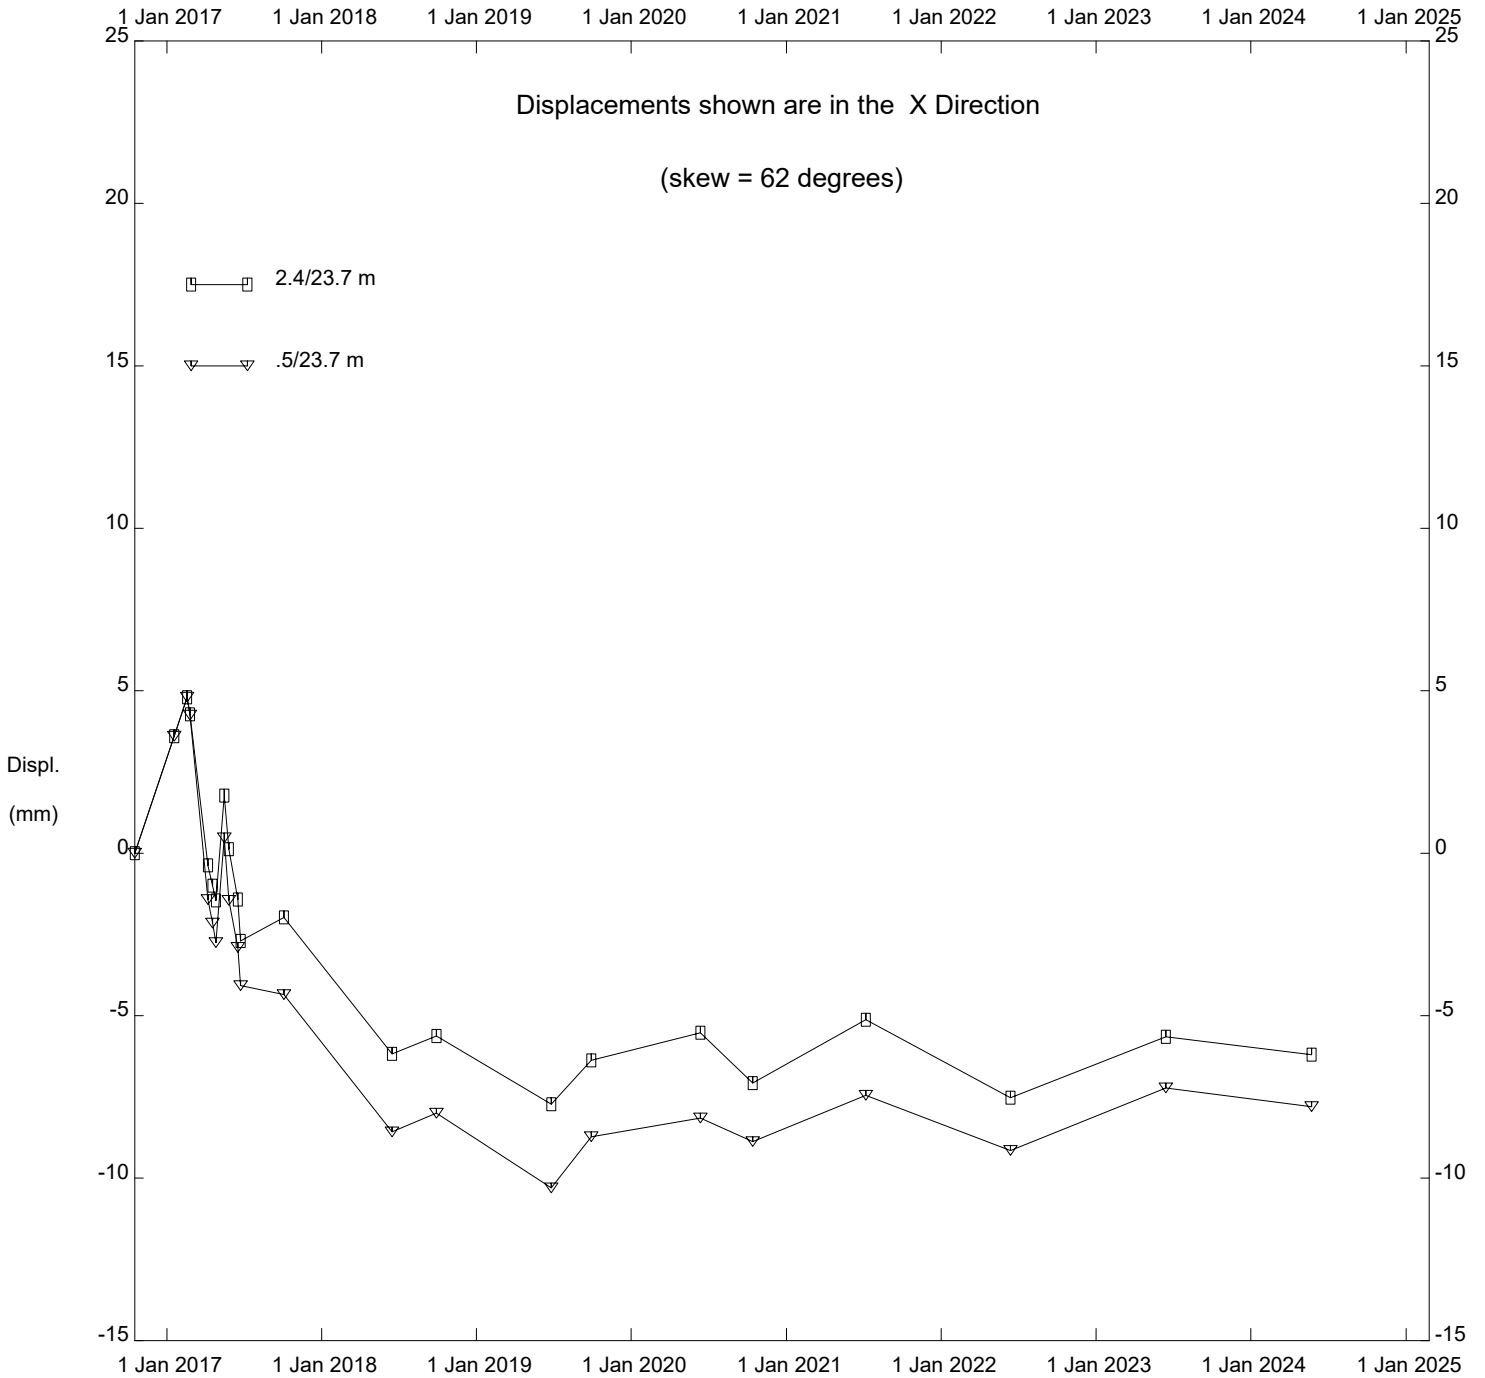
Peace River East Hill PH070, Inclinometer P58

SI-P58, installed in Pile 58, showed no discernible movement over both the length of the pile and over the combined length of the pile and water since the spring of 2023 readings. The cumulative pile head movement was 6.2 mm in the upslope direction and the cumulative movement at the top of the water was 7.8 mm in the upslope direction.

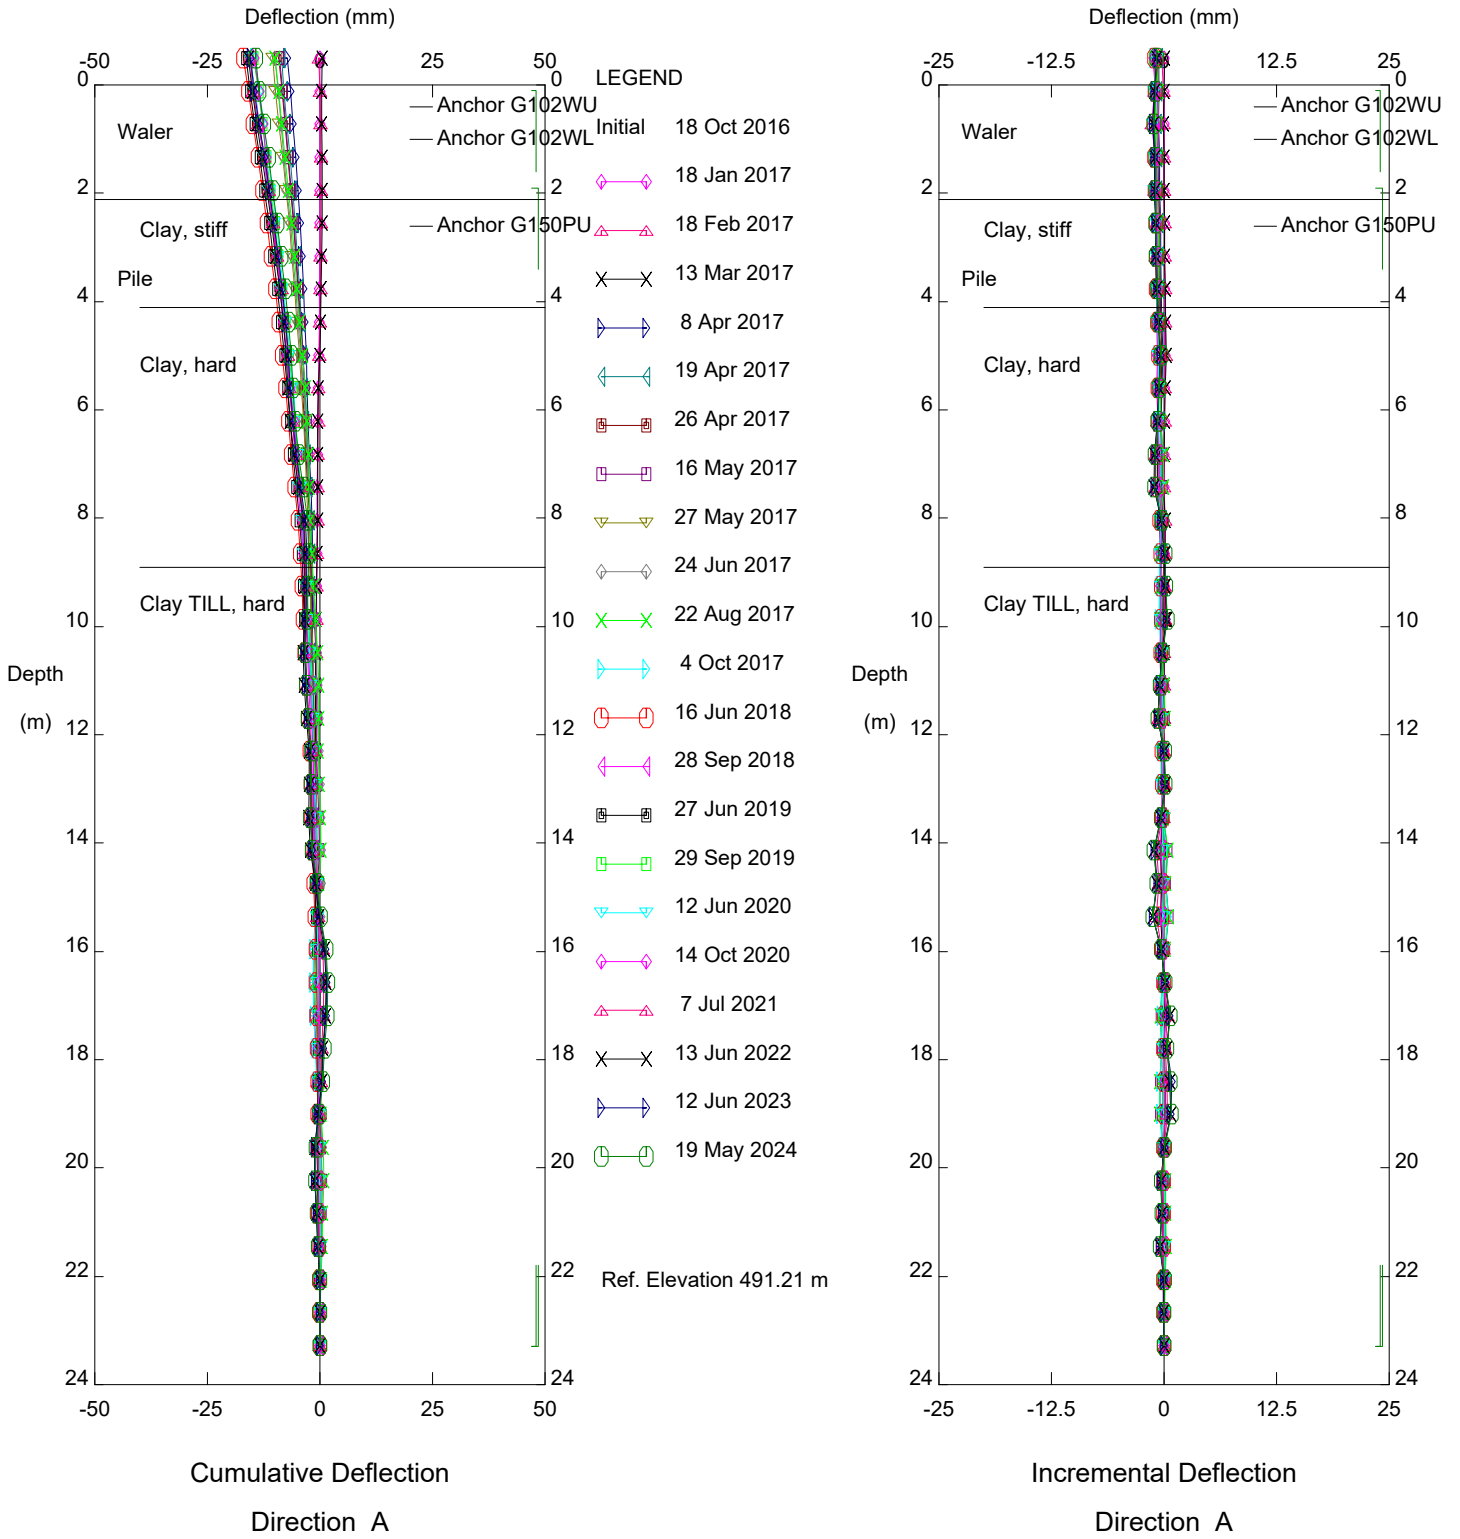
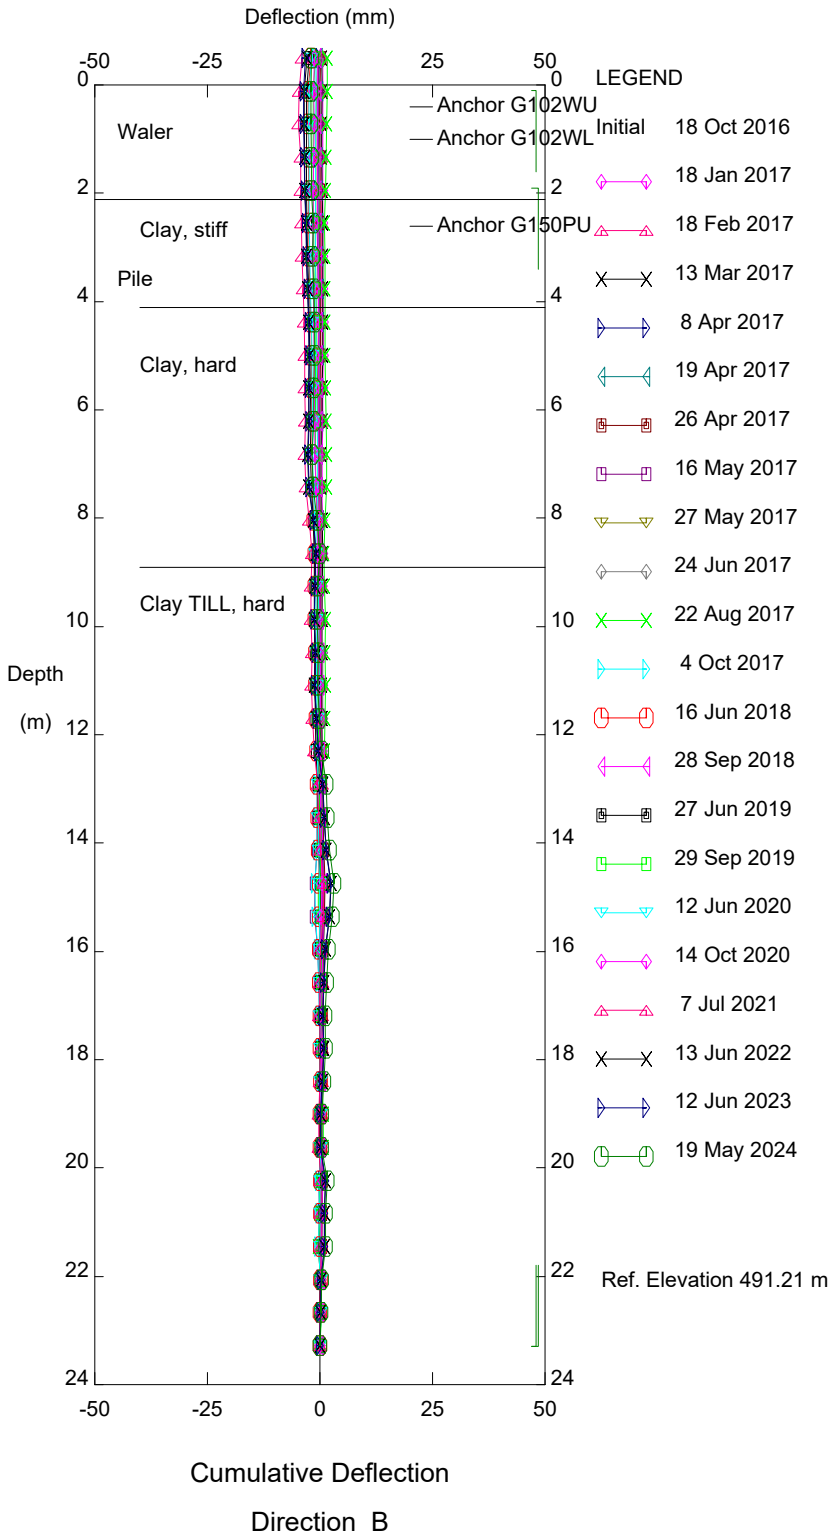
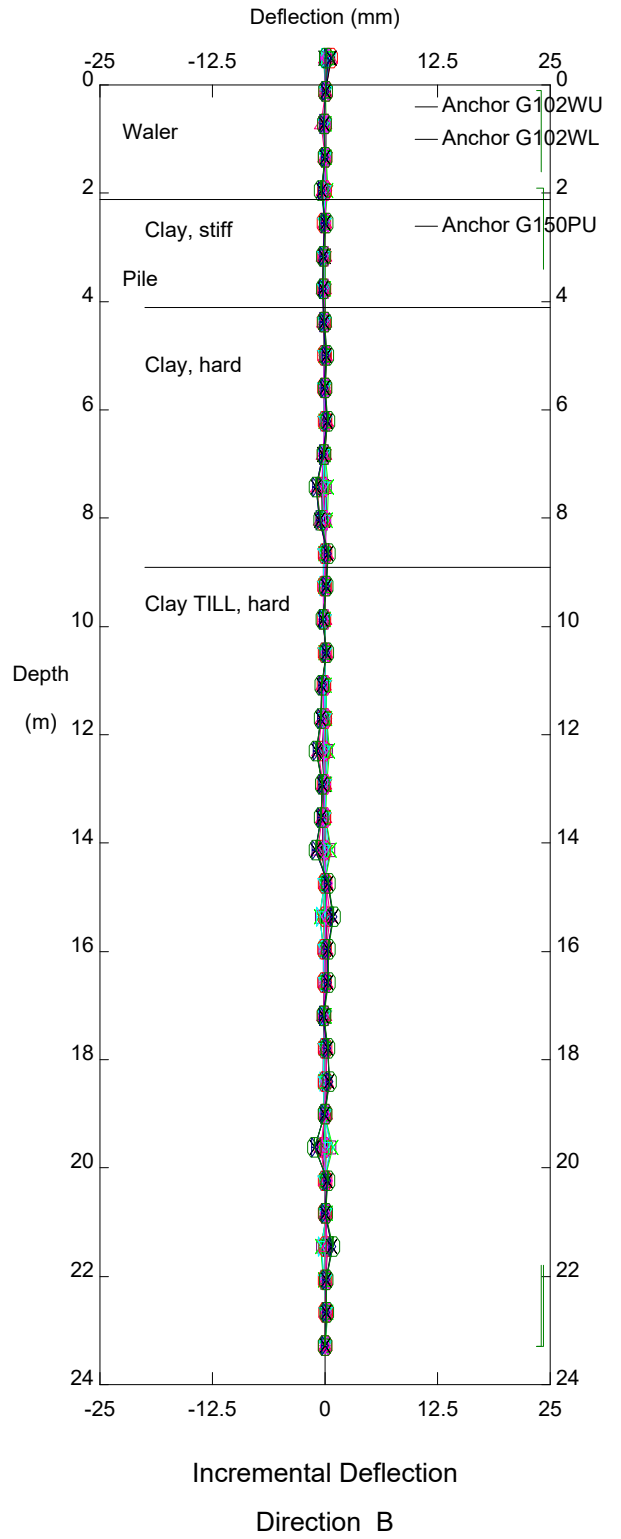
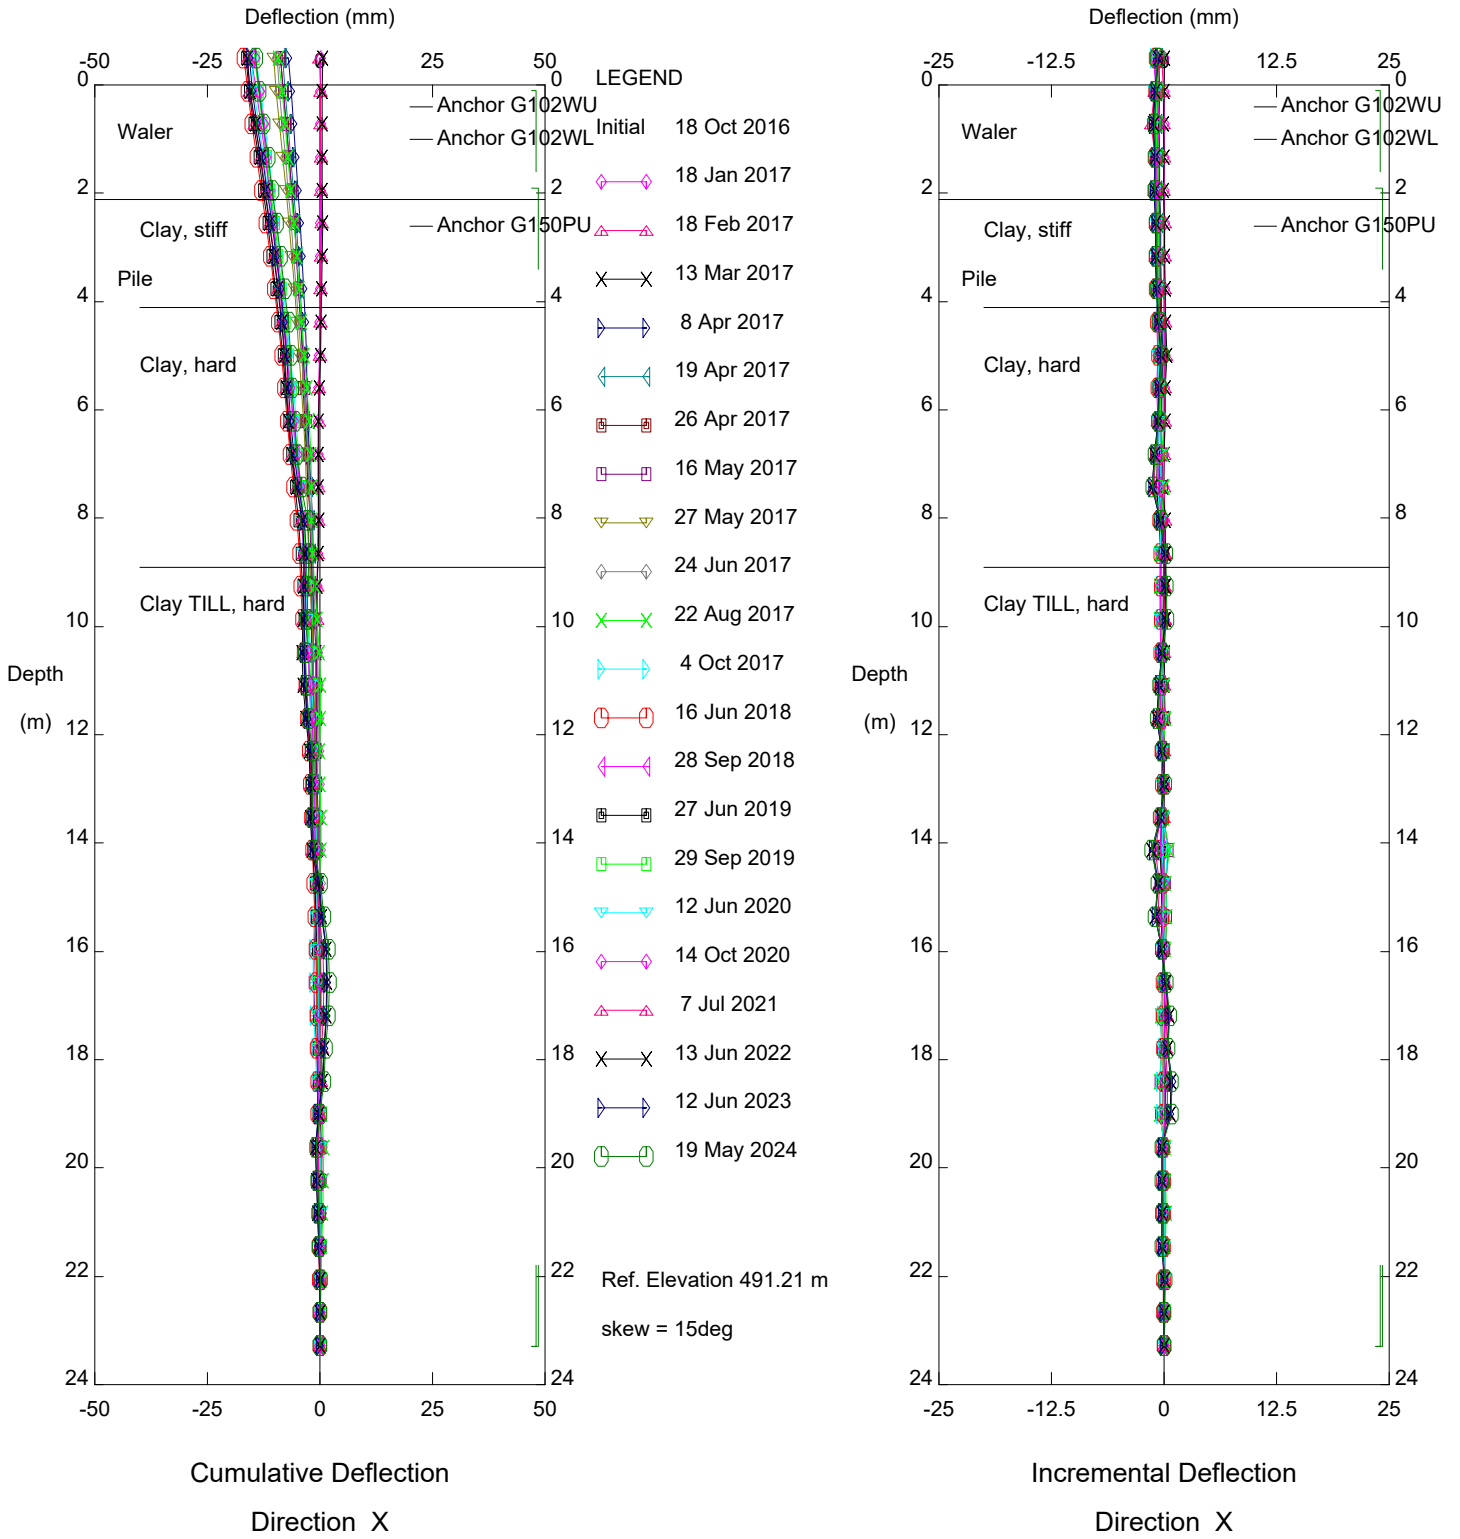
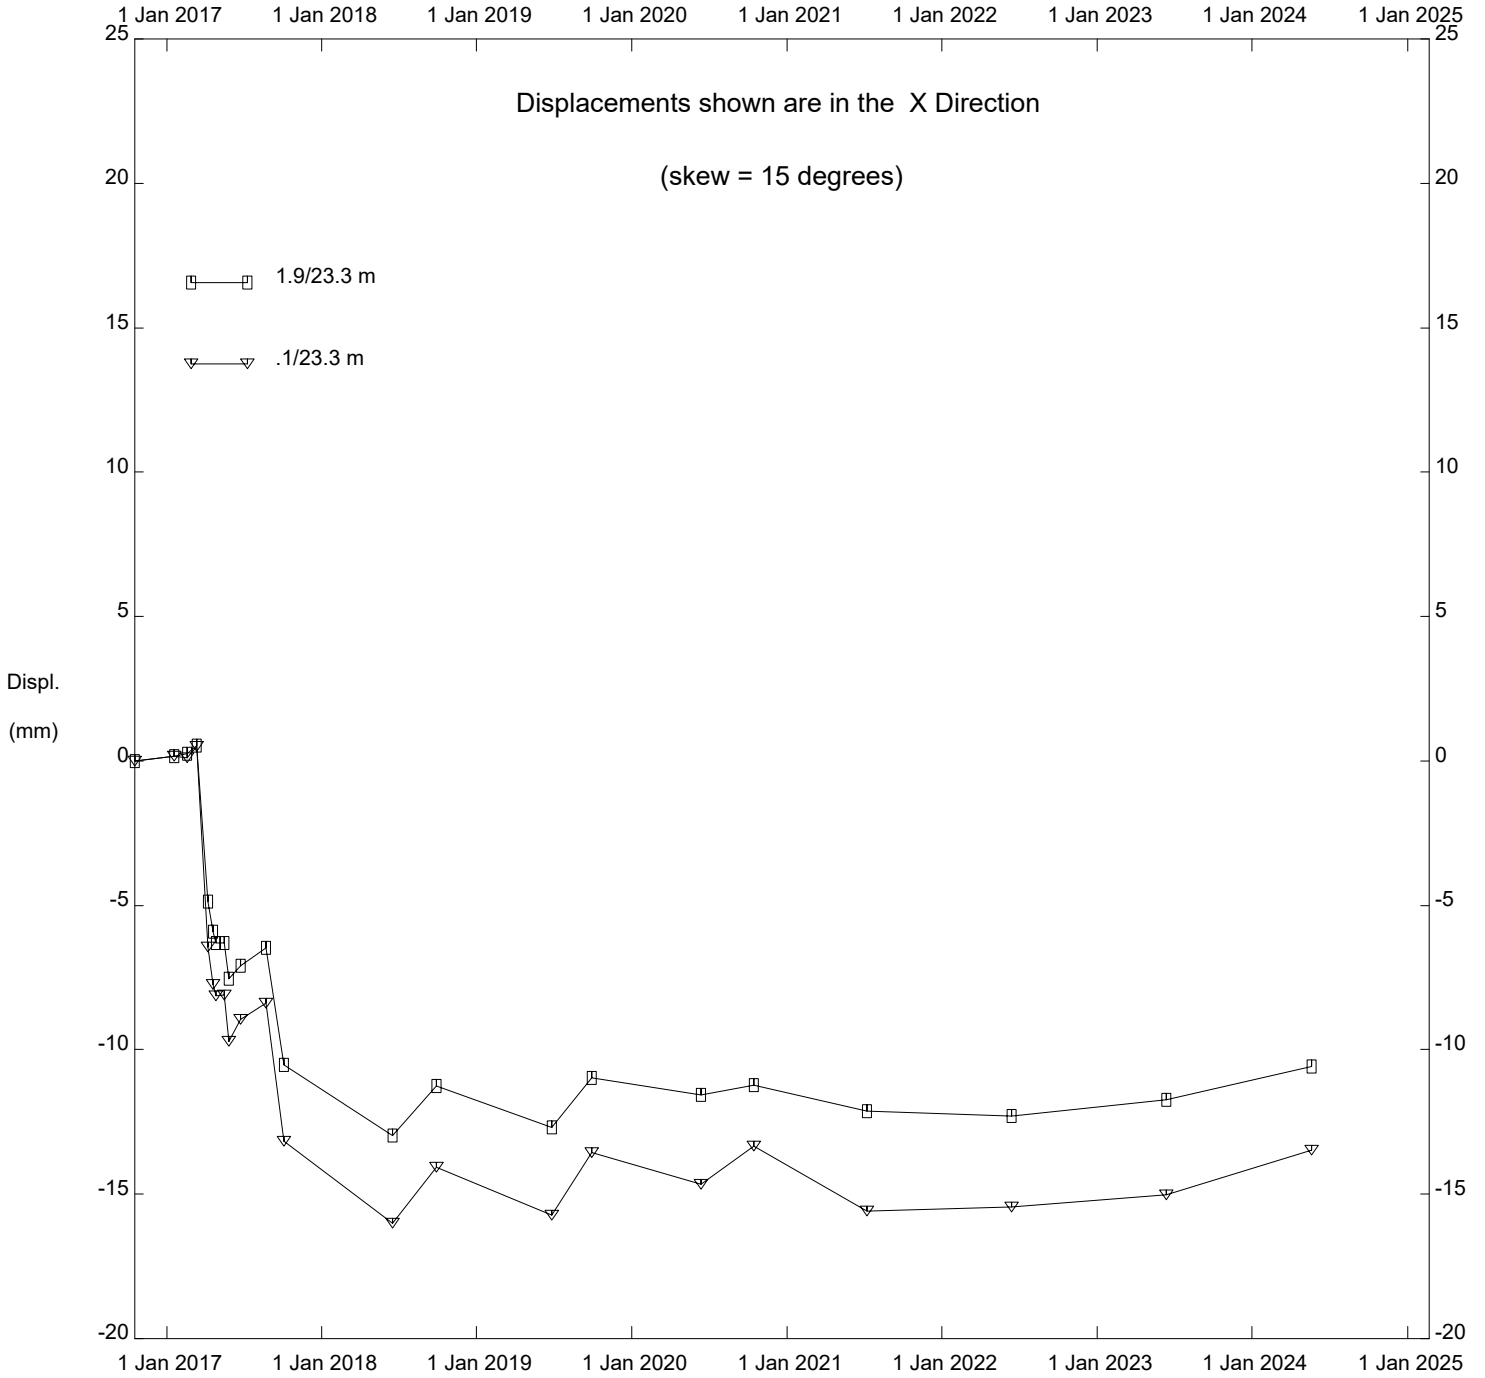
Peace River East Hill PH070, Inclinometer P90

SI-P90, installed in Pile 90, showed a rate of movement of 1.2 mm/yr over the length of the pile and a rate of movement of 1.6 mm/yr over the combined length of the pile and water since the spring of 2023 readings. Pile 90 has shown a total cumulative pile head movement of 10.6 mm in the upslope direction and a total cumulative movement of 13.5 mm in the upslope direction over the combined length of the pile and water.
