Site Number	Location	Name	Hwy	km
PH070	HWY 2:60 C1 33.840	East Hill Retaining Wall Site	2:60	Km 33.84
<b>Legal Description:</b> 4-27-83-21 W5		<b>UTM Co-ordinates</b>		
		11U E 485285	N	6230649

<b>Current Monitoring:</b>	19-May-2024	<b>Previous Monitoring</b>	12-Jun-2023
<b>Instruments Read By:</b>	Mr. Niraj Regmi, G.I.T and Mr. Nixon Mationg, of Thurber

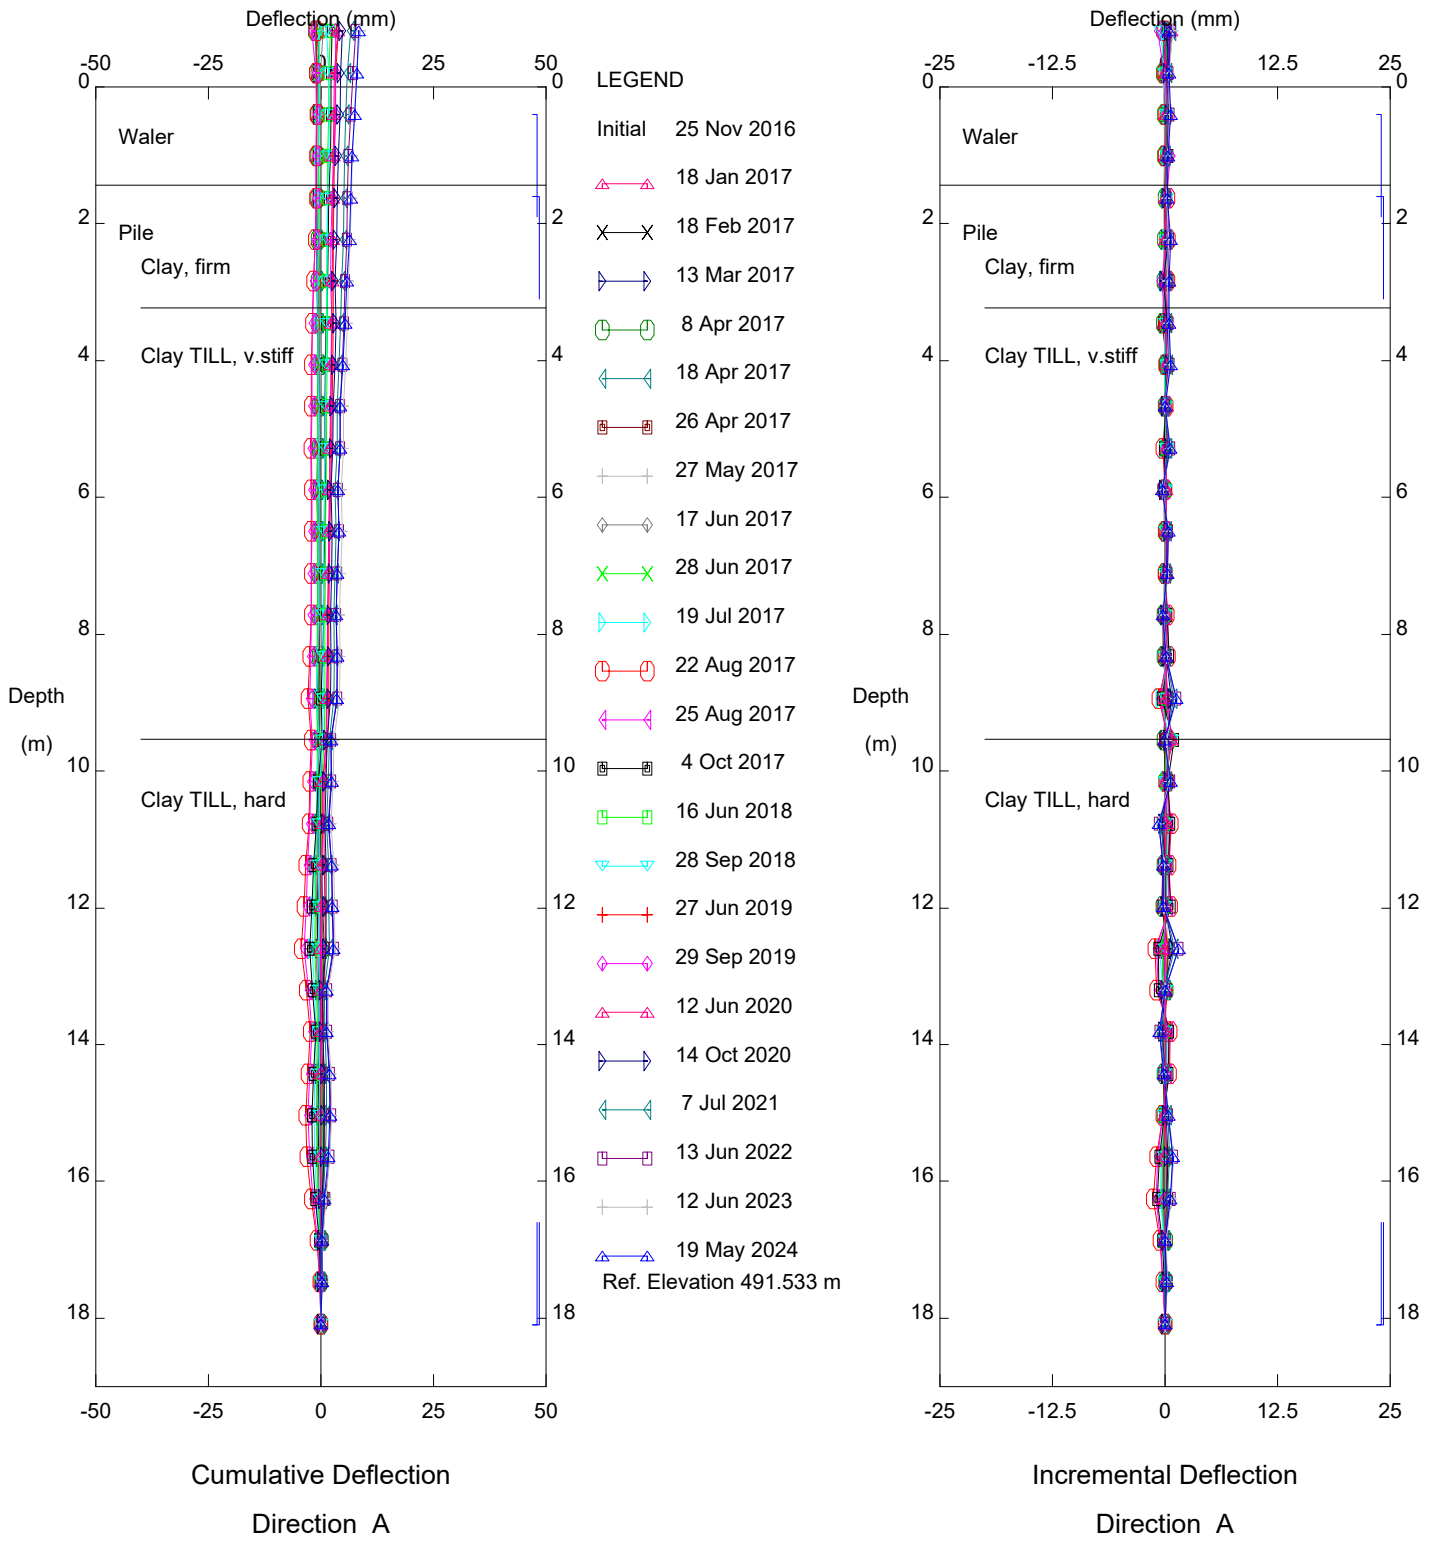
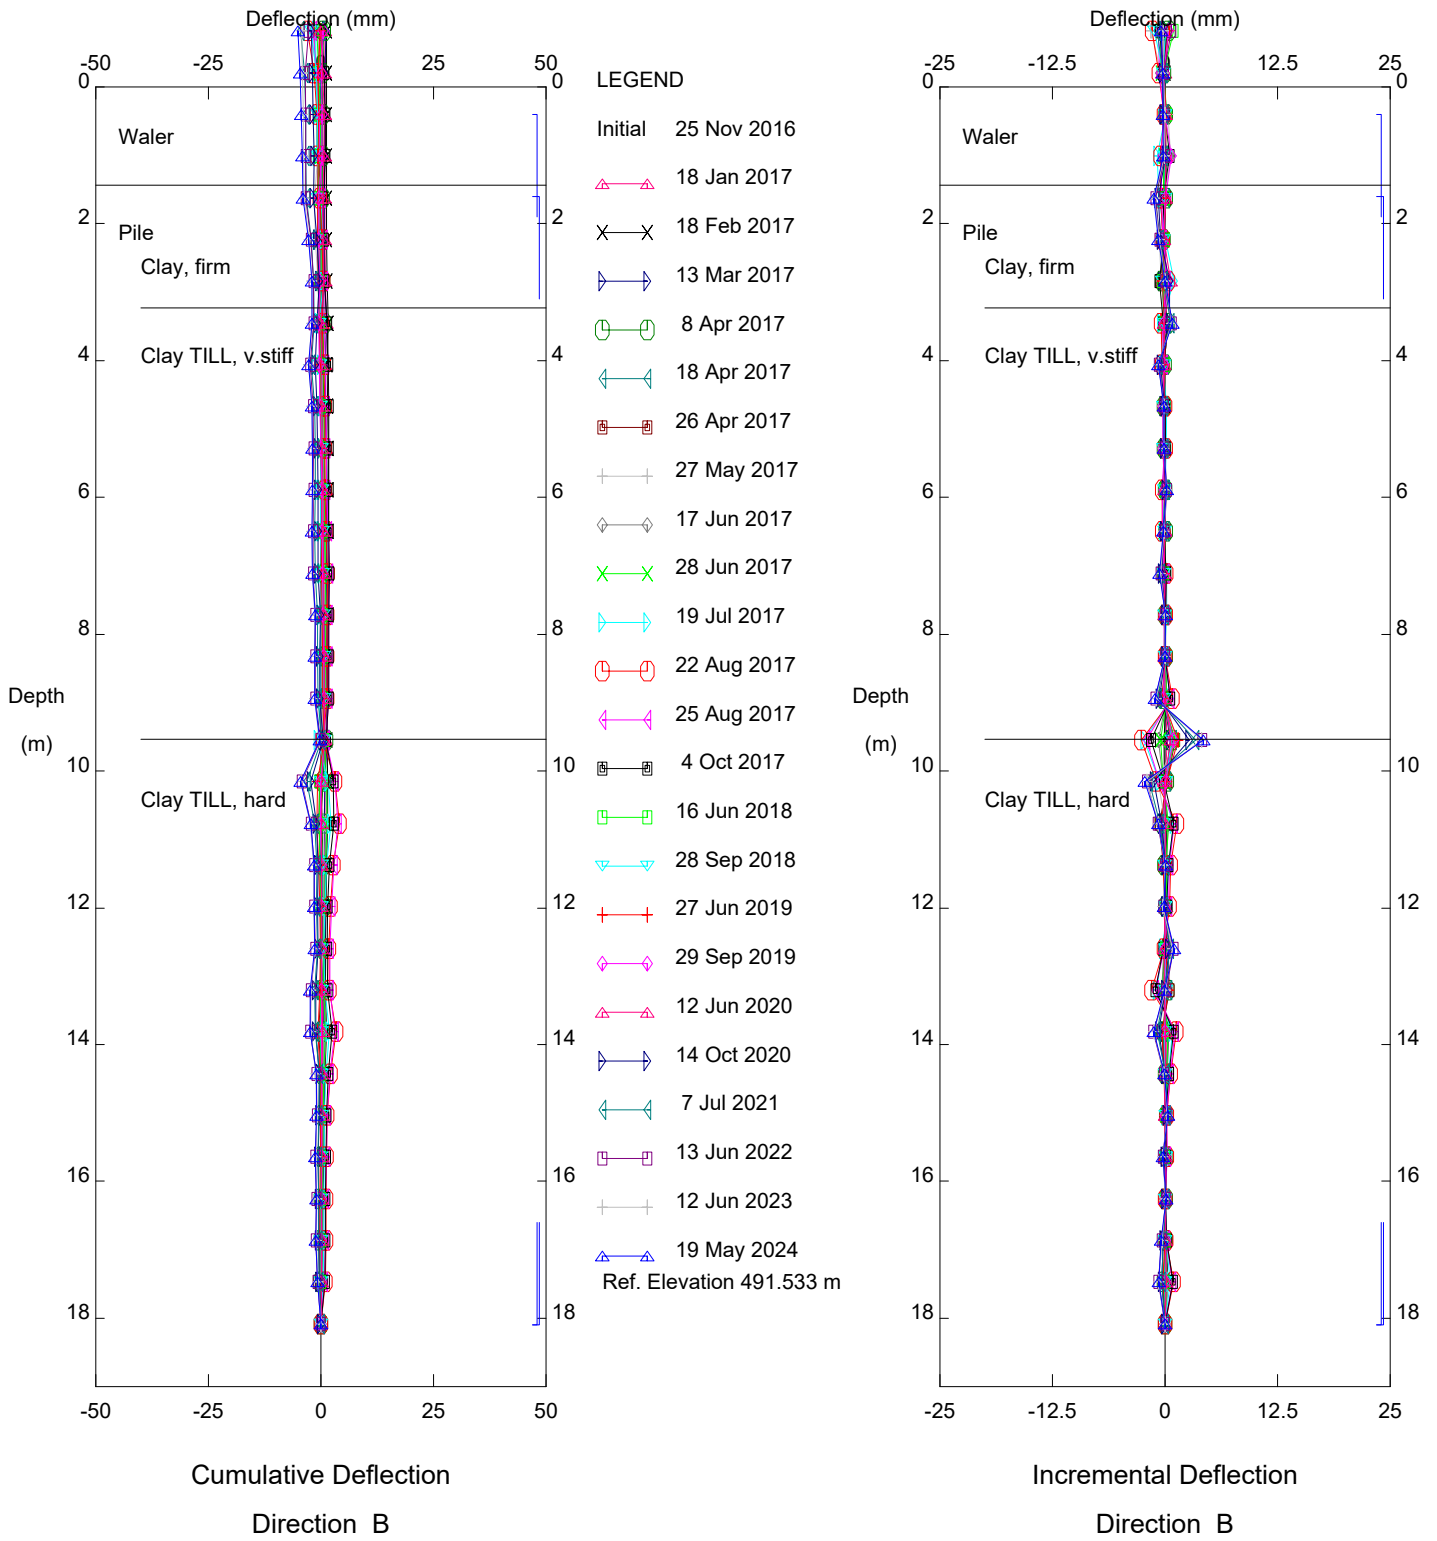
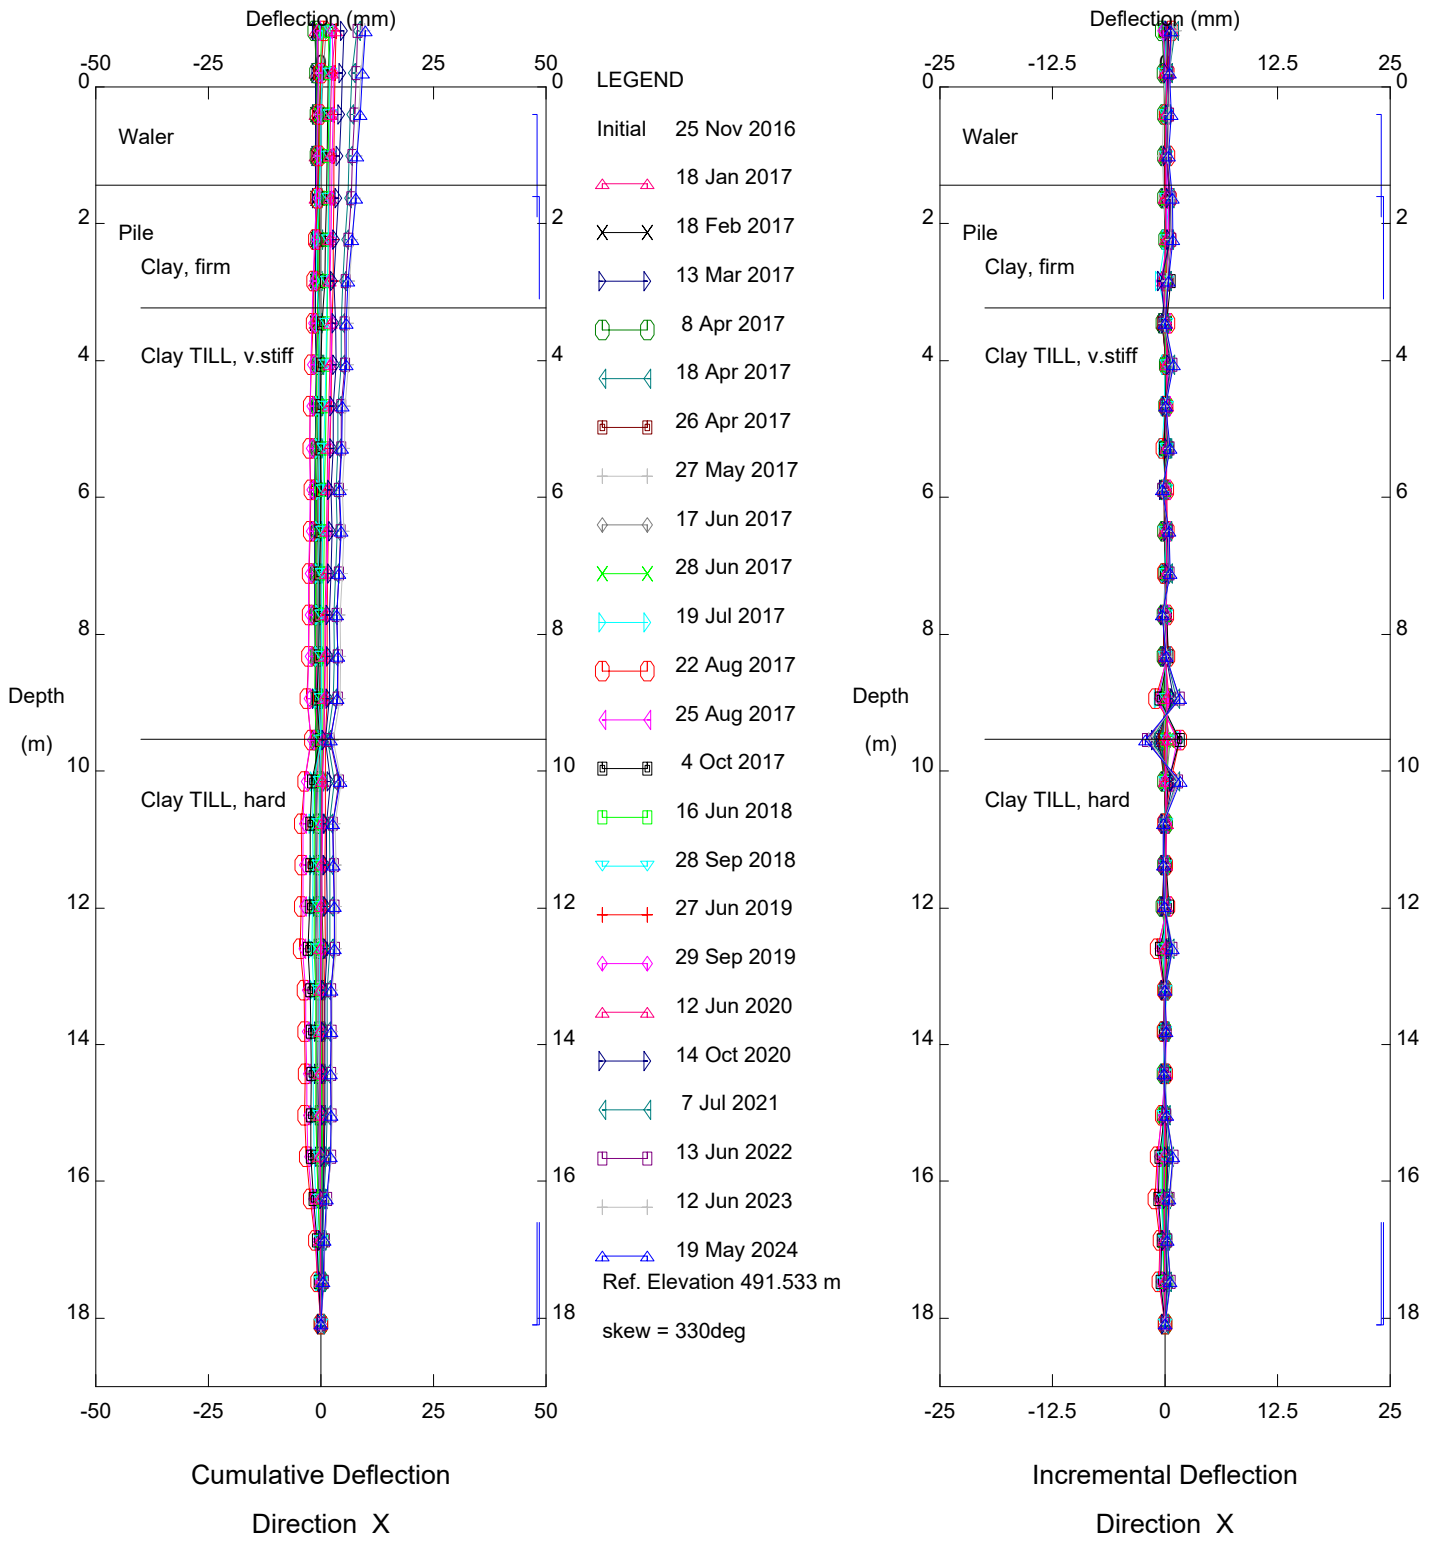
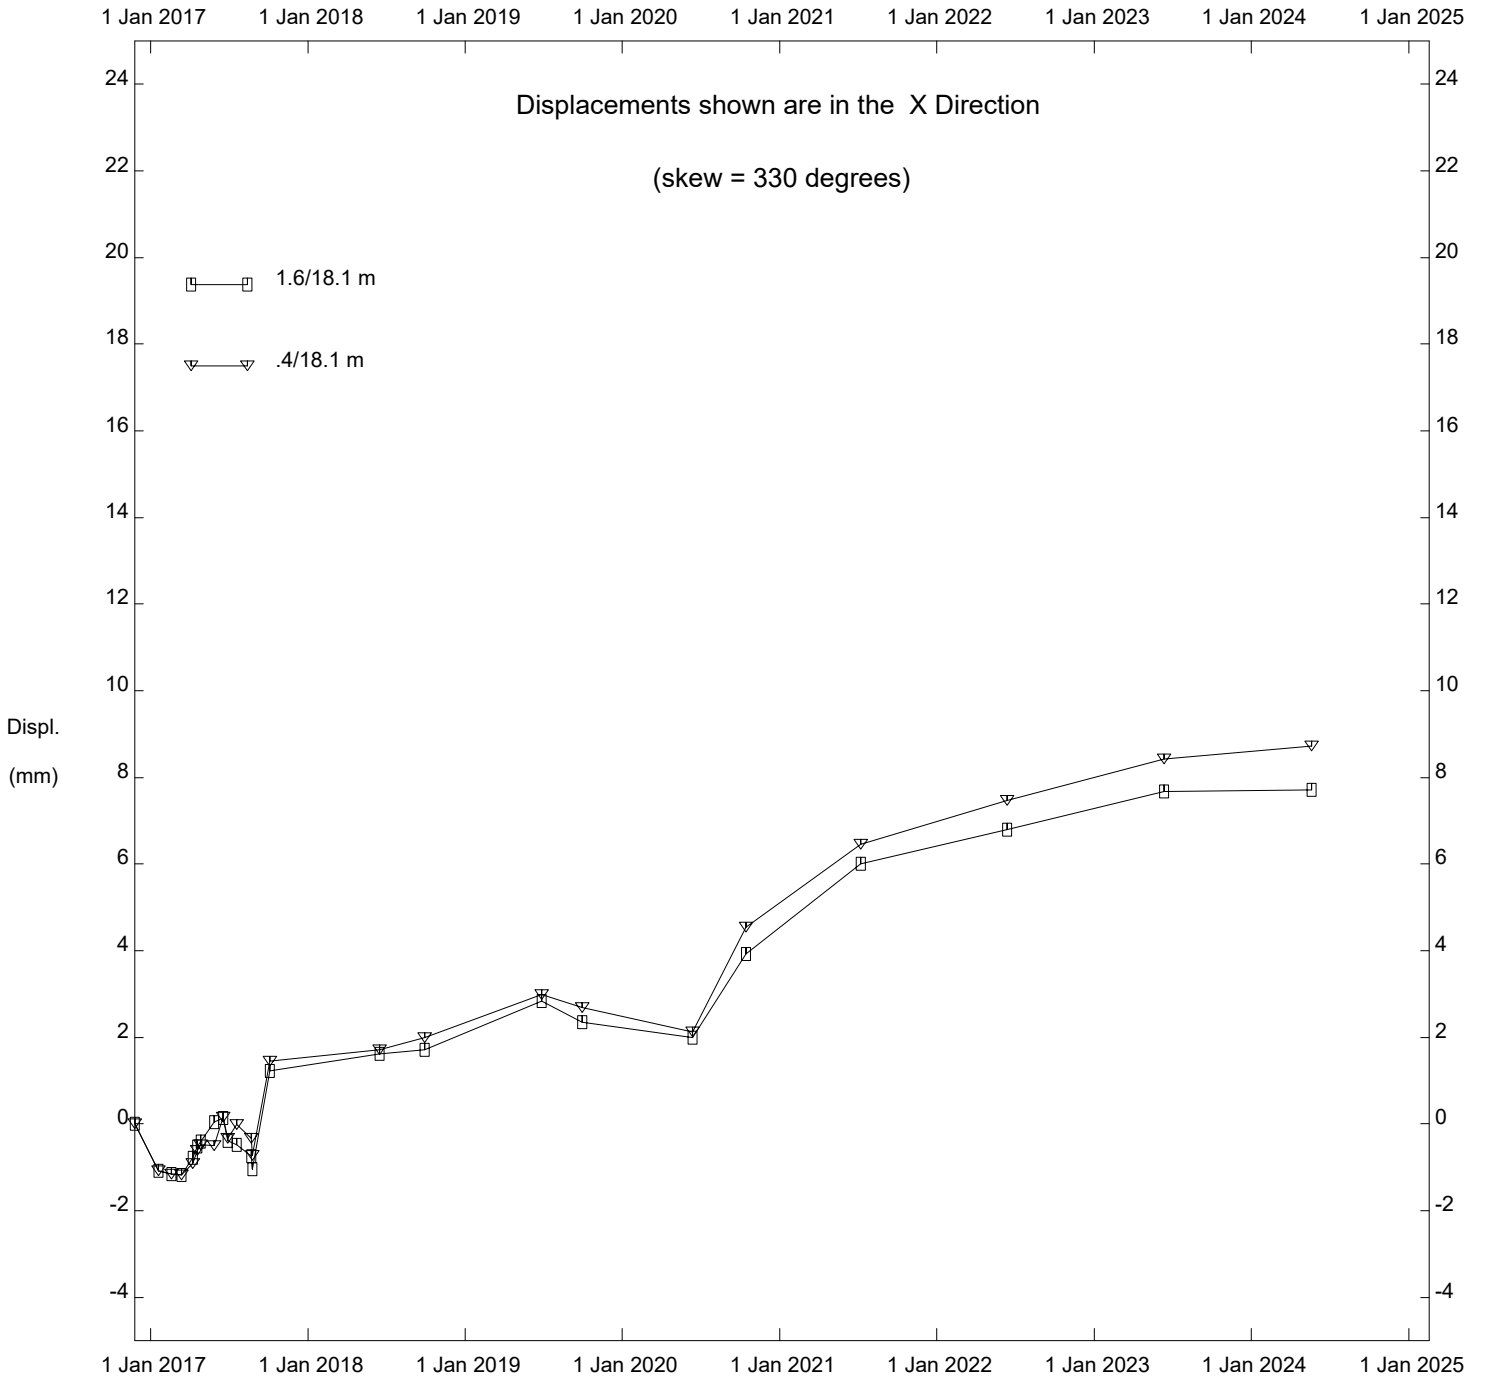
Peace River East Hill PH070, Inclinometer P116

SI-P116, installed in Pile 116, showed a rate of movement of less than 0.1 mm/yr over both the length of the pile and a rate of movement of 0.3 mm/yr over the combined length of the pile and water since the spring of 2023 readings. Pile 116 has shown a total cumulative pile head movement of 7.7 mm in the downslope direction and a total cumulative movement of 8.7 mm in the downslope direction over the combined length of the pile and water.

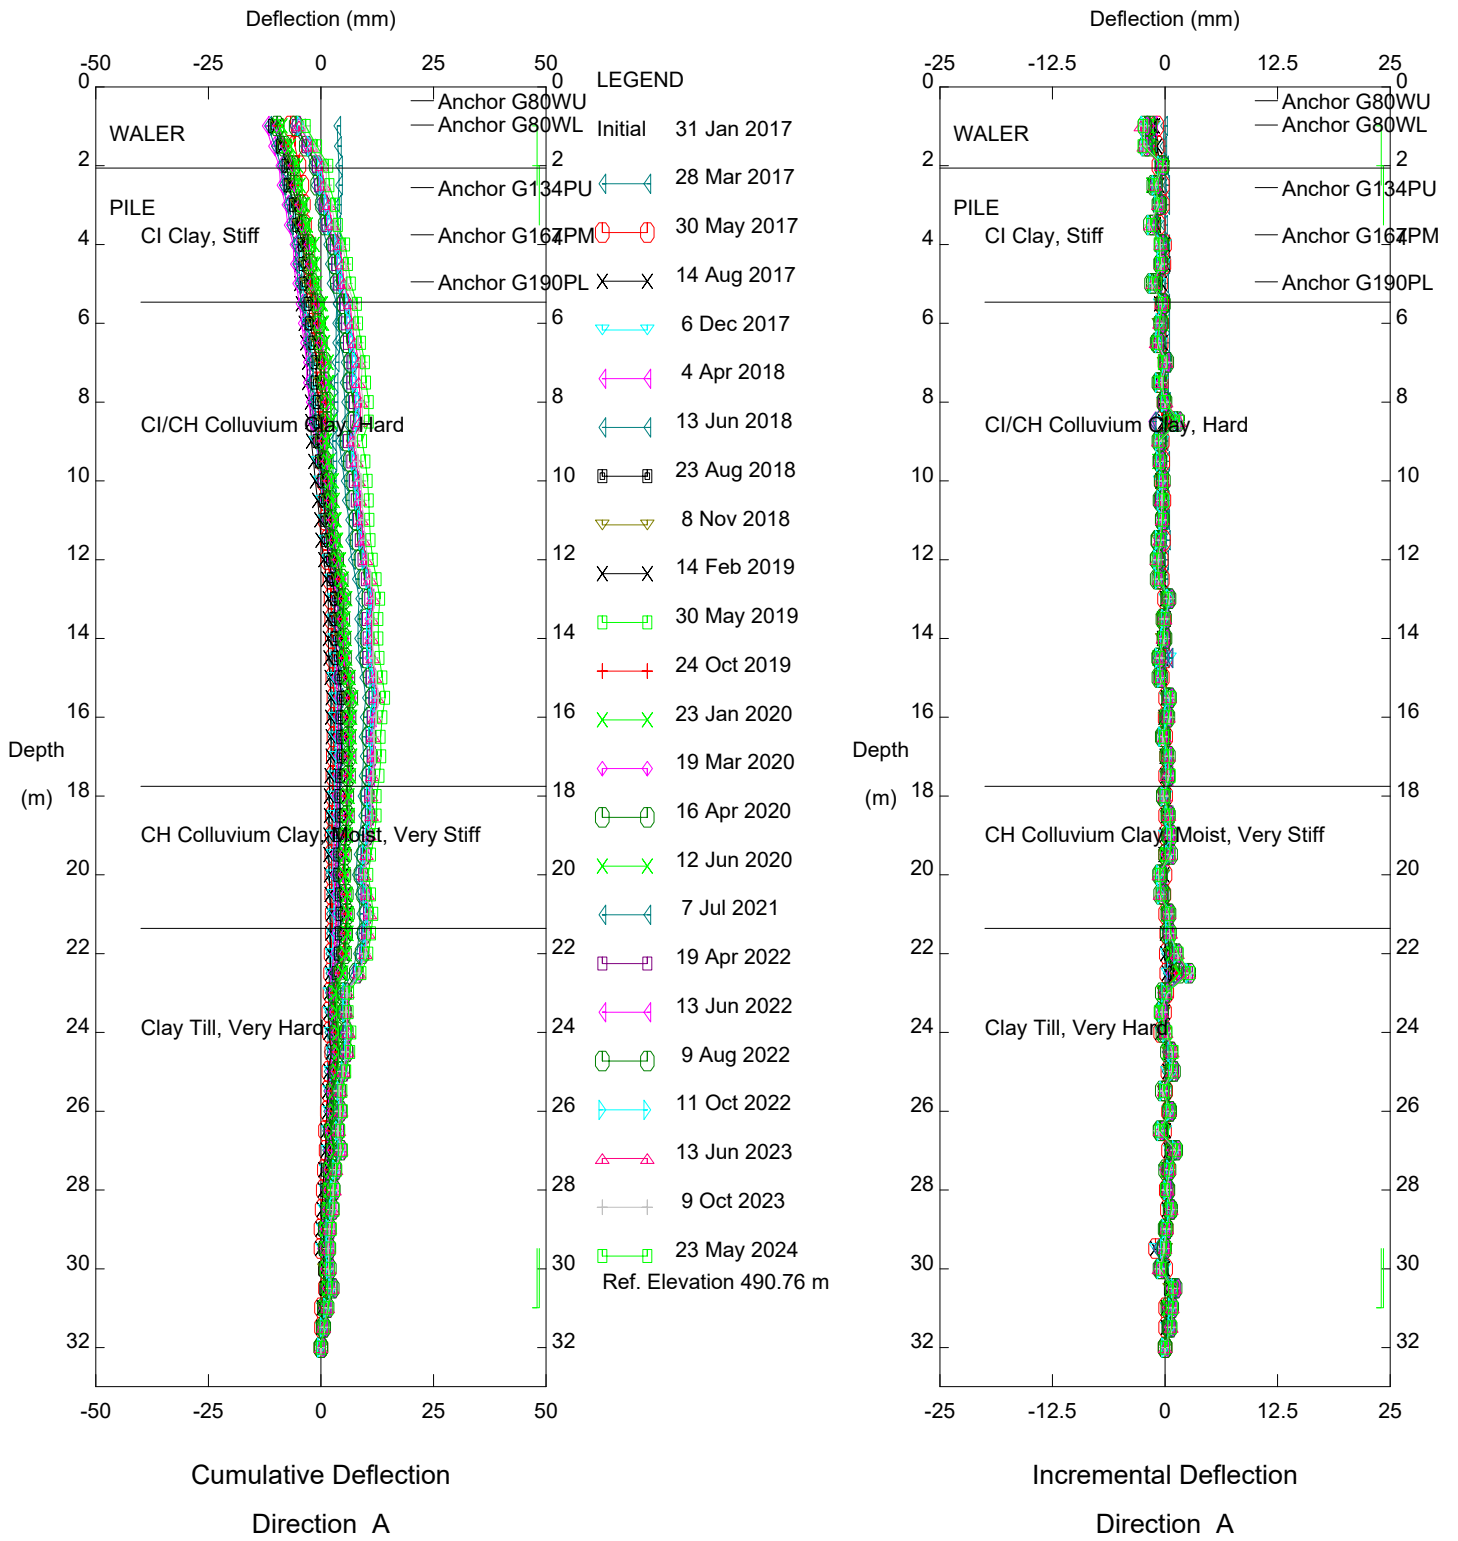
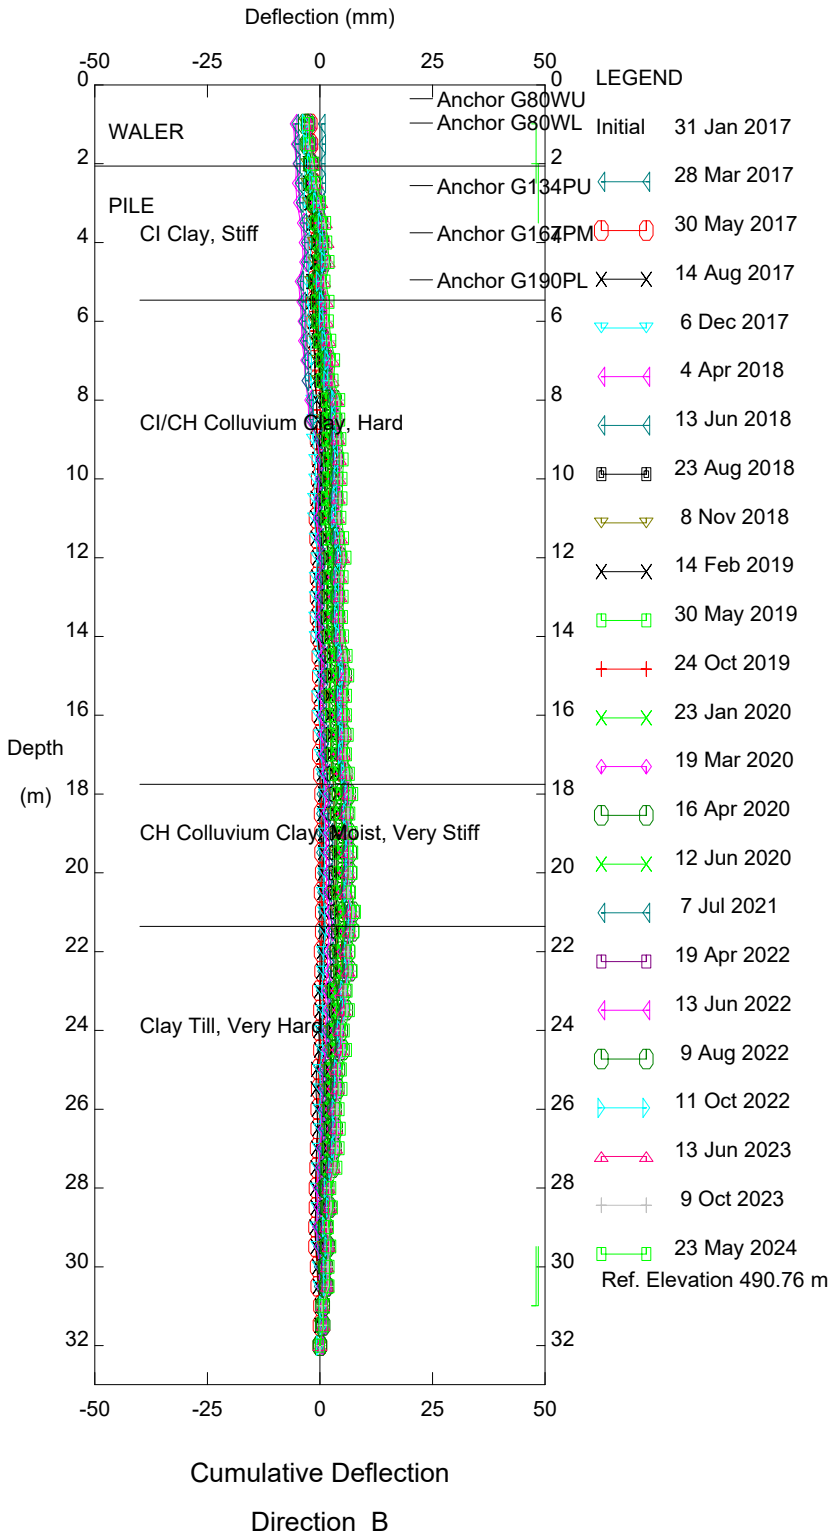
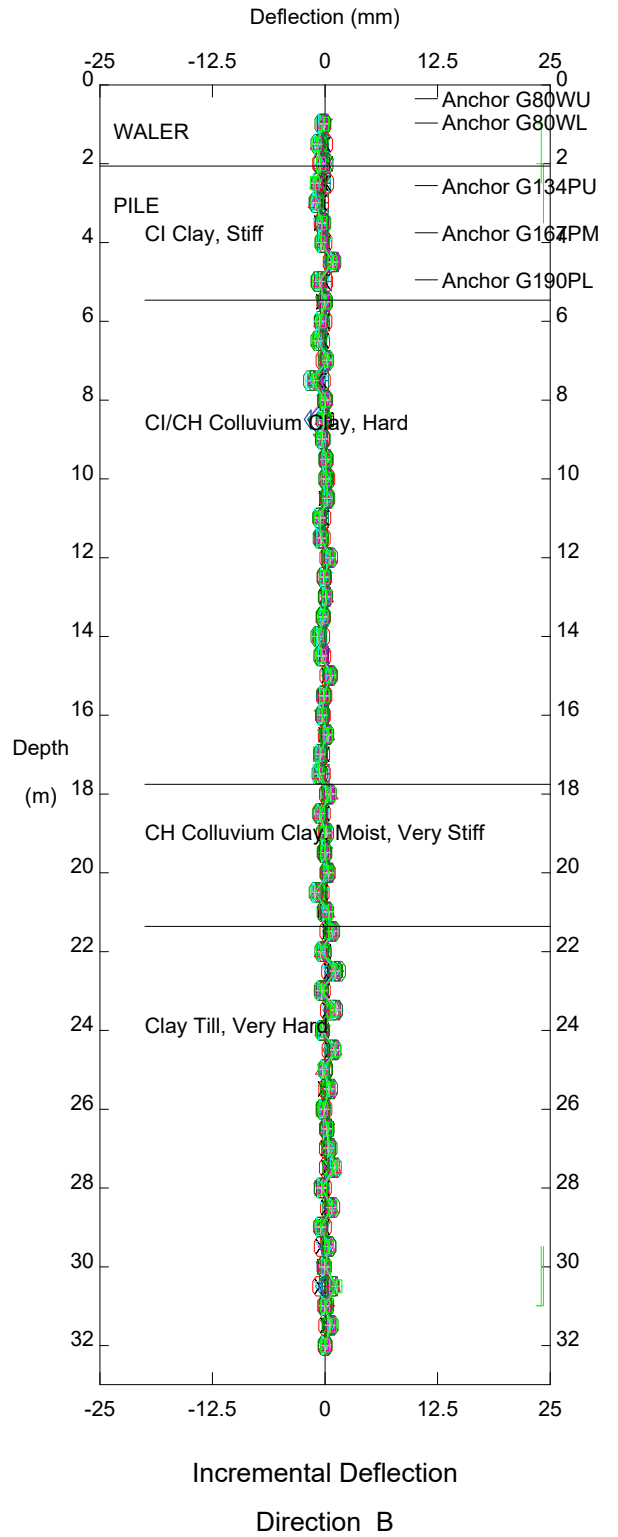
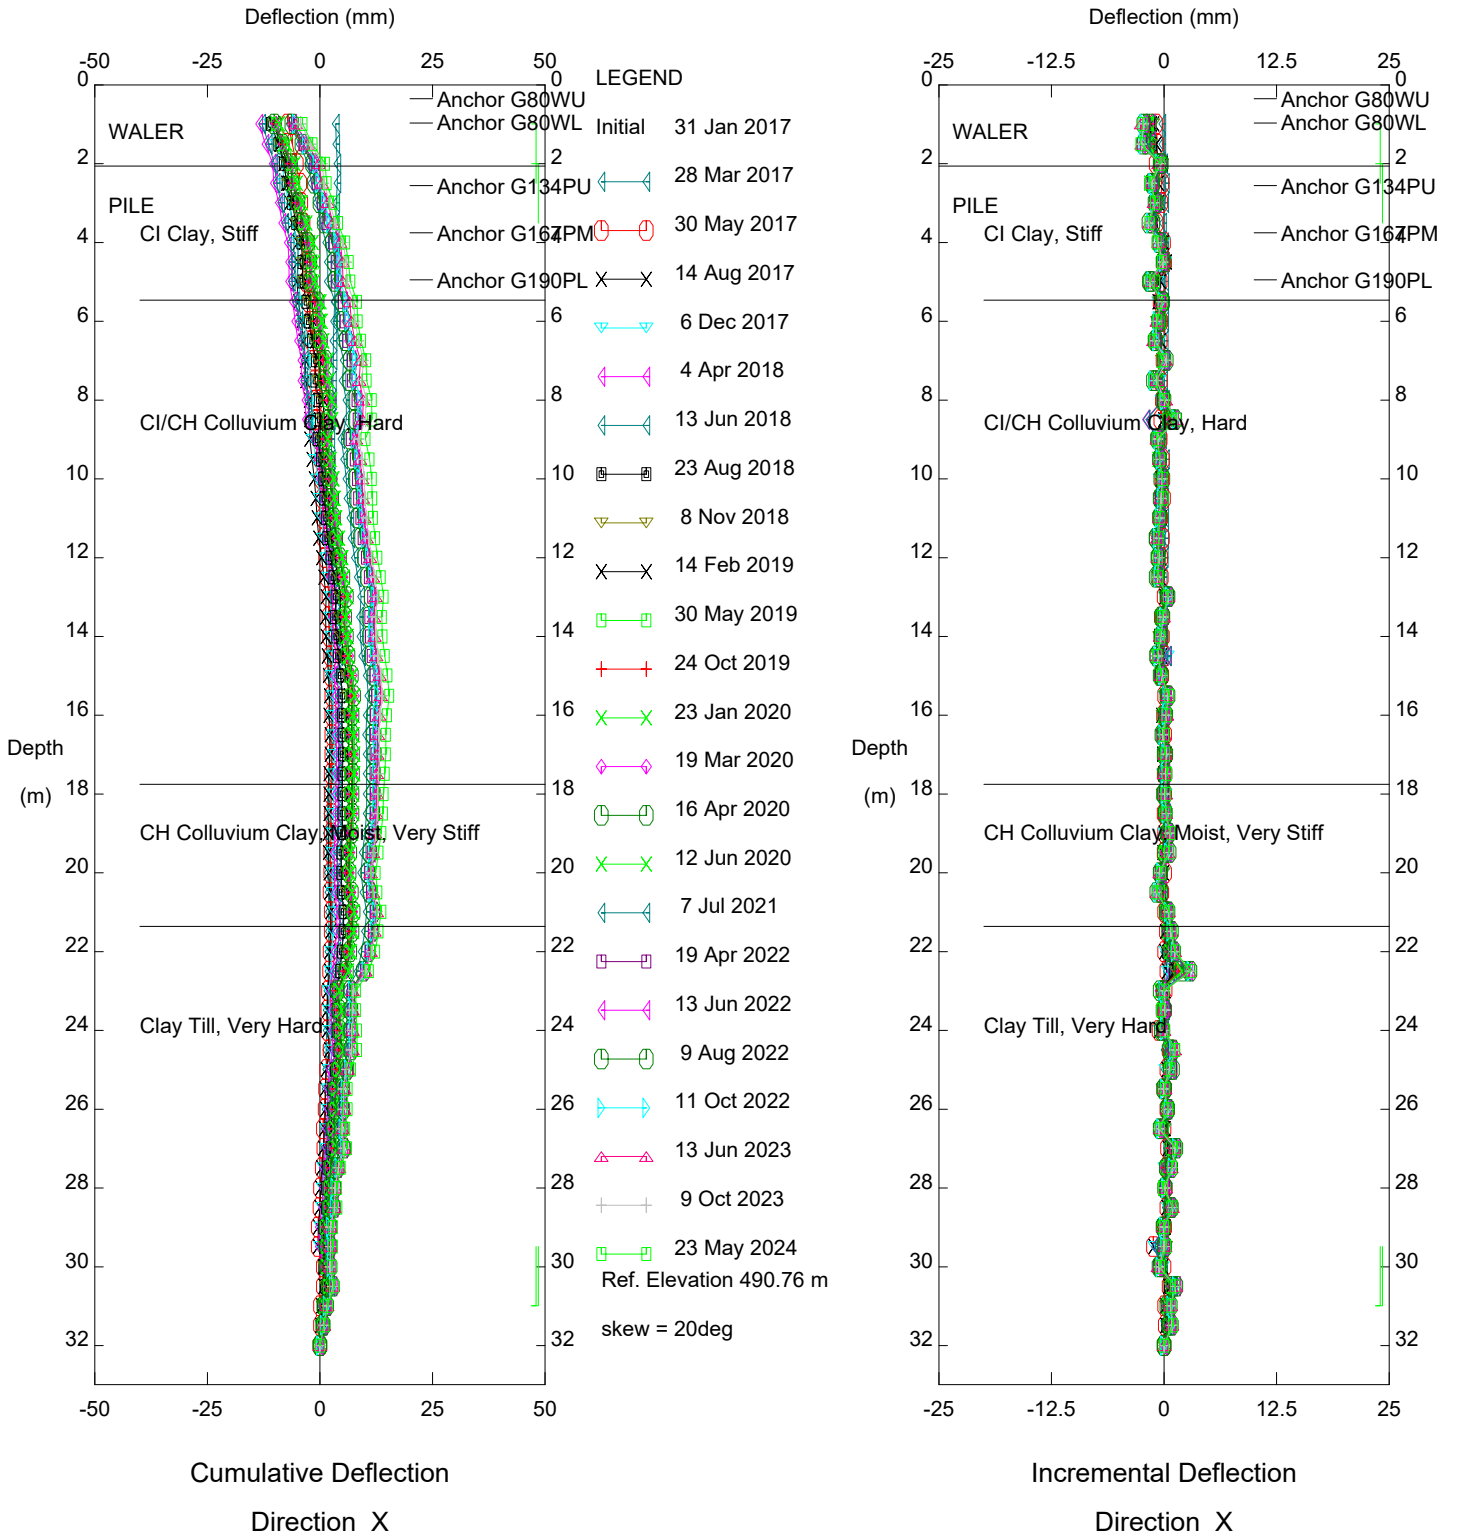
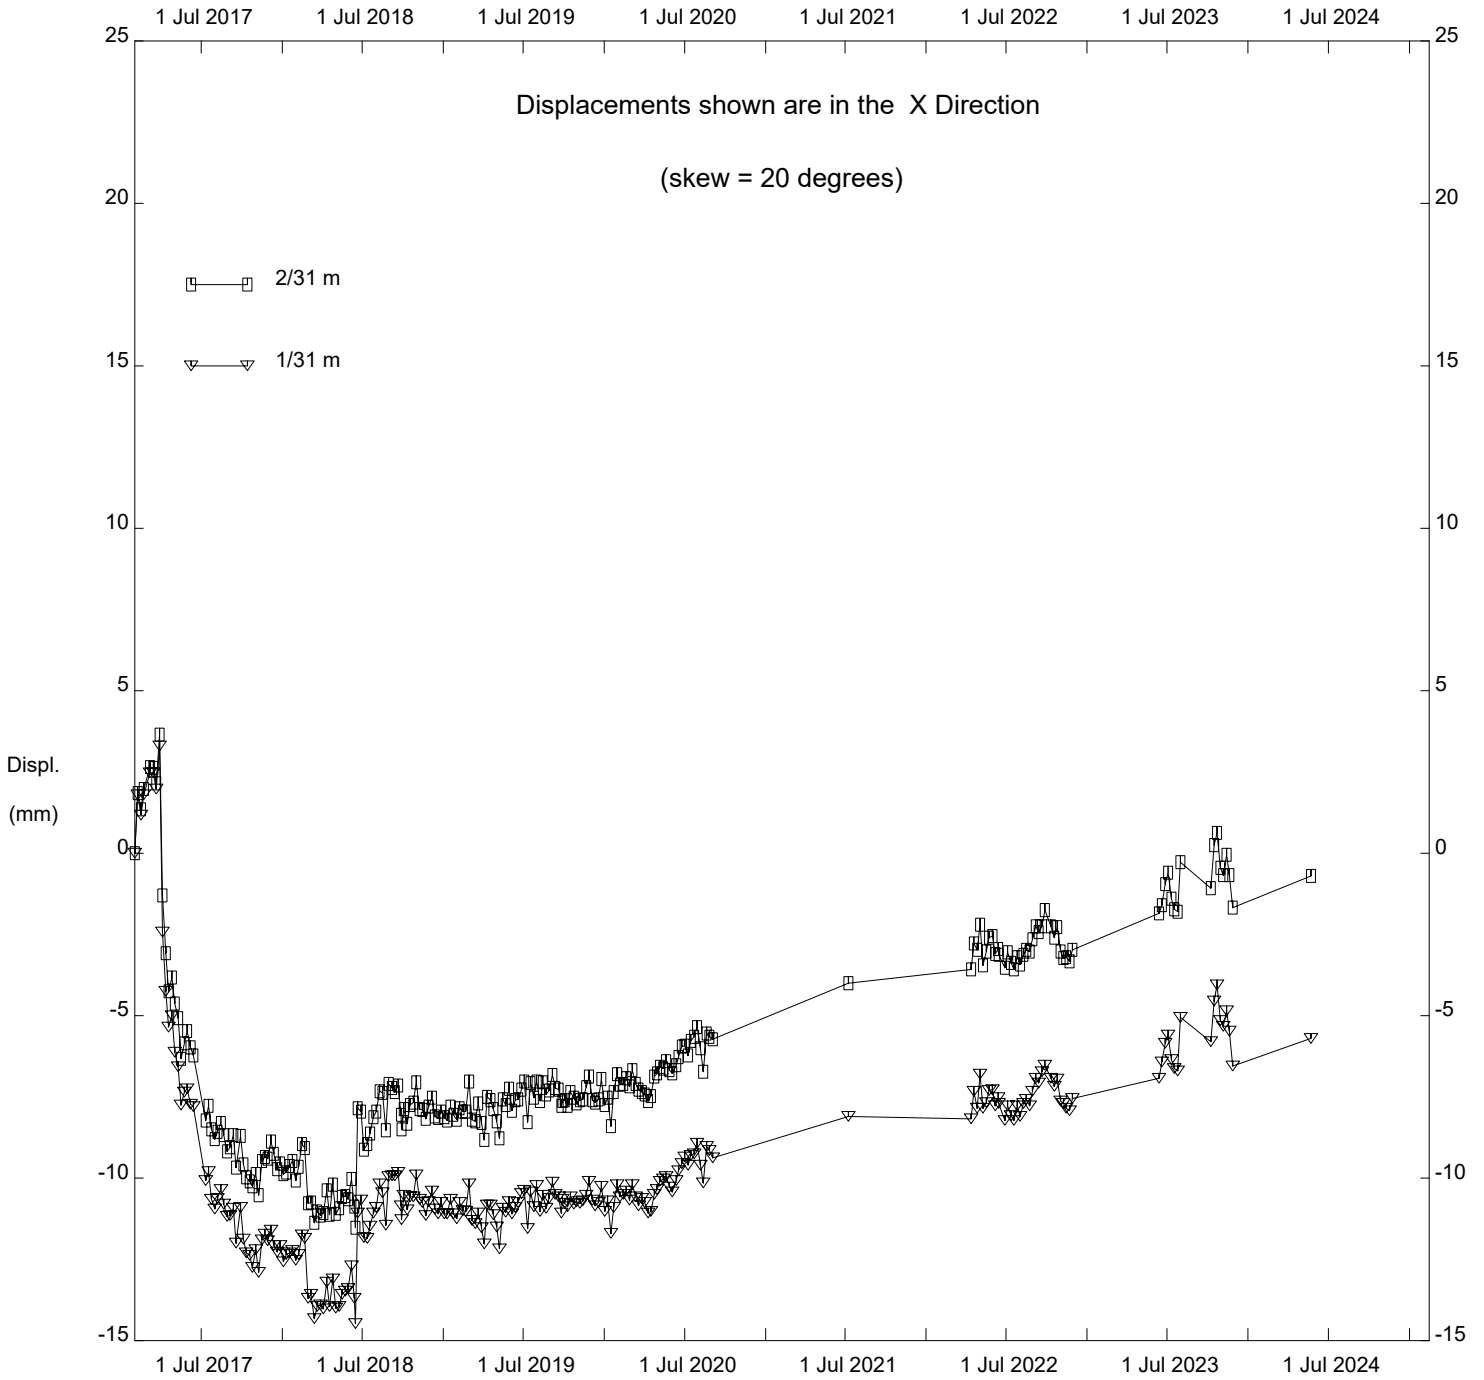
PH070 Hwy 2:60 East Hill, Inclinometer SAA-P74

SAA-P74, installed in pile P74 of the pile wall, showed an average rate of movement of 1.2 mm/yr in the downslope direction over the length of the pile and an average rate of movement of 1.3 mm/yr over the combined length of the pile and water in the downslope direction since the spring of 2023 readings. SAA-P74 has shown a total cumulative pile head movement of 0.7 mm in the upslope direction and a total cumulative movement of 5.7 mm in the upslope direction over the combined length of the pile and water.

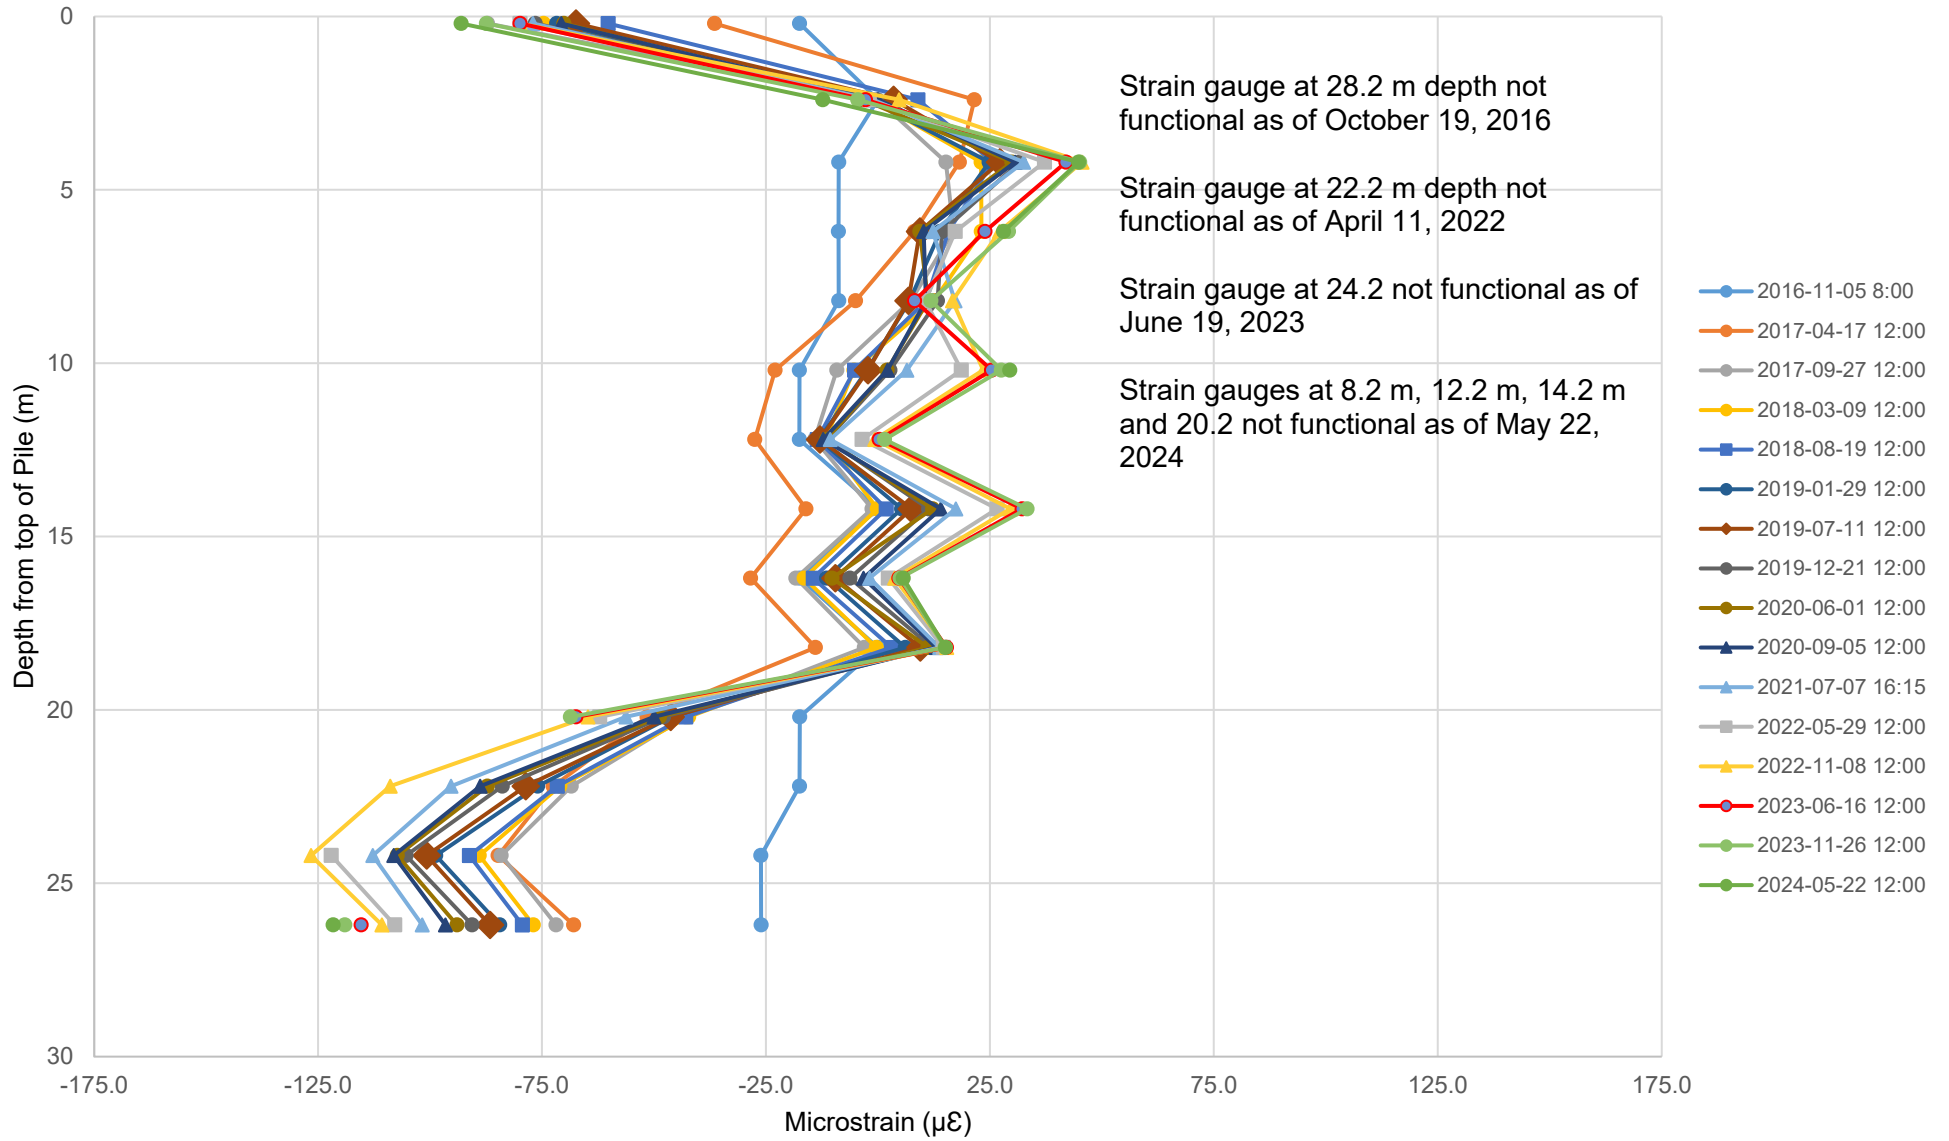
**FIGURE PH070-1**  
**HWY 2:60 PEACE RIVER EAST HILL RETAINING WALL SITE (km 33.84)**  
**PILE P74 DOWNSLOPE SIDE STRAIN GAUGE VALUES VS DEPTH**

The strain gauges generally showed small increases in negative (compressive) strain on the upslope pile face. On the downslope pile face, there was not a clear trend of overall increasing or decreasing strain; seven of the strain gauges on the downslope pile face were not functioning during the current readings which also made it difficult to observe a trend in the strain. The maximum change in microstrain since the previous readings was  $-22.4 \mu\epsilon$ , measured at 20.2 m depth on the upslope pile face.

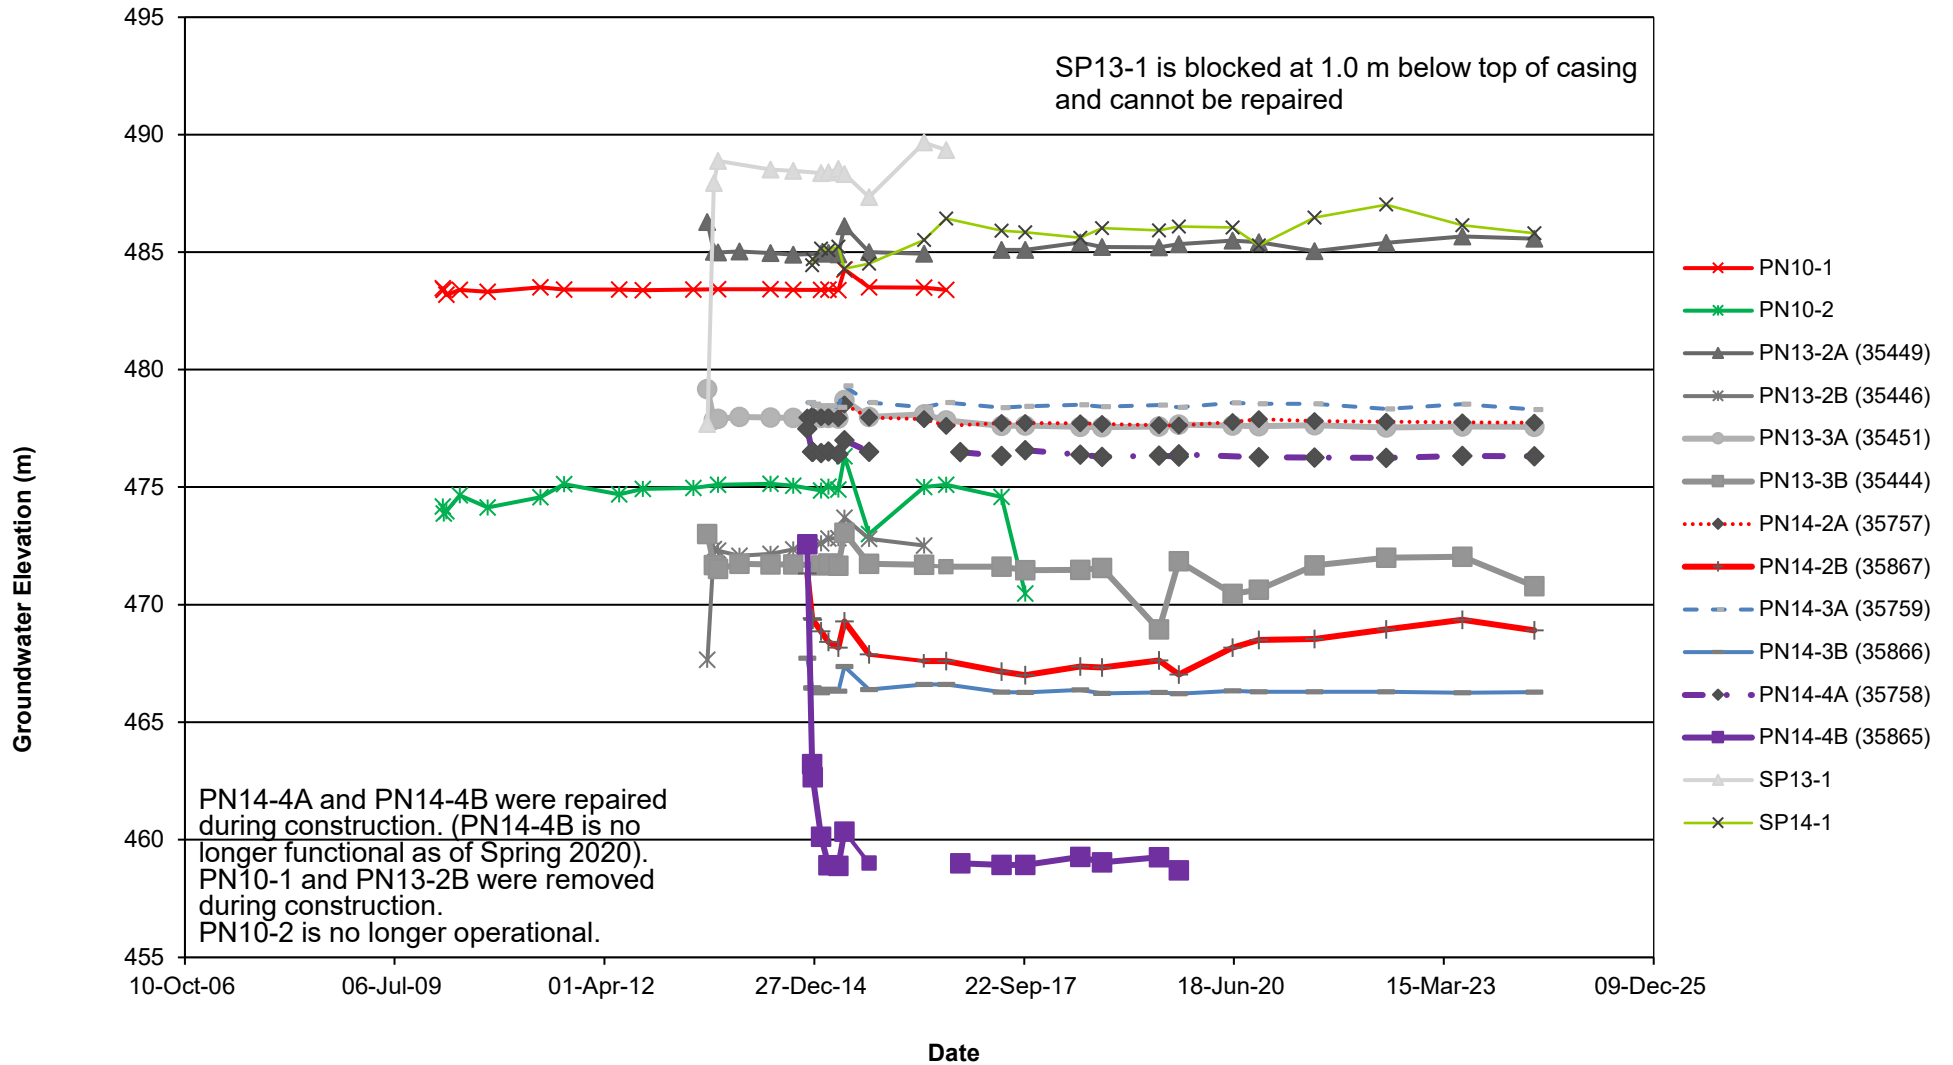
**FIGURE PH070-3  
HWY 2:60 PEACE RIVER EAST HILL RETAINING WALL SITE (km 33.84)  
PIEZOMETRIC ELEVATIONS**

Pneumatic piezometers PN13-2A, PN13-3A, PN13-3B, PN14-2A, PN14-2B, PN14-3A and PN14-4A showed decreases in groundwater level of 0.09 m, 0.01 m, 1.27 m, 0.01 m, 0.45 m, 0.22 m and 0.01 m, respectively, since the spring of 2023 readings. PN14-3B showed an increase in groundwater level of 0.02 m since the spring of 2023 readings.

Overall, the piezometers have shown relatively stable groundwater levels for the past several years, with the exception of PH13-3B which showed a significant drop in groundwater level, and is currently showing the lowest groundwater level measured since the fall of 2020 readings.
