Site Number	Location	Name	Hwy	km
PH070	HWY 2:60 C1 33.840	East Hill Retaining Wall Site	2:60	Km 33.84
<b>Legal Description:</b> 4-27-83-21 W5		<b>UTM Co-ordinates</b>		
		11U E 485285	N	6230649

<b>Current Monitoring:</b>	19-May-2024	<b>Previous Monitoring</b>	12-Jun-2023
<b>Instruments Read By:</b>	Mr. Niraj Regmi, G.I.T and Mr. Nixon Mationg, of Thurber

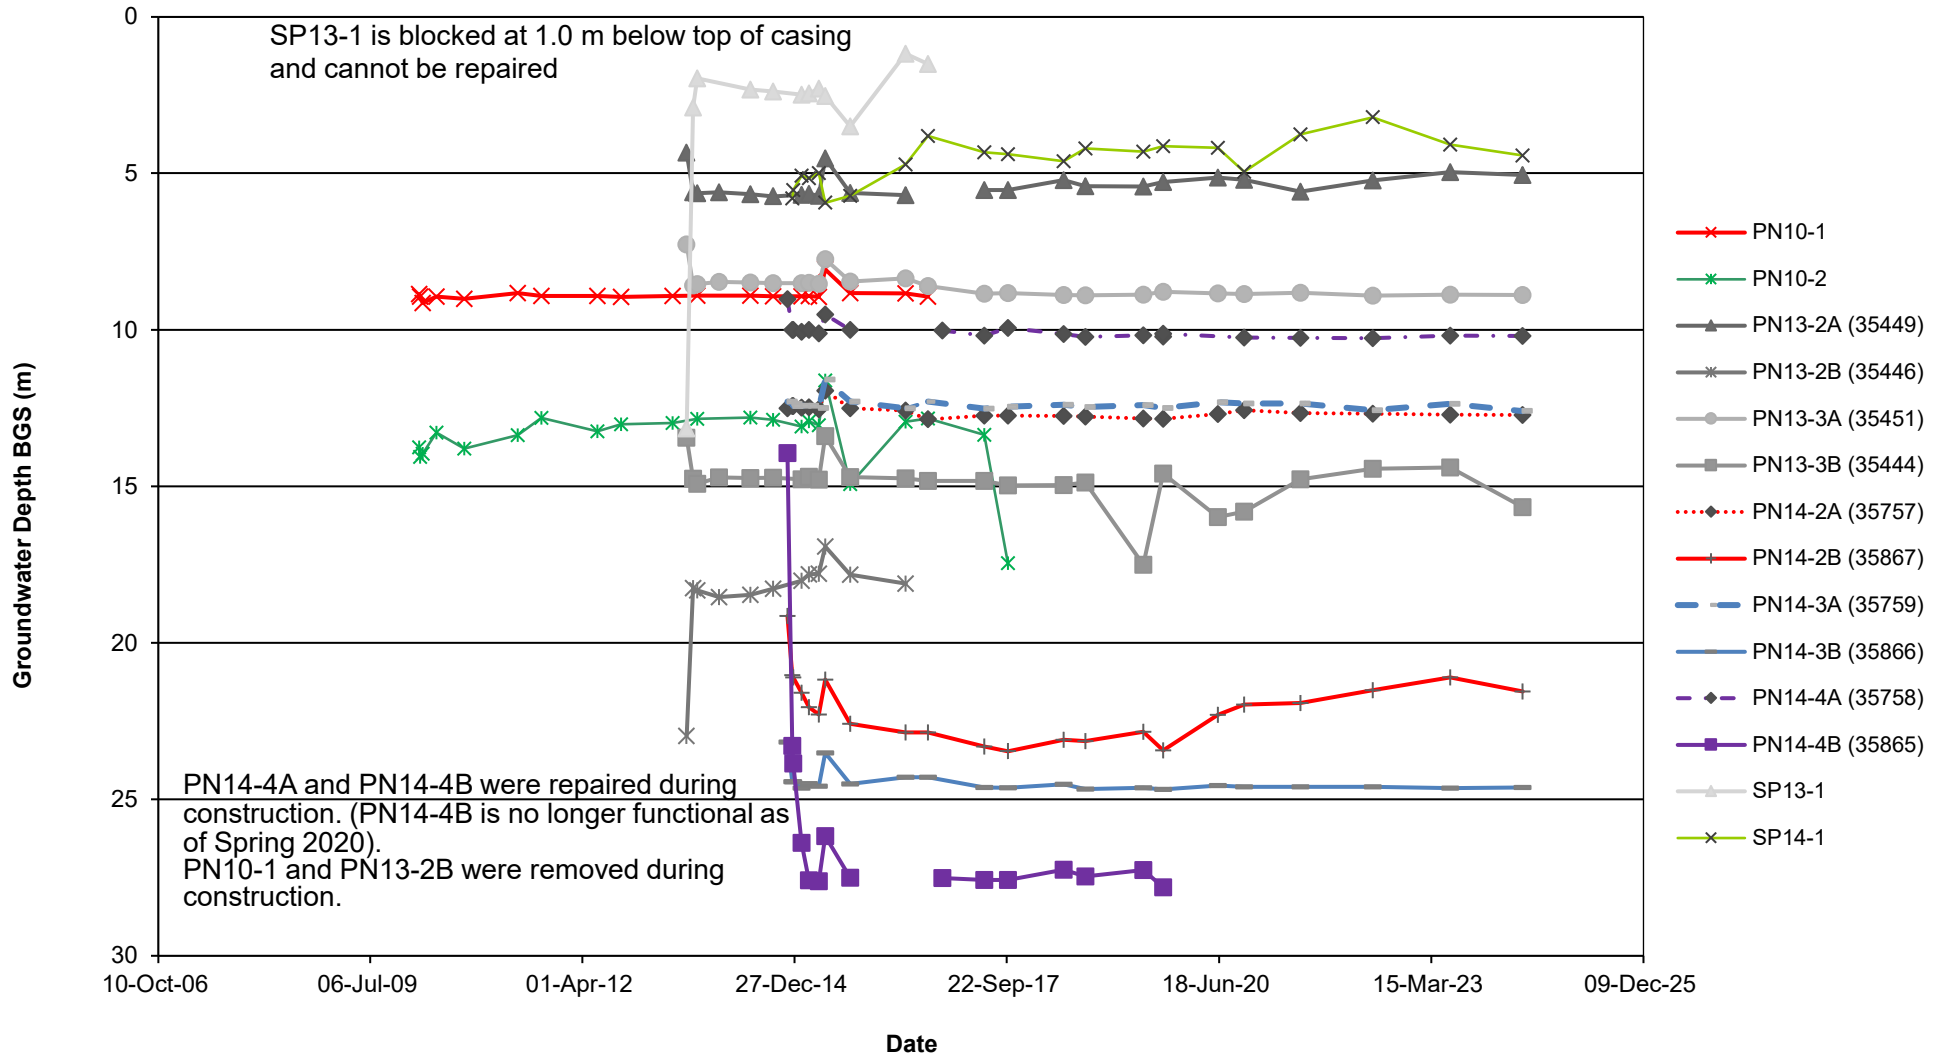
**FIGURE PH070-4**  
**HWY 2:60 PEACE RIVER EAST HILL RETAINING WALL SITE (km 33.84)**  
**PIEZOMETRIC DEPTHS**

Pneumatic piezometers PN13-2A, PN13-3A, PN13-3B, PN14-2A, PN14-2B, PN14-3A and PN14-4A showed decreases in groundwater level of 0.09 m, 0.01 m, 1.27 m, 0.01 m, 0.45 m, 0.22 m and 0.01 m, respectively, since the spring of 2023 readings. PN14-3B showed an increase in groundwater level of 0.02 m since the spring of 2023 readings.

Standpipe piezometer SP14-1 showed a decrease in groundwater level of 0.34 m since the spring of 2023 readings.

Overall, the piezometers have shown relatively stable groundwater levels for the past several years, with the exception of PH13-3B which showed a significant drop in groundwater level, and is currently showing the lowest groundwater level measured since the fall of 2020 readings.

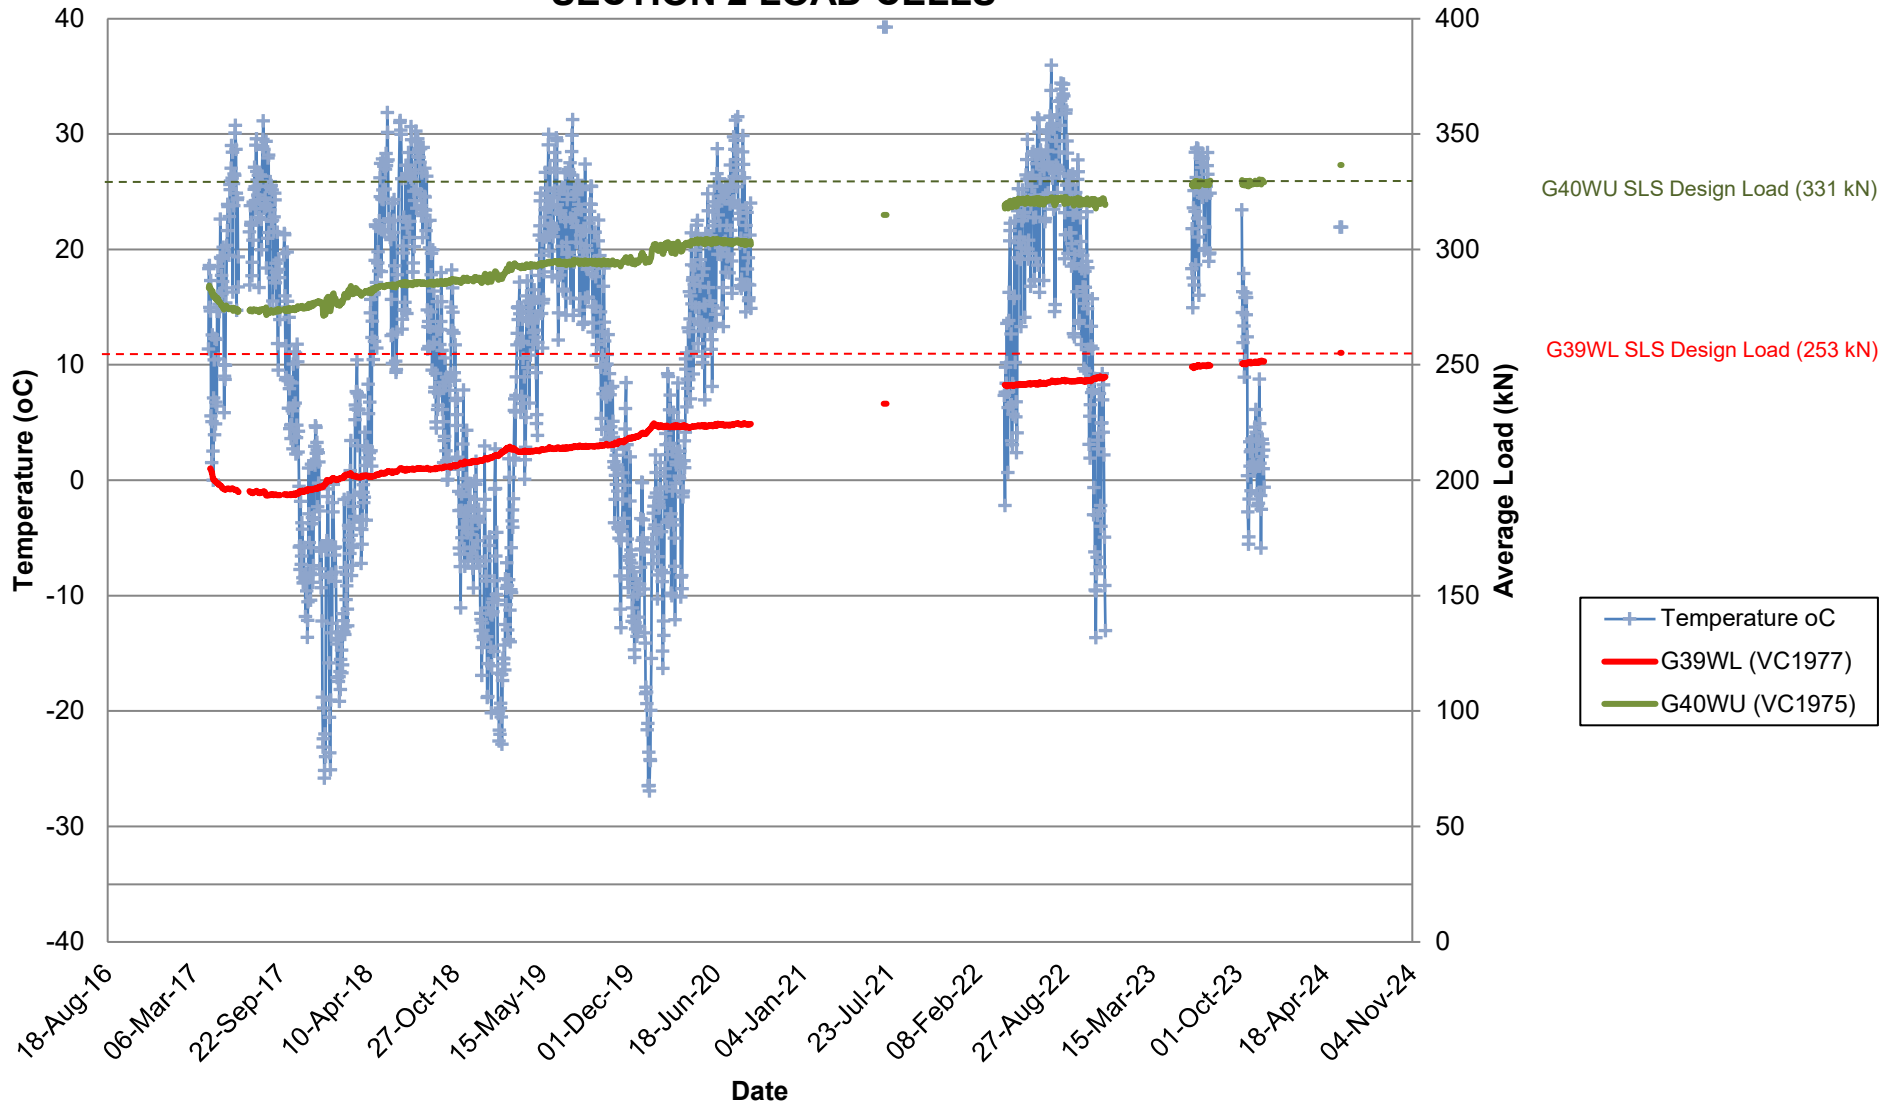
# FIGURE PH070-5 HWY 2:60 PEACE RIVER EAST HILL RETAINING WALL SITE (km 33.84) SECTION 2 LOAD CELLS

The majority of the load cells showed an increase in measured load compared to the spring of 2023 readings, ranging from 0.01 kN in VC1976 (anchor G102WL) to 25.97 kN in VC1968 (anchor G190PL). Load cells VC2023

<p>(G182PL) showed a decrease in measured load of 1.08 kN since the spring of 2023 readings. The current loads for load cells VC1977 (anchor G39WL), VC1975 (anchor G40WU) and VC1972 (anchor G58WU) are the highest ever recorded by the respective load cells. It should also be noted that the datalogger did not record any readings between November 29, 2023 and May 22, 2024, when the datalogger was manually read on site. Historically, the load cells have registered higher loads during the winter months, which may have been missed during the last winter.</p> <p>Anchors G39WL and G40WU in Wall Section 2 currently show a trend of gradually increasing load. G39WL and G40WU are currently 2.24 kN and 5.58 kN, respectively, above their SLS design loads. Anchor G58WU in Wall Section 3A also shows a trend of slowly increasing loads, and the current load is currently 16.85 kN above the SLS design load. Anchor G190PL, in the bottom (fifth) row of anchors in Wall Section 4, shows a trend of increasing load, however the design of the wall assumes that the anchors installed through the piles in this wall section will pick up load over time.</p> <p>Load cells VC2023, VC2024, and VC2025 were installed on stiff anchors (G182PL, G188PL and G202PL', respectively) that were left with some slack to allow the piles to deform before the anchors pick up load. These anchors are located in wall Design Section 4. These load cells were connected to the datalogger on September 27, 2017. These load cells indicate current loads ranging from 13.58 kN to 16.15 kN, and these anchors have not shown significant changes in the loads since the end of construction, suggesting that there may still be some slack at the nut in these anchors.</p> <p>The load cells on G80WU and G80WL in Design Section 4 are showing loads that are 57.25 kN and 24.04 kN above SLS design load, respectively. However, these anchors were intentionally locked off at a higher load than the SLS load during construction, with the expectation that they would slacken over time.</p>
