**ALBERTA TRANSPORTATION
GEOHAZARD ASSESSMENT PROGRAM
PEACE REGION – PEACE-HIGH LEVEL
2017 INSPECTION**

Site Number	Location	Name	Hwy	km
PH009-2	Peace River	Shafsbury Trail - Overpass Slide	2:62	1.299
Legal Description		UTM Co-ordinates		
SW¼ 31-083-21 W5M		11V E 480201	N 6232475

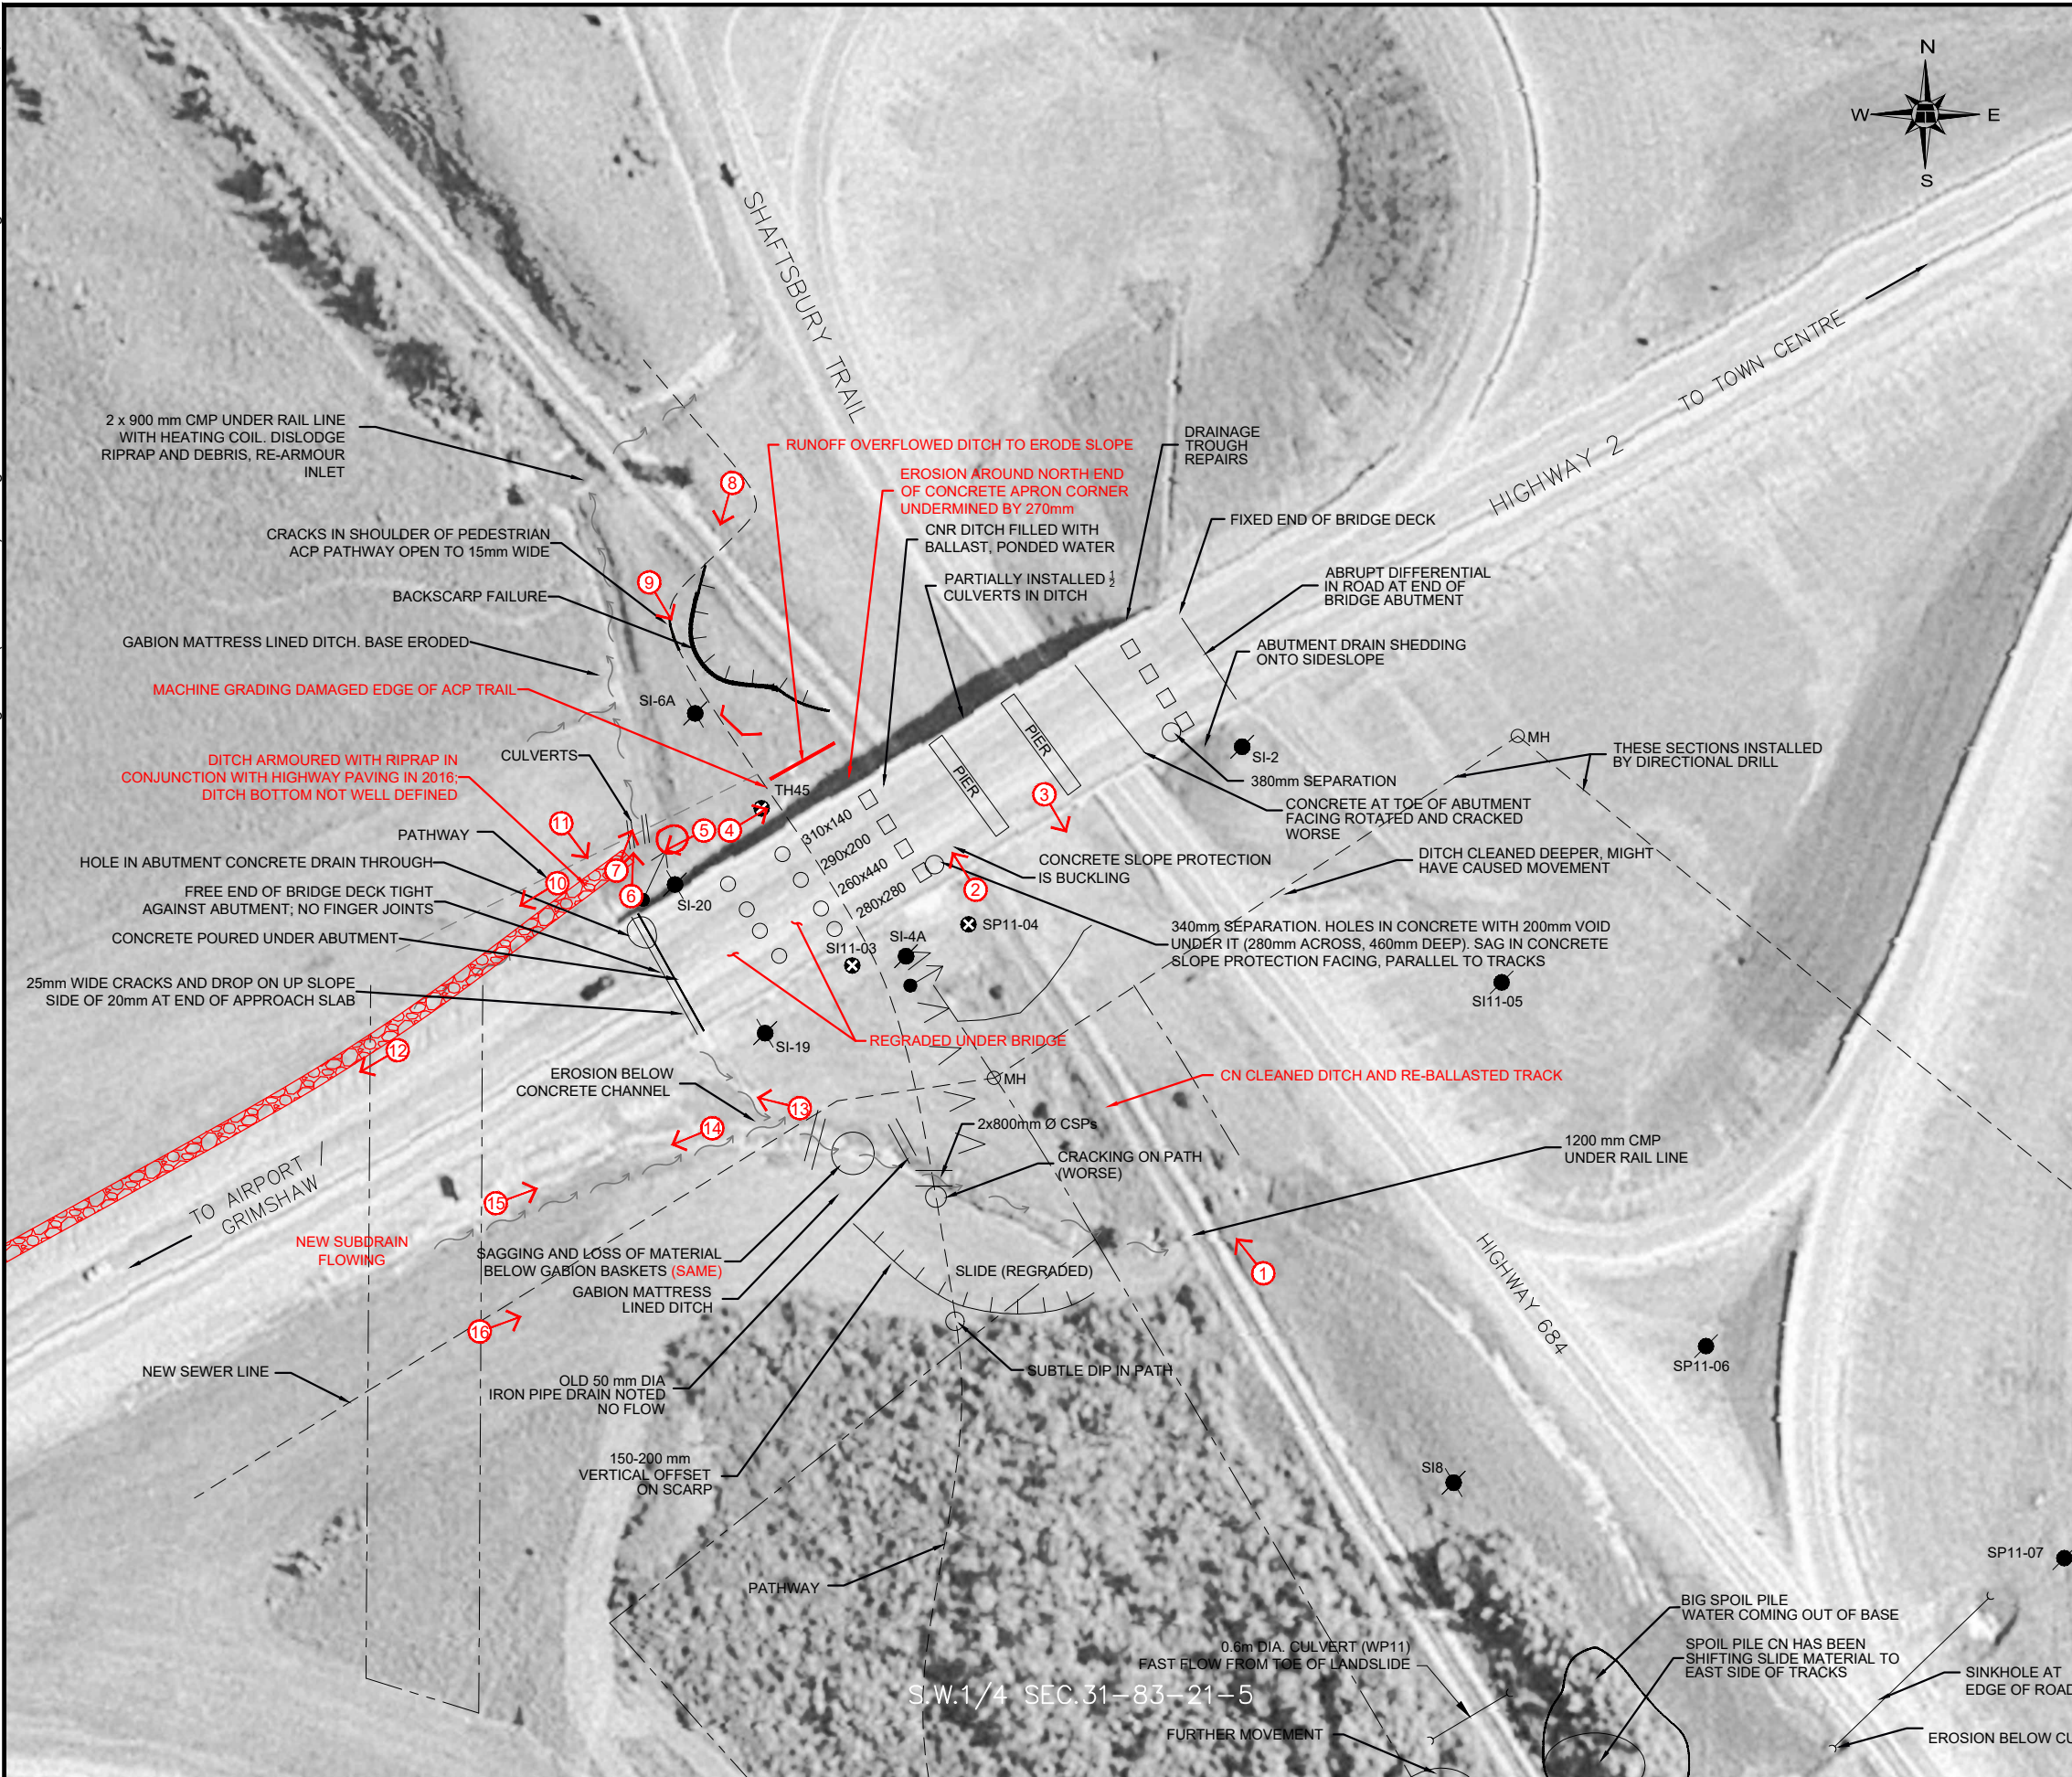
- LEGEND**
- INSTRUMENT
 - SPRING OR SEEPAGE
 - INSTRUMENT (INACTIVE)
 - SLOPE INCLINOMETER
 - AECOM INSTRUMENT
 - DIRECTION AND PHOTO NUMBER
 - 2016 BURIED STORM DRAIN

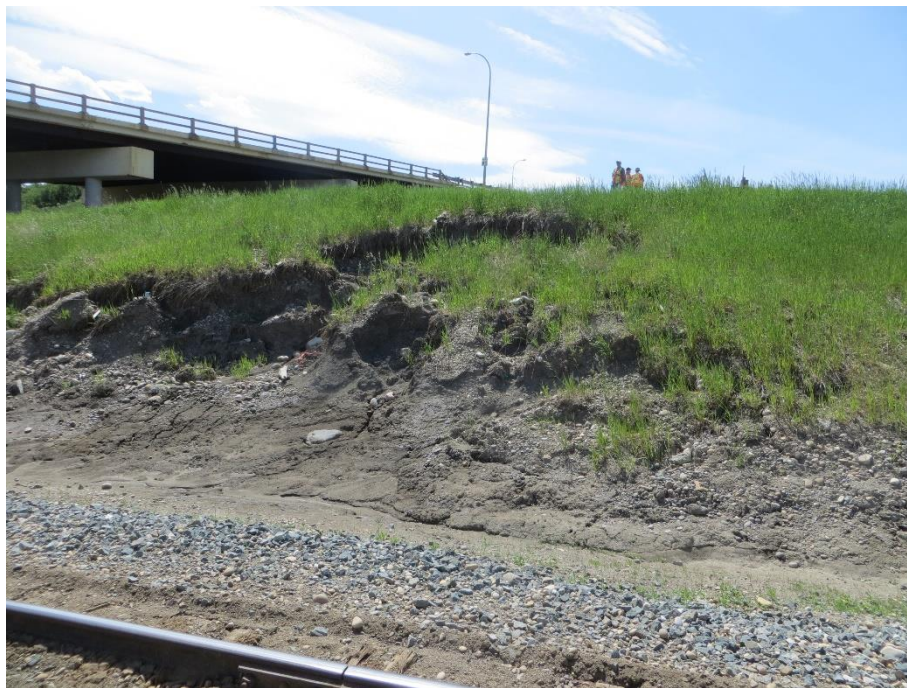
Photo 8.
Looking
southwest at the
small backslope
failure above the
CNR railway line
and ACP trail the
runs beneath the
west abutment.

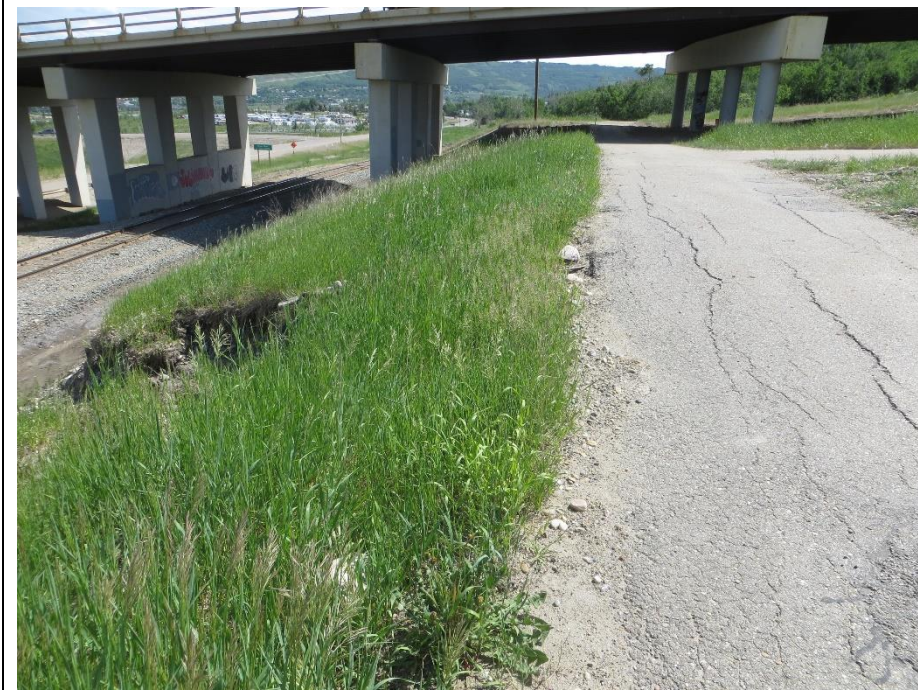
Photo 9.
Looking southeast at the cracks forming in the ACP trail above the small backlope failure above the CNR railway line.

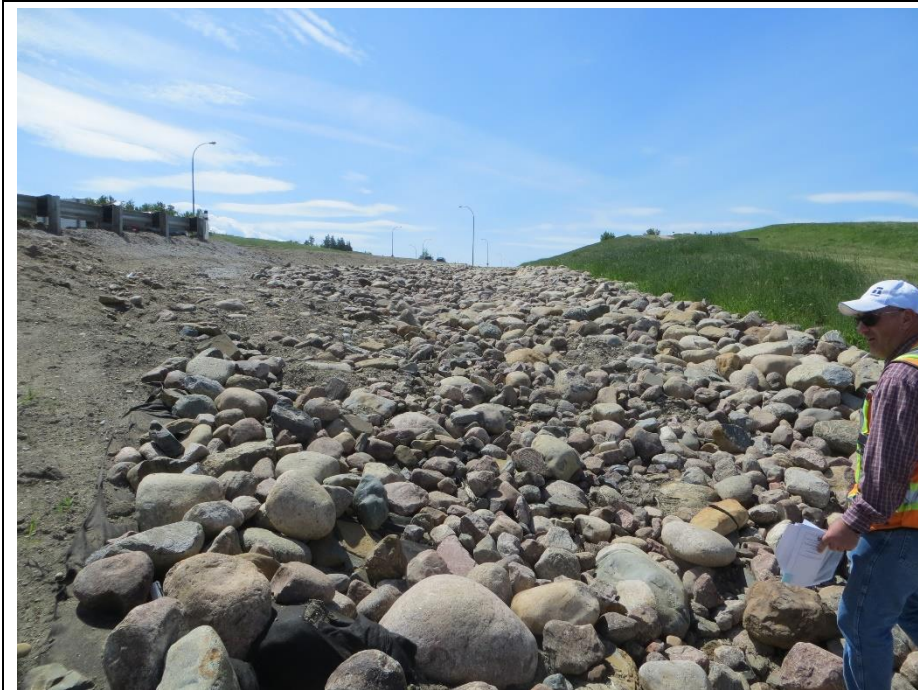
Photo 10.
Looking southwest at the rip rap placed in 2016 on the regraded WBL ditch bottom.
