November 6, 2023

**ALBERTA TRANSPORTATION AND ECONOMIC CORRIDORS GRMP (CON0022164)
PEACE REGION (PEACE RIVER DISTRICT)
INSTRUMENTATION MONITORING RESULTS – FALL 2023**

SECTION C

SITE PH009: OLD HWY 2:02 SHOP SLIDE

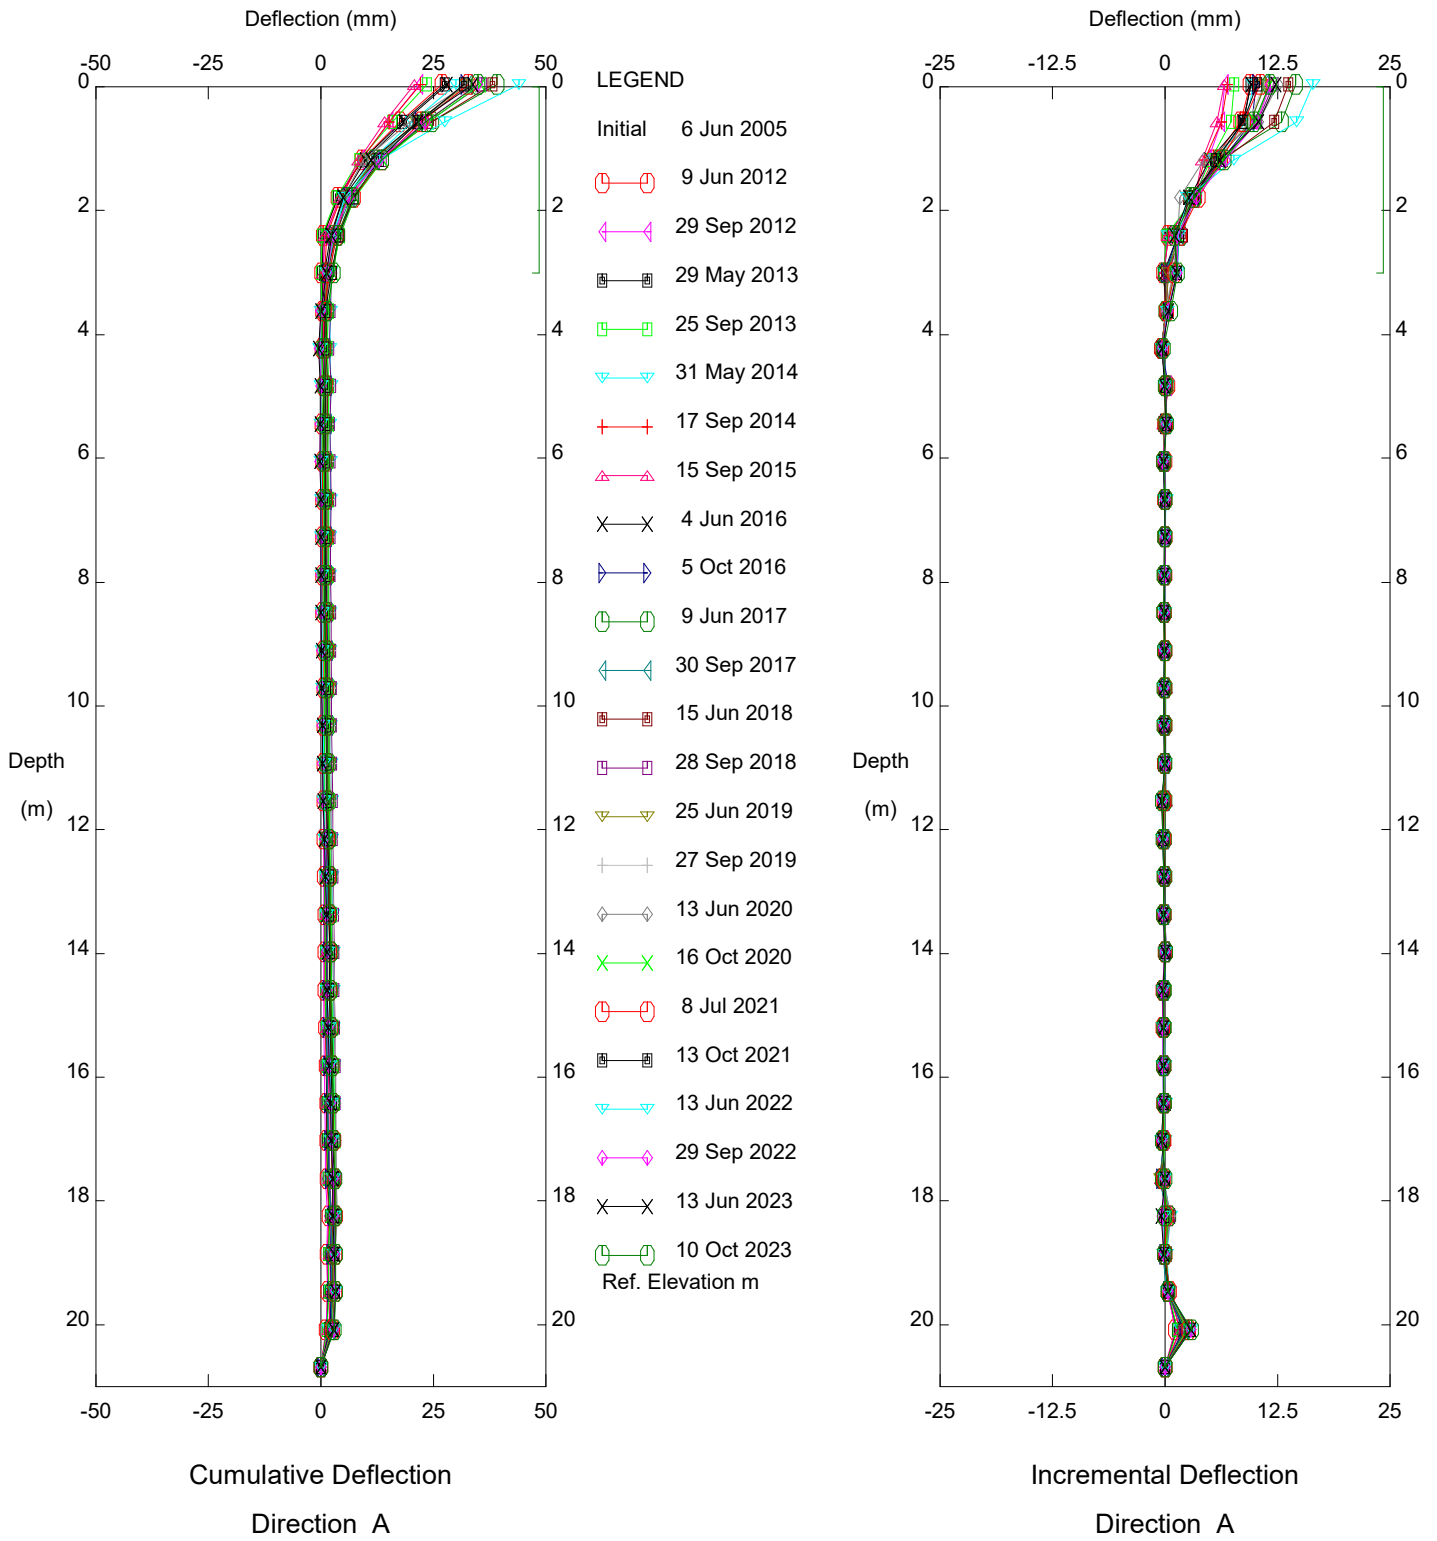
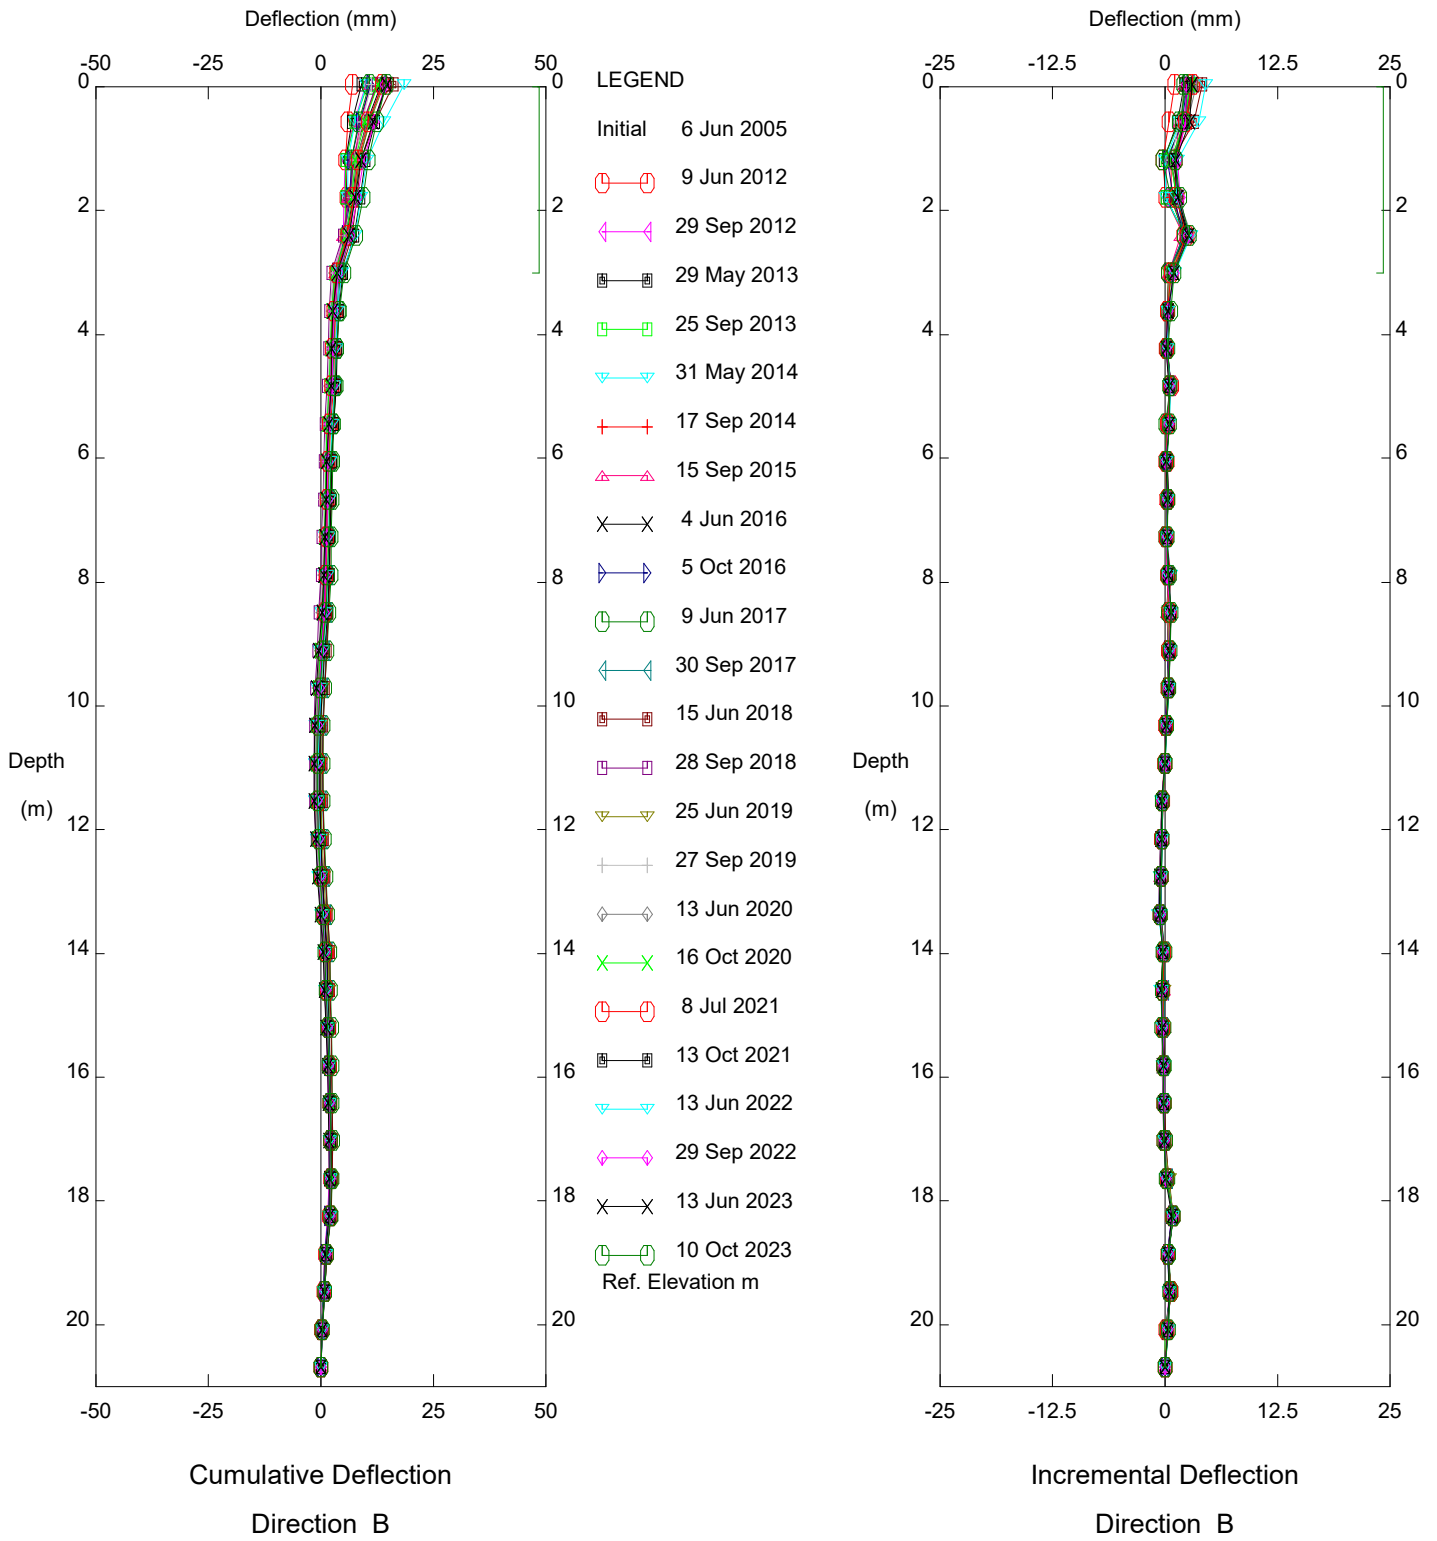
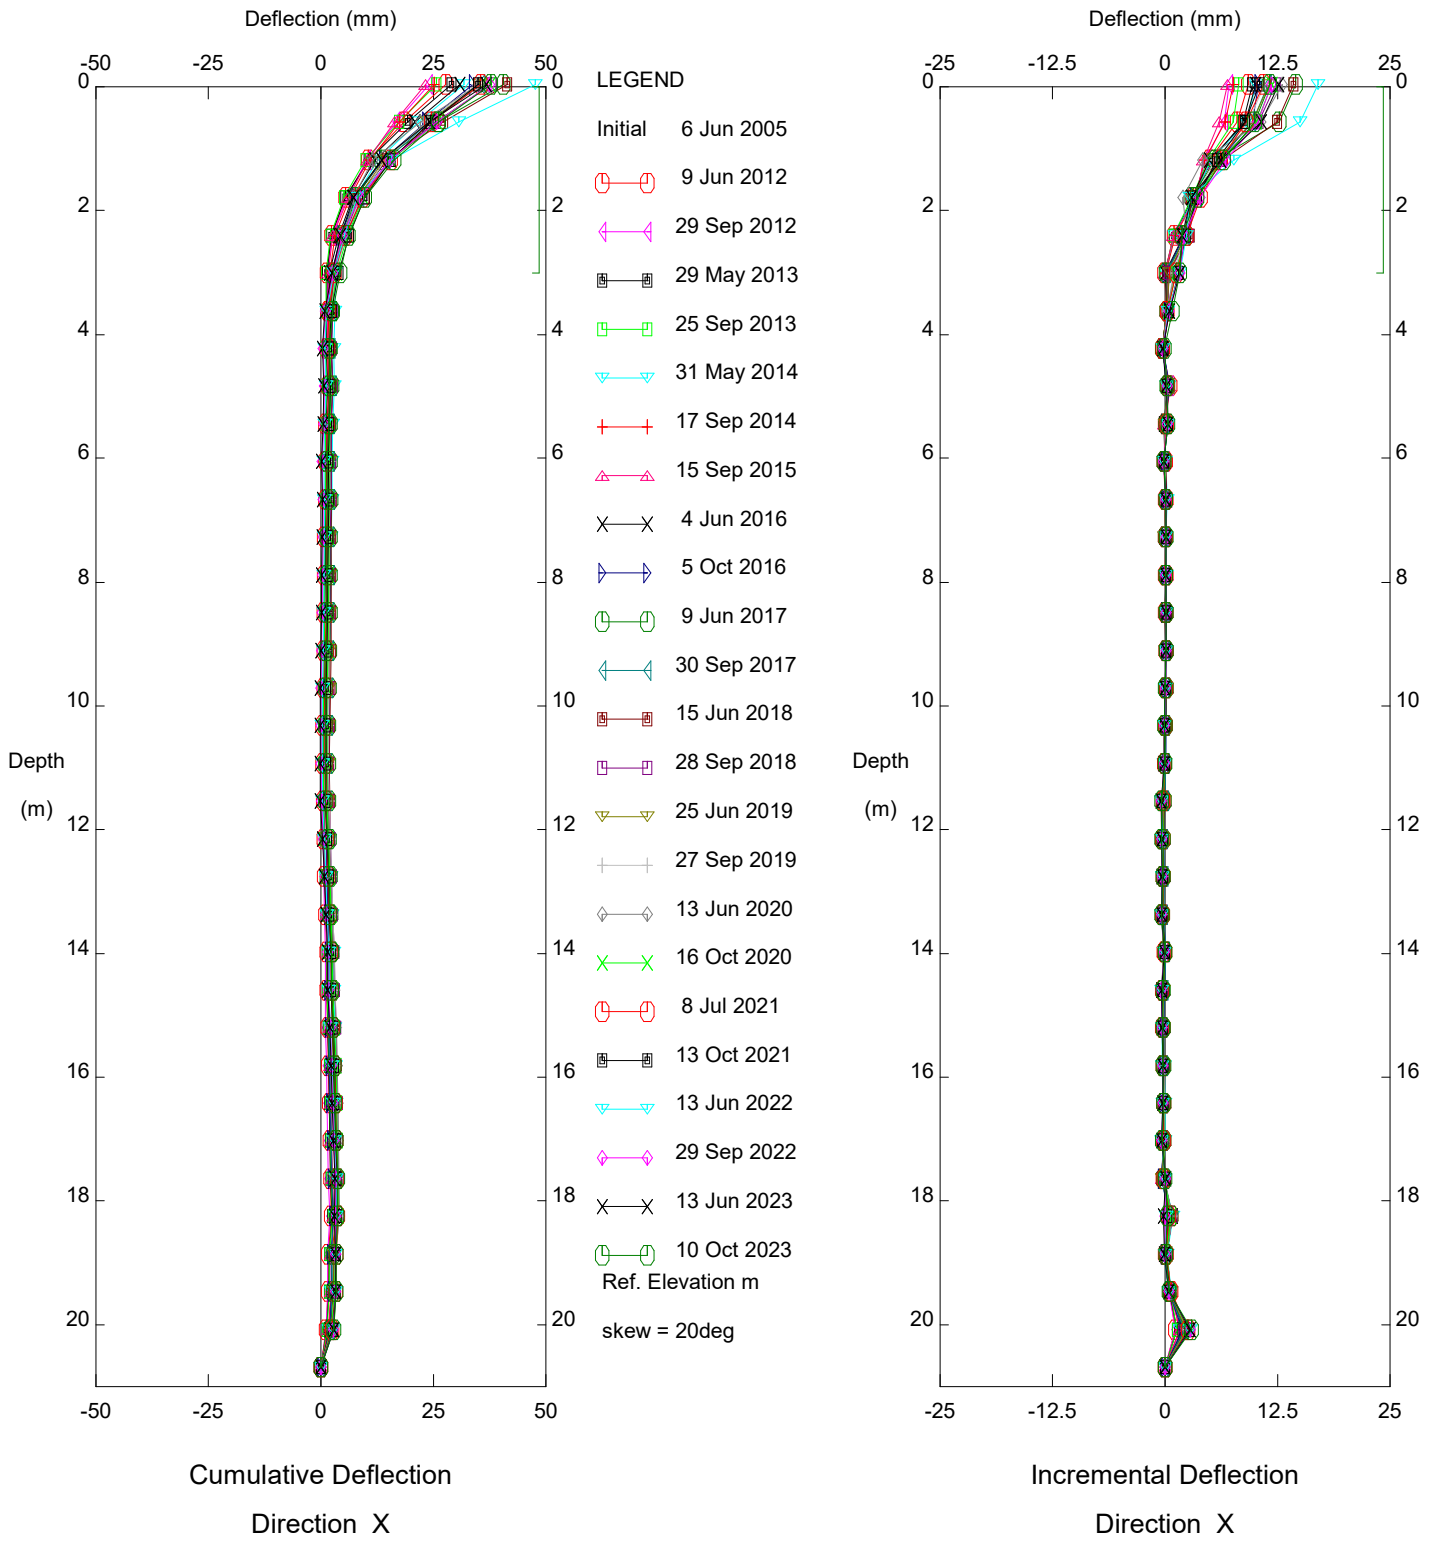
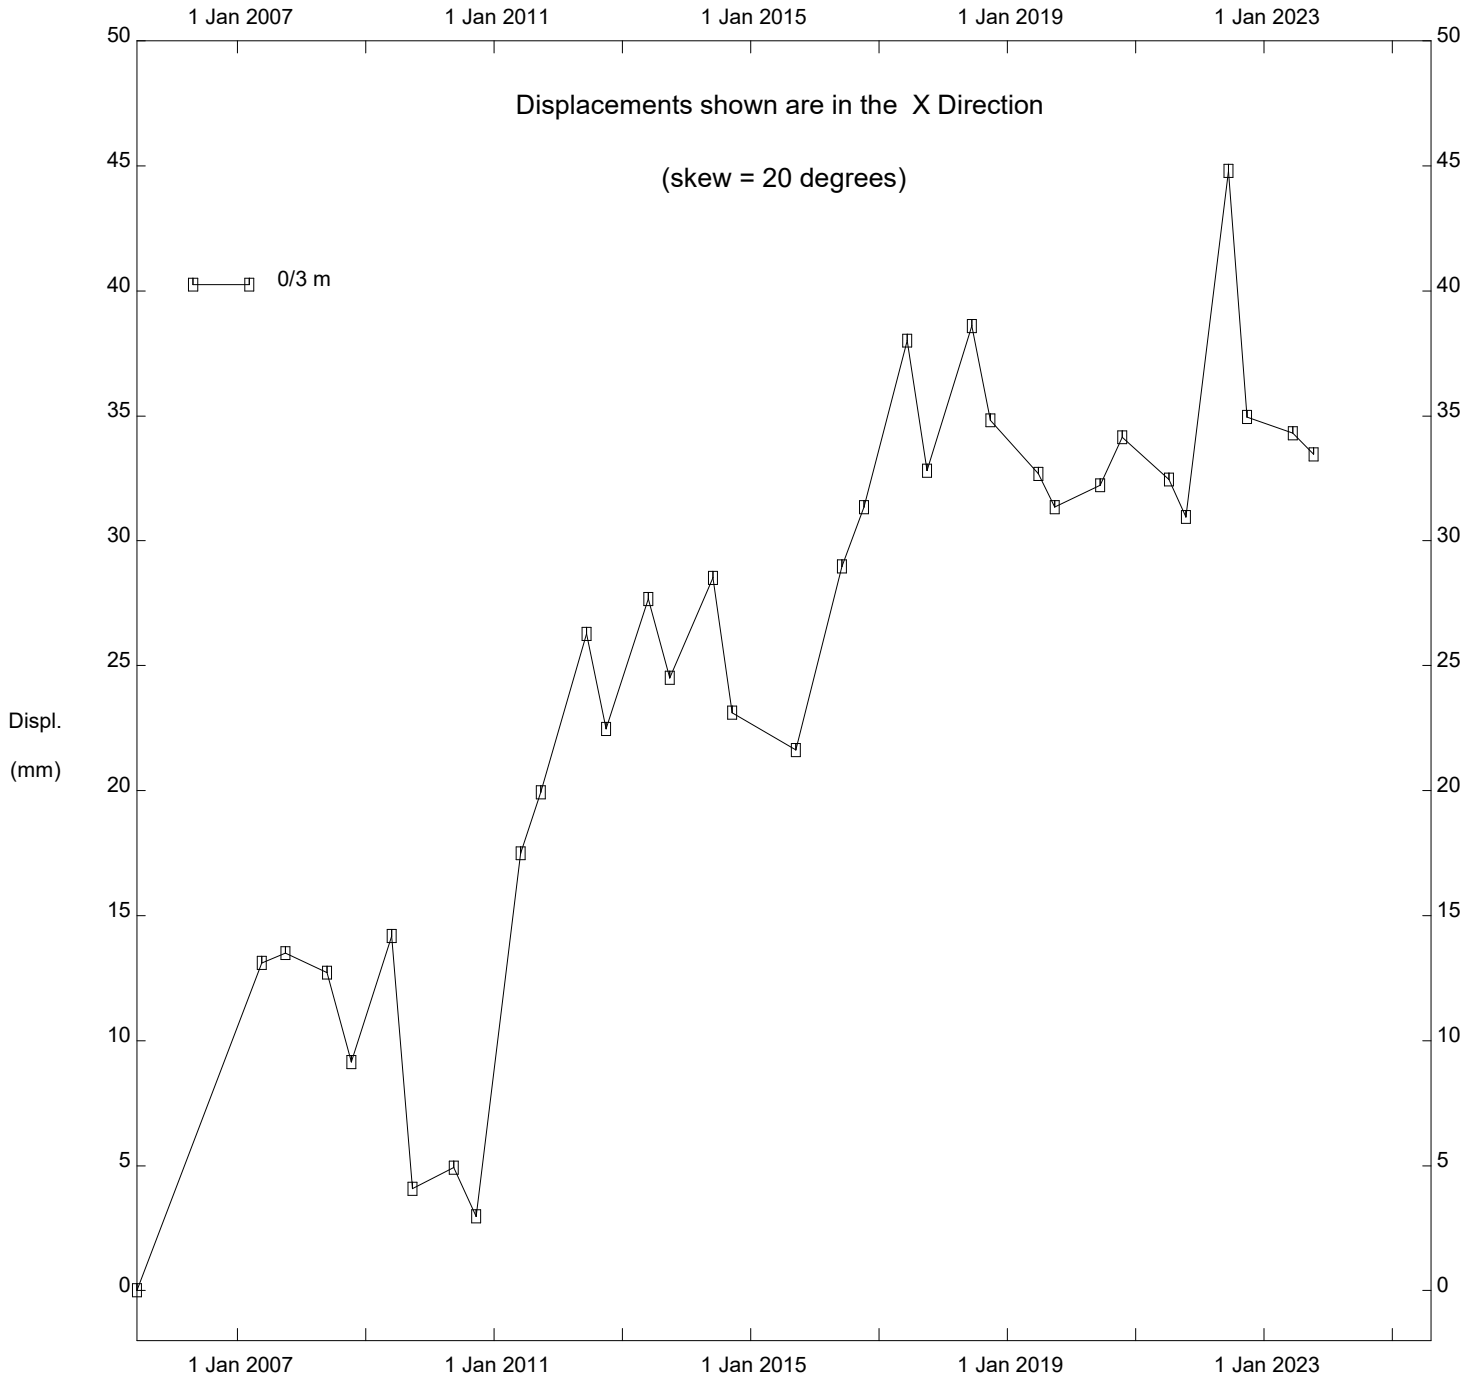
PH009 Old Hwy 2:02 Shop Slide, Inclinometer SI05-1

Slope inclinometer SI05-1 showed no discernible movement over 0.0 m to 3.0 m depth since the spring of 2023 readings. The slight incremental deflection at about 20 m in SI05-1 appears to be an artifact from one reading as there has been no further displacement at that depth. SI09-3 continued to show no discernible movement. SI09-4 showed no discernible movement over 8.6 m to 10.5 m depth and 0.3 mm/yr over 8.6 m to 10.5 m depth and 11.7 m to 13.5 m depth, respectively, since the spring of 2023 readings. These movement zones were first observed in 2021 during construction and displacement has been gradually levelling off with each subsequent set of readings. Inclinometer SI09-4 was slightly damaged during construction but was repaired at the completion of grading. SI11-01 had a rate of movement of 2.6 mm/yr over 13.9 m to 16.3 m depth. SI11-01 had a maximum rate of movement of 34.3 mm/yr over this zone in June 14, 2022, near the end of construction; however, the movement rate has decreased for three consecutive readings cycles indicating it may be approaching a stable state. SI19-5 showed no discernible movement over 8.2 m to 11.2 m depth over 17.9 m to 19.7 m depth. The overall movement in SI19-5 has slowed significantly since slope offloading and the completion of construction.

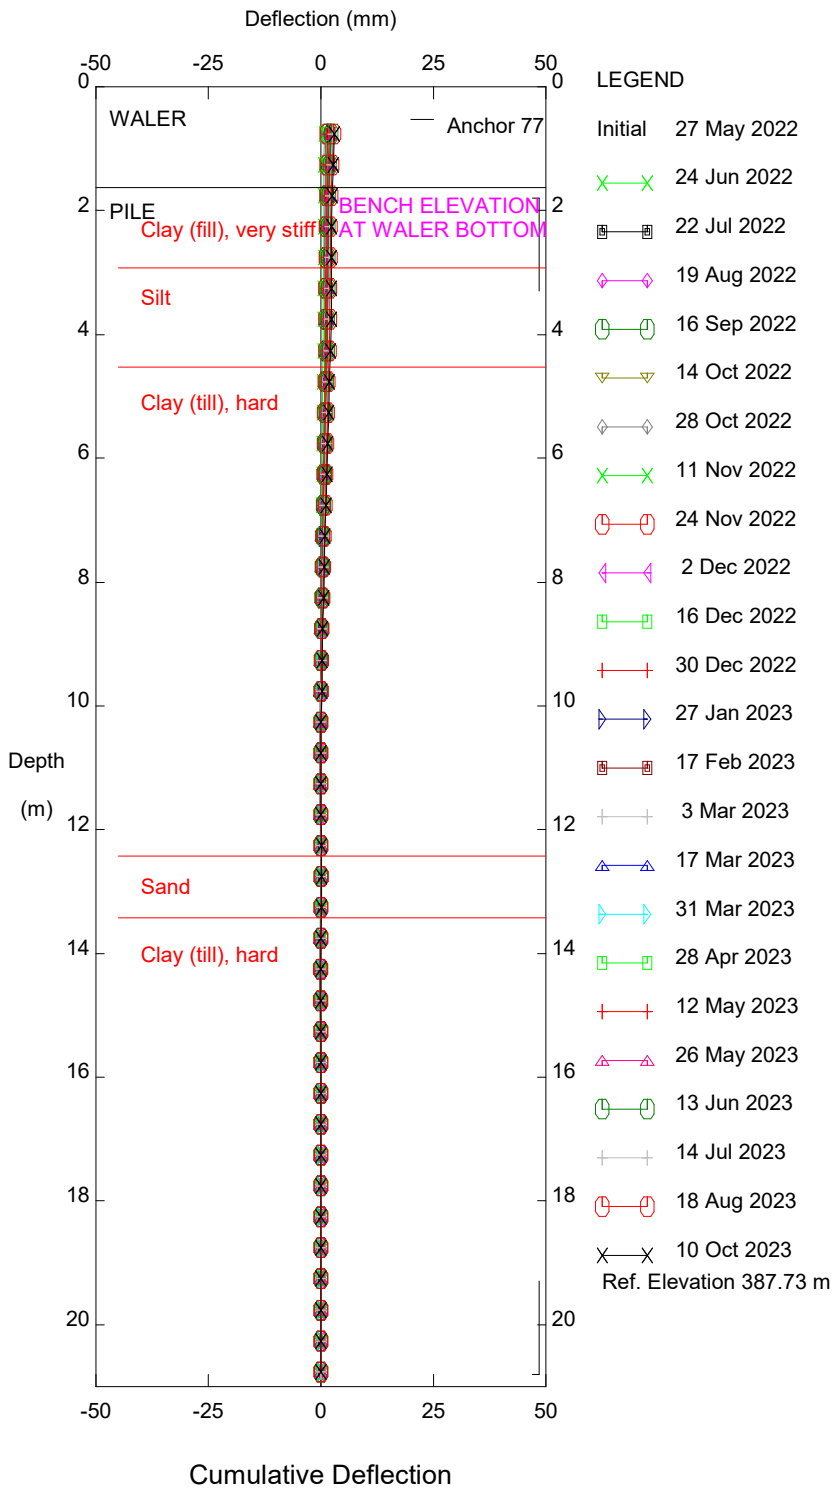
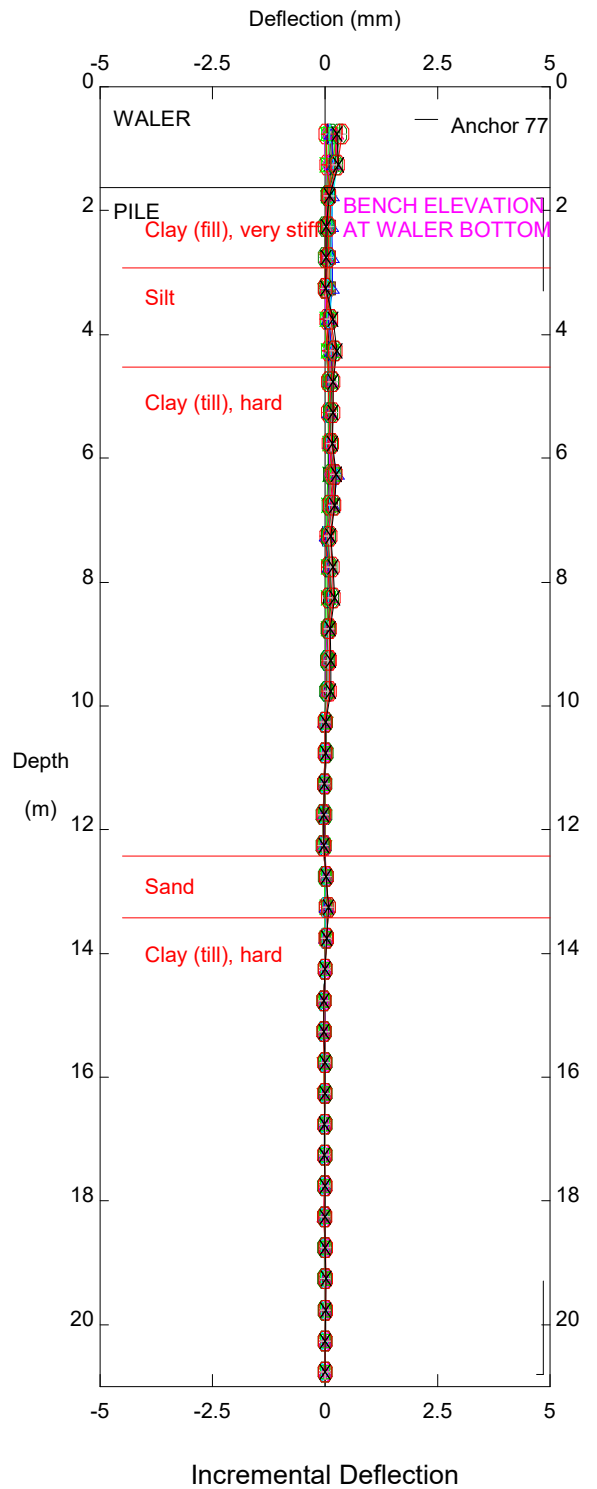
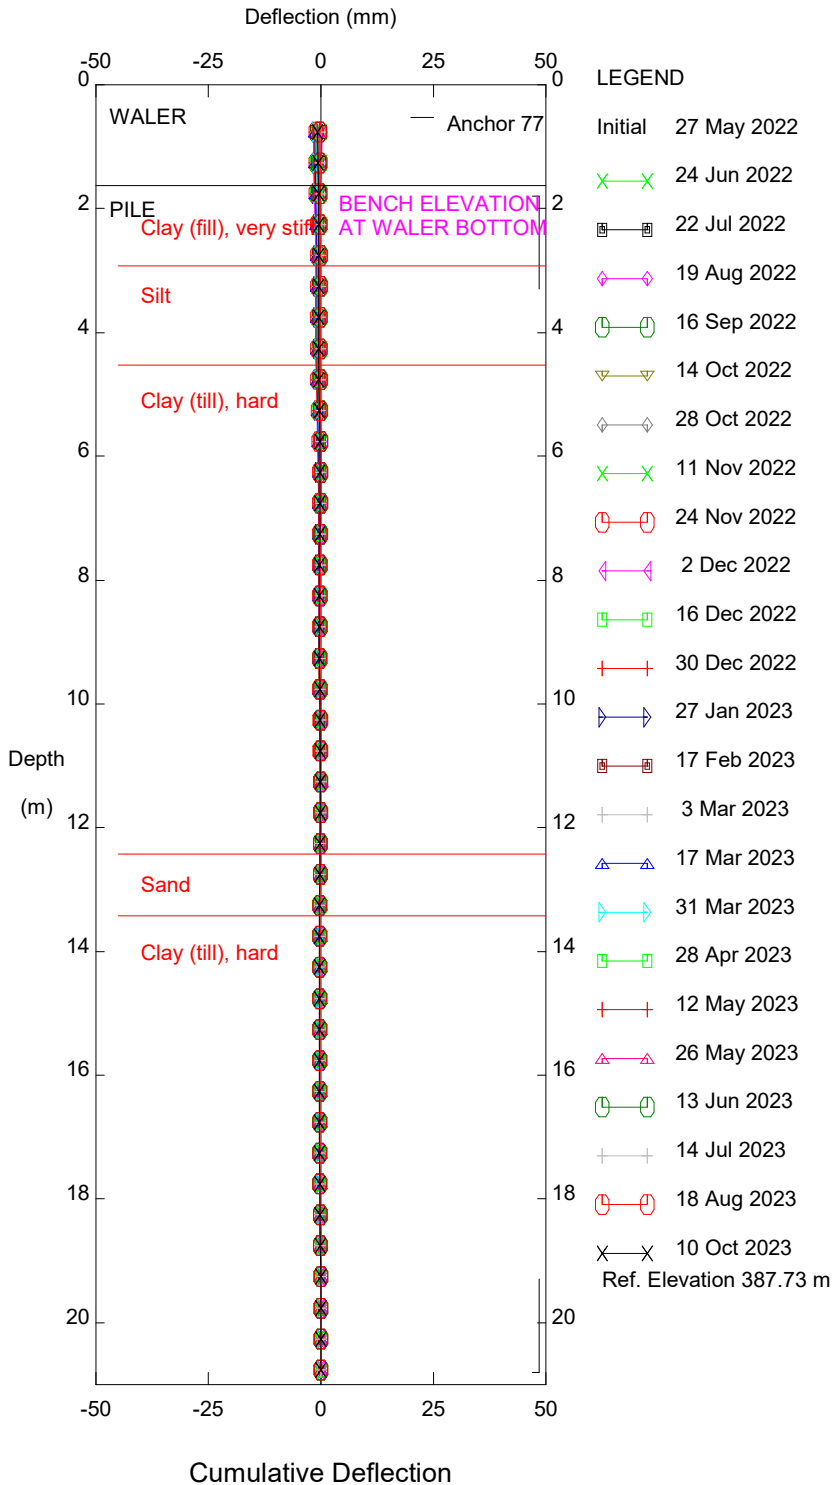
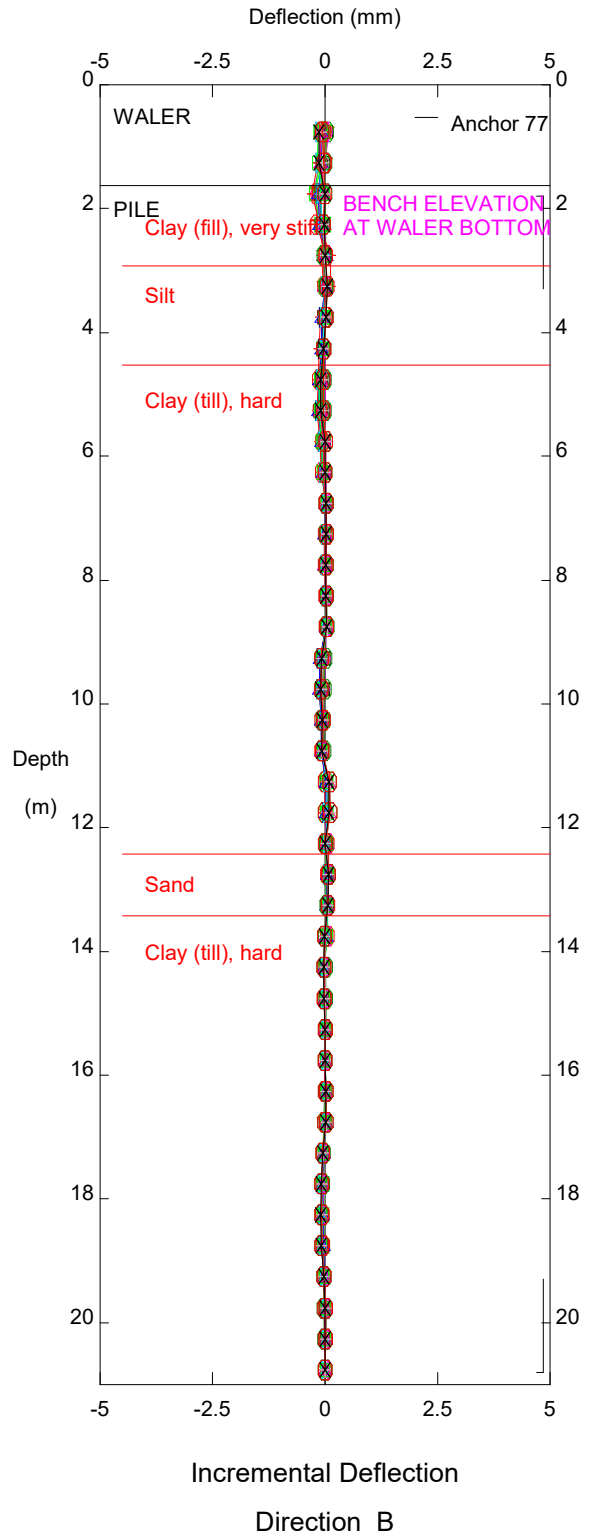
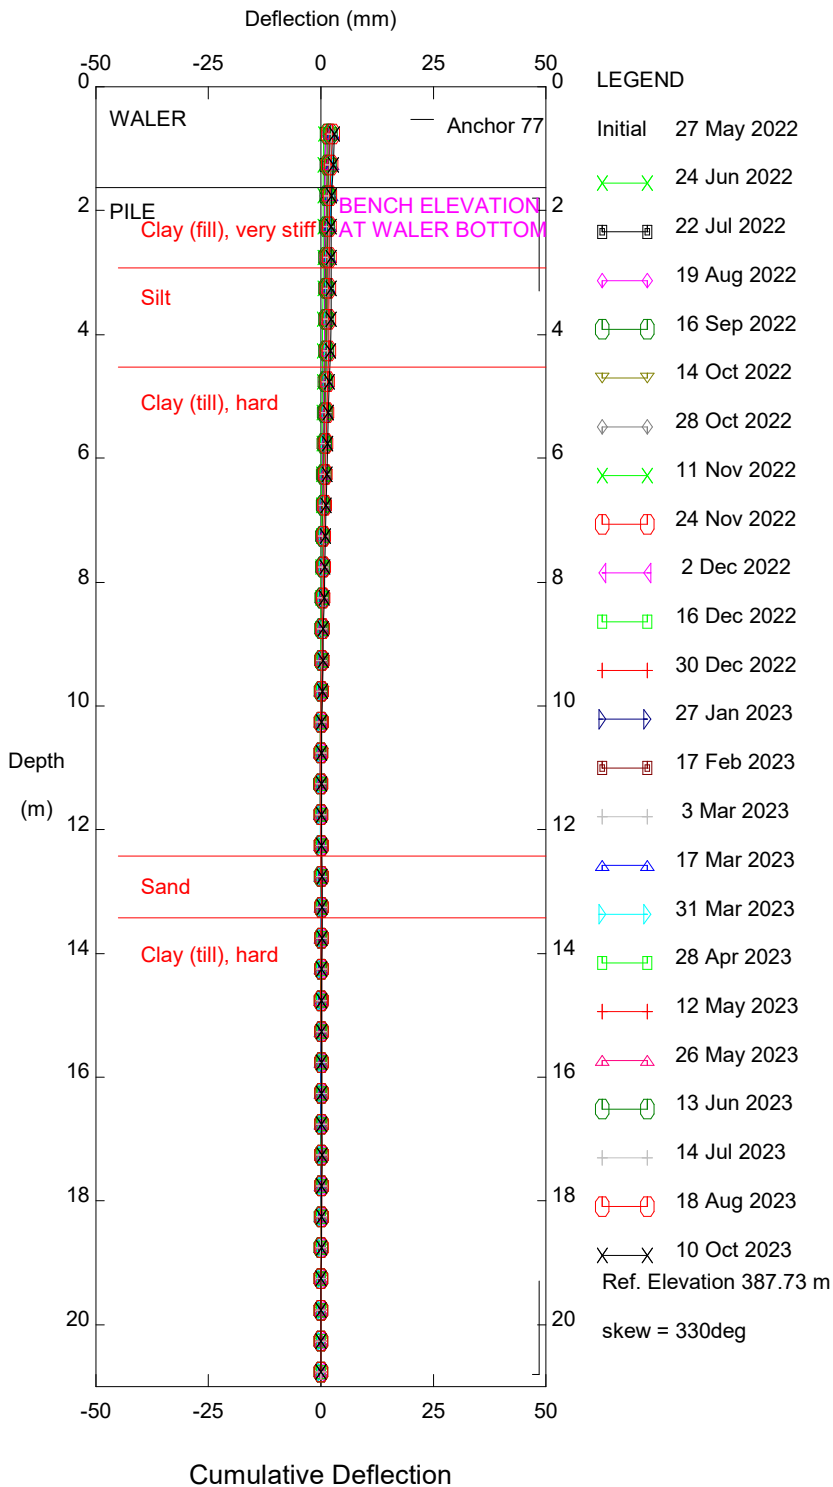
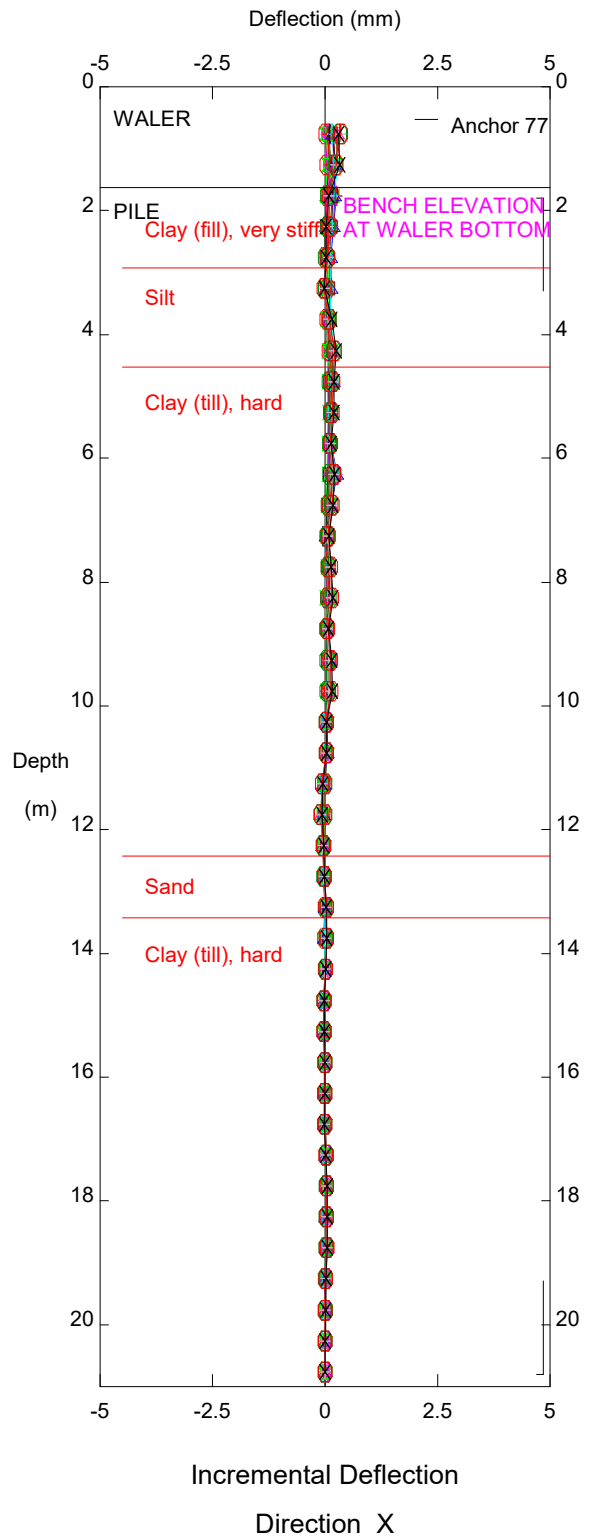
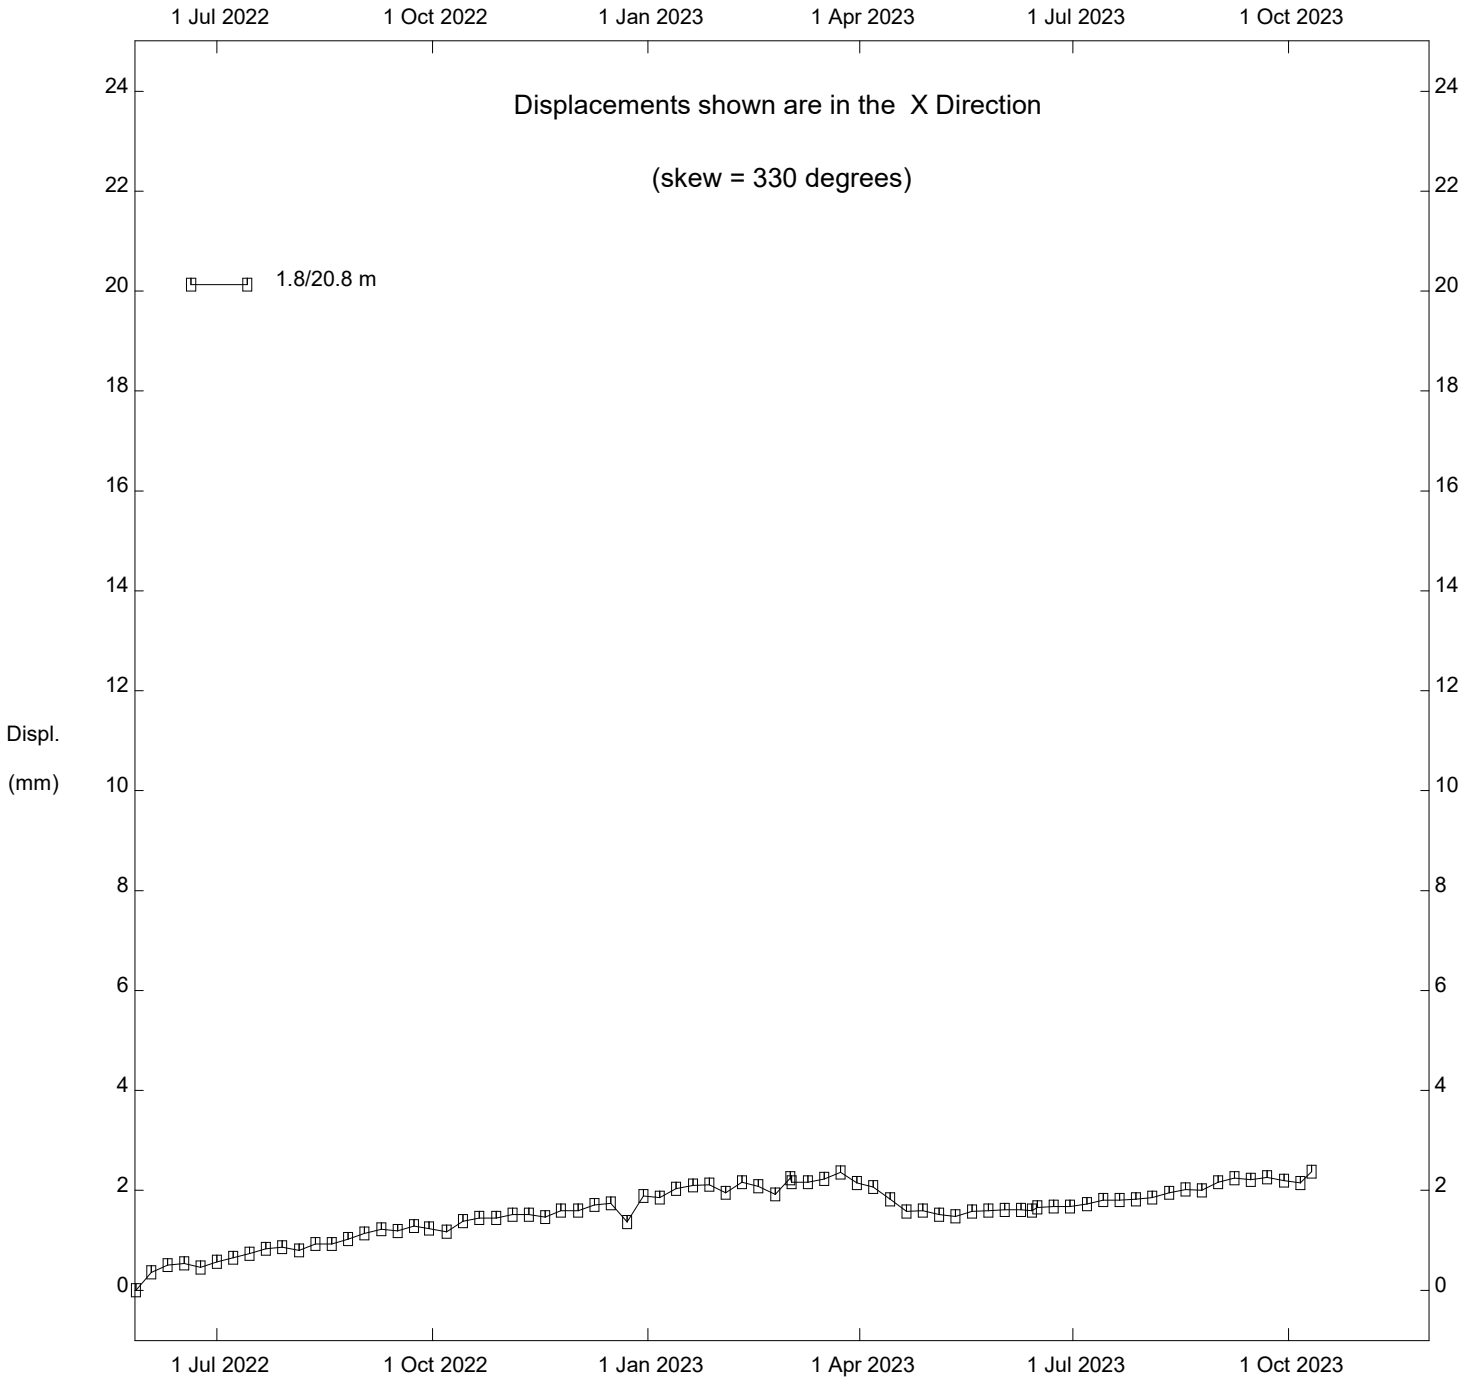
SAA-P77 showed a rate of movement of 2.4 mm/yr since the spring of 2023 readings. SAA-P77 has shown a total pile head movement of 2.4 mm since datalogger readings began on May 27, 2022. SAA-P77 had a maximum pile head deflection of about 2.4 mm in March 2023 before dropping off to 1.5 mm in May 2023, as was observed at SAA-P34. The rate of movement has been similar to that observed before the April 2023 drop. The total pile head
