November 6, 2023

**ALBERTA TRANSPORTATION AND ECONOMIC CORRIDORS GRMP (CON0022164)
PEACE REGION (PEACE RIVER DISTRICT)
INSTRUMENTATION MONITORING RESULTS – FALL 2023**

SECTION C

SITE PH009: OLD HWY 2:02 SHOP SLIDE

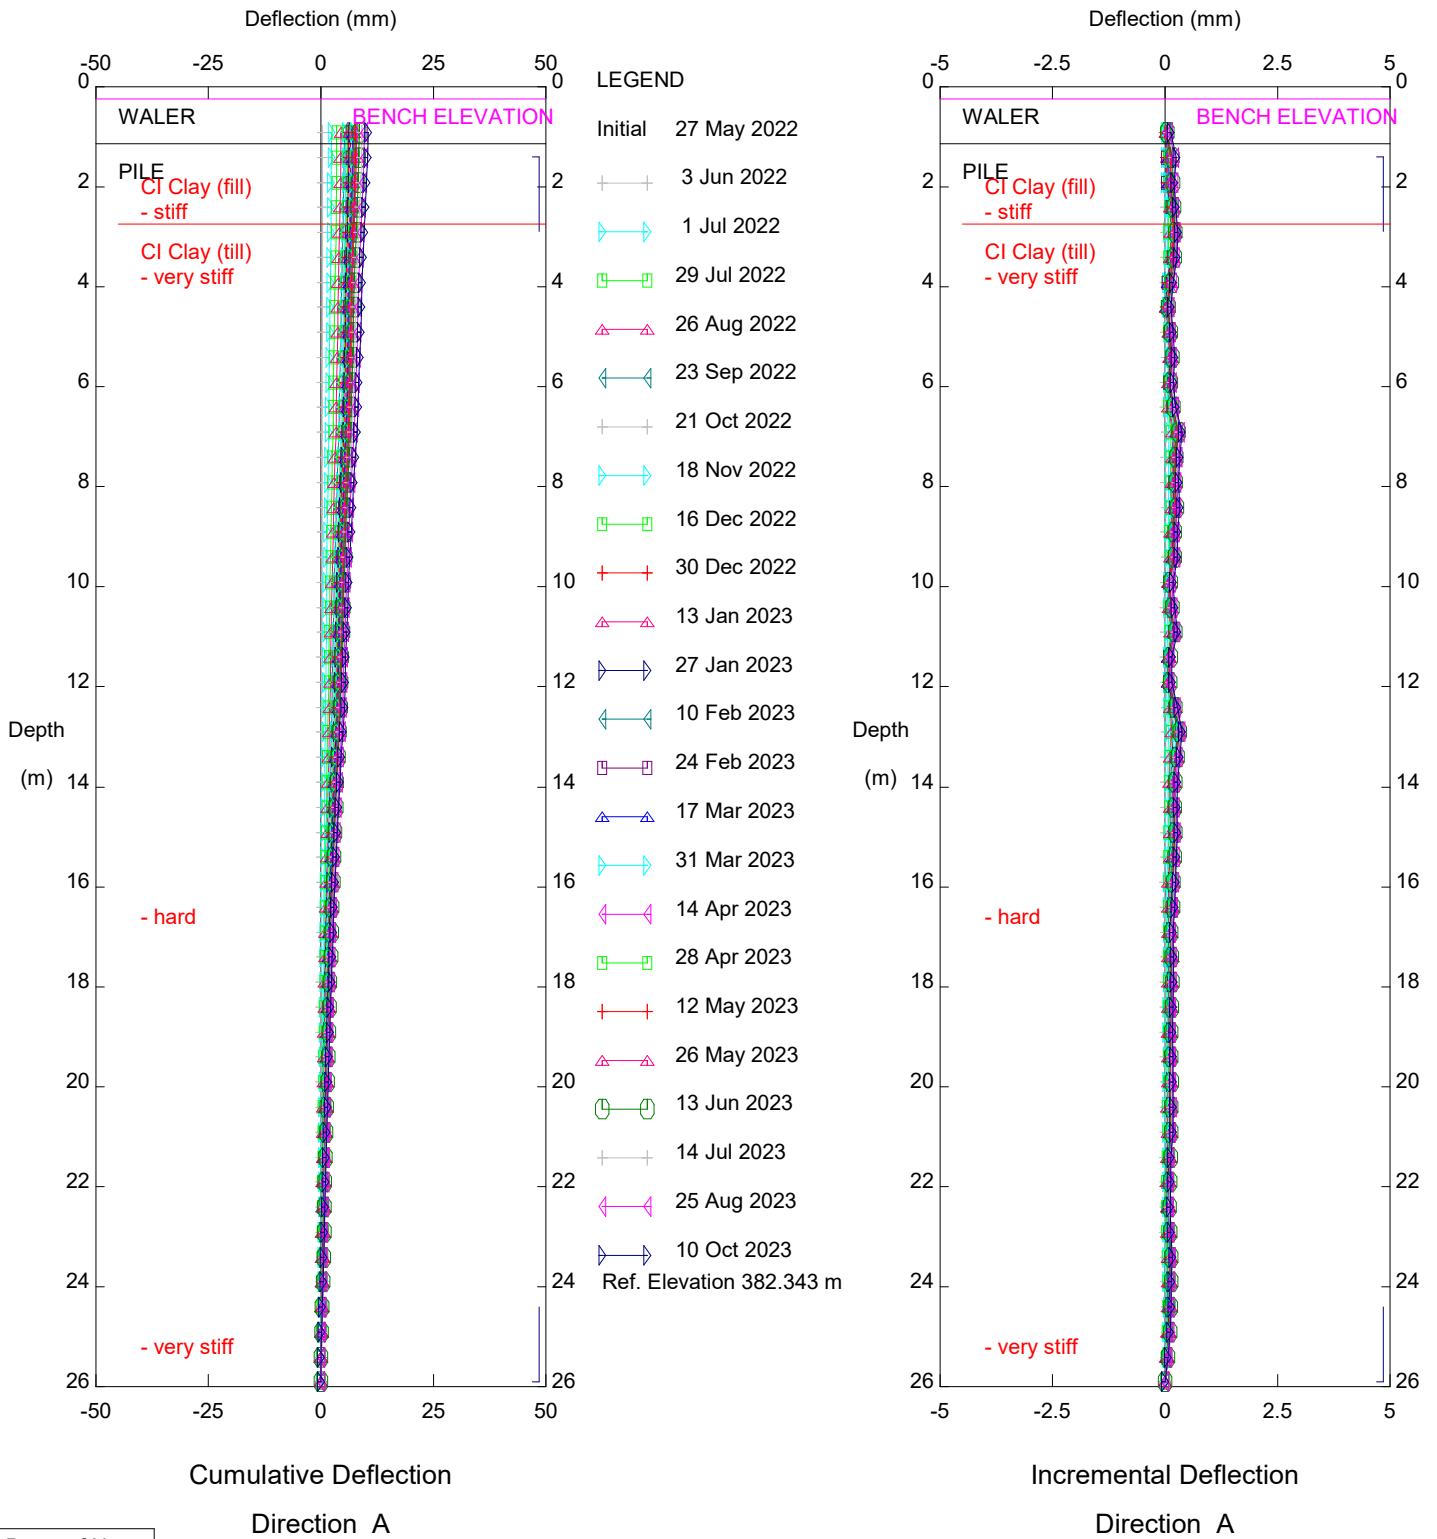
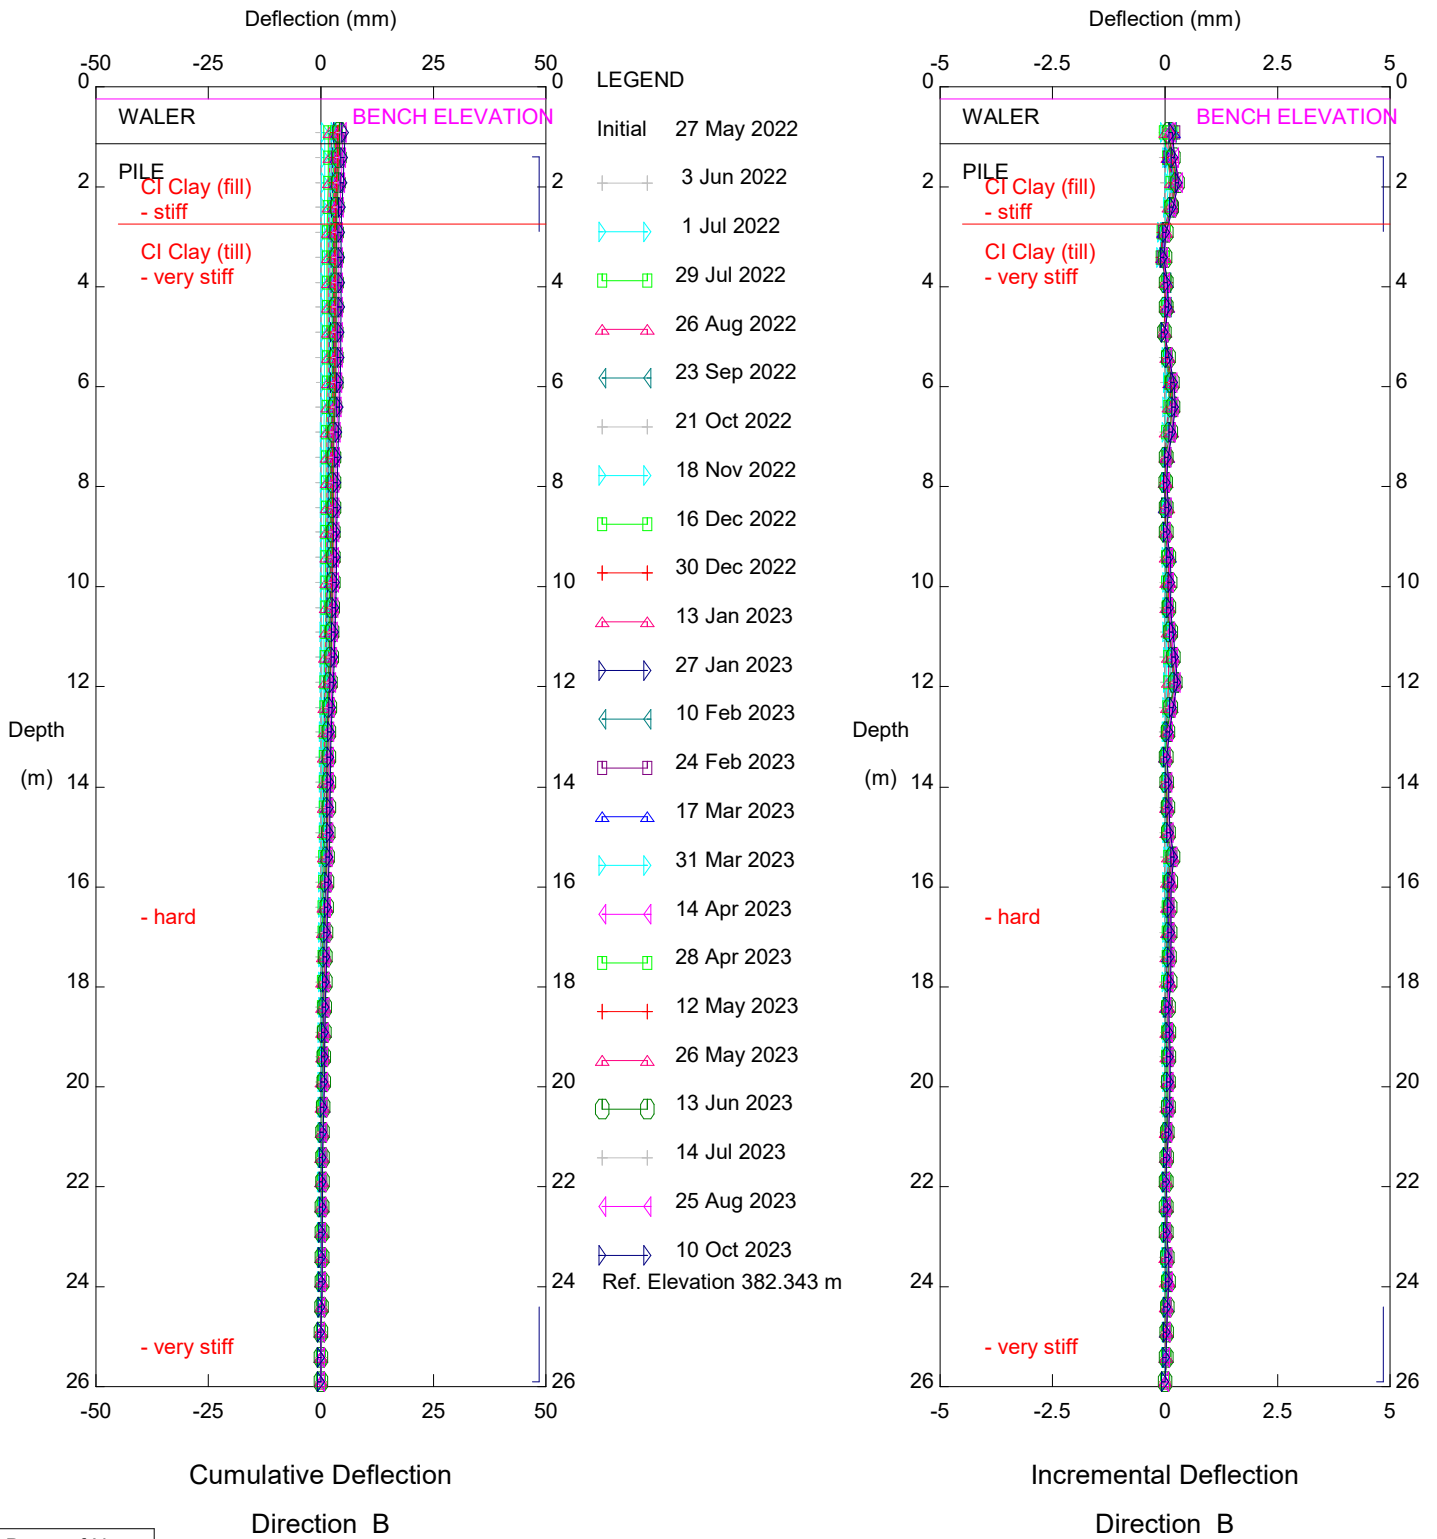
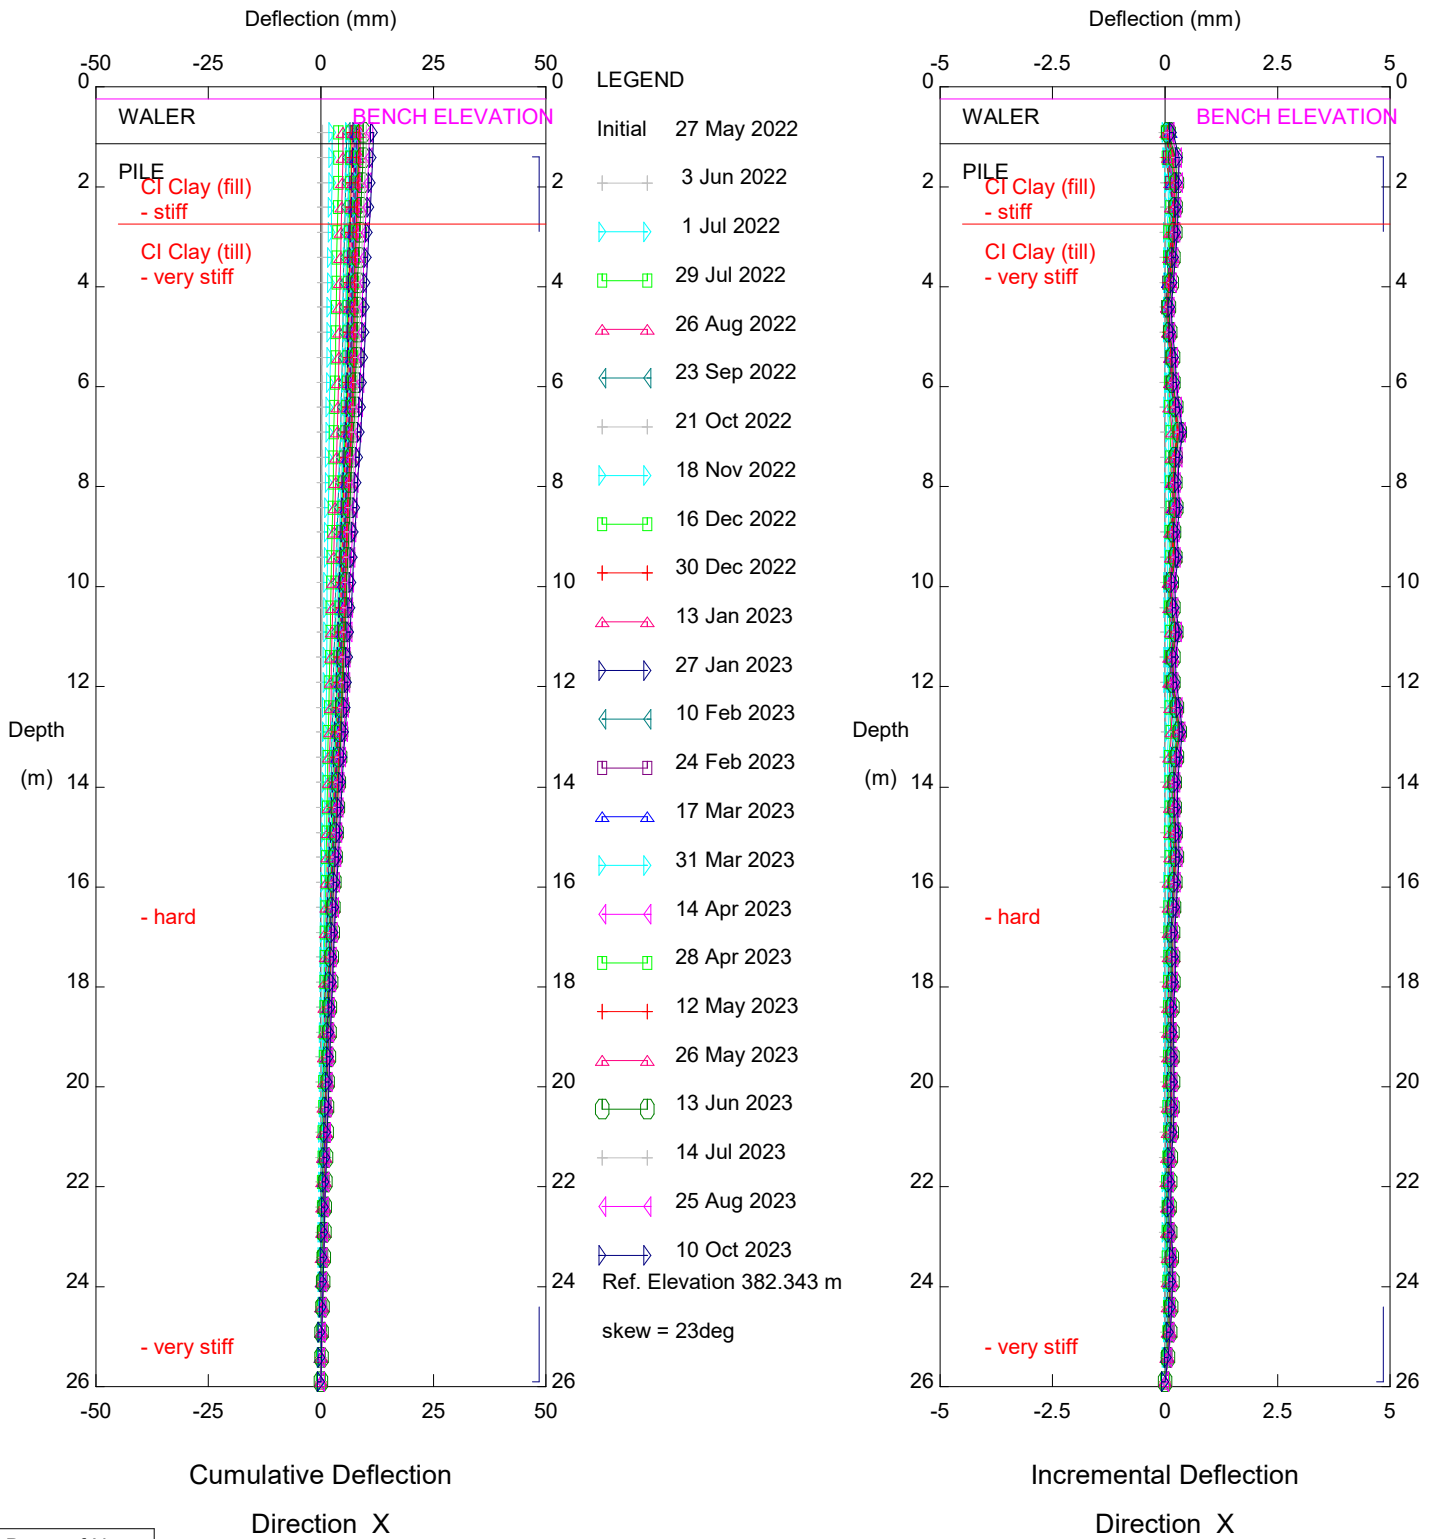
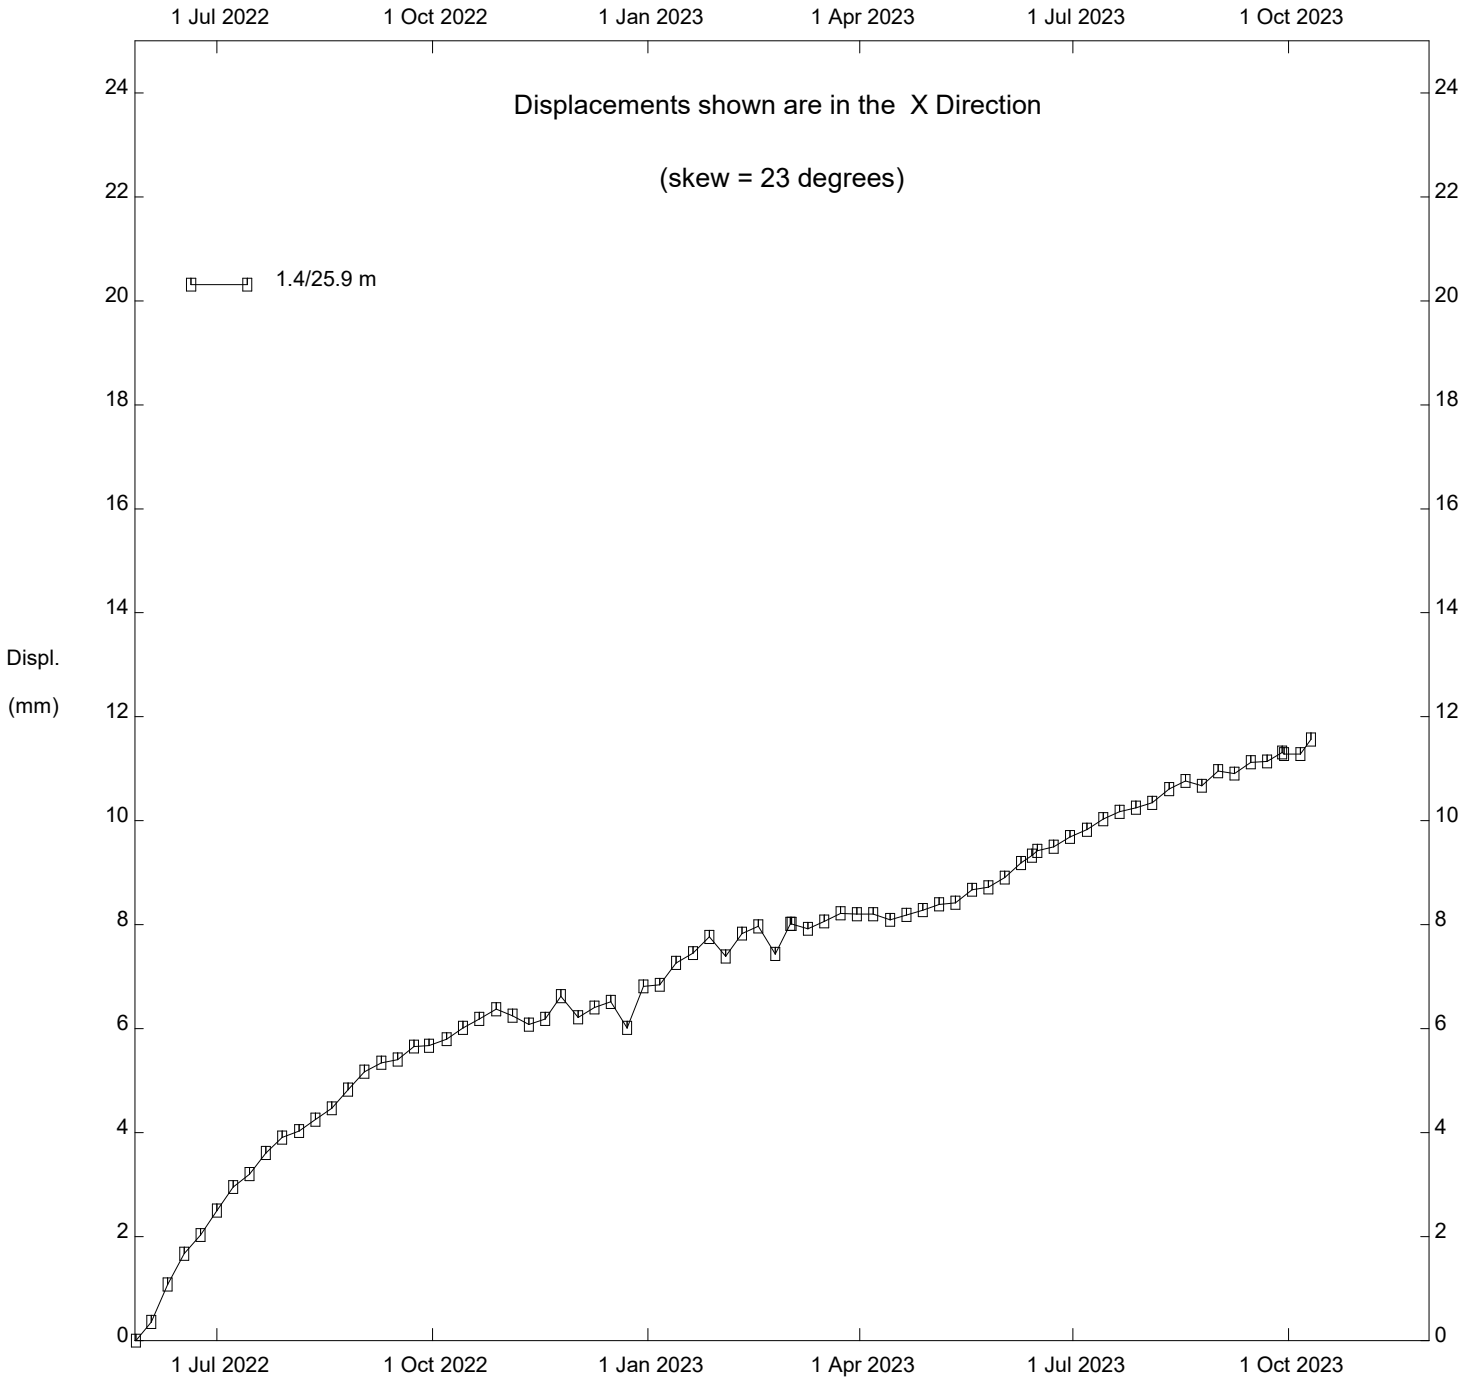
Shop Slide Wall Type 3, Inclinator SAA-P113
 Alberta Transportation

SAA-P113 has shown an average rate of movement of 6.8 mm/yr in the downslope direction since the spring of 2023 readings, with a total pile head deflection of 11.6 mm since datalogger readings began on May 27, 2022. The higher observed movement in SAA-P113 can be attributed to the fact that the pile wall at this location is cantilevered rather than tied-back like the other portions of the wall. The movement rate measured in the instrument has stayed fairly steady since the spring of 2023 readings with only a slight decrease in rate observed when the other two SAA had a noticeable drop. The total pile head deflection to date, combining the data before and after resetting the SAA has been at least 15.5 mm.

The maximum negative strain for P113, of -123.0 microstrain, was measured on the downslope side at 19.0 m depth. The depth of the main slip surface of the deep-seated landslide at this location, as indicated by former SI05-3, was at 17.5 m below original ground prior to wall construction. The strain gauges are plotted on Figures PH009-1 through PH009-12 in Appendix A.

Pile head deflections measured by the SAA are within an acceptable range. More deflection is noted in the cantilever section of the wall (SAA-P113) which would be expected. The additional deflection in SAA-P34 may be due to the deeper amount of cut as compared to the slope below SAA-P77. The March-April 2023 drop in deflection corresponds with a drop in the loads carried by some of the anchors (A34, A51, and A67 and to a lesser extent at A19) which could indicate a post-winter shifting of the slope. Interestingly, there was not a drop off in the load carried by Anchor A77 despite the drop in the pile head deflection. This will require additional readings and analysis to interpret and will be considered as part of the ongoing development of threshold criteria for this pile wall.

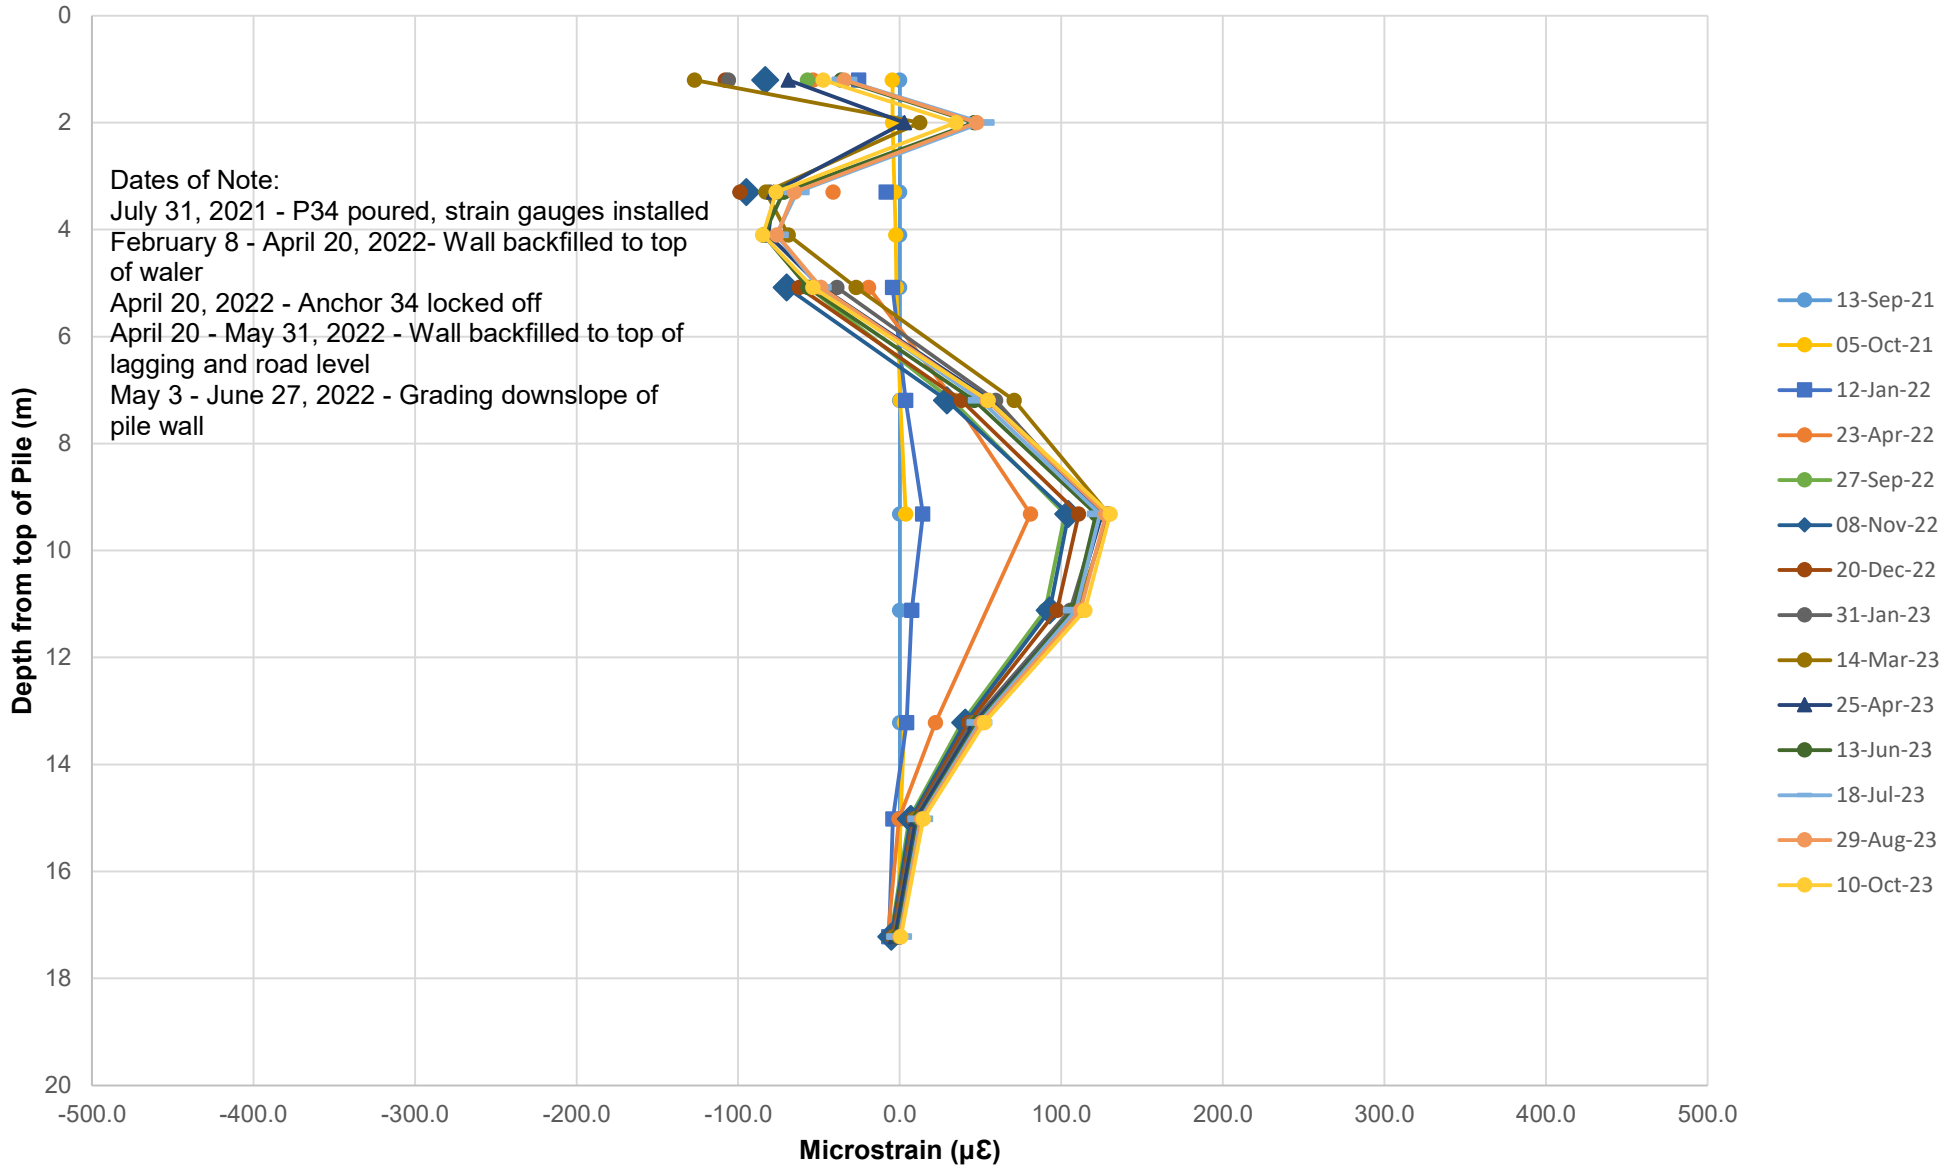
**FIGURE PH009-1: PEACE RIVER SHOP SLIDE
P34 UPSLOPE SIDE STRAIN GAUGE VALUES VS DEPTH**

The strain gauges in P34 show their maximum positive (tension) strain (130.2 microstrain) on the upslope pile face at 9.3 m depth, with a corresponding trend of negative (compression) strain (-206.1 microstrain) on the downslope pile face at the same depth. This seems to correspond to the observed deflection of the pile in the downslope direction noted in the SAA above 9 m depth.

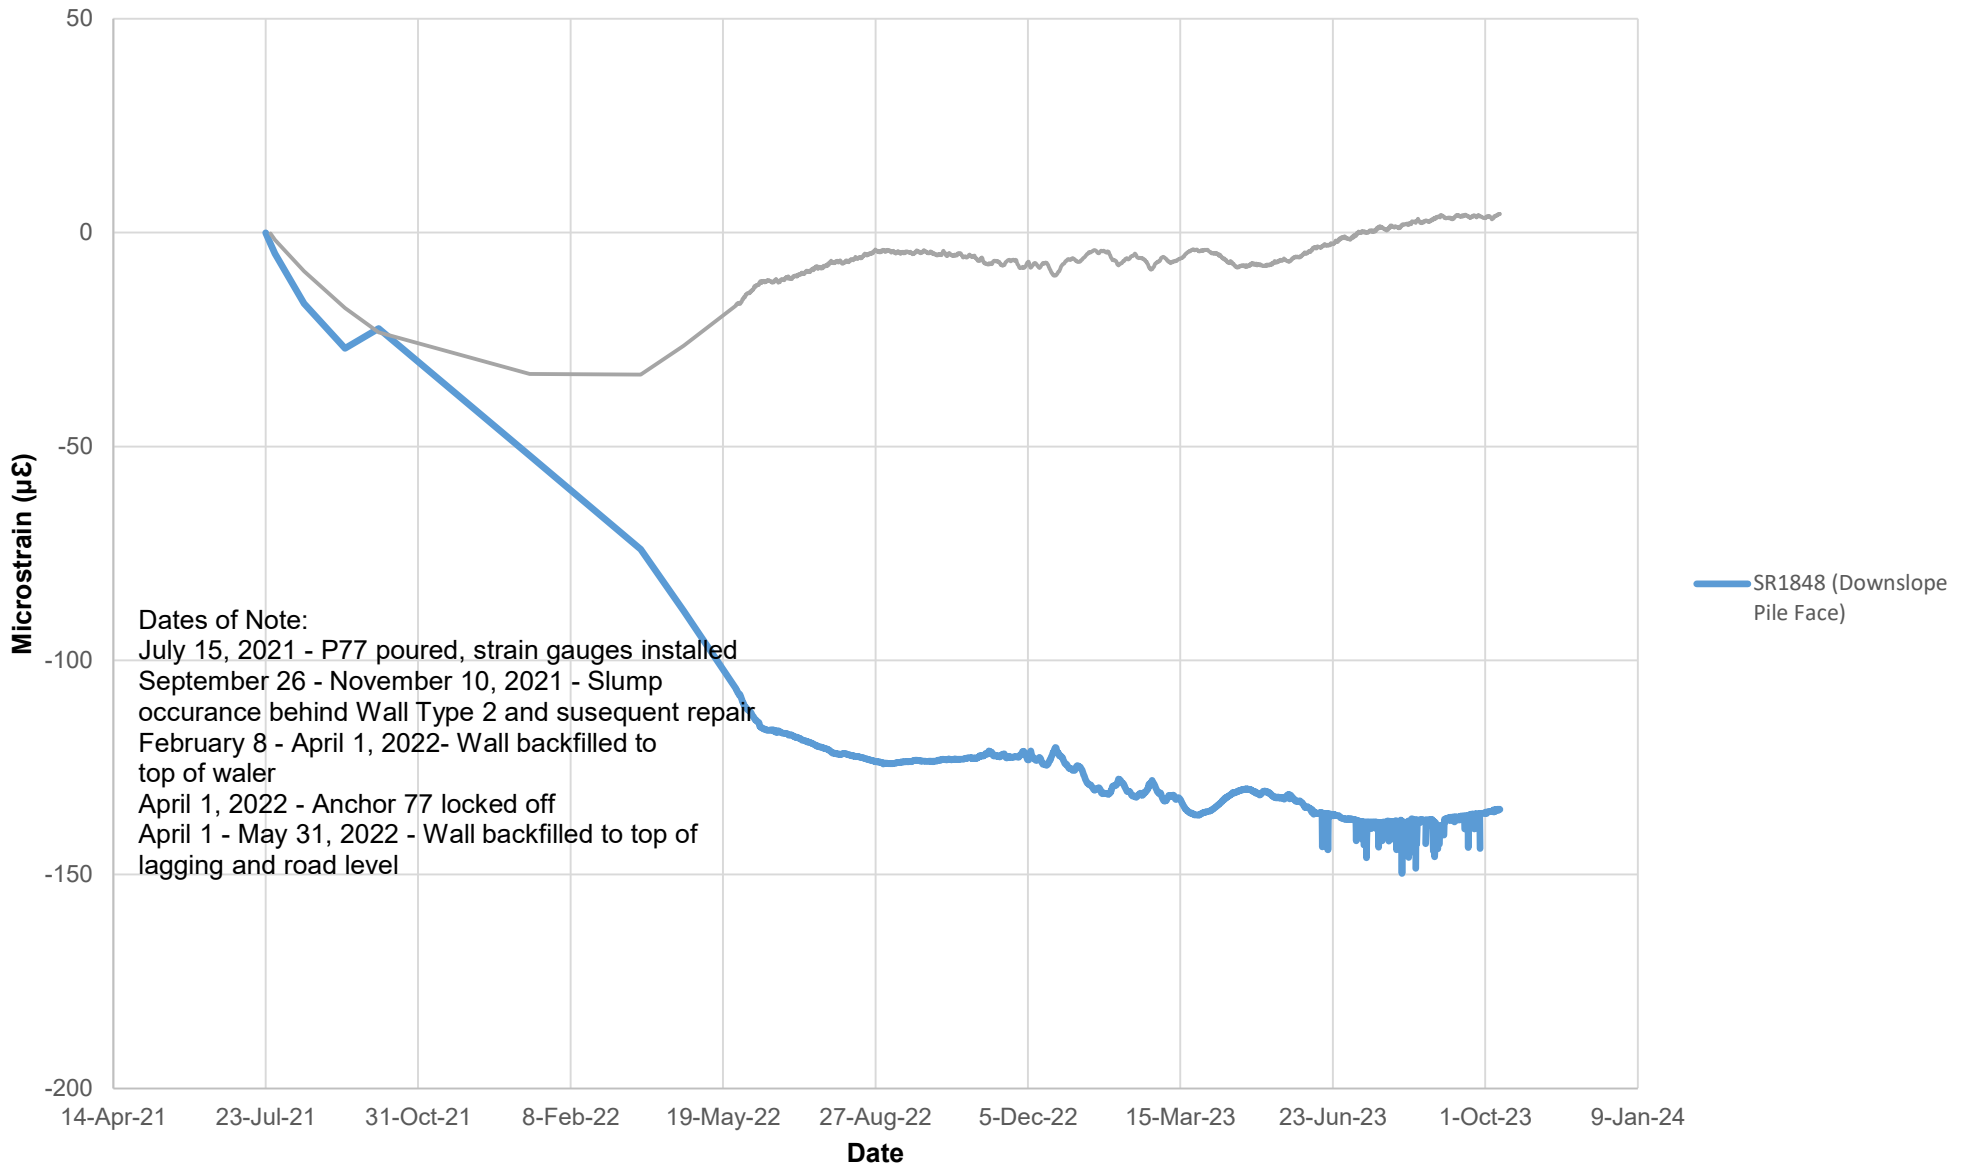
**FIGURE PH009-6: PEACE RIVER SHOP SLIDE
P77 MAXIMUM STRAIN VS TIME (7.1 m DEPTH)**

The strain gauges on the downslope side of P77 indicate a maximum negative strain of -134.8 microstrain at a depth of 7.1 m. P77 does not show as clear of a trend of strain in the upslope pile strain gauges compared to P34.

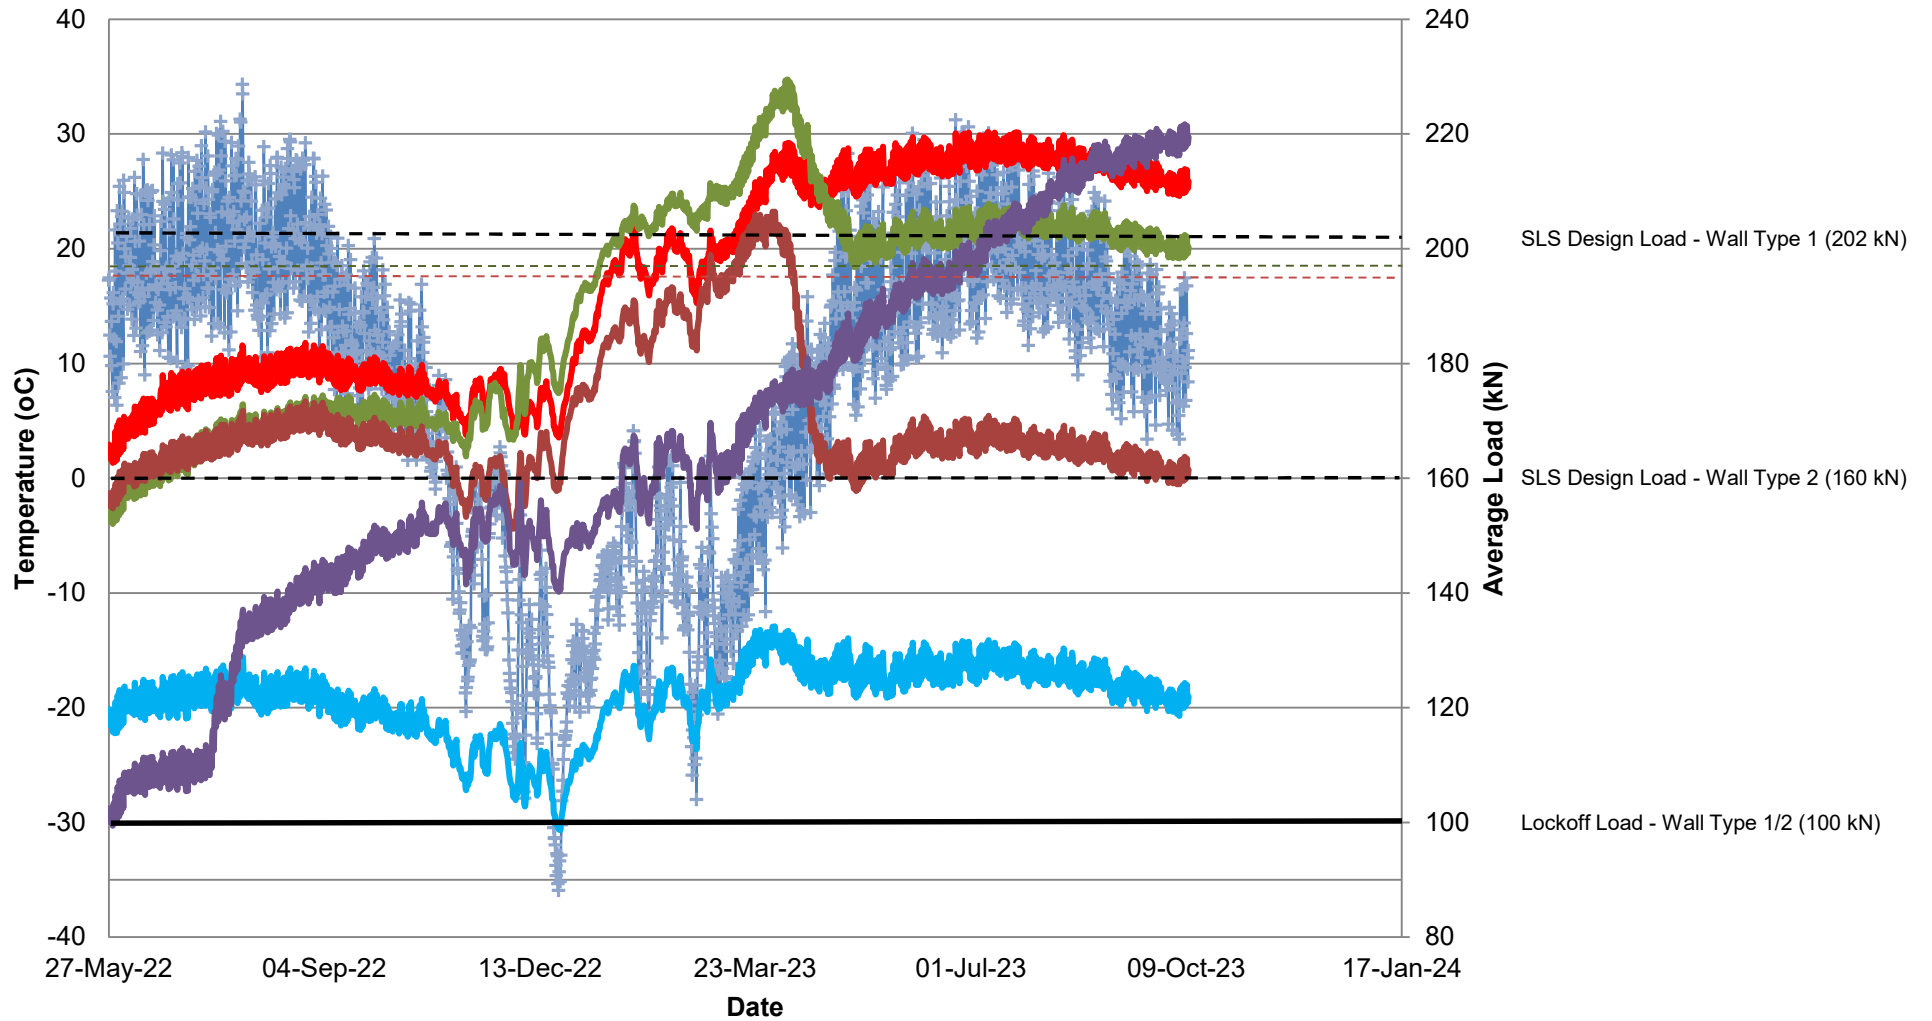
**FIGURE PH009-13
OLD HWY 2:02 SHOP SLIDE LOAD CELL READINGS**

Load cells VC2431 (anchor A34), VC2342 (anchor VC2342), and VC2343 (anchor A67) all recorded their maximum loads during the late winter months of 2023 before relaxing during the spring thaw. This is attributed to frost pressures on the back of the wall. Load cell VC2340 (anchor A19) measured its highest load after the spring thaw in July 2023, before relaxing slightly. Load cell VC2344 (anchor A77) has continued showing an overall trend of increasing load without the post-winter relaxation seen in the other anchors. However, within the last month of monitoring the load in this anchor shows potential signs of levelling off. Overall, the anchor loads have risen significantly since they were locked off, and anchor A19 and anchor A77 are currently above their SLS design loads. The load cells will need to be closely monitored to see if the increased movement trend continues. The load cell readings are plotted on Figure PH009-13 in Appendix A.
