THURBER ENGINEERING LTD.

July 14, 2023

**ALBERTA TRANSPORTATION AND ECONOMIC CORRIDORS GRMP (CON0022164)
PEACE REGION (PEACE RIVER DISTRICT)
INSTRUMENTATION MONITORING RESULTS – SPRING 2023**

SITE PH009: OLD HWY 2:02 SHOP SLIDE

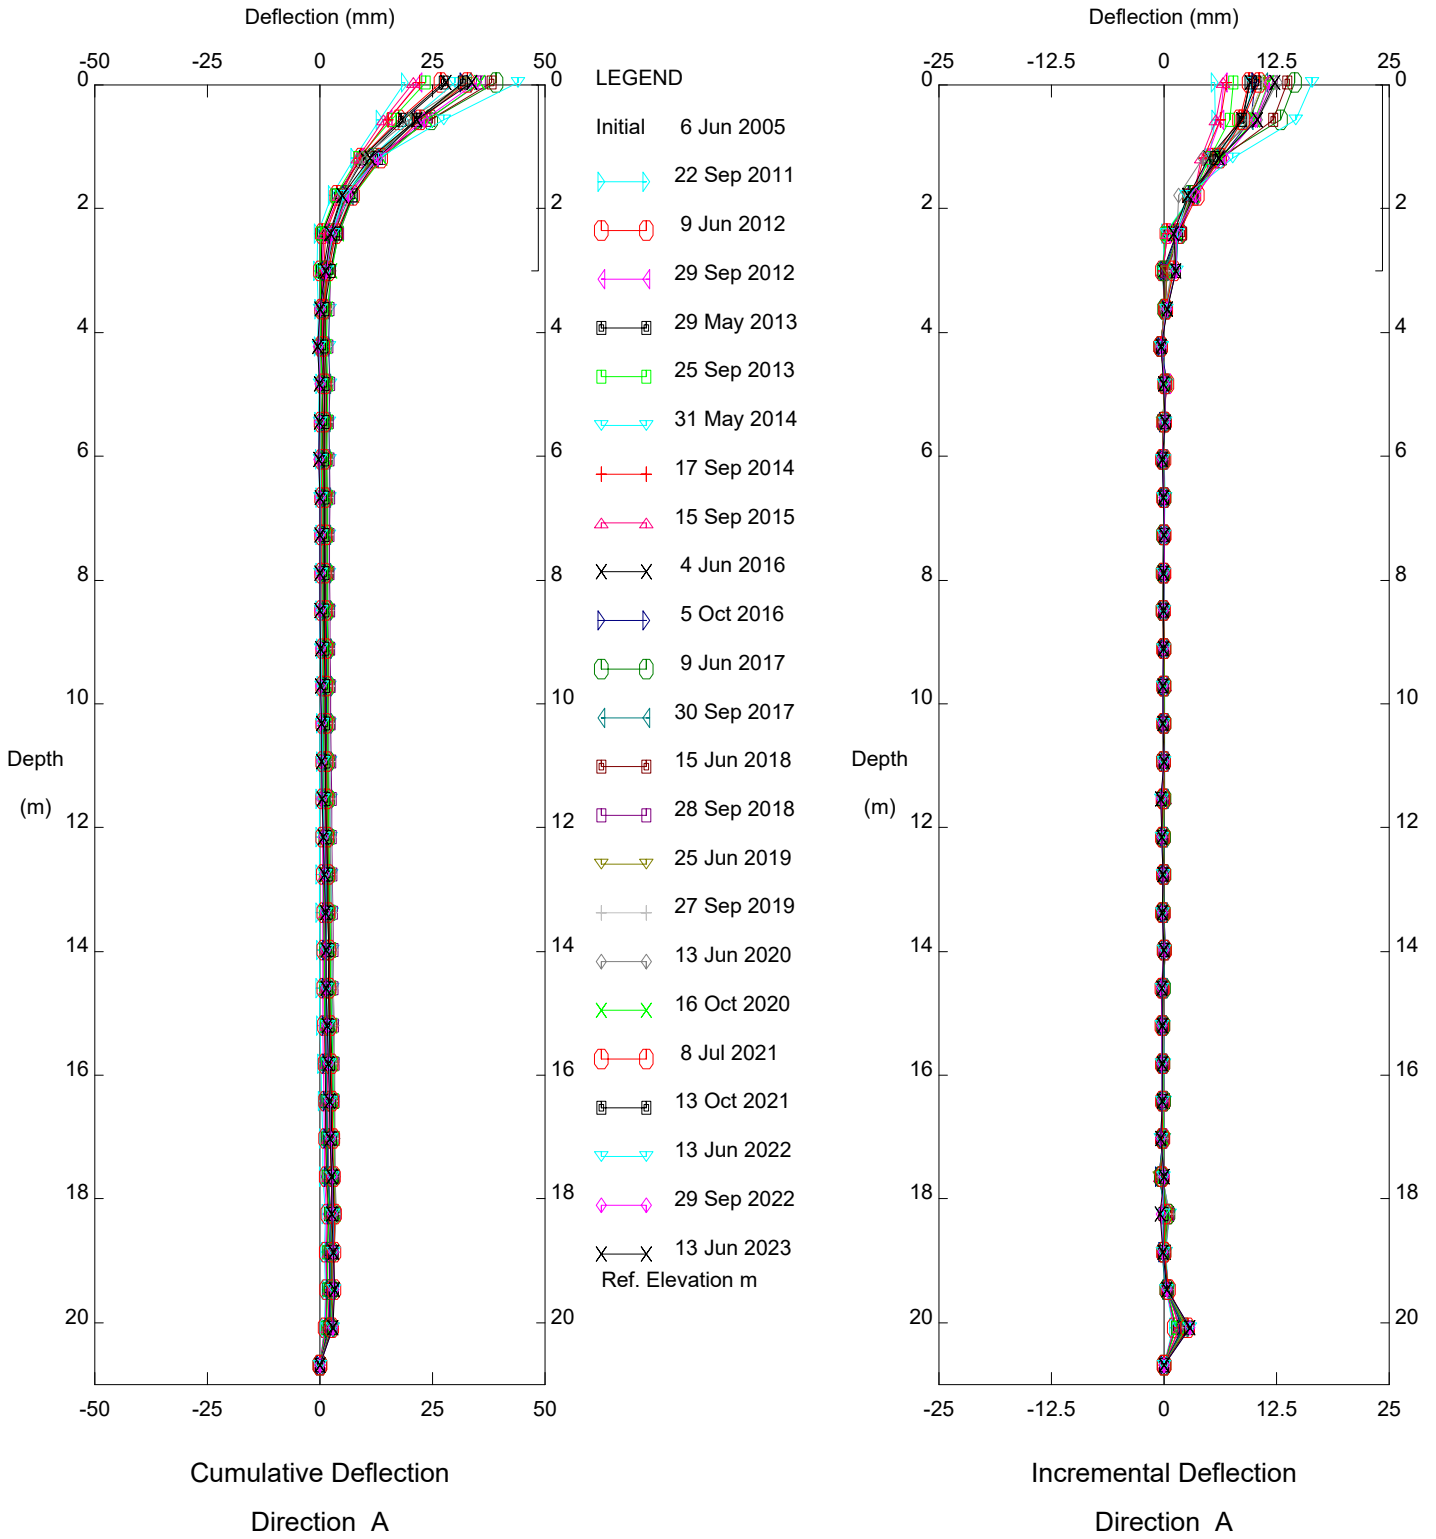
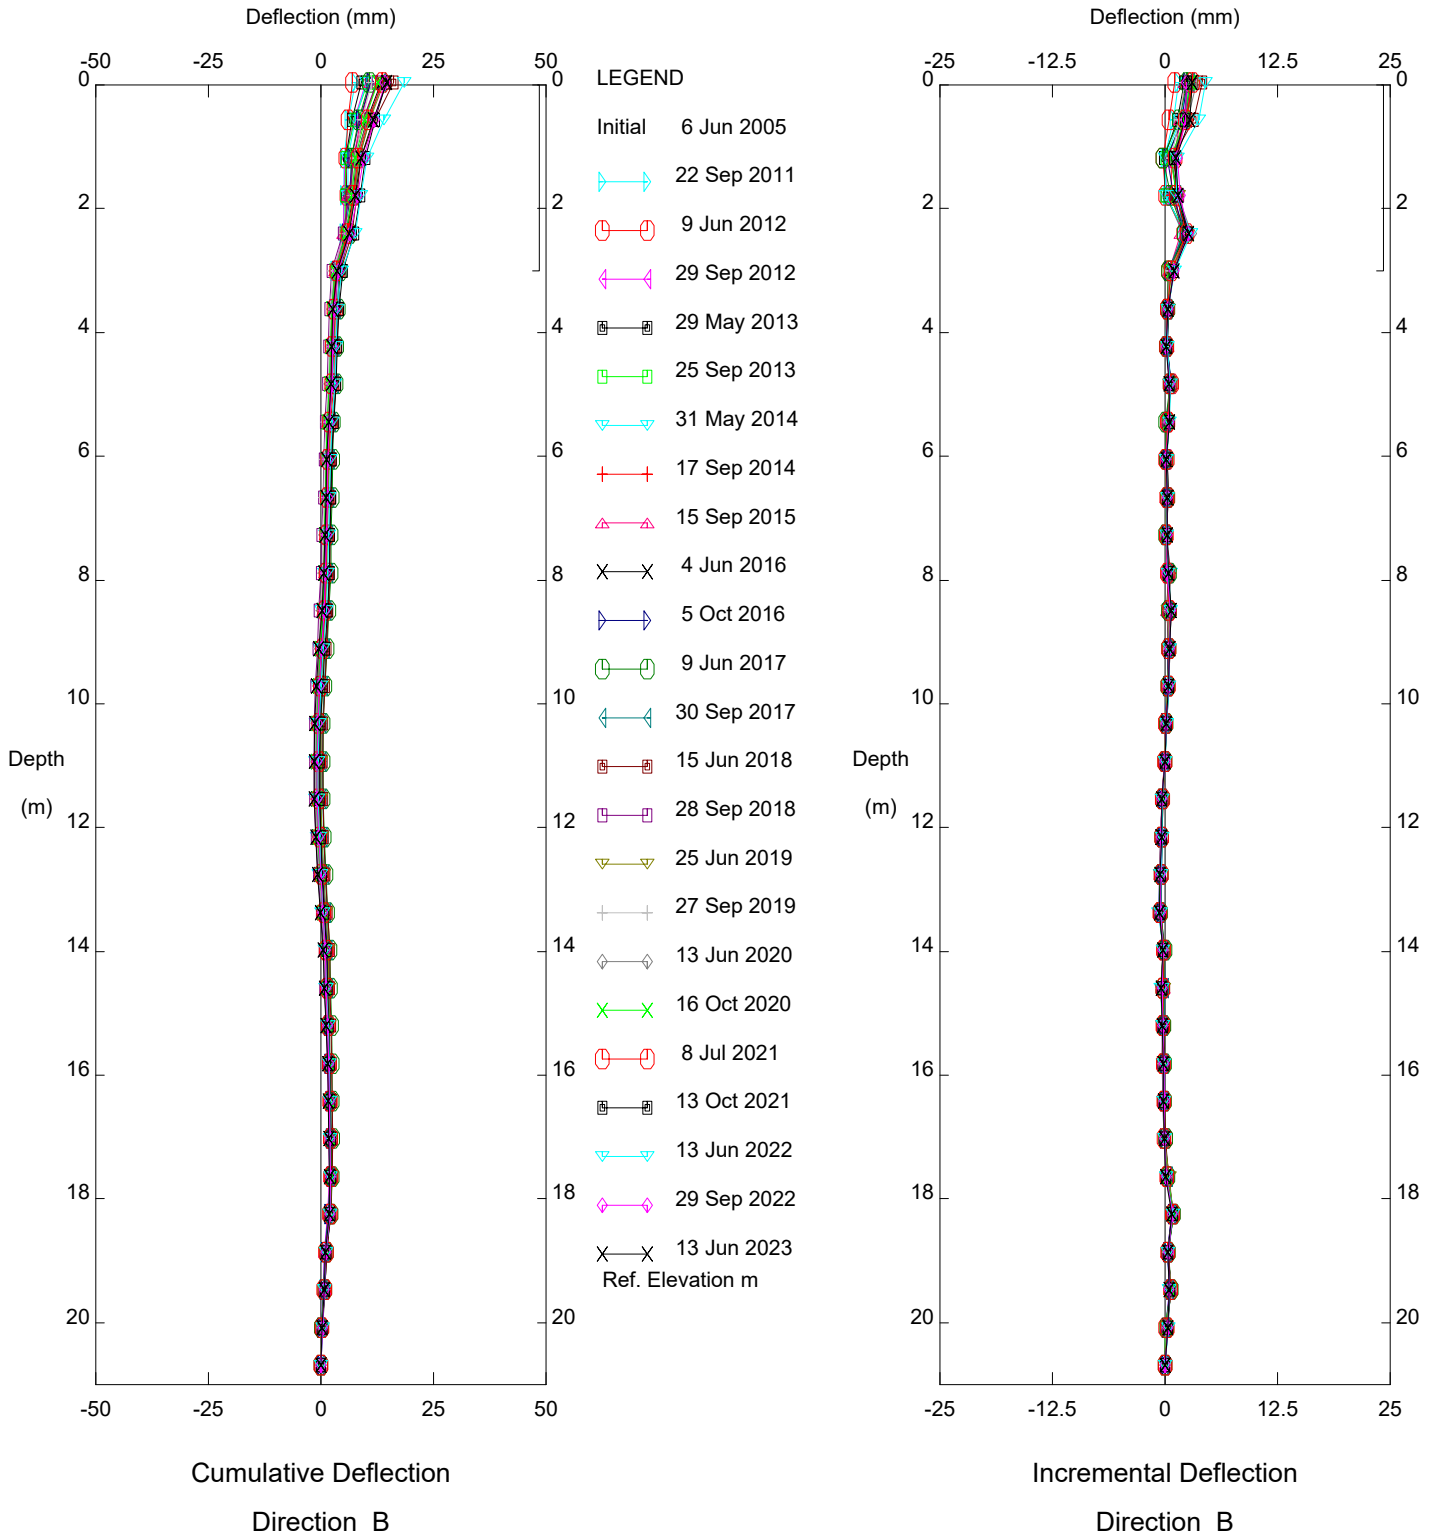
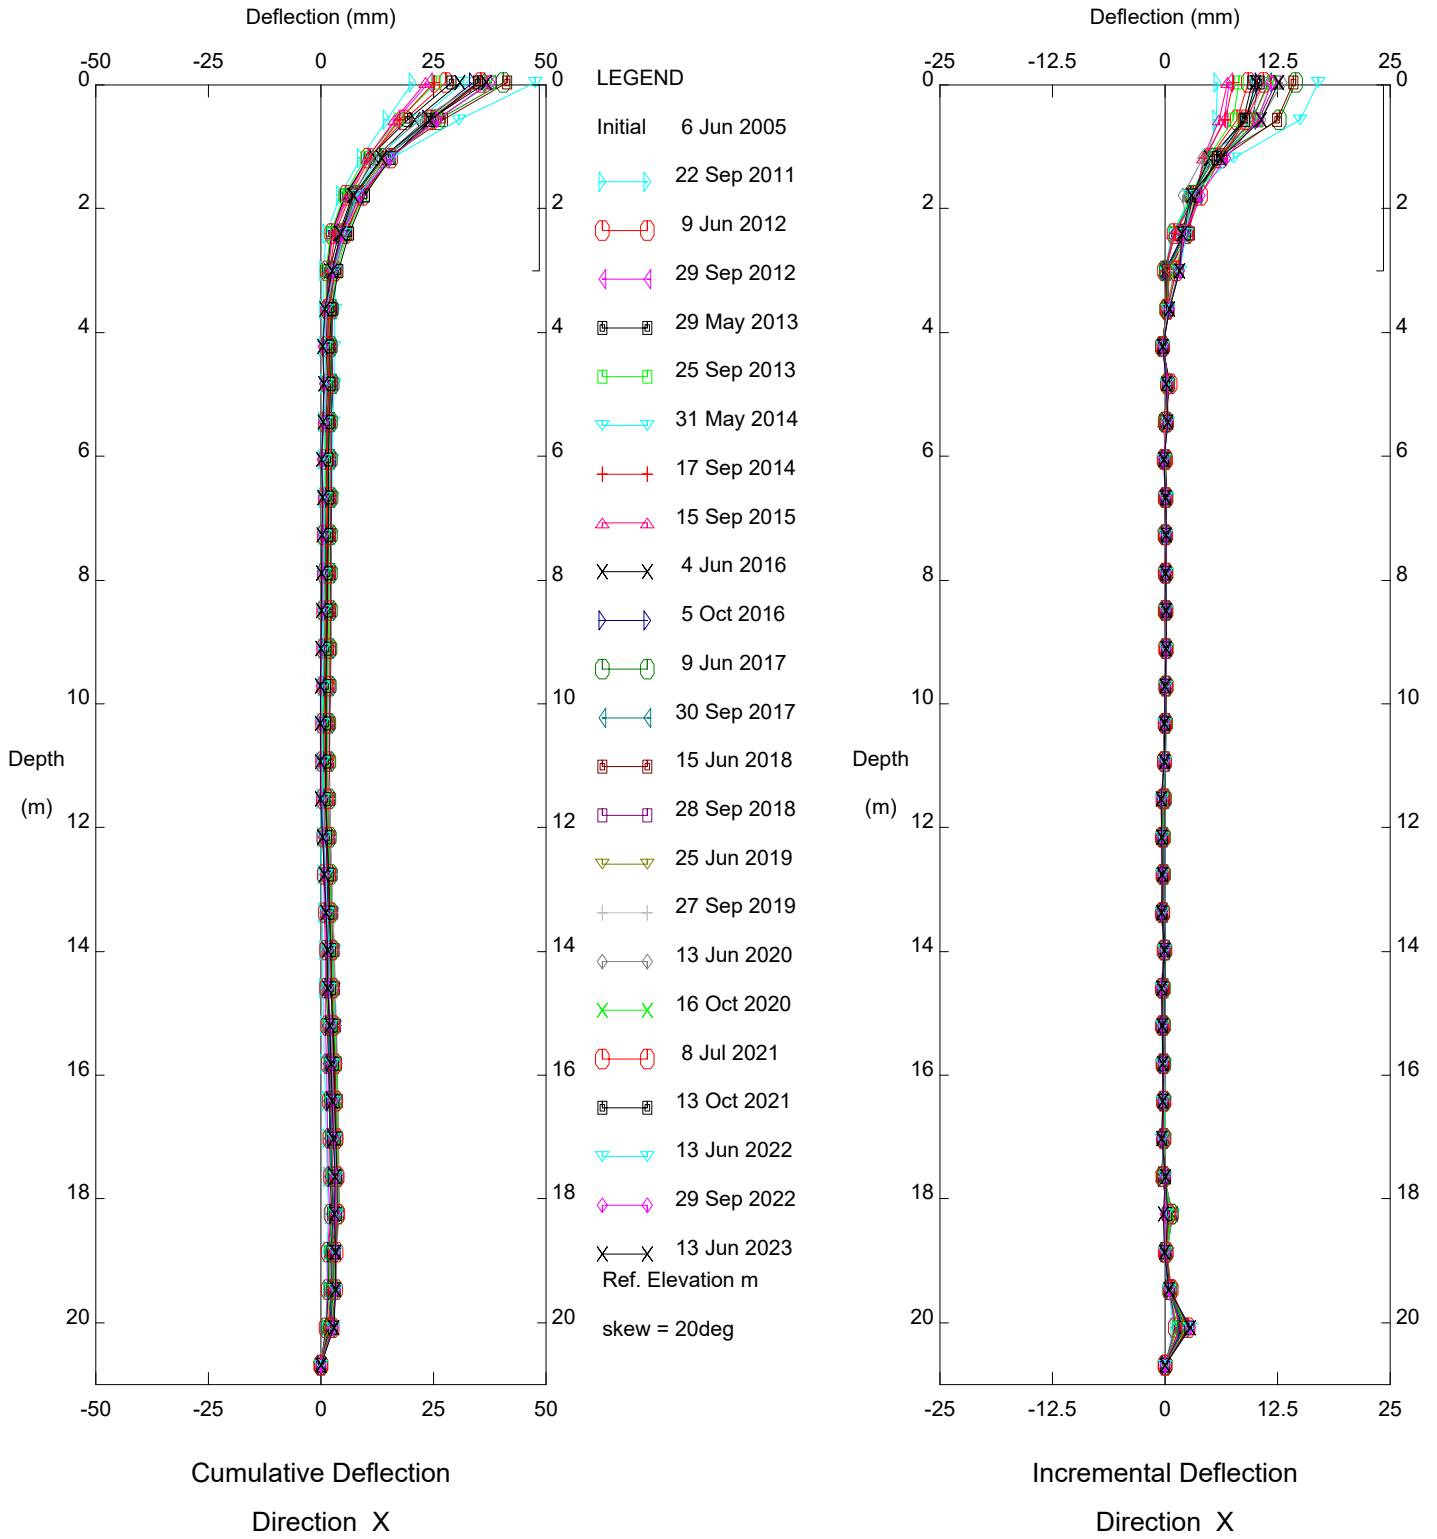
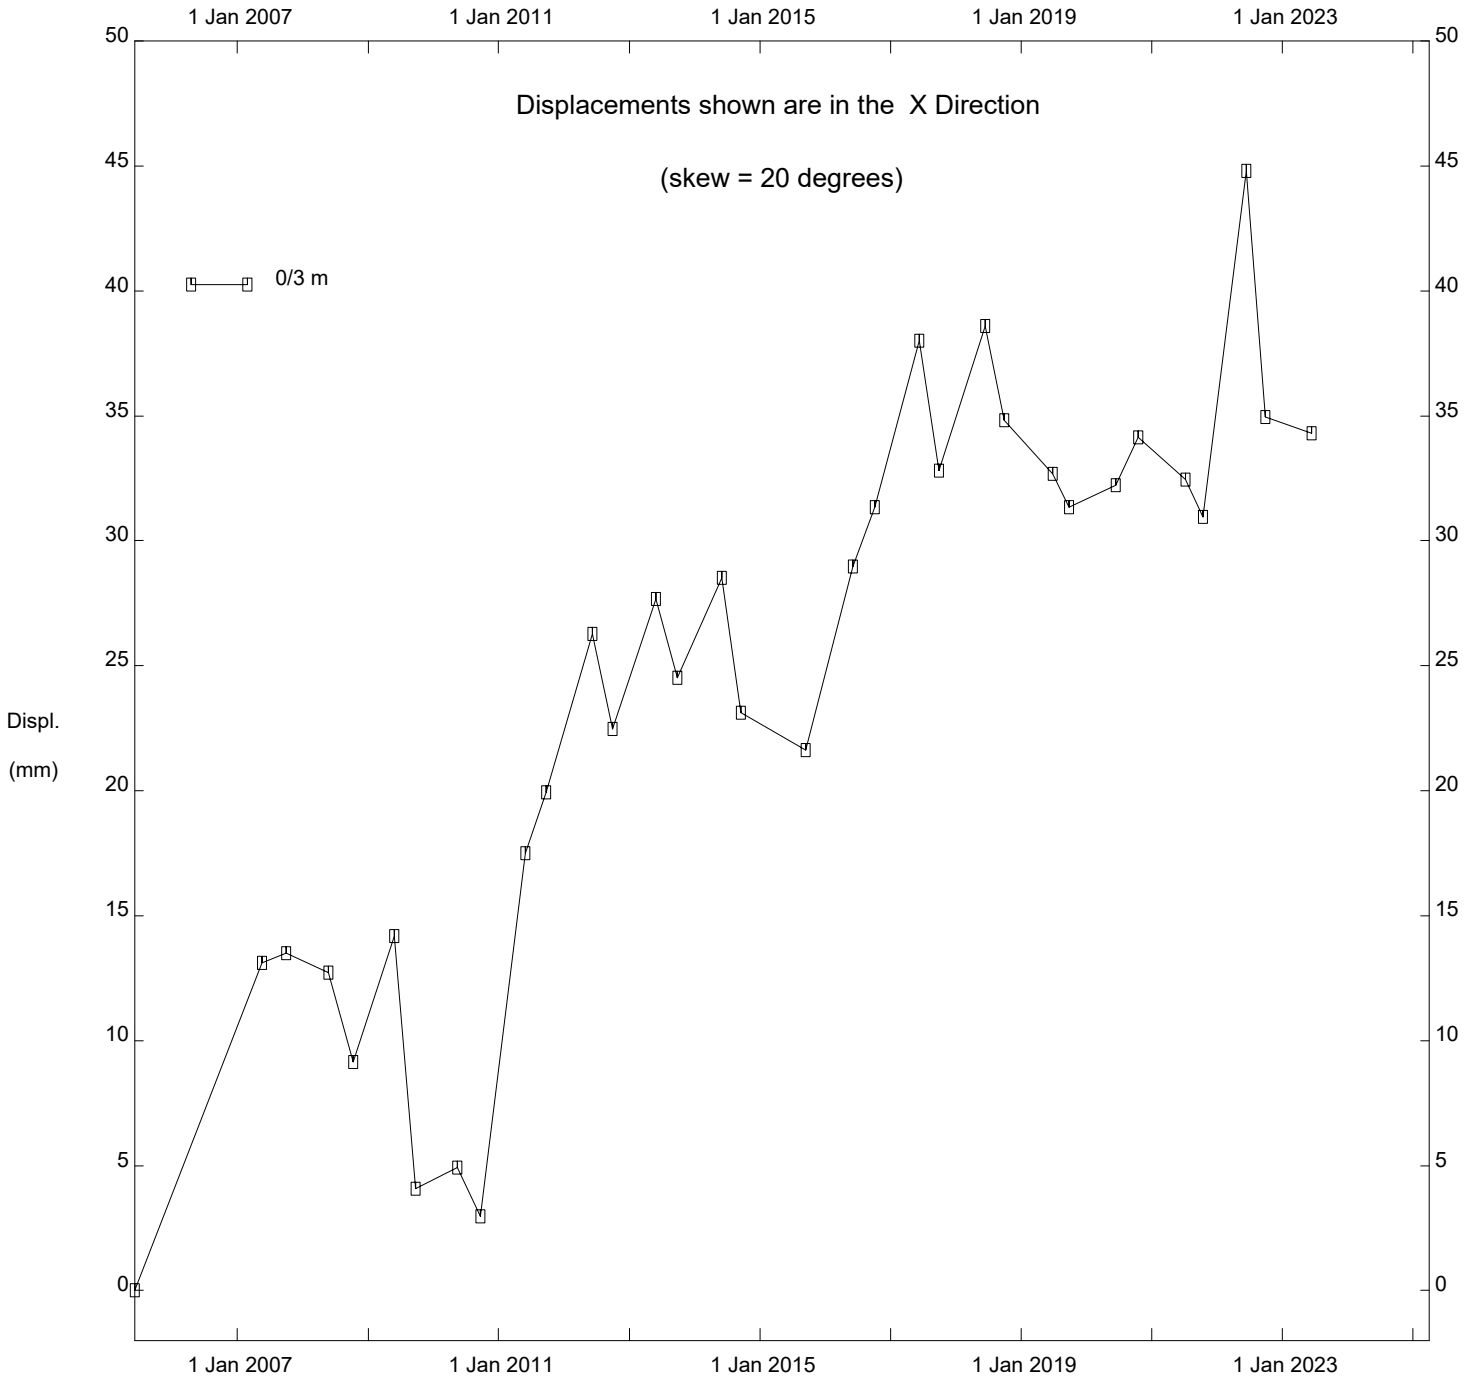
PH009 Old Hwy 2:02 Shop Slide, Inclinometer SI05-1

Slope inclinometer SI05-1 showed no discernible movement over 0.0 m to 3.0 m depth since the fall of 2022 readings. SI09-3 continued to show no discernible movement. SI09-4 showed rates of movement of 0.2 mm/yr and 0.4 mm/yr over 8.6 m to 10.5 m depth and 11.7 m to 13.5 m depth, respectively, since the fall of 2022 readings. These movement zones were first observed in 2021 during construction and displacement has been increasing slightly with each subsequent set of readings. The upper portion of SI09-4 was bent during grading and related shortening of the instrument during construction. SI11-01 showed a rate of movement of 4.1 mm/yr over 13.9 m to 16.3 m depth. SI11-01 showed a maximum rate of movement of 34.3 mm/yr over this zone in June 14, 2022, near the end of construction, however the movement rate has decreased for two consecutive readings cycles. SI19-5 showed no discernible movement over 8.2 m to 11.2 m depth and a rate of movement of 0.2 mm/yr over 17.9 m to 19.7 m depth. The overall movement in SI19-5 has slowed significantly since slope offloading and the completion of construction.

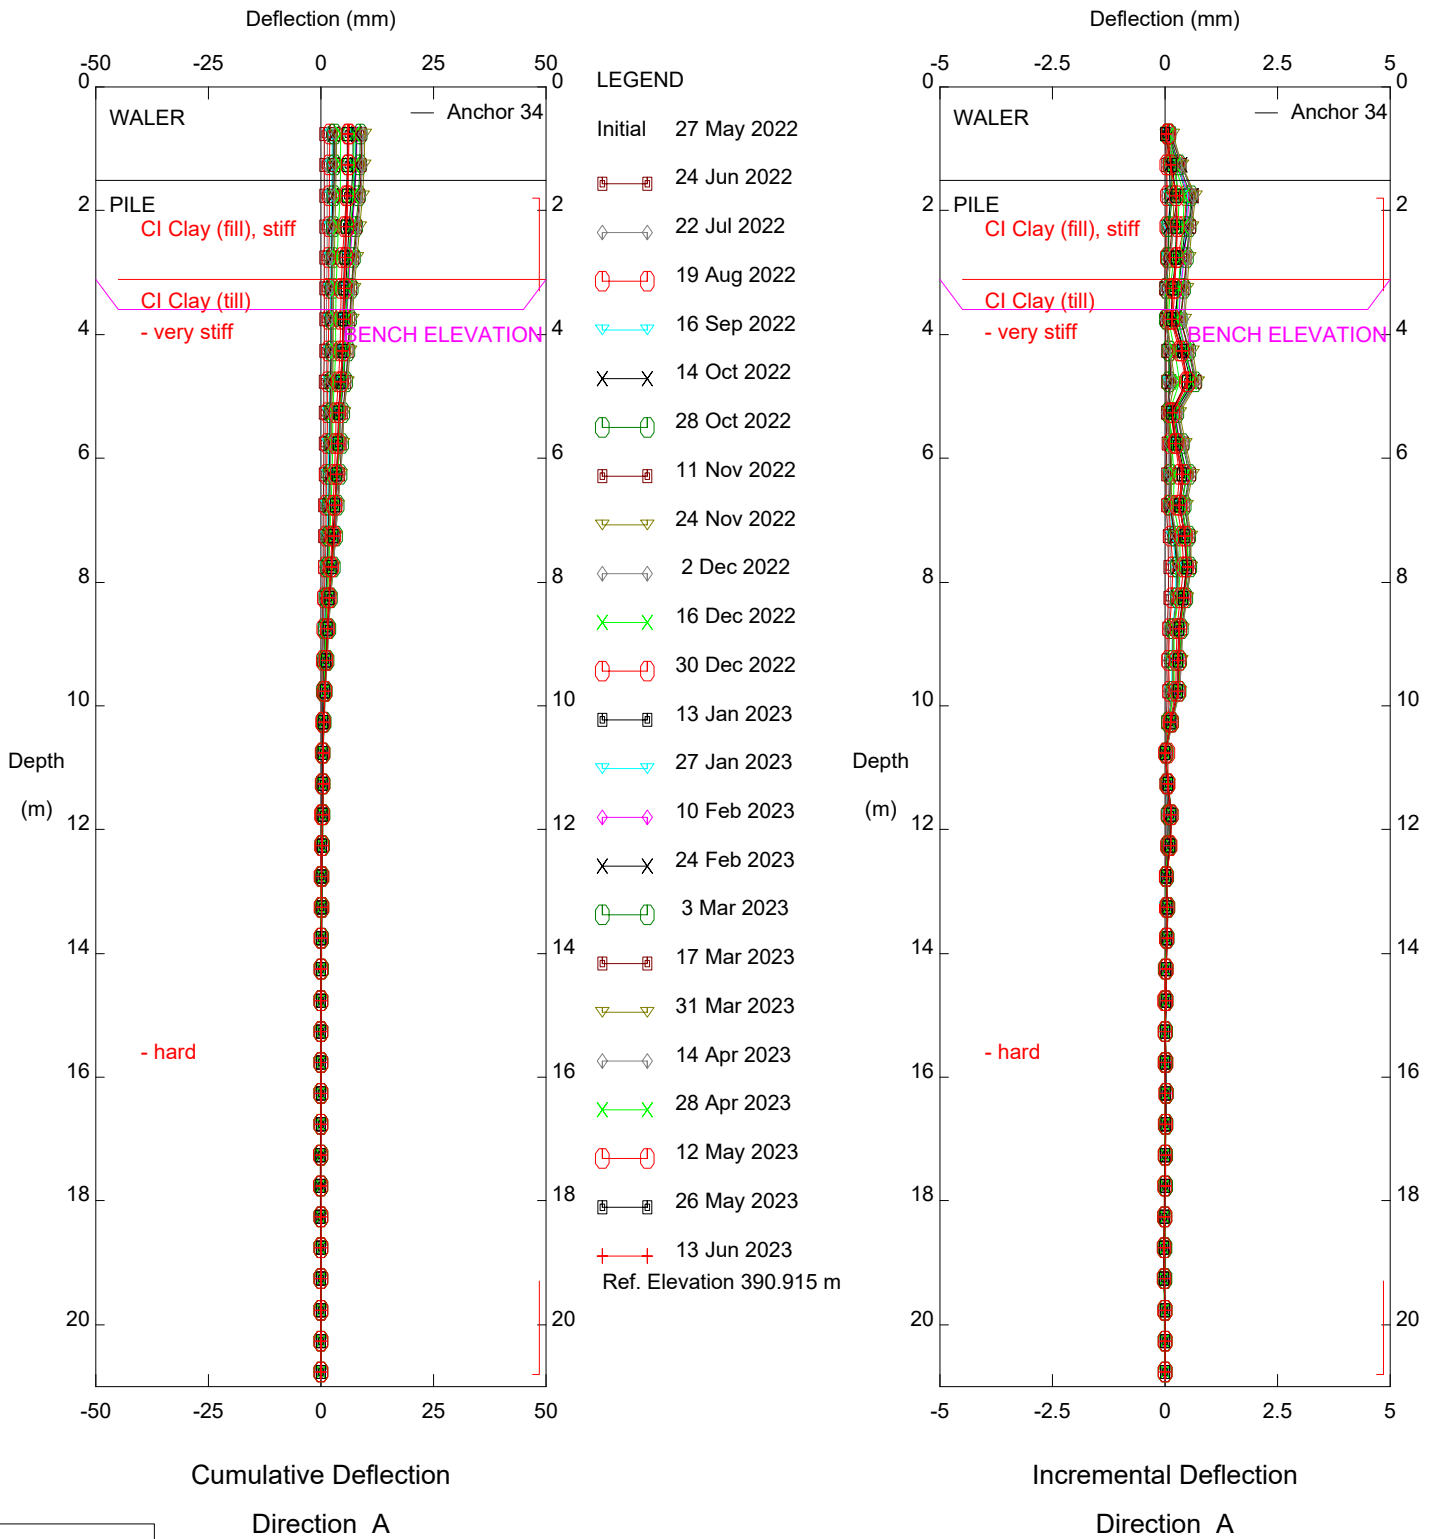
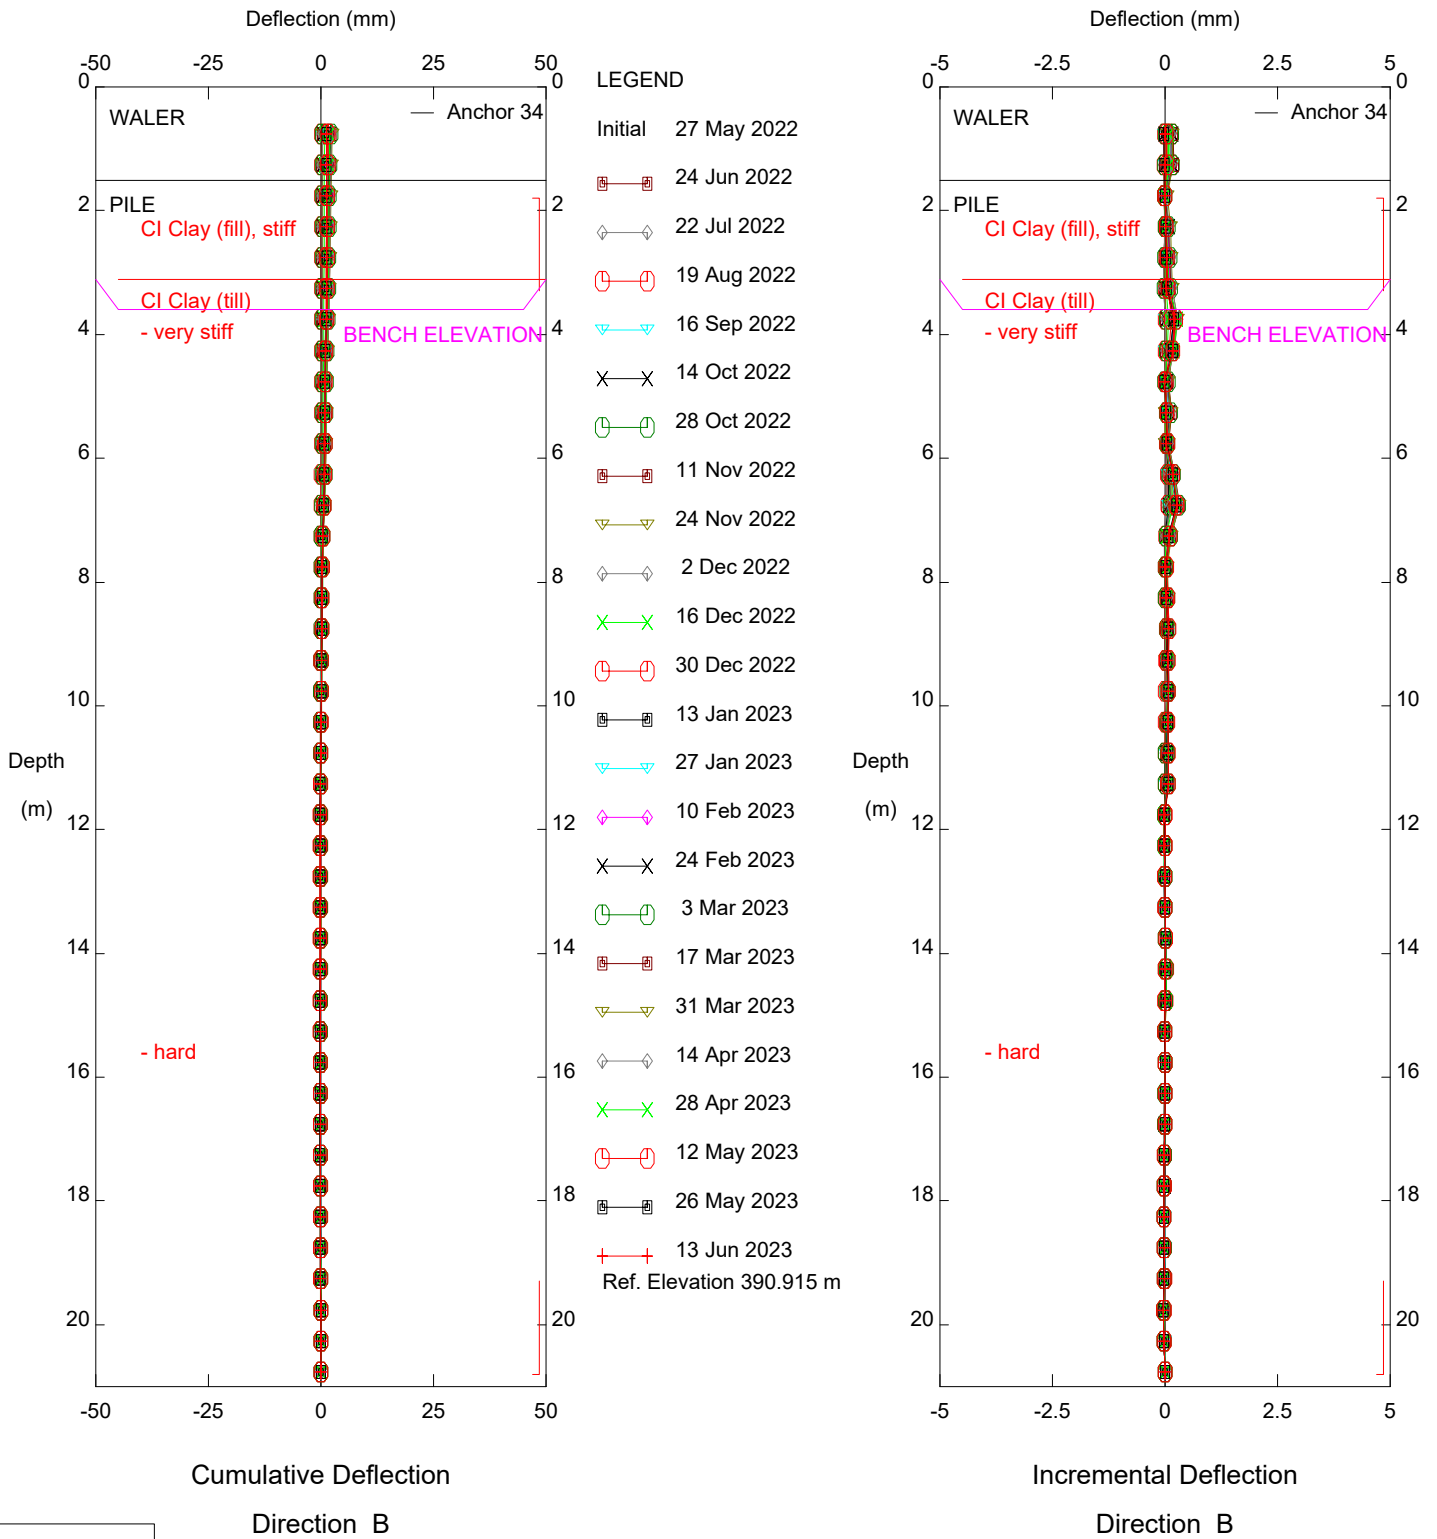
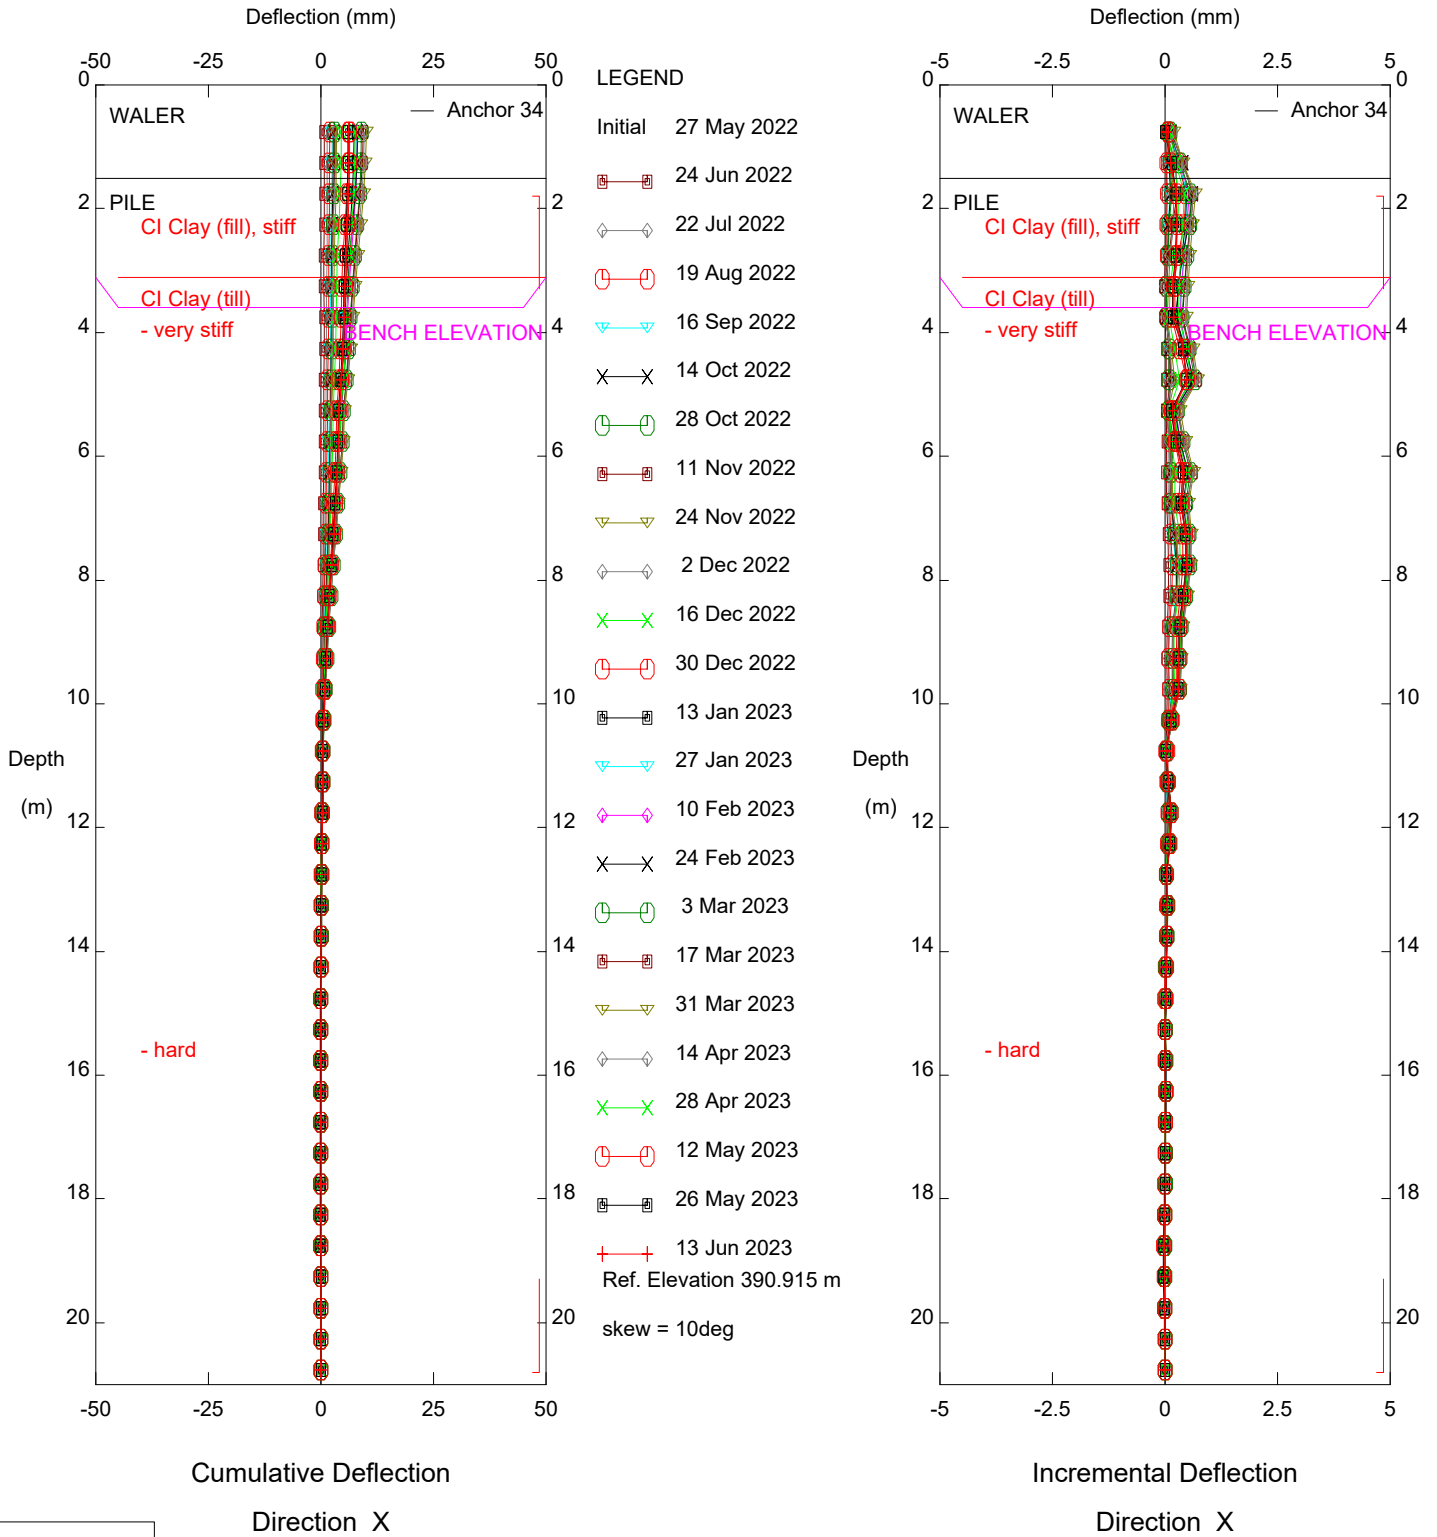
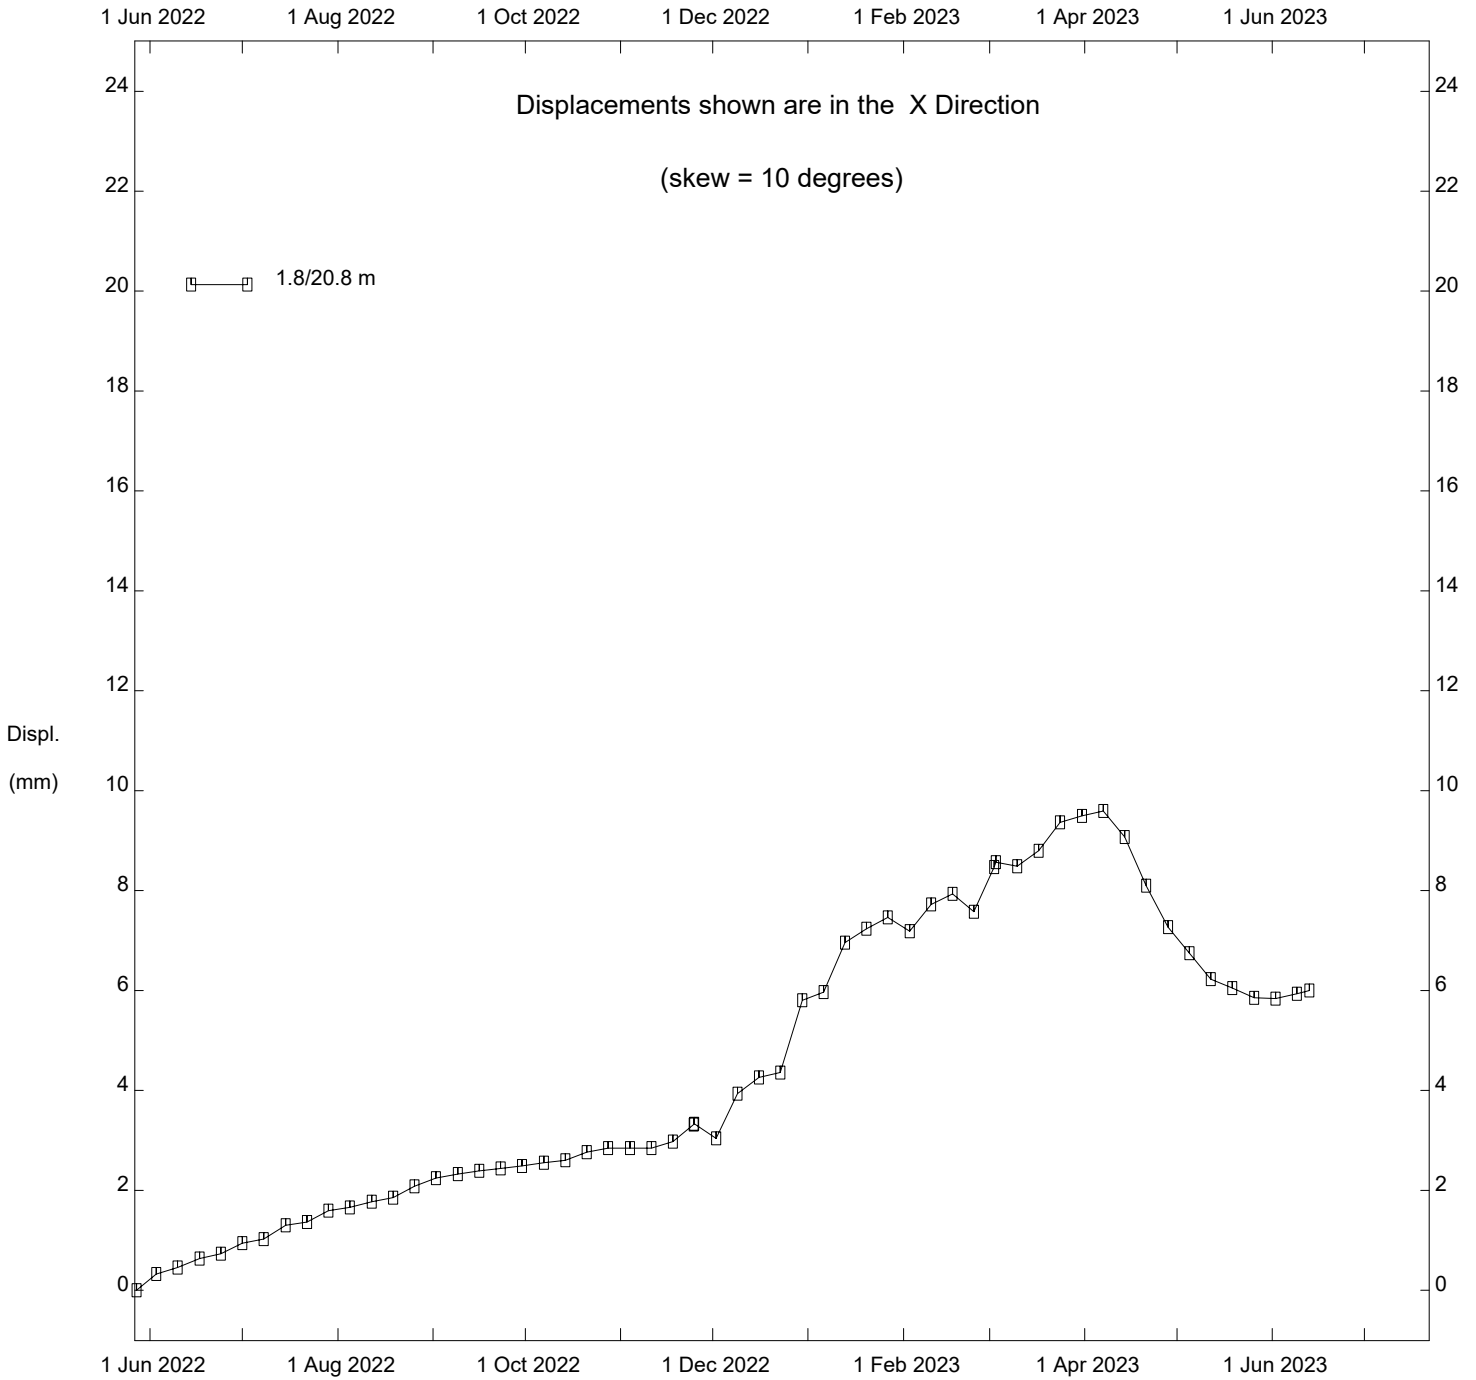
Shop Slide Type 1 Wall Section, Inclinometer SAA-P34
 Alberta Transportation

SAA-P34 has shown an average rate of movement of 4.9 mm/yr in the downslope direction since the fall of 2022 readings, with a current pile head movement of 6.0 mm since datalogger readings began for this instrument on May 27, 2022. SAA-P34 showed an increased rate of movement during the winter months and showed a maximum pile head movement of close to 10 mm in early April 2023 before moving in the upslope direction. This increased movement in the winter months appears to correspond to the increased load cell readings also observed at this pile over the same time period and is considered to be due to expansion of the soil behind the wall upon freezing.
