THURBER ENGINEERING LTD.

July 14, 2023

**ALBERTA TRANSPORTATION AND ECONOMIC CORRIDORS GRMP (CON0022164)
PEACE REGION (PEACE RIVER DISTRICT)
INSTRUMENTATION MONITORING RESULTS – SPRING 2023**

SITE PH009: OLD HWY 2:02 SHOP SLIDE

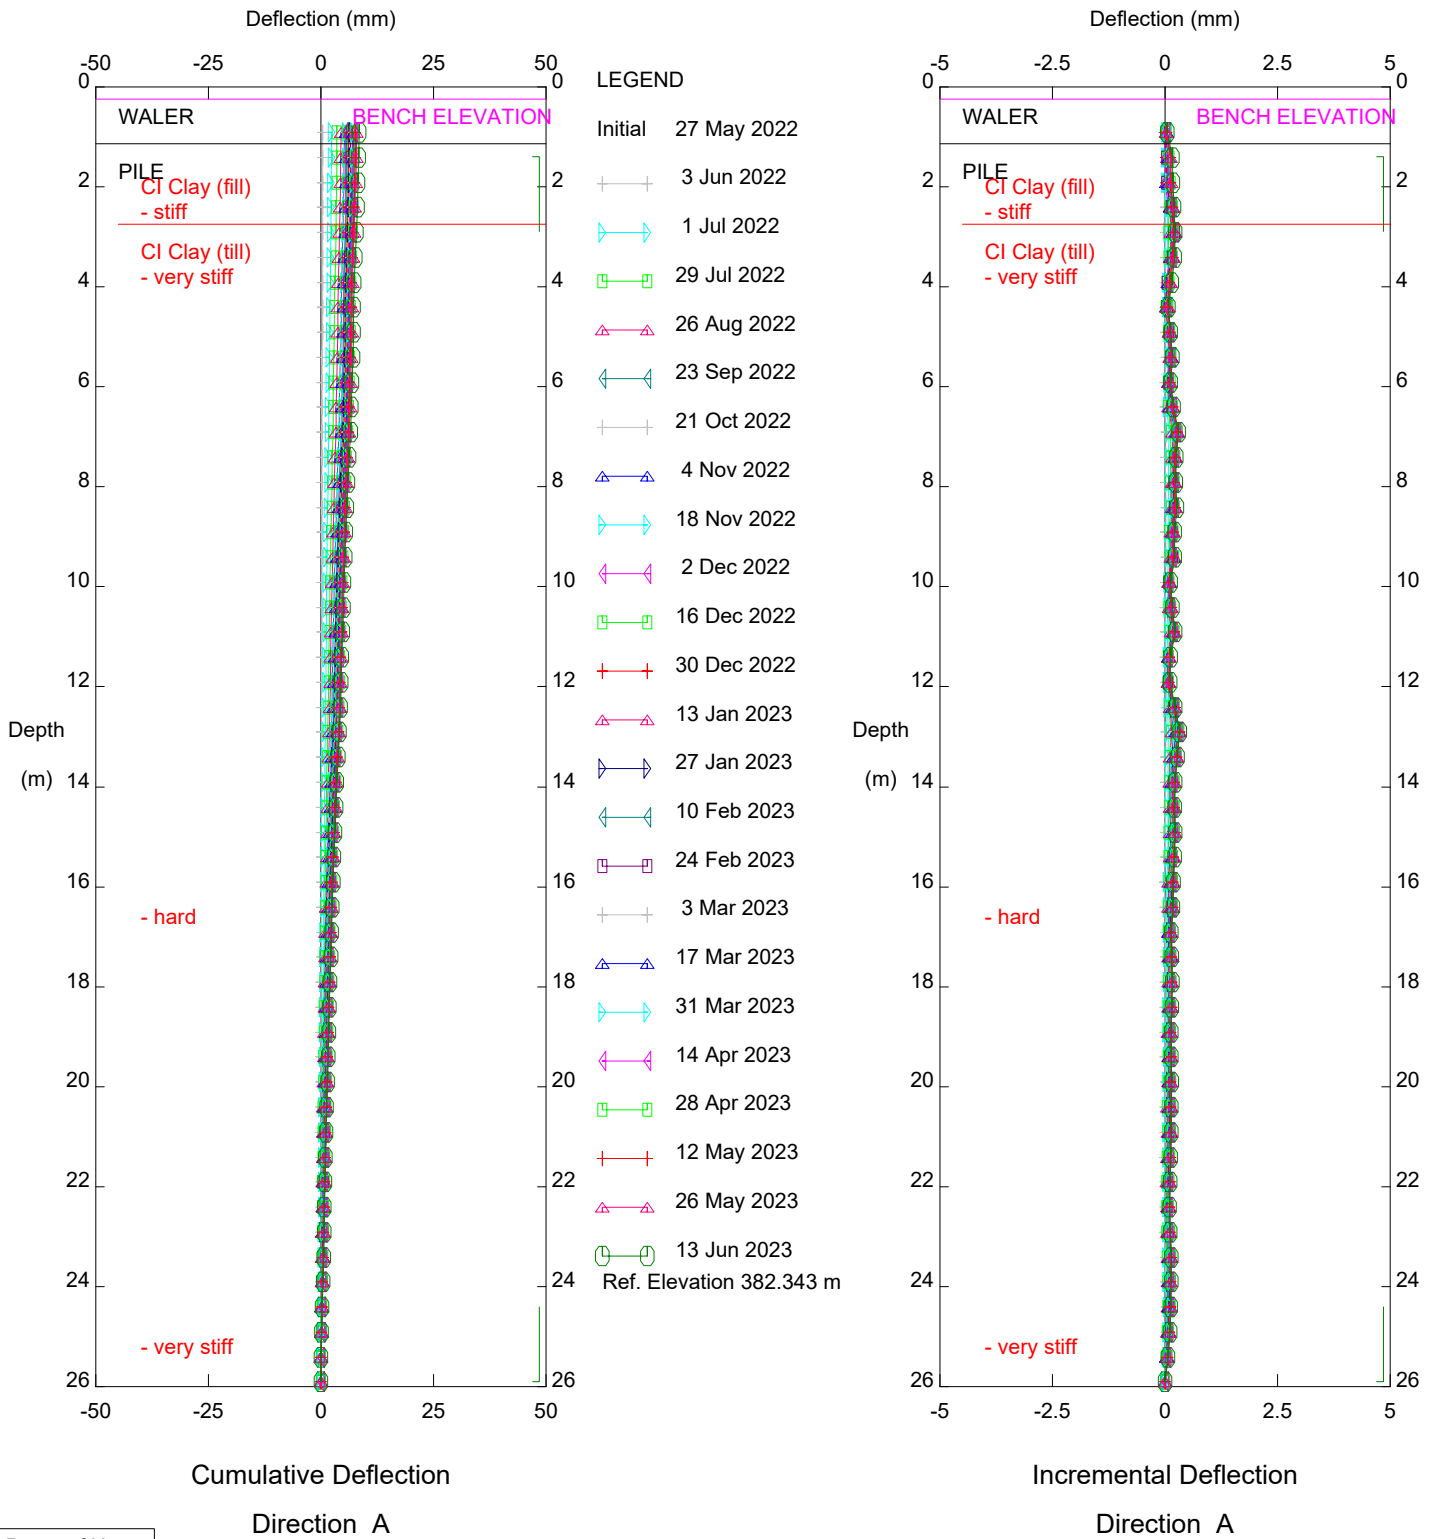
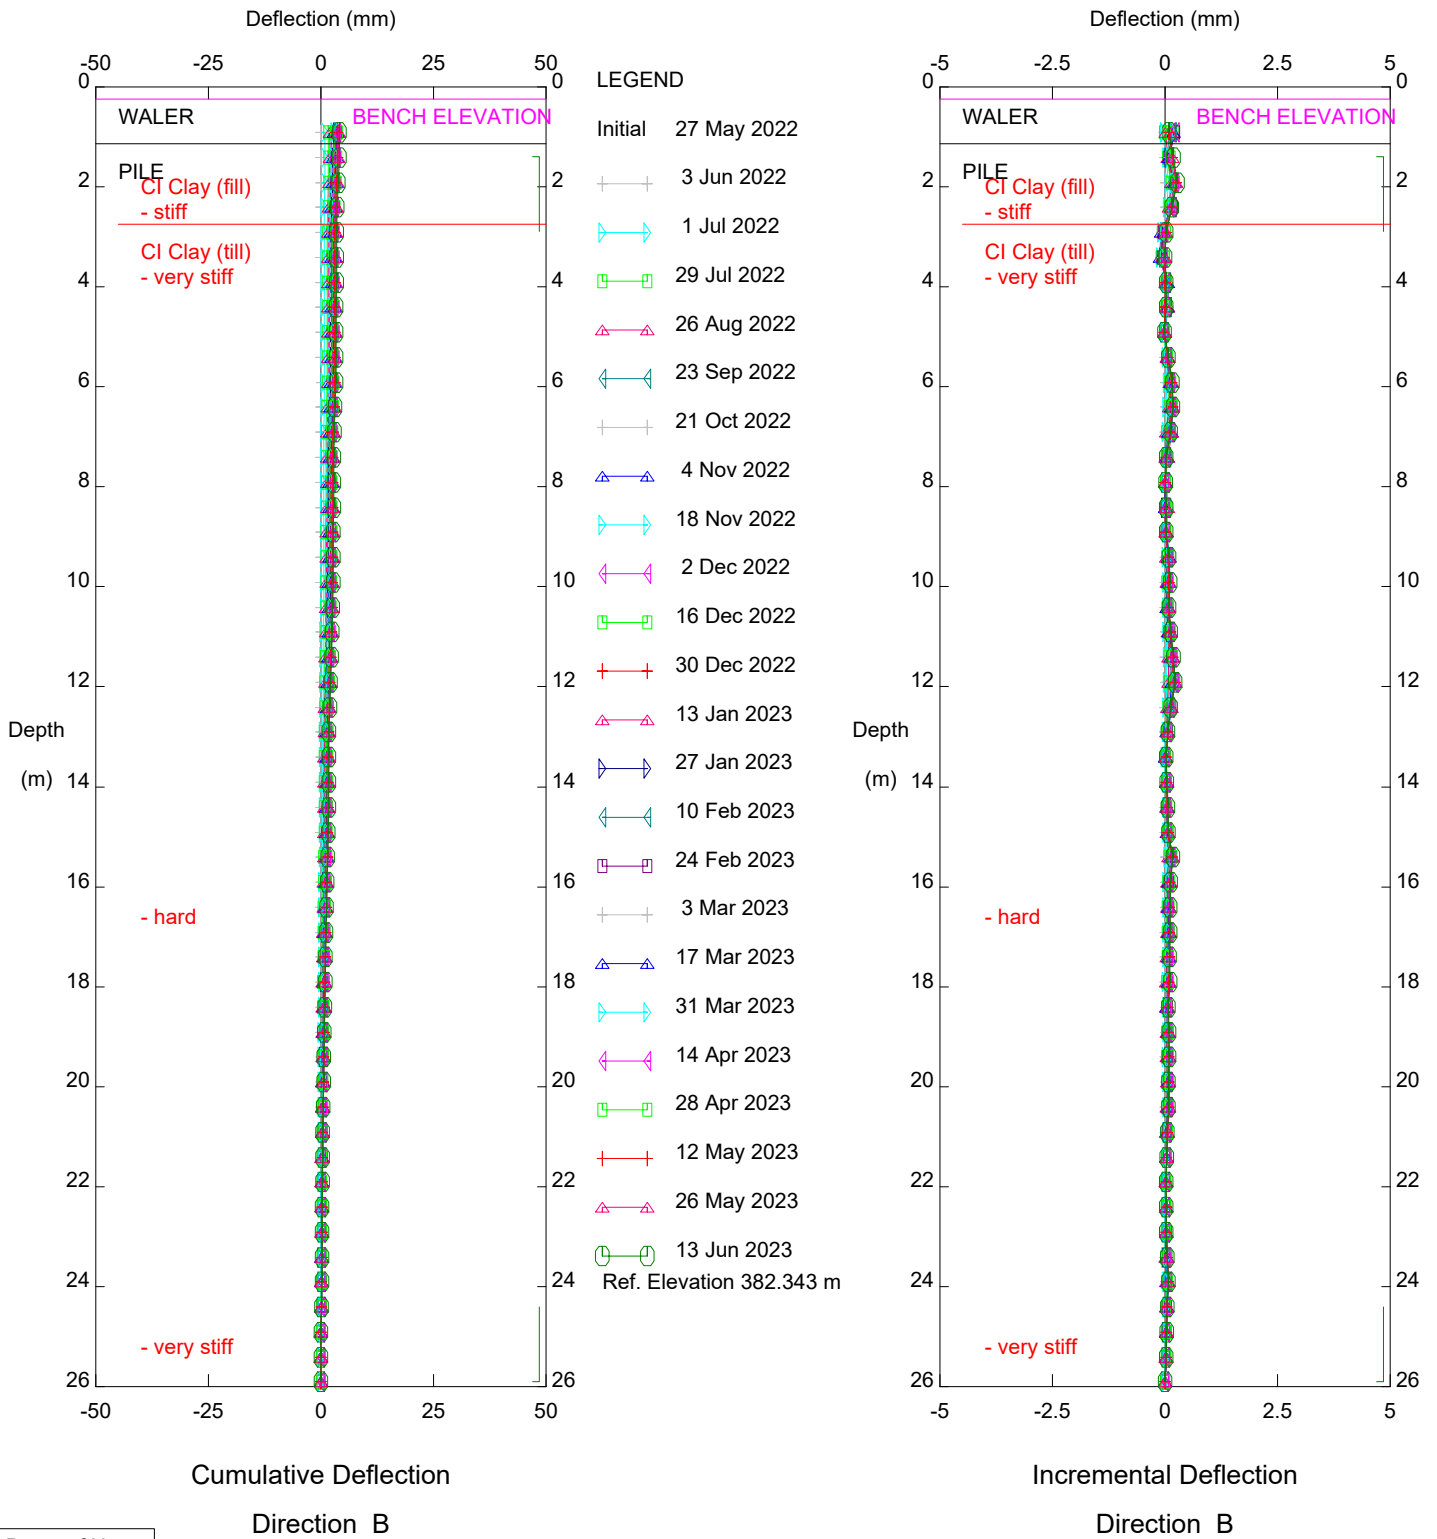
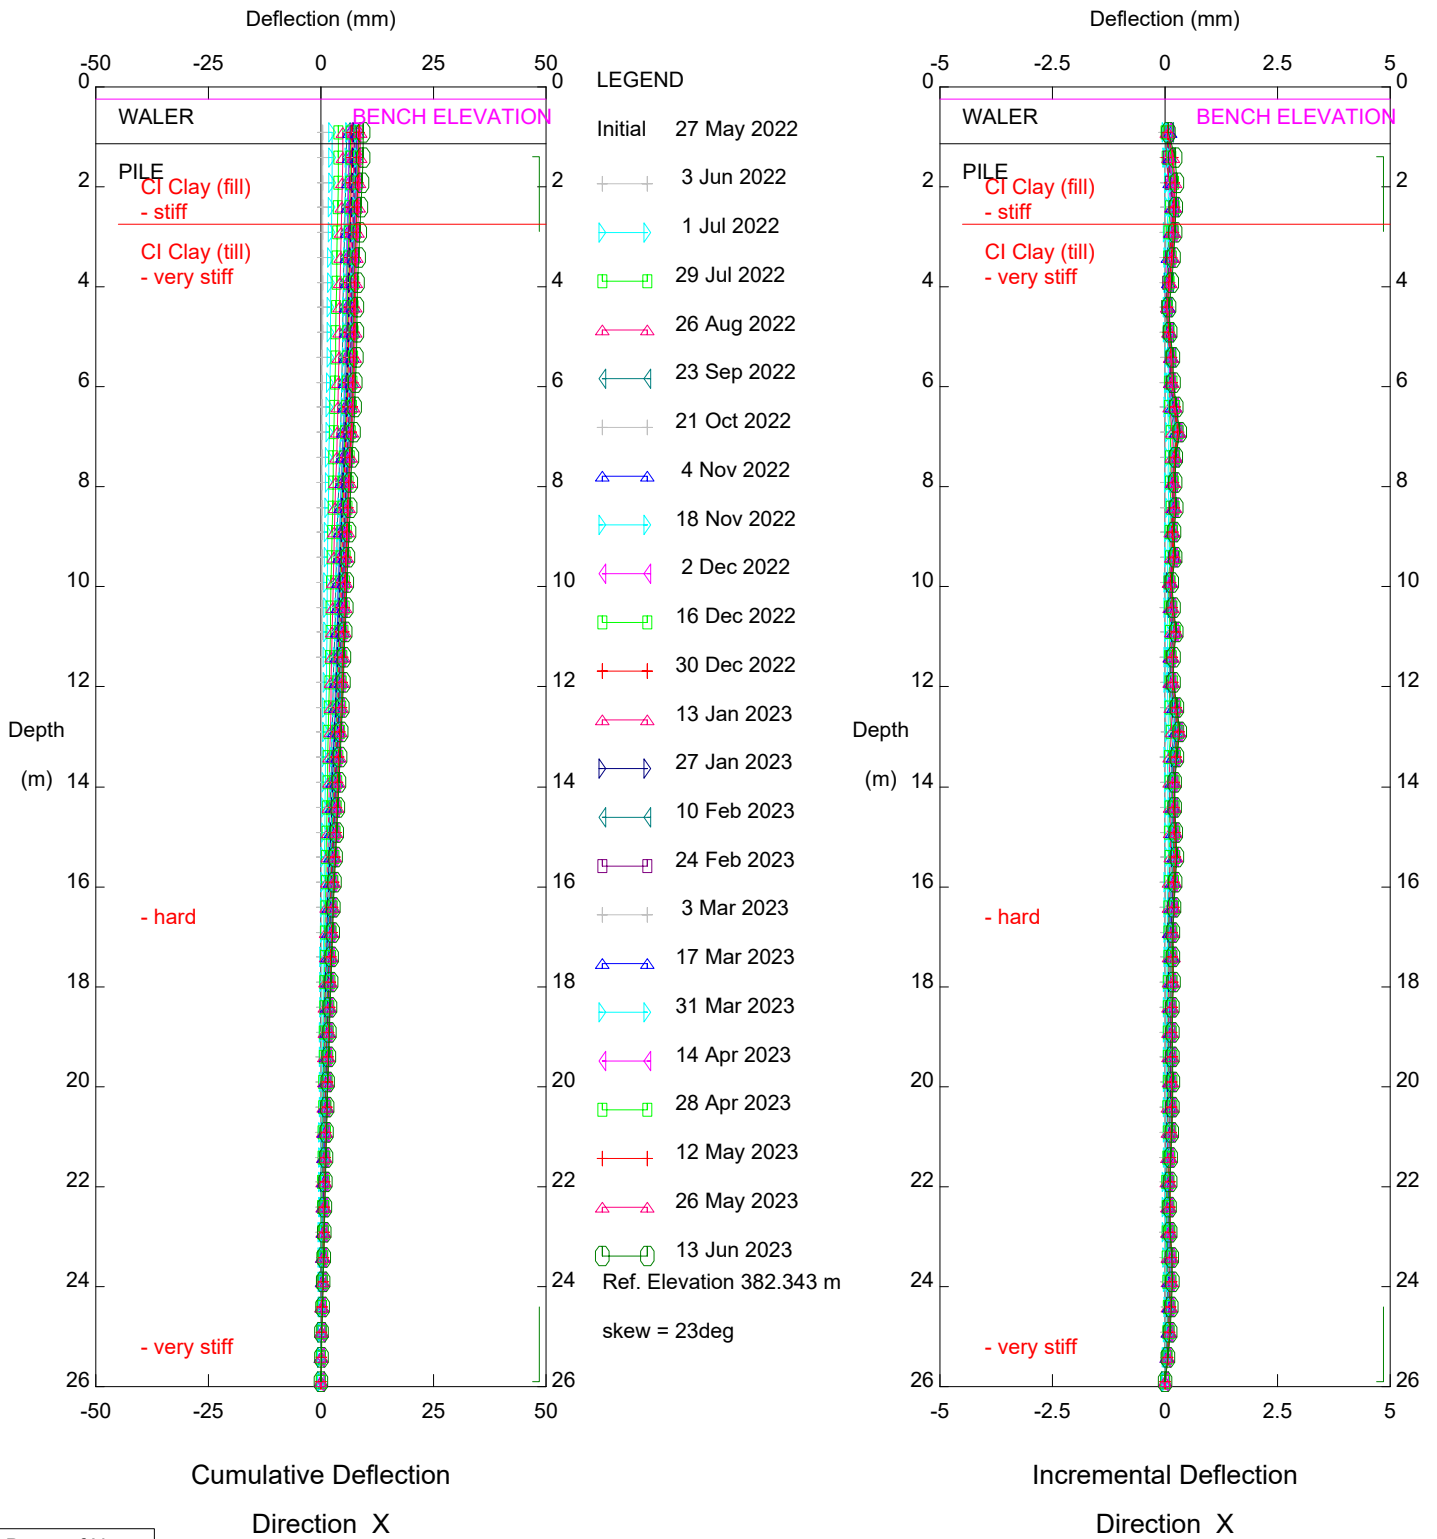
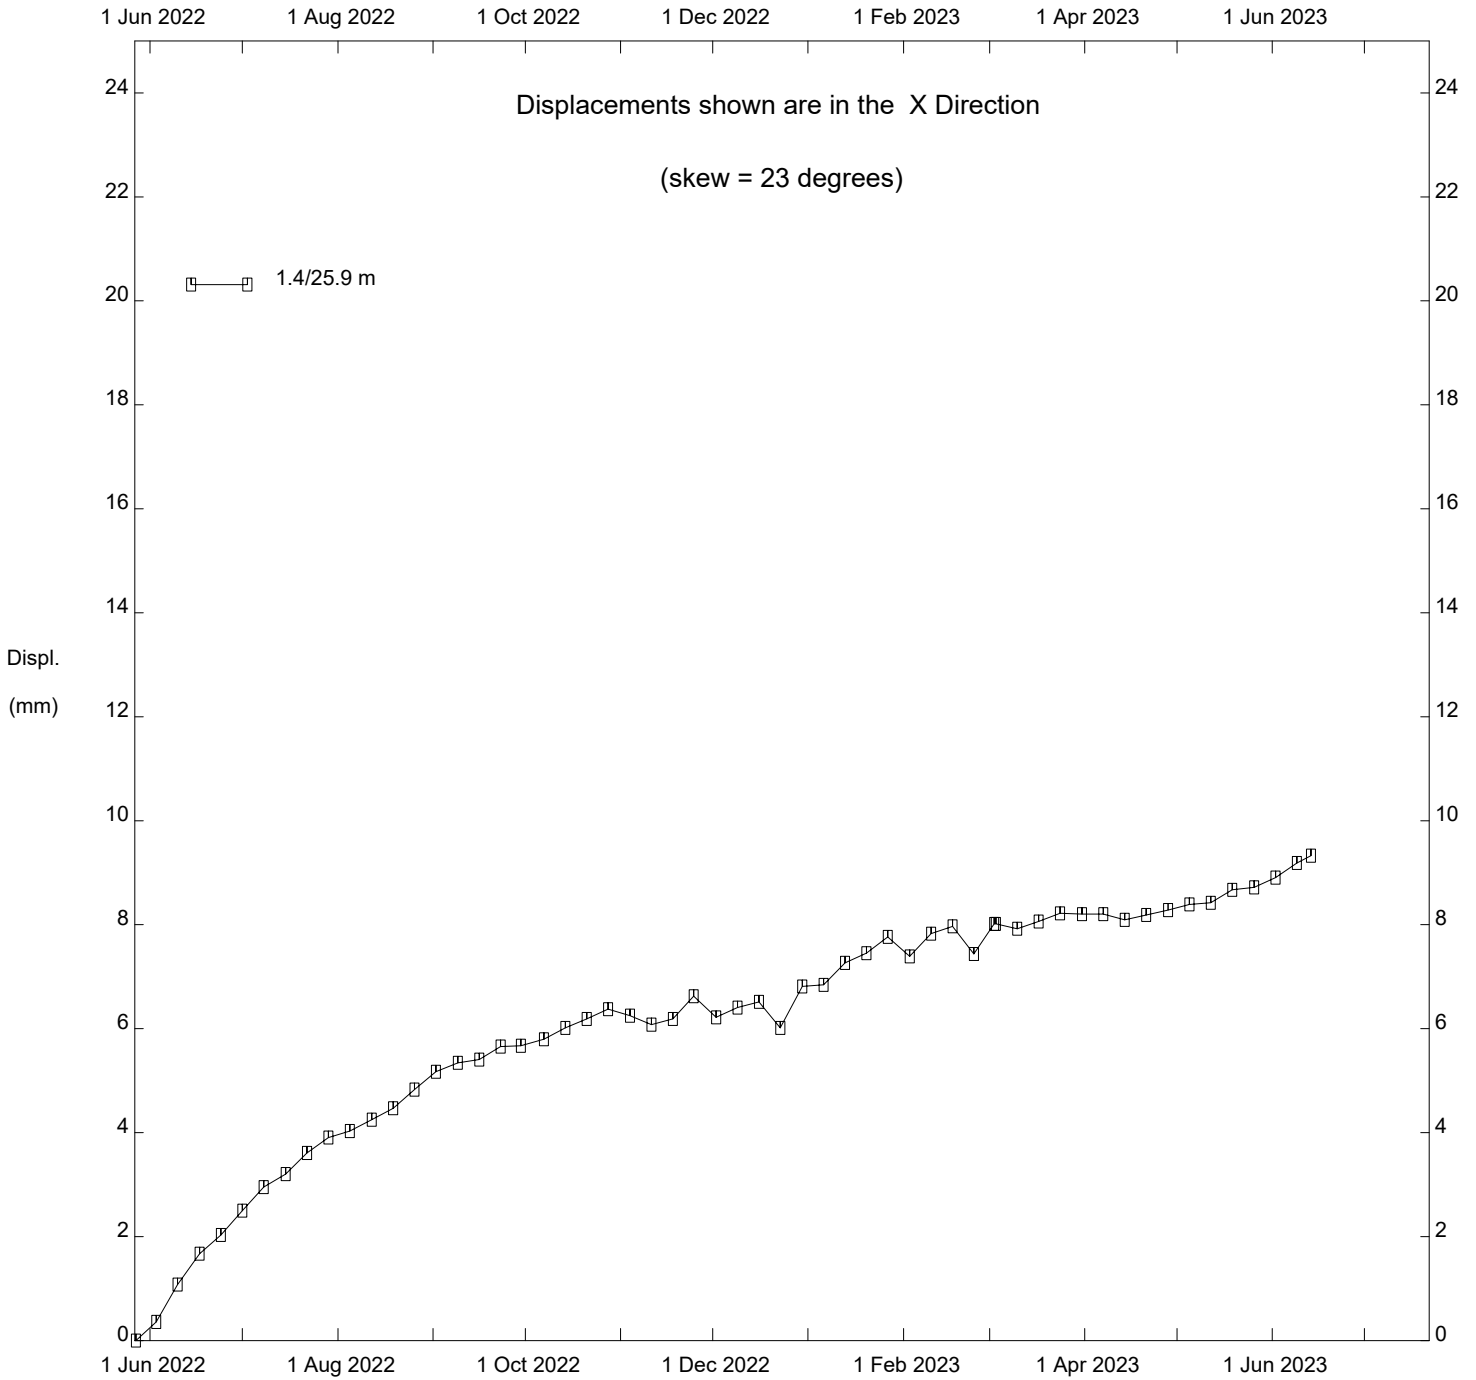
Shop Slide Wall Type 3, Inclinometer SAA-P113
 Alberta Transportation

SAA-P113 has shown an average rate of movement of 4.9 mm/yr in the downslope direction since the fall of 2022 readings, with a total pile head movement of 9.3 mm since datalogger readings began on May 27, 2022. The higher observed movement in SAA-P113 can be attributed to the fact that the pile wall at this location is a cantilever arrangement, and not a tied-back wall. The last two months of readings in this SAA show a trend of accelerating movement, and this instrument should be closely monitored to see if this trend continues. The total pile head deflection to date, combining the data before and after resetting the SAA has been at least 13.2 mm.

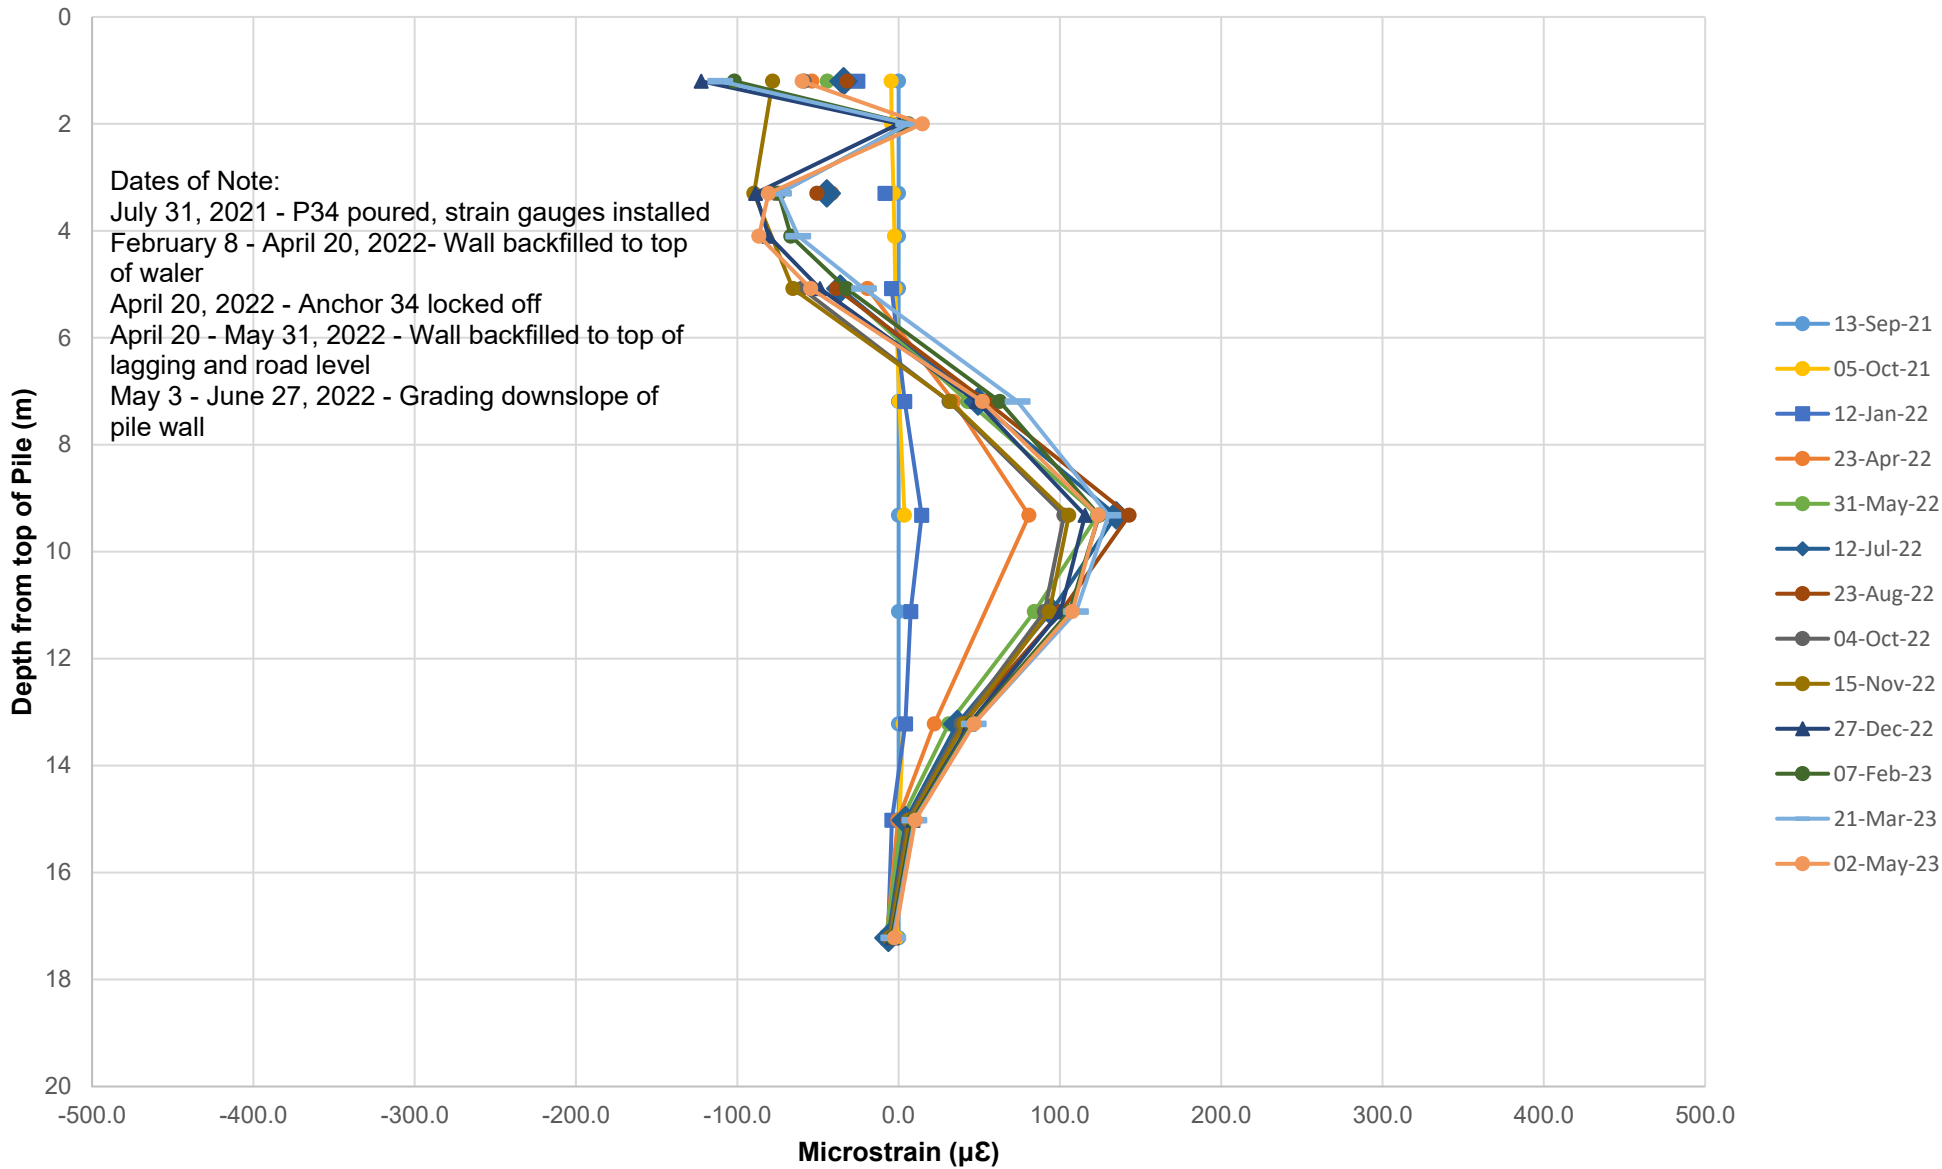
**FIGURE PH009-1: PEACE RIVER SHOP SLIDE
P34 UPSLOPE SIDE STRAIN GAUGE VALUES VS DEPTH**

The strain gauges in P34 show their maximum positive (tension) strain (121.4 microstrain) on the upslope pile face at around 9 m depth, with a corresponding trend of negative (compression) strain (-202.1 microstrain) on the downslope pile face at the same depth. This seems to correspond to the observed deflection of the pile in the downslope direction noted in the SAA above 9 m depth. The strain gauges on the downslope side of P77 indicate a maximum negative strain of -135.7 microstrain at a depth of 7.1 m. P77 does not show as clear of a trend of strain in the upslope pile strain gauges compared to P34. The upslope strain gauges for P113 show a noticeable increase in positive strain at 15 m depth on the upslope face of the pile, which may indicate an inflection point where the pile is bending. The strain gauges are plotted on Figures PH009-1 through PH009-9 in Appendix A.

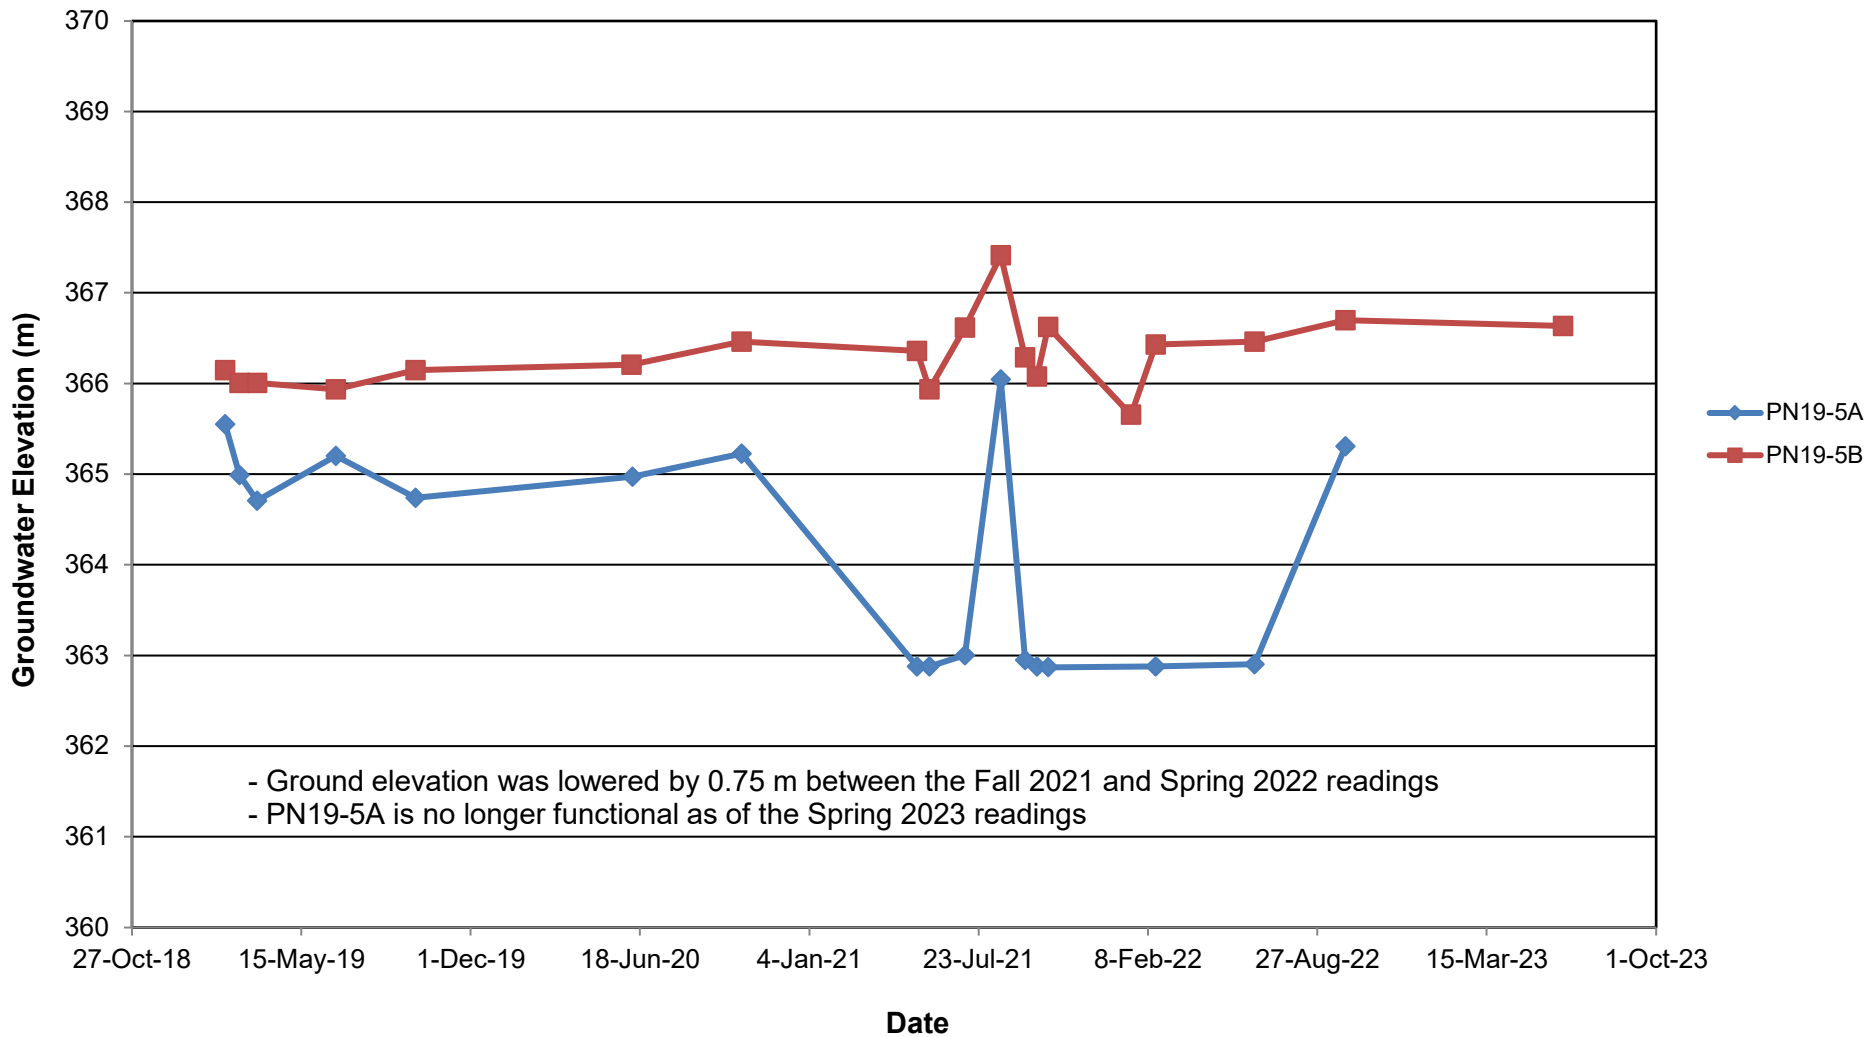
FIGURE PH009-13
PNEUMATIC PIEZOMETER READINGS: OLD HWY 2:02 (SHOP SLIDE)

Pneumatic piezometer PN19-5A was found to be malfunctioning during the current readings. This instrument has been found to be malfunctioning for two consecutive readings cycles and should be removed from the readings program.
