Site Number	Location	Name	Hwy	km
PH006	North of Paddle Prairie	Tompkins Landing	697:02	Km 17.5
<b>Legal Description:</b>		<b>UTM Co-ordinates</b>		
12-30-103-19 W5		11U E 491173.98	N	6425582.21

<b>Current Monitoring:</b>	24-May-2024	<b>Previous Monitoring</b>	18-Jun-2023
<b>Instruments Read By:</b>	Mr. Niraj Regmi, G.I.T., and Mr. Nixson Mationg, of Thurber

**ALBERTA TRANSPORTATION AND ECONOMIC CORRIDORS GRMP (CON0022164)  
PEACE REGION (PEACE RIVER DISTRICT)  
INSTRUMENTATION MONITORING RESULTS**

**SITE PH006: HWY 697:02, TOMPKINS LANDING**

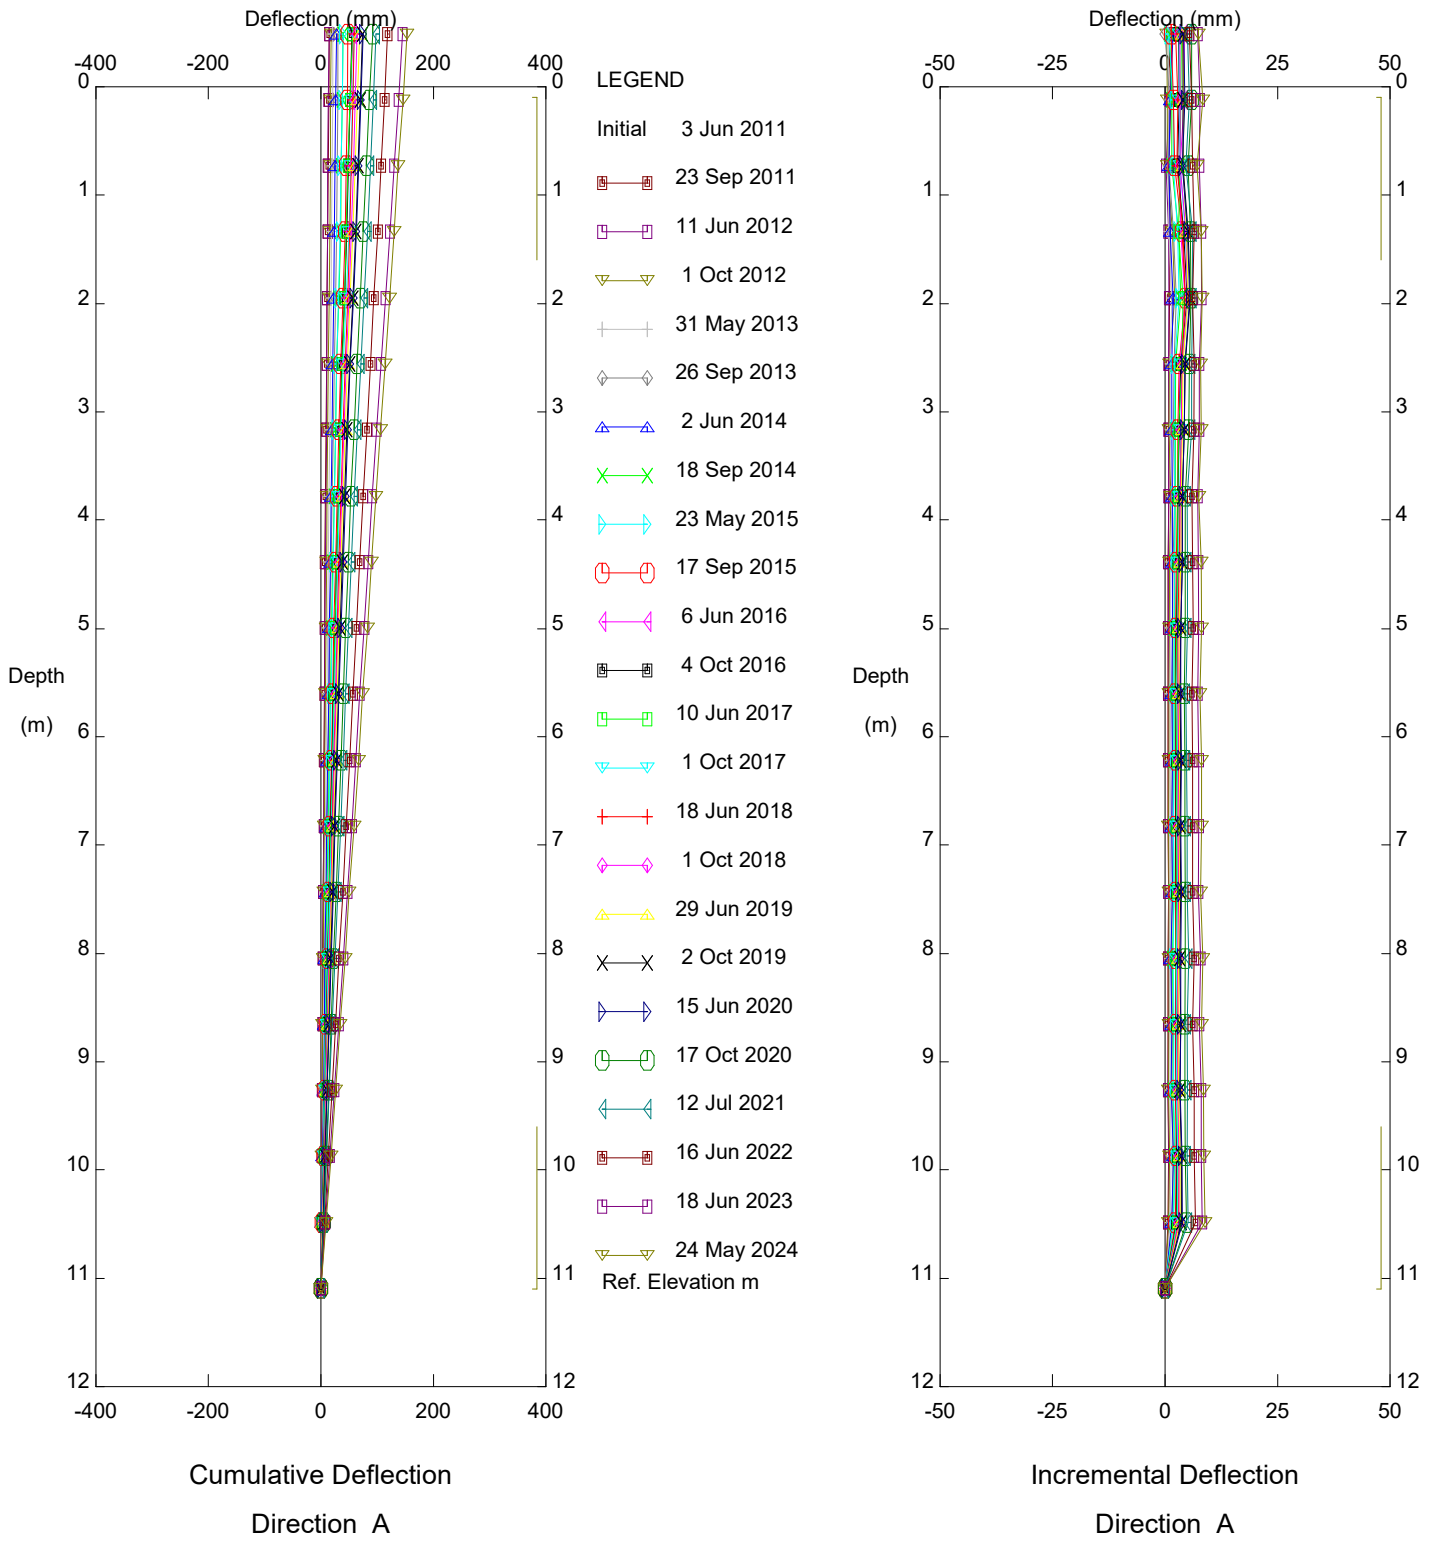
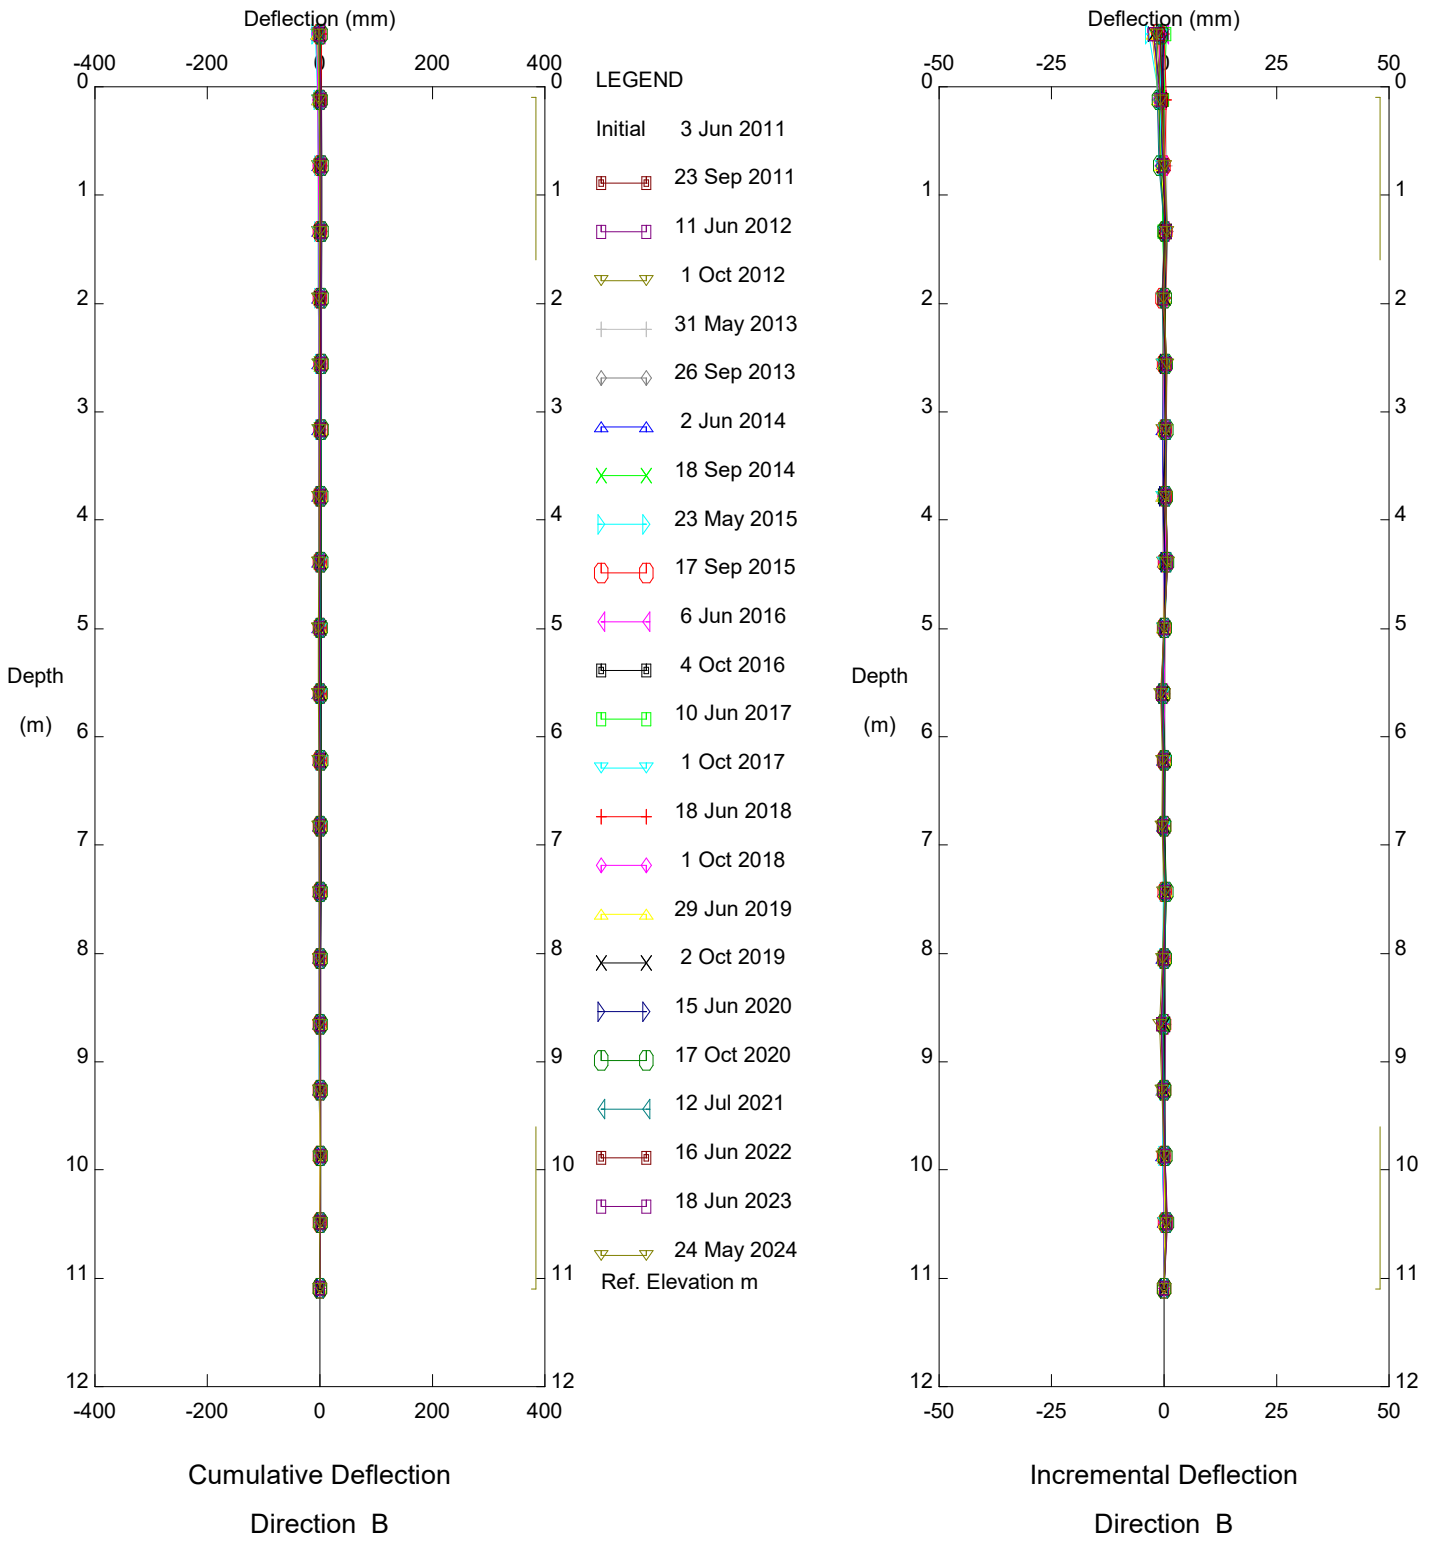
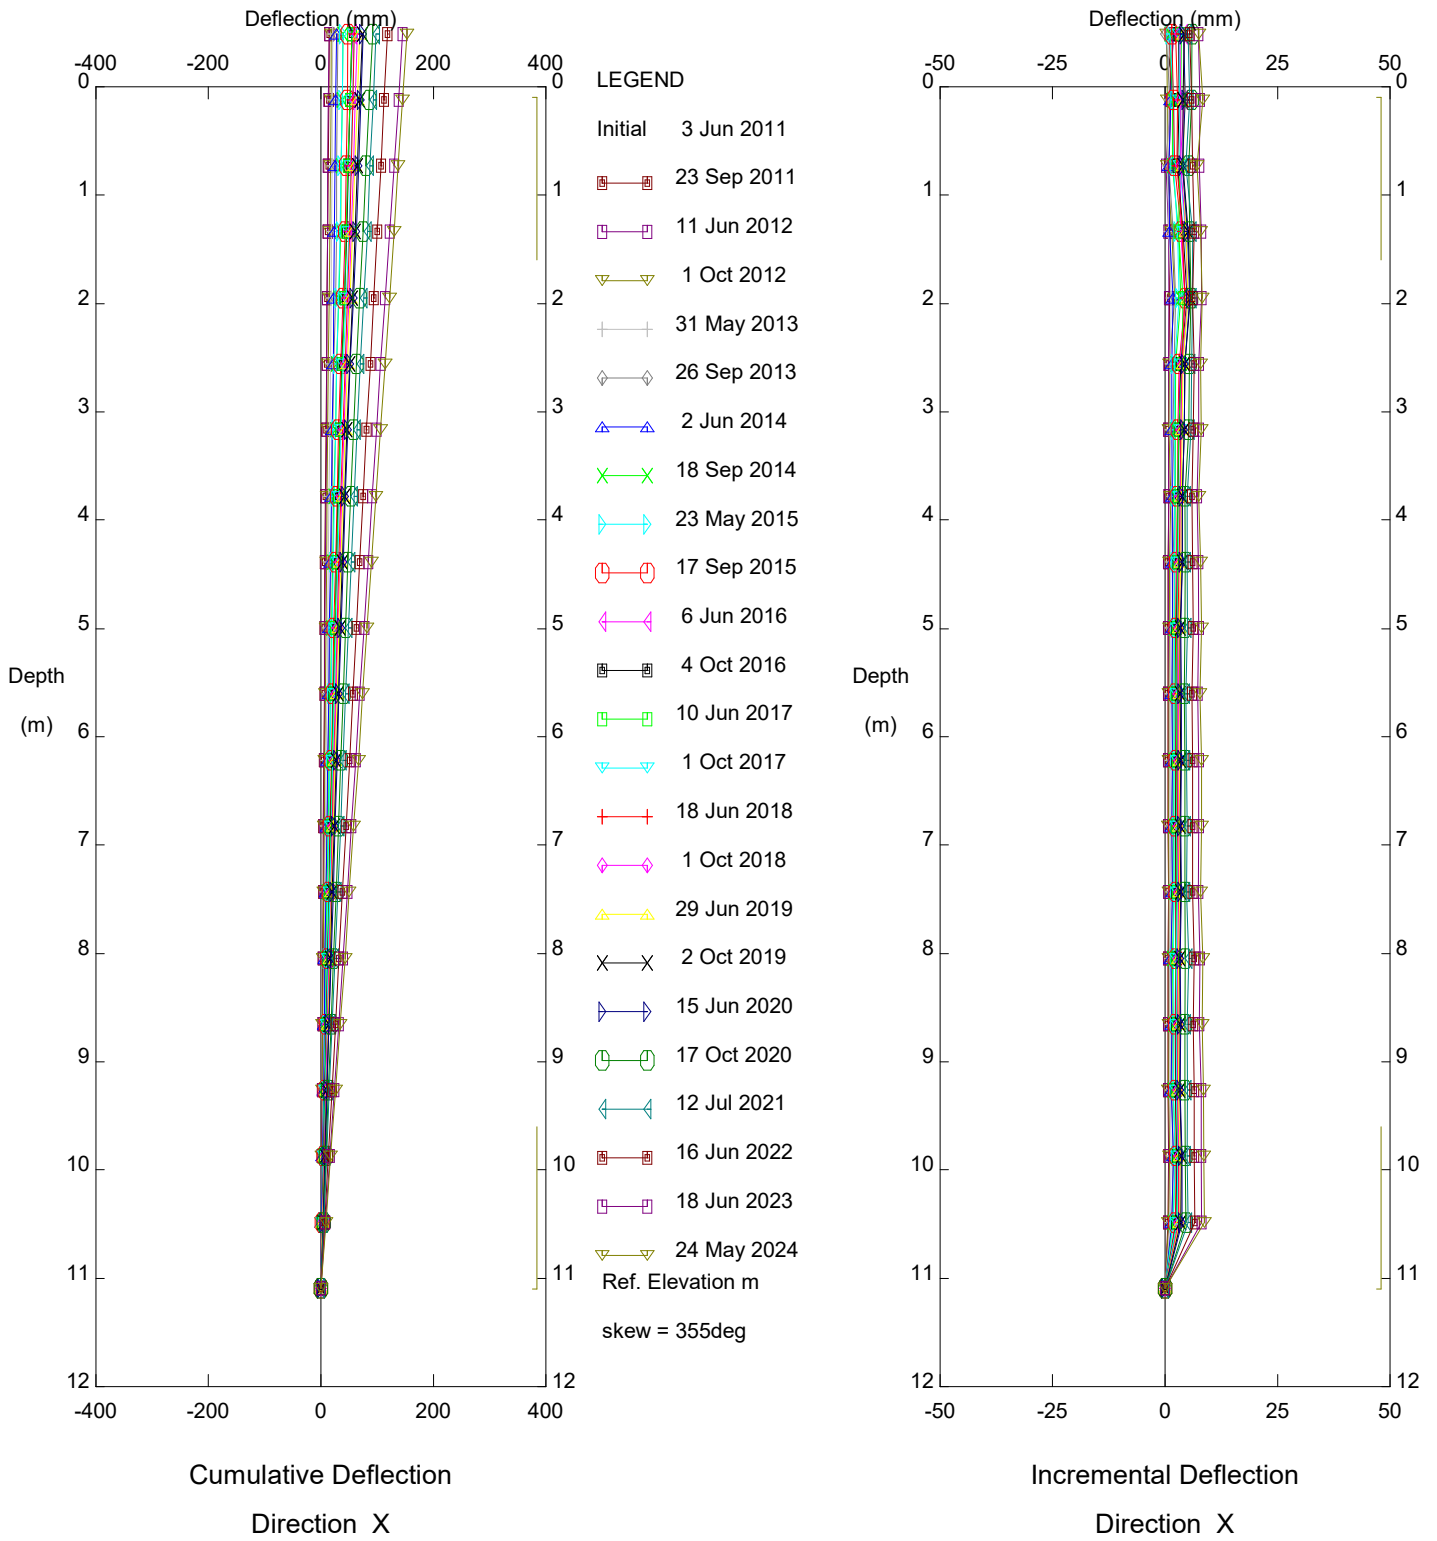
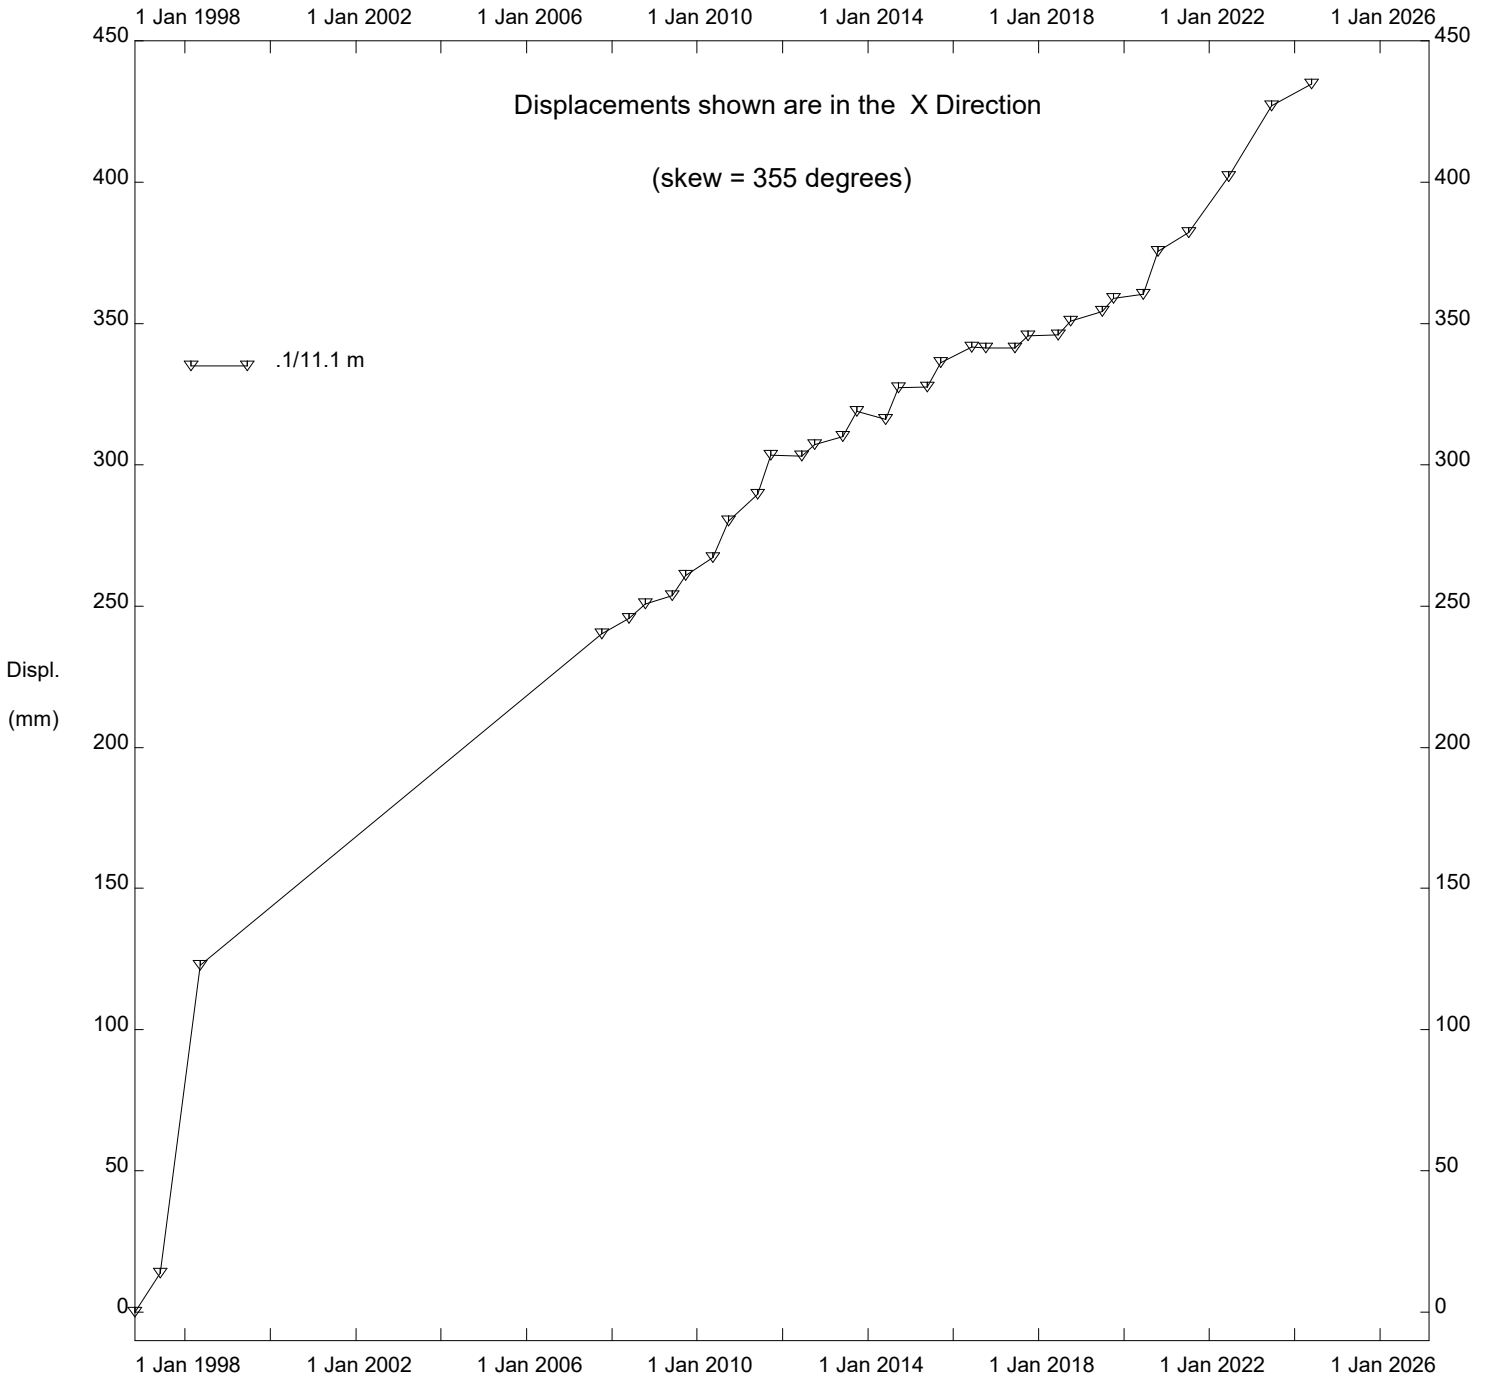
HWY 697:02 - STA. 17+360, Inclinator SI-5

Discussion	
<b>Zones of New Movement:</b>	None
<b>Interpretation of Monitoring Results:</b>	<p>Slope indicator SI-1 was found to have been blocked or sheared at approximately 3 m below ground surface.</p> <p>SI-5 showed a movement rate of 7.7 mm/yr over 0.1 m to 11.1 m depth since the spring of 2023 readings. This rate is consistent with a long term trendline of the movement rate since 1999. Of noted there are long periods of time where movement rates exceeds or fall short of the long term trendline. Since the fall of 2020 the movement rate is about 19 mm/yr.</p> <p>Slope inclinometer SI13 showed a rate of movement of 20.4 mm/yr over 1.7 m to 14.5 m depth compared to the overall rate of 13.1 mm/year. From installation in 1998 to the spring of 2020, the overall movement rate was 10.4 mm/yr. Since the fall of 2020, the overall rate has accelerated to 24.8 mm/yr. This accelerated movement coincides with the acceleration observed in SI-5 and an increase in groundwater level as noted below.</p> <p>Based on previous instrument readings and site observations, it appears that the two operational SIs at this site were installed too shallow to intercept the main slip surface of the slide but are, nonetheless, moving significantly within the overall slide blocks.</p>

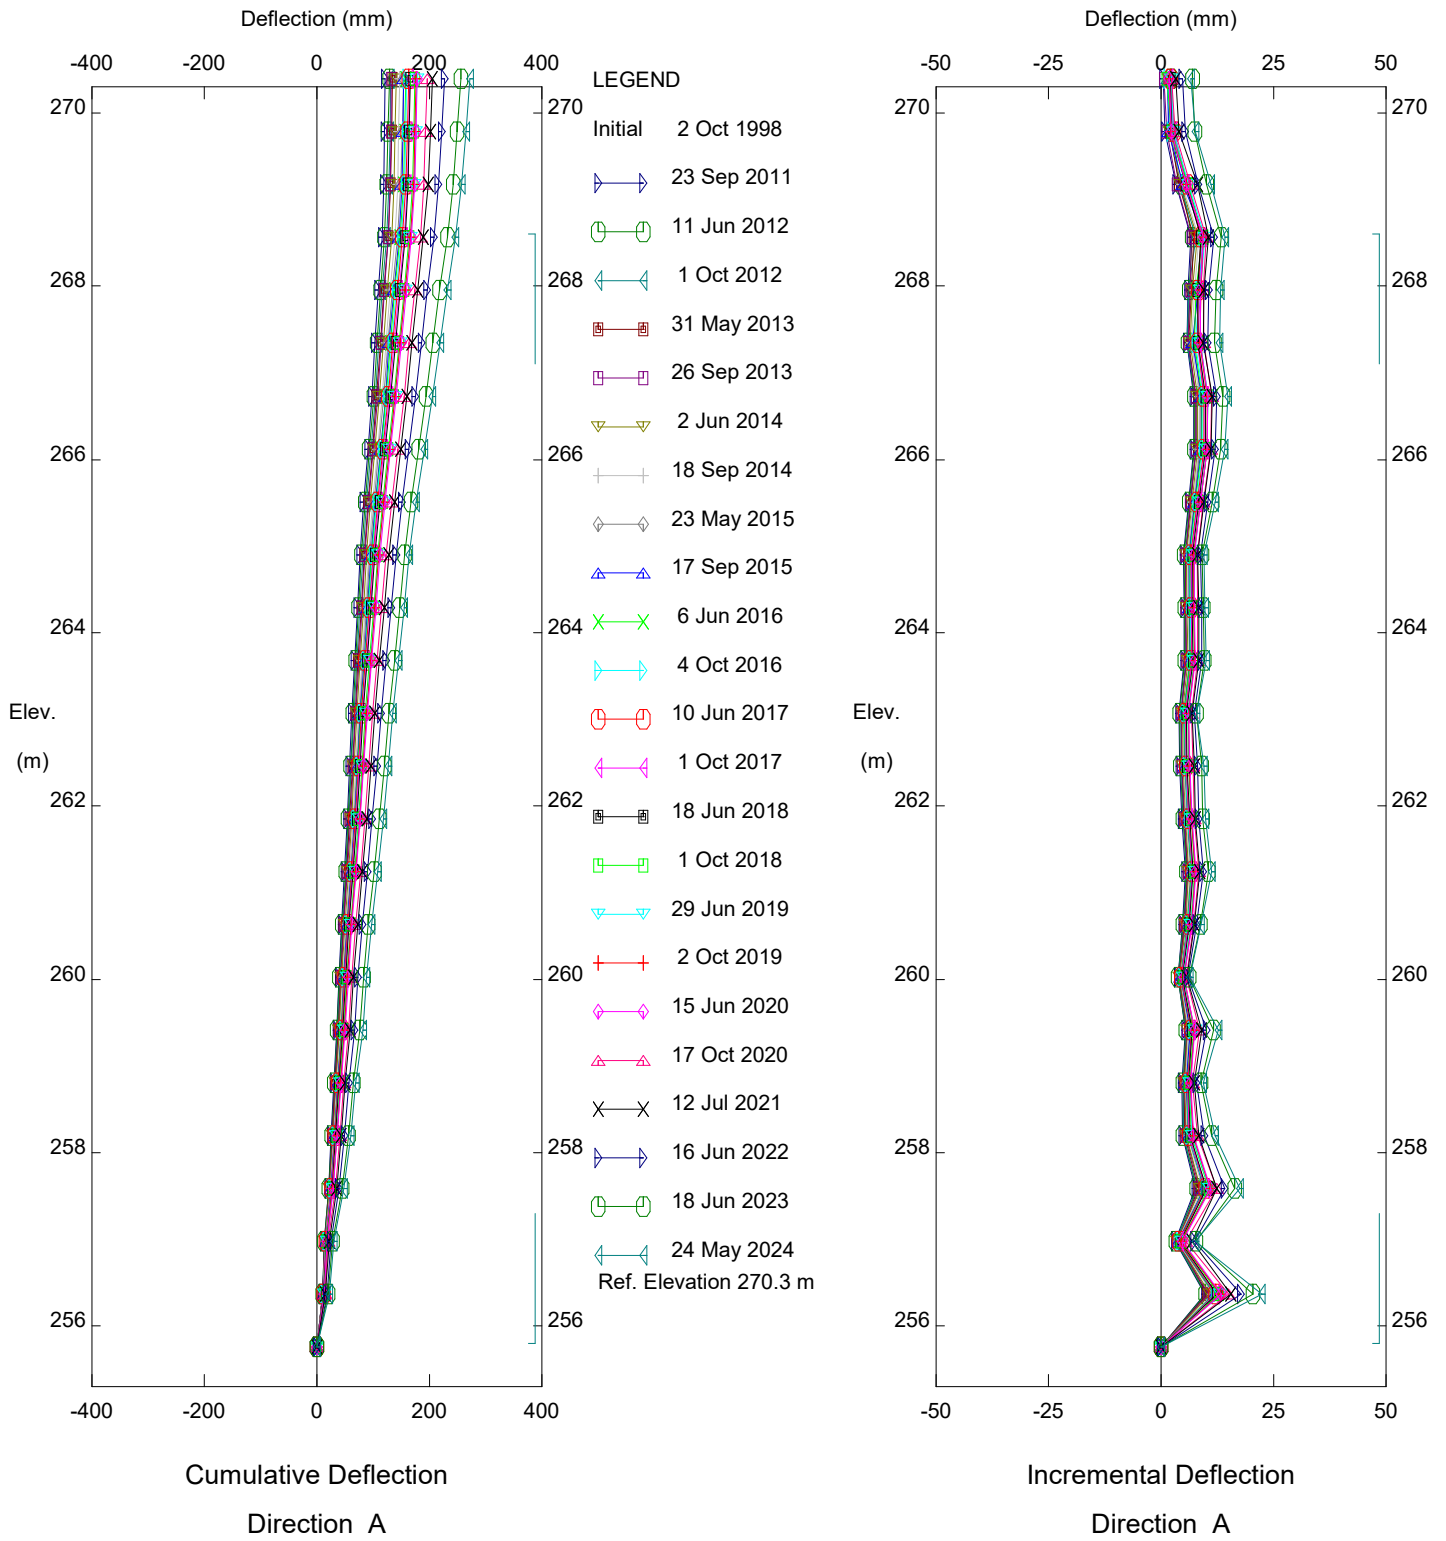
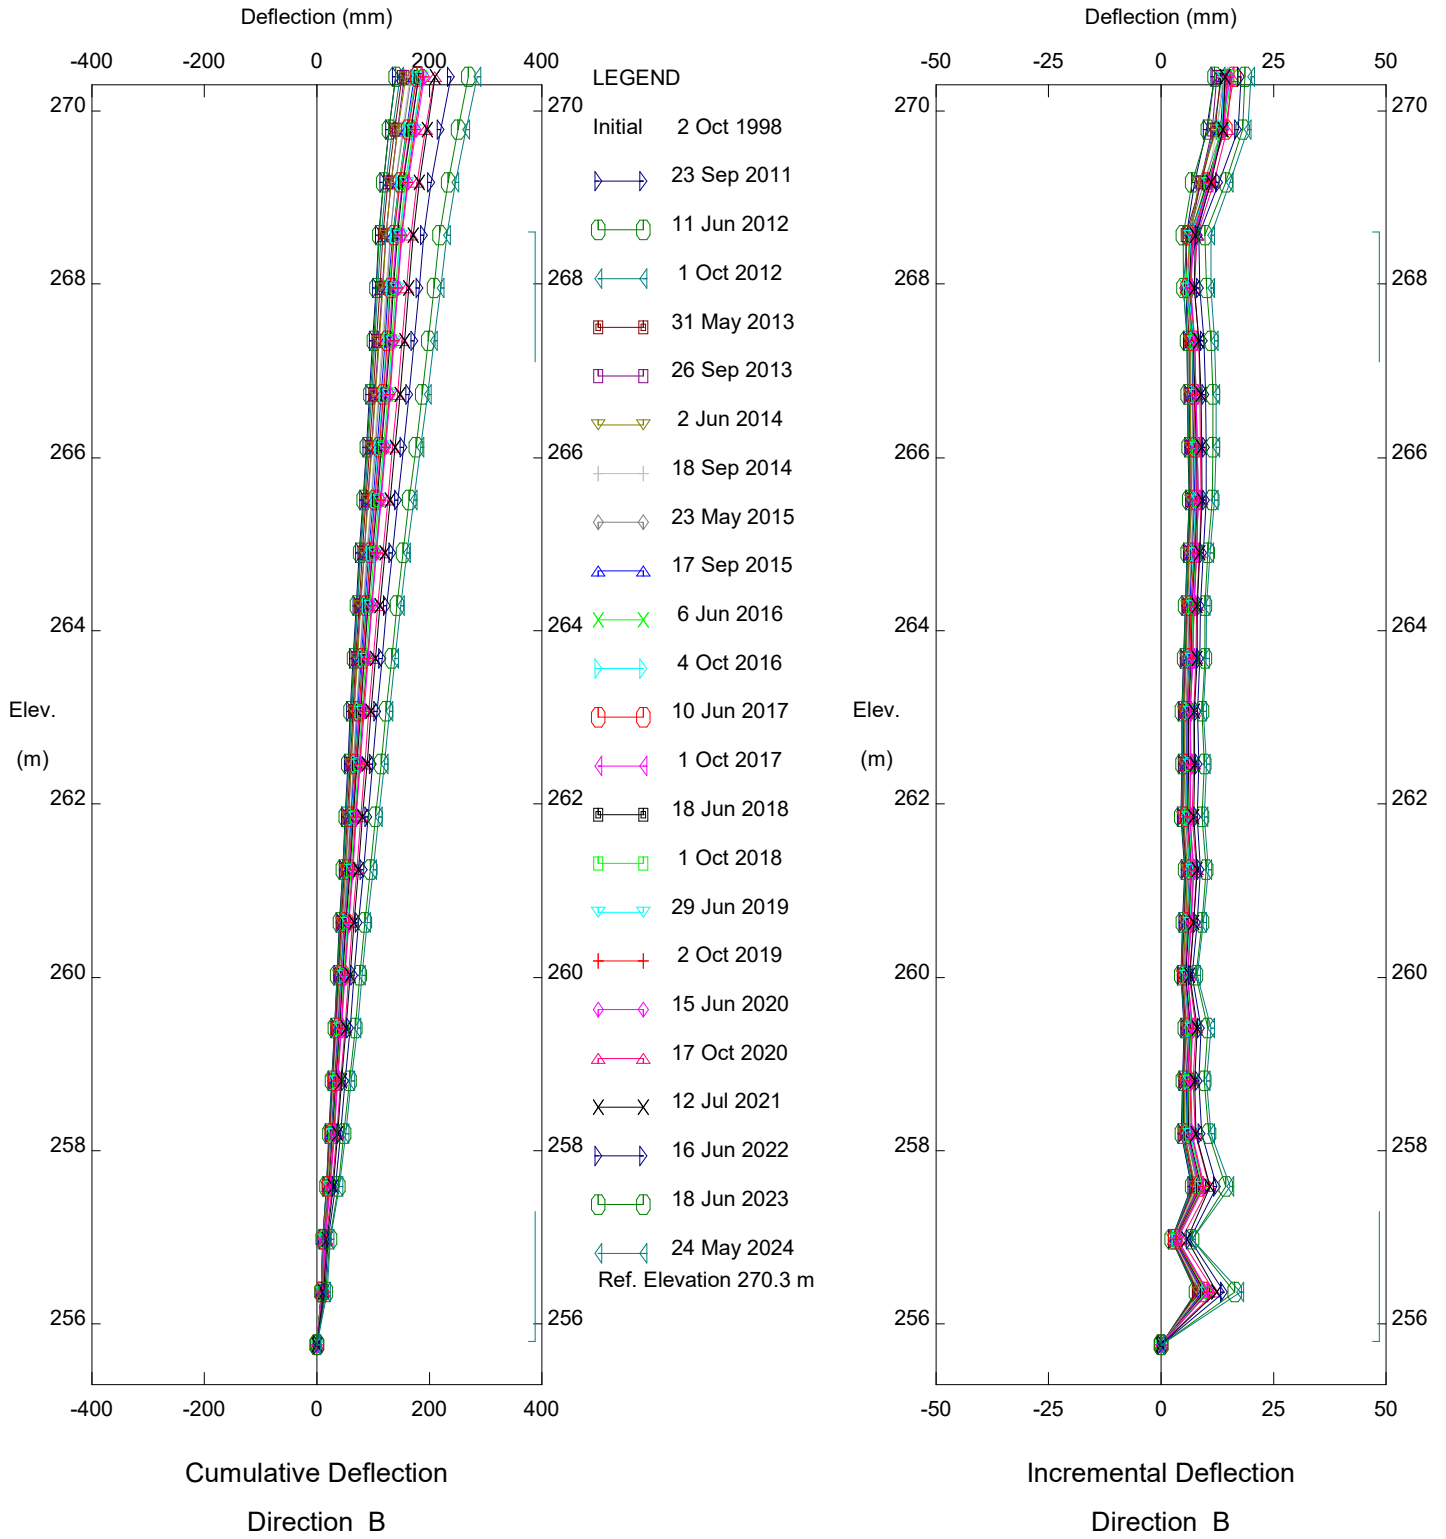
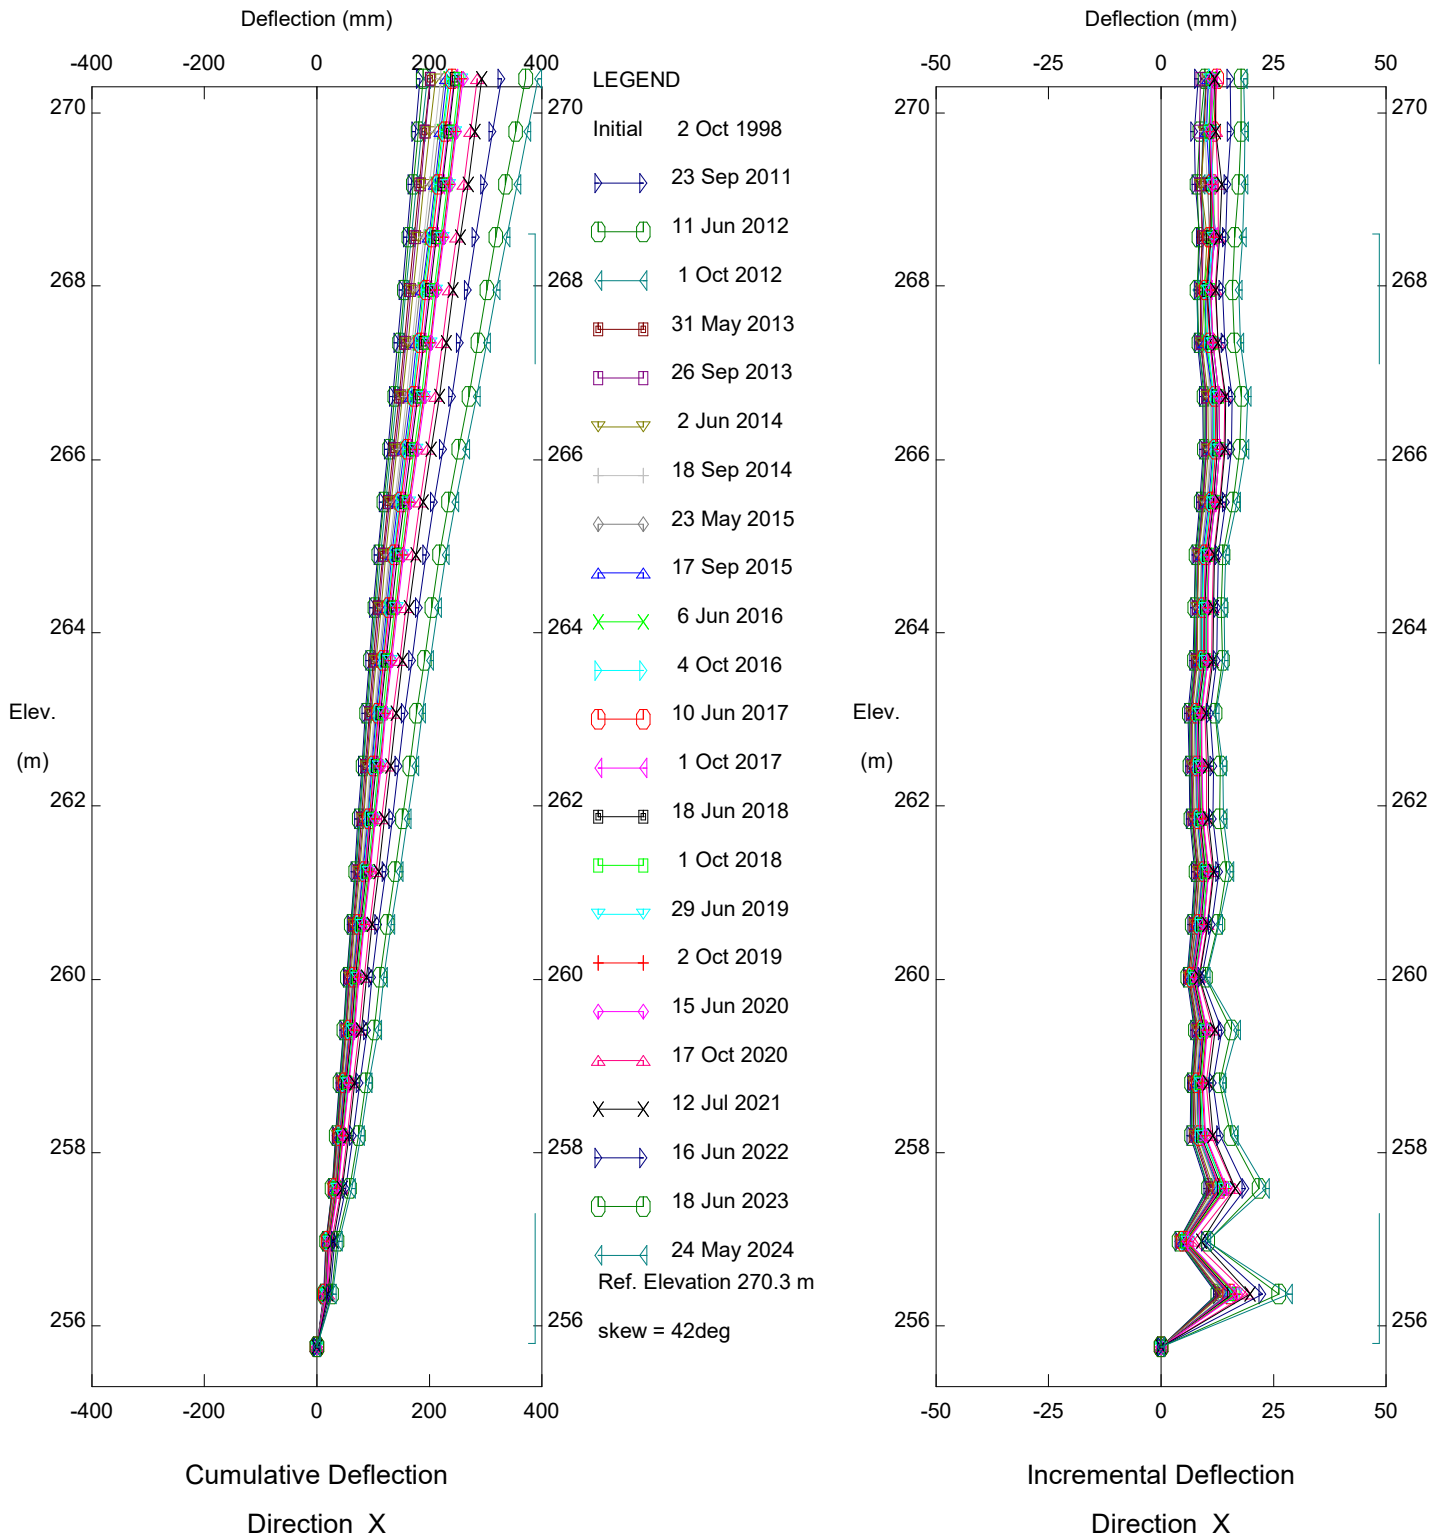
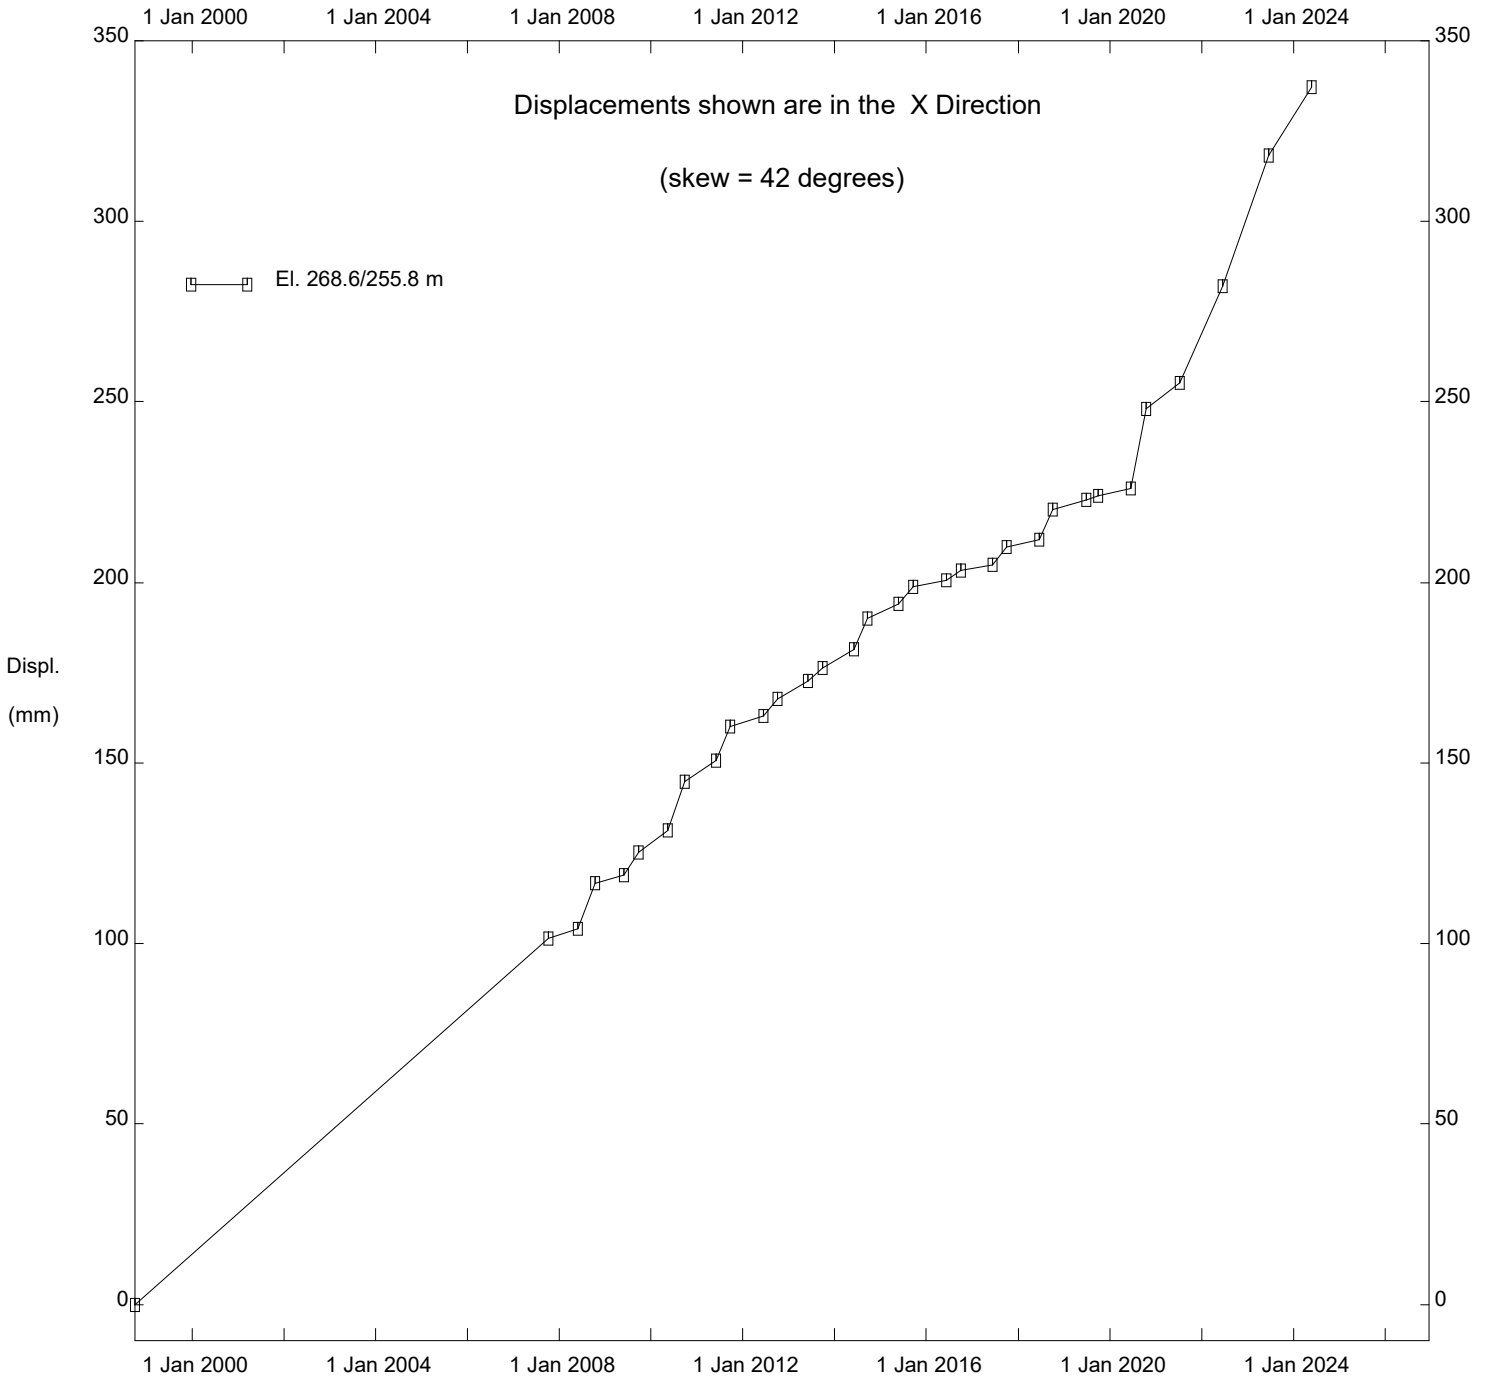
HWY 697:02 - STA. 17+360, Inclinometer SI-13

14.6 mm over 11.5 m to 12.8 m depth in 100° direction	8.4 mm/yr in Oct. 1998			N/A	N/A	N/A
SI-13	Oct. 2, 1998	337.2 mm over 1.7 m to 14.5 m depth in 113° direction	64.5 mm/yr in October 2020	Operational	June 18, 2023	19.0	20.4	-15.6

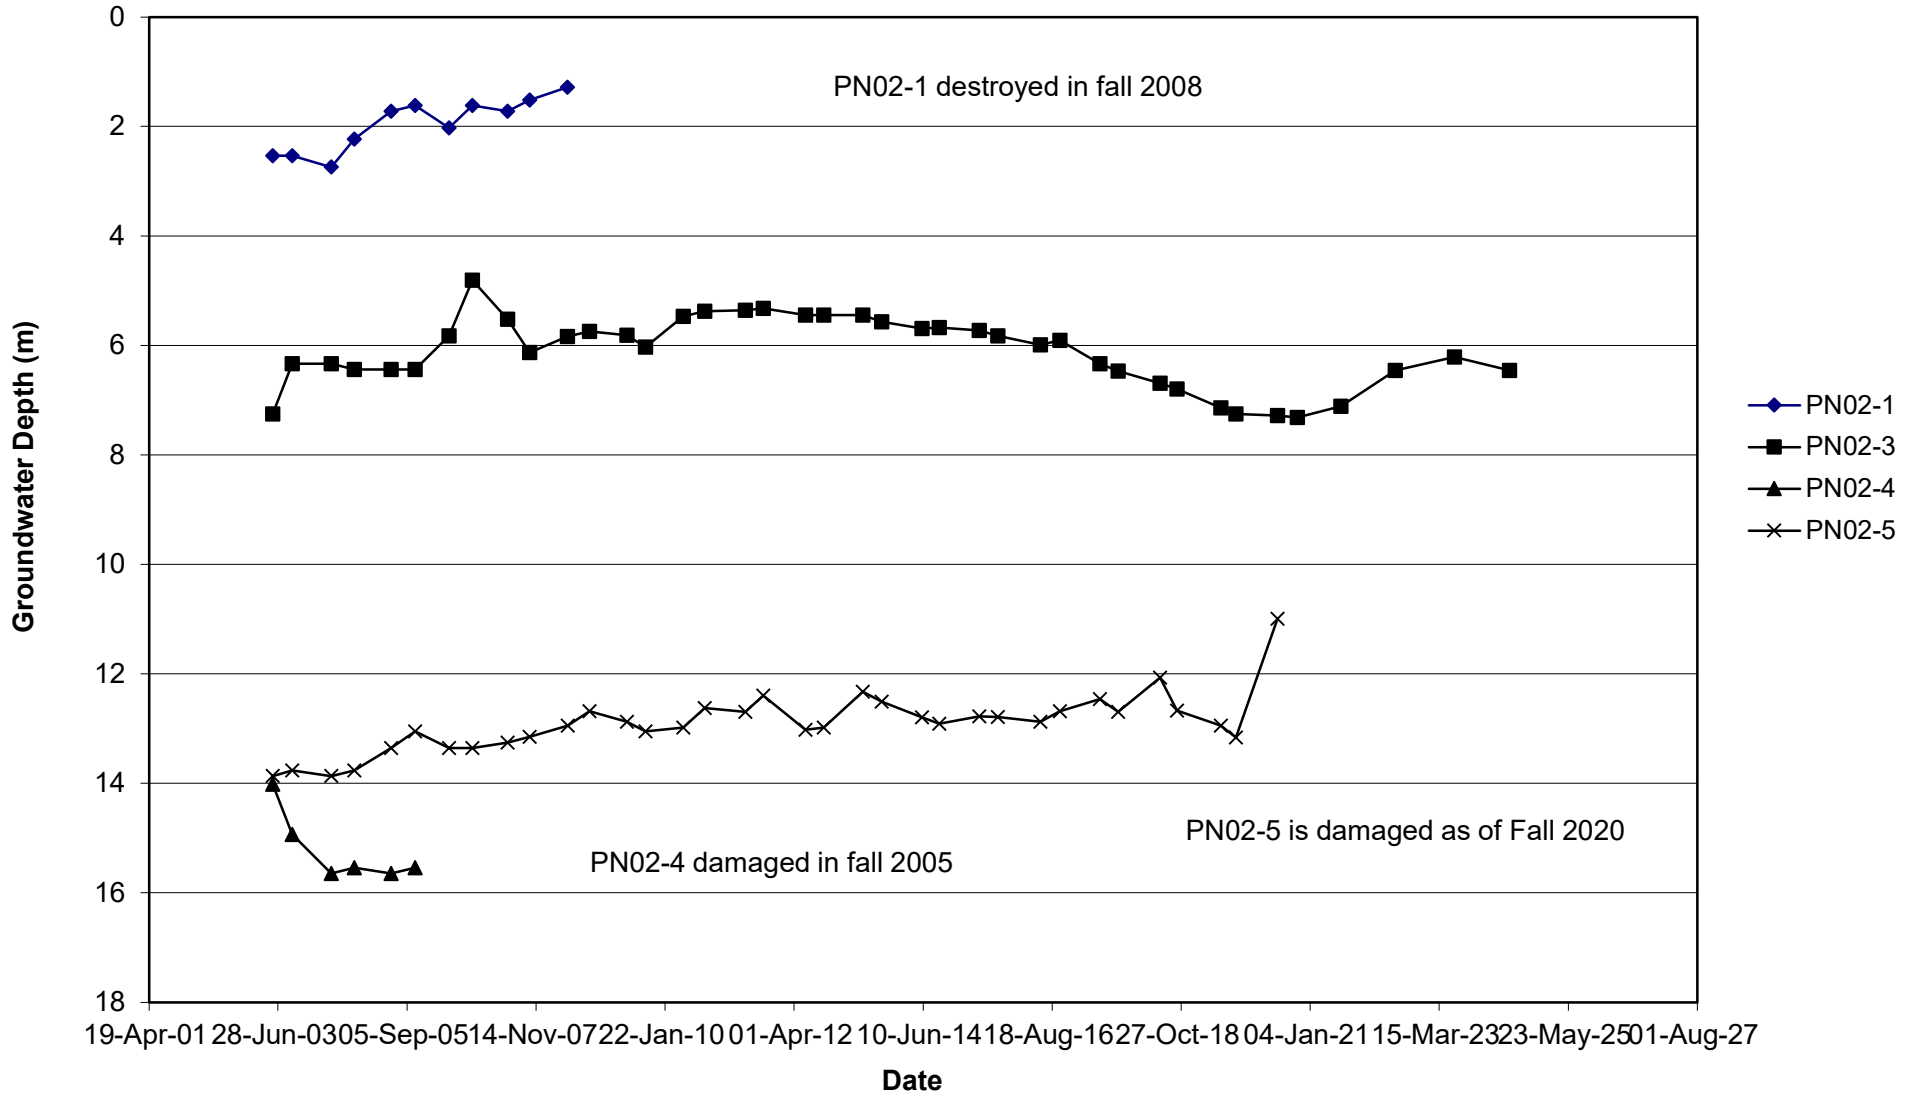
**FIGURE PH006-1  
PIEZOMETER DATA FOR HWY 697:02 TOMPKINS LANDING**

The groundwater level decreased in pneumatic piezometer PN02-3 by 0.25 m since the spring of 2023. PN02-3 has shown a trend of increasing groundwater levels since the fall of 2020 readings; however, the current readings are still within the historic range of the instrument.
<b>Future Work:</b>	SI-1 was found to have been blocked or sheared at approximately 3 m below ground surface. SI-1 should be skipped until repaired.  The instruments should be read again during the spring of 2025.
<b>Instrumentation Repairs:</b>	SI-1 and PN02-5 are damaged and would require significant additional cost to investigate and repair. If TEC requests Thurber can refine a cost estimate for investigation and repair of the damaged instruments at this site.
<b>Additional Comments:</b>
