**ALBERTA TRANSPORTATION AND
ECONOMIC CORRIDORS
GEOHAZARD ASSESSMENT PROGRAM
PEACE REGION - SWAN HILLS
2024 INSPECTION**

Site Number	Location	Name	Hwy	km
SH006-1	North of Swan Hills	Klumph Creek	33:14	18.1-18.6
Legal Description		UTM Co-ordinates		
NE28/SE33-70-9-W5M		11U E 608,502	N 6,107,107

Date	PF	CF	Total
Previous Inspection:	30-May-2022	10	4	40
Current Inspection:	5-Jun-2024	10	4	40
Road AADT:	680		Year:	2023
Inspected By:	Rishi Adhikari, TEC Robert Senior, TEC		Ken Froese, Thurber Roger Skirrow, Thurber	
Report Attachments:	<input checked="" type="checkbox"/> Photographs		<input checked="" type="checkbox"/> Plans	<input checked="" type="checkbox"/> Maintenance

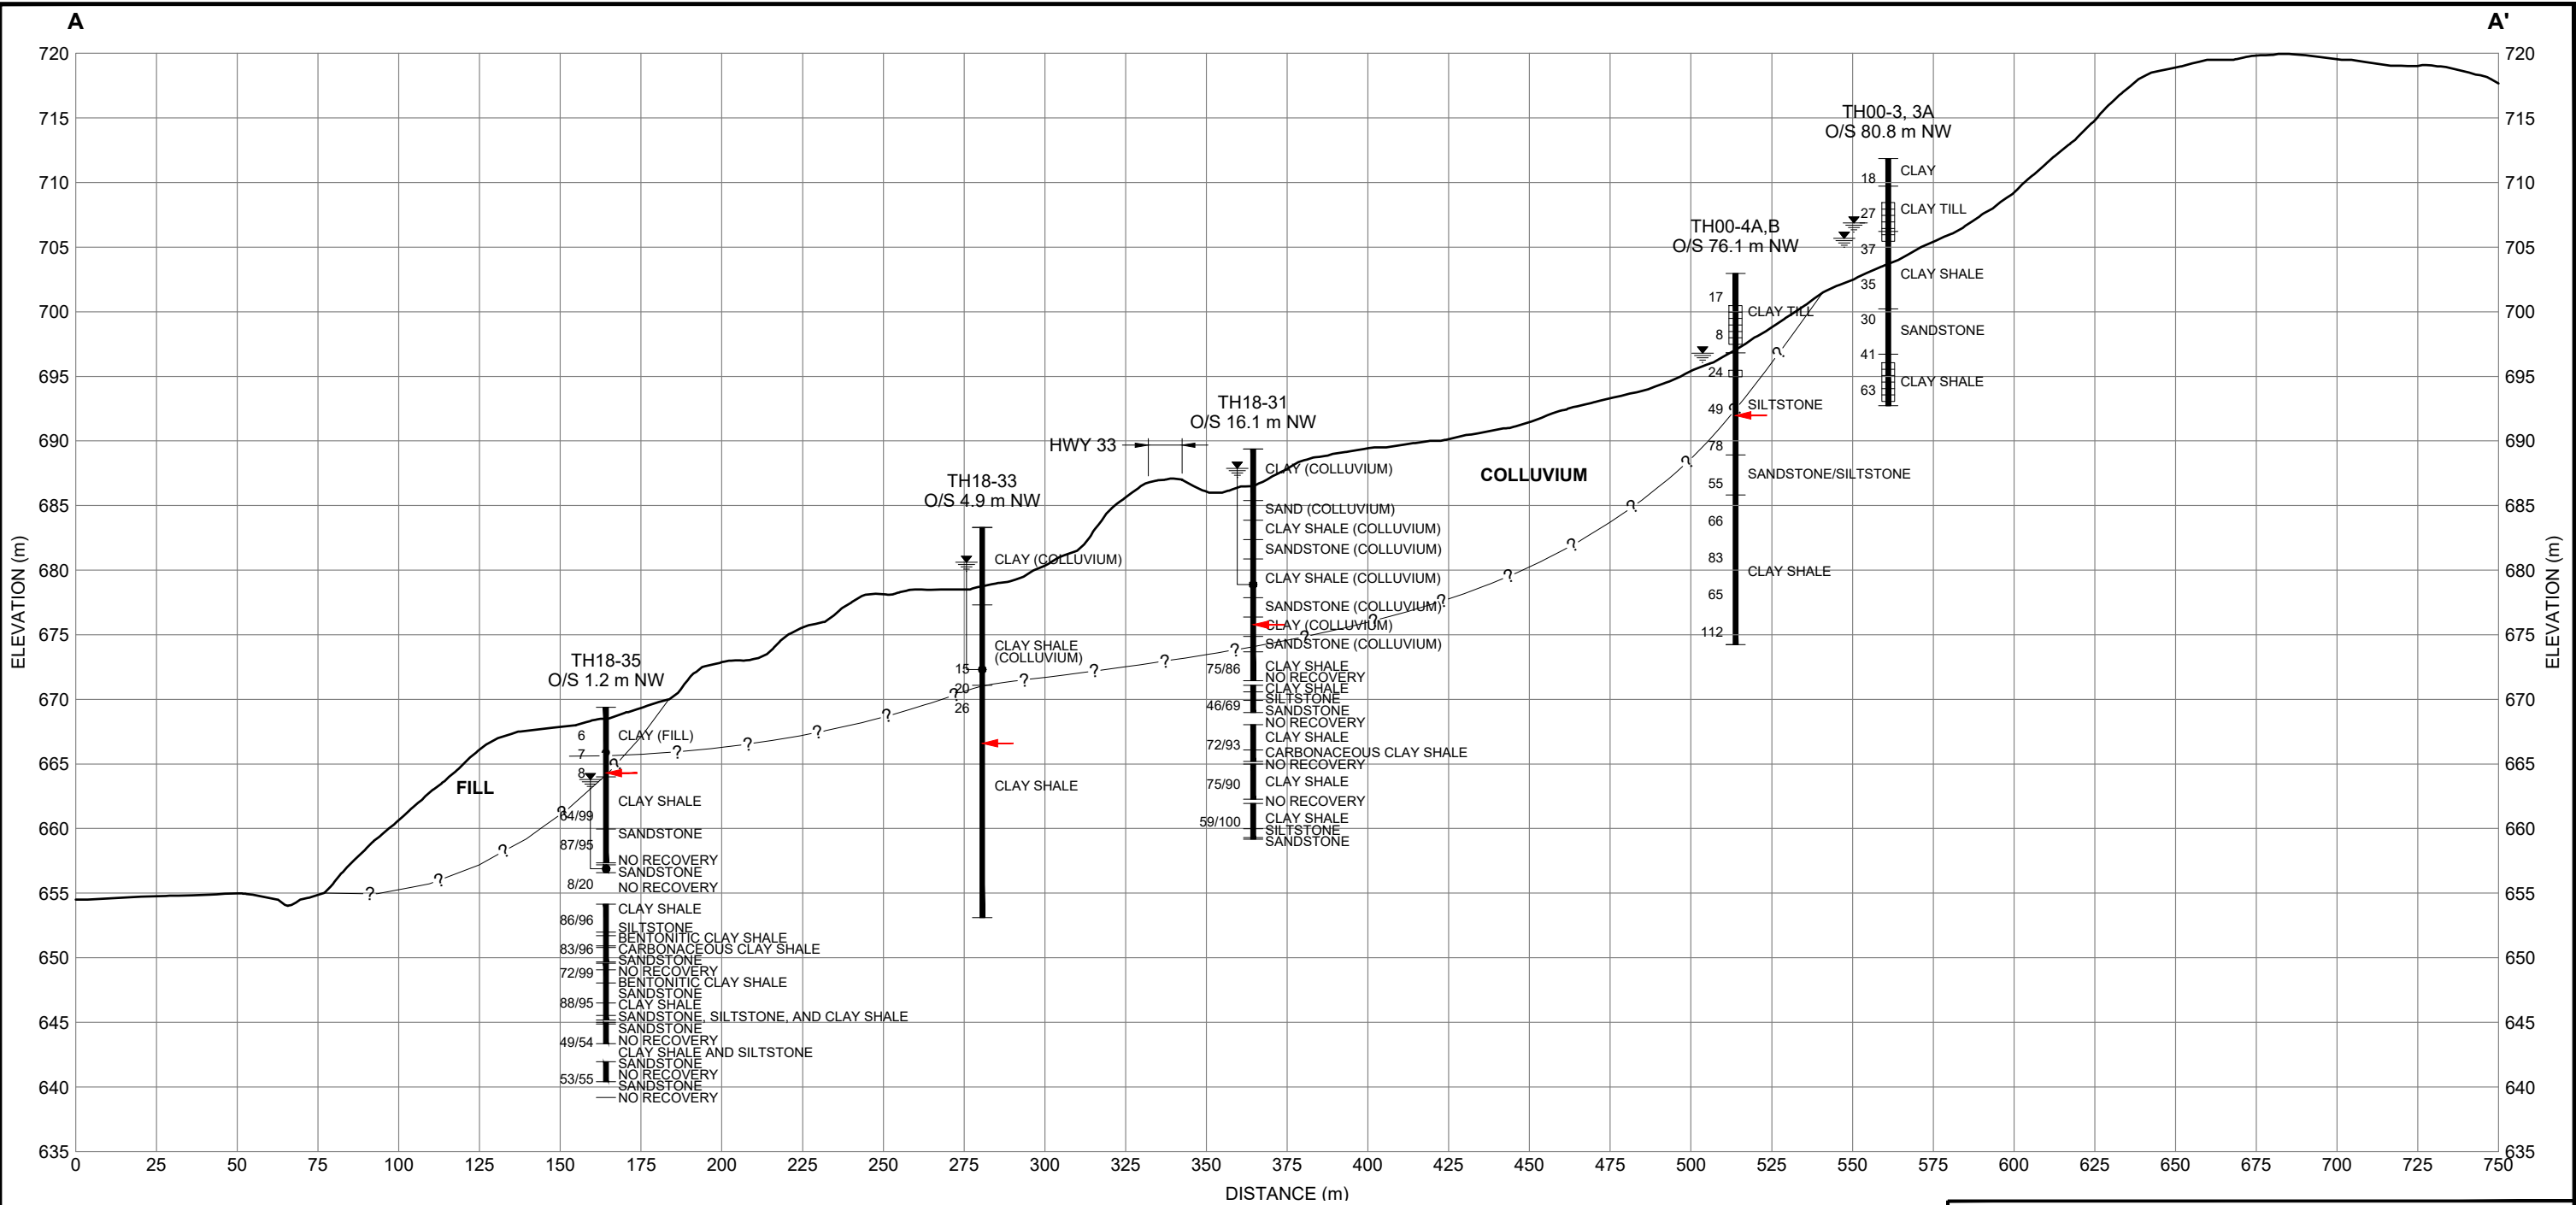
**SH006-1: KLUMPH CREEK SLIDE ON HWY 33:14
CROSS - SECTION A - A'**

Instrumentation (Spring 2024):	
SI18-30 to -35	SI18-30 has a cumulative movement of 28 mm at 14 m depth representing an increase of 2.1 mm since Spring 2023. SI18-31 has a cumulative movement of 27 mm at 13.2 m depth. SI18-32 has a cumulative movement of 12 mm at 15.5 m depth., SI18-33 has a cumulative movement of 23 mm at 16.4 m depth. SI18-34 shows no discernible movement. SI18-35 has cumulative movement of 5 mm at 5.4 m depth.
SP00-2, SP00-6A, SP00-6B	SP00-2, SP00-6A and SP00-6B have decreased in the last year after reaching historical high water levels.
PN18-30 to -35	Water levels increased to historical highs in Fall 2019 or Spring 2020 and have now begun to decrease with PN18-34 and -35 below initial measured water levels. PN18-32 has been relatively stable over the last two years. PN18-30, -31, and 33 increased in Spring 2024.
Damaged/ Destroyed	SI10 (11 m depth), SI11 (5.7 m depth), SI00-5, SI00-6, SP00-5 (unable to locate)

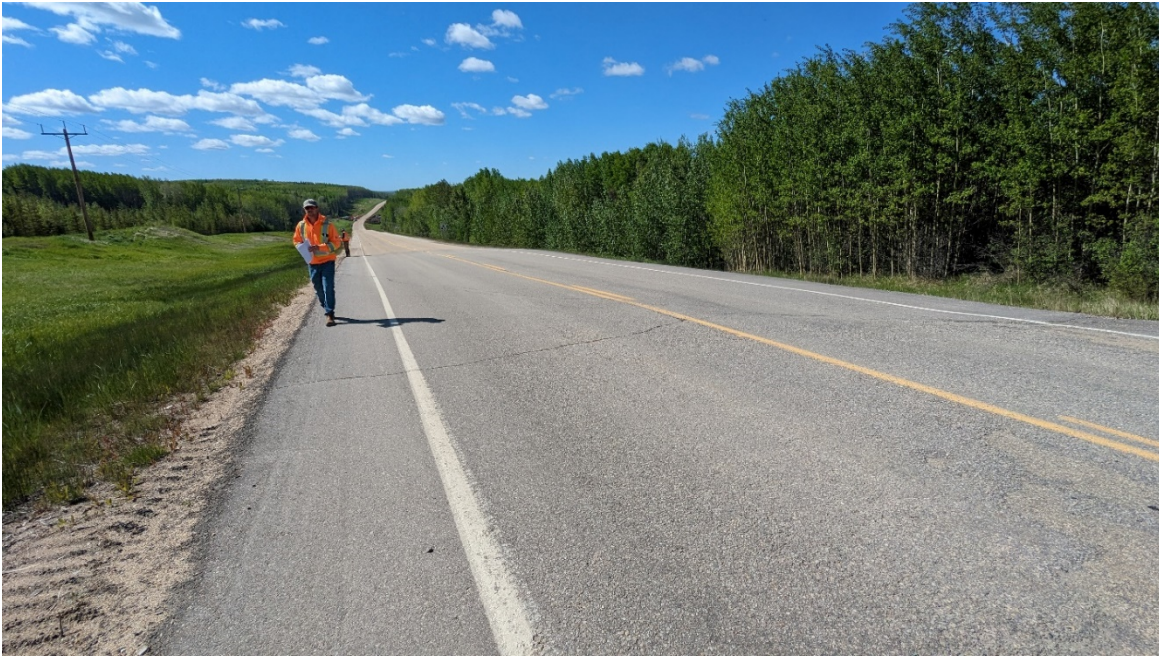
Photo 1 – Looking south from east shoulder at main scarp crack and patch at north end of site.

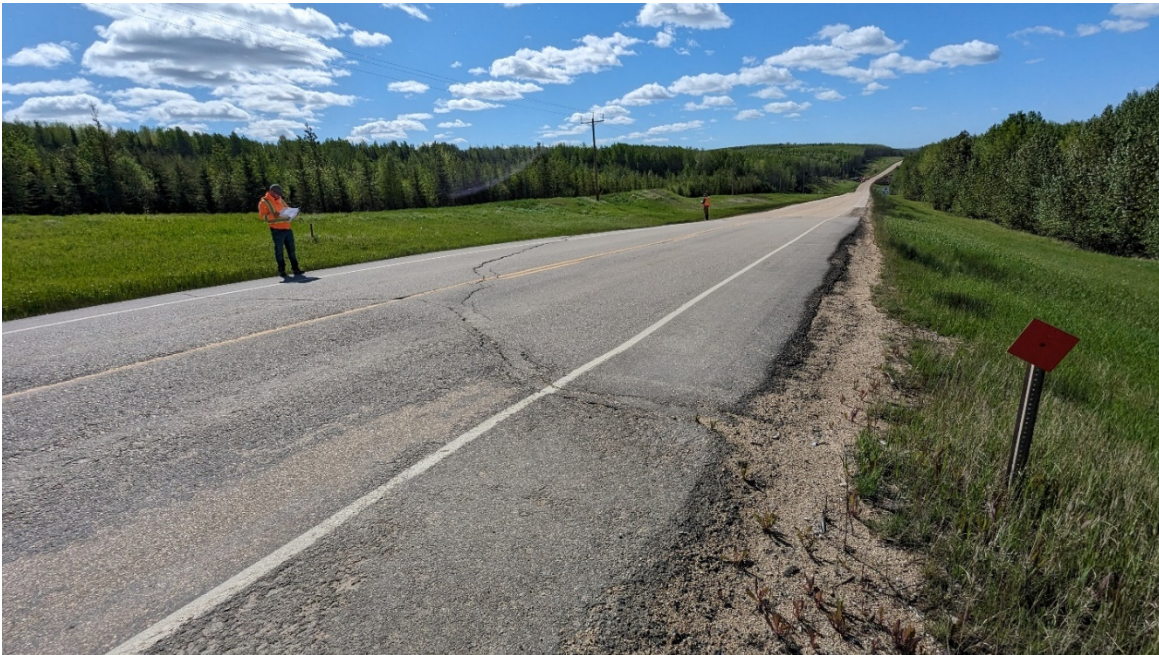
**Photo 2 – Looking south from west shoulder at main scarp crack and patch at north end of site.
Note powerline installed on east side of highway since 2017 visit.**

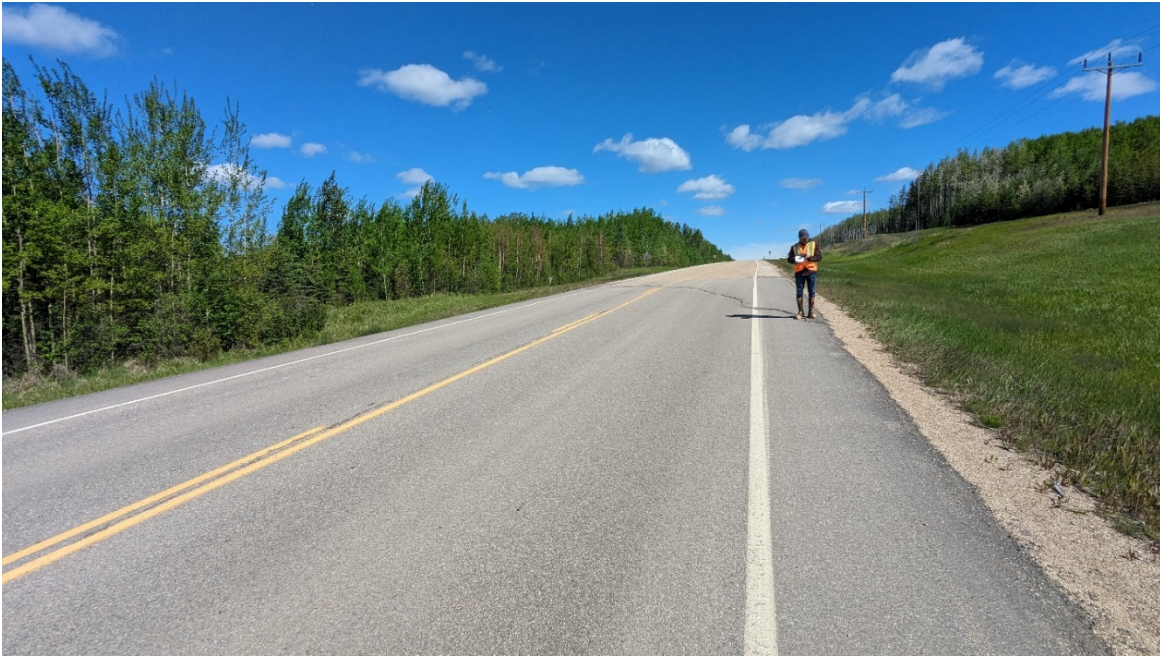
Photo 3: Looking north at hump over main scrap crack at north end of the site.

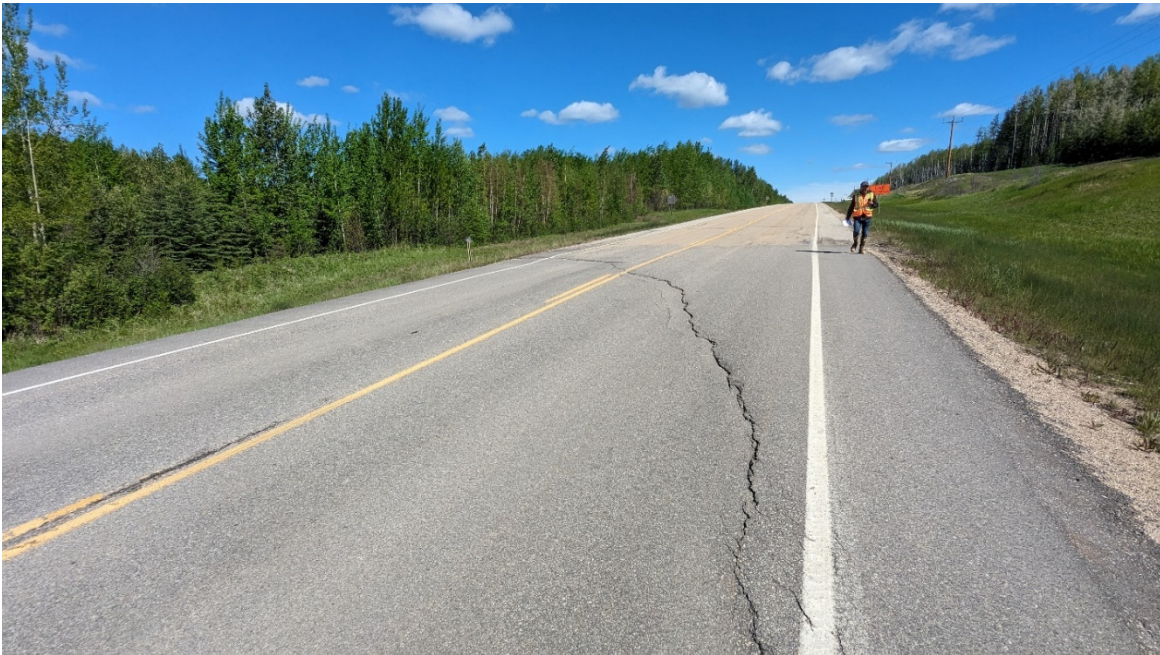
Photo 4: Looking south at crack at south end of patch at north end of the site.

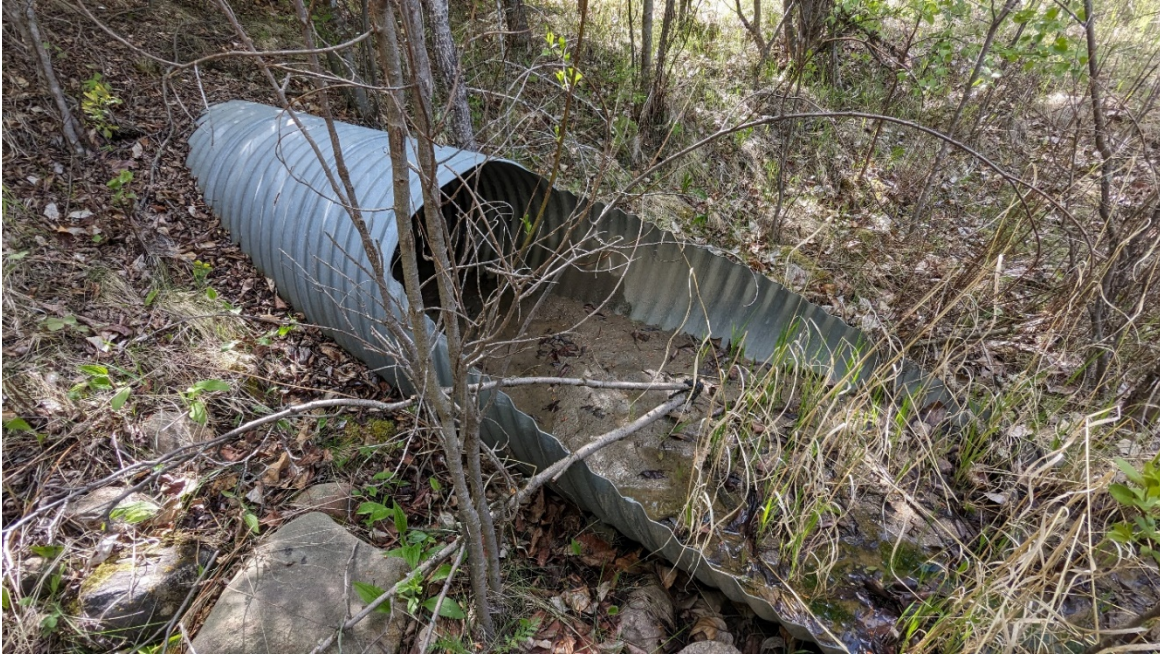
Photo 5: Looking at south culvert which had build up of sediment at outlet.

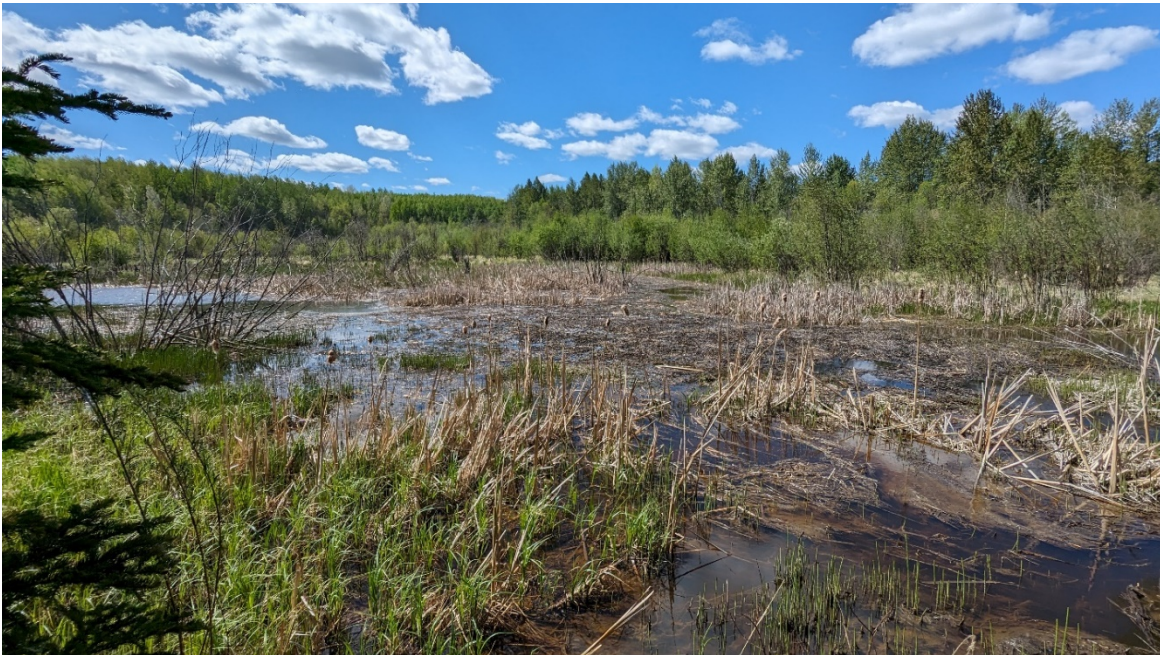
Photo 6: Looking at broad beaver pond and wetland area downslope of the highway.
