**ALBERTA TRANSPORTATION AND  
ECONOMIC CORRIDORS GRMP  
PEACE REGION – (PEACE RIVER DISTRICT)  
INSTRUMENTATION MONITORING - FALL 2024**

Site Number	Location	Name	Hwy	km
PH045	Hwy 35:08 C1 26.2	Meikle Pile Wall	35:08	Km 26.2
<b>Legal Description:</b>		<b>UTM Co-ordinates</b>		
6-7-94-22 W5		11U E 467580.75	N	6333080.85

<b>Current Monitoring:</b>	23-Sep-2024	<b>Previous Monitoring</b>	24-May-2024
<b>Instruments Read By:</b>	Mr. Niraj Regmi, G.I.T., and Mr. Nixson Mationg, Thurber

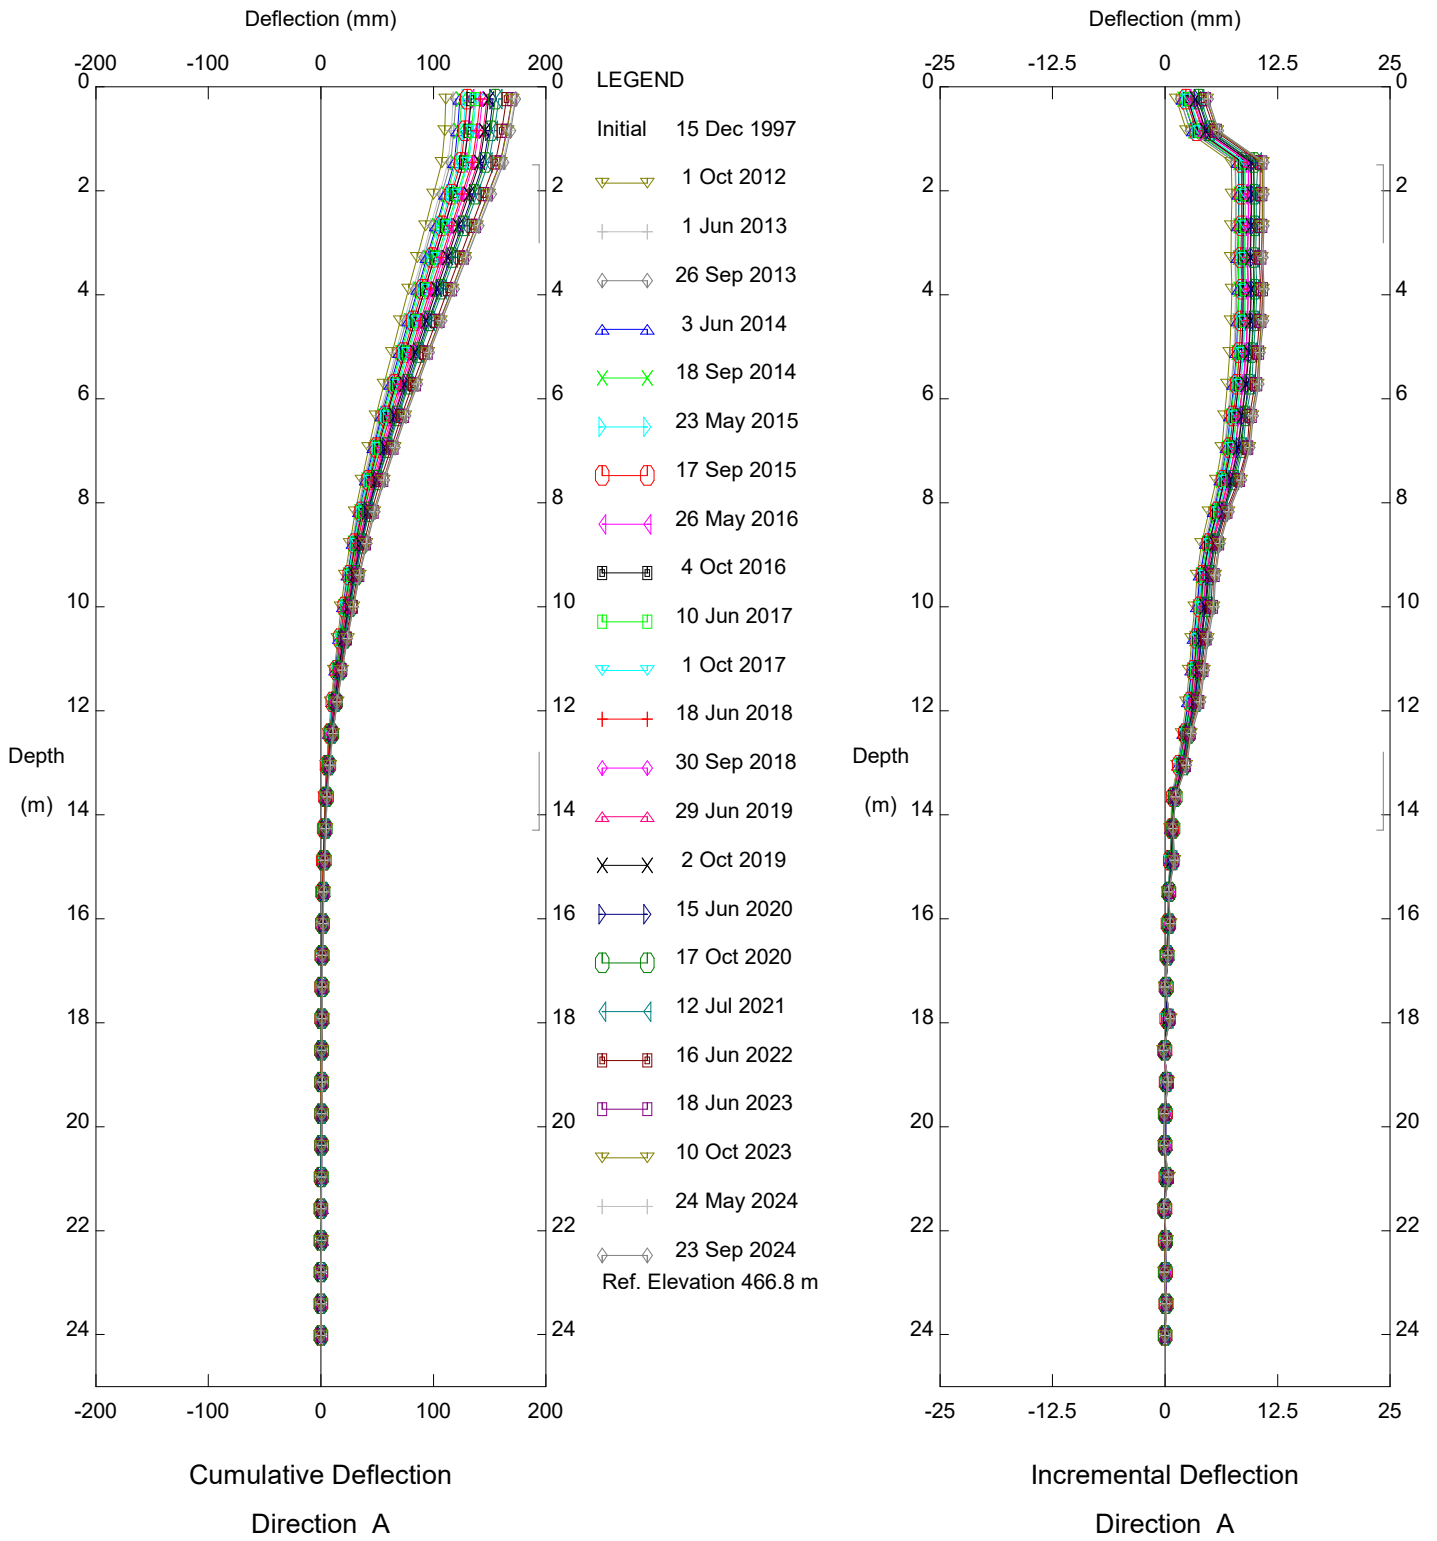
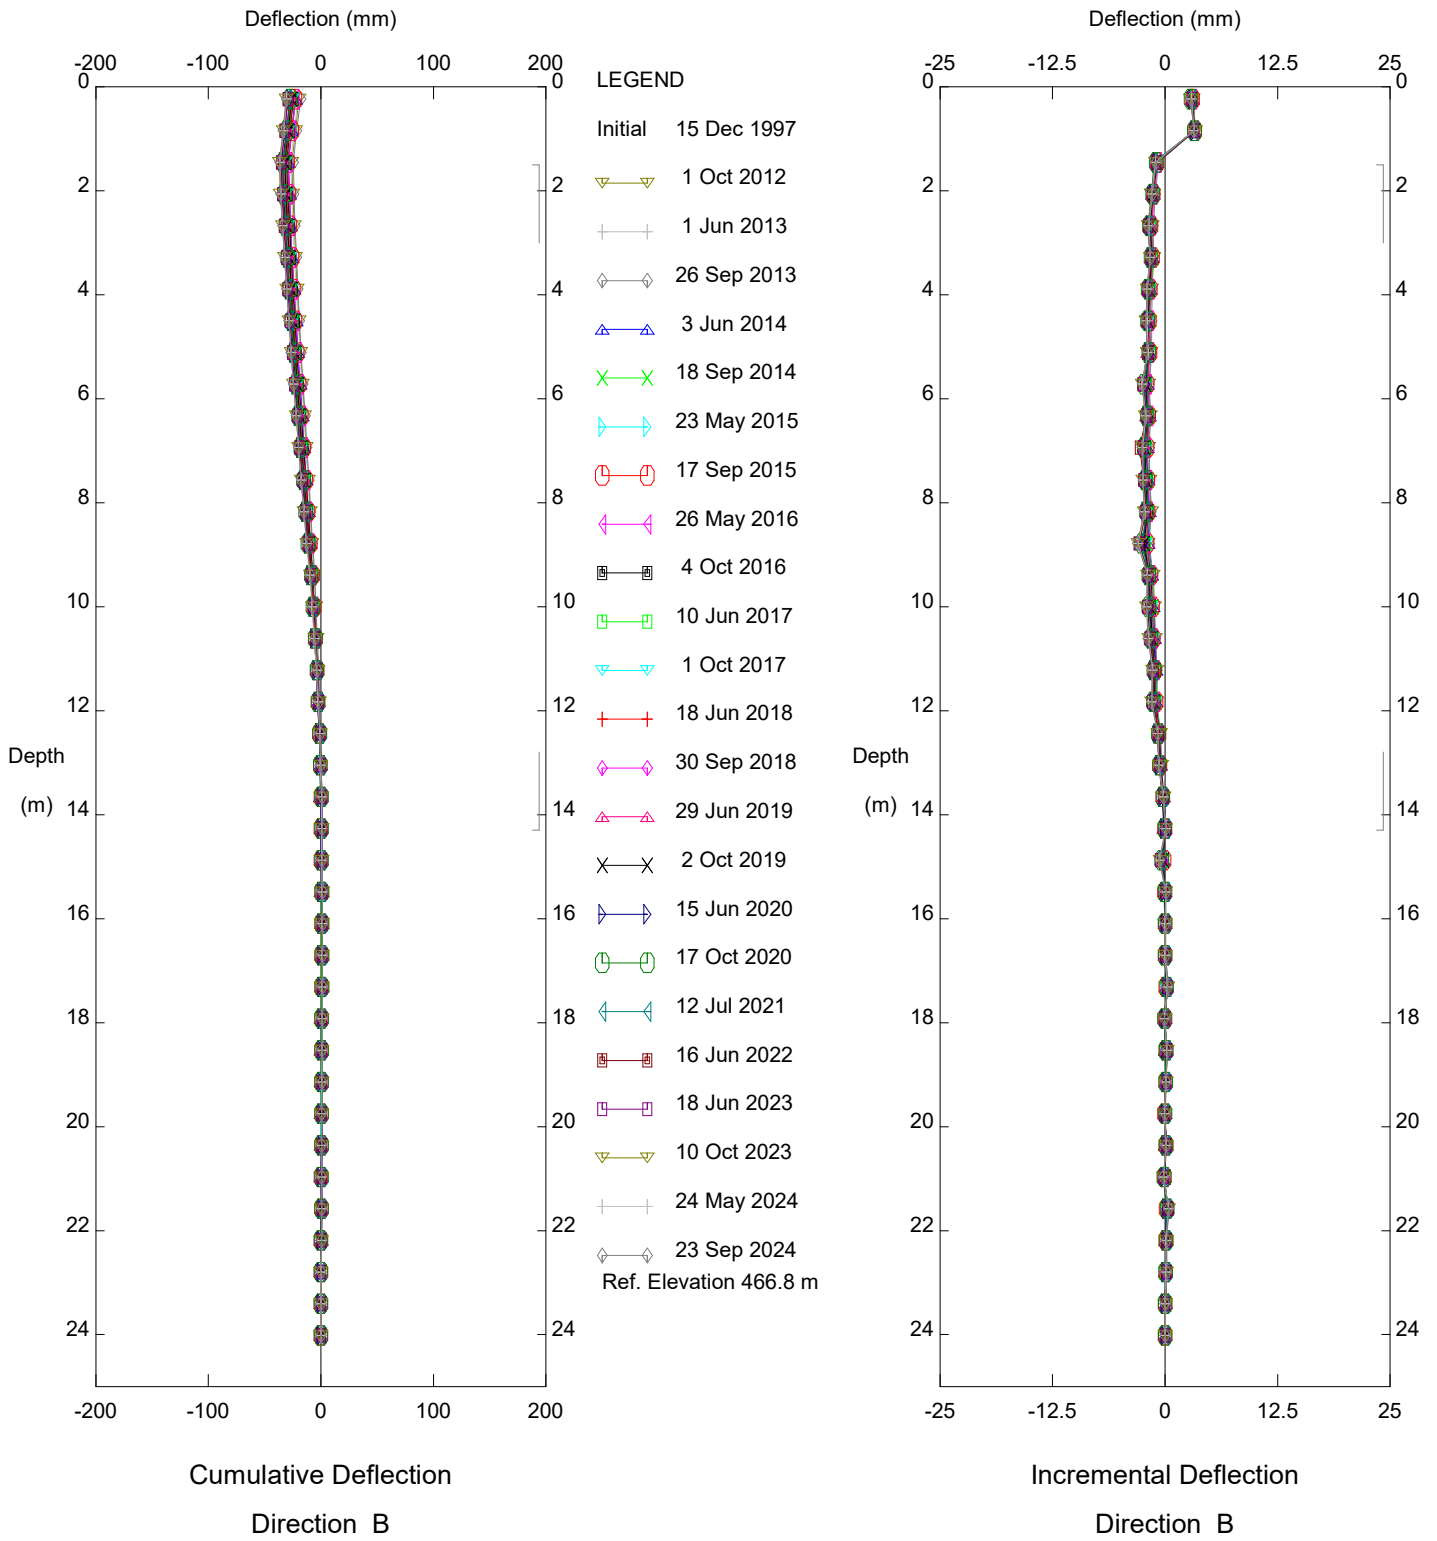
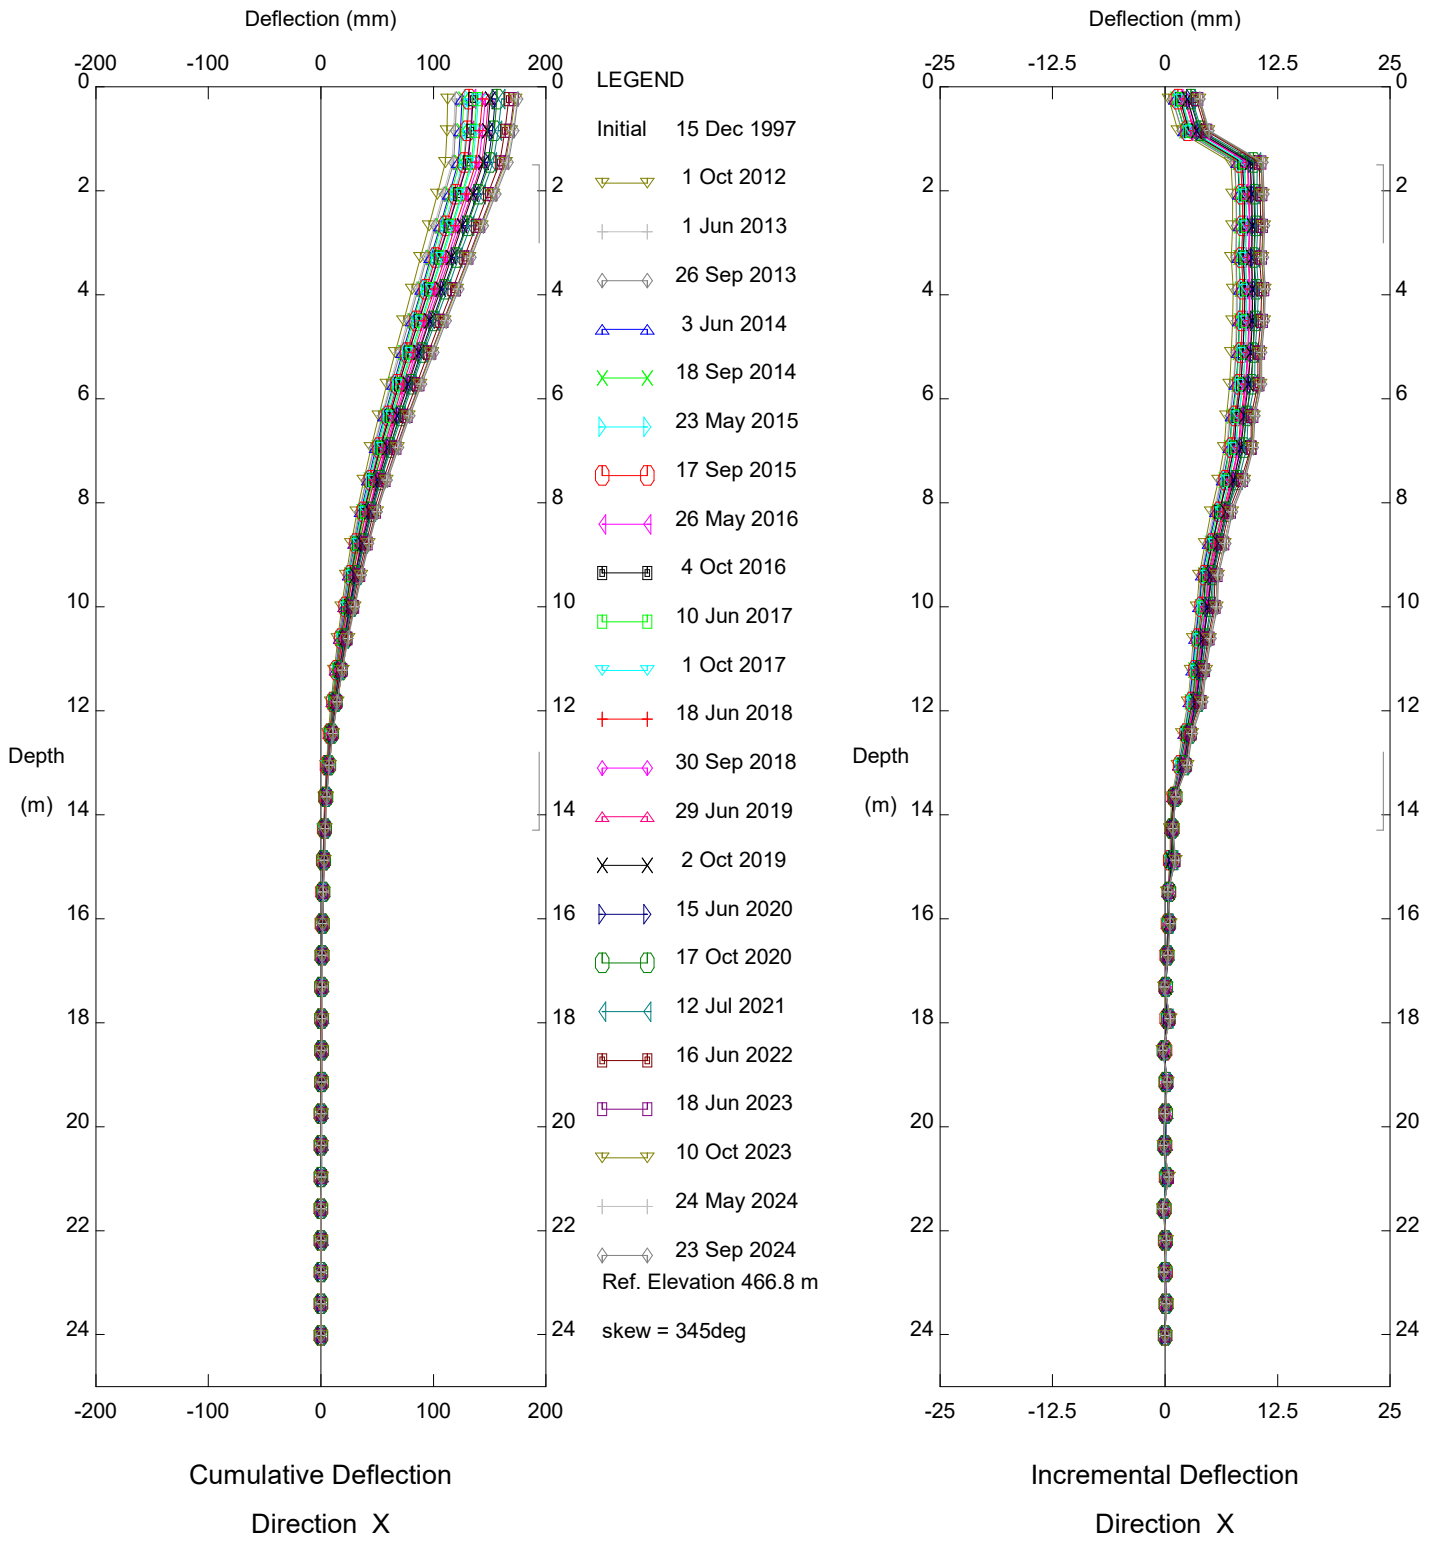
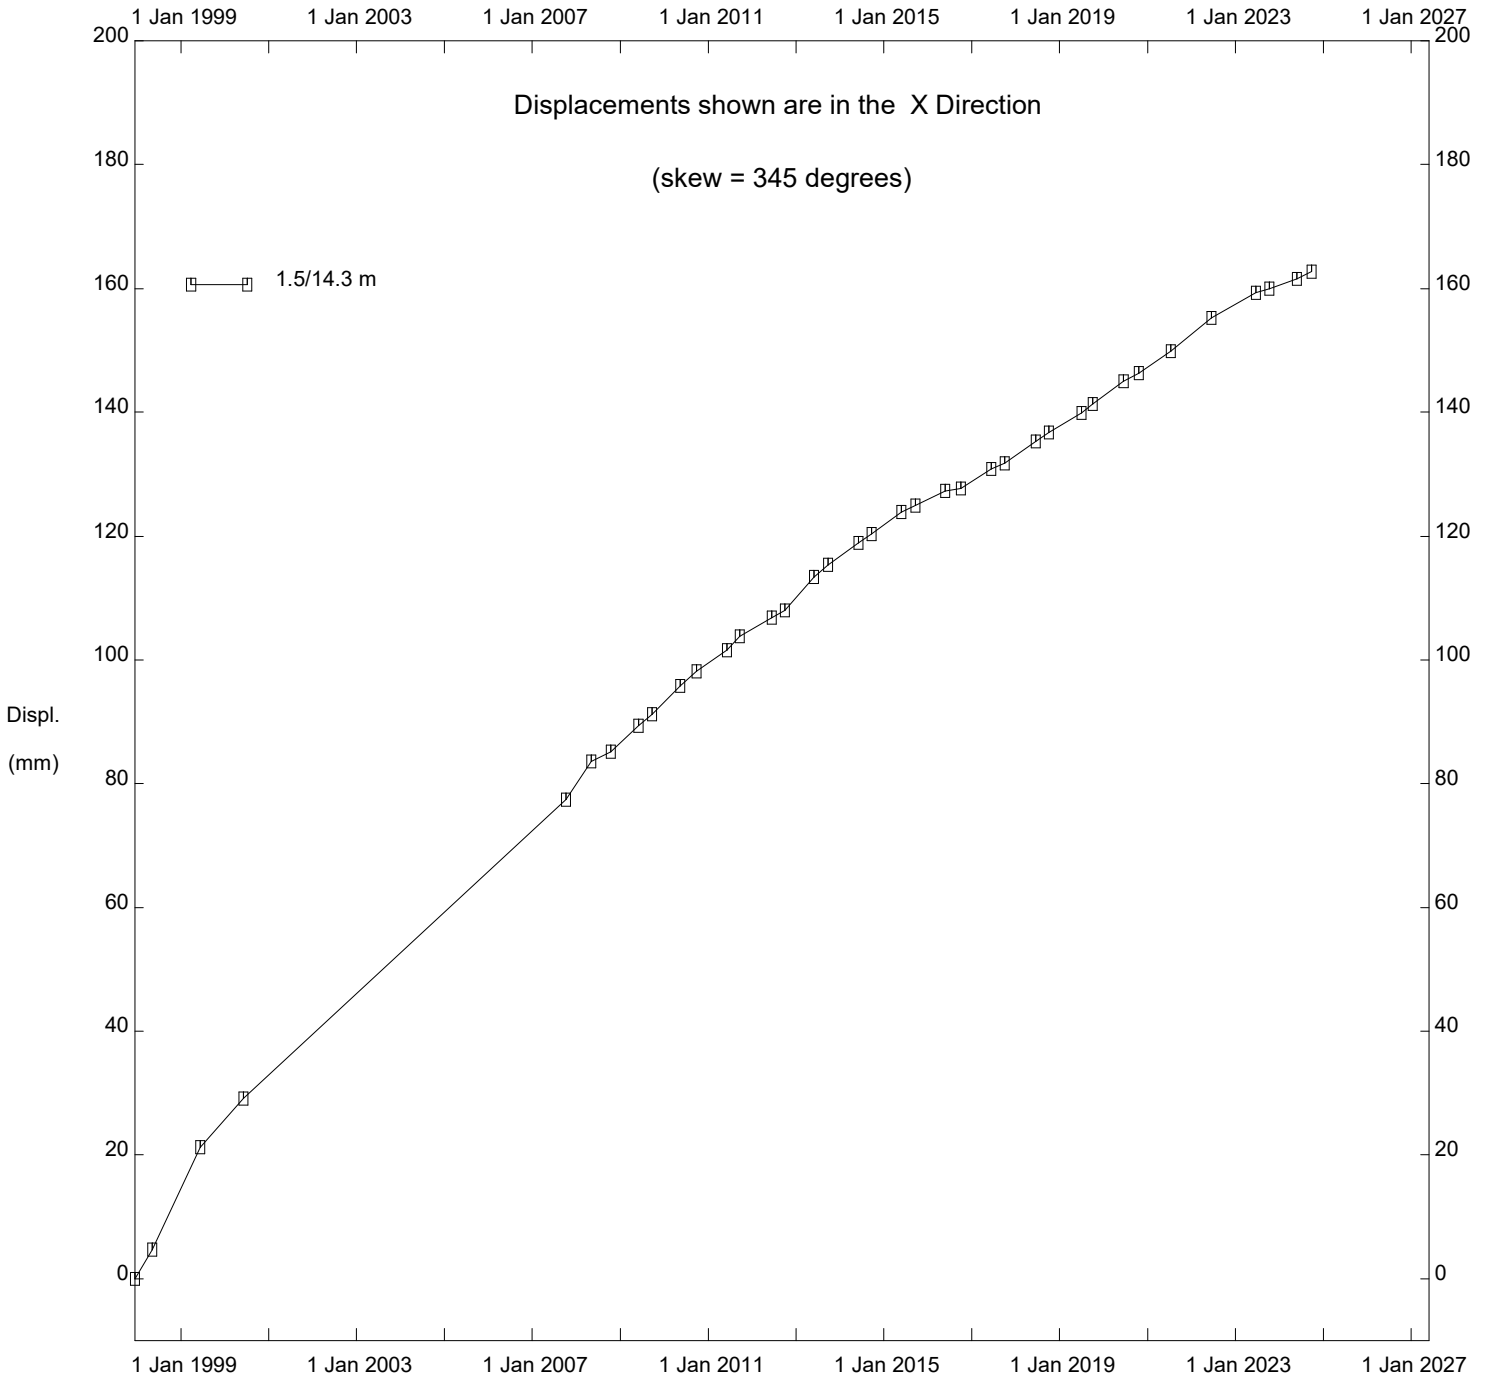
HWY 35:08 (PH045), Inclinometer SI-49

<b>Zones of New Movement:</b>	None
<b>Interpretation of Monitoring Results:</b>	<p>Slope inclinometers SI-49, -50, and -51 were installed inside the pile wall along the south shoulder of the highway. The movement zones for the slope inclinometers installed in the piles are defined over the length of the pile and water.</p> <p>SI-49 is installed near the east end of the wall. Since the spring of 2024 readings, slope inclinometer SI-49 showed a rate of movement of 3.6 mm/yr over 1.5 m to 14.3 m depth with a total cumulative deflection to date of 162.8 mm. The current rate of movement in SI-49 is lower than the overall rate of movement of 6.1 mm/yr measured since initialization. Overall, the movement pattern at SI-49 appears to have been unaffected by the repairs undertaken in 2016.</p> <p>SI-50 is installed in the central portion of the wall. SI-50 showed a rate of movement of 5.0 mm/yr since the spring of 2024 readings with a total</p>

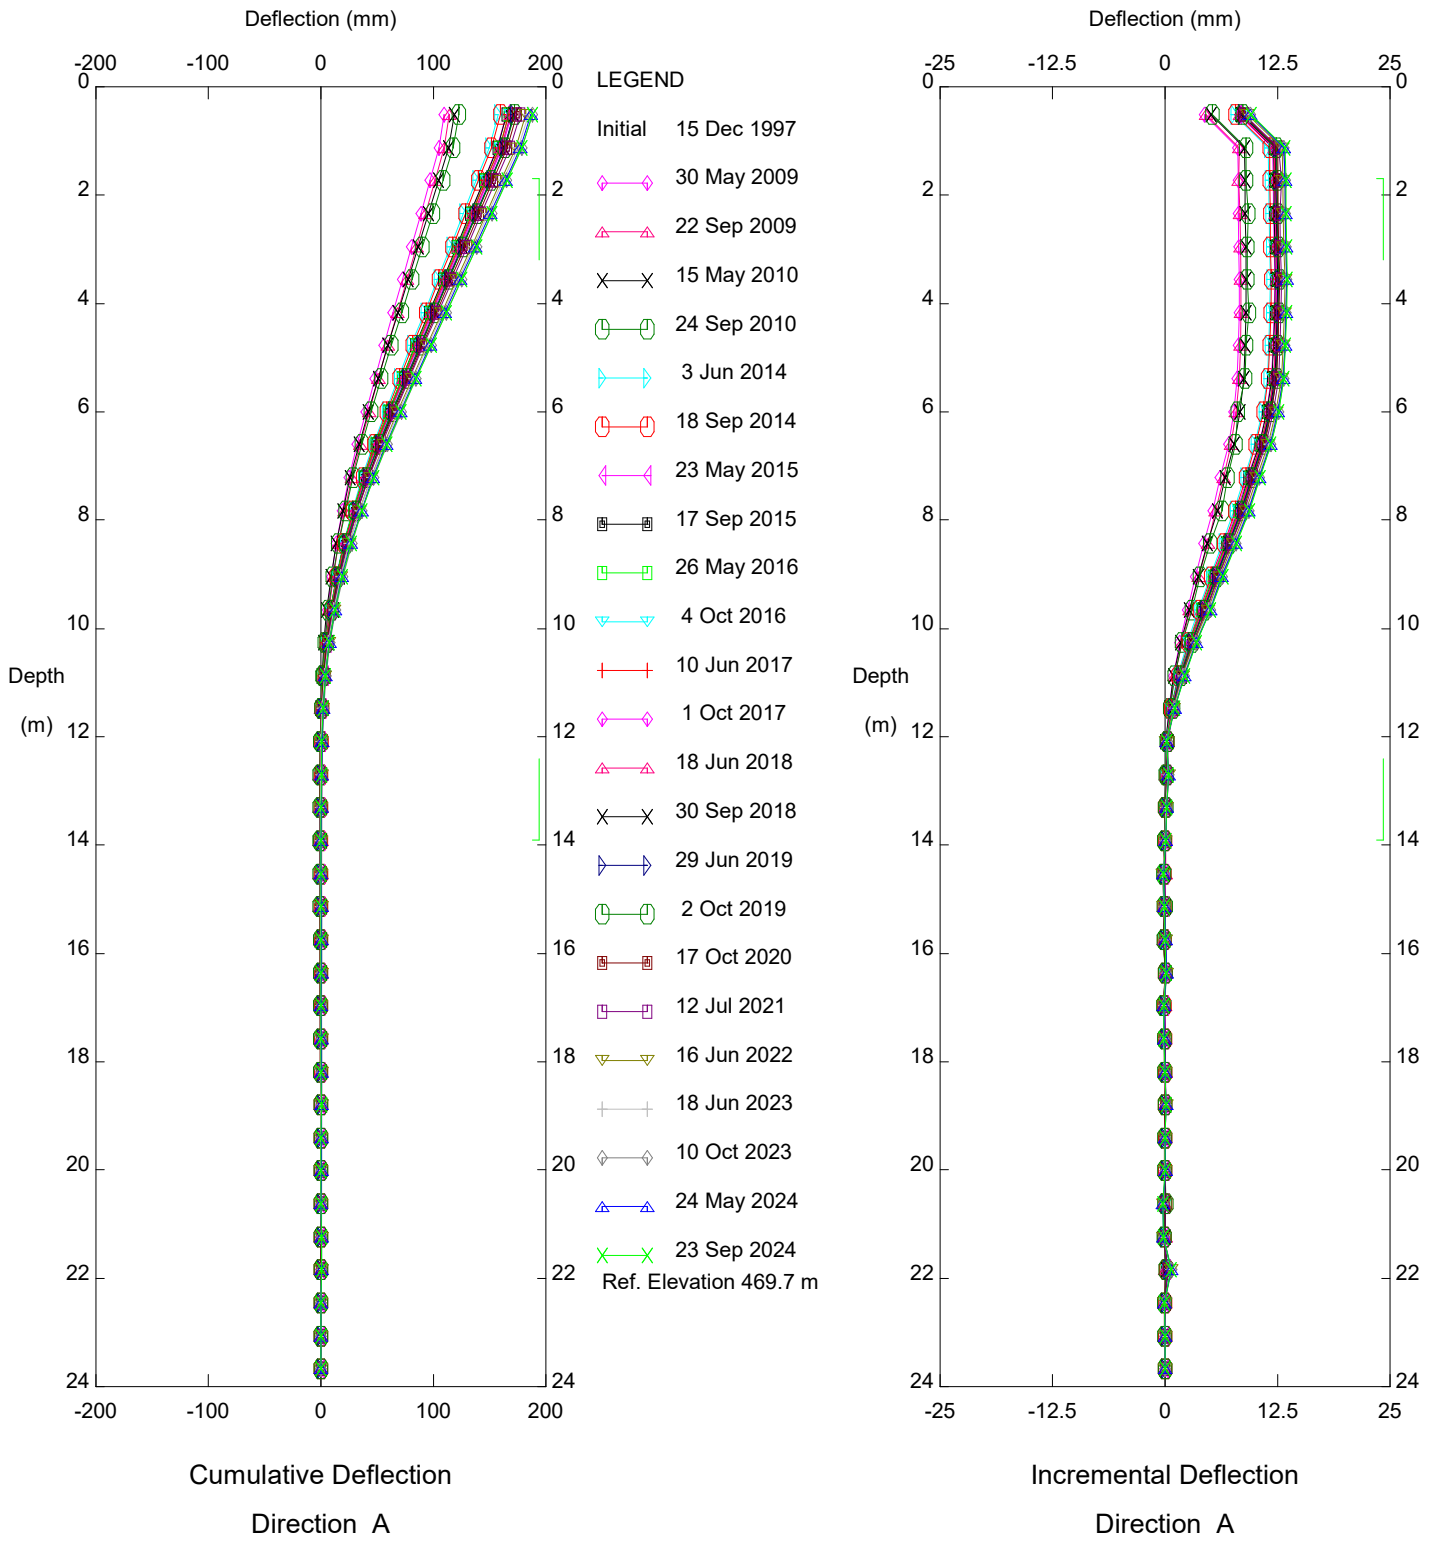
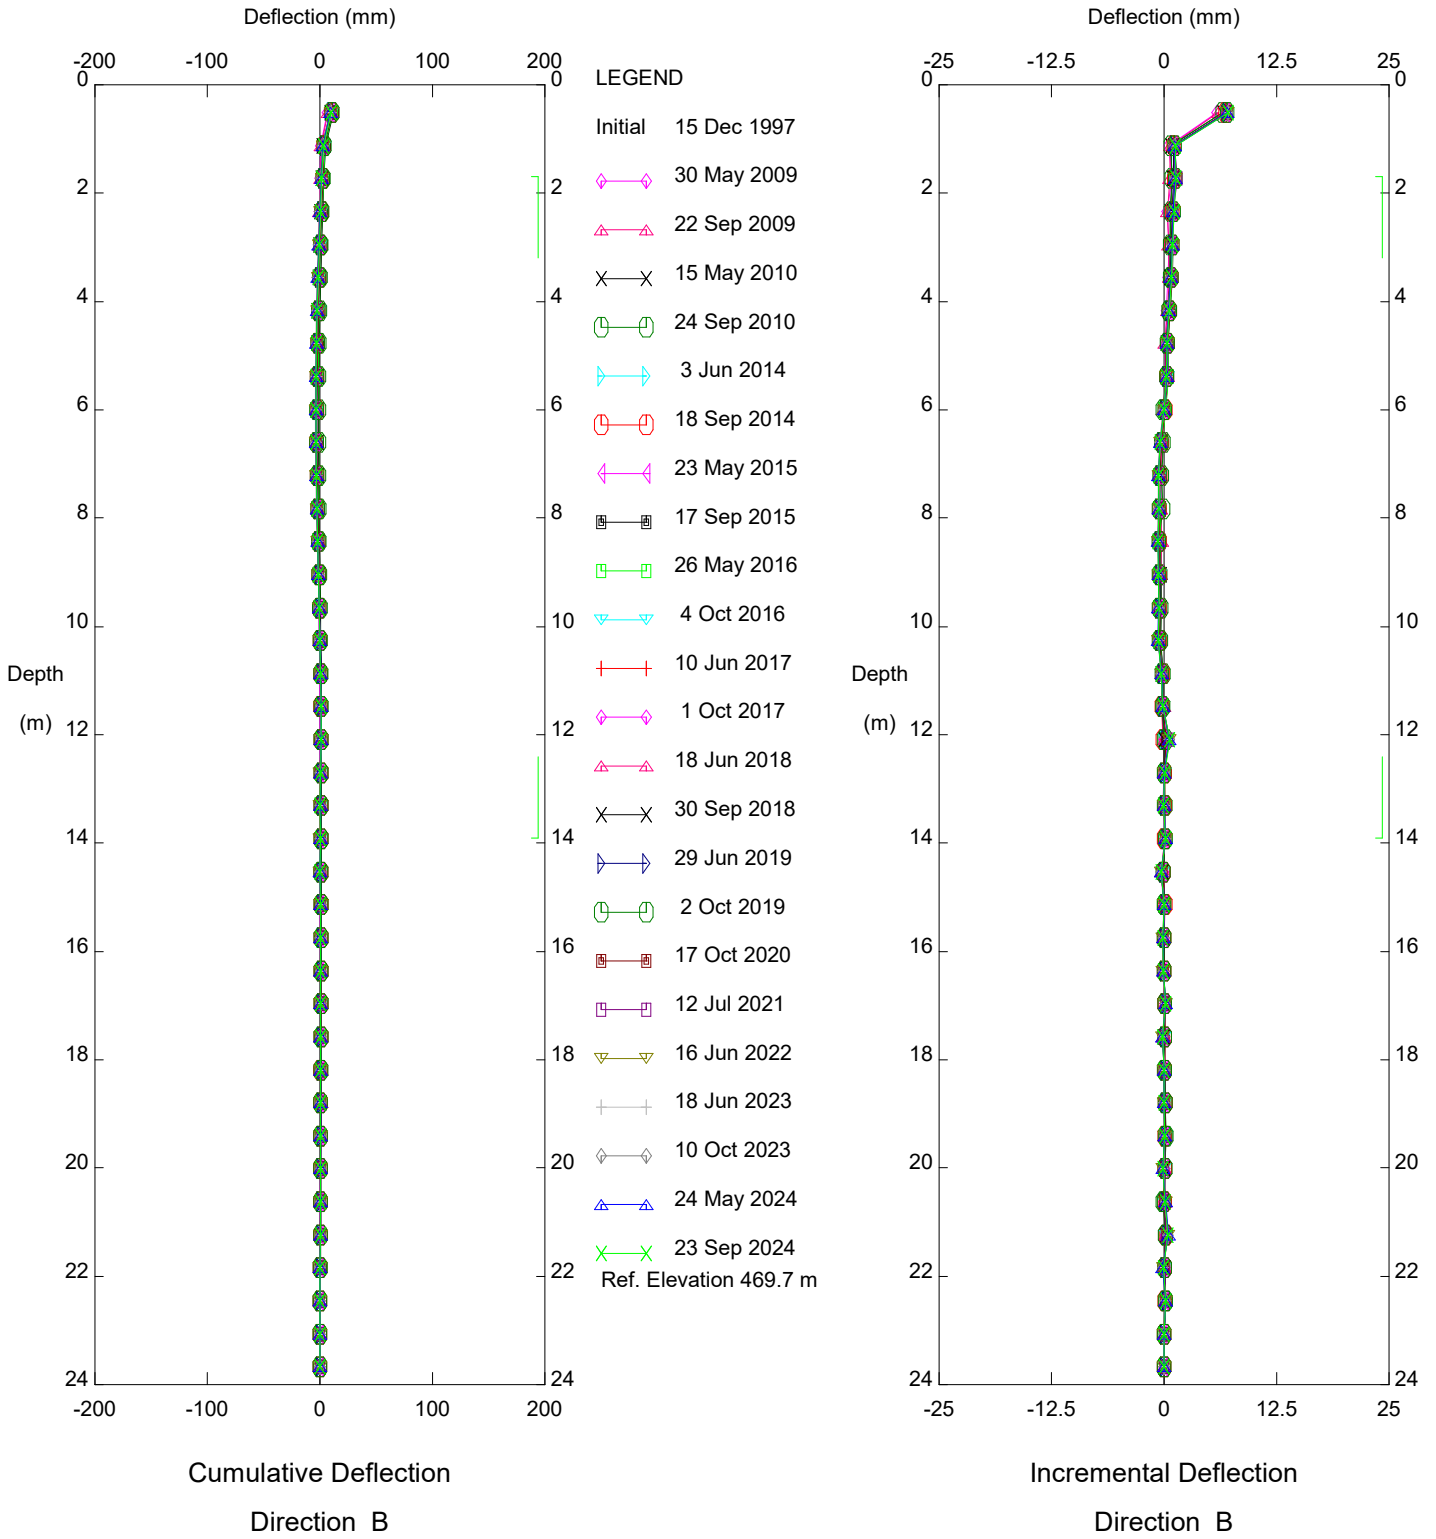
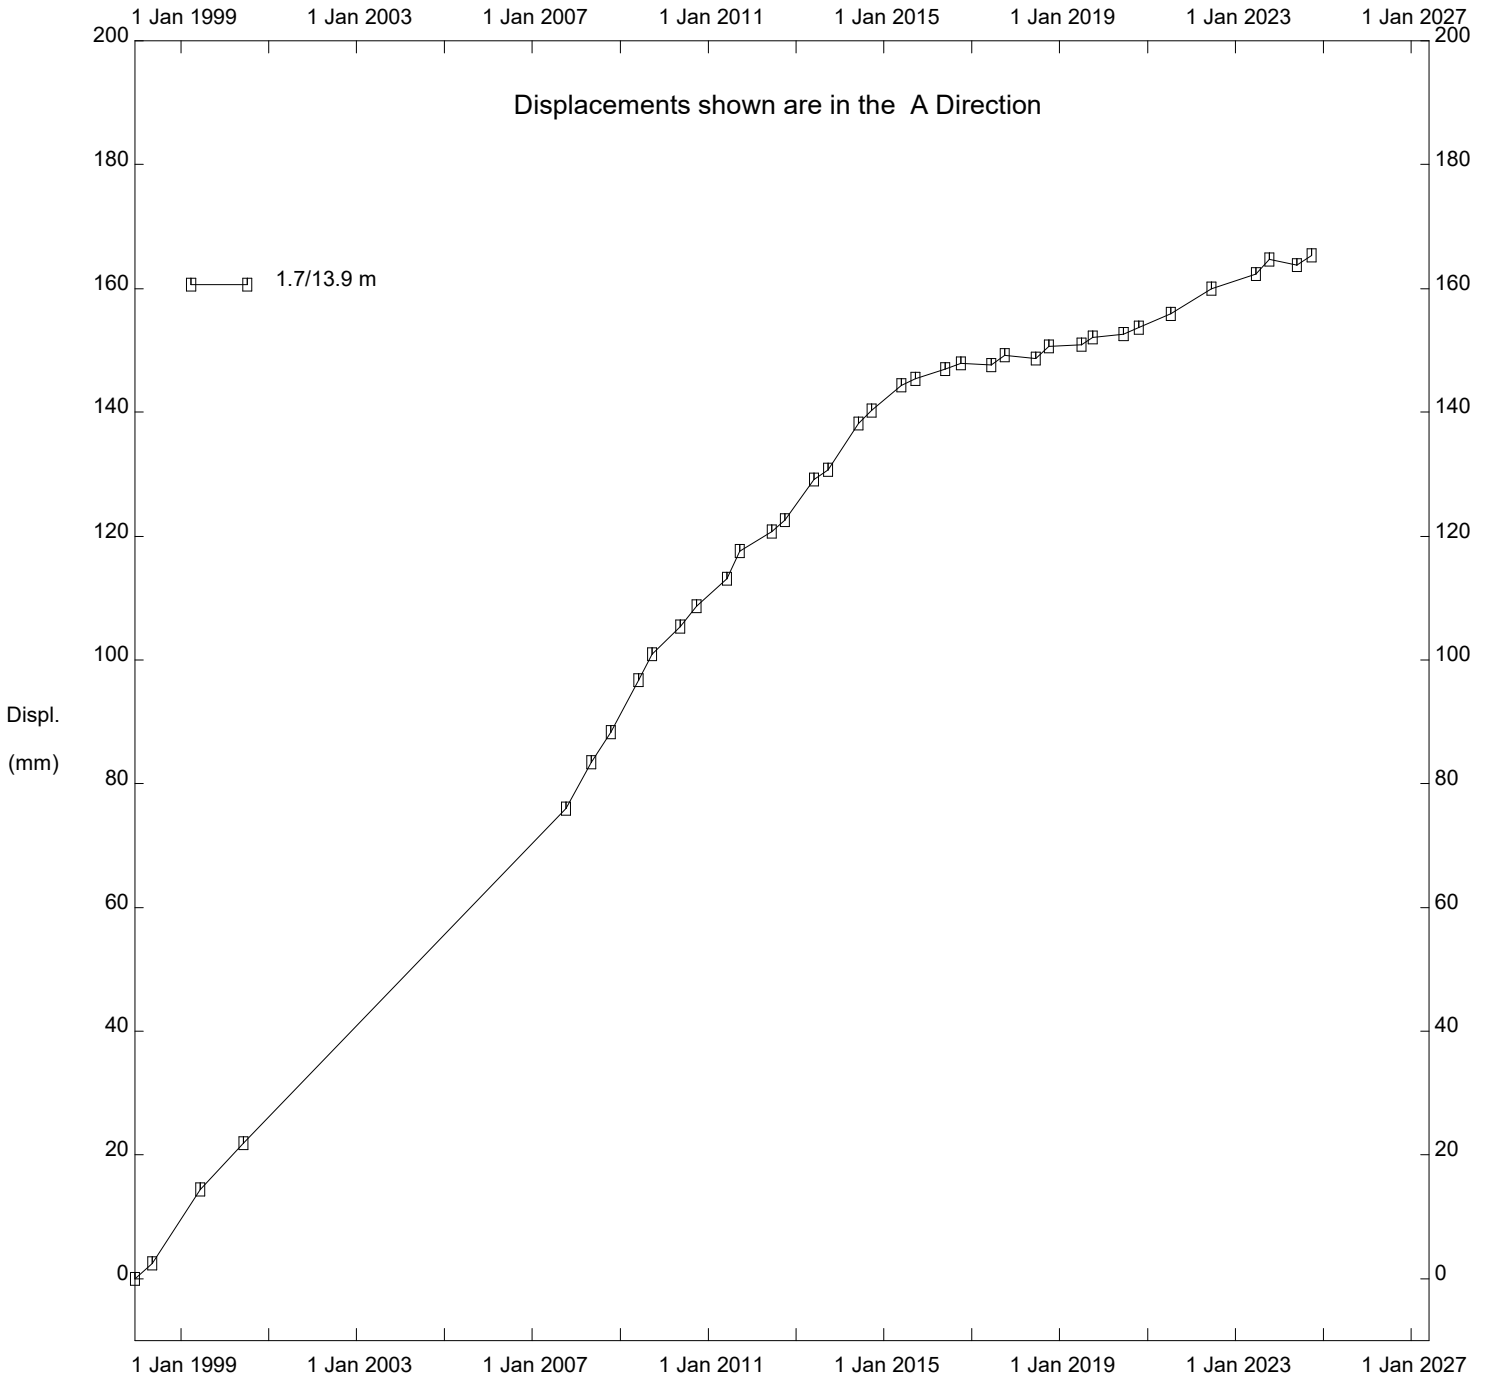
HWY 35:08 (PH045), Inclinometer SI-50

<p>cumulative movement to date of 165.4 mm. The overall movement rate in this SI since initialization is 6.2 mm/yr. SI-50 showed a marked reduction in movement rate post-construction although the rate has since increased but is lower than it was before construction.</p> <p>SI-51 is installed in near the west end of the wall and may be outside of the influence of the main slide area. SI-51 showed a rate of movement of 18.3 mm/yr since the spring of 2024 readings with a total cumulative movement to date of 80.7 mm. The overall movement rate at SI-51 since initialization is 3.0 mm/yr. The pattern at SI-51 is irregular likely due to the casing damage (at depth and near surface); however, the overall trend indicates that this inclinometer was also unaffected by the 2016 repairs.</p> <p>Slope inclinometer SI23-100 is located downslope of the pile wall and showed a rate of movement of 8.9 mm/yr over 4.8 m to 7.8 m depth, and no movement over 21.9 m to 24.3 m depth since the Fall 2023 readings. The lower zone may need more readings to confirm if this is a zone of movement but is of concern as it is below the adjacent pile wall. There is also a potential shallower zone developing at about 3 m which is the contact between the fill and native materials that will be analyzed in Spring 2025.</p> <p>The vibrating wire piezometers show current groundwater depths ranging from 2.98 m in VW23-100B to 8.92 m below existing ground surface in VW23-100A. VW23-100A, VW23-100B, VW23-101, VW23-102 and VW23-103 showed increases in groundwater level of 0.30 m, 0.28 m, 0.94 m, 0.45 m, and 0.14 m, respectively, since the spring of 2024 readings. The greatest increase, in VW23-101, corresponds to the piezometer located in the central portion of the slide mass. The current groundwater level readings in VW23-100B and VW23-101 are the highest since the instruments were initialized. The nested piezometers at VW23-100 indicate an upward trend to the groundwater flow pattern. The vibrating wire piezometer readings are summarized in Table PH045-2 below and are plotted on Figure PH045-1 in Appendix A.</p>
