**ALBERTA TRANSPORTATION AND  
ECONOMIC CORRIDORS GRMP  
PEACE REGION – (PEACE RIVER DISTRICT)  
INSTRUMENTATION MONITORING - FALL 2024**

Site Number	Location	Name	Hwy	km
PH045	Hwy 35:08 C1 26.2	Meikle Pile Wall	35:08	Km 26.2
<b>Legal Description:</b>		<b>UTM Co-ordinates</b>		
6-7-94-22 W5		11U E 467580.75	N	6333080.85

<b>Current Monitoring:</b>	23-Sep-2024	<b>Previous Monitoring</b>	24-May-2024
<b>Instruments Read By:</b>	Mr. Niraj Regmi, G.I.T., and Mr. Nixson Mationg, Thurber

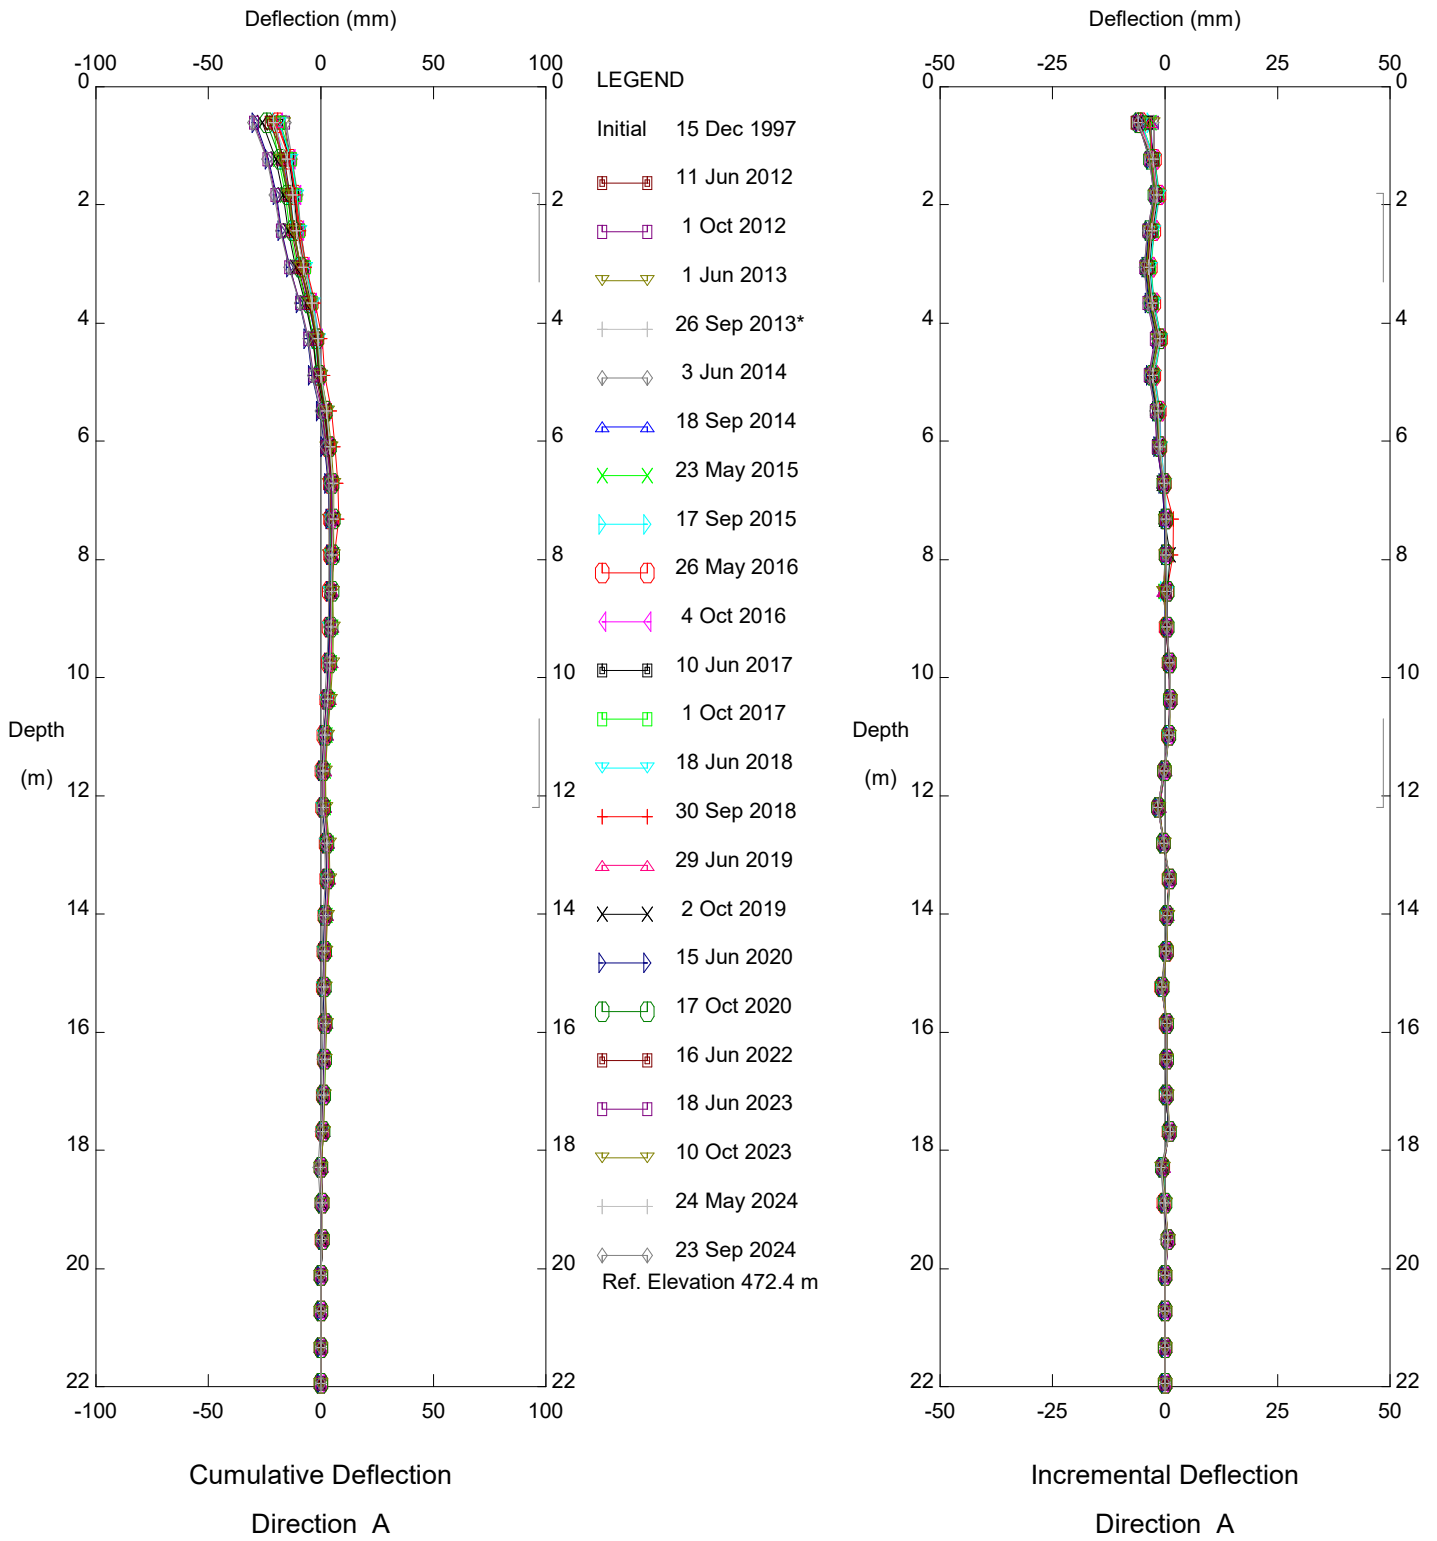
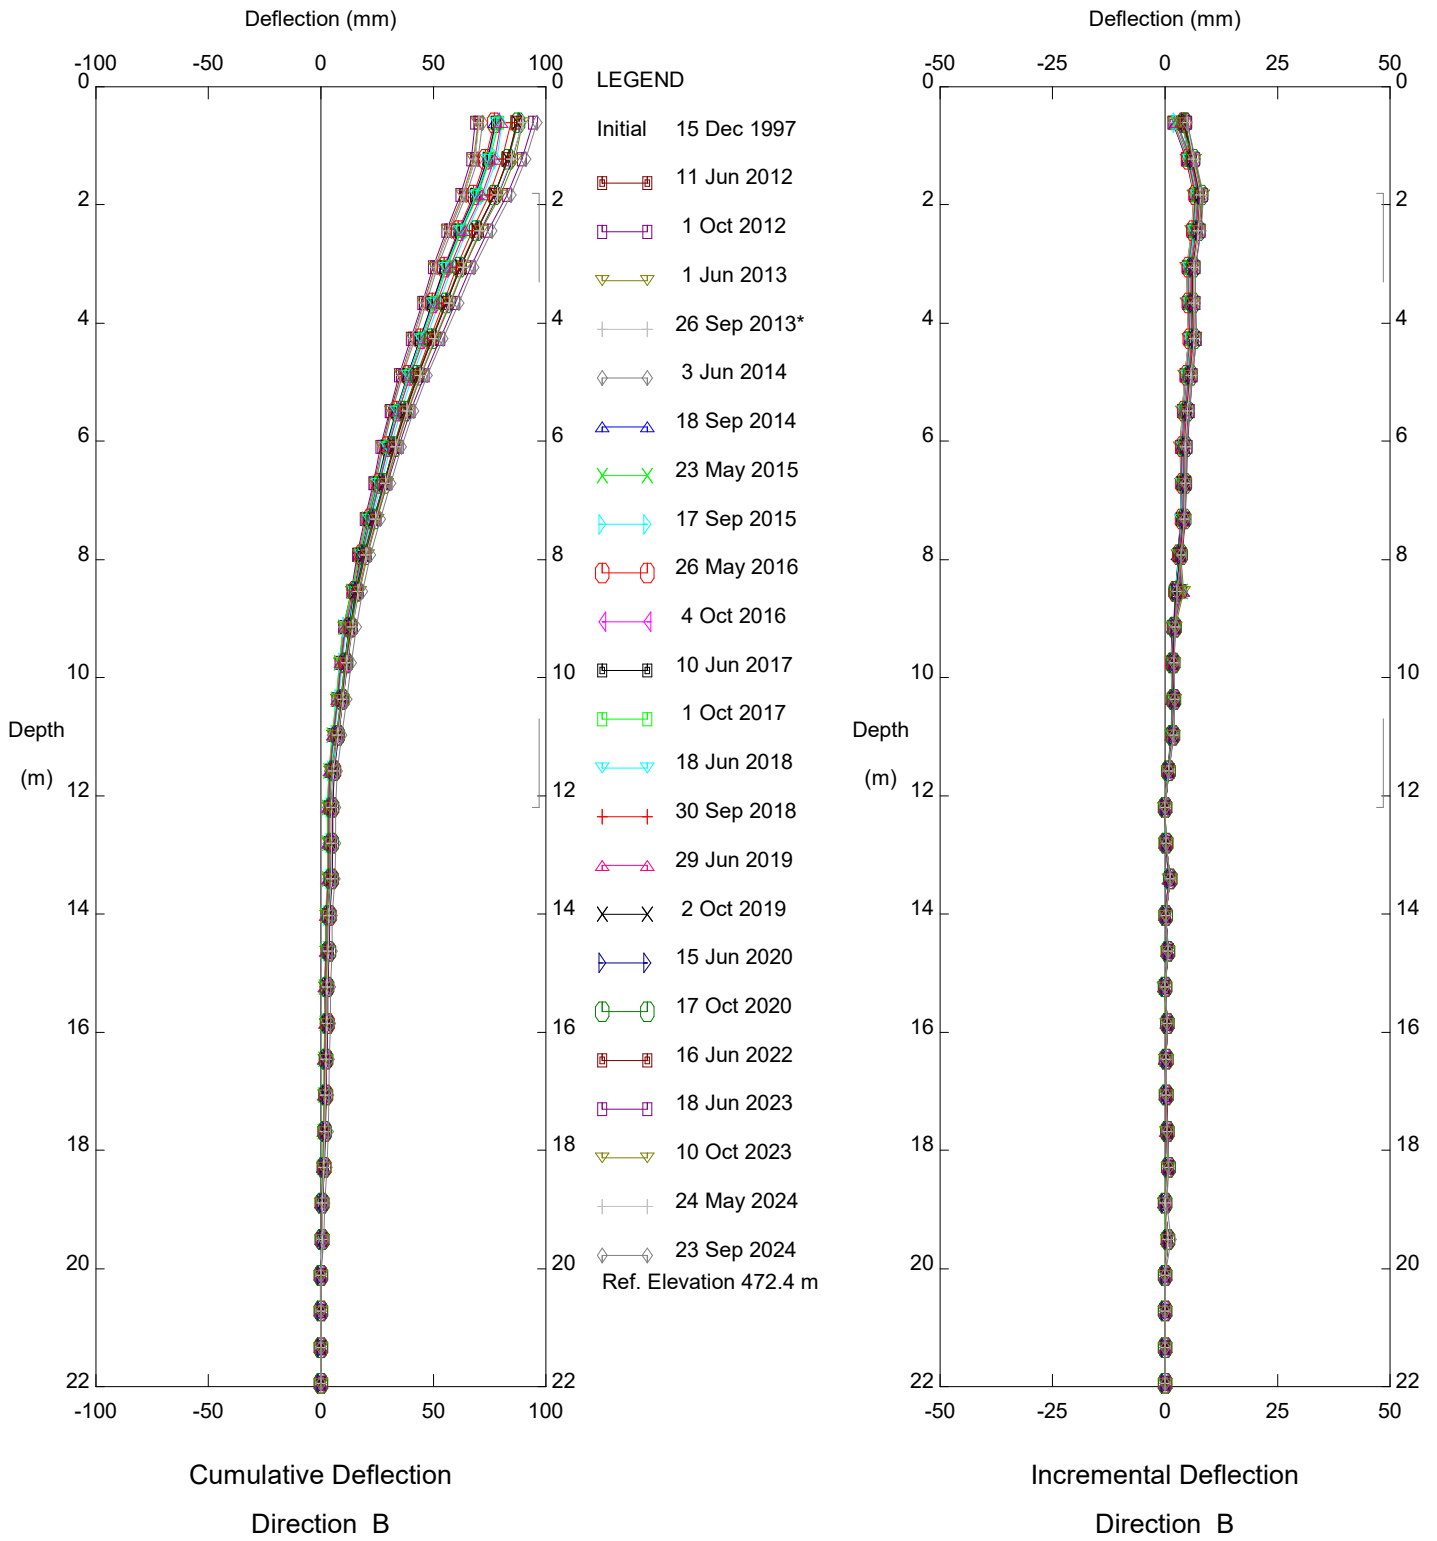
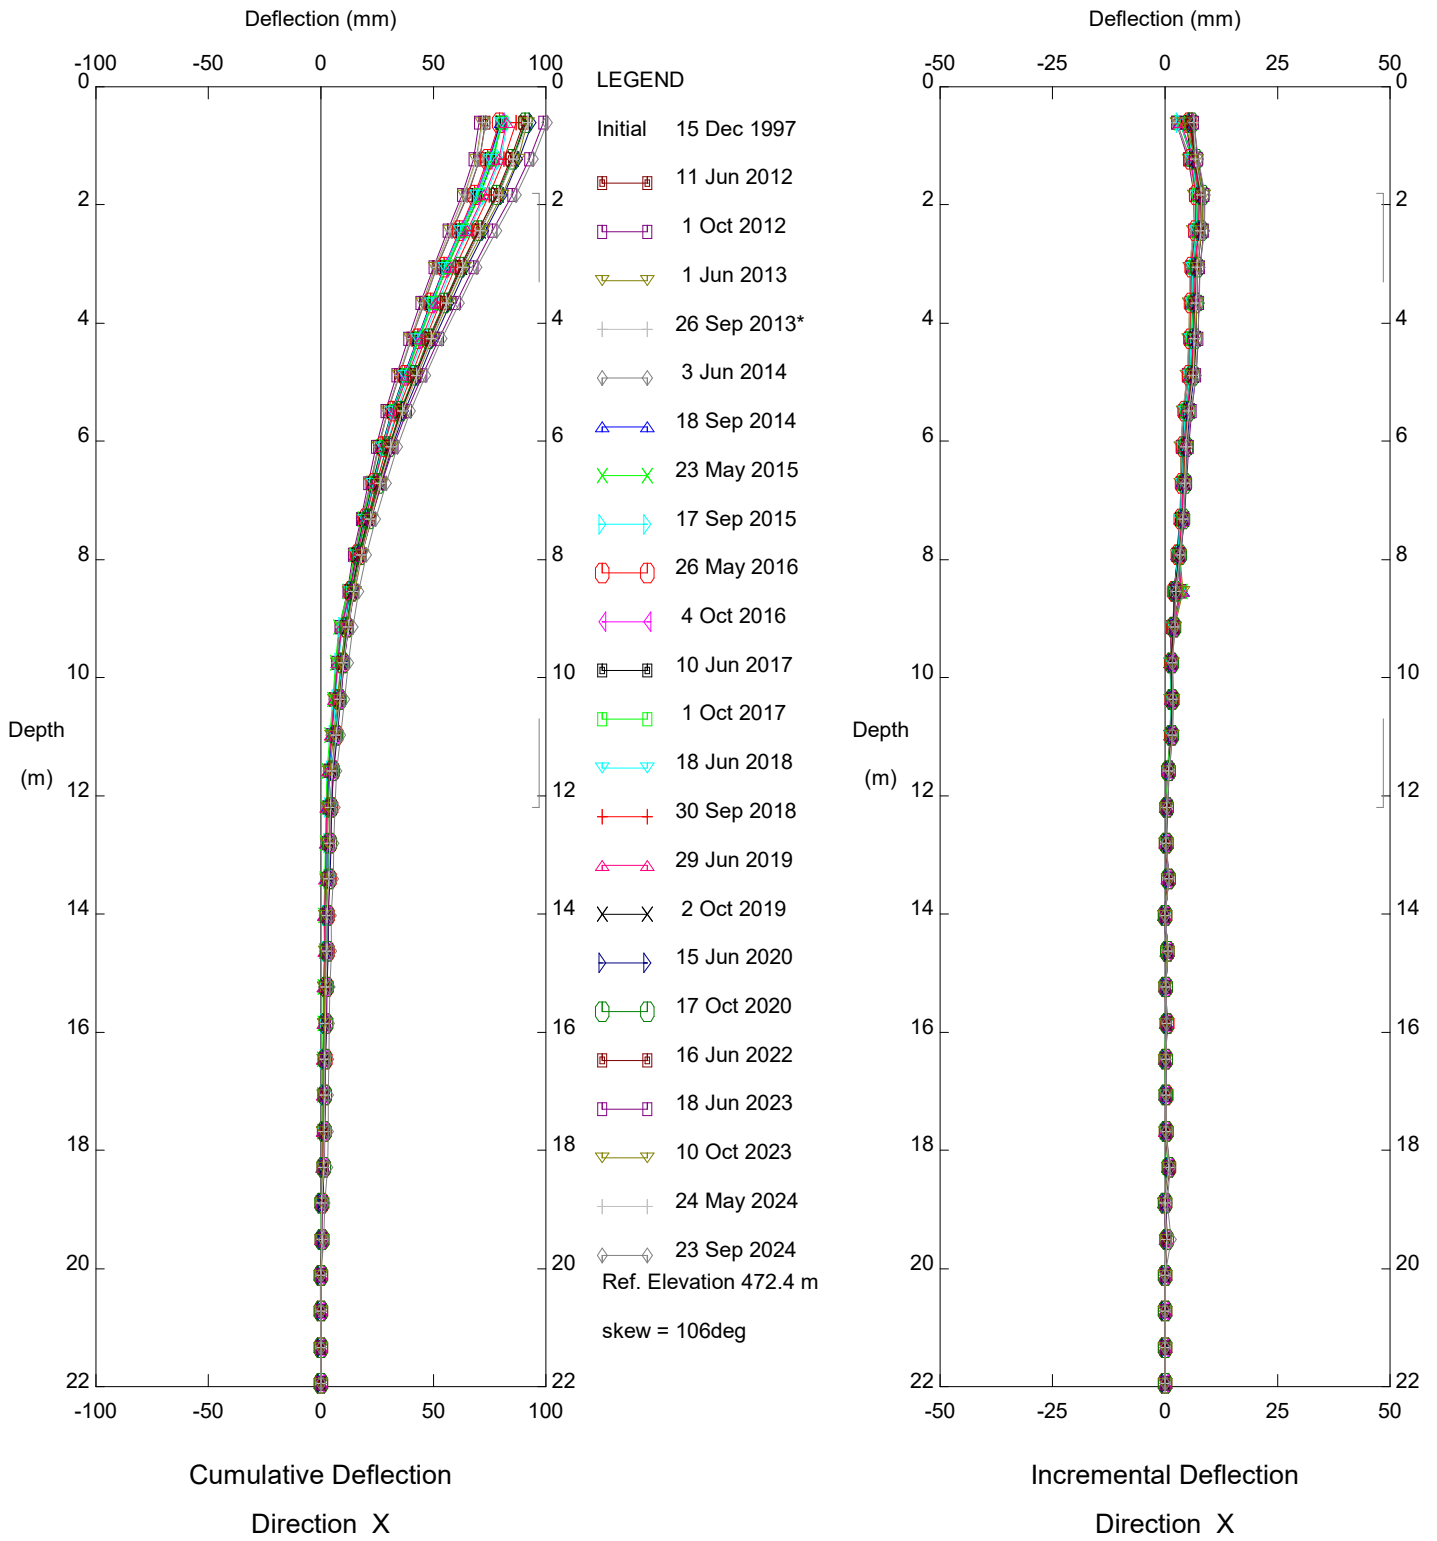
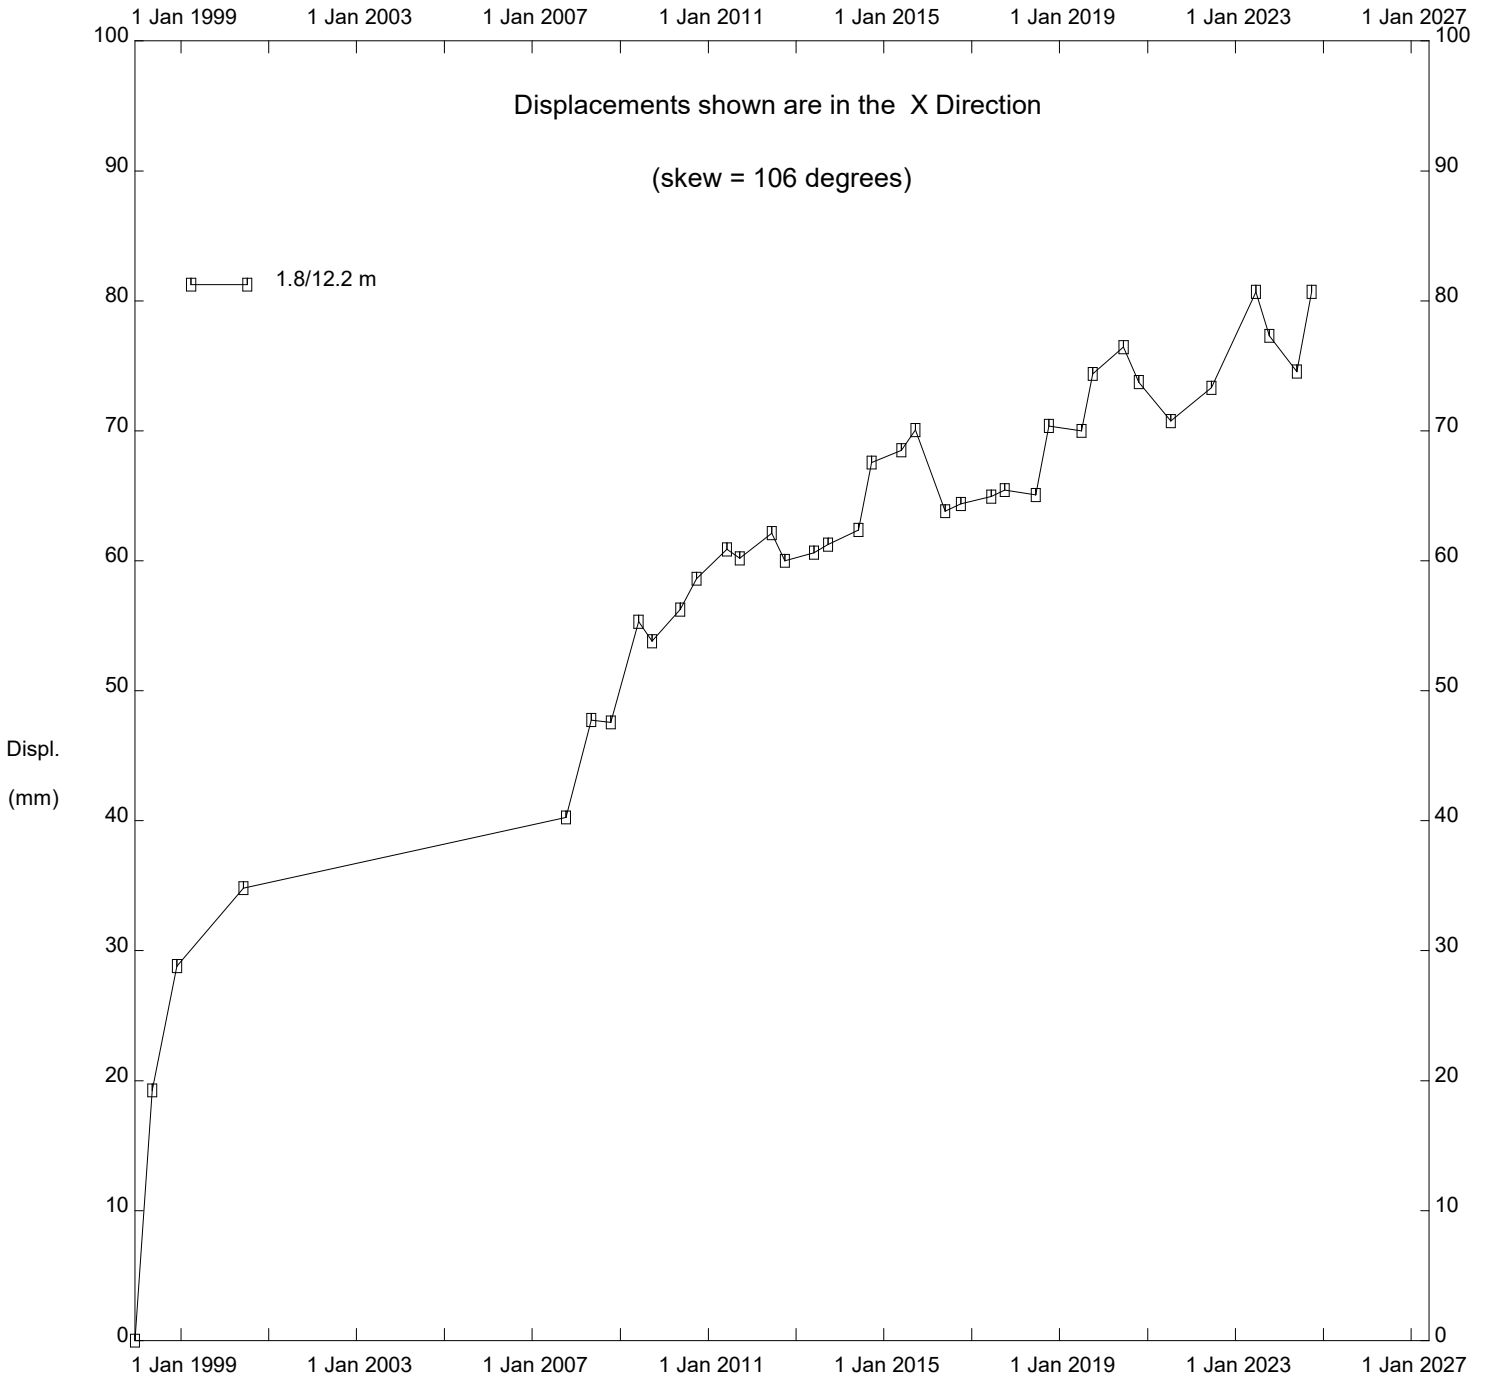
HWY 35:08 (PH045), Inclinometer SI-51

<p>cumulative movement to date of 165.4 mm. The overall movement rate in this SI since initialization is 6.2 mm/yr. SI-50 showed a marked reduction in movement rate post-construction although the rate has since increased but is lower than it was before construction.</p> <p>SI-51 is installed in near the west end of the wall and may be outside of the influence of the main slide area. SI-51 showed a rate of movement of 18.3 mm/yr since the spring of 2024 readings with a total cumulative movement to date of 80.7 mm. The overall movement rate at SI-51 since initialization is 3.0 mm/yr. The pattern at SI-51 is irregular likely due to the casing damage (at depth and near surface); however, the overall trend indicates that this inclinometer was also unaffected by the 2016 repairs.</p> <p>Slope inclinometer SI23-100 is located downslope of the pile wall and showed a rate of movement of 8.9 mm/yr over 4.8 m to 7.8 m depth, and no movement over 21.9 m to 24.3 m depth since the Fall 2023 readings. The lower zone may need more readings to confirm if this is a zone of movement but is of concern as it is below the adjacent pile wall. There is also a potential shallower zone developing at about 3 m which is the contact between the fill and native materials that will be analyzed in Spring 2025.</p> <p>The vibrating wire piezometers show current groundwater depths ranging from 2.98 m in VW23-100B to 8.92 m below existing ground surface in VW23-100A. VW23-100A, VW23-100B, VW23-101, VW23-102 and VW23-103 showed increases in groundwater level of 0.30 m, 0.28 m, 0.94 m, 0.45 m, and 0.14 m, respectively, since the spring of 2024 readings. The greatest increase, in VW23-101, corresponds to the piezometer located in the central portion of the slide mass. The current groundwater level readings in VW23-100B and VW23-101 are the highest since the instruments were initialized. The nested piezometers at VW23-100 indicate an upward trend to the groundwater flow pattern. The vibrating wire piezometer readings are summarized in Table PH045-2 below and are plotted on Figure PH045-1 in Appendix A.</p>

* SI-51 probe comes to surface not in grooves, may be damaged at 2 feet depth. Top of casing damaged
*SI-51 Probe did not go past 65 ft, SI was read from 2 ft to 64 ft
** SI-50 - top of SI slightly damaged
