**ALBERTA TRANSPORTATION AND
ECONOMIC CORRIDORS
GEOHAZARD ASSESSMENT PROGRAM
PEACE REGION (PEACE RIVER DISTRICT)
2024 INSPECTION**

Site Number	Location	Name	Hwy	km
PH045-1	North of Manning, AB	Meikle River (Pile Wall)	35:08	26.2
Legal Description		UTM Co-ordinates		
SW7-94-22-W5M		11U E 467,581	N	6,333,081

**PH045: HWY 35:08 - MEIKLE RIVER
GEOHAZARD ASSESSMENT**

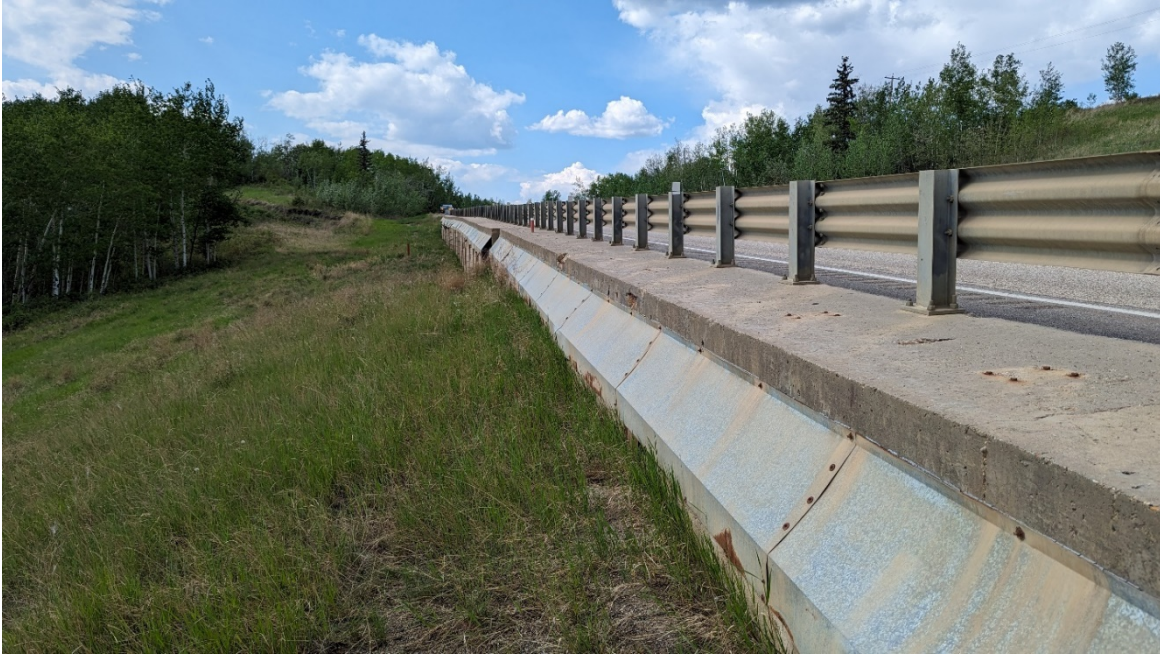
Photo 1 – Looking northwest along the pile wall.

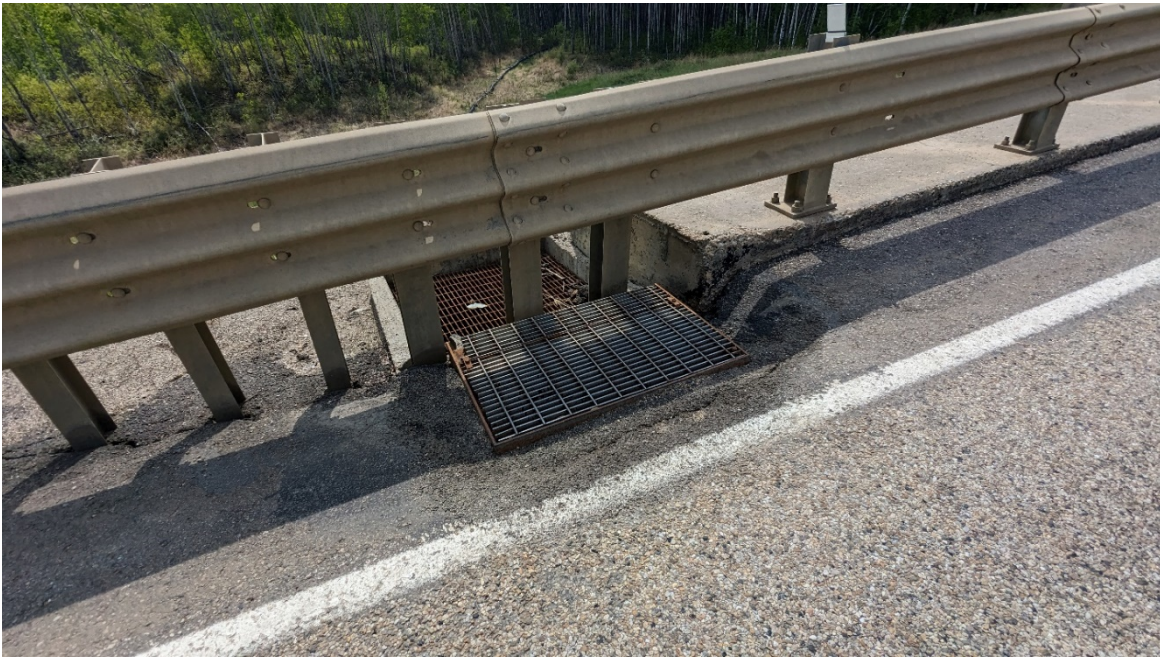
Photo 2 – Catch basin inlet at the south end of the wall leading to the elephant trunk downpipe.

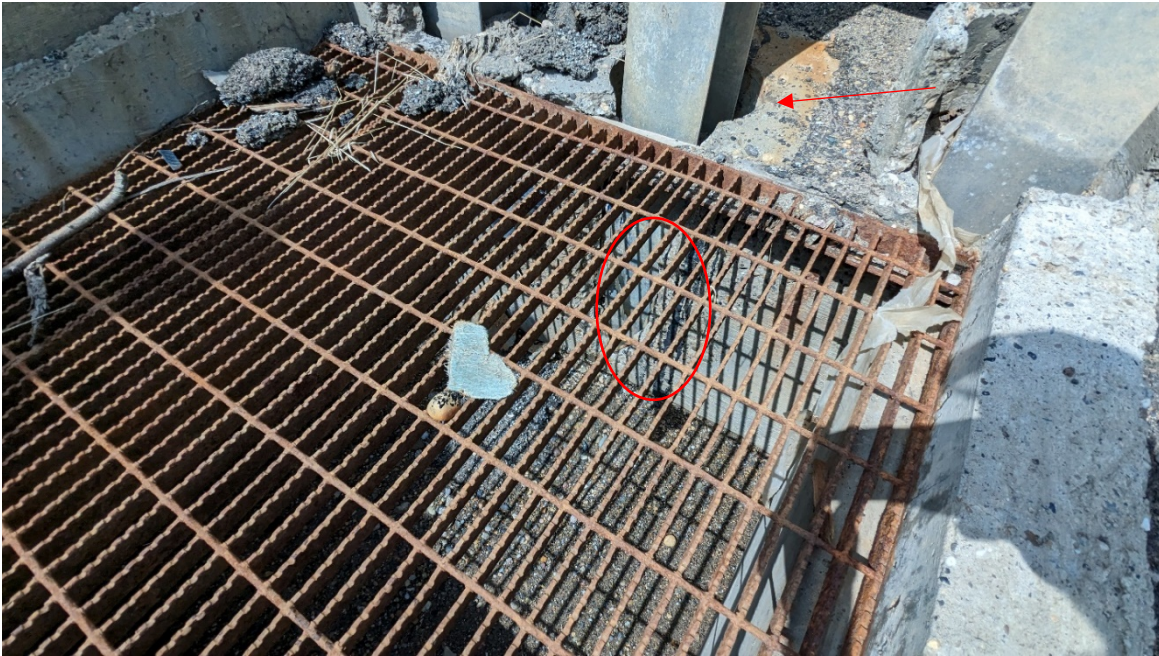
<input checked="" type="checkbox"/> Seepage	Pile wall voids repaired; subdrain pipe in lower portion of slope exposed and extended; only trace moisture observed	<input type="checkbox"/>
<input checked="" type="checkbox"/> Bridge/Culvert	Cracking concrete was noted in the catch basin with water ponding in the exposed guardrail post sleeves.	<input checked="" type="checkbox"/>
<input checked="" type="checkbox"/> Other	H-piles and timber lagging damaged by slope movement and pulling away from the waler	<input checked="" type="checkbox"/>

Photo 3 – The thin concrete on the side of the catchbasin (red circle) has crack and water from the surface (red arrow) is ponding in the void left during pouring of the basin.

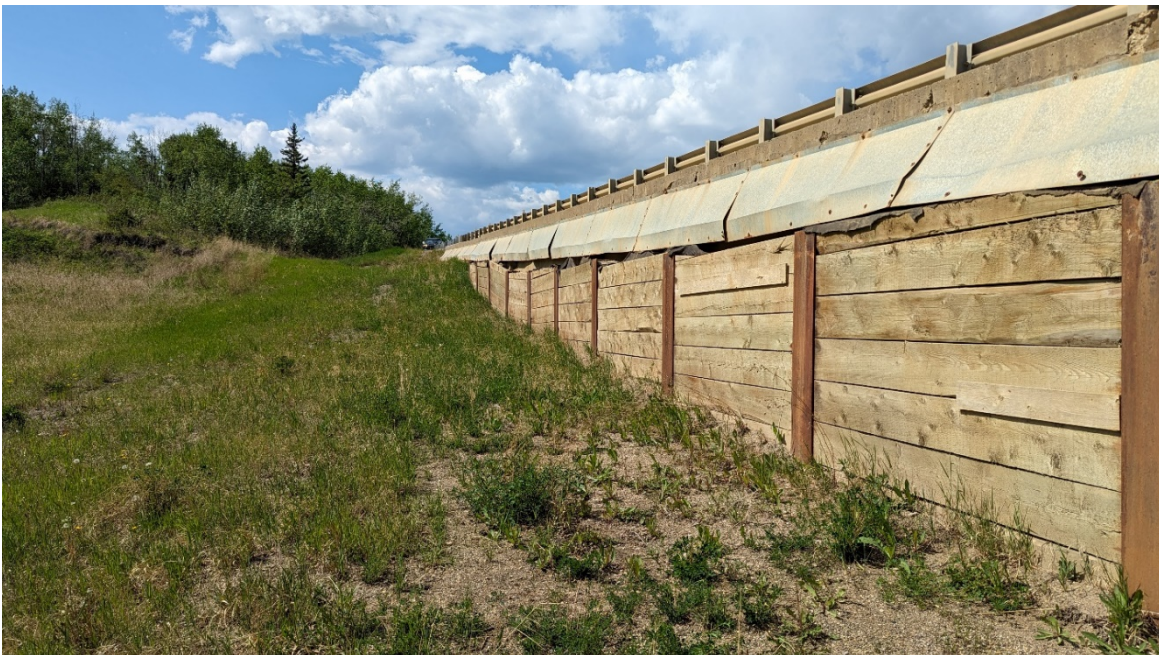
Photo 4 – Looking north at the displaced H-pile and timber lagging wall near the scarp at the north end of the wall.

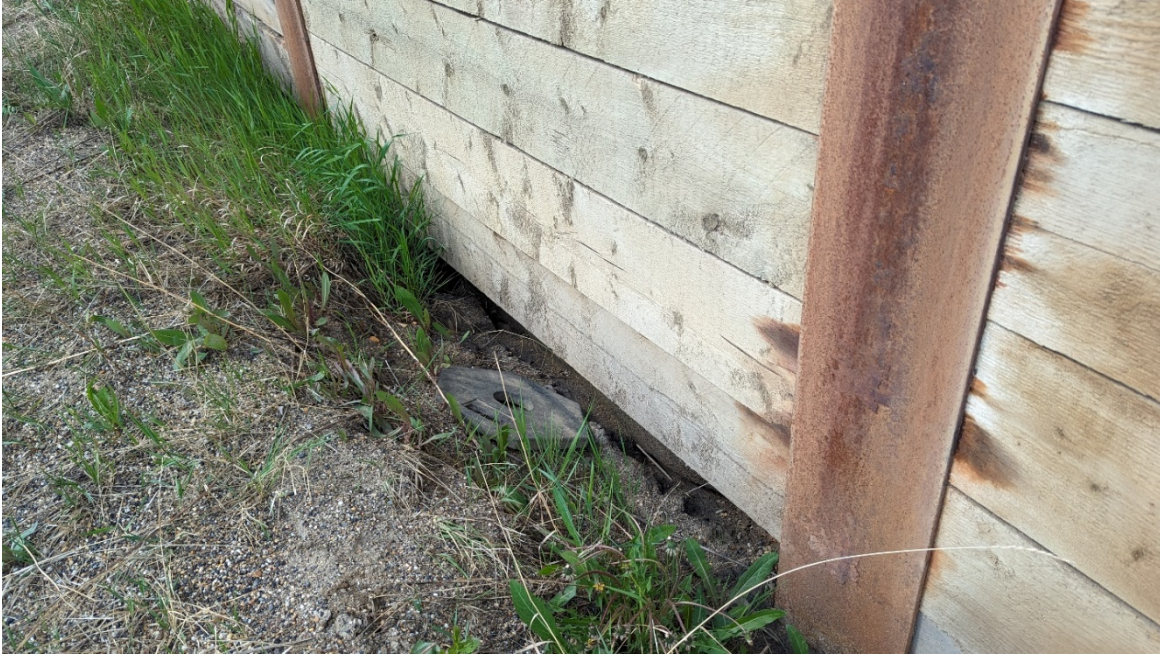
Photo 5 – Crack and void opening up below the timber lagging.

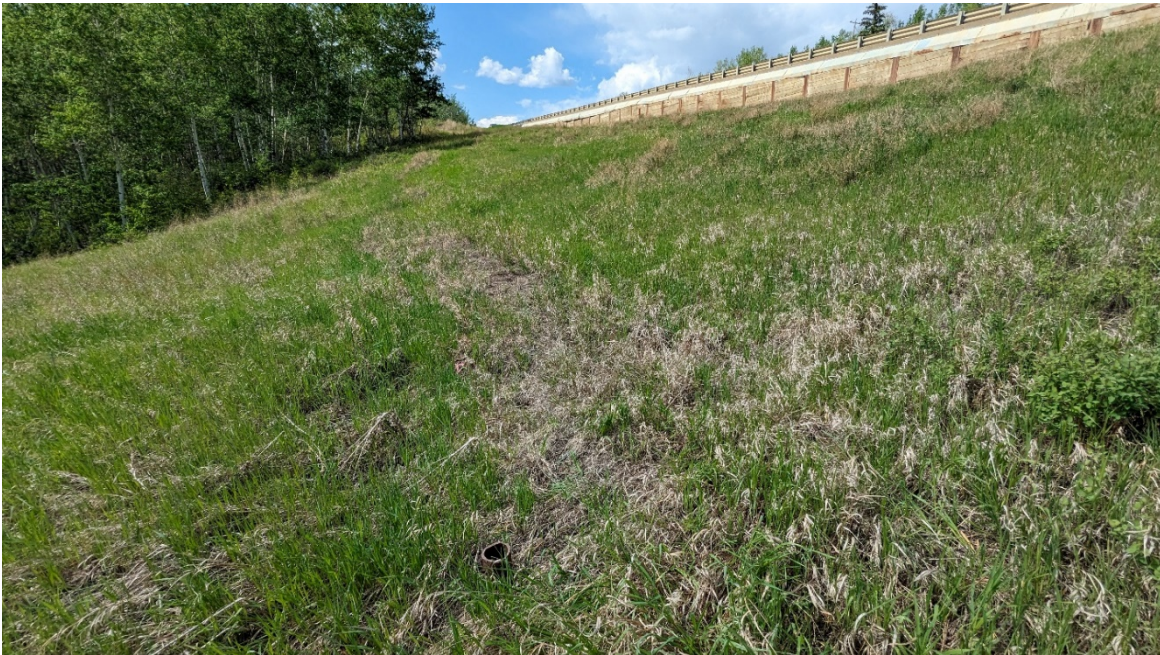
Photo 6 – Looking northwest at the gabion basket wall a newly-protruding screw pile.

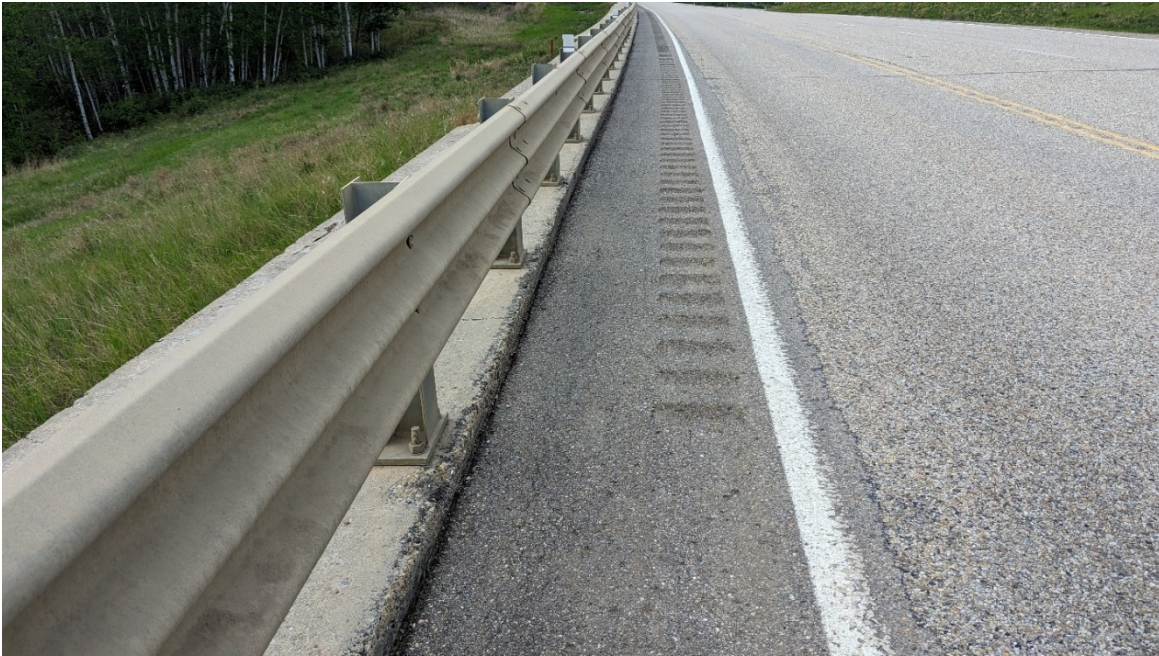
Photo 7 – Looking at the crack that is opening up again between the cap beam and asphalt.

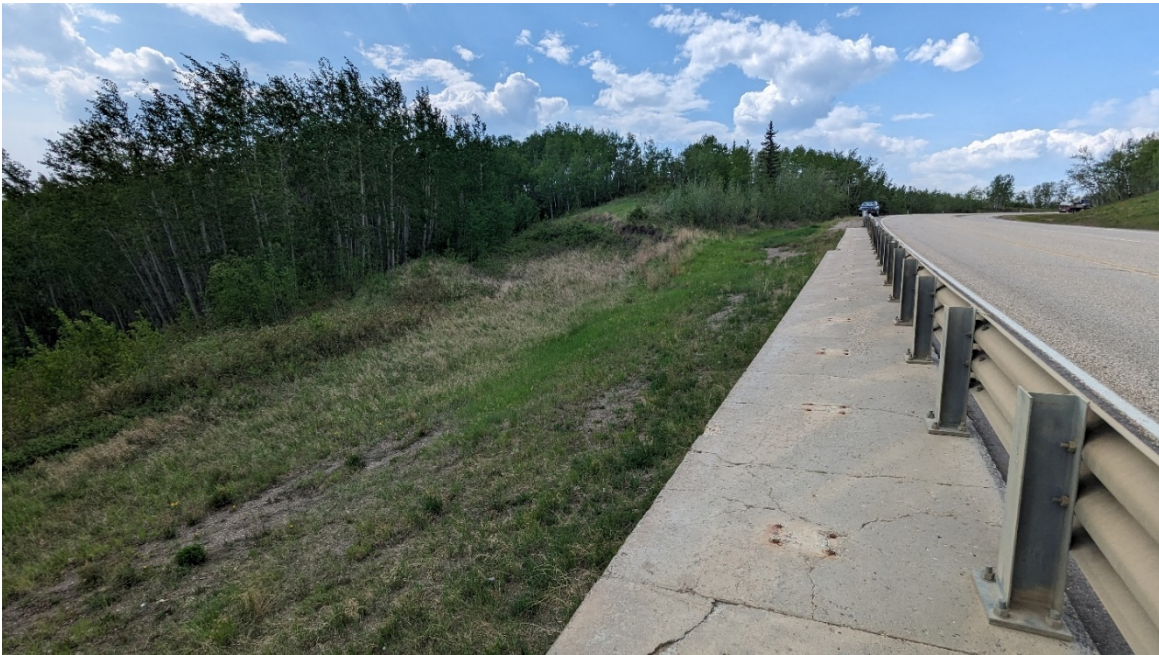
Photo 8 – Looking west at graben block northwest of the wall, which appears to have become re-activated.
