| Site Number | Location | Name | Hwy | km |
|---|---|---|---|---|
| PH045 | Hwy 35:08 C1 26.2 | Meikle Pile Wall | 35:08 | Km 26.2 |

**ALBERTA TRANSPORTATION AND ECONOMIC CORRIDORS GRMP (CON0022164)
PEACE REGION (PEACE RIVER DISTRICT)
INSTRUMENTATION MONITORING RESULTS**

SPRING 2024

SITE PH045: HWY 35:08, MEIKLE RIVER (km 26.2 PILE WALL)

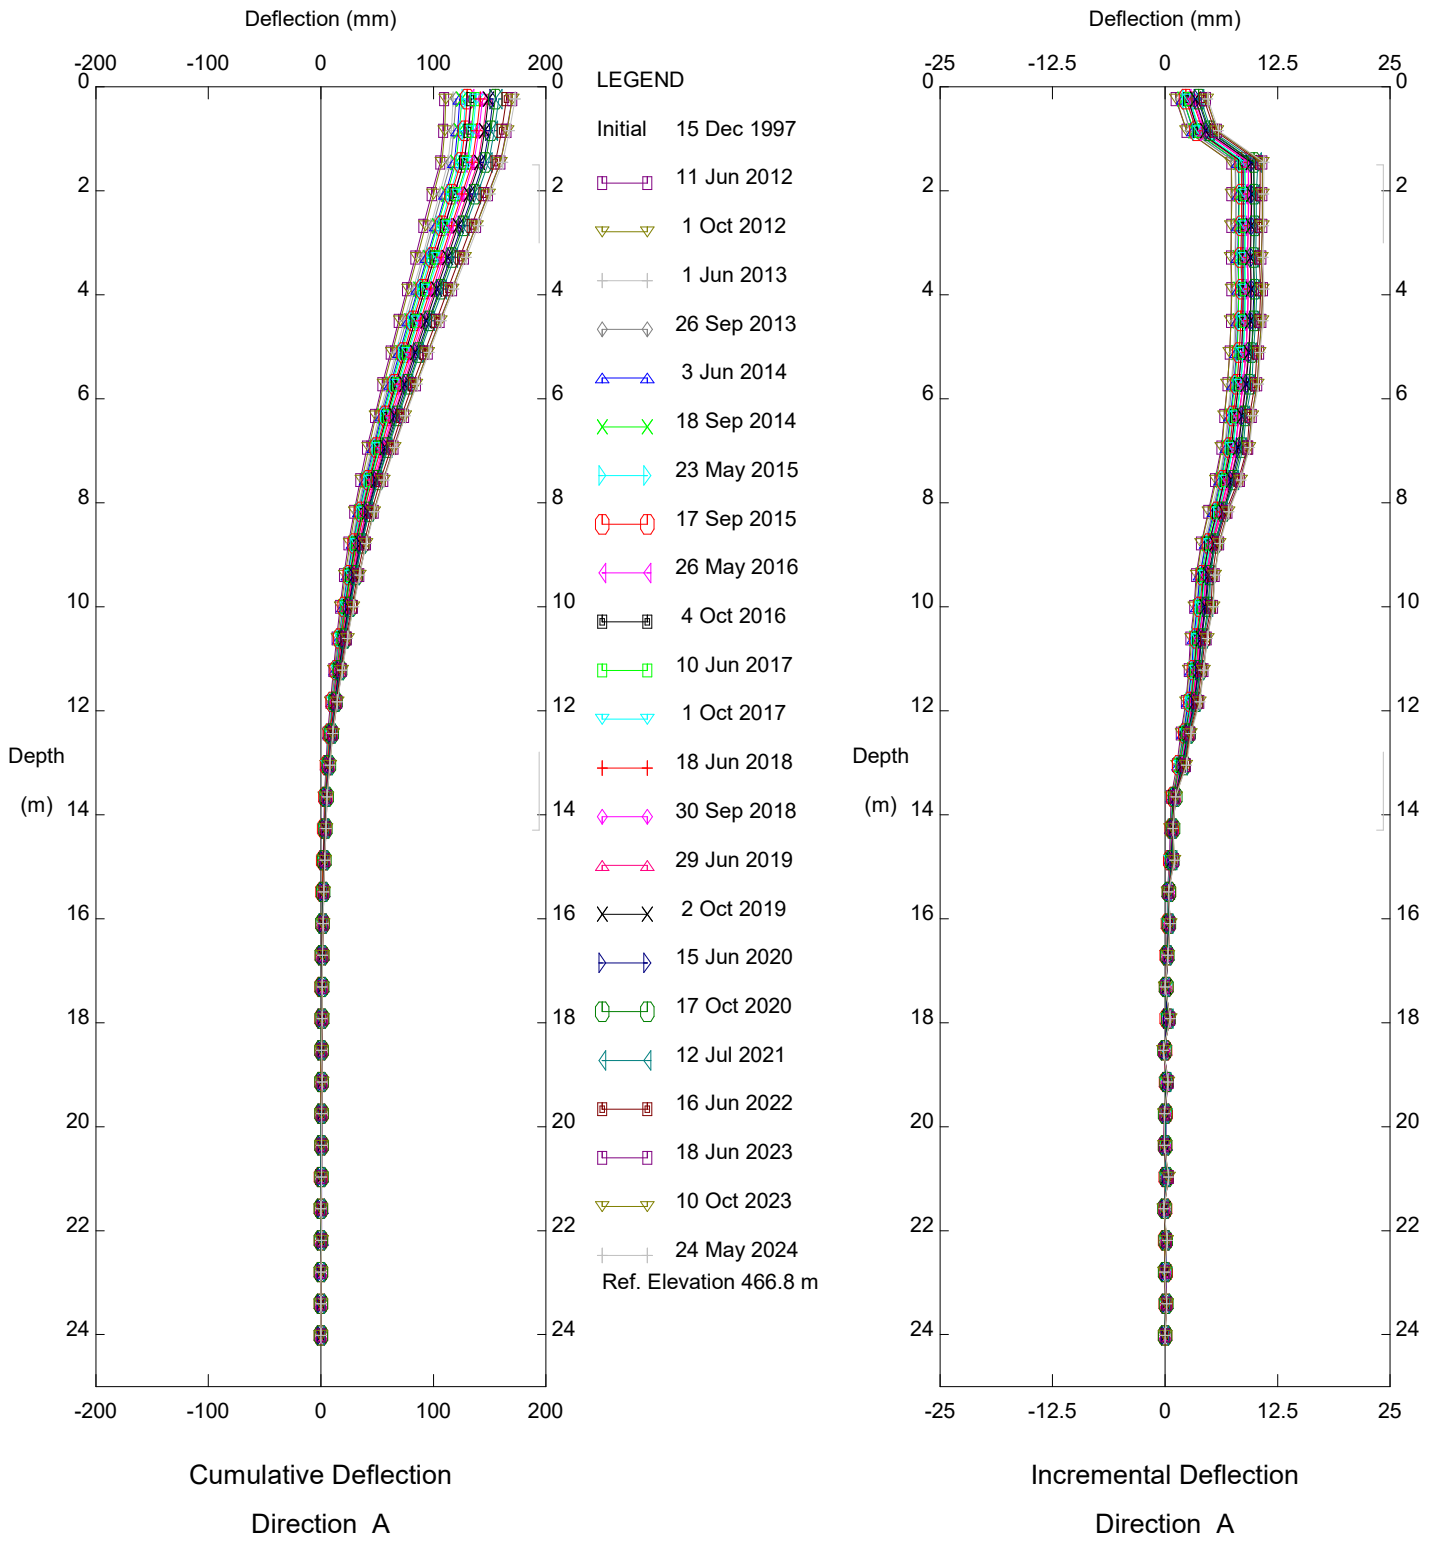
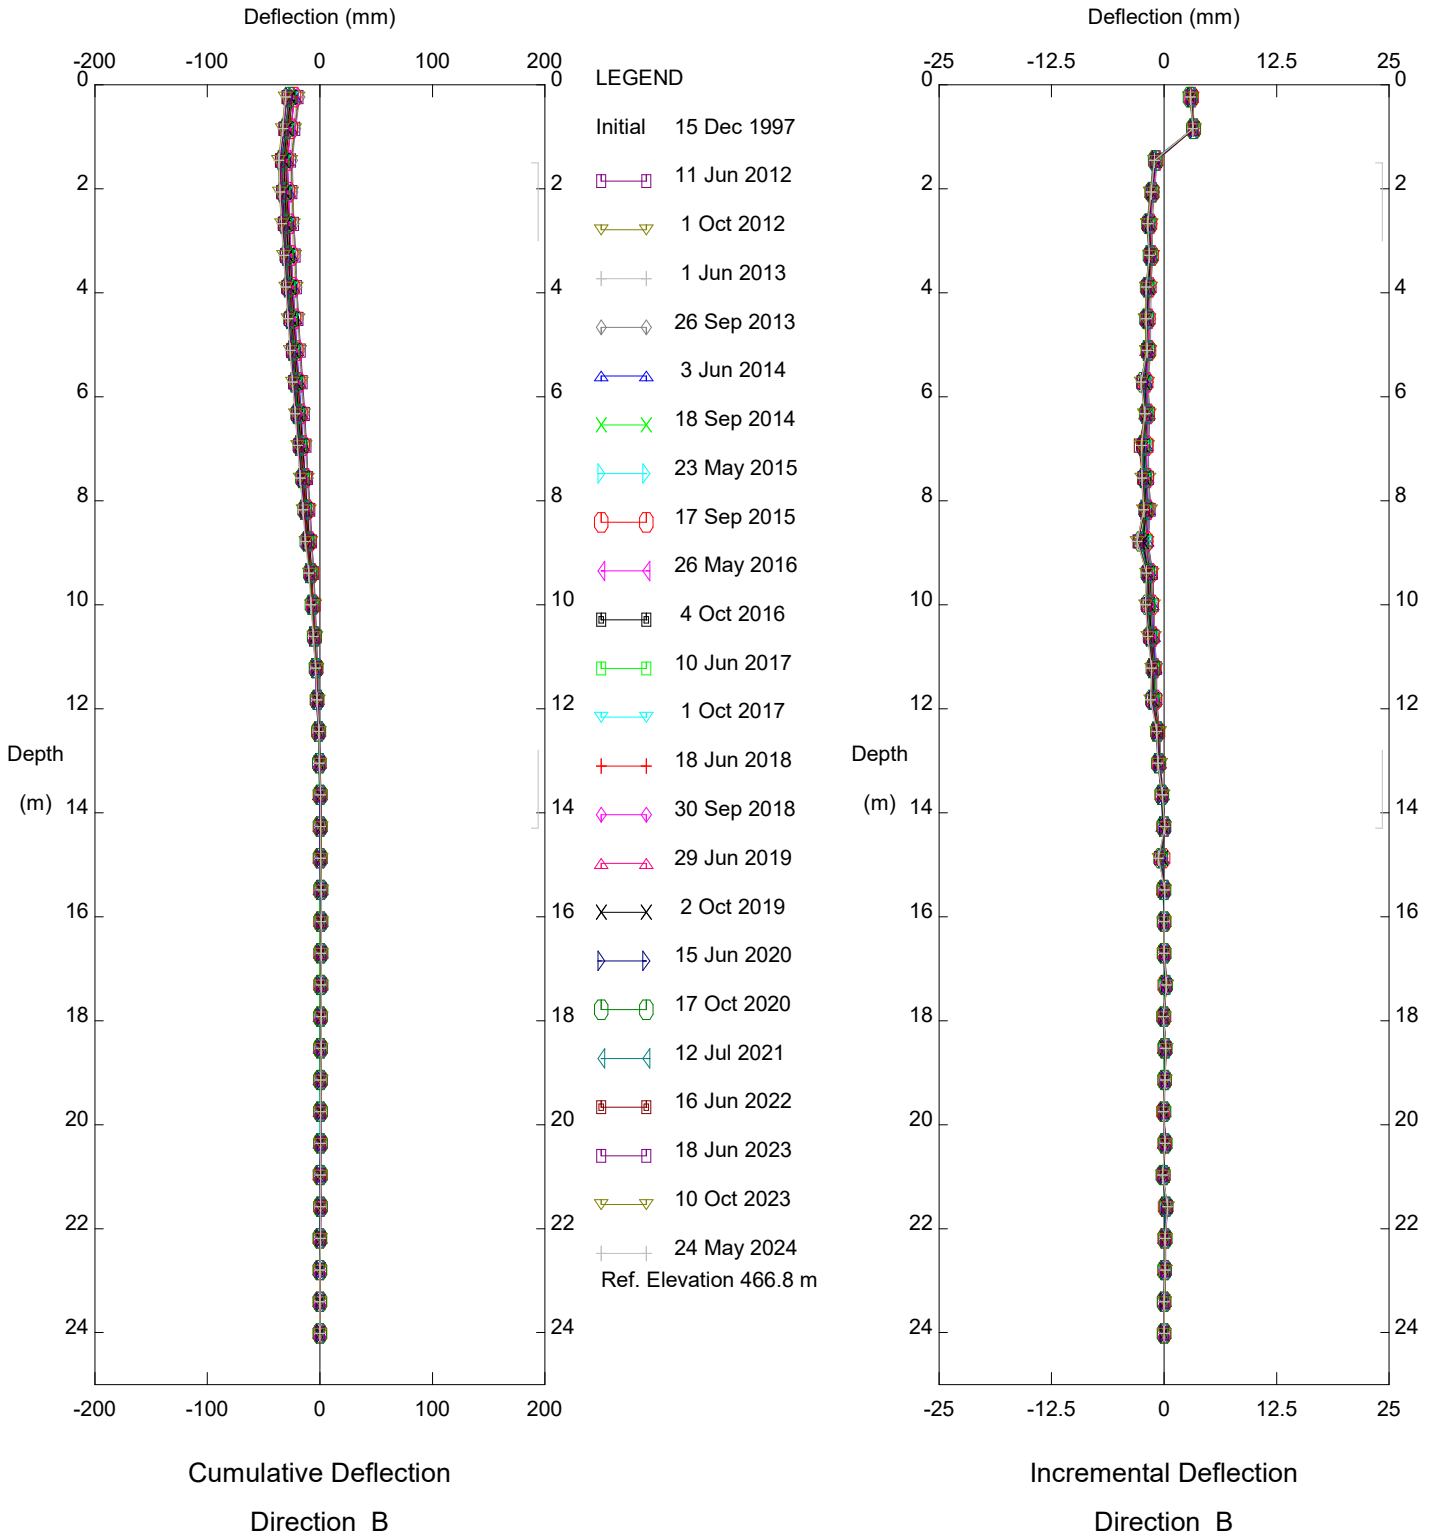
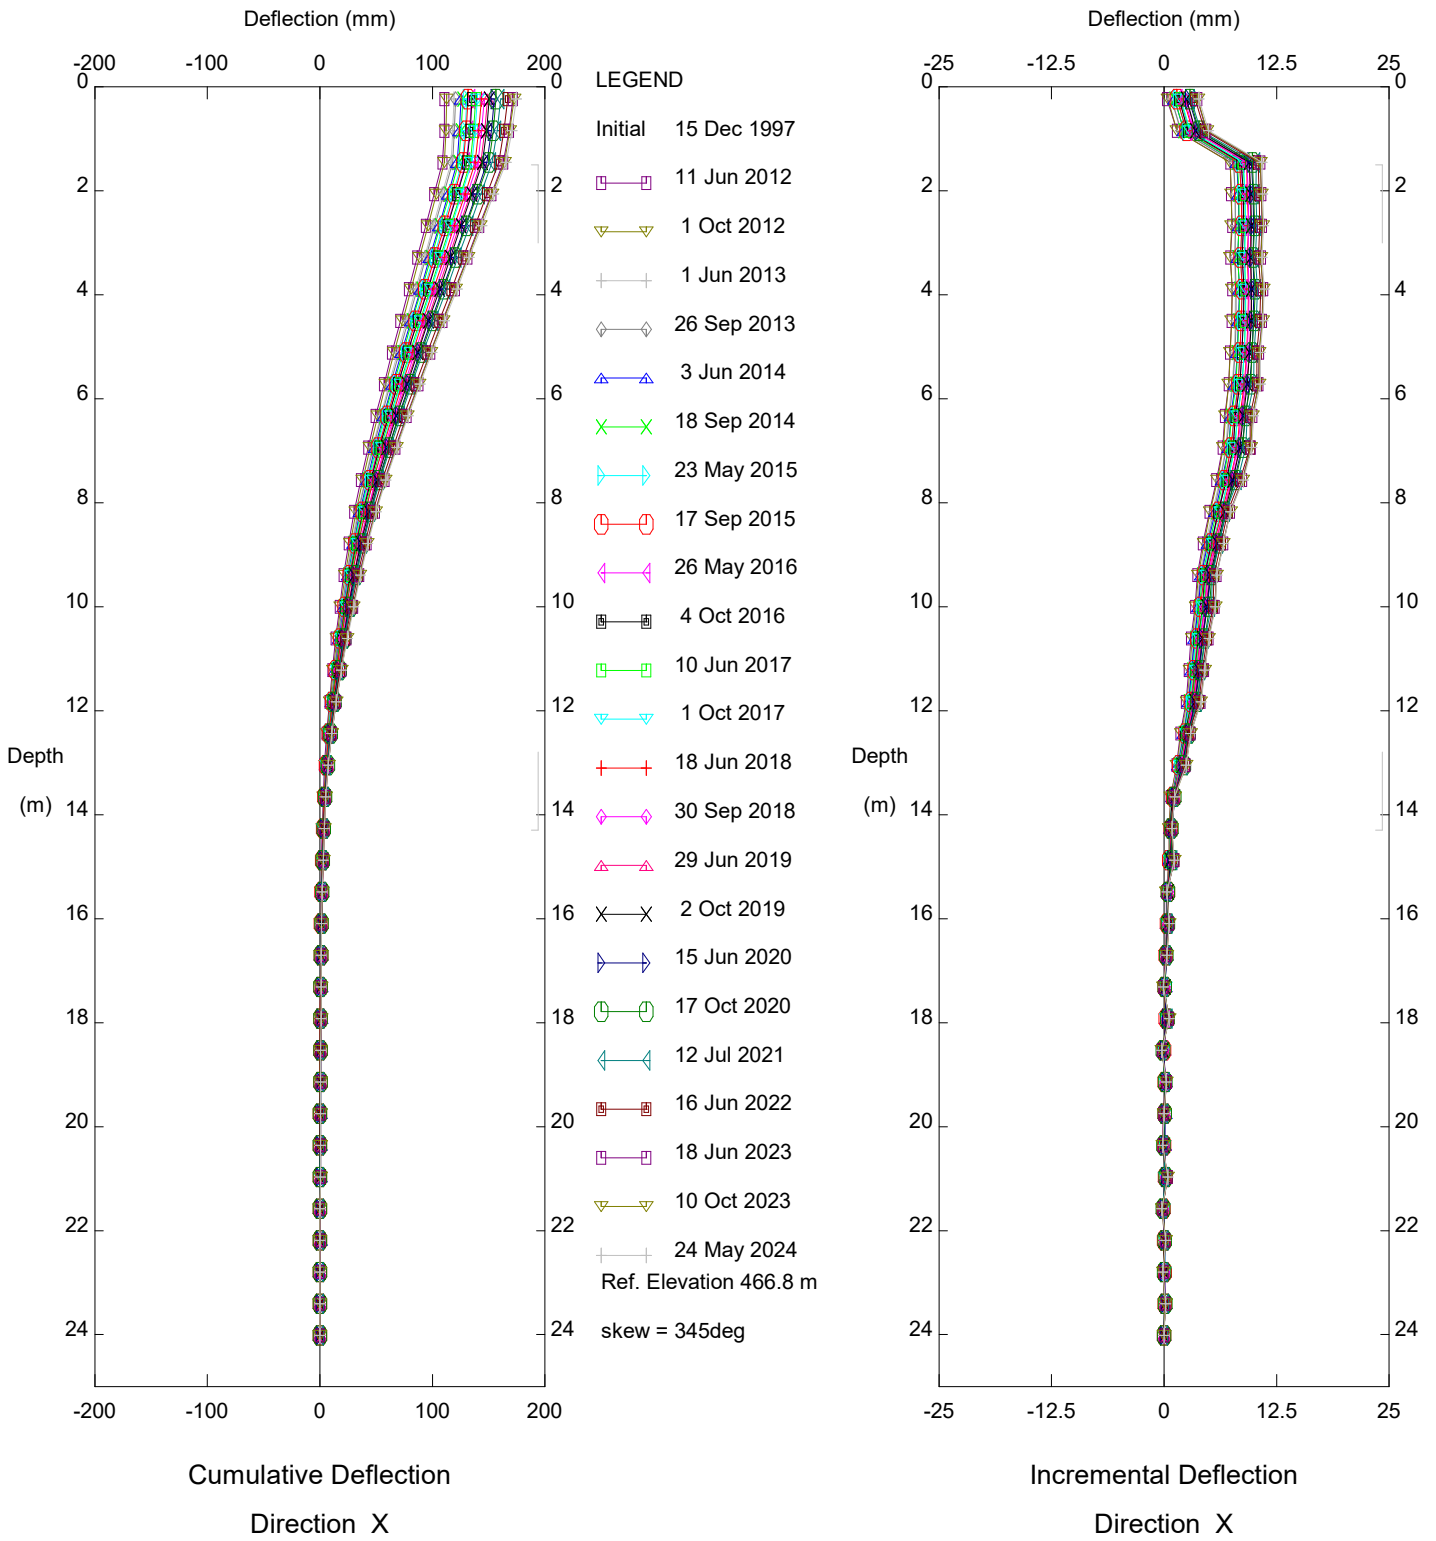
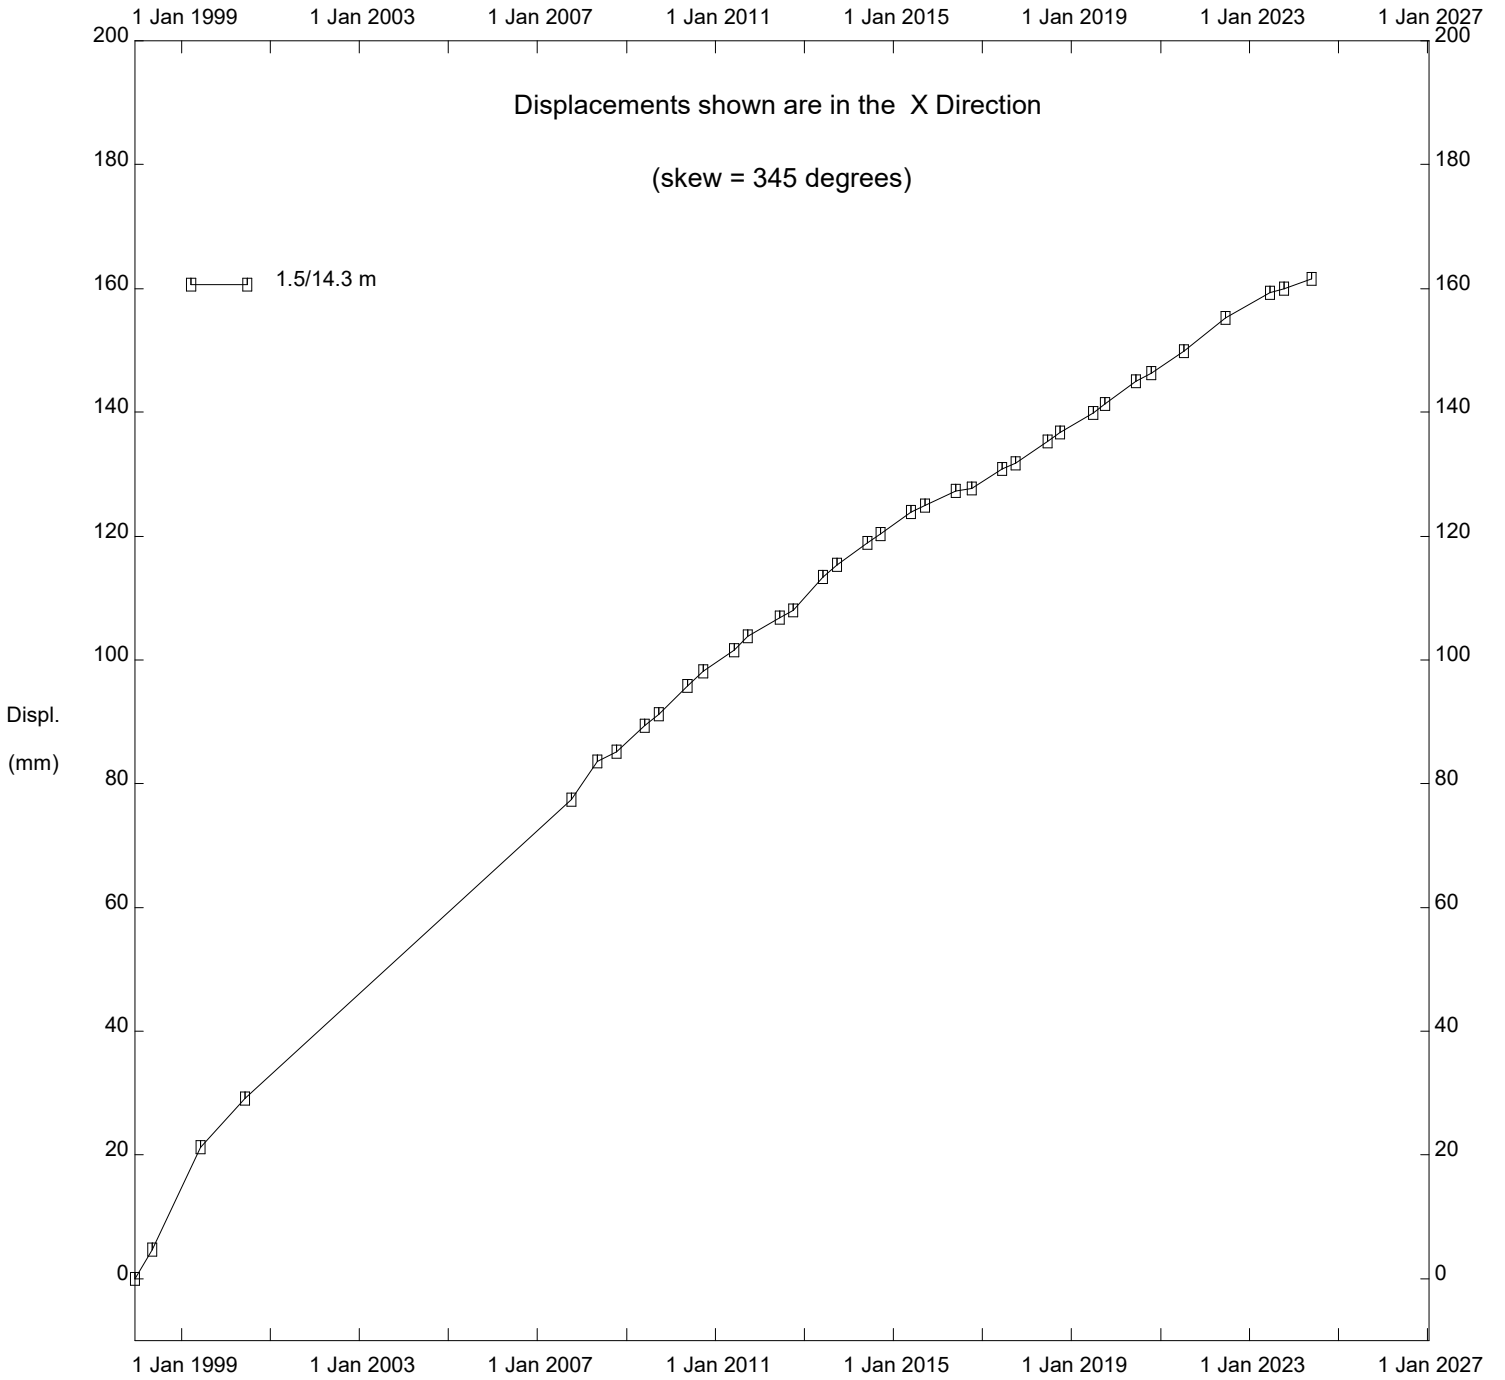
HWY 35:08 (PH045), Inclinometer SI-49

| INSTRUMENT # | DATE INITIALIZED | TOTAL CUMULATIVE RESULTANT MOVEMENT AT NOTED DEPTH SINCE INITIAL READING (mm) | MAXIMUM RATE OF MOVEMENT (mm/yr) | CURRENT STATUS | DATE OF PREVIOUS READING | INCREMENTAL MOVEMENT SINCE PREVIOUS READING (mm) | CURRENT RATE OF MOVEMENT (mm/yr) | CHANGE IN RATE OF MOVEMENT SINCE PREVIOUS READING (mm/yr) |
|---|---|---|---|---|---|--|---|---|
| SI-49 | Dec. 15, 1997 | 161.5 mm over 1.5 m to 14.3 m depth in 216° direction | 15.2 mm/y In June 1999 | Operational | October 10, 2023 | 1.6 | 2.6 | 0.5 |

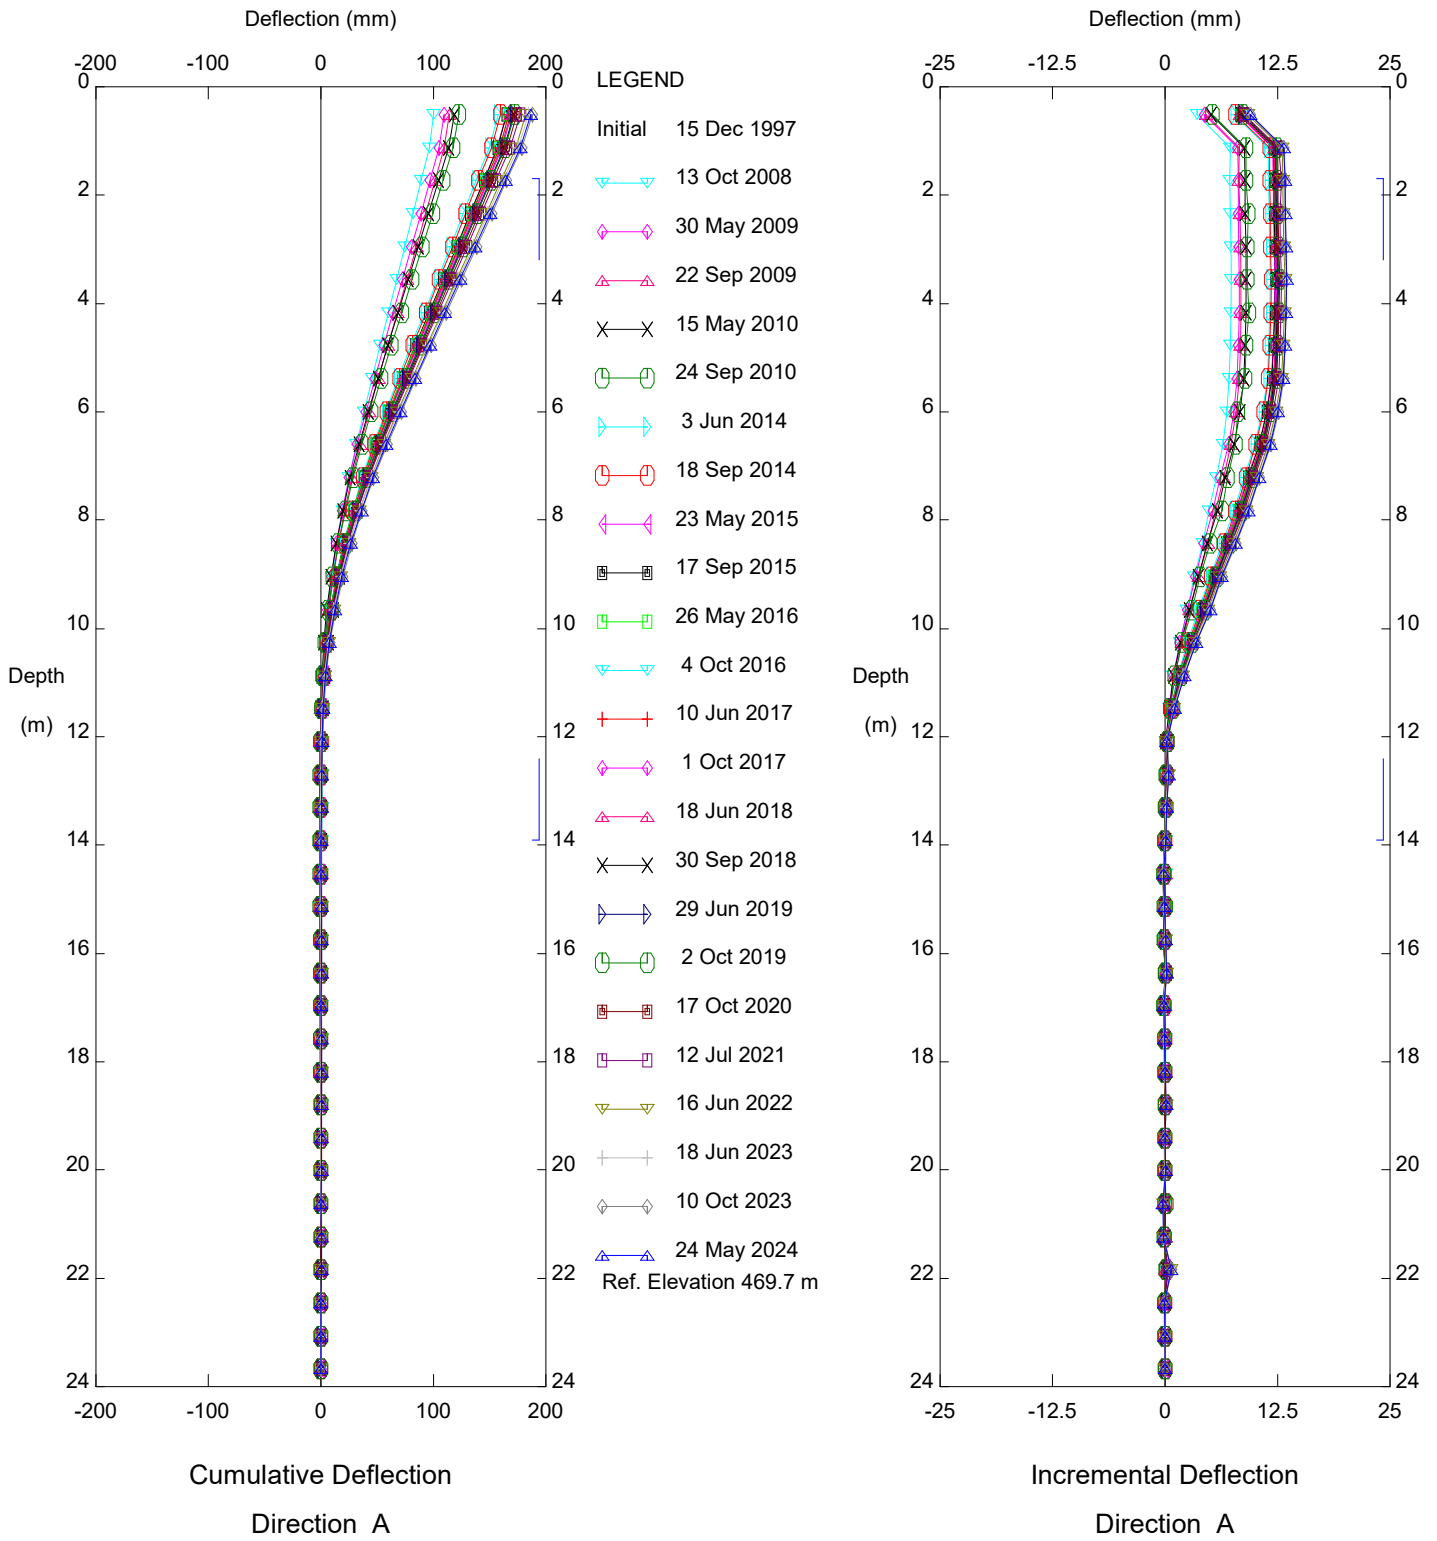
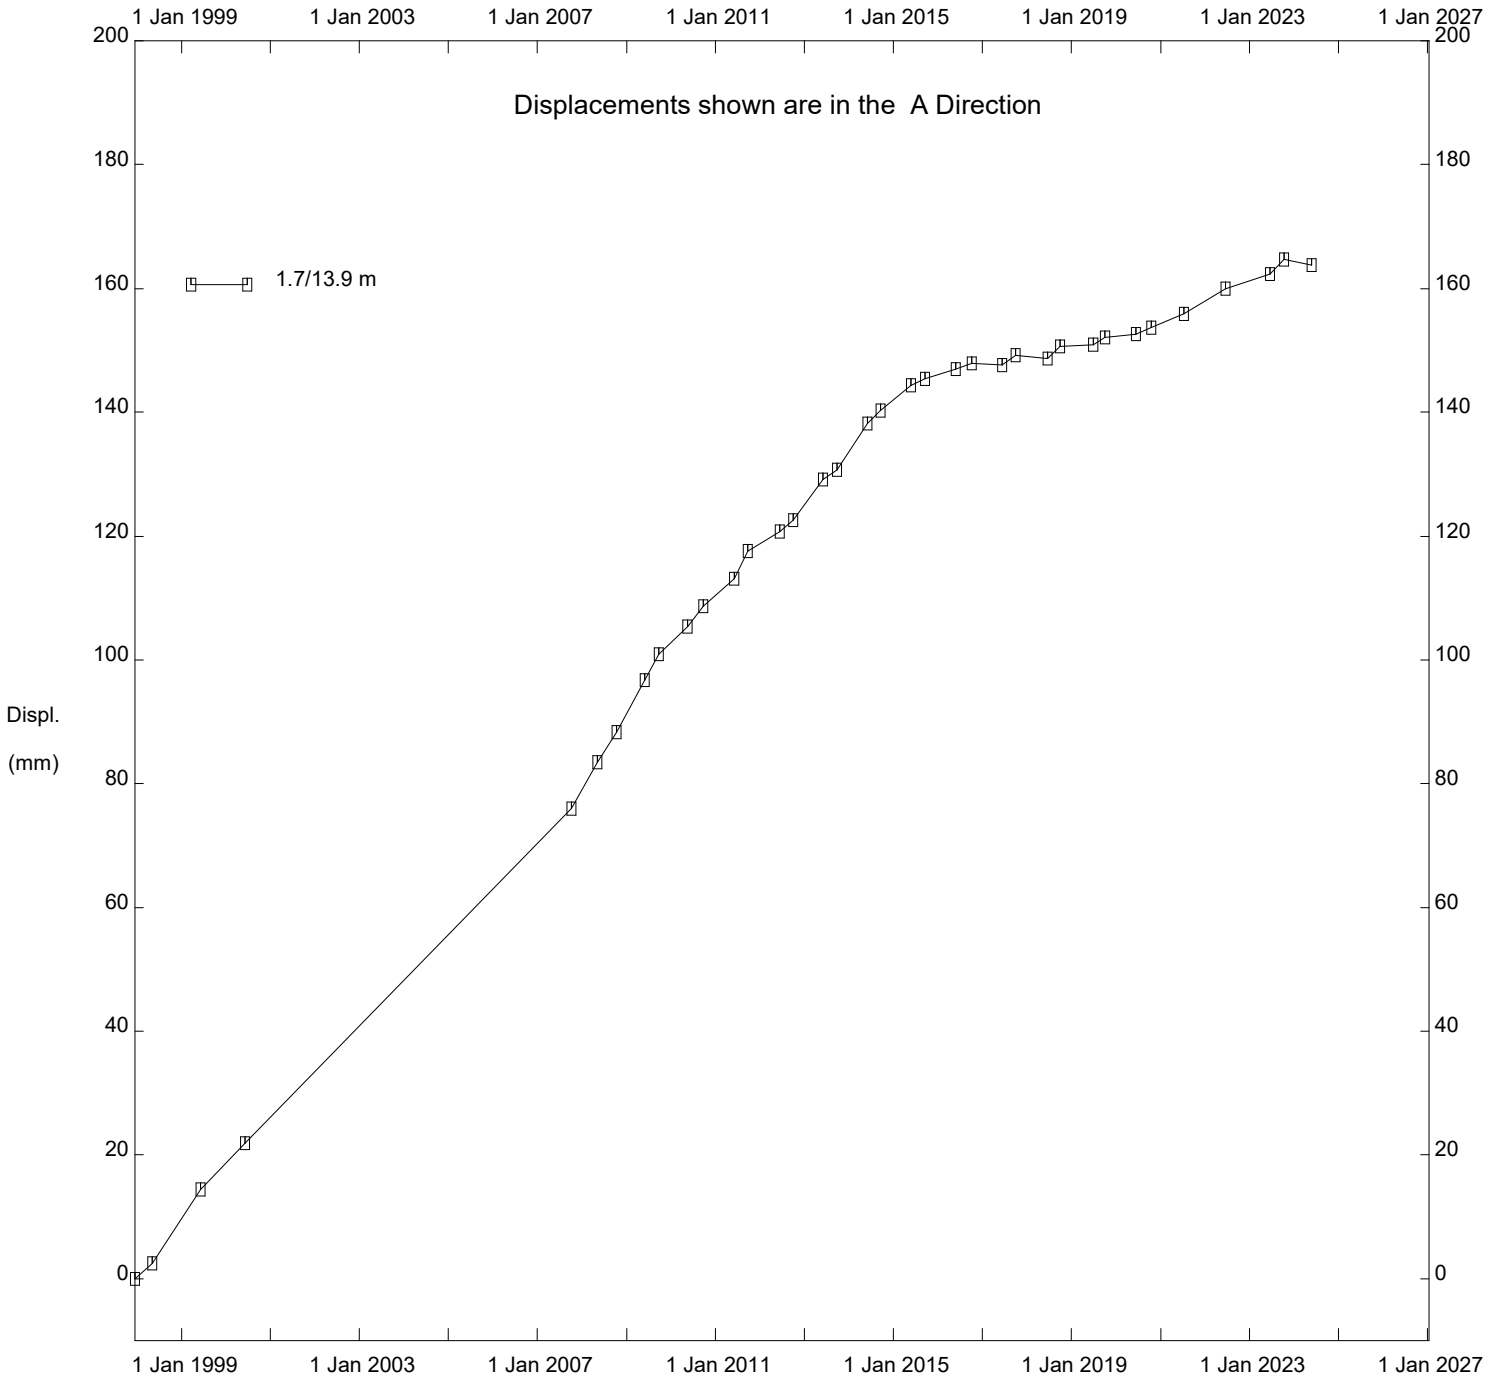
HWY 35:08 (PH045), Inclinometer SI-50

| | <p>movement rate in this SI since initialization is 6.2 mm/yr. SI-50 showed a marked reduction in movement rate post-construction although the rate has since increased over the last three years</p> <p>SI-51 showed no discernible movement since the fall of 2023 readings with a total cumulative movement to date of 74.6 mm. The overall movement rate at SI-51 since initialization is 2.8 mm/yr. SI-51 is somewhat inconclusive due to the irregular movement trends; however, the overall trend indicates that this inclinometer was also unaffected by the 2016 repairs.</p> <p>Slope inclinometer SI23-100 is located downslope of the pile wall and showed a rate of movement of 7.8 mm/yr over 4.8 m to 7.8 m depth, and a rate of movement of 1.1 mm/yr over 21.9 m to 24.3 m depth since the fall 2023 readings. The lower zone needs more readings to confirm but it is of concern as this depth of movement is below the adjacent pile wall.</p> <p>The vibrating wire piezometers show current groundwater depths ranging from 3.26 m in VW23-100B to 9.22 m below existing ground surface in VW23-100A. Vibrating wire piezometers VW23-100A, VW23-100B, and VW23-101 showed increases in groundwater level of 0.25 m, 0.14 m, and 0.30 m, respectively, since the fall 2023 readings. The current groundwater level reading in VW23-100B is the highest since the instrument was initialized. VW23-102 and VW23-103 have shown decreases in groundwater of 1.25 m and 1.05 m, respectively, since the fall 2023 readings, with the reading at VW23-103 the lowest since installation. The nested piezometers at VW23-100 indicate an upward trend to the groundwater flow pattern. The vibrating wire piezometer readings are summarized in Table PH045-2 above and are plotted on Figure PH045-1 in Appendix A.</p> |

| INSTRUMENT # | DATE INITIALIZED | TOTAL CUMULATIVE RESULTANT MOVEMENT AT NOTED DEPTH SINCE INITIAL READING (mm) | MAXIMUM RATE OF MOVEMENT (mm/yr) | CURRENT STATUS | DATE OF PREVIOUS READING | INCREMENTAL MOVEMENT SINCE PREVIOUS READING (mm) | CURRENT RATE OF MOVEMENT (mm/yr) | CHANGE IN RATE OF MOVEMENT SINCE PREVIOUS READING (mm/yr) |
|---|---|---|---|---|---|--|---|---|
| SI-50 | Dec. 15, 1997 | 163.7 mm over 1.7 m to 13.9 m depth in 241° direction | 14.2 mm/yr in Sept. 2011 | Operational | October 10, 2023 | No discernible movement | N/A | -9.2 |

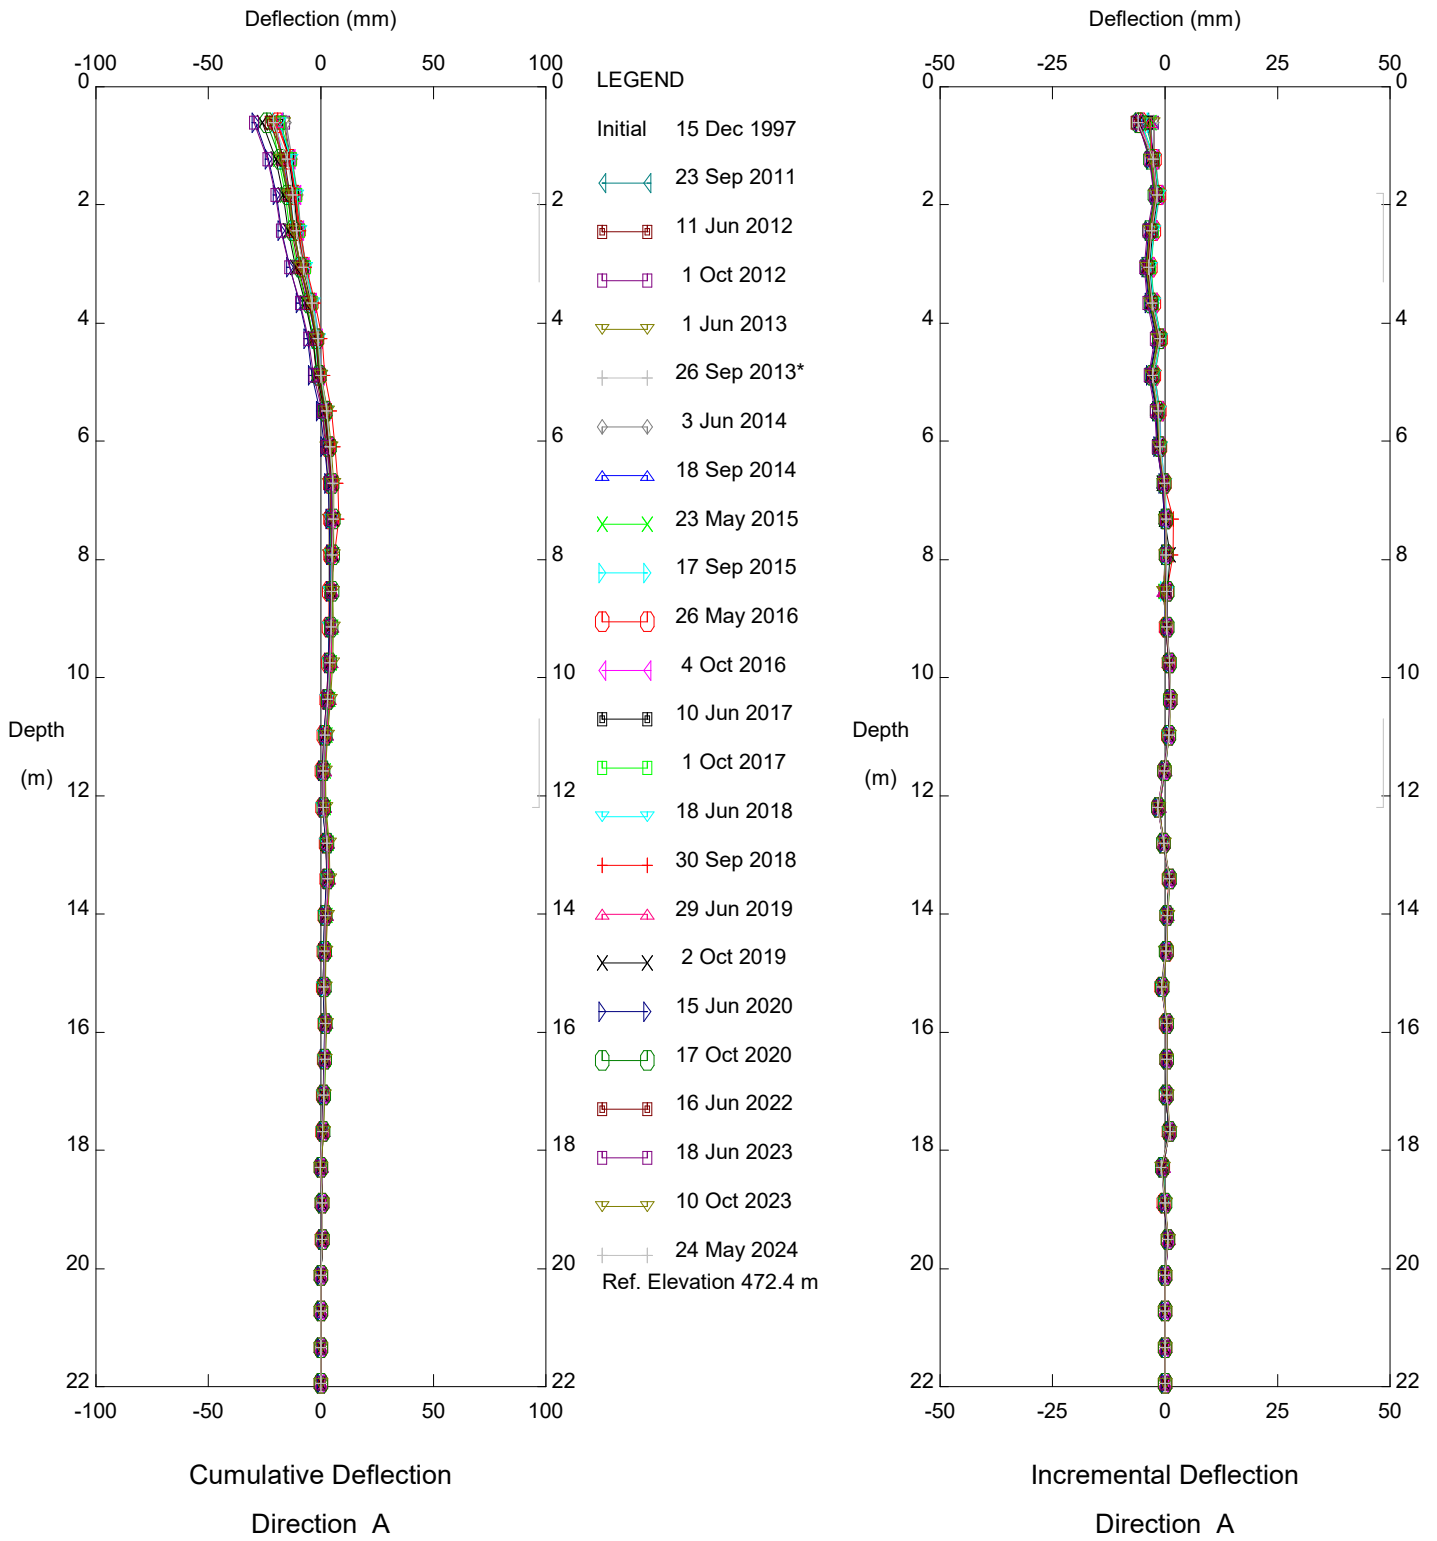
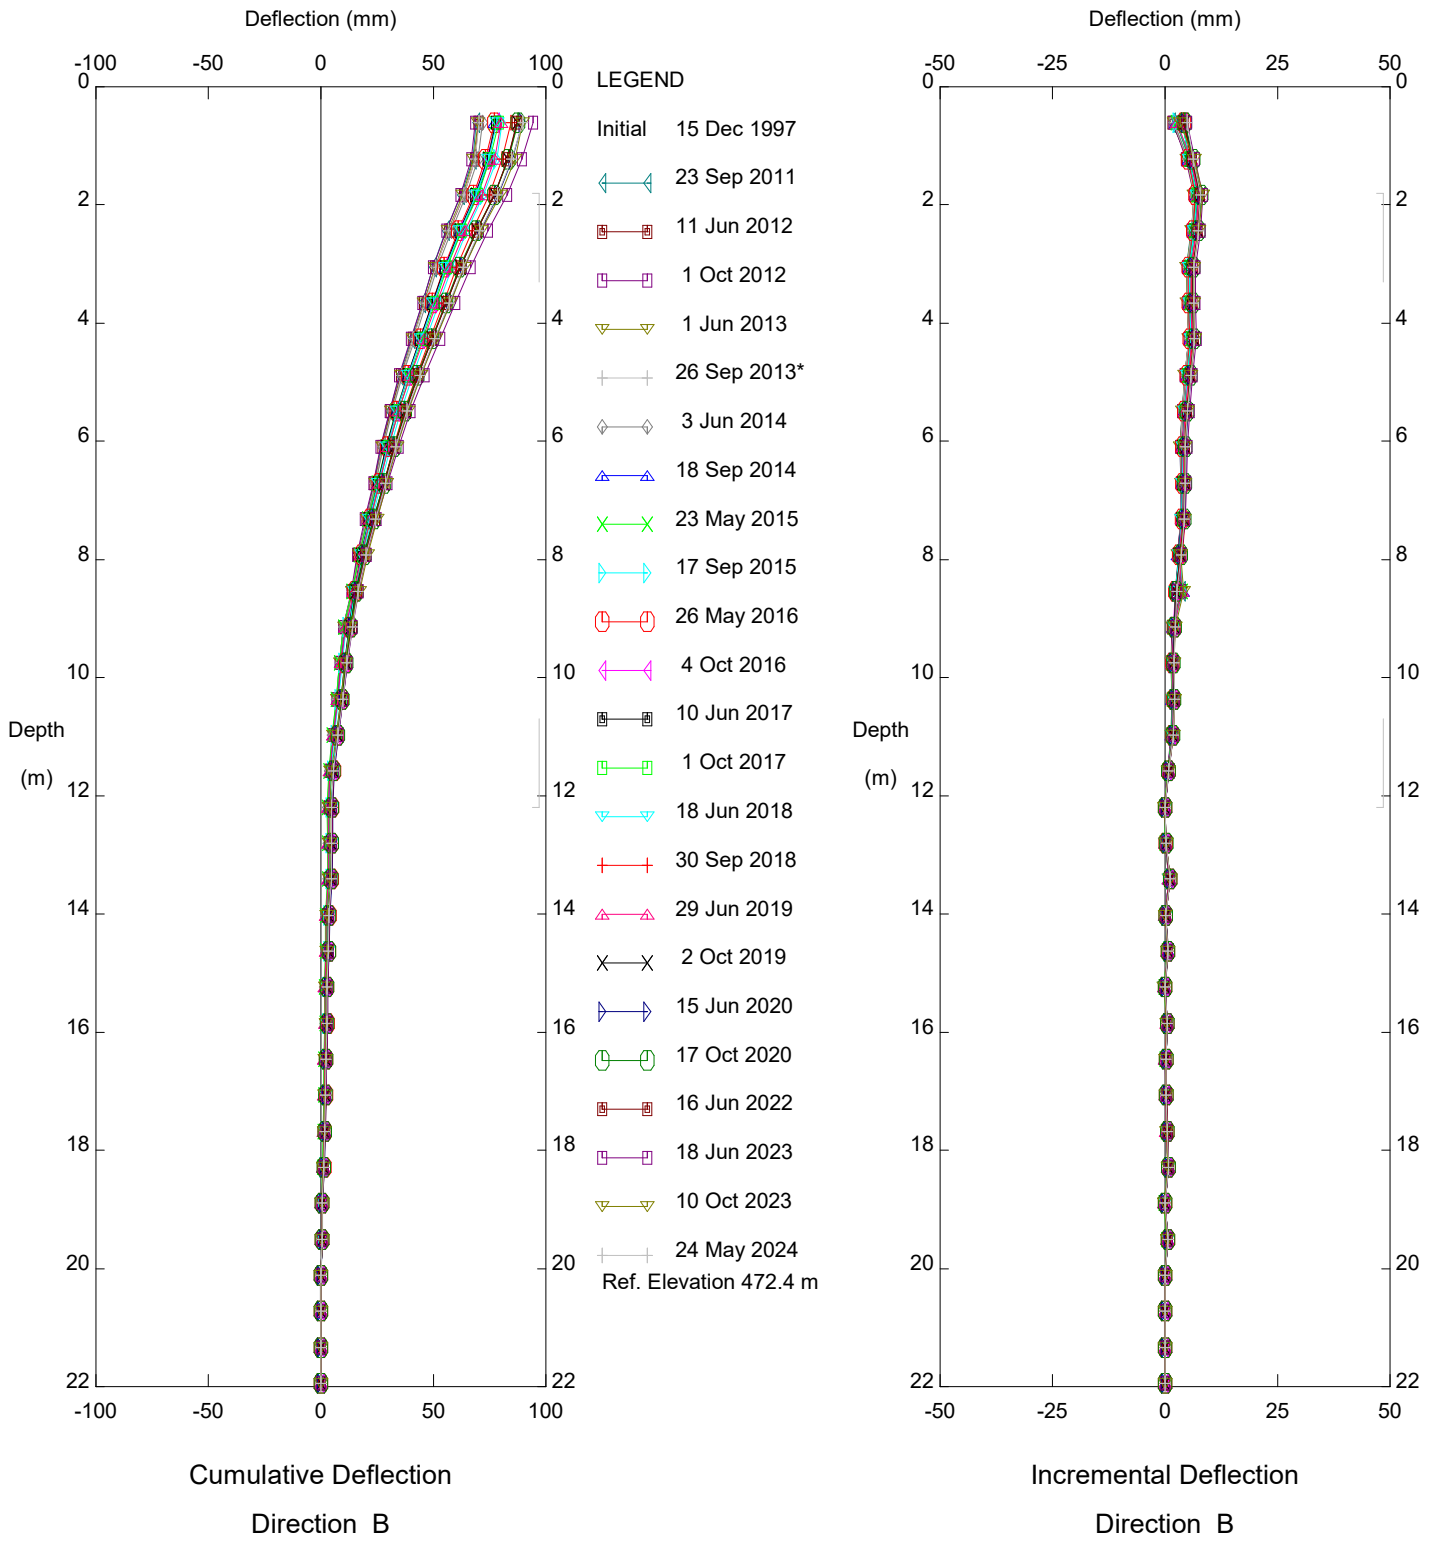
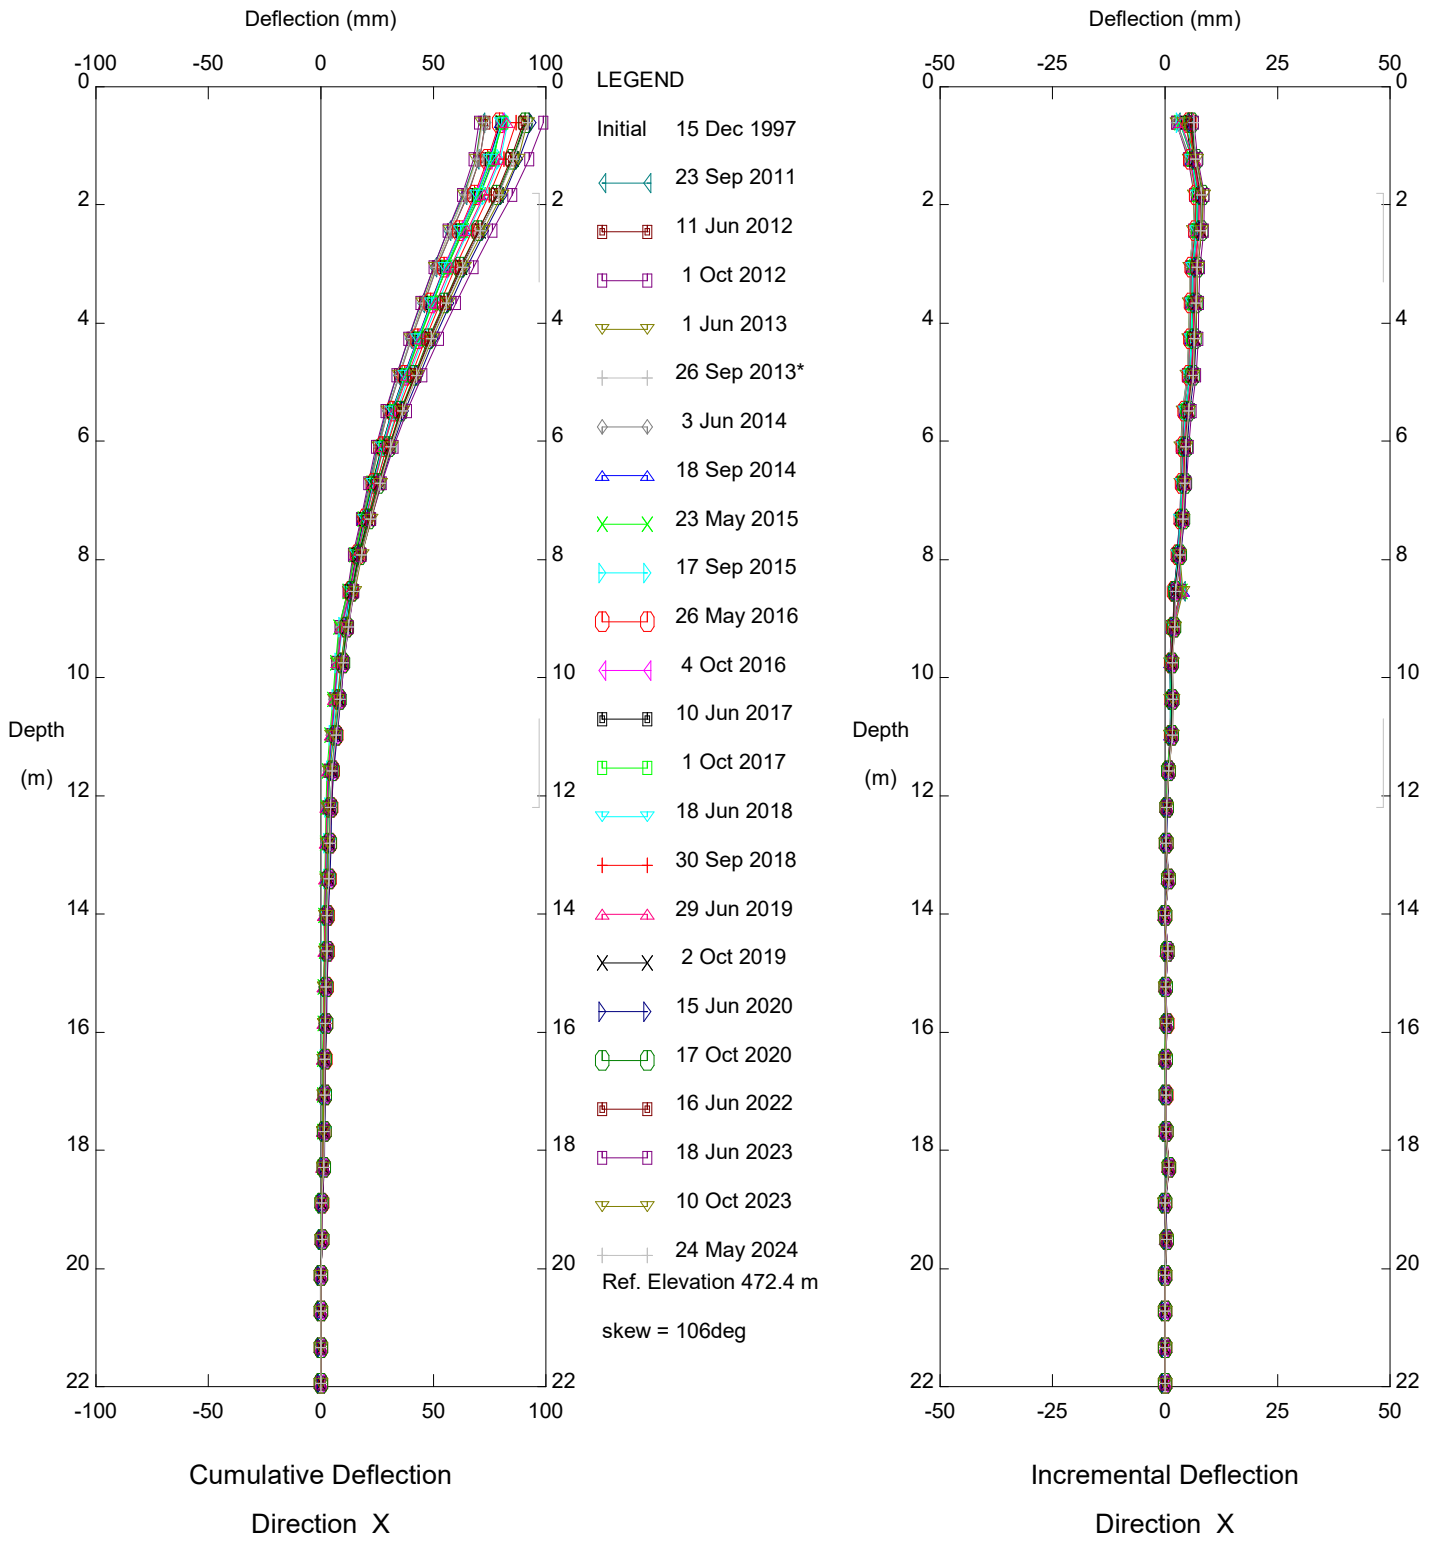
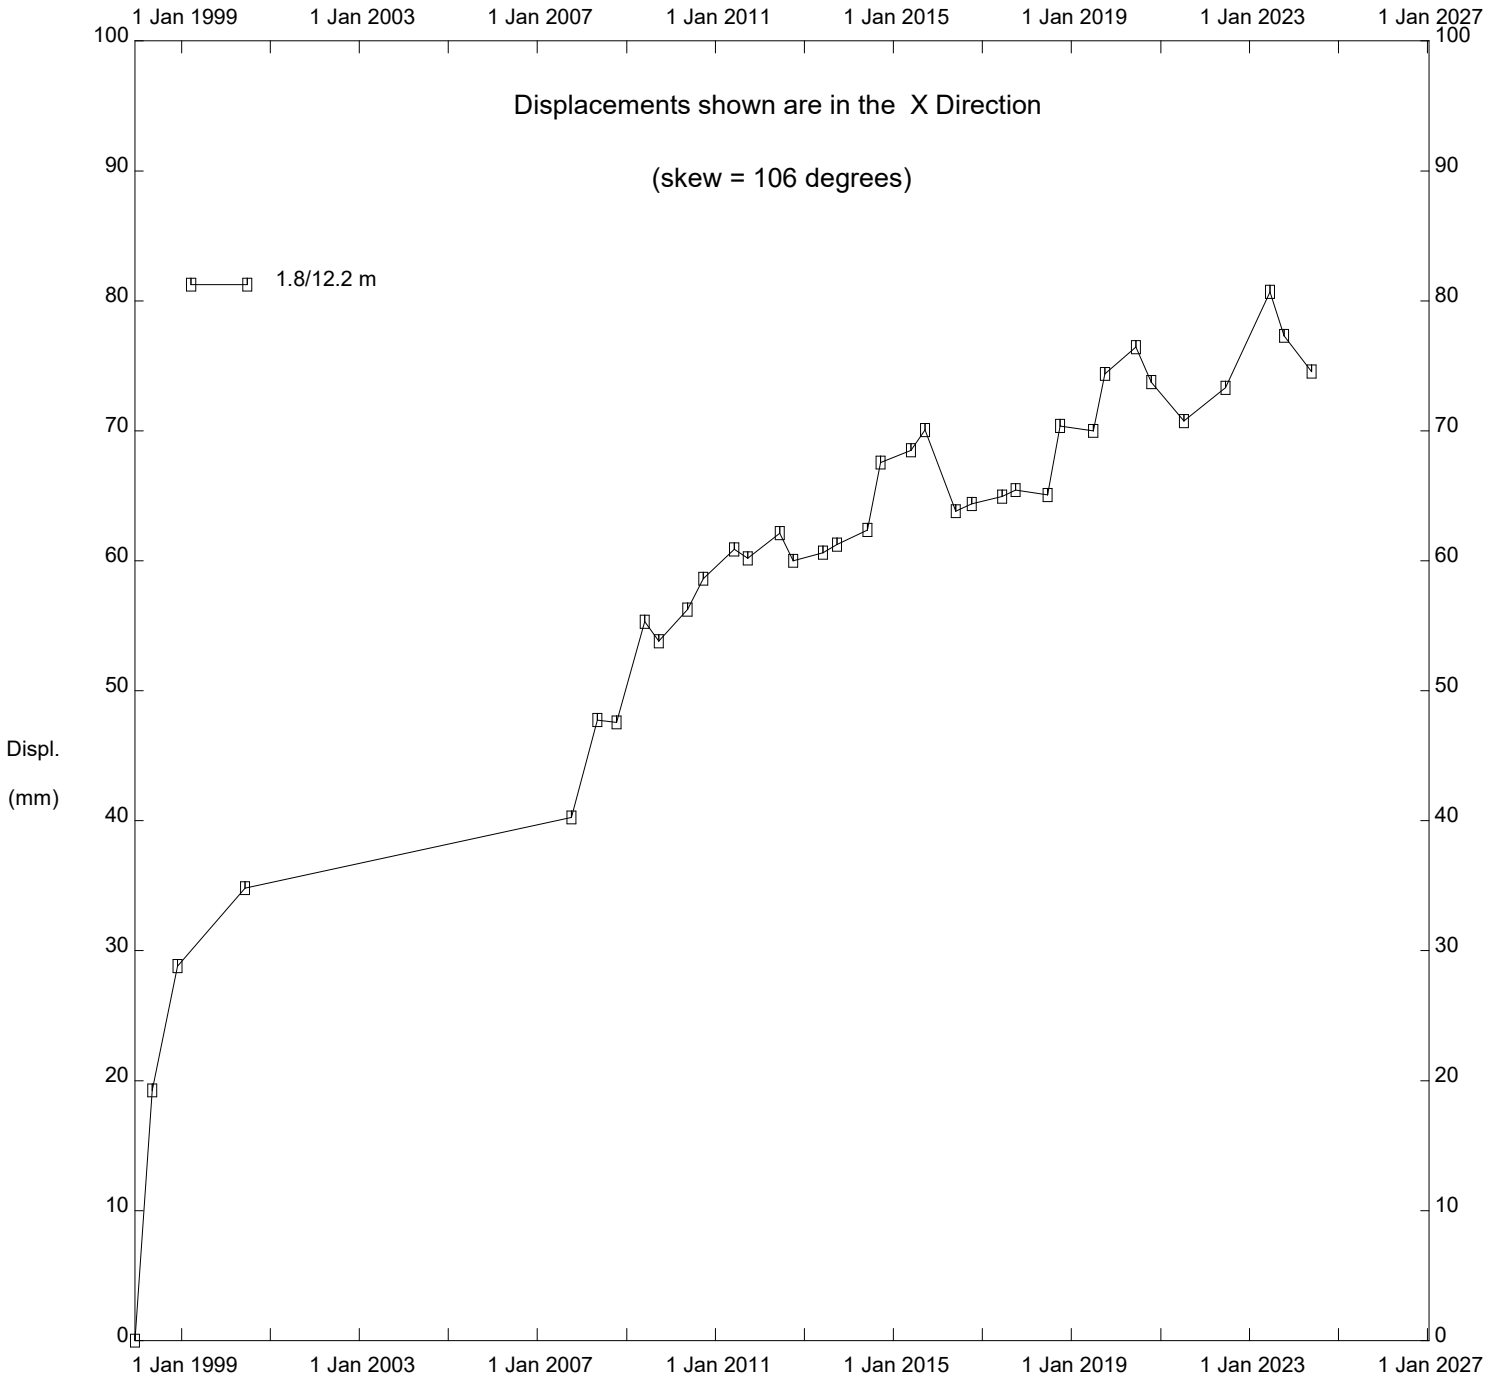
HWY 35:08 (PH045), Inclinometer SI-51

| INSTRUMENT # | DATE INITIALIZED | TOTAL CUMULATIVE RESULTANT MOVEMENT AT NOTED DEPTH SINCE INITIAL READING (mm) | MAXIMUM RATE OF MOVEMENT (mm/yr) | CURRENT STATUS | DATE OF PREVIOUS READING | INCREMENTAL MOVEMENT SINCE PREVIOUS READING (mm) | CURRENT RATE OF MOVEMENT (mm/yr) | CHANGE IN RATE OF MOVEMENT SINCE PREVIOUS READING (mm/yr) |
|---|---|---|---|---|---|--|---|---|
| SI-51 | Dec. 15, 1997 | 74.6 mm over 1.8 m to 12.2 m depth in 267° direction | 48.8 mm/yr In May 1998 | Operational | October 10, 2023 | No discernible movement | N/A | 6.4 |

* SI-51 probe comes to surface not in grooves, may be damaged at 2 feet depth. Top of casing damaged
*SI-51 Probe did not go past 65 ft, SI was read from 2 ft to 64 ft
** SI-50 - top of SI slightly damaged
